The behaviour of structures in earthquakes

By Dr B. L. Deam of the Department of Civil Engineering, University of Canterbury, New Zealand, and Prof. R. C. Fenwick of the Department of Civil and Environmental Engineering, University of Auckland, New Zealand

Beam column joint details

Perimeter frame buildings

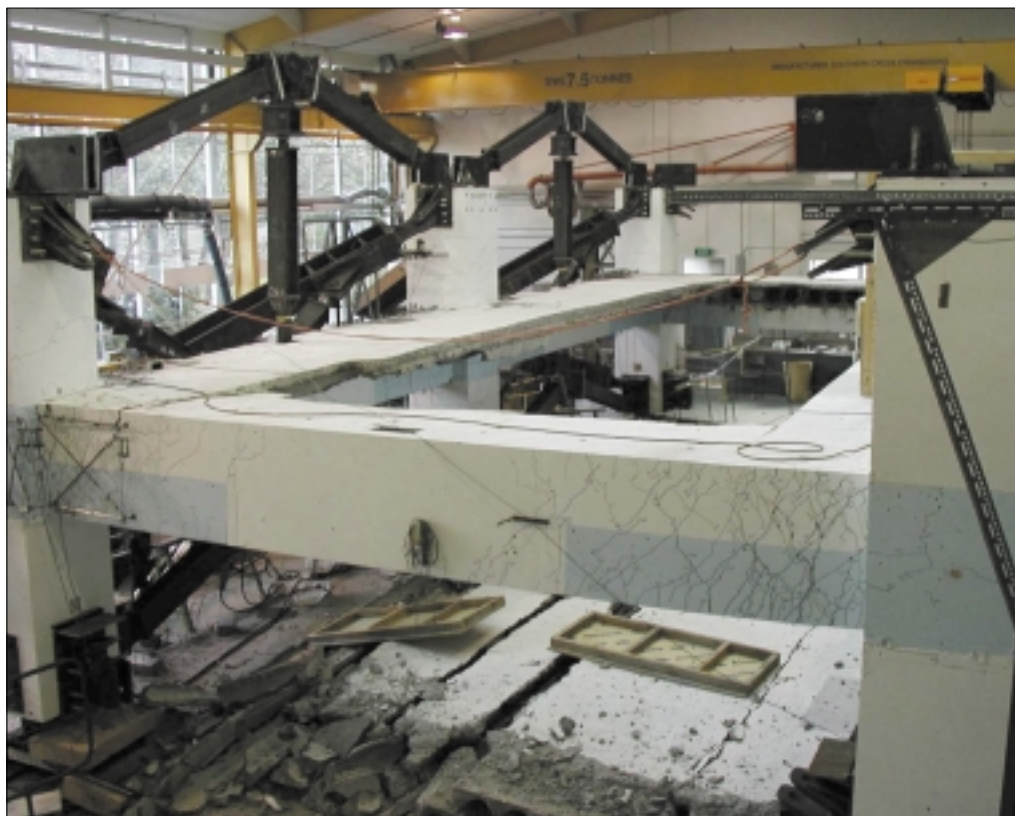
Fig 1. View of test unit from the Northeast corner after testing was completed. The steelwork on the three southern columns (part of the perimeter frame) was used to rack the unit in the East-West direction.

A full-scale test of a segment of a perimeter frame building incorporating a hollowcore floor slab has been carried out at the University of Canterbury. The hollowcore units spanned 11.8m and were topped with 75mm of *in situ* concrete reinforced with mesh. The test unit, which is shown in Fig 1, was subjected to three sets of cyclic displacements, initially racking the unit in the East-West direction, followed by cyclic displacements in the North-South direction and, finally, in the East-West direction again.

In the first set of cyclic displacements, there was significant horizontal splitting of the webs within the southernmost hollowcore unit during the first cycle past yield. This damage, at an inter-storey drift of about 1%, is irreparable and typically would be unseen.

A major crack developed in the *in situ* topping-slab, between the southernmost hollowcore unit and its

neighbour, at the same stage during the test. This crack grew in width, eventually fracturing the mesh reinforcing crossing it at an interstorey drift of 1.9%. This left an L-shaped beam resisting the bending moments in the perimeter frame.

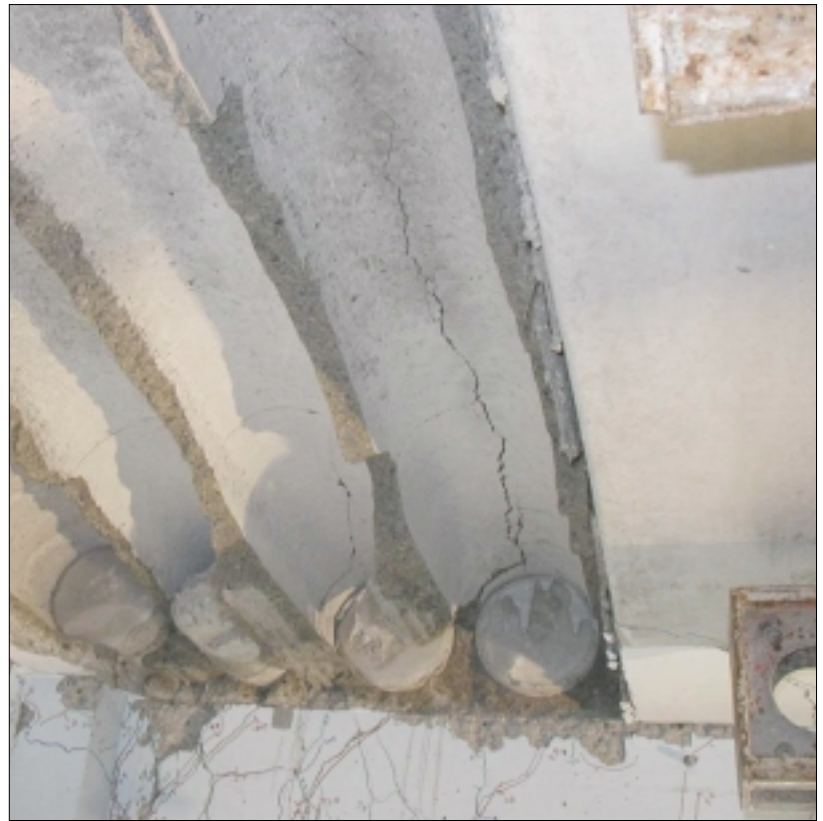
The strength increase due to composite action observed in the Auckland test were not observed in this unit as the actions were skewed to the principal axes of this member. Also, later in the displacement set, safety props beneath the southernmost hollowcore unit were removed, allowing the lower portion of the unit to fall off as shown in Fig. 2.

The slab collapsed completely during the third displacement set, at an inter-storey drift of about 2.5%. This unanticipated failure occurred as a result of flexural cracking of the hollowcore units at the face of the seating. It appears that high friction forces between the hollowcore unit and the beam seat induced tensile stresses close to the end of the unit. The prestressing strands could not resist these stresses because there was insufficient development length available. The formation of the flexural cracks was accompanied by extensive shear cracking along the webs of the hollowcore units, similar to those in the southernmost hollowcore unit (Fig 2).

Fig 2.
View of the Southwest corner after the lower portion of the southernmost hollowcore unit had fallen off. The adjacent hollowcore unit is still intact.

As the failure occurred at an inter-storey drift that is comparable to the design limit, there is an urgent need to assess the likelihood of other flooring systems collapsing in a similar

manner and to develop suitable design and retrofit methods.
