**THE BAM EARTHQUAKE OF 26 DECEMBER 2003, IRAN**

*J. Motamed<sup>1</sup> BSc (Lon), MSc*

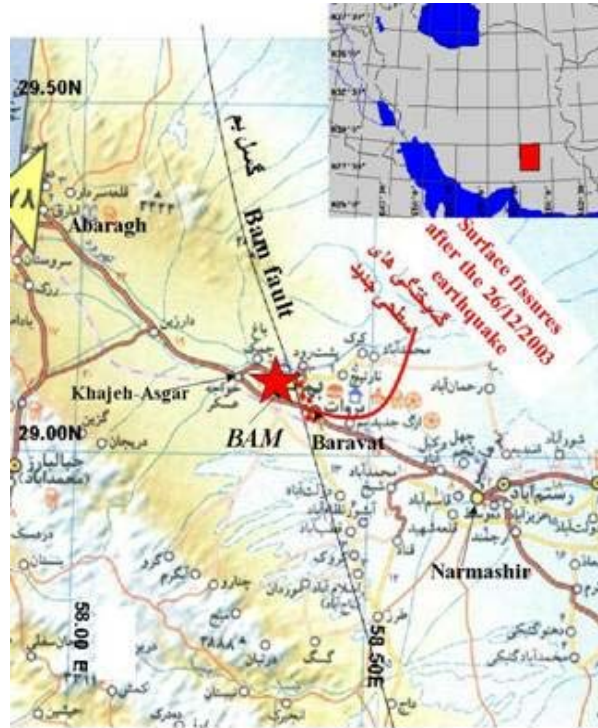
*Bam Earthquake of December 26, 2003,  
Mw 6.5*

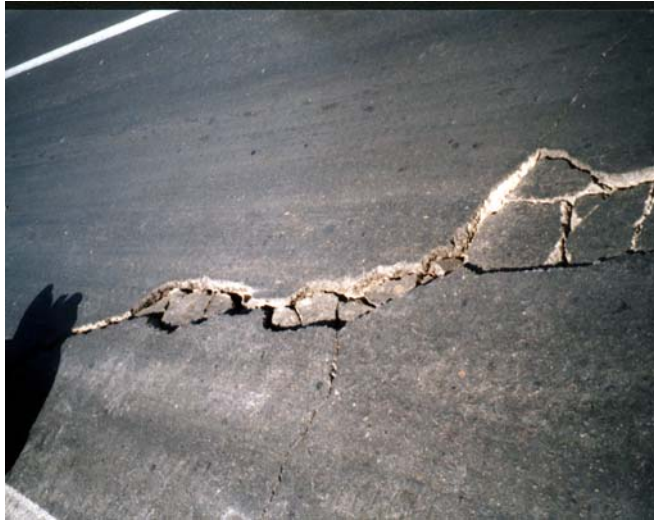
**Photograph 1: Surface cracks 50mm wide appeared near the fault on the main roads close to Baravat**

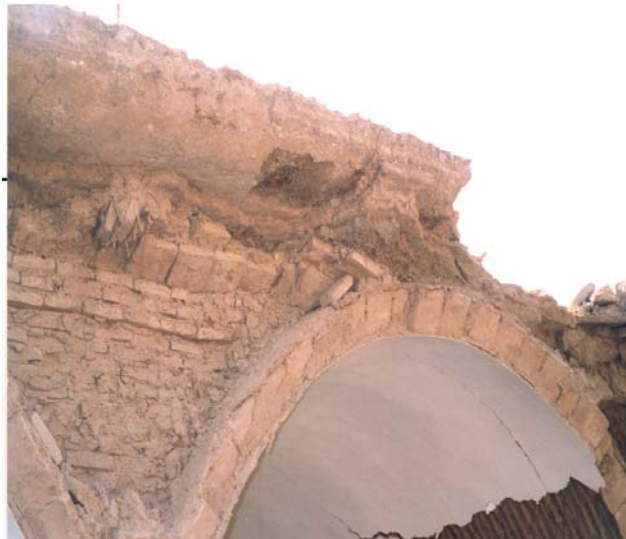
**Photograph 2: Successively layers of mud and straw insulation overloaded the roof increasing loading which was further increased with vertical seismic loading, resulting in failure of the walls which could not resist the tension from horizontal seismic loading resulting in progressive collapse of adobe( 9EMS)**

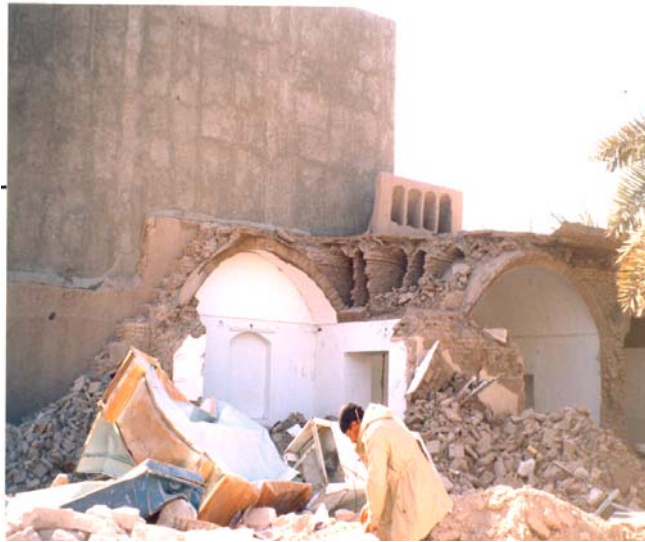
**Photograph 3:** This adobe's roof collapsed after the displacement and failure of its walls. Incidentally, the traditional form of air conditioning on the roof (wind-catchers) insulated the heat.

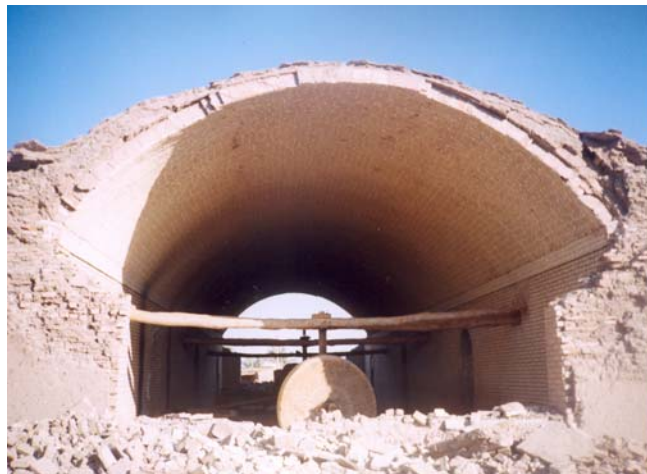
**Photograph 4:** This adobe 16 m span arch roof of the Henna factory survived ( 9 EMS) because the load bearing walls were strong and restrained enough to resist movement from lateral loading . The flank wall failed since it was not laterally restrained (Photo by:H. Darejati)

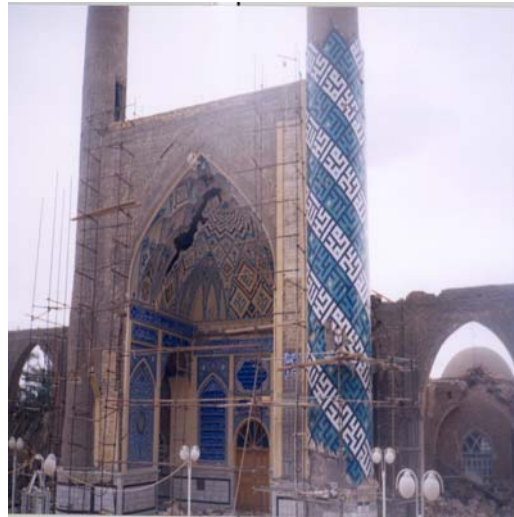
**Photograph 5:** This mosque with minarets about 20m tall and vault of 7m span wide 13m tall survived with damage to the false ceiling plaster and structural damage to the minaret with no tiles (Photo by: H. Darejati)

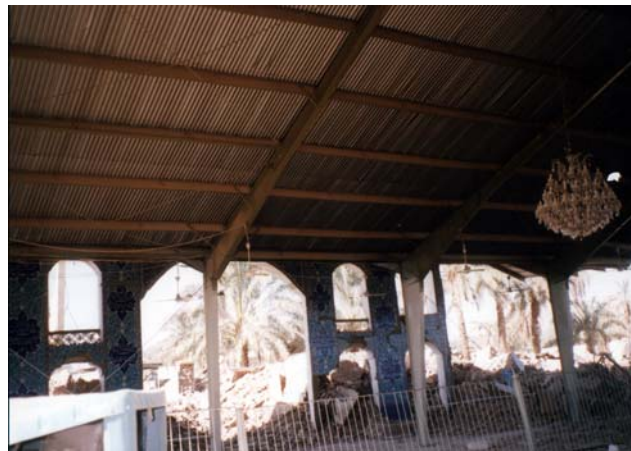
**Photograph 6:** Rafter stays (bracings) between the rafters at eave level and purlins and cable diagonal bracing between columns at every other bay provided sufficient stiffness to stop longitudinal collapse of this mosque hall.

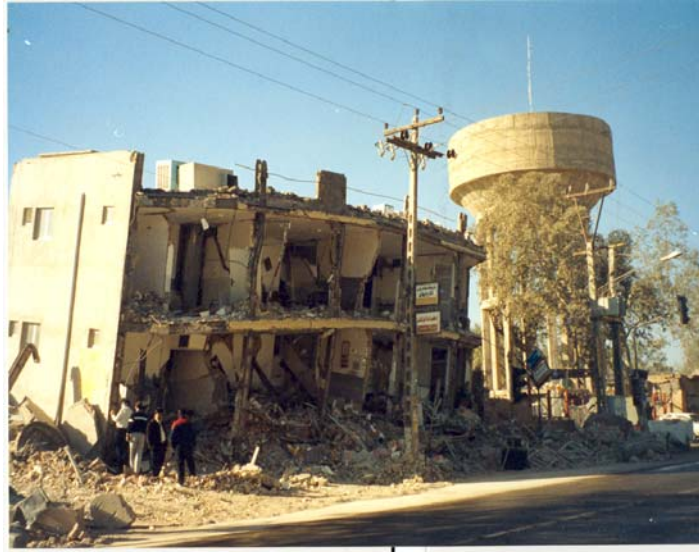
**Photograph 19: Buildings surrounding the water tower were severely damaged.**

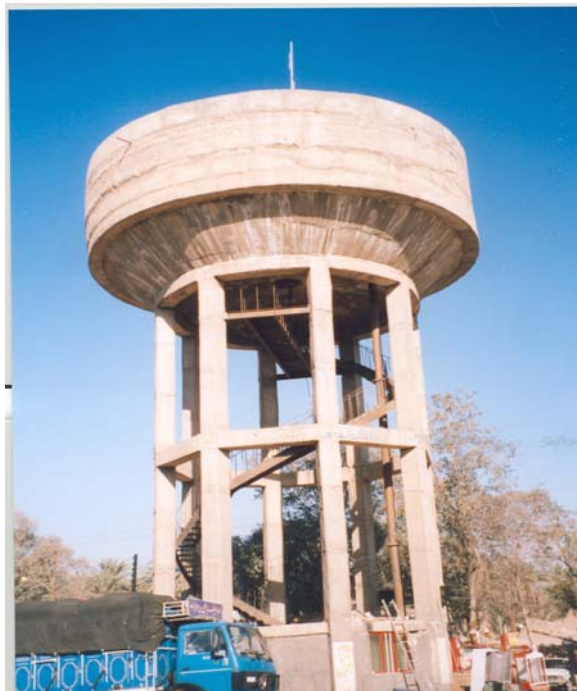
**Photograph 20: The main reinforced concrete water tower in the centre of Old Bam, in the fire station. Survived with shear cracks in the beam at column beam connection (9EMS)**

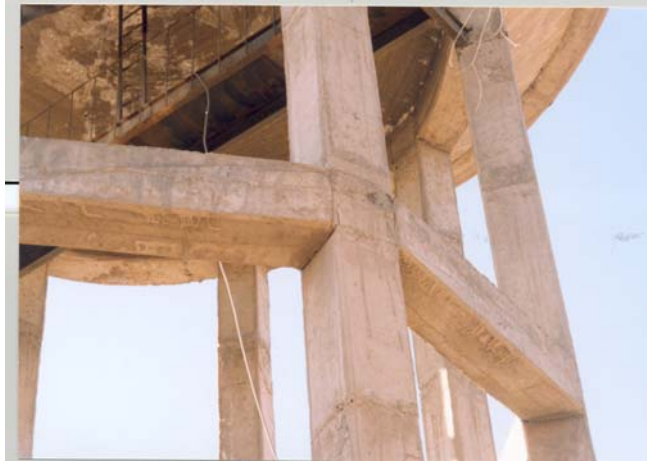
**Photograph 21: Structural shear cracks in the beam at beam column connection, reinforced concrete water tower shown in Photograph 20**

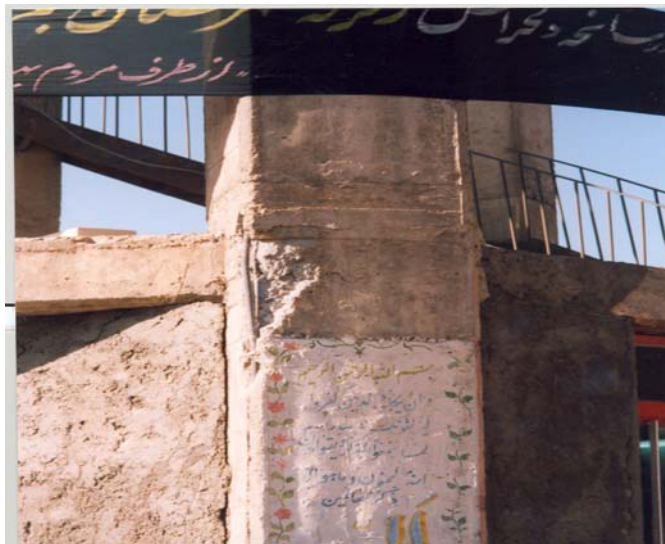
**Photograph 22: Buckling of column reinforcement resulting from missing confinement traverse bars, Main reinforced concrete water tower in the centre of Old Bam. The earthquake intensity was 9 EMS**

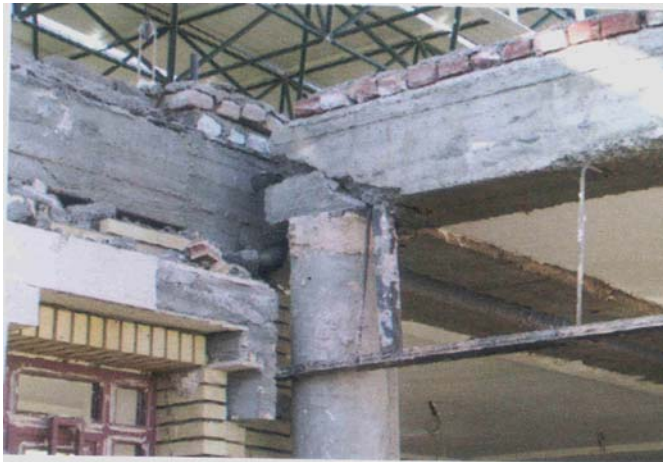
**Photograph 23: Bam Railway terminal, failure of support due to insufficient bearing (extract from figure 13 taken by M.Moghtaderi-Zadeh, *et al.* Ref: 14 )**

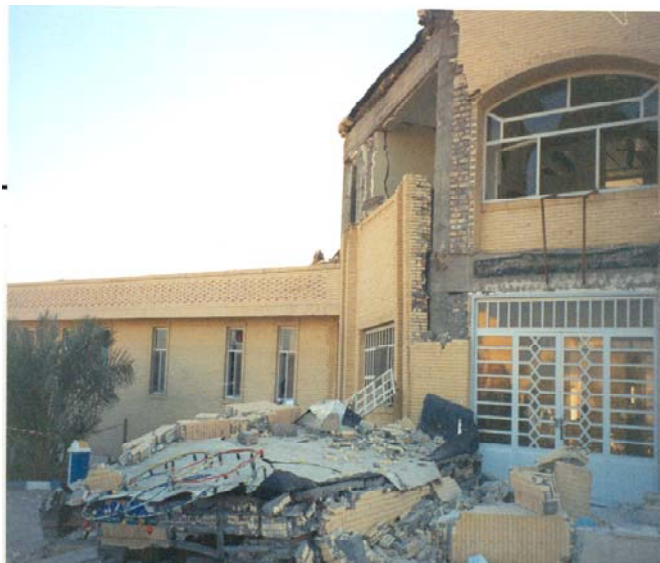
**Photograph 24: The reinforced concrete structure of the main building of Aflatoni hospital survived, however, the extended canopy structure of the jack arch on brick walls collapsed due to wall failure**

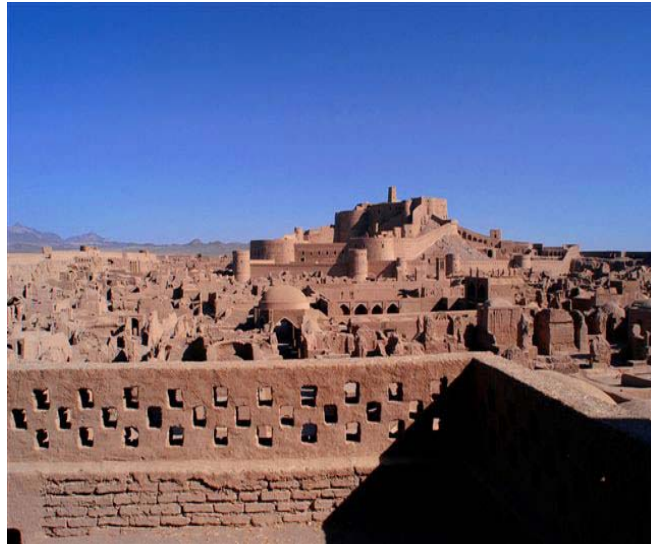
**Photograph 25:** Citadel Arg-e Bam which was restored during Safavid about 600 years ago with original parts dating back 2000 years. The above picture was taken two months before the earthquake of 26 December 2003

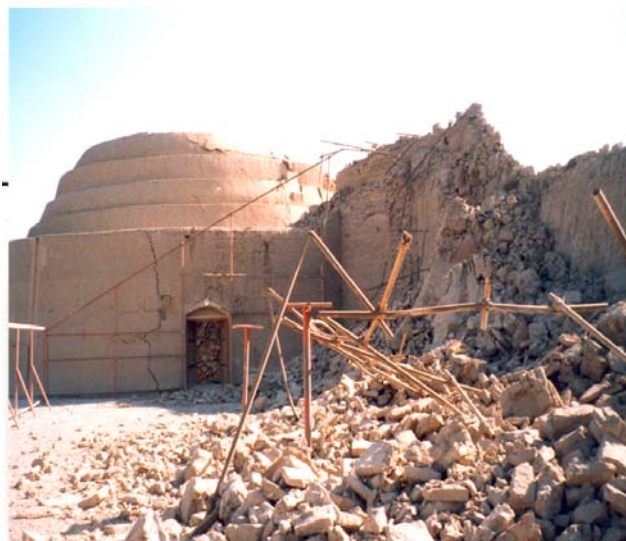
**Photograph 28:** Southern elevation of the Ice House, after the earthquake. The dome was reconstructed between 1974 and 2003, the original earthen walls survived the seismic forces (9EMS) with a vertical crack near the entrance in spite of the additional loading from the dome

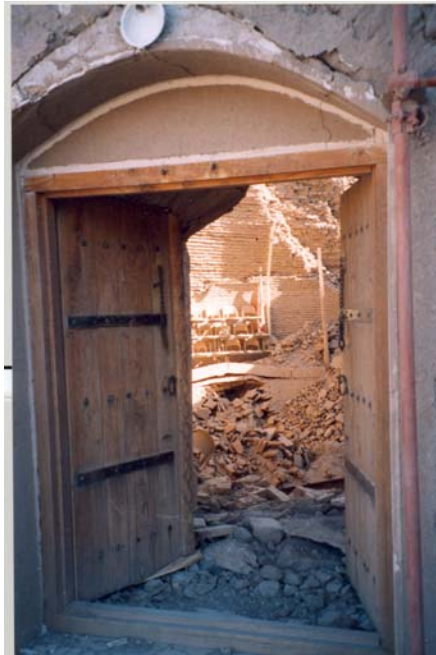
**Photograph 29: The reconstructed part of the inner wall of the Ice House collapsed inward as the result of the additional weight of the recently reconstructed stepped dome**

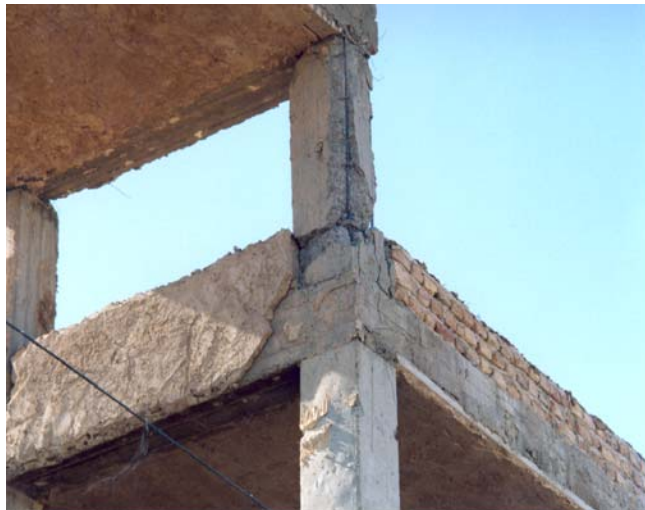
**Photograph 32: Reinforced concrete column-beam connection under construction. ABA (ref:10) recommends maximum spacing of column confinement links at connections not to exceed (0.5xwidth) of column) 100mm. The picture shows a spacing of more than 200mm between links in the column after failure.**

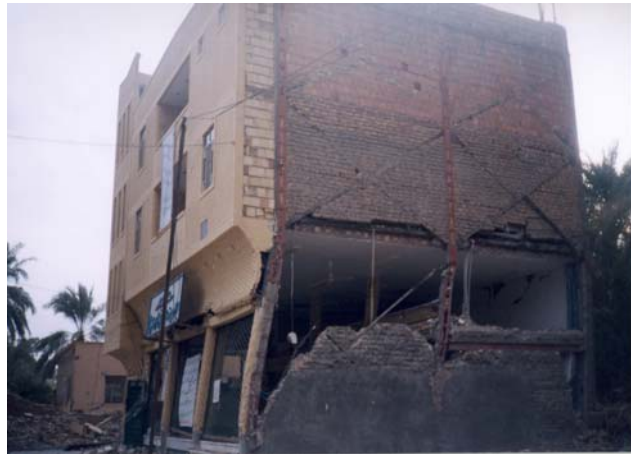
**Photograph 33: Ground floor level shop with high floor to ceiling and no internal cross walls. The steel frame cross bracing at ground floor level is missing at the rear, batten column buckle about its hollow axis resulting in soft storey structural damage. (photo by: H. Darejati)**
