**SEISMIC RISK MITIGATION
FOR THE EAST AFRICAN
COUNTRIES. CASE STUDY:
SALIMA, MALAWI**

EEFIT research grant - 2018

Dr. Viviana Iris Novelli
PRA in Earthquake Impact

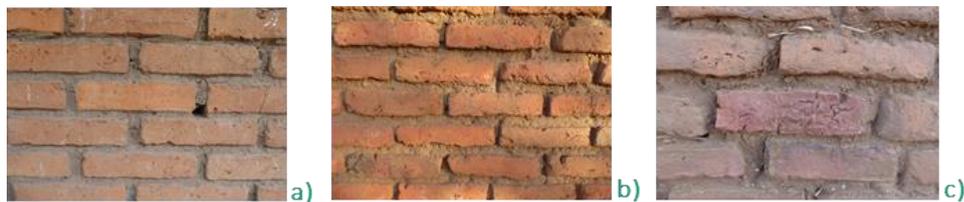
1. good fabric quality (see Figure 3a): bricks have regular shapes and mortar layers. The clay, from which the bricks were made, has a homogeneous texture. Brick bonding is regular. The bricks might have hair-line cracks or cracks are apparently absent (Novelli et al. 2019-b, 2019-c).
2. medium fabric quality (see Figure 3b): bricks have partially regular shapes and mortar layers. The clay, from which the bricks were made, has a medium porosity. Brick bonding is partially regular. The bricks might have light cracks or small holes (Novelli et al. 2019-b, 2019-c).
3. poor fabric quality (see Figure 3c): bricks have irregular shapes and mortar layers. The clay, from which the bricks were made, has high porosity. Overlapping of bricks is irregular. The bricks have deep cracks or are partially lost (Novelli et al. 2019-b, 2019-c).

Figure 3: a) Good fabric quality; b) medium fabric quality; c) poor fabric quality; (Adapted from Novelli et al. 2019-c).

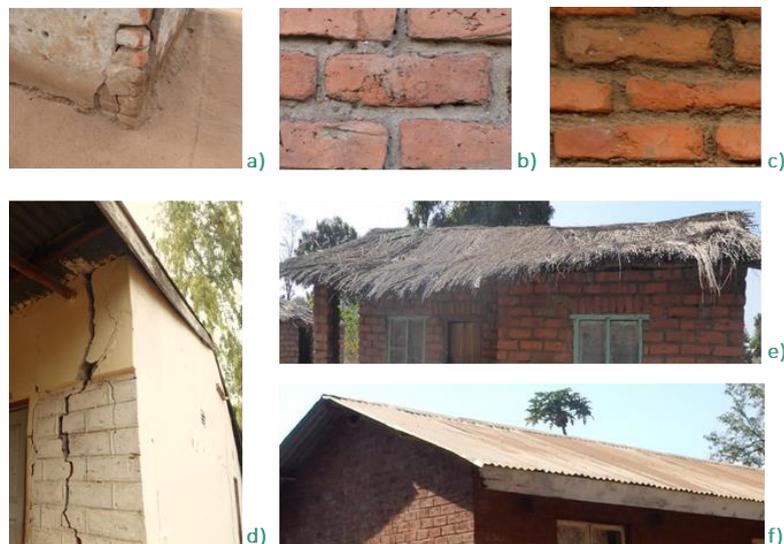
Figure 4: a) poor connection at the bottom of walls; b) local masonry made of fired brick with cement mortar; c) local masonry made of fired brick with mud mortar; d) complete disconnections between adjacent walls due to poor connection e) thatched roof; and f) metallic sheet roof. (Adapted from Novelli et al 2019-c).

42% of the inspected houses were built with single-skin walls with thickness varying from 100 mm to 160 mm. For these structures, the connections between adjacent walls were assumed poor, while for the remaining inspected houses with double-skin walls and thickness varying from 210 mm to 260 mm, the connections between walls were assumed stronger only if cement mortar was employed. According to the on-site observations, 53% of the inspected houses were deemed to have good quality of the connections. Regarding building roofs, these were made of timber rafters supporting thatch for 13% of the inspected buildings or light metallic corrugated sheets for the remaining ones. Both roof types were

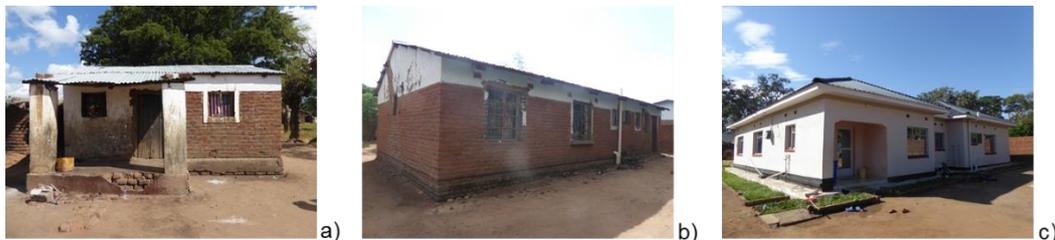
Buildings with by high seismic vulnerability are classified in typology A. This class is representative of 8% of the inspected buildings (see Figure 5 (a)). These buildings were made with fired bricks of poor fabric quality (see Figure 3(a)) bonded with mud mortar. These houses had a smaller building footprint than the typical floor plan of 8 m × 6 m. These houses had thatched roof or corrugated metallic sheets supported by light timber elements of section 100 mm x 50 mm. Constructional detailing (e.g. interlocking between bearing walls and between those and roof systems) were poorly made and lack of ordinary maintenance was evidently the major cause of the deterioration, resulting in loss of bricks, severe cracks on walls and rot in timber elements adopted for roofs and opening frames.

Figure 5: Typical masonry buildings in Malawi; a) typology A; b) typology B; and c) typology C. (Adapted from Novelli et al. 2019-c).

The most common typology observed in Salima is B, class defined to characterise uses with medium seismic vulnerability. This typology covers 50% of the inspected buildings, (see Figure 5(b)). These buildings were made of fired bricks with a quality fabric which varied from medium to good (Figure 3(b) and Figure 3(c)). The type of mortar adopted for these houses was mud, therefore the bonding between bricks and connections between walls were highly weak. These houses had a typical floor plan of 8 m × 6 m. The construction details varied significantly as well as the maintenance levels.

Buildings in typology C have a low seismic vulnerability. This class covers 42% of the inspected houses, (see Figure 5(c)). These were made of fired bricks with a quality fabric varying from medium to good (Figure 3(b) and Figure 3(c)). The mortar adopted to bond bricks was cement. These houses had a larger building footprint than the typical floor plan of $8\text{ m} \times 6\text{ m}$. Due to the extended plan size, irregularities in plan were likely to occur (e.g. portico and re-entrant corner). Most of these houses had corrugated metallic sheets supported by timber elements or trusses, and good structural detailing (e.g. adjacent walls and walls/roof are well connected). The good structural quality of these houses can be also attributed to the presence of strengthening elements (e.g. ring beams).

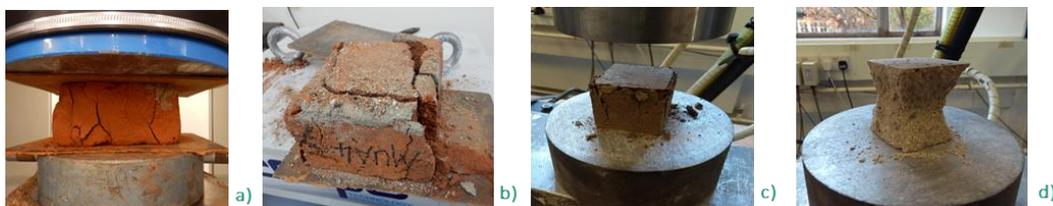
The results highlight a significant scatter in the values measured to characterise the mechanical properties of the tested masonry: compressive strength varies from 2MPa to 10 MPa (Kloukinas et al., 2019). Since compressive strength depends on the fabric quality, and the masonry adopted in the test was significantly characterised by irregular shapes and colours; the scatter measured in the strength for the tested bricks was an expected result.

Figure 8: a) and c) Compressive test on bricks and mortar samples and b) and d) related failure modes.

The test on mortar were performed on 50mm mortar cubes, as the ones illustrated in Figure 8c. Three sets of samples were employed: 1) mud, 2) cured cement in water for 28 days and 3) air-dried cement. Figure 8d shows the typical failure mode observed during the compressive tests on mortar samples. The test on the mortar exposes a compressive strength of 2 MPa for mud cubes, and a reduction of compressive strength for cubes with a smaller cement content, from 13 MPa to 4MPa for cured samples and from 6MPa to 2 MPa for air-dried samples (Kloukinas et al., 2019). The tests show not only a 50% reduction of compressive strength in the cement sample due to bad curing conditions, but also that the weakest cement mortars under bad curing conditions, proved to be as weak as the traditional mud mortar material.

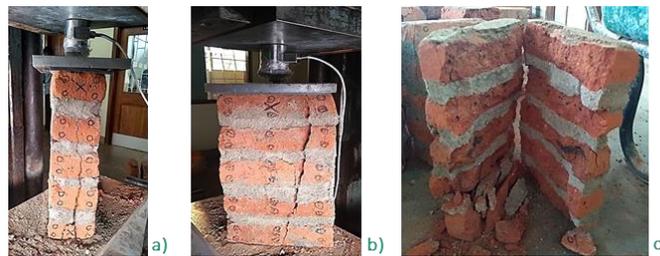
The masonry prisms were made of five brick high to satisfy standard slenderness limits (EN 1052-1, 2002) and a base around 1060mm, in agreement with standard method presented by Brignola et al. (2008), as illustrated Figure 9. The values obtained for the compressive strength on prisms are lower than the ones obtained for brick units and mortar samples (e.g. values vary from 0.75MPa to 1 MPa for the weaker prisms made with mud mortar, and from 1MPa to 2MPa for strongest prisms made with cement-sand ration of 1:4, Kloukinas et al., 2019). The failure mechanism in these tests was governed by local crushing of the weakest bricks in the stack.

Figure 9: Compressive tests and related failure modes for masonry prisms; note the local brick crushing mechanism in the bottom pictures.

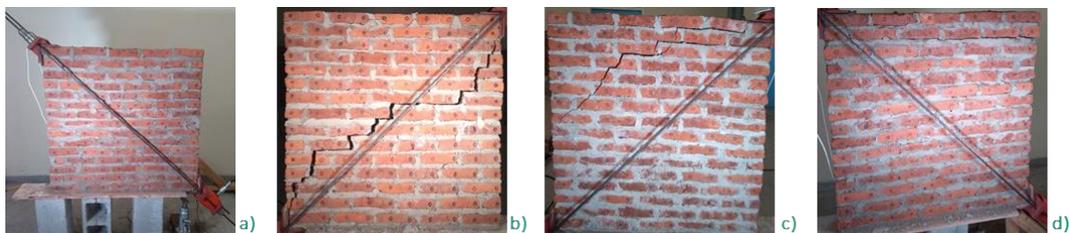
Diagonal shear tests were performed on square panel five brick unit long (or around 1060mm), according to the standard method, presented by Brignola et al. (2008). Panels were made only using a cement-sand ratio of 1:6U and 1:4F, see Figure 11. The differences in strength and stiffness are obvious for the different configurations. During the test, the premature failure of many specimens corresponded to parallel sliding along a “weak” joint, rather than a diagonal crack. The results exposed a maximum shear stress varying from 0.2 MPa to 0.3 MPa and from 0.05 MPa to 0.1 for panel with cement-sand ratio of 1:6U, for panel with cement-sand ratio of 1:4F, respectively (Kloukinas et al., 2019).

Figure 11: a) Typical setting for diagonal shear test on square panels. b) failure mode along the weak bed joint c) failure mode along the weak bed joint and weak bricks d) failure mode along the weak bed joint associated to a “dry” joint.

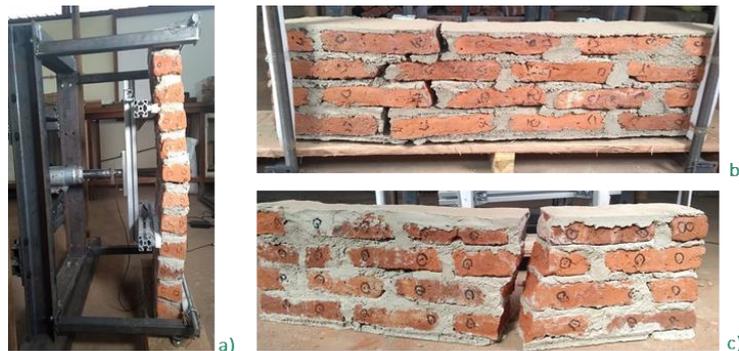
The out-of-plane flexure test on panels were performed along two different axes, parallel and perpendicular to the brick bending (EN 1052-2, 2002, MS791-1, 2014). In both cases, the span of the supports for the bending beam was 800 mm, to satisfy standard length to thickness limits (MS791-1, 2014). Panels were made using only cement mortar with a cement-sand ratio of 1:6U 1:4F, see Figure 12. The value of the mean flexure strength (~0.05 MPa) measured parallel to the brick bending has similar values for the various panels made with different cement sand ratio of 1:4F and 1:6U (Kloukinas et al., 2019). This was observed because quality of the interface bonding governs the behaviour, causing cracks in the middle span of the bending beam, i.e. the location of maximum bending

moment. On the other hand, it was observed that the flexure strength in the perpendicular to the brick bending test had a notable different value for panels with cement sand ratio of 1:4F made and 1:6U (i.e. 0.5 MPa and 0.3 MPa, respectively (Kloukinas et al., 2019)). The weaker 1:6U panels failed due to parallel sliding of the bricks on the interfaces, with the bricks left intact, whereas the stronger 1:4F failed with a vertical crack passing through vertical mortar joints and bricks (Kloukinas et al., 2019).

Figure 12: Out-of-plane flexural failure modes: (a) parallel and (b) perpendicular to the brick bending.

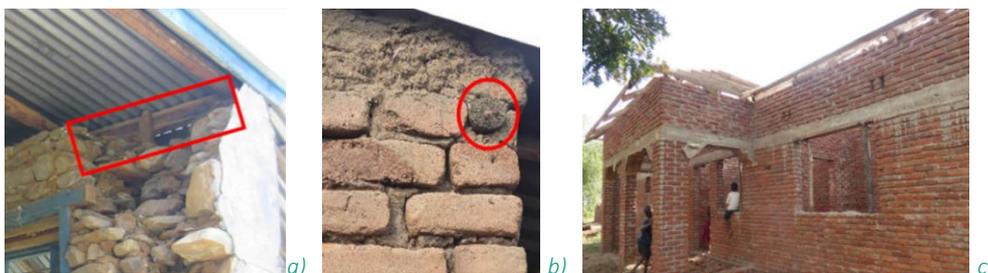
Figure 14: a) Timber wall plate of rectangular section, b) timber wall plate of circular section, and c) concrete ring beam. (Novelli et al. 2019-a).

- Wall plates (see Figure 14a, and b).

These elements are made as horizontal timber bands installed along the tops of walls under the roof to provide a fixing point at the ends of the rafters and to ensure connection between the tops of walls and the roof. These elements are fixed to walls through steel or timber pegs. In the inspected houses in Salima these elements were rarely used under the rafters, which generally seated directly on top of walls, which often resulted in severe local damage to the walls by the rafters due to stress concentration. To prevent high stress concentration at rafter-wall contact points and to improve connections between walls and the roof structure, wall plates are highly recommended.

- Ring beams (see Figure 14c).

Ring beams (also known as a crown, collar, band or tie beams or seismic beams) are made of reinforced concrete or timber and are located as a belt at roof and/or lintel level. These elements are used to ensure that gravitational/seismic loads are properly transferred, and connections on top of walls prevent out-of-plane failure modes. In this respect, in the Safer Housing Construction Guidelines (Bureau TNM, 2016), there is a specific section for ring beams, where it is advised to combine ring beams at lintel and roof levels as only one beam, which should be located at roof level.

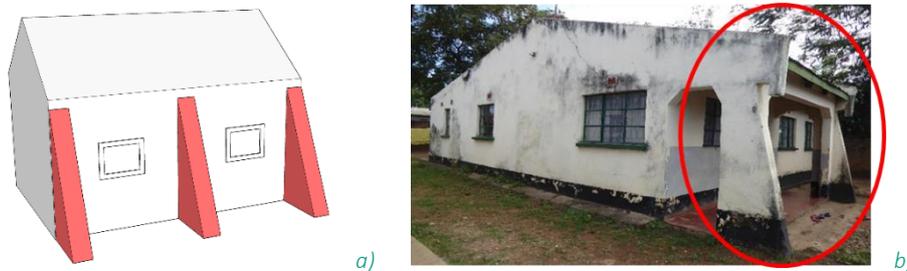
The failure mode that has the highest possibility of occurrence in buildings made of masonry with poor fabric quality and lack of connections between walls and the roof, is *OOP*. This was confirmed by the results obtained in Section 6.1, as well as by many of the recent post-earthquake assessments performed on unreinforced masonry constructions (Wilkinson et al., 2011; Ioannou et al. 2012; Novelli and D'Ayala, 2012; Kaushik et al., 2016).

Figure 15: a) Buttresses: structures made of stones or bricks, built against walls, to prevent overturning b) buttresses observed on-site during structural surveys. (Novelli et al. 2019-a).

In order to prevent this failure mode, in this section the use of buttresses is proposed as a low-cost engineering solution to enhance the seismic resilience of the Malawian houses. An example of buttresses can be found in Figure 15a. These structural elements could be constructed using fired bricks and cement or mud mortar and should be located perpendicular to walls which are vulnerable to fail in overturning under seismic loads. Buttresses have not only the function to prevent out-of-plane failure modes, but also to increase stability of buildings, reducing the structural period (Ortega et al., 2018).

In Salima, buttresses are elements built in new houses made of fired bricks and cement mortar, and are used on the outside of the houses, to create a space which is not exposed to sun. These elements are generally located on the longest wall of the front side. Commonly, only two buttresses are built, one is generally located on the edge of the wall while the second one is on the centre of the wall. In order to prevent building to fail for torsion under seismic events, it is recommended to ensure that buttresses are well connected to the entire houses and located symmetrically respect to the house plan.
