**The Indian Ocean Tsunami of 26 December 2004:
Mission Findings in Sri Lanka and Thailand**

**Antonios Pomonis, Risk Management Solutions
Dr Tiziana Rossetto, University College London
Dr Navin Peiris, Arup, London
Dr Sean Wilkinson, University of Newcastle
Domenico Del Re, Buro Happold, London
Raymond Koo, Arup, Hong Kong
Raul Manlapig, Arup, Philippines
Dr Stewart Gallocher, Halcrow, Glasgow**

Earthquake Engineering Field Investigation Team
Institution of Structural Engineers
11 Upper Belgrave Street
London SW1X 8BH
United Kingdom

February 2006

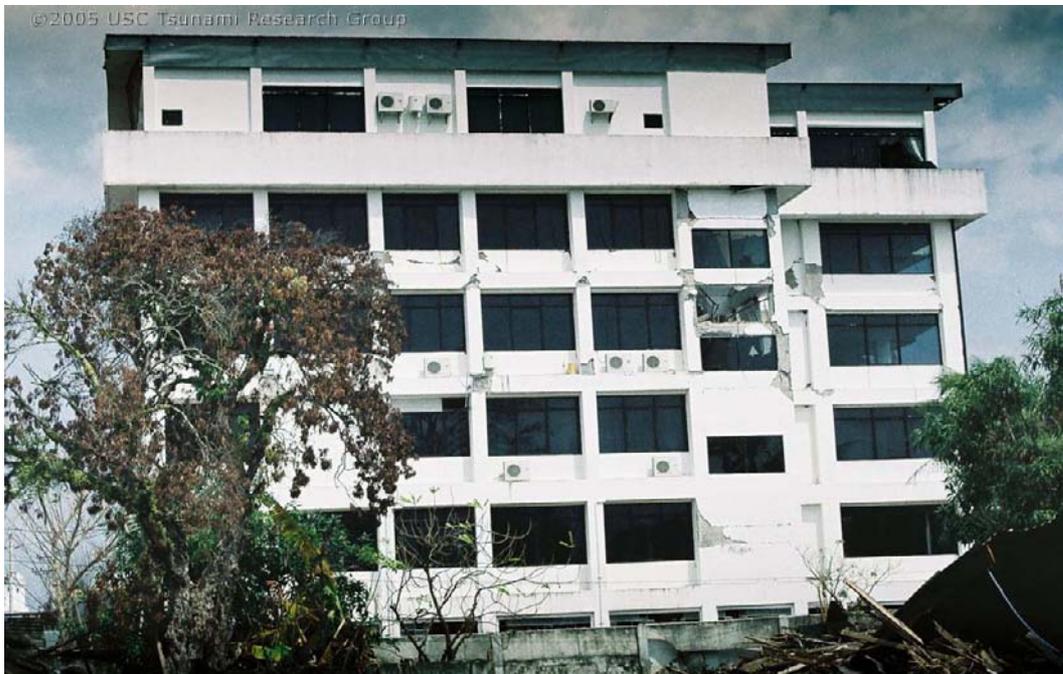
Figure 1.7: Ground shaking damage to 6-storey RC frame structure in Banda Aceh
(Source:http://www.usc.edu/dept/tsunamis/2005/tsunamis/041226_indianOcean/sumatra/sumatra.html)

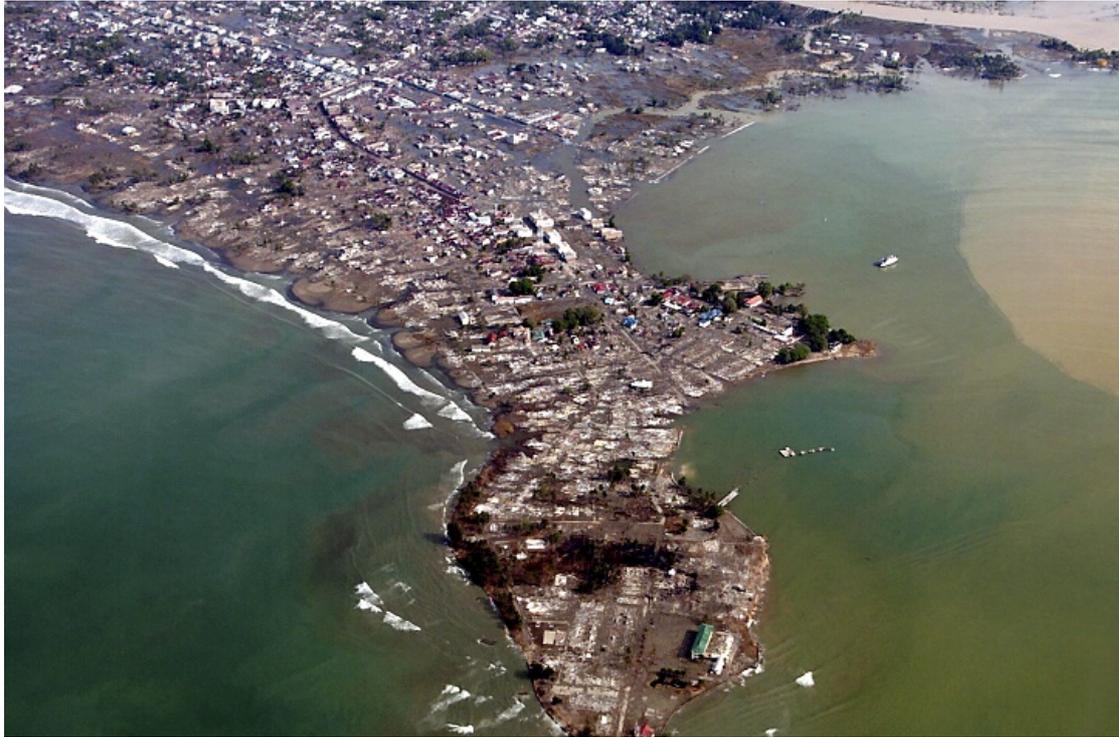
Figure 1.13: The devastating effects of the tsunami on the city of Meulaboh.

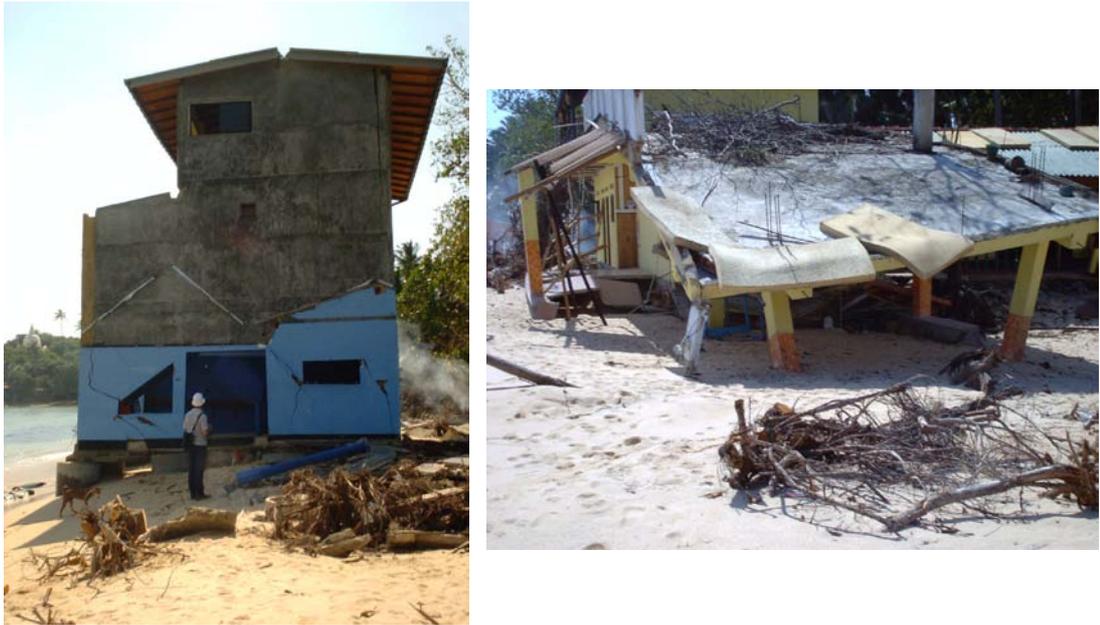
Figure 2.5: Damage to hotel structures observed on the beachfront of Unawatuna (Galle District)

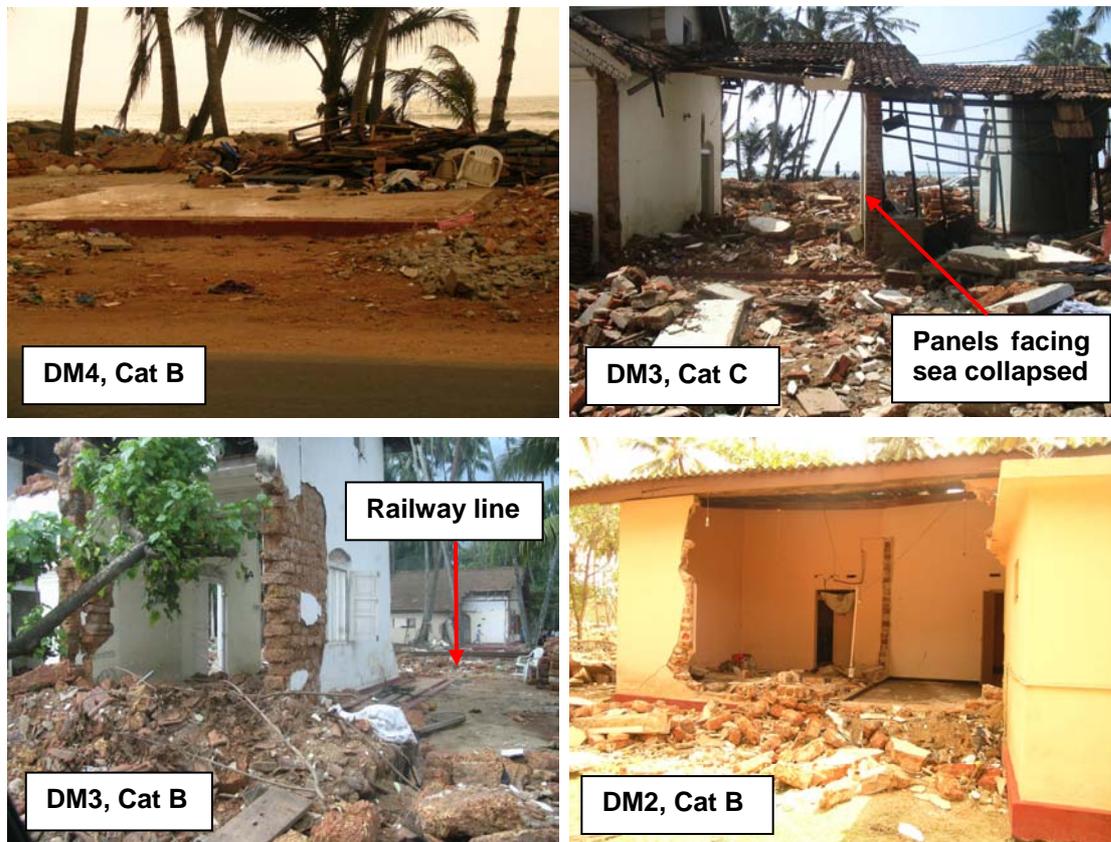
Figure 2.24: Damage to Cat. B and Cat. C masonry houses in Paiyagala, Sri Lanka

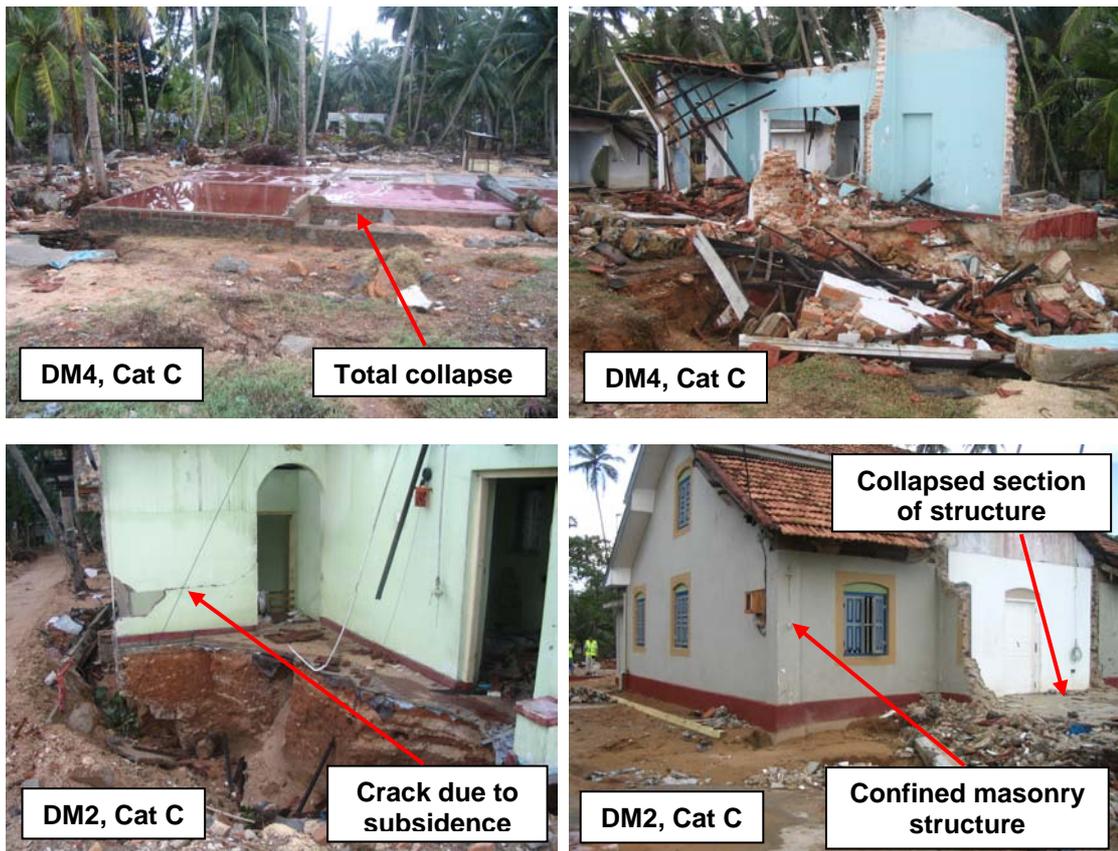
Figure 2.28: Direct structural damage to masonry houses in Kahawa

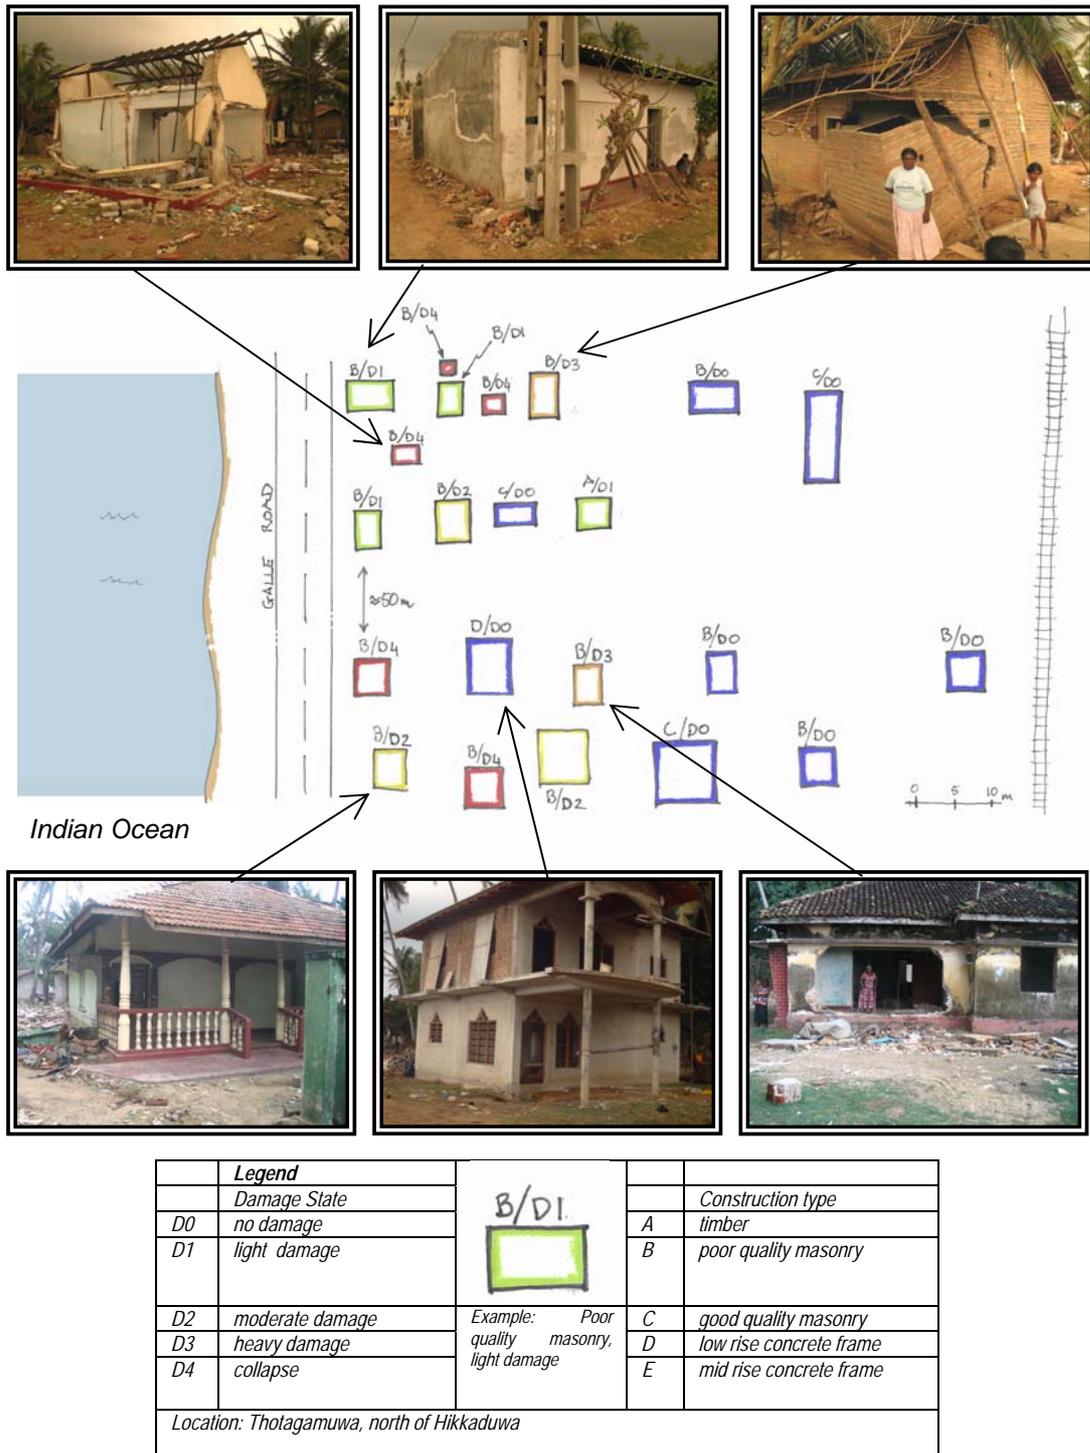
Figure 2.34: Detailed walkover survey observations at Thotagamuwa

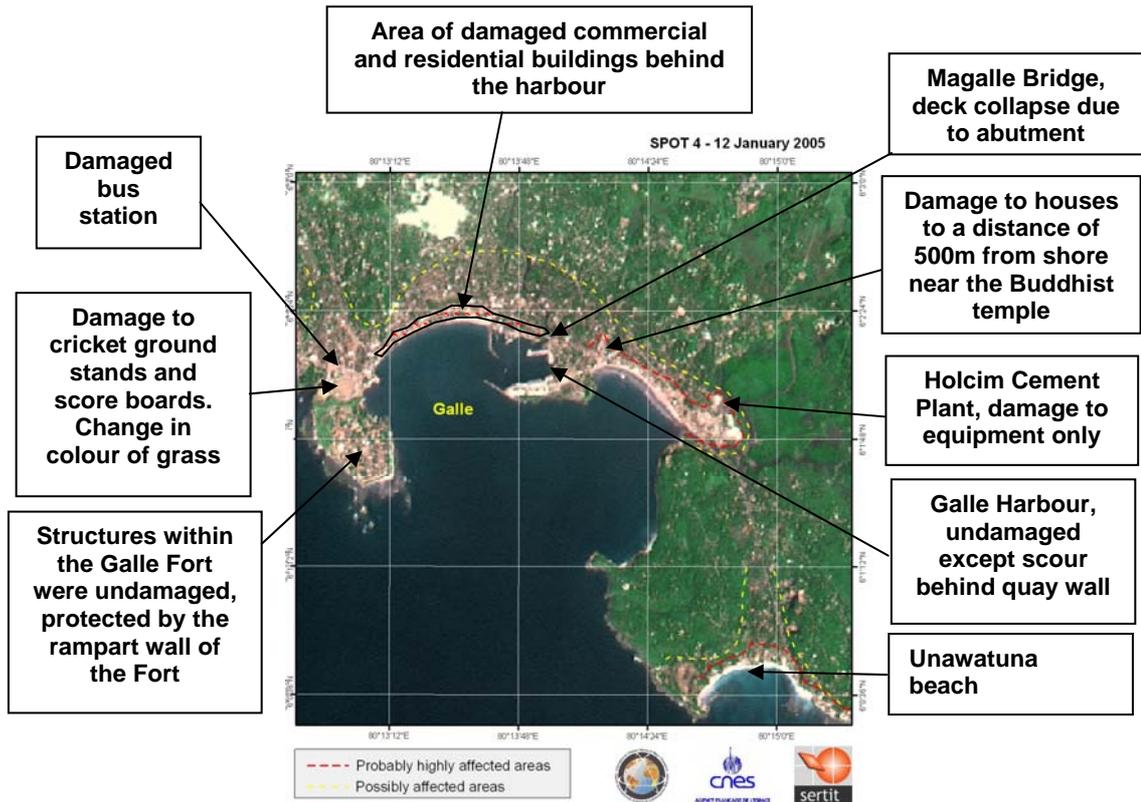
Figure 2.35: Damage survey in Galle city by EEFIT overlaid on satellite image following the tsunami (Sertit, 2005)

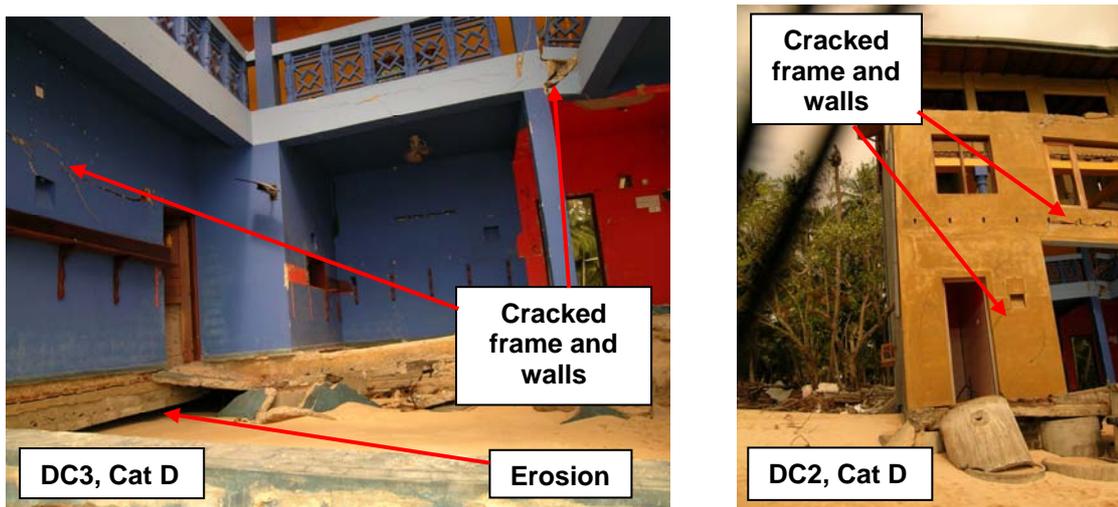
Figure 2.40: Erosion underneath the foundations resulted in settlement induced damage to an RC frame hotel structure. Damage and settlement of concrete foundations leading to tilting and cracked walls in the RC frame building

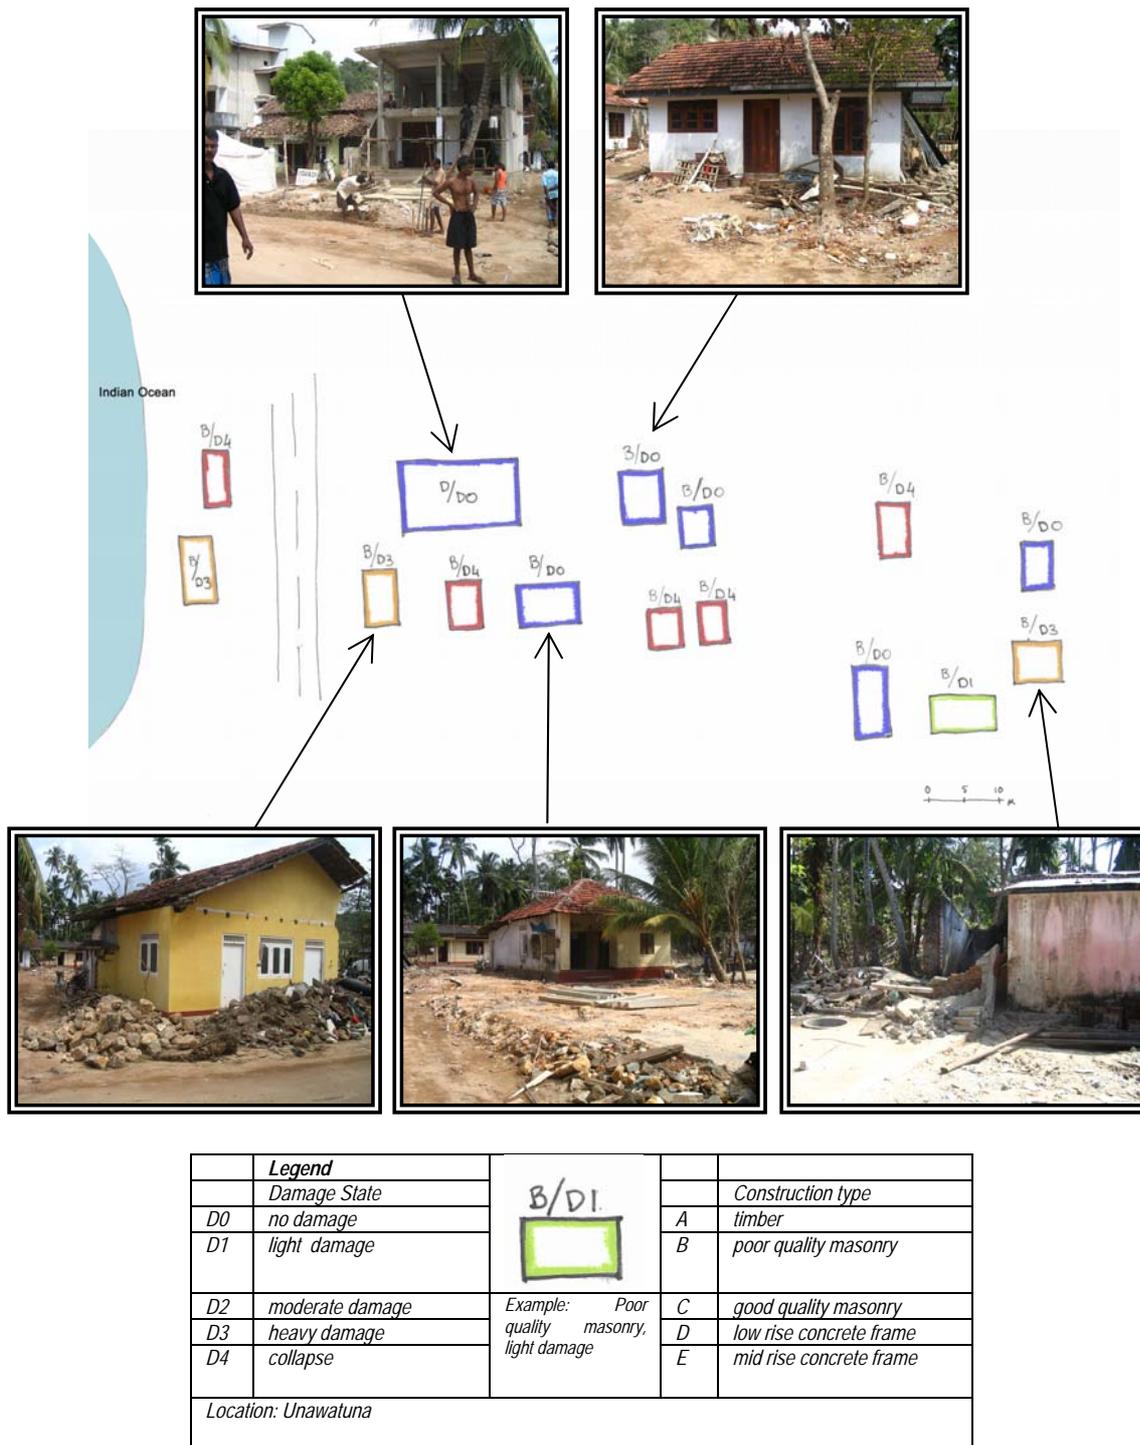
Figure 2.41: Detailed walkover survey observations at Unawatuna

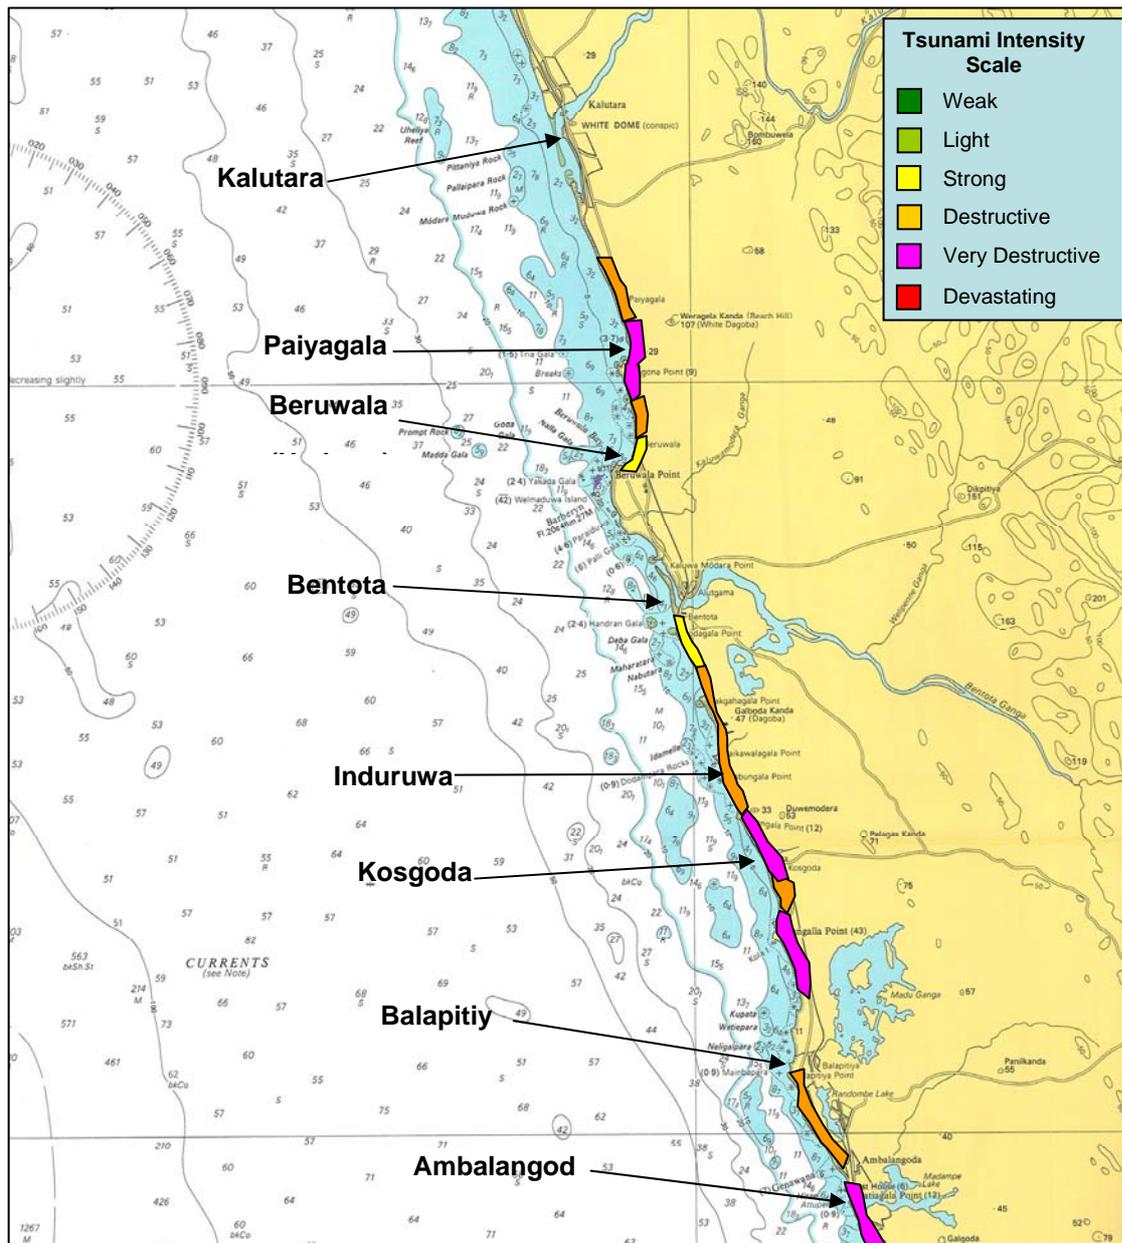
Figure 2.44: The surveyed damage and tsunami intensity between Kalutara and Ambalangoda

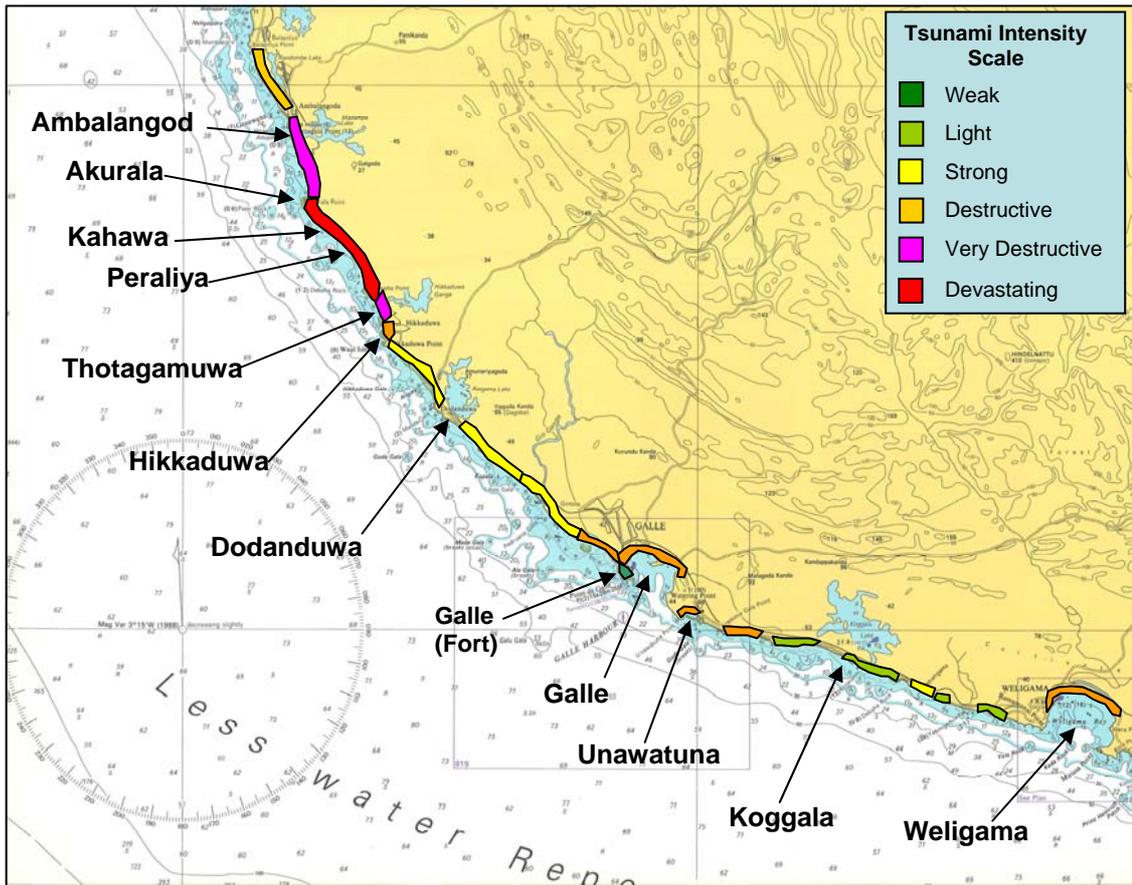
Figure 2.45: The surveyed damage and tsunami intensity between Ambalangoda and Weligama

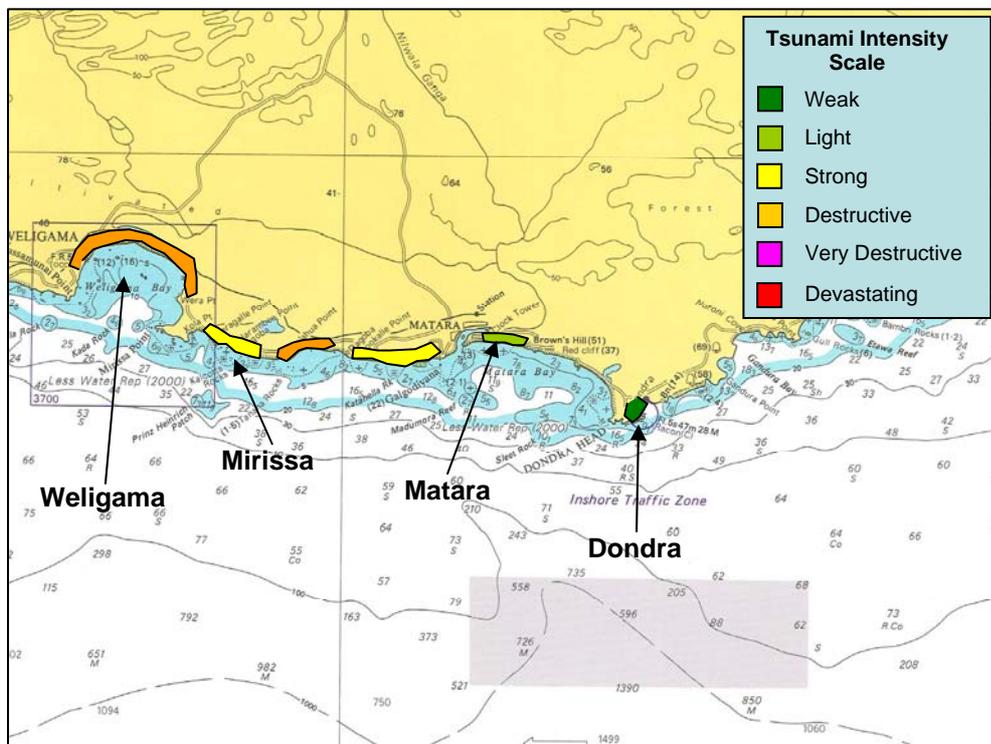
Figure 2.46: The surveyed damage and tsunami intensity between Weligama and Dondra

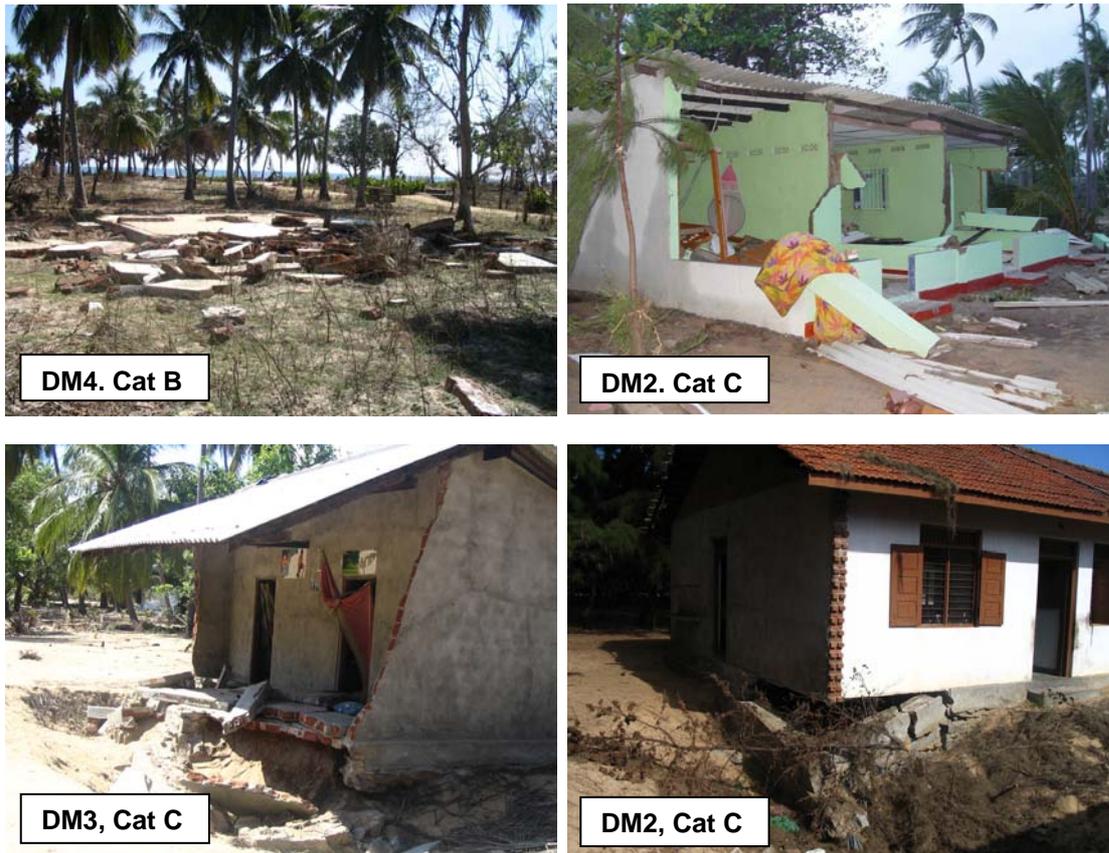
Figure 2.49: Typical damage to masonry houses in Eastern and Northeast Provinces (Pillai, 2005)

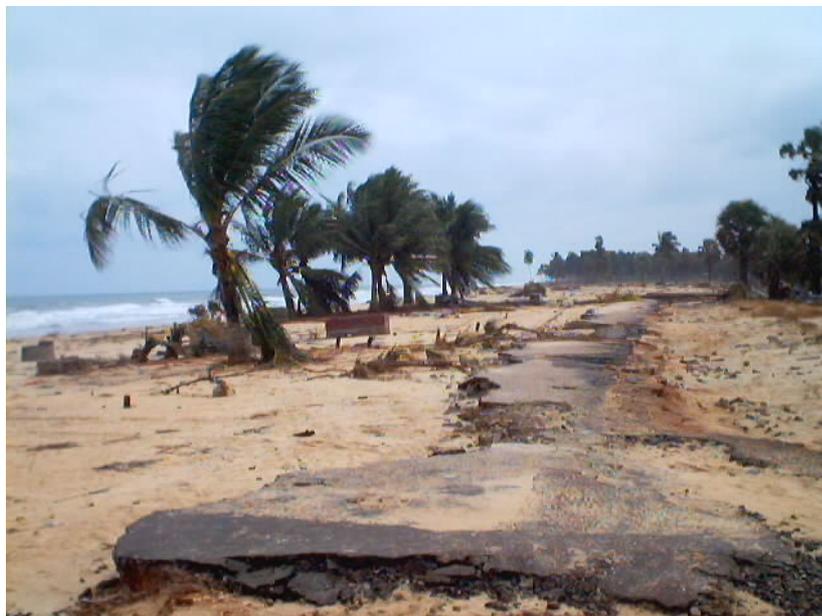
Figure 2.56: Typical heavily damaged road section near Batticaloa (Photo by Anton Pillai, Arup)

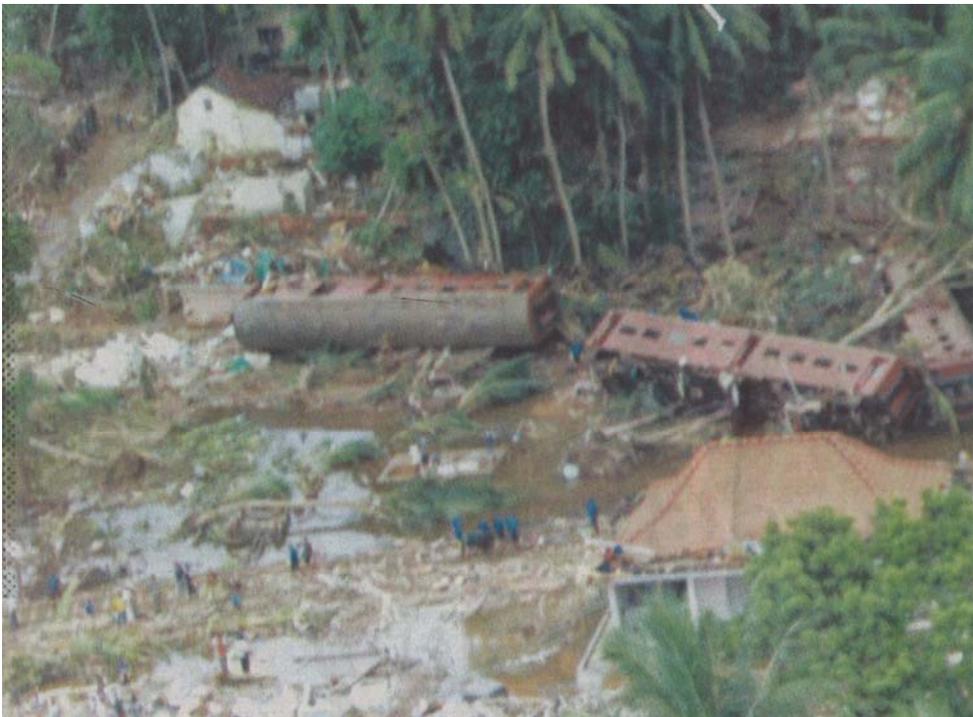
Figure 2.58: Derailment in Peraliya, north of Hikkaduwa (by “Silumina” Newspaper, Sri Lanka)

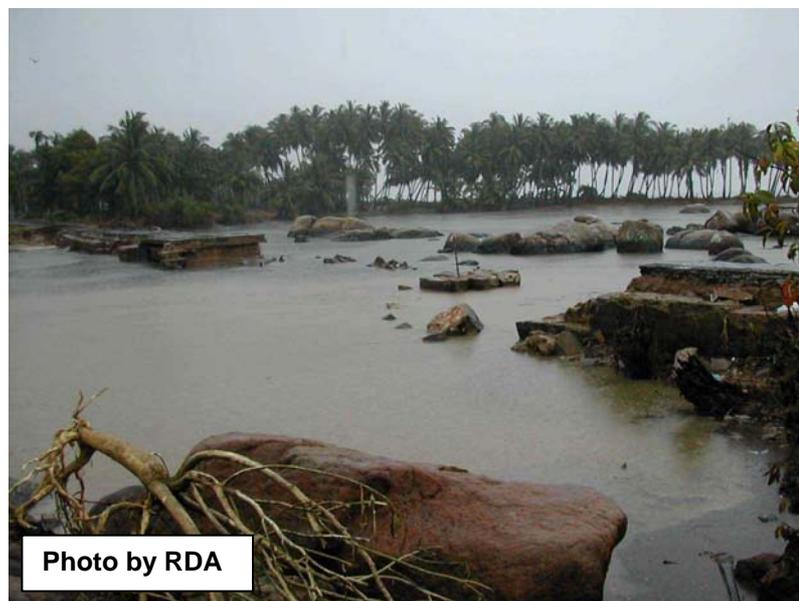
Figure 2.66: Destroyed Komari causeway bridge on the Road A4 from Colombo to Batticaloa

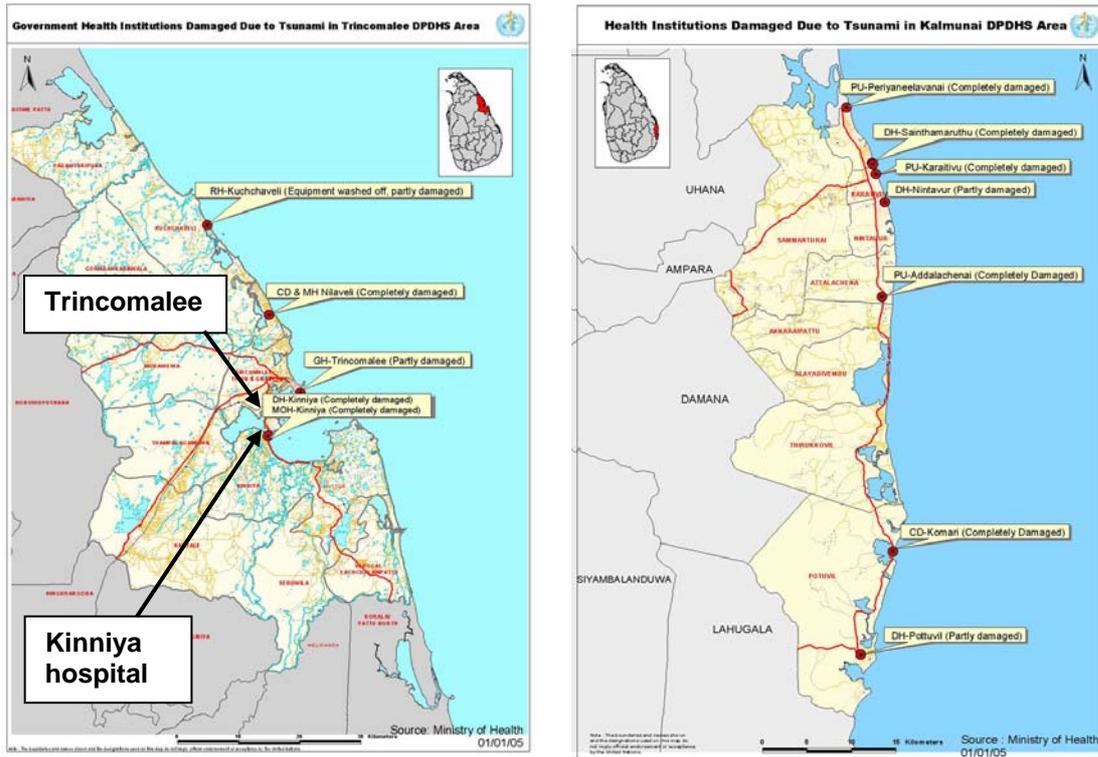
Figure 2.75: Damaged hospitals in Trincomalee district and Ampara district (Eastern province)

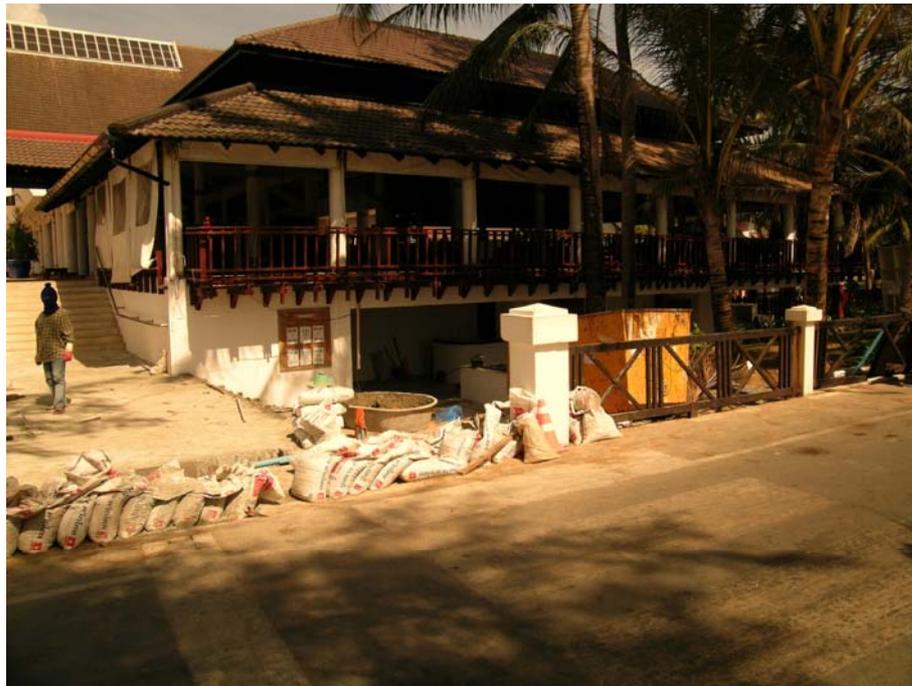
Figure 3. 2: Minor damage to Club Mediteranée Resort at Kata Beach. Damage was mainly restricted to the ground floor and was not structural in nature.

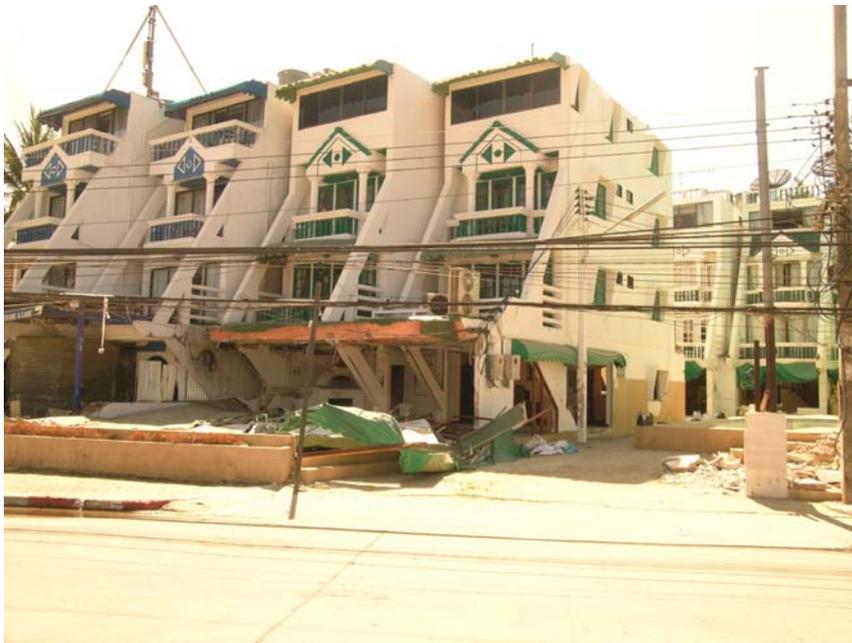
Figure 3. 4 Heavily damaged ground floor infill walls and columns of the Patong Swiss Hotel on Thaweewong Road, located about 90m from the sea front .

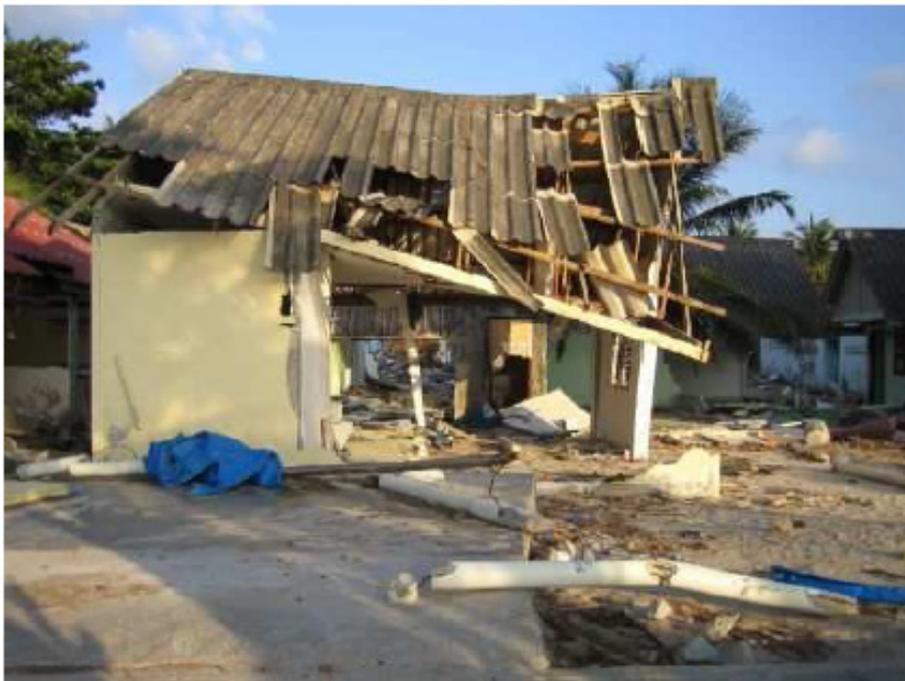
Figure 3. 6: Seriously damaged single storey house located 100m from the shore line at Kamala Beach. Example of typical timber roof system and its poor connection to the supporting structure.

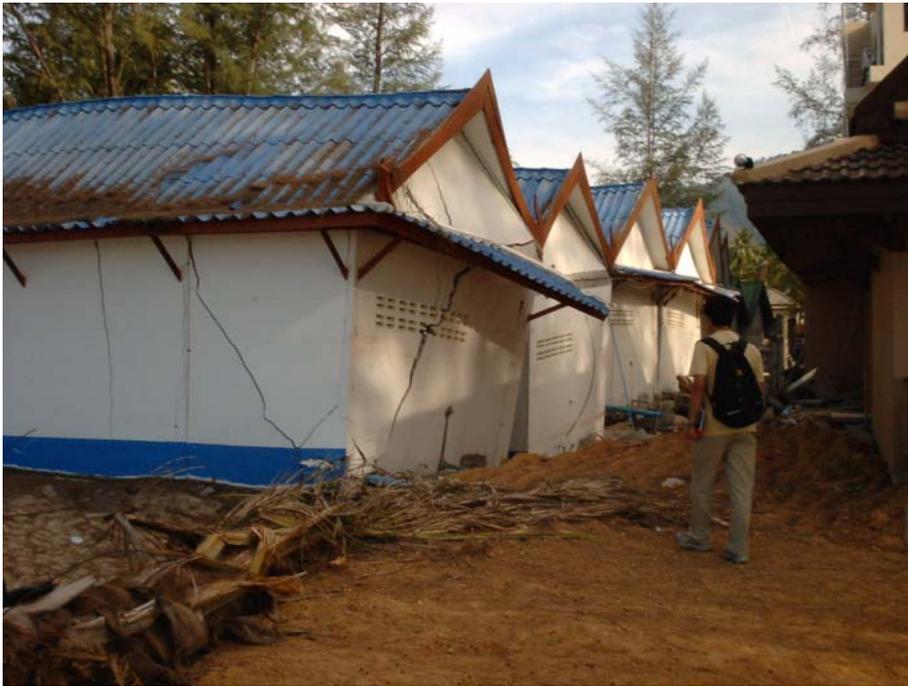
Figure 3. 9: Foundation failure of bungalows on Bang Tao beach front.

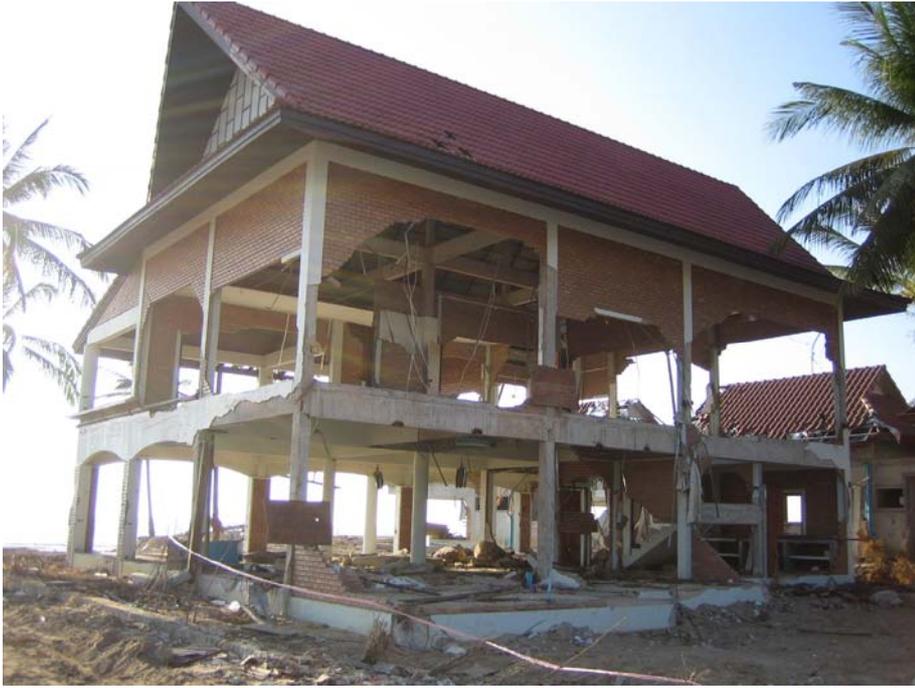
Figure 3. 11: Damage to a two storey resort on Bang Niang Beach in Khao Lak, situated approximately 50m from the sea.

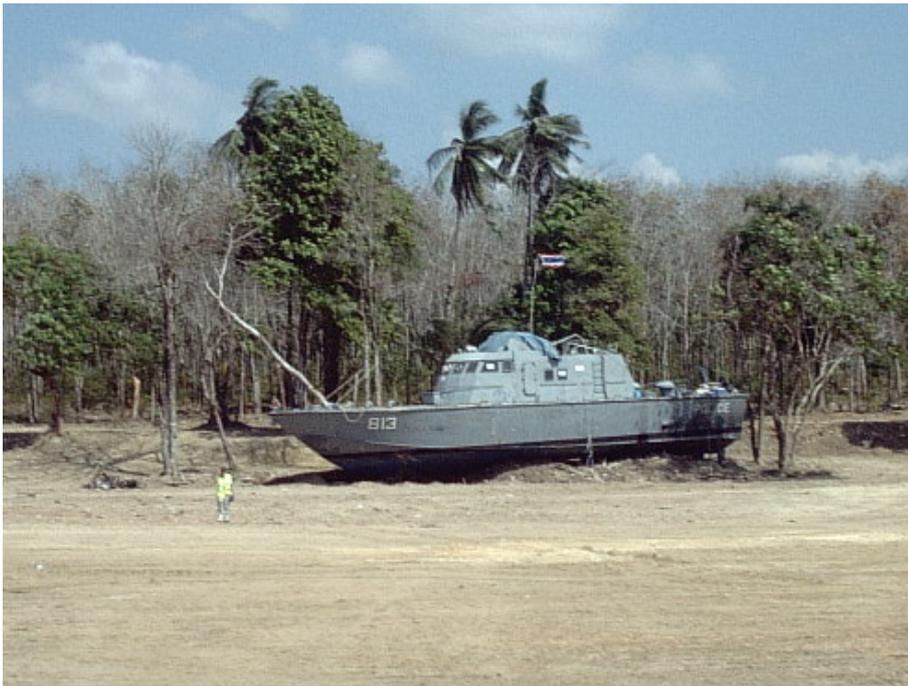
Figure 3. 12: A Thai police patrol boat left stranded 1.2km inland at Khao Lak.

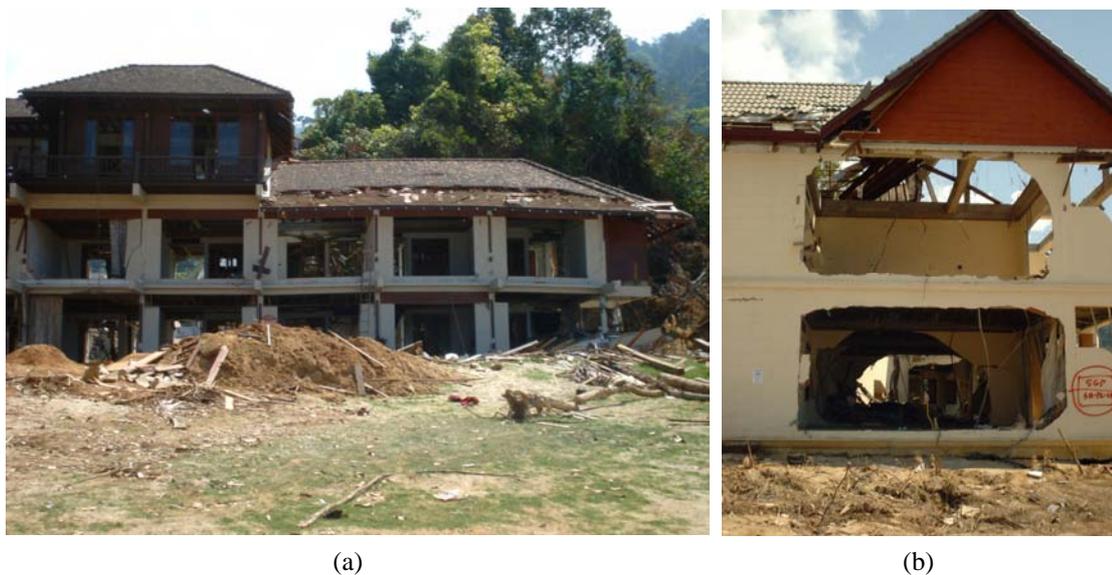
Figure 3. 14: Damage to RC buildings in Khao Lak: (a) Damage to the Laguna Hotel, situated 100m from the seafront. The displaced roof tiles indicate a water height of nine metres above sea level. (b) Damage to the infill partition walls (parallel to the seafront) of a hotel situated at 120m from the seafront.

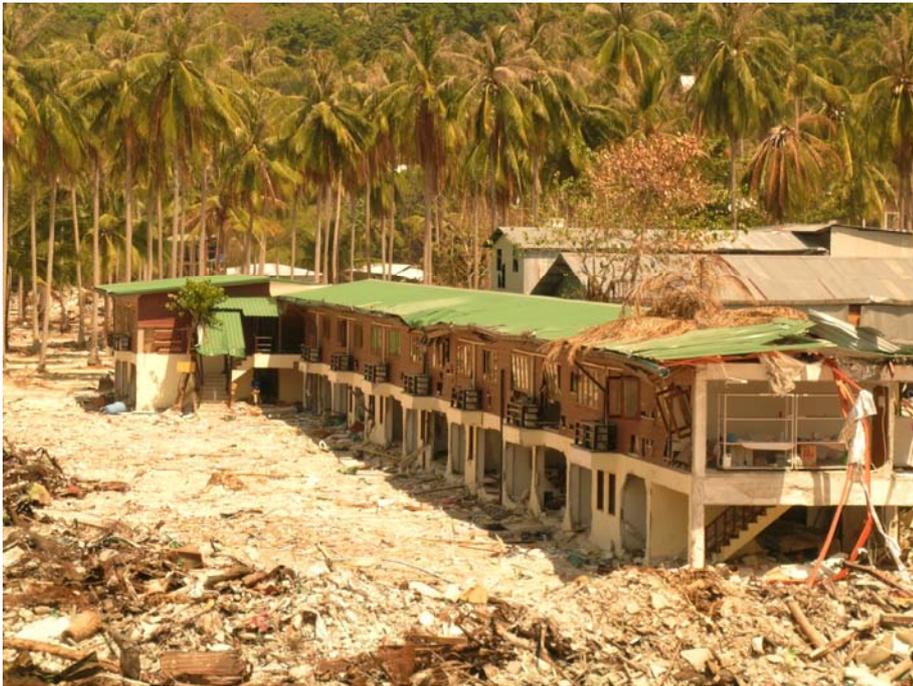
Figure 3. 19: Major damage to a resort on Phi Phi Island. The structure is located about 50m from the north beach and has extensive damage to lower storey windows and masonry walls. Debris damage to the roof is visible.

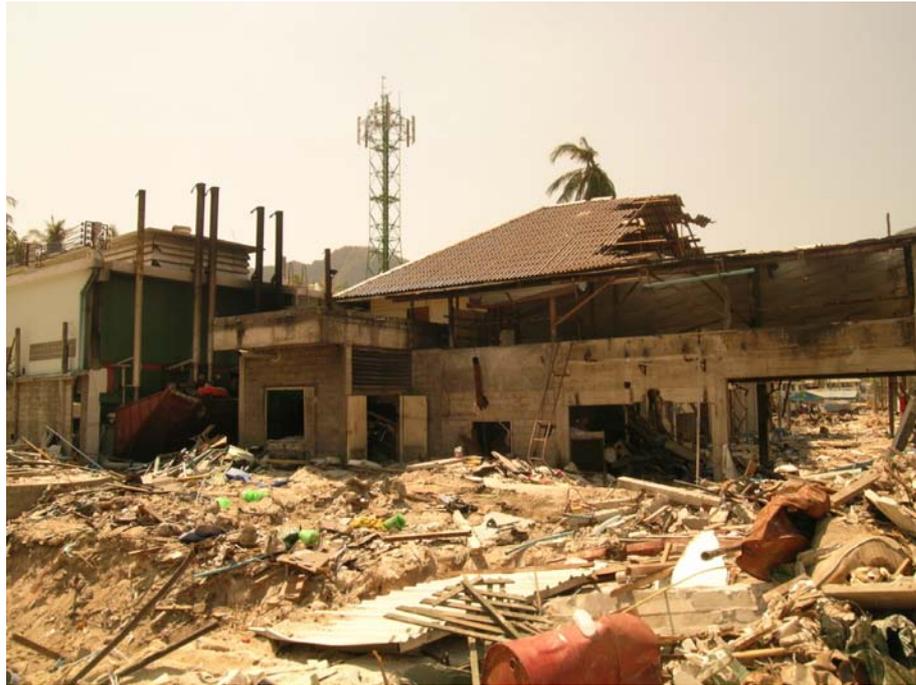
Figure 3. 20: Local power station and telecommunications building extensively damaged on Phi Phi Island. The exhaust pipes for the diesel generators remain standing at left hand side of the picture.

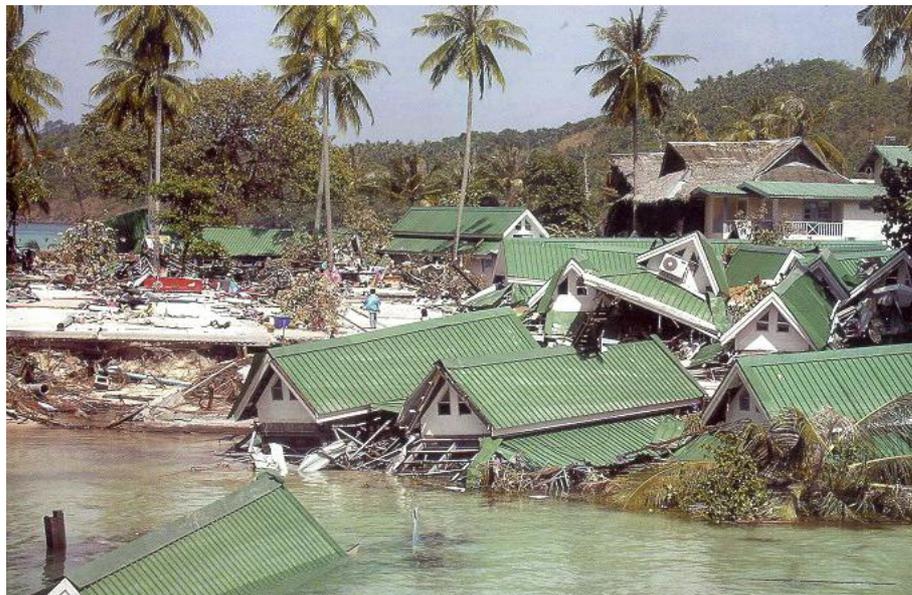
Figure 3. 21: Collapse and transport of wooden detached bungalows by tsunami waters along the south west coast of Ton Sai Bay, Phi Phi Island (Source: Warnitchai 2005).

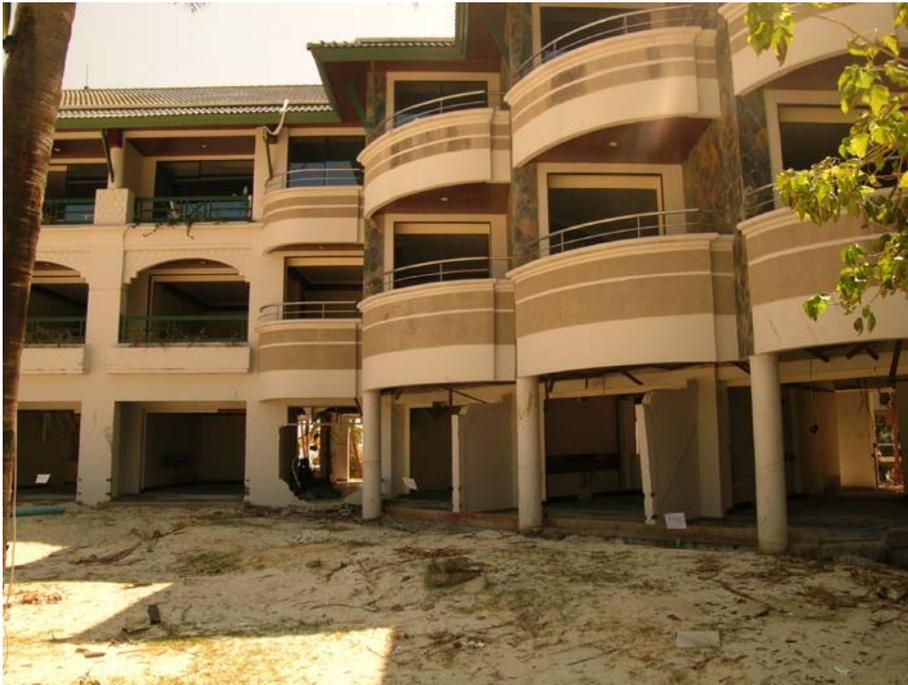
Figure 3. 22: The Cabana Resort on Phi Phi Island. Although this resort was close to the beach, it was at the western end and therefore probably more sheltered. Structural damage is restricted to windows on the lower two storeys and a few masonry panels on the ground floor.
