**The Indian Ocean Tsunami of 26 December 2004:
Mission Findings in Sri Lanka and Thailand**

**Antonios Pomonis, Risk Management Solutions
Dr Tiziana Rossetto, University College London
Dr Navin Peiris, Arup, London
Dr Sean Wilkinson, University of Newcastle
Domenico Del Re, Buro Happold, London
Raymond Koo, Arup, Hong Kong
Raul Manlapig, Arup, Philippines
Dr Stewart Gallocher, Halcrow, Glasgow**

Earthquake Engineering Field Investigation Team
Institution of Structural Engineers
11 Upper Belgrave Street
London SW1X 8BH
United Kingdom

February 2006

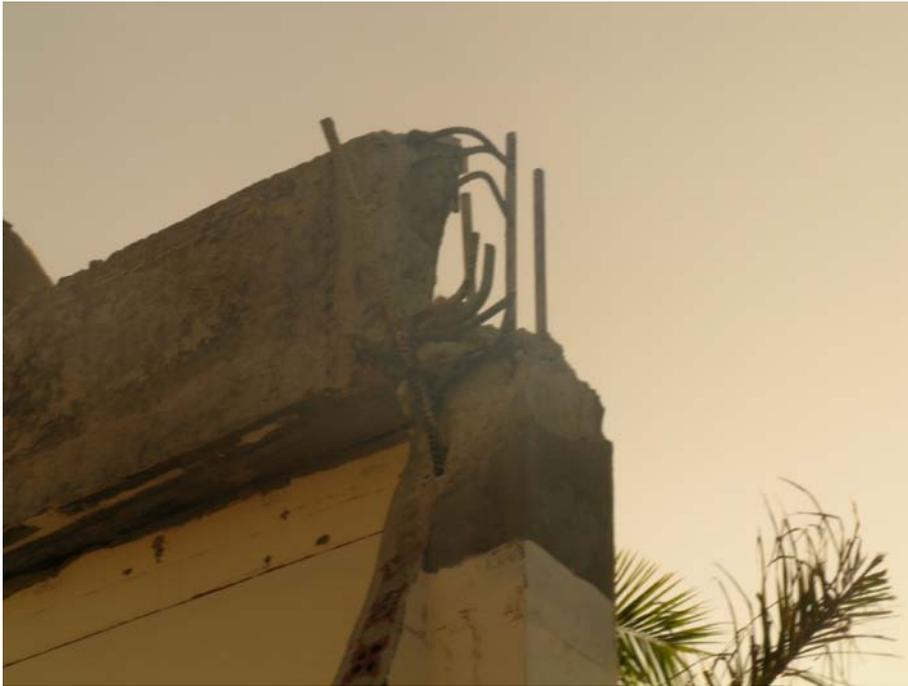
Figure 3. 24: Typical example of poor connection detail. The beam reinforcement is insufficiently anchored to the column reinforcement, leading to a lack of integrity of the connection and partial collapse of the structure shown as DC4 on the left hand side of Figure 3.32.

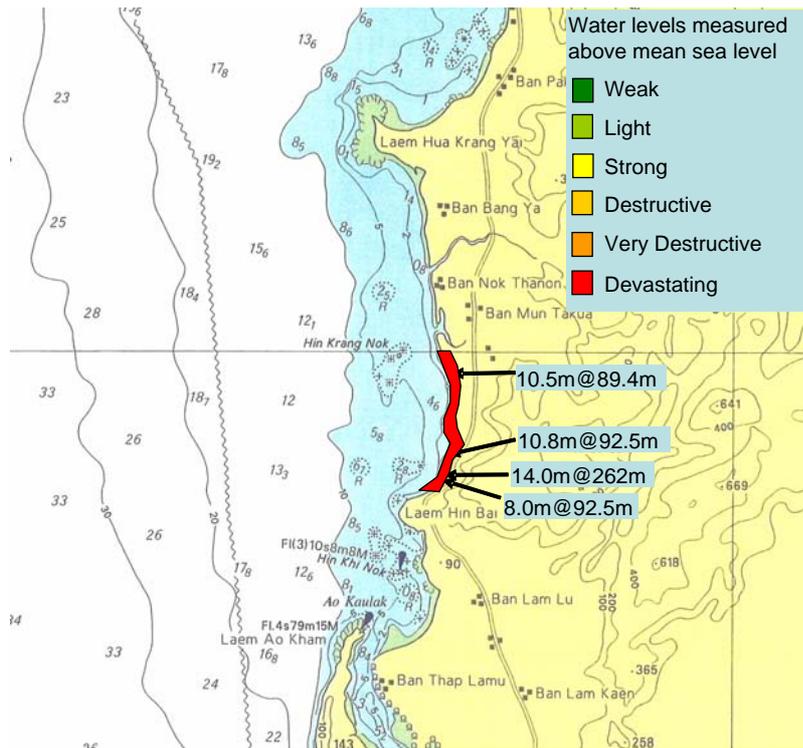
Figure 3. 33: The surveyed damage in the Khao Lak region, Phang Nga Province, Thailand. The arrows indicate locations of inundation height measurement (e.g. 10.5m@89.4m means a water height of 10.5m above mean sea level was measured a distance 89.4m from the shore).

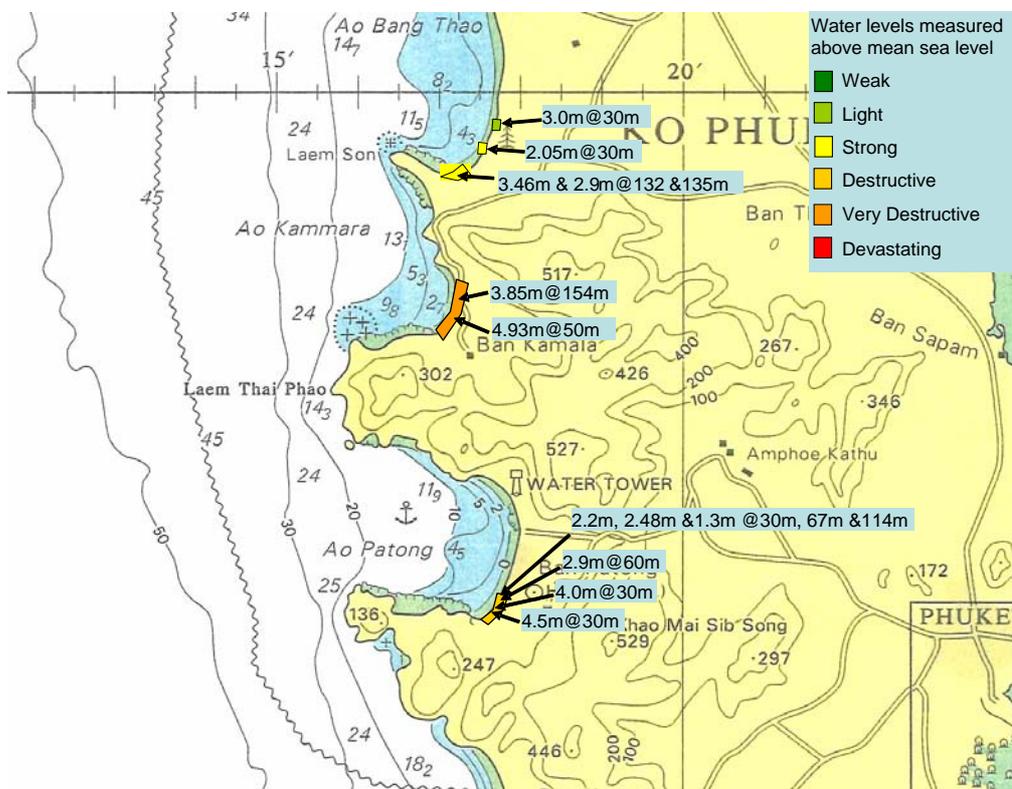
Figure 3. 34: The surveyed damage on the Western coast of Phuket Island, Thailand. The arrows indicate locations of inundation height measurement (e.g. 4.5m@30m means a water height of 4.5m above mean sea level was measured a distance 30m from the shore).

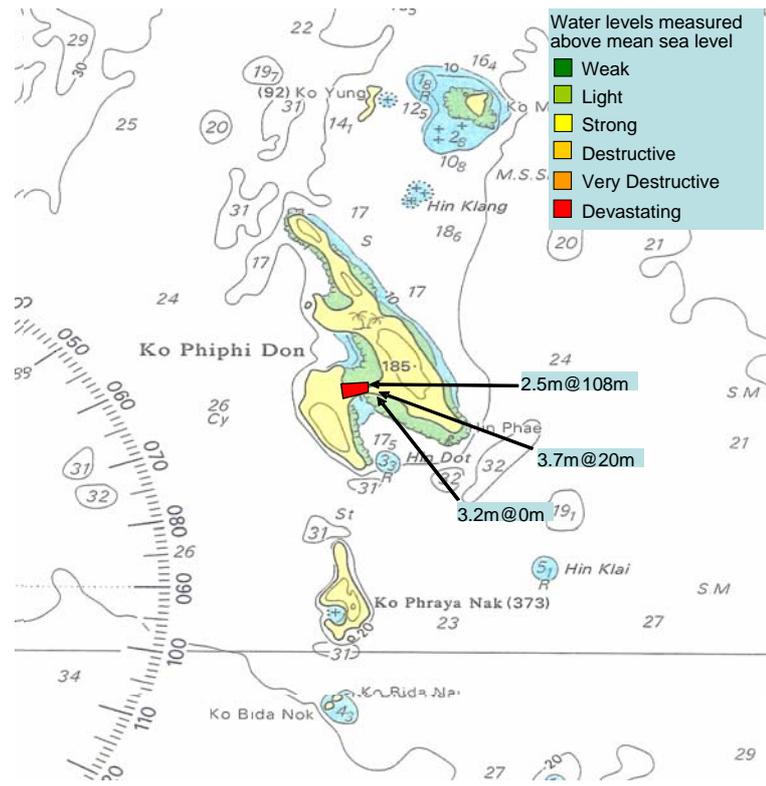
Figure 3. 35: The surveyed damage on Phi Phi Island, Krabi Province, Thailand. The arrows indicate locations of inundation height measurement (e.g. 3.2m@0m means a water height of 3.2m above mean sea level was measured a distance 0m from the shore).

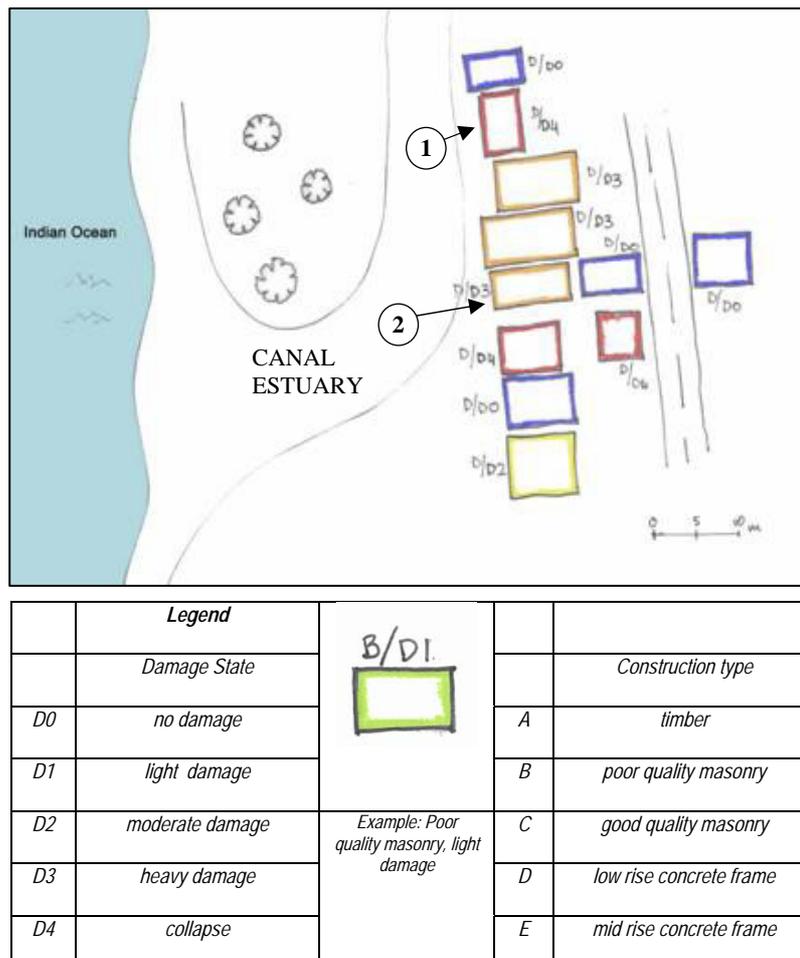
Figure 3. 39: Detailed damage survey carried out by EEFIT at Kamala Beach. The building typologies and damage states are described in Sections 2.32 and 3.4. The circled numbers refer to the locations of the damaged building pictures shown in Figure 3.40.

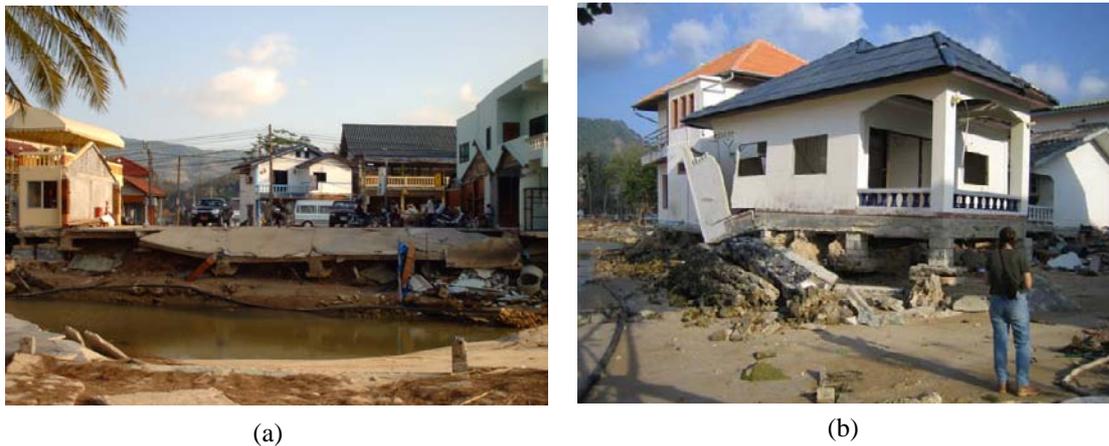
Figure 3. 40: Photographs of building damage at Kamala Beach taken at survey locations 1 and 2 shown on Figure 3.39: (a) taken at location 1, shows the sea wall failure at Kamala caused by beach erosion, (b) the footings of the house at location 2 are left exposed by the erosion caused by the tsunami.

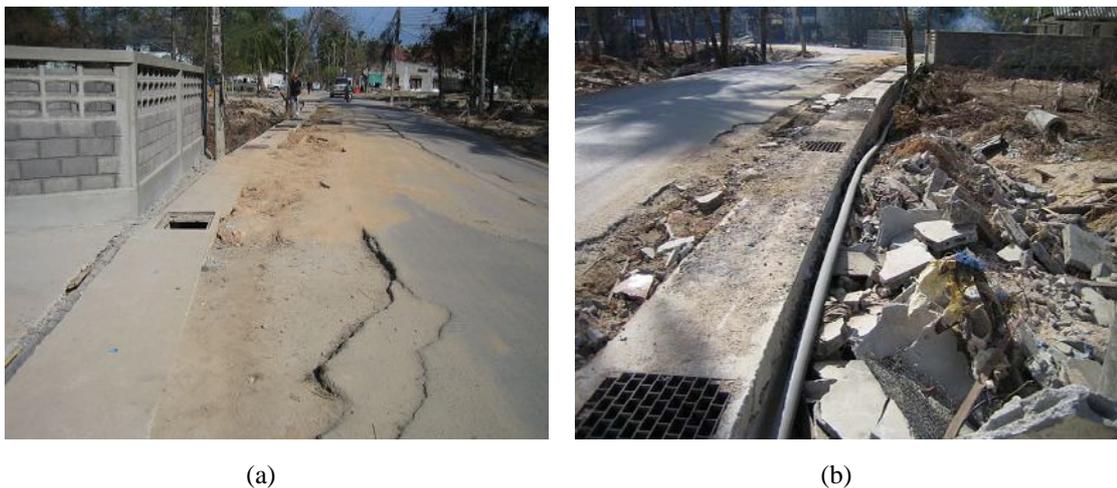
Figure 3. 41: Road damage near Bang Thao Beach, approximately 120m inland.

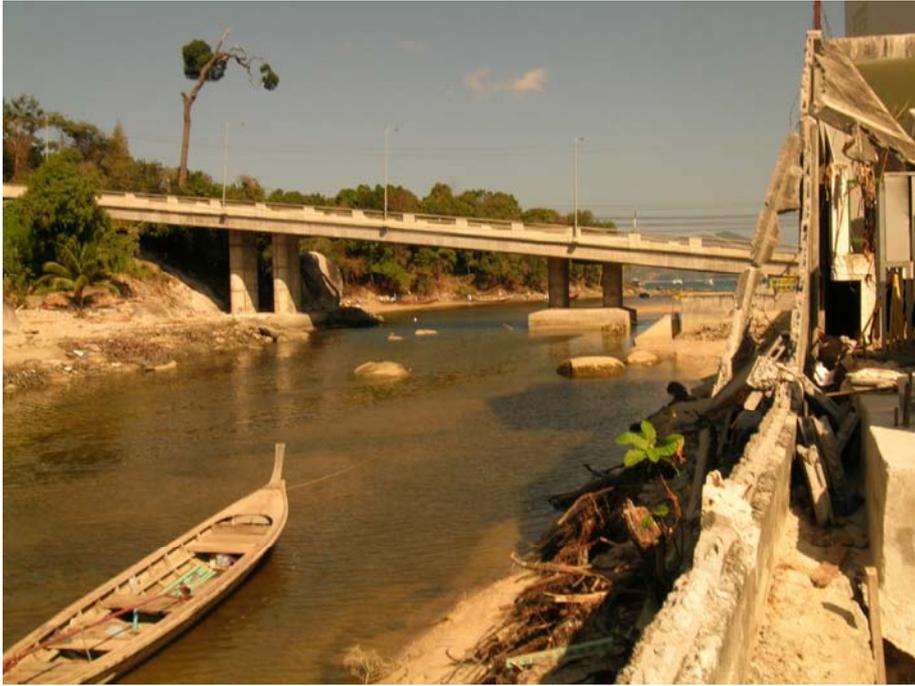
Figure 3. 43: No damage was observed on the cross-river bridge at the south of Patong Beach, however the pile caps under the piers have been partially exposed by erosion.

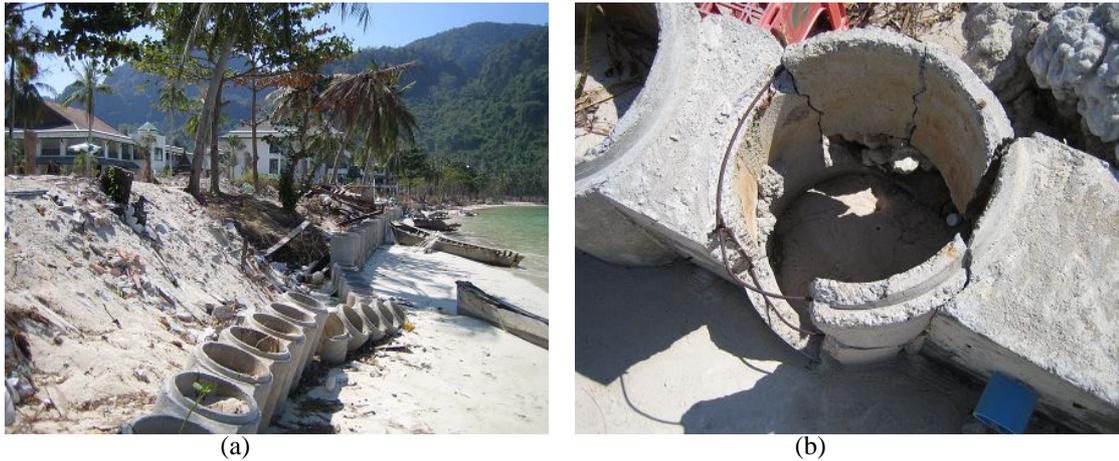
Figure 3. 45: Damaged 500mm inner diameter gravity retaining sea wall with sand infill on Loh Dalam Bay in Phi Phi Island located at approximately 10m from the coastline.

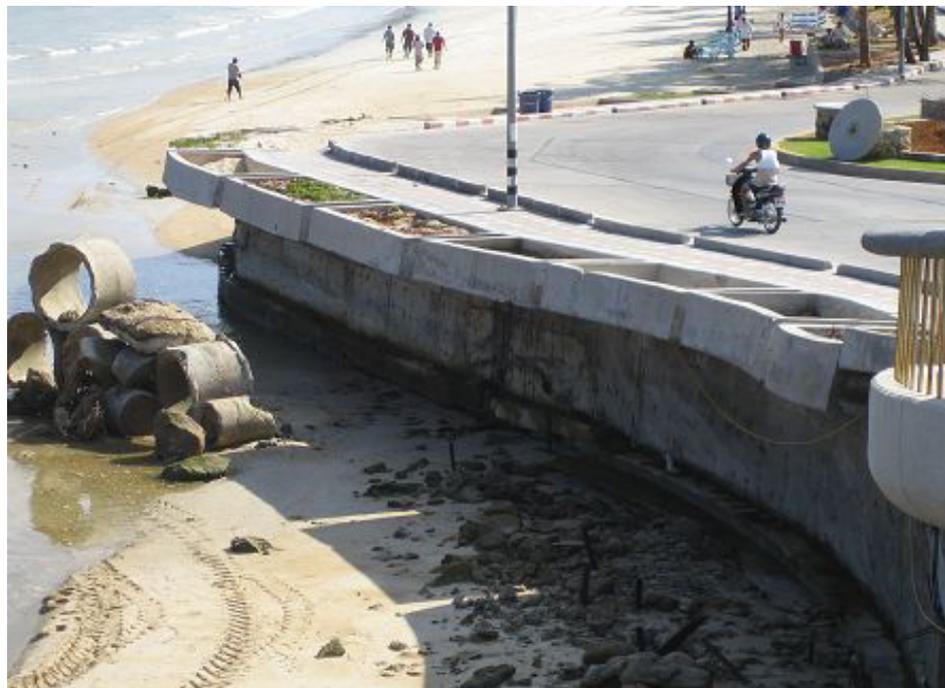
Figure 3. 46: No apparent damage on the RC retaining sea-wall at the south of Patong Beach.

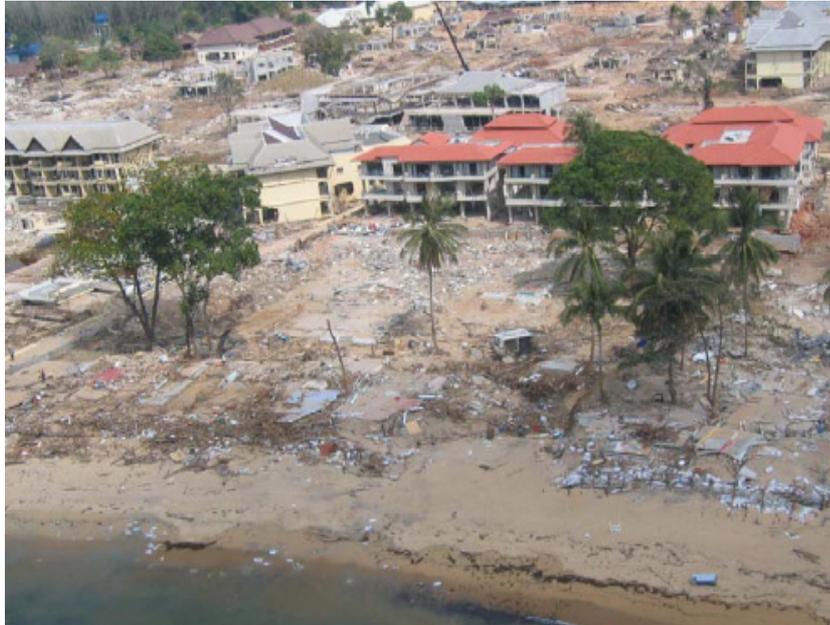
Figure 3. 49: Aerial view of tsunami damage to hotels in the Khao Lak region of Thailand, (Source: http://www.undp.org/bcpr/disred/documents/tsunami/thailand/ocha_assreport1201.pdf)

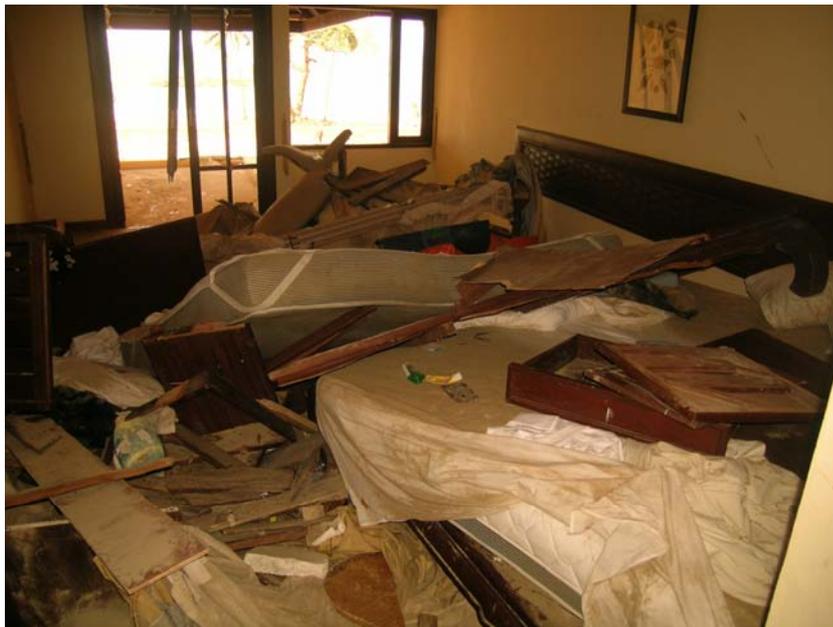
Figure 3. 50: The condition in the interior of a second floor hotel room in Khao Lak following the tsunami.
