THE LOMA PRIETA EARTHQUAKE OF 17 OCTOBER 1989

A FIELD REPORT BY EEFIT

EEFIT July 1993

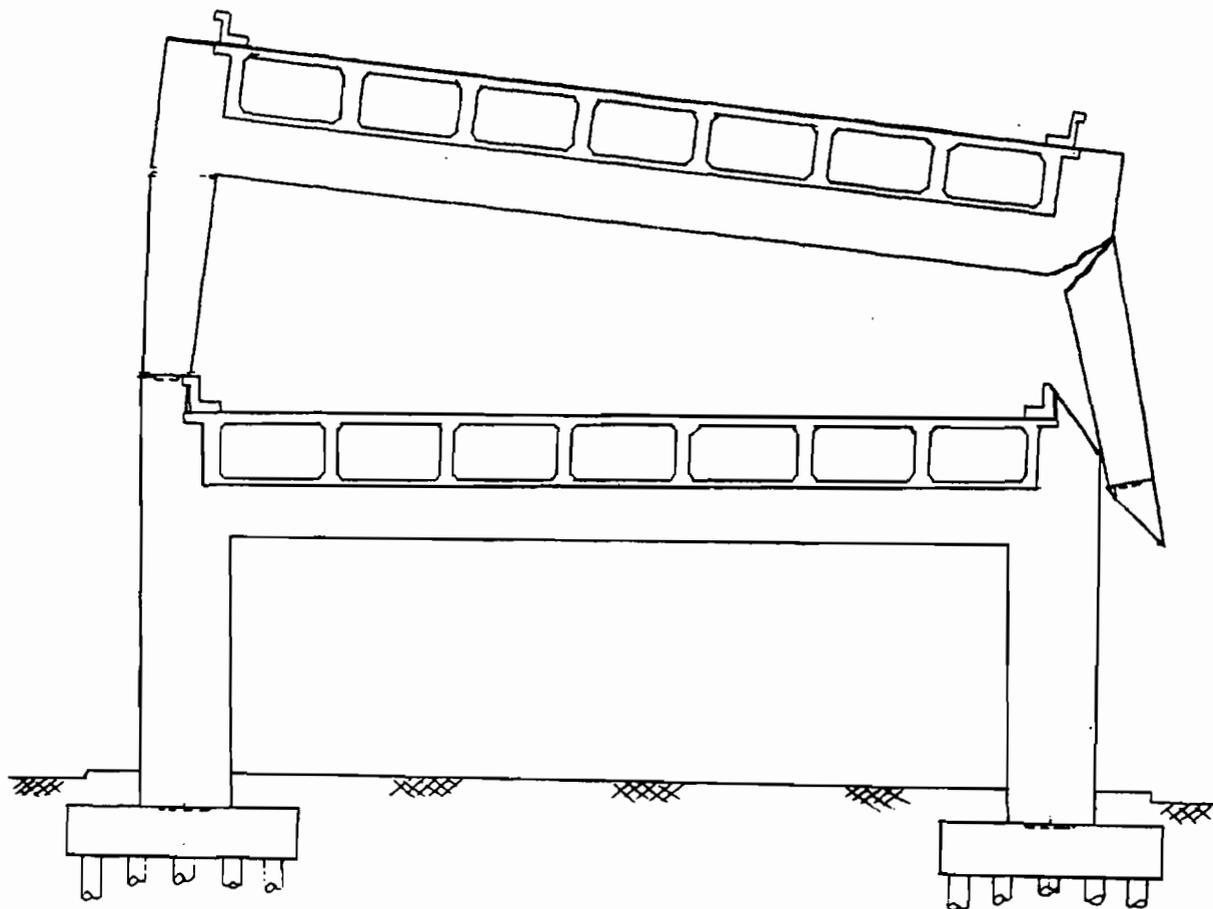
Figure 5.5 : Typical failure mode initiated by brittle shear at base of upper column

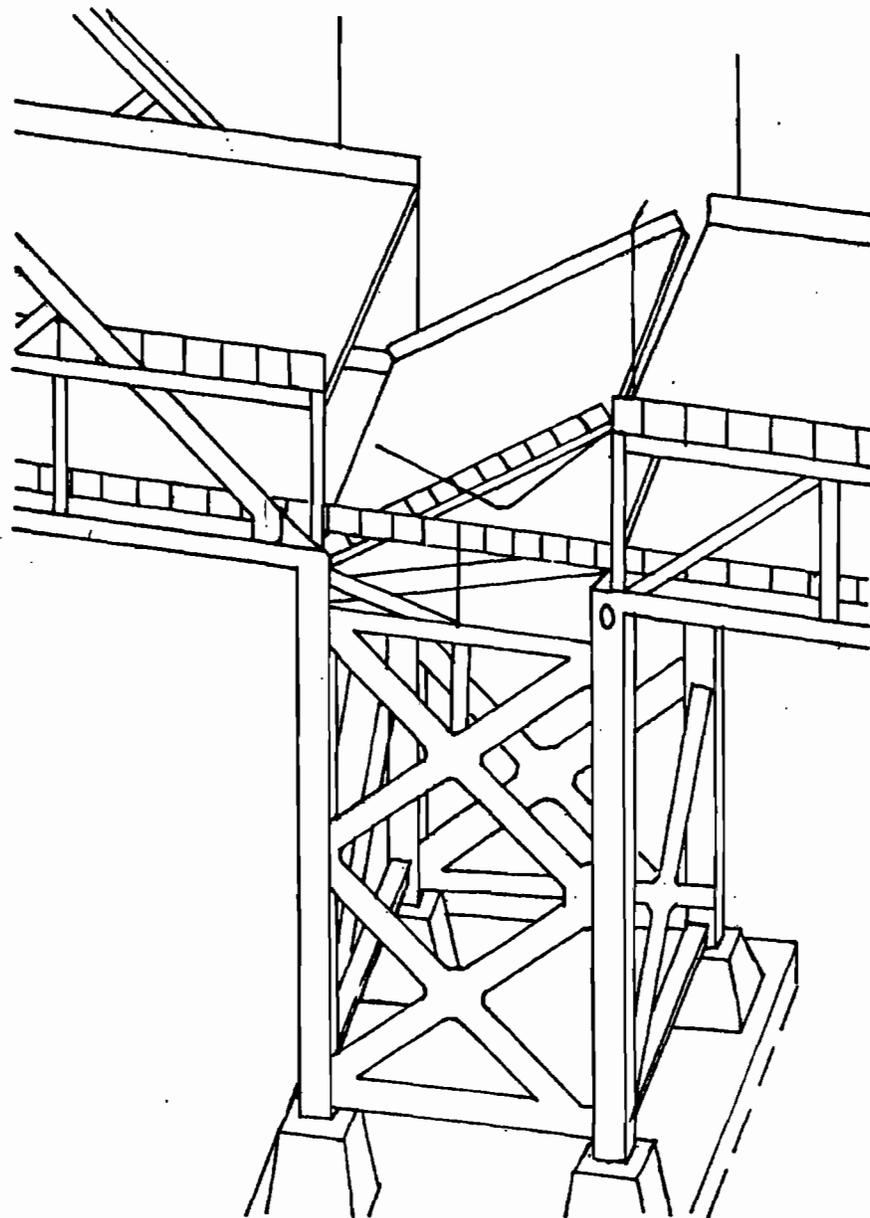
Figure 5.8 : Collapse of Bridge Decks at Pier E9

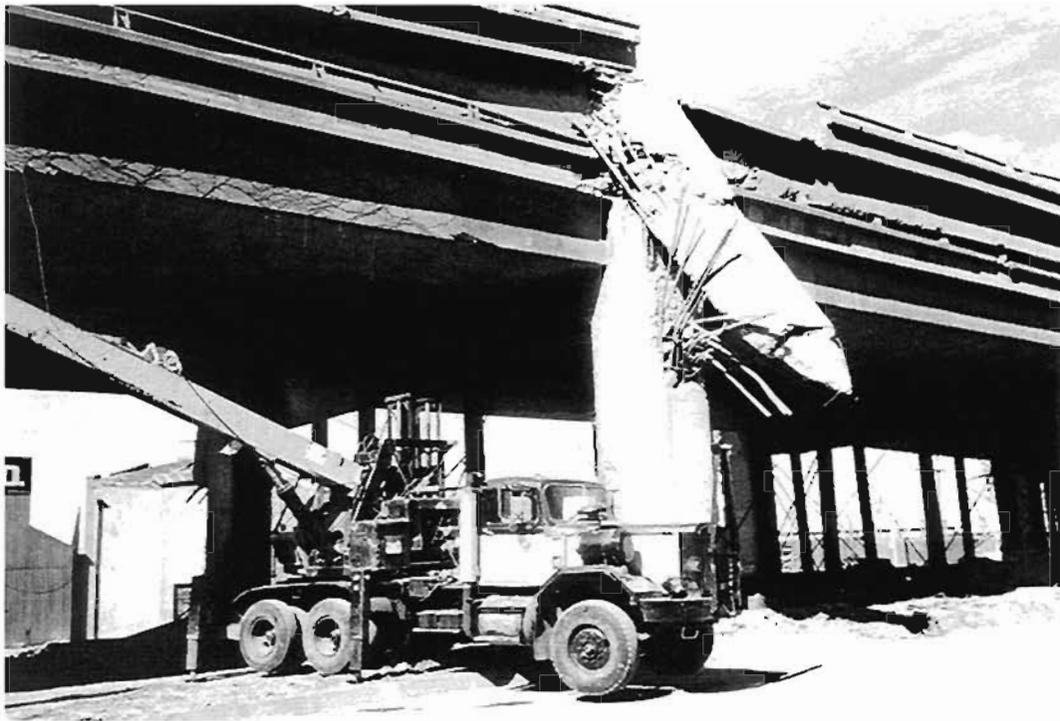
Plate 5.3 : Cypress Street Viaduct - Typical brittle failure of upper column

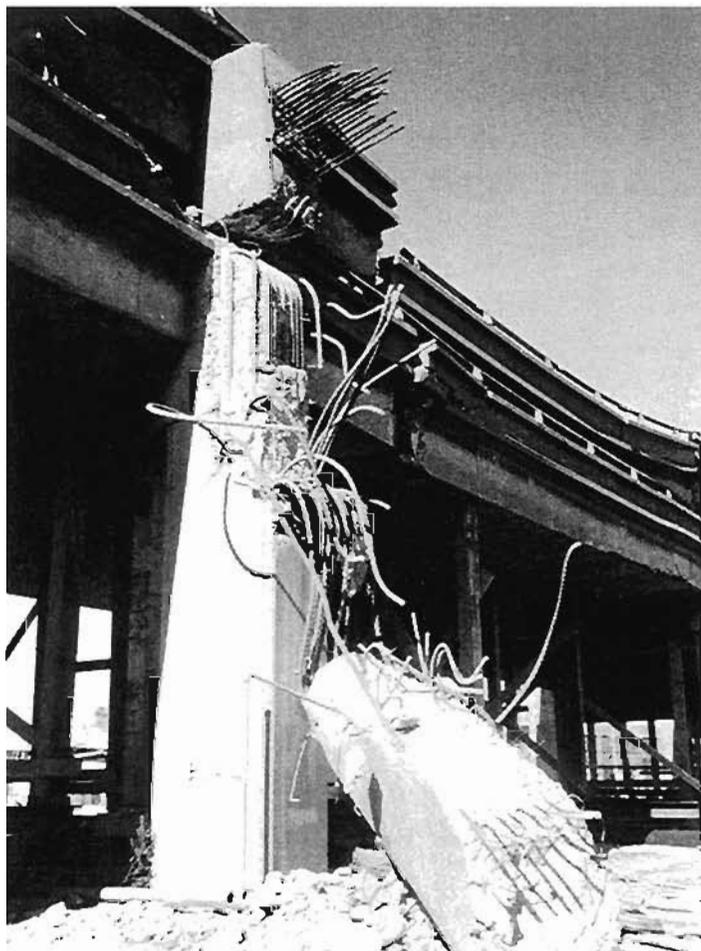
Plate 5.4 : Cypress Street Viaduct - Outer layer of lower column reinforcement and cover pushed off

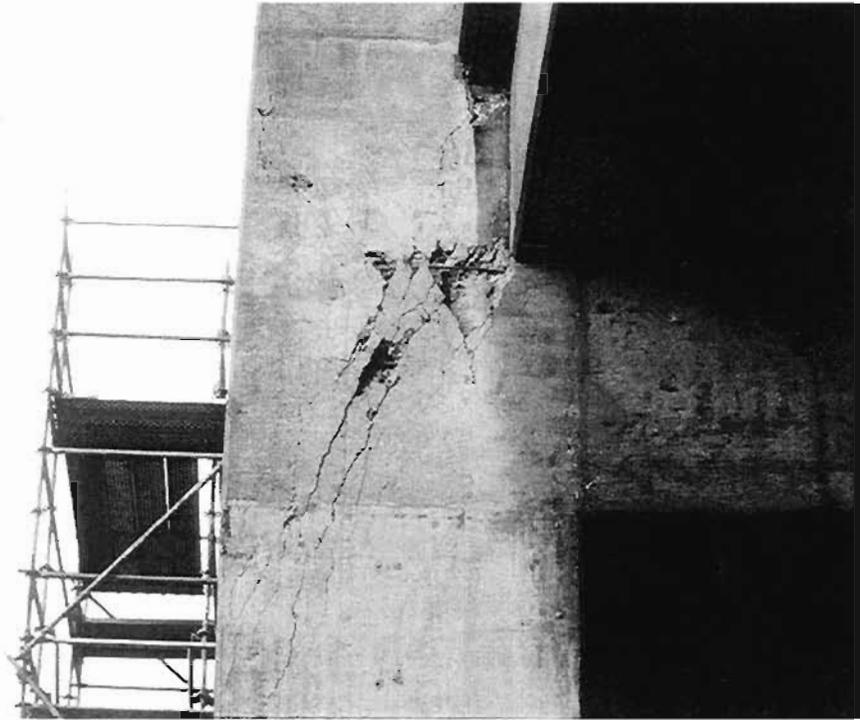
Plate 5.7 : Embarcadero Viaduct - Concrete spalling at beam/column connection

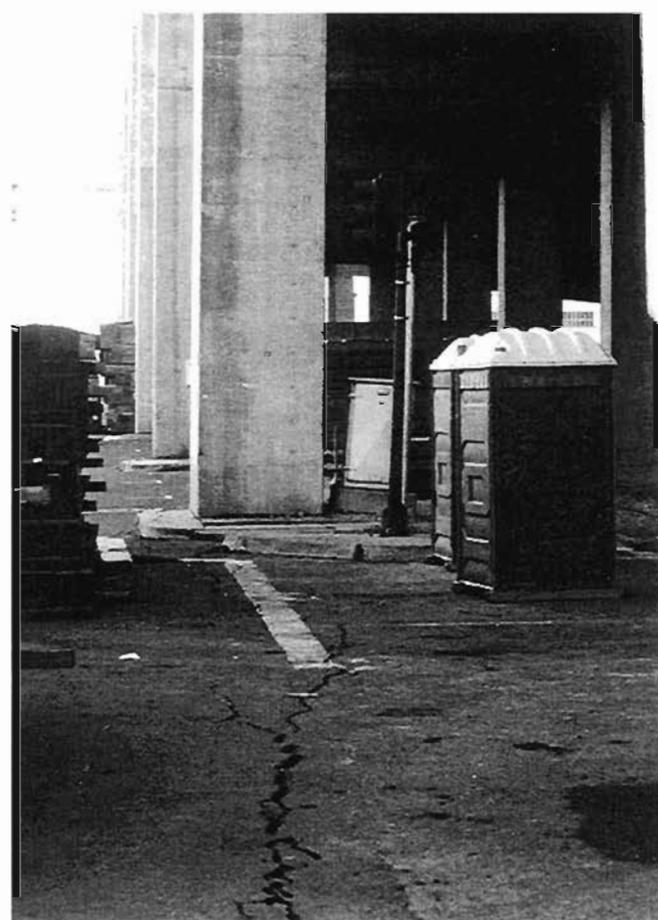
Plate 5.8 : Ground settlement and cracking

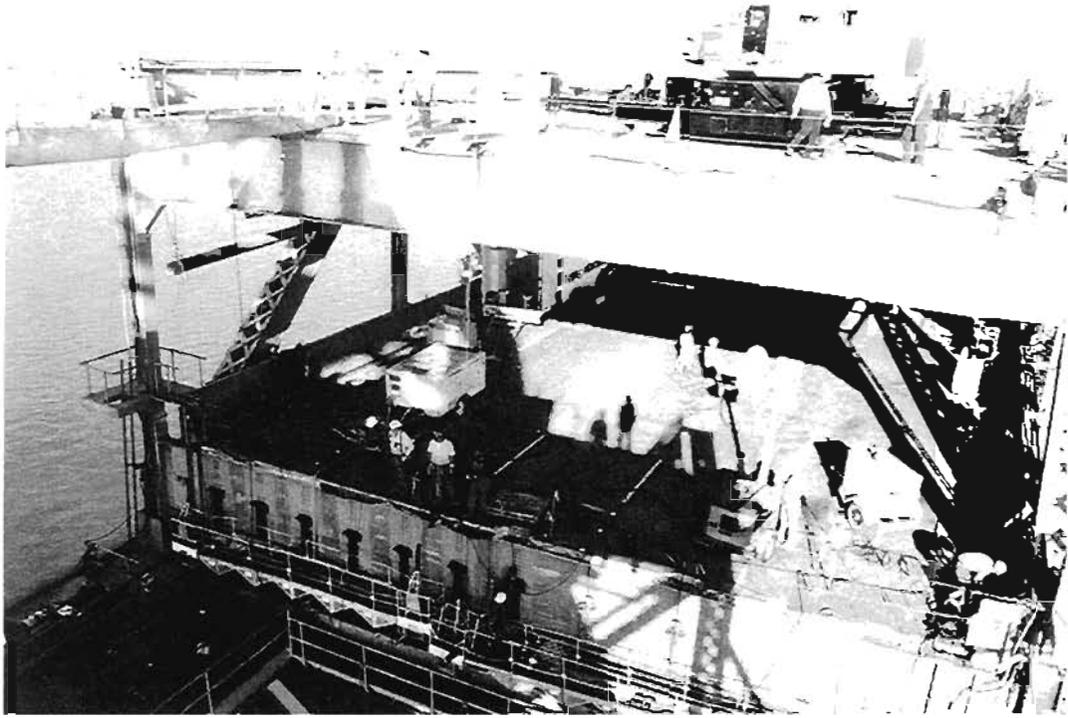
Plate 5.9 : Oakland Bay Bridge - View across collapsed deck

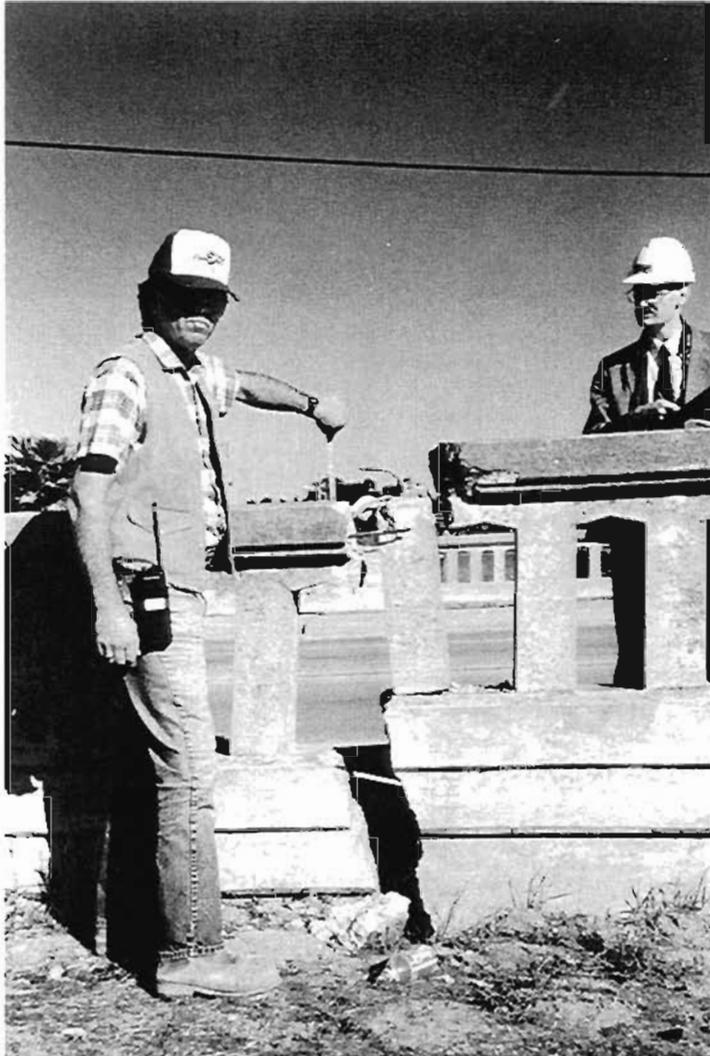
Plate 5.15 : Riverside Avenue Bridge - Damage to parapet

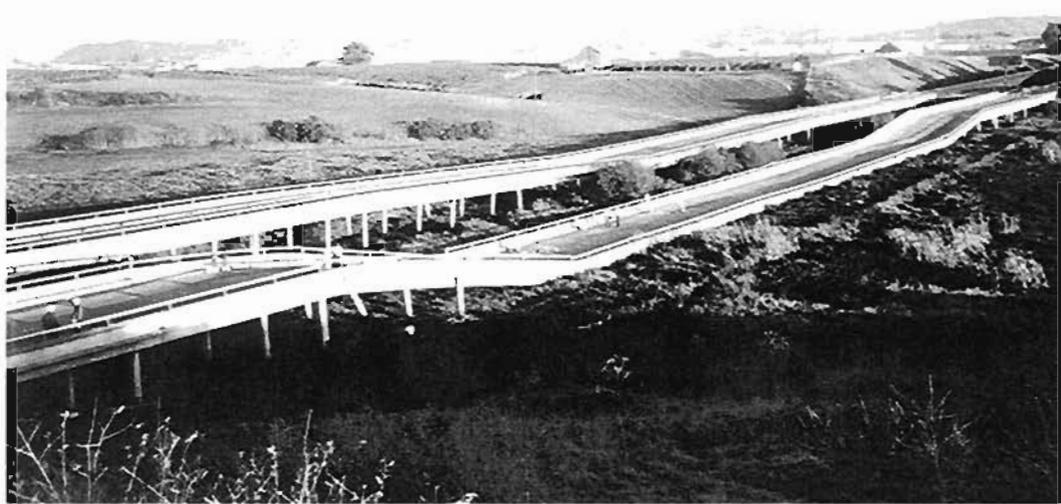
Plate 5.22 : Struve Slough Bridge - General view of collapsed section

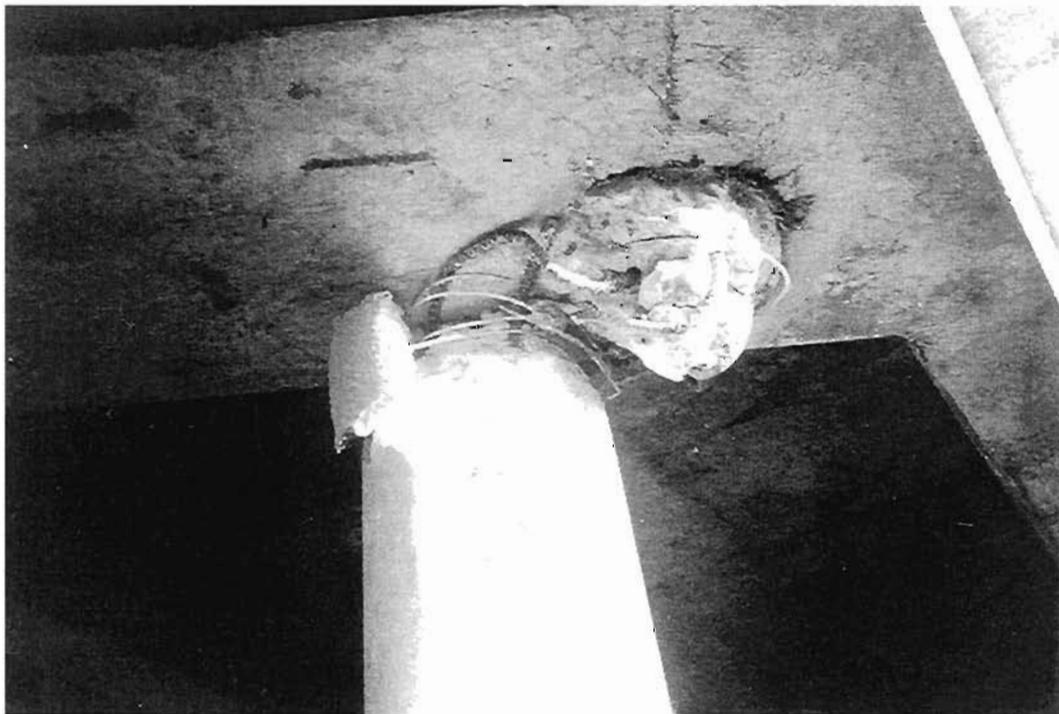
Plate 5.25 : Struve Slough Bridge - Failed pile/deck joint, note inadequate spiral binding reinforcement

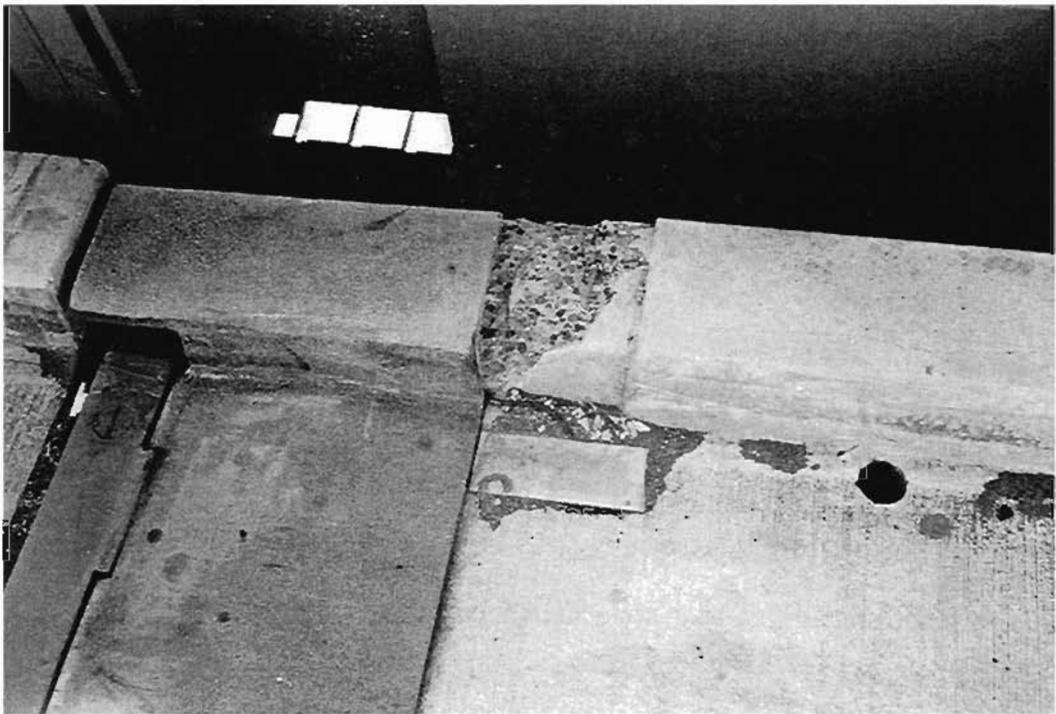
Plate 5.27 : Golden Gate Bridge - Minor impact damage adjacent to joint

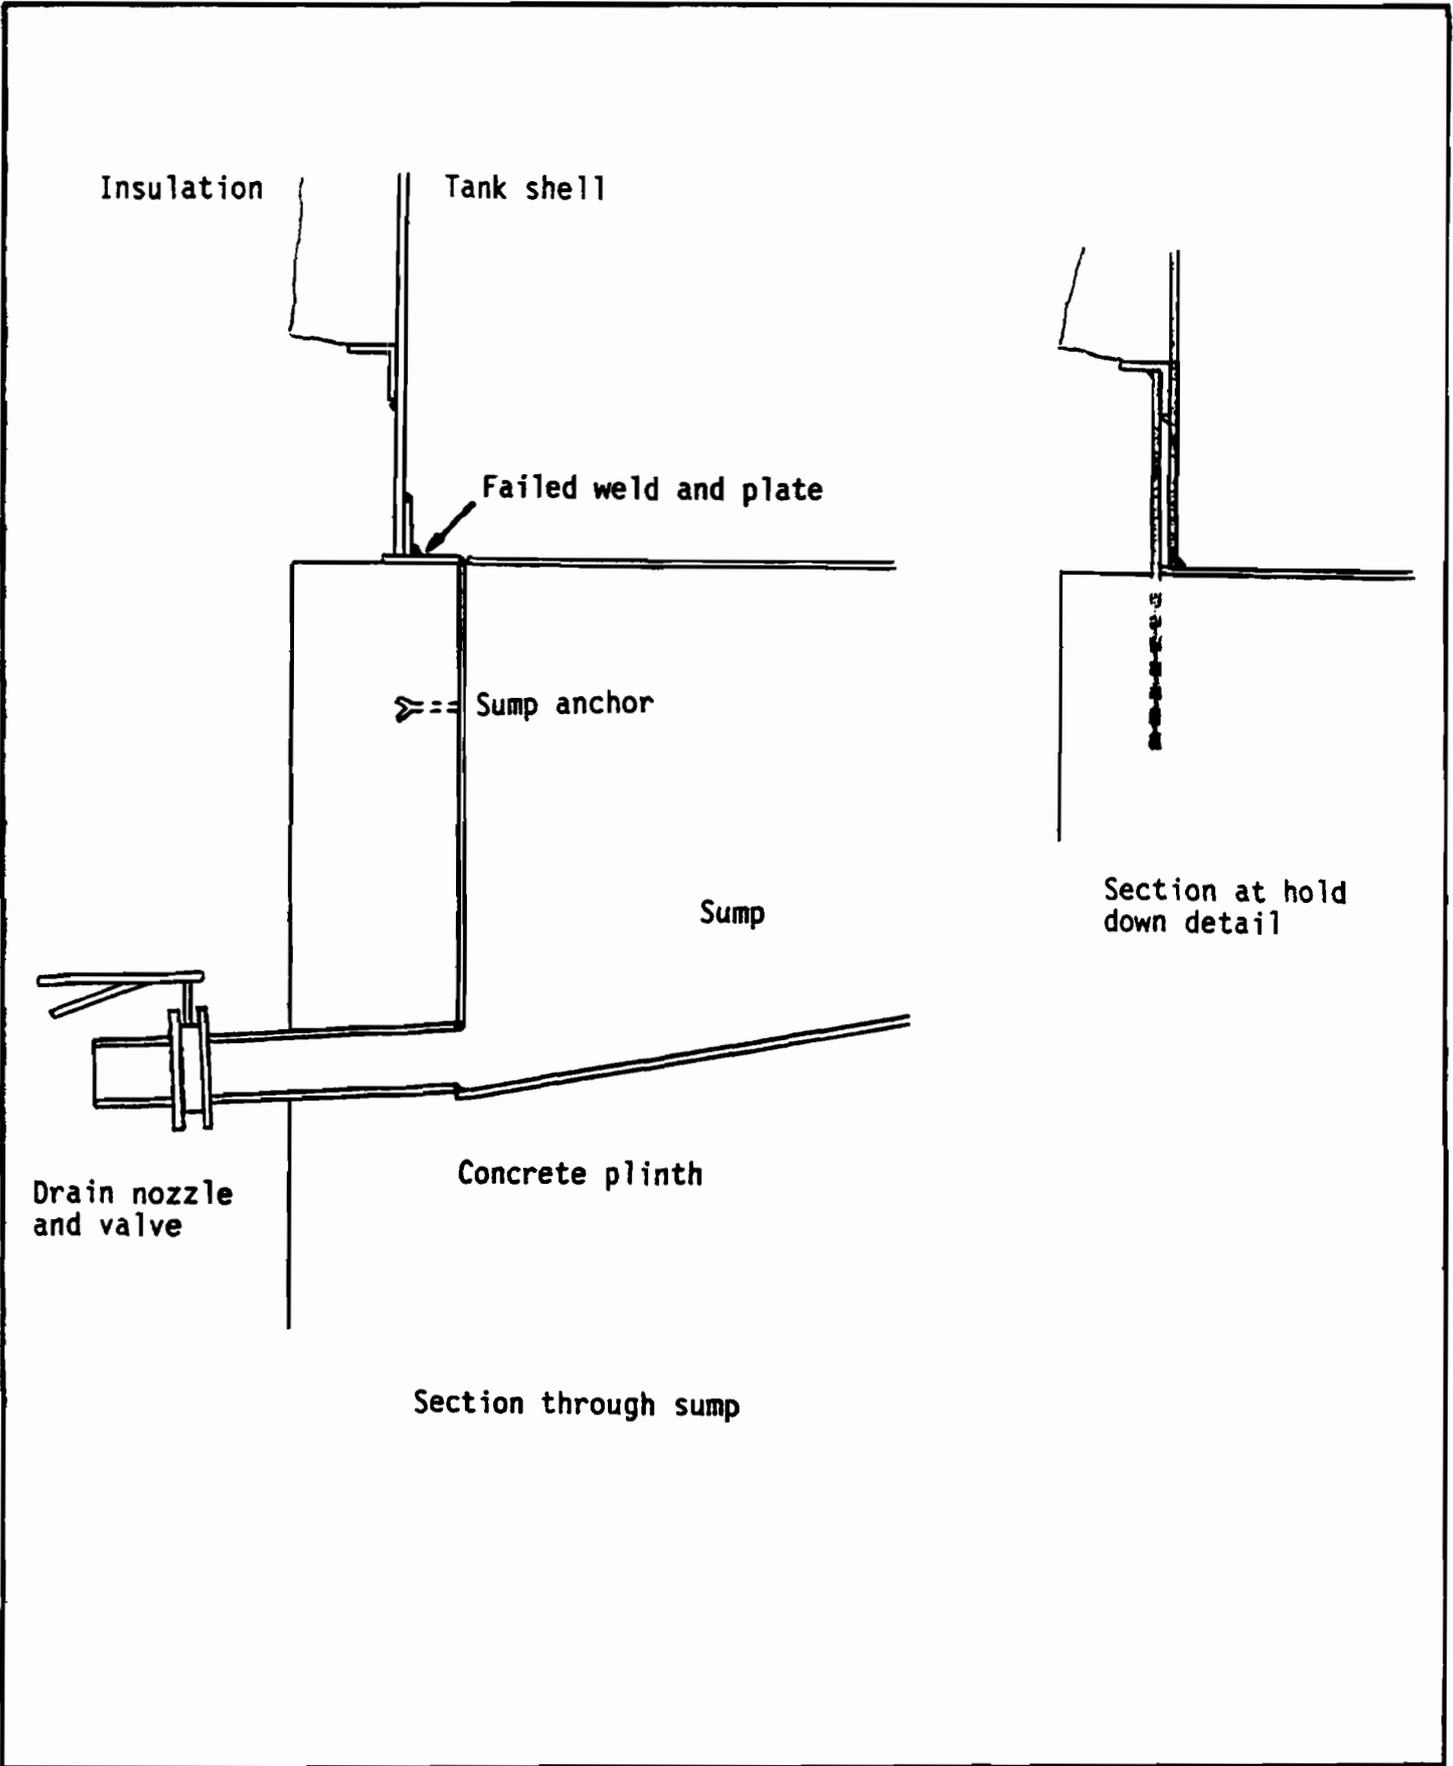
Figure 6.2 : International Vintners, Gonzales - Wine storage tank failure

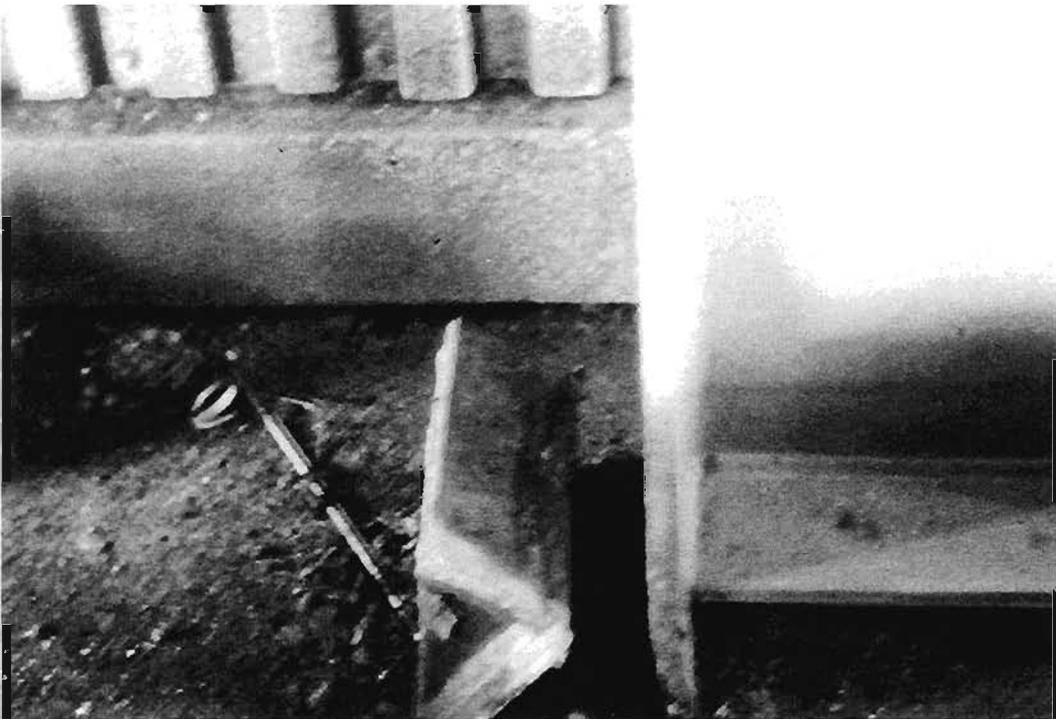
Plate 6.4 : PG and E Shear Block Failure

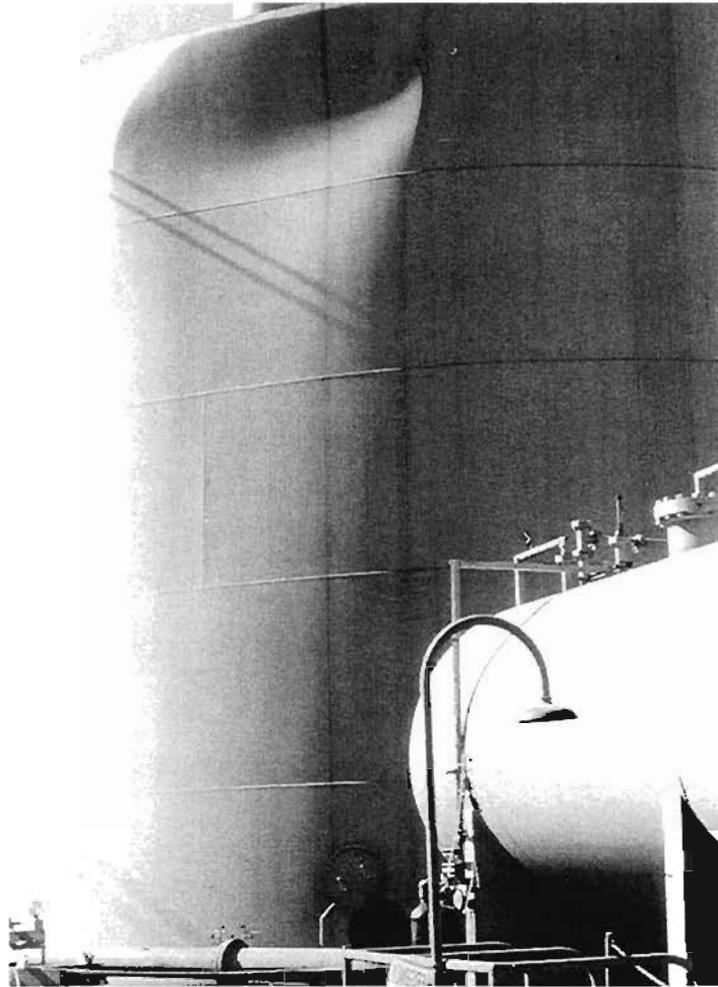
Plate 6.12 : Hollister - Drums (Buckle/Nearly Topple)

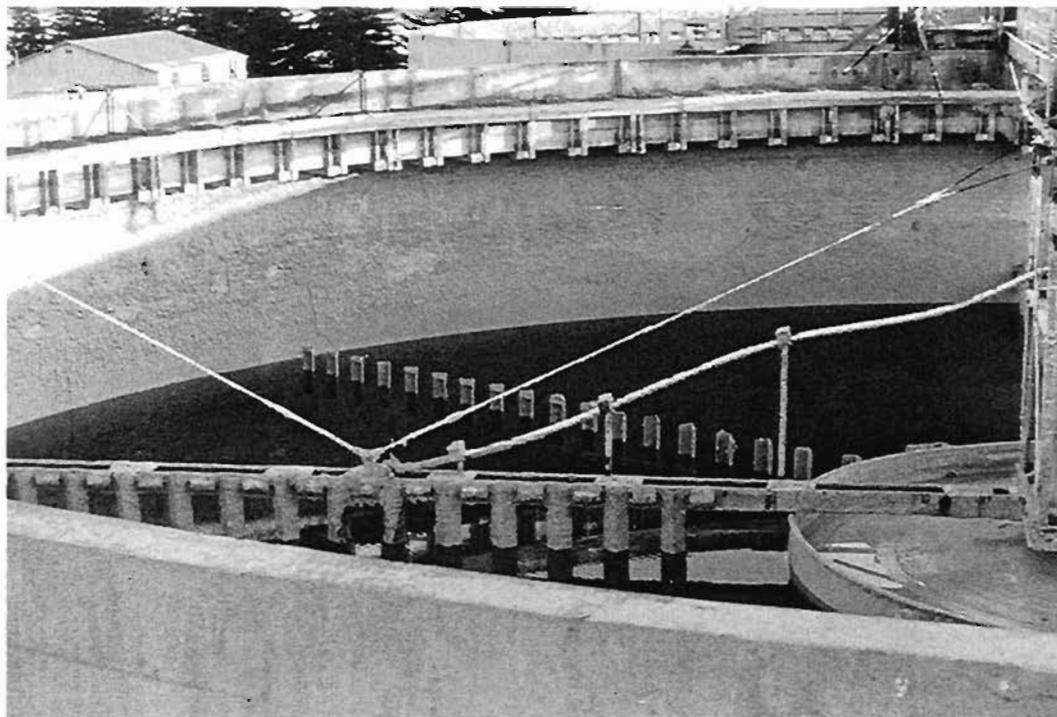
Plate 6.13 : PG and E - Tank Failure
