Observations from the 28th April 2007 Kent (Folkestone) Earthquake and Implications for EMS-98 Intensity Evaluation

Tiziana Rossetto¹, Matthew Free² and Marc Hill³

First published: 8 June 2012

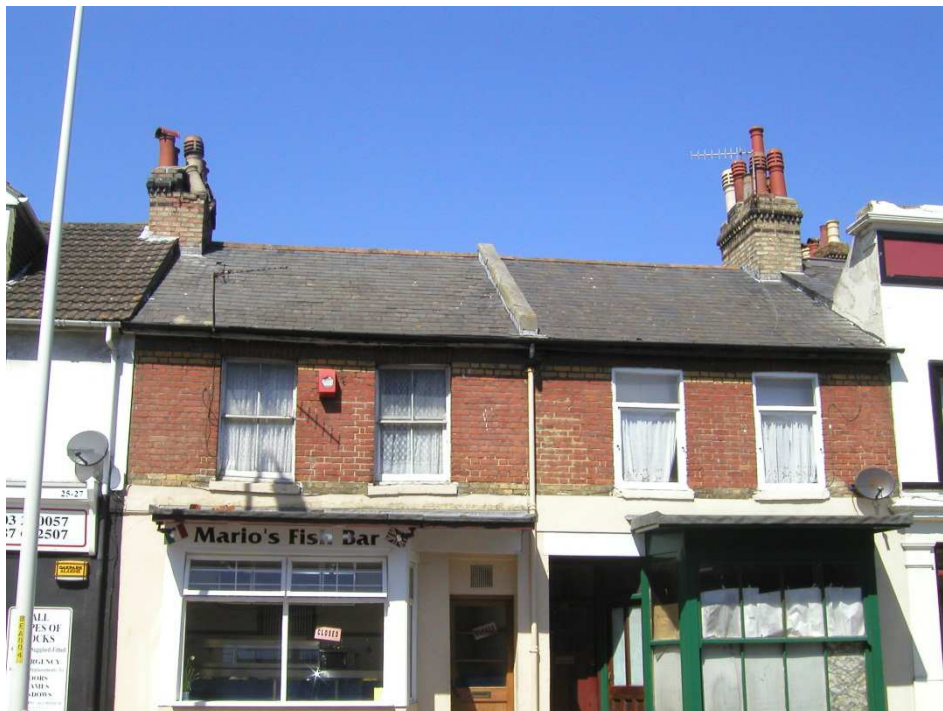
The chimneys consist of brick stacks on which multiple cylindrical clay chimney pots are mounted with mortar (see Figures 3). The heavy clay chimney pots were commonly seen to dislodge during the ground shaking, often together with bricks in the chimney stacks. Some chimneys were observed to be damaged more than others despite being of similar type and in close proximity (see Figures 4, 5 and 6). It is interesting to note that in Figure 6 the newer and more slender chimney on the left suffered no damage to the stack.

Figure 4: Similar chimneys damaged to different extents at two ends of same building on Black Bull Road.

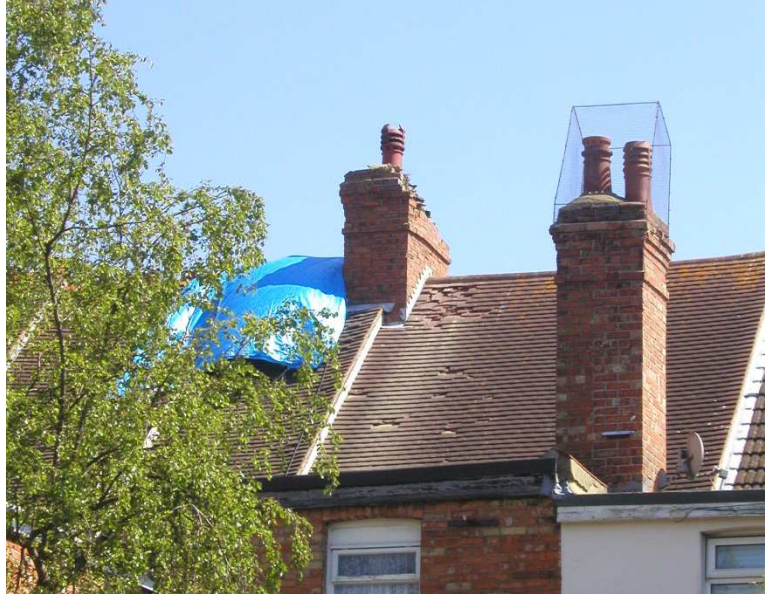
The failure of chimneys was also seen to cause secondary damage to roofs. In most cases this was limited to the removal of roof tiles (commonly seen in the lea of falling chimney pots) and in rare cases damage to the roof structure (Figure 5).

Figure 5: Park Farm Road. Chimney damage causing secondary damage to the roof.

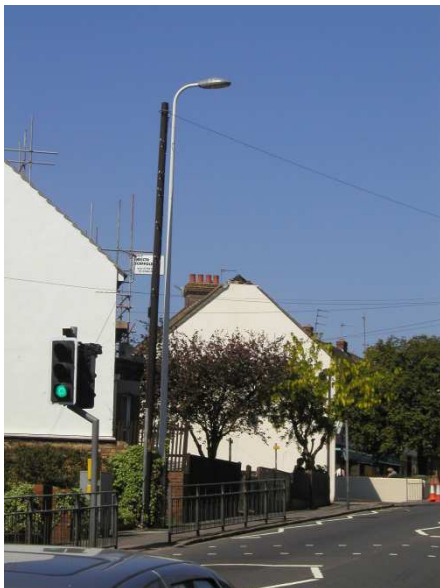
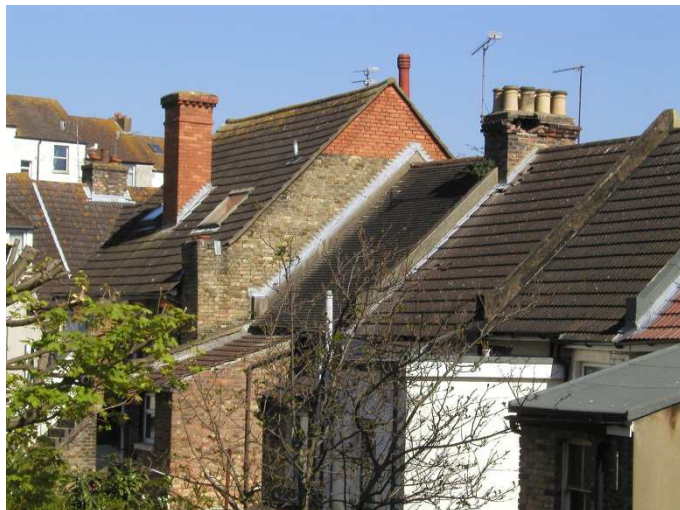
Figure 6: Damage to end of gable-end wall on Black Bull Road (left). No damage observed in the newly rebuilt gable and chimney in Foord Road (right).

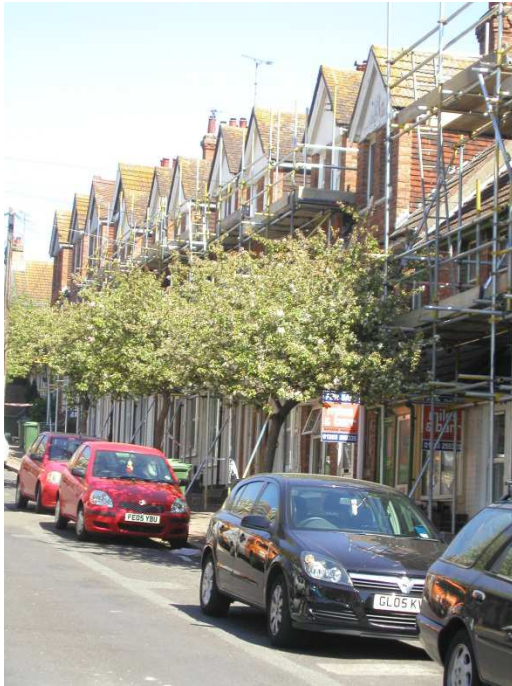
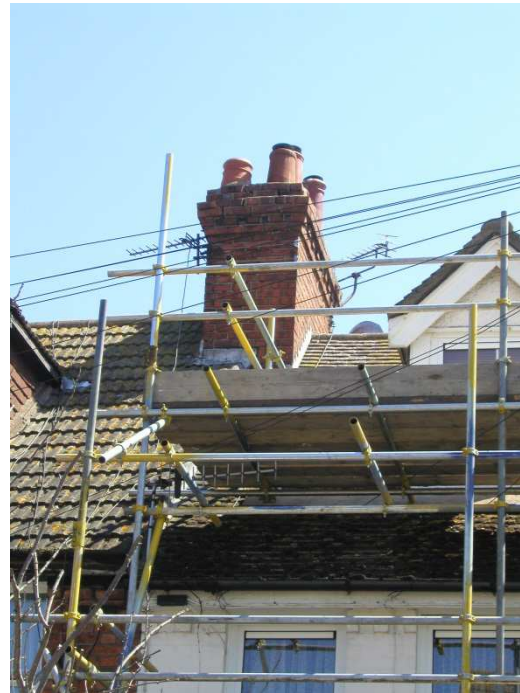
Figure 7: Marshall Street. View of scaffolding. Damage to these houses was in the form of non-structural chimney damage as seen in the picture on the right.

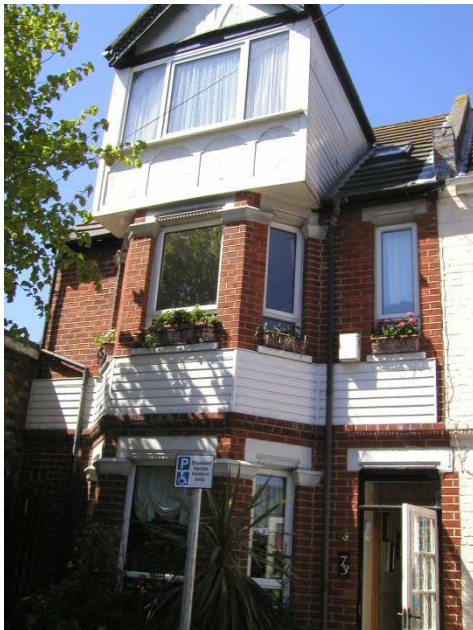
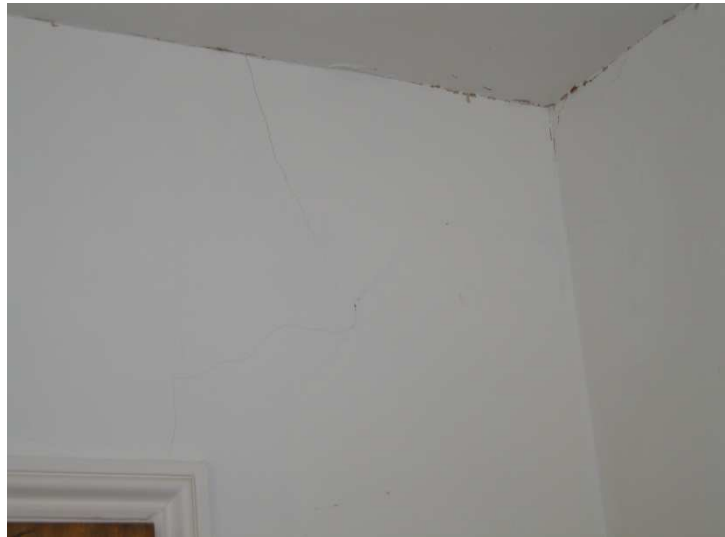
Other non-structural damage observed was damage to a gable-end wall in Black Bull Road and the cracking of plaster in some houses. The authors were able to visit the interior of a house in Linden road where minor cracking of plaster was observed. Cracking was mainly seen to occur along joints of ceiling plaster board panels. Diagonal cracking of plaster was also observed to occur above door frames (see Figure 8). This damage will only require minor cosmetic repair.

Figure: 8. Examples of hairline cracks in plaster observed within a house on Linden Road (right). External view of the property (left).

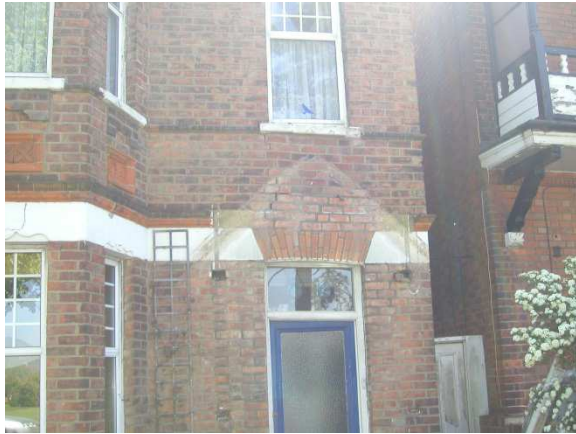
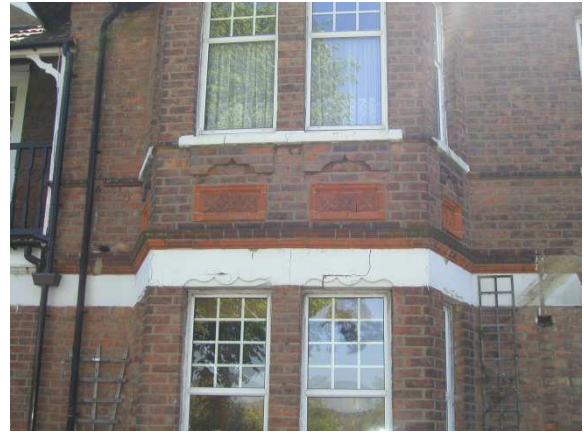
Some light structural damage was seen in a very few locations, mainly on Radnor Park Road (Figure 9) and Broadmead Road (Figure 10 and 12). Here, buildings were observed to have suffered some vertical cracking of walls and lintels. It is interesting that this observation differs from the damage reports given by the news which seem to relate the worst affected areas as being Black Bull road, Marshal Road and Linden gardens where more spectacular chimney failures occurred.

Figure 9: Light structural damage in a house on Radnor Park Road. First floor window sill is tilted, structural vertical crack to door, crack in ground floor lintel, detachment of wooden portico and significant chimney damage.

Assigning EMS-98 masonry building damage grade 2 to some buildings in Folkestone requires more judgement from the assessor. Grade 2 damage is defined as slight structural damage with moderate non-structural damage. This is described to consist of cracks in many walls, fall of fairly large pieces of plaster and partial collapse of chimneys. Whilst the partial collapse of chimneys certainly occurred extensively in Folkestone, the criteria of structural cracks in many walls was not observed except for in a small number of properties on Broadmead Road and Radnor Park Road. However, even this damage would be at the lower bound of grade 2.

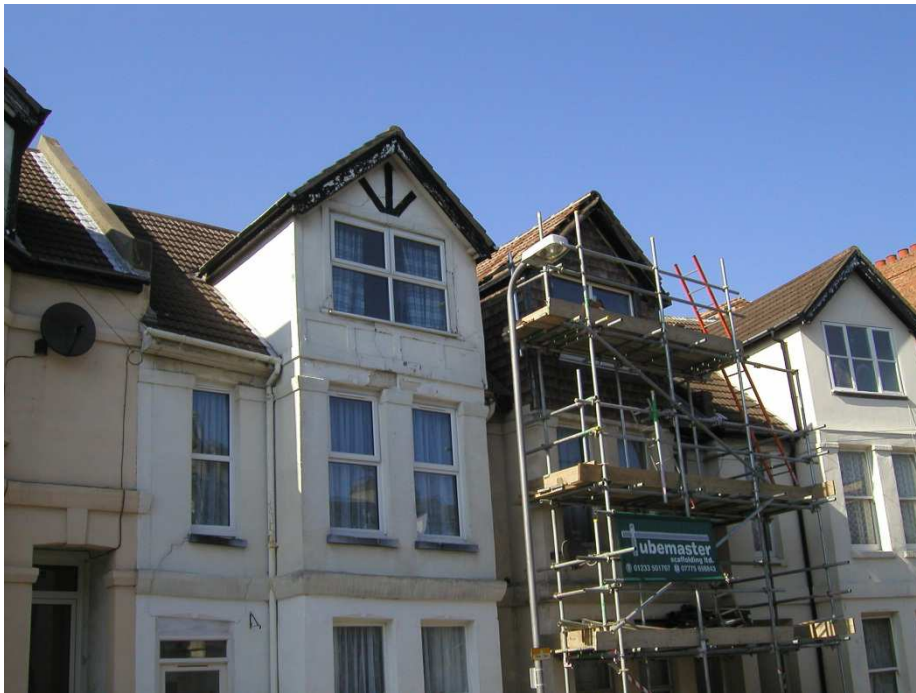
Figure 10: Broadmead Road. Structural cracking and cracking of render in the façade of a three storey house.

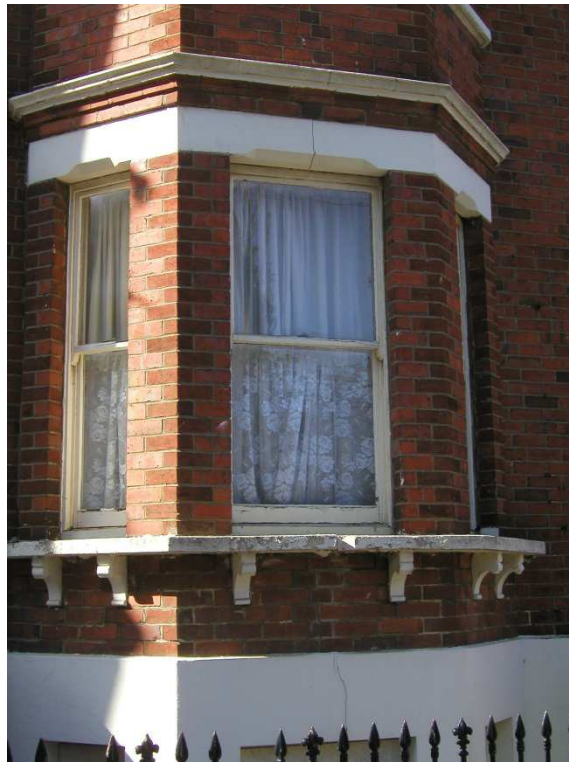
Figure 11: Broadmead Road. Vertical cracks in lintels, window sill and wall.

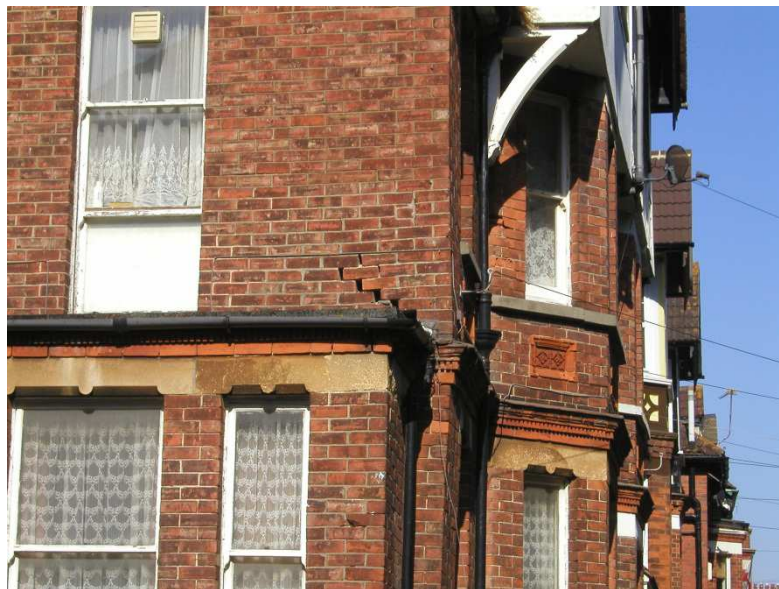
Figure 12: Broadmead Road. Large crack in the external wall of a house.

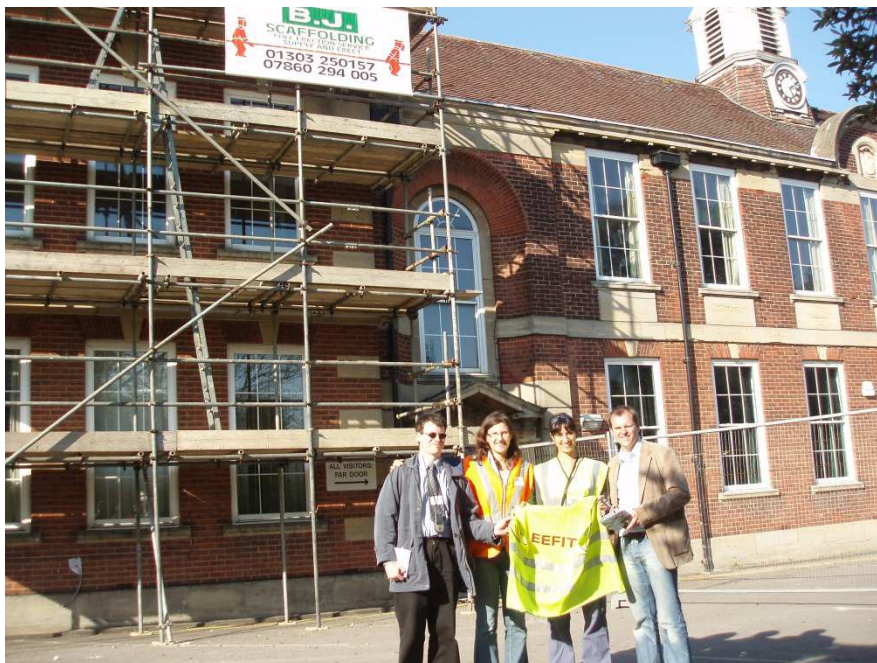
about 2km west of the main areas of damage (at Waypoint 42 on Figure 13). The school was built in 1912 to have symmetrical façades. During WWII the western façade was bombed and later rebuilt in 1945. The “plane of weakness” locally created between the old school building and the newer façade partially explains why this particular section suffered cracking along its height at its connection with the old building. Cracking was also observed in the ceilings of two classrooms on the second floor adjoining this façade.

Figure 14: Picture of eastern side of Harvey Grammar School, showing damaged façade. Photo care of Neena Saith and Torolf Hamm of Risk Management Solutions.

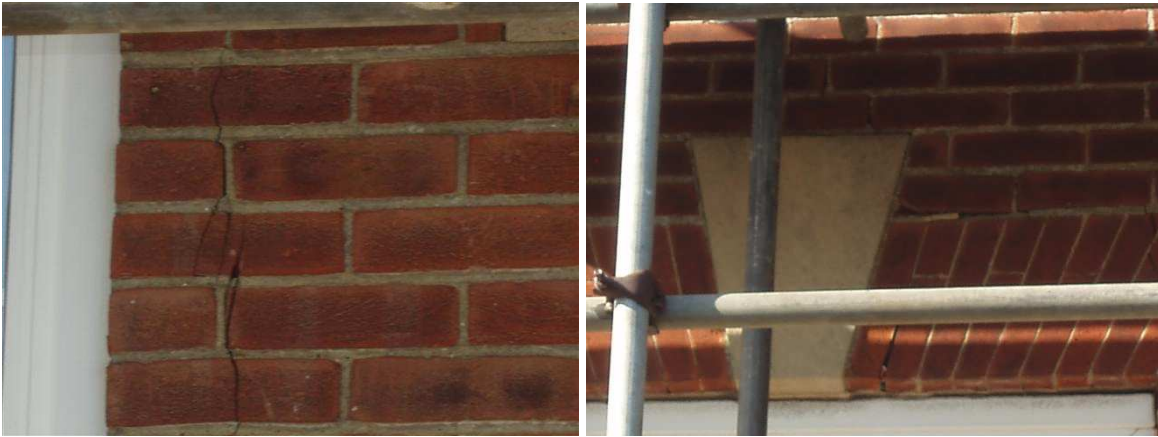
Figure 15: Cracks in western façade of Harvey Grammar School. Photos care of Neena Saith and Torolf Hamm of Risk Management Solutions.

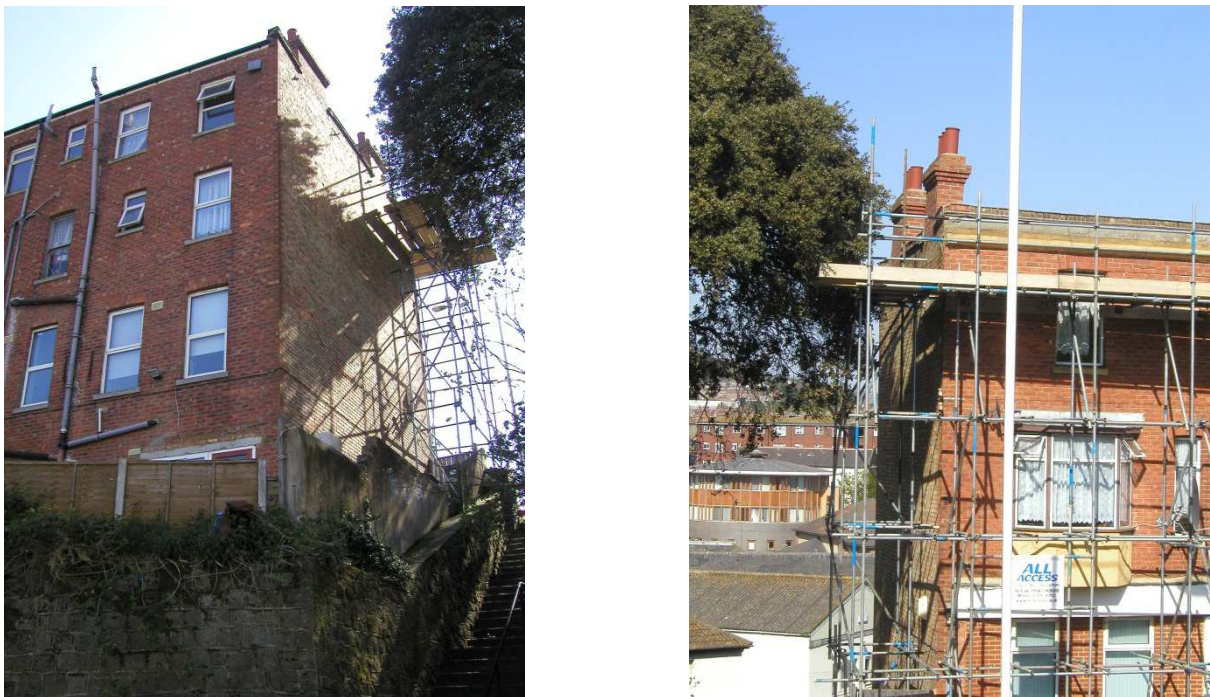
The only case of Moderate damage was observed in the building adjoining Grace Independent Baptist Church and School on Grace Hill. This building was cordoned off and condemned as it was reported to have suffered severe internal damage. A vertical crack was observed along the front of the building. Some possible torsion of the building was observed, although its severity was difficult to determine from rapid visual inspection. The authors consider this building to be particularly susceptible to earthquake damage due to its irregularity in elevation and location, (i.e. it is built on a slope so that the front is 3 storeys and the back is 4 storeys high, see Figure 16).

Figure 16: Moderately damaged building on Grace Hill.
