The Ji-Ji, Taiwan Earthquake of 21 September 1999

Earthquake Engineering Field Investigation Team

Institution of Structural Engineers

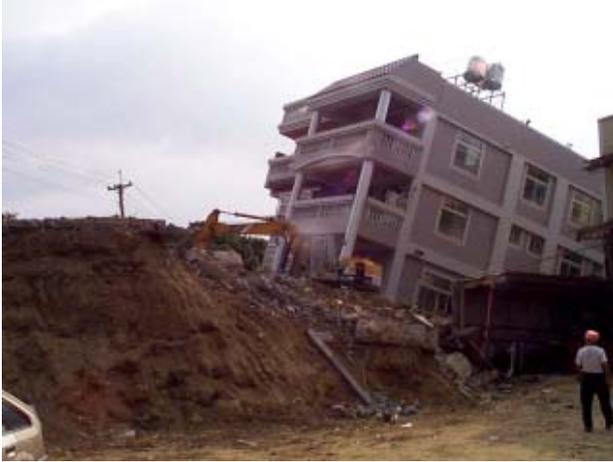
Figure 1: Fault movement caused this spectacular lift of this building that straddled across the fault

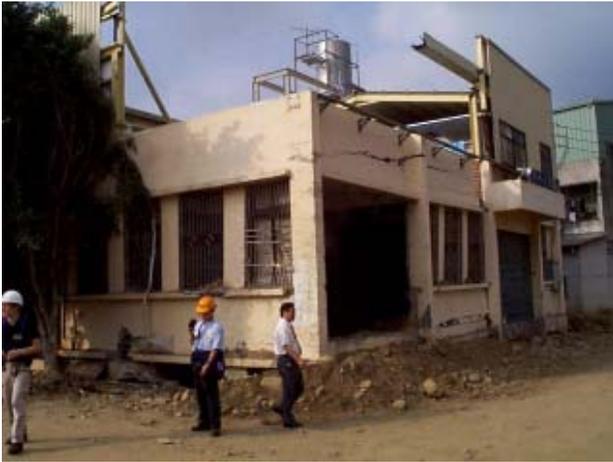
Figure 2: The building next to the one seen in the figure before suffered damage but survived without collapse

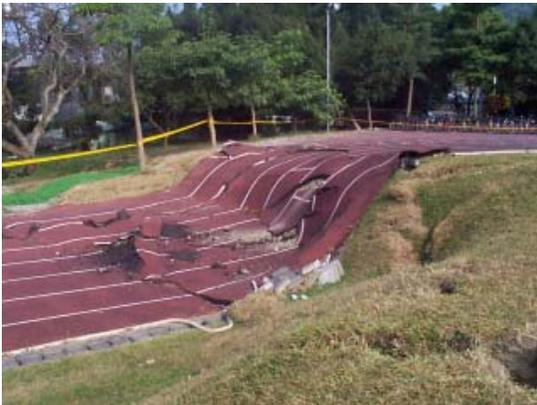
Figure 3: The athletic track at Wu Fang School suffered badly due to fault movements

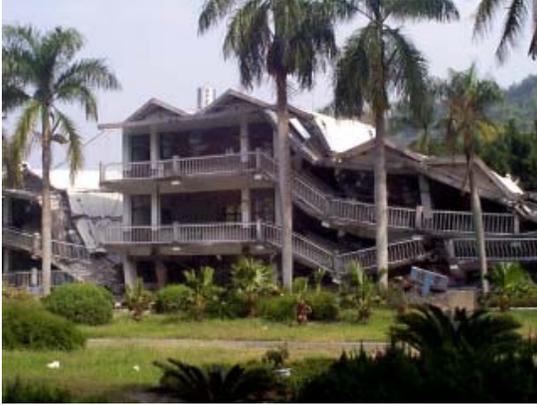
Figure 4: Collapsed Wu Fang school building close to the athletic track

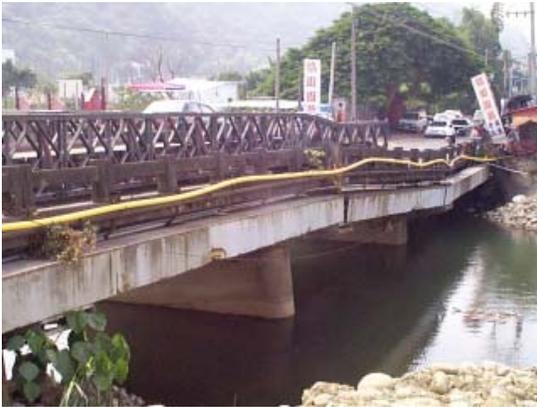
Figure 5: Where fault movements were smaller, bridges survived collapse

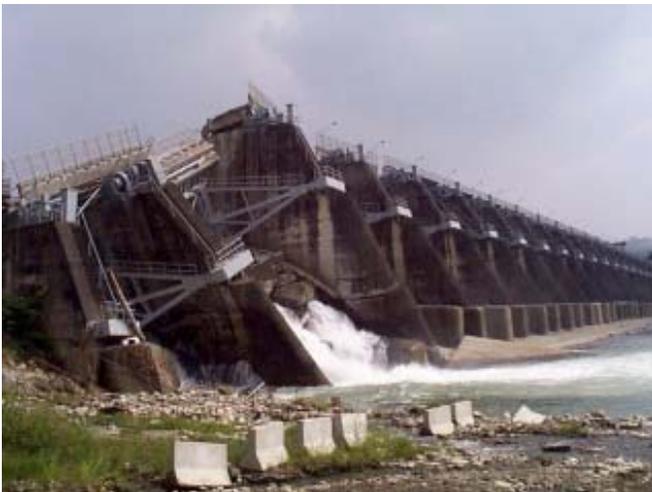
Figure 6: Failure of the dam due to fault movement (right hand side was uplifted by the earthquake)

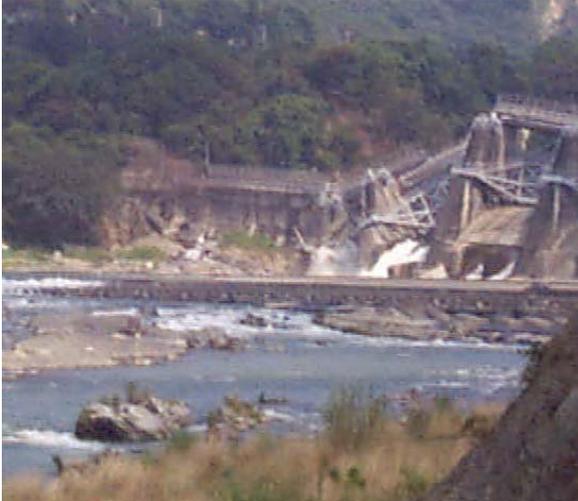
Figure 7: Left hand edge of the dam which indicates the original level of the dam crest

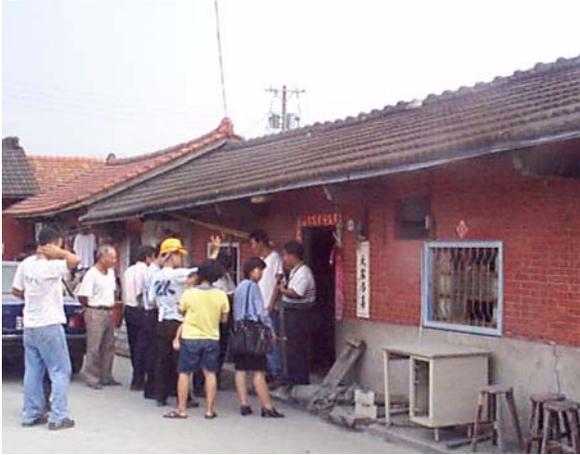
Figures 8 and 9 show a block of single storey houses in the suburbs of Yuan Lin city which suffered extensive liquefaction. The buildings settled and liquefied soil flowed into the rooms through the floor slabs, filling the rooms and lifting the furniture.

Figure 8: Single floor tiled roof house suffers settlement following liquefaction of sub-strata

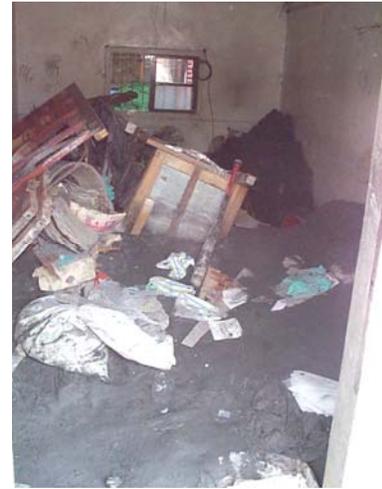
Figure 9: A view inside the house showing the inflow of sub-strata filling the room and lifting the furniture

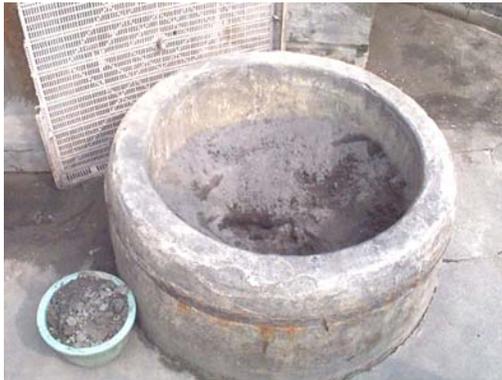
A nearby well was filled with liquefied soil flowing from the sub-strata (Figure 10), and eye witness accounts suggest that immediately following the earthquake there was high pressure ejection of soil from the sub-strata.

Figure 10: Well filled by liquefied soil

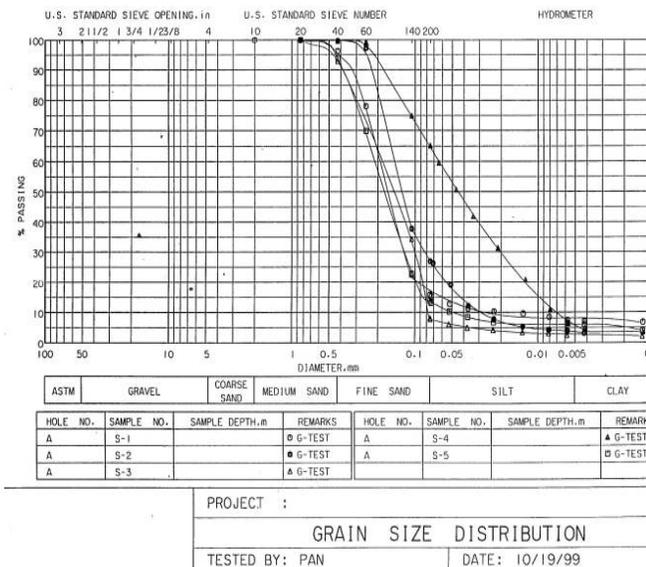
Fig.11: Particle size distribution of soil from the well in Fig.10, (courtesy A J Brennan, Research Student, Cambridge University)

Fig. 11 shows the particle size distribution of the soil samples collected from the well site, which confirm that the sub-strata consisted of fine grained sandy soils, which are susceptible to liquefaction. Following the EEFIT visit to this site, data was also obtained from bore samples in the area, and the sub-strata interpreted as shown in Fig.12. This indicates that the top soil layer consisted of clayey soil, with liquefiable layers below. It therefore seems likely that the excess pore water pressures generated in the sub-strata were initially retained by the upper clayey soil, leading to a sudden burst into the floor slabs of the houses and the well and an outflow of the material from the sub-strata.

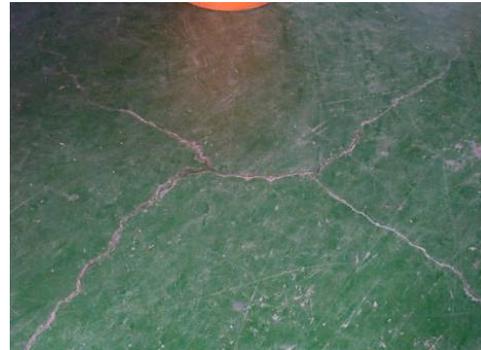
A nearby factory compound displayed sand boils and mud volcanoes in the open compound. The factory floor slabs also exhibited classical yield line patterns (Figure 13), indicating that the ground below suffered settlement following liquefaction, offering little support to the floor slabs and causing them to fail.

Figure 13: Yield lines in floor slab

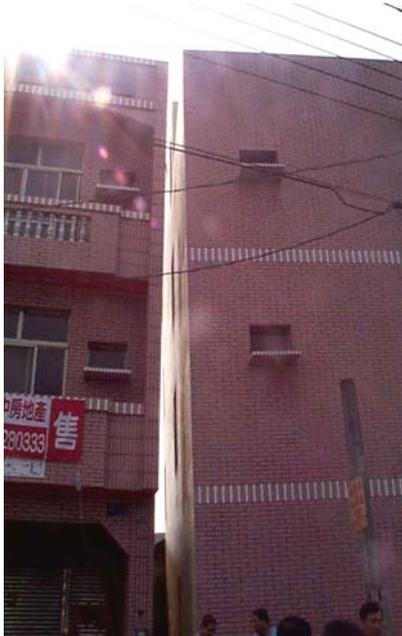
In Yuan Lin city, there were many buildings which suffered liquefaction induced settlements. Figure 14 shows rotation of a three storey building towards its neighbour. Figure 15 shows the settlement of this building relative to the road level, while Figure 16 shows a column breaking away from the floor slab at foundation level.

Figure 14: Building rotation due to differential settlement following liquefaction of the foundation soil

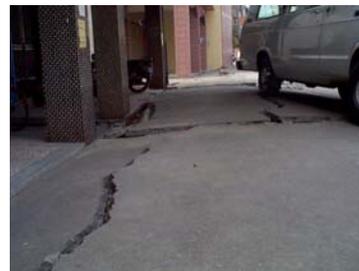
Figure 15: Settlement of the ground floor relative to road level

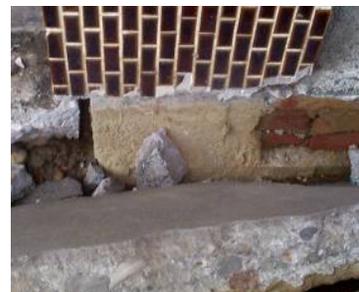
Figure 16: Settlement of a column at the foundation

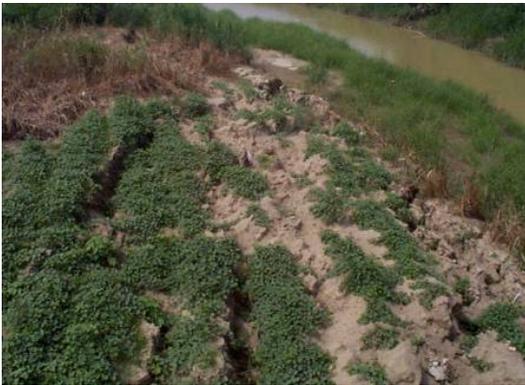
There were many examples of lateral spreading in this earthquake, and a typical example is at the site of a new bridge near Nantou city, shown in Figure 17. Liquefaction of the soil was very obvious at this site with sizeable sand boils visible on the ground surface, examples of which are shown in Figure 18.

Figure 17: Lateral spreading of the slopes parallel to abutments showing deep tensile cracks

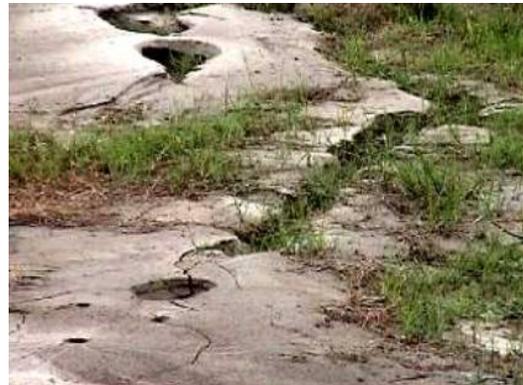
Figure 18: Sand boils at the new Nantou Hsou-Shi bridge site

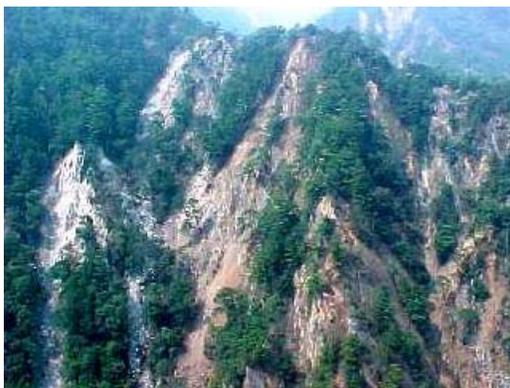
Taichung and neighbouring districts witnessed landslides on a massive scale, resulting in major destruction of the overgrowth, as shown in Figure 19.

Figure 19: Landslides causing loss of over growth

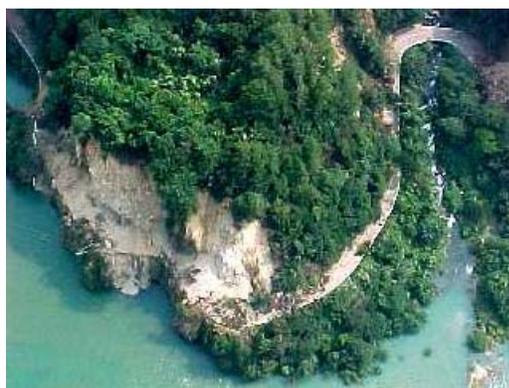
Figure 20: Blocking of hill roads due to landslides

By and large, the land slides seem to have occurred at fairly shallow depth, and were not deep seated slope failures. A shallow depth of the top soil has suffered slippage causing the tree and plant debris to slide downhill thereby exposing the soil layers below. Figure 20 shows blockage of the hill roads, which was a common result, leading to a loss of communication between Taichung city and interior villages.

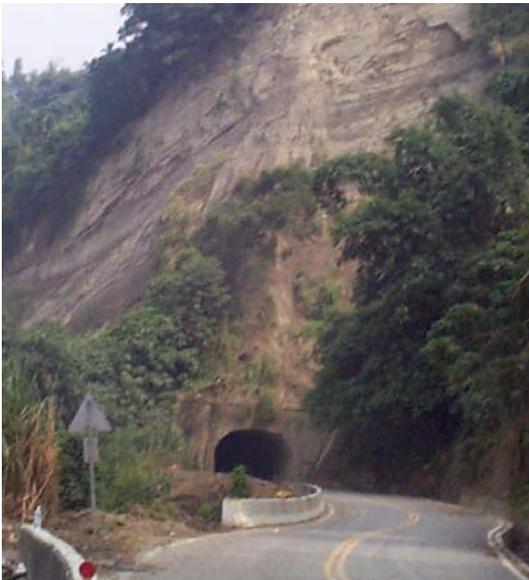
The performance of tunnels following the earthquake was mixed. Figure 21 shows one such tunnel which suffered structural damage to its lining. However, the tunnel was located in a hill side which suffered landslides with material from the top of the slope sliding parallel to the tunnel axis. It was therefore not clear whether the damage to the tunnel lining was due to the earthquake loading causing additional stresses in its lining or due to material flow close to the tunnel crest. The tunnel was leaking water and the road was blocked off by the authorities.

Figure 21: Tunnel located in the side of a hill with landslides at the surface

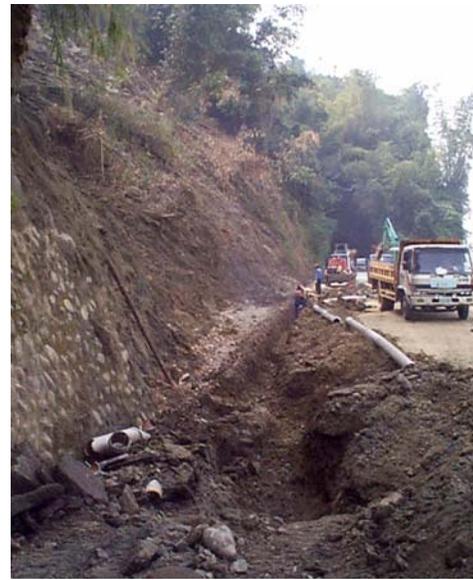
Figure 22: Landslides caused failure of the lifelines laid next to the roadway

The landslides also caused to damage to the lifelines laid next to the road way. In Figure 22, the re-laying of new lifelines can be seen.

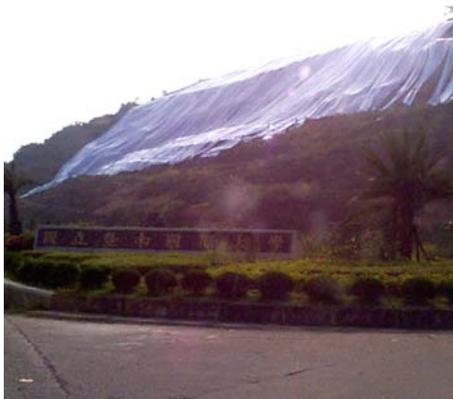
Figure 23: Reinforced slope failure

The earthquake provided an example of the performance of a reinforced slope. The slope is located at the campus of the National Chihnan University of Information, and is approximately 120 m high, with failure occurring over a width of about 300 m. Figure 23 shows the failure.

A polyethylene cover had been placed on the upper reaches of the slope after the earthquake, to prevent further sliding due to rain water seeping into the slope. The slope angle is very steep and was estimated at approximately 70° . As a result a reinforcement was used which consisted of geotextiles and geonets. The geotextile appeared to have been laid horizontally and was wrapped around a geonet filled with locally available material (rocks plus coarse sand) similar to the rock filled wire mesh gabions used in the UK to stabilise slopes. The geotextile was anchored to a depth of about 2m into the slope. The slope appeared to be well designed with adequate drains at regular intervals running horizontally and well connected to vertical drains running down the slope. However, it is not known whether the slope was designed to sustain dynamic earth pressures generated during the earthquake.

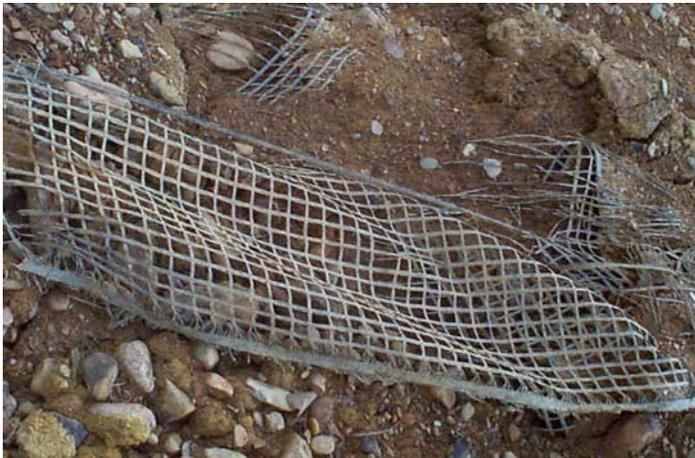
The failure of this reinforced slope was mainly due to pull out of the geotextile from its embedment. The geotextile was 'pushed out' by the material in the slope flowing downwards and outwards, and Figure 24 shows the freely hanging geotextile. The gabions made from geonets simply moved out with the geotextile as seen in Figure 25, although at some locations the geotextiles showed clear signs of tensile failure as shown. It may be possible to investigate whether such failures can be avoided by increasing the geotextile anchorage depth.

Figure 24: At some locations, the geotextile failed in tension

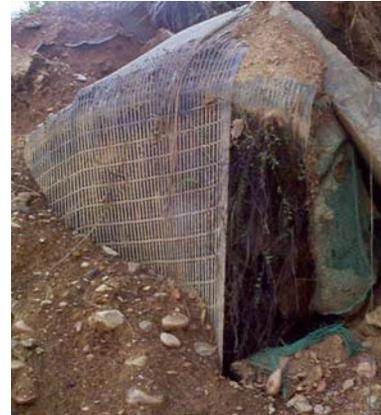
Figure 25: The wrapping of the Geotextile around Geonet gabions filled with was pulled out en bloc

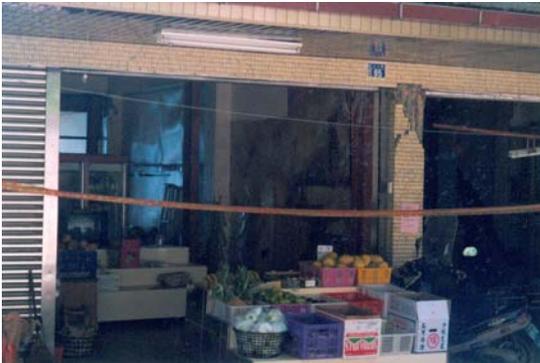
Figure 27 shows a typical open shop front; loss of concrete cover at top and bottom of the columns is noticeable, but in this case the building has survived. Figure 28 shows typical shear cracking of internal walls

Figure 27: Typical Open Shop Front

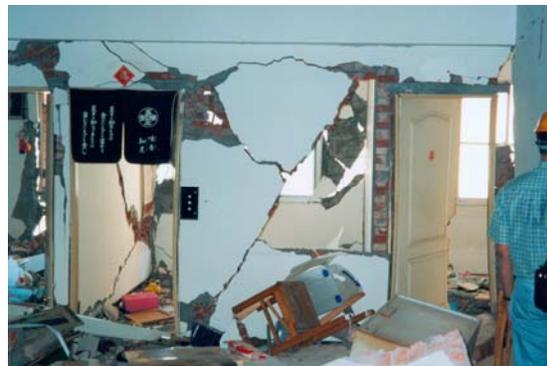
Figure 28: Shear Cracking of Internal Walls

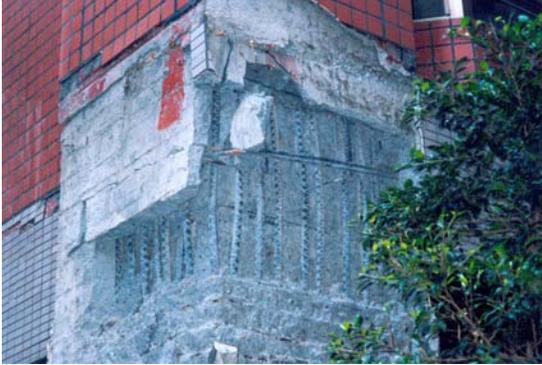
A number of common failure modes were evident. Figure 29 shows loss of cover concrete at a beam/column interface. However, it can be seen that there is closely spaced confinement reinforcement in the column in the potential hinge area immediately below the beam and this area of the building structure has remained standing.

Figure 29: Loss of Cover at Beam/Column Interface

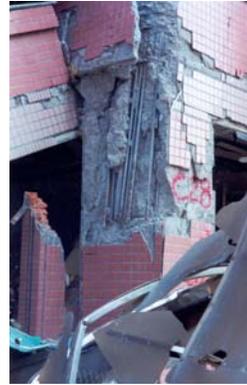
However, Figure 30 shows another column of the same building, where lack of confinement has permitted serious damage and partial collapse of this area of the building.

Figure 30: Lack of Confinement at Column Head

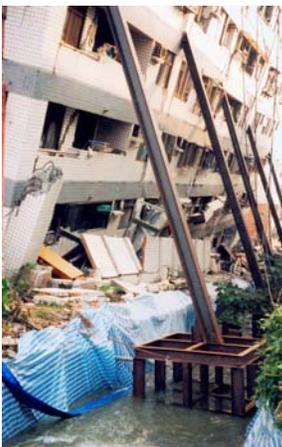
Figure 31 shows a soft storey failure, with the building now propped as an emergency measure. A failed column is visible in left centre, and the small amount of main reinforcement is striking, as is the absence of adequate confinement. Figure 32 shows another example, this time in a part complete building. The form of construction here, with part height concrete infill walls, gives rise to a very much softer storey at ground level. Again, a detached column with very limited reinforcement is visible in the foreground.

Figure 31: Soft Storey Failure

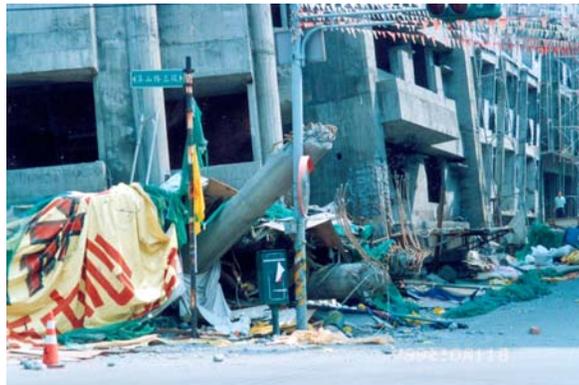
Figure 32: Soft Storey Failure

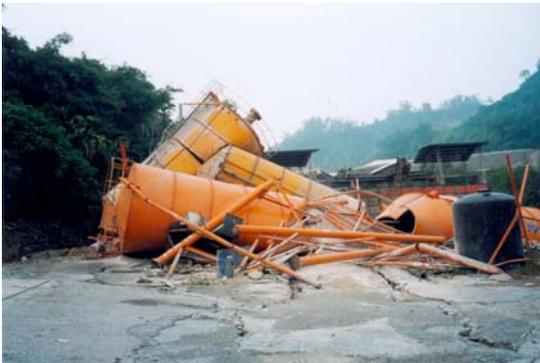
Figure 33: Collapsed Silos

However, there were many reports of damage to aggregate and concrete plants, with silos of heavy materials collapsing and damaging surrounding plant. Figure 33 shows one such example.

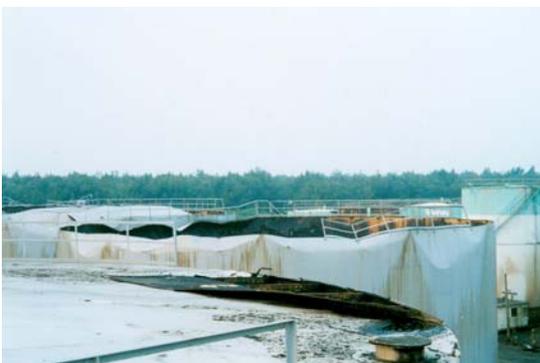
Sloshing of the contents of molasses storage tanks at Taichung port caused significant tank damage as shown in Figure 34, while Figure 35 shows settlement of pipeline supports due to ground liquefaction.

Figure 34: Tank Damage at Taichung Port

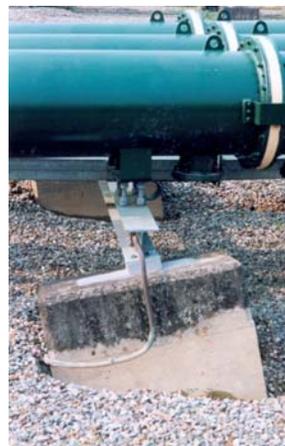
Figure 35: Pipeline Settlement Through Ground Liquefaction

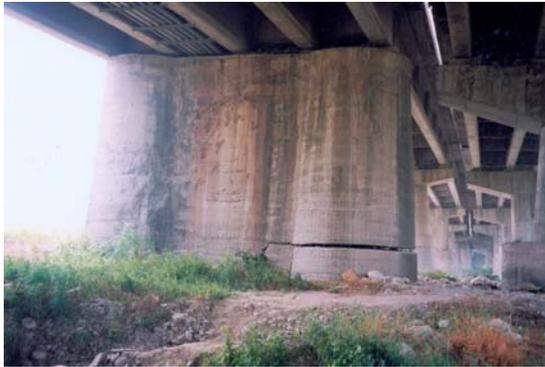
Figure 36: Bridge Pier Failure from Transverse Acceleration

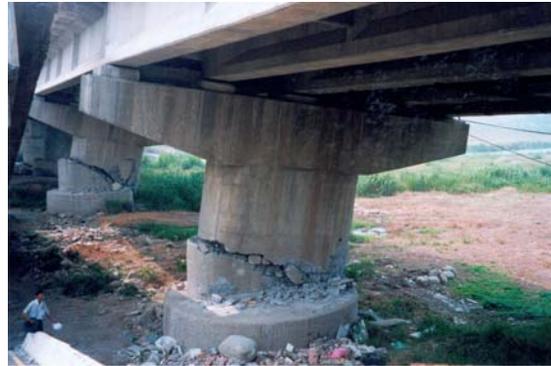
Figure 37: Shear and Transverse Displacement of Bridge Piers

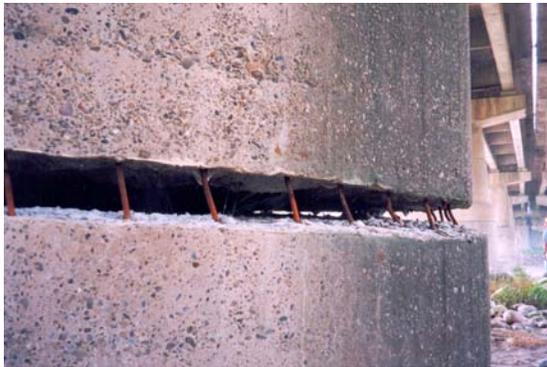
Figures 36, 37, 38 show structural failures of bridge piers; note the light reinforcement in Figure 38.

Figure 38: Close Up of Bridge Pier Reinforcement

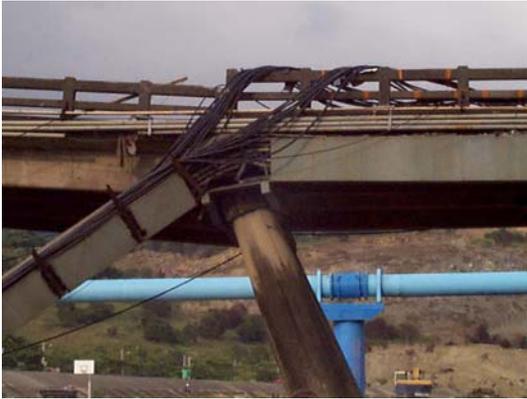
The old bridge suffered total damage with decks falling off the bearing pads on the supporting piers. The pier rotation was largely driven by the deck movements as seen in Figure 39. In Figure 40 the new bridge pier with no bridge deck in place can be seen in the foreground. This pier has suffered rotations in the opposite direction compared to the old bridge piers. This example illustrates the dynamics of the bridge deck, bridge pier and the foundation soil system.

Figure 39: Rotation of the old bridge piers due to deck movements

With the inertia of the bridge decks driving the movements the old piers were forced to rotate due to the lateral inertial forces being applied by the deck. The foundation soil appeared to be silty sand in a fully saturated state owing to the proximity of the river (see Figure 40). As a result, there would have been some excess pore water pressure generation, leading to a degradation of its stiffness. Unable to resist the moment being applied by the deck, the foundation block supporting the pier simply rotated in an anti-clockwise direction. The new bridge pier with no load on the top had an opportunity to undergo free vibrations. With the foundation soil softening it suffered differential settlements and rotated clockwise. Full liquefaction was obviously not realised as the overall settlement of both the old and new bridge piers seem to be small.

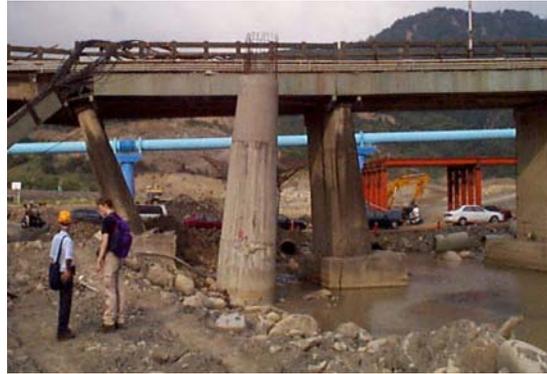
Figure 40: The new piers with no bridge deck suffered rotation in the opposite direction

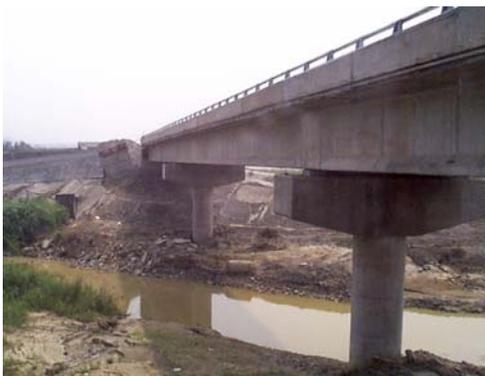
Figure 41 shows a bridge near Nantou city while Figure 42 shows a close up of the far abutment, which was completely destroyed. Lateral spreading was also very clearly evident at the base of the bridge piers. Local enquiries confirmed that the piers were designed to modern standards and were founded on deep piles carrying loads to competent bed rock.

Figure 41: Overview of the bridge and the piers, the abutment on the far side was destroyed as seen in Figure 42

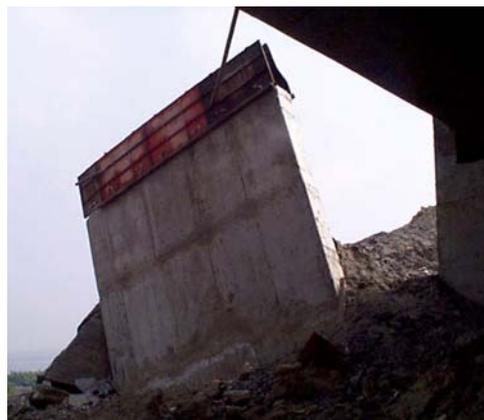
Figure 42: Bridge abutment completely destroyed

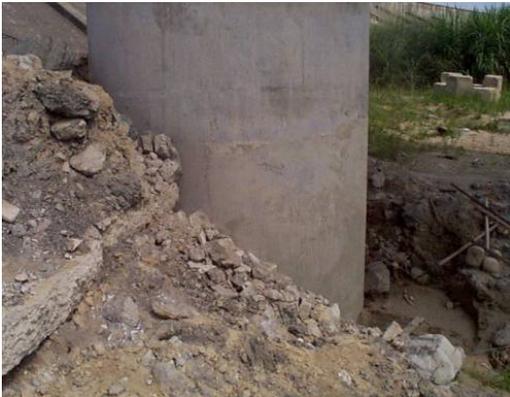
Figures 43 and 44 show the soil flow at the base of the piers. As the soil flow towards the river is obstructed by the pier, there was a ground heave observed in the regions behind the piers.

Figure 43: Soil flow obstructed by the pier causes a ground heave behind the pier

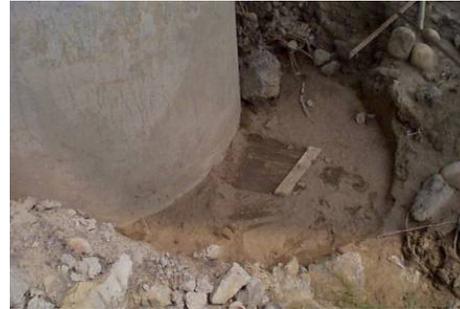
Figure 44: Close up view at the base of the pier showing the original mark of the pier before lateral spreading

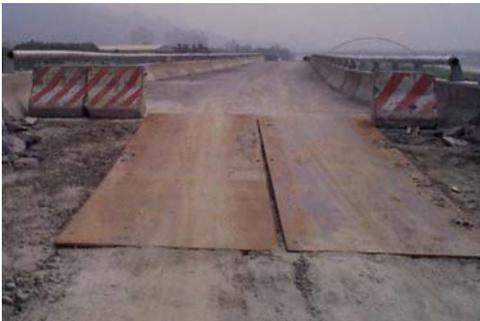
In Figure 45 the approach roads are seen to have settled relative to the bridge deck. This is consistent with the fact that the piled foundations and piers supported the deck well and consequently no settlement of the deck was visible.

Figure 45: Settlement of the approach roads relative to the bridge deck

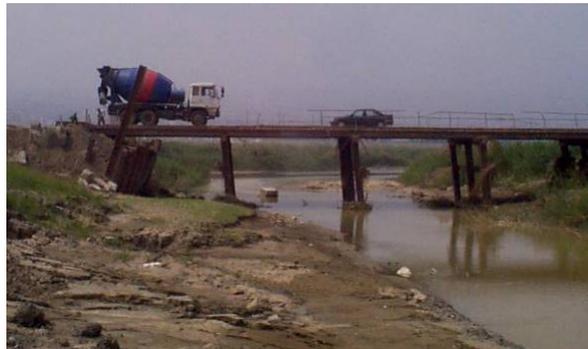
Figure 46: Precarious rotations of the old bridge piers, pressed into action to ferry materials to repair the new bridge abutment

Figure 46 shows the piers of an old bridge, which was brought into use following the failure of the abutments and approach roads of this new bridge. The piers of the old bridge show extensive rotation, confirming the lateral spreading at this site.

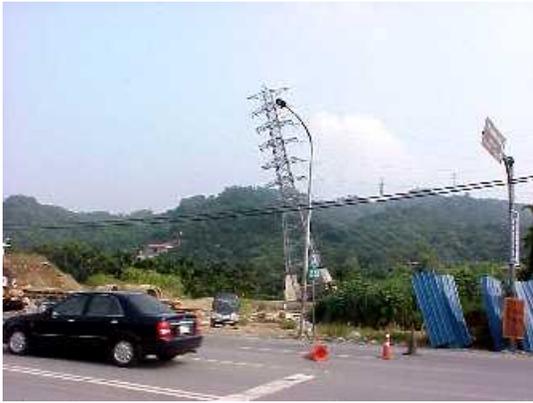
Although it seems that generating capacity remained largely operational, there was significant damage to substations and to the transmission system (Figures 47 and 48). However, the Taiwan Power Company did anticipate restoring virtually all supply within a month of the earthquake.

Figure 47: Typical Transmission Tower Damage

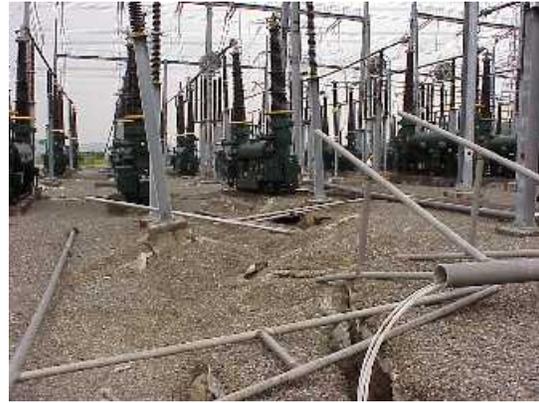
Figure 48: Damaged Substation

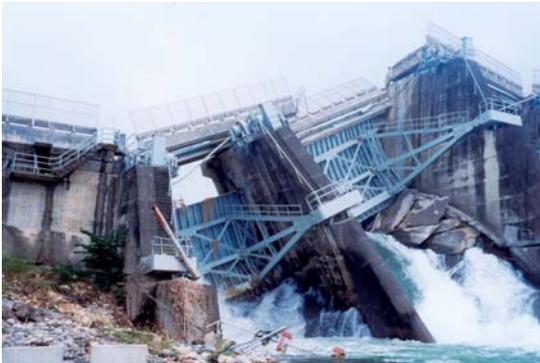
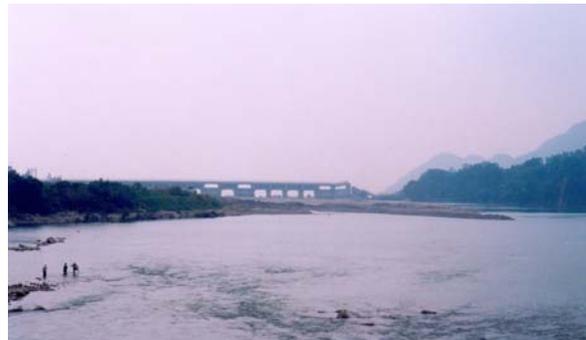
Figure 49: Shih-Kang Dam

It is estimated that there are 5 million water consumers in the region, and around 80% suffered some disruption of supply. The most spectacular effect, widely reported, was failure of the Shih-kang dam, some 50km from the epicentre, which supplied about half the water for the area. The fault passed through one end of the dam, and the vertical ground movement of 10m caused collapse of that end of the dam (Figures 49 and 50).

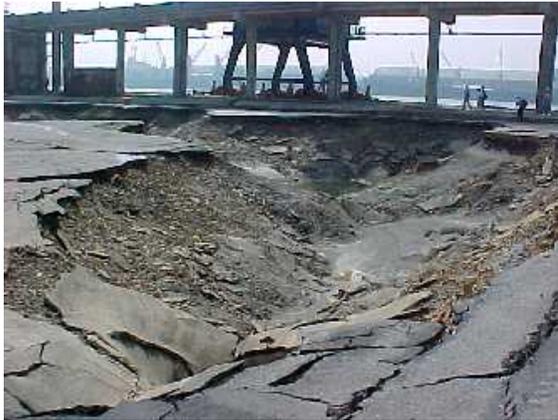
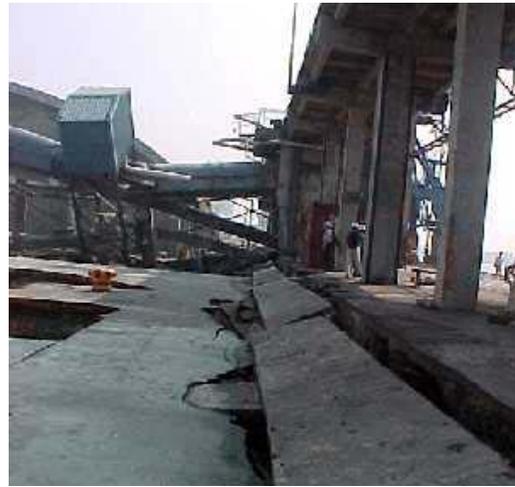
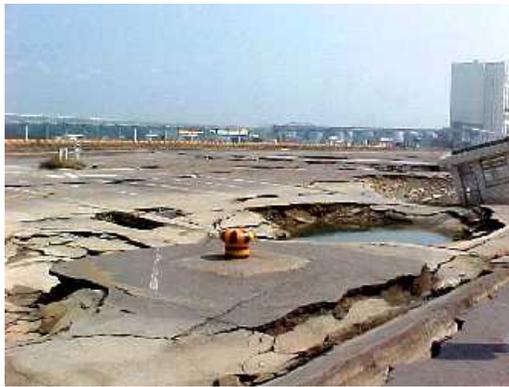
Figure 51: Taichung Port

Taichung port was significantly affected by liquefaction, with numerous sink holes appearing. The quay walls also moved slightly, with the ground behind them reported to have settled up to 2m. Figures 51, 52 and 53 show typical damage.
