THE KASHMIR, PAKISTAN  
EARTHQUAKE OF 8 OCTOBER 2005  
A FIELD REPORT BY EEFIT

## A FIELD REPORT BY EEFIT

July 2008

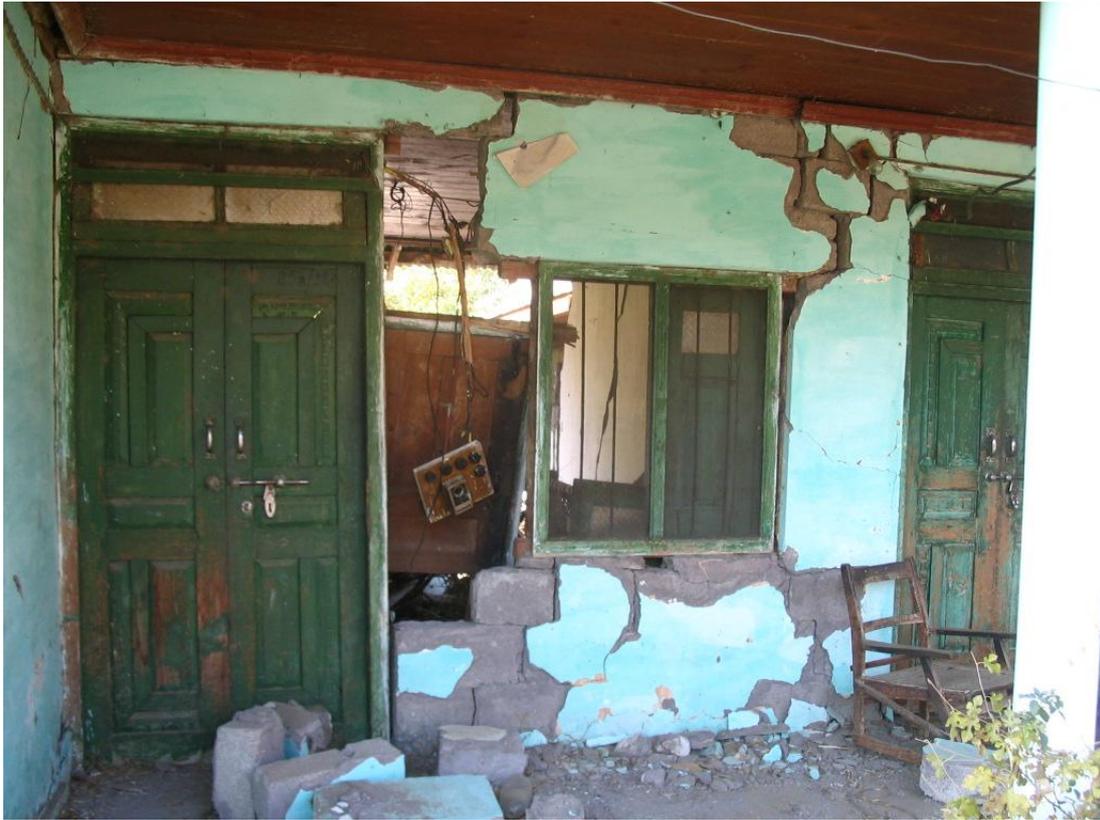
**Figure 3.3: Damaged unreinforced concrete block masonry office building south of Balakot**

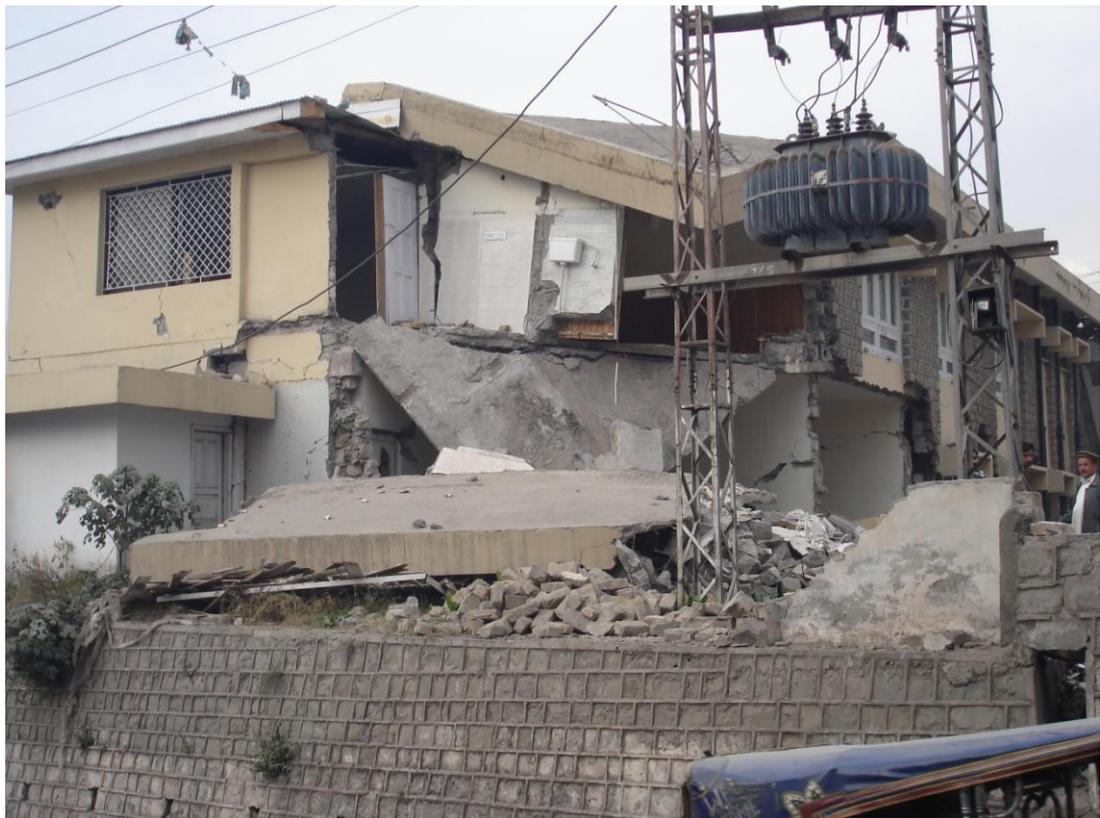
**Figure 3.4: Damaged 2-storey concrete block masonry building in Muzaffarabad**

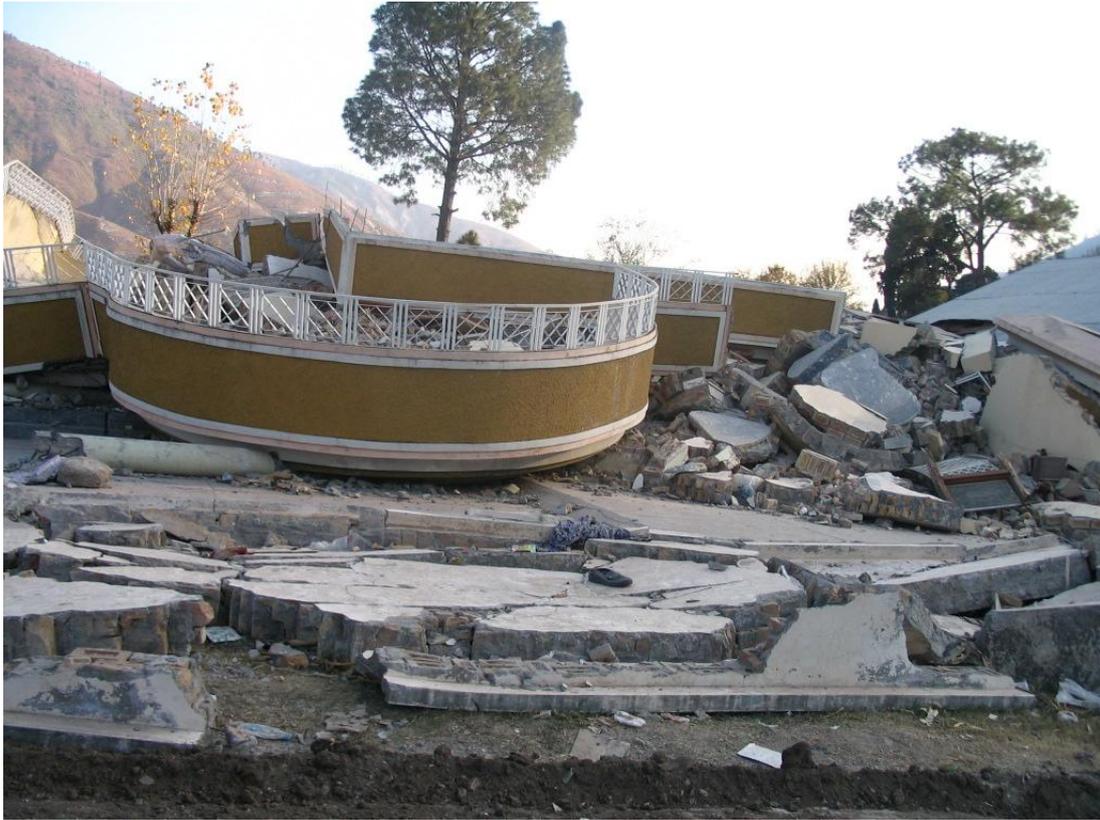
**Figure 3.5: Collapsed unreinforced brick masonry house in Balakot**

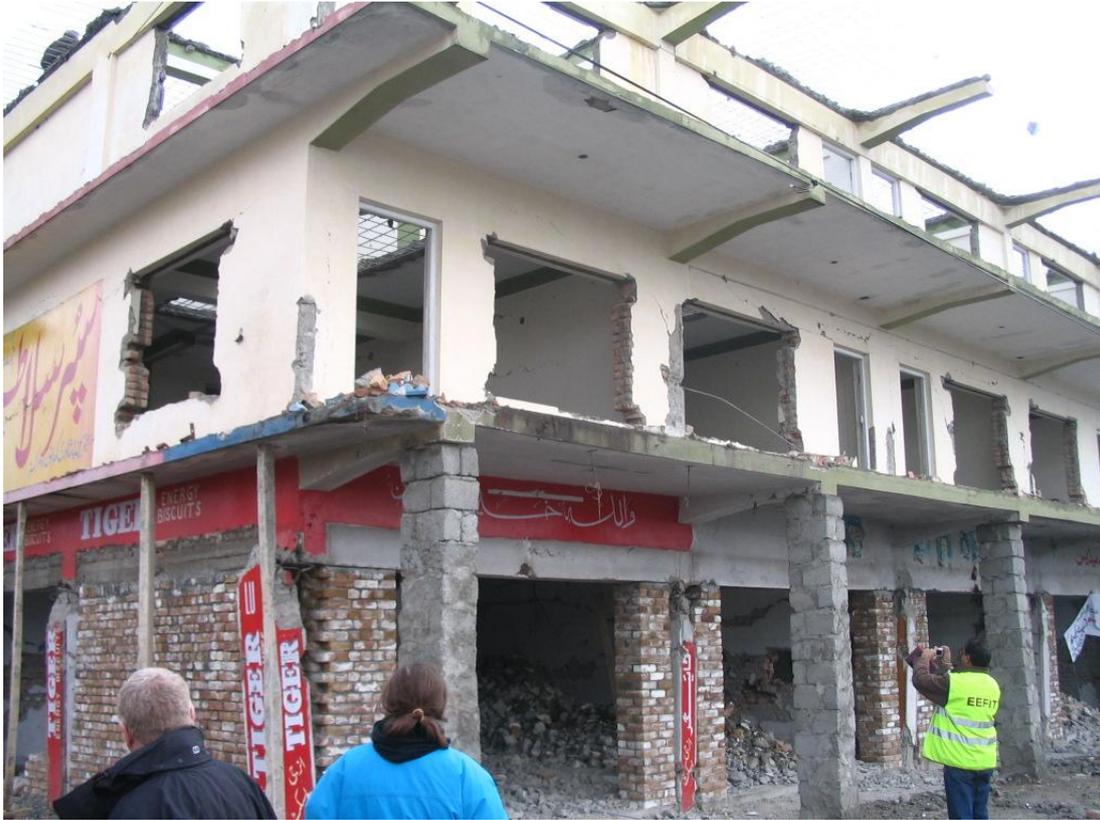
**Figure 3.7: Moderately damaged commercial/retail building of RC frame and slab construction with brick masonry infill in Abbotabad**

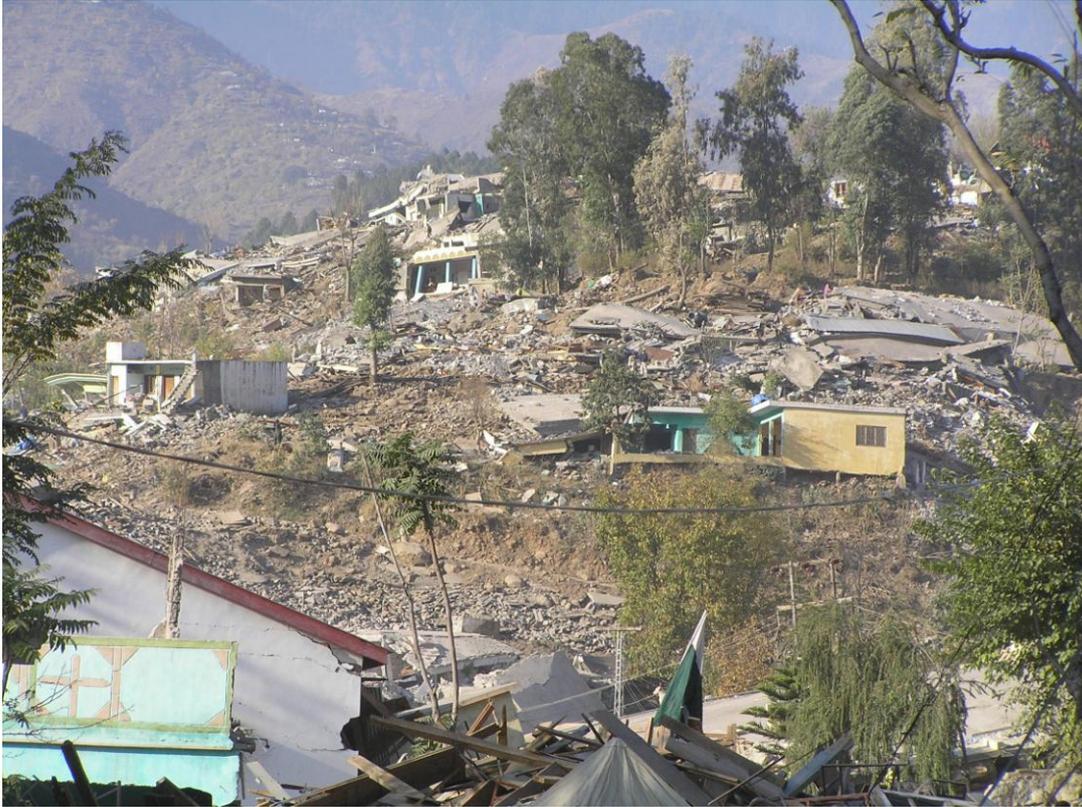
**Figure 3.11: Collapsed and extensively damaged concrete block URM residential units on a hill northwest of Balakot city centre (zone 1)**

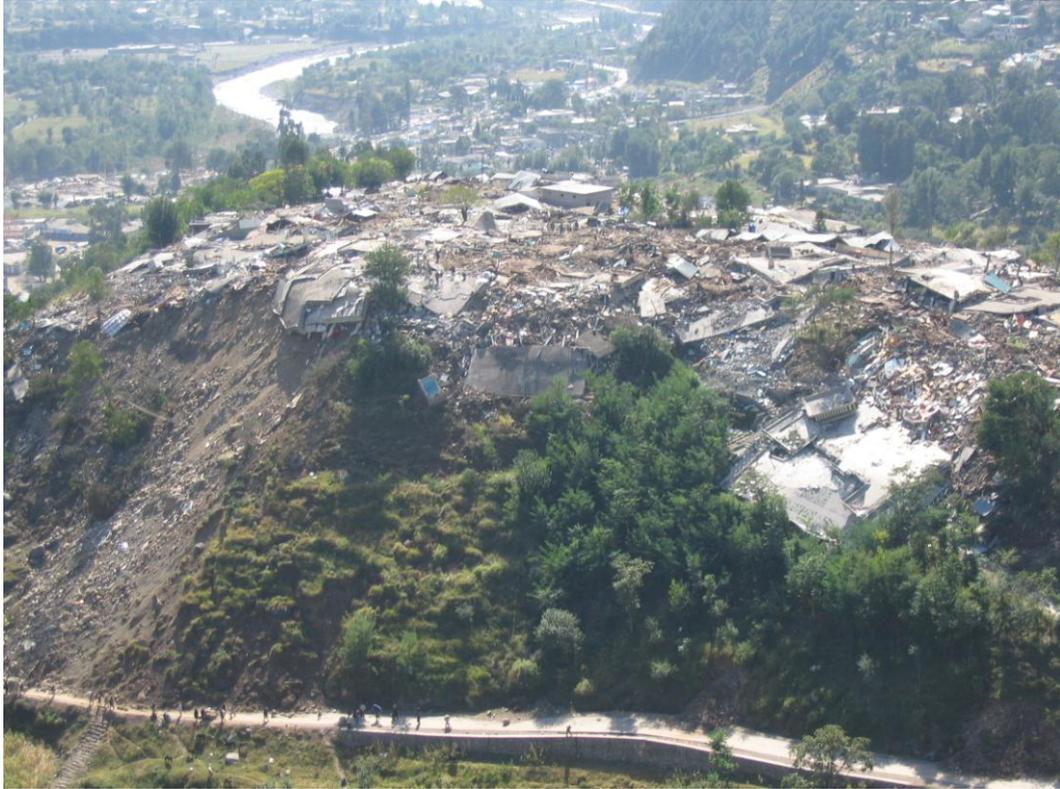
**Figure 3.12: Collapsed and extensively damaged concrete block URM residential units in zone 1 overlooking Balakot city centre (photo by Kathrin Renner (Arup) and US Army)**

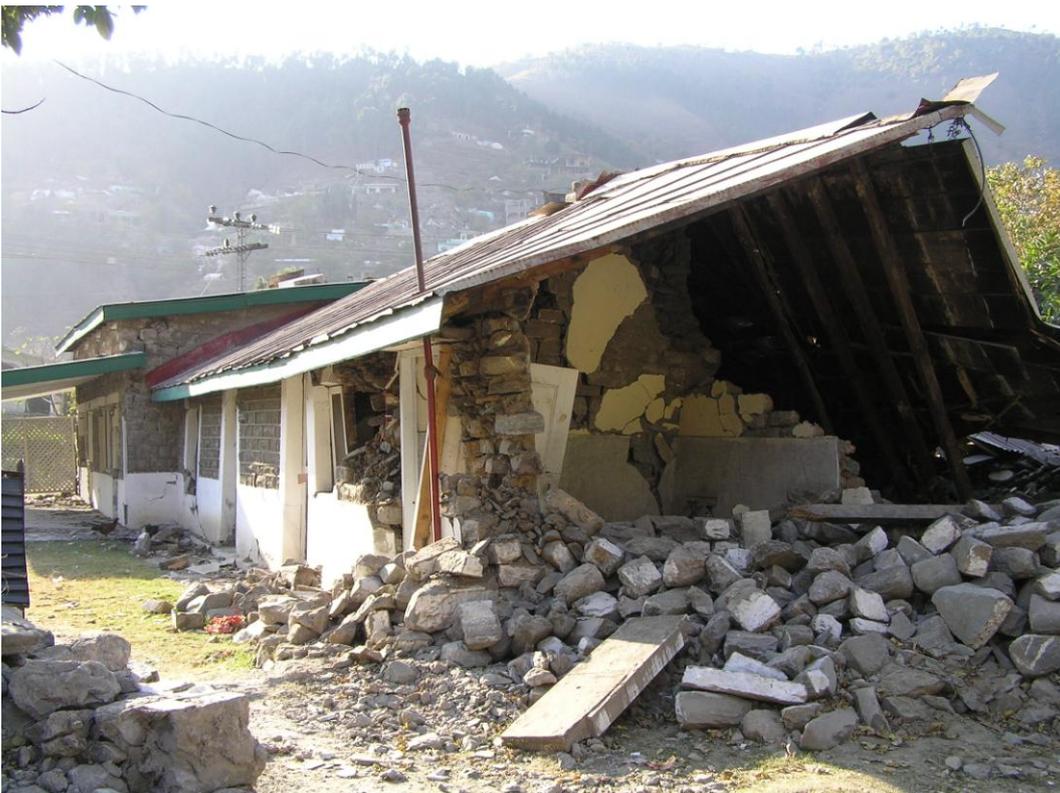
**Figure 3.13: Extensively damaged stone URM building with metal roof in Balakot, used by the local audit officer**

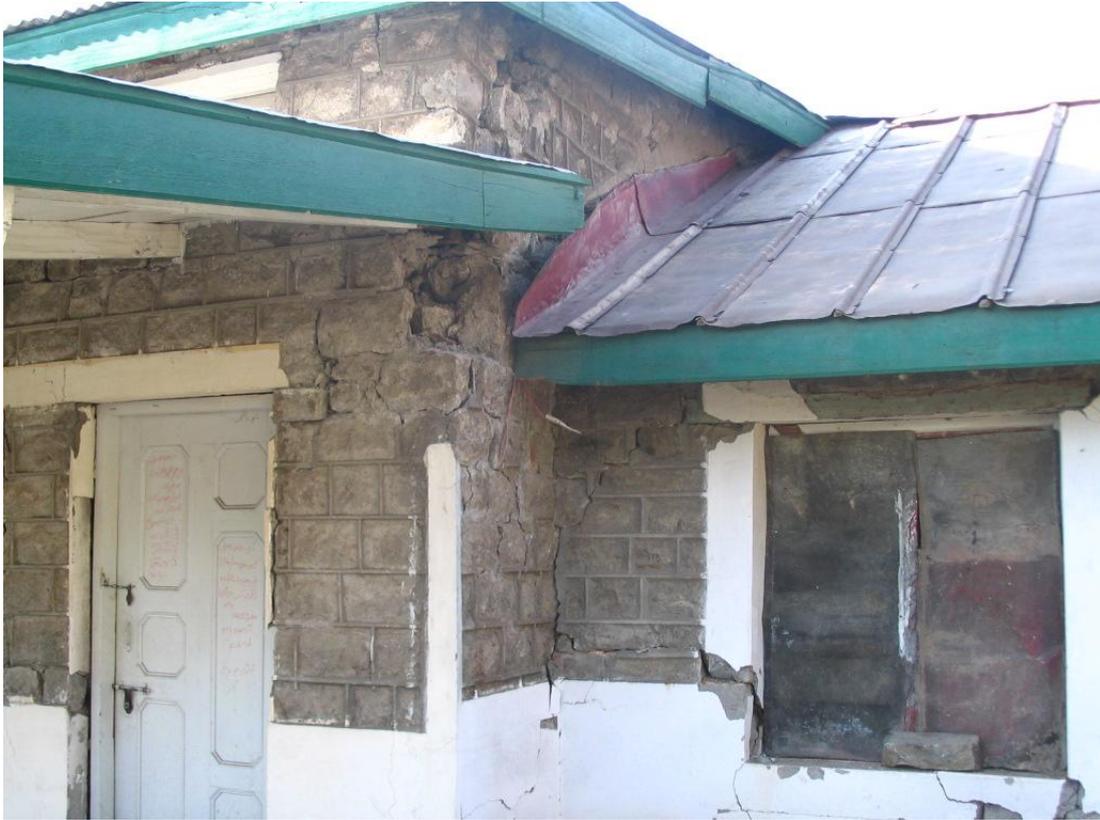
**Figure 3.14: Cracks through stone and mortar in a stone URM building adjacent to the extensively damaged stone building in Figure 3.5**

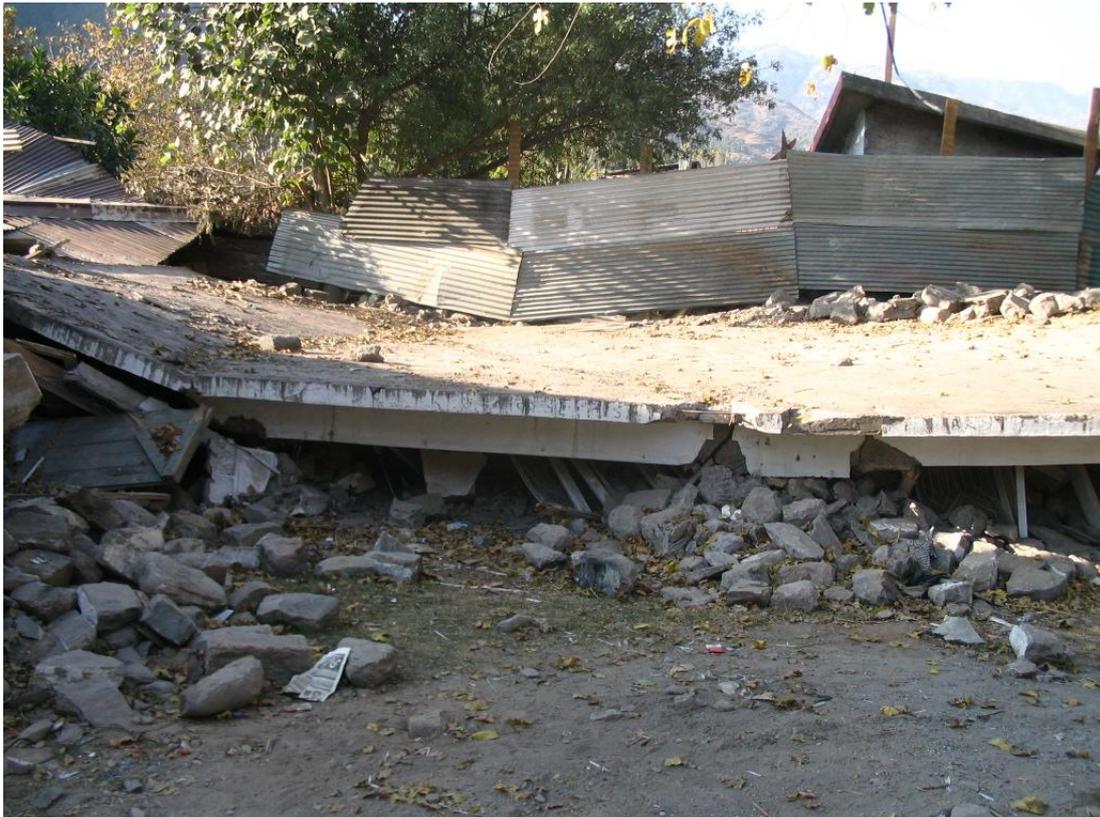
**Figure 3.15: Collapsed concrete block URM residential building in Balakot**

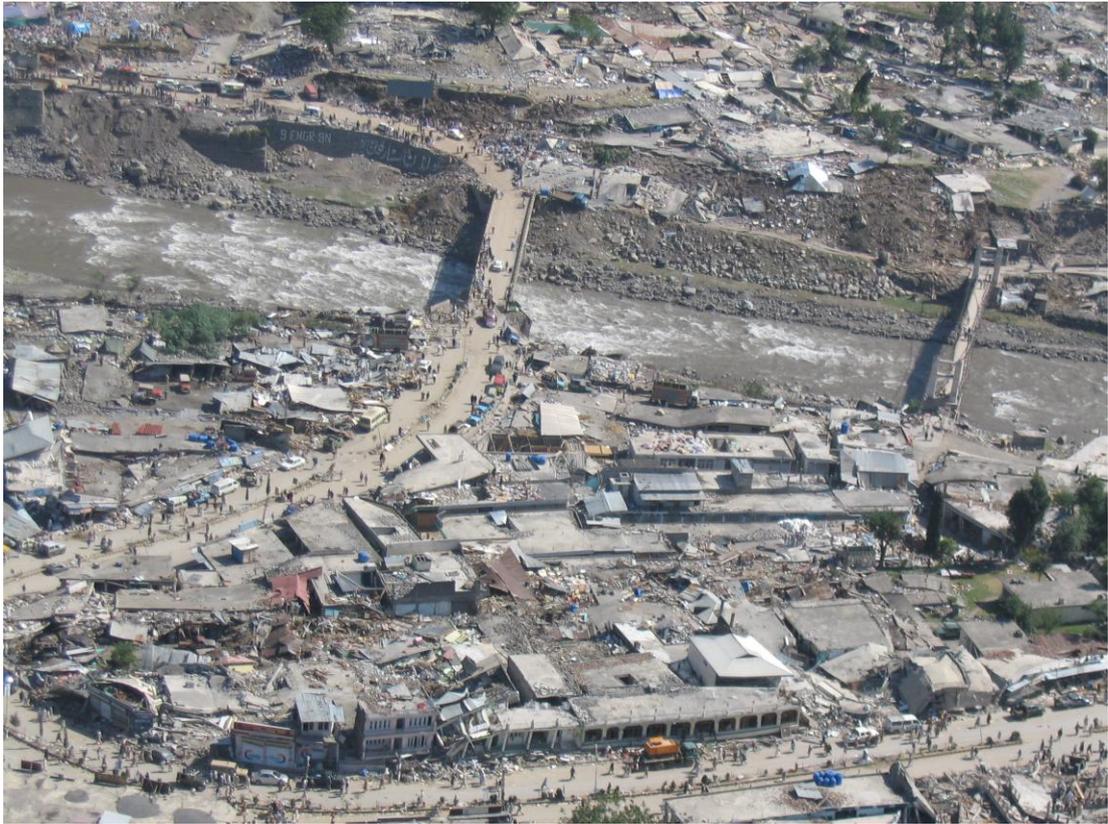
**Figure 3.16: Aerial view of the damaged Balakot city commercial area (photo by Kathrin Renner (Arup) and US Army)**

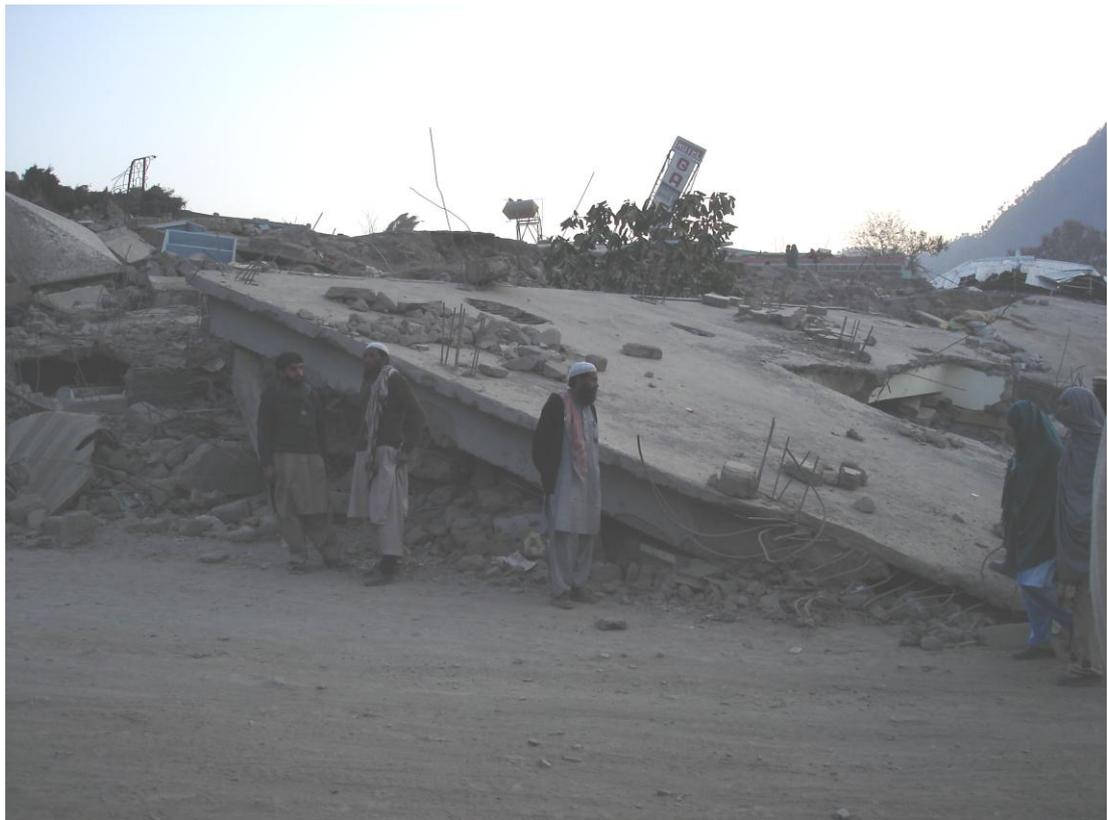
**Figure 3.17: Collapsed single storey RC frame and slab commercial/retail building in Balakot city centre**

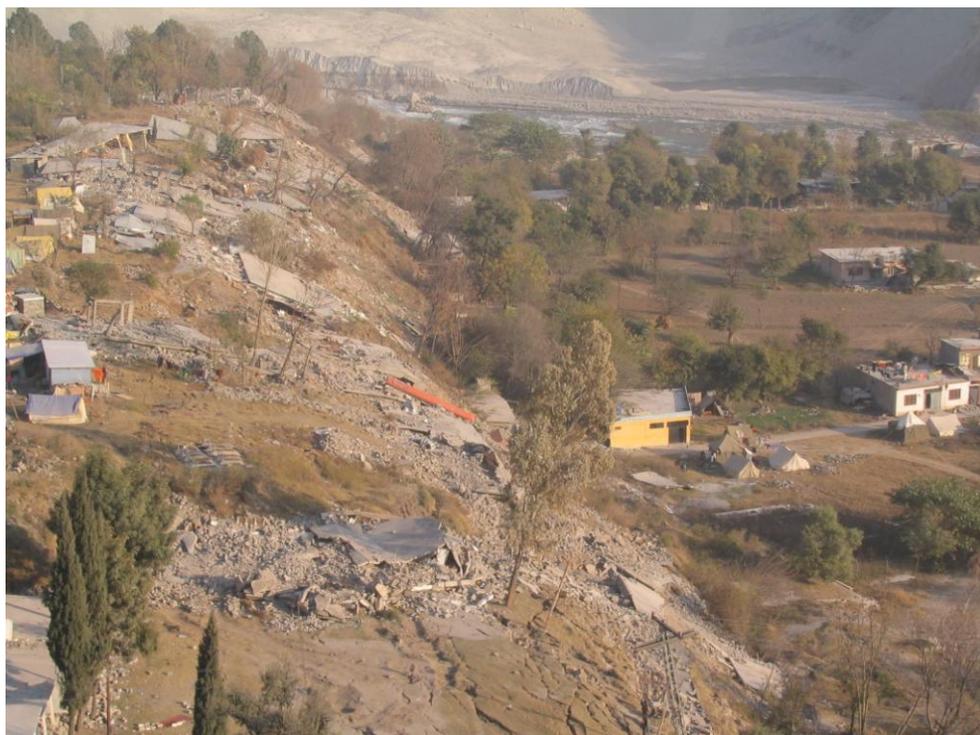
**Figure 3.20: Collapsed stone and concrete block URM residential buildings on the hill and slight to moderately damaged residential buildings in the valley below. Collapse may be due to ridge effect or slope failure, Muzaffarabad**

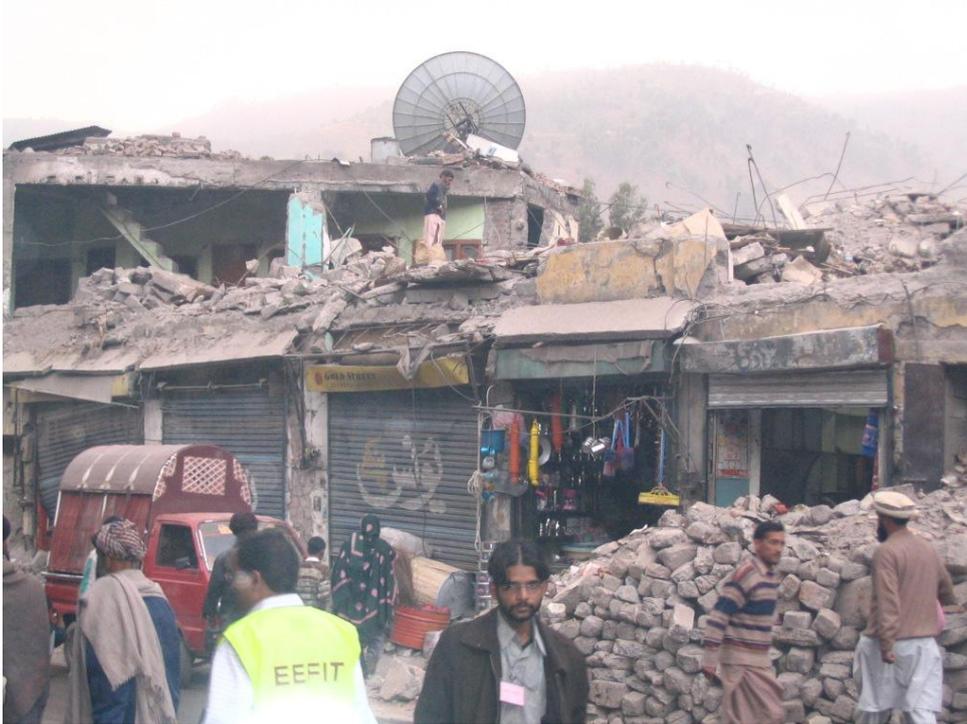
**Figure 3.25: Collapsed roof of 2-storey RC frame and slab commercial buildings with concrete block masonry infill walls. Failure of beam/column connections at upper floor. Intact ground floor walls and first floor slab, Muzaffarabad**

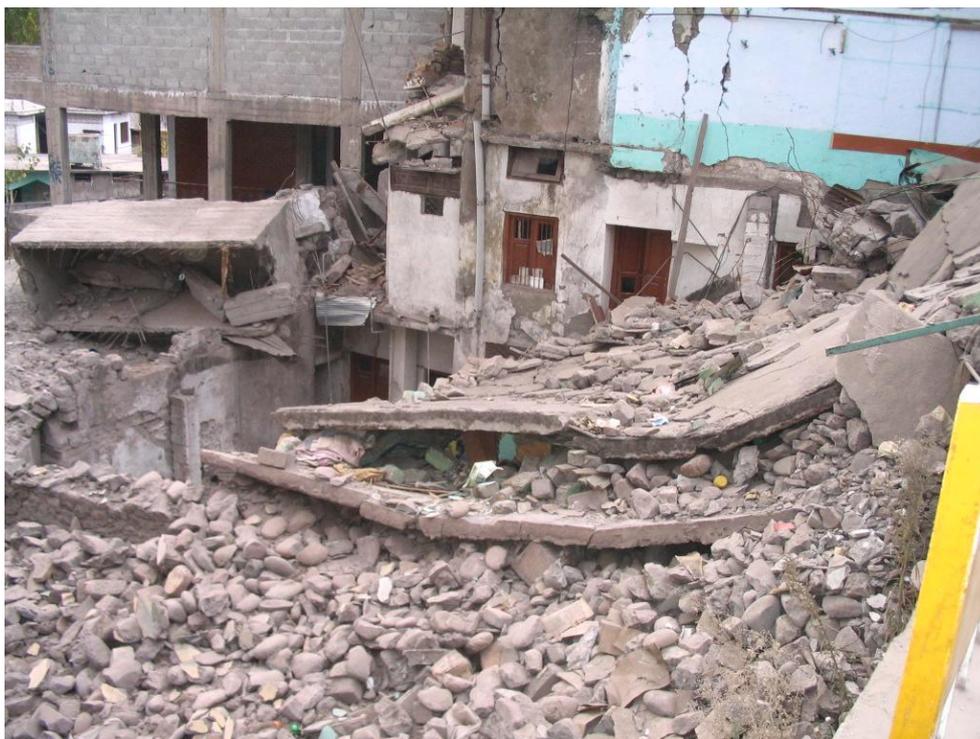
**Figure 3.26: Collapsed 2-storey concrete block URM commercial building. Floor and roof collapse possibly due load bearing wall failure in shear and out-of-plane and high inertia loads from RC slabs, Muzaffarabad**

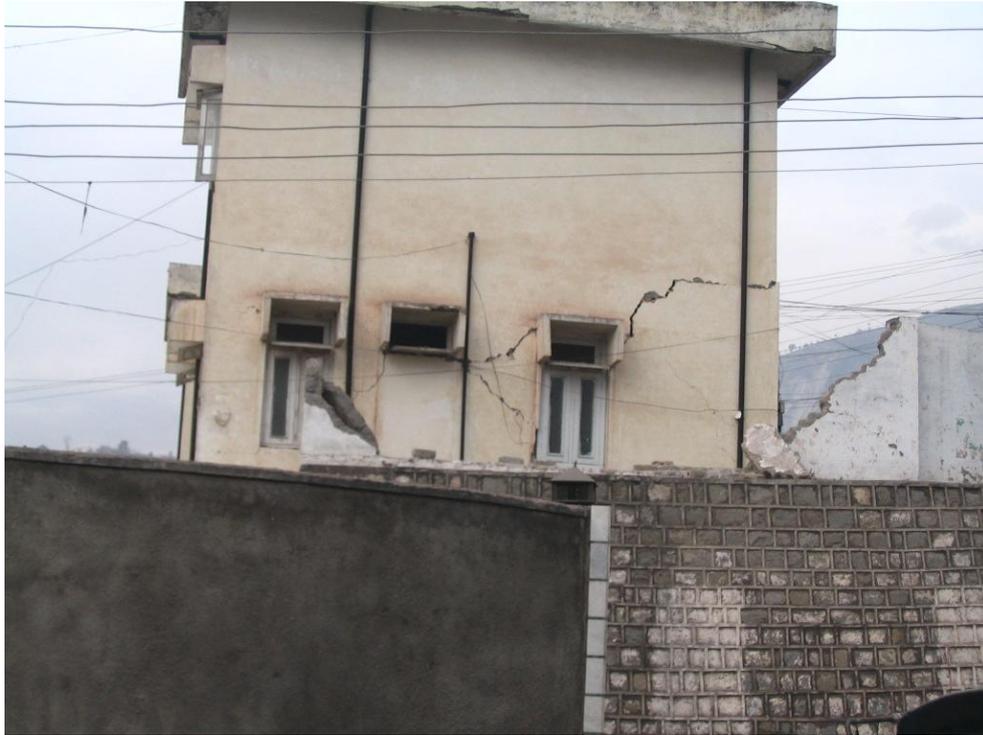
**Figure 3.27: Diagonal shear cracks through concrete block wall of RC frame and slab commercial building with masonry infill walls, moderate damage, Muzaffarabad**

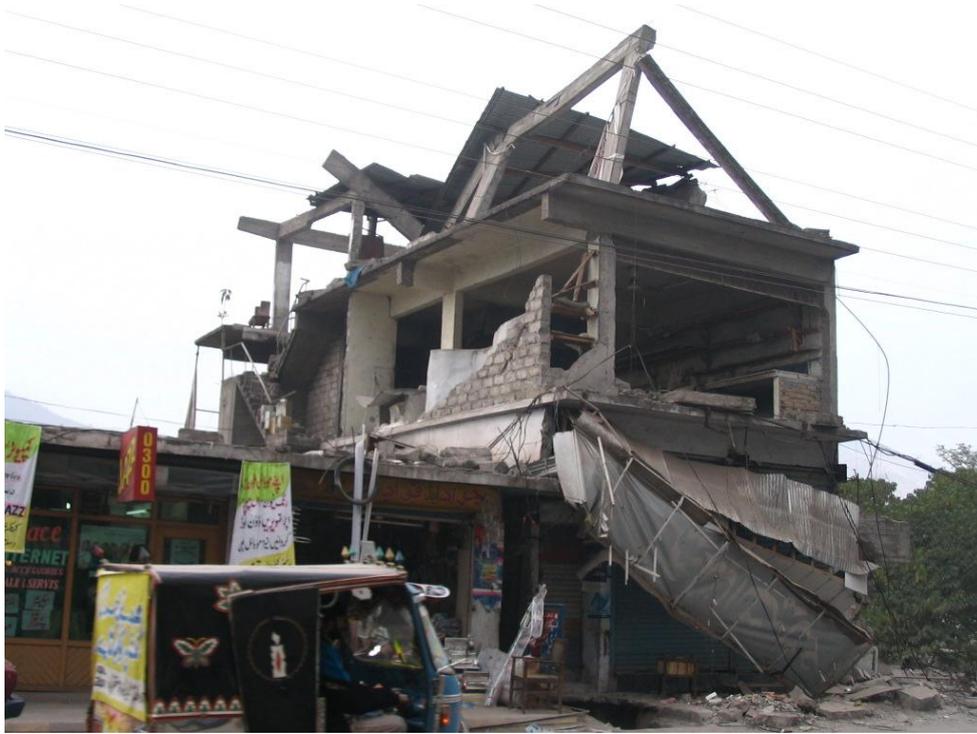
**Figure 3.29: Collapsed RC frame of upper floor of 3-storey commercial building with concrete block masonry infill walls. Failure at beam/column connections of upper floor frame, Muzaffarabad**

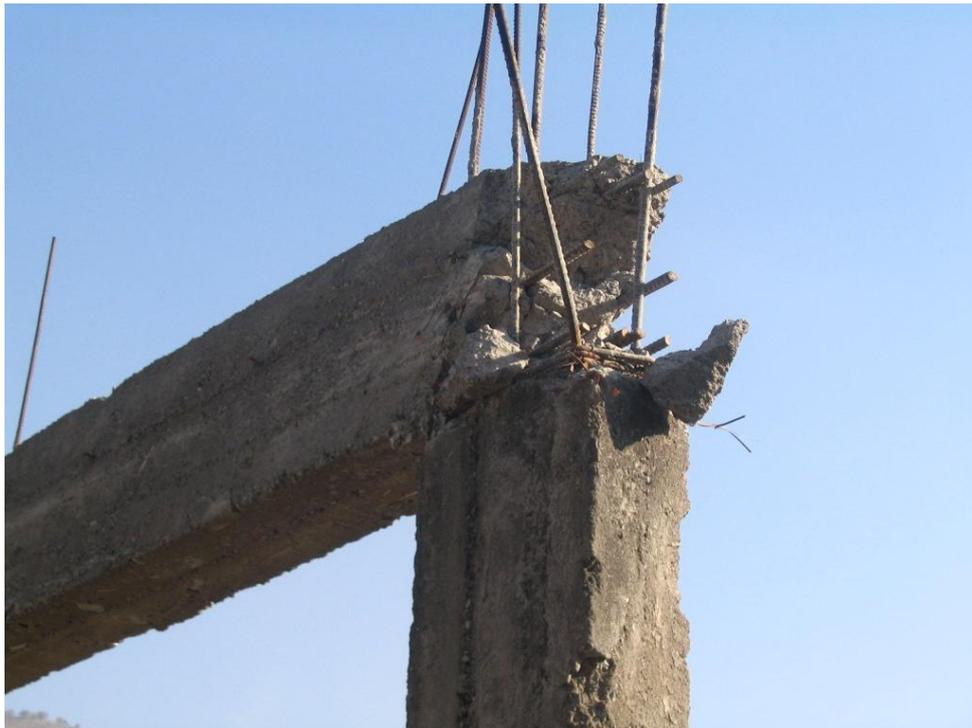
**Figure 3.30: Example of poor beam/column reinforcement detailing. No proper connection of column and beam reinforcement for moment resisting action**

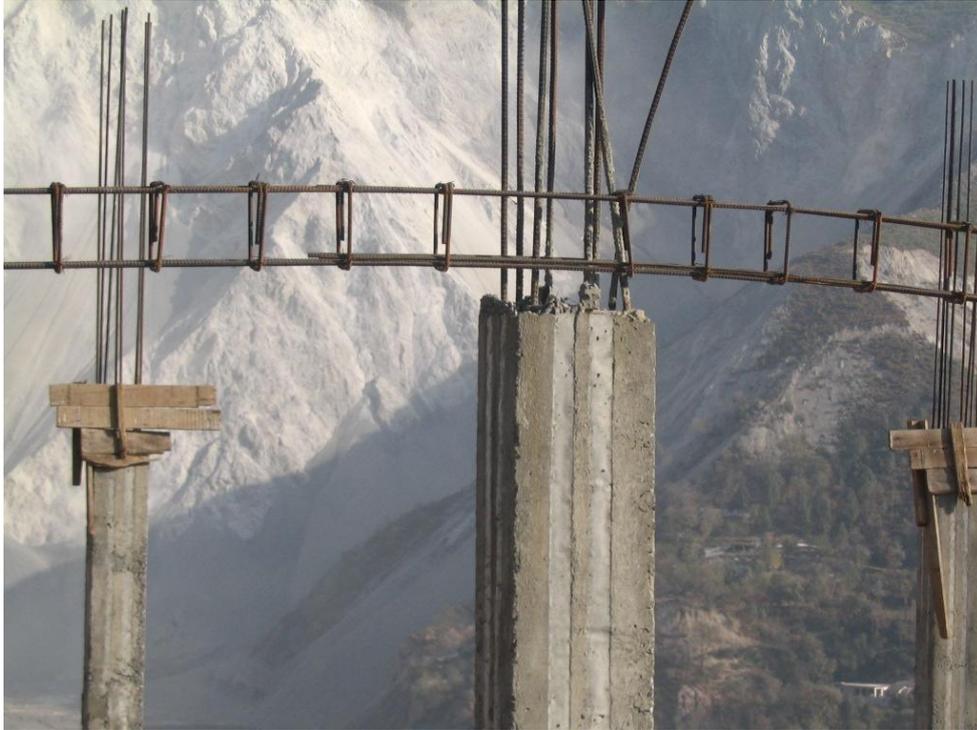
**Figure 3.31: Incorrect splicing of reinforcing bar at beam/column connection of a moment frame under construction. Shear links configuration inadequate for seismic shear forces**

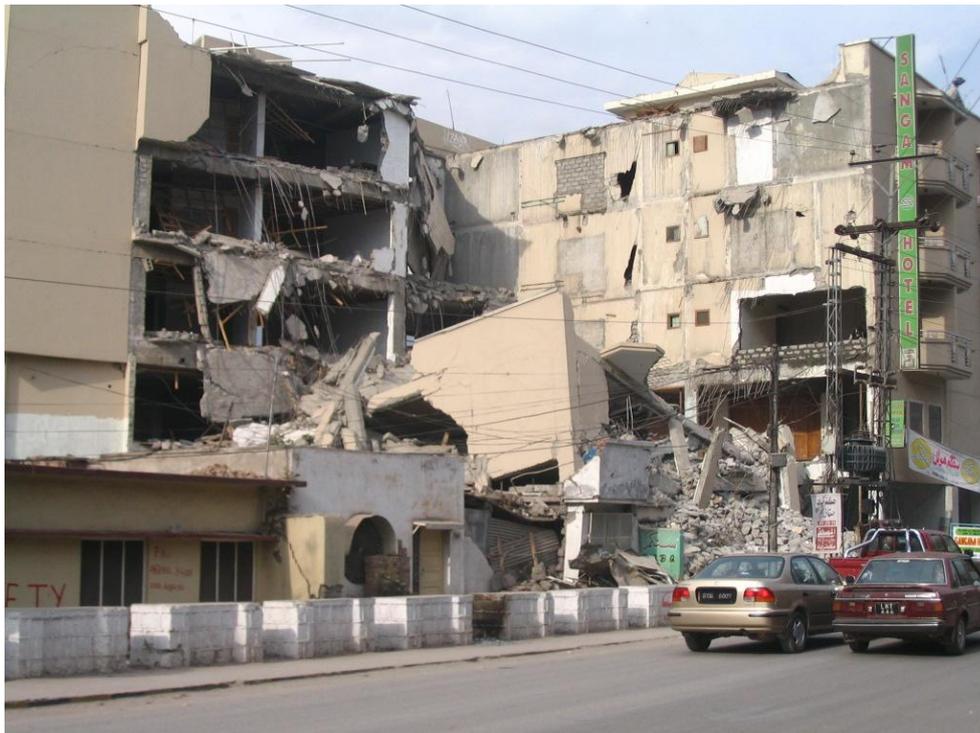
**Figure 3.32: Collapsed section of Samgam Hotel, RC frame and slab construction, 5-storey. Collapse due to failure at beam/column connections, Muzaffarabad**

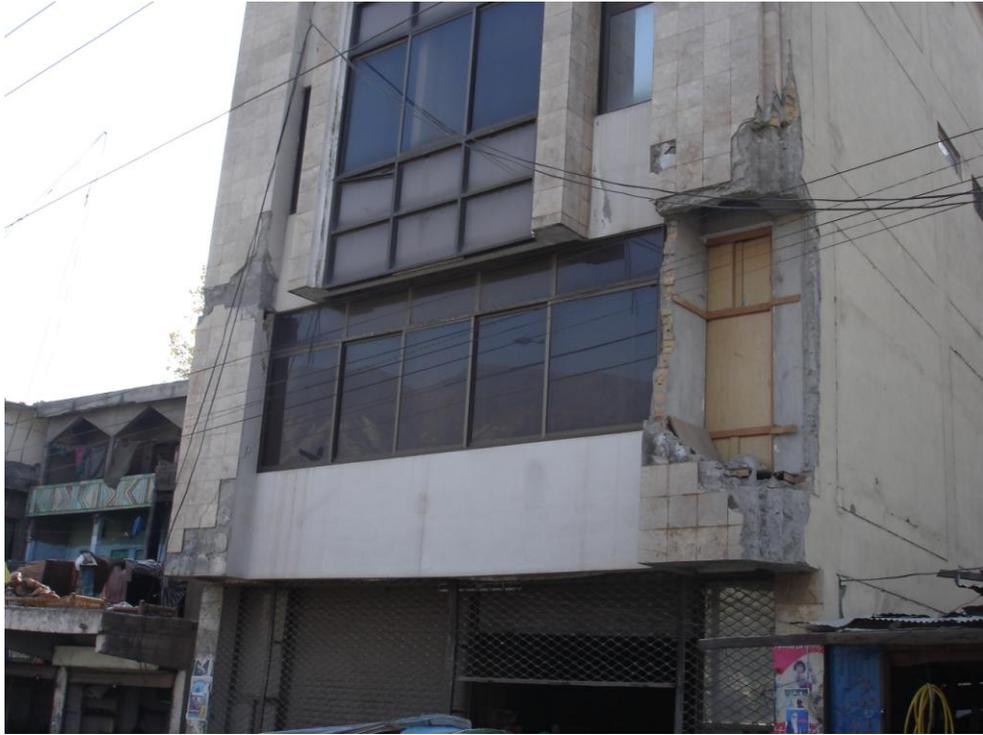
**Figure 3.33: Slightly damaged 4-storey RC frame and slab commercial building with concrete block masonry infill, Muzaffarabad**

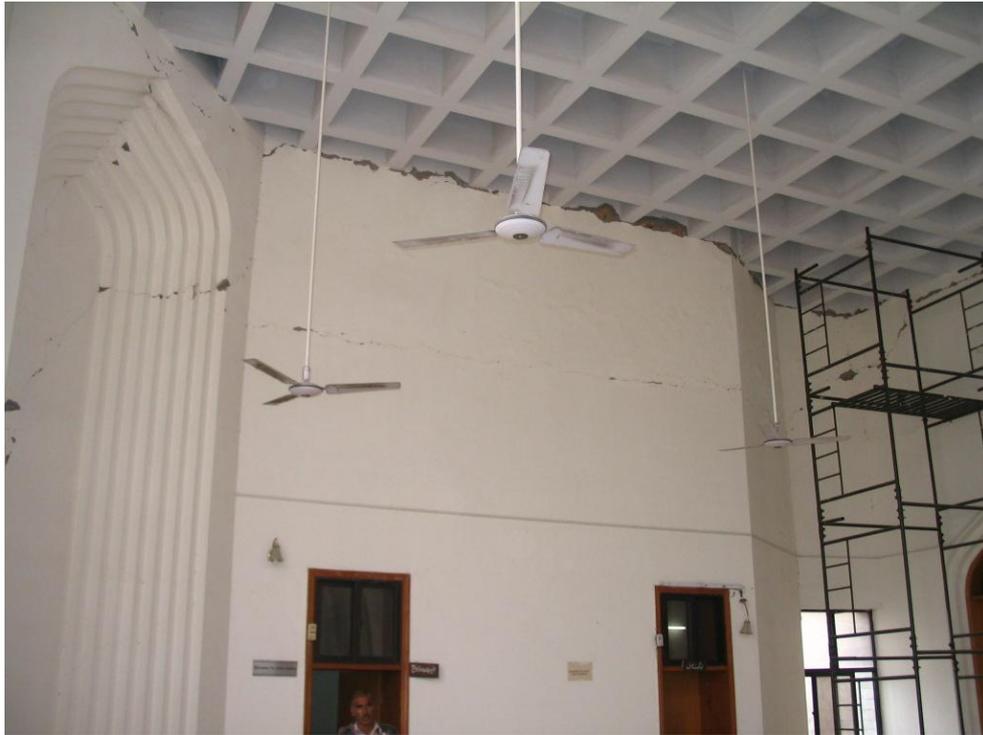
**Figure 3.35: Shear cracks through the brick masonry walls of the Muzaffarabad Supreme Court building. Cracking visible at the roof/wall intersection, moderate damage**

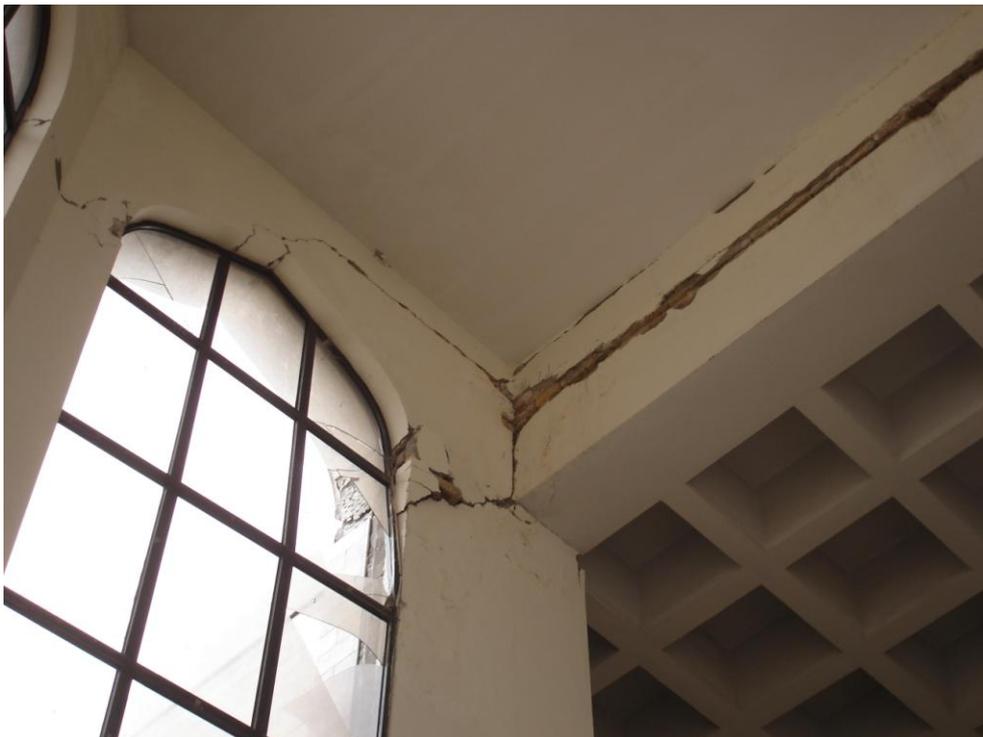
**Figure 3.36: Shear cracks through the brick masonry column and roof beam connection at the Muzaffarabad Supreme Court building. Damaged glass due to shearing through the window**

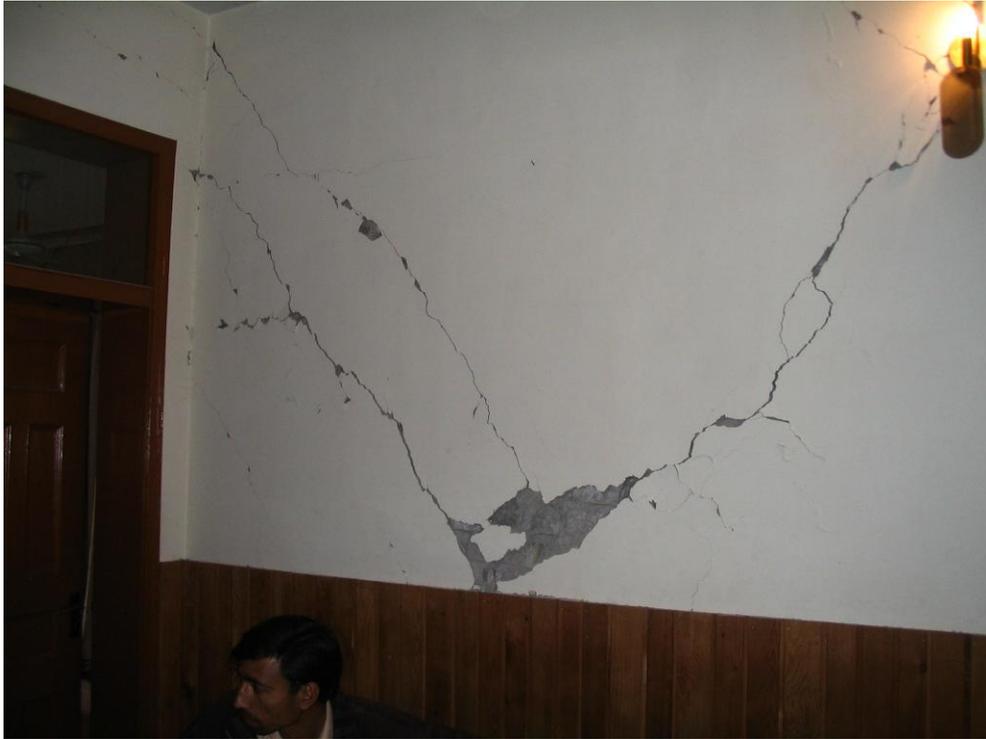
**Figure 3.37: Diagonal shear cracks through the brick URM walls of the Muzaffarabad Tourist Information Office, moderate damage**

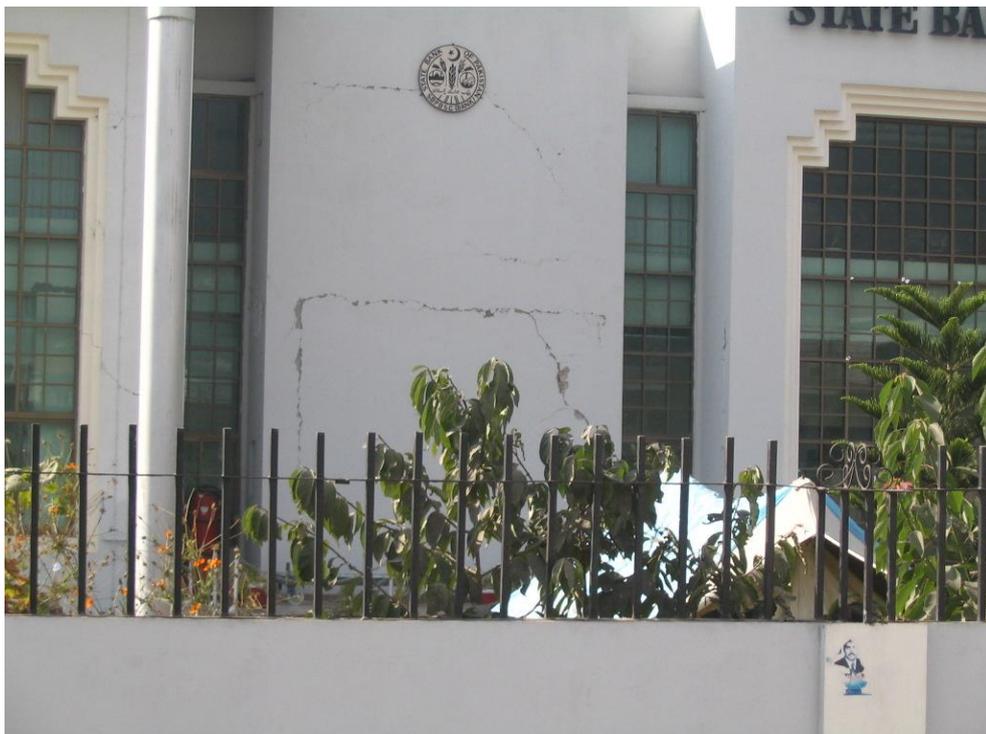
**Figure 3.38: Shear cracks through the brick URM walls of the State Bank of Pakistan building, moderate damage**

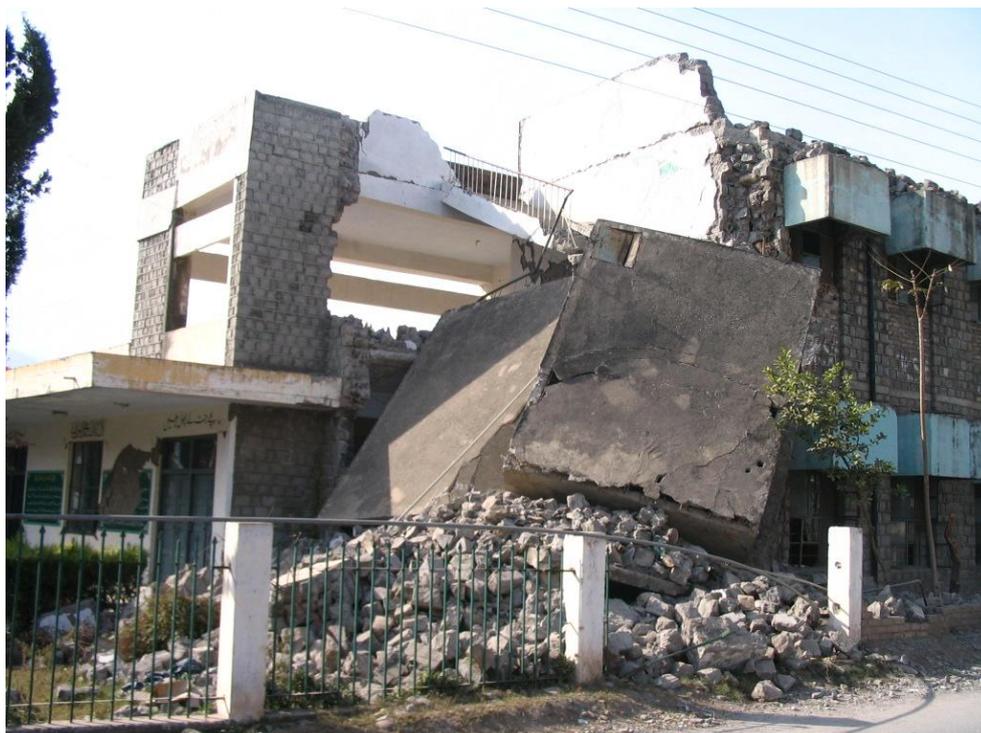
**Figure 3.40: Collapsed sections of the concrete block URM, 2-storey school building. Roof and floor slab collapse due to failure of masonry bearing walls, Muzaffarabad**

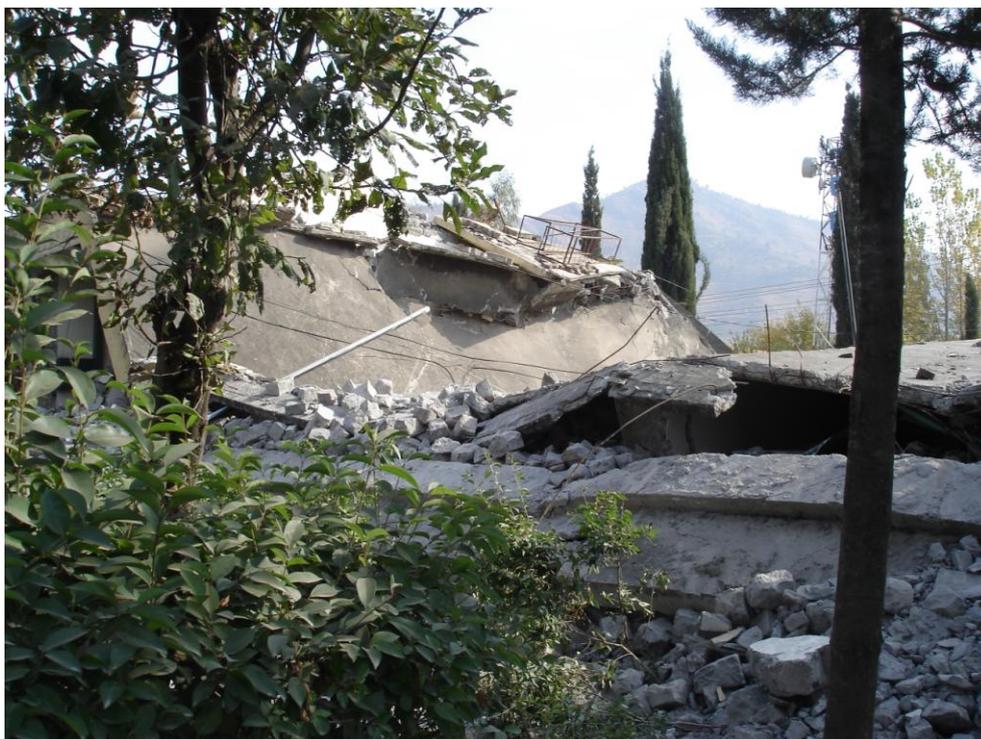
**Figure 3.41: Collapsed concrete block URM school building, Muzaffarabad**

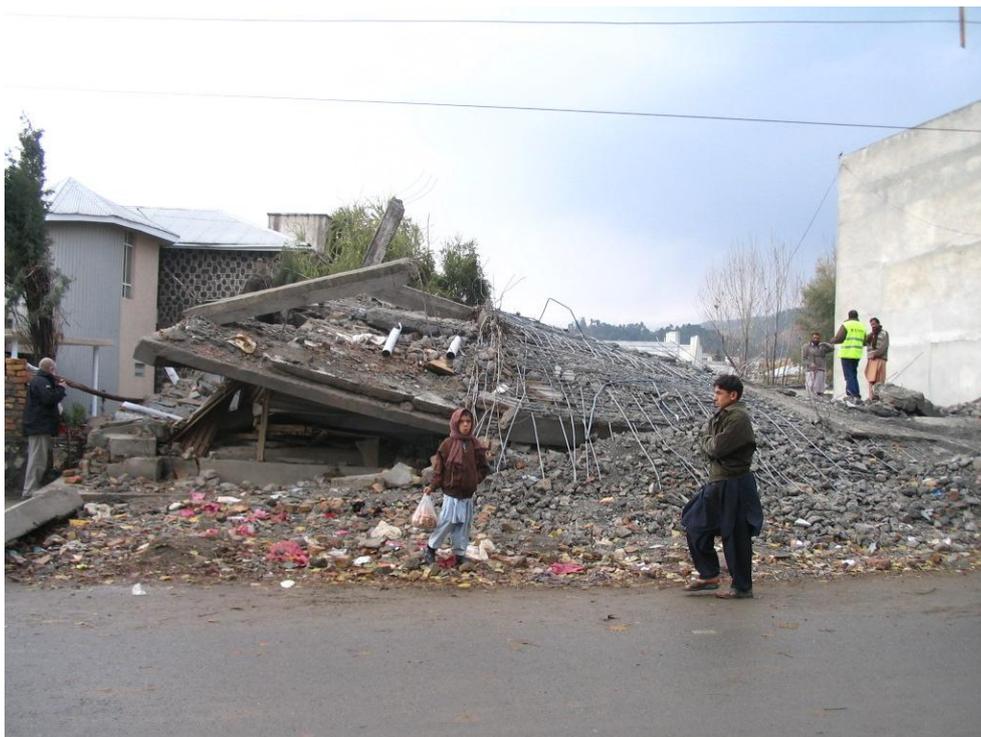
**Figure 3.43: Collapsed RC 3-storey commercial and residential building. Collapse appears to be due to failure of beam/column connections, Abbottabad**

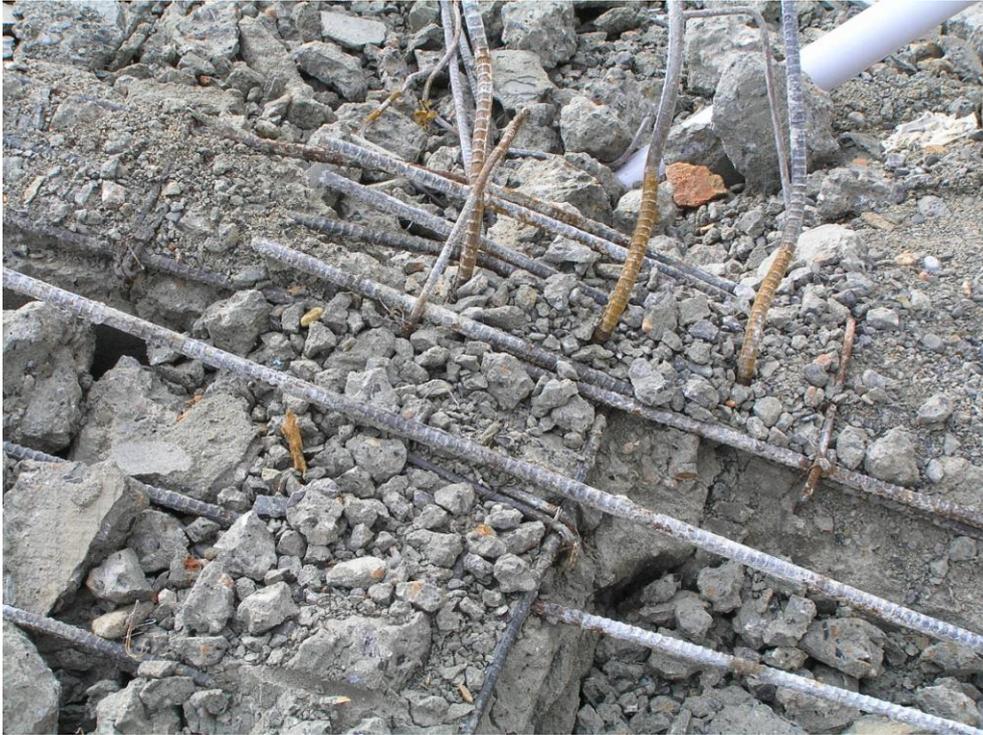
**Figure 3.44: Lack of continuity of reinforcement detailing at the beam/column connection**
