THE KASHMIR, PAKISTAN  
EARTHQUAKE OF 8 OCTOBER 2005  
A FIELD REPORT BY EEFIT

## A FIELD REPORT BY EEFIT

July 2008

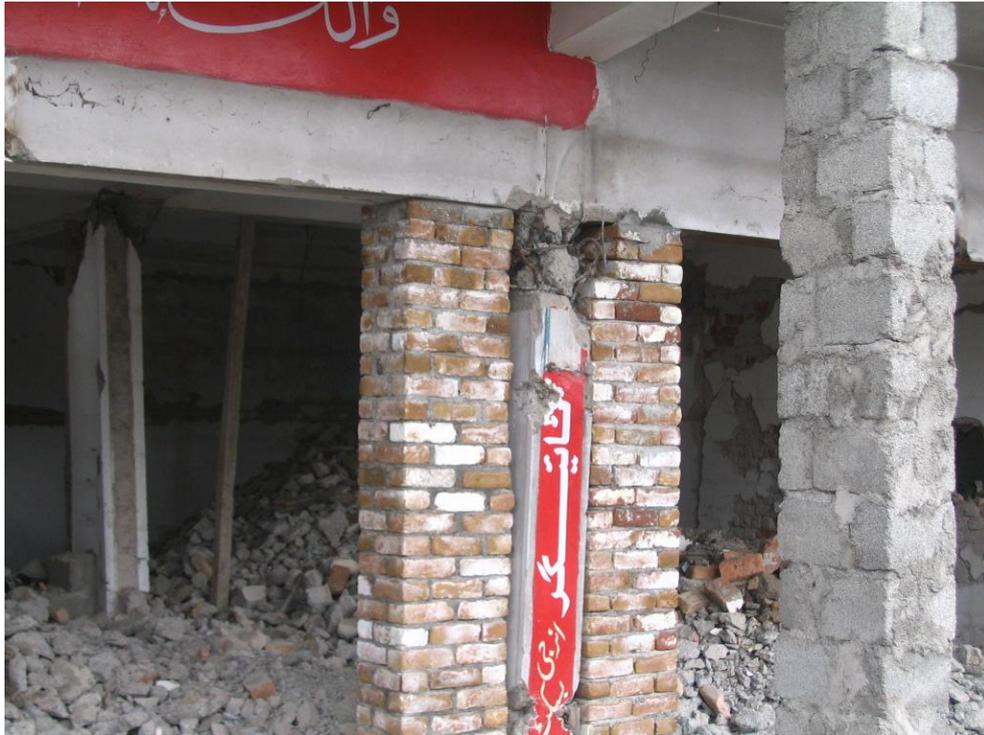
**Figure 3.46: Extensively damaged 3-storey RC commercial building. Failed beam/column connections due to lack of shear or confinement reinforcement and inadequate layout, collapsed and cracked brick masonry infill walls inside the building, Abbottabad**

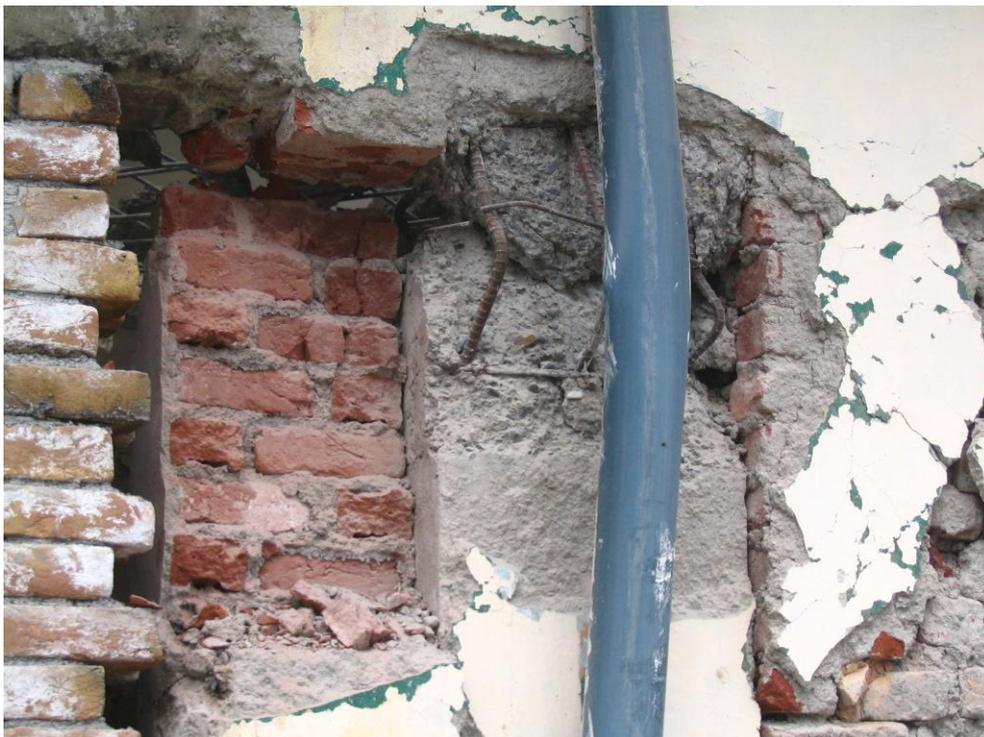
**Figure 3.47: Example of failed beam/column connection due to poor shear and confinement reinforcement detailing**

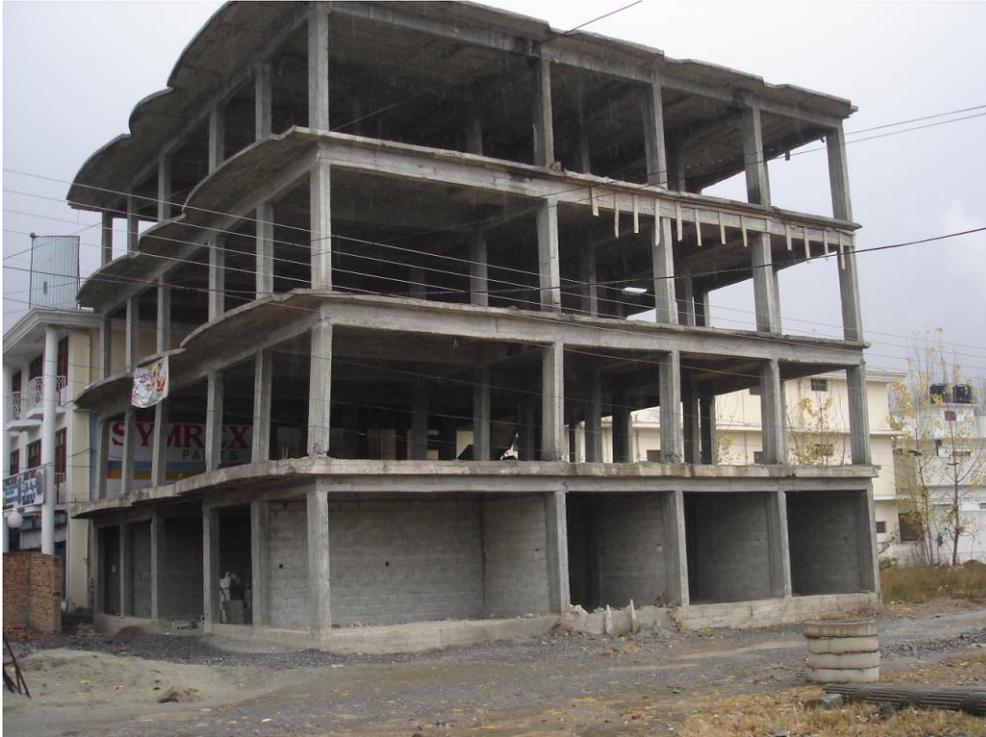
**Figure 3.48: Permanent drift at the first floor of an RC frame and slab 4-storey commercial structure under construction, Abbottabad. Ground floor drift may have been prevented by the infill masonry walls**

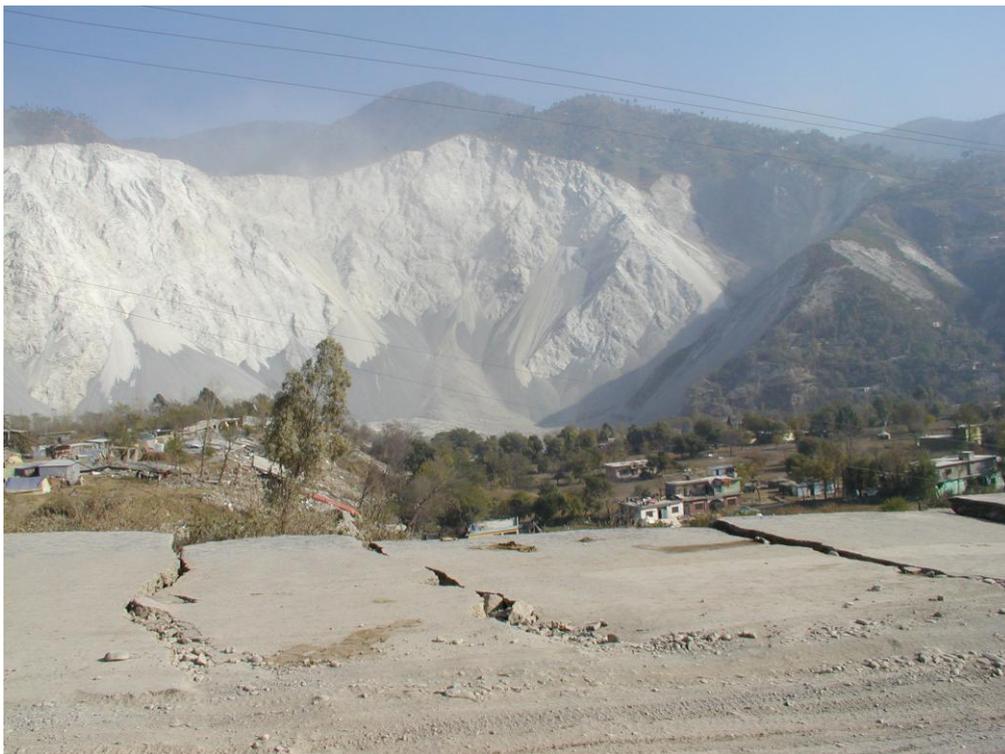
**Figure 4.5: Kashmir earthquake October 8, 2005. Landslide in dolomite mountainside just north of Muzaffarabad at Chela Bandi. Also note cracks through road in foreground and damage to buildings in mid-distance**

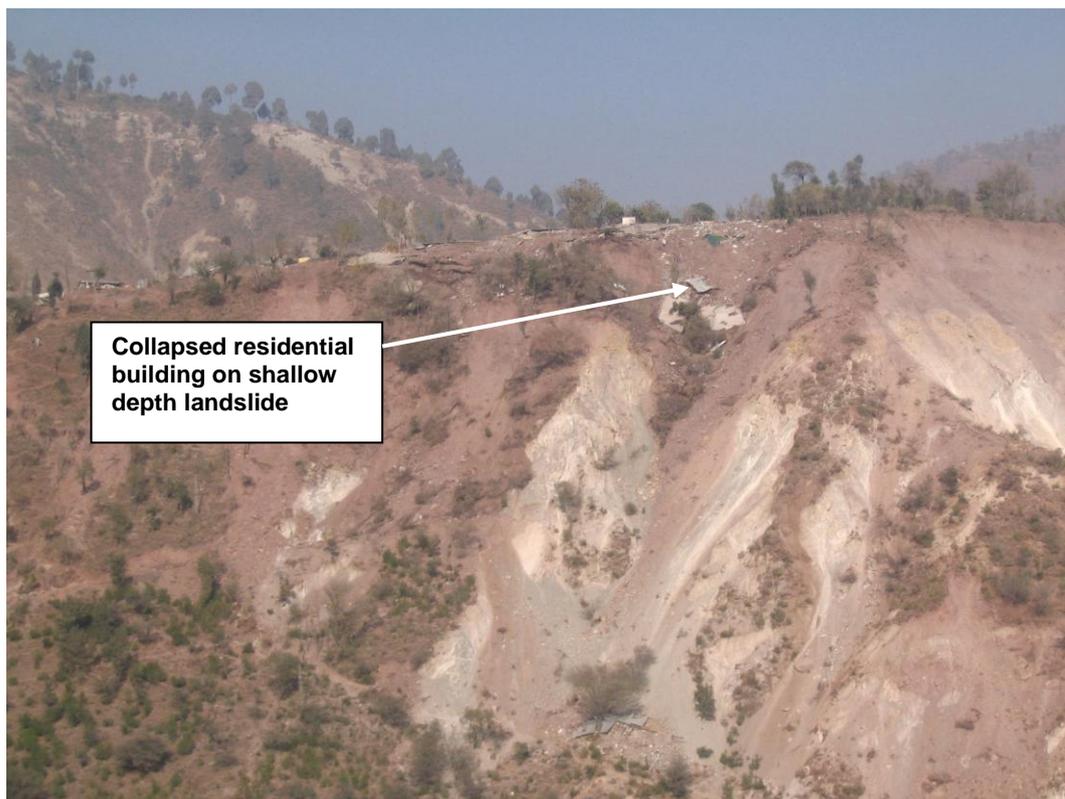
**Figure 4.17: Collapsed residential building due to a shallow depth landslide north of Muzaffarabad City**

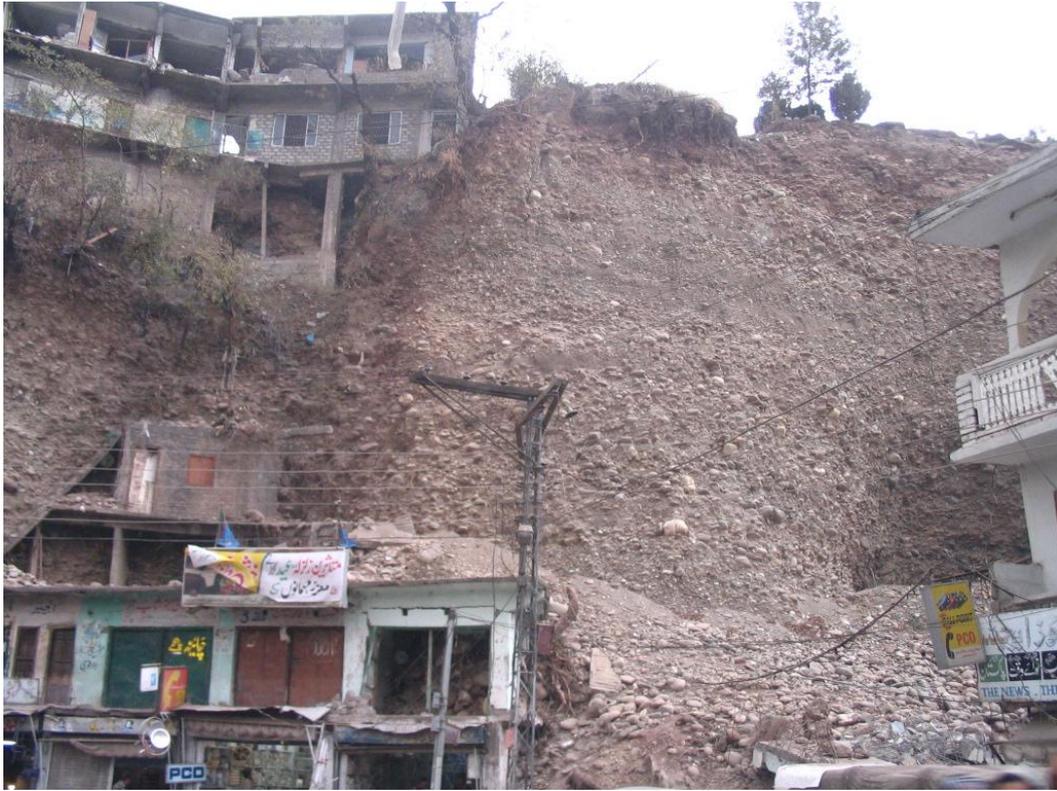
**Figure 4.18: Slope failure burying and extensively damaging the commercial building below and destabilising the residential structure above, Muzaffarabad**

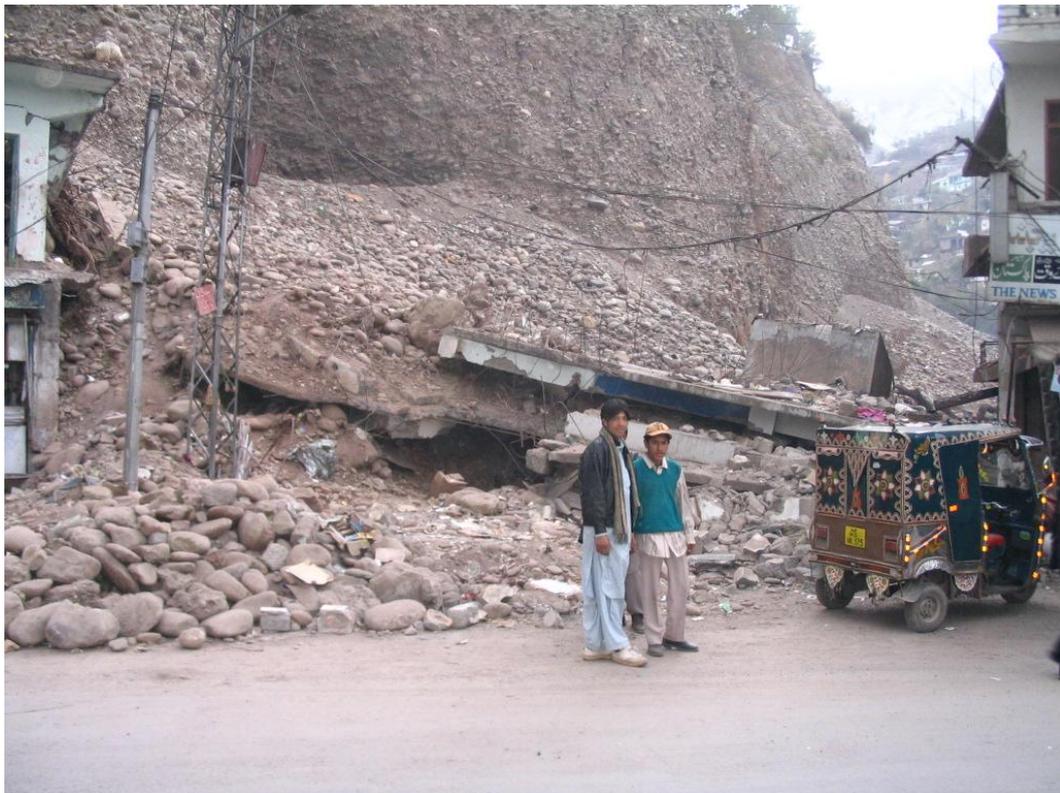
**Figure 4.19: Collapsed and buried commercial building from the soil and rock due to the slope failure shown in Figure 4.18, Muzaffarabad**

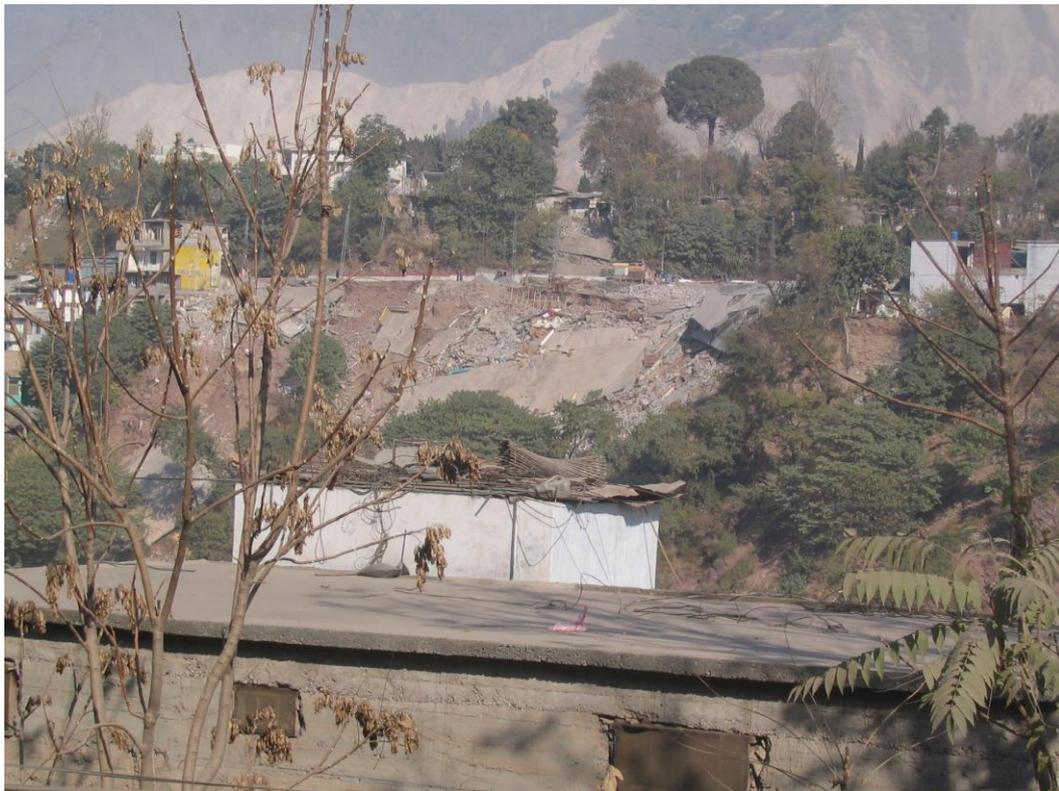
**Figure 4.24: Collapsed concrete retaining wall section in Muzaffarabad leaving the road above vulnerable to further collapse**

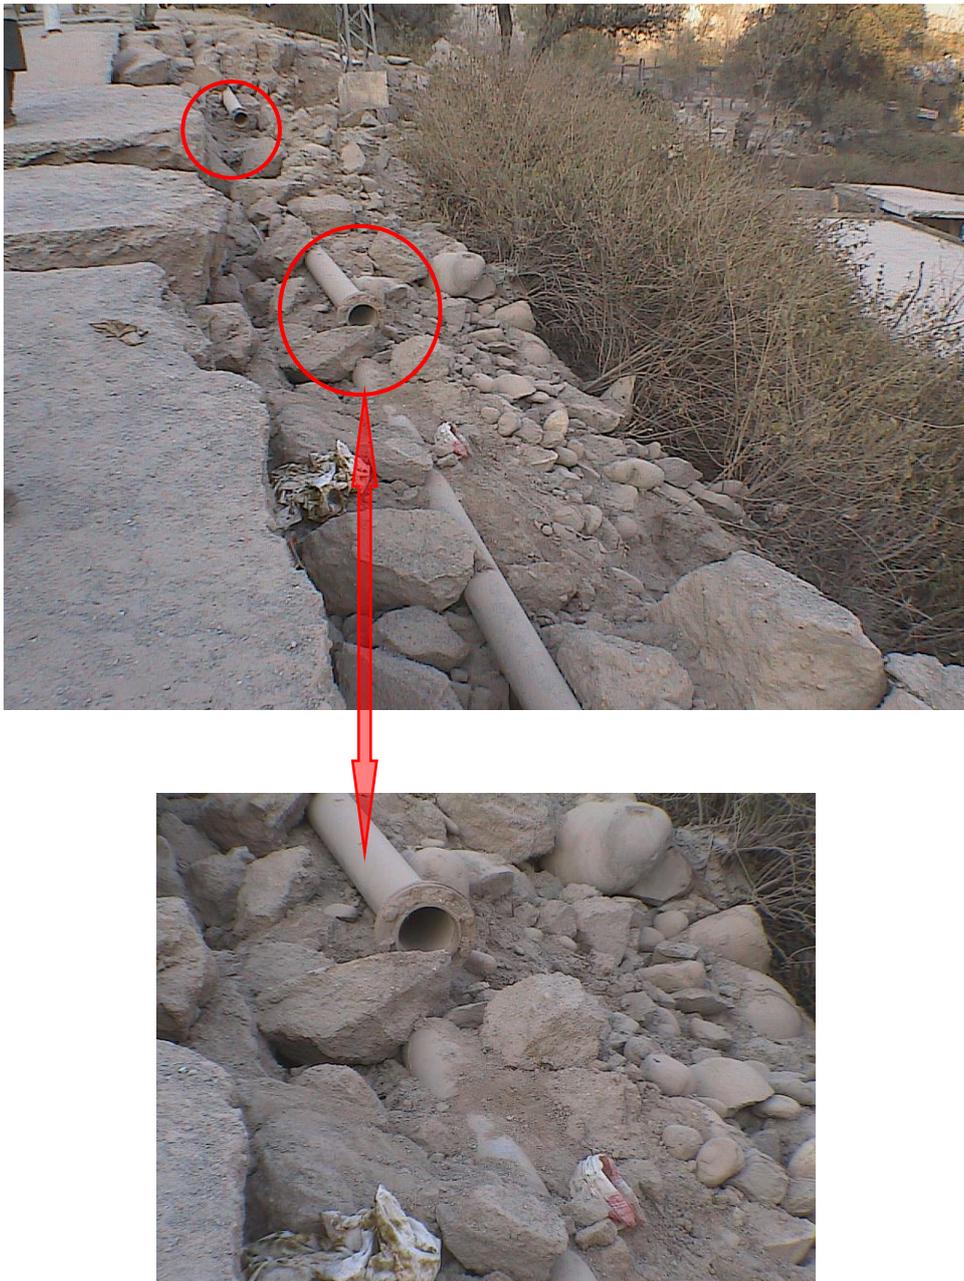
**Figure 4.39: Smaller geotechnical failures: ruptured cast iron water pipe adjacent to the cracked and subsided road visible in the foreground of Figure 4.5**

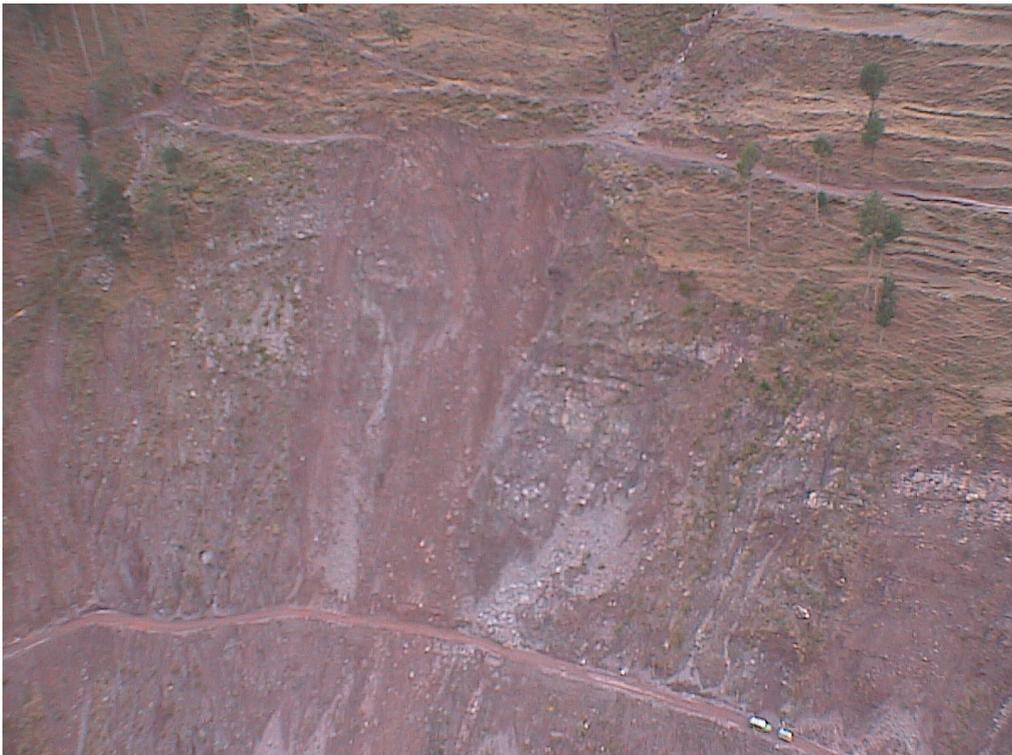
**Figure 4.43: Agricultural terraces slipping down steep terrain and valley-side road, all threatened by landslide, near Dhanni Nelam (Dhanni Nelam-Islamabad flight)**

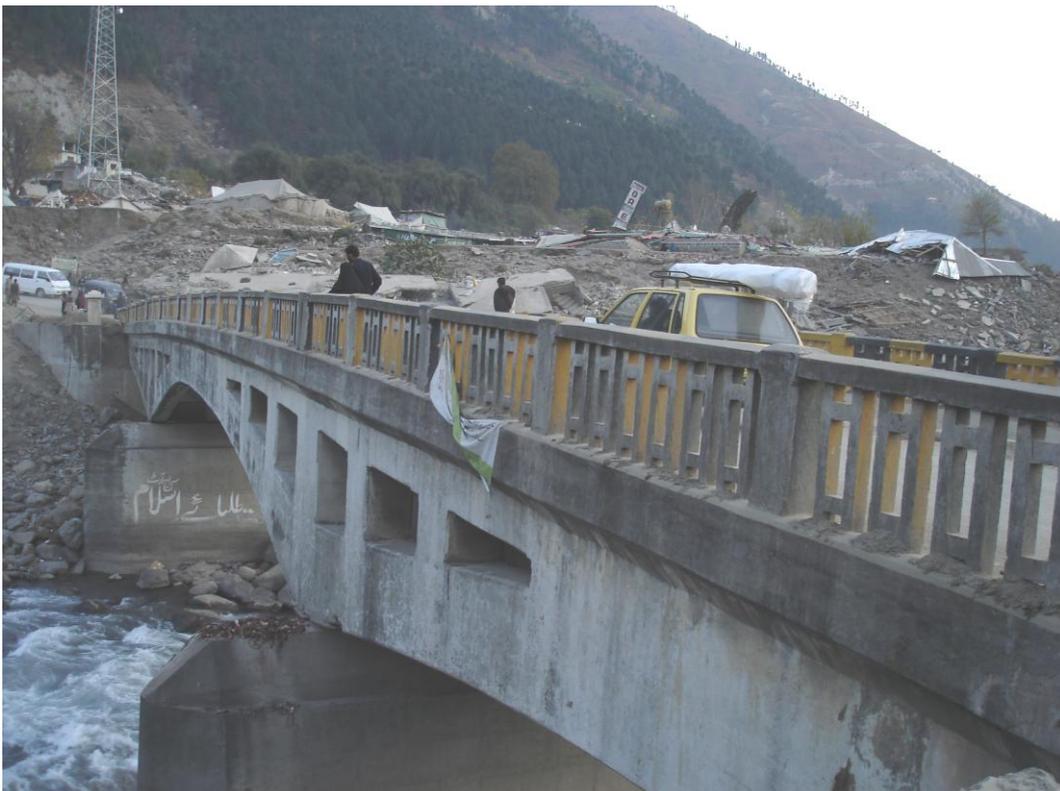
**Figure 5.1: Laterally displaced RC deck of the vehicle bridge in Balakot**

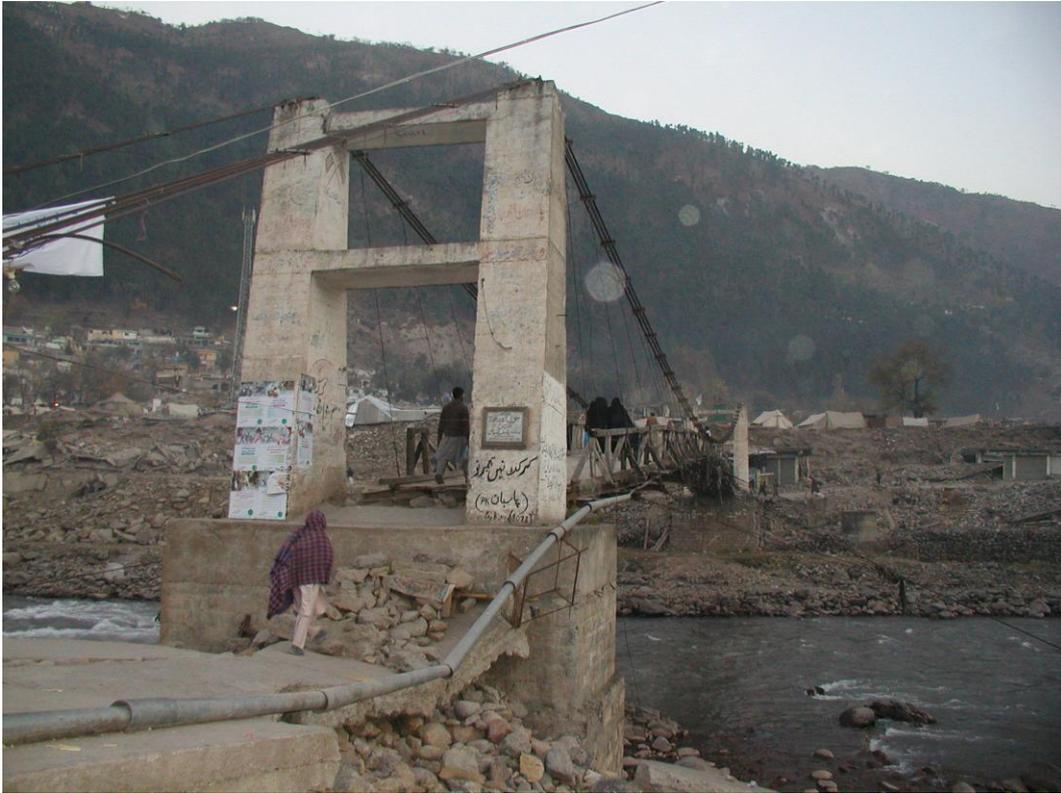
**Figure 5.2: Pedestrian bridge with damaged approaches in Balakot**

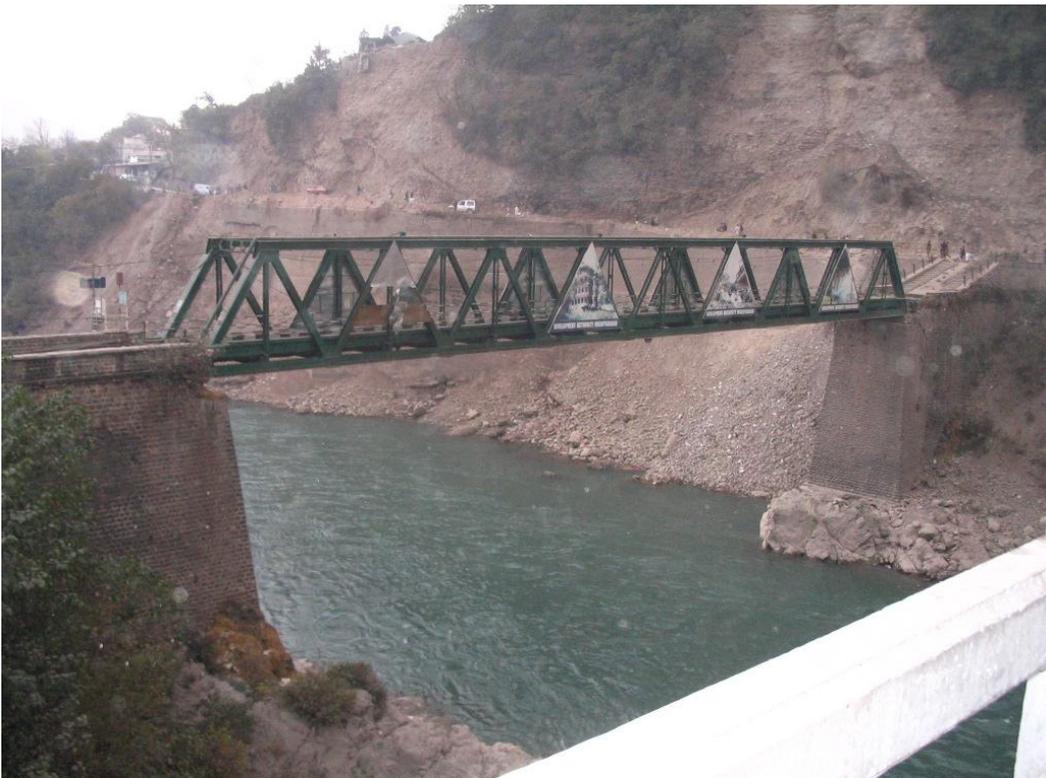
**Figure 5.8: Slightly damaged pedestrian bridge across Nelum River, Muzaffarabad. Steel truss single span simply supported on brick masonry abutments**

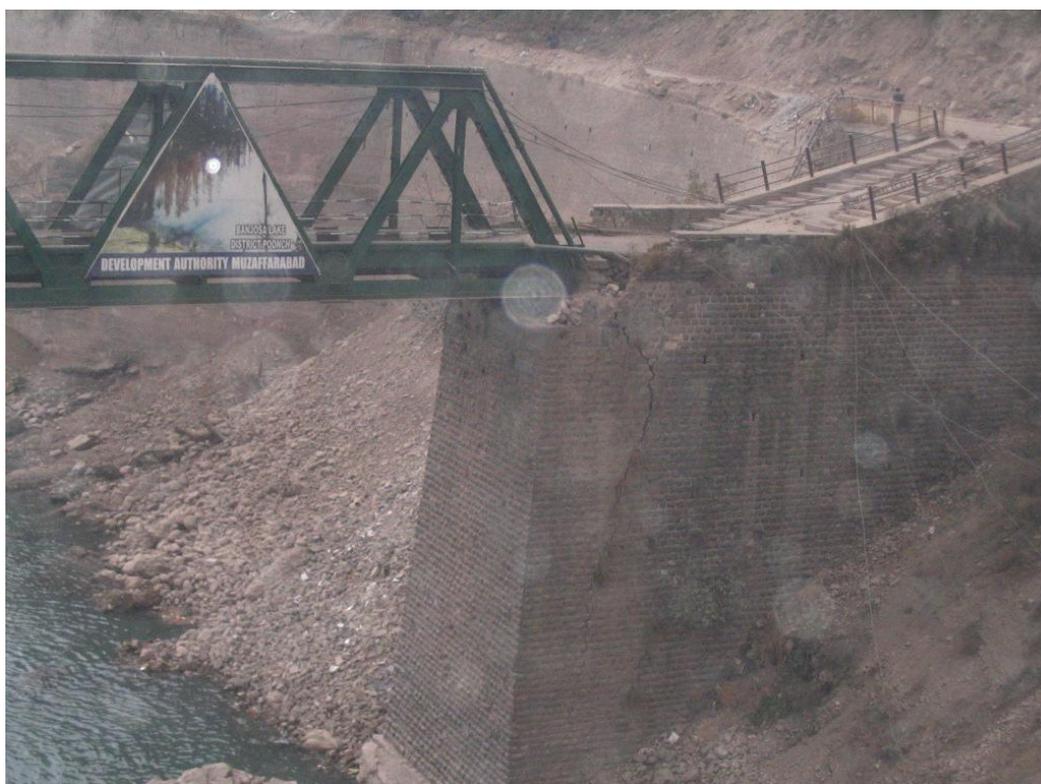
**Figure 5.9: Crack at one of the masonry abutments of the pedestrian bridge shown in Figure 5.8**

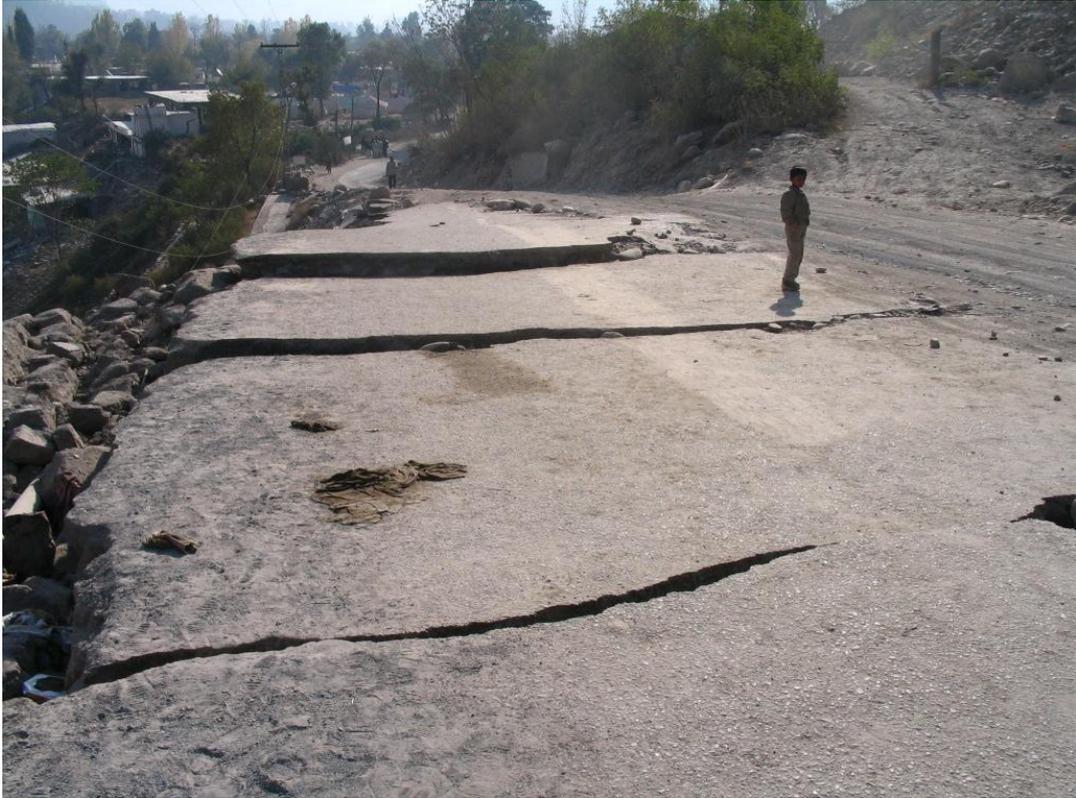
**Figure 5.10: Ground cracks through a road in Muzaffarabad**

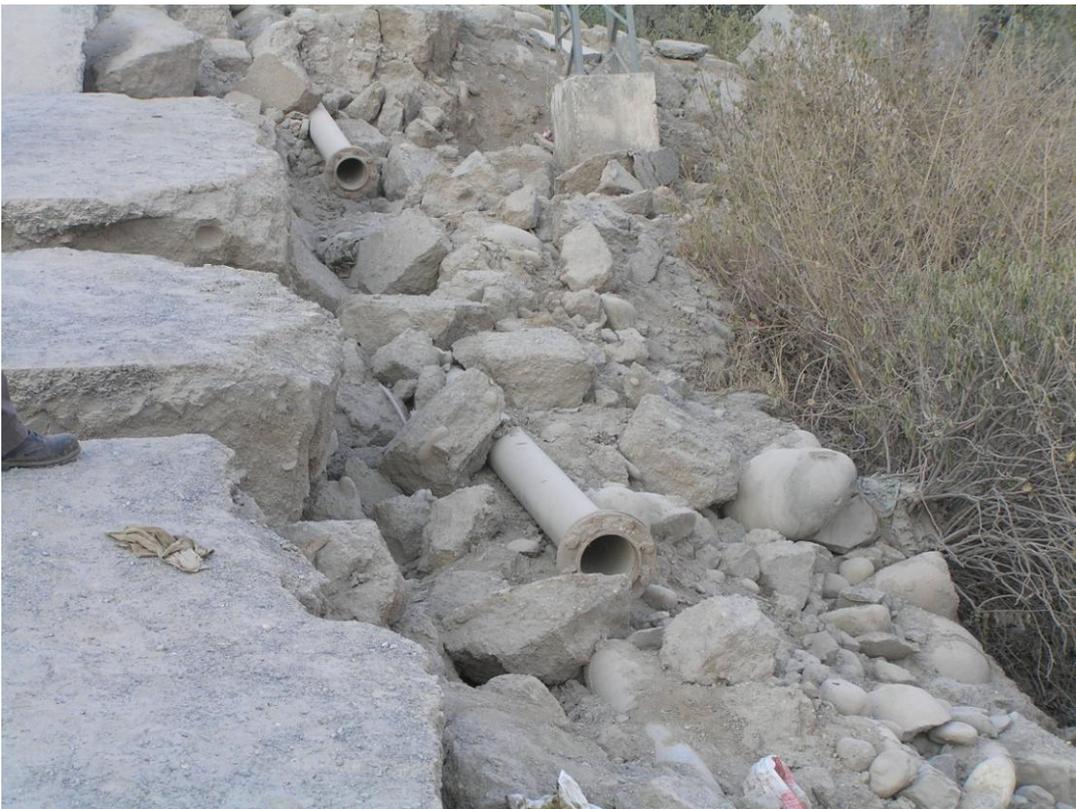
**Figure 5.11: Separated segments of a water supply system due to ground cracks, Muzaffarabad**
