THE LUZON, PHILIPPINES EARTHQUAKE OF 16 JULY 1990

A FIELD REPORT BY EEFIT

SUMMARY

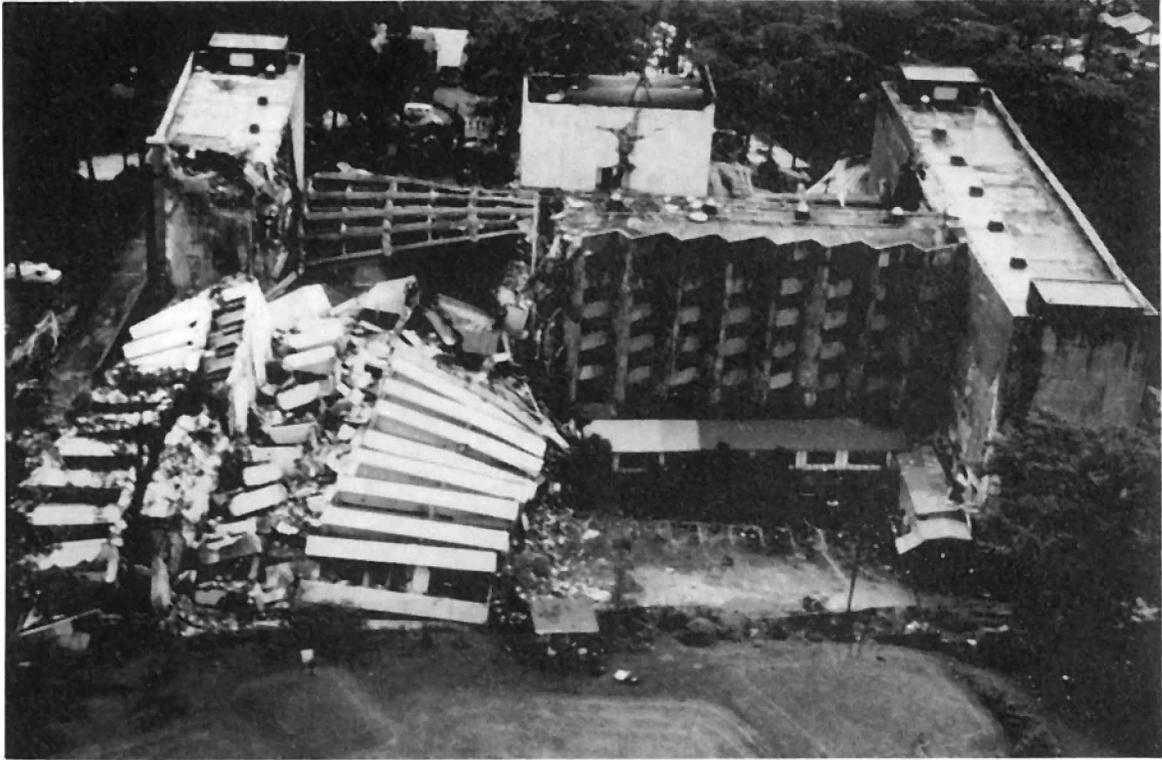
Figure 5.5 Hyatt Terraces Hotel from the air, looking north

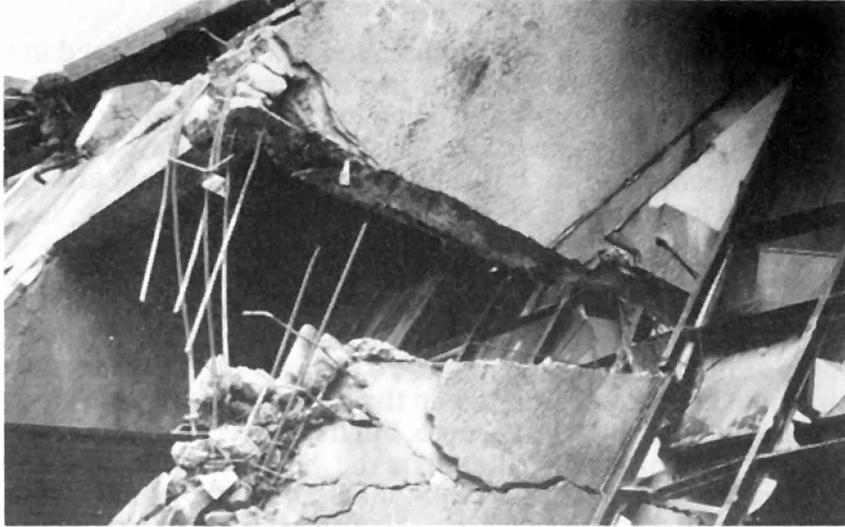
The collapse was probably initiated by weakening of the reinforced concrete A-frames due to collapse of the Aparthotel onto the rear of the main building. Failure of the A-frames occurred generally along construction joints on the sloping legs (Figure 5.10), where there was little vertical (tension) or confining (horizontal) reinforcement. The entire upper portion of the sloping, front face of the hotel collapsed. The upper portion of the vertical, rear face collapsed where it was impacted by the Aparthotel.

Figure 5.10 Failure of A-frame along construction joint, main hotel

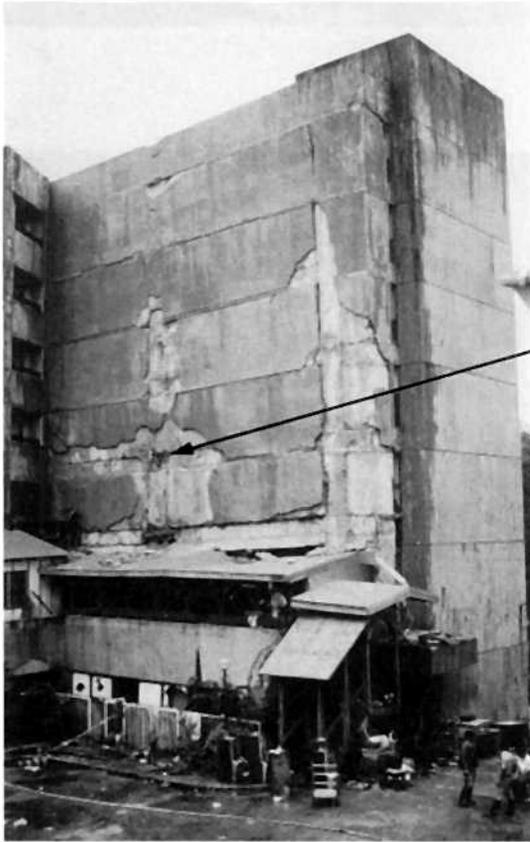
The west face of the east wing of the Hotel is shown in Figure 5.11. The damage in this part of the building was less severe than elsewhere, but there was compression buckling failure of the columns at second floor level on both sides of the building (Figures 5.12 and 5.13). This appears to have been as a result of the external infill walls above level 2 acting as a shear wall and concentrating ductility demand in the short columns at ground floor level (Figures 5.13 and 5.14). Reinforced concrete shear walls in both the east and west wings of the main hotel building were apparently provided to resist forces in the east-west direction. Figure 5.11 shows the end wall in the east wing. These walls appeared to be without damage, but were rare examples of this form of construction in Baguio City.

Figure 5.11
West face of East Wing,
Hyatt Terraces Main Hotel

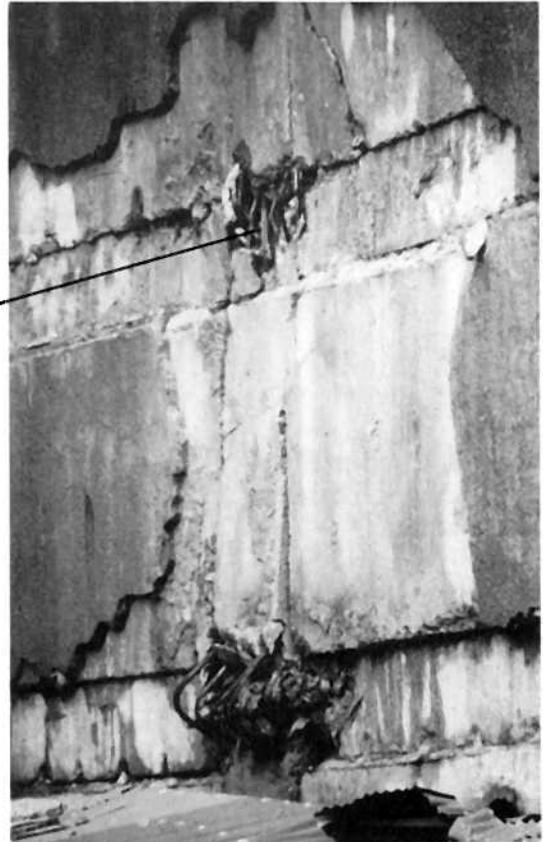
Figure 5.12
Compression failure in columns
(detail of Figure 5.11)

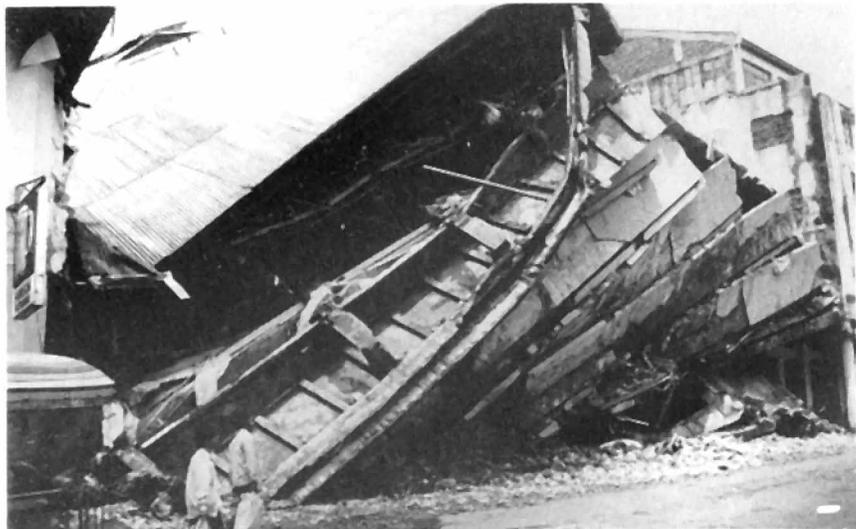
Figure 5.16

The Baguio Park Hotel (Figure 5.16) was a seven-storey reinforced concrete frame building, where only part of the first storey had survived, the rest having collapsed. Neighbouring buildings of up to five storeys were very close but suffered no apparent damage, apart from local impact damage to the building on the northwestern side (Figure 5.17).

Baguio Park Hotel

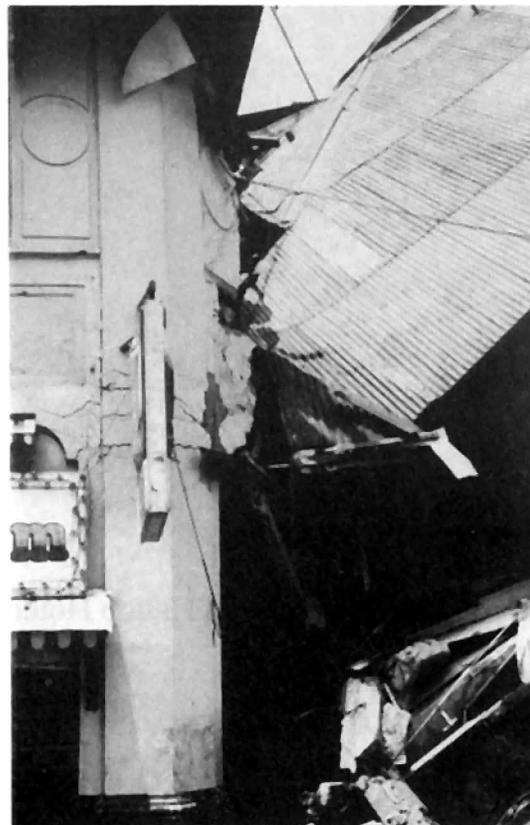
Figure 5.17

Impact damage caused
by collapse of
Baguio Park Hotel

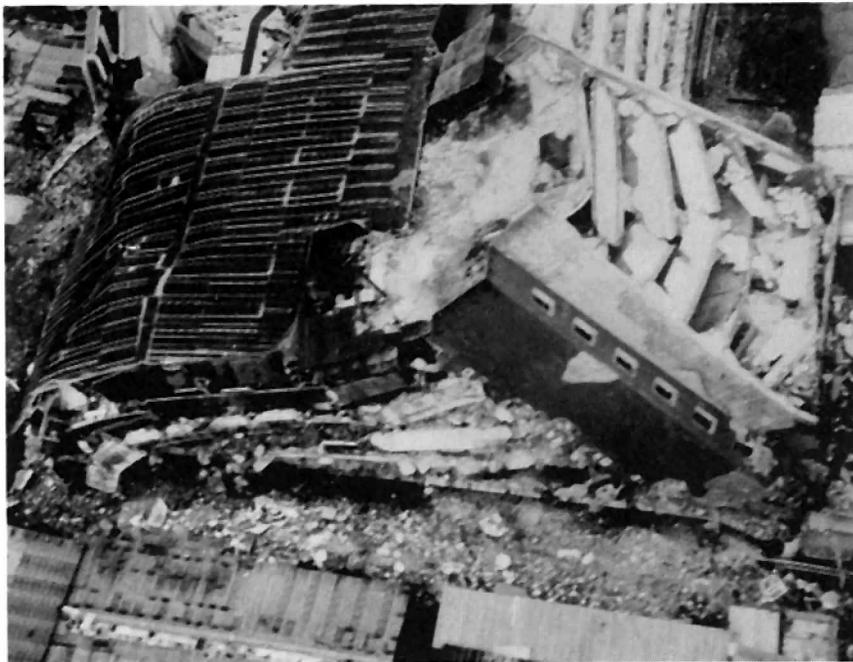
The Hilltop Hotel (Figure 5.18) was another example of a modern reinforced concrete frame building which suffered total "pancake" collapse. This nine-storey hotel in central Baguio close to the Market was condemned and abandoned following significant damage in a previous earthquake in 1985, but not subsequently demolished. The building was apparently built originally with only six or seven storeys and was subsequently extended.

Figure 5.18 Aerial view of Hilltop Hotel, Baguio

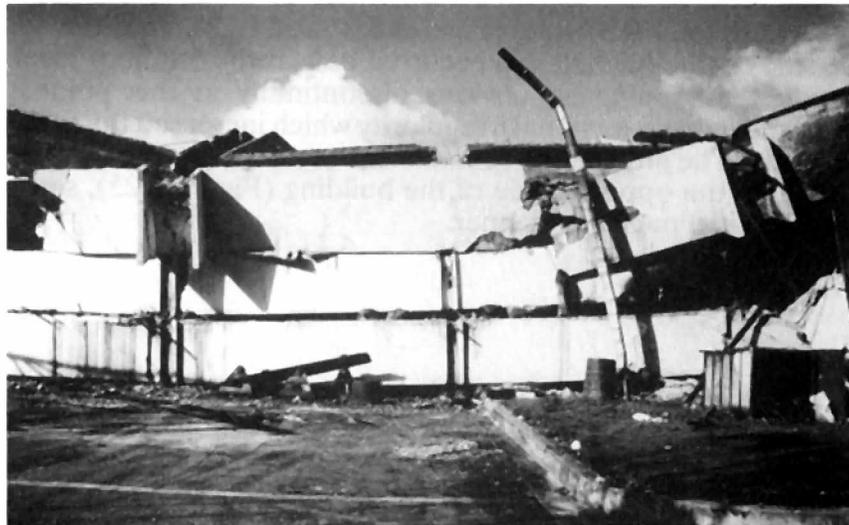
The Baguio Export Processing Zone is an industrial park near the airport (Figure 5.19), which includes warehouses and light manufacturing operations. Within the export zone, five large, concrete frame buildings collapsed, reportedly trapping several hundred workers. One collapsed building, the 3-storey reinforced concrete Arax factory contained plastic resin, which caught fire on the day following the earthquake (to the right in Figure 5.19). This building suffered a pancake collapse at the time of the earthquake (Figure 5.20).

Figure 5.20 Baguio Export Processing Zone: Arax factory

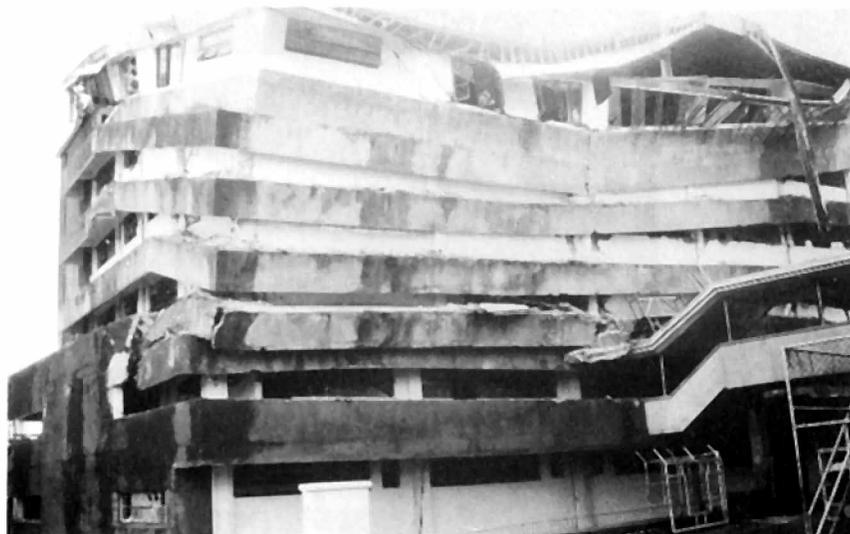
A notable example of soft-storey collapse in a multi-storey reinforced concrete frame structure is shown in Figures 5.24 and 5.25, taken from opposite sides of the building. This is a nine-storey reinforced concrete frame building with block infill, built around 1980, and forms part of the University of Baguio. It is adjacent to the FRB Hotel (Figures 5.21 and 5.22). In this case, the failure on one side of the building had occurred only at the 5th floor level (Figure 5.24), despite there being no obvious discontinuity at this point. The building appeared to have torsional irregularity which increased the forces on the frame elements. The infill panels remained intact above and below the failure (Figure 5.24). On the opposite side of the building (Figure 5.25), several storeys had collapsed in a pancake manner.

Figure 5.25 University of Baguio from north

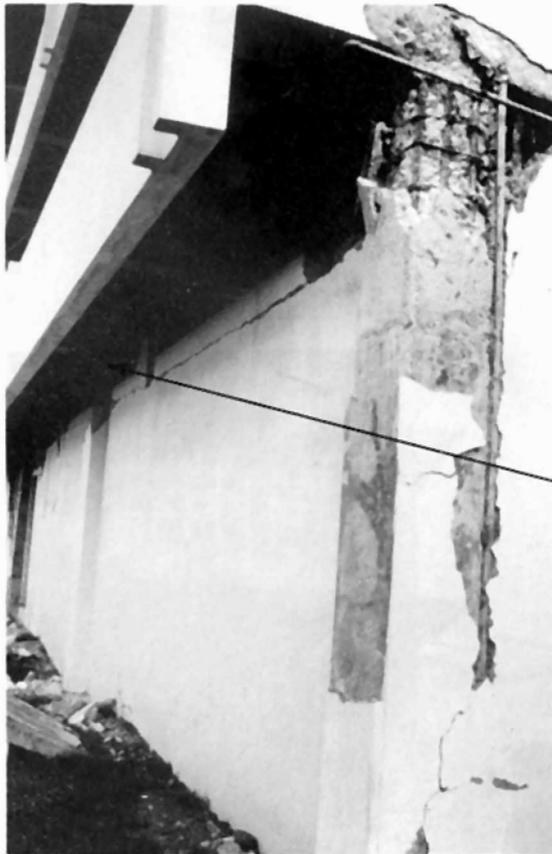
A building opposite to the Arax factory in the Baguio Export Processing Zone (to the left in Figure 5.19), which was the same height and of similar construction, suffered column failure where the infill blockwork stopped short of the beam soffit (Figure 5.26). The confining steel (Figure 5.27) apparently prevented a catastrophic collapse, though the building was said to be propped inside. Another notable feature of these two buildings is that the collapsed Arax factory was built on filled ground created when the natural slope was levelled, whereas the second building, which did not collapse, was built on the cut side.

Figure 5.26
Column failure in building
opposite Arax factory, Baguio

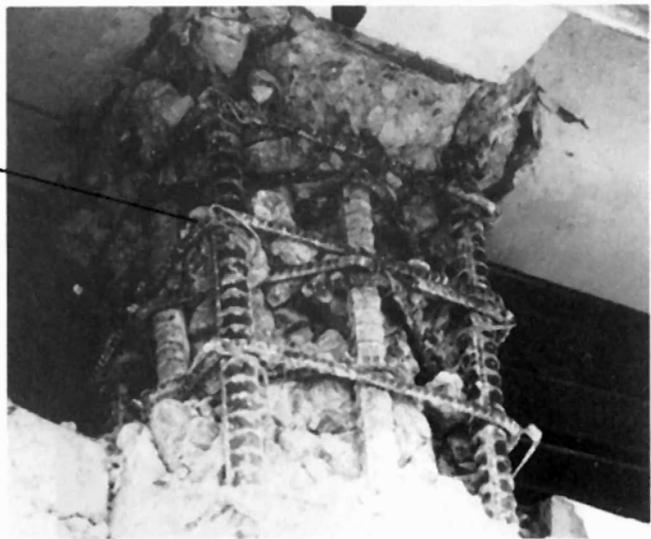
Figure 5.27
Detail of Fig 5.26

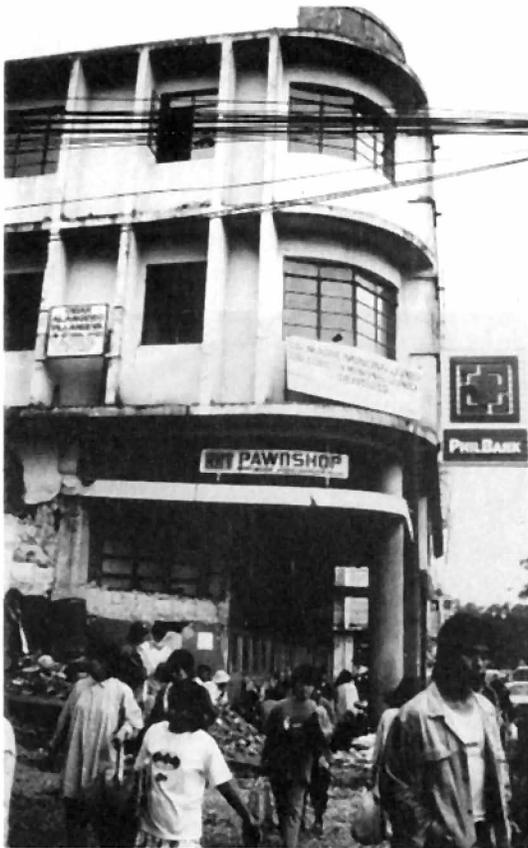
A commercial reinforced concrete building in the centre of Baguio showed severe cracking in a corner column (Figure 5.28). Further south up General Luna Avenue, the 5-storey St. Louis University Elementary High School (Figure 5.29) had some cracked glass and infill masonry.

Figure 5.28
Corner building
in Baguio

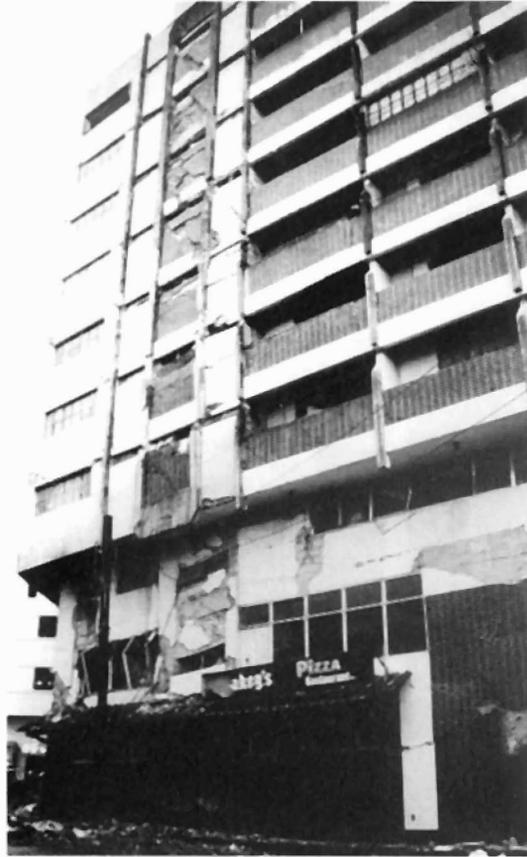
Figure 5.33 Damage to multistorey r.c. building, Baguio

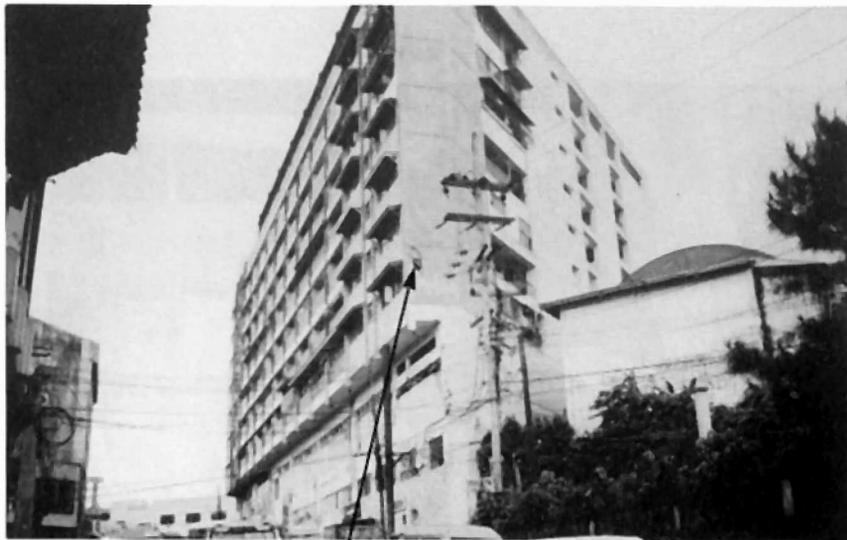
Figure 5.34 Damage to triangular multistorey r.c. building, Baguio

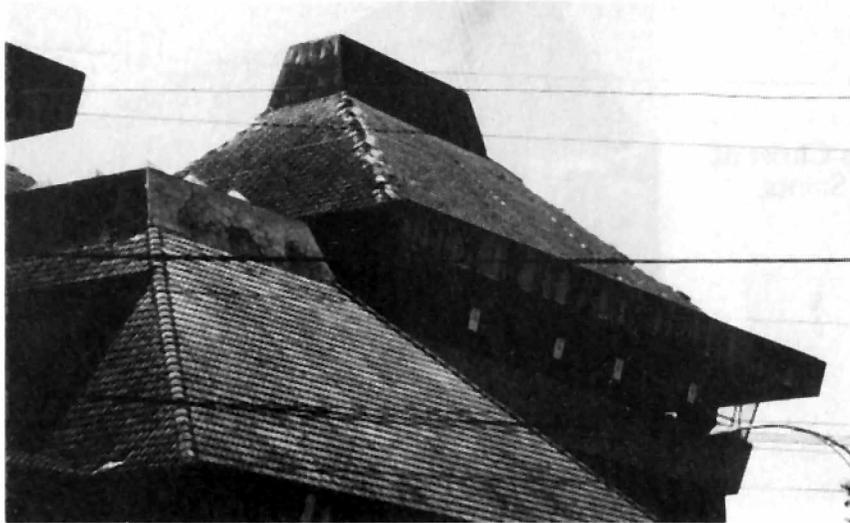
Figure 5.39 Roof of shopping centre, Baguio showing dislodged tiles

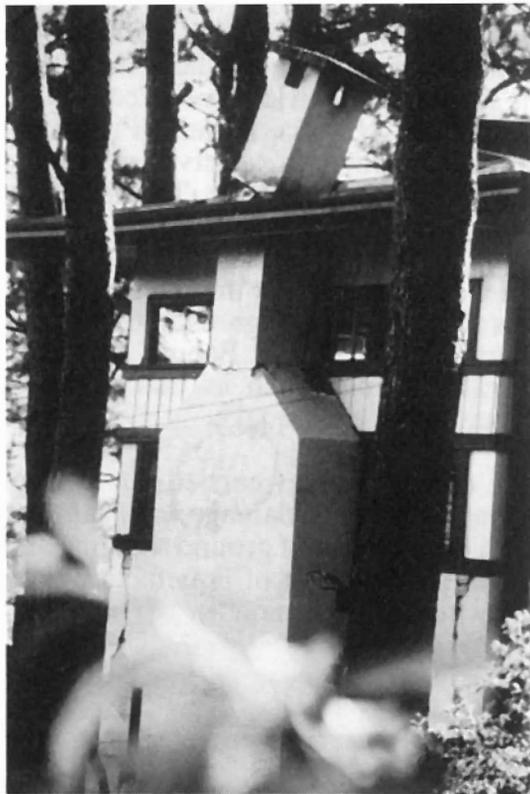
Figure 5.43 Partial collapse of chimney stack in house, Baguio

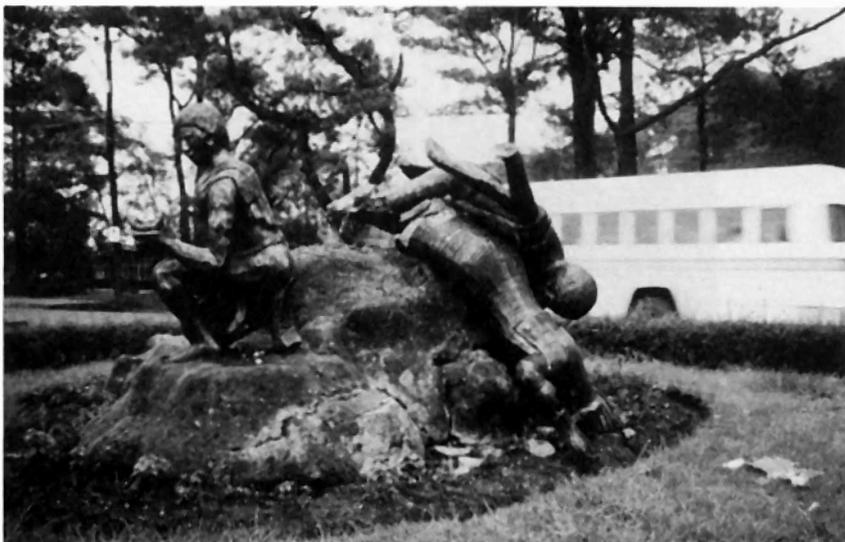
Bronze sculptures were also toppled from their mountings (Figure 5.44).

Figure 5.44 Toppled bronze sculptures near Nevada Hotel, Baguio

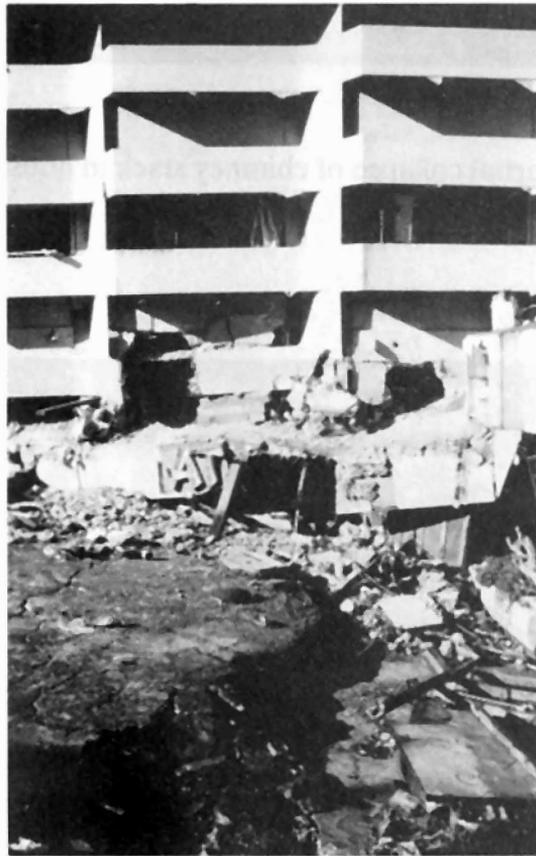
Figure 5.45 Ground settlement near Nevada Hotel, Baguio

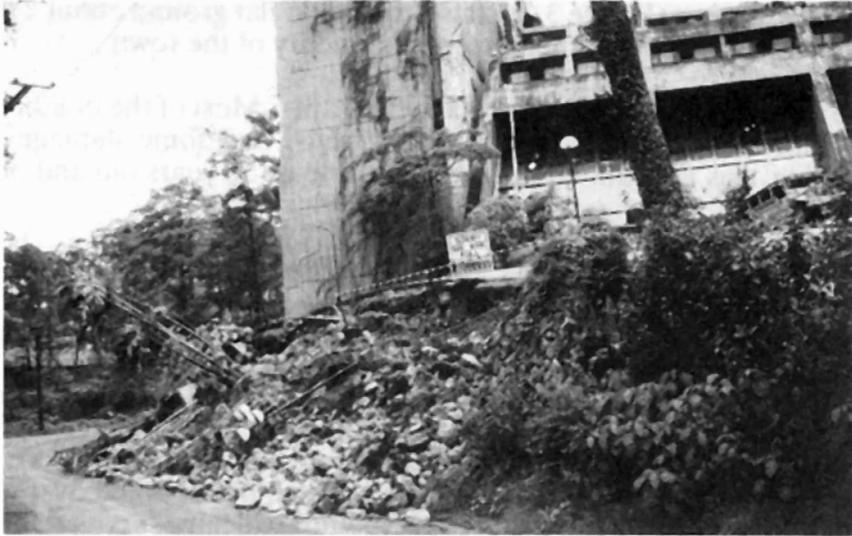
Figure 5.46 Failed slope near Hyatt Terraces Hotel, Baguio

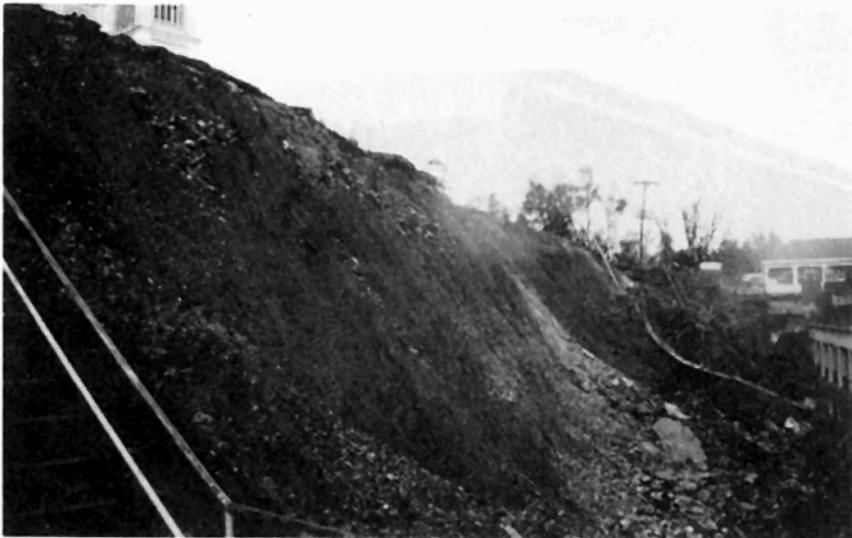
Figure 5.47 Failed slope near Baguio Cathedral

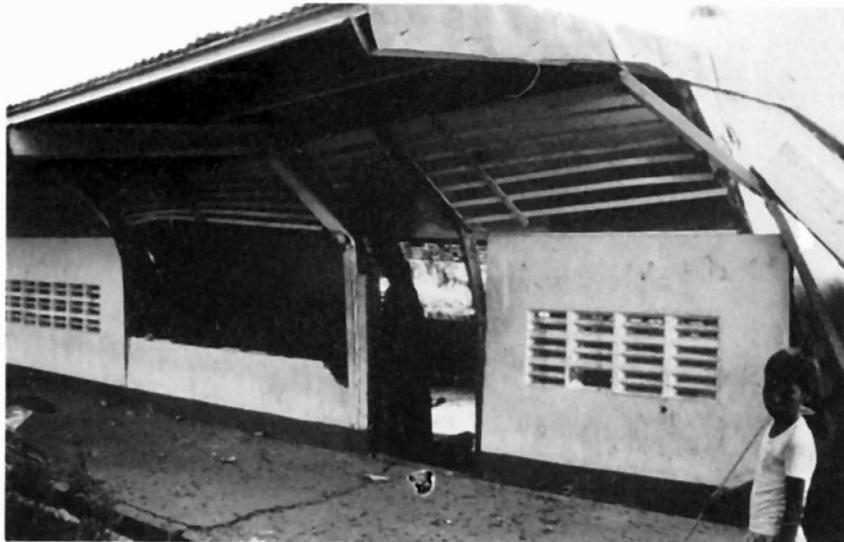
Figure 5.48 Don Marcos Center, Ago: damage to steel frame classroom

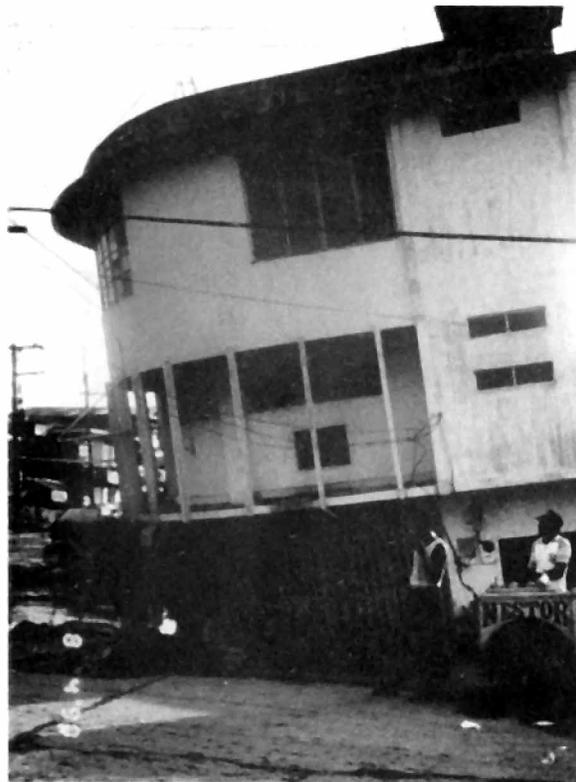
Figure 6.4 Foundation failure of building in Dagupan

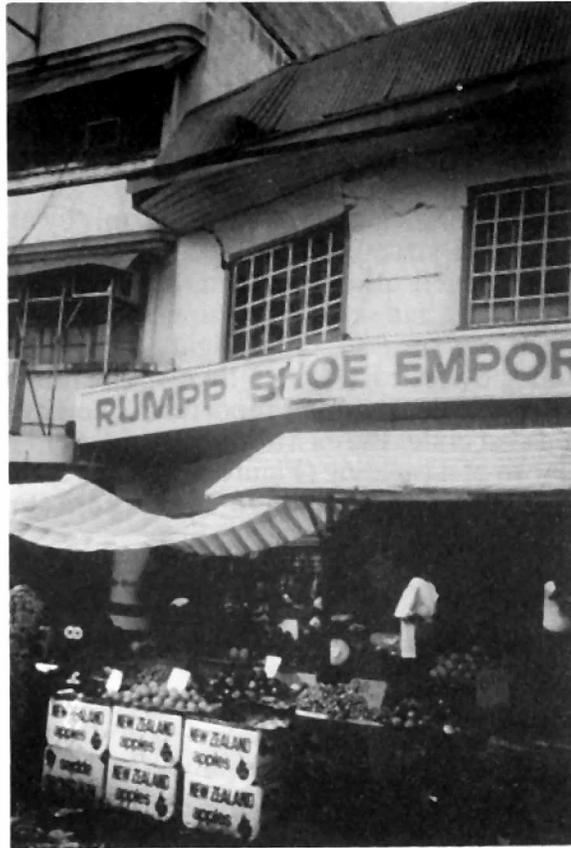
Figure 6.8
Buffeting damage in
Dagupan

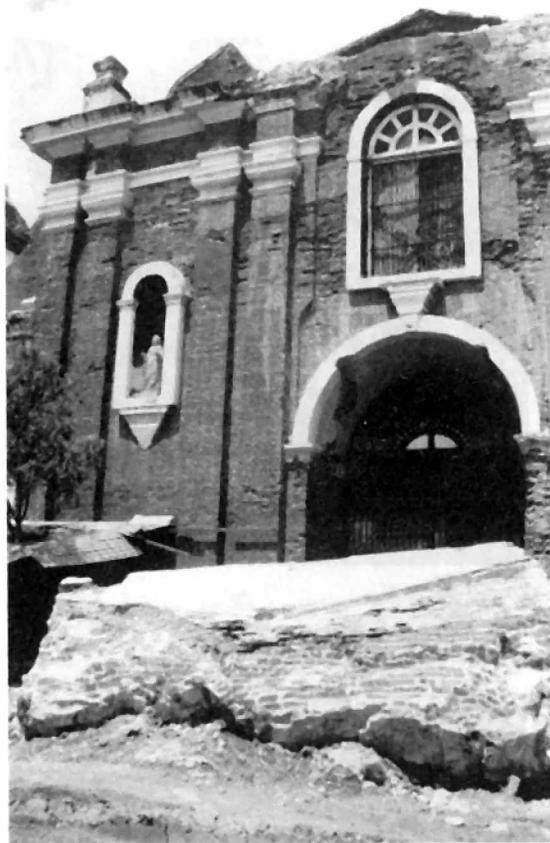
An old masonry church building in the west of the town had part of its roof dislodged (Figure 6.14). Although there was some evidence of liquefaction in areas close to this church, it was not as severe as in the centre of the city and ground shaking seemed to be the source of damage. A recent eight-storey reinforced concrete building opposite the church suffered very little structural damage, although it was reportedly flooded at the basement.

Figure 6.14 Roof failure of masonry church building, Dagupan

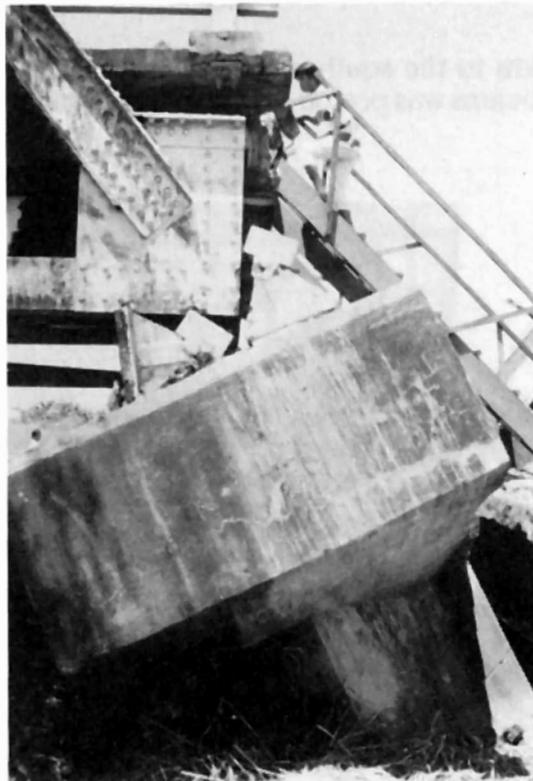
Figure 6.30

Carmen Bridge:
Typical pier failure

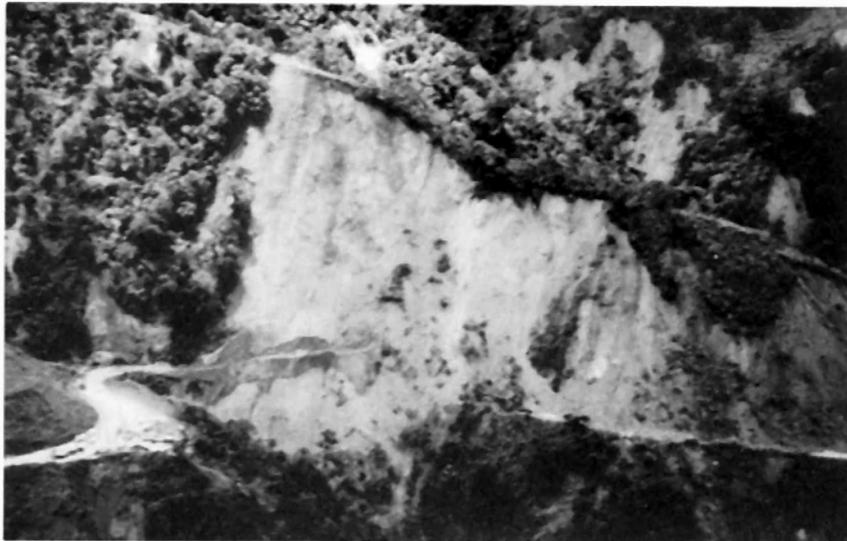
Figure 7.1 Landslide on Kennon Road below Baguio

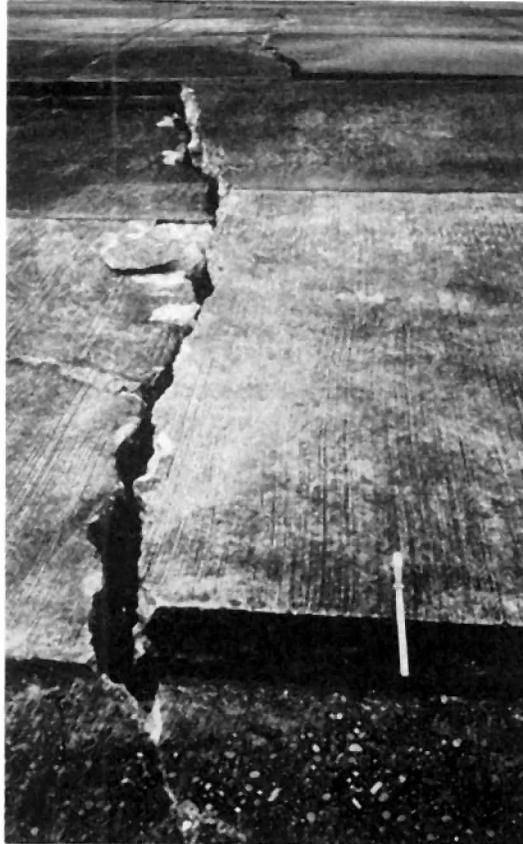
The concrete pavement at Baguio Airport was severely cracked in places, but was re-opened within 48 hours of the earthquake to assist in the evacuation of the injured and homeless. The damage shown in Figure 7.2 is typical, with cracks of about 100mm width together with some smaller vertical movement. Baguio airport is on sloping ground, and the cracks are likely to have been associated with slope stability failure.

Figure 7.2 Damage to concrete pavement, Baguio Airport

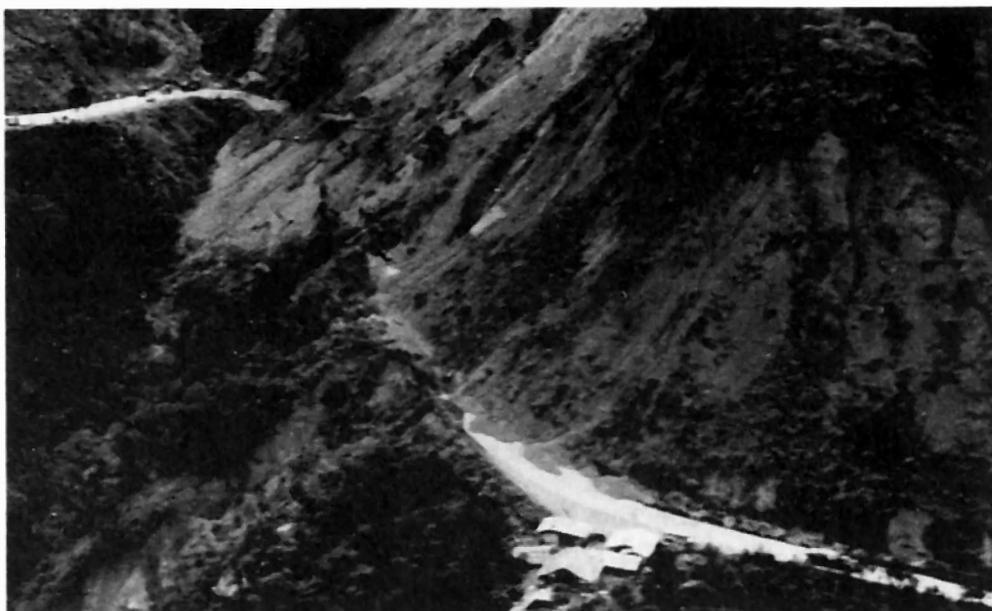
The interruption to the transportation systems, described in Section 7.1 above, affected a very wide region serving central and western Luzon. Landslides were the biggest problem, closing all of the major roads through the Central Cordillera mountains. Amongst the most important of these is the road running northwards from Cabanatuan towards the northern part of the province, which crosses the Cordillera at the Dalton Pass (Figure 3.2). This road was closed by several massive slope failures, as shown in Figure 7.3, and was expected to remain impassable for several months.

Figure 7.3 Slope failure in Dalton Pass

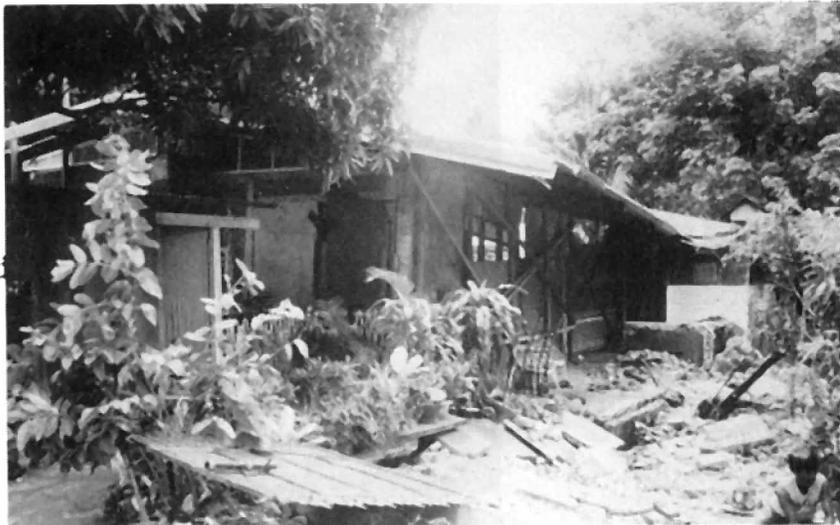
Figure 8.2

Rizal building spanning fault trace without collapse

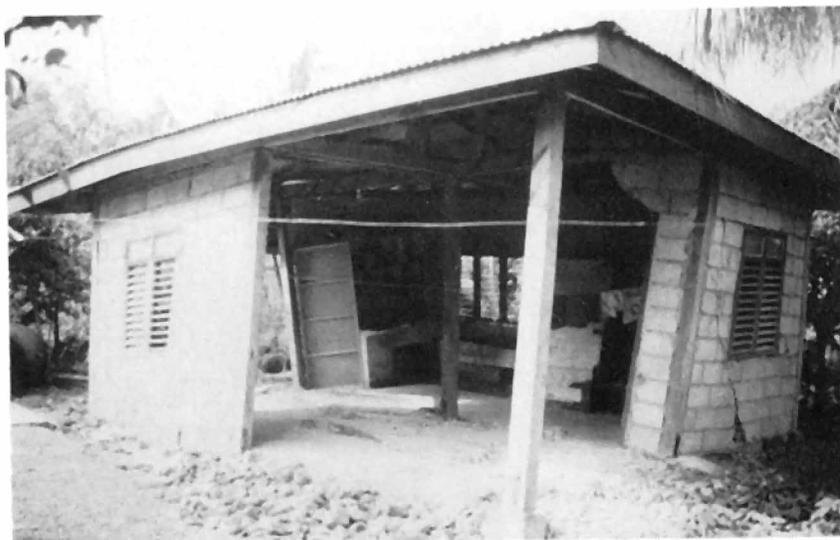
Figure 8.3

Damage to poorly attached blockwork walls at Rizal Central School.
