THE M_w8.8 MAULE CHILE EARTHQUAKE OF 27TH FEBRUARY 2010

A PRELIMINARY FIELD REPORT BY EEFIT

The M_w 8.8 Maule Chile Earthquake of 27th February 2010

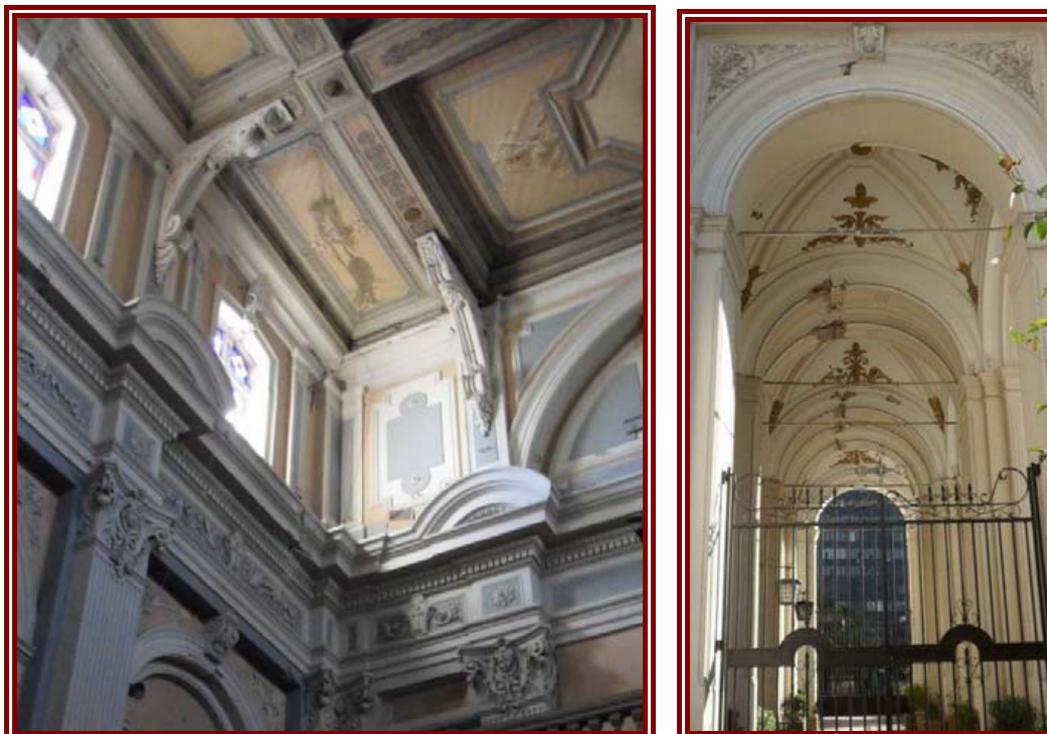
Figure 3-4: Interior corner between façade and south wall of the nave. A crack of separation between the two walls is visible. In the portico a longitudinal cracks runs through all keystones of the vaults supporting the tower. However no lateral permanent sway of the springs is detectable.

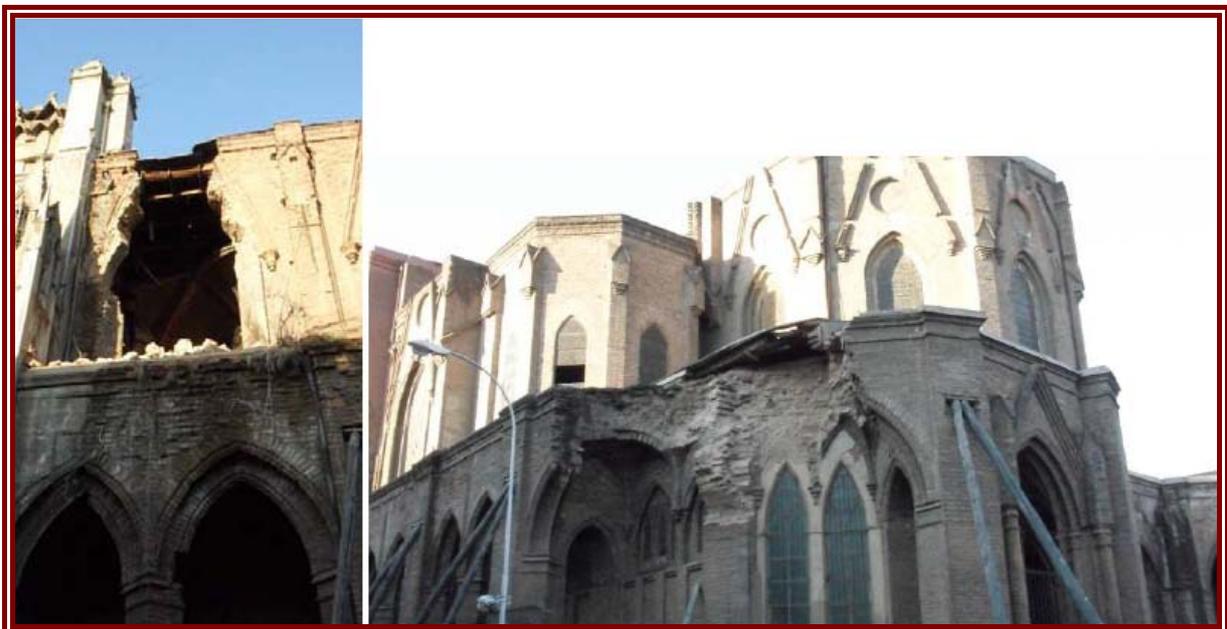
Masonry around the opening at the connection between the façade and the south elevation was lost together with material at connection between the south elevation and the apsidal area.

Figure 3-6: Loss of material at the intersection between façade and southern elevation where there is an abrupt change in stiffness. The missing portion of the south east chapel fell as a solid boulder.

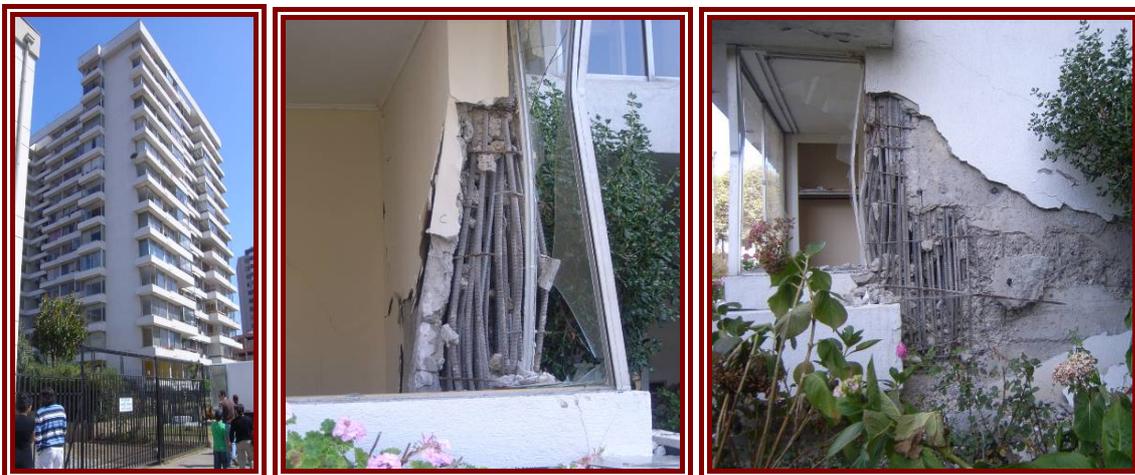
A common cause of failure in reinforced concrete shear wall buildings was buckling of longitudinal reinforcement in boundary zones of slender walls. One example was the 15-storey Edificio Festival, near the waterfront in Viña del Mar (Figure 3-10). Failure of external shear walls at ground level is shown in Figure 3-10 (middle and right). Note that the boundary zones were heavily reinforced with longitudinal reinforcement, but that the transverse reinforcement appeared to be inadequate. The stairwells also experienced severe damage (Figure 3-11).

Figure 3-10: Edificio Festival, Viña del Mar, and damage to shear wall boundary zones

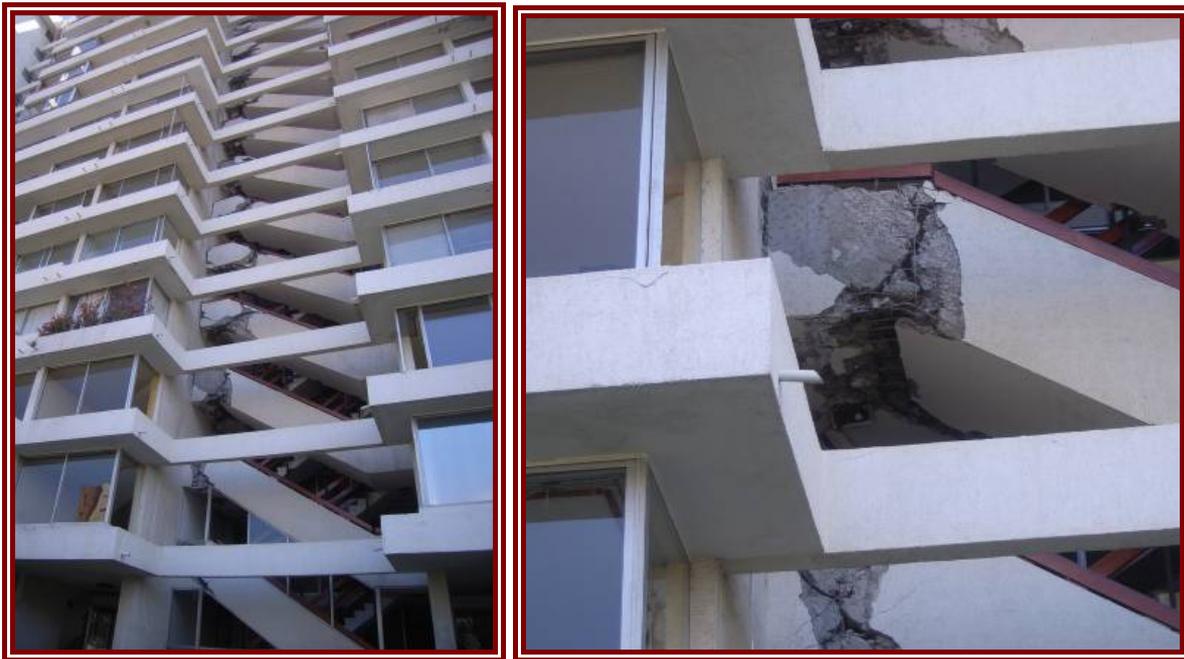
Figure 3-11: Edificio Festival, Viña del Mar, damage to stairwells

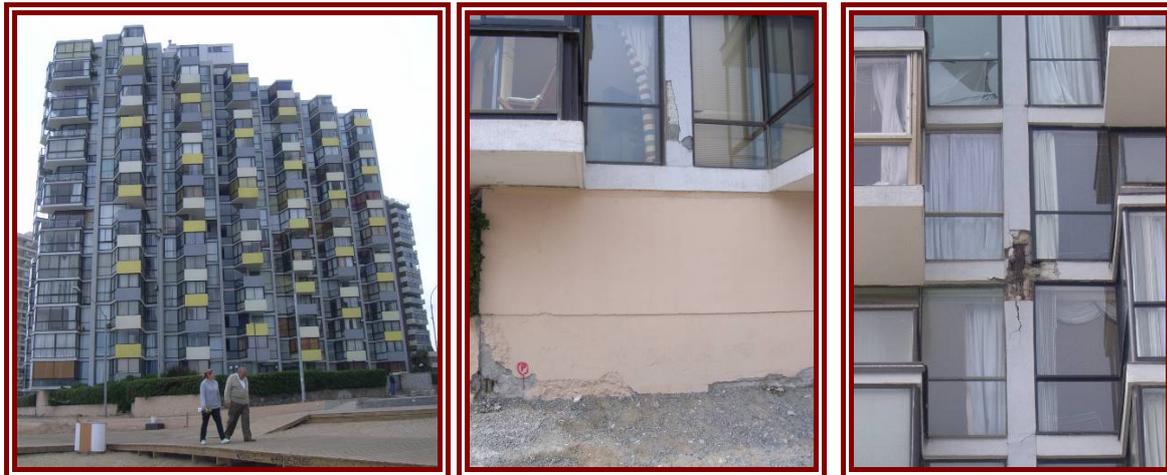
Several apartment buildings on the waterfront in Viña del Mar also suffered damage. The 15-storey waterfront apartment building shown in Figure 3-13 appeared to be a mixed reinforced concrete shear wall and moment frame system. There was evidence of damage at the base of shear walls (Figure 3-13, middle) and at beam-column joints (Figure 3-13, right). Internally, there was also evidence of punching shear failure (Figure 3-14, left) and damage to shear walls and ceilings (Figure 3-14, right).

Figure 3-13: Waterfront apartment building, Viña del Mar, external damage

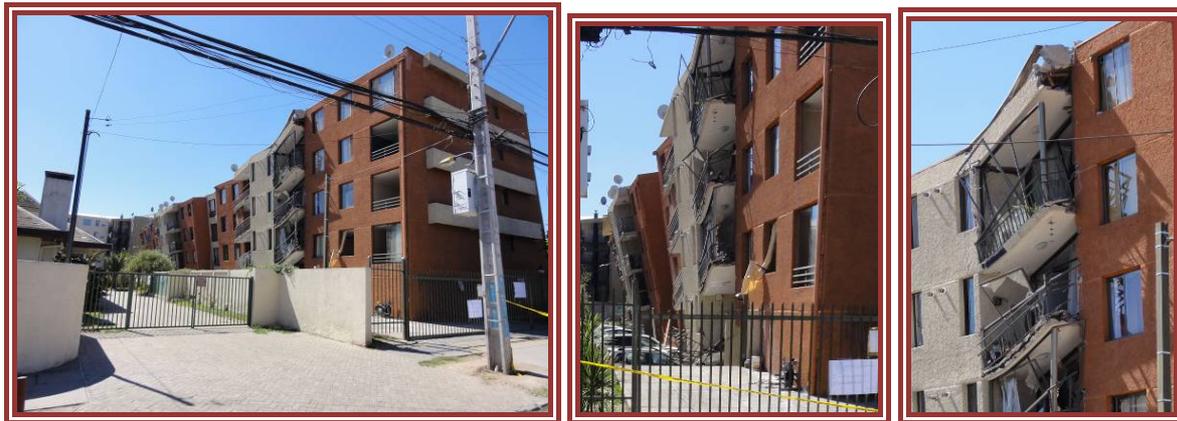
Figure 3-15: Damaged apartment block in Maipu district (Tristan Valdes), Santiago, general views and detail of the damage at the connection of two parts of the building with different ground floor structural system.

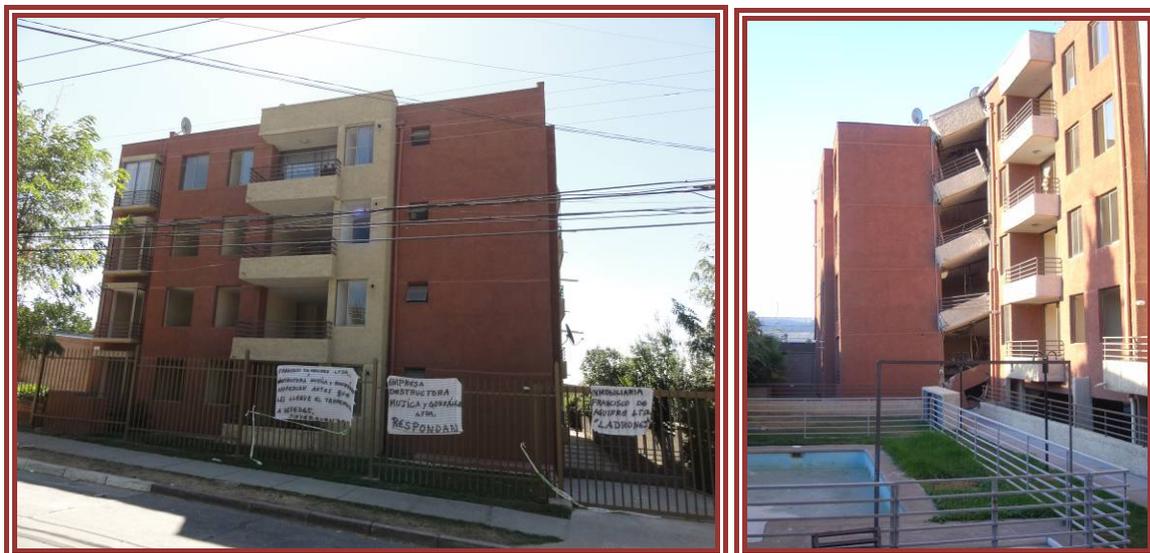
Another building block with a similar structural system collapsed with partial soft storey failure mechanism at the ground level. Figure 3-16 shows the general views of the building and the details of the damage to structural system can be seen in Figure 3-17. It is evident that slender columns (walls) have not been able to produce sufficient strength and stiffness at the point of irregularity between two adjacent floors. While the exact cause of damage and partial collapse of these few buildings among other similar buildings remains to be investigated, from our observations some signs of poor concreting were identified and recorded.

Figure 3-16: Another damaged apartment block in Maipu district, Santiago (general views)

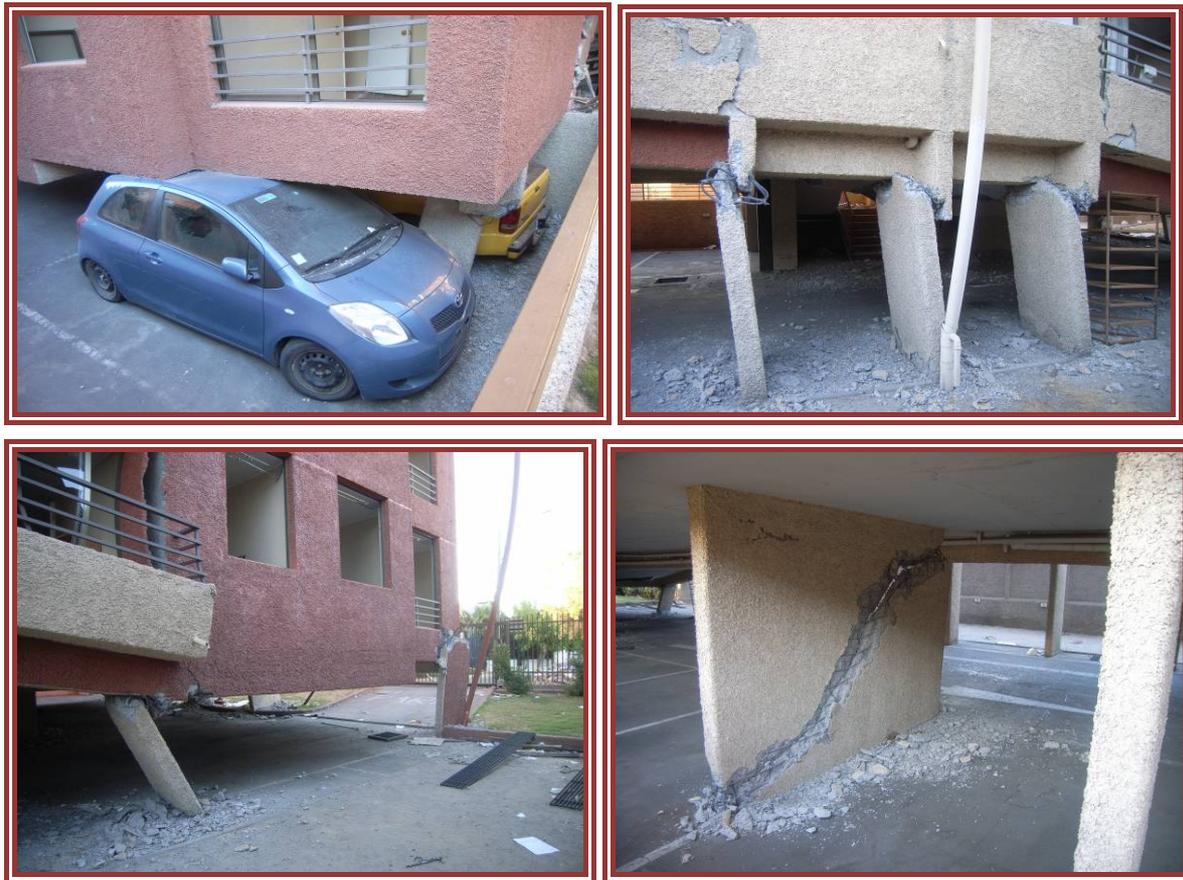
Figure 3-17: Details of the damage to the ground floor of the apartment block in Figure 3-16

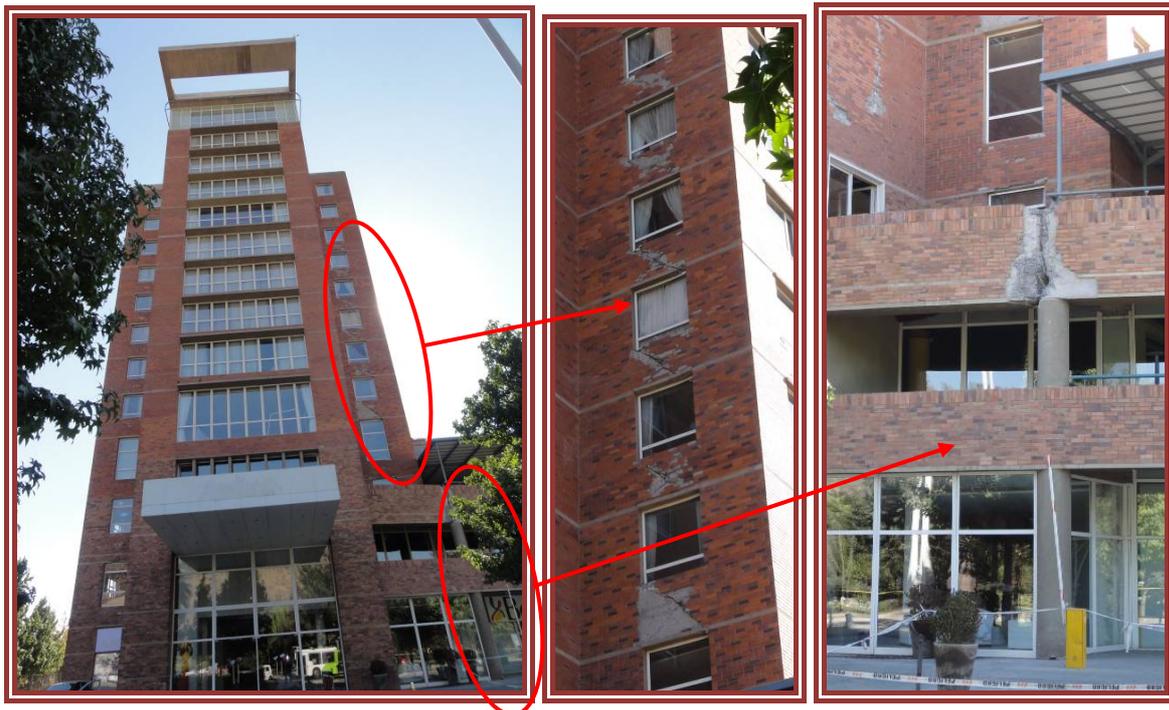
Another part of the city with modern buildings which showed significant damage in the earthquake was located in the north eastern suburb of Santiago, Ciudad Empresarial. The area is well developed with several modern buildings. Francisco Medina from the EERI team reported (<http://www.eqclearinghouse.org/20100227-chile/general-information/observations-on-building-damage-from-francisco-medina>) that the buildings were mainly reinforced concrete frame buildings, in contrast to the stiffer shear wall buildings used more commonly in Chile. The buildings housed the headquarters of many international companies, and the non-structural damage has forced closure of many of the buildings. Structural damage was mainly concentrated in areas around the openings (windows) and staircases (Figure 3-18, Figure 3-19 and Figure 3-20). The coupling elements between two parts of the wall on the sides of the openings were damaged with classic diagonal shear cracks (Figure 3-18 and Figure 3-19). Aside from the use of a more flexible lateral system, local media has suggested effects relating to the soil under Ciudad Empresarial, and possibly three-dimensional wave propagation effects related to the close proximity of the mountains as a reason for the severe damage experienced there (Personal communication: Juan Ferrer).

Figure 3-18: Damage to a hotel in Ciudad Empresarial, Santiago

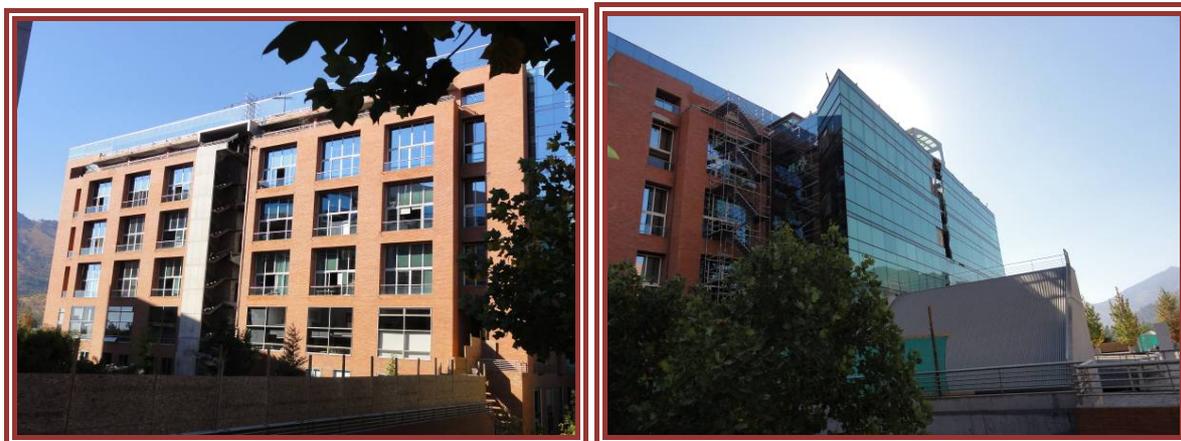
Figure 3-19: Damage to the stair cases and surrounding area in a modern building in Ciudad Empresarial, Santiago (part of stair case has collapsed in the left and similarly the glassy facade on the other side of the building was broken with differential displacement at both sides)

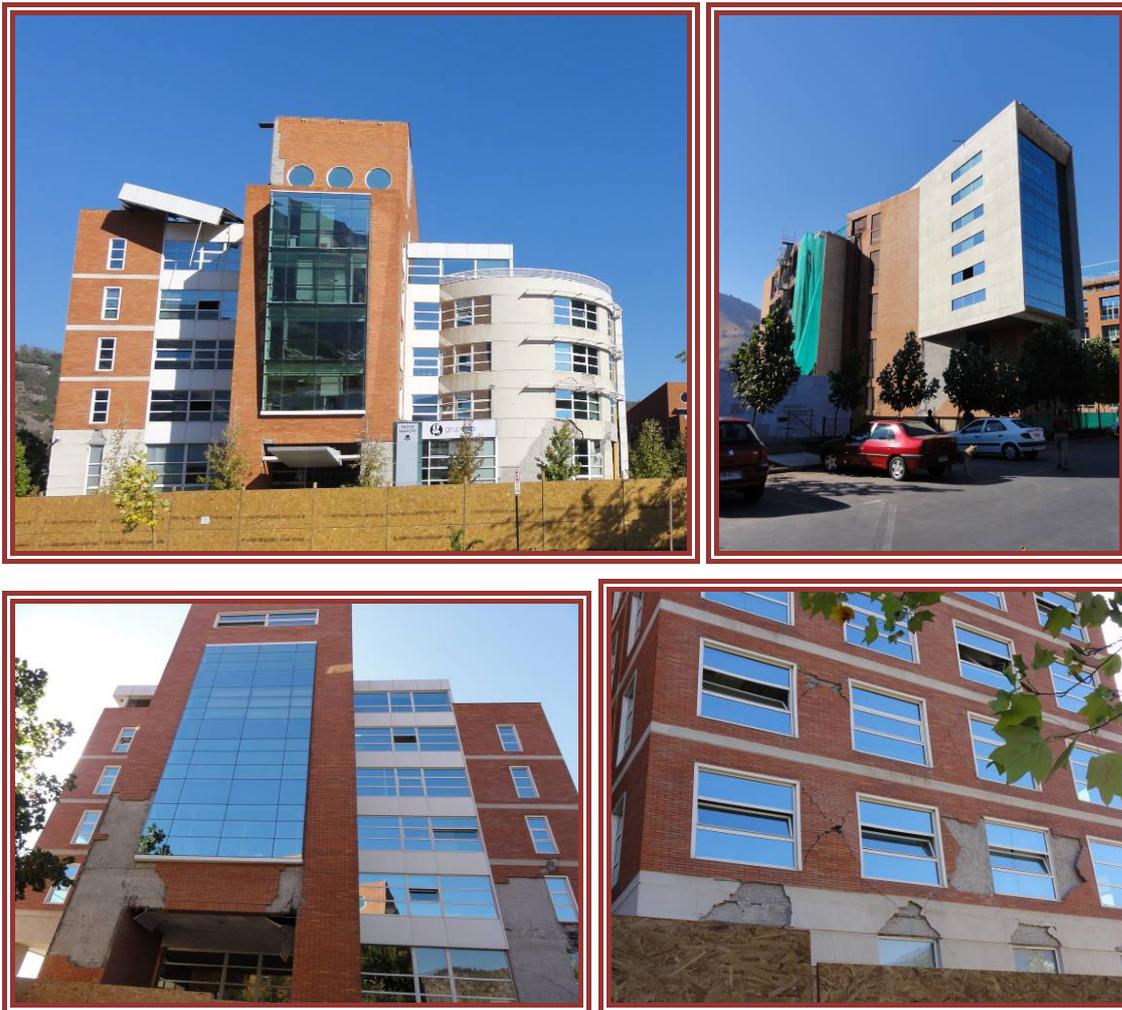
Figure 3-20: Damage to the structural system and facade of some modern buildings in Ciudad Empresarial, Santiago

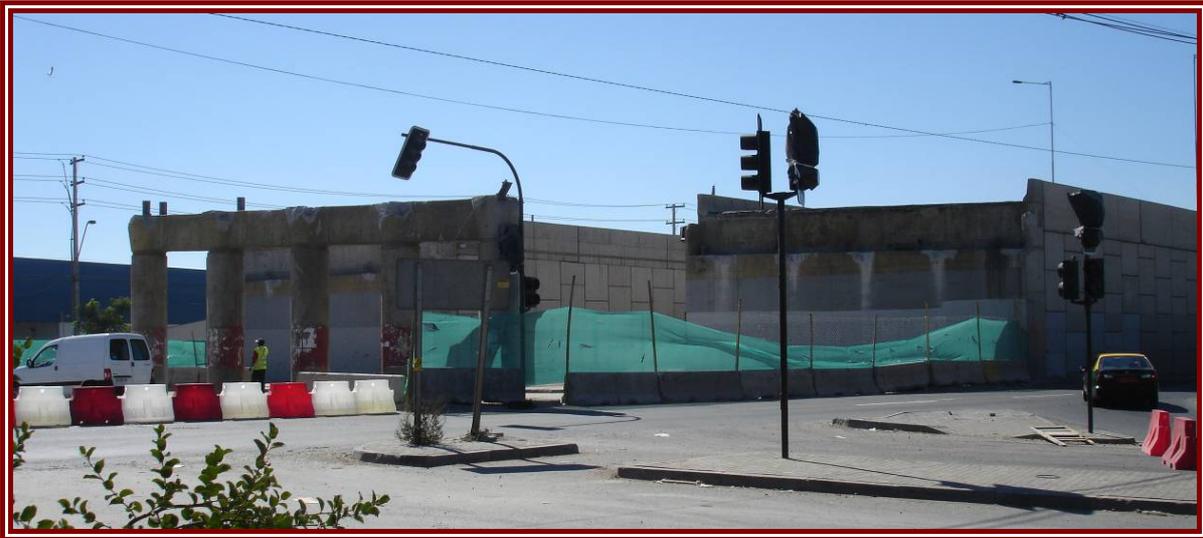
By the time the team arrived at the site of the southern most of the set of bridges, comprising two parallel 3 span skew bridges, the decks had been removed (Figure 3-23) leaving the abutments and two internal portal supports.

Figure 3-23: Remains of the southernmost set of overpass bridges.

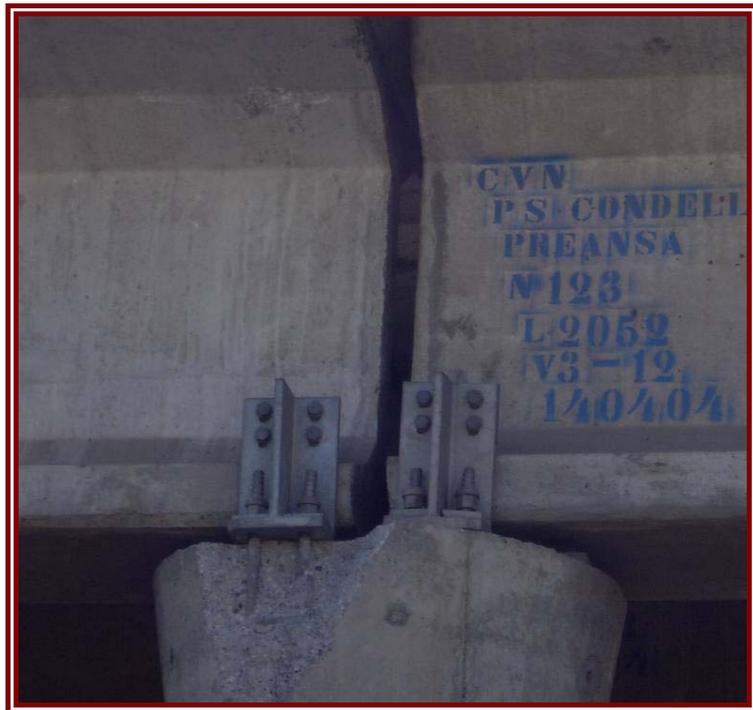
It was clear that these bridges had also experienced significant lateral forces but, in this case, the forces were not high enough to unseat the deck beams. Many of the steel brackets restraining the bridge deck were bent (Figure 3.27) and several showed signs of shear failure of the concrete (Figure 3.28). As with the southernmost set of bridges those steel restraints that remained undamaged suggested that the deck beams had also rotated clockwise on plan.

Figure 3-27: Damage to deck restraints. Figure 3-28: Spalling of concrete around holding down bolts

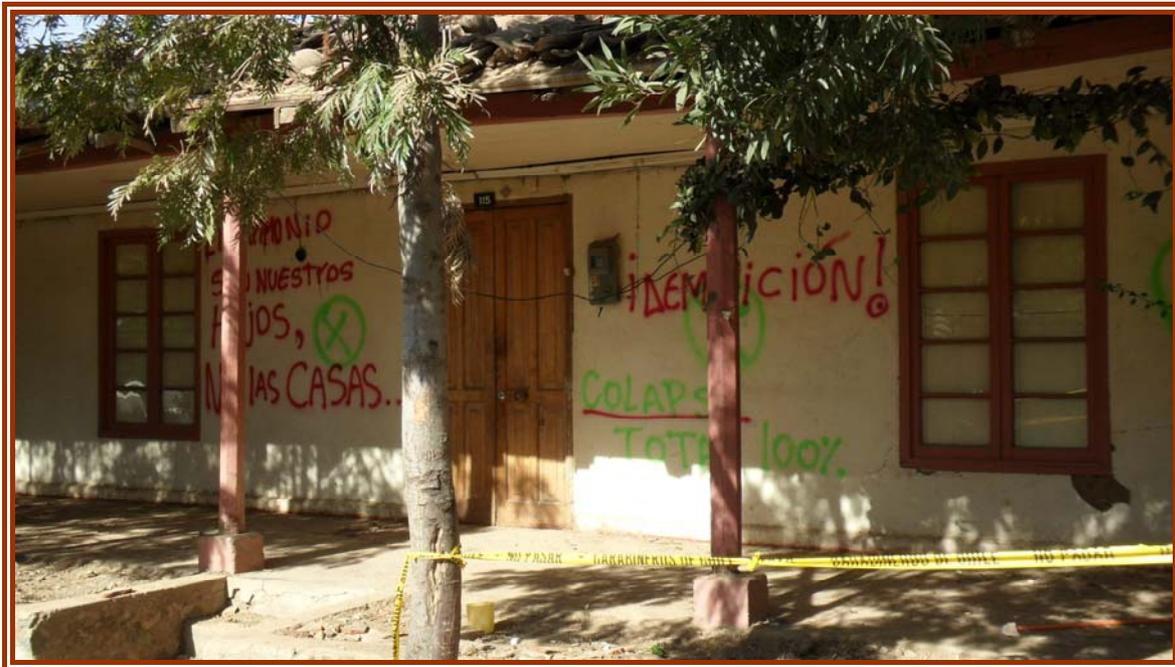
Figure 4-8 Lolol: One of the listed houses on the main street. The graffiti in red on the left reads: “Patrimonio es nuestros niños, no las casas” (heritage (but in this case also asset) are our children not our houses) and on the right in green “colapso total 100%” (total collapse).

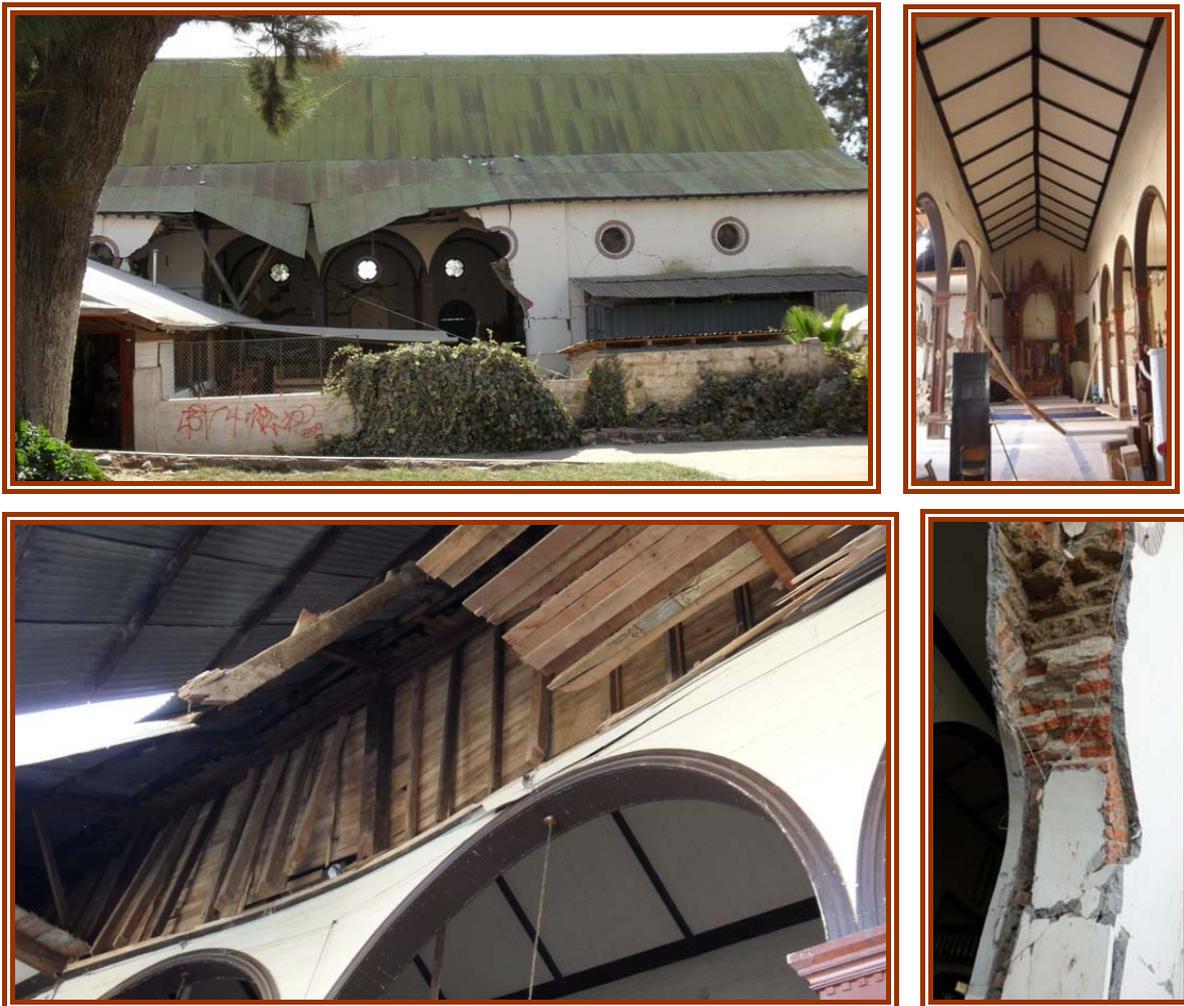
The parish of Lolol was established in 1824, while the current parish church was first erected in 1915 and consecrated in 1916. The church is built in adobe with a base in brickwork and fired bricks around the circular windows and around the two doors opening on each side wall. With respect to the original building, the bell tower was added in 1951, a wooden screen was added at the back of the façade, and the floor was tiled. The church suffered substantial damage in 1985 and was retrofitted with a thick shotcreting with wired mesh, both internally and externally but apparently without metal ties between the two. Failure seems to have been initiated around the openings at the interface between adobe and brickwork. The Council technical office is hopeful that the church can be restored.

Figure 4-9: The parish Church of Lolol: failure of the side walls around the lateral door, view of the internal structure of the nave in timber, Detail of the timber cladding above the arches, detail of the shotcreting of the external sidewalls introduced as repair after 1985 earthquake.

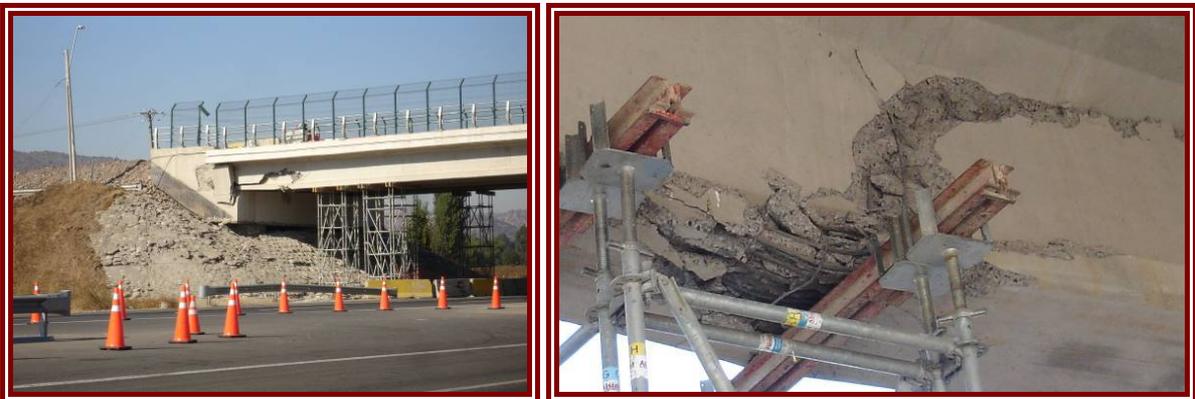
Figure 4-11: Typical damage to overpass bridges near Santiago (left). Prestressing tendons can be seen in the detail on right (right).

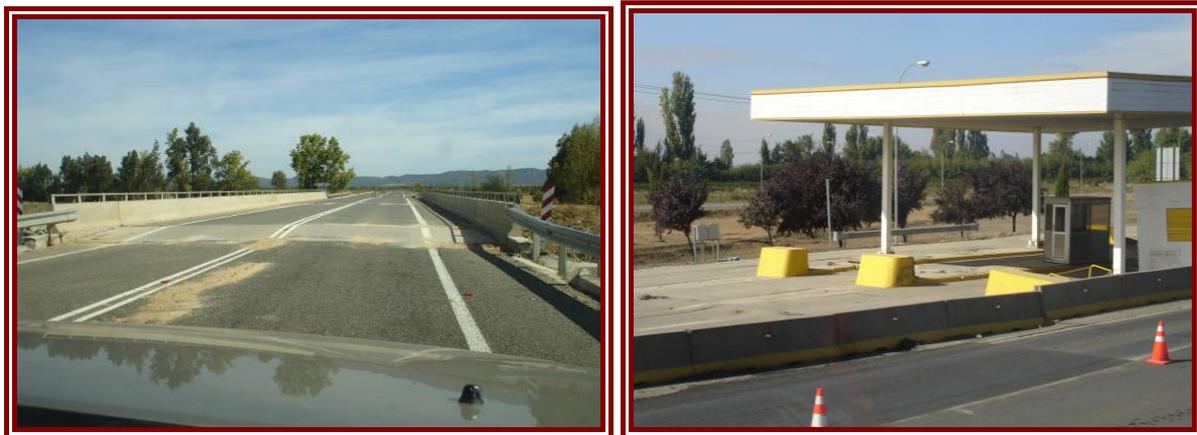
Figure 4-12: Lateral spreading and settlement of bridge abutments occurred at many bridges (left). Road settlement at toll station (right).

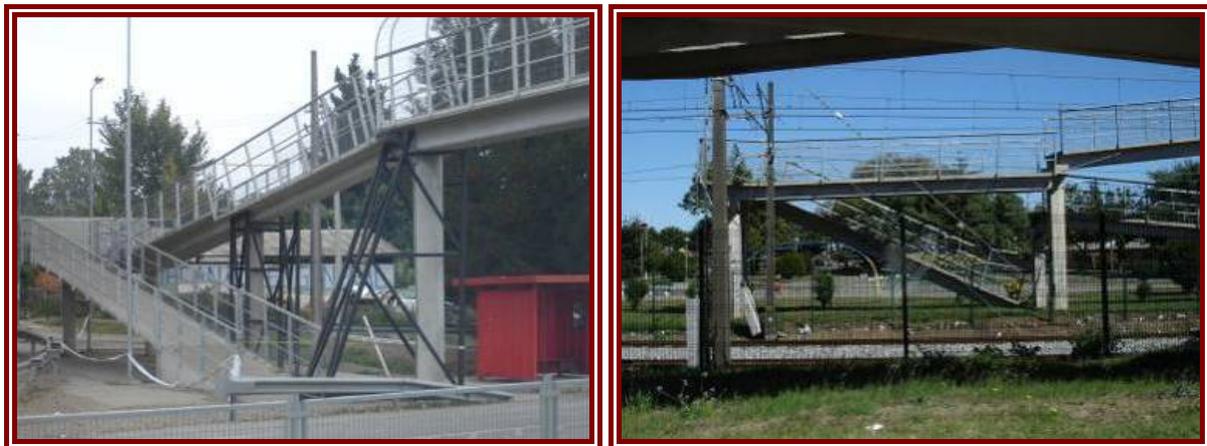
Figure 4-13: Typical footbridge failures

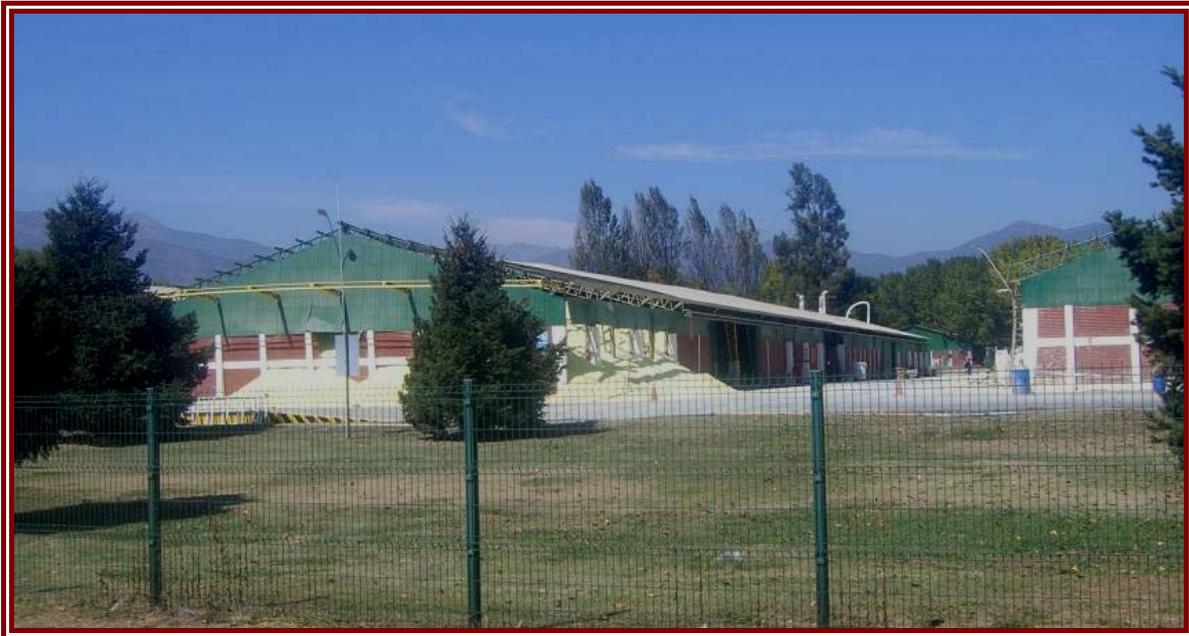
Figure 4-18: Damage to sulphur storage facility south of San Fernando

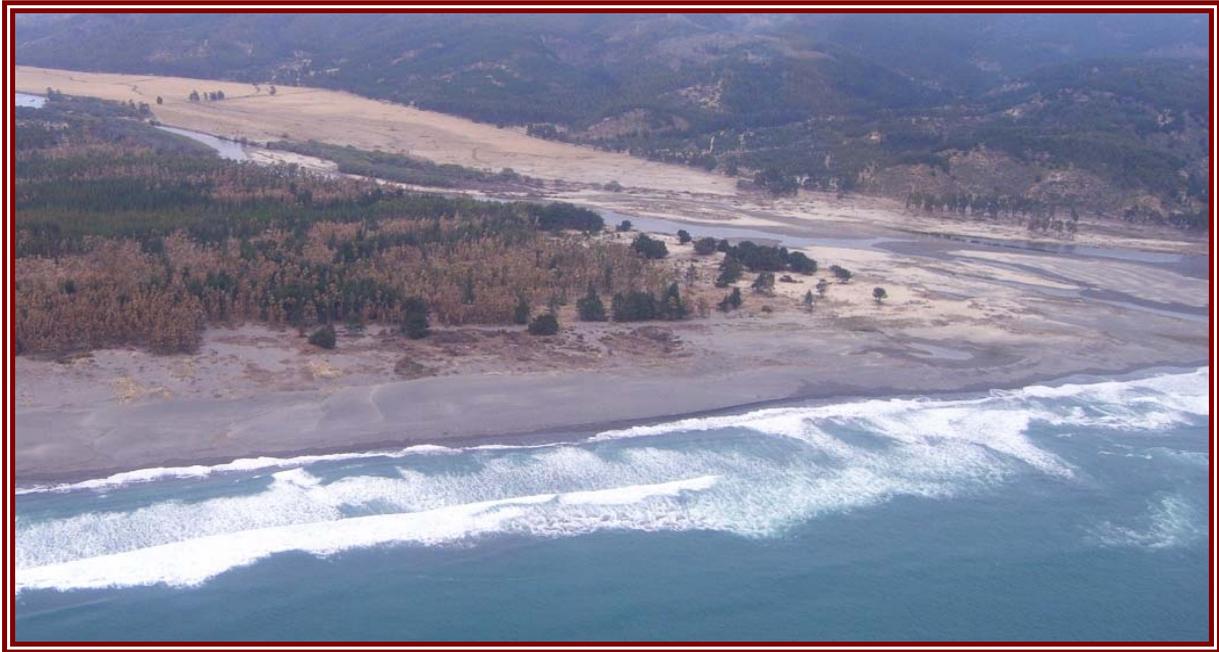
Figure 4-19: Saline intrusion from tsunami inundation, Northern O'Higgins Region

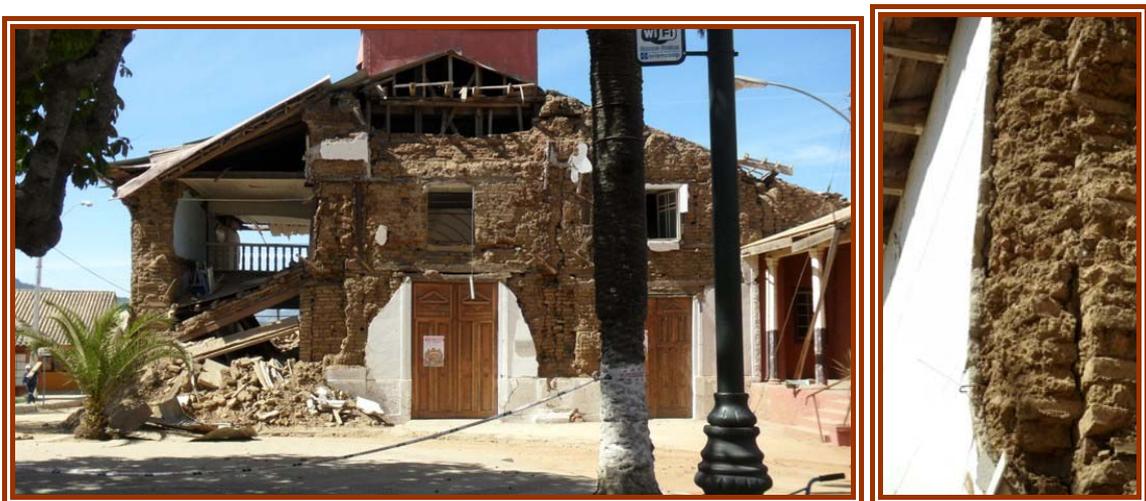
Figure 5-4: The parish Church in Curepto: loss of the façade plaster and partial collapse of the south nave. The anchoring system is visible in façade at the ceiling level.

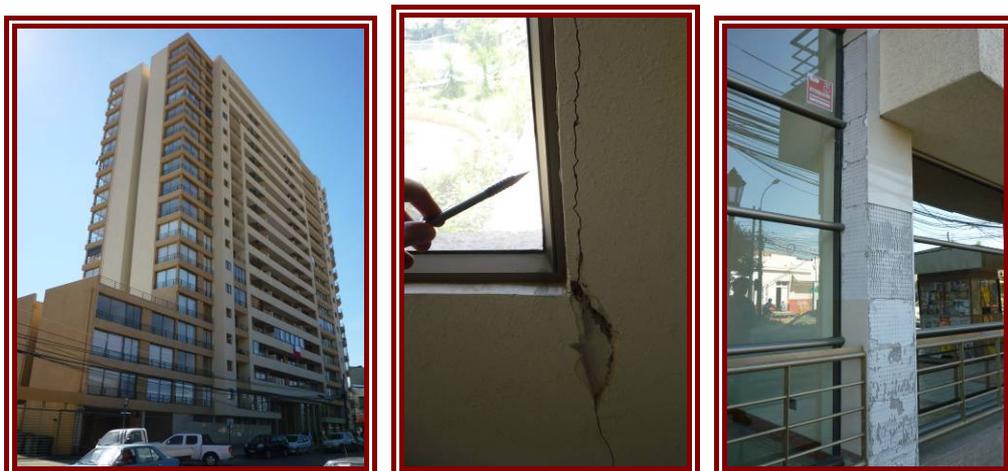
Figure 5-7: Edificio Amalfi, damage to finishes at movement joint in building, and damage to façade tiles.

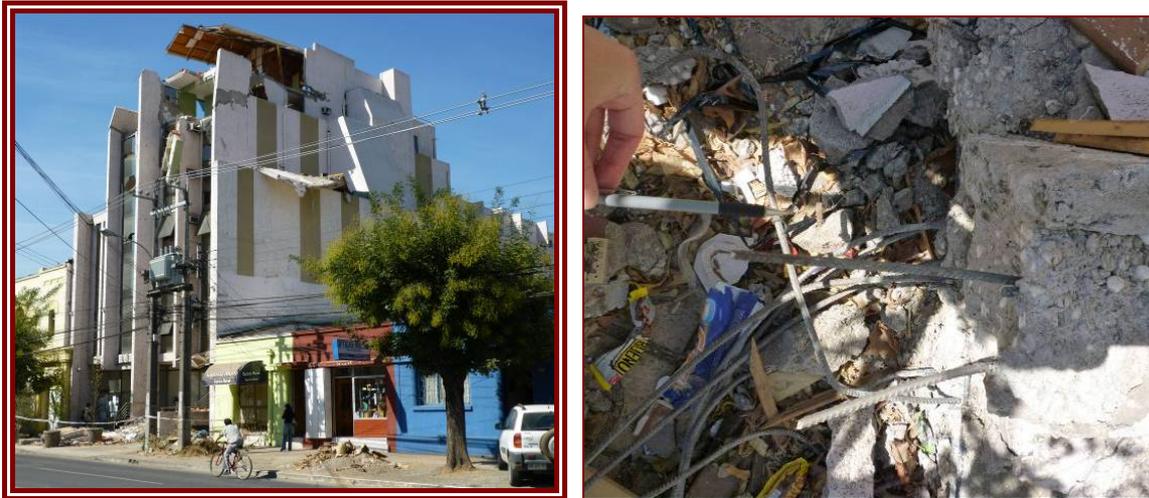
Figure 5-9: Edificio Aranjuez: out-of-plane failure of walls and reinforcement in rubble

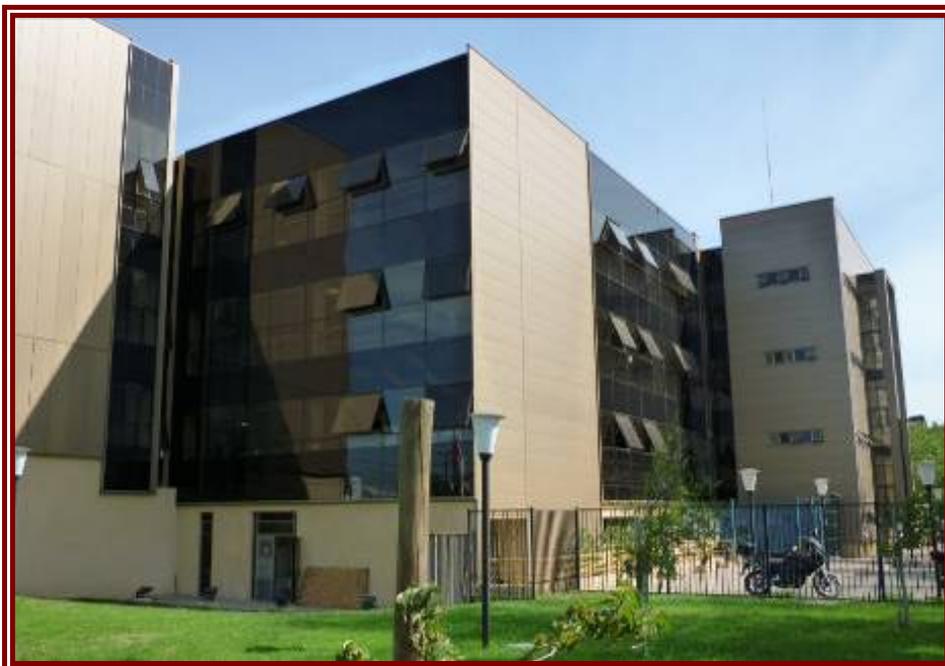
Figure 5-14: Damage to old hospital building and no discernable damage to modern hospital building in Talca

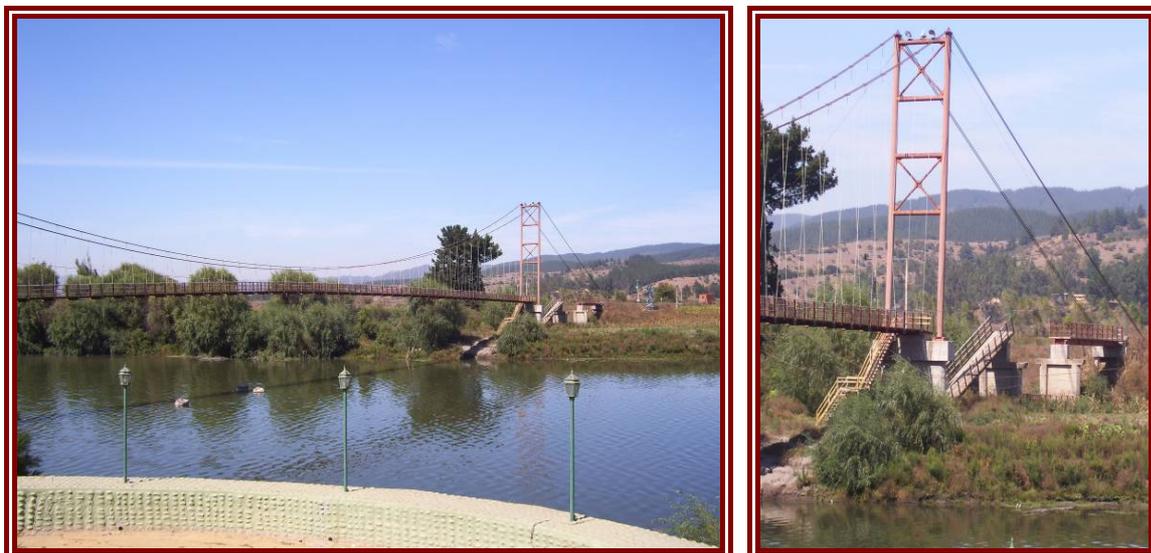
Figure 5-18: Suspension bridge failure, Lincantén

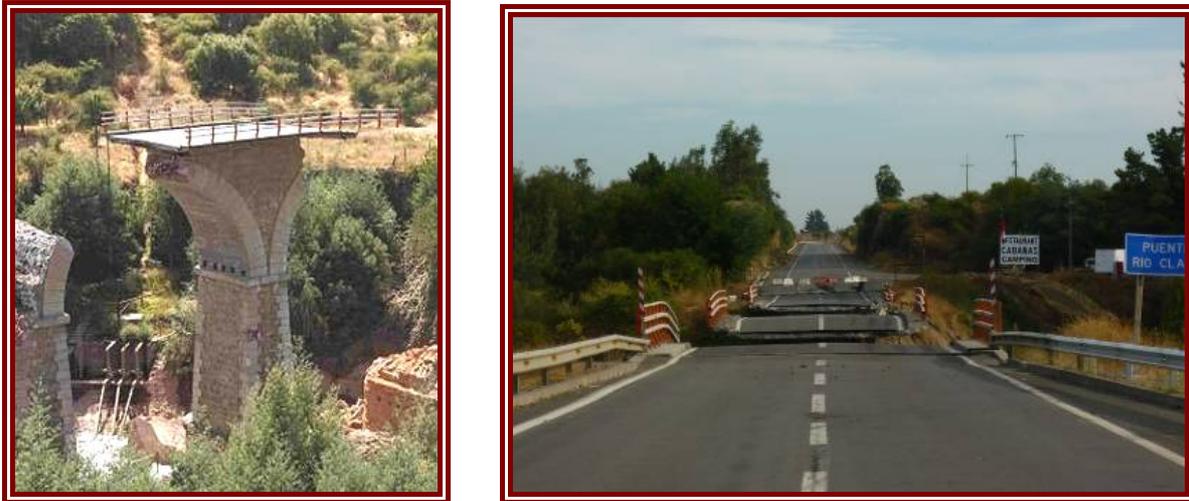
Figure 5-19: Rio Claro Bridge (southbound traffic) collapse

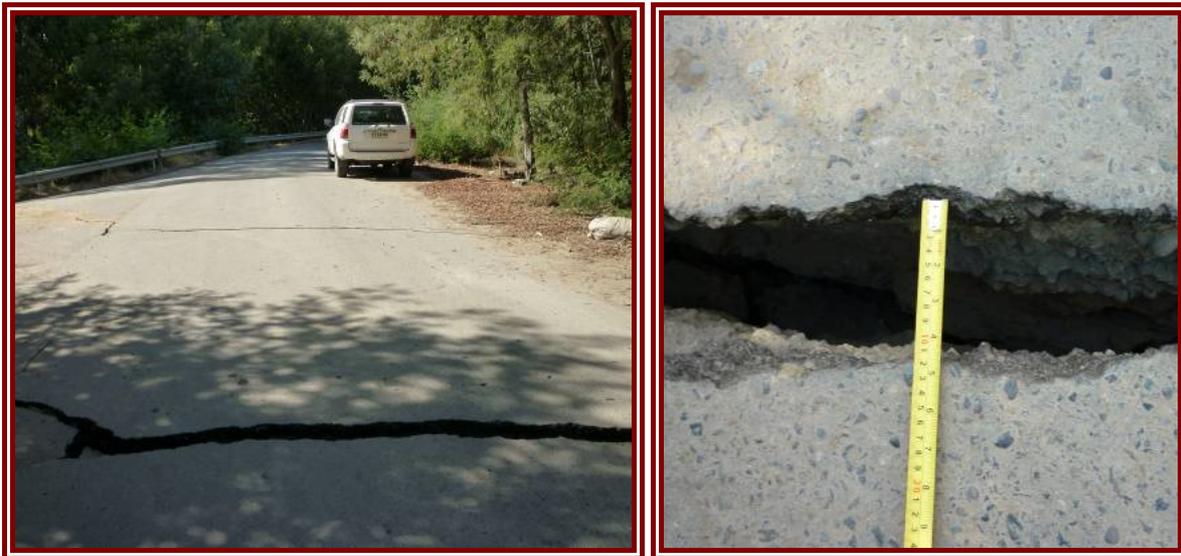
Figure 5-23: Significant lateral spreading of soil and damage to roadway close to Cardenal Raul Silva Henriquez Bridge, Constitución.

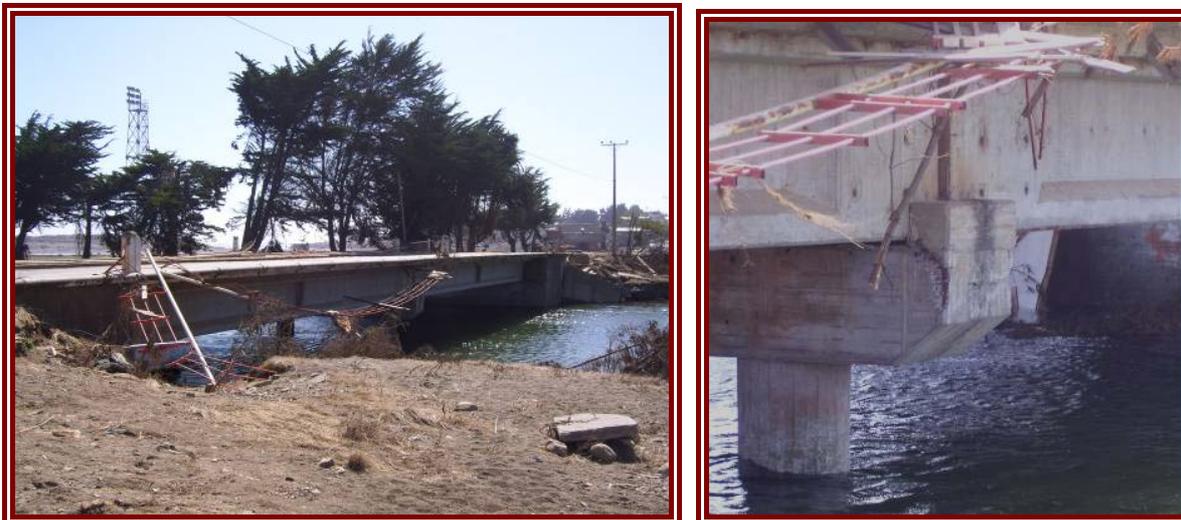
Figure 5-24: Bridge on M-80-N in Pelluhue, and damage to shear key on upstream side.

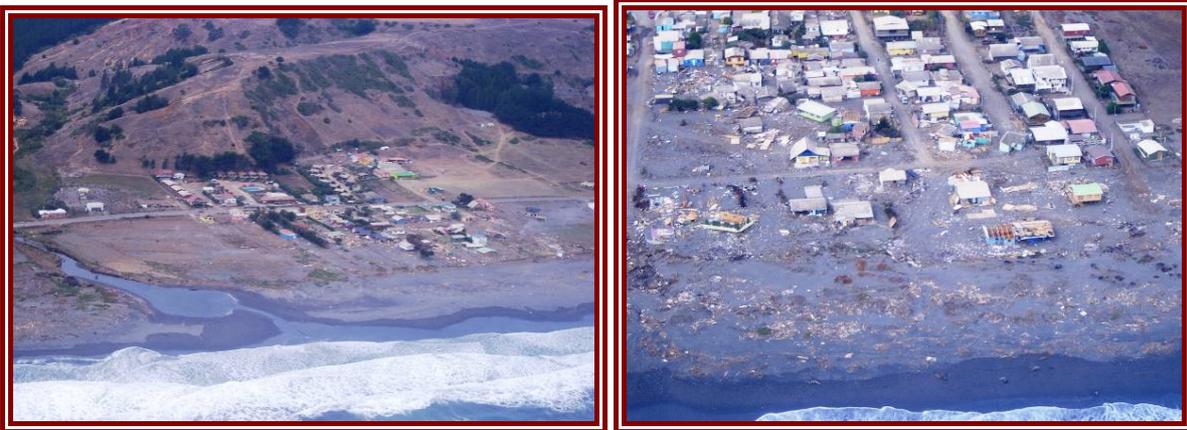
Figure 5-27: Severe damage to villages around Iloca

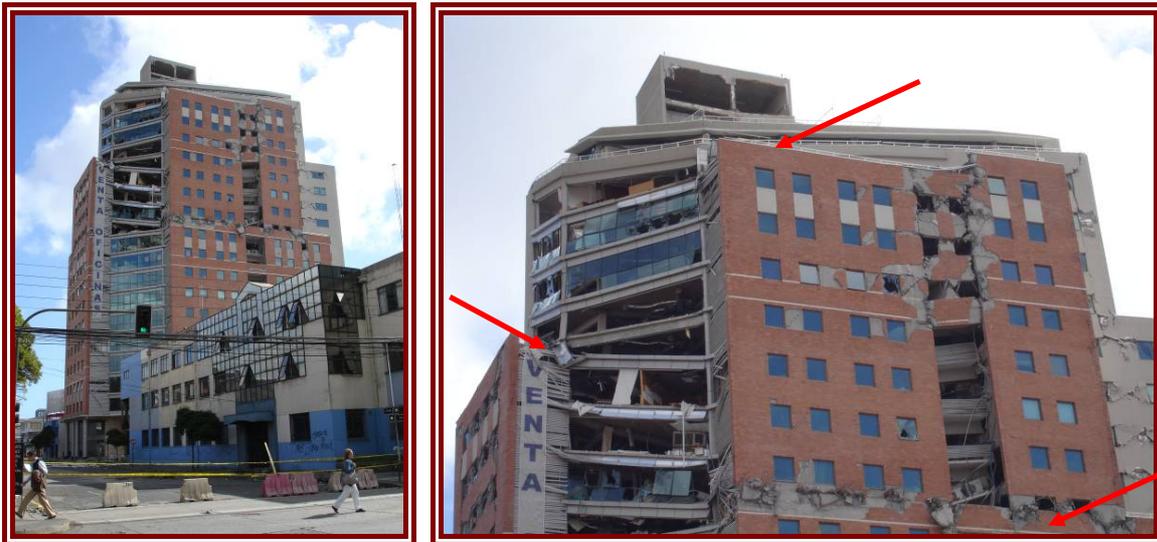
Figure 6-5: Torre O'Higgins 241. On right the 3 soft storey collapses are identified with the arrows.
