THE M_w8.8 MAULE CHILE EARTHQUAKE OF 27TH FEBRUARY 2010

A PRELIMINARY FIELD REPORT BY EEFIT

The M_w 8.8 Maule Chile Earthquake of 27th February 2010

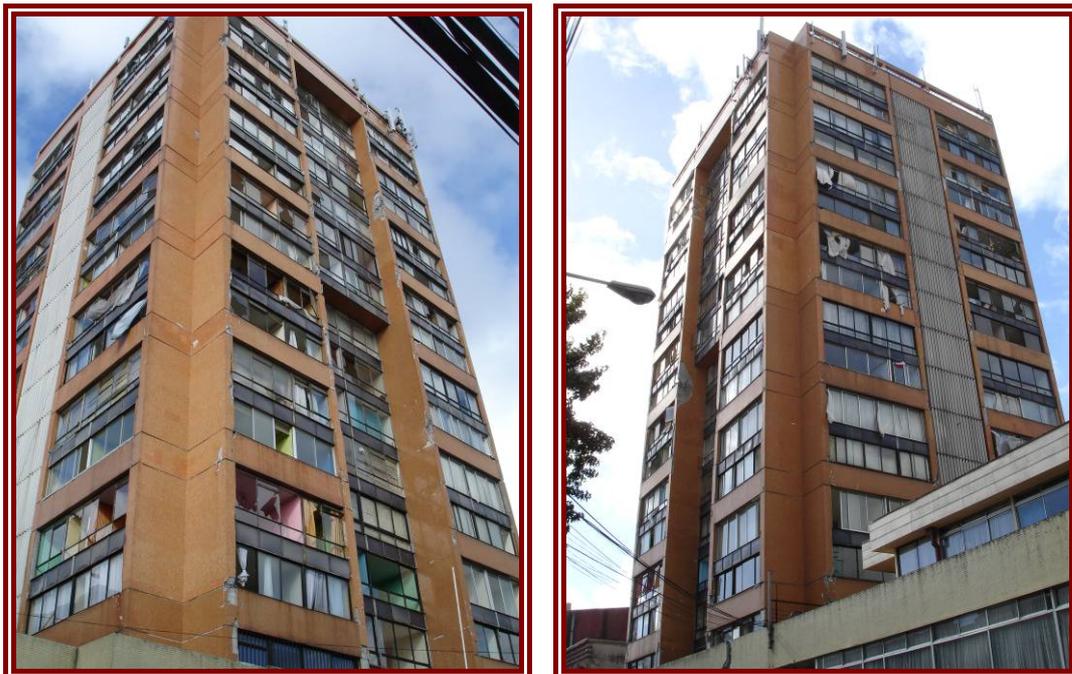
Figure 6-8: Damage to beam column joints over the full height of Lincoyan 440

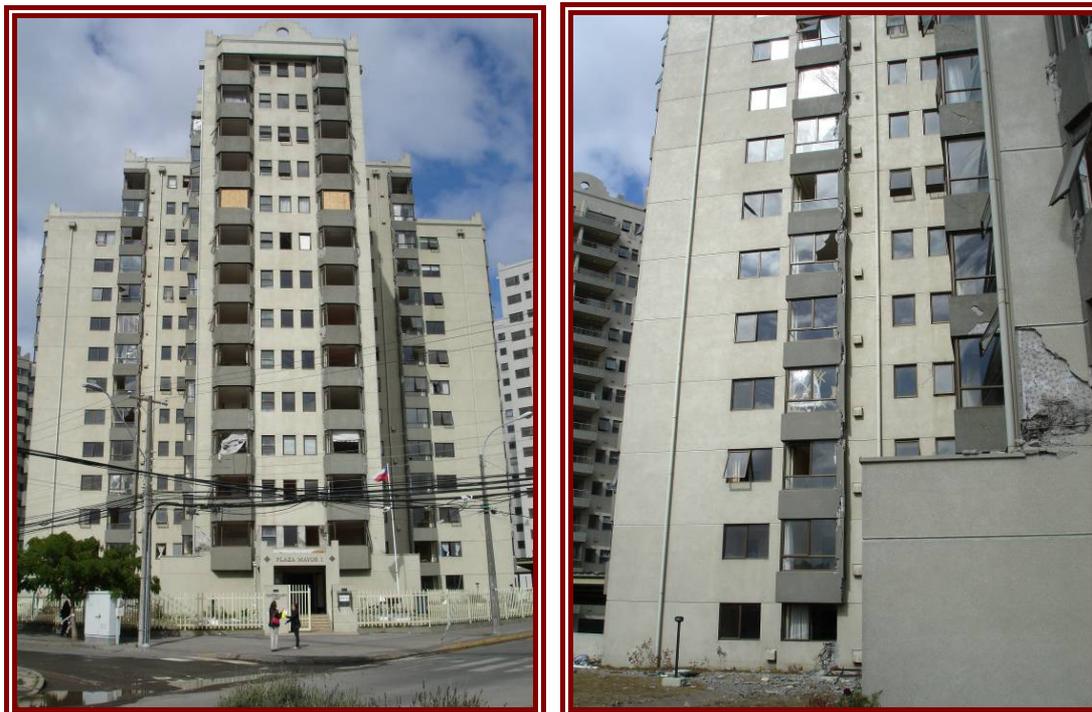
Figure 6-9: Plaza Mayor I (2002) showing extensive damage around projecting windows.

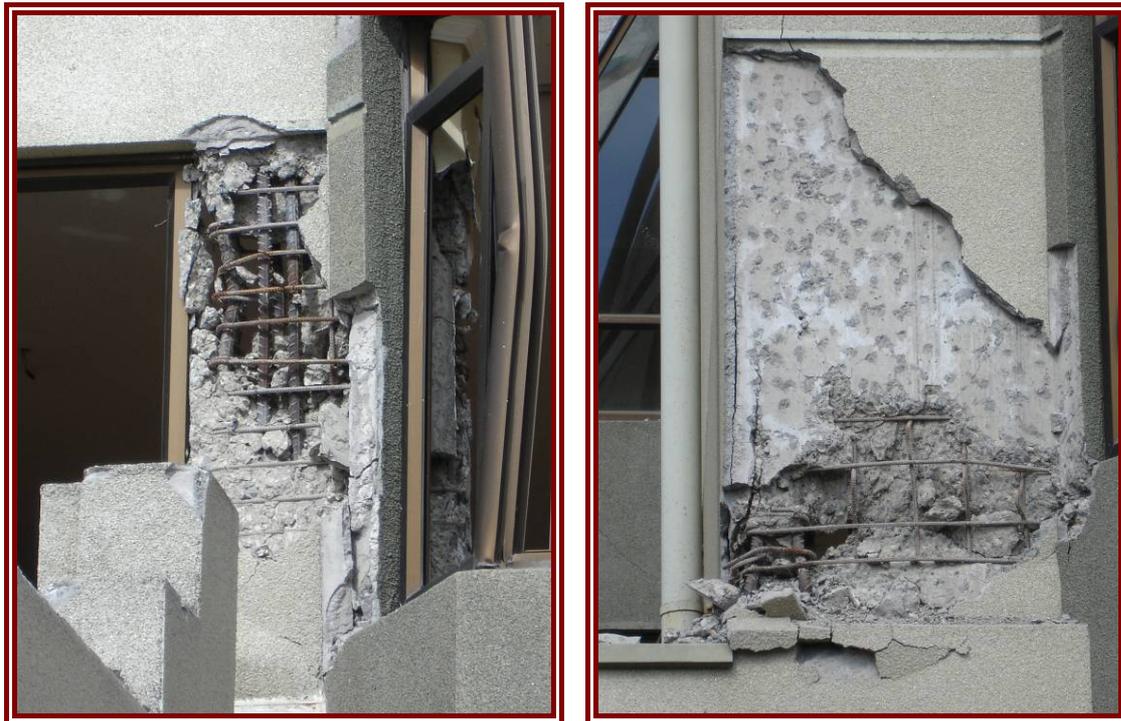
Figure 6-10: Failures to Plaza Mayor I at 1st floor level. Left: Buckling of steel and loss of cover in column elements, Right: lack of links in shear wall elements

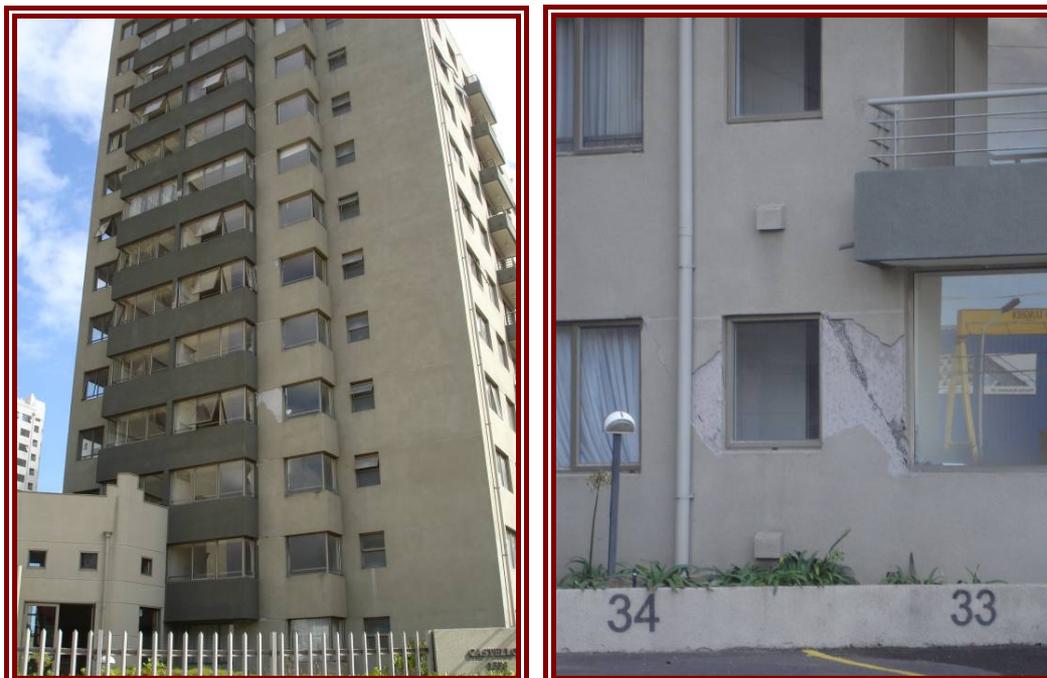
Figure 6-11: Minor external damage to Plaza Mayor II (left), Detail of cracking of shear walls in Plaza Mayor III (right)

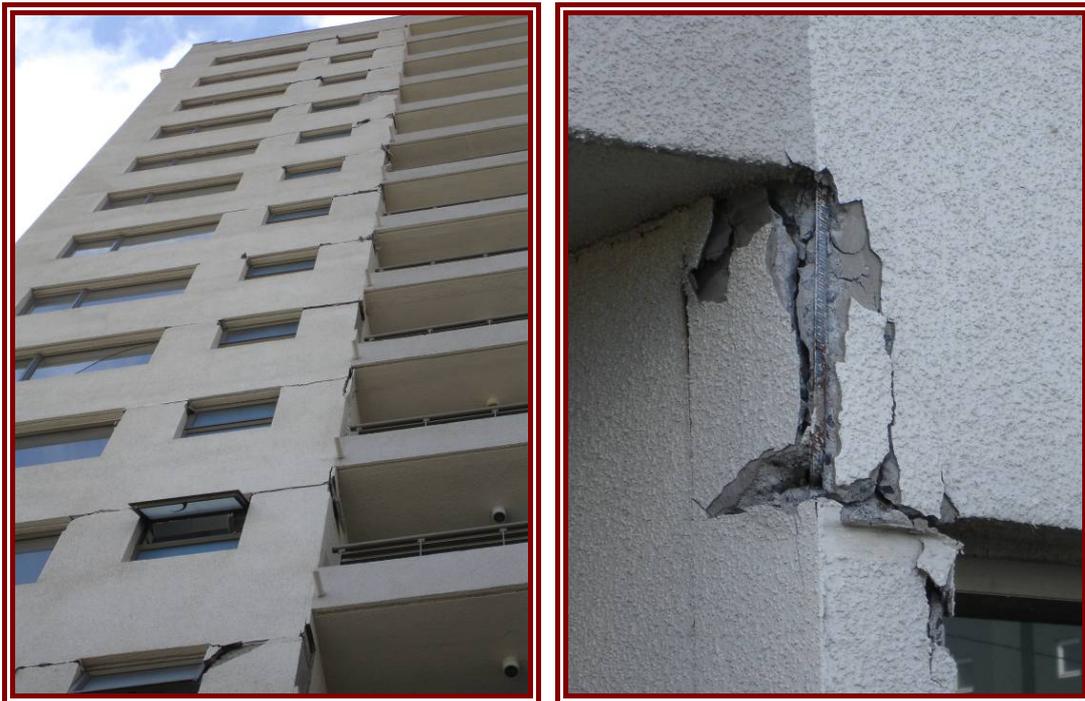
Figure 6-12: Damage up the full height of Plaza Mayor IV (left), Detail of beam column connection in Plaza Mayor IV (right).

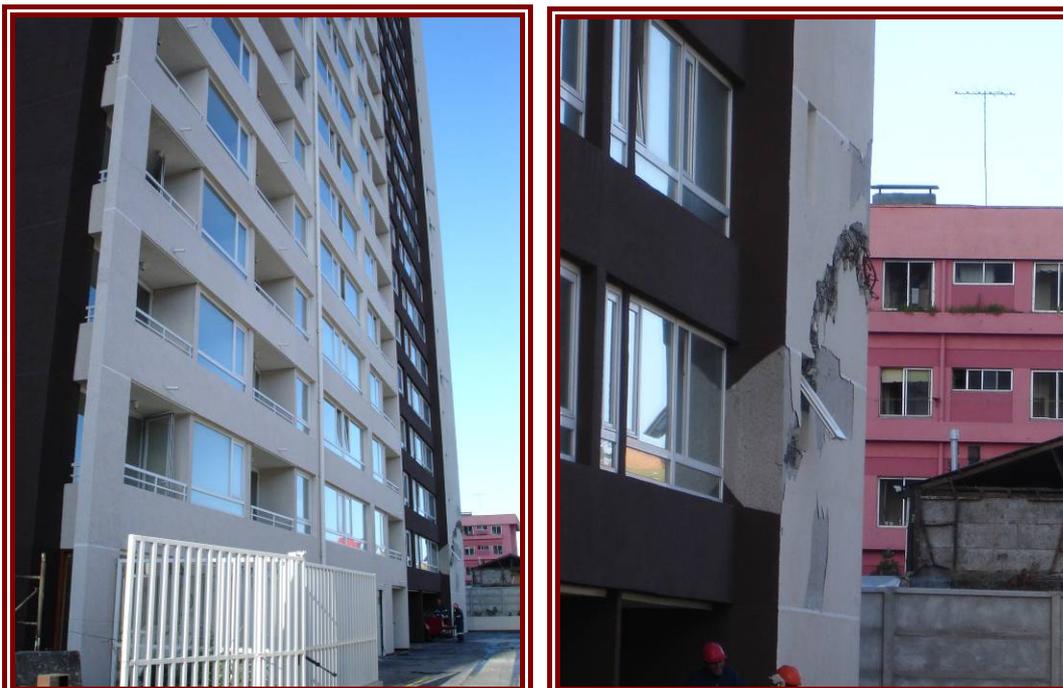
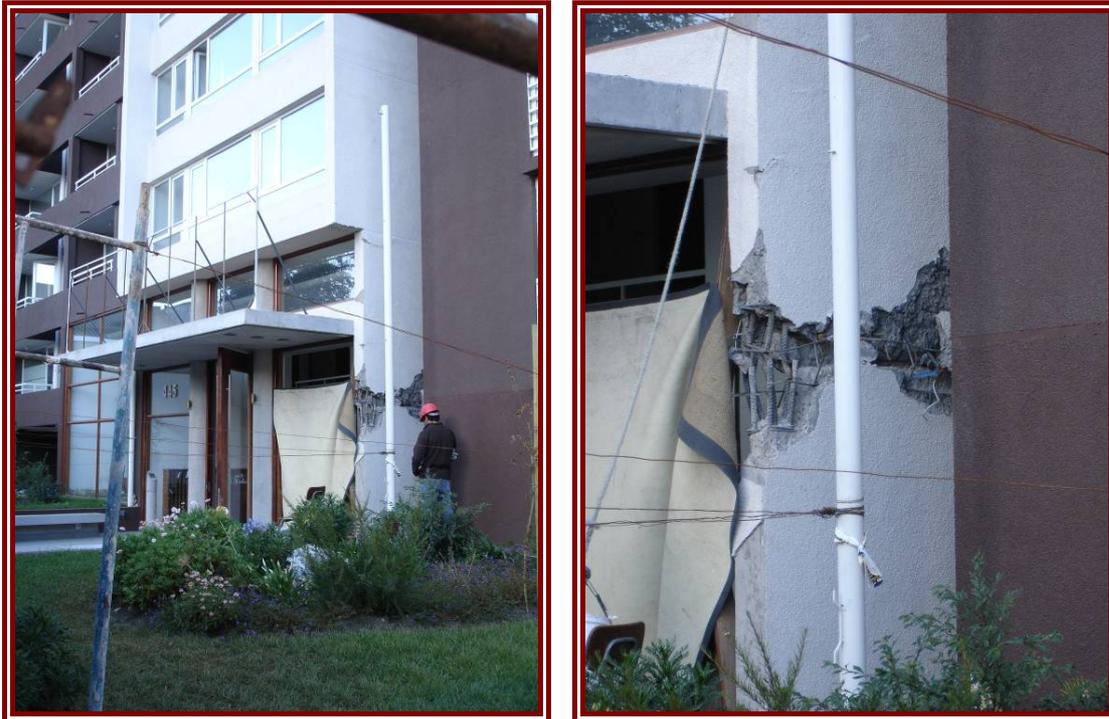
Figure 6-13: Views of the damage to Salas 445

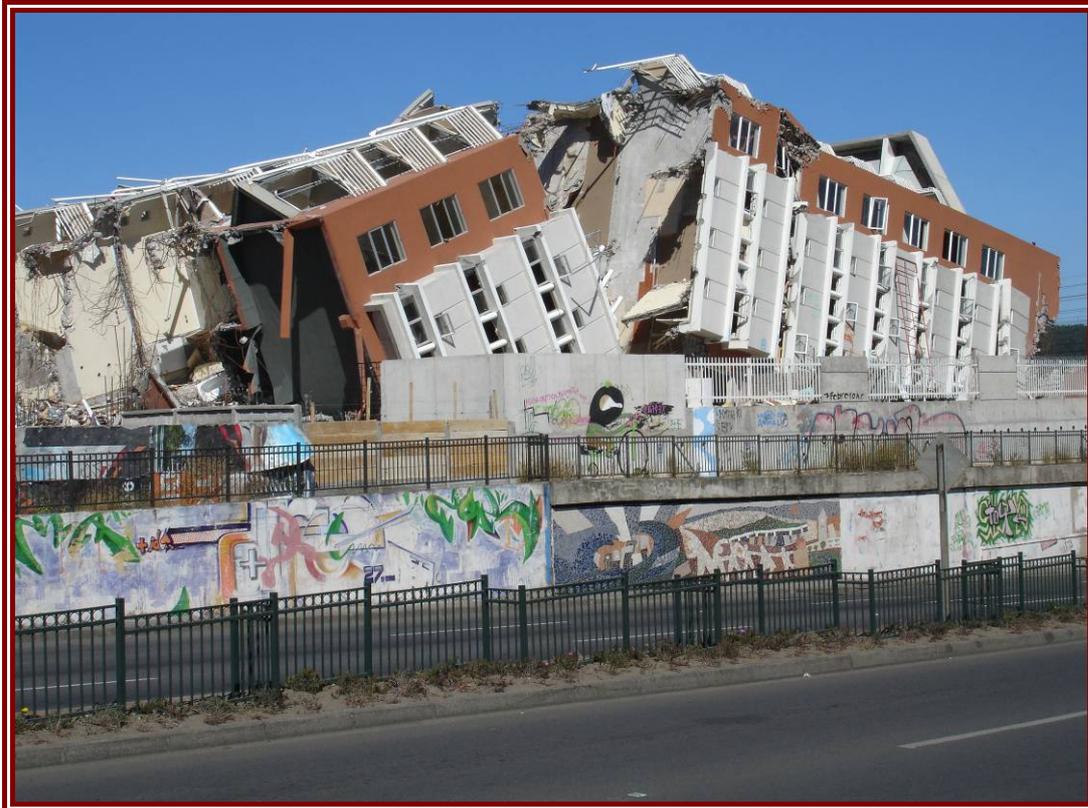
Figure 6-15: The collapsed Torre Alto Rio (collapsed towards photographer)

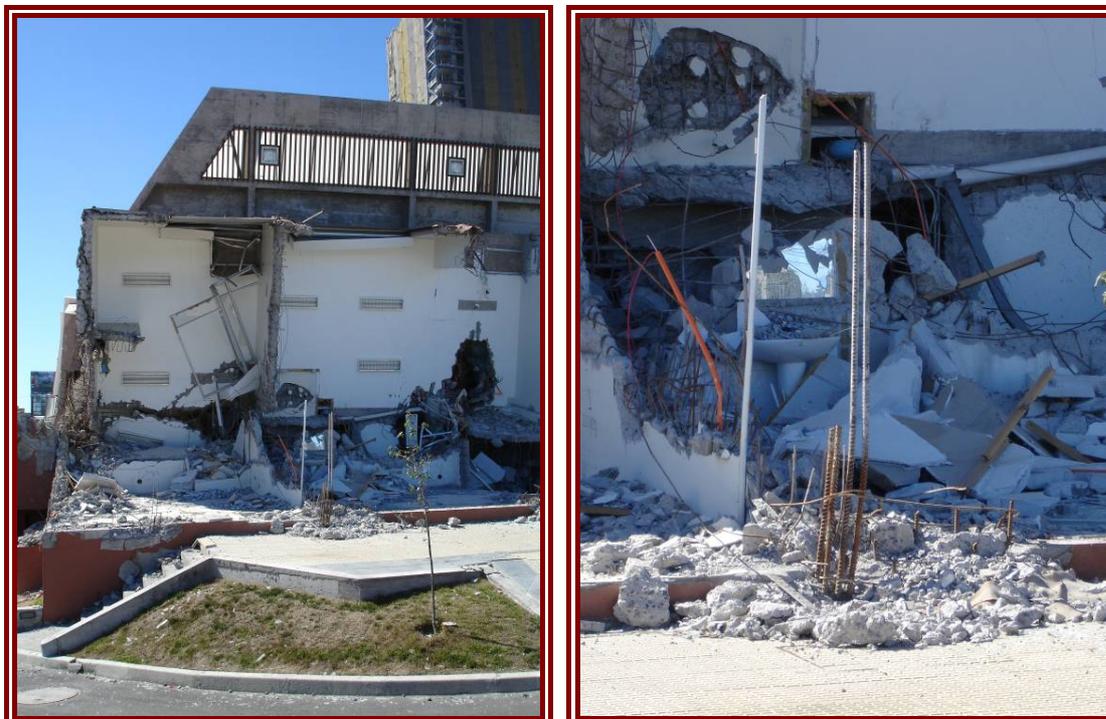
Figure 6-17: Torre Alto Rio. View of 1st floor ceiling (left), Detail of remains of 1st floor columns at foundation level (right)

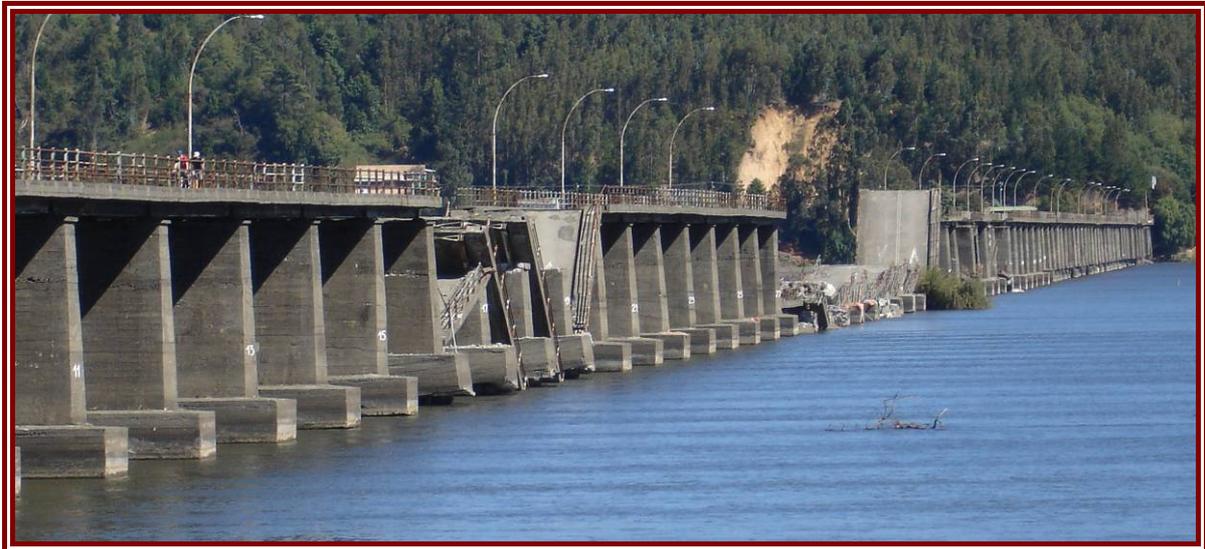
Figure 6-23: Collapsed spans in the Puente Viejo Bridge in Concepción

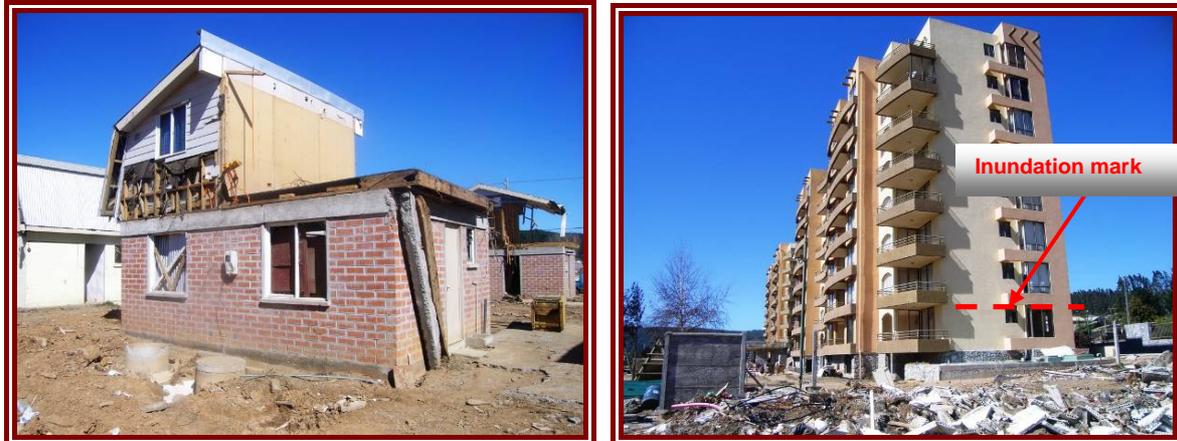
Figure 6-34: Damage to rows of housing, and tall structure, Dichato

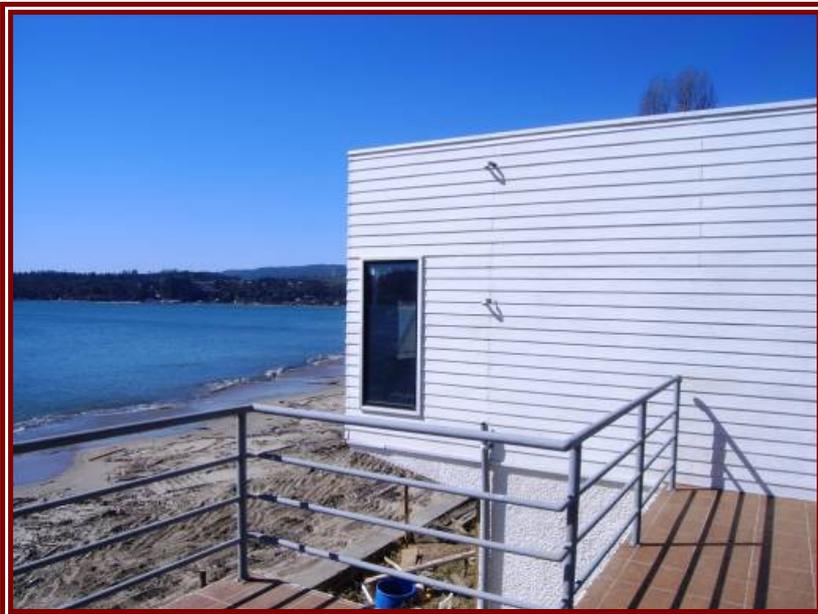
Figure 8-5: Timber top floor survived undamaged despite being completely submerged
