THE CHILEAN EARTHQUAKE OF 3 MARCH 1985

A FIELD REPORT BY EEFIT

ED Booth MA MICE MStructE
Ove Arup & Partners, London

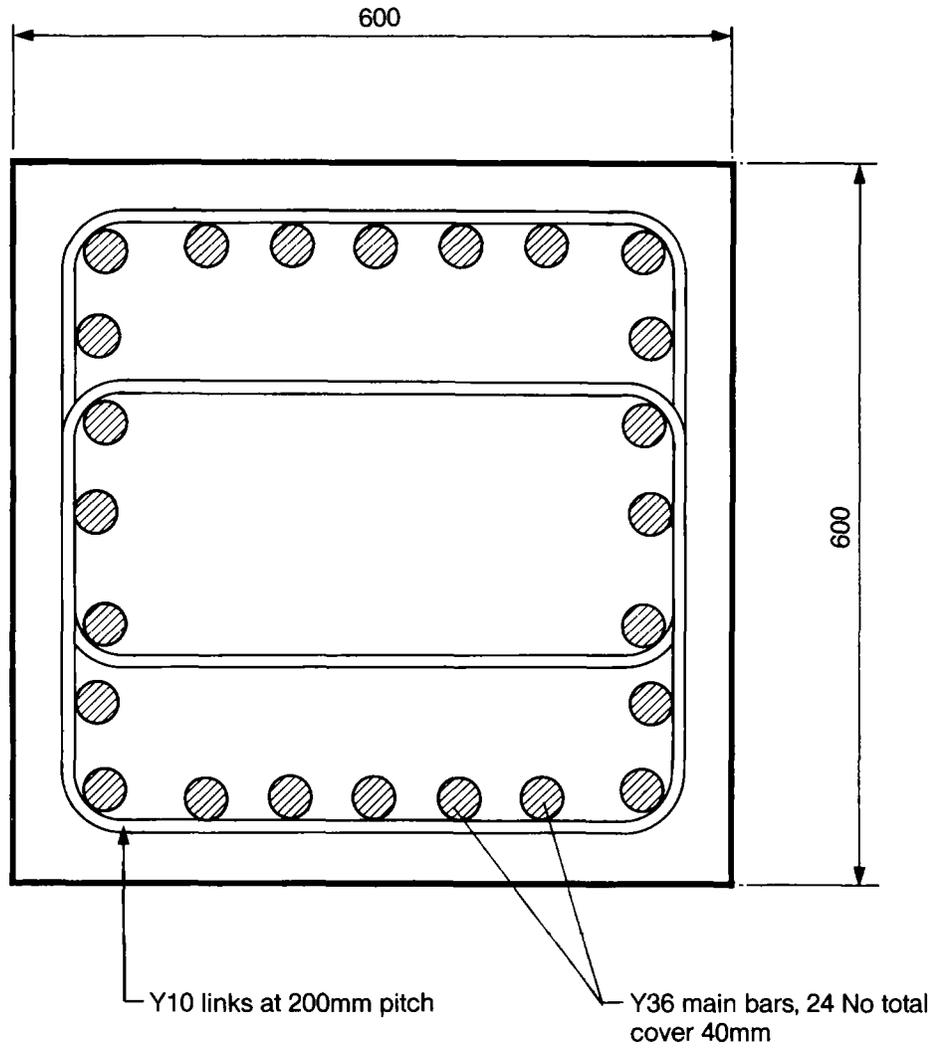
Figure 5.1

CLAUDIO VICUNA HOSPITAL, SAN ANTONIO
 SKETCH OF REINFORCEMENT IN COLUMN
 SHOWN IN PLATE 5.1

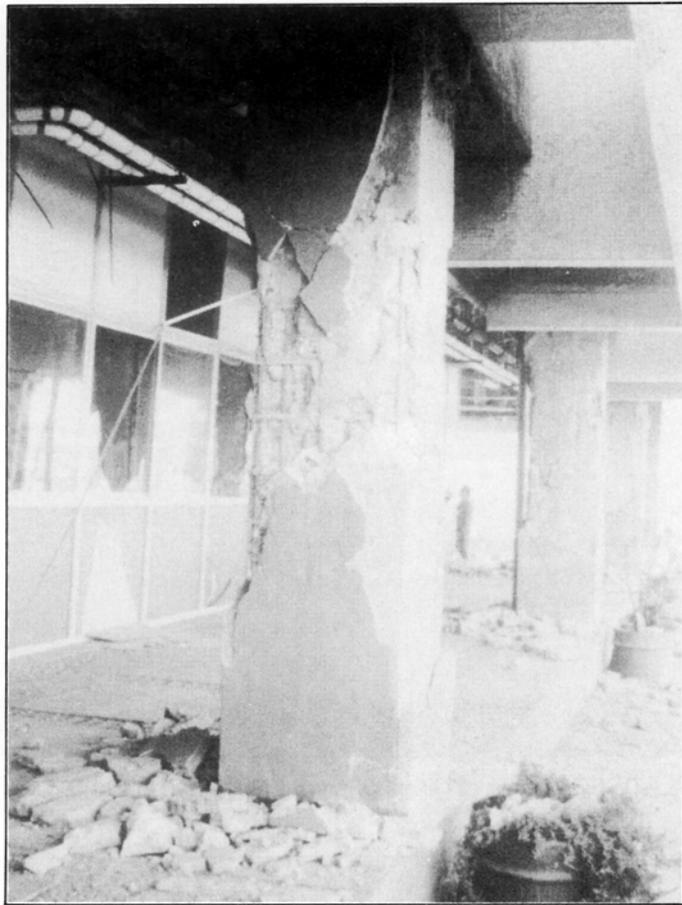
PLATE 5.1 Compression failure in external columns
Claudio Vicuna Hospital, San Antonio

the columns. The most dramatic damage was to an external line of columns at 2nd storey level, on the east facade of the northern half (Plate 5.1). All these columns had extensive spalling around their perimeter at mid height suggesting a compression failure mechanism. The concrete cores appeared intact. Figure 5.1 shows the reinforcement based on visual inspection; although the percentage of vertical reinforcement is high (6%) the lack of restraint by links at right angles to most of the main bars means that modern codes would not be satisfied.

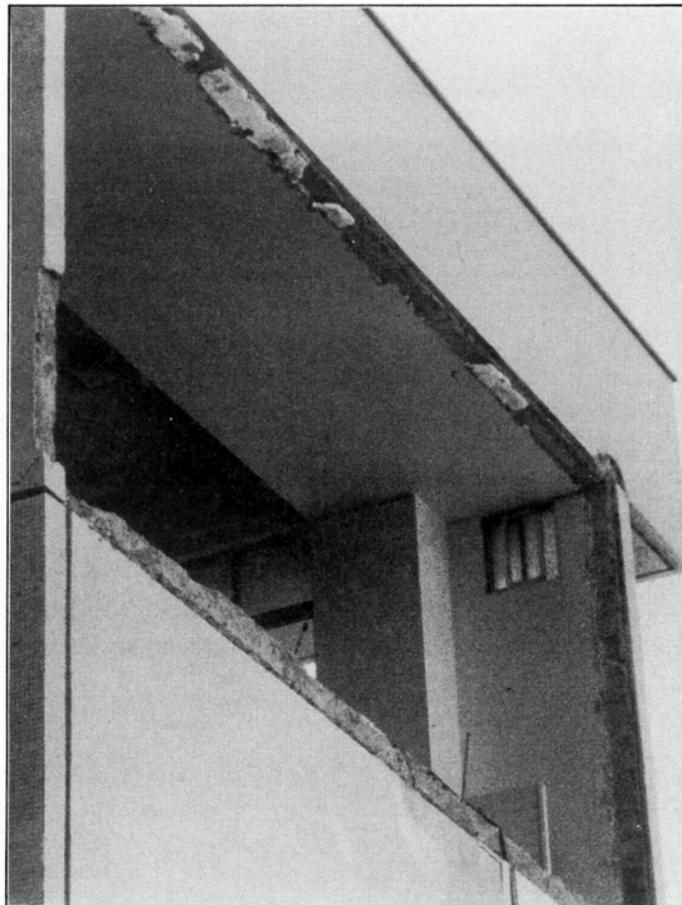
PLATE 5.2 Failed infill panel, Claudio Vicuna Hospital,
San Antonio

The non failures at the hospital were equally interesting and puzzling. One external infill panel at 3rd storey level at the north end of the northern half had fallen out (Plate 5.2). There appeared to have been no positive connection between panel and structural frame, and if the same applied to the other panels, it was surprising they had not also fallen out. There was no buffeting damage across the joint between the two halves of the structure (the joint being about 20mm wide). Some internal shear walls were slightly cracked, but generally non-structural damage appeared slight (Plate 5.3). By eye, the two halves of the building lined through well, though there was possibly some settlement to the north end of the northern half.

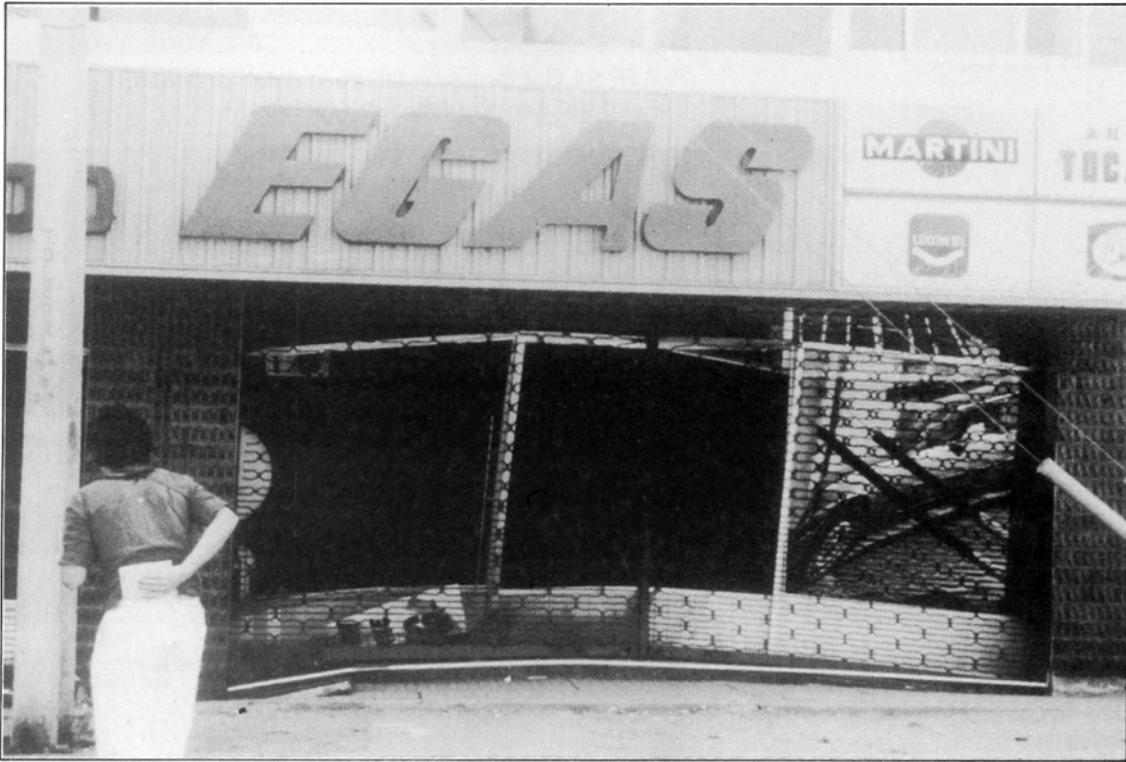
PLATE 5.4 Large settlements in 2 storey building on sloping ground, San Antonio

- c) Foundation settlements affected a number of r.c. structures in the slopes above the harbour to the north side of the town, where there was evidence of extensive ground movement. Plate 5.4 shows a 2 storey r.c. frame shop where very large settlements of edge and internal columns occurred, though there was little evidence of distress in the r.c. frame, suggesting that the differential settlements were small. There was direct evidence for the mechanism of failure. A similar building next to that pictured was undamaged. An r.c. frame school north of the harbour was also severely damaged and was apparently affected by foundation movements.

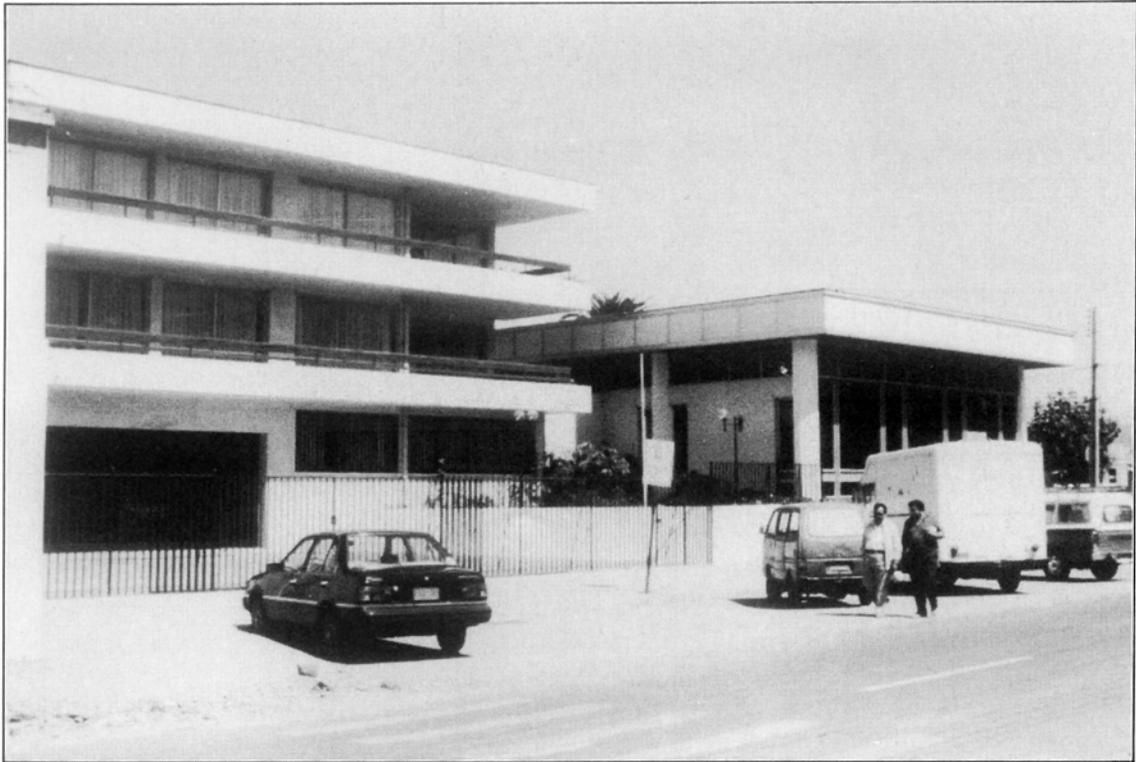
PLATE 5.5 Modern undamaged buildings near San Antonio waterfront

- d) Undamaged r.c. structures could be found throughout the worst affected areas of San Antonio. For example, the modern Banco de Chile building on flat, possibly made, ground adjacent to the harbour, was unaffected (Plate 5.5) as was an r.c. frame building with block infill on higher, sloping ground (Plate 5.6).

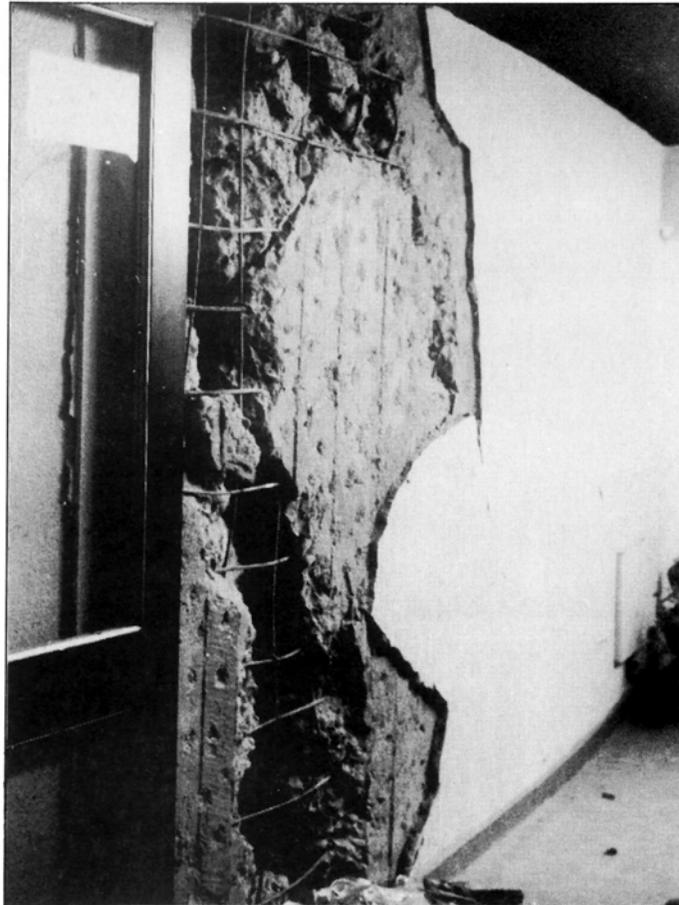
PLATE 5.8 Major vertical crack in Hangaroa apartments

The main failure in the primary structure was a major vertical crack (Plate 5.8) at the junction of one of the shear wall arms with the core which had apparently racked extensively during the earthquake. The shear wall was perforated on alternate floors along the line of failure by door openings.

In comparison with minimum requirements, though of course not necessarily imposed design stresses, the horizontal steel appears just adequate. Bonelli has postulated (Ref. 2) that the failure was due to the different mode shape between the x-braced twin shear walls in the central core, and the circular shear wall in the wing; a full dynamic back analysis would clearly be valuable to investigate this further.

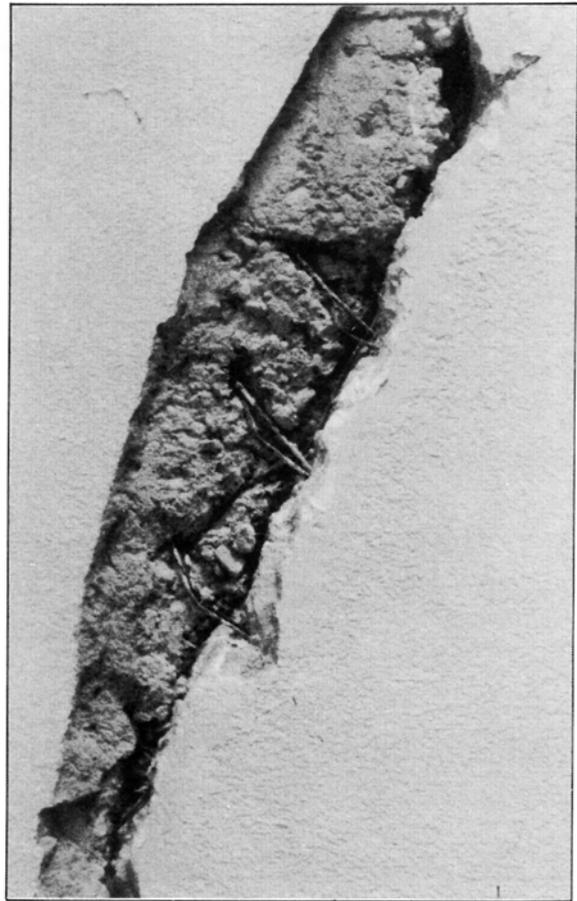
PLATE 5.9 Patch repair to previous earthquake damage, Acapulco apartments, Viña del Mar

This 15 storey r.c. shear wall apartment block was completed in 1964. It is adjacent to the Hangaroa. The shear walls were damaged during earthquakes in 1965 and 1971, and superficially patched with inadequate reinforced plaster (Plate 5.9). The building had extensive structural and non-structural damage, (Plate 5.10) though the lifts were still operational. Structural damage was observed in shear walls. Cracks a few millimetres wide were observed in the soffits of some floor slabs. The cracks ran parallel to the long axis of the building. The building was being emptied of its contents by the apartment owners during the EEFIT inspection. There was some broken glass but mainly the glazing stayed intact.

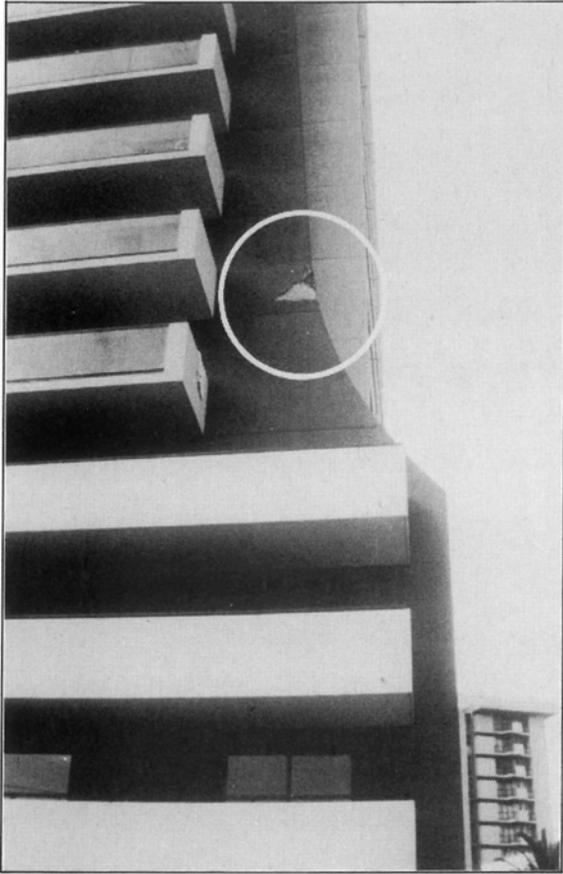
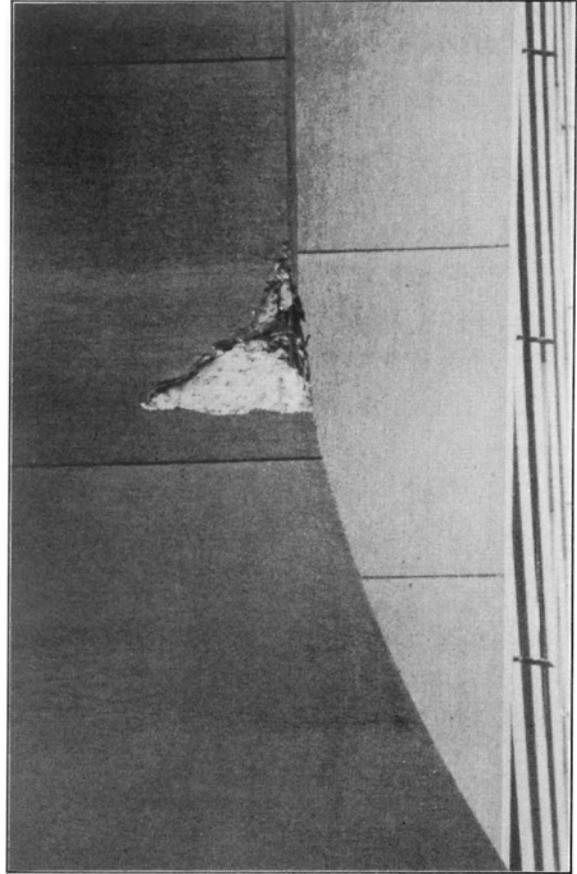
PLATE 5.11(a) Elevation
Spalling in shear wall of building adjacent to Acapulco apartments, Viña del Mar

Six high rise concrete buildings adjacent to the Hangaroa and Acapulco showed little superficial damage. The nearest one (Edificio Marina Real) had some spalling on one external shear wall (Plate 5.11).

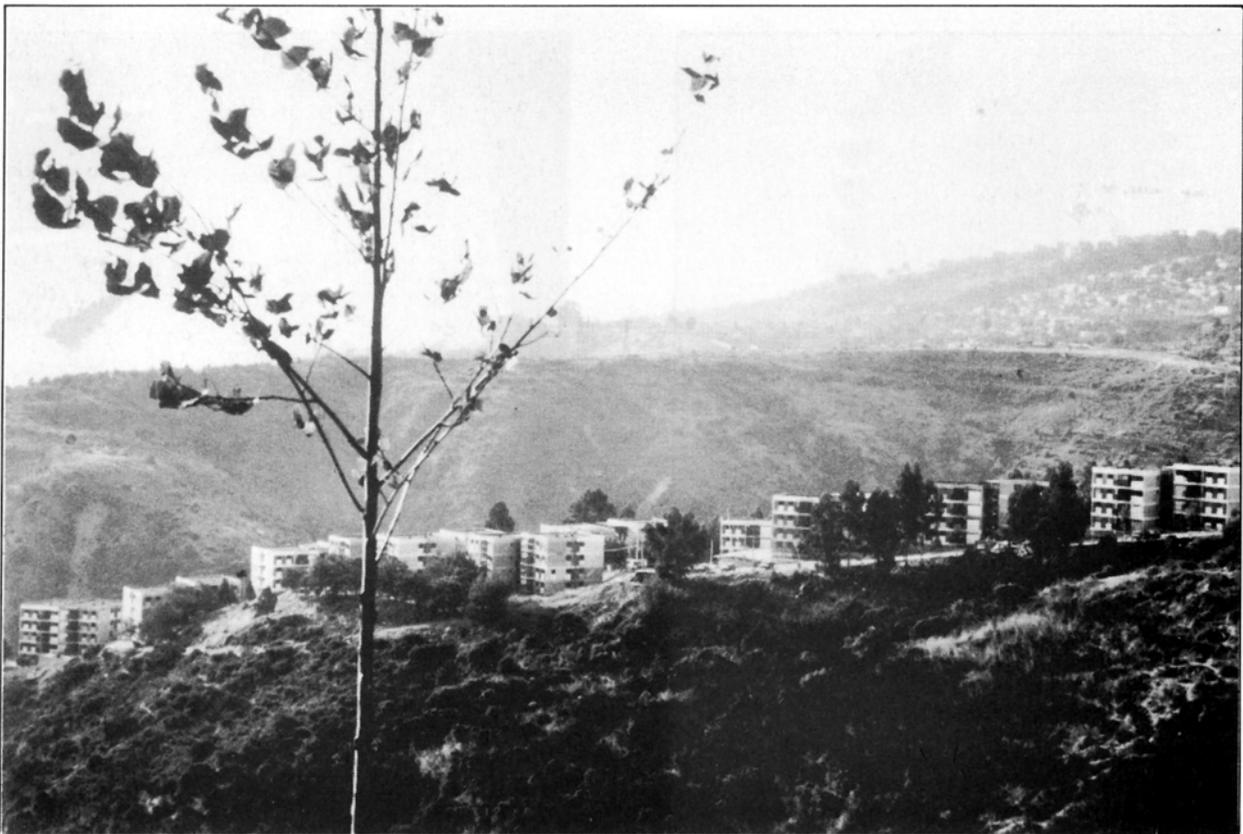
PLATE 5.12 Canal Beagle estate, Viña del Mar

This is a complex of about 40 four and five storey buildings, with concrete cores, concrete columns and shear walls and lightly reinforced blockwork infill panels. They are built around a steep ridge (Plate 5.12). There was extensive structural and non-structural damage (Plate 5.13), with buildings at the top of the ridge being severely damaged, and those at the base experiencing little or no damage. Similar developments elsewhere were little affected. The estate had been partially evacuated, though the buildings near the base of the slope remained occupied.

In so far as it could be determined on site, there seemed no obvious correlation between the disposition of shear walls and extent of damage; some buildings appeared to have shear walls in one direction only; others equally affected, had well disposed walls. Generally, quality of materials and workmanship seemed adequate, though there was some evidence of poorly prepared construction joints and a wooden block was found cast into the section of one column which failed. The percentage of vertical reinforcement in the shear walls, around 0.08% each face, though rather light, was not negligible.

Overall, the extent of the damage appeared to be surprisingly high. Topographical effects, namely ridge amplification, were postulated as the cause, and other examples from around Vina in this earthquake were cited of correlation between damage and position on the tops of ridges. Subsequent research has confirmed the existence during small earthquakes of significant amplification of ground motions on top of the Canal Beagle Ridge compared with motions at the base (Celebi, Ref. 10).

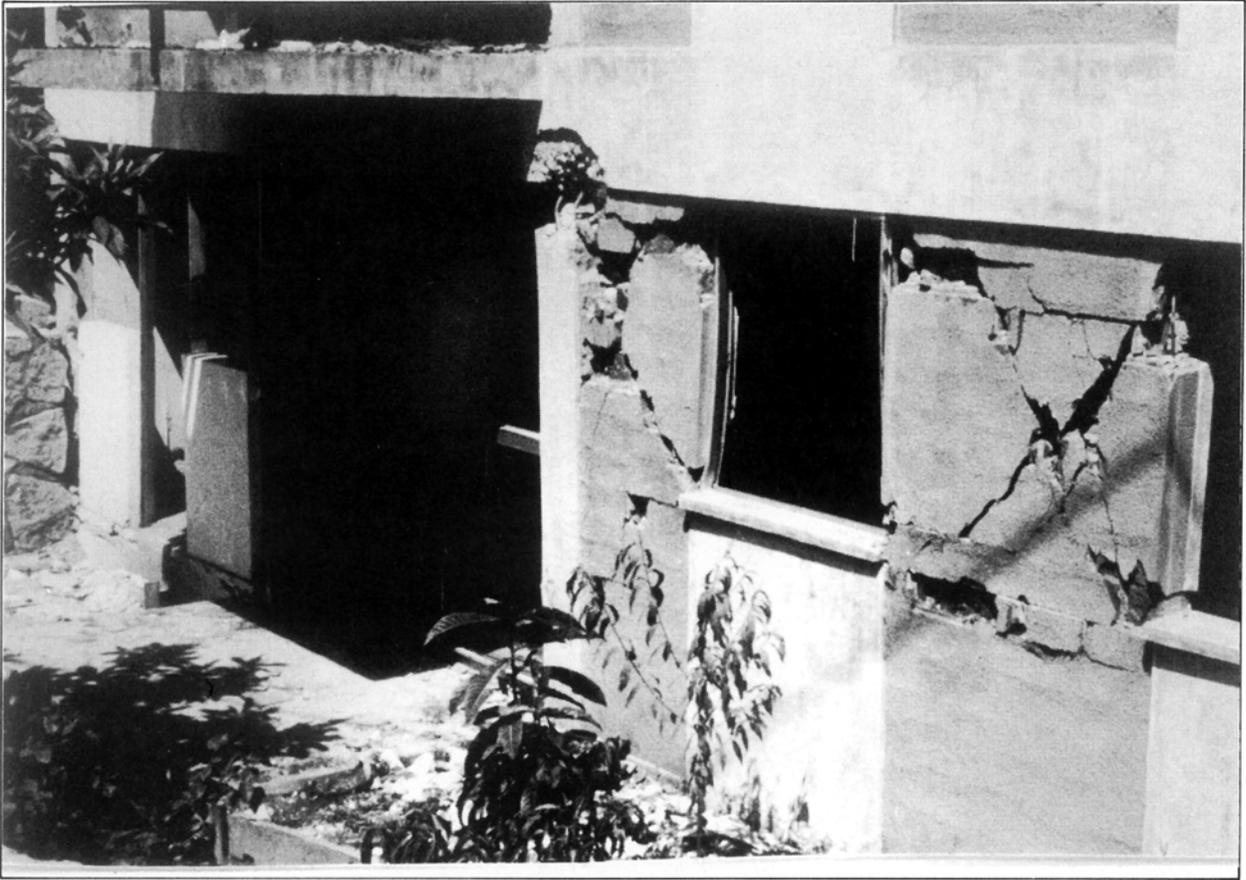
PLATE 5.13 Damage at Canal Beagle estate, Viña del Mar

Full height shear wall
added after earthquake
damage in 1971 →

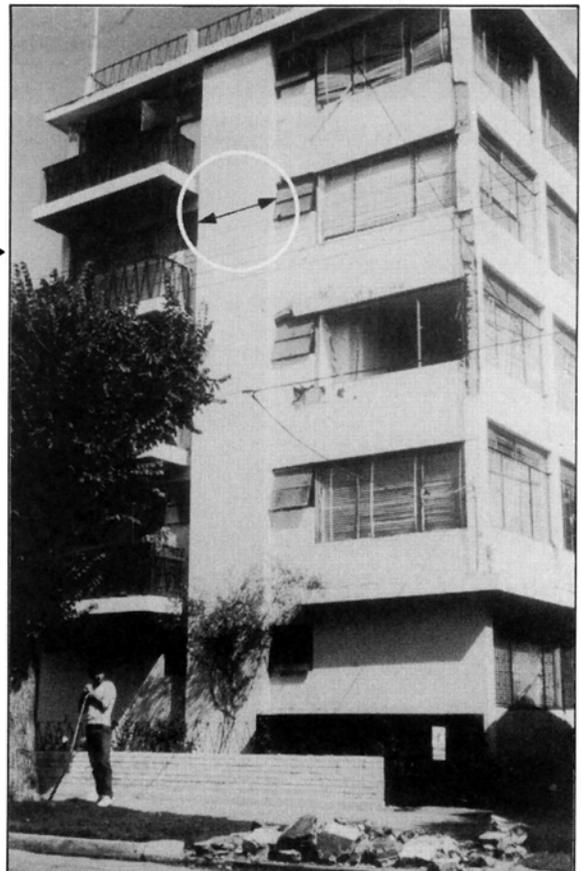
PLATE 5.14 Barrios Edificio, Viña del Mar

This 5-storey r.c. apartment building had been damaged in previous earthquakes and repaired but again suffered severe damage in the present earthquake. It was located on level ground in the centre of the city. The central staircase was flanked by concrete shear walls which were perforated by door openings. All the lintols above the doors had failed. Previous earthquakes had led to severe cracking of one end wall and the latest earthquake had reopened the old cracks which had simply been patched over. At the other end wall a new, narrow shear wall had been added following the previous earthquake. Although the new shear wall was undamaged, it did not prevent old cracks from reopening (see Plate 5.14).

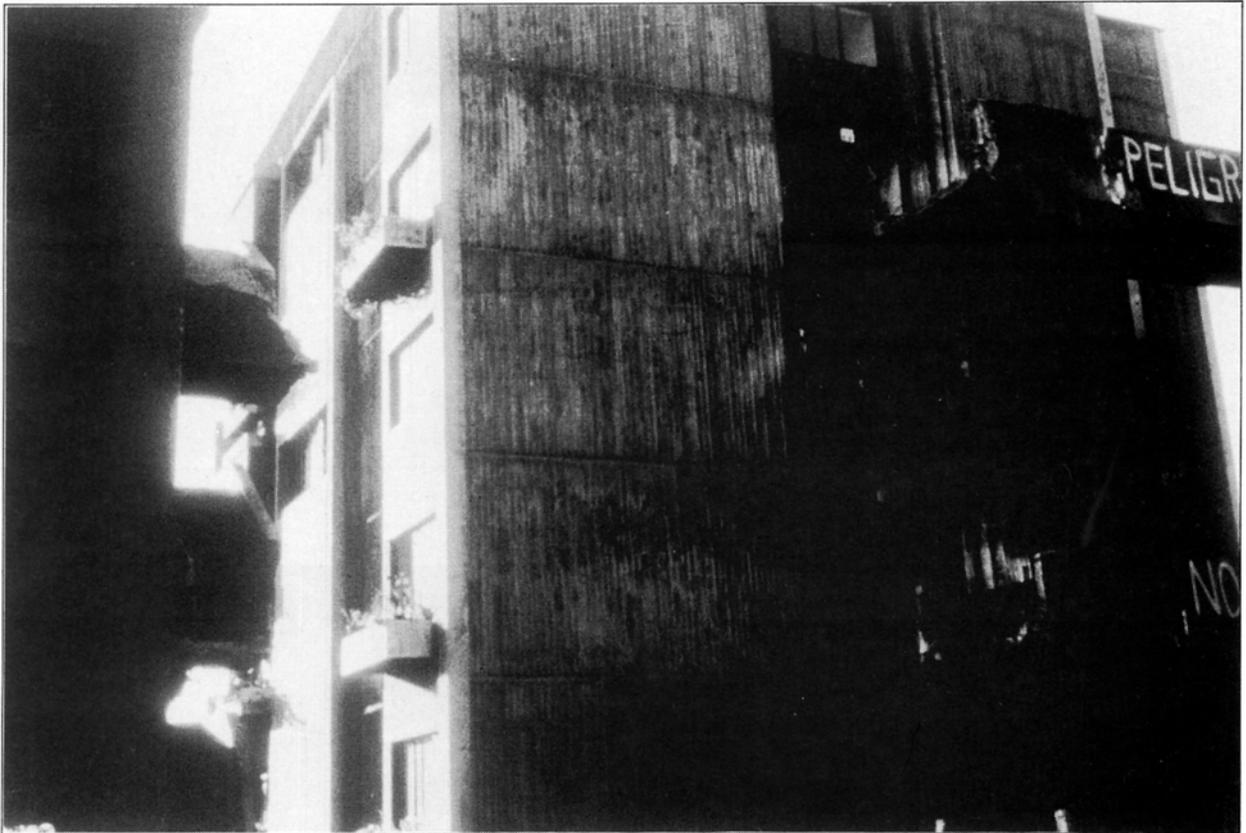
PLATE 5.15 Damaged bridge links in Viña del Mar building

Bridge links connecting some 5 storey r.c. housing blocks were damaged (Plate 5.15) though they were not visited by the EEFIT team. The buildings themselves were apparently unaffected. Professor Bonelli also reported extensive non-structural damage, but no structural damage, to a 50 storey building.

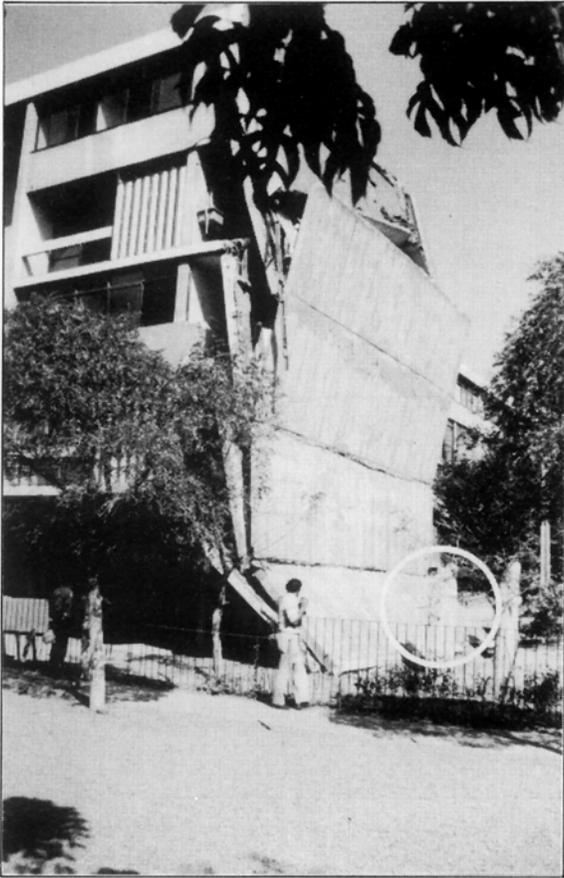
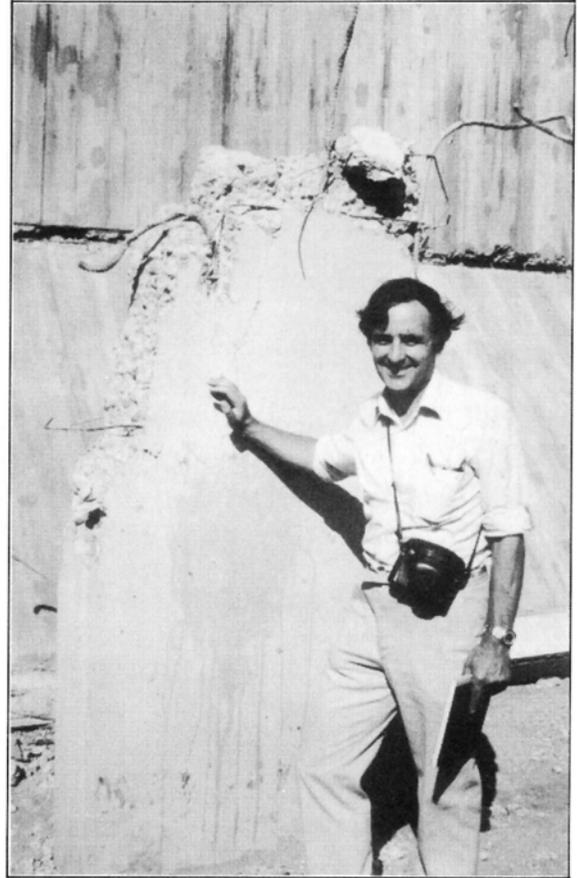
PLATE 5.16(a) Elevation
Collapsed end of block at Villa Olympia, Santiago

The only major damage that the EEFIT team observed, or that was reported to them, was the total collapse of an end section of one block - (Plate 5.16). A 240mm thick r.c. shear wall 4 storeys high supported by 2 r.c. columns from ground to first floor level formed the end elevation. The columns had failed at the junction with the shear wall, and the floors above had suffered a pancake collapse. The columns, originally 3.2m high, now stood at a maximum of 2m high. The framing of the block is sketched in Figure 5.3.

Three major causes of the collapse are indicated. Firstly, the lower relative horizontal stiffness of the column supported end bay, compared with the core supported internal bays, may have led to torsional amplification of earthquake motions at the end of the building. Secondly, the sharp change in stiffness and strength on the end elevation between shear wall and column formed a classic 'soft storey', with its consequent high ductility demand on the ground floor columns. Thirdly, there was a lack of redundancy; the presence of only two columns meant that there was no scope for redistribution of loads, and incipient failure in either column meant almost inevitable collapse.
