THE M_w 6.2 AMATRICE, ITALY EARTHQUAKE

OF 24th AUGUST 2016

A FIELD REPORT BY EEFIT

May 2019

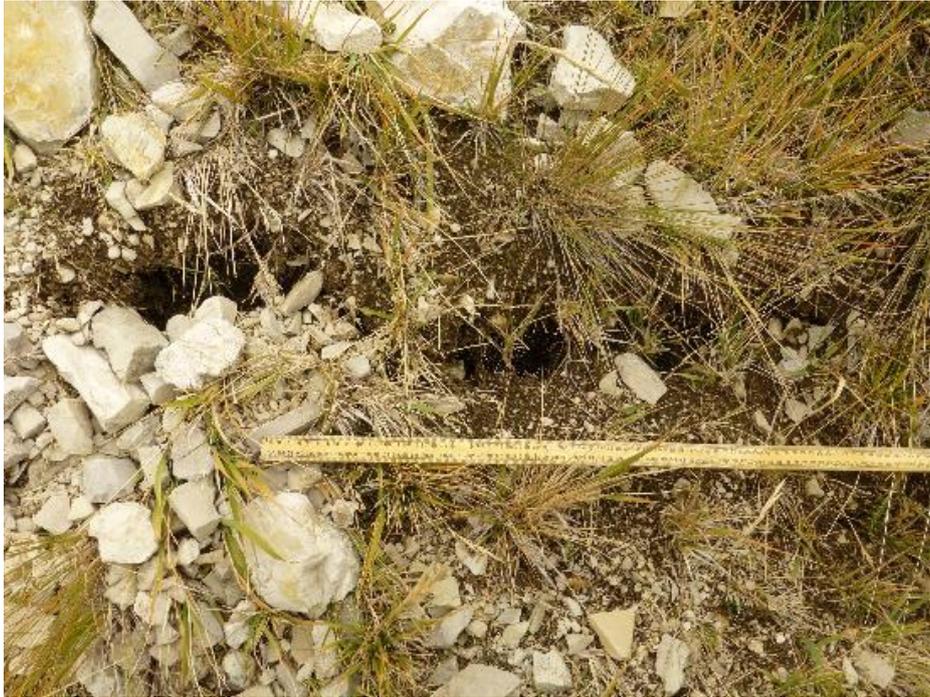
Figure 2-8 Example of a colluvium offset seen continuously along the rupture. Throw (vertical offset) is approximately 11cm, slip is approximately 14cm. At this site, slip vector azimuth is 2400, the slip vector plunge is 600. UTM: 33T 357961 4740995.

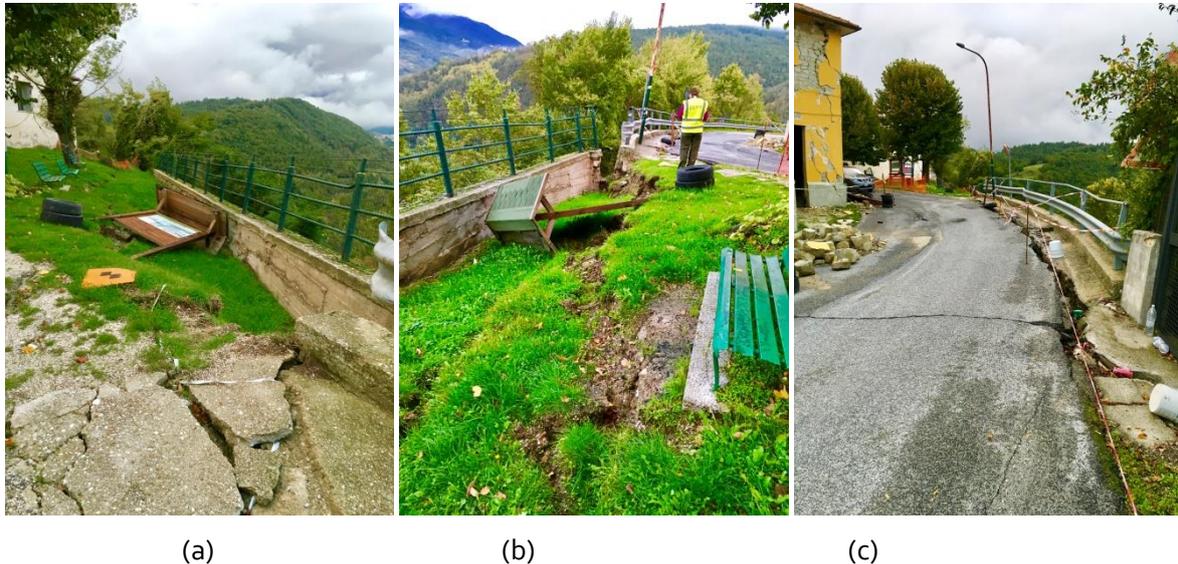
Figure 4-13: Slope instability phenomenon that occurred on the eastern side of Accumoli in the locality of "Fonte del Campo": (a) lateral ground displacement and settlement occurring on the rear at the retaining wall; (b) rotation and outwards displacement of the reinforced concrete retaining wall; longitudinal and transverse cracks on adjacent to pavement road.

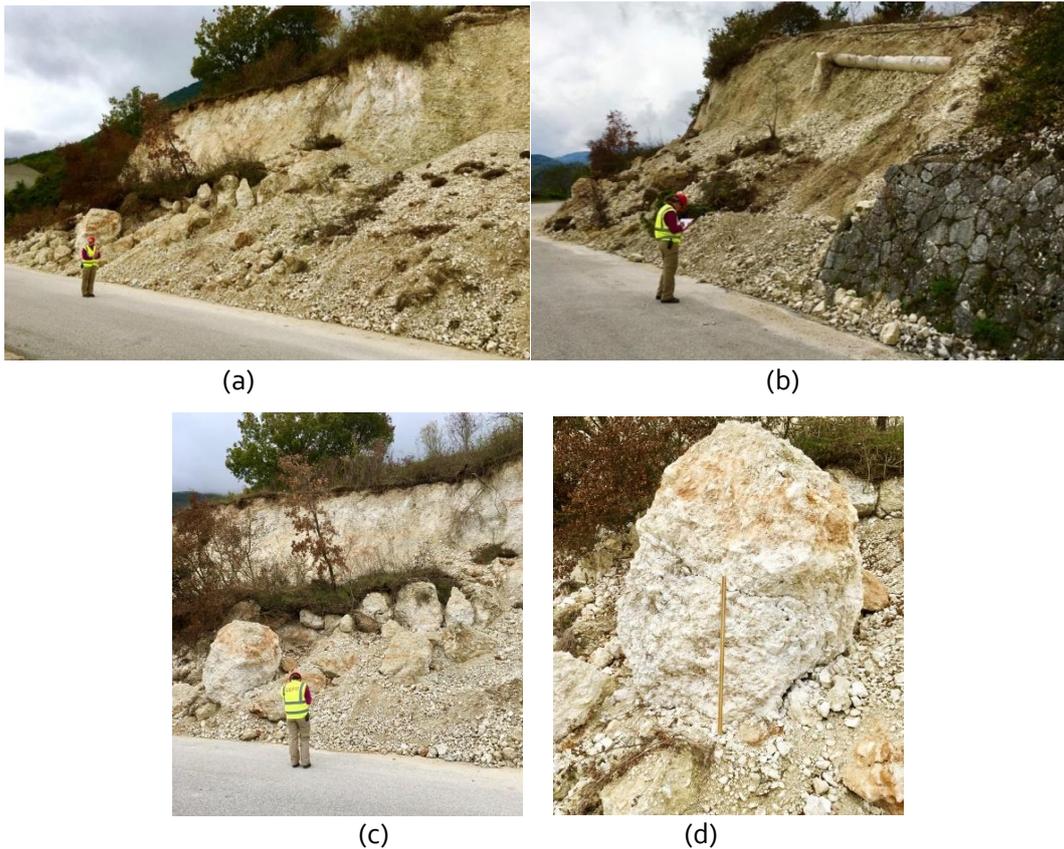
Figure 4-19: Disrupted soil slide observed at the gravel pit in Pescara del Tronto: (a) view of the slide from SP129 road; (b) pipeline exposed on the failure plane; (c) blocks of displaced material; (d) largest block with dimensions up to 1.2m across.

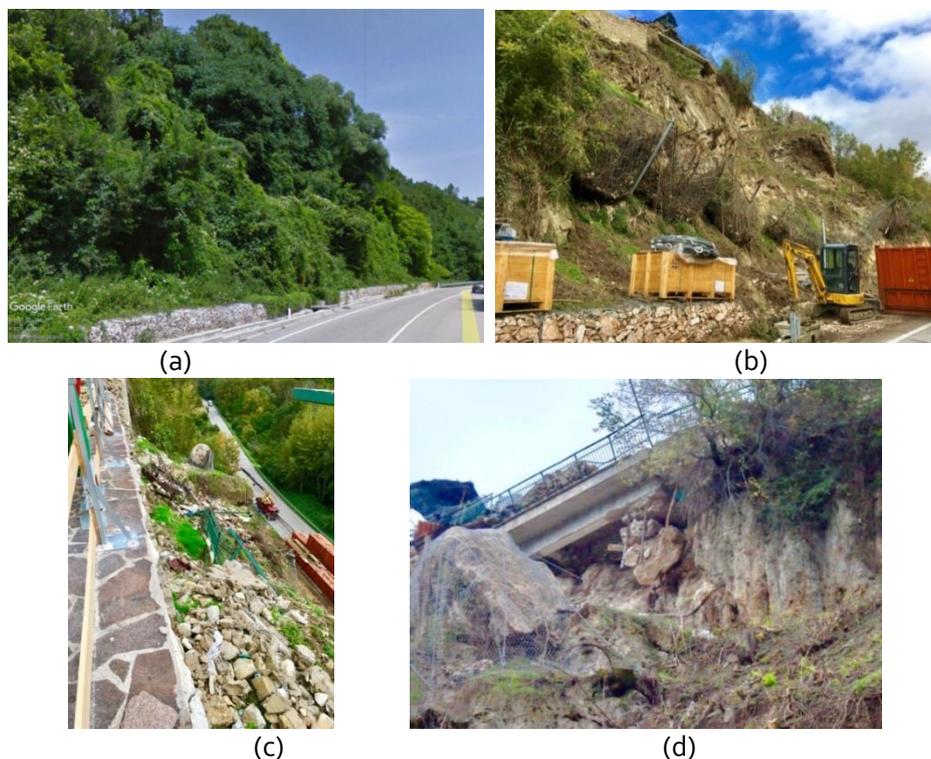
Figure 4-20: Largest slide observed in Pescara del Tronto: (a) Google street view from SS4 highway before the 24 August 2016 earthquake; (b) view from SS4 highway of slide and damaged retaining wall; (c) view from the crest of the slide; (d) large block of travertine captured by the steel wire mesh.

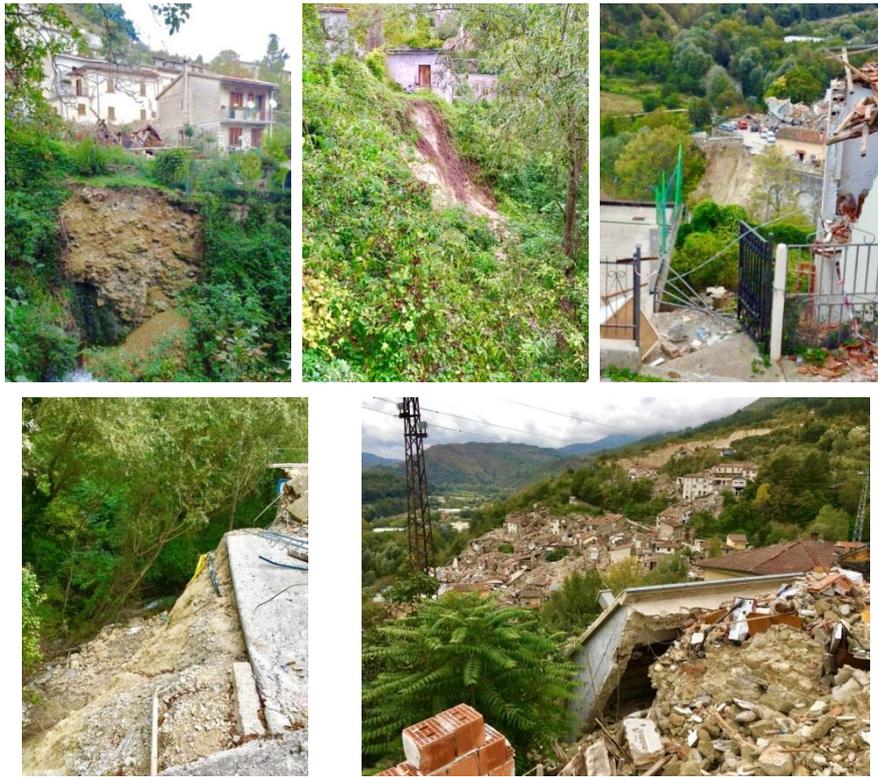
Figure 4-21 Observed slides in the locality of Pescara del Tronto and related induced-damage.

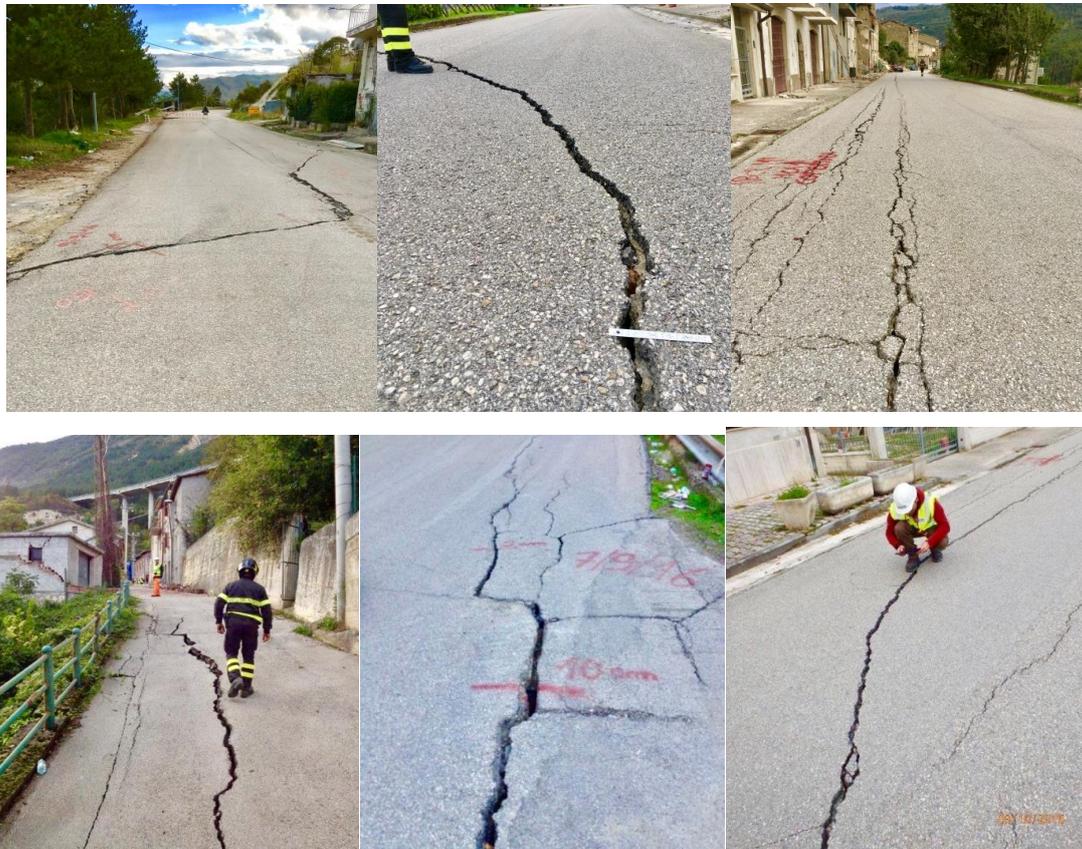
Figure 4-22: Ground cracks on paved roads along SP129 road.

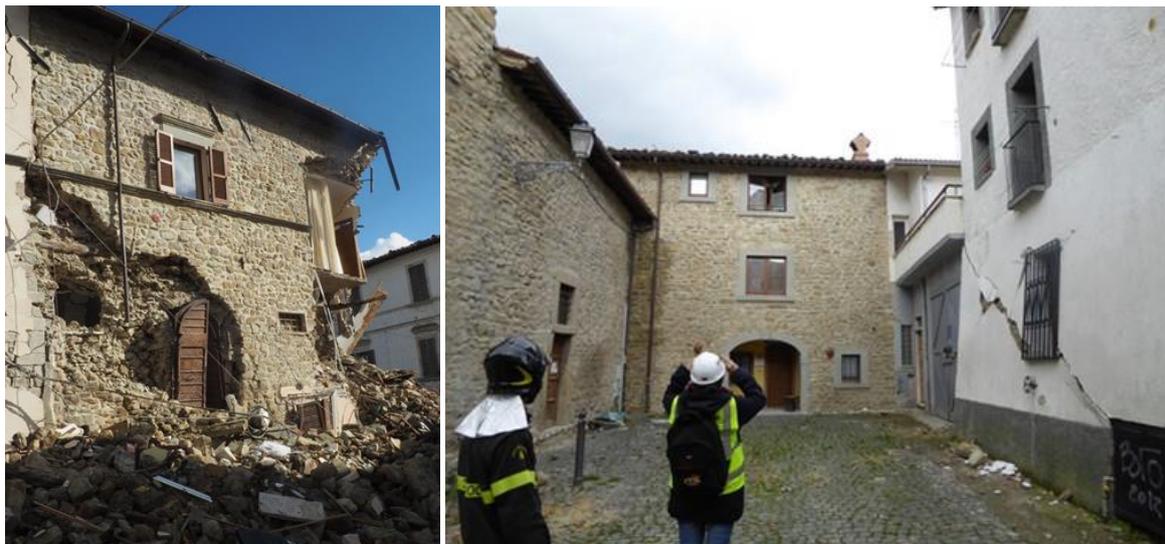
Figure 5-6: Consolidation of local masonry fabric: a) poor grouting in Arquata del Tronto; b) adequate quality grouting and rc frames around opening, delivered a better seismic performance (Amatrice)

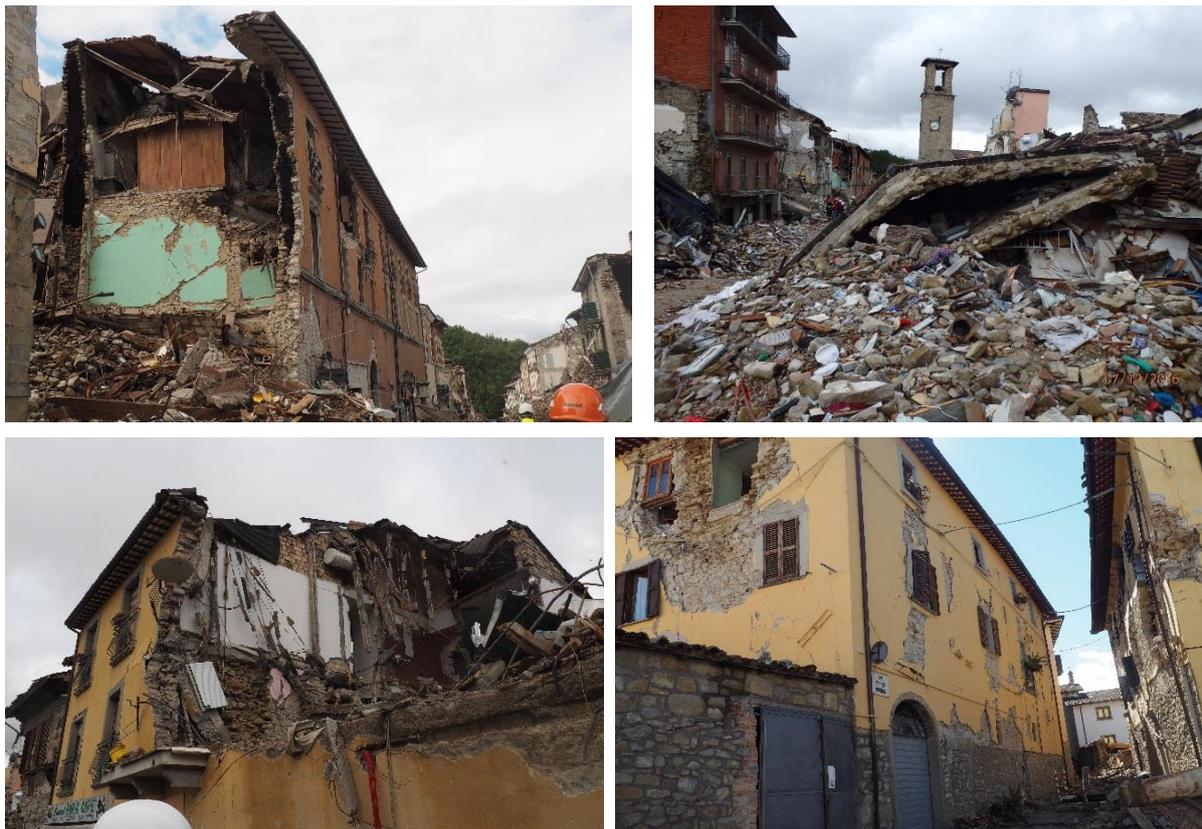
Figure 5-9: Out-of-plane failures and total collapse caused by concrete roof slabs.

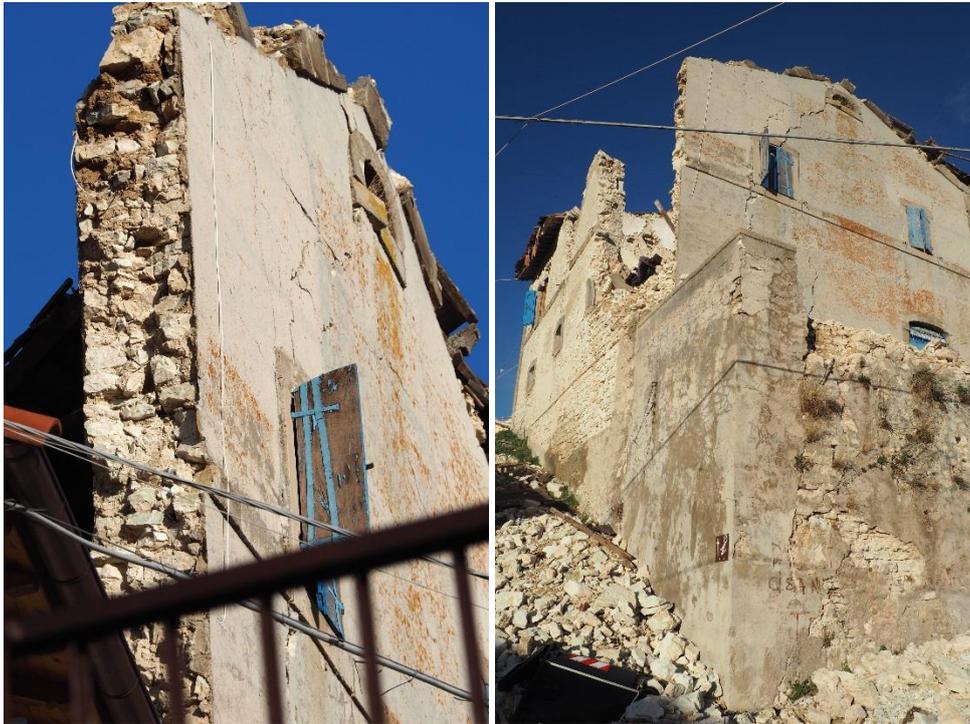
Figure 5-32 a) and b) Failure Mechanisms: partial overturning of the façade and collapse of the corner

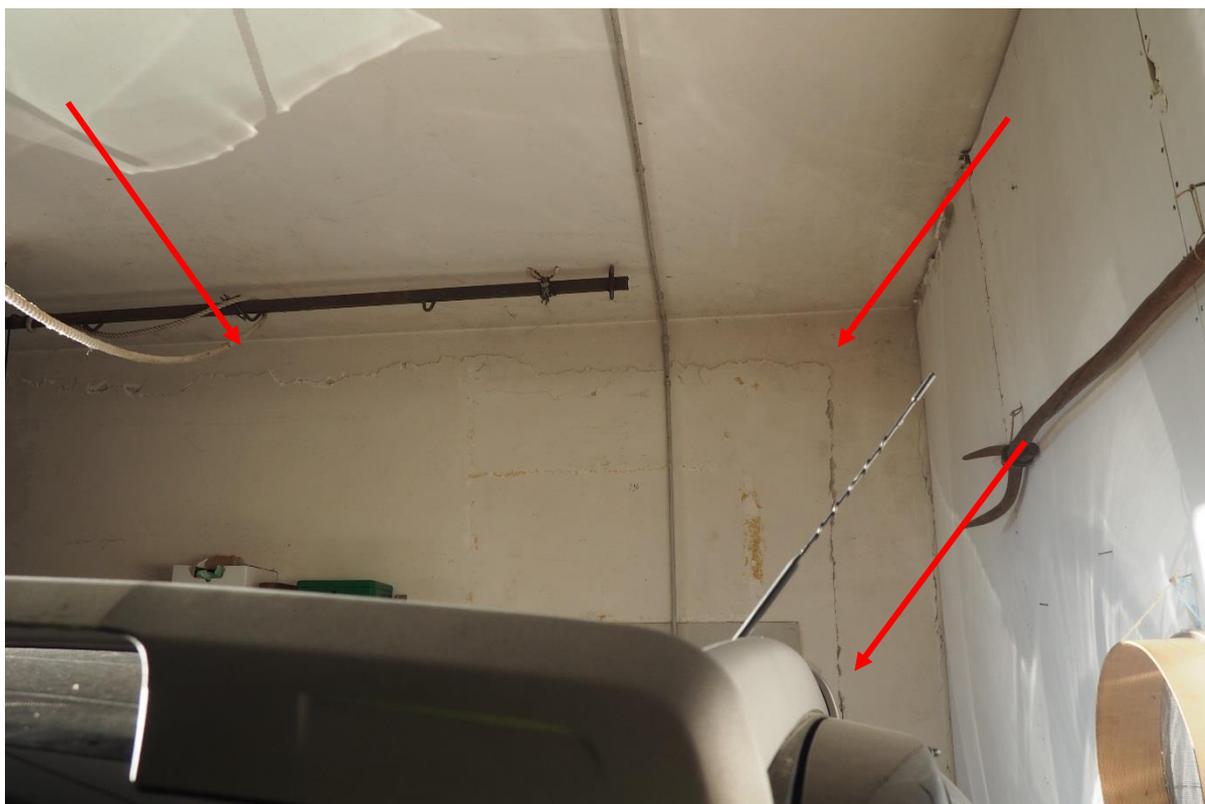
Figure 5-34 Cracks surveyed in RC buildings in Castelluccio di Norcia

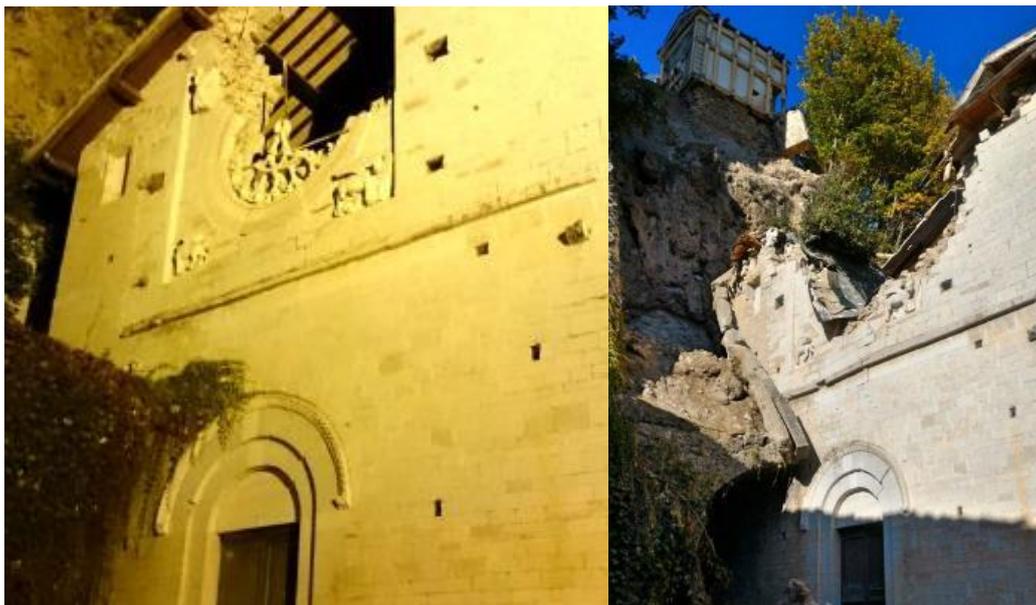
Figure 6-21 Partial façade collapse a) after the 26th October; and b) after the 30th October earthquakes (images from <http://www.umbria24.it>).

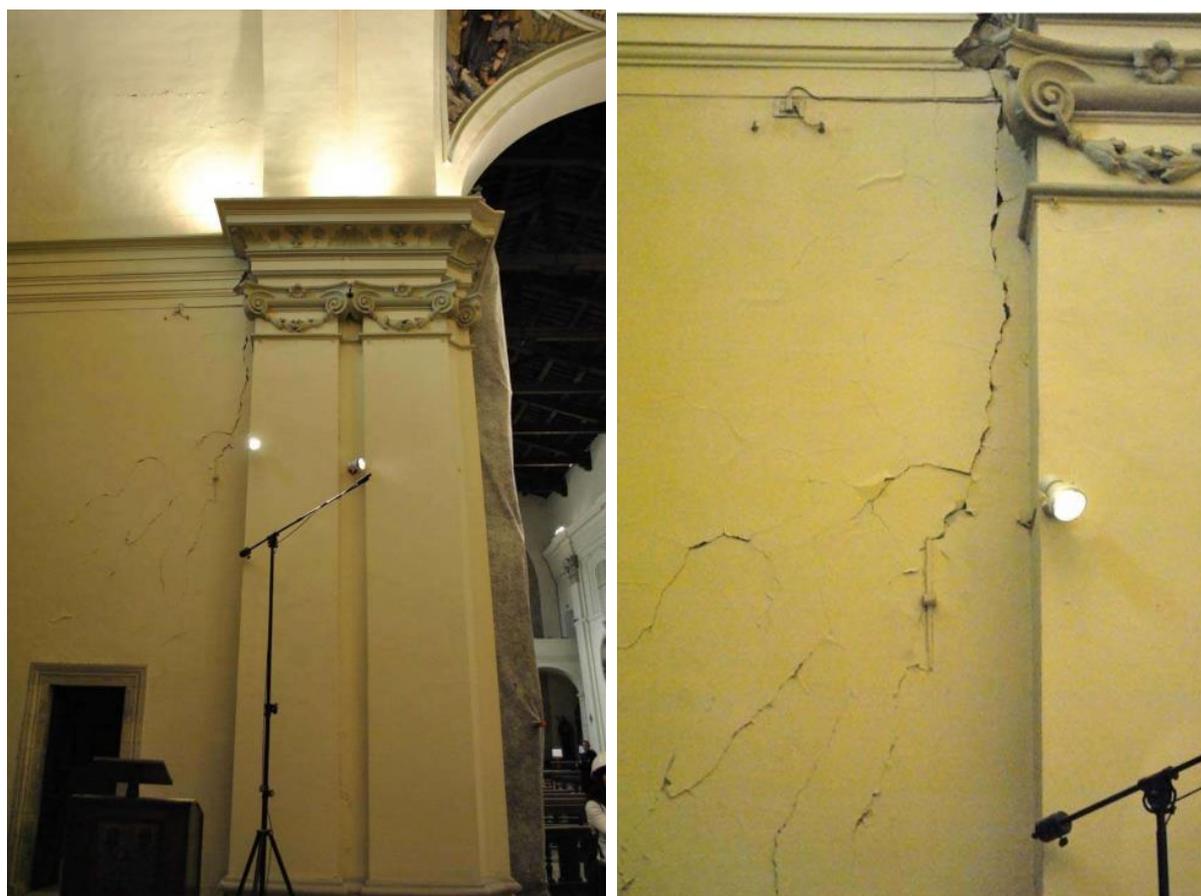
Figure 6-26 Detachment of the chancel arch pier from the south transept wall.

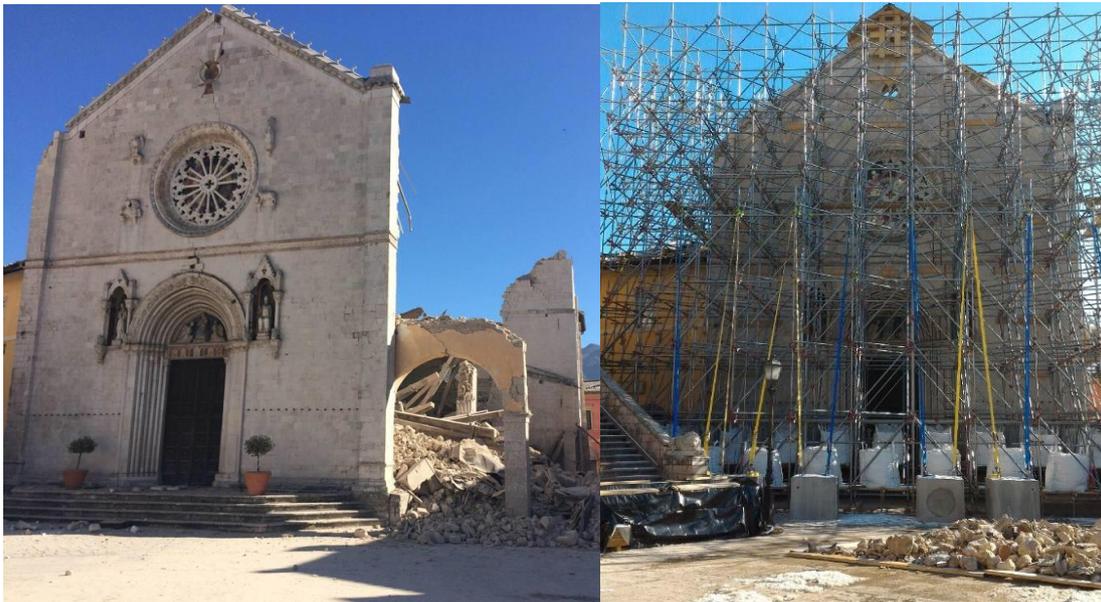
Figure 6-28 Cathedral front façade still standing after 30th October earthquake (note the vertical crack), and with the shoring structure installed in December (images from <http://www.umbria24.it>).

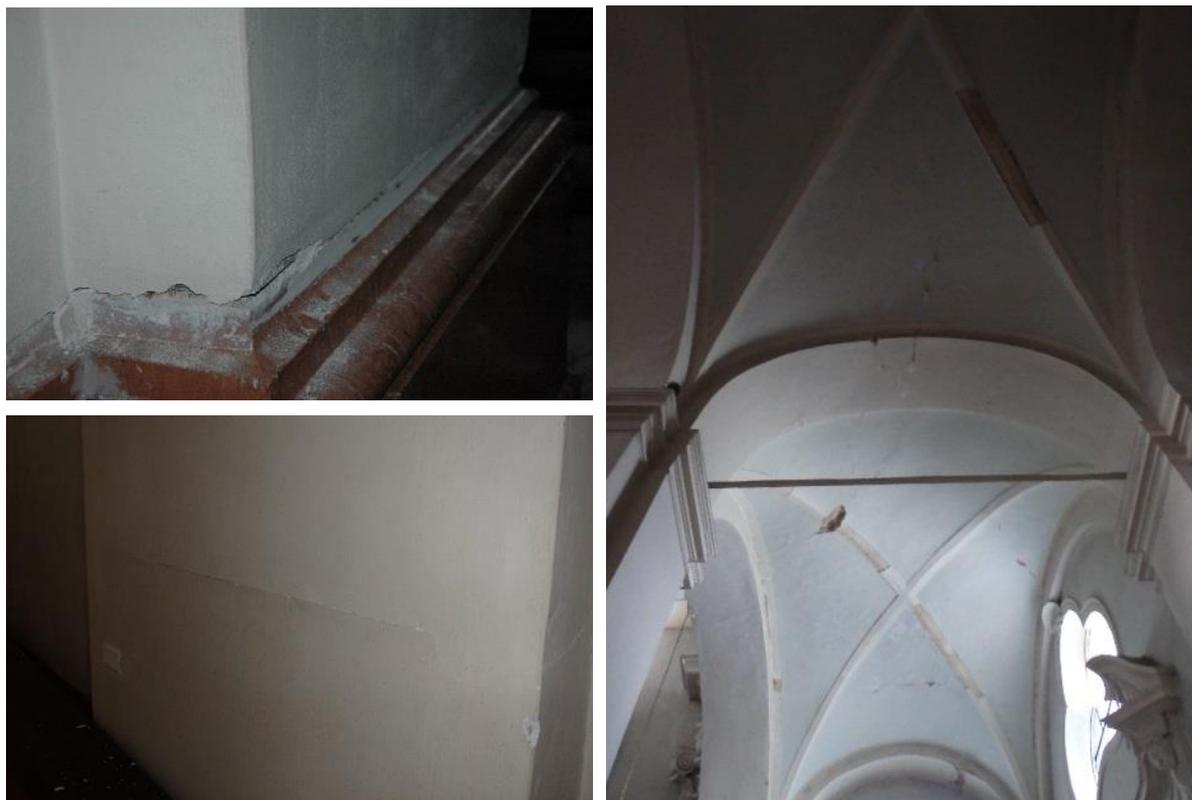
Figure 6-31 a) East aisle cracks at the pillar base (top left), b) at the vault crown (right) and c) at the side wall base (bottom left).

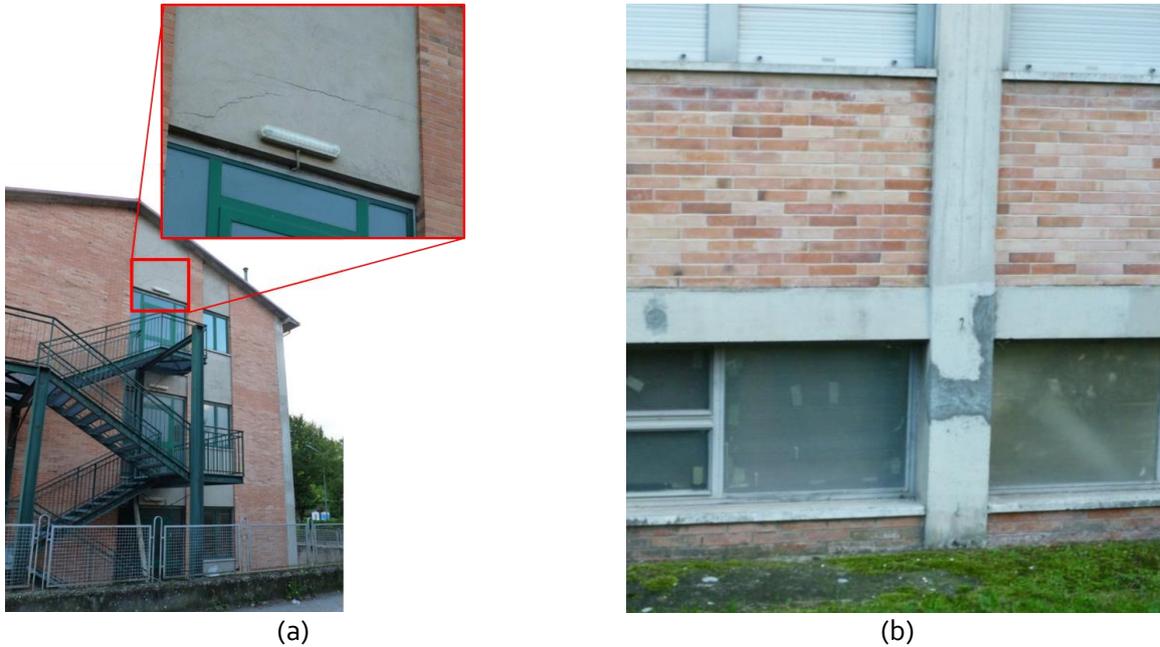
Figure 7-9 Istituto Tecnico commerciale (lat. 42.791702, long. 13.095641), (a) minor cracking in the gable end; (b) possible repaired damage to the column. (DG1)

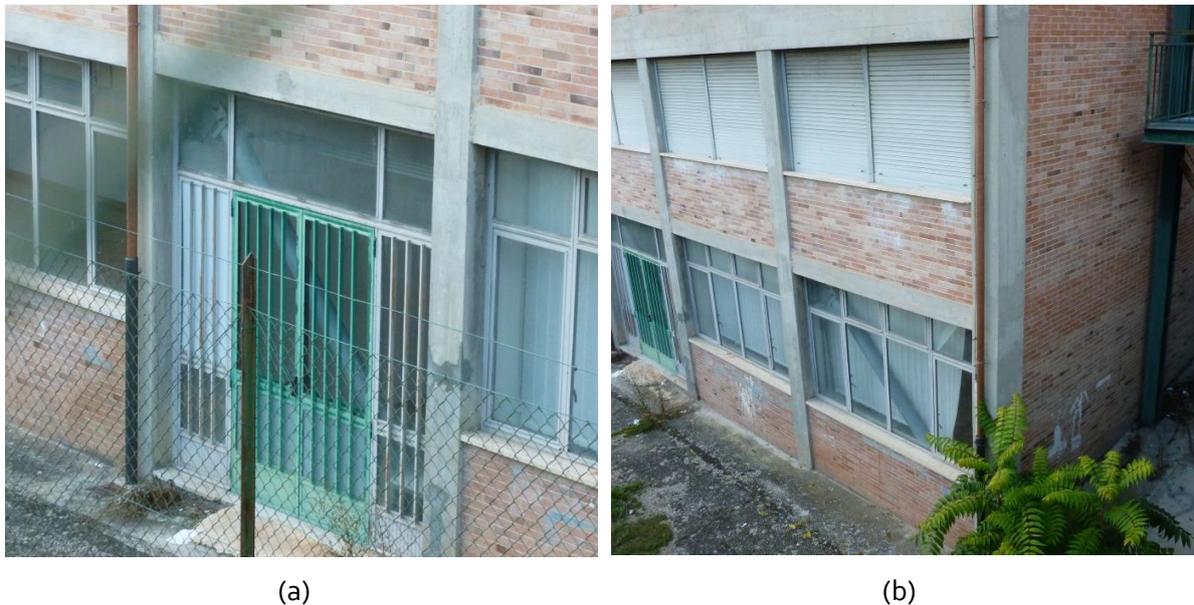
Figure 7-10 Istituto Tecnico commerciale (lat. 42.791702, long. 13.095641), (a), (b) North elevation illustrating tubular steel bracing in bays along the length of the building and possible, repaired damage to the columns.

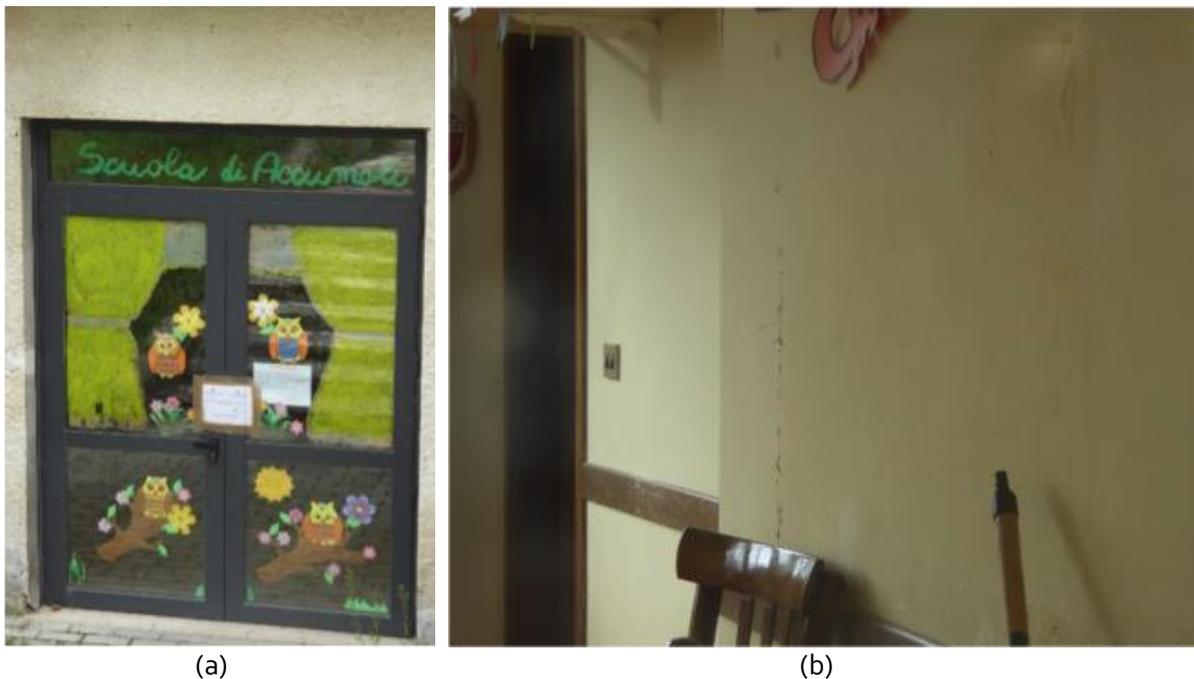
Figure 7-23 Accumoli Scuola dell'Infanzia (lat. 42.693956, long. 13.246677), (a) main entrance of the school with indication of prevented use. (b) cracks in masonry infill walls.

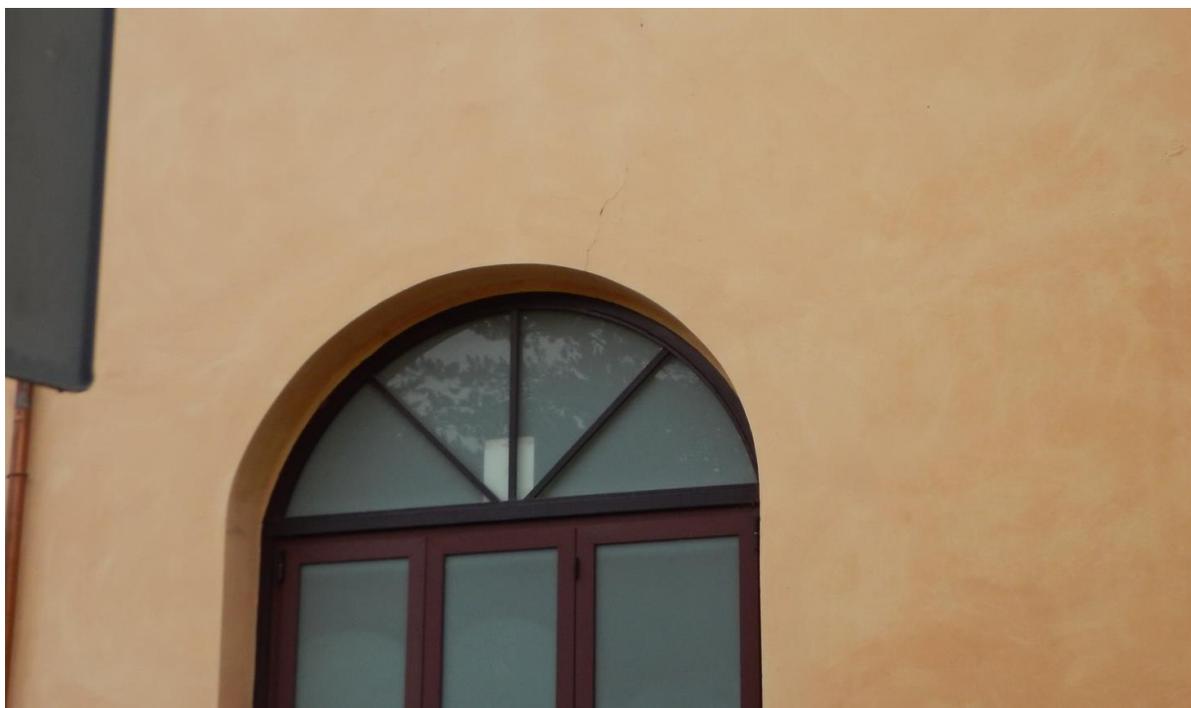
Figure 7-41 Norcia hospital (lat. 42°47'22.83"N, long. 13° 5'50.28"E). Cracking above window.

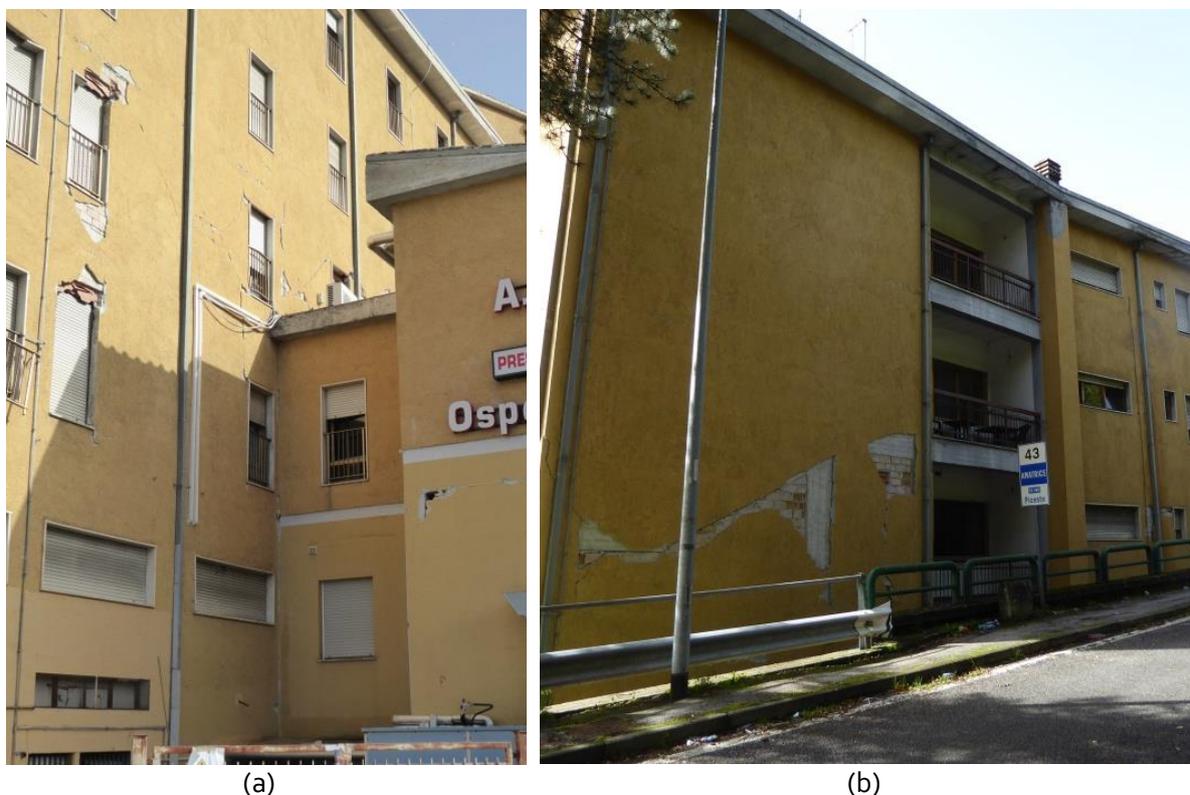
Figure 7-46 Amatrice hospital (lat. $42^{\circ}37'40.85''\text{N}$, long. $13^{\circ}17'10.37''\text{E}$). RC part of the building, damage to masonry infills, no structural damage was detected from the survey made from the outside of the building.

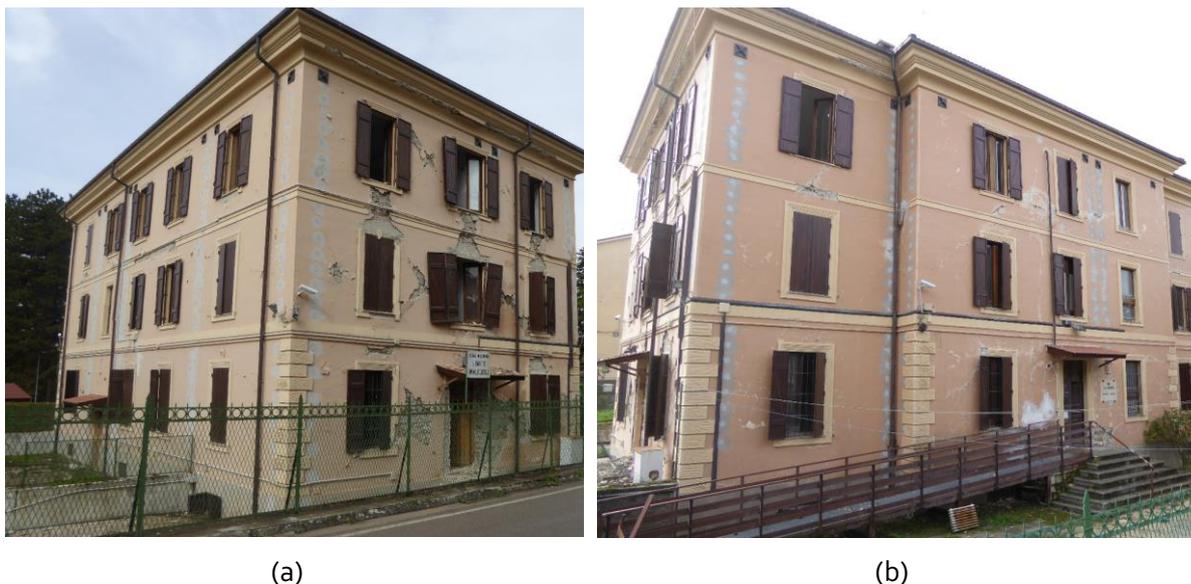
Figure 7-55 Amatrice Caserma Carabinieri (lat. 42°37'37.72"N; long. 13°17'27.14"E) damage (a) in South and East facades, (b) North façade.

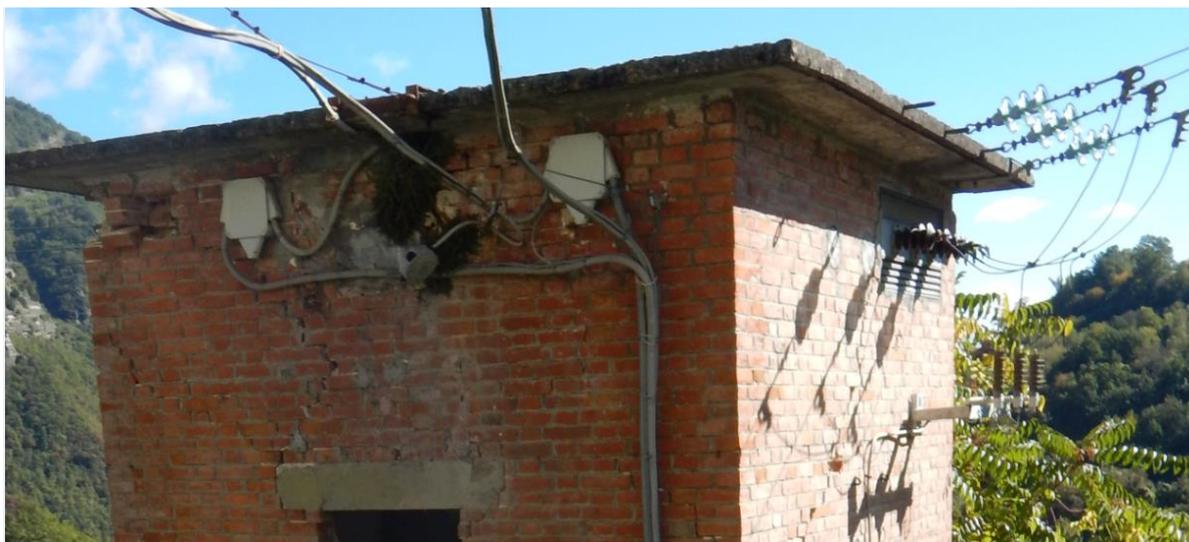
Figure 7-61 Arquata del Tronto – Electricity Transformer (lat. $42^{\circ}46'21.912''N$; long. $13^{\circ}17'50.022''E$), zoom of damage at the roof level.

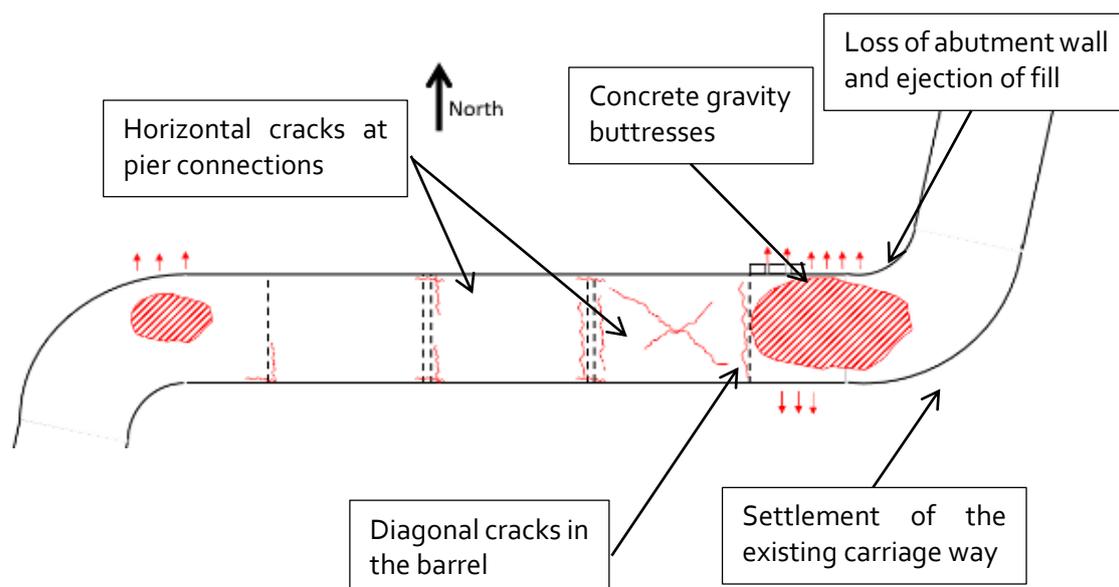
Figure 8-5 Layout of the bridge and summary of observed damage

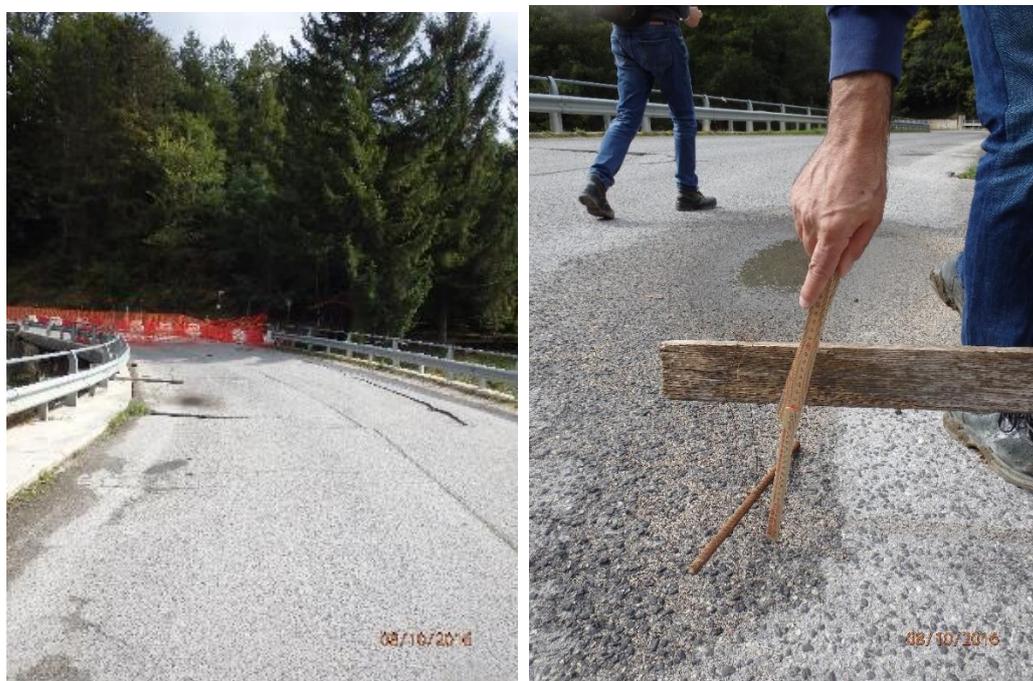
Figure 8-6 Vertical sag of the carriageway at the eastern abutment

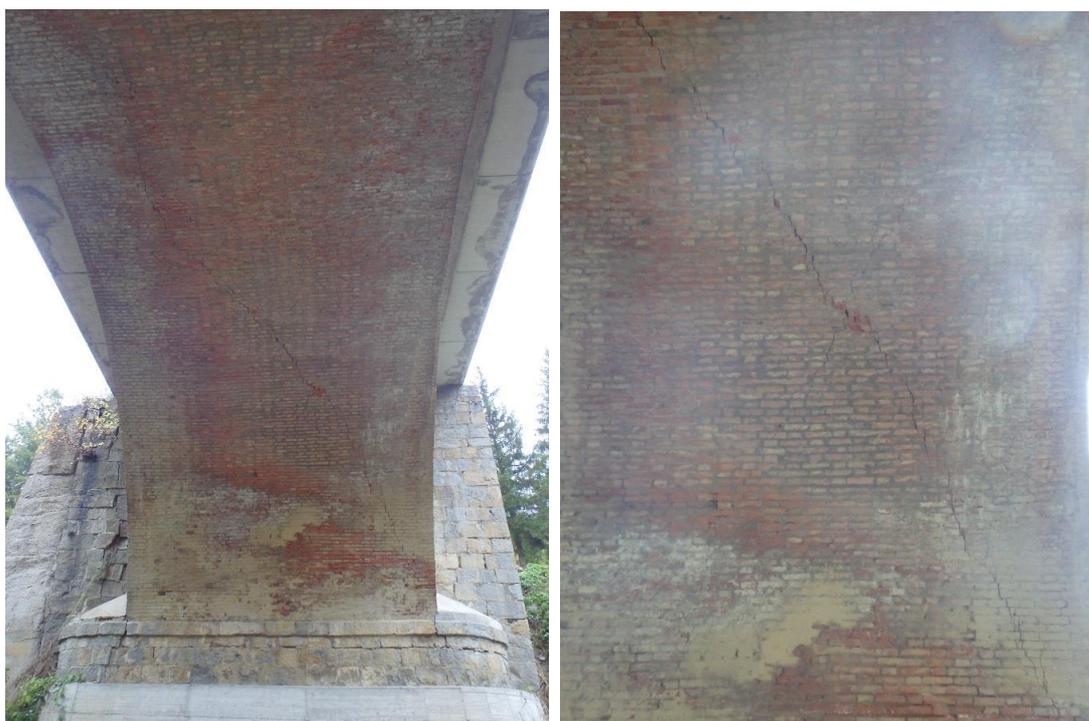
Figure 8-10 Photographs of the eastern arch X-shaped cracks.

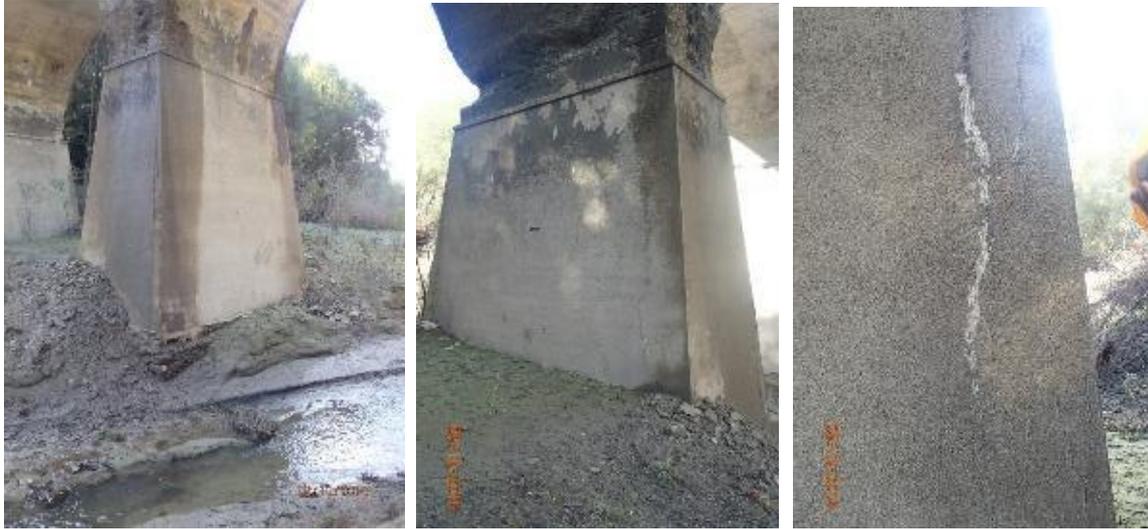
Figure 8-14 Images highlighting foundation scour (left) and vertical cracks in the bridge piers.

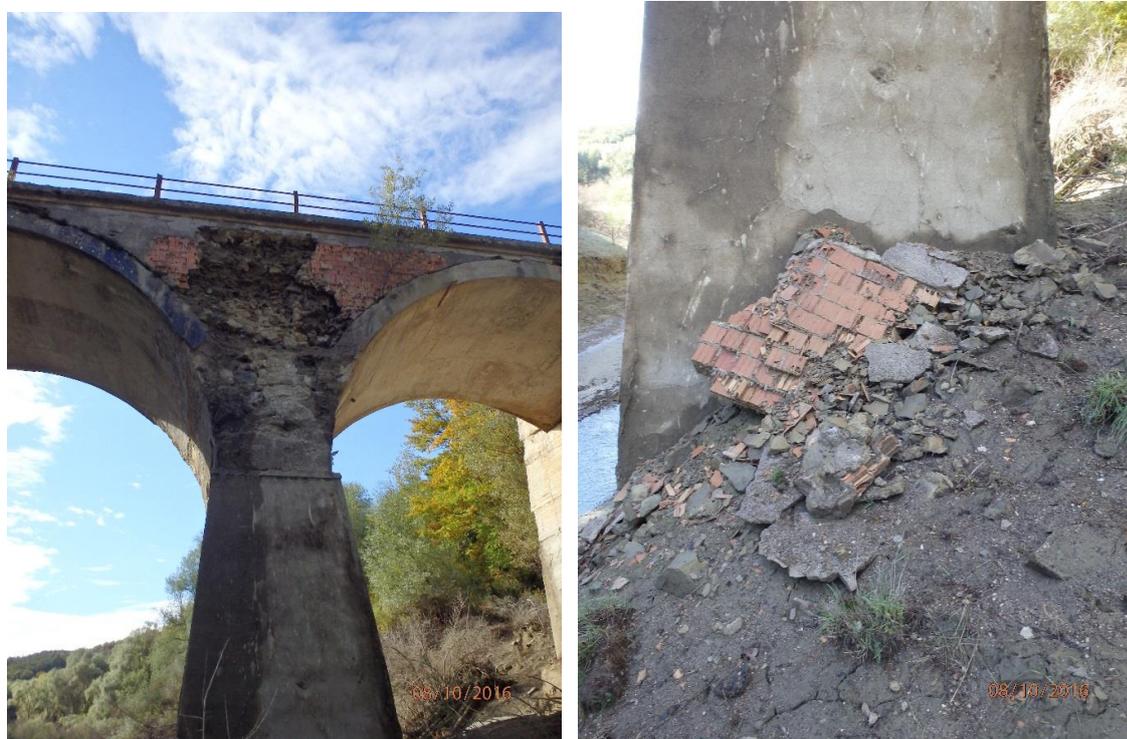
Figure 8-17 Spandrel masking walls failure

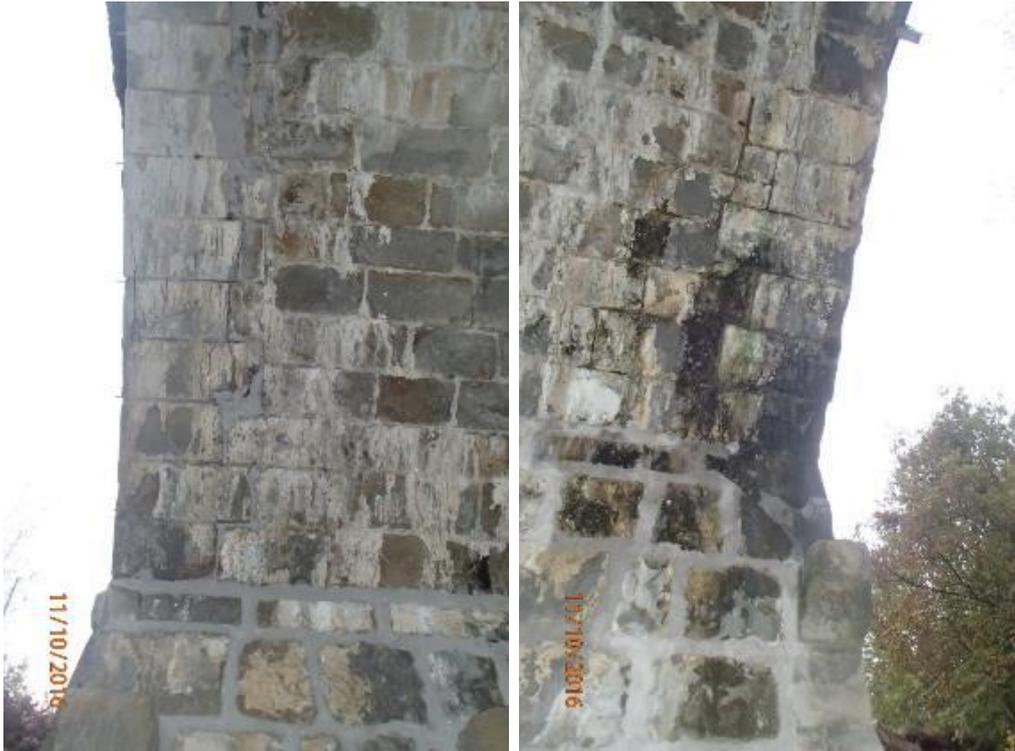
Figure 8-20 Meridian cracks by the side arches, South on the left and North on the right

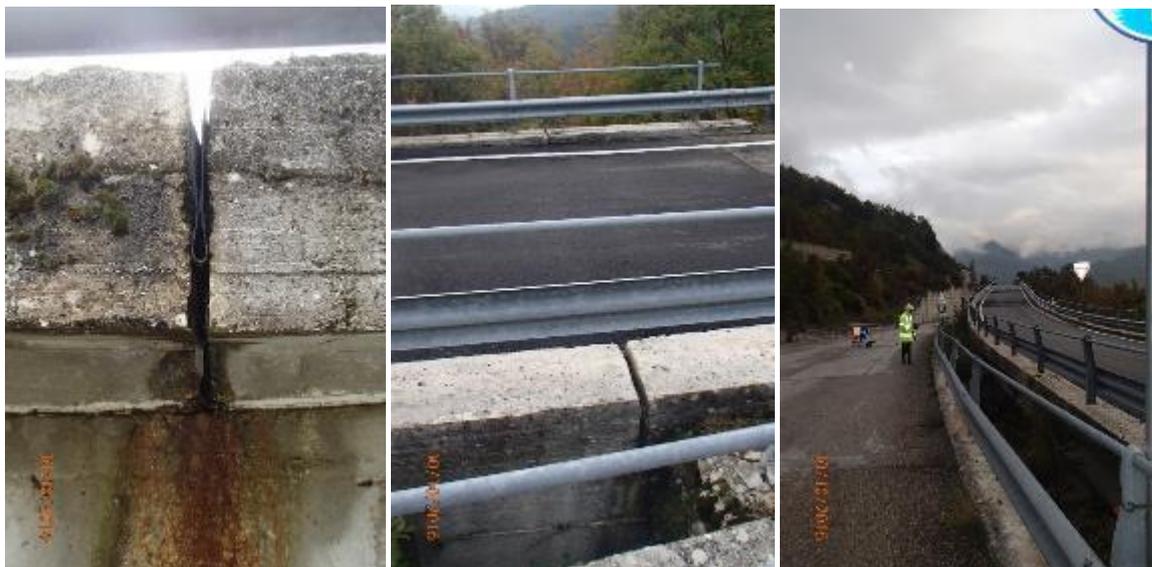
Figure 8-36 Expansion joint and repair works on the surface of the second viaduct investigated

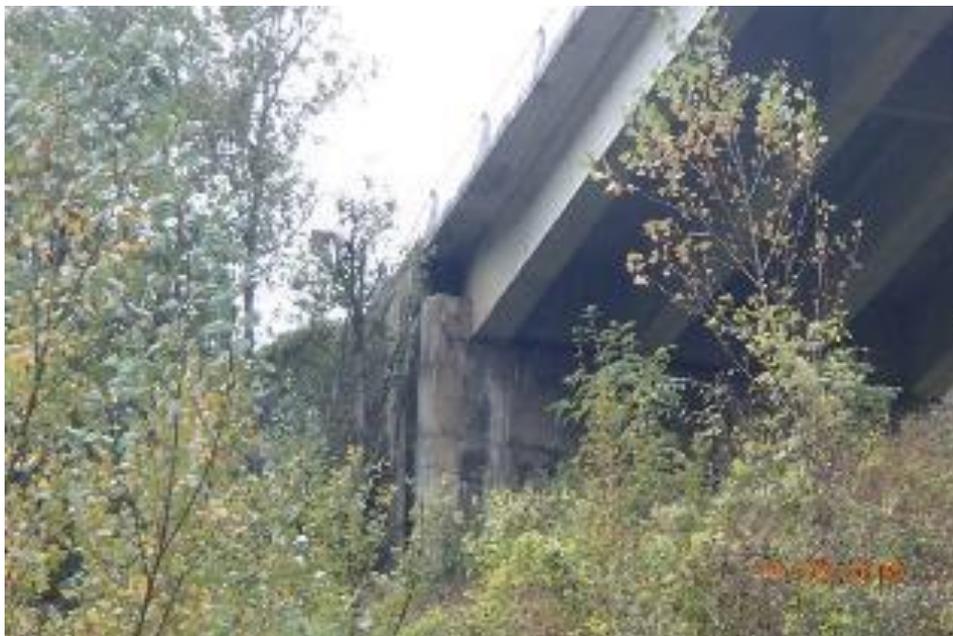
Figure 8-38 Damage observed at the viaduct abutment
