THE MUISNE, ECUADOR EARTHQUAKE OF 16 APRIL 2016

A FIELD REPORT BY EEFIT

THE M_w7.8 MUISNE ECUADOR EARTHQUAKE OF 16 APRIL 2016

September 2018

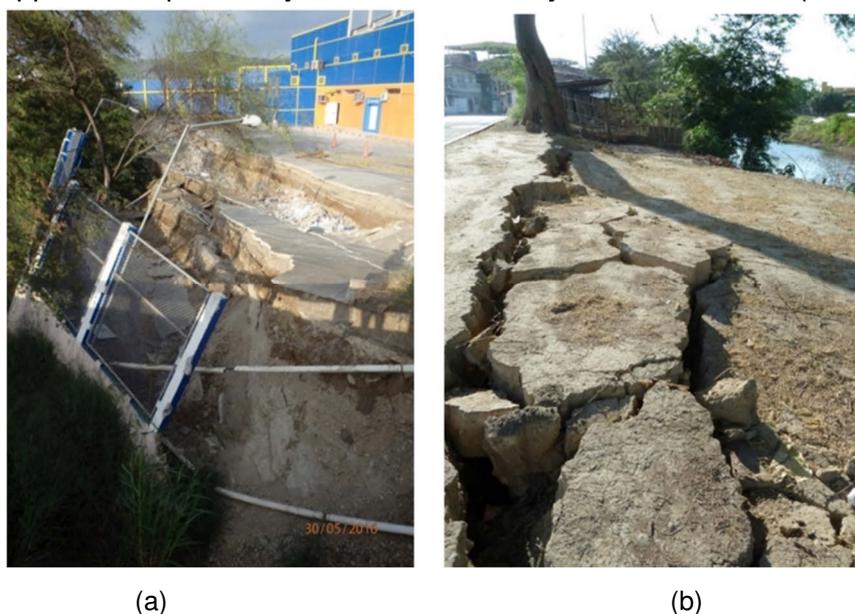
Figure 4-3 Lateral spreading in Portoviejo (a) liquefaction of fill below VelBoni carpark (b) tension cracking due to liquefaction of a lower layer.

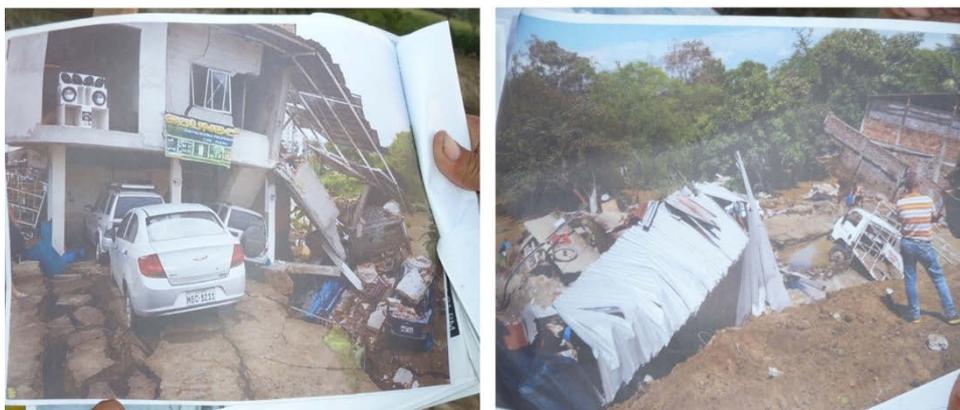
Figure 4-5 Collapse of structures along Rio Portoviejo due to liquefaction induced lateral spreading.

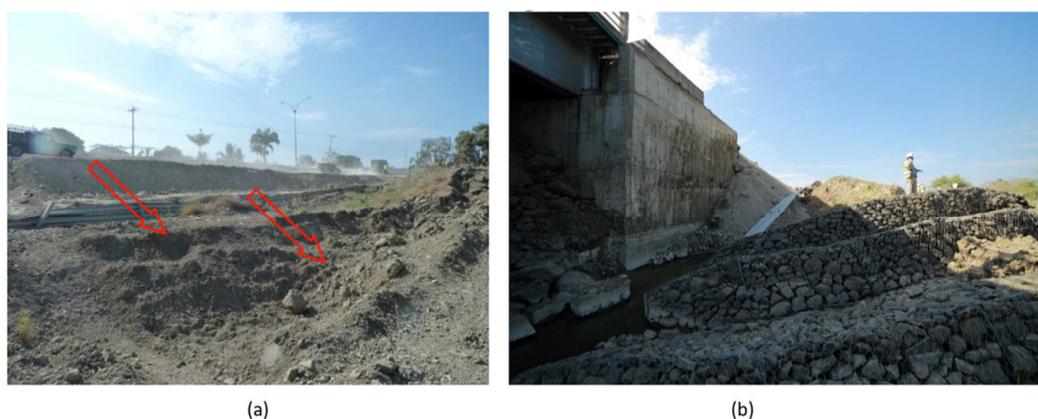
Figure 4-6 Damage to south-west of Mejía Bridge (a) lateral spreading of embankment, (b) sliding and rotation of gabions.

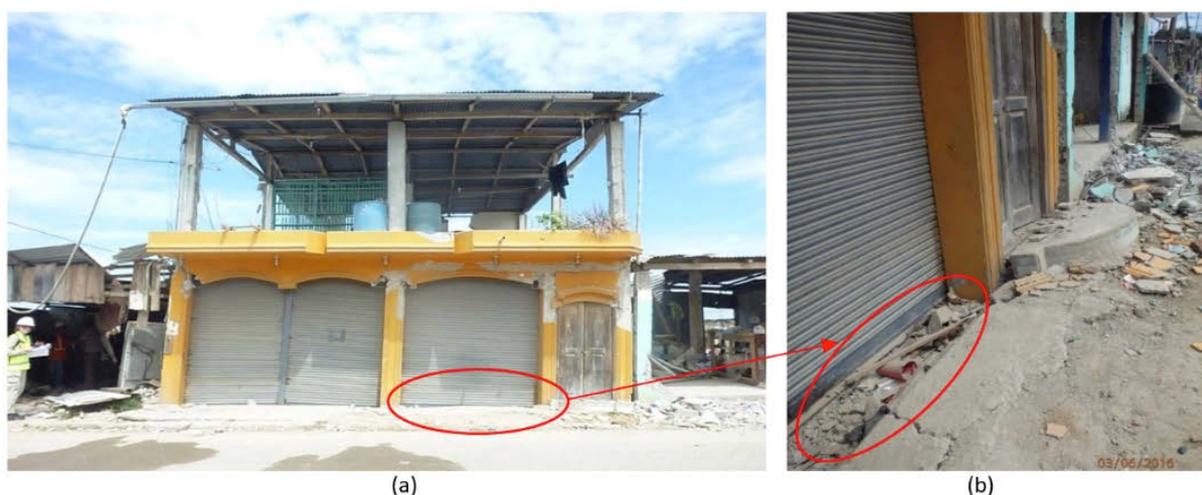
Figure 4-12 Settlement of building in Chamanga (a) increased settlement from left to right of structure (b) settlement relative to road and step.

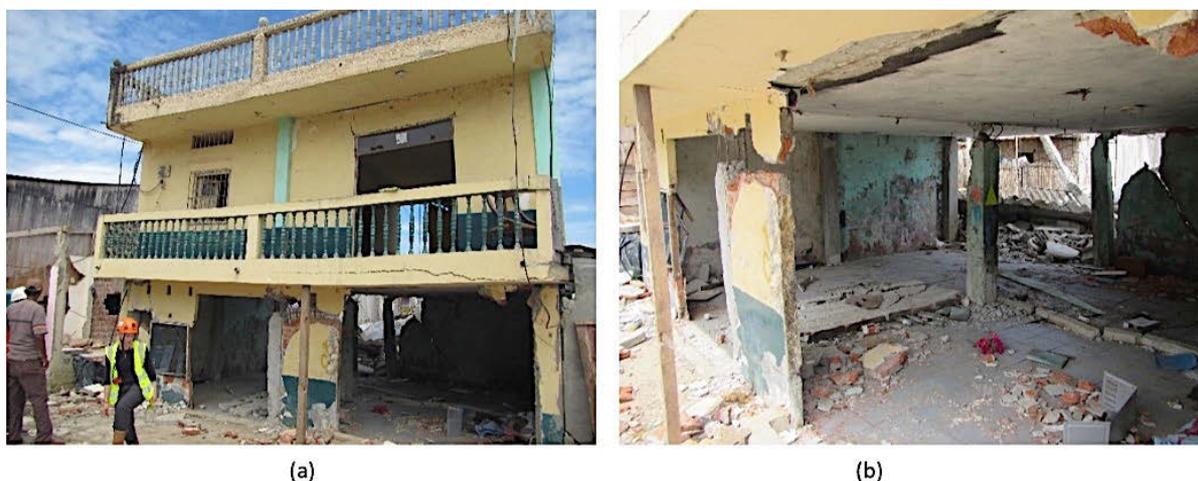
Figure 4-13 Damage due to differential settlement of building in Chamanga (a) concrete cracking due to differential settlement, (b) detail of structural damage to building.

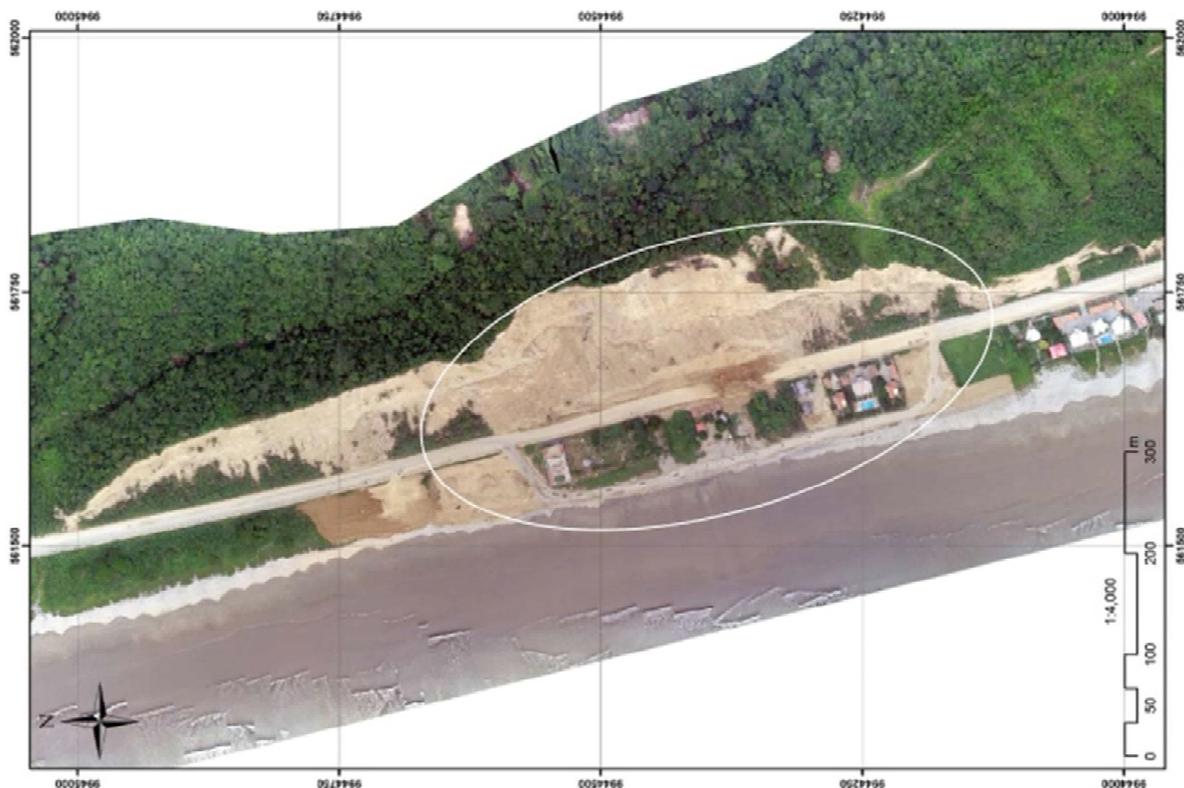
Figure 4-25 Example of a landslides on the coastal road between San Vicente and Canoa (Echeverria, 2016).

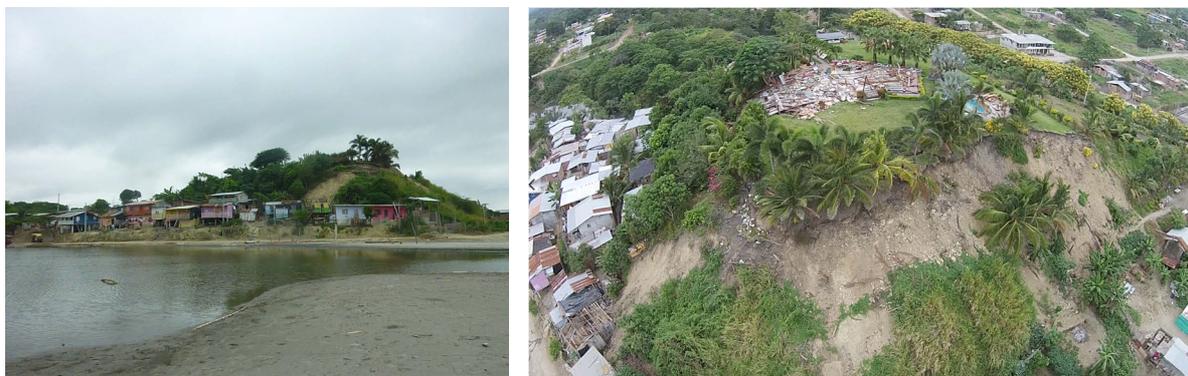
Figure 4-27 Informal settlement damage South of Pedernales due to slope failure (drone image of the head of the slope on the right).

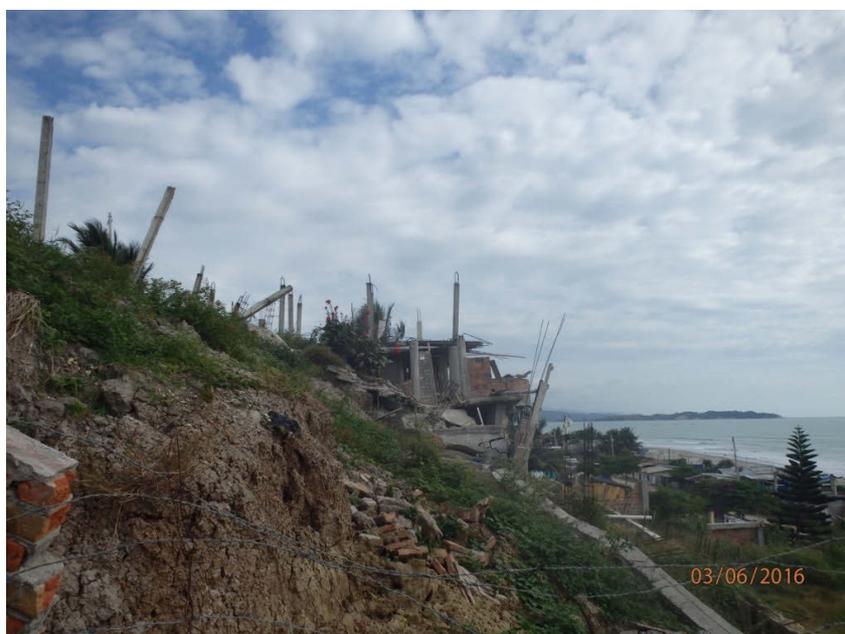
Figure 4-28 Slope instability damage North of Pedernales.

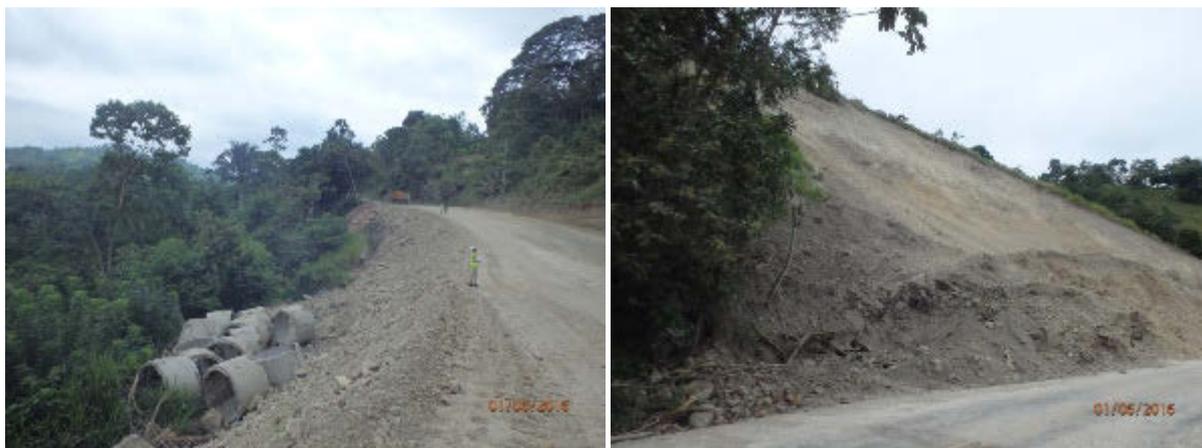
Figure 4-29 Major landslide observed on the road from Canoa to San Isidro

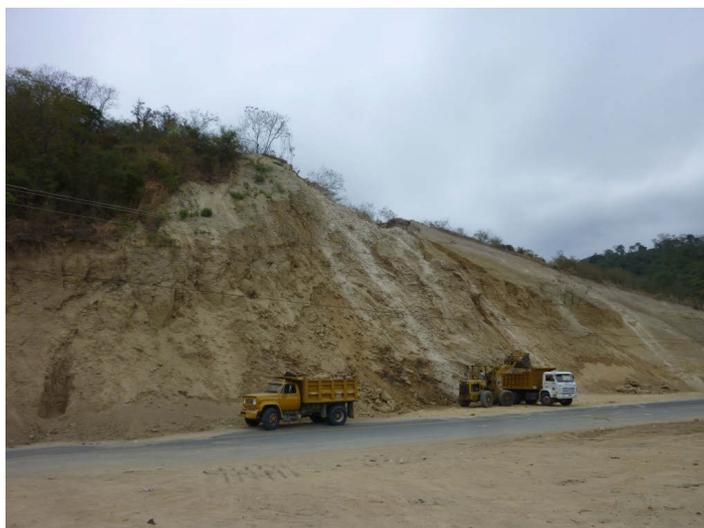
Figure 4-31 Unsafe practice clearing landslide debris (Chone Estuary).

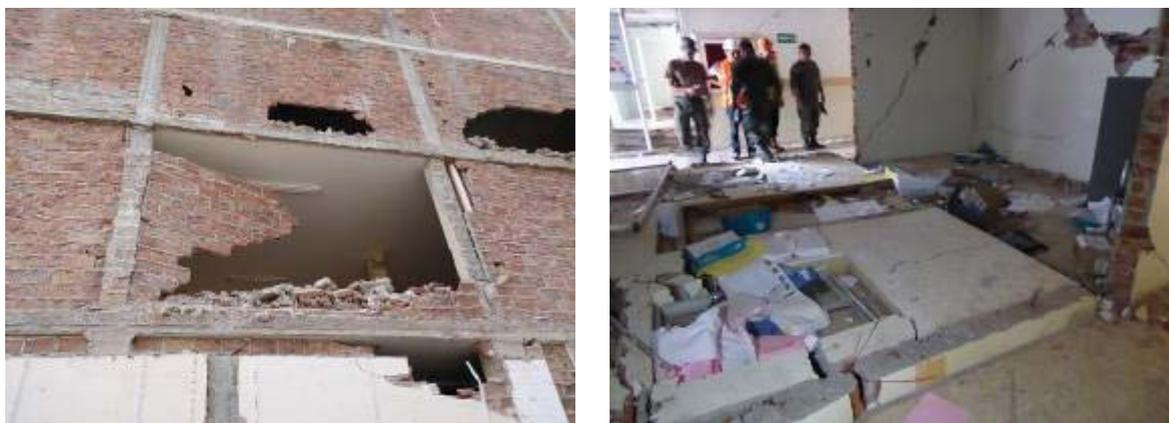
Figure 6-7 Inadequate masonry infill wall design and construction.

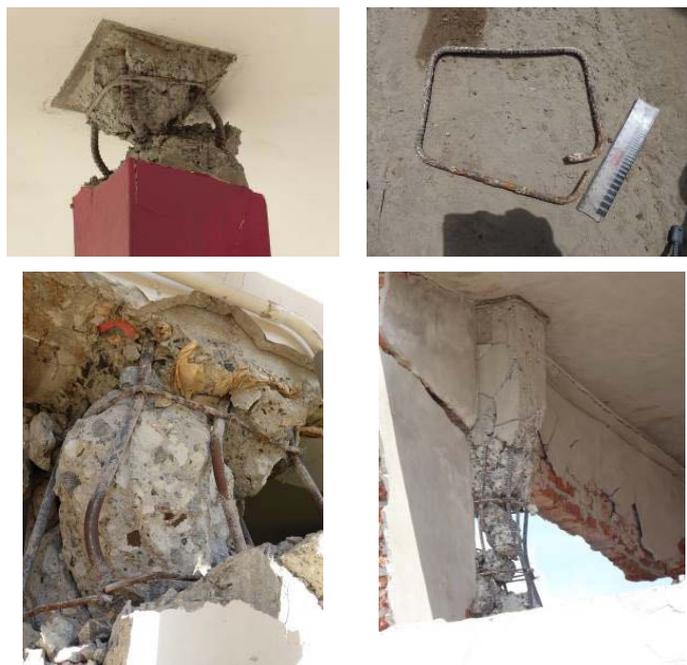
Figure 6-8 Inadequate design and detailing for shear – insufficient link spacing, poor link detailing and plain links used.

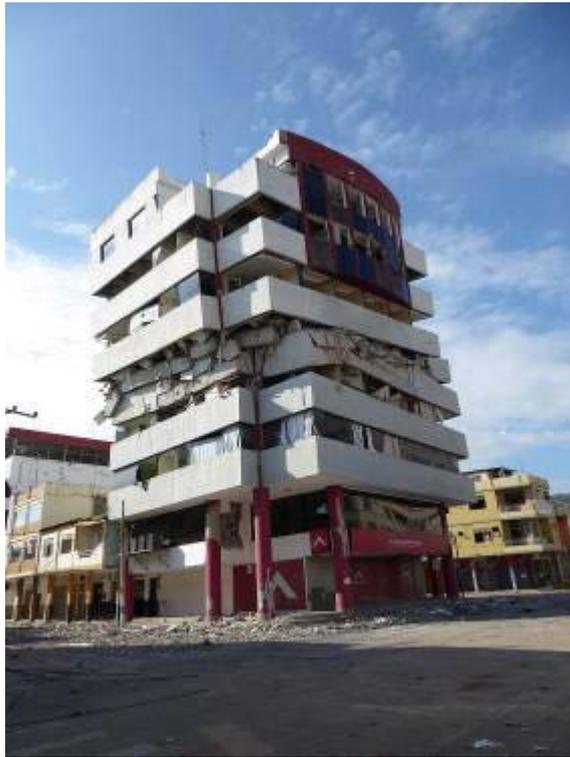
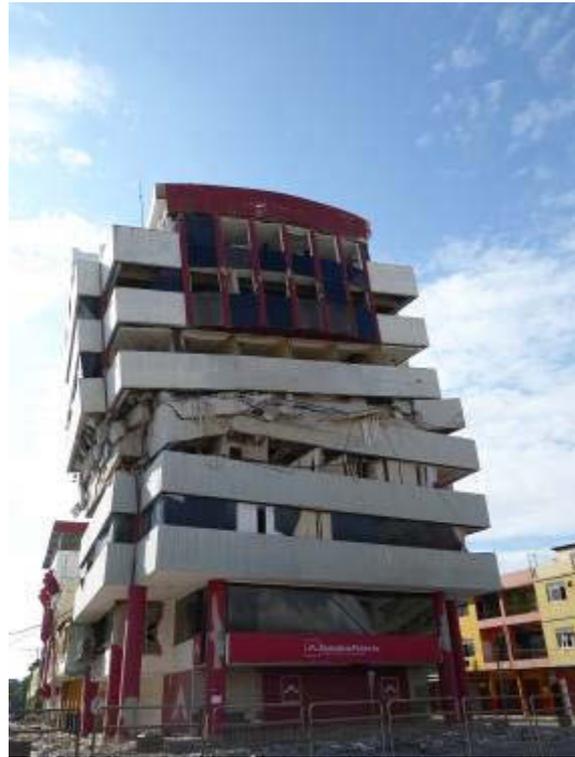
Figure 6-9 Weak and soft storey failures.

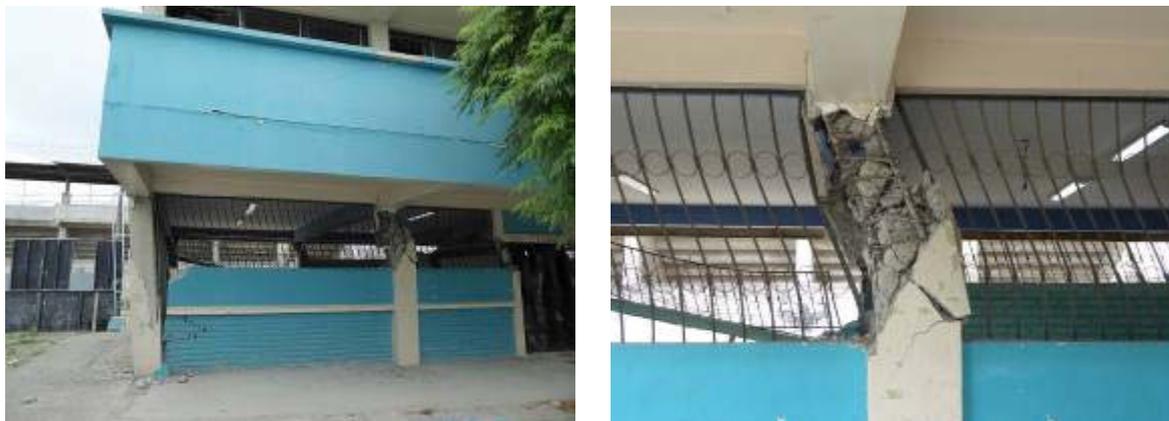
Figure 6-11 Short columns at a school in Pedernales.

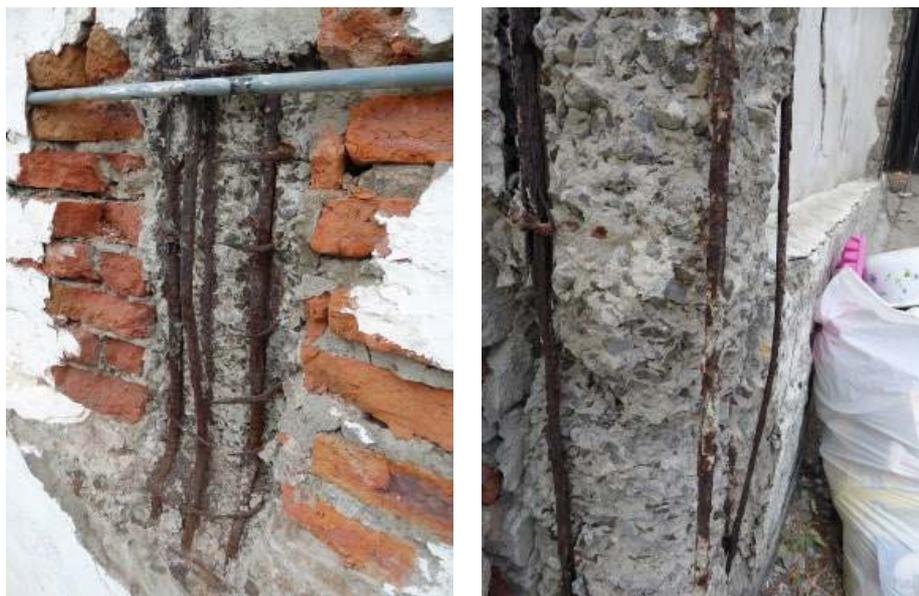
Figure 6-13 Insufficient cover to rebar – note 100% section loss to some of the links.

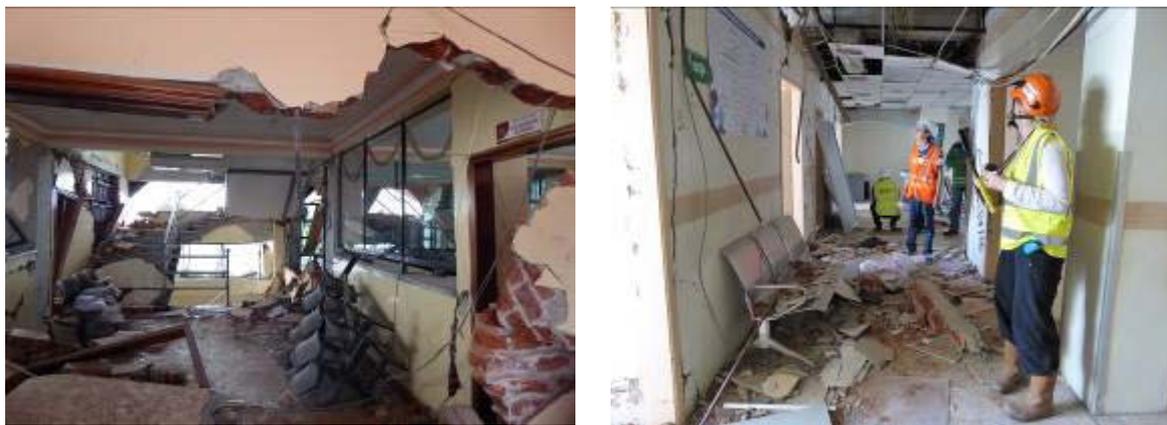
Figure 6-16 Inadequate securing of non-structural elements – the image on the right depicts a hospital corridor.

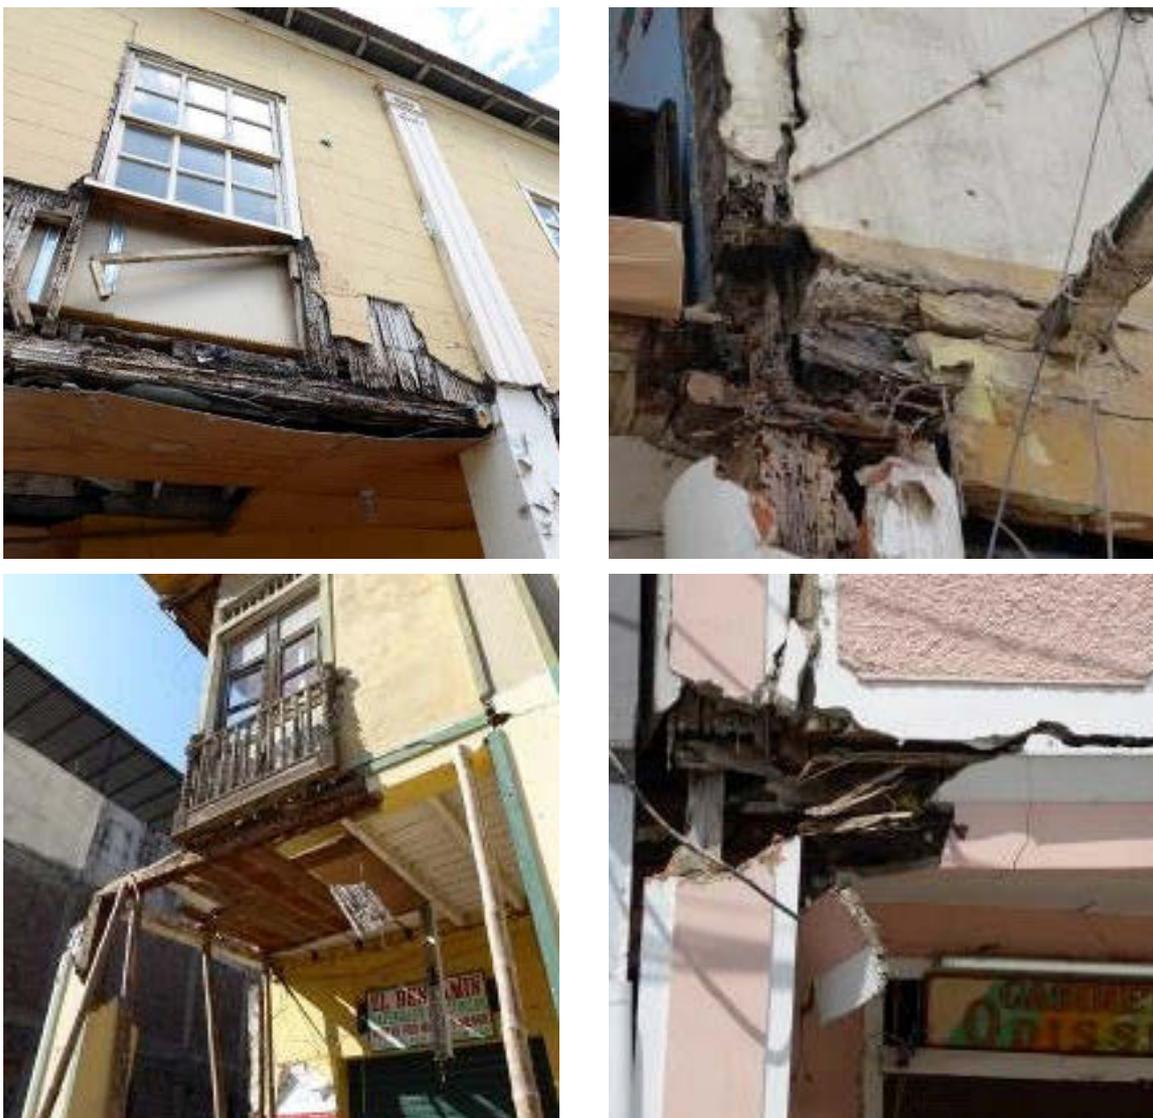
Figure 6-18 Examples of rot and insect damage.

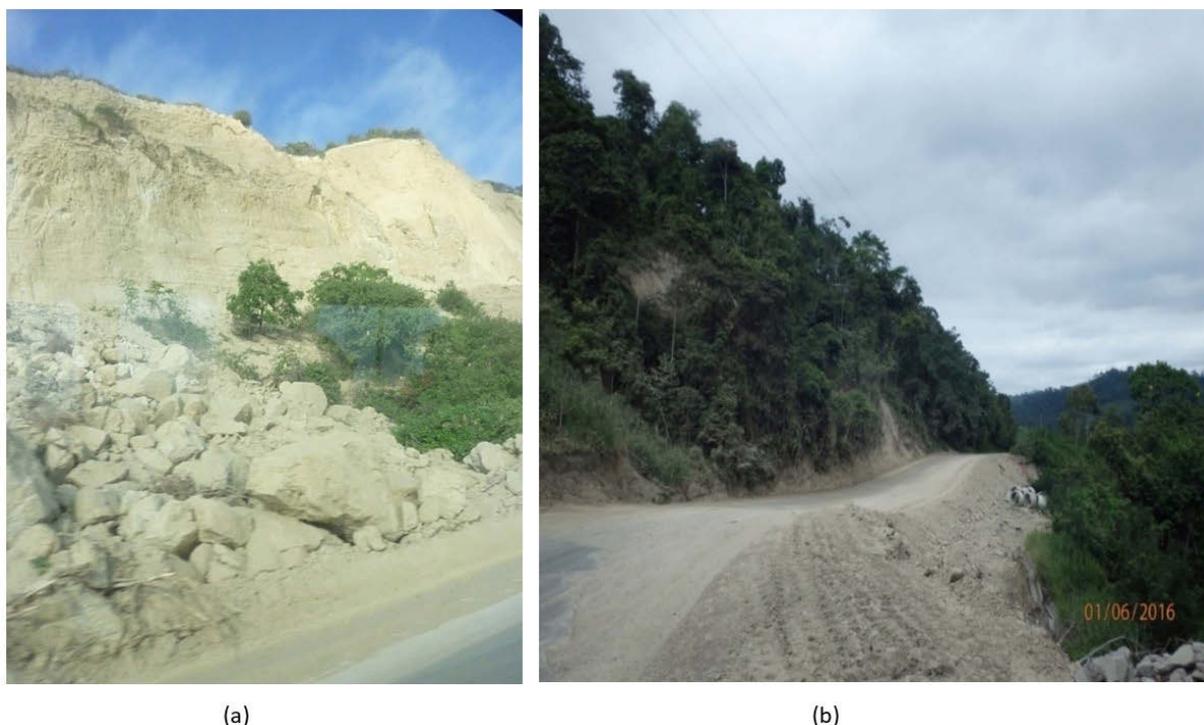
Figure 7-1 Landslide damage to roads (a) on the Highway 15, near Canoa (b) on rural road near San Isidro.

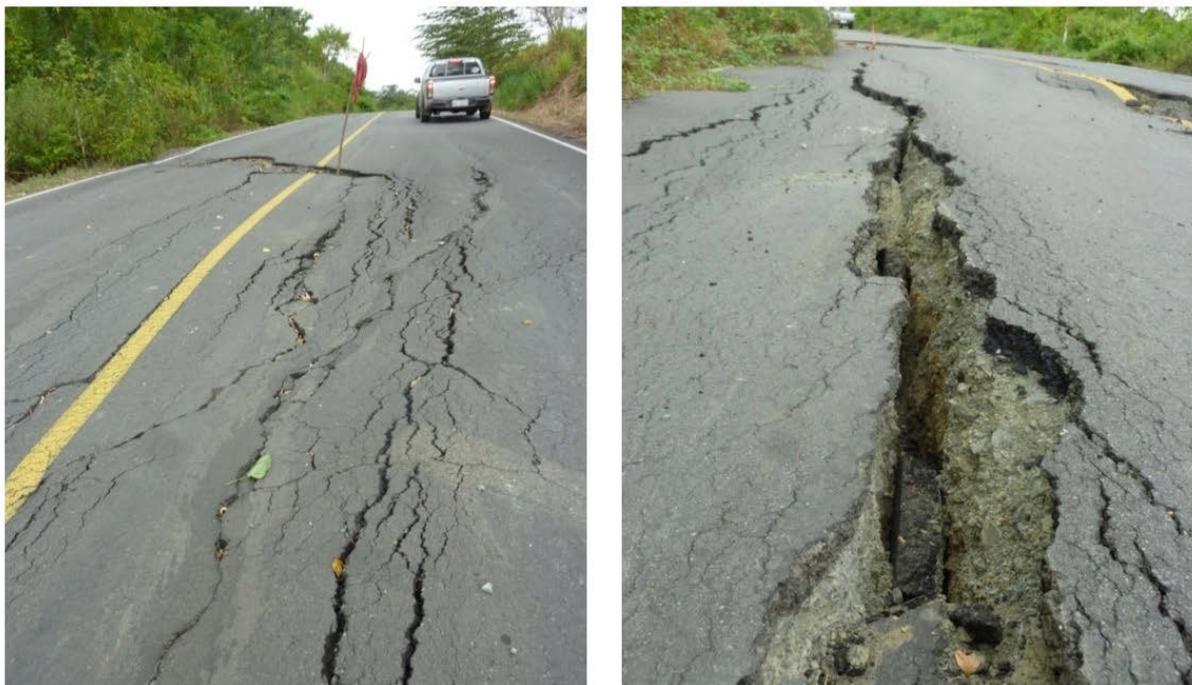
Figure 7-2 Examples of cracking on roads near San Isidro.

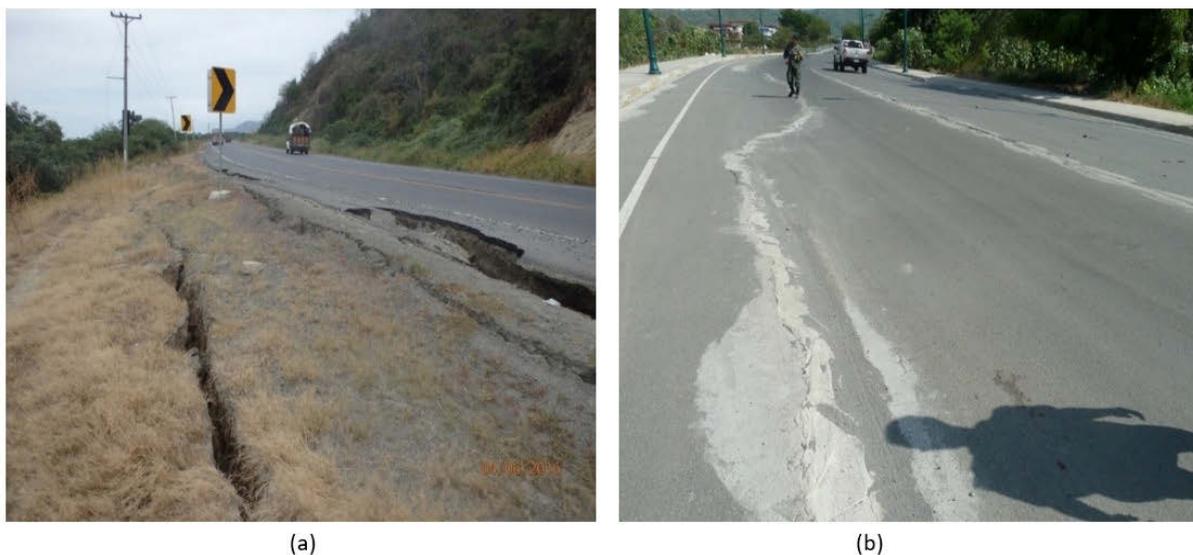
Figure 7-3 Damage to roads due to liquefaction induced lateral spreading (a) Chone river estuary near San Vicente, (b) Portoviejo, close to the Rio Portoviejo.

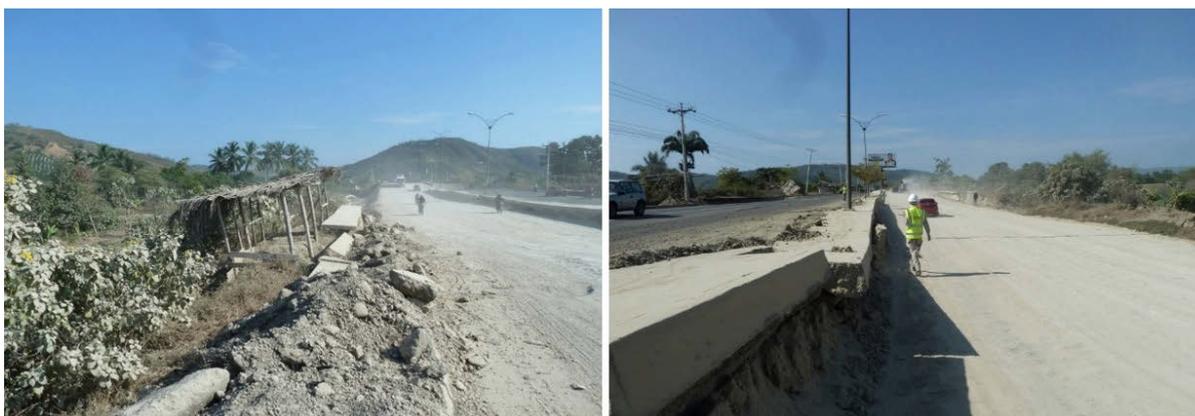
Figure 7-6 Mejía bridge, differential settlement between the two separate sections as seen from the bridge's approach.

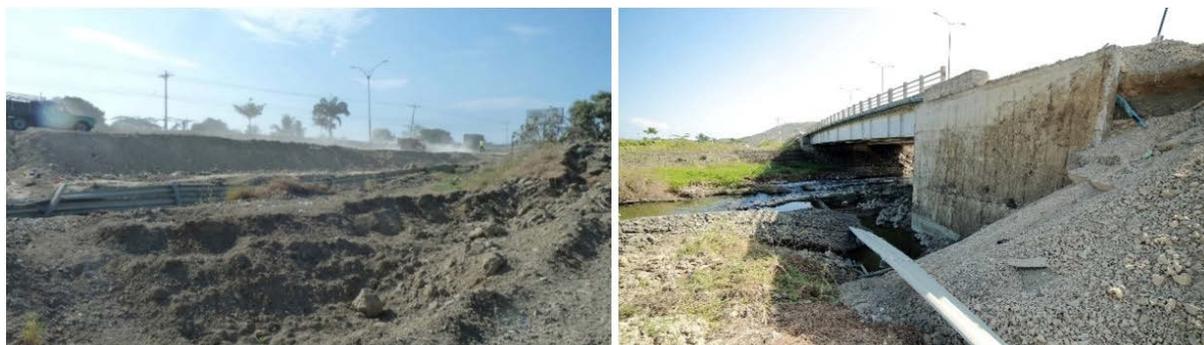
Figure 7-7 Mejía bridge, embankment (left) and gabion wall (right) failure.

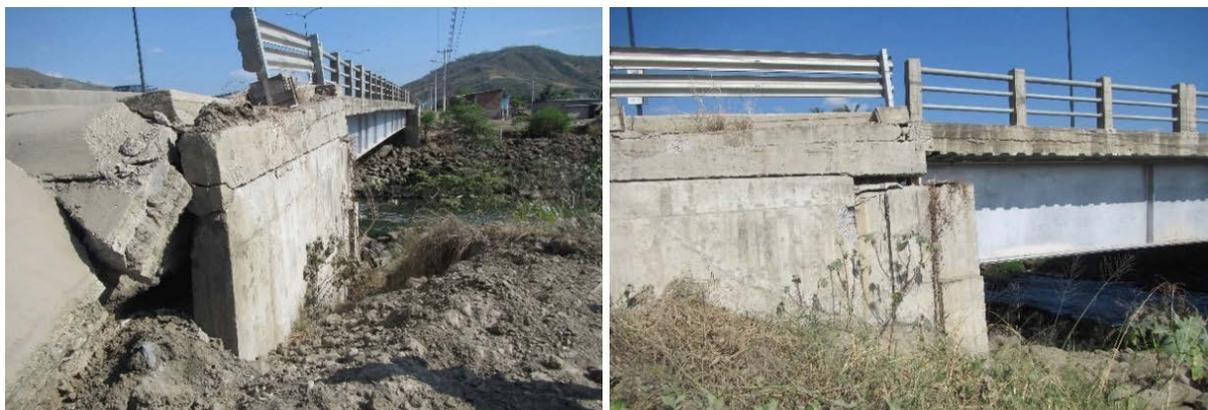
Figure 7-8 Mejía bridge, damage in abutment.

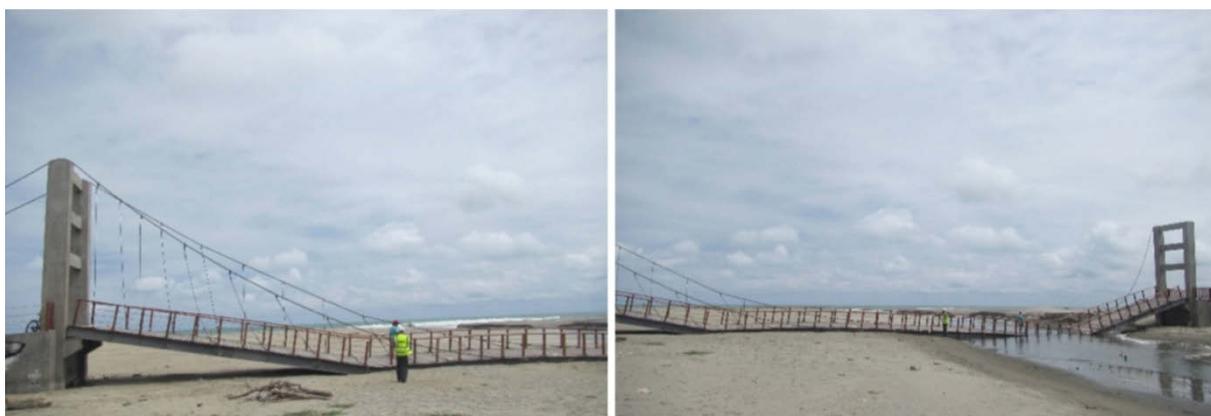
Figure 7-14 Collapsed footbridge in Canoa.

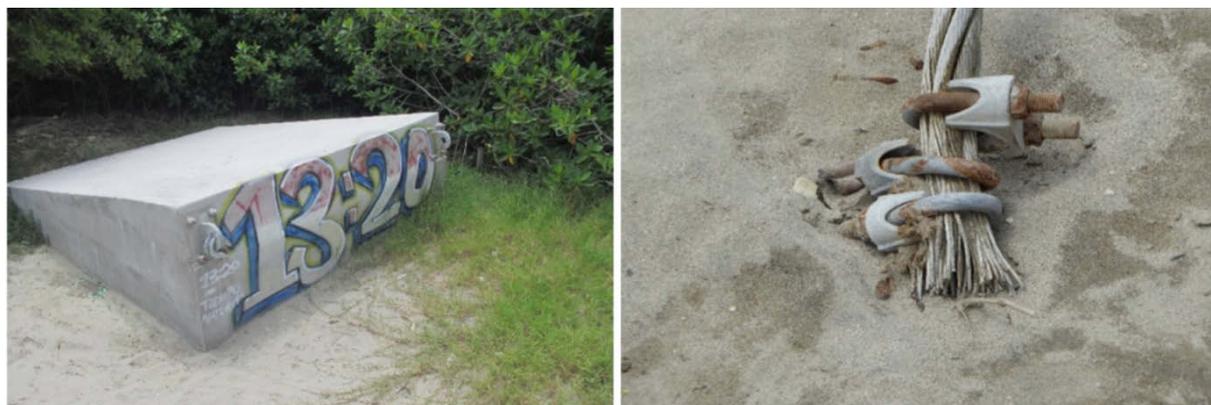
Figure 7-15 Footbridge in Canoa, right end anchorage block (left) and suspension cable end that failed at anchorage (right).

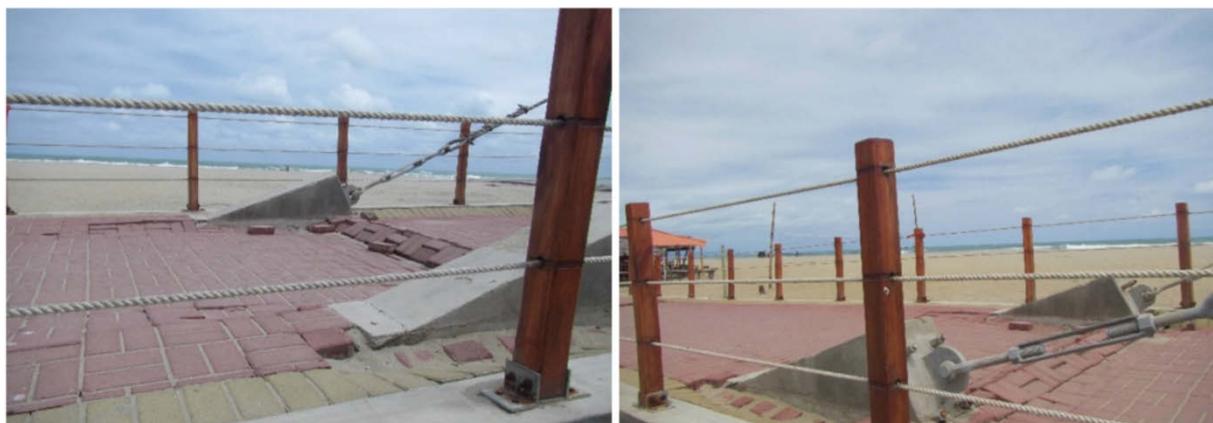
Figure 7-16 Footbridge in Canoa, left end anchor points experienced uplift.

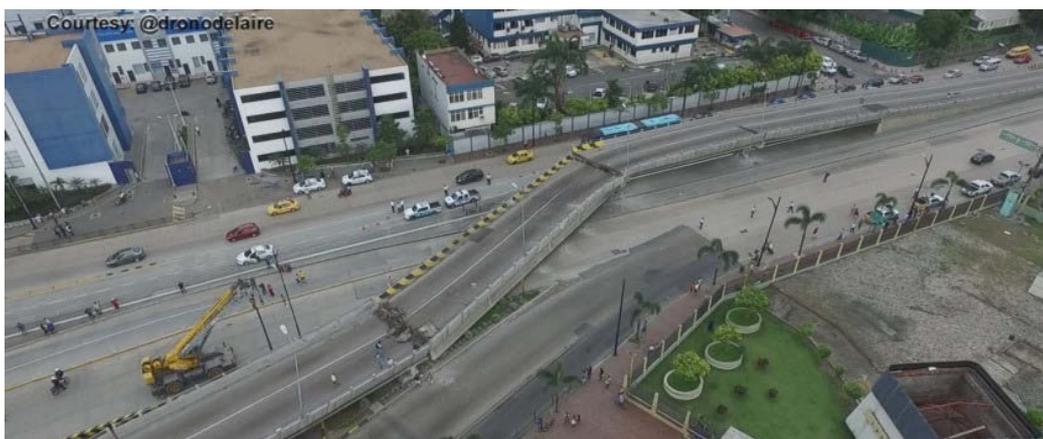
Figure 7-19 Bridge collapse in Guyaquil after the 2016 Ecuador Main Shock (<http://abcnews.go.com/International/drone-video-captures-deadly-earthquake-aftermath-ecuador/story?id=38473672>).

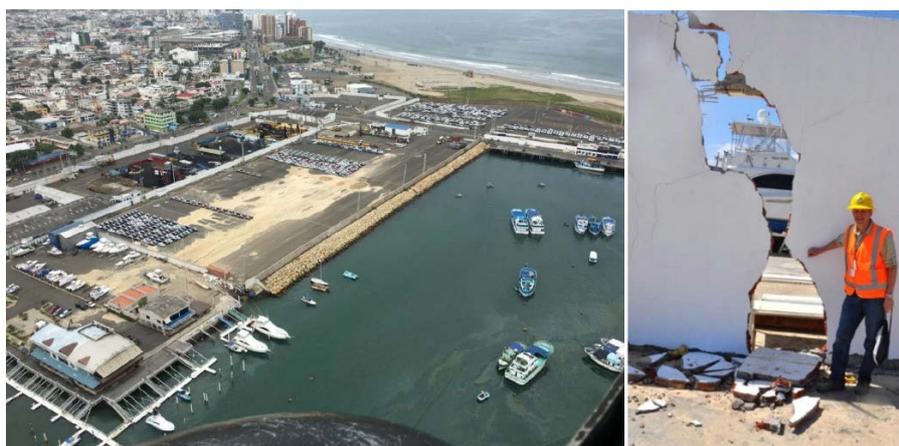
Figure 7-20 Manta Port damage (left: aerial photograph showing extent of liquefaction damage at surface; right: port wall damage, showing for scale K. Rollins, at GPS 0o56'29.6"N, 80o43'27.4"E – from GEER, 2016).
