# **The Central Sulawesi, Indonesia Earthquake and Tsunami of 28<sup>th</sup> September 2018 – A Field Report by EEFIT-TDMRC**

01/11/2019

Prof Tiziana Rossetto, EPICentre, University College London

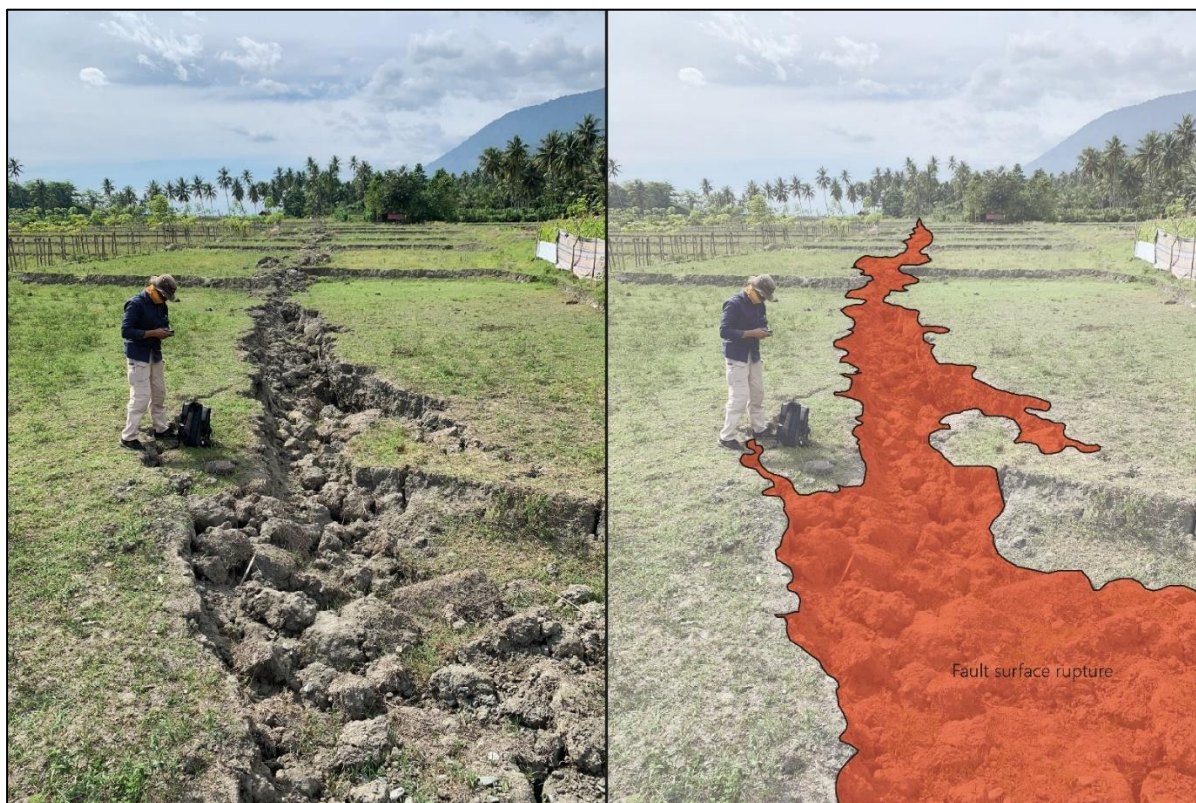
Figure 3.5 – Fault surface rupture through rice paddy field.

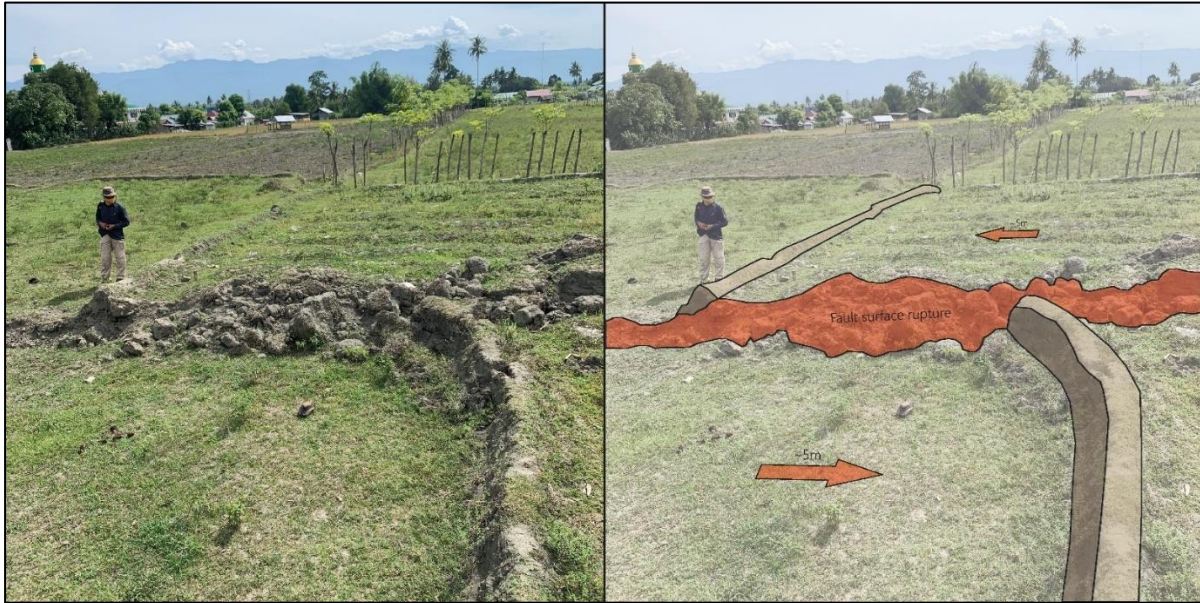
Figure 3.6 – Displacement of approximately 5m along fault surface rupture shown due to offset rice paddy terraces.

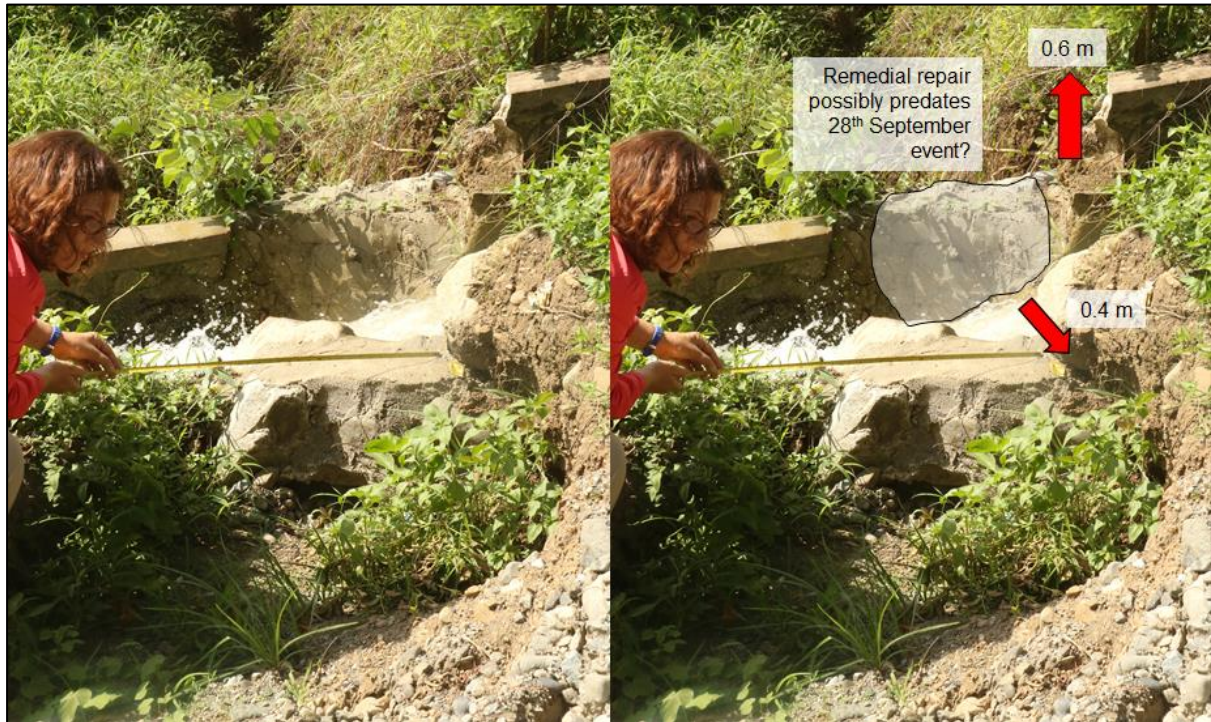
Figure 3.8 – Damage to water channel on North side of large rupture at Labua indicates observed total displacement may be only partly due to 28<sup>th</sup> September event

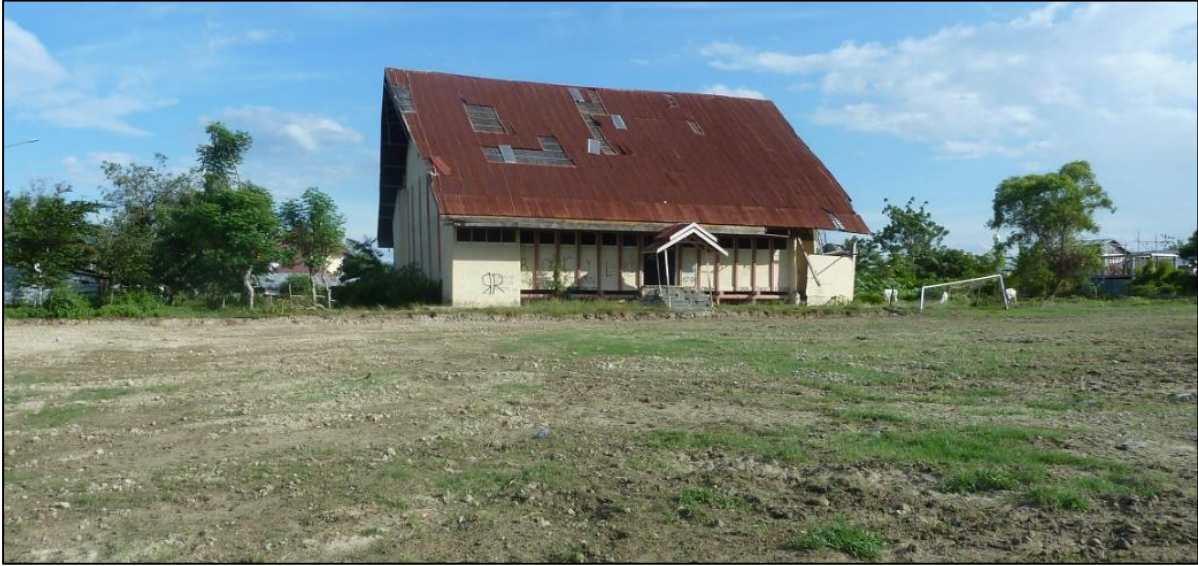
*Figure 5.2.- Liquefaction ejecta in a field at Gelanggang Mahasiswa, Kabonena. Observe the vertical offset in front of the pavilion where the field has settled relative to nearby intact ground.*

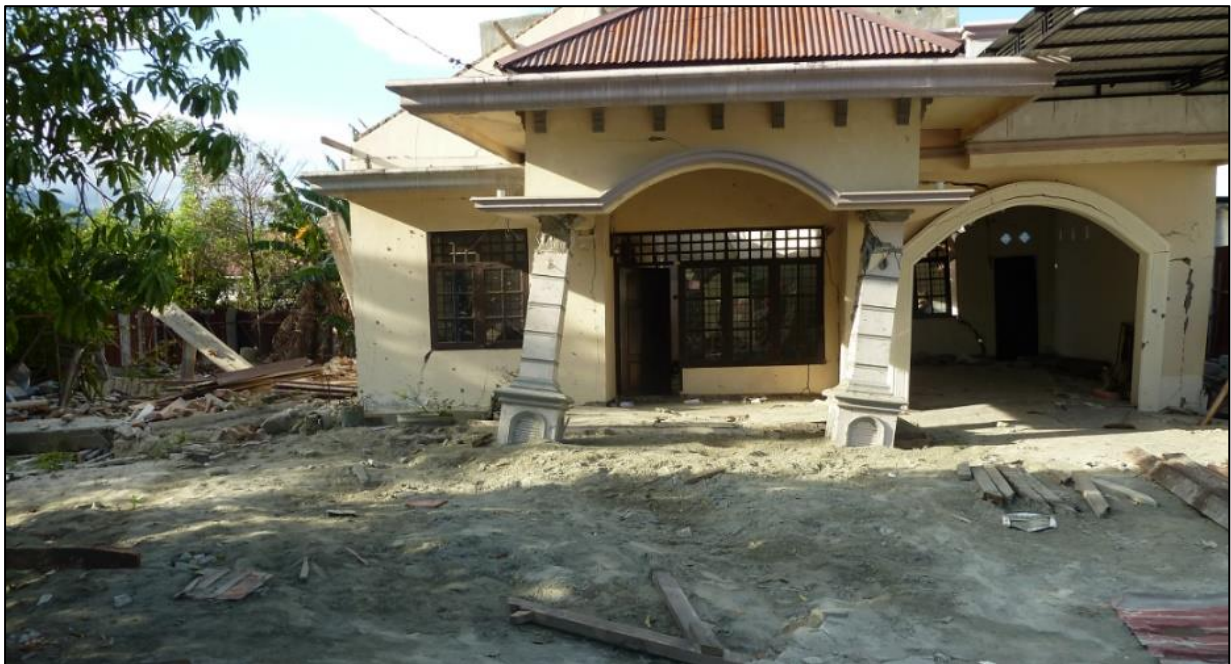
Figure 5.5. - Damage to a one-storey building in Lasoso due to differential settlement induced by liquefaction. Sandy ejecta in garden.

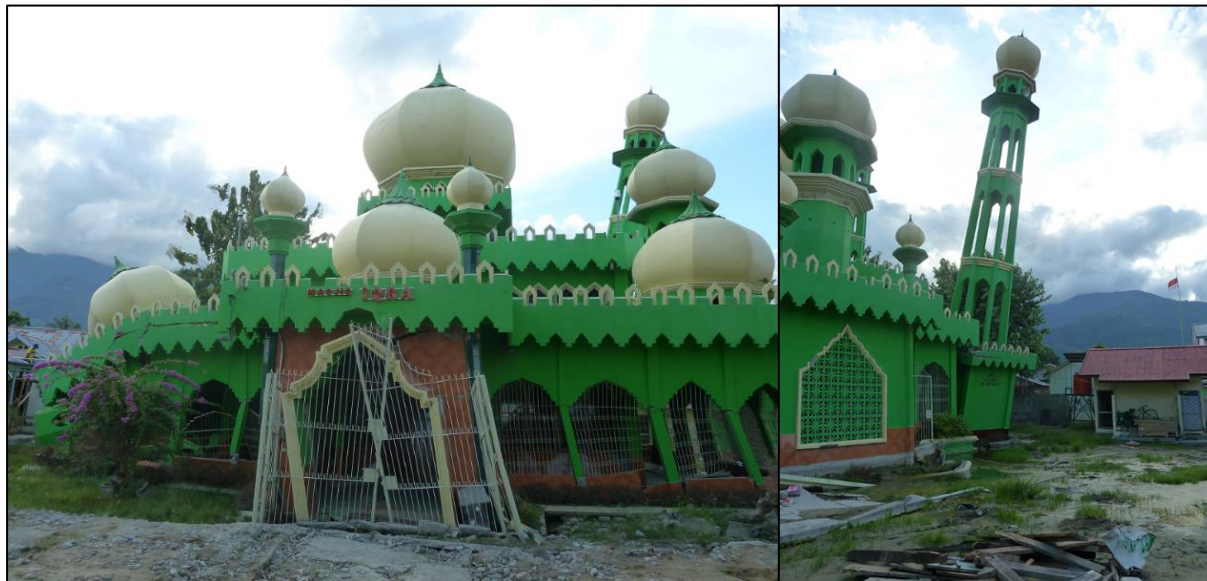
Figure 5.6 – Left: Front of Masjid Iqra. Right: Masjid Iqra in Lasoso. Severe liquefaction-induced damage and tilting of minaret due to liquefaction beneath base.

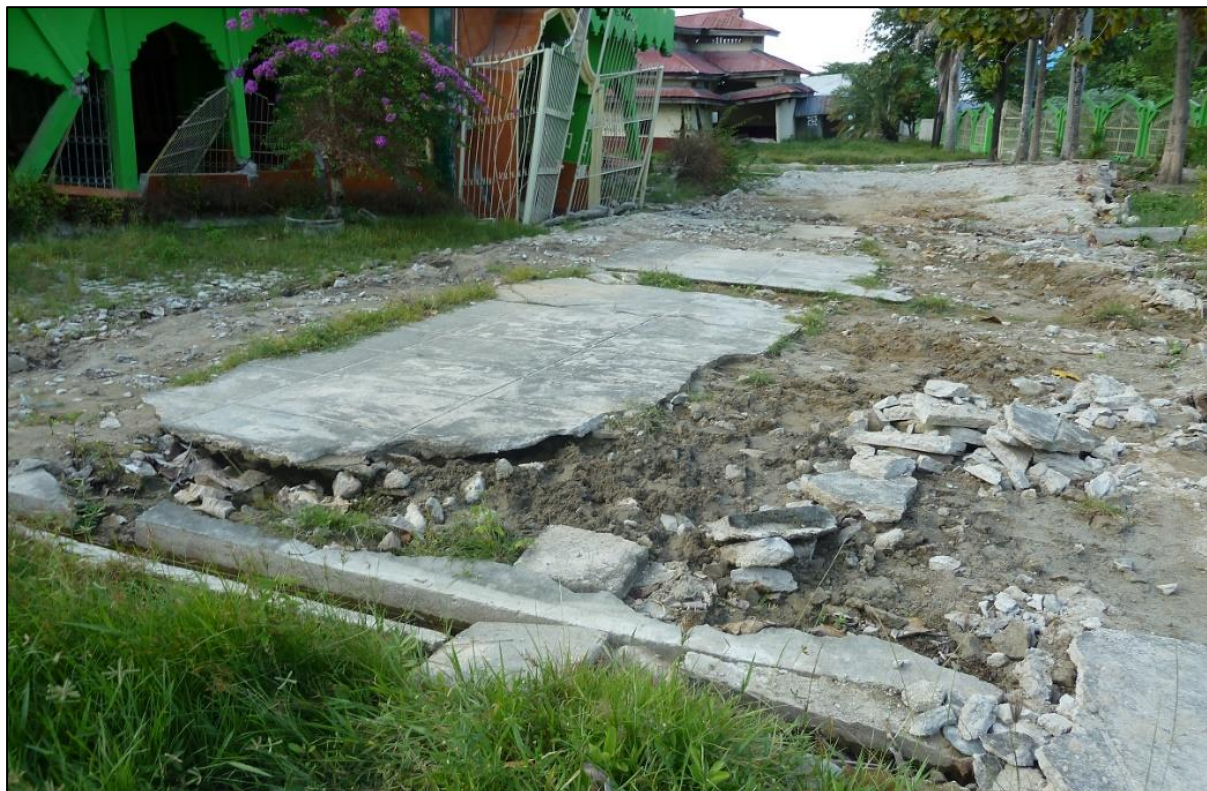
Figure 5.7 -. Masjid Iqra. Failure of garden paving above sandy soil, and ejecta in background.

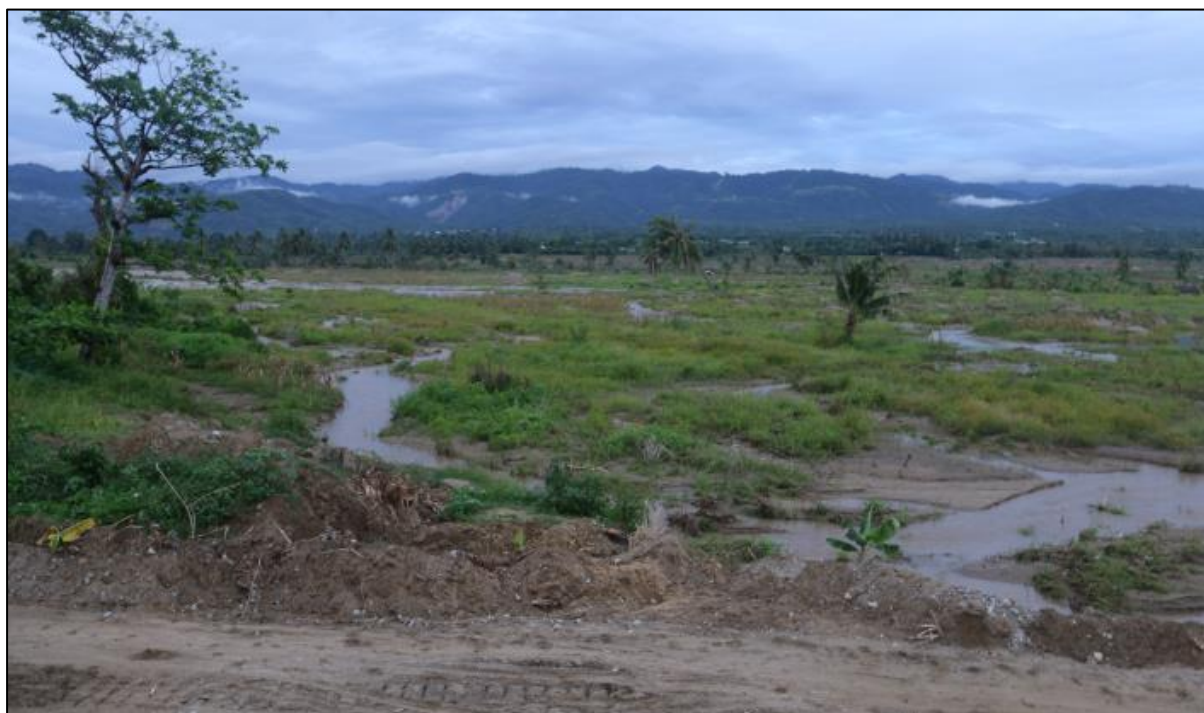
Figure 5.11 - Settlement and spreading cracks outside the town of Sigi

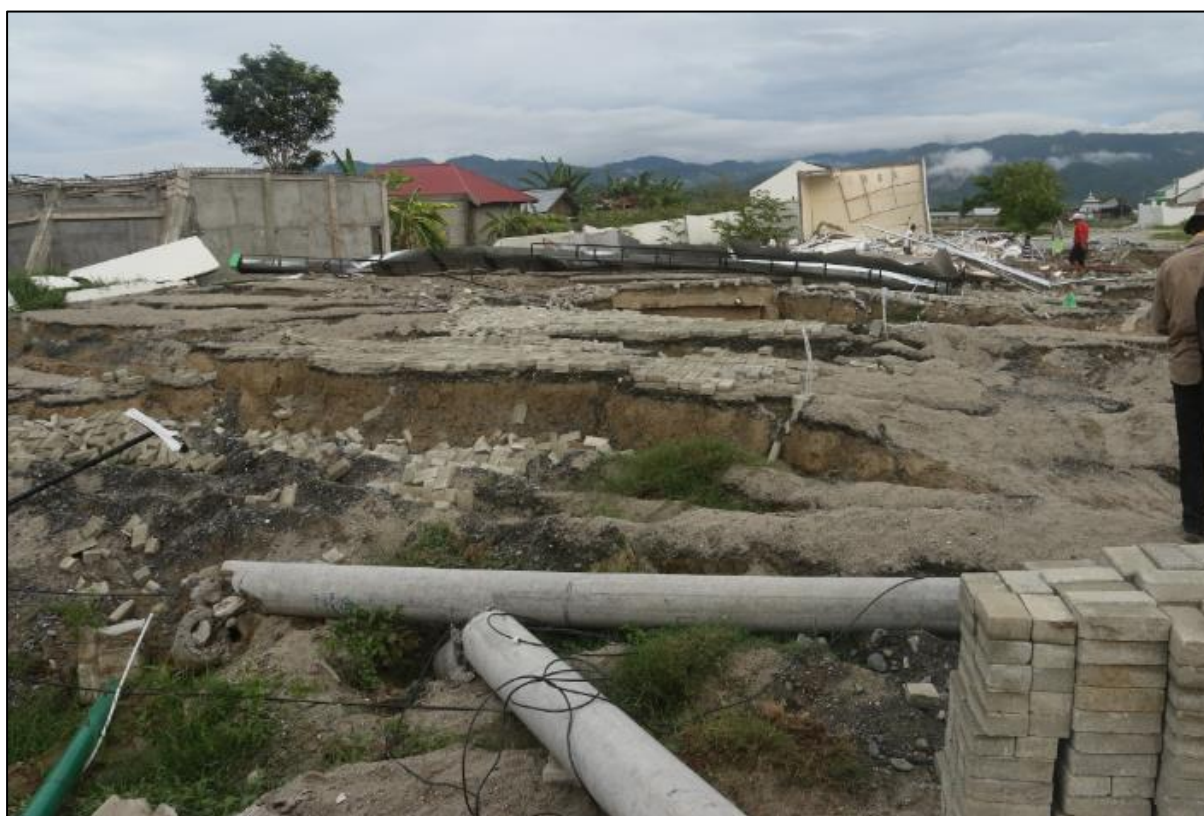
Figure 5.12 - Differential settlement and ground disturbance in Sigi. Pipework in foreground appears to be new rather than uplifted.

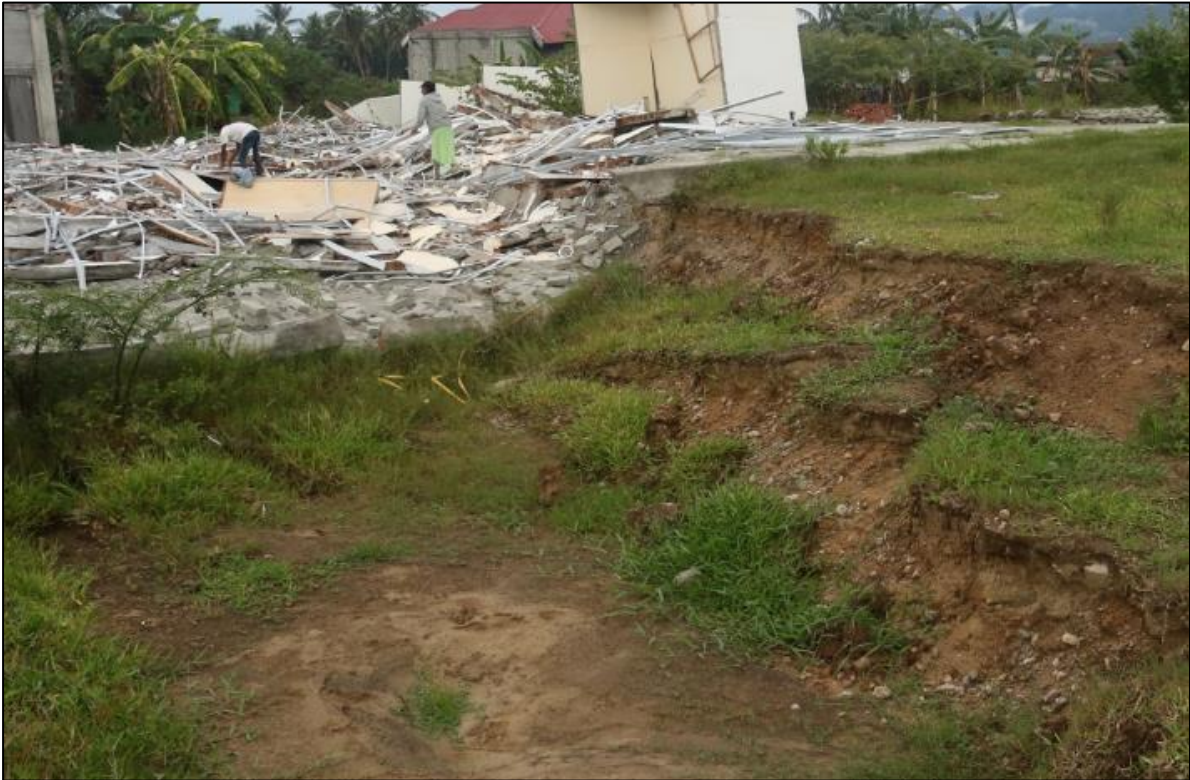
Figure 5.13 - Large settlements with sandy ejecta adjacent to relatively unaffected soil in Sigi.

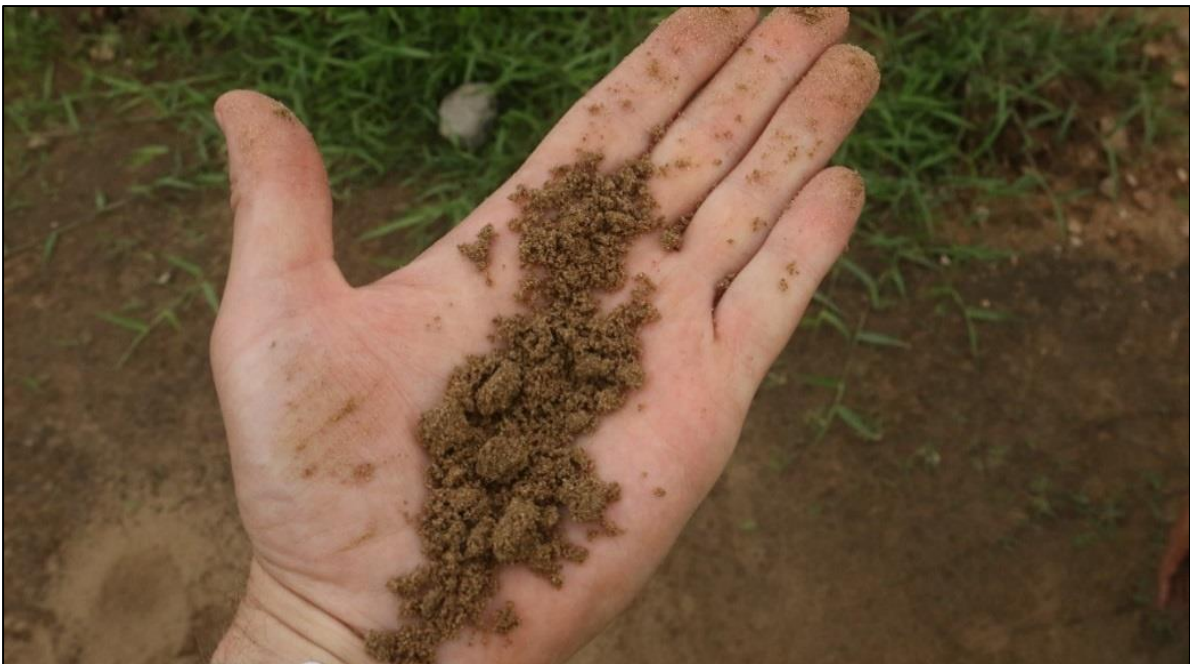
Figure 5.14 - Ejecta at Sigi. Uniform sand, in damp condition.

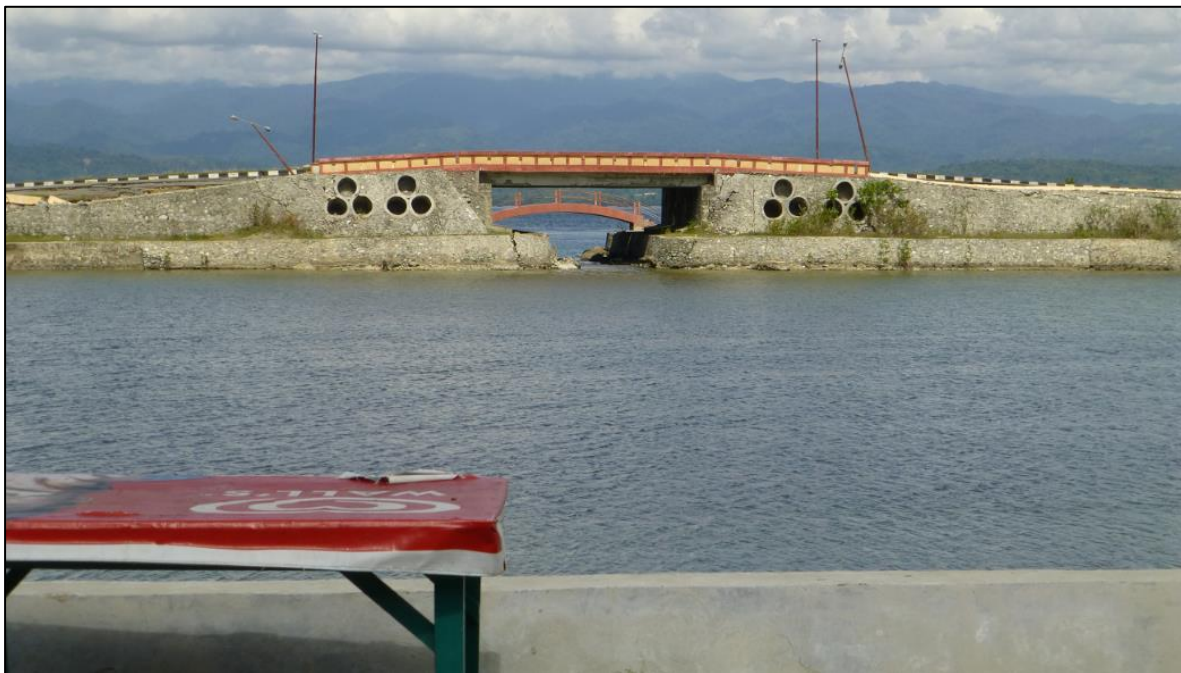
*Figure 5.16 - View across dolphin enclosure to sea road. Slight damage to bridge abutments consistent with soil displacements, though bridge remains operational.*

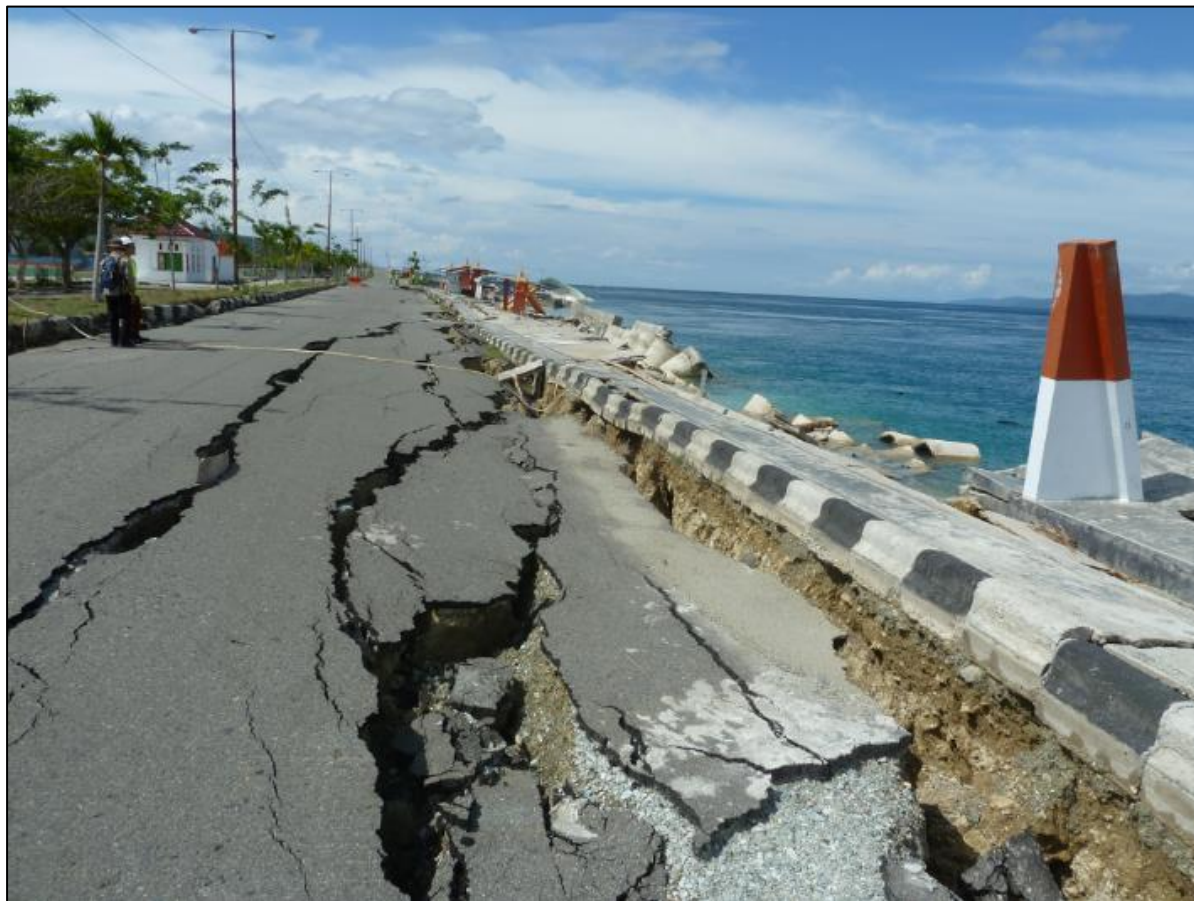
Figure 5.17 - Cracks parallel to coastline, consistent with lateral spreading of the ground.

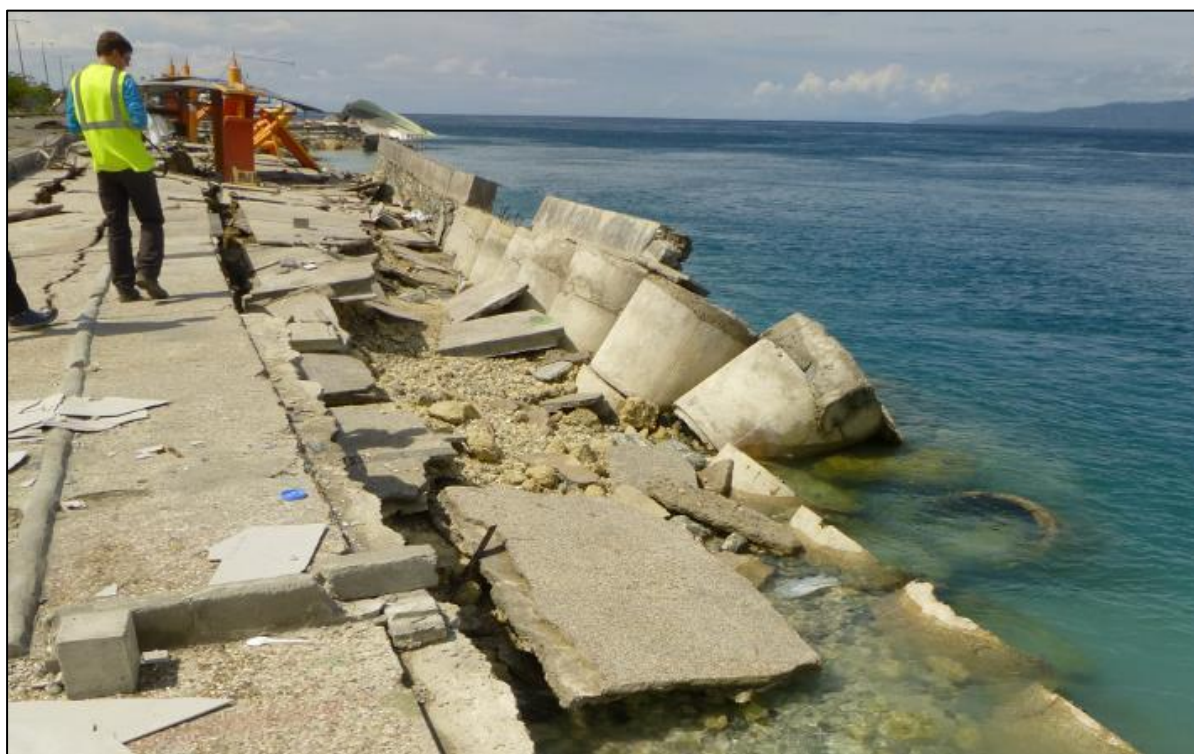
Figure 5.18 - Failure of piled sea wall at Donggala Koto Wisata

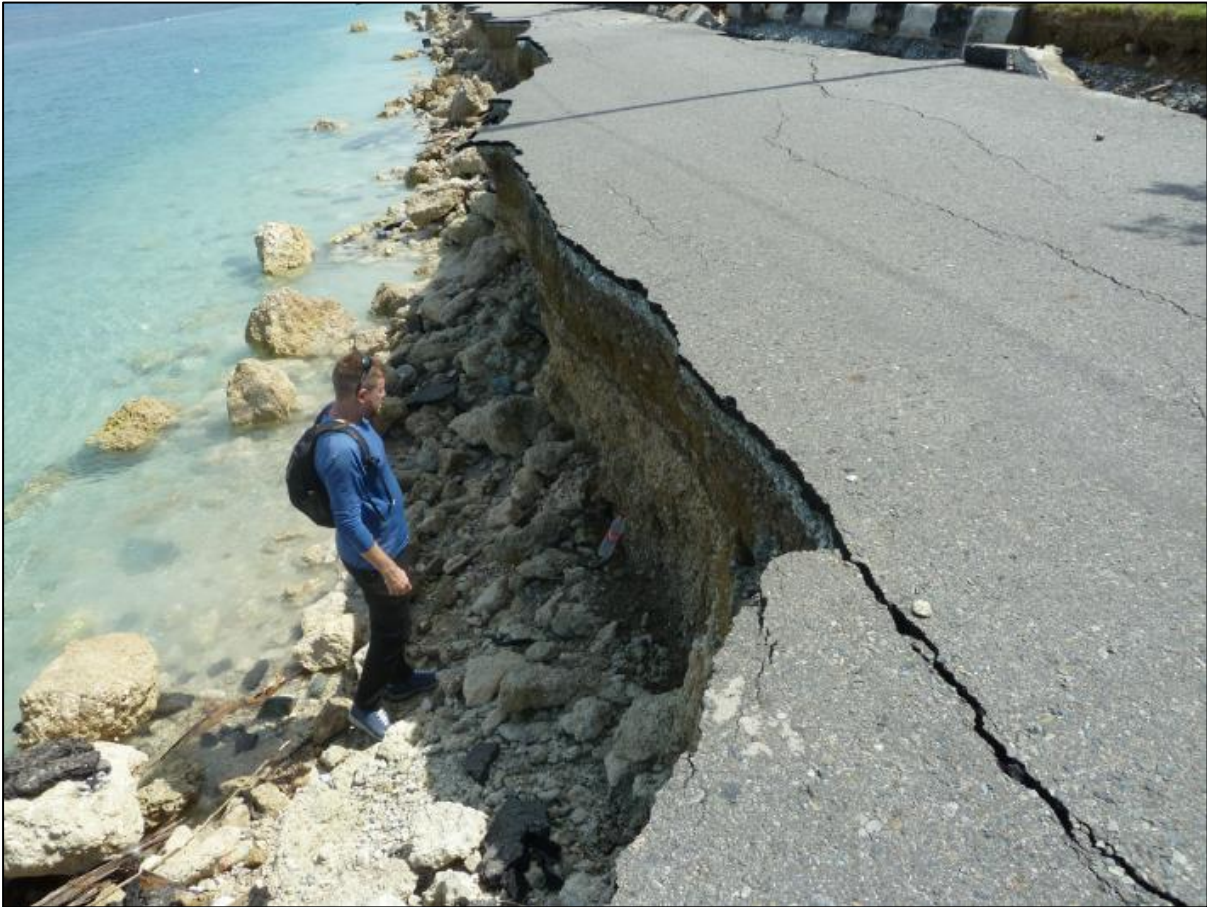
Figure 5.19.- Soil layers exposed by lateral spreading at Donggala Koto Wisata.

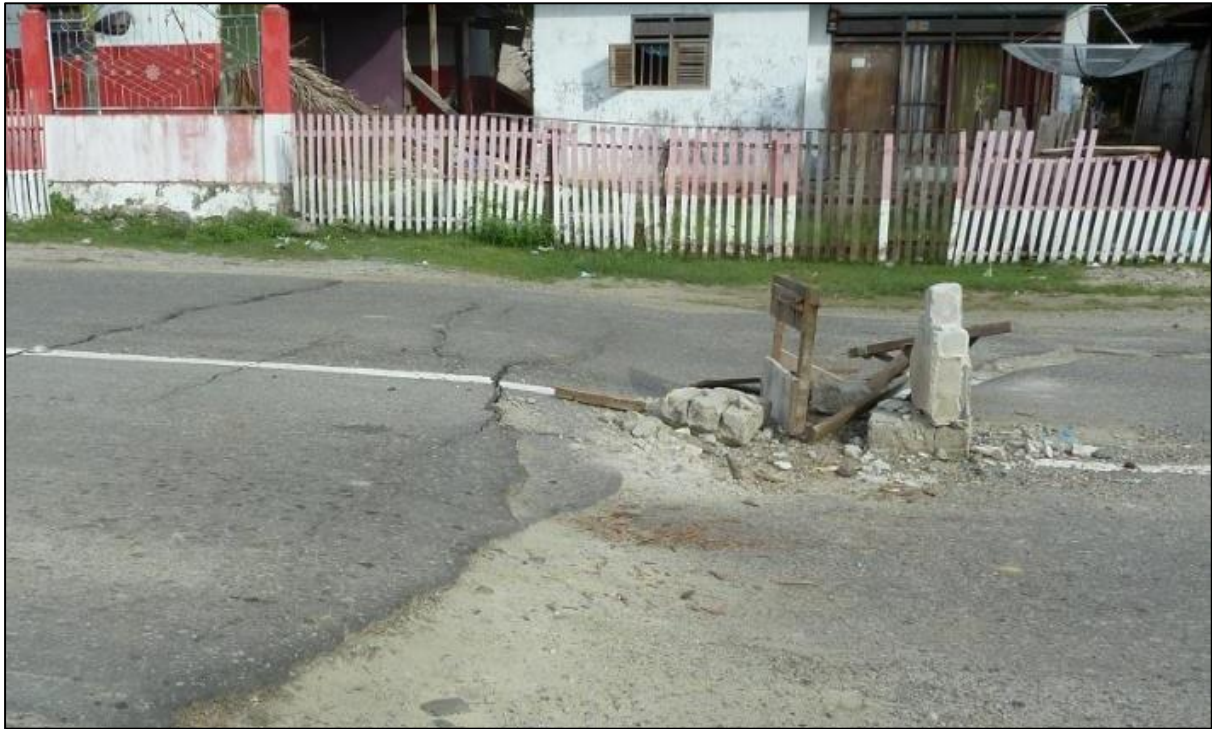
Figure 5.24 – Settlement in the road with sandy soil ejected through cracks.

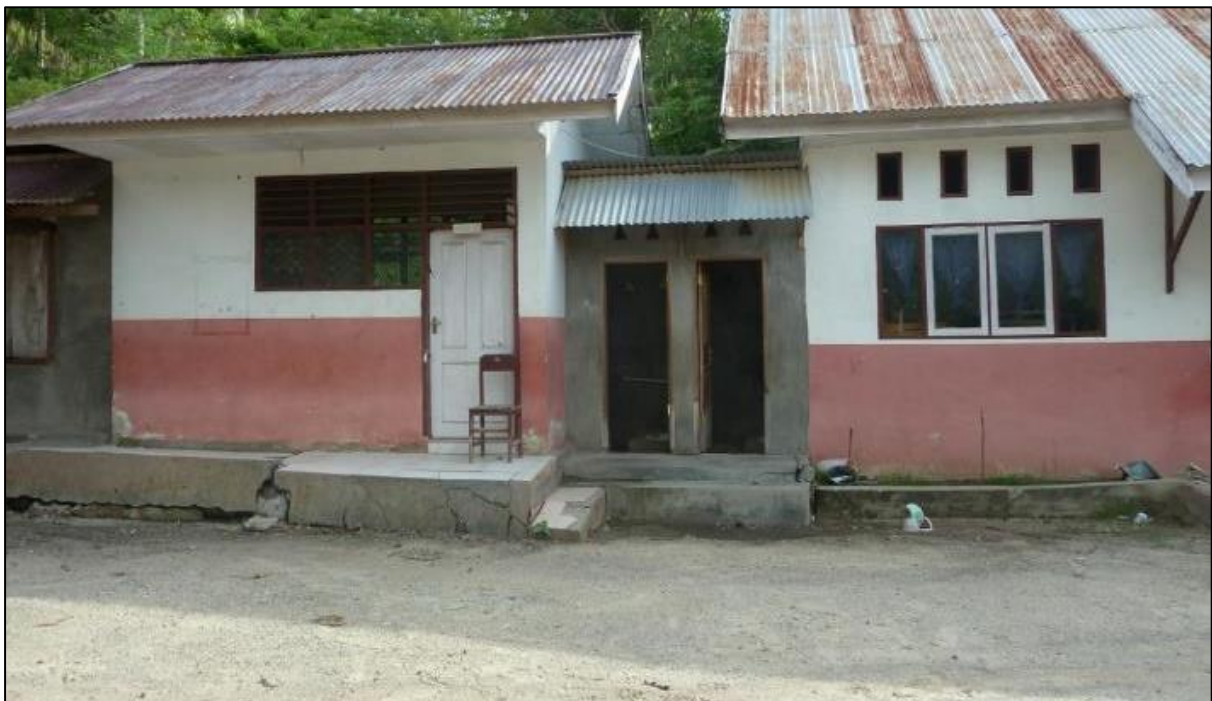
Figure 5.25 – Differential settlement of School in Lero, with liquefaction ejecta in the yard

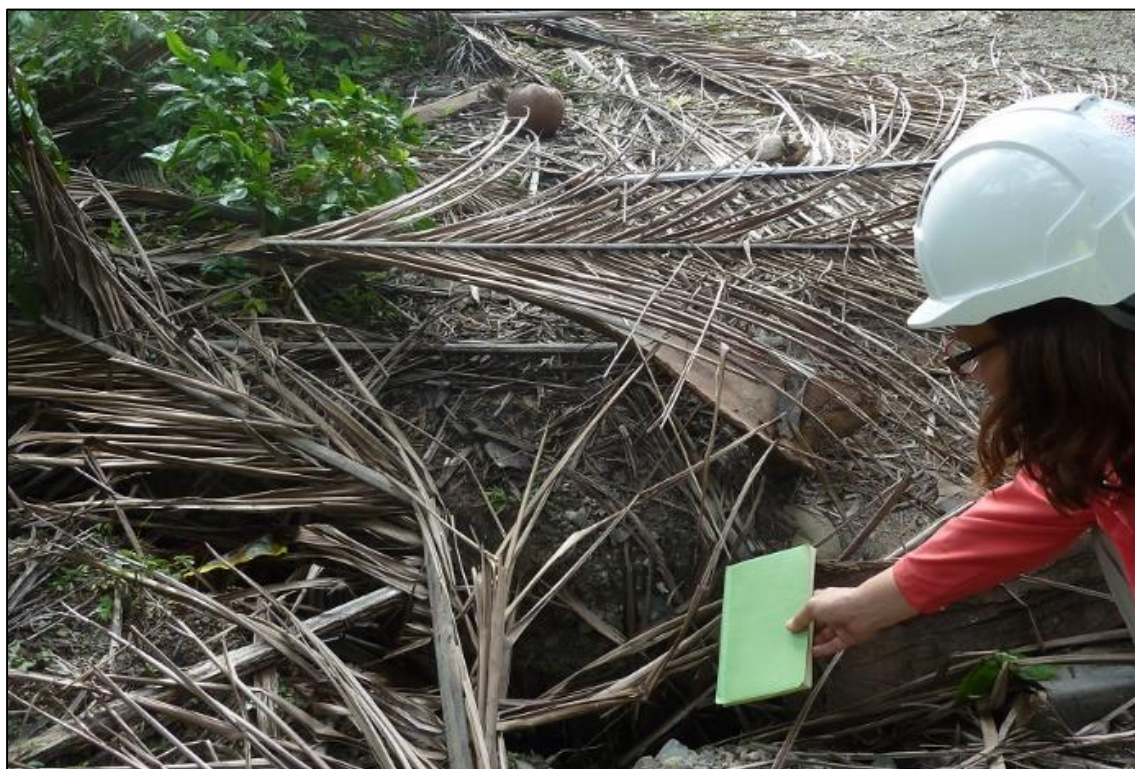
Figure 5.27 – Lero: Cracks observed parallel to shoreline consistent with lateral spreading.

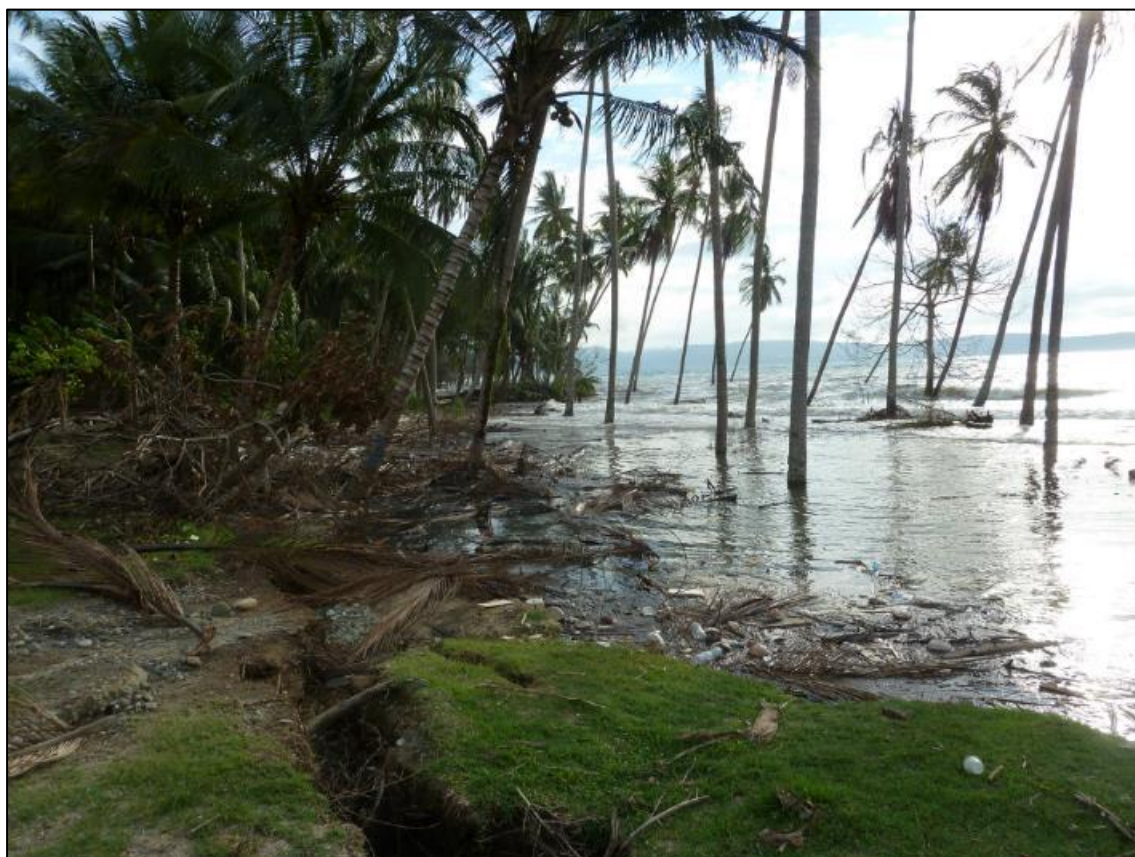
Figure 5.28 – Further cracks, and submerged land and palm trees, in Lero.

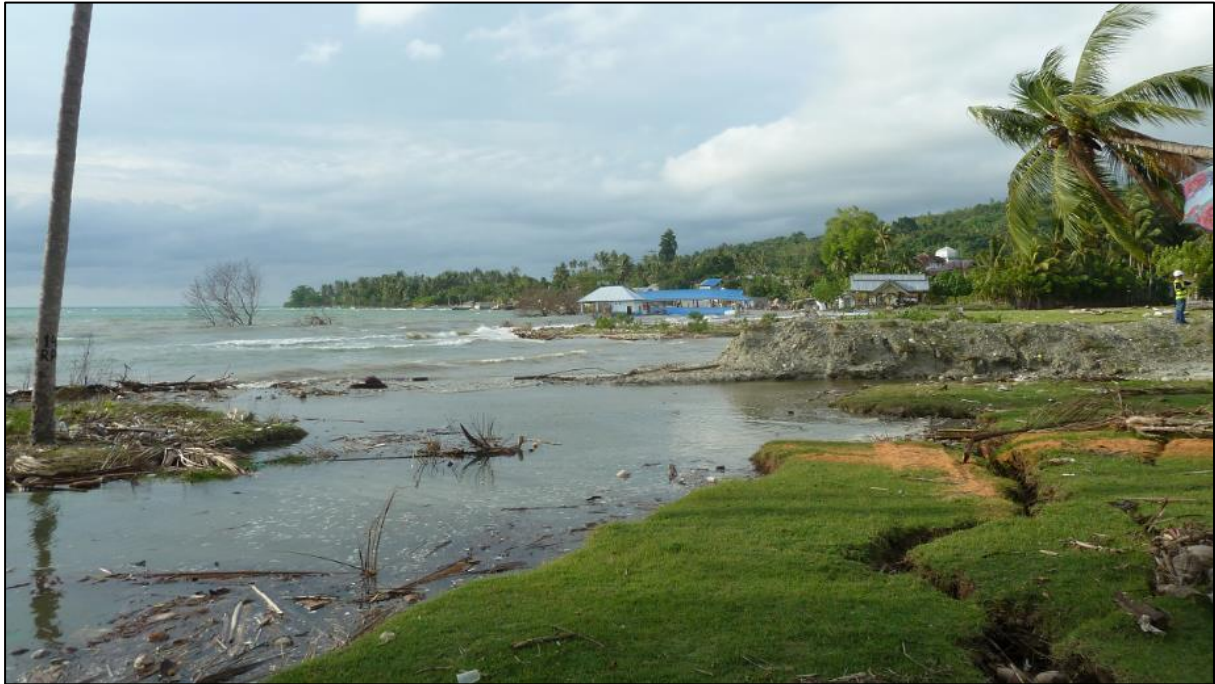
Figure 5.29 – More ground cracks at Lero, and view across the estuary towards a now submerged restaurant.

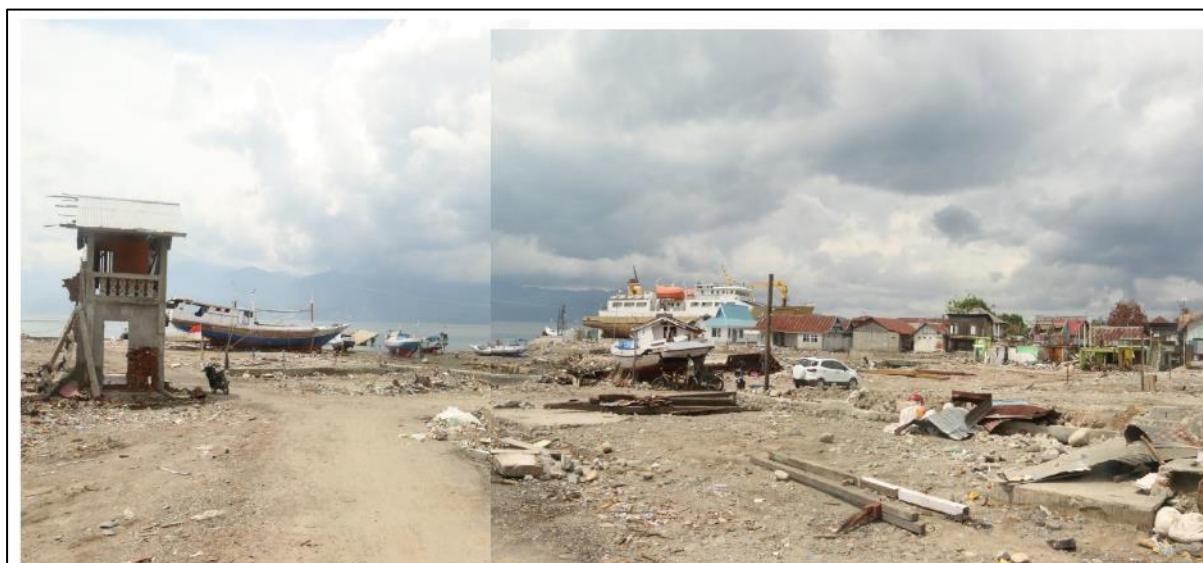
Figure 6.10 - Wani village on the east coast of Palu bay which experienced considerable damage

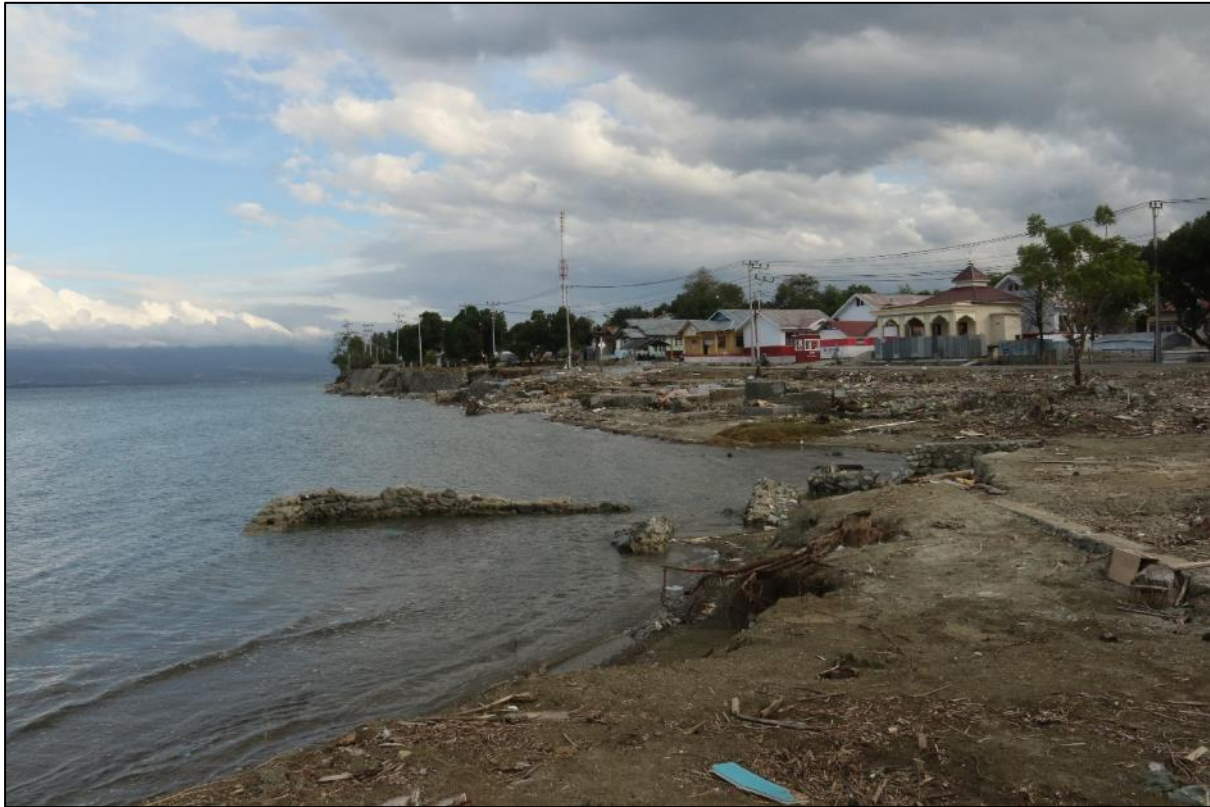
Figure 6.16 - Damage in Labuhan Bajo.

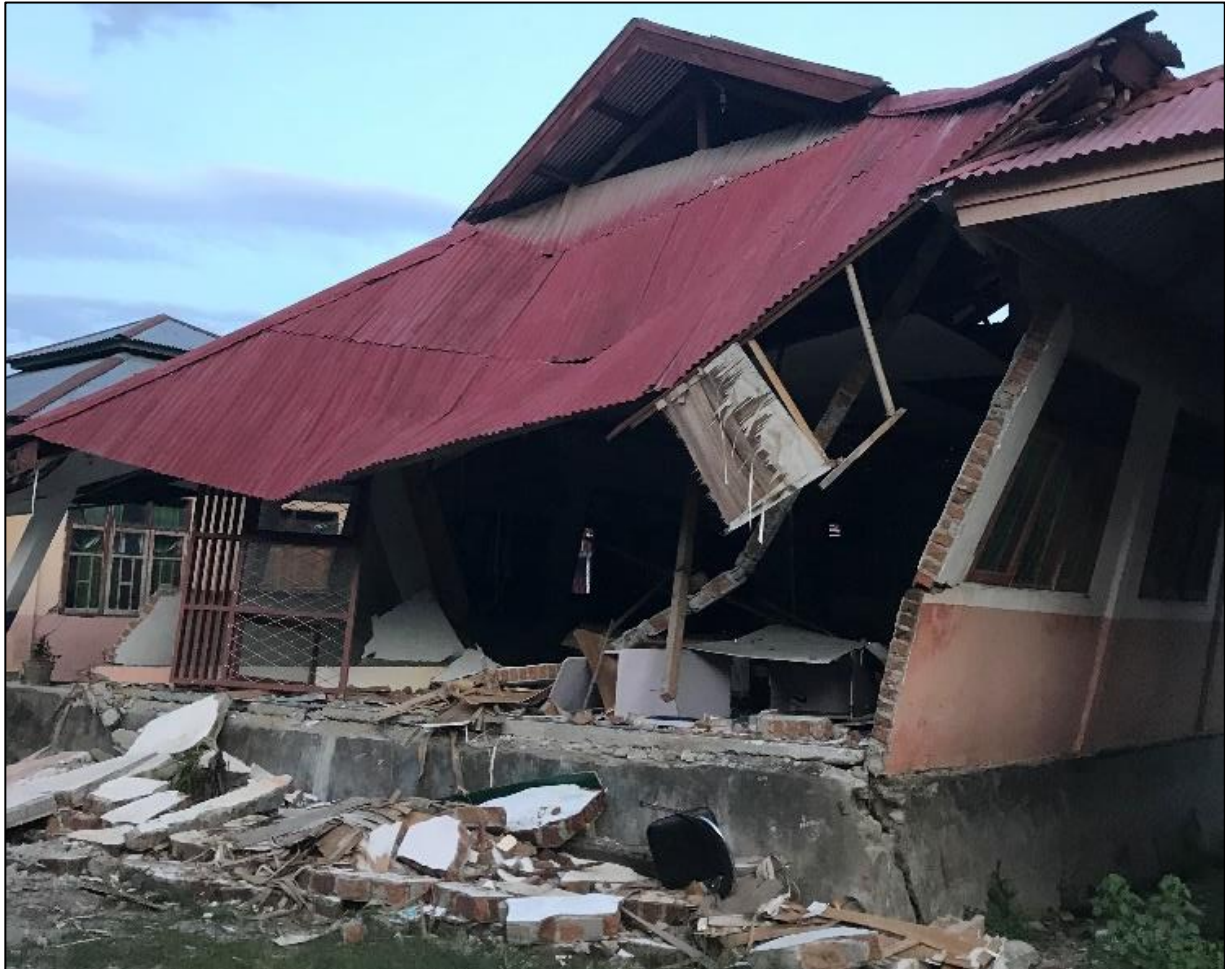
*Figure 7.25 - Collapse of a CM school building in SMP Negeri 1 Biromaru School, Sigi.*

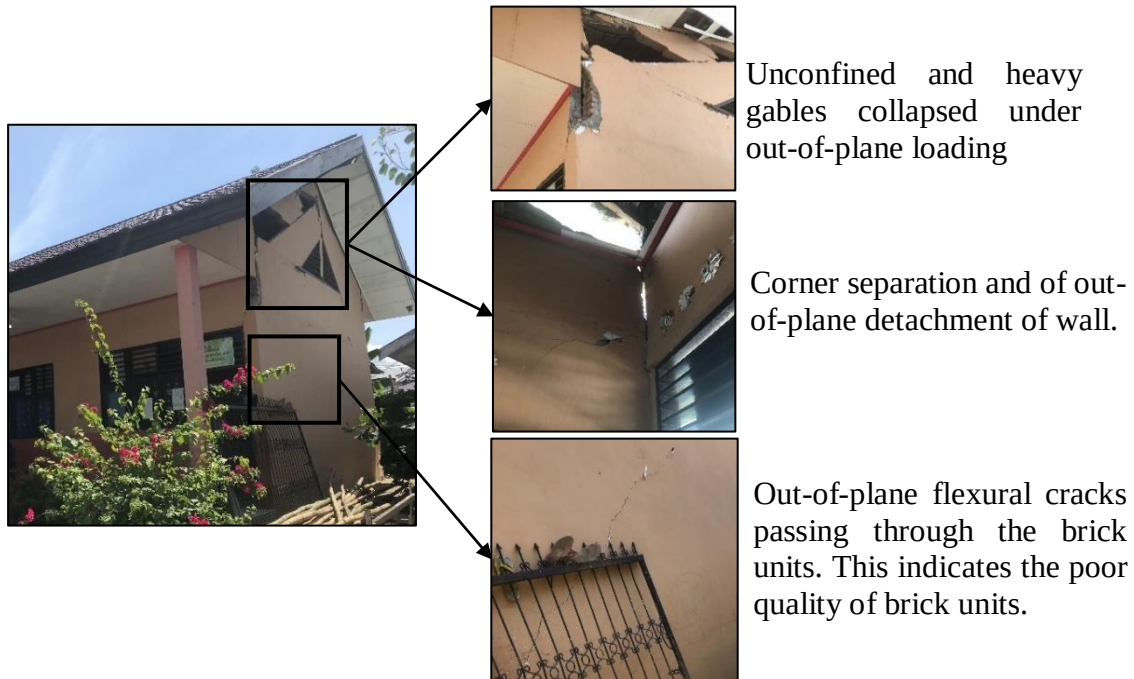
Figure 7.27 - Typical failure mechanisms observed in CM school buildings. Picture shows damage in building A at SD Inpres 1 Talise school.

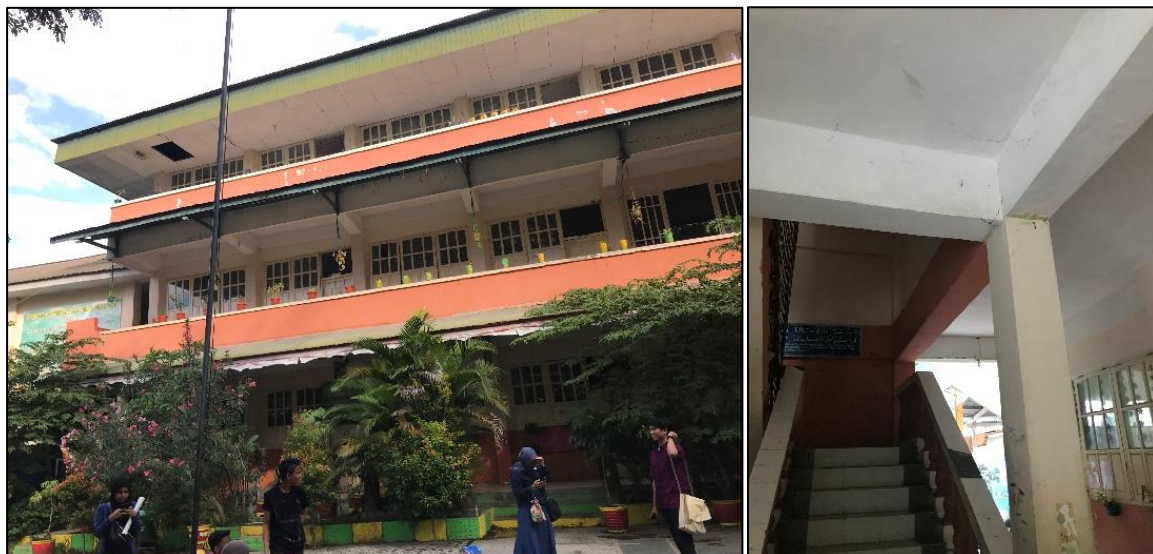
Figure 7.32 - MTS Alkhairaat Pusa Palu School. Left – 3-storey RC frame building that sustained minor damage to infill panels. Right – Typical sizes of beams and columns in RC frame schools.

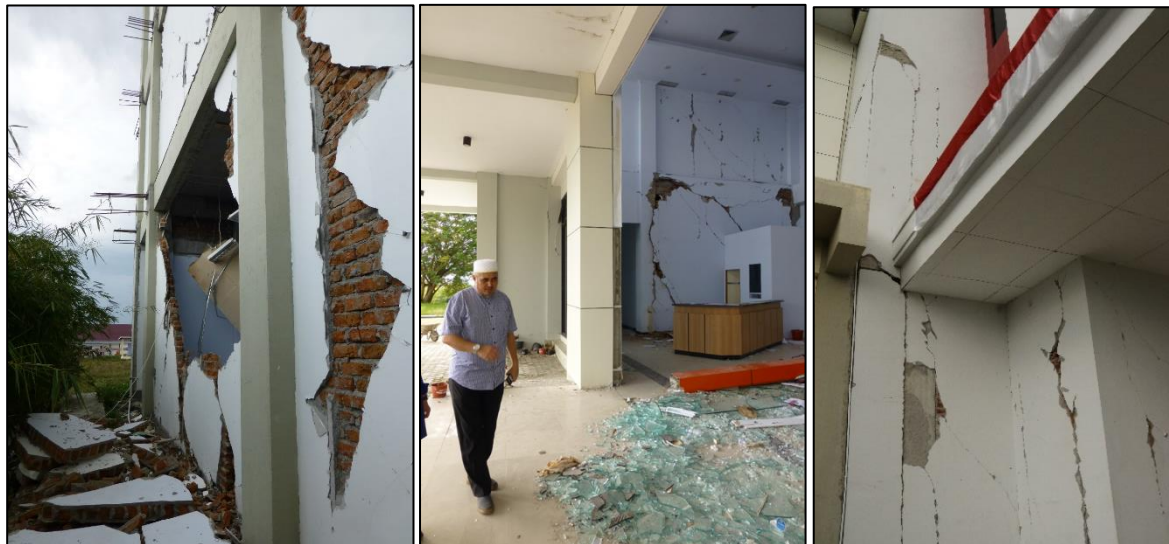
Figure 7.39 - Tadulako University Hospital Buildings: Left - Building A out-of-plane failure of infill walls (plane of walls is E-W). Middle - Damage to entrance and interior fittings of Building A. Right – Detail of damage due to pounding between Buildings A and B.
