# **The Central Sulawesi, Indonesia Earthquake and Tsunami of 28<sup>th</sup> September 2018 – A Field Report by EEFIT-TDMRC**

01/11/2019

Prof Tiziana Rossetto, EPICentre, University College London

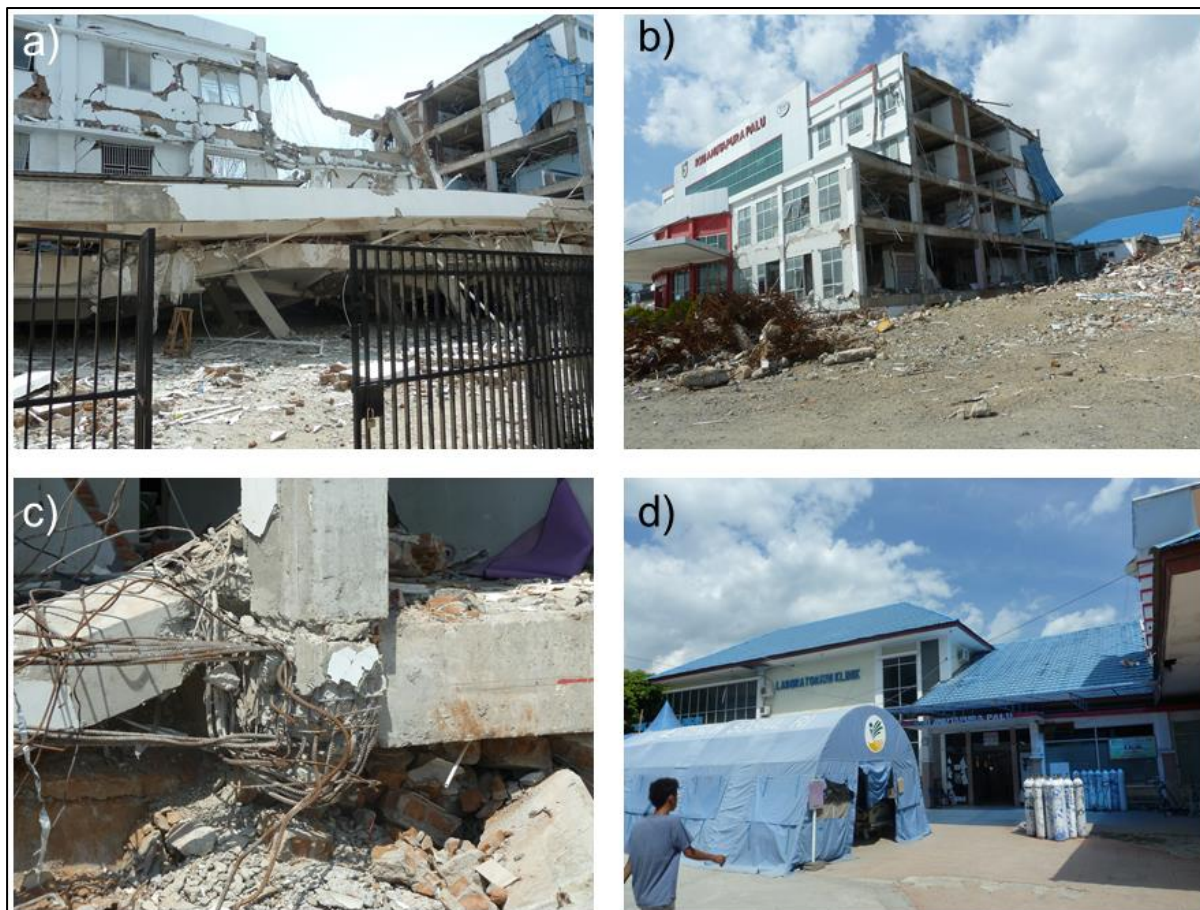
Figure 7.40 - Damage at Anutapura Hospital a) soft story collapse of four story RC frame structure; b) RC frame of remaining structure visible following removal of collapsed debris; c) column=beam joint reinforcement exposed in collapsed structure; d) low-rise hospital structures were relatively undamaged and remained operational.

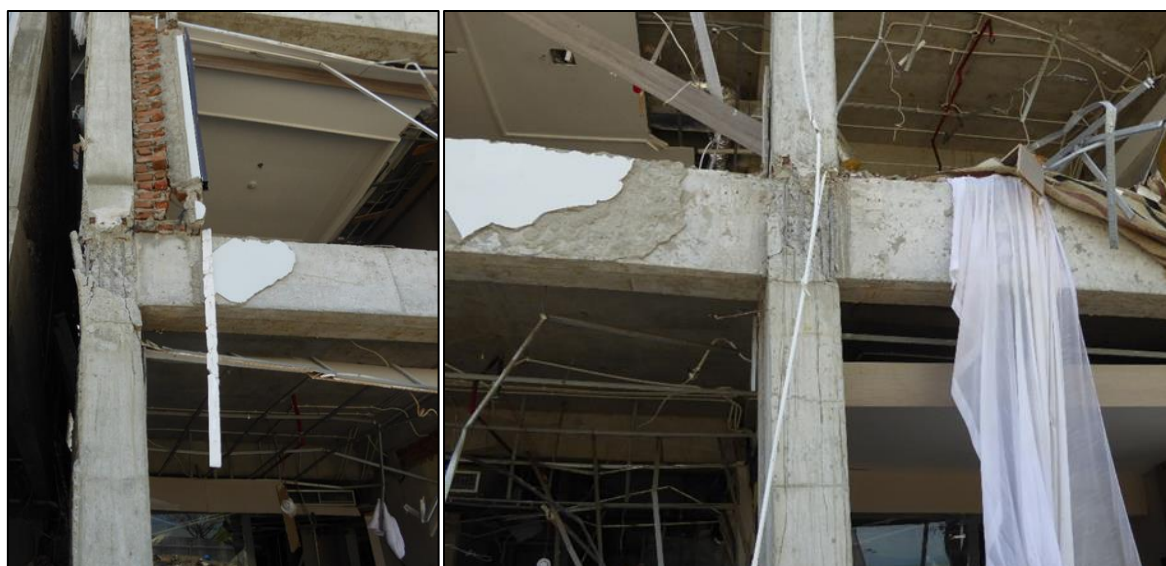
Figure 7.46 – Mercure Hotel – Images of cover spalling in RC frame joints in the second storey of the structure

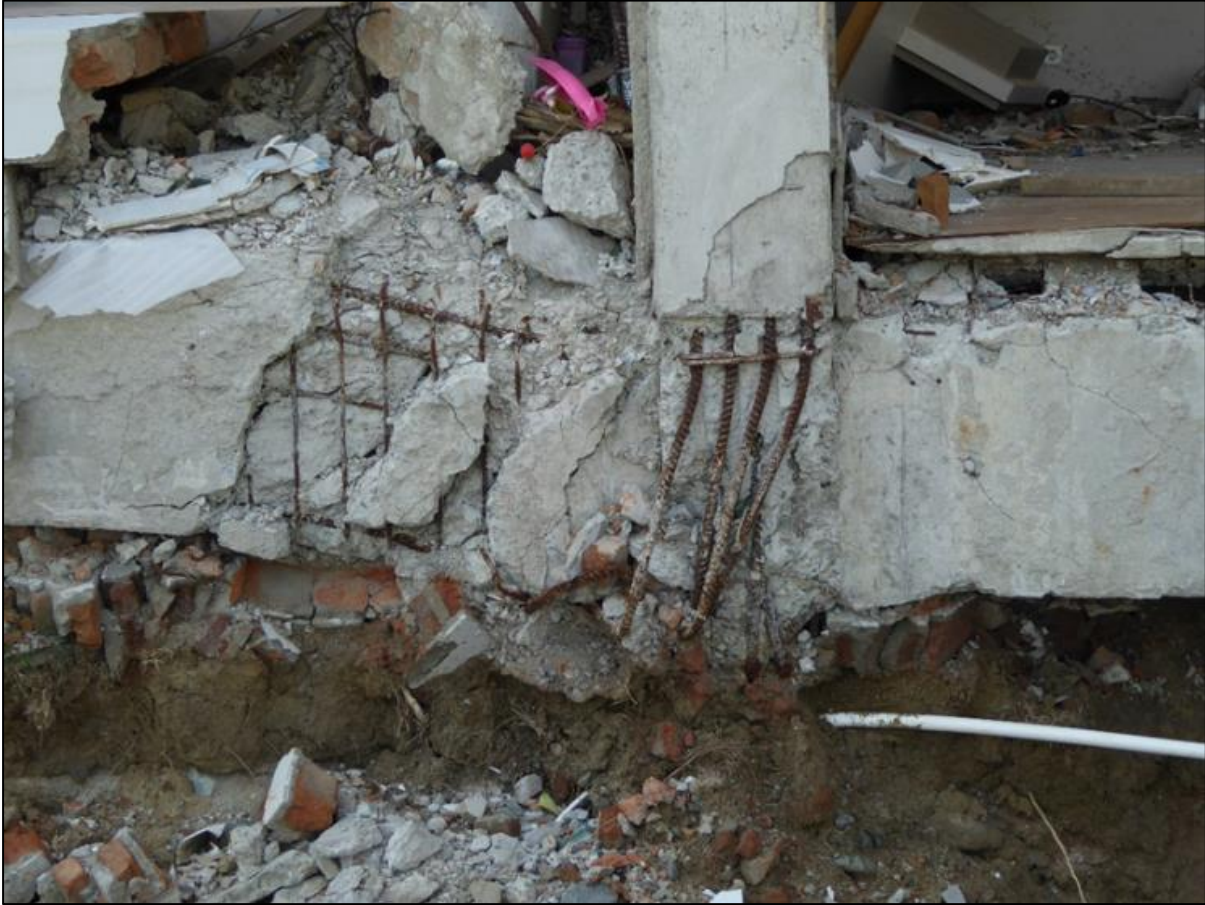
*Figure 7.47 – Mercure Hotel – Detail of a joint within the first floor of the building (now at ground level following soft-storey collapse of ground floor).*

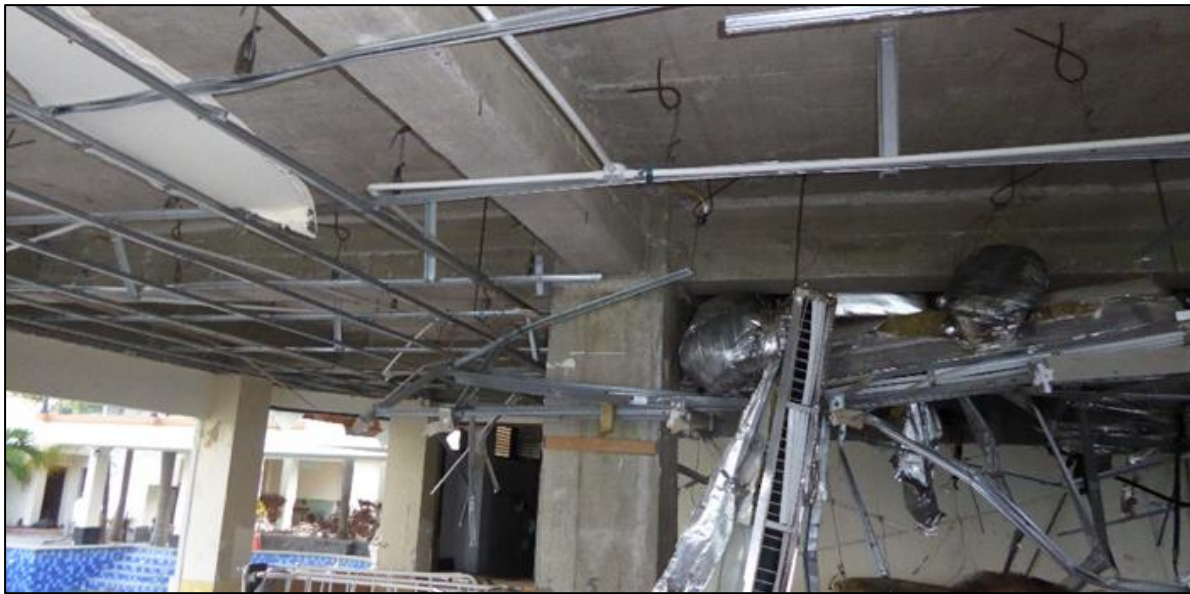
Figure 7.49 - Swiss Belhotel - damage to internal fittings at the ground storey of the shoreward side of the hotel. No structural damage observed in the main RC structure.

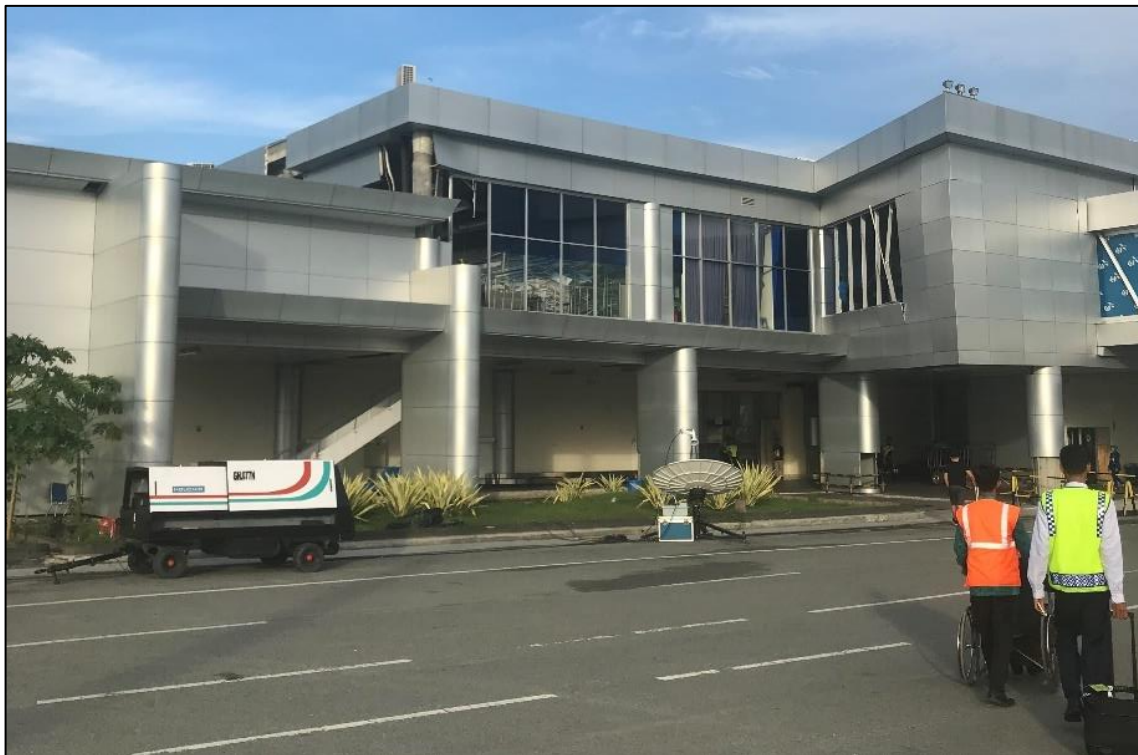
Figure 7.50 - View of Palu Airport passenger building from the runway. Damage to the infill walls at the ground floor is observed. A stack of fallen ceiling cladding can be seen in upper storey window.

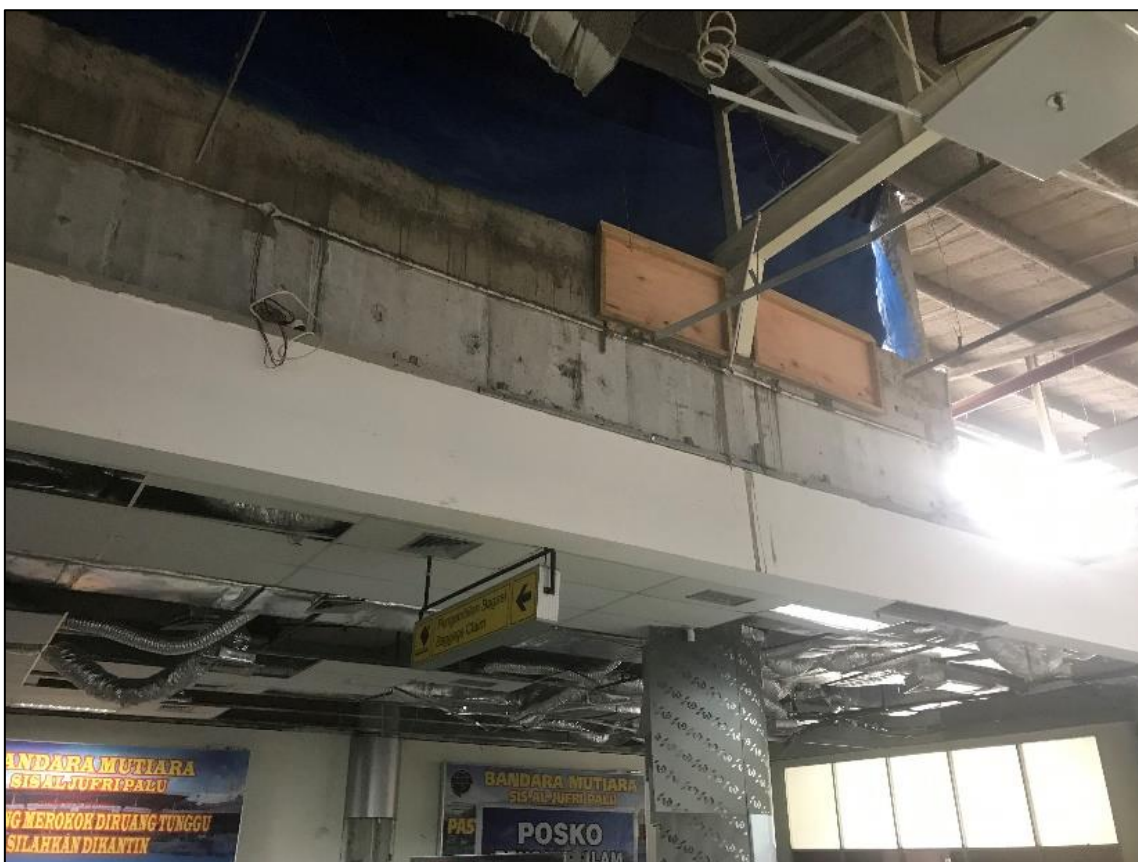
Figure 7.51 - Picture of missing ceiling cladding and damaged fixtures, inside Palu Airport passenger building.

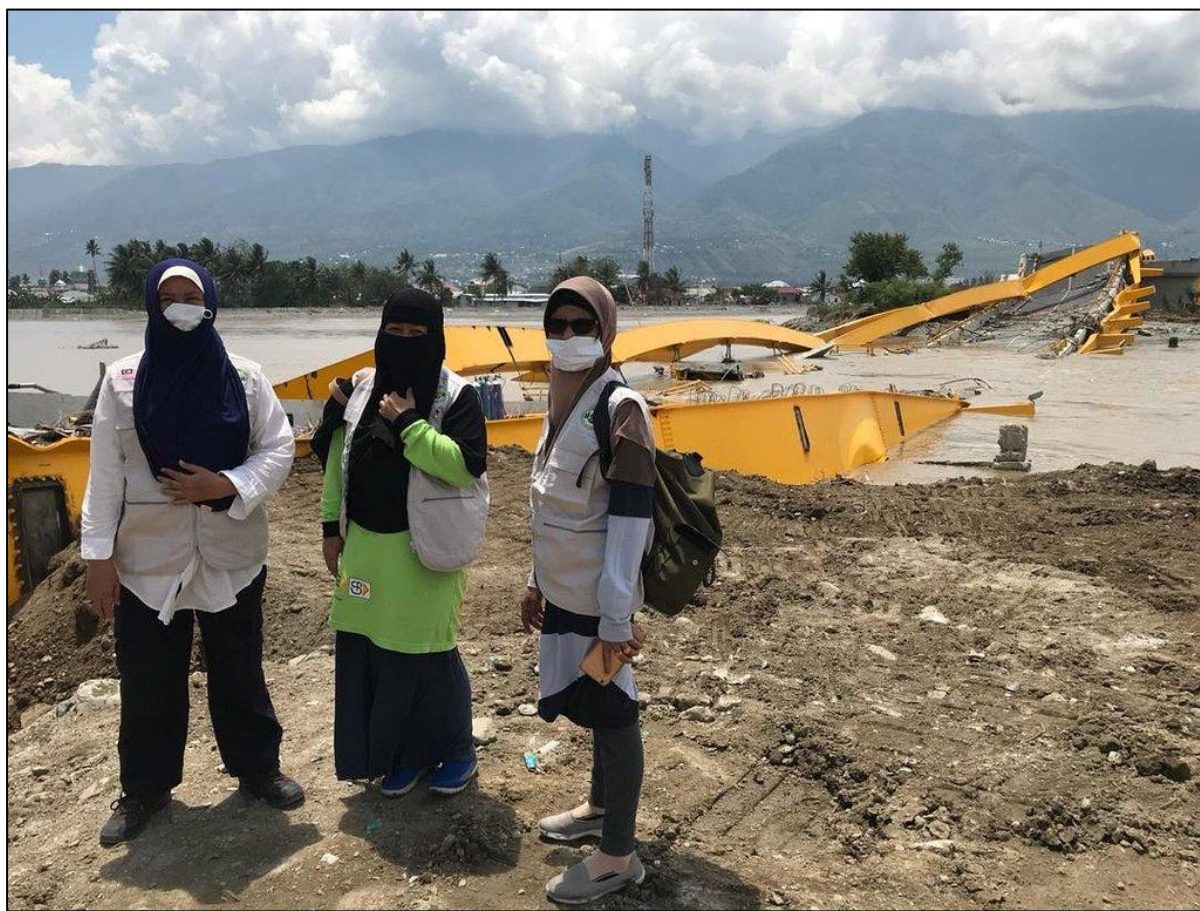
Figure 7.53 - Picture of Ponulele bridge showing the failed deck. Source: Tripadvisor.

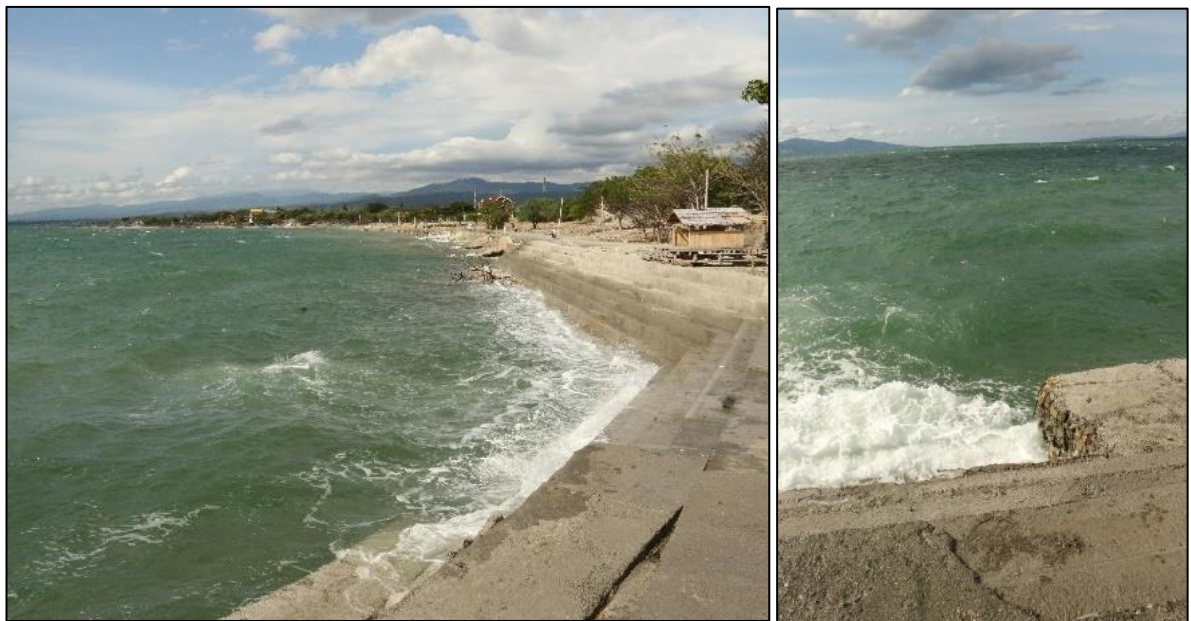
Figure 7.56 - Stepped revetment South of Mamboro missing its crest.

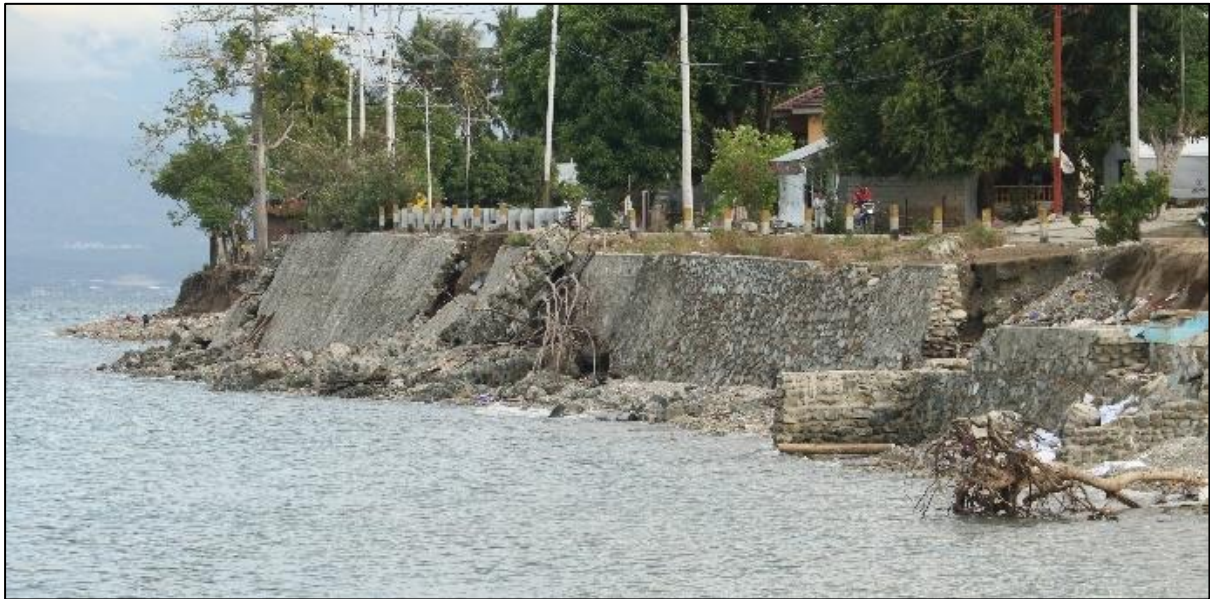
Figure 7.57 - Damaged masonry seawall just to the south of Tasiburi

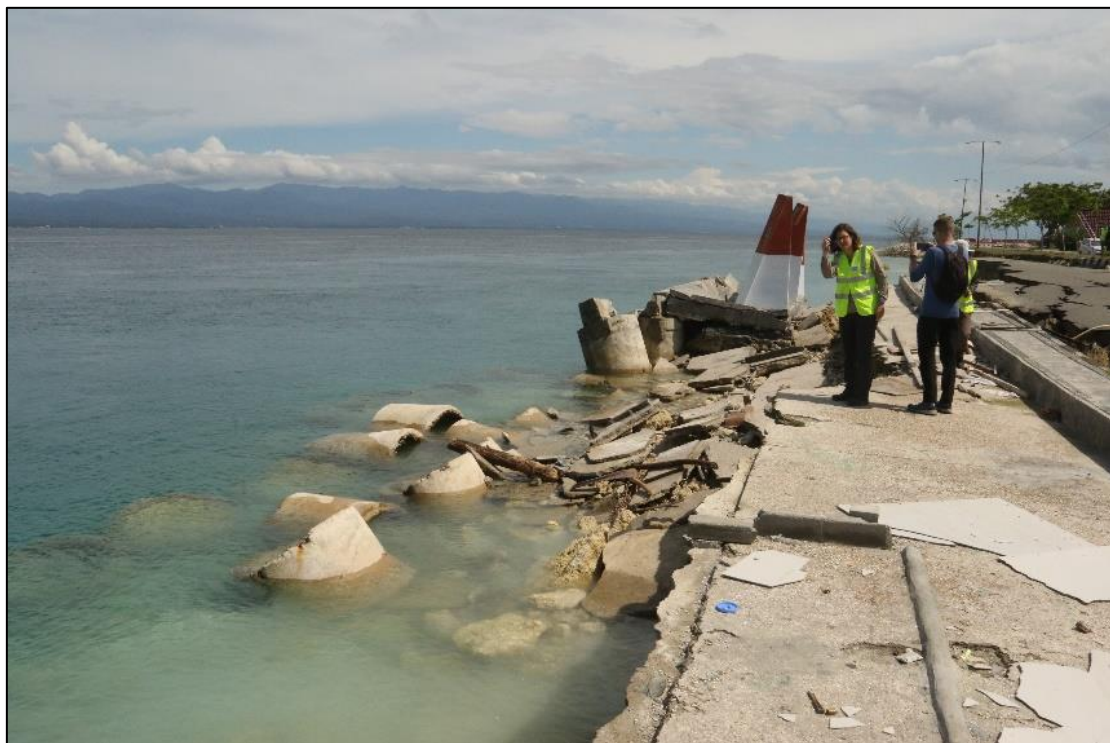
Figure 7.58 - Collapse of quay wall at ‘Dolphin Park’ at Donggala Koto Wisata.

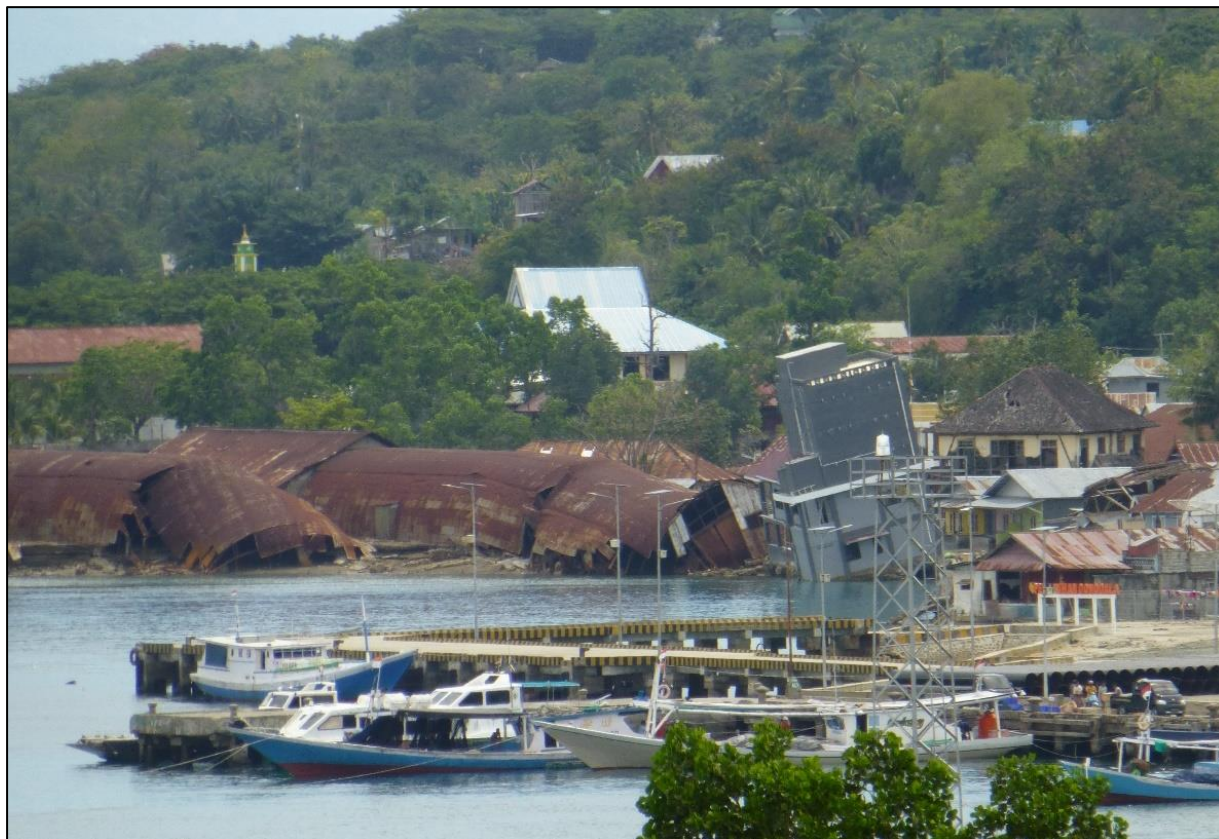
Figure 7.59 - Damage to old port of Donggala

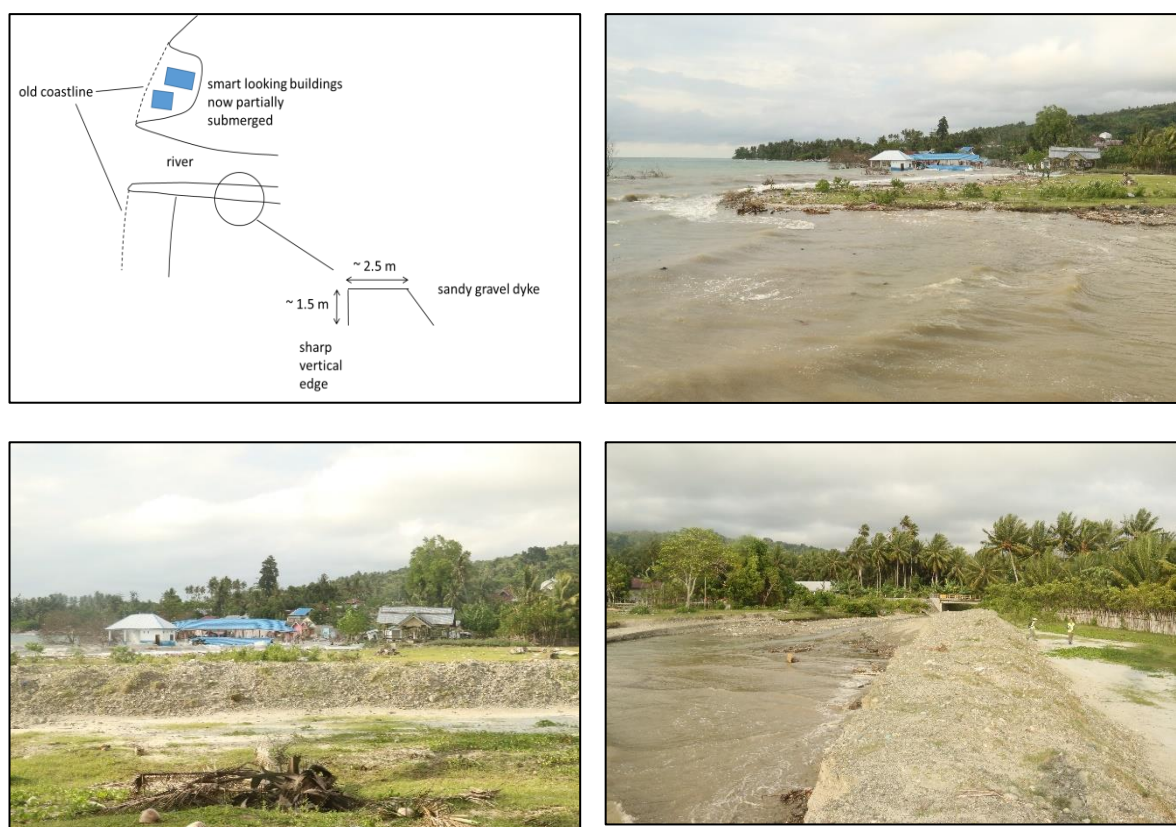
Figure 7.62 - River wall and surroundings at Lero. Top left - Schematic layout of site. Top right - River mouth. Bottom left - Landward side of river wall. Bottom right - Sheared face of river wall.
