# THE 1989 NEWCASTLE AUSTRALIAN EARTHQUAKE

## A FIELD REPORT BY EEFIT

MARCH 1991

**J. W. Pappin**

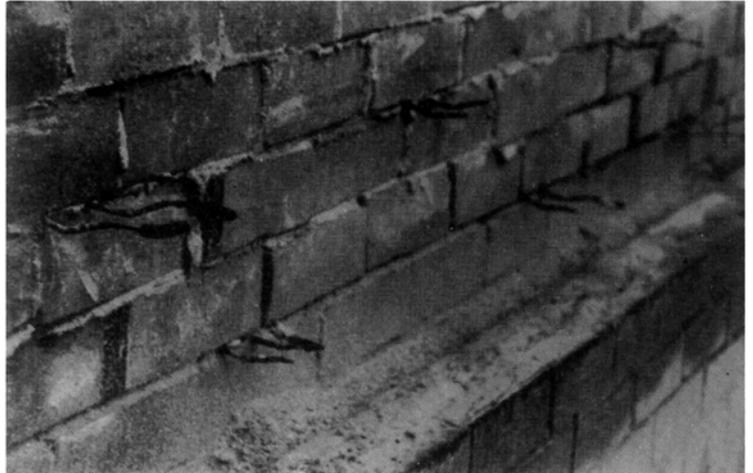
PLATE 5.2 *Corroded ties in cavity brick masonry wall construction (location 18)*

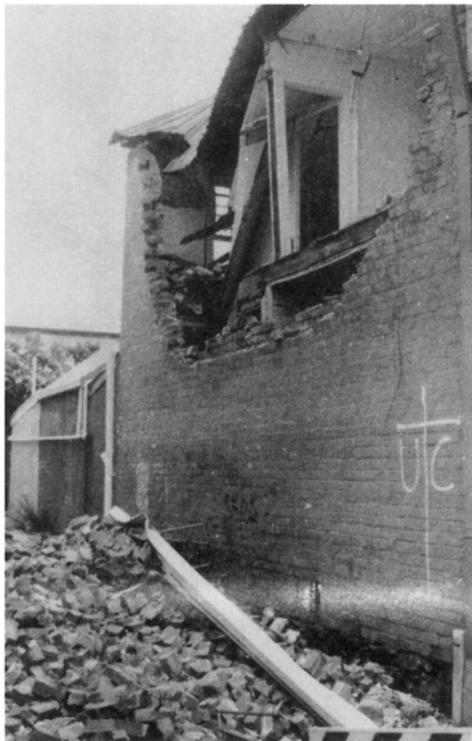
PLATE 5.3 *Collapse above first floor level of solid double unreinforced brick masonry wall (location 25)*

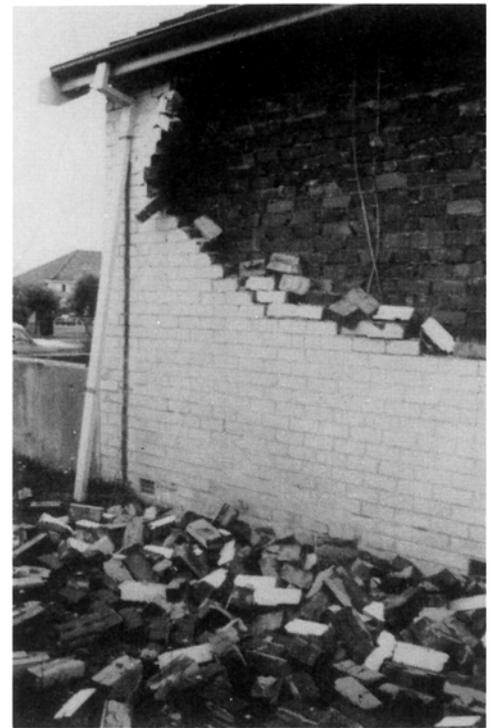
*PLATE 5.6 Outer skin cavity wall failure in older residential brick masonry building (location 4)*

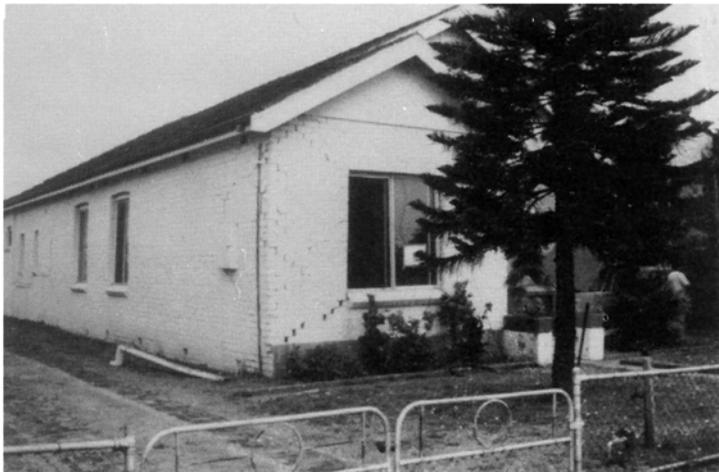
*PLATE 5.7 Diagonal shear cracking near corners of brick masonry dwelling (location 4)*

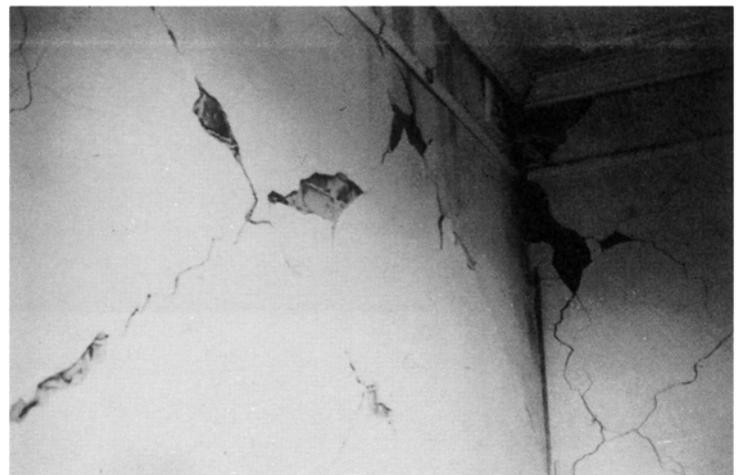
*PLATE 5.8 Cracking of internal load-bearing walling in single-storey brick*

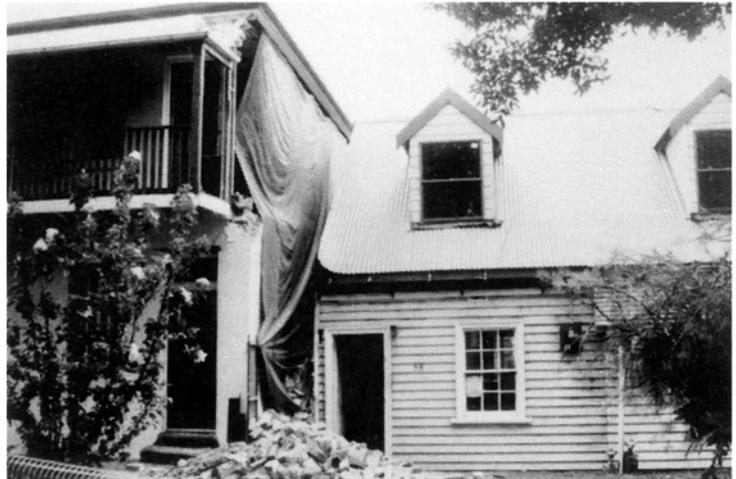
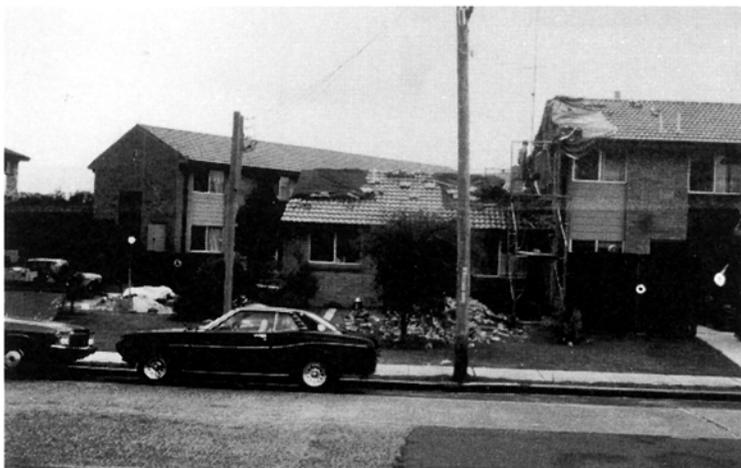
PLATE 5.10 *Secondary damage to buildings on right occurred due to side wall collapse in the left-hand building (location 23)*

PLATE 5.11 *Secondary damage to roofing due to chimney and side wall collapse in an adjacent building (location 37)*

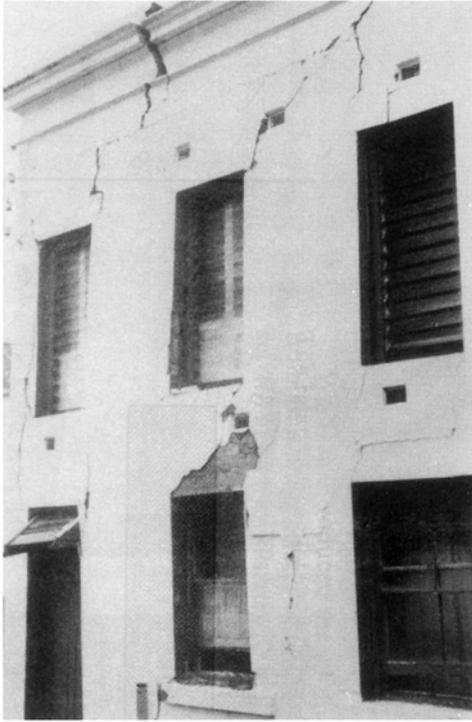
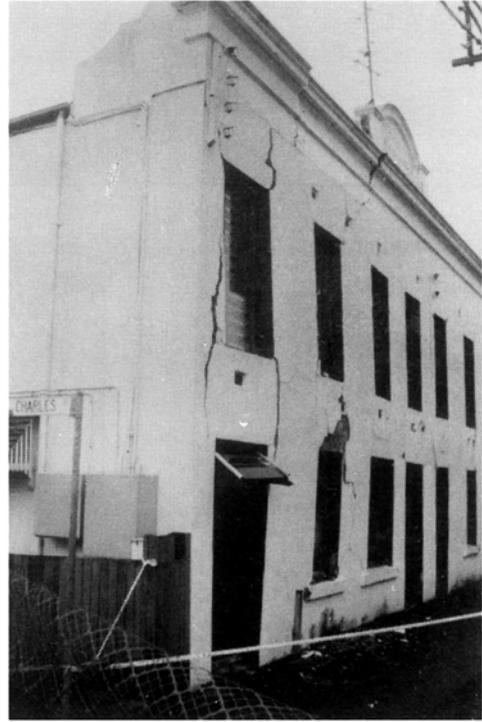
PLATES 5.12 and 5.13 *Cracking and leaning of parapets and facades in an older two storey brick masonry building (location 24)*

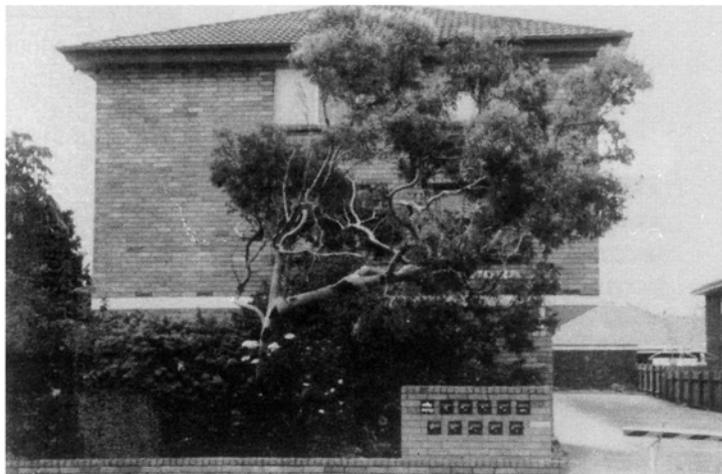
Modern masonry buildings were generally less heavily damaged, although poor design features resulted in some cases of failure. An example of this is shown in Plates 5.14 and 5.15. This three-storey apartment building in The Junction area of Newcastle has a pronounced lack of stiffness at the ground floor level on one side (to the right in Plate 5.14) due to the garage entrances (Plate 5.15). In contrast, access at the rear of the building to the first and second floor apartments is via stairwells sited close to the rear facade, and consequently there is a high longitudinal stiffness in the direction of the photograph shown in Plate 5.14 (left hand side). As a result, the earthquake loading was transferred almost completely to the walls and stairwells at the rear entrances to the building (Plates 5.16, 5.17), resulting in wide cracking of the unreinforced brickwork, especially near corners, doors and window openings. This building was evacuated following the earthquake, pending a decision on whether or not repair of the damage could be effected.

PLATE 5.14 *Modern three storey unreinforced brick masonry apartment building with severe damage to left side-wall (see PLATES 5.16, 5.17) (location 40)*

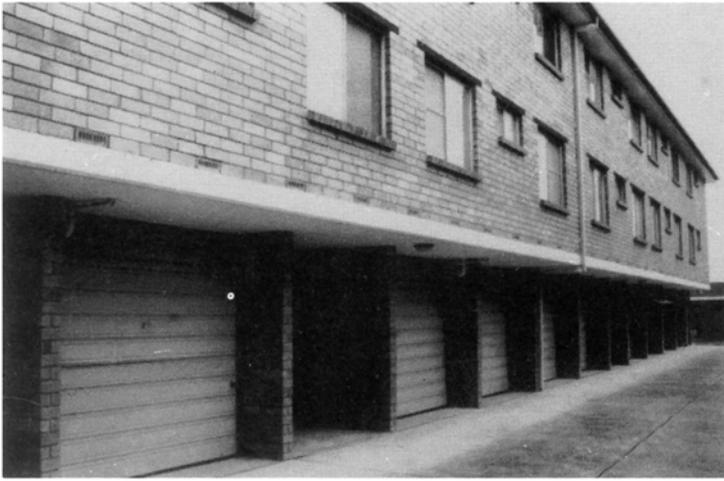
PLATE 5.15 *Ground floor garage entrances to three storey apartment building shown in PLATE 5.14. Damage to opposite side wall is shown below*

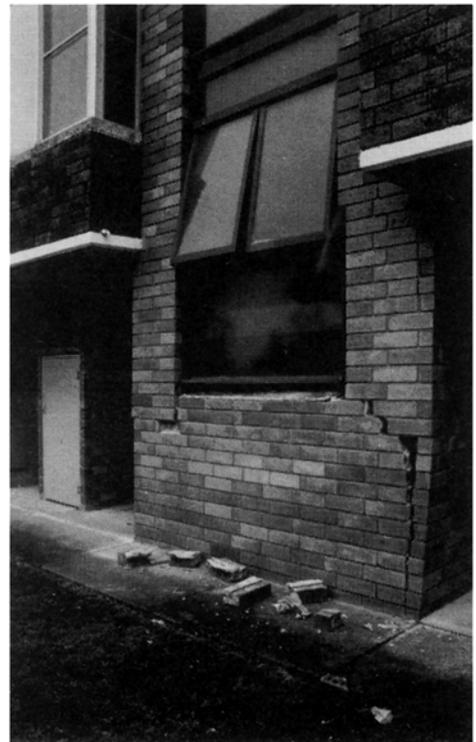
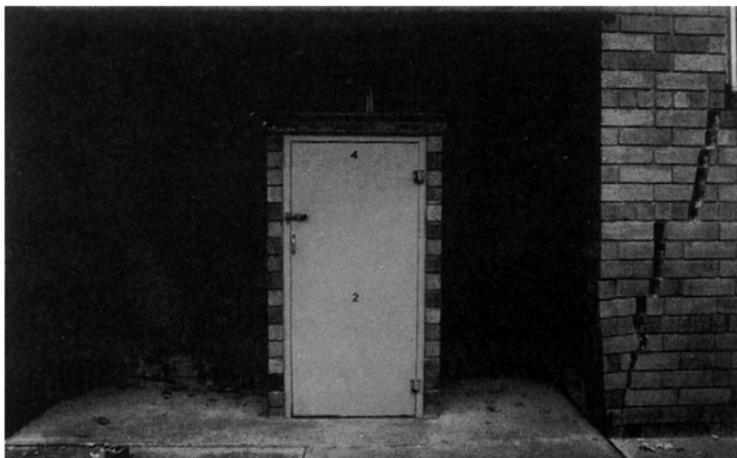
PLATES 5.16 and 5.17 *Severe cracking in unreinforced brickwork near corners, doors and window openings at first storey level of the building shown in PLATES 5.14 and 5.15*

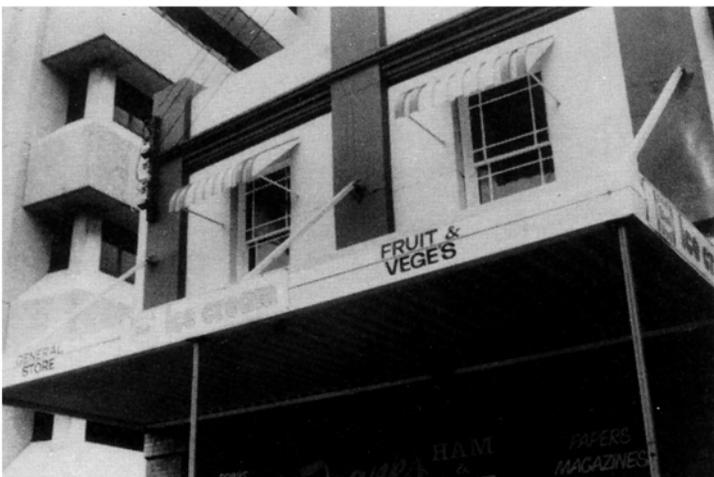
A significant contributory factor to failures of building facades was the presence of awnings in the front of shops, hotels, theatres and so forth. (Plates 5.34, 5.35). Originally, such buildings had balconies or awnings supported by timber posts at the edge of the footpath. During the 1950's this form of construction was considered to be a hazard to traffic and consequently to pedestrians should traffic accidentally remove one or more of the posts. As a result of this, the posted verandas and awnings were removed and replaced by suspended awnings. These are held up by so-called 'tie-backs' to the masonry walls above the ground floor level (Plate 5.35). In most cases the tie-backs are anchored in the masonry wall using a plate on the inside face of the wall. In other cases the tie-backs are anchored at cross-walls, and in very few cases anchored back further into the cross-wall through a connecting set of plates or bars. This form of construction has proved quite adequate for conventional wind loads, but the earthquakes caused exceptionally high additional dynamic loads which resulted in many cases in the collapse of the facade, or rendered it dangerous as a result of cracking close to the connecting points (Plate 5.35).

PLATE 5.35 *Cracking of facade near tie-back positions for suspended awning*

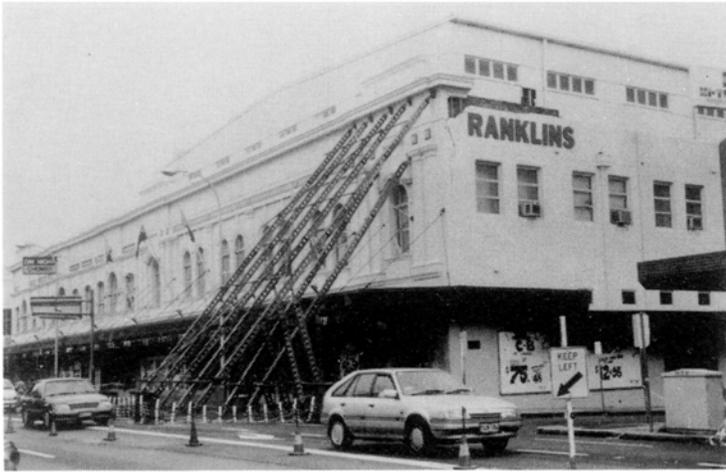
Had the earthquake been of longer duration, it is very likely that many more awnings and facades would have collapsed. Plate 5.36 shows a commercial building in the central business district with an unstable facade showing evidence of cracking and parapet collapse. Modern unreinforced masonry commercial buildings also suffered large numbers of failures, particularly to tall parapets (Plate 5.37) and to gable ends (Plate 5.38).

PLATE 5.36 *Commercial building in the Newcastle central business district with an unstable facade following the earthquake (location 13)*

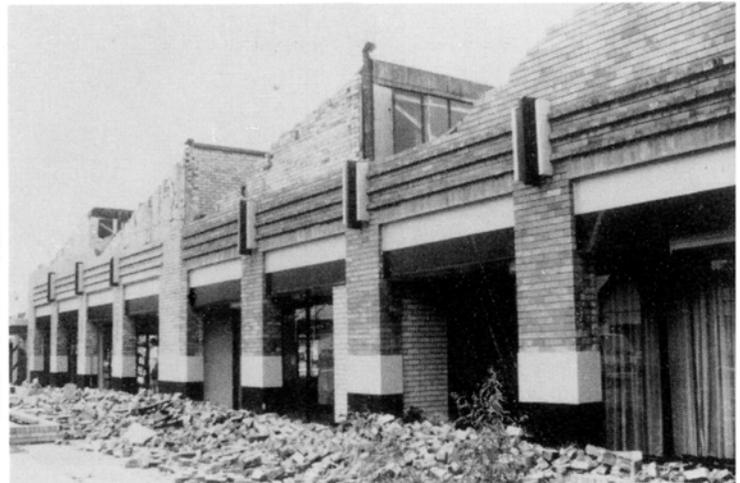
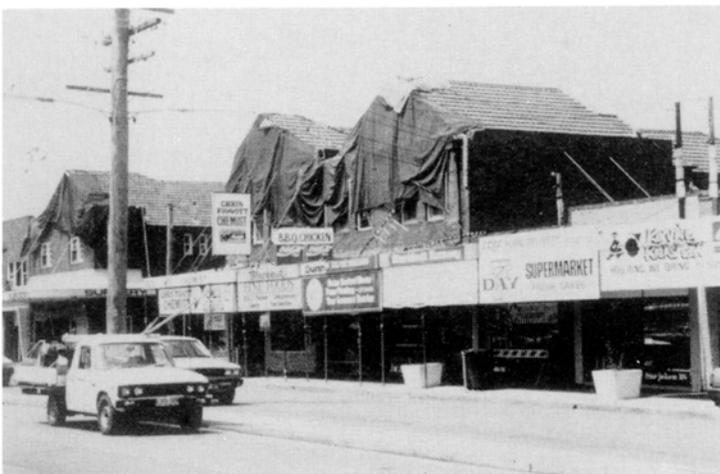
PLATE 5.37 *Failure of tall parapet in a modern commercial unreinforced brick masonry building (location 10)*

PLATE 5.38 *Gable end failures in a group of modern two storey commercial brick masonry buildings (location 2)*

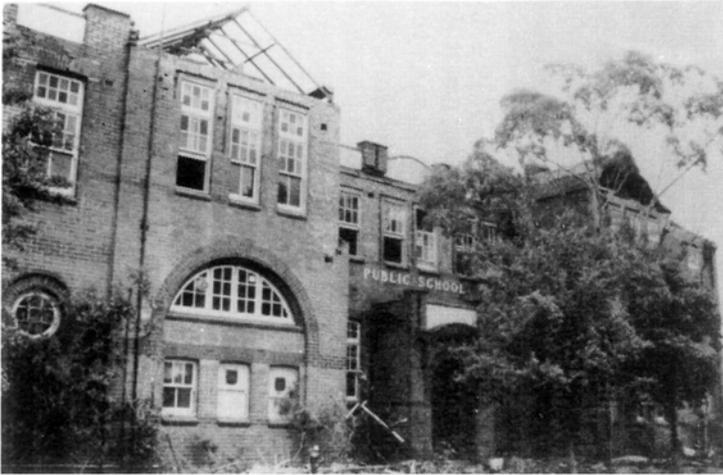
PLATES 5.39 and 5.40 *Extensive damage to roof, parapets and gable ends in a 100 year old school in The Junction, Newcastle (location 38)*

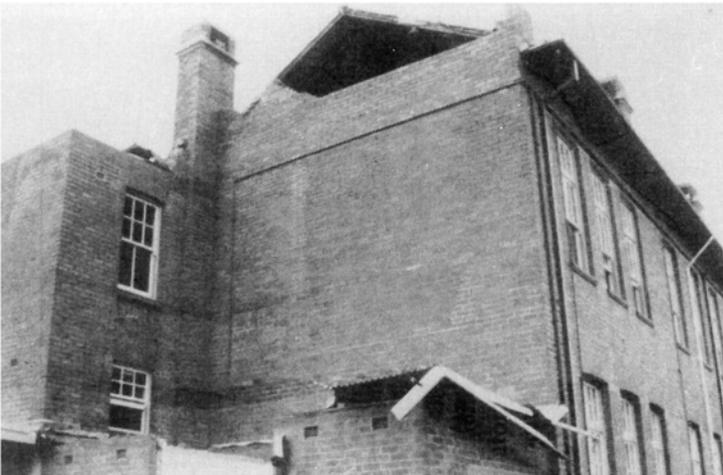
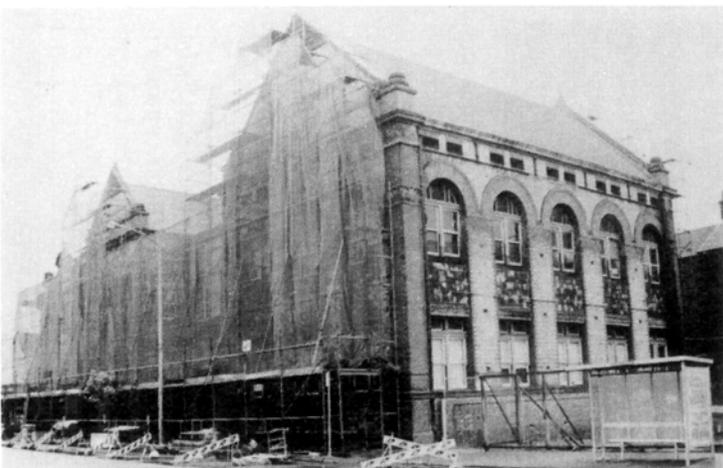
PLATE 5.41 *Extensive cracking was observed in the facade of this brick masonry college building in the Newcastle central business district (location 17)*

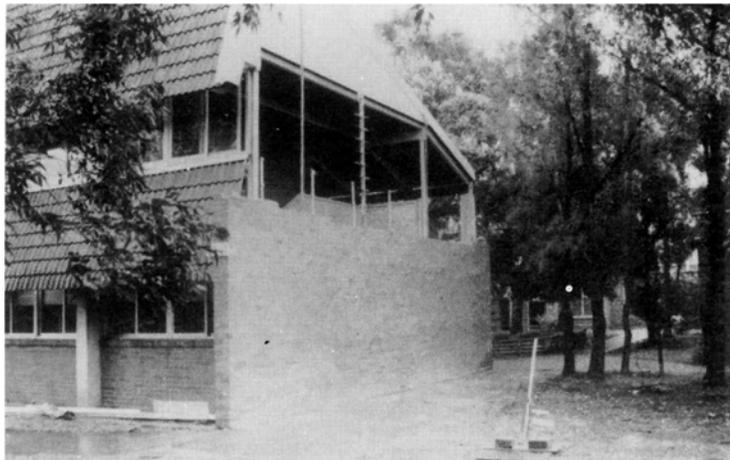
PLATES 5.42 and 5.43 *Partial collapse of unreinforced brick masonry walls due to inadequate tying back to building or roof frames (location 3)*

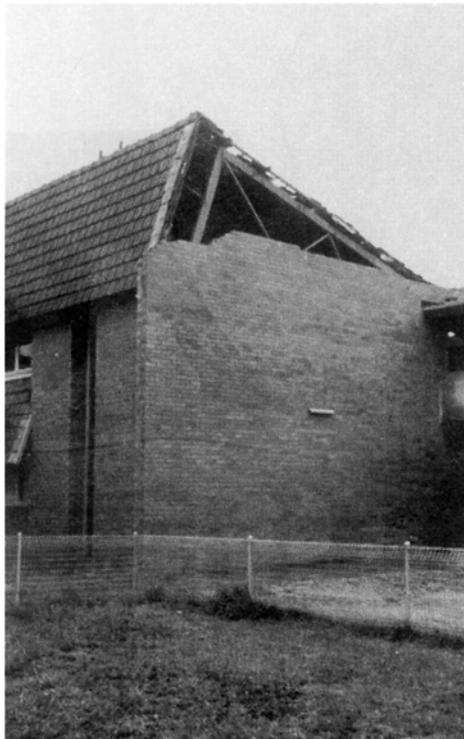
PLATE 5.44 *Brick masonry parapet collapse at the Tighes Hill Technical College, Newcastle (location 6)*

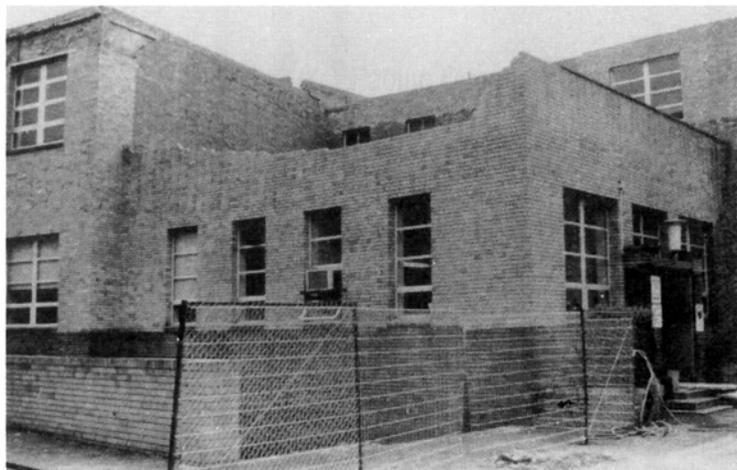
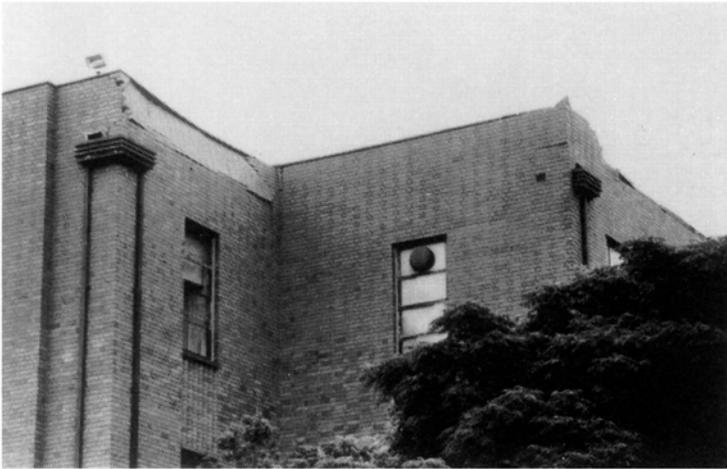
*PLATE 5.45 Damage to brick masonry cladding at the Tighes Hill Technical College, Newcastle (location 6)*

*PLATE 5.46 Diagonal shear failure in internal masonry walls in-filling reinforced concrete frame structure, Tighes Hill Technical College*

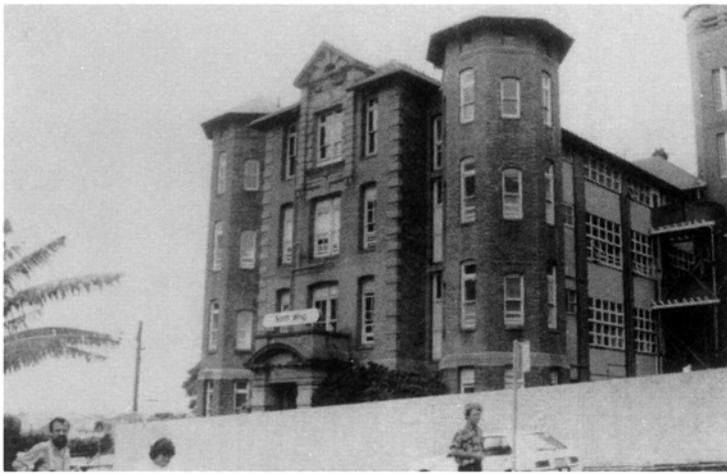
*PLATE 5.48 Extensive internal damage and plant failure was reported in the North Wing of the Royal Newcastle Hospital, which was evacuated after the earthquake (location 36)*

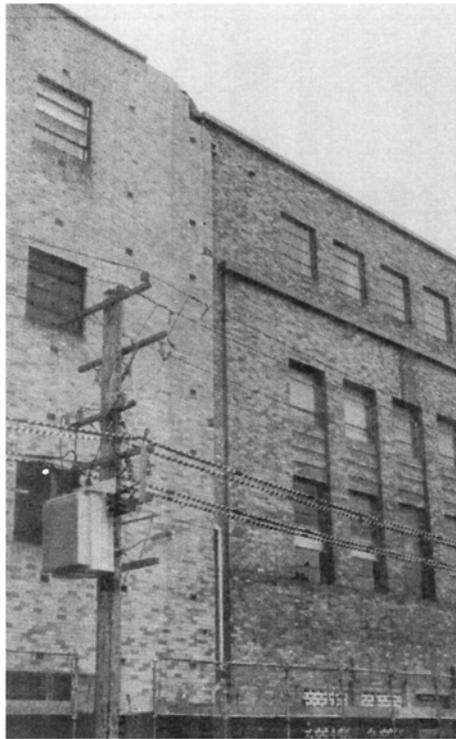
PLATE 5.51 *Partial collapse of parapet in the steel-framed Hamilton Telephone Exchange building (location 9)*

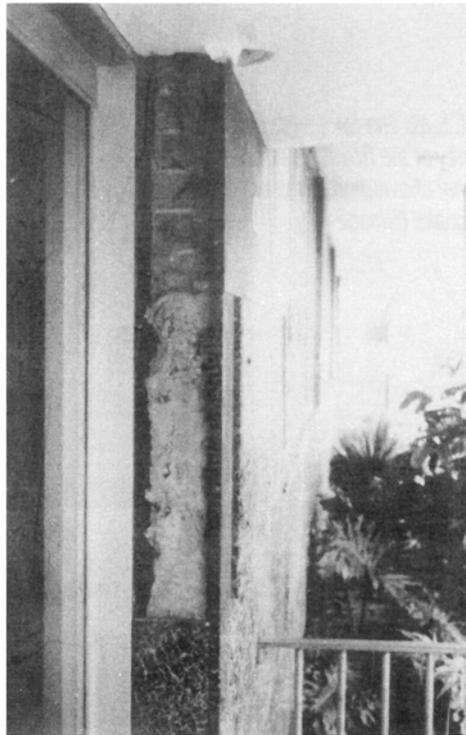
PLATES 5.52 and 5.53 *Loss of cladding and cracking of masonry in-fill in a modern office building in King Street, Newcastle (location 19)*

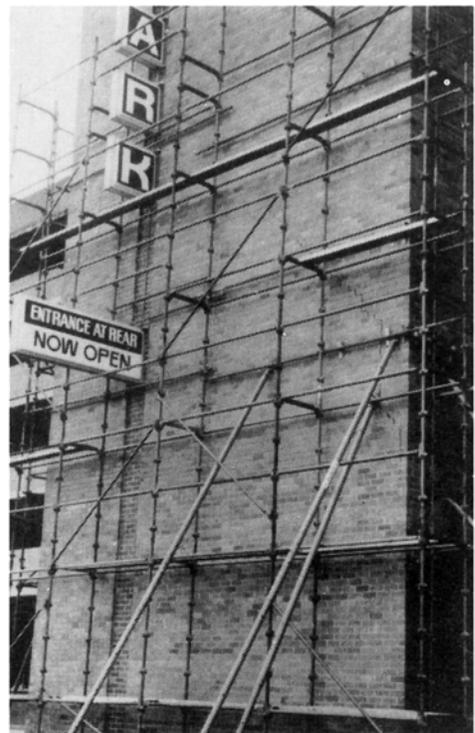
PLATE 5.56 *Total collapse of the lower five storeys of unreinforced brick masonry walling attached to reinforced concrete frame car park and office building (location 29)*

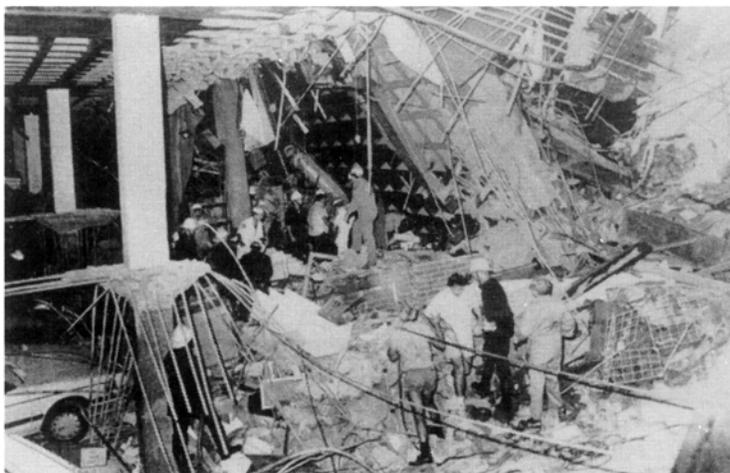
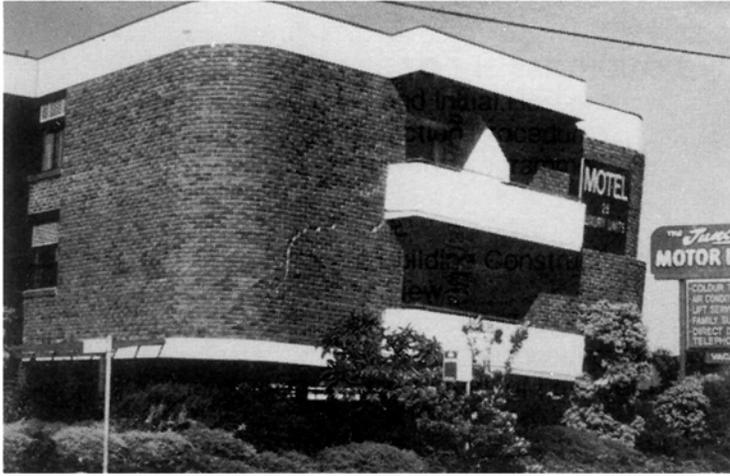
Few modern engineered steel or reinforced concrete frame buildings suffered more than relatively minor non-structural damage, such as cracking of in-fill panels or facades. The collapse of the Working Mens' Club in King Street (where 9 of the 12 fatalities occurred) was an exceptional case, with failure caused probably as a result of the poor detailing to reinforced concrete floor slabs at their column and wall connections. Another notable example of poor resistance to dynamic earthquake loading was The Junction Motel, a three storey reinforced concrete frame building with pronounced vertical and horizontal stiffness irregularities. This building was demolished following shear failure of the outer columns along one side of the structure. These are discussed further in Section 5.3.

PLATES 5.63 and 5.64 *The combination of a soft first storey and a highly asymmetric stiffness layout led to shear failure and crushing at the top of a row of exterior reinforced concrete columns at the Junction Motel. This building was demolished immediately after the earthquake (location 39)*

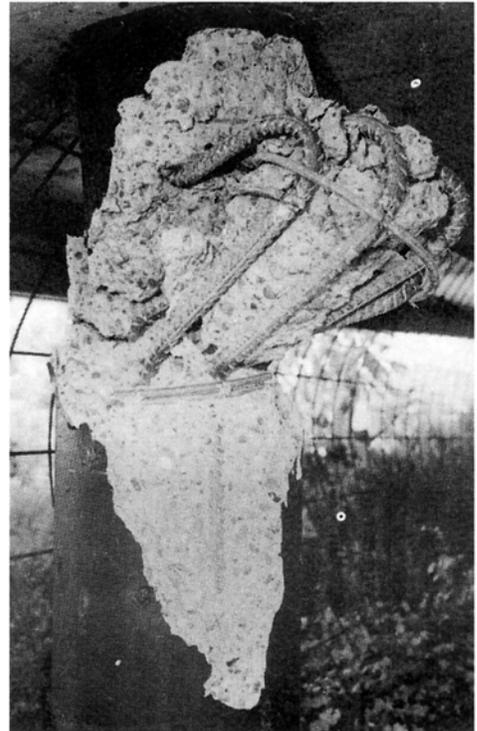
PLATE 5.65 *Rotation of finials mounted on top of the brick masonry parapet at Christ Church Cathedral, Newcastle (location 32)*

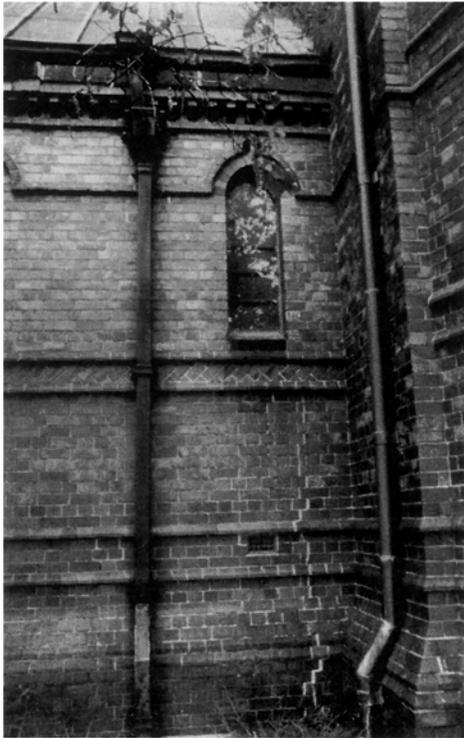
PLATE 5.66 *Vertical crack in the outer wall of the Newcastle Christ Church Cathedral, reportedly dating from the earthquake in 1925 (location 32)*

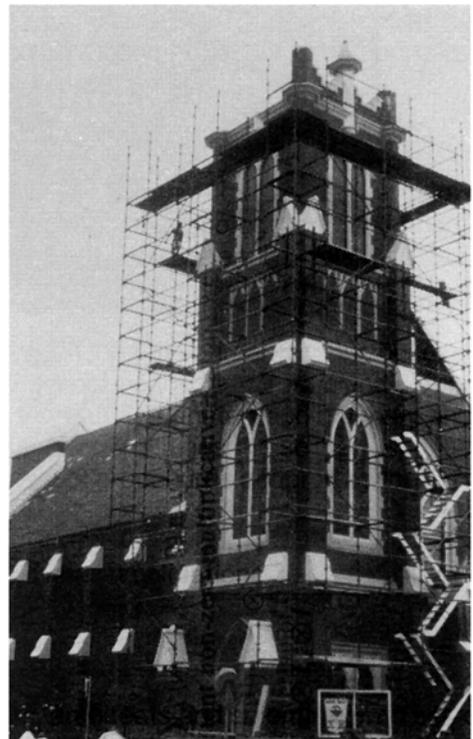
PLATES 5.67 and 5.68 *Partial collapse and severe cracking of masonry spire and tower, a common form of damage to churches in Newcastle (locations 26 and 7)*

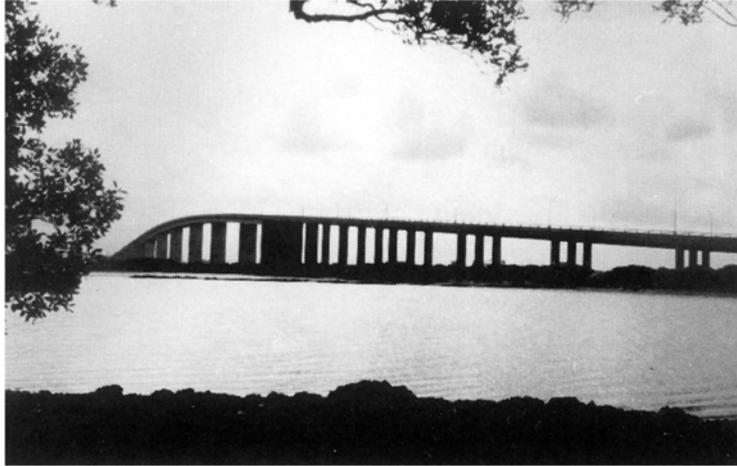
*PLATE 5.77 General view of the Stockton Bridge, north of Newcastle which showed slight settlement of the western abutment due to the earthquake (location 1)*
