THE PADANG, SUMATRA - INDONESIA EARTHQUAKE OF 30 SEPTEMBER 2009

A FIELD REPORT BY EEFIT

Earthquake Engineering Field Investigation Team
Institution of Structural Engineers
11 Upper Belgrave Street
London SW1X 8BH
Tel 0207235 4535
Fax 0207235 4294
Email: mail@eefit.org.uk
December 2009

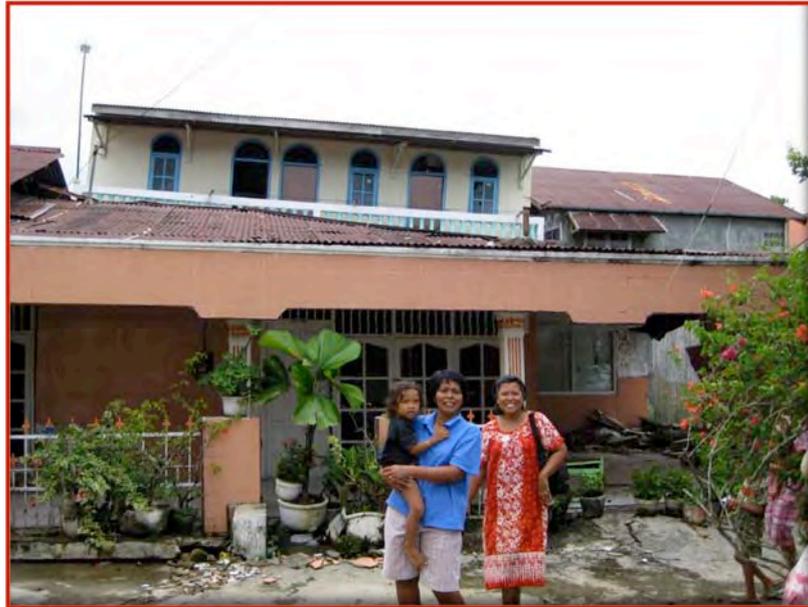
Figure 15. Siteba Perumdam Village Home with Foundation Failures, Still Occupied.

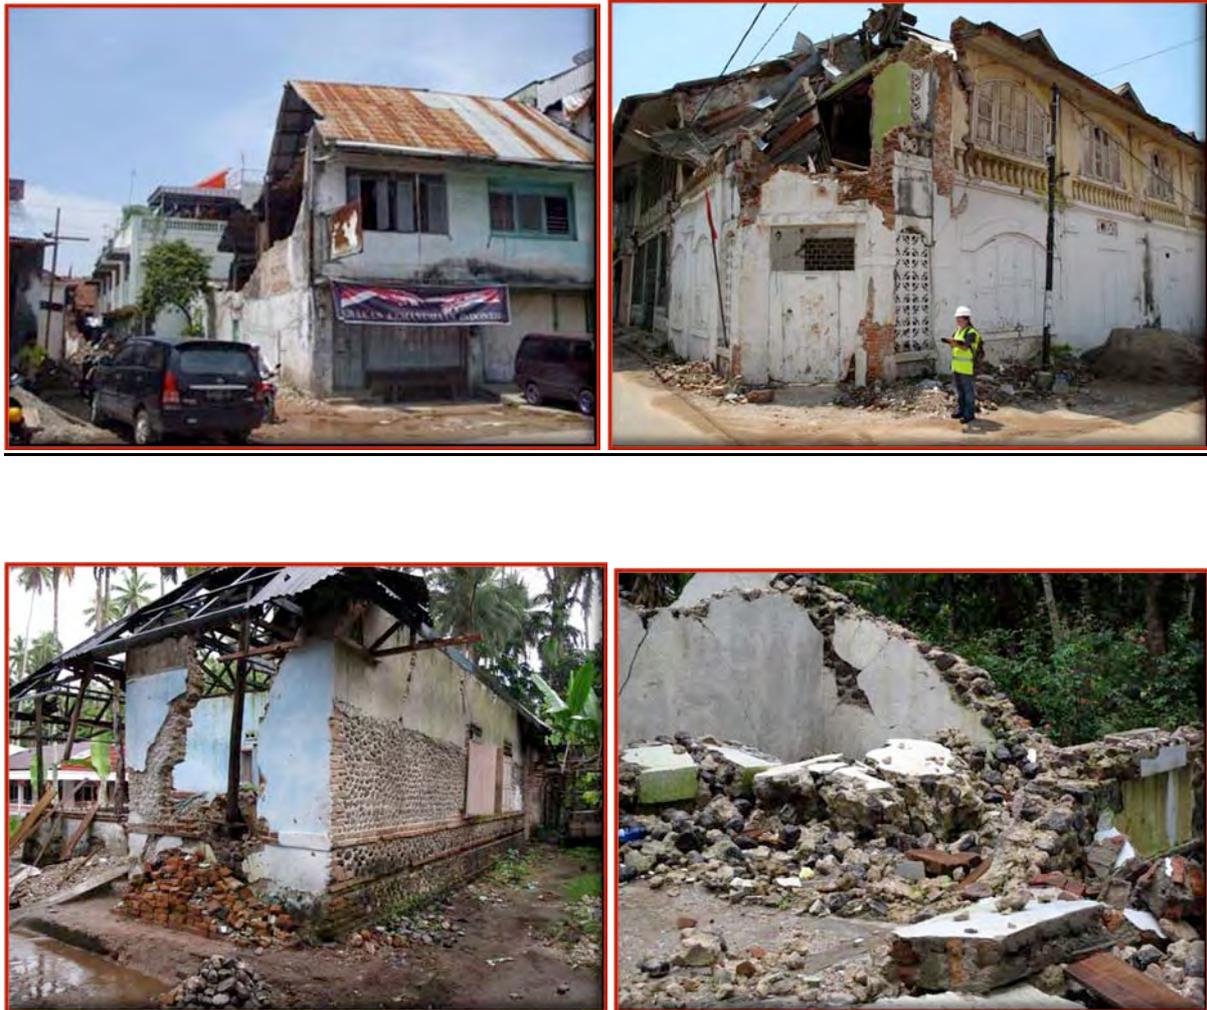
Figure 23. Damage to residential buildings. Top: households in Padang.
Bottom: structures in Pariaman county.

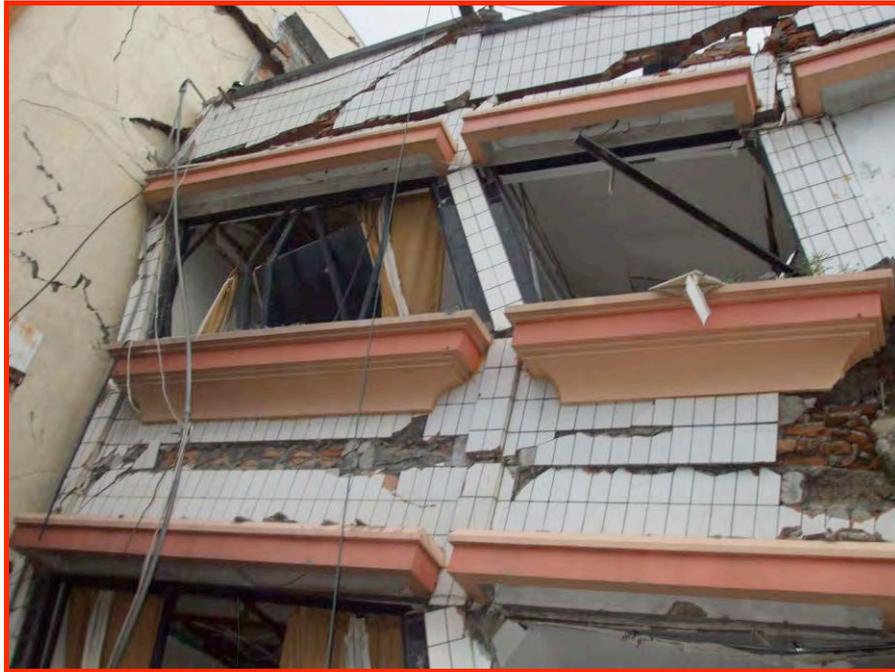
Figure 25. Plastic hinging at column ends of reinforced structure.

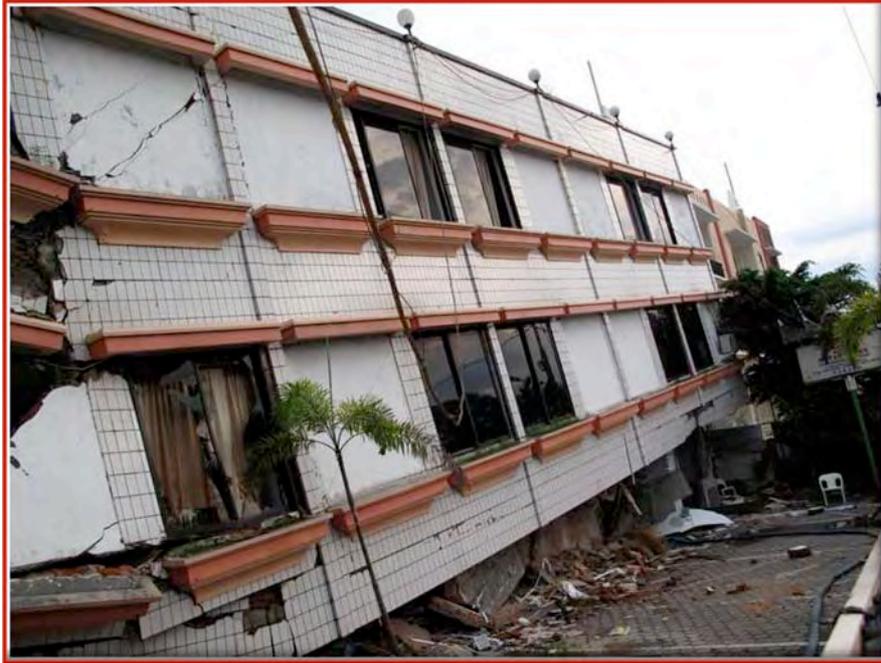
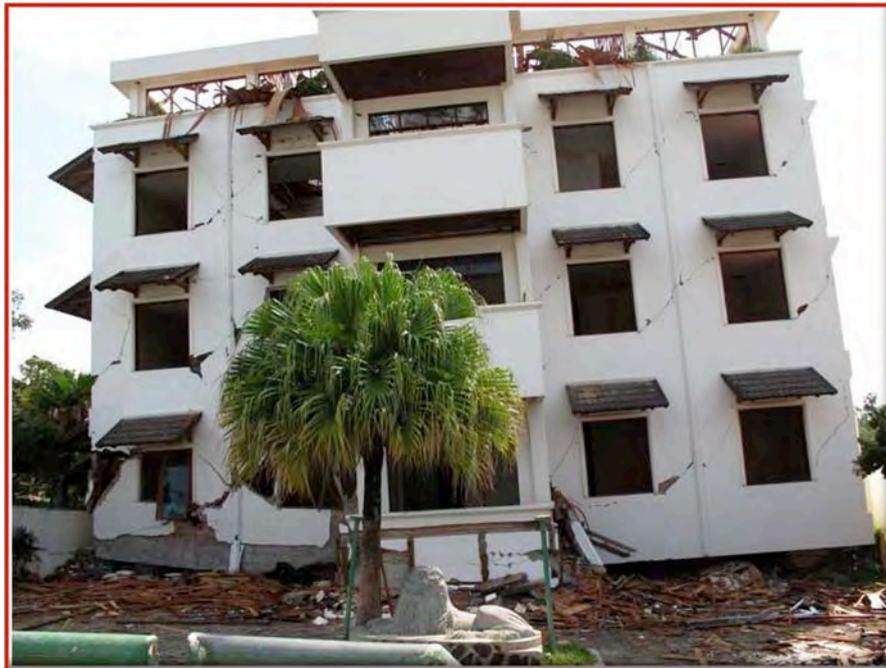
Figure 26. Examples of Soft-storey Hotel Failures.
Top: Hotel Hayam Wuruk. Bottom: Beach Front Hotel.

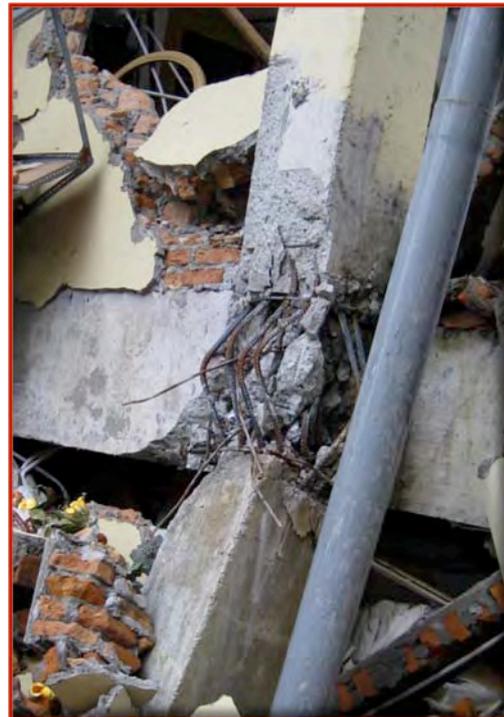
Figure 28. Evidence of soft-storey failure, light-fixture and chair at ground level (left) and lack of transverse reinforcement in beam-column connection (right).

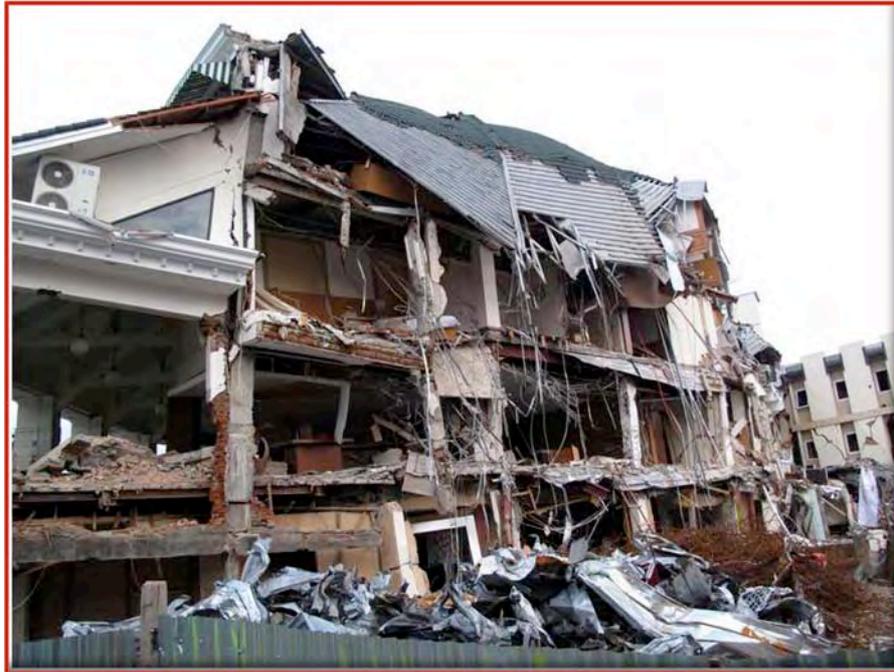
Damage to the hotels did not seem to correlate to the age of the building or client affluence. For example, the Ambacang hotel and Inna Maura hotel, both multi-story, expensive hotels, suffered major damage. The Ambacang hotel was the most severely damaged hotel

Figure 29. Ambacang Hotel Damage.

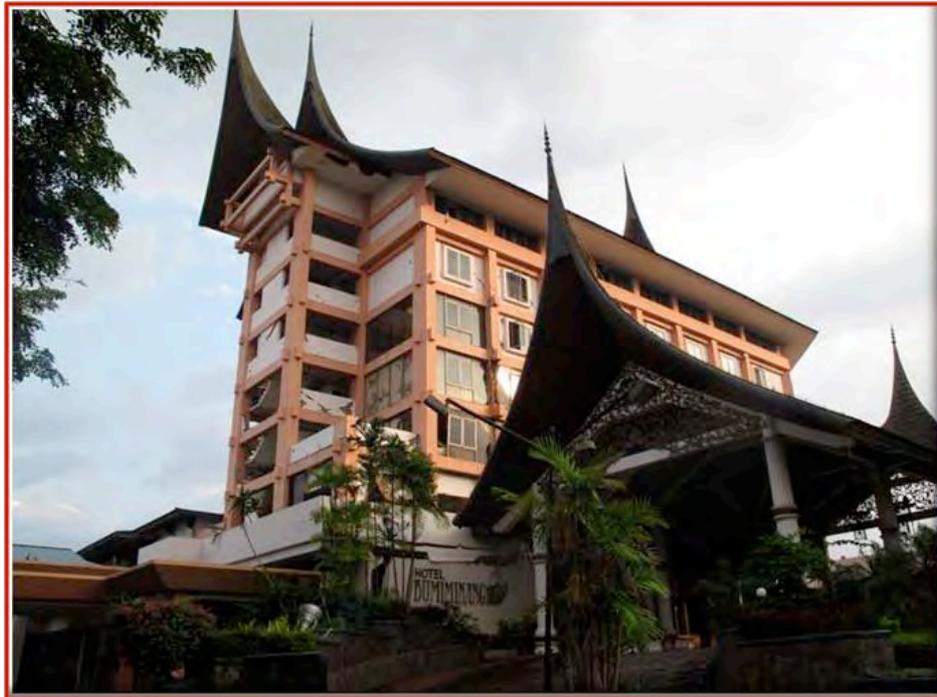
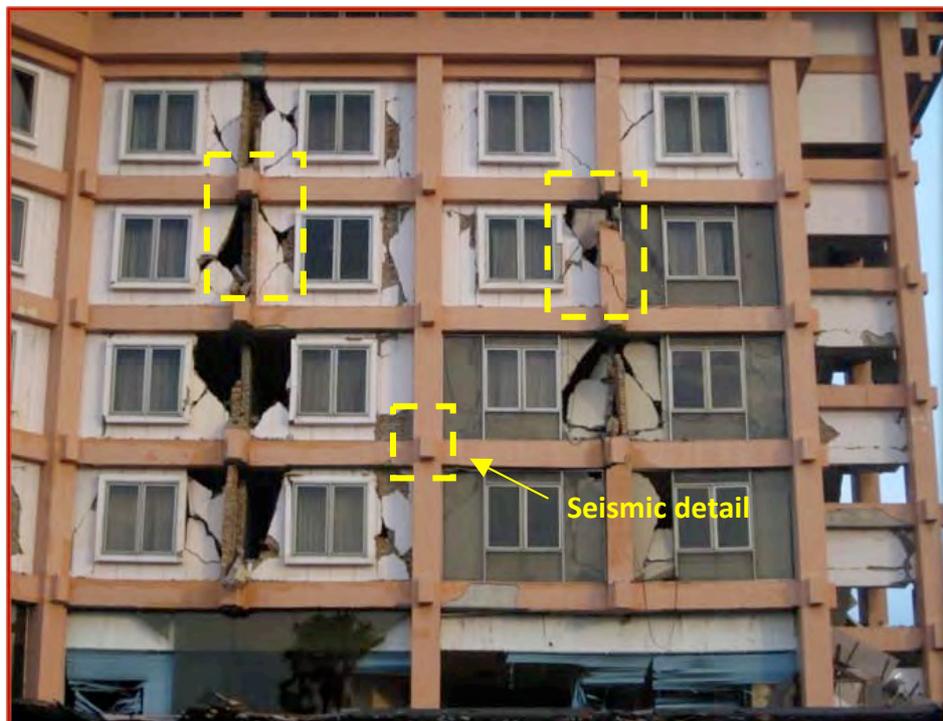
In some cases, there was little to no structural damage of the multi-storey hotels. The Bumiminang hotel experienced masonry damage but no obvious primary structural failure. False masonry “columns” (two adjacent masonry walls) were also damaged, but the reinforced concrete columns appeared undamaged (Figure 30). The extension of the beams past the exterior of the columns depicted in Figure 30 is likely to be a seismic rather than an architectural detail and indicates that this building is likely to have been constructed with good seismic practice in mind. The strong ground shaking (evidenced by the failed masonry infills) and the lack of obvious structural damage suggests that this building and the seismic practices employed have worked well. However, the team was informed that the hotel would be demolished and not repaired. It is likely that the decision to not repair is due to damage to architectural elements inside the building as well as the obvious external damage, but this could not be confirmed as access was restricted. The Basko Grand Mall, recently constructed and owned by the Western hotel chain – Best Western, had no apparent structural damage from an exterior survey. The on site guards would not permit

Figure 30. Bumiminang Hotel, shear cracking and damage to false masonry columns.

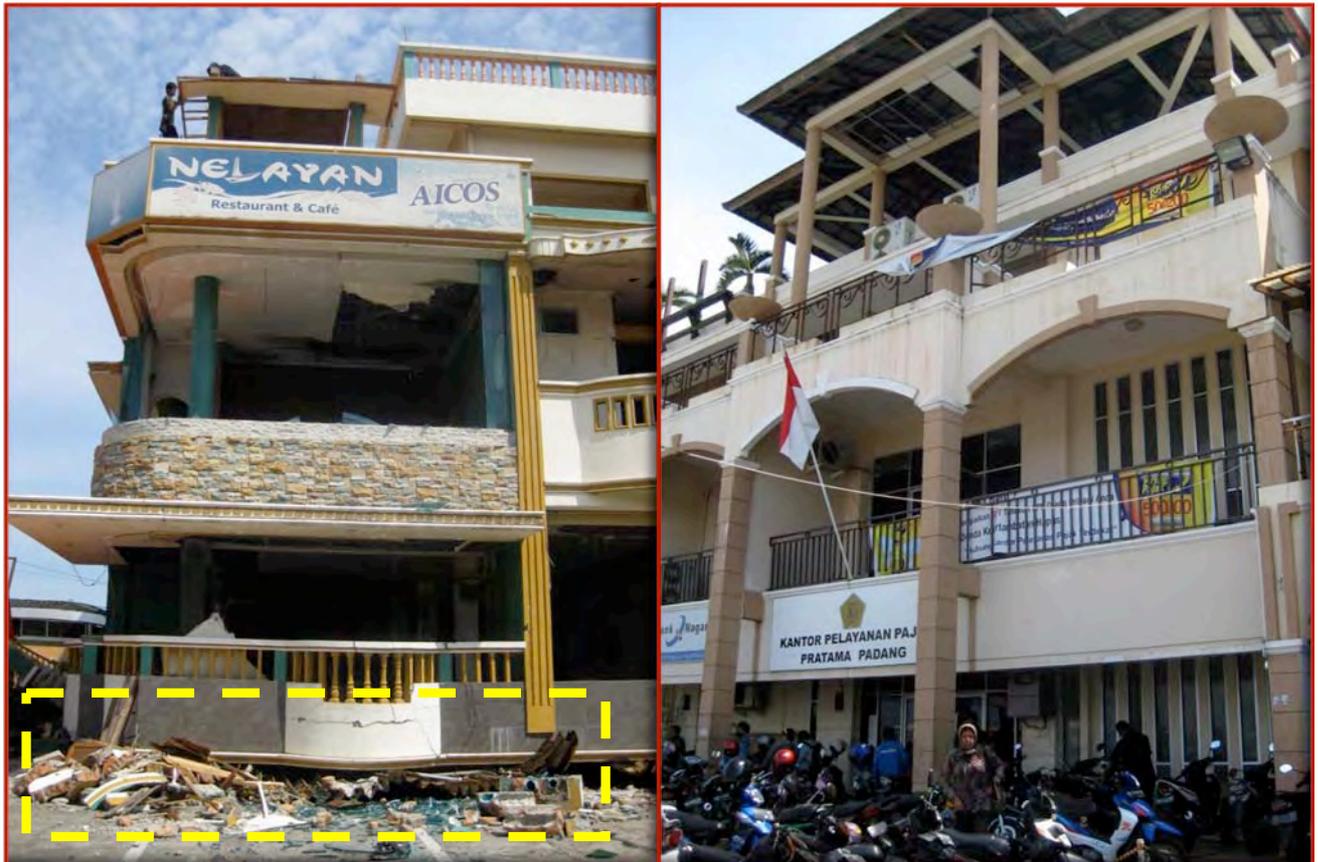
Figure 31. Small Shopping Centres; Left: soft-storey failure, Right: Minimal damage.

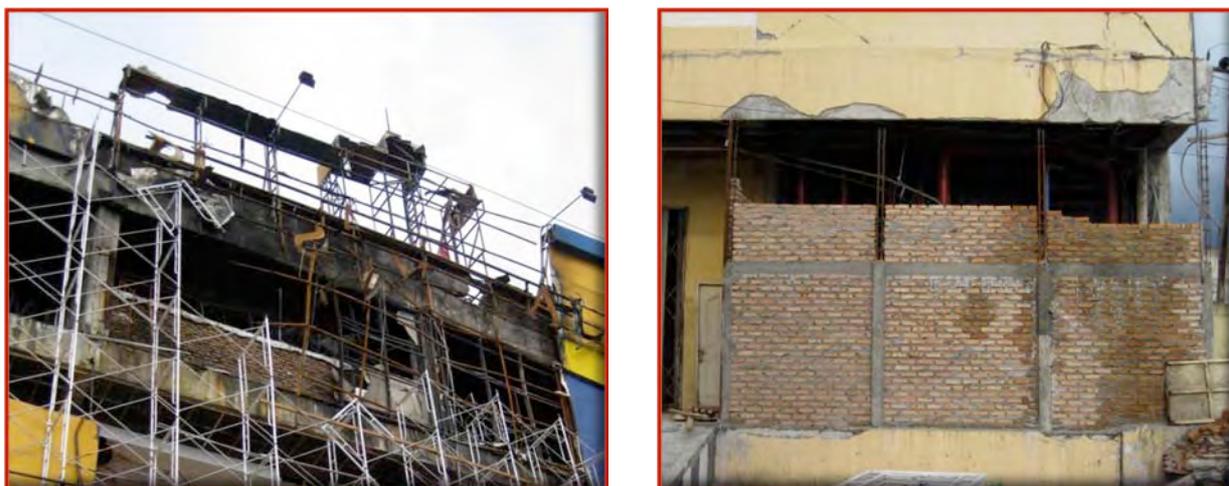
The Ramayana shopping centre was a large four-storey structure. Damage caused by fire was noticeable along a section near the roof, and construction workers were beginning the reconstruction of the masonry walls. It appeared that the masonry infill walls had completely failed, although the primary reinforced concrete columns were robust and suffered no obvious damage. Narrow columns supporting the roof cantilever failed.

Figure 34. Ramayana Shopping Centre: fire damage (left) and new masonry construction (right).

Different construction techniques were being implemented for the reconstruction of the masonry infill. The concrete confining columns were placed more frequently, likely in an attempt to provide additional support for the masonry walls. See Figure 33 and Figure 34.

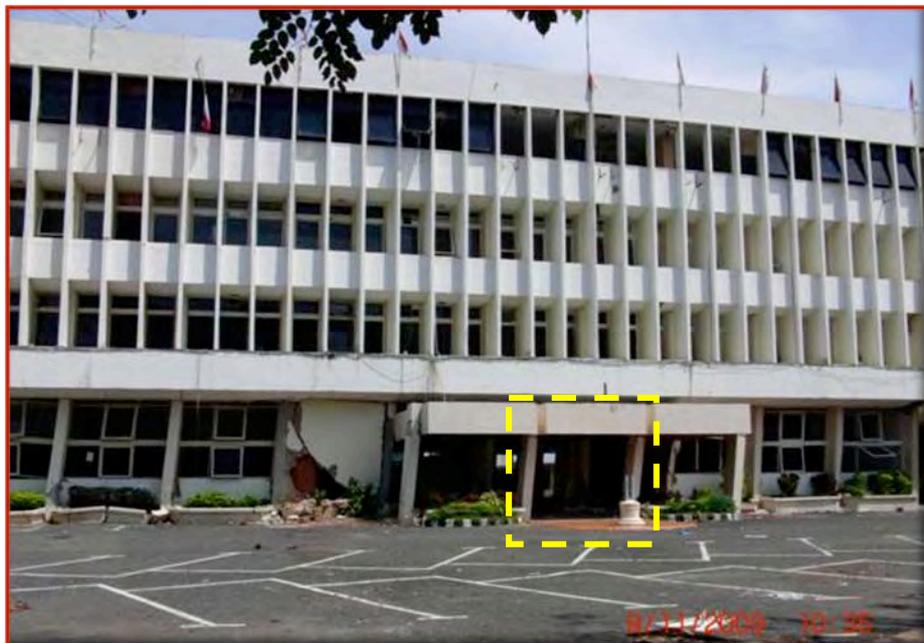
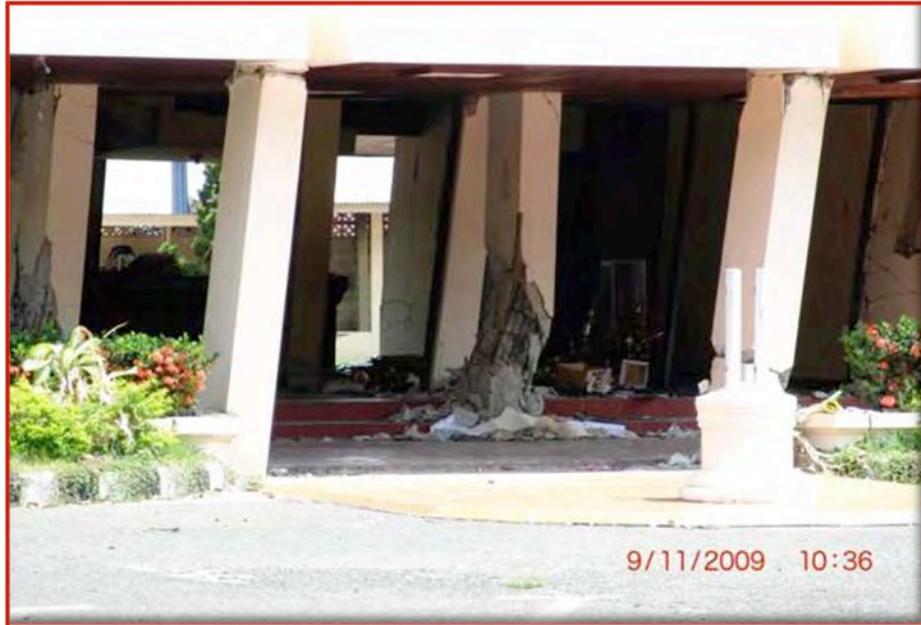
The observed Governmental buildings in Padang are constructed of reinforced concrete with moment resistant frames and infill walls. Most of the damage observed in these buildings was caused by soft storey failures. A typical example is presented in Figure 35 where the differences in rigidity between the ground floor and the floors above are severe. Other examples of structural failures of governmental buildings are shown in Figure 36. The

Figure 35. Soft storey failure of a governmental building in Padang, with the bottom photograph showing the failure of the column in the area indicated in the upper photograph.

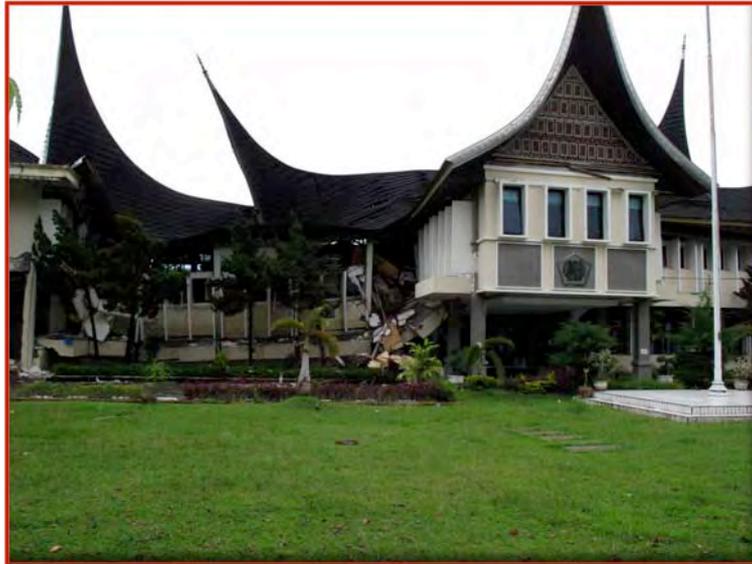
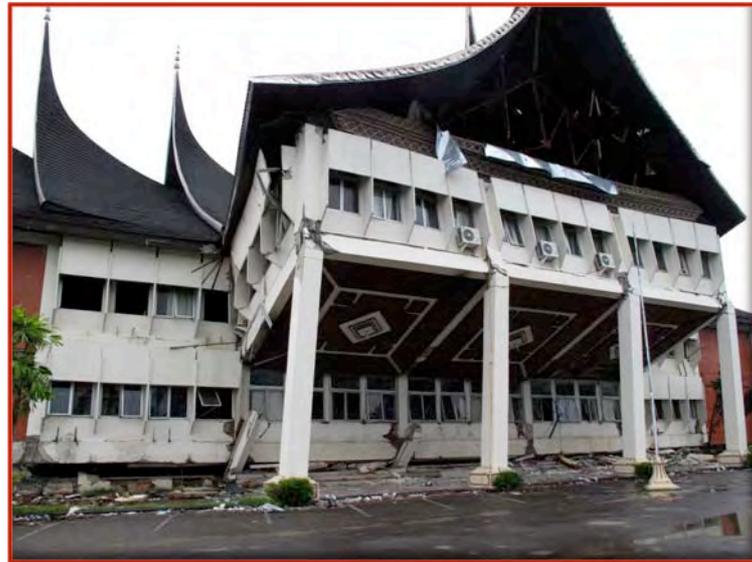
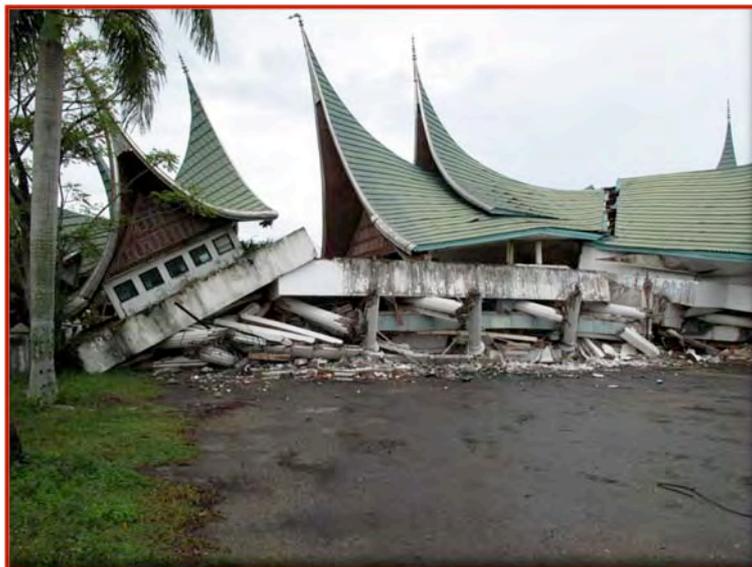
Even though the construction of governmental buildings requires the supervision of the correct implementation of the design specifications, some quality faults (such as lack of enough reinforcement and the use of plain reinforcement bars contrary to ribbed bars) were observed during the survey.

The use of inappropriate design codes and poor quality of construction may be the major causes of damage to governmental buildings in Padang. A governmental building in Pariaman (closer to the fault rupture) that had a very good structural behaviour is presented in Figure 37.

Figure 36. Examples of soft storey failures in governmental buildings in Padang.

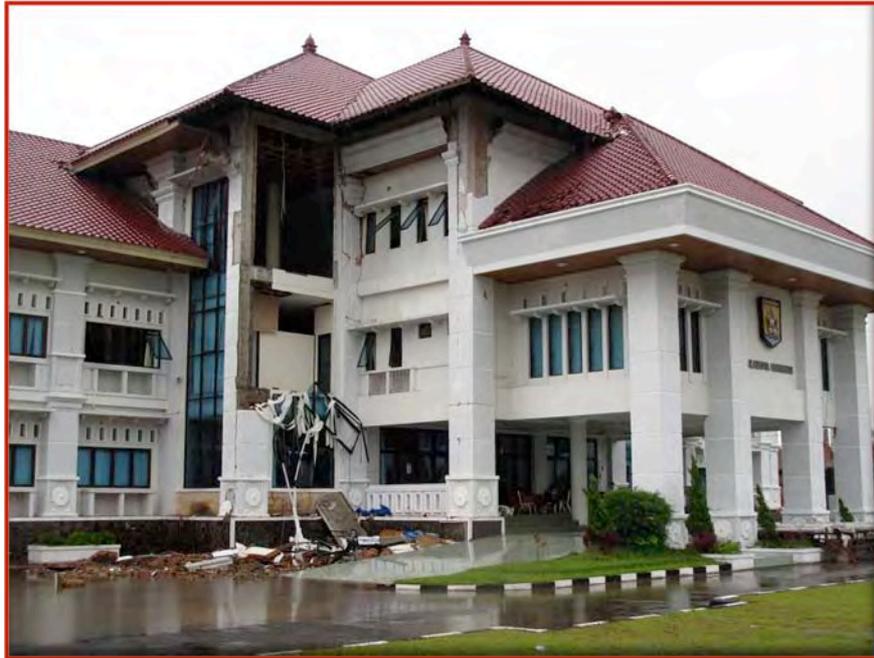
Figure 37. Governmental building in Pariaman city. In spite of the irregular geometry of the building, the observed damage was limited to the two infill walls.

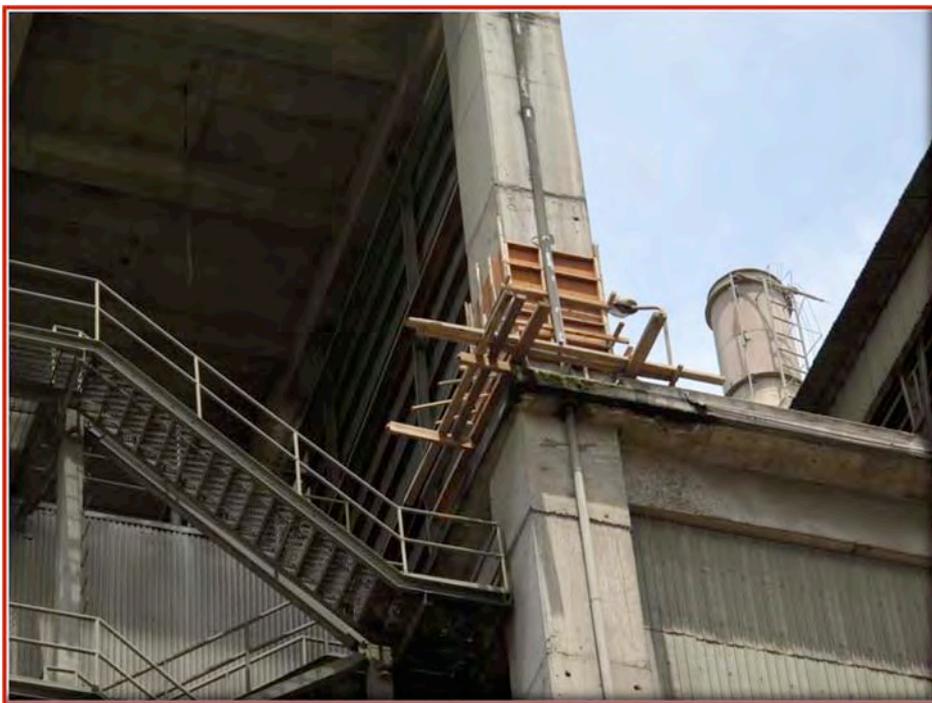
Figure 39. A minor problem with a RC column in the cement factory where part of the face concrete was damaged and then repaired. This did not represent a structural problem.

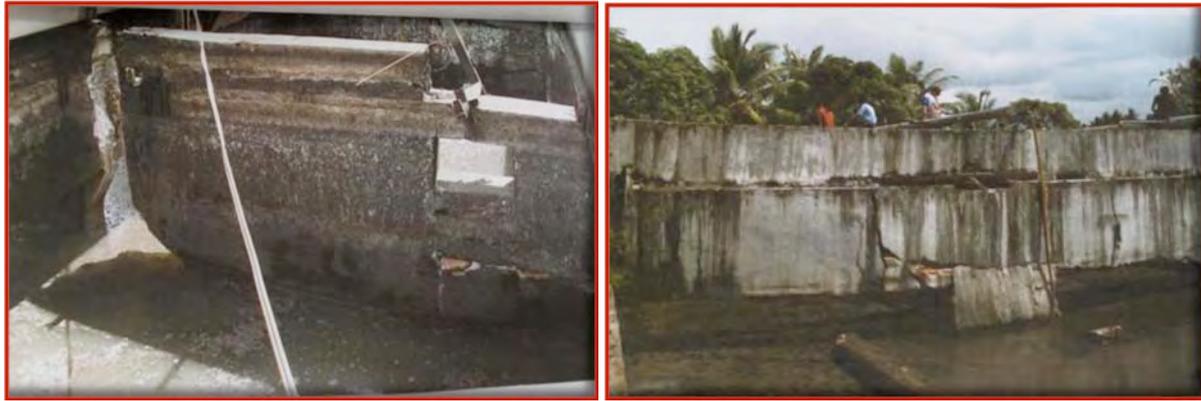
Figure 41. Damage to the reservoir where poisonous materials are removed before disposal of residual waters (photos provided by the plant manager).

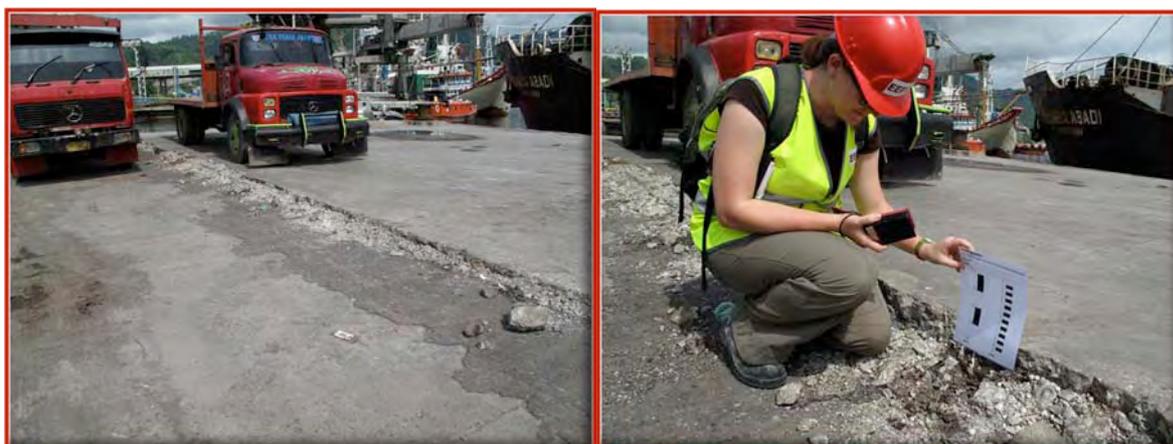
Figure 43. Settlement of the access to the dock.
Maximum measured settlements were 60mm.

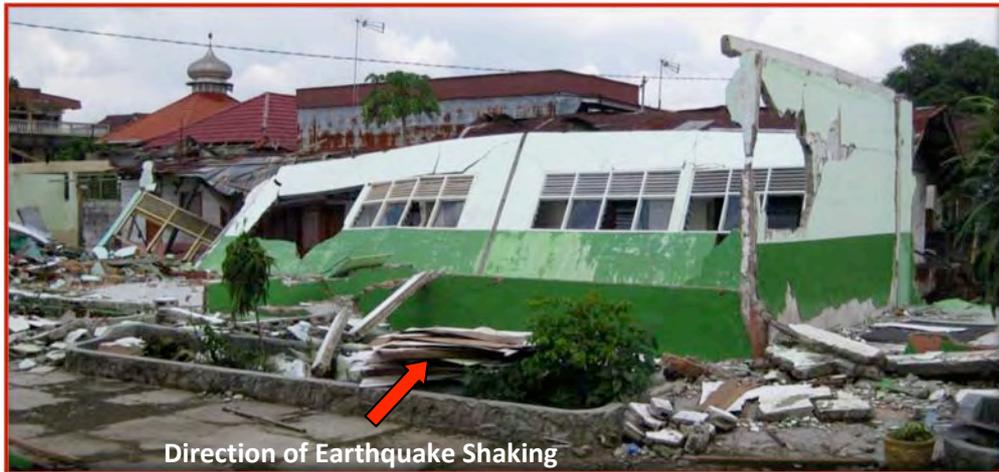
Figure 44. SDN 24 Ujung Gurun Elementary School in Padang – collapsed building.

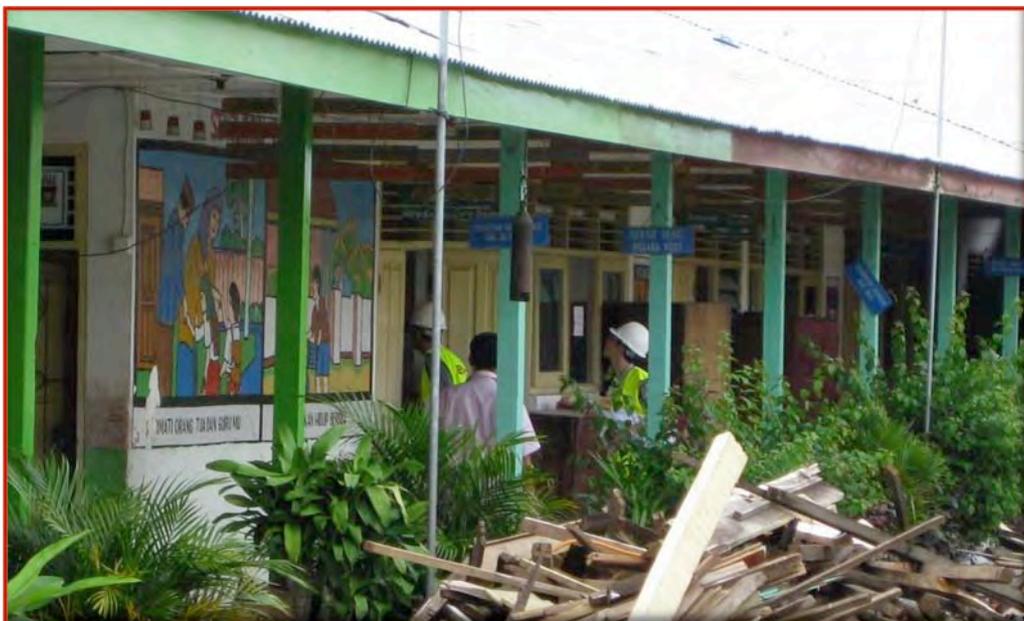
Figure 45. SDN 24 Ujung Gurun Elementary School in Padang – less-damaged building.

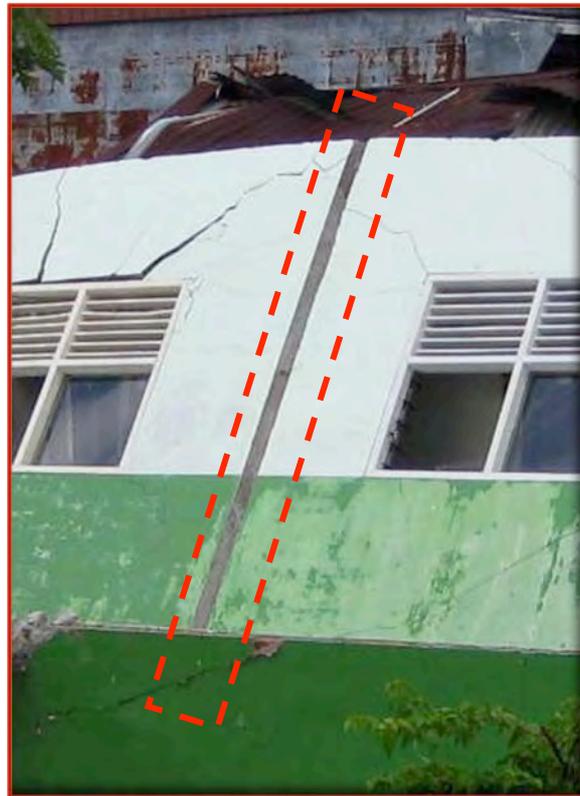
Figure 46. Location of wall to wall joint – no connection between orthogonal walls.

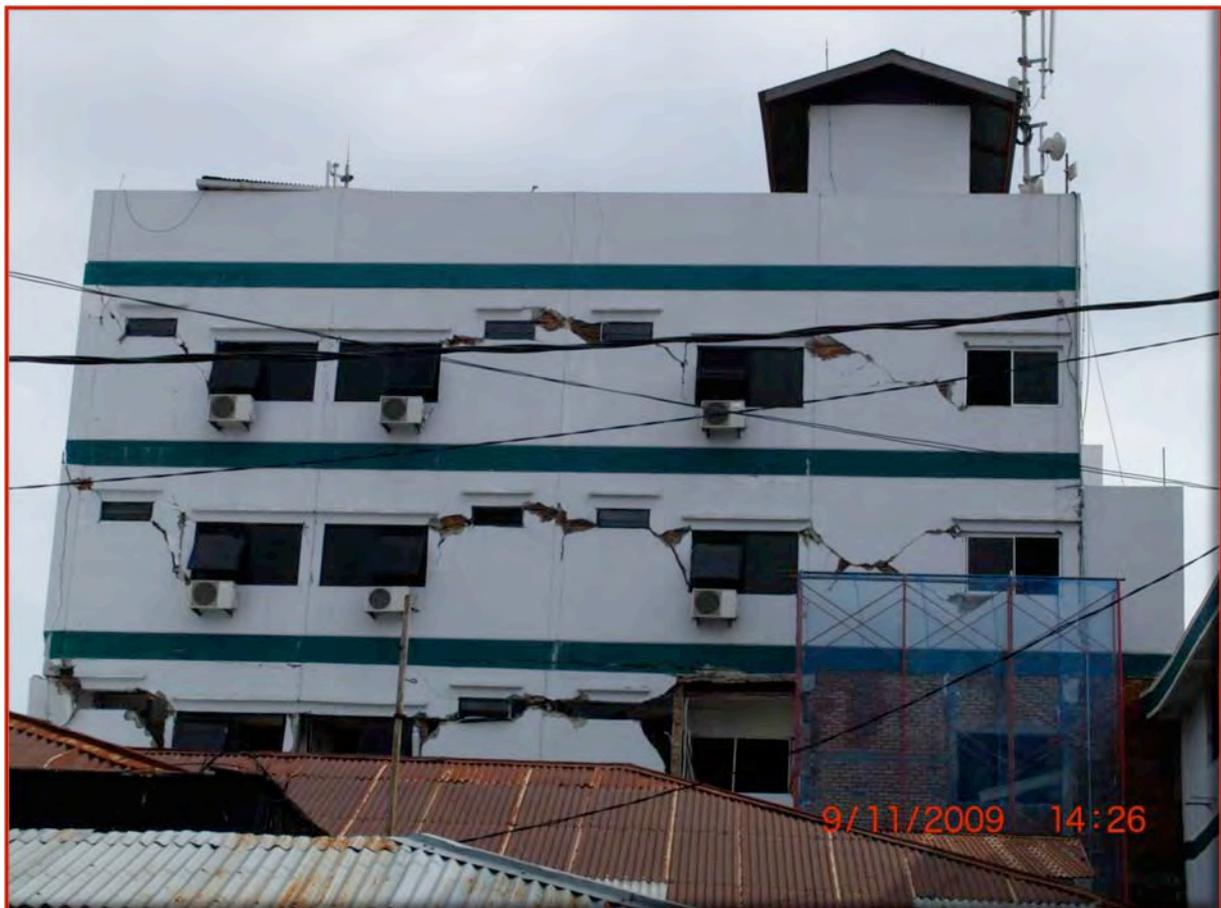
Figure 51. Bunda Medical Centre showing extensive cracking of non-structural masonry.

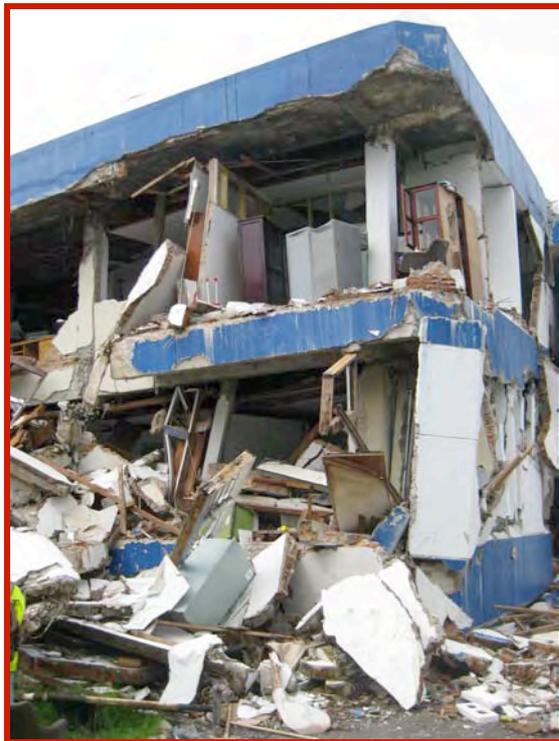
a) Polyclinic

b) failed Connection detail in Polyclinic

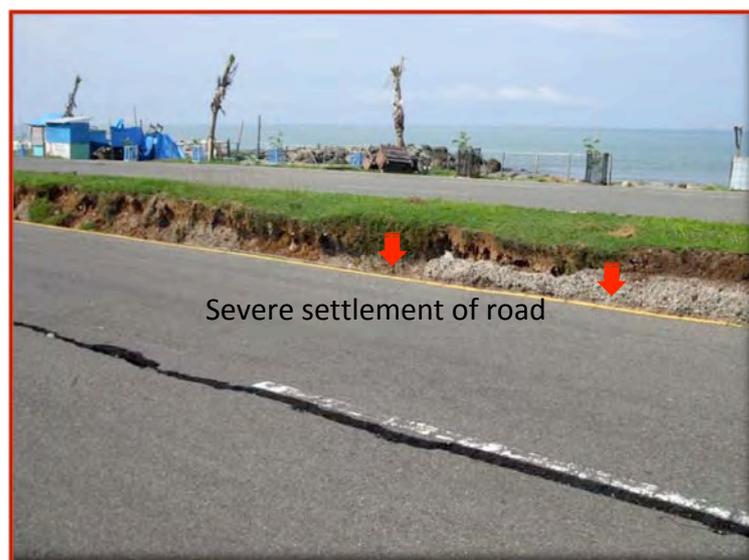
Figure 54. Settlement and cracks on road parallel to the coastline.

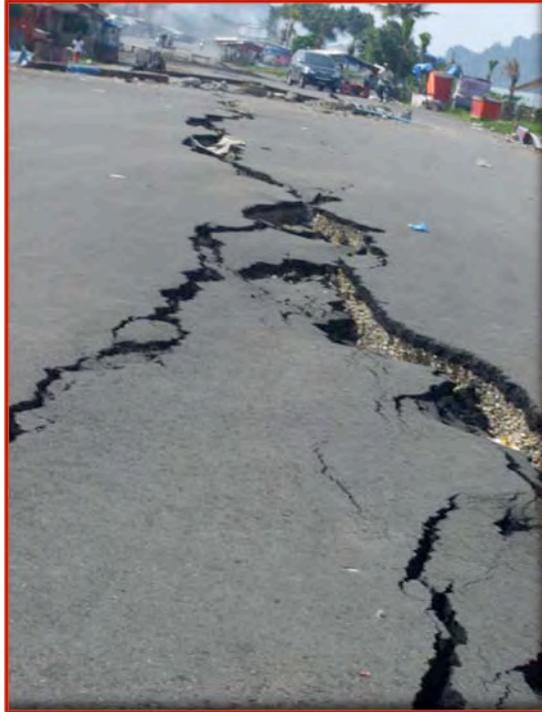
Figure 55. Tension cracks propagating parallel to the longitudinal axis of the road.

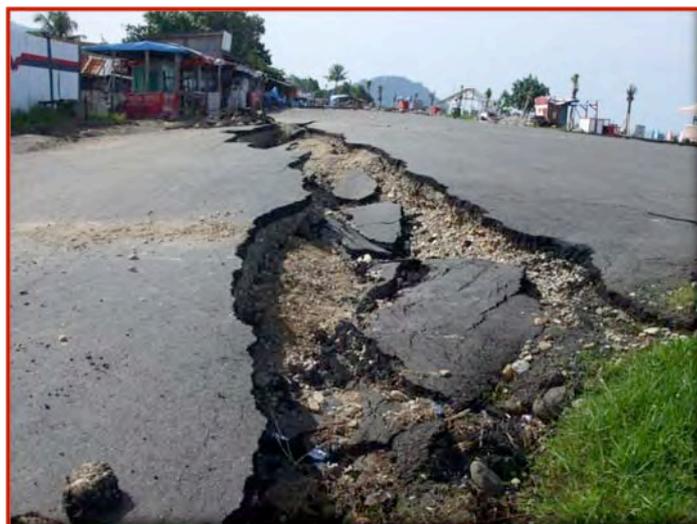
Figure 56. Severe failure of road at the crest of the embankment.

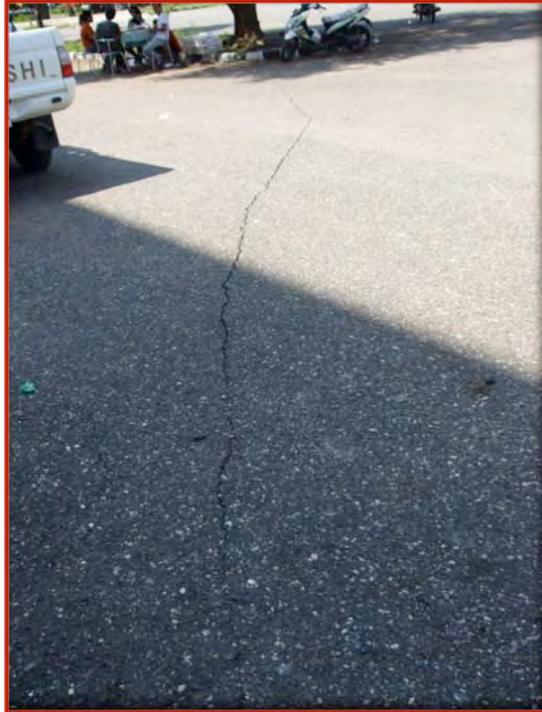
Cracks parallel to the plane of fault rupture were also sighted in an open car park near a stadium as shown in Figure 57.

Figure 57. Road cracks parallel to the plane of fault rupture.

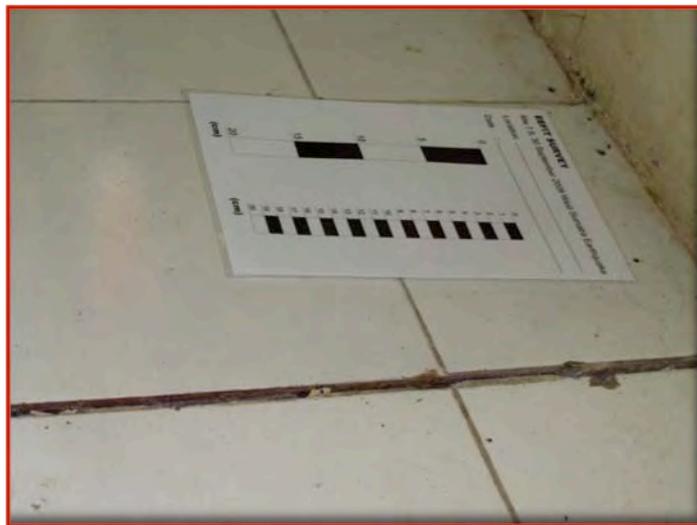
Figure 58. Crack on floor tiles of classroom due to differential settlement.

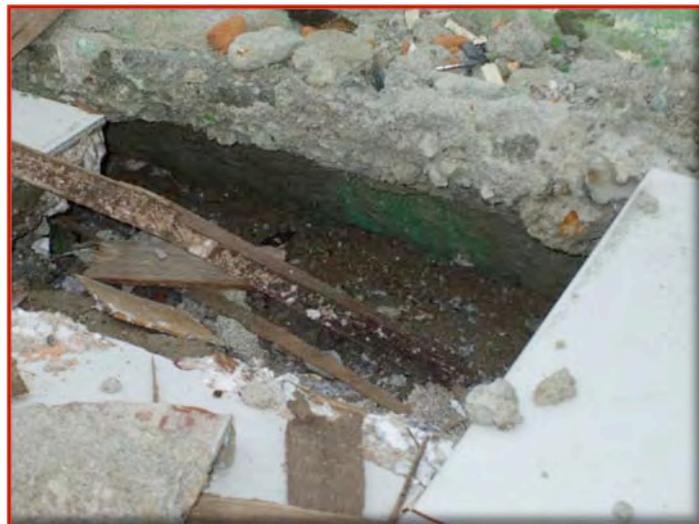
Figure 61. Wall collapse due to insufficient embedment of strip foundation.

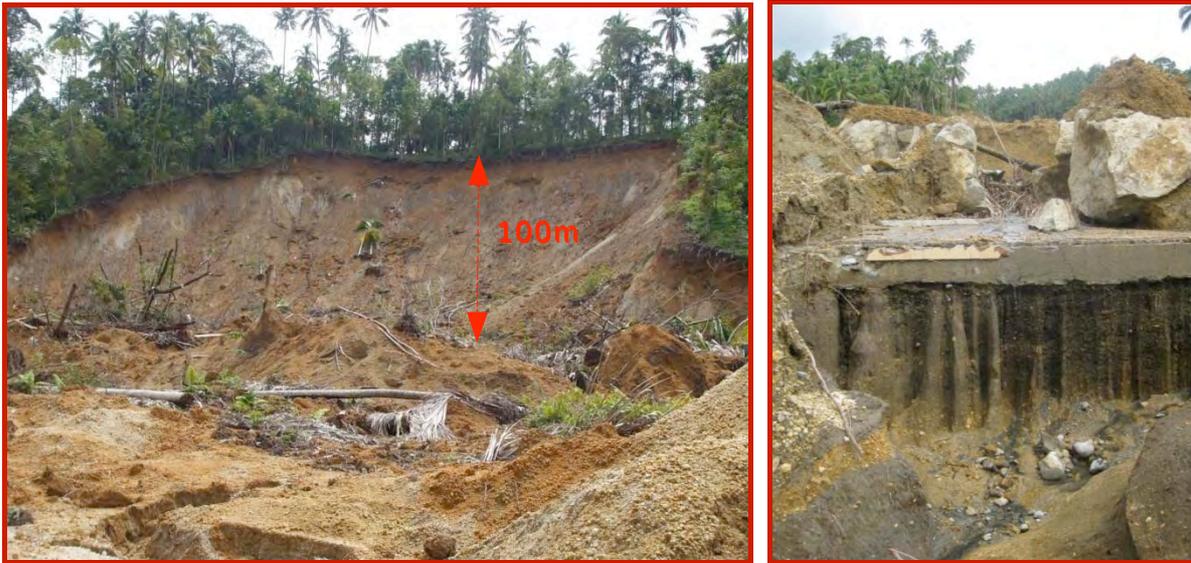
Figure 65. Slope failure (left) and the foundation of a destroyed school (right) at Landslide Site 2.

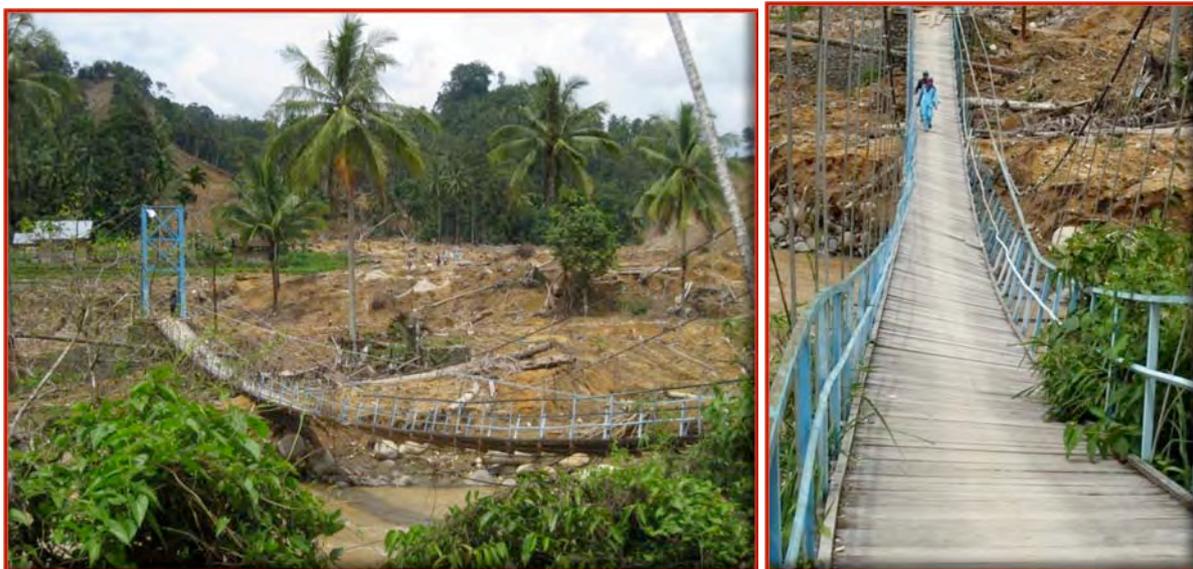
Figure 70. Damaged pedestrian bridge still frequently used by residents.

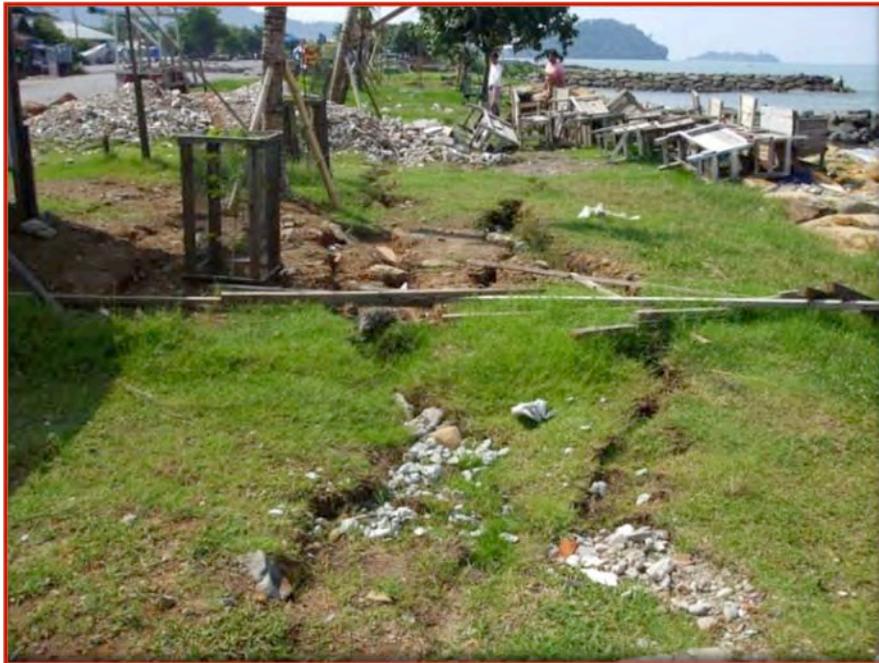
Figure 71. Tension cracks arising from lateral spreading.

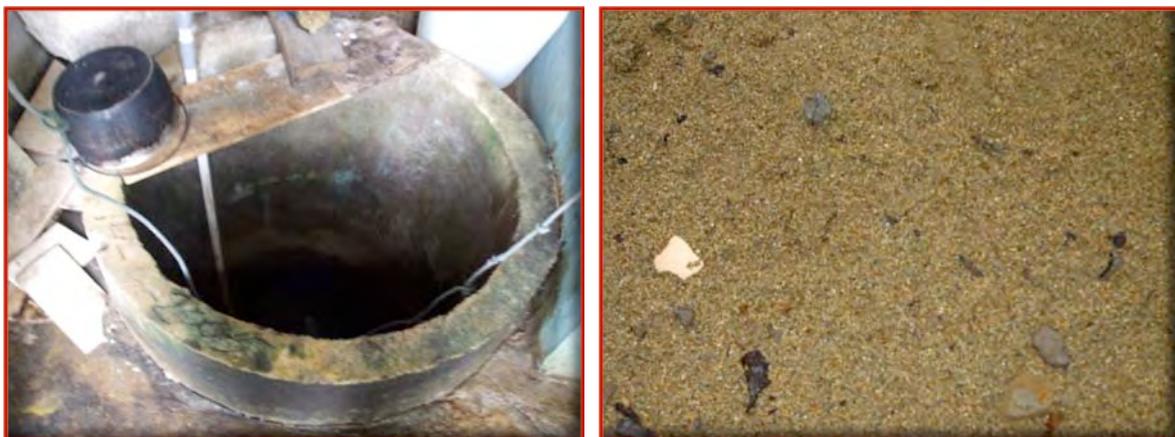
Figure 73. The well (left) that was blocked with sand (right) due to liquefaction.

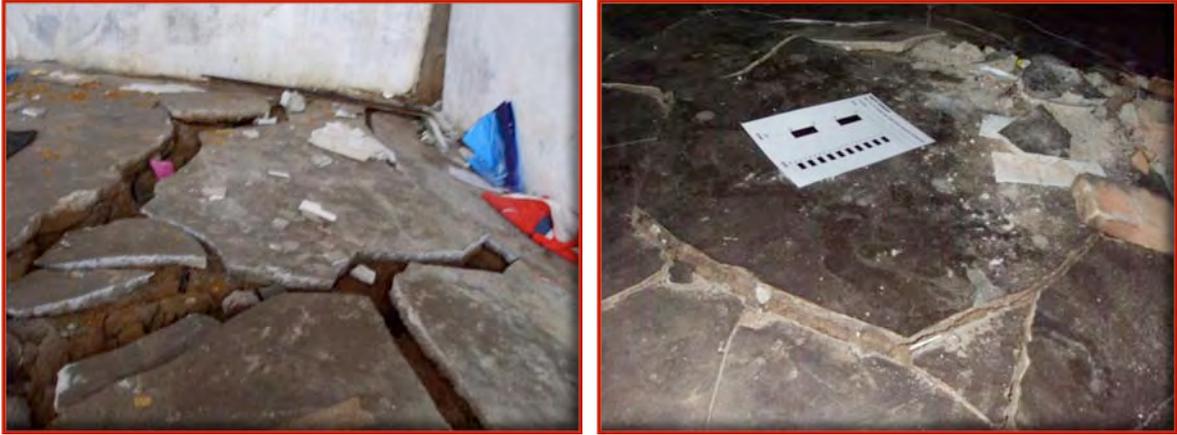
Figure 74. Upheaval of floor slabs due to liquefaction.

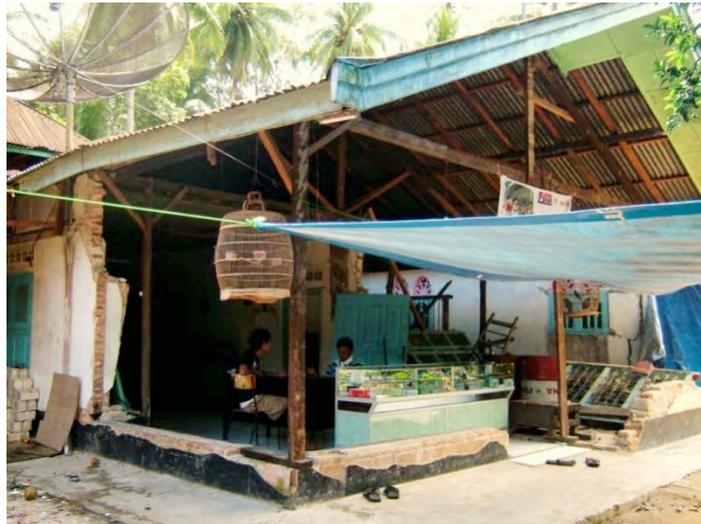
Figure 77. A small shop in V Koto Timur district had lost most of its wall component and immediately opened after clearing the rubble caused by the earthquake.
