THE VRANCEA, ROMANIA
EARTHQUAKES OF 30-31 MAY 1990

A FIELD REPORT BY E.E.F.I.T.

November 1990

EEFIT
Earthquake Engineering Field Investigation Team
Institution of Structural Engineers
11, Upper Belgrave Street
London SW1X 8BH, U.K.

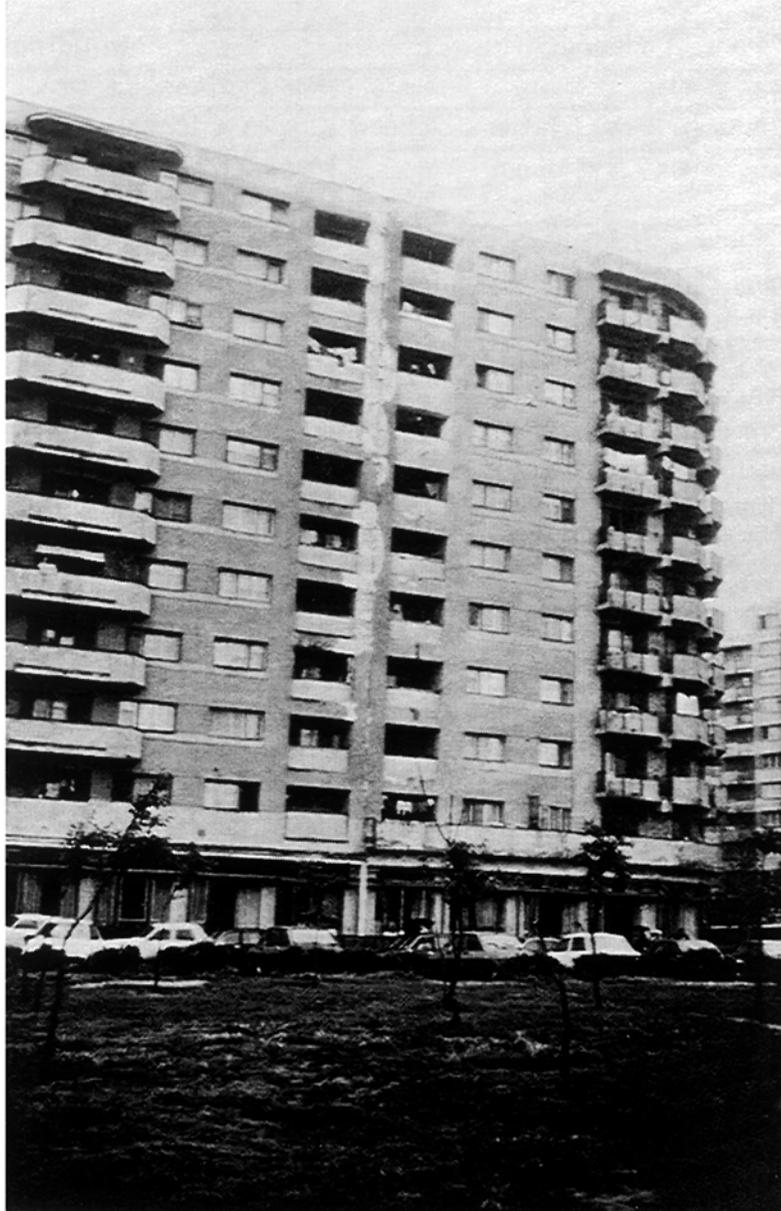
Plate 1: General view of the apartment building Colentina no. 81, Block 84/I. This is where the two Bucharest fatalities occurred due to the collapse of the plasterboard along the seismic gap, as a result of pounding between the two structural parts of the large complex.

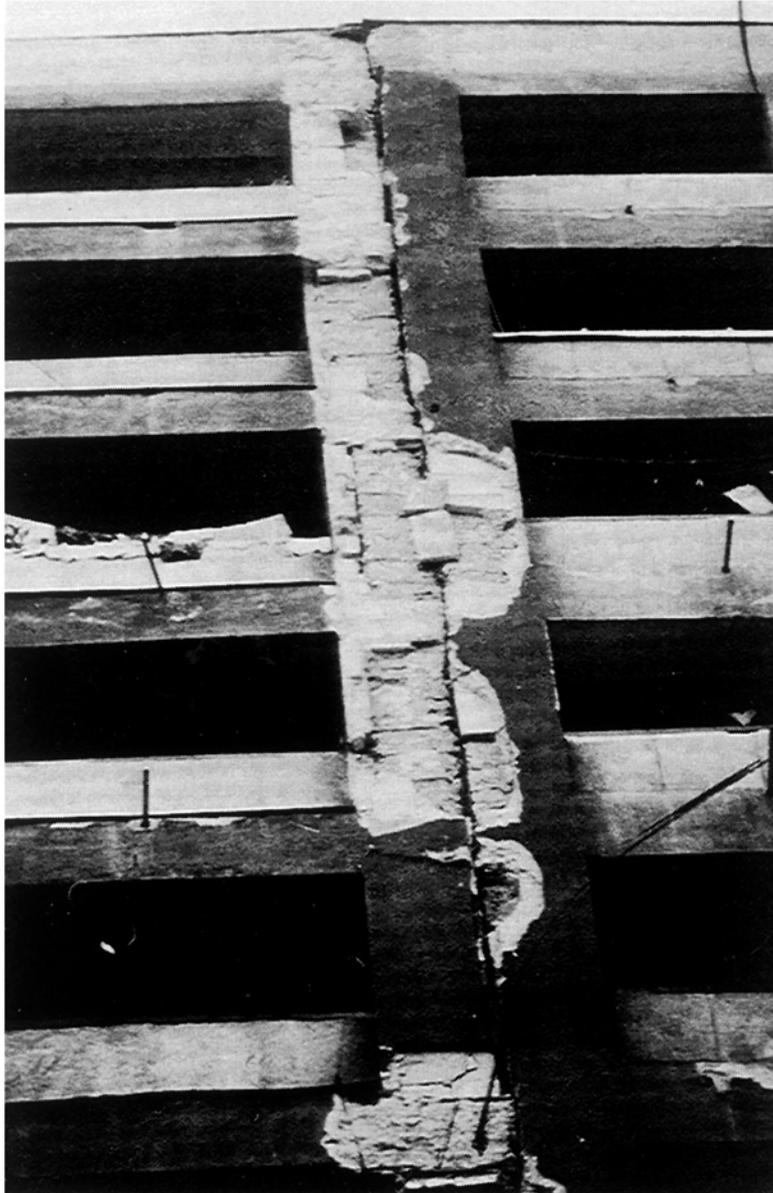
Plate 2: Close view of the collapsed plasterboard along the seismic gap line.

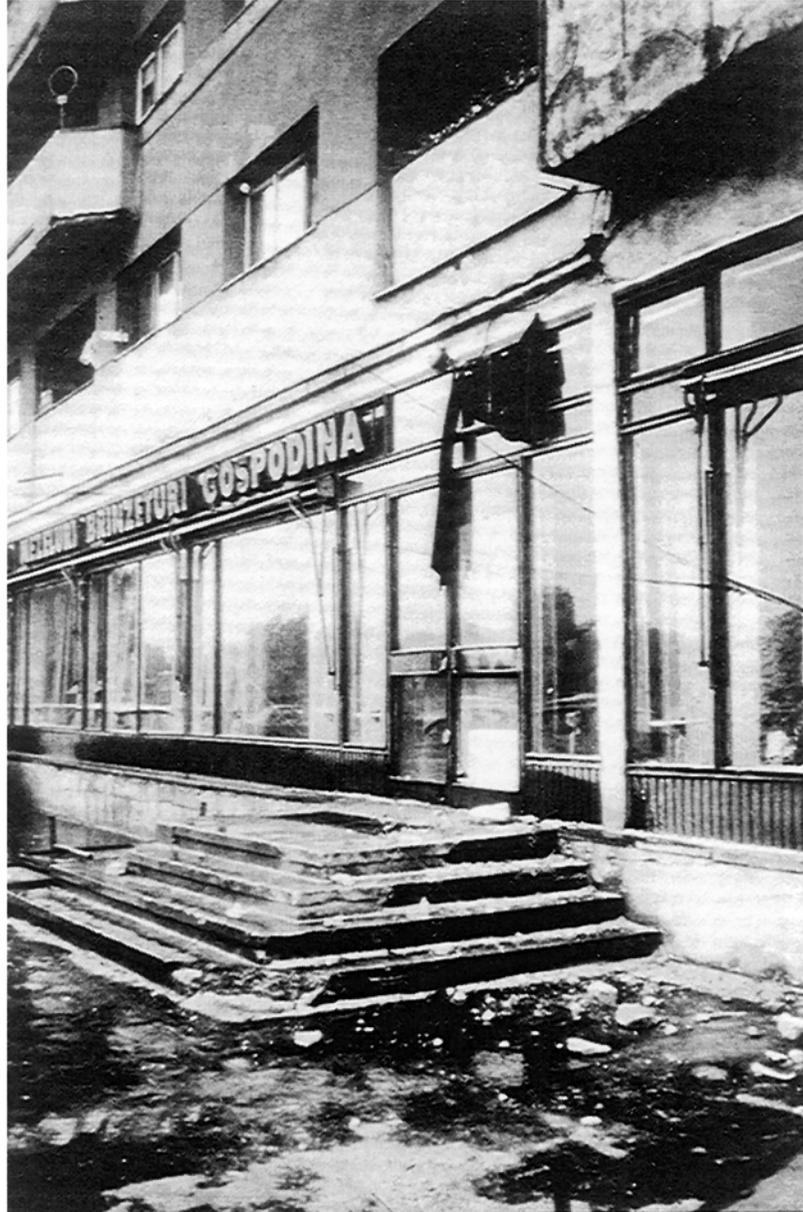
Plate 3: The unfortunate location of the entrance of the store, exactly along the seismic gap line contributed to the death of the two people, who were trying to run out of the building.

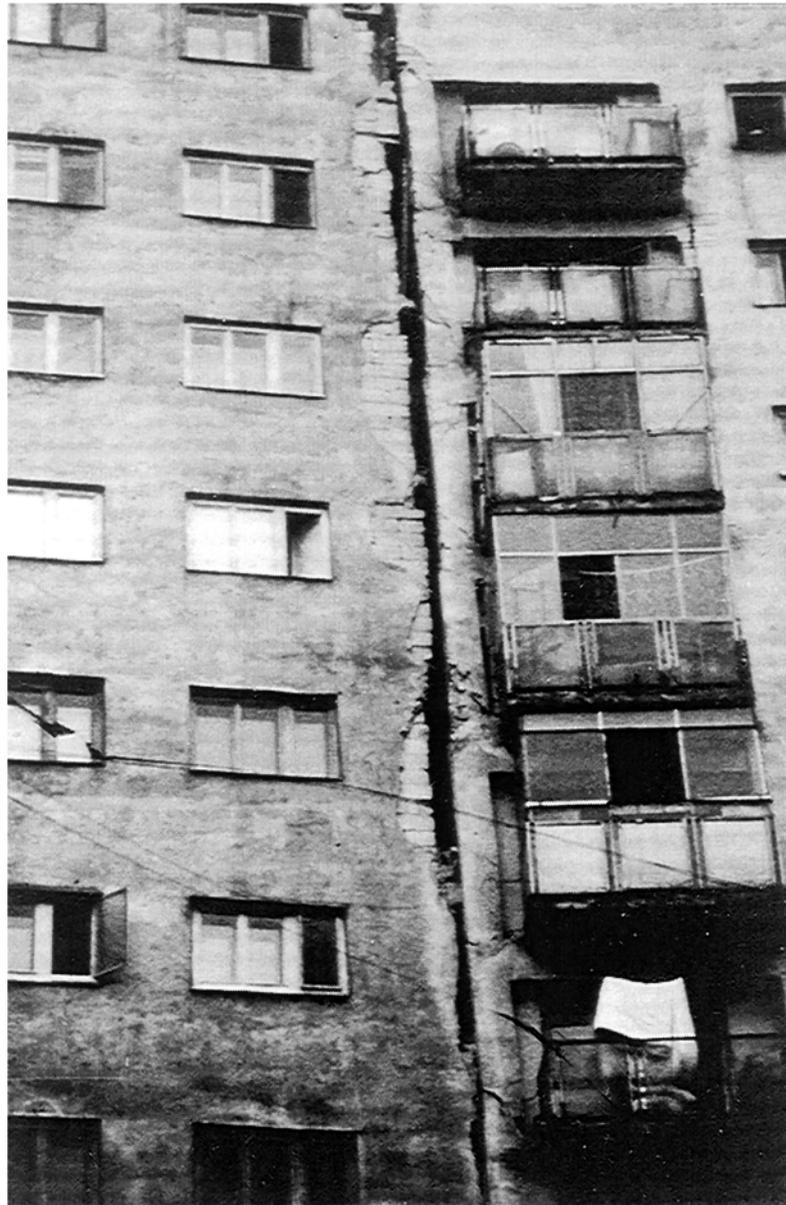
Plate 4: Colentina district, damage down the seismic gap line, due to pounding.

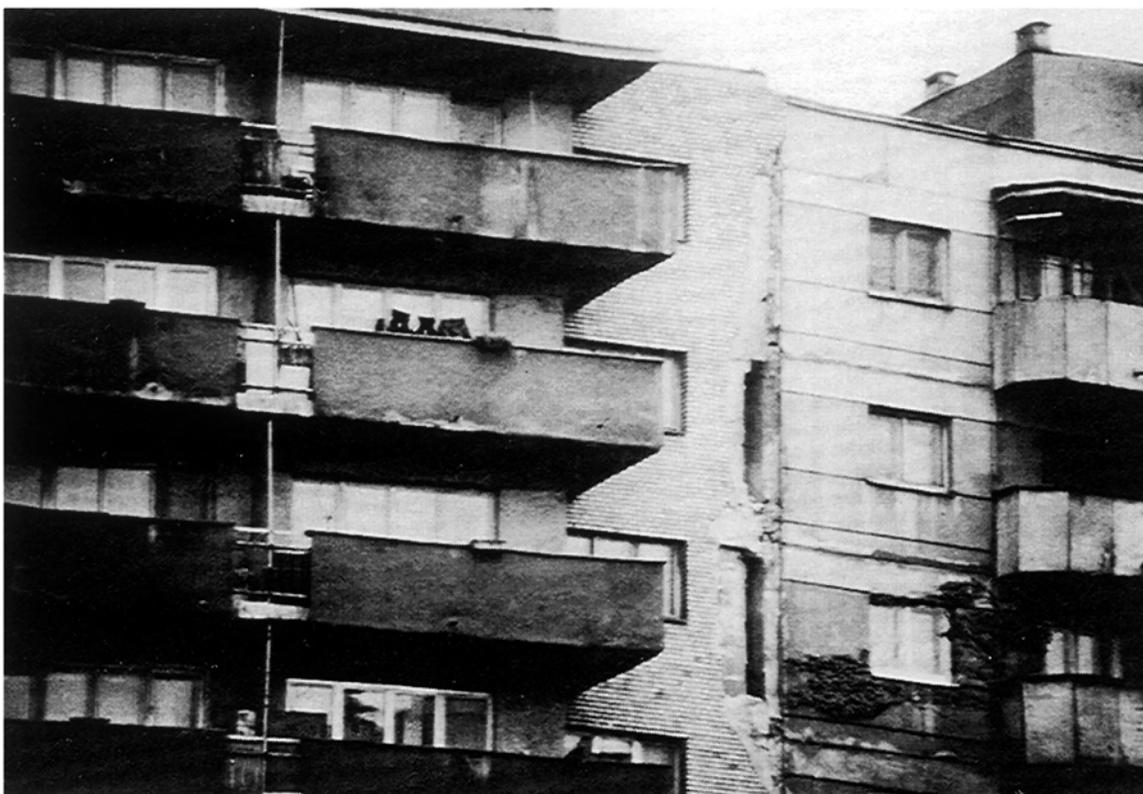
Plate 5: Damage to the expansion joint in another part of Bucharest.

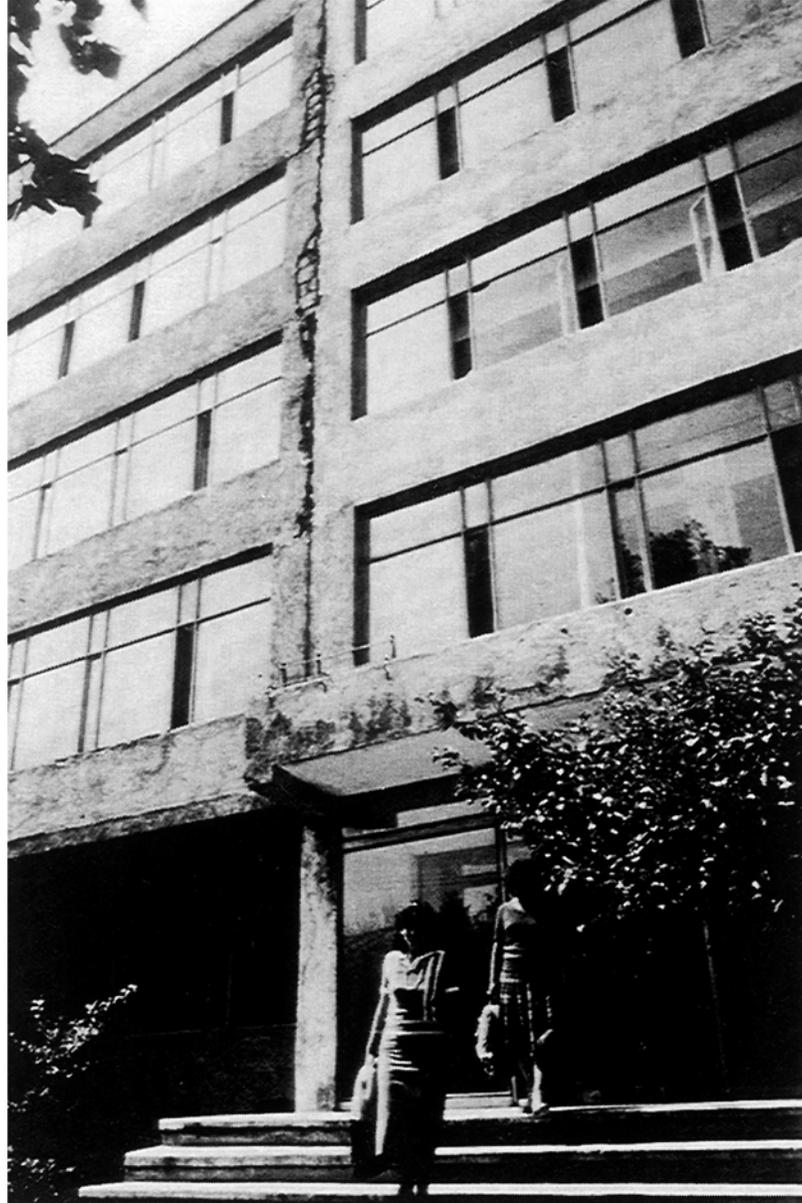
Plate 6: Similar damage down the seismic gap line, in the town of Buzau, 78 km from the epicentre. Office of the Local Planning Authority, opposite to the strong motion observation station of Buzau.

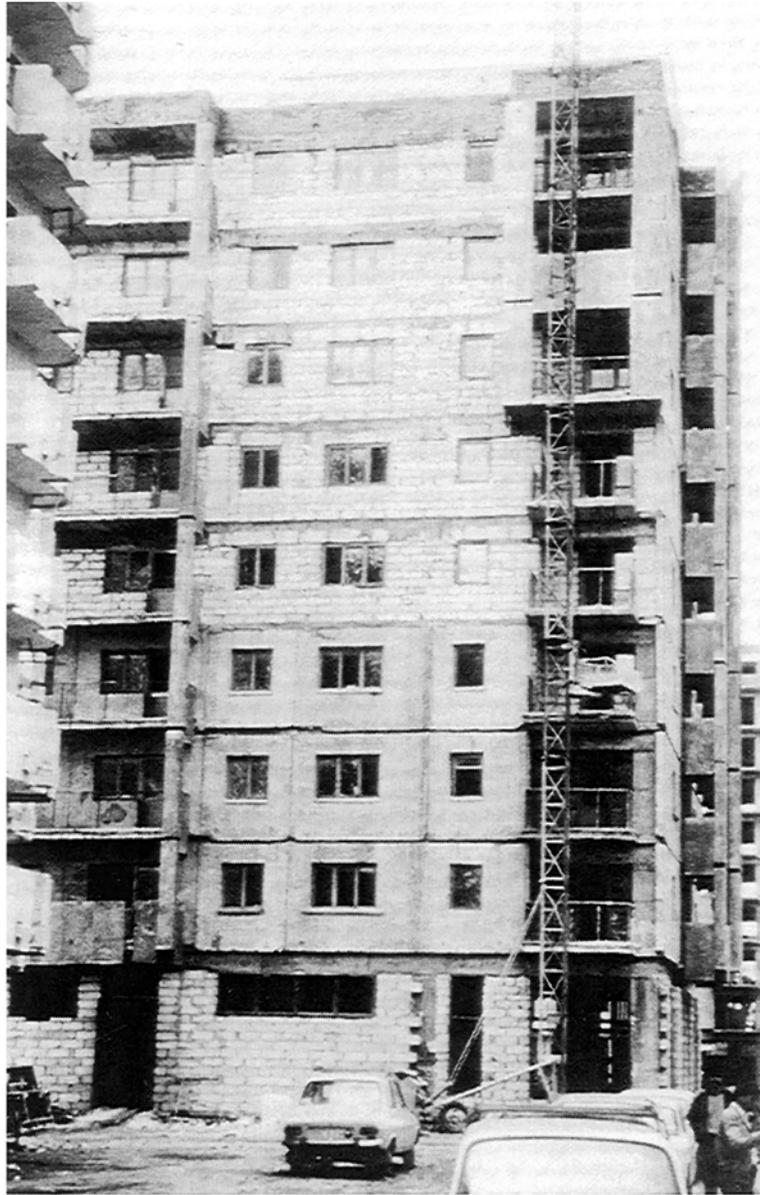
Plate 15: Three types of frame infill in a single building due to material supply shortage (Location: Focsani).

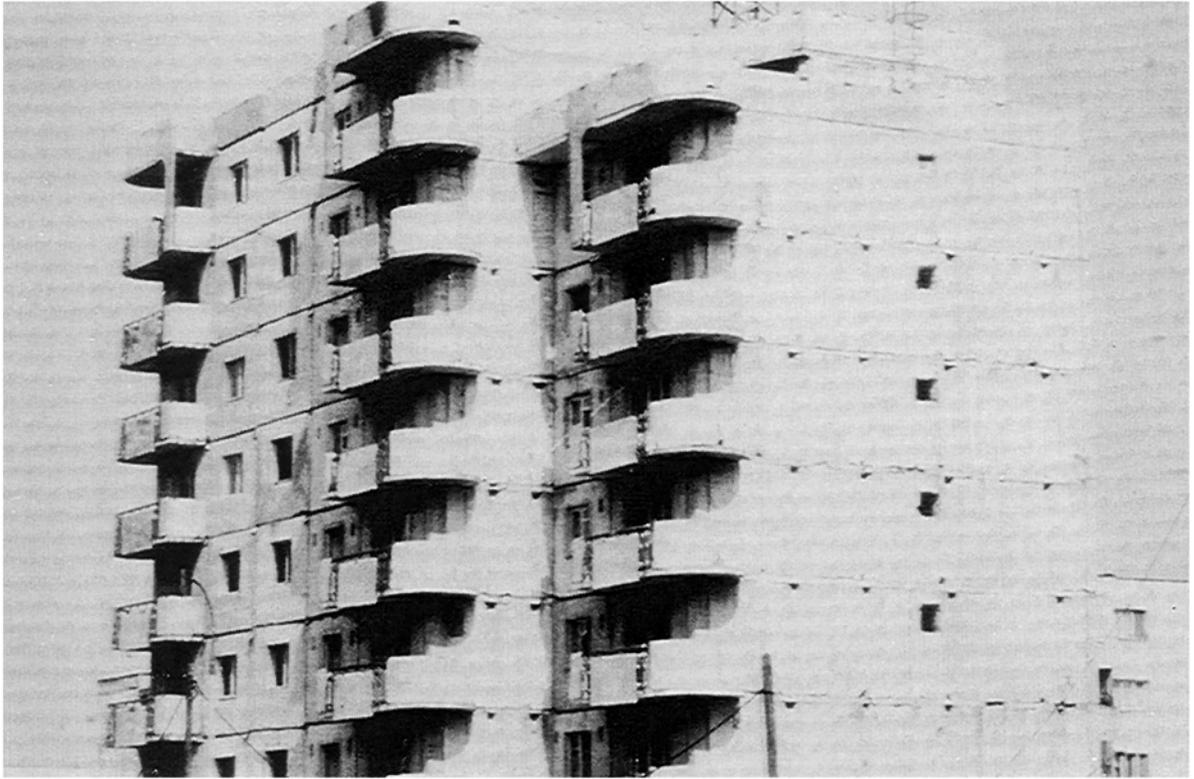
Plate 18: RC large panel construction before plastering. Notice the poor details in the connections.

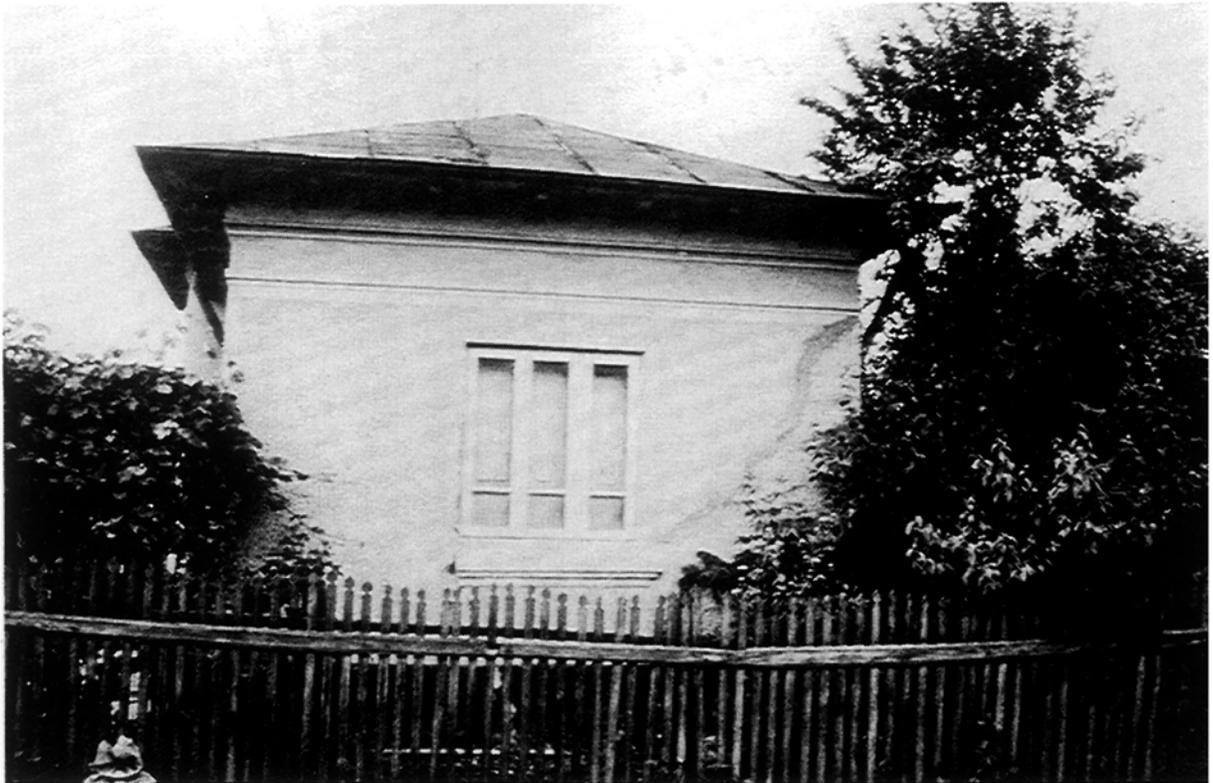
Plate 21: Evidence of repairs after the 1986 earthquake was widespread (Location: Buzau survey).

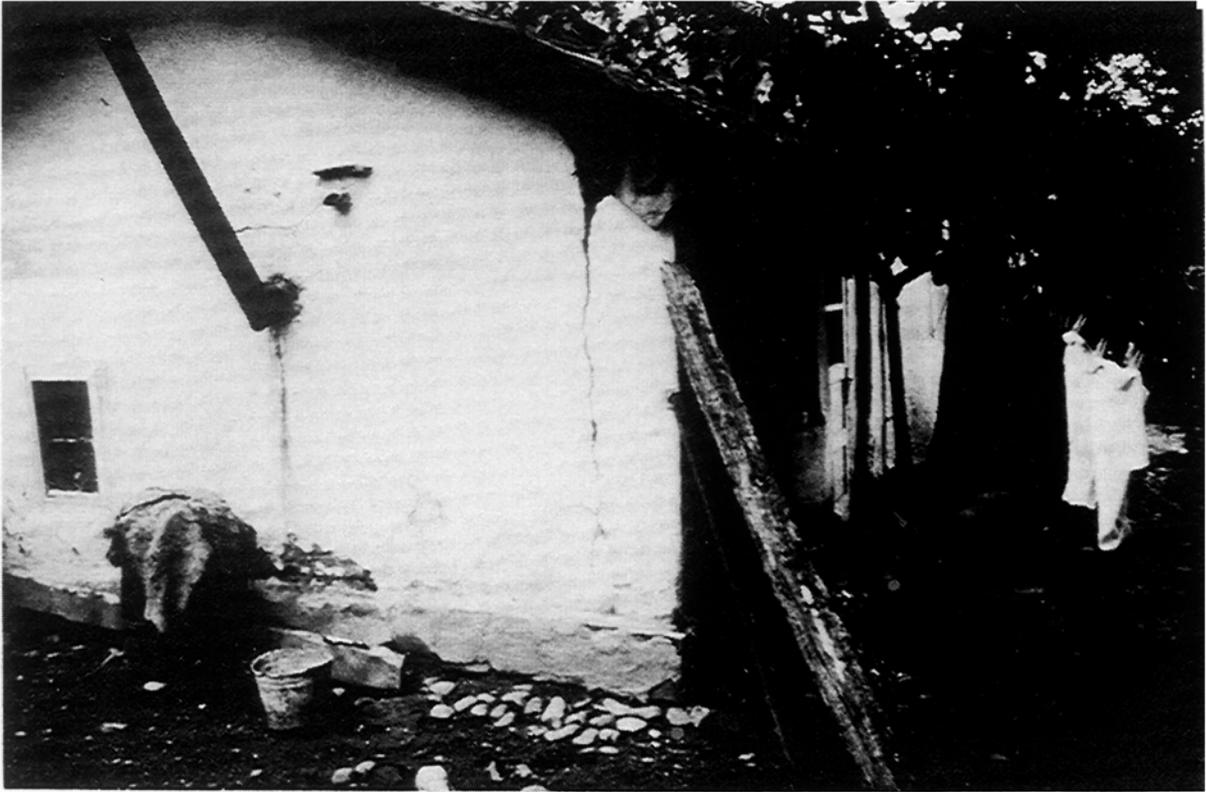
Plate 22: Old adobe house with wall separation (Location: Buzau survey).

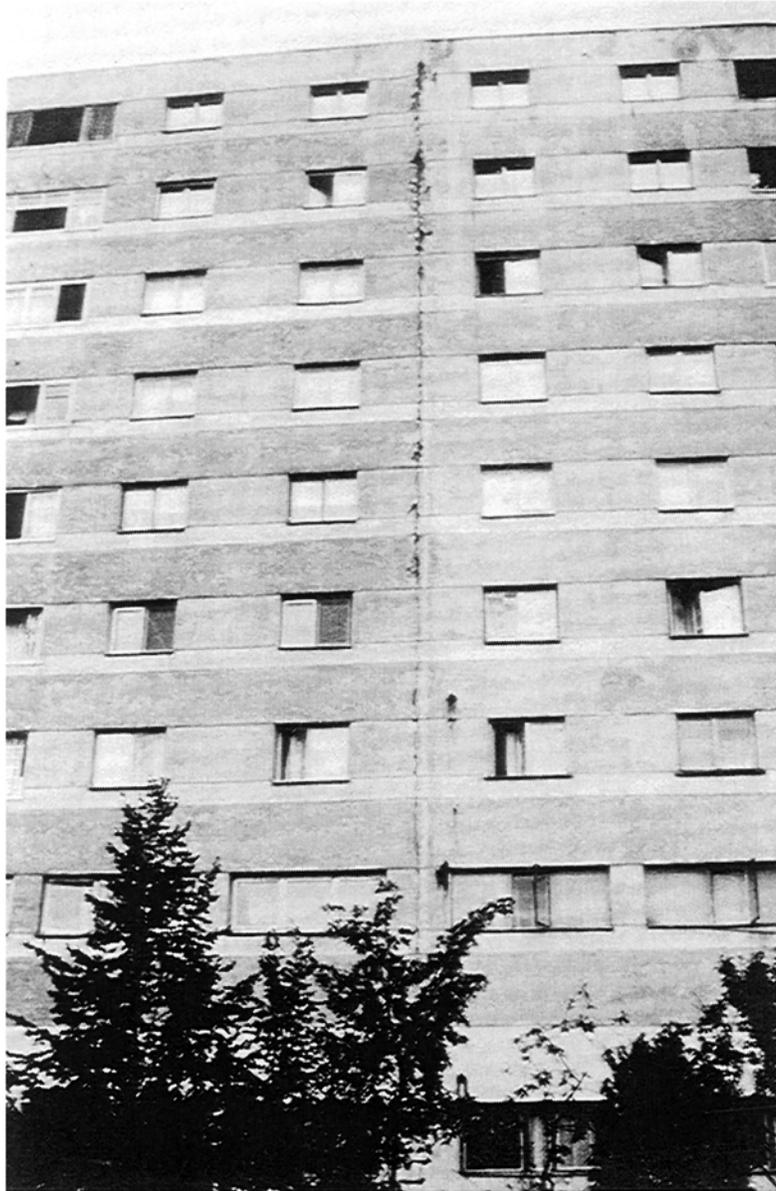
Plate 24: Damage to the expansion joint (Location: Buzau survey).

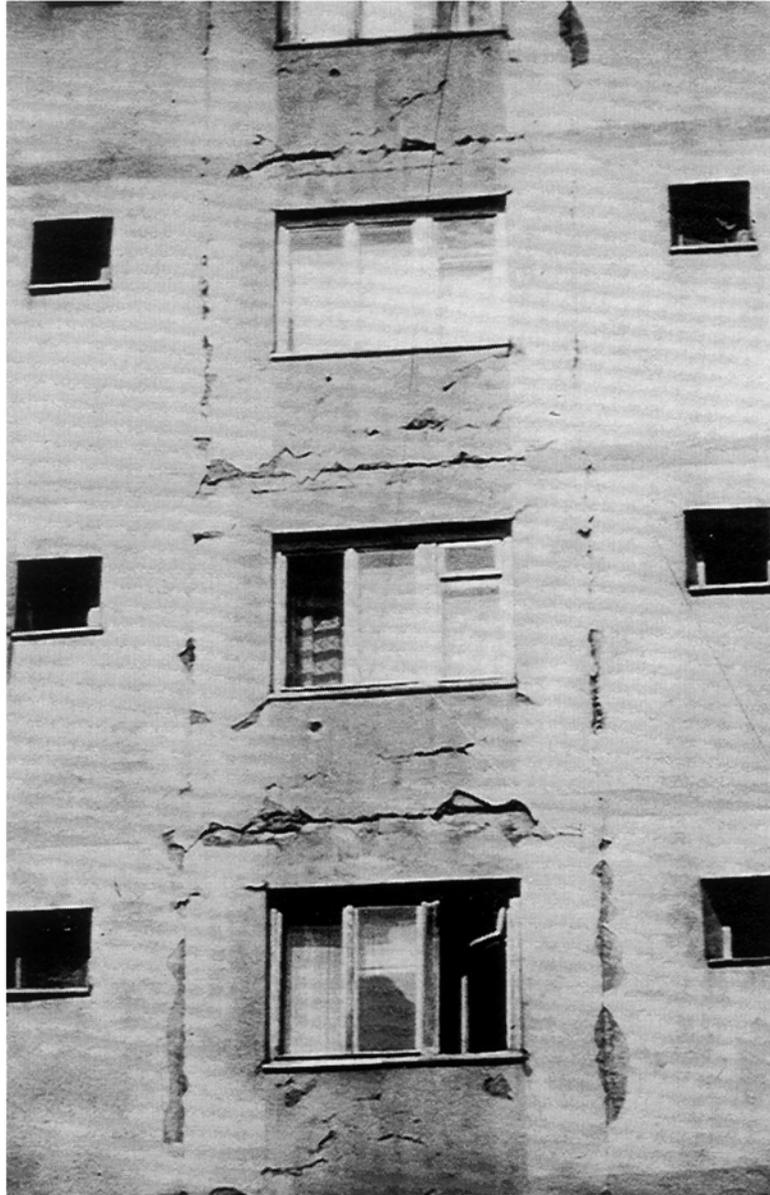
Plate 25: Widespread cracks around the panel perimeter (Location: Ploiesti survey)

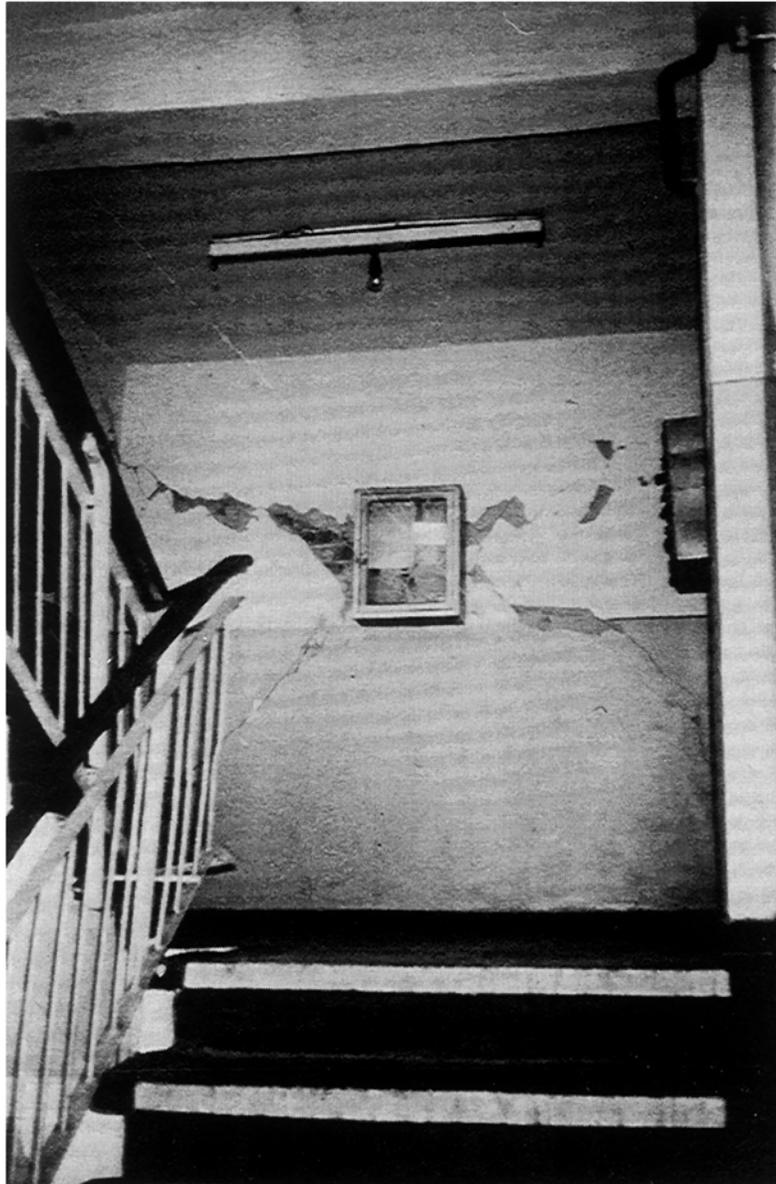
Plate 26: Diagonal cracks in the infill masonry (Location: Buzau survey).

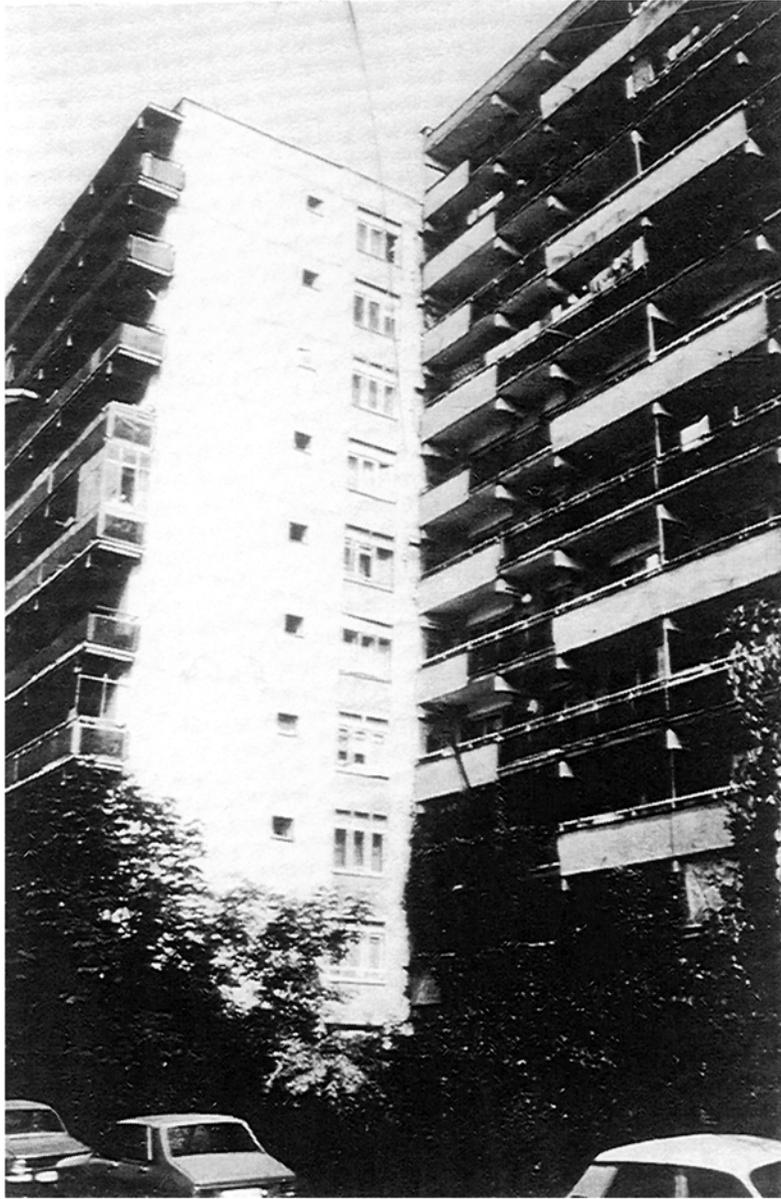
Plate 27: Ploiesti survey: the building where the strong motion instruments were installed. For a close view of the damage see Plate 28.

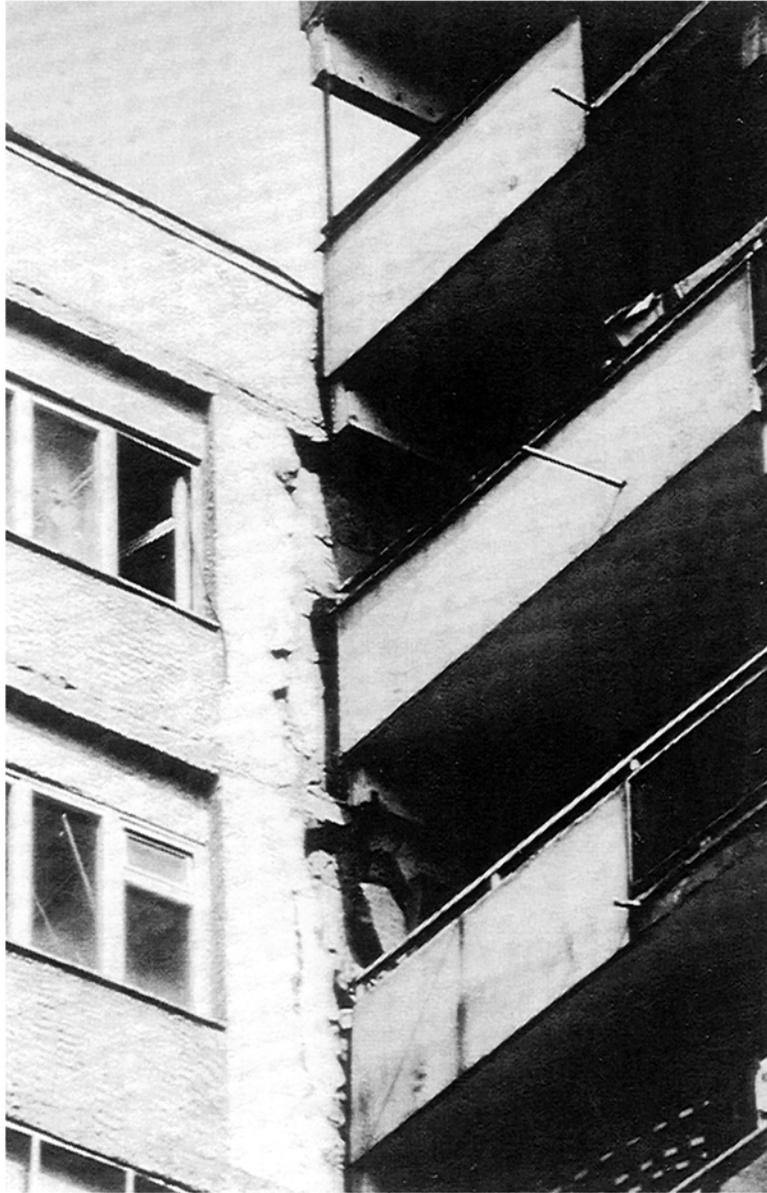
Plate 28: Close view of the damage due to pounding between the two structural parts of different shape and height.
