**THE WENCHUAN, CHINA EARTHQUAKE
OF 12 MAY 2008**

A PRELIMINARY FIELD REPORT BY EEFIT

**Matthew Free
Tiziana Rossetto
Navin Peiris
Fabio Taucer
Bin Zhao
Raymond Koo
Jung Wang
Xianfeng Ma
Enrica Verrucci**

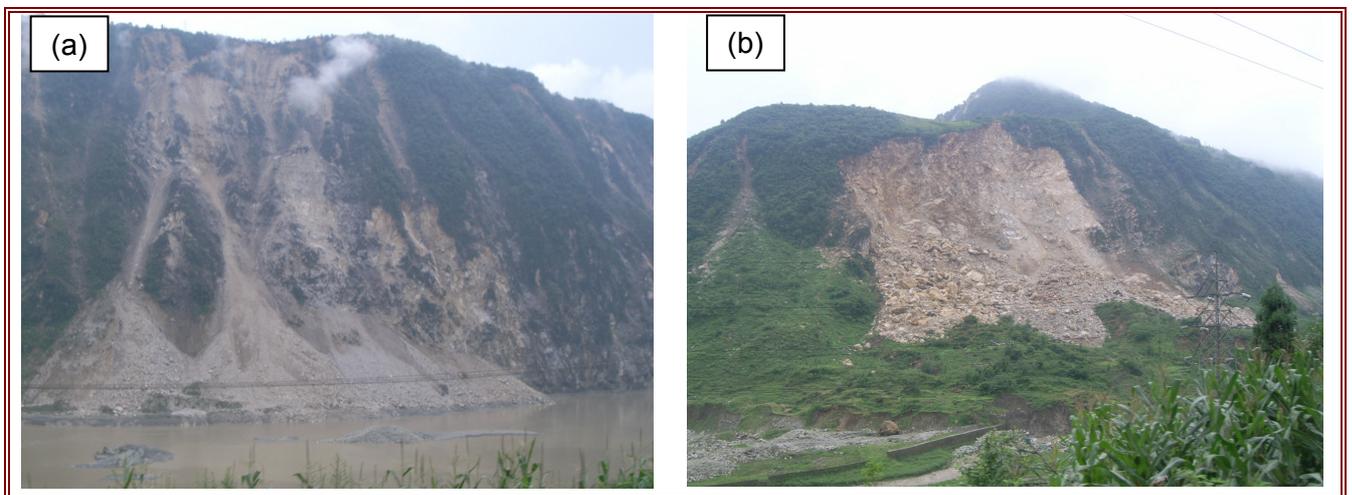
The landslides observed were predominantly shallow rock and debris slides and rock falls on very steep hillsides (45° to 75°) where the shallow soil and weathered rock overlying more competent rock had failed due to the ground shaking. Further landslides are interpreted to have been triggered on slopes near failure due to aftershocks and most commonly the wet weather conditions in the weeks and months following the event. Figure 3.1 shows typical shallow rock and debris slides observed near Ying Xiu. The rock type was interpreted to comprise jointed, limestone, and calcareous siltstones and sandstones. Several deeper landslides (10 to 30 m thick) were also observed where the slip surfaces occur within the fractured rock mass along pre-existing discontinuities. Landslides were observed in a wide range of rock types including sandstones, siltstones, granite and metamorphic rock such as shales and phillites.

Figure 3.1 (a) Shallow slip landslide involving the surficial soils (b) Deep slip landslide mobilizing the fractured rock mass. Both hillsides are approximately 300m high.

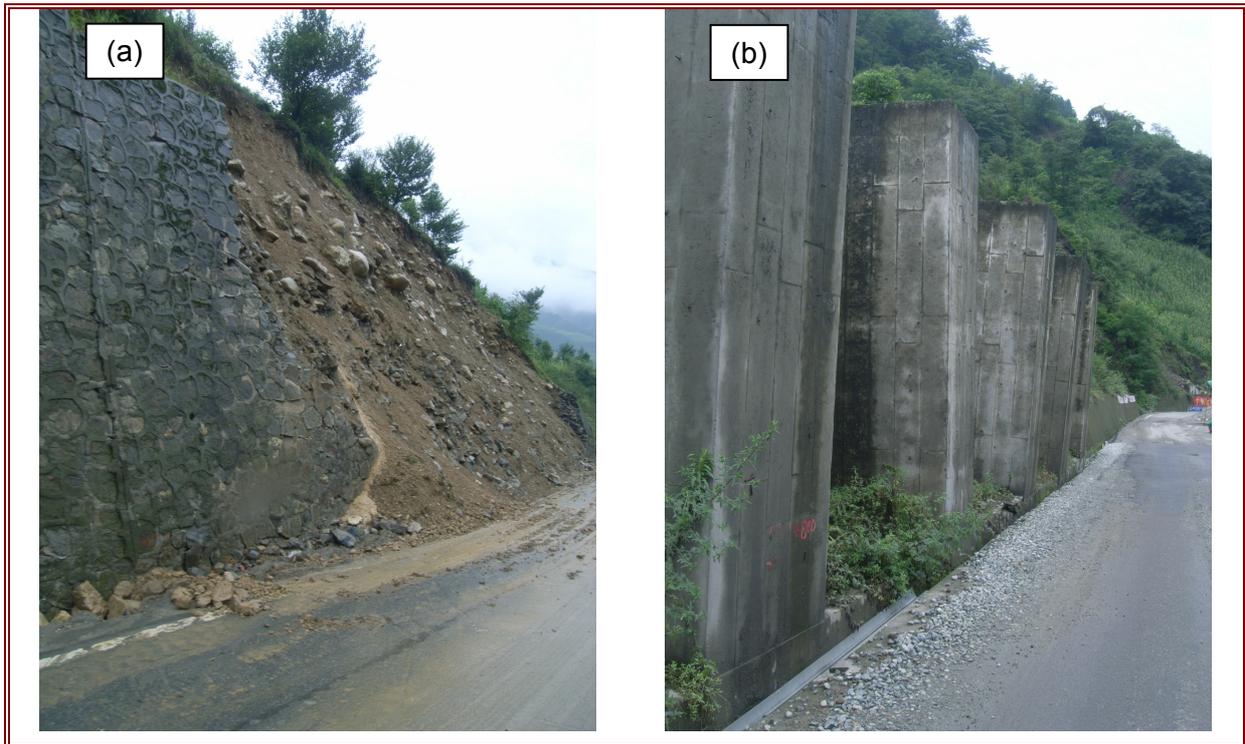
survey. Figure 3.2(b) shows an RC bored pile retaining wall stabilizing a pre-existing landslide and only experienced a stable head displacement of about 15cm, hence the road was unaffected.

Figure 2.2 (a) Collapsed section of stone gravity retaining wall near Ying Xiu (b) Displaced section of RC bored pile retaining wall stabilizing a pre-existing landslide to protect the road, near Ying Xu.

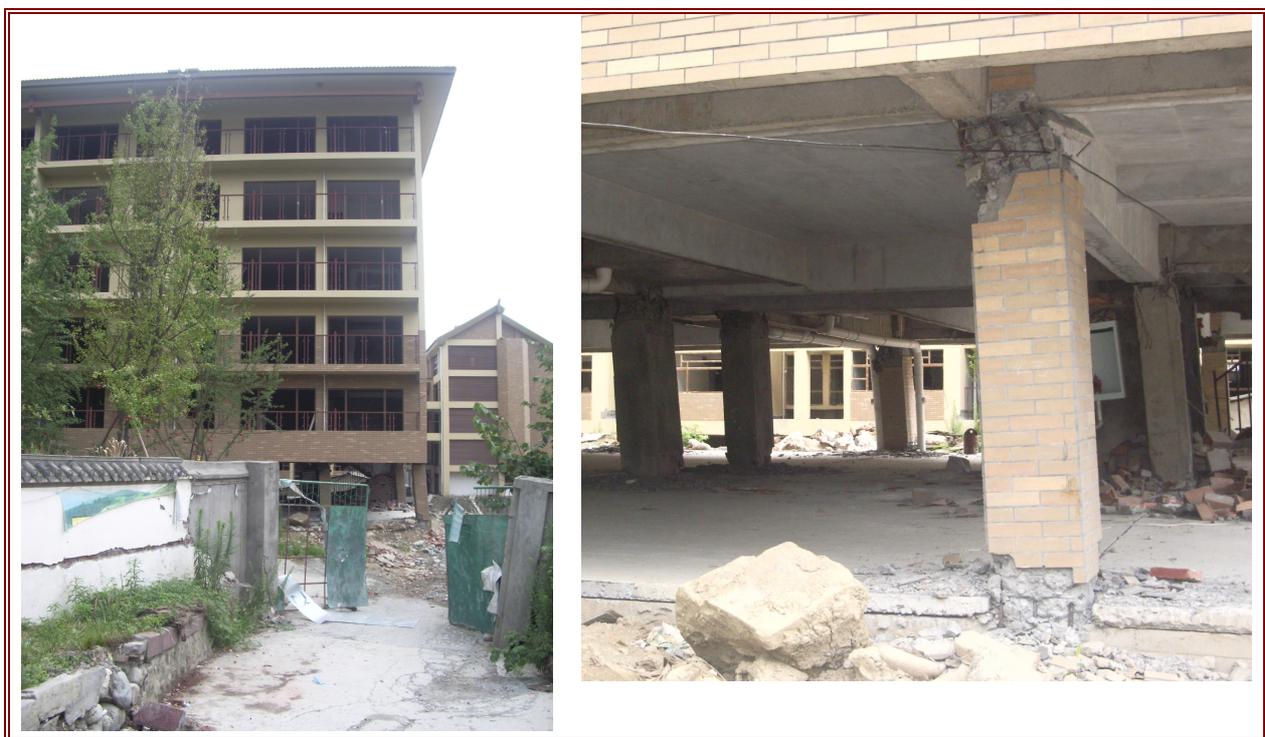
The performance of the mid-rise RC MRF varied substantially according to location. No difference was observed between the performances of buildings built to different codes, due to the predominance of soft-storey type failure even in those designed to the most recent code. For example, the Yazhouyan housing development in Dujiangyan composed of 27 buildings between 4 and 6 stories in height. Construction of these buildings began in 2006 and some were still under construction at the time of the earthquake. These structures are founded on very stiff soil with driven pile foundations of 300-400mm diameter and 900kN maximum axial capacity. Although designed to the most recent Chinese seismic code, about 70% of the structures had suffered some degree of damage with many suffering soft-storey failure at either the ground or first floor, mainly due to non-consideration of the added stiffness due to the presence of infill. Figure 4.1 shows a typical example where this type of failure was also precipitated by the presence of reinforcement bar splices in plastic hinge zones and inadequate confinement reinforcement. Overall, RC MRF performed well and achieved life-safety performance despite the fact that the reported ground motions are much larger than the design values for the area. Part of this good performance is however attributed to the fact that construction of these buildings in China is as terraces. Multiple residences are built attached to each other and often act as a single structure with greater seismic resistance.

Figure 3.1 Six-storey RC MRF in Yazhouyan housing development, Dujiangyan that is exhibiting a soft-storey failure mechanism at ground storey (detail of ground floor columns, right).

From observation of the performance of reinforced concrete moment resisting frames it is clear that soft ground-storey modes of failure were a problem. These resulted from uneven distribution of infill walls between the ground and upper stories of structures. This has been seen as a major problem in many past earthquakes around the world, and provisions should be taken to guide the placement of infill in seismically designed structures to avoid occurrence of stiffness irregularities. Furthermore, more stringent detailing criteria for the curtailment of reinforcement bars need to be enforced.

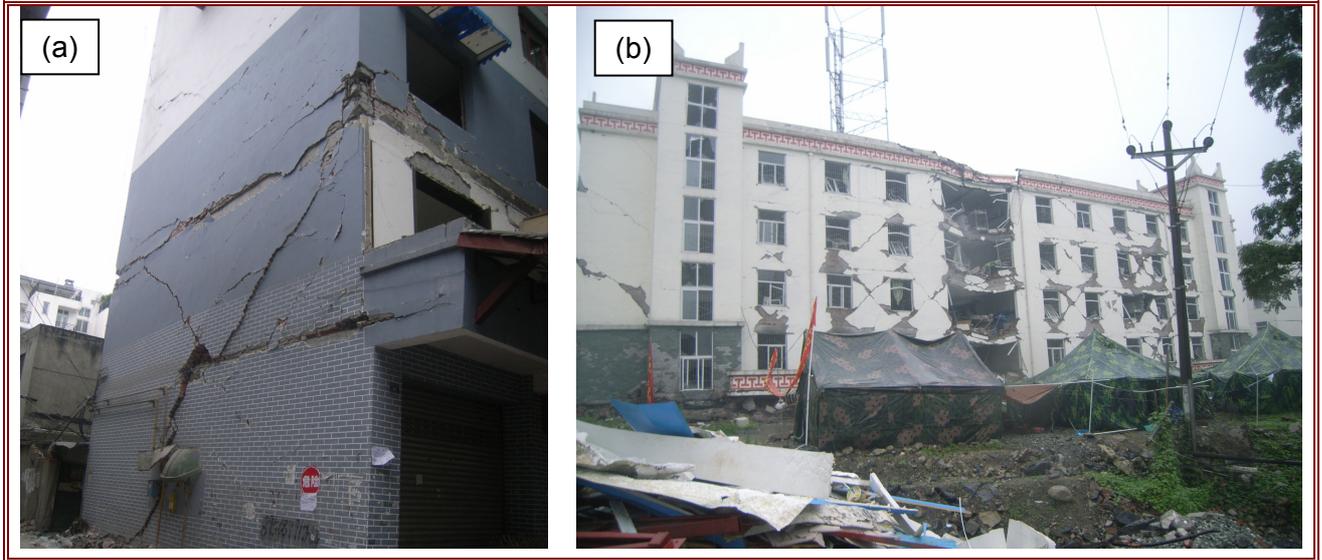
In Sichuan, unreinforced masonry construction is used for residential as well as commercial buildings. In towns these buildings are typically 1-2storey where the ground floor is used for commercial purposes and the upper floor for residential. There are some masonry structures built to 4-storeys or higher for commercial, residential and for schools. In the rural areas, masonry structures are largely residential and of single storey. The performance of masonry structures was seen to depend on their location with respect to the epicentre. The 1-2storey masonry structures in Dujiangyan generally performed well, probably because of terraced construction giving greater seismic resistance. Failures of this type of structures involved shear cracks running through the masonry bearing walls and damage to masonry columns. Figure 4.2(a) shows a 5-storey commercial structure appears to be using masonry bearing walls through confined masonry construction in Dujiangyan. The end bearing walls have experienced large diagonal shear cracks running through the RC beam and exposing a column section. Figure 4.2(b) shows a 5-storey masonry school building in Ying Xiu that has a

collapsed ground floor and collapsed section of the building through all the floors. The masonry houses in rural areas performed badly, most houses having collapsed or suffered damage beyond repair.

Figure 4.2 (a) 5-storey confined masonry building in Dujiangyan with shear cracks on bearing walls, (b) 5-storey masonry school building in Ying Xiu partially collapsed.

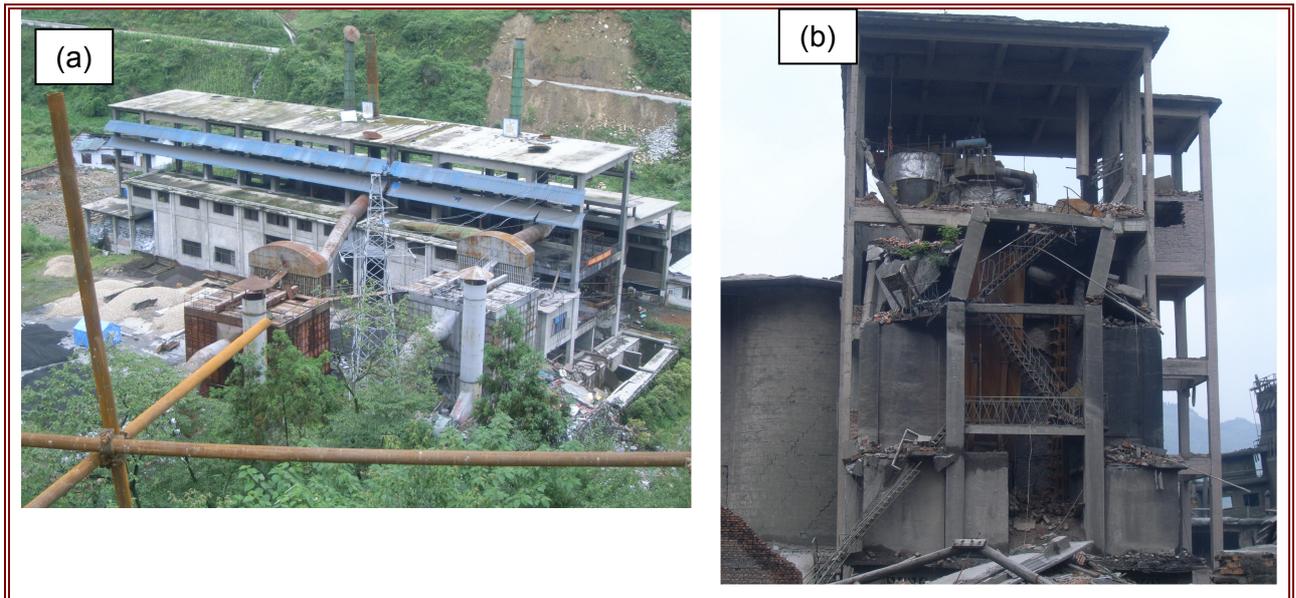
A few industrial facilities were visited in rural areas closer to the epicenter. These are of older construction than those observed in Chengdu and suffered substantial damage. Figure 4.3(a) shows a cement processing factory that was out of action following the earthquake. The building structure appears to be intact but there may have been damage to the equipment since the factory was not operational at the time of the survey. Figure 4.3(b) shows a cement manufacturing plant with damaged structures at several locations at the site. There were damages to masonry silos ranging from shear cracks to collapsed section of one silo. Factories such as these, sited in rural towns, were the main source of employment for local people, and also provided them with accommodation. Hence, the closure of these factories has a huge impact on the recovery of the local communities.

Figure 4.3 Damaged cement factories in (a) Ying Xiu and (b) Xiao Yu Dong.

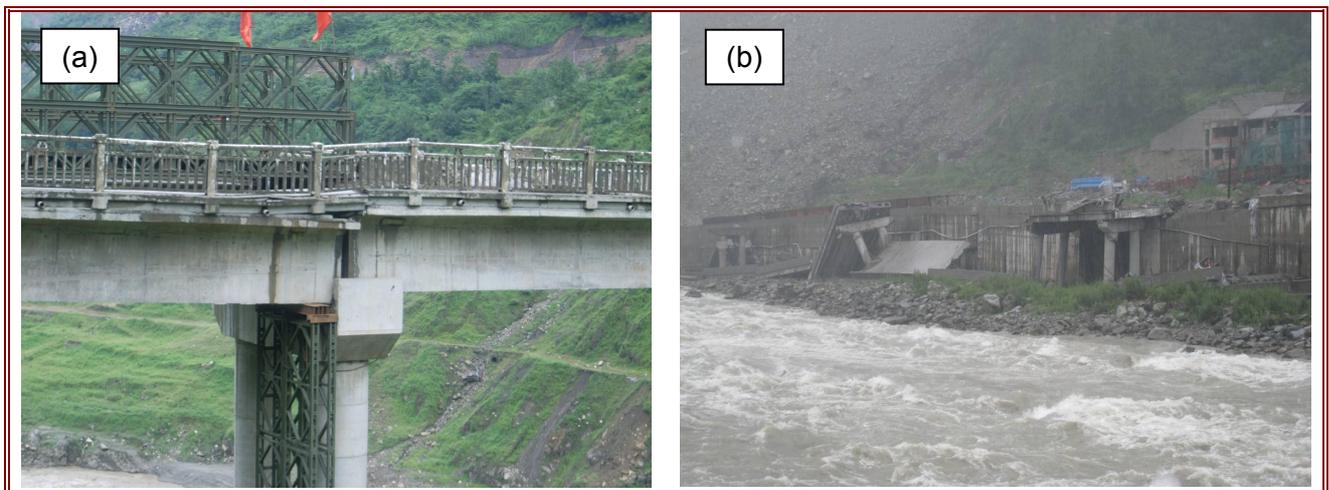
The EEFIT team inspected about 10 bridges along the road between Dujiangyan City to Ying Xiu town. Most of the bridges are damaged due to horizontal accelerations during the earthquake and were associated to one of the following patterns (see Figures 5.1 and 5.2):

- (a) Loss of support in the superstore in the longitudinal direction
- (b) Damage of parapets in the transverse direction, resulting from pounding of the superstructure after sliding with respect to the pier in transverse direction
- (c) Damage due to rotation of the deck on the horizontal plane, due to differential ground settlements or to differences in the stiffness of piers and abutment
- (d) Damage due to rock fall, landslides and loss of support of the bridge piers on the foundation

Figure 5.1 Damaged bridges (a) Longitudinal displacement of simply supported beam at Shoujiang Bridge (b) Collapsed bridge viaducts along Mingjiang River in Ying Xiu Town.

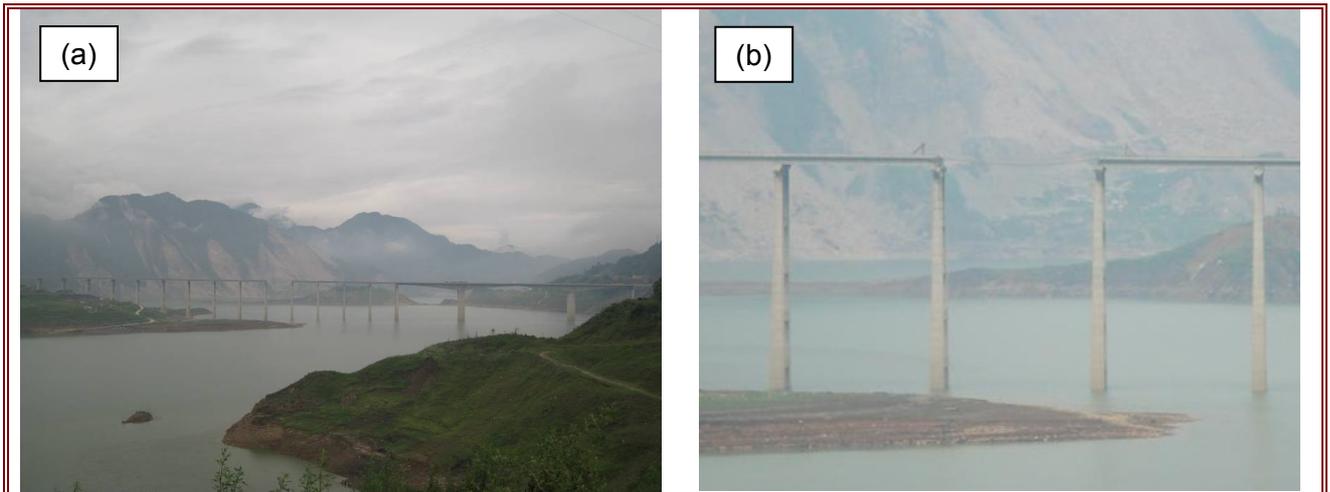
Figure 5.2 Damaged bridges (a) shows Minjiang Bridge crossing the Zipingpu reservoir where one span is unseated. (b) view of missing span.

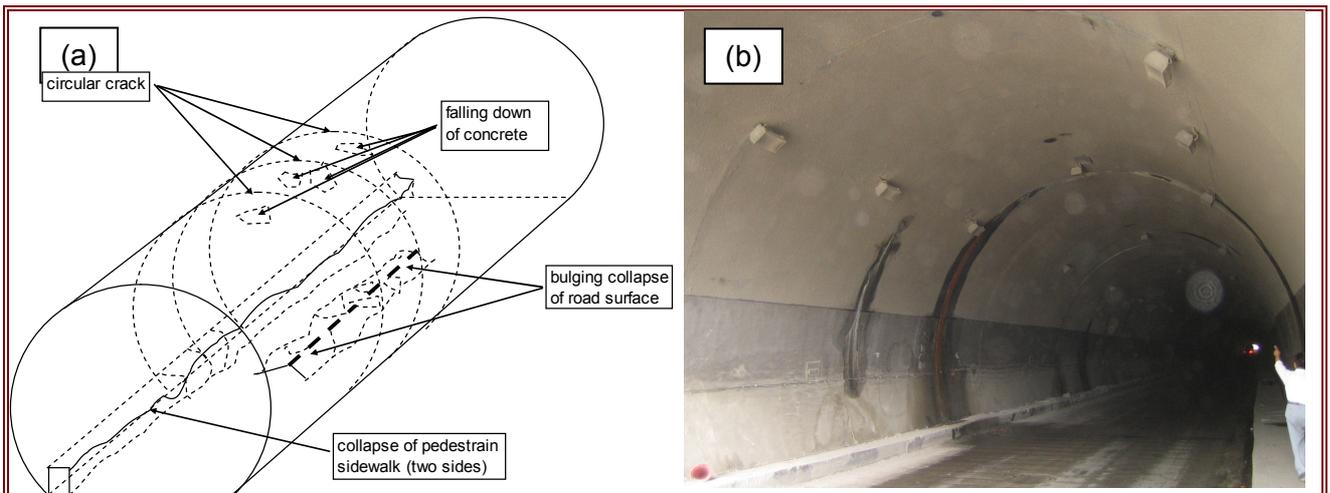
Damage to tunnels was also observed (Figure 5.3). Damage and obstruction of tunnel portals was caused by landslides. Damage to sprayed concrete tunnel linings including; longitudinal and circumferential cracking at axis knee and invert level level, bulging of the invert, spalling of concrete from the crown.

Figure 5.3 Damage to Friendship Tunnel (Youyi Tunnel) (a) Location and types of damage including bulging of the invert, spalling from the roof, longitudinal cracks at the axis and knee and cracks and b) circumferential cracks in sprayed concrete lining.

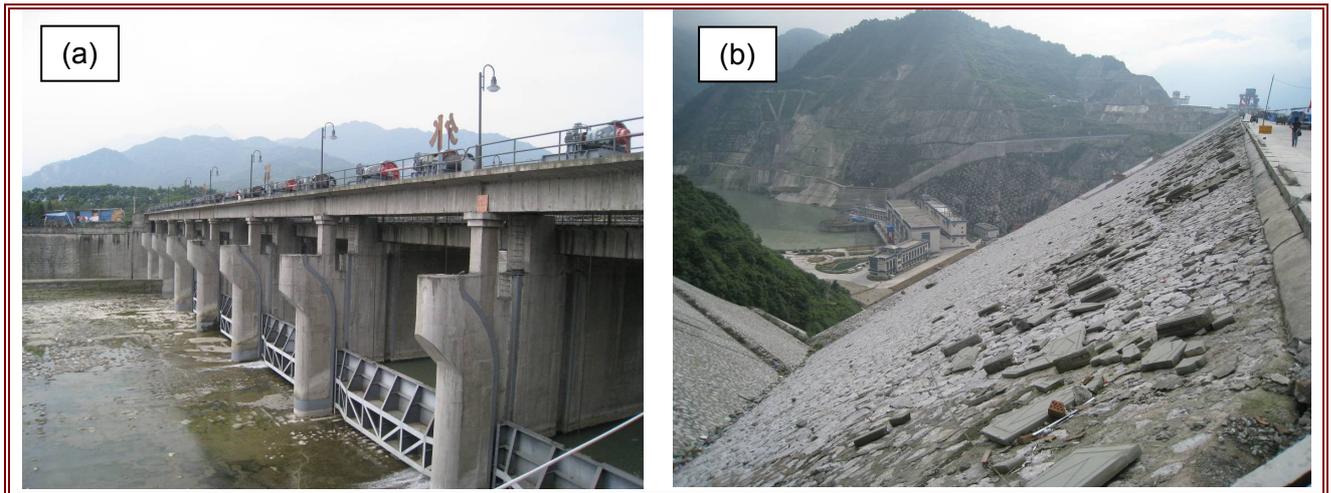
The team visited two dams during the field investigation (Figure 5.4). The Zipingpu dam is located 10km east of the earthquake epicenter. The dam had recorded a maximum vertical settlement and horizontal displacement of 800mm and 300mm, respectively. Differential settlement of the crest could be observed. Cracks of 20mm width and a few meters long were observed on the concrete facing on the upstream side of the dam. Spalling and slight bulging of the masonry facing on the downstream side of the dam was observed in minor areas toward the crest. At the time of earthquake, the stored water only reached one third of designed capacity. The discharge of the reservoir was ordered immediately after the main shock in order to minimize the potential risk to nearby towns and cities.

Damage was also observed at the Dam at the Fish Mouth of the Dujiangyan Irrigation Project. The beam supporting the gates was observed to be laterally offset by approximately 100mm in the downstream direction. Longitudinal cracks were observe in the Fish Mouth diversion embankment.

Figure 5.4 Damage to Dams (a) View of dam at Dujiangyan Irrigation Project Fish Mouth where the beam that supported the dam gates experienced a 100mm lateral displacement in the downstream direction, and b) View of downstream side of Zipingpu Dam where cracking, slight bulging and differential settlement was visible at the crest (the loose slabs visible on the surface are from the collapse of a light-weight pedestrian footpath barrier along the crest of the dam).

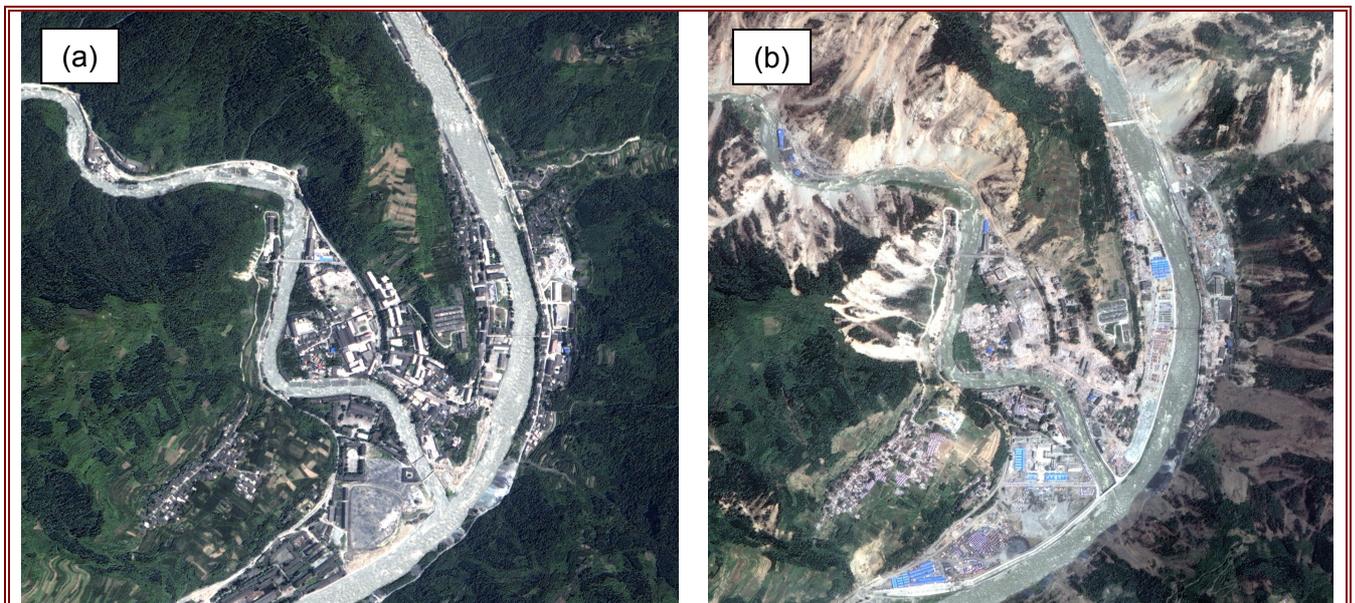
Figure 6.1 Satellite imagery view of Ying Xiu a) pre-earthquake b) post earthquake. The high density of landslides in the post-earthquake image can be clearly seen. (Quickbied Image distributed by Digital Globe)
