# **The Liège Earthquake 8th November 1983**

**Damage Inspection Report  
Volume I**

**Ove Arup & Partners**

Job No. 5270/16  
Ref. No. IOE 84-05  
January 1984

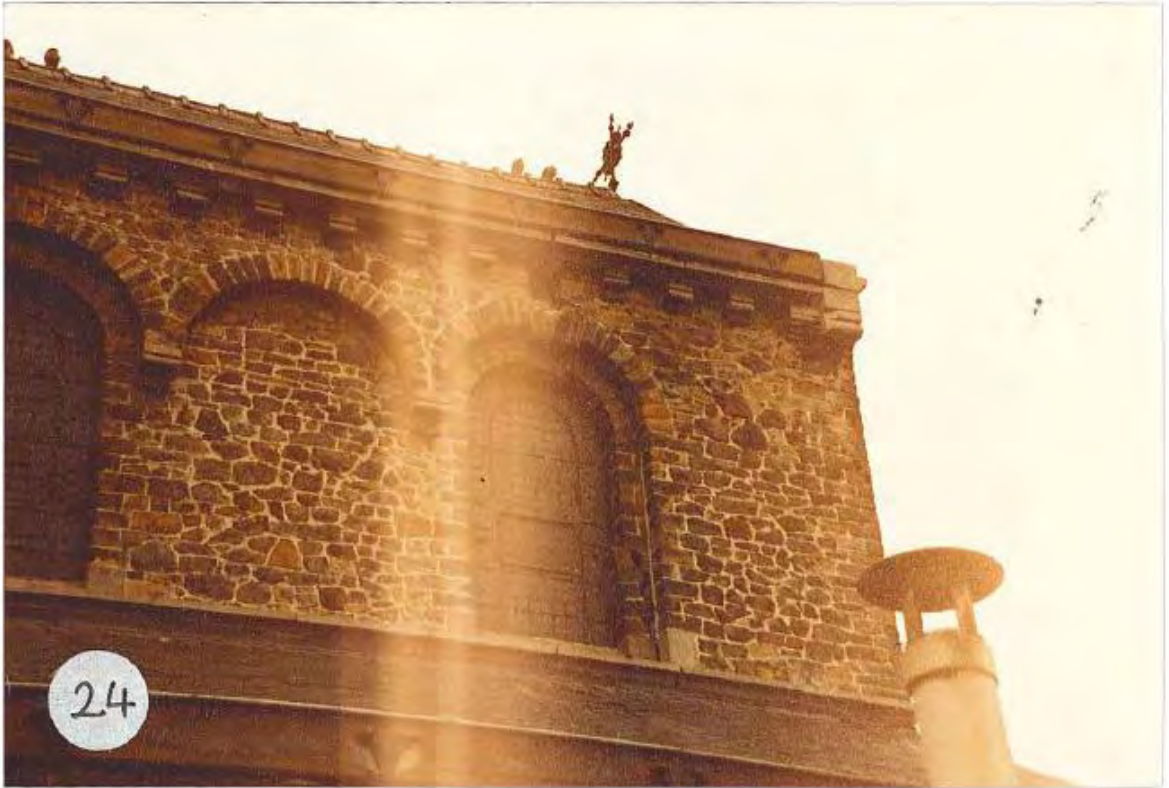
23

23. The church is closed as a safety measure.
24. Eglise St Gille. Displaced capping stone, and vertical crack in east end window.
25. Damaged gable end on brick 3 storey house opposite church (maison de M. le Cure).

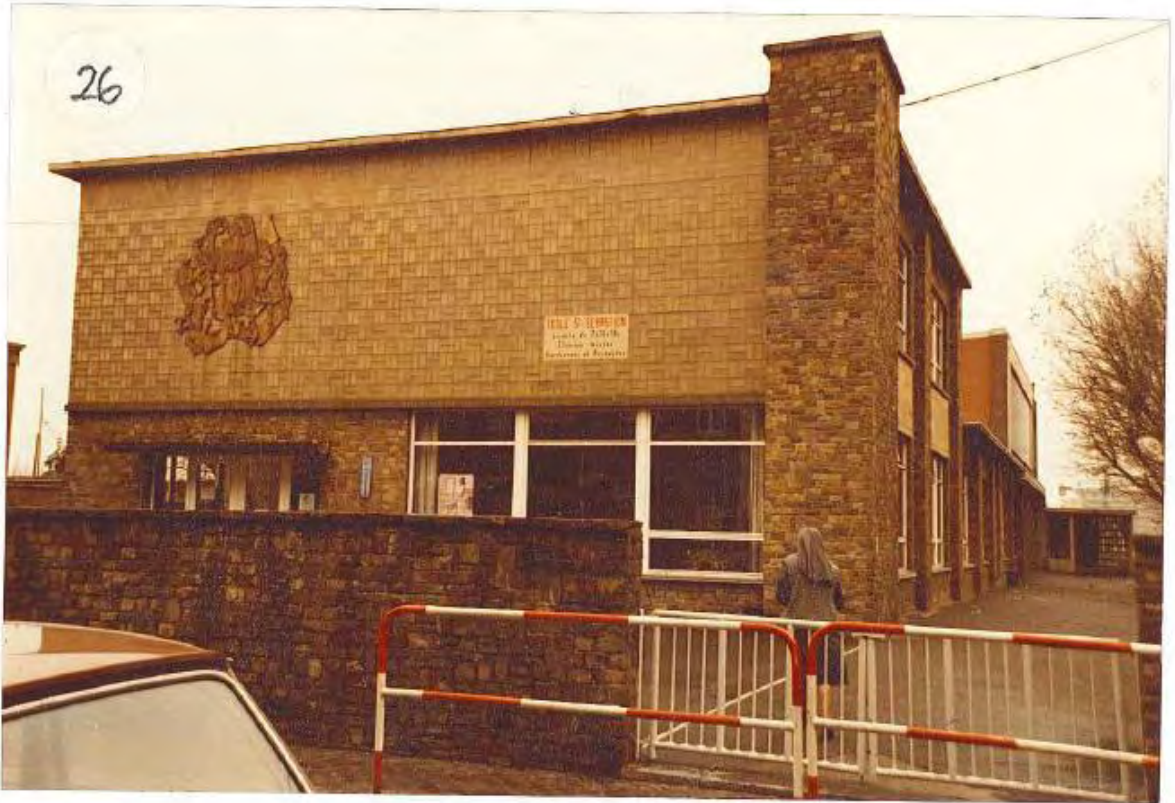
26

26. Ecole St Sebastien next to 25. According to the sister in the picture, a light and a few small windows were broken by the earthquake, but there was no other damage.

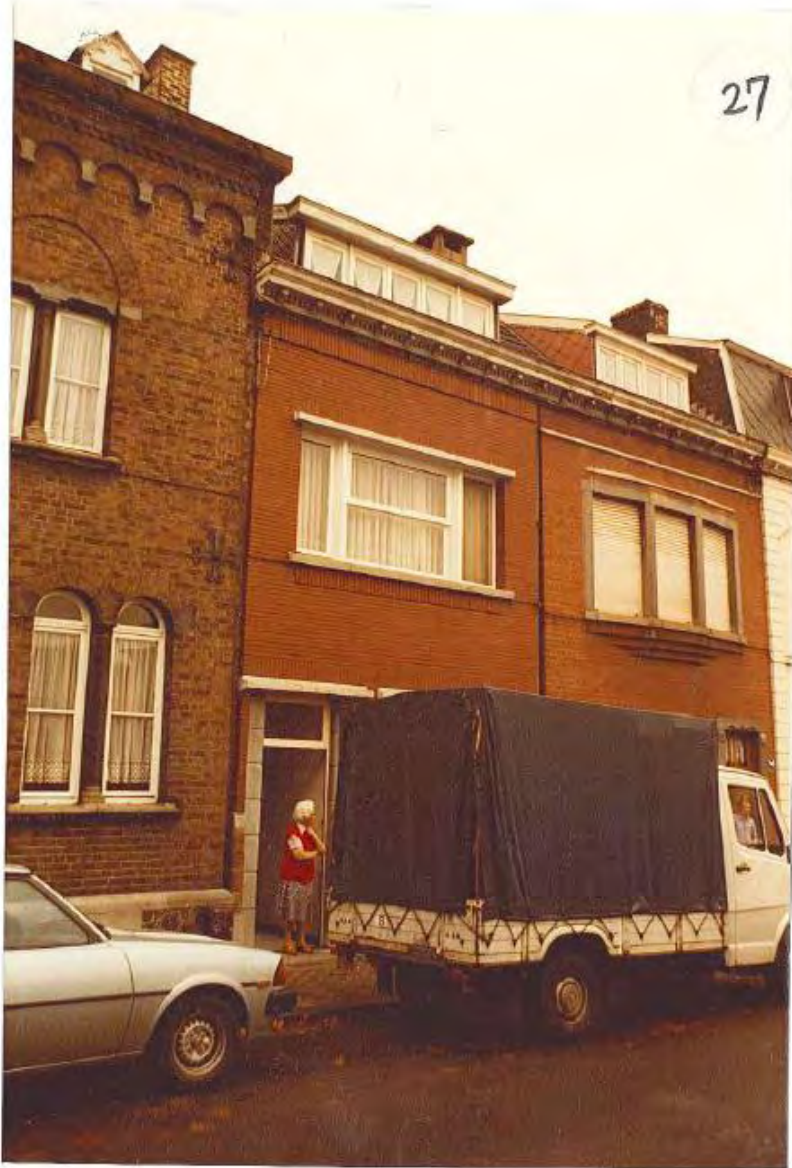
27

27. Houses opposite Ecole St Sebastien. No observable or reported damage, apart from a few small cracks, as reported by householder.
- 28&29 Rue St Nicholas. 5 storey (including semi-basement at back) brick house on steep slope. Reported extensively damaged inside.

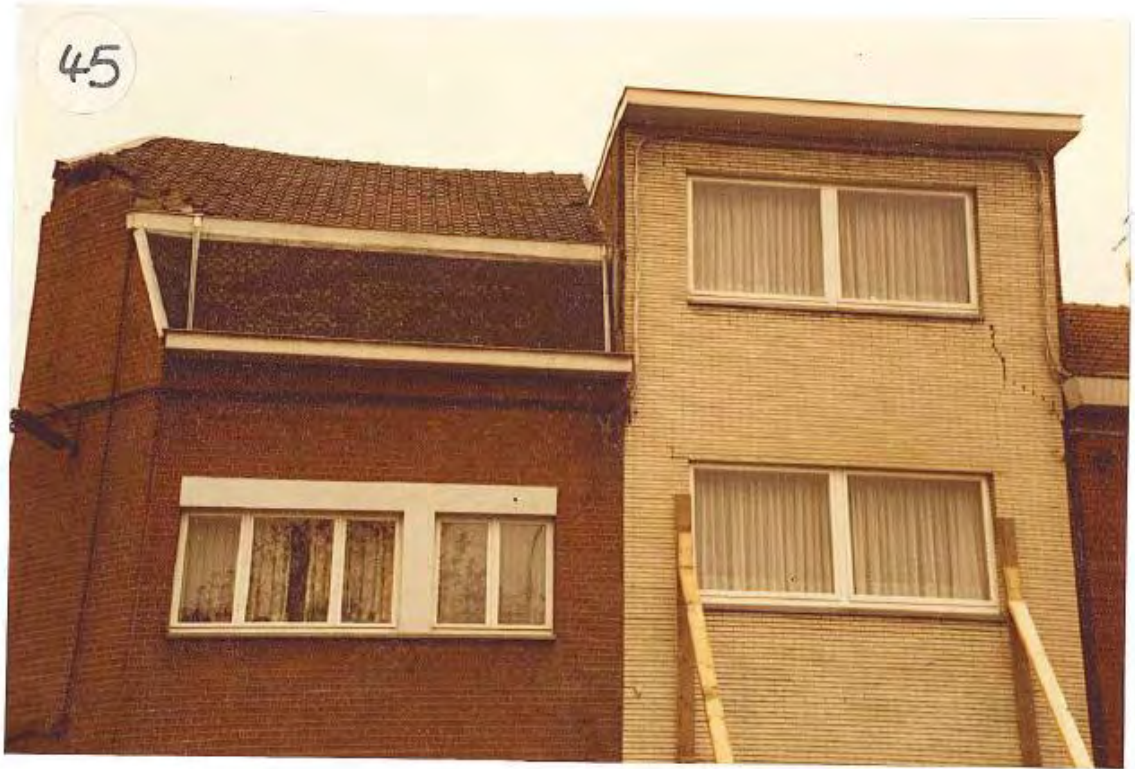
45

44. Rue St Nicholas at Place St Nicholas. Vertical crack at corner of house.
45. Same house as 44.
46. Place St Nicholas. Municipal lorries preparing shoring.

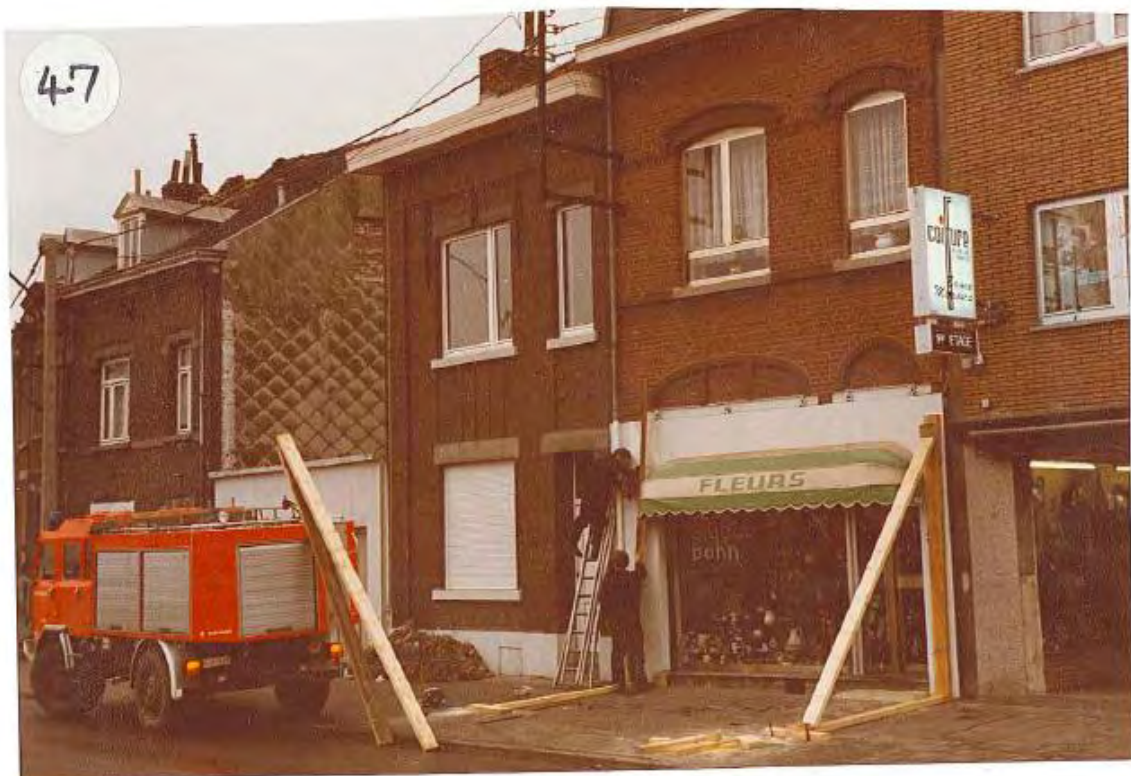
47

- 47&48 Rue St Nicholas. Shores being erected.
49. Rue St Nicholas. Evidence of large settlements before earthquake.
50. Rue St Nicholas. Whiskey in Liège lasts longer than buildings.

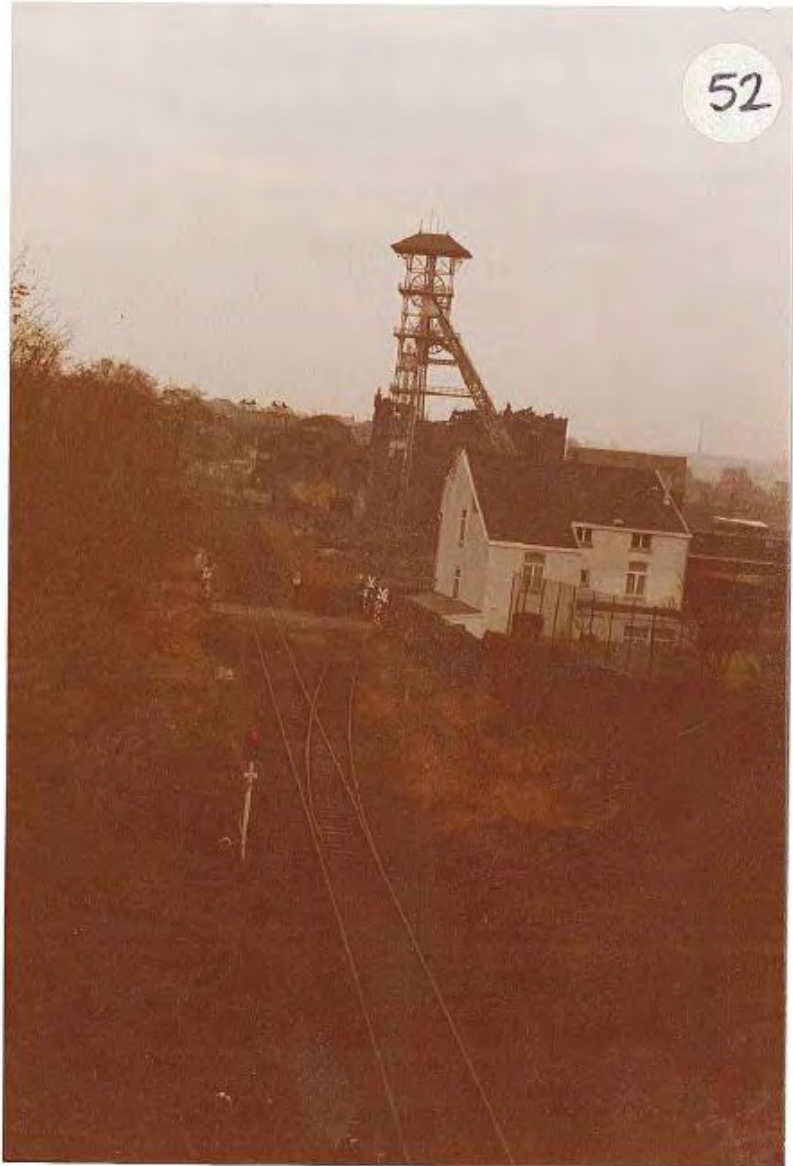
52

51. Clinique de l'Esperance. No signs of damage.
52. Pit head, view from top of railway tunnel in Rue St Nicholas. The brick portal to the tunnel had been propped by a steel portal frame, evidently added some time ago, and suggesting settlement problems.

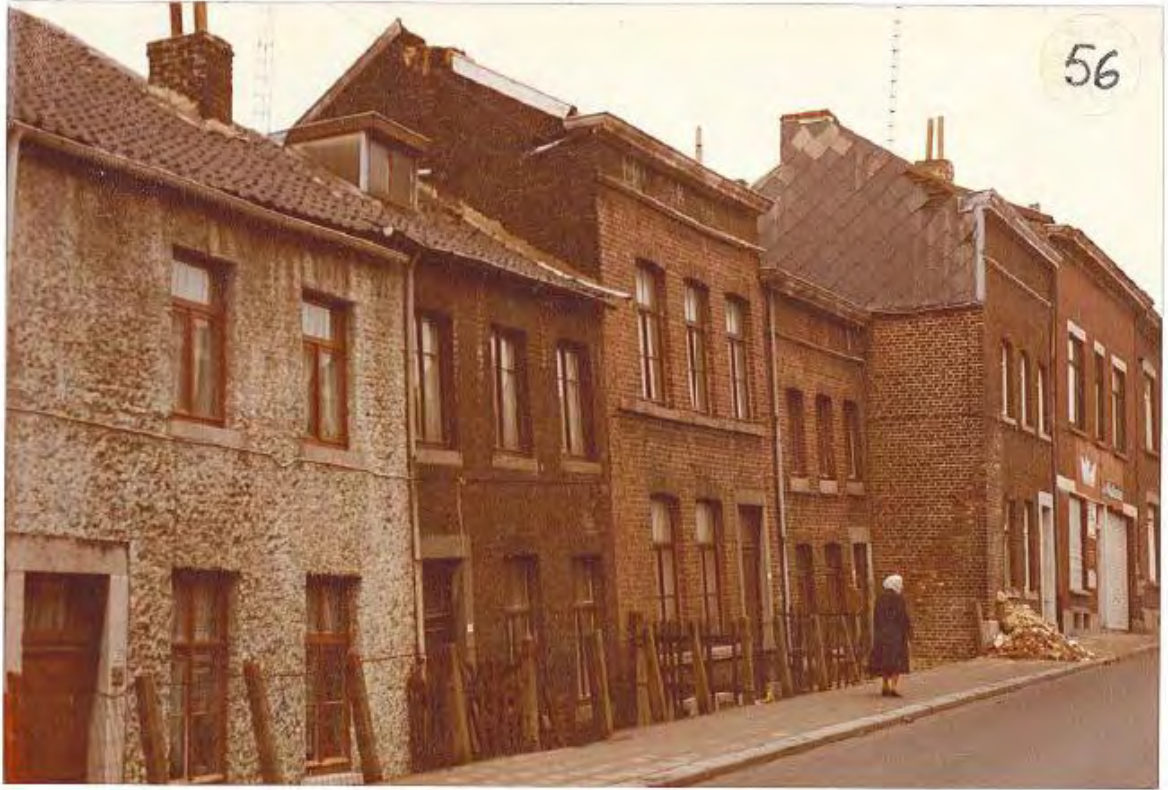
56

- 56-58 Rue de Burenville. 3 out of 4 of these buildings were considered uninhabitable. Cracks and settlement were present before the quake, according to householders. A steep slope behind these houses leads to pithead.

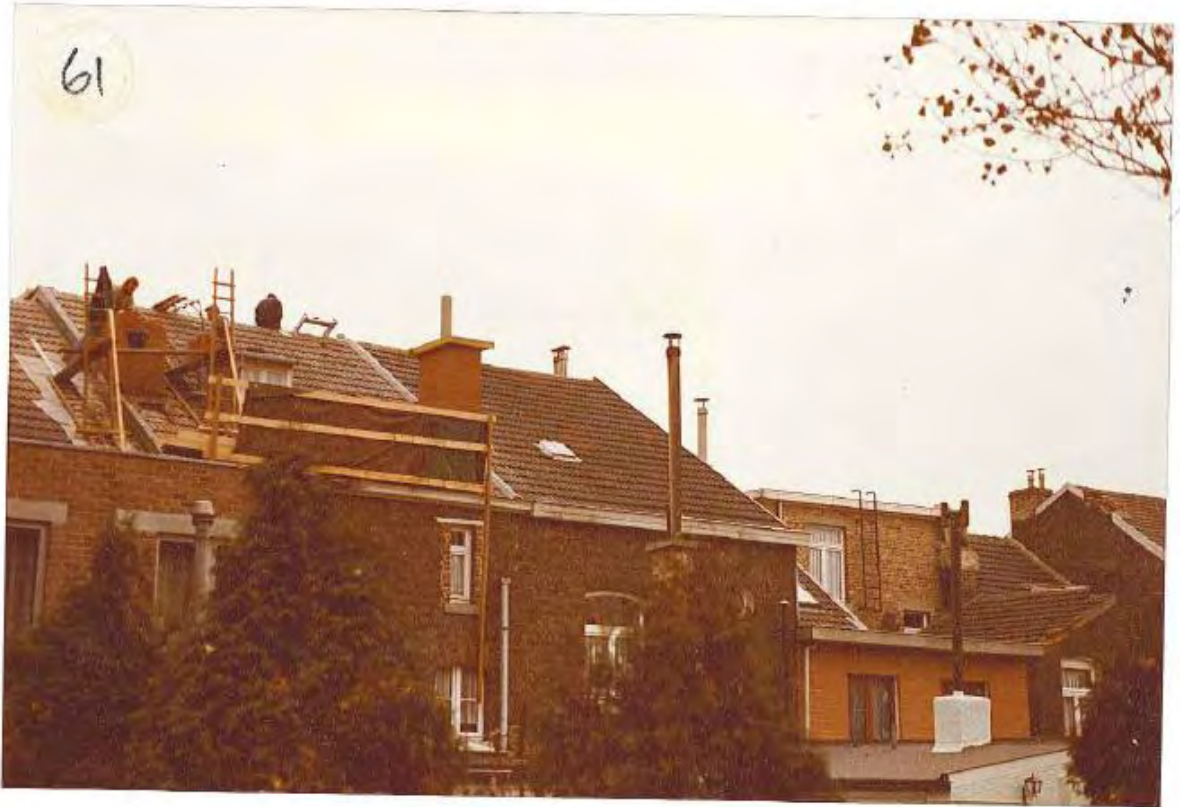
61

61. Older houses backing onto previous in Rue St. Nicholas, most of which had damaged chimneys.
- 62&63 Rue St Laurent. Shoring and cracking in brick terraced houses. Piles of rubble observed outside nearby Rue Sorbier.
