Temporary Works Toolkit

Part 5: Temporary works failures – what are the common causes?

In the first of two articles examining temporary works failures, Director of Structural-Safety, **Alastair Soane**, describes common reasons for their occurrence, illustrating the risks with a number of examples.

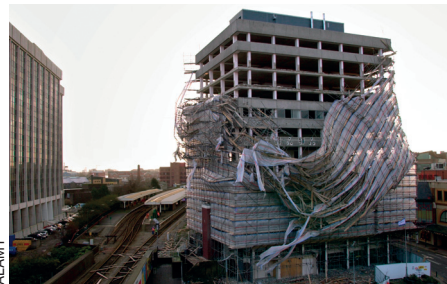
Thirty tonnes of scaffolding fell from a 12-storey office building in Cardiff city centre, Wales, in 2000 while winds were gusting at 39m/sec (87mph)³ (Figure 1). A catastrophe was avoided only because the street was deserted as it was after midnight. At a subsequent court hearing, it was said that the scaffolding should have withstood the storm, but 70% of the ties to hold it in place had never been installed. The remaining ties came away from the building because they were not fixed sufficiently well to the structure. It was also said that this was 'an accident waiting to happen' because it was built by untrained workers using the wrong equipment.

Figure 1
Fanum House scaffold collapse

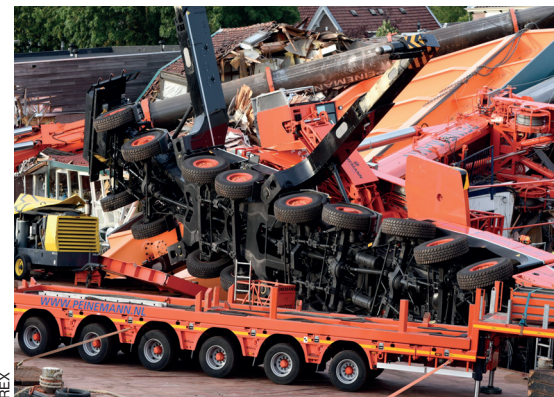
A new section of a bridge in Alphen aan den Rijn was due to be lifted into position in 2015⁹. Two mobile cranes were positioned on barges and the intention was to simultaneously lift the bridge section from another barge in a tandem lift. While the bridge section was being manoeuvred between the two cranes, the barges capsized, and the cranes and the bridge section fell onto adjacent buildings (Figure 2). A number of these were destroyed, but miraculously there were no injuries or fatalities. It was established during the

Figure 2
Queen Juliana Bridge crane collapse

investigation that there were shortcomings in the preparation for the lift by both the crane operator and the barge operator. The barge carrying one of the cranes was insufficiently stable and movement of the load during the lift caused the crane to topple and bring everything else down with it.
