Newsletter 56

Confidential Reporting on Structural Safety (CROSS)

852: Rotting of cross-laminated timber roof panels Report

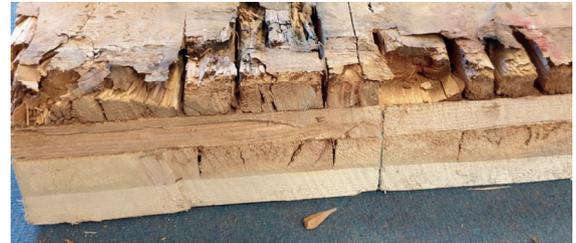
As part of their investigation, CLT panels on the roof, parapets and terrace were exposed. Inspection found that not only was the ply under the membrane rotten, but areas of CLT had also severely rotted (Figure 1). The reporter was shocked to see that in some areas, three of the typical five plies in the CLT panels had rotted through both on parapets and roof panels. Sloping sections of roof with the membrane on top of insulation seemed fine.

The reporter speculates that the issue is due to hidden water entrapped between an impervious roof membrane and the effectively impervious CLT panels. They were told that the roof had been allowed to become wet during construction, but it is not clear if the water which caused the rotting developed during construction or was allowed in following construction due to incorrect design and detailing.

CLT, like timber in general, will rot when excess moisture is present over long periods of time. It is worth considering how the CLT became exposed to water in the first place. The reporter speculates that the water could have developed during construction. It could also be

due to condensation, or leaks in the waterproof membrane, or both.

↑ Figure 1 Rotting of CLT panel

The remedial works for the heavily damaged areas resulted in replacement of much of the flat roof areas using parallel-chord timber trusses with metal webs for the longer spans, with more traditional joists used elsewhere. Less damaged areas were repaired by replacing the ply under the membrane, and in other areas, steel beams were connected to the CLT wall panels with shear rings cut into the panels.
