Following the recent fire at Notre-Dame de Paris, **Professor Jacques Heyman** discusses the construction of the cathedral and considers some of the questions that will arise in agreeing an approach to repair.

The fire at Notre-Dame cathedral

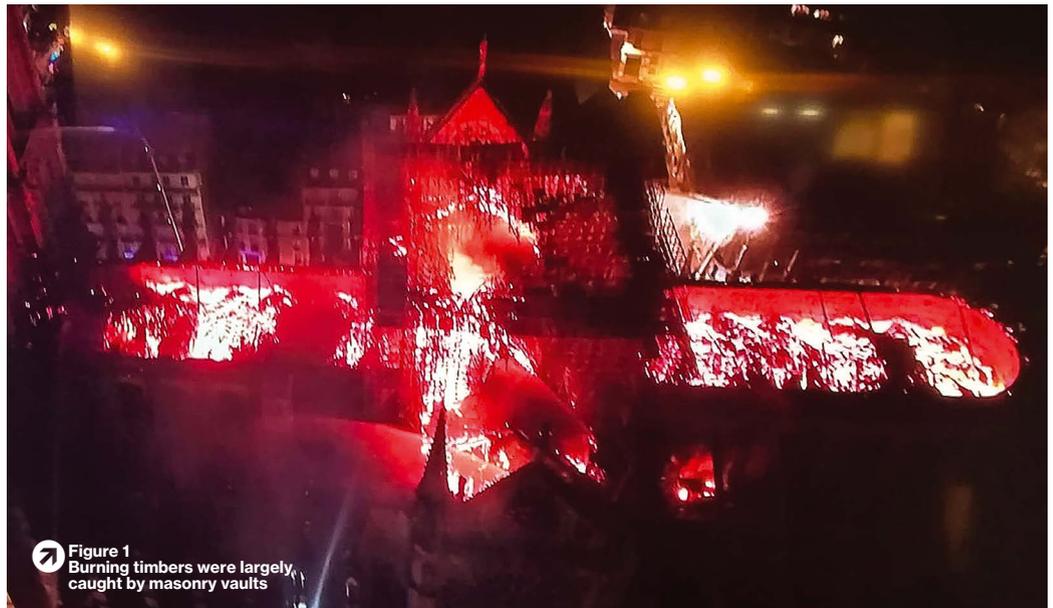
This dual action was very evident in the fire of 15 April 2019 at Notre-Dame de Paris. Severe damage was done, but this would have been very much worse if the ‘fireproofing’ had not been effective. Videos of the conflagration show the whole of the roofs on fire, but in fact the falling timbers were largely caught by the masonry vaults (Figure 1).

Figure 1
Burning timbers were largely caught by masonry vaults

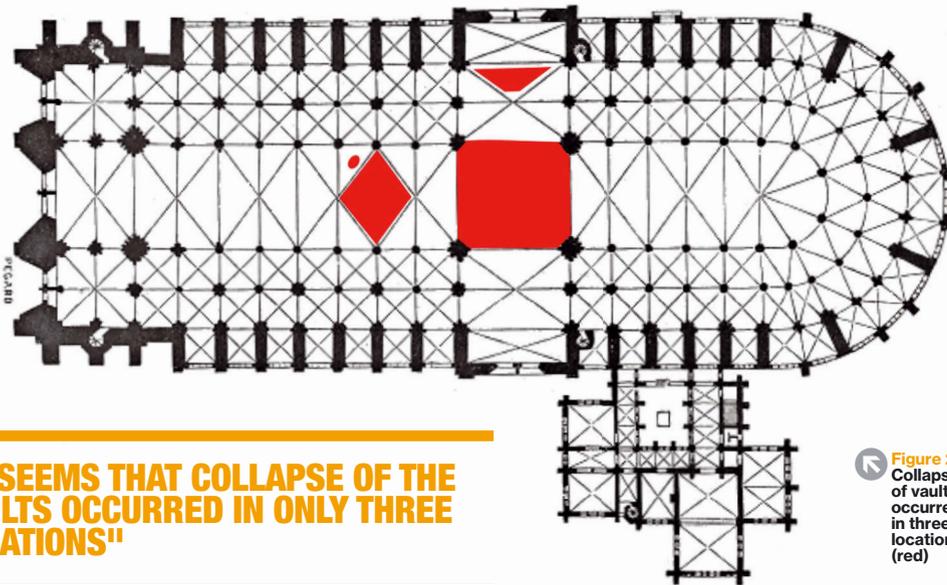
It seems that collapse of the vaults occurred in only three locations – the last bay of the north transept, one bay in the

nave, and the (roughly) square vault at the crossing (Figure 2). They all appear to result from the spectacular collapse of sections of the 500t lead-covered oak spire (the flèche) over the crossing (Figure 3).

Figure 2
Collapse of vaults occurred in three locations (red)

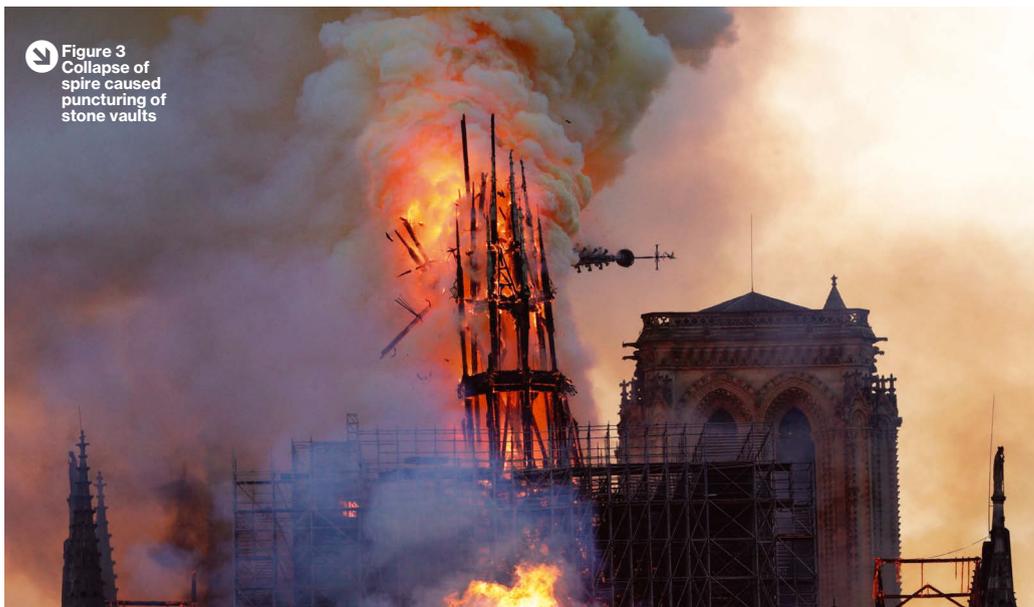
Figure 3
Collapse of spire caused puncturing of stone vaults

might be innovation lies in the crossing. Something other than a 500t flèche could be designed, and there have already been suggestions. It would probably have to be something unexpected, like I.M. Pei's pyramid at the Louvre – which is outrageous, but it works.

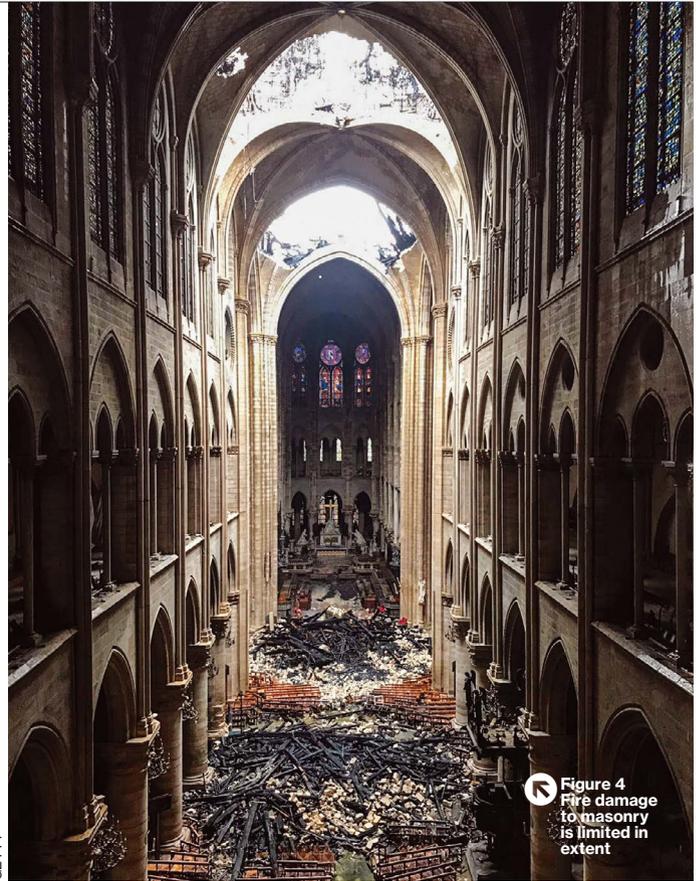
There is some fire damage to the masonry of Notre-Dame (Figure 4), and experienced stone masons will be needed. France will certainly be able to supply these, in contrast to recent experience in Australia. The cathedral in Brisbane, to the design of John Loughborough Pearson, was completed just at the start of the present century after 100 years of construction; it was necessary to involve masons trained in England.

Figure 4
Fire damage to masonry is limited in extent
