THE TÜRKİYE EARTHQUAKE SEQUENCE OF FEBRUARY 2023

A LONGITUDINAL STUDY REPORT BY EEFIT

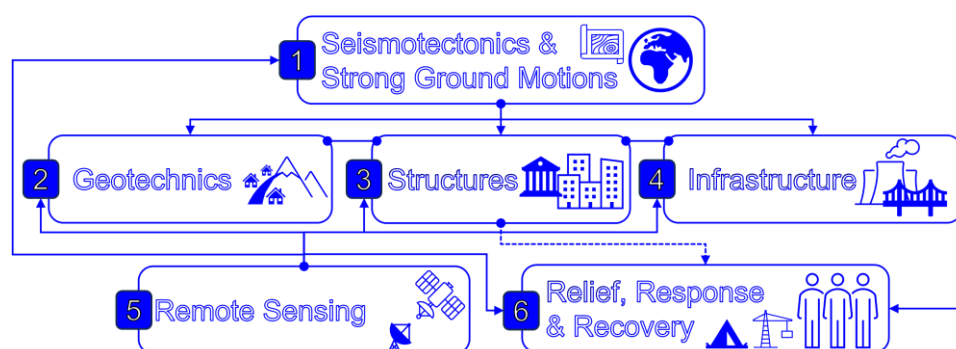
Established EEFIT working groups and organization of the team.

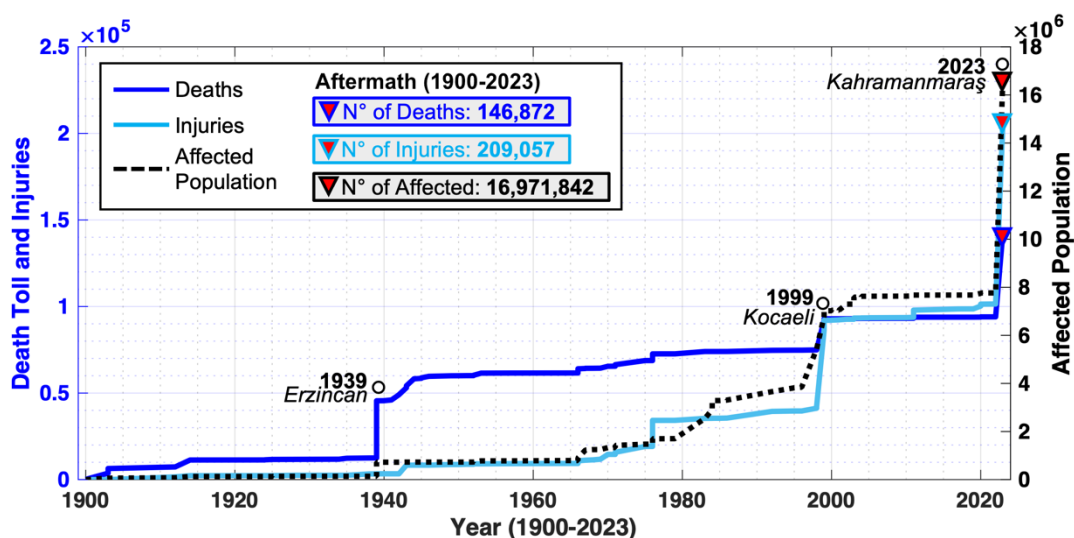
Figure 1: Earthquake-induced impact in Türkiye: Fatalities, injuries and affected population in the 20th century & early 21st century (developed by the team based on data from EM-DAT, 2023).

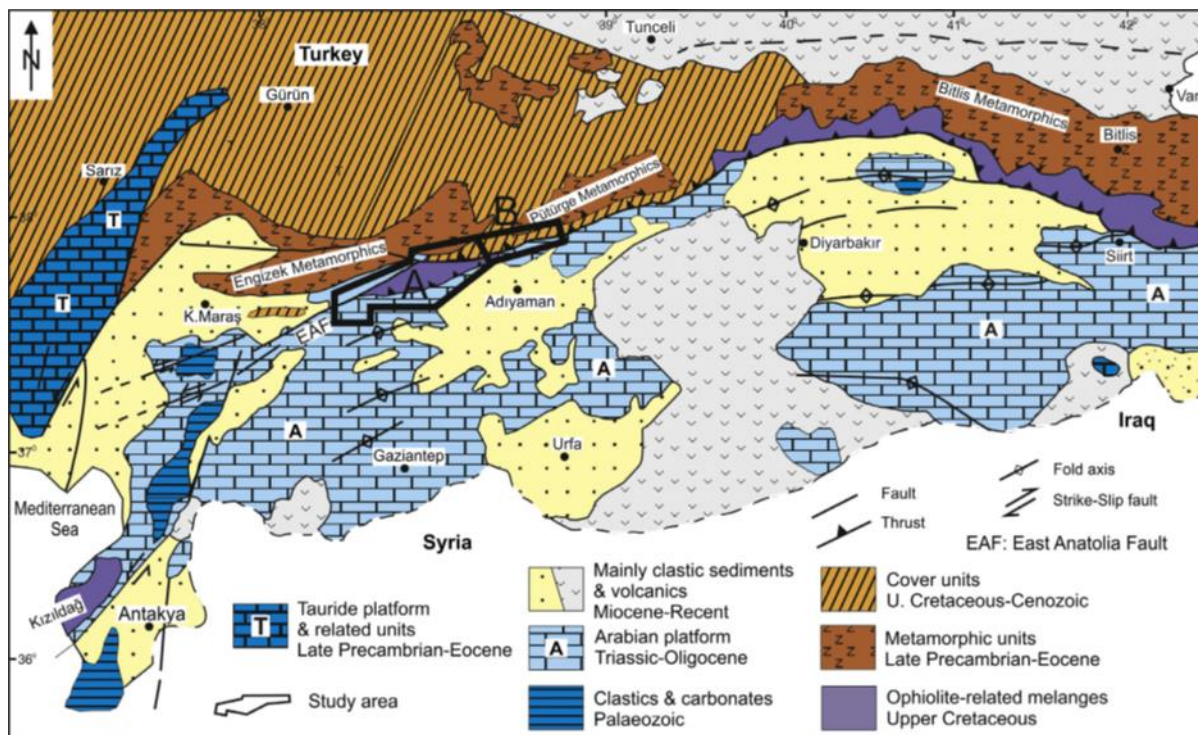
Figure 4: Geological map of the region (Robertson et al., 2016).

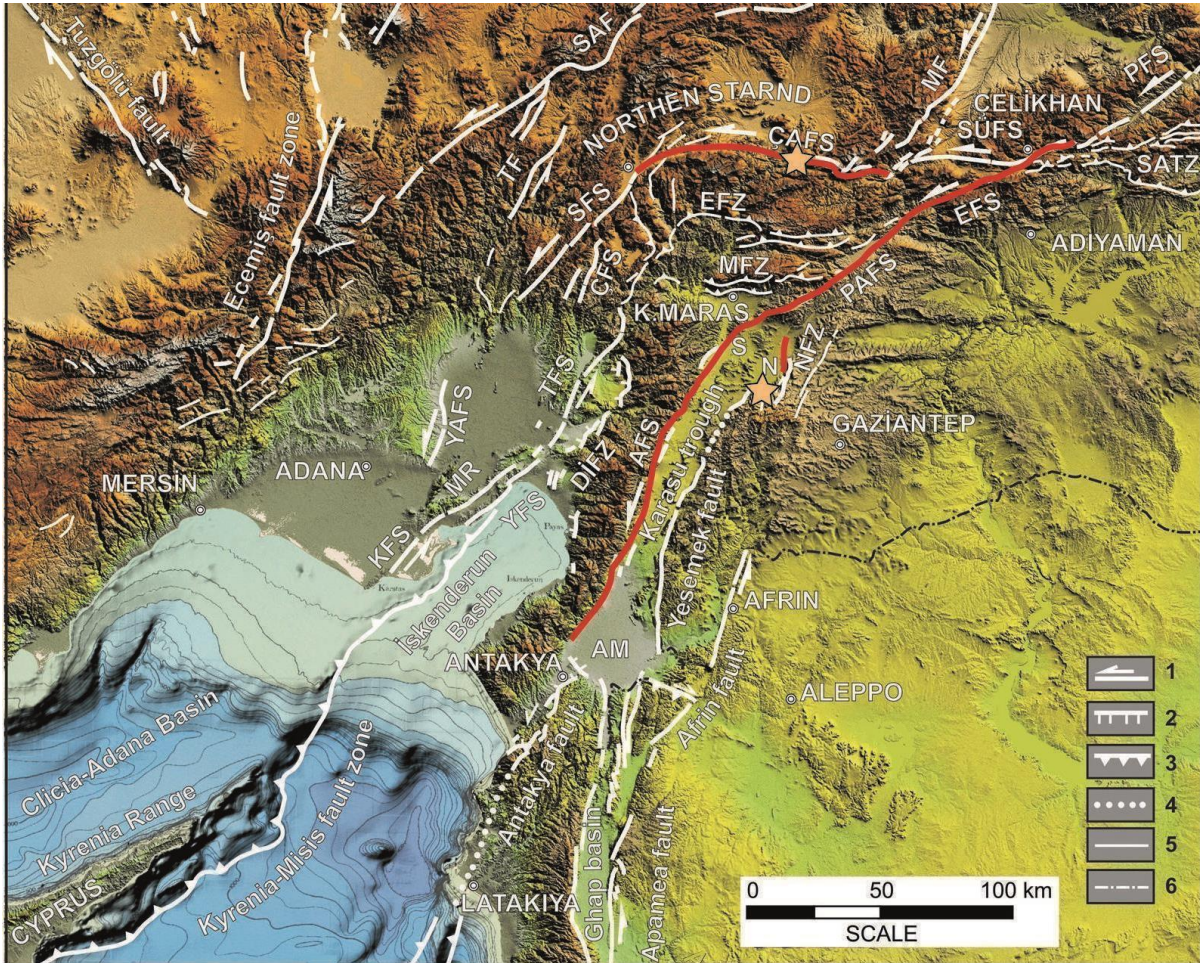
The later M_w 7.5 earthquake ruptured the Çardak Fault, which has been proposed to be a northern strand of the EAFZ (Duman and Emre, 2013). This sinistral strike-slip fault is 85 km long with a reported offset of only 135 m but a Holocene slip-rate of 2.5 mm/yr (Duman and Emre, 2013).

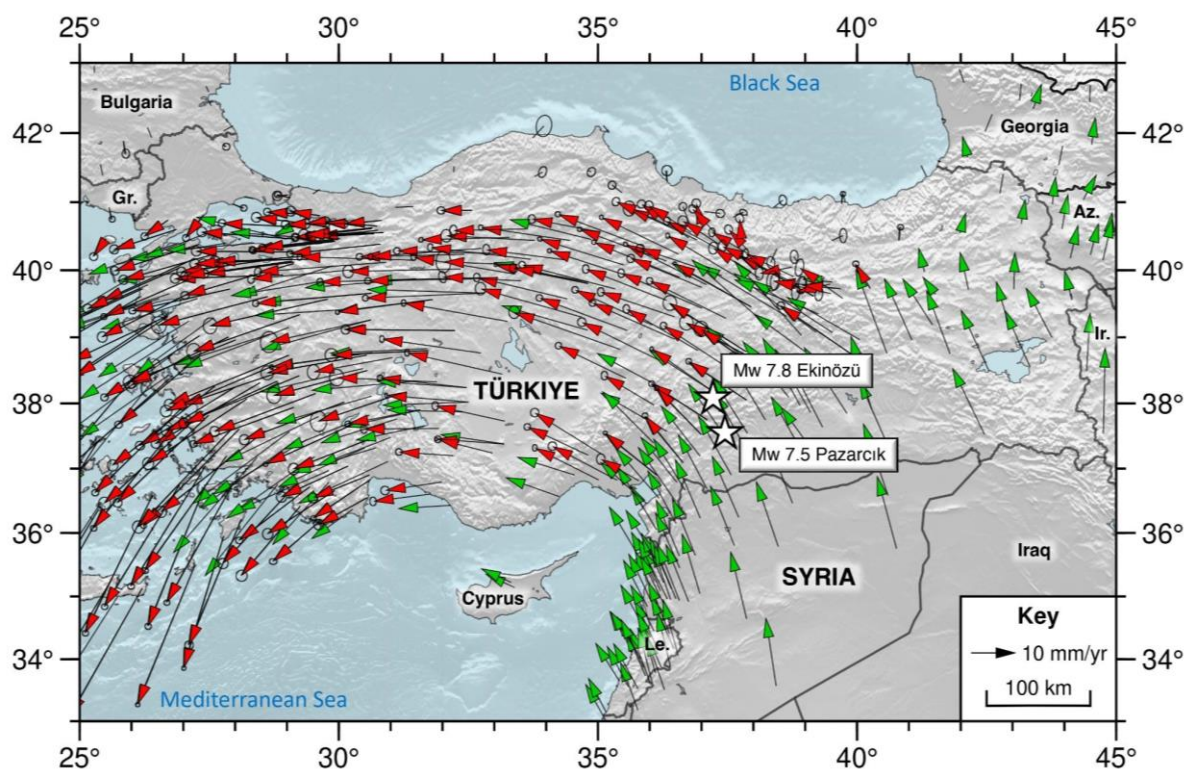
Figure 6: Velocity field for Anatolia and Arabia relative to stable Eurasia. Green and red GPS velocity vectors are from the Nocquet (2012) and England et al. (2016) catalogues, respectively.

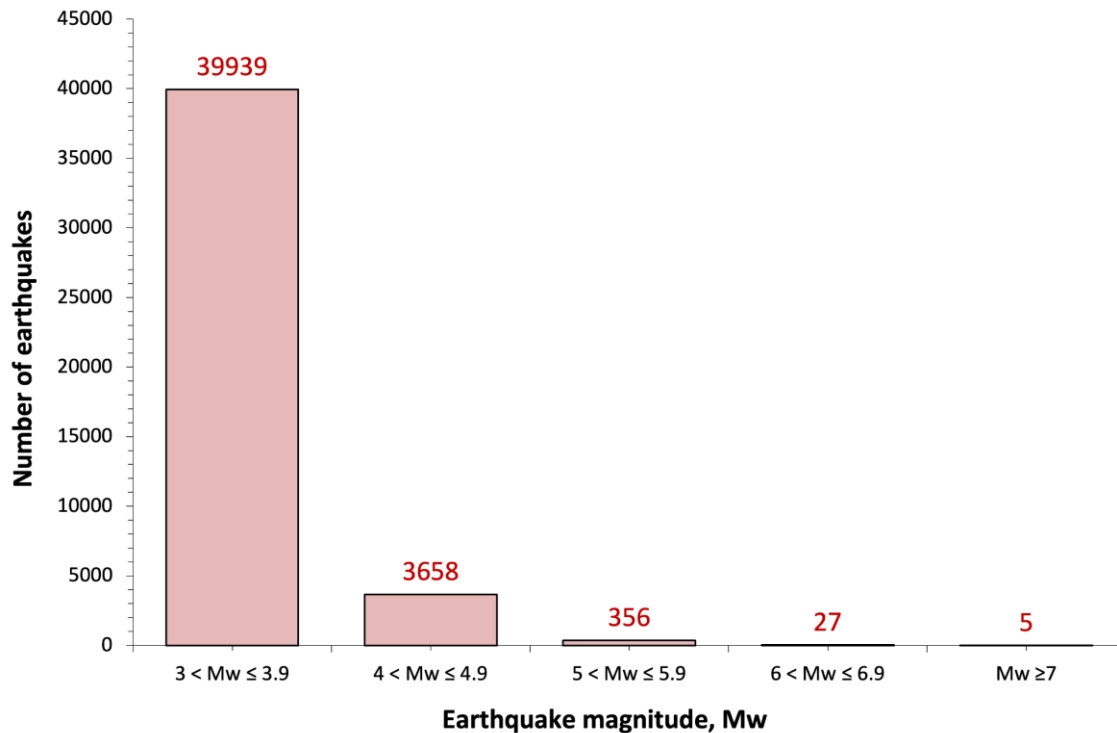
Figure 8: Earthquakes that occurred across Türkiye and Syria (within the geographical extents of Figure 7) since the advent of the AFAD instrumental catalogue in 1990 to present-day, August 2023 (AFAD, 2023).

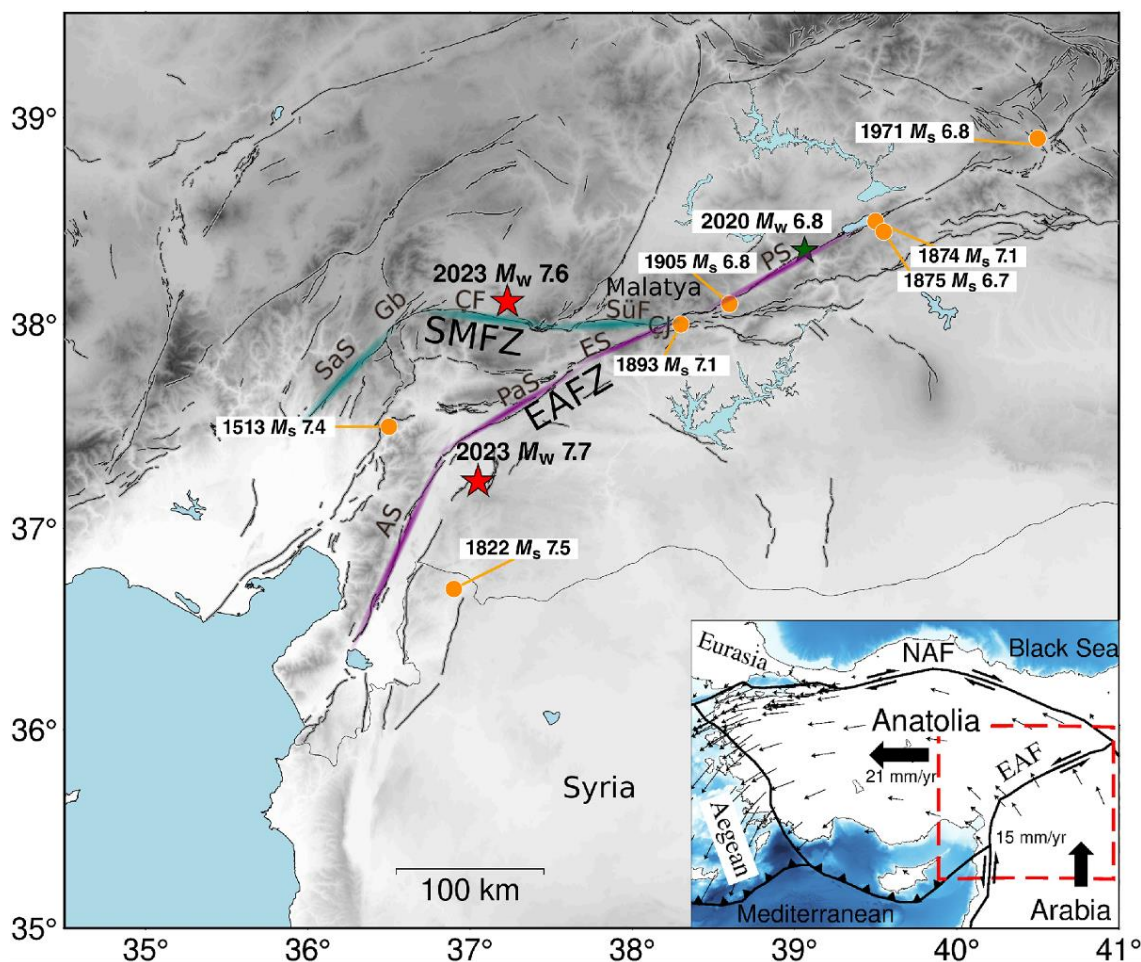
Figure 9: Map published in Petersen et al. (2023) illustrating the affected regions across Türkiye and Syria, with the annotated earthquake epicentre locations as red stars and the main fault systems which ruptured during these events: the East Anatolian fault zone (EAFZ) and the Sürgü-Misis Fault Zone (SMFZ).

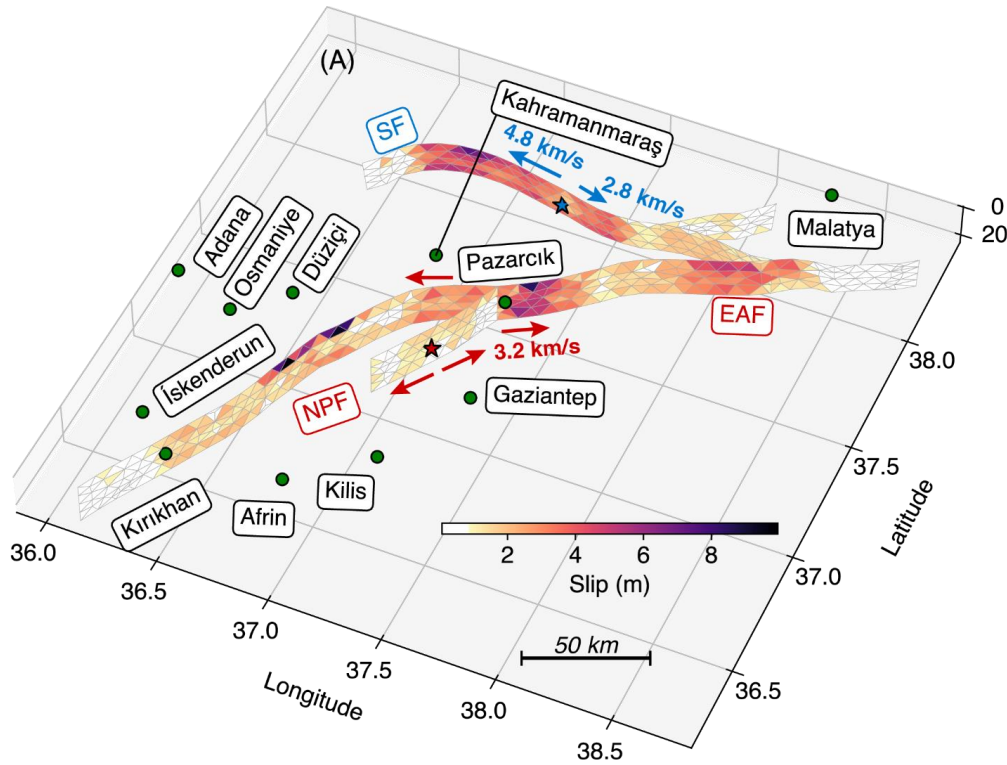
Figure 10: Melgar et al.'s (2023) best-fitting slip distributions and inverted rupture geometry for the Pazarcık and Ekinözü earthquakes.

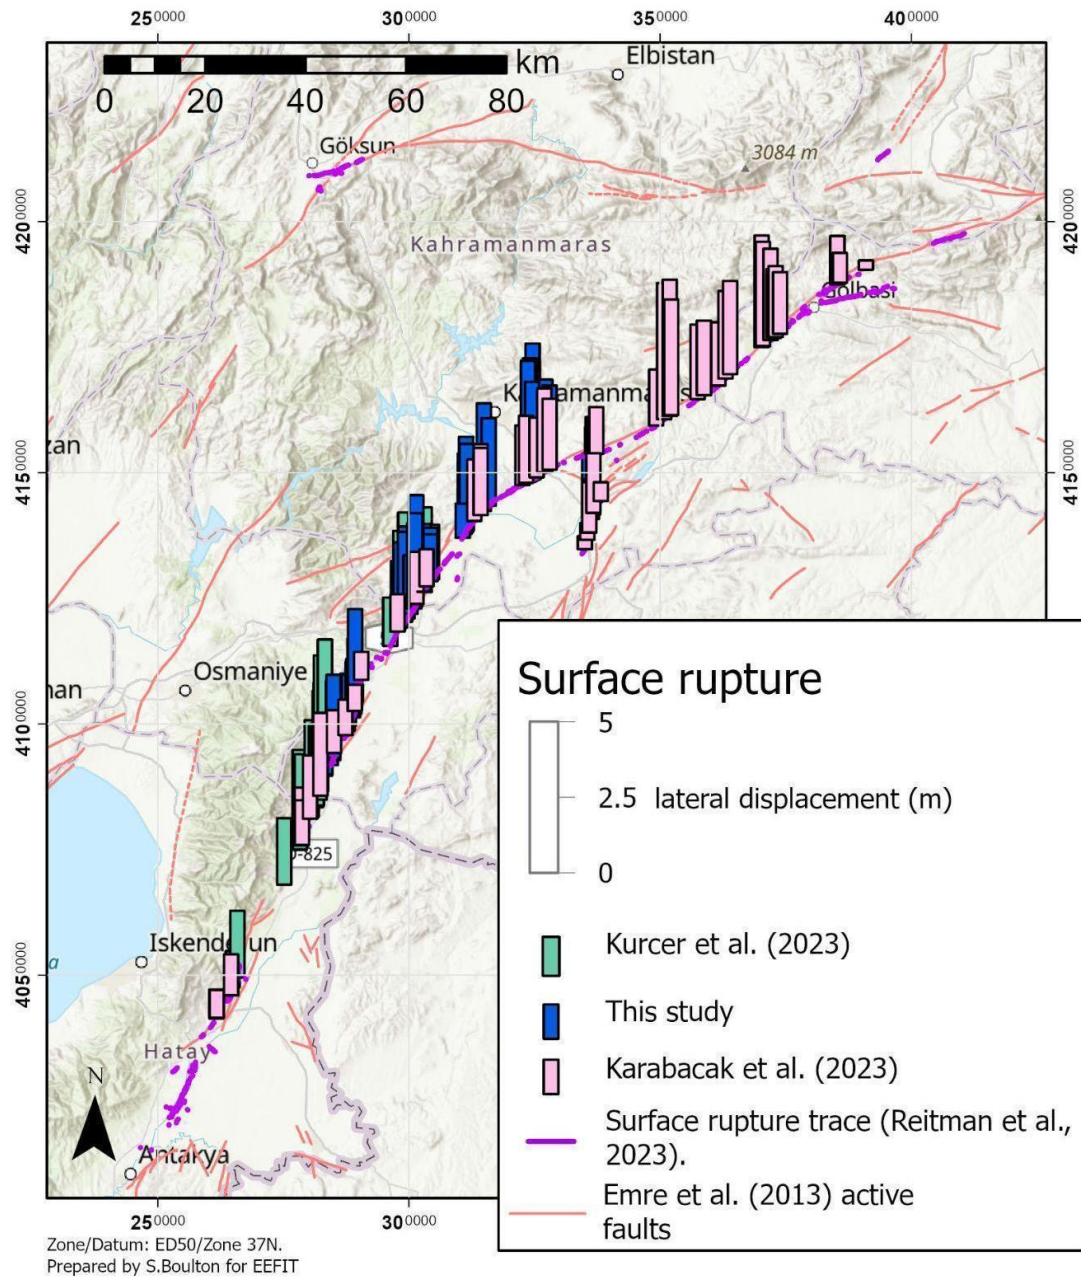
Figure 11: Map of the area showing a compilation of surface ruptures mapped from remote sensing imagery (this study, Reitman et al., 2023) and ground observations (Kurcer et al., 2023). Active fault traces are taken from Emre et al. (2018).

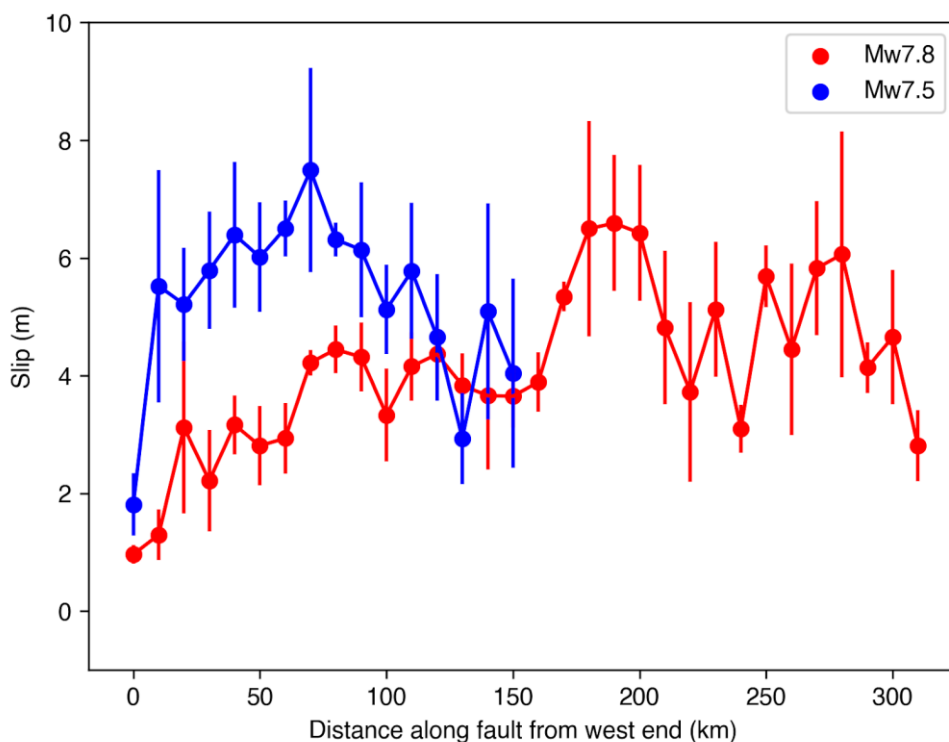
Figure 12: Graph showing variations in lateral (horizontal) slip along the strike of the main EAFZ (red) and the Cardak Fault (blue) calculated from Sentinel 1 data by COMET (Ou et al., 2023).

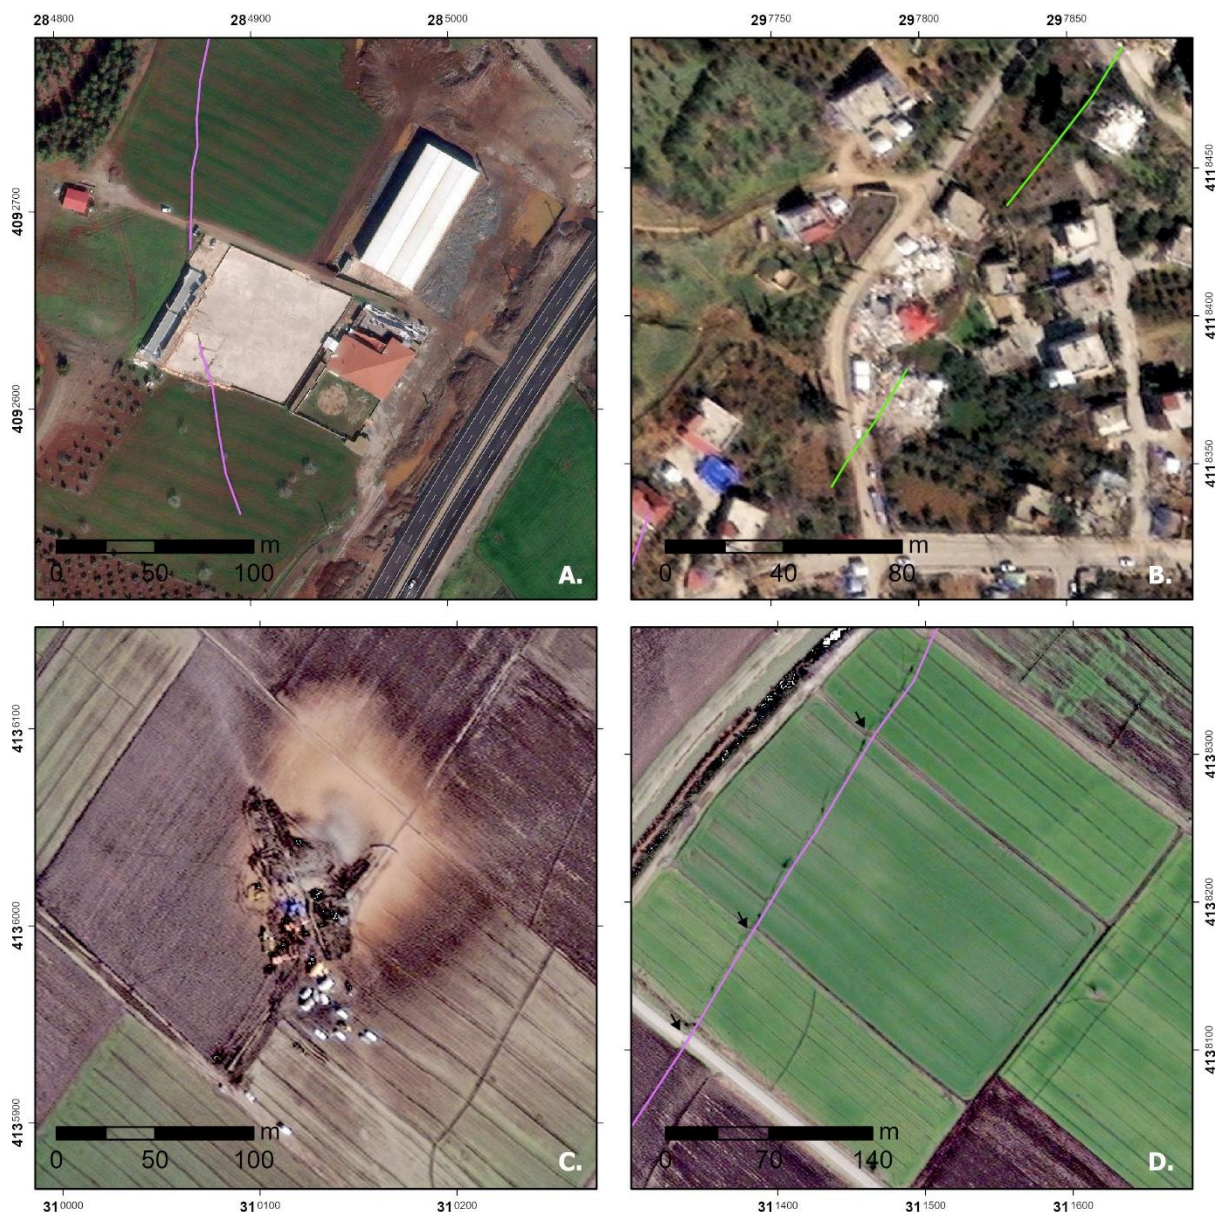
Figure 13: High-resolution Maxar satellite images of offset features caused by the surface ruptures created by the main Pazarcik earthquake. A) illustrates an offset corner of an industrial unit, B) shows collapsed domestic buildings on and adjacent to the fault rupture, C) demonstrates a gas pipeline which was cut by the fault (although the surface rupture at this location is unclear), D) is an example of the surface rupture cutting field boundaries.

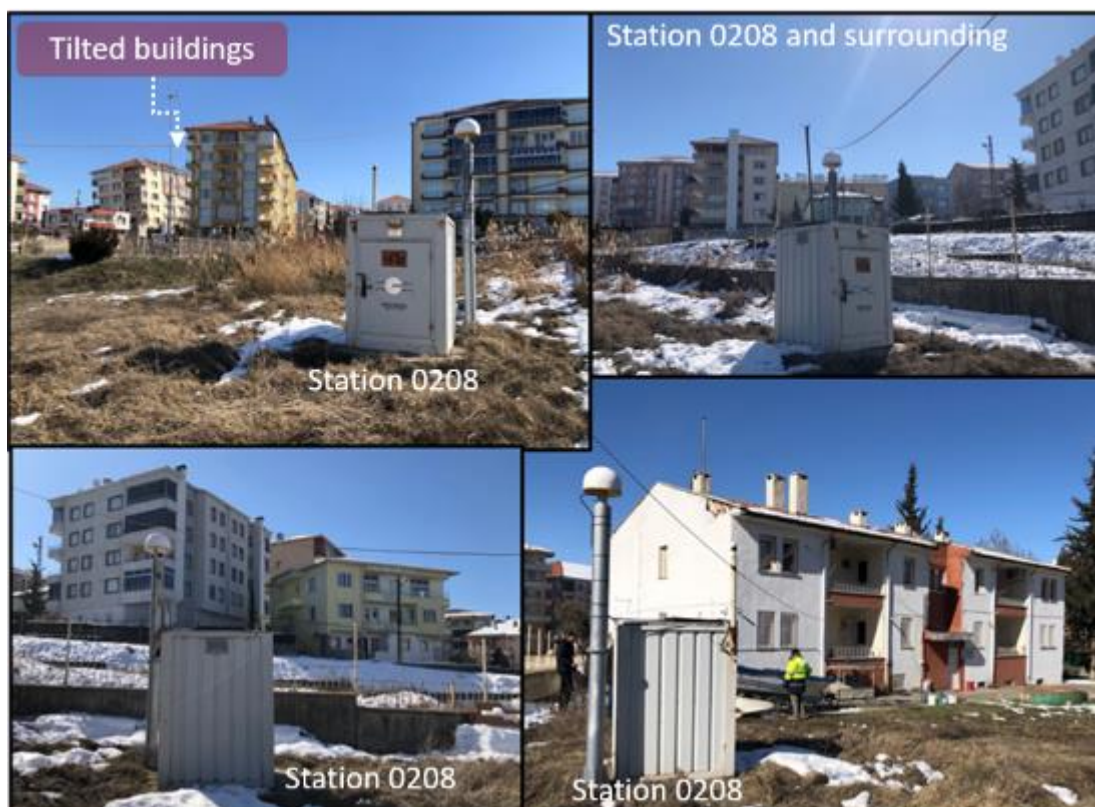
Figure 15: External views of station 0208 with structures nearby.

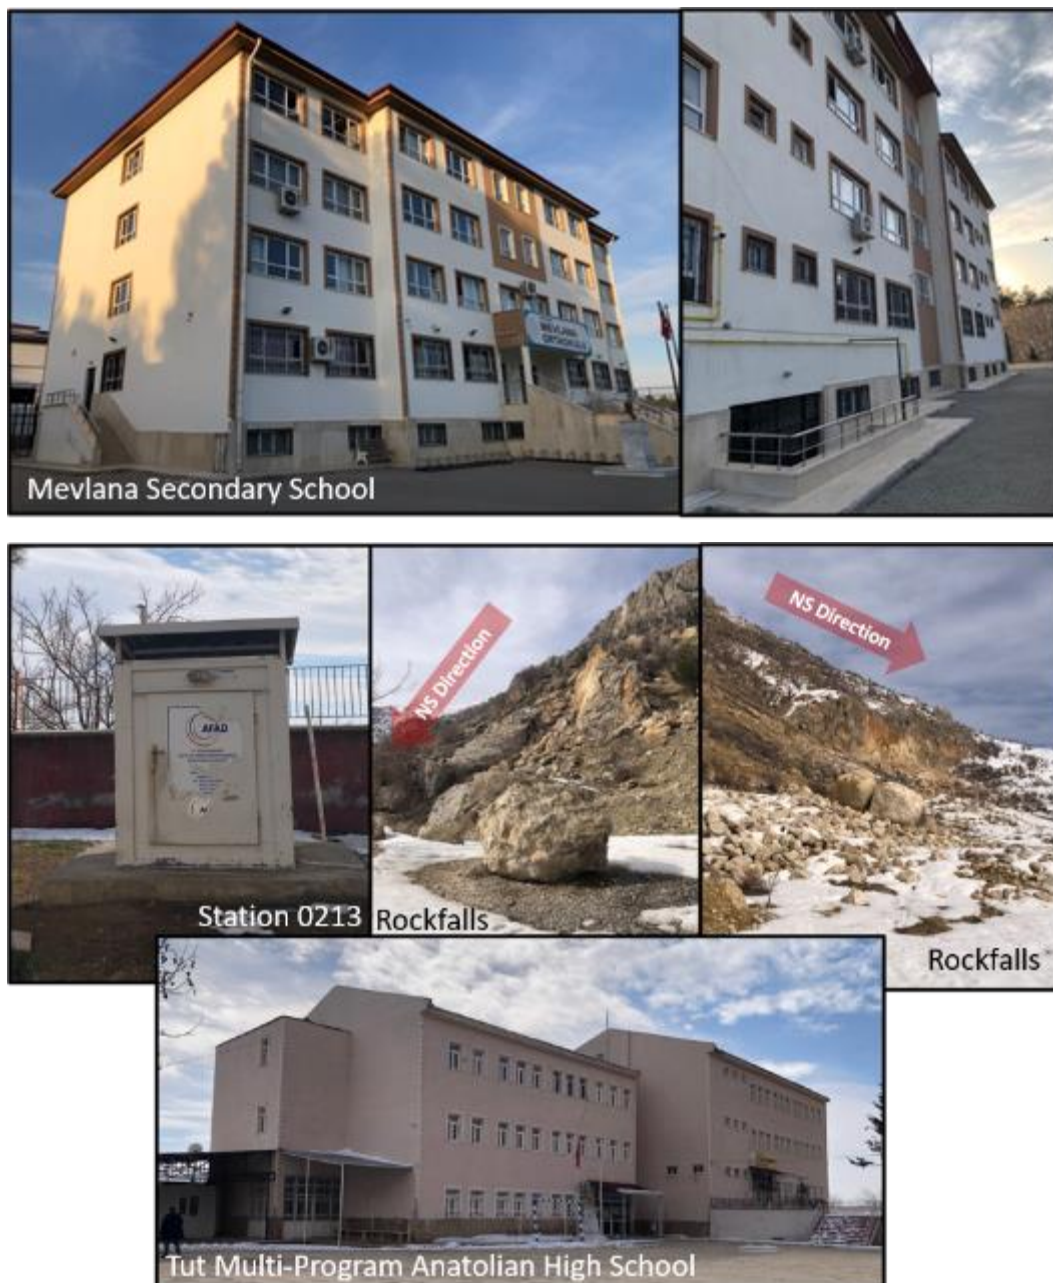
Figure 16: External views of (top) Mevlana Secondary School where station 0210 is deployed, (bottom) station 0213, and rockfalls nearby station 0213.

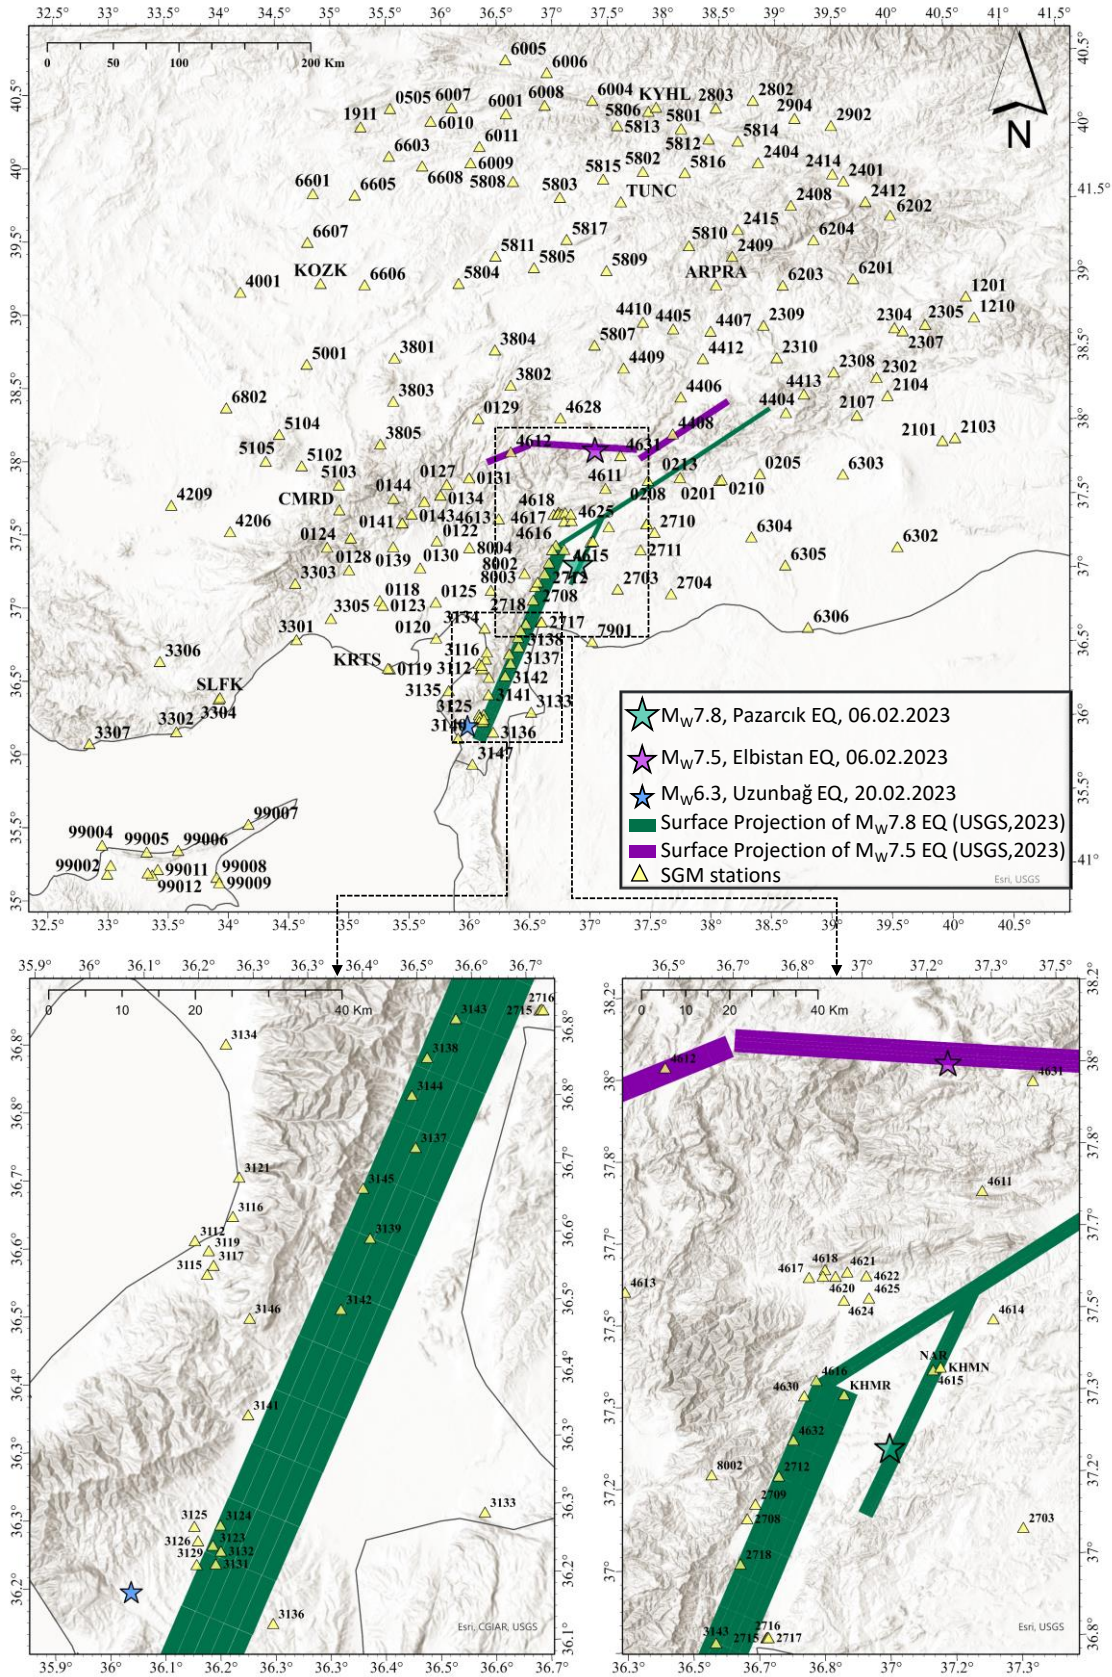
Figure 17: (top) Spatial distribution of strong ground motion stations recording the MW 7.8 Pazarcık, MW 7.5 Ekinözü and MW 6.3 Uzunbağ events, (bottom left) Closer views to stations in Antakya, (bottom right) Closer view to stations around epicentre of MW 7.8 Pazarcık and MW 7.5 Ekinözü earthquakes.

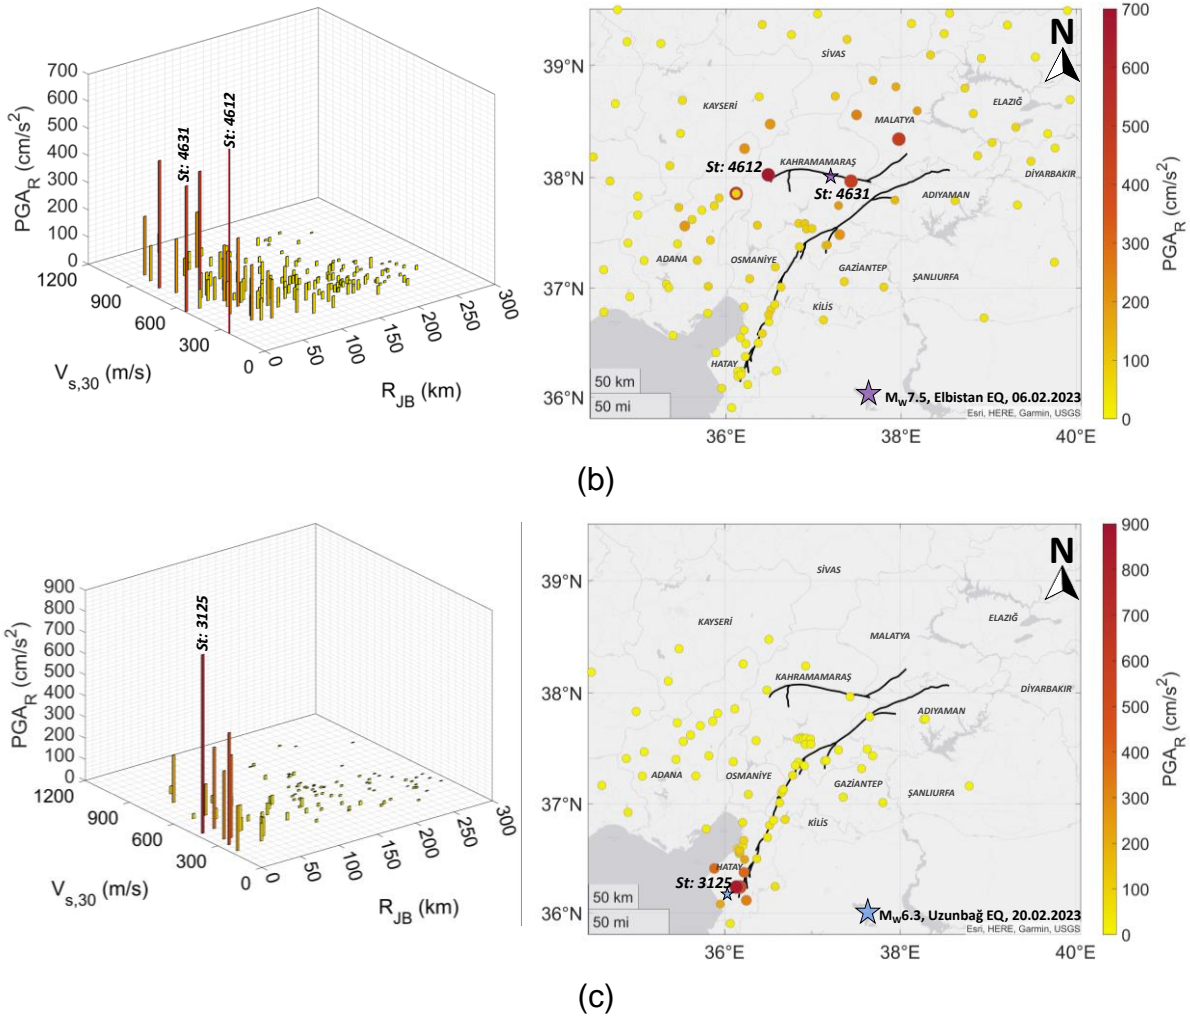
Figure 21: Spatial and statistical distribution of resultant peak ground accelerations (PGAs) with respect to RJB and VS30 for the (a) MW 7.8 Pazarcık, (b) MW 7.5 Ekinözü, and (c) MW 6.3 Uzunbağ events. Black lines on the maps are traced after the USGS published surface rupture (USGS, 2023).

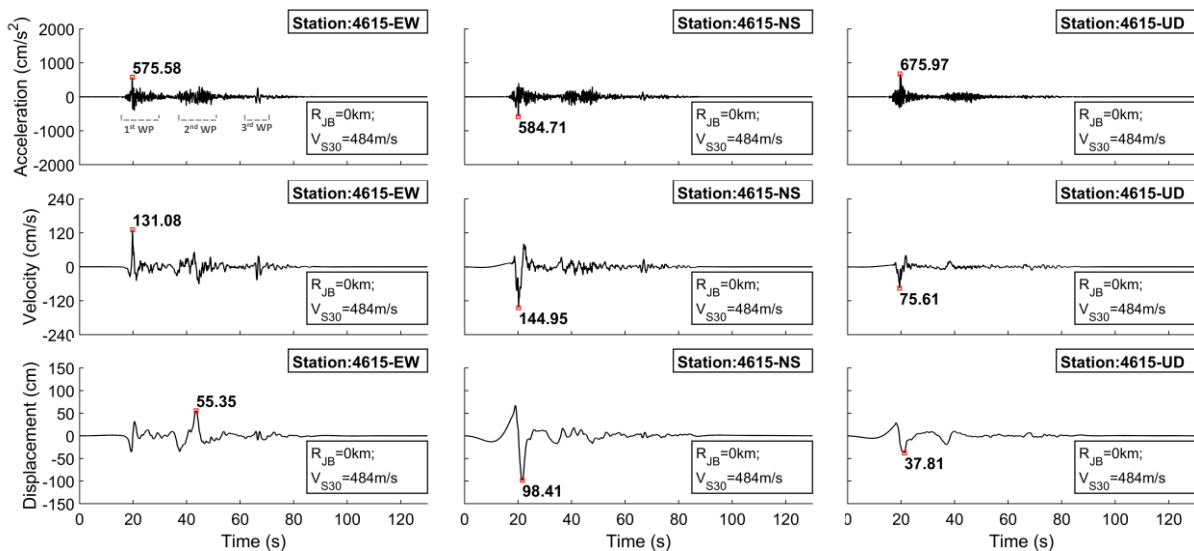
Figure 22: Multiwave patterns detected in three-component acceleration, velocity, and displacement time histories of station 4615 from $M_w7.8$ Pazarcık earthquake (WP= Wave package).

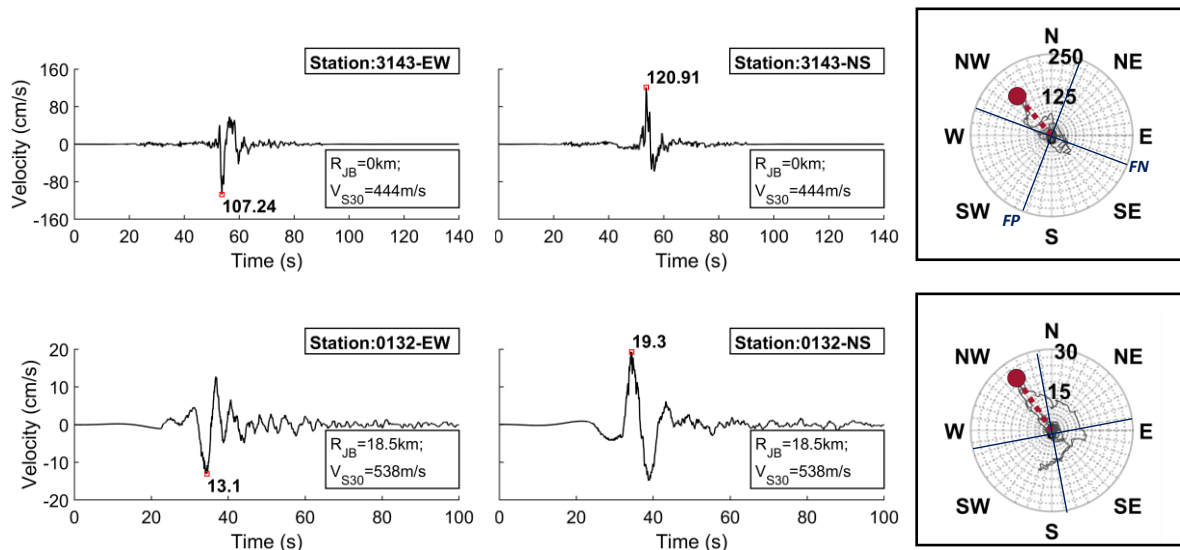
Figure 23: Pulse-like velocity waveforms along with its velocity path (within black squares on the right) for (top) station 3143 for MW7.8 Pazarcık earthquake, (bottom) station 0132 for MW7.5 Ekinözü earthquake (FN=Fault-normal; FP=Fault-parallel; Red dashed line=Predominant direction of ground motion).

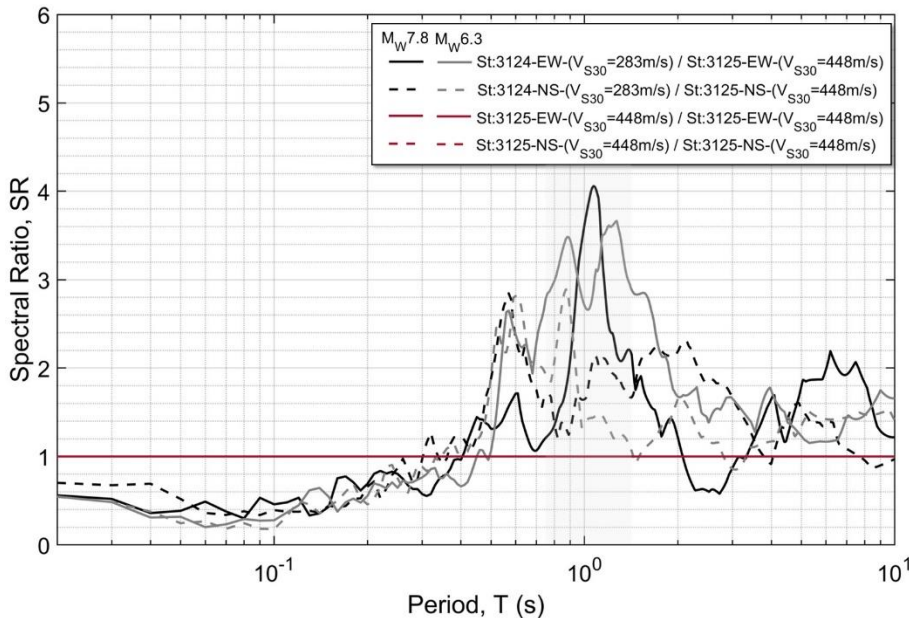
Figure 24: Spectral ratios of station 3124 to station 3125 for M_w 7.8 Pazarcık and M_w 6.3 Uzunbağ earthquakes.

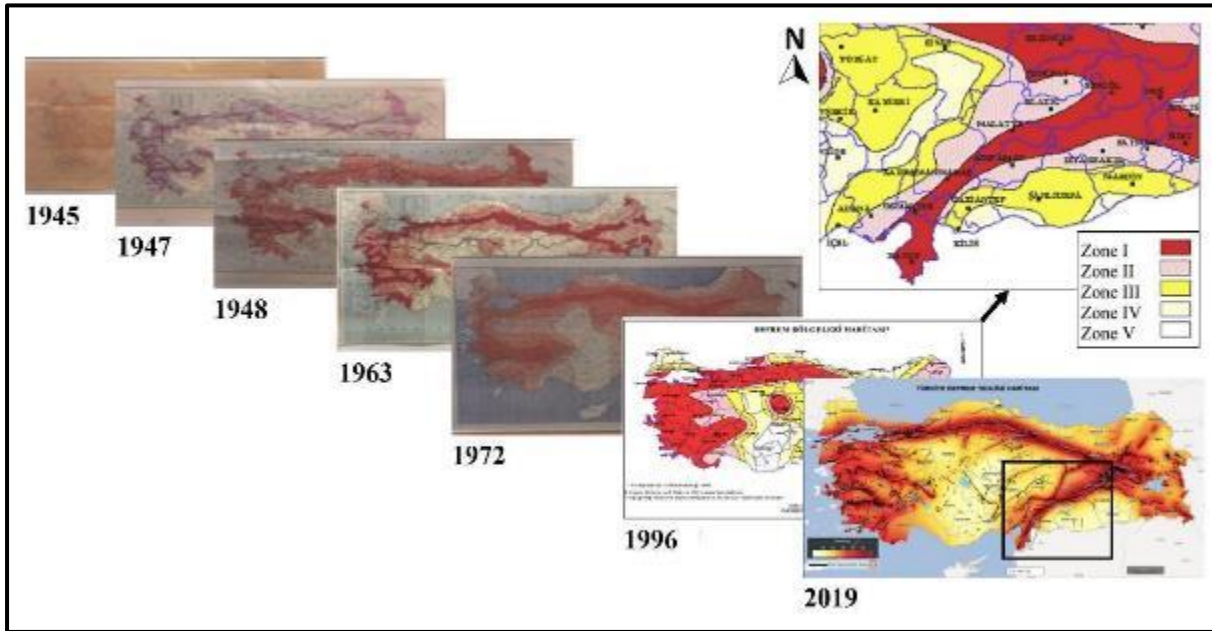
Figure 25: Historical development of Türkiye Earthquake Hazard Maps (modified from AFAD, 2018). The affected region of the 2023 Kahramanmaraş earthquake sequence is marked by a black square in the 1996 and 2018 maps.

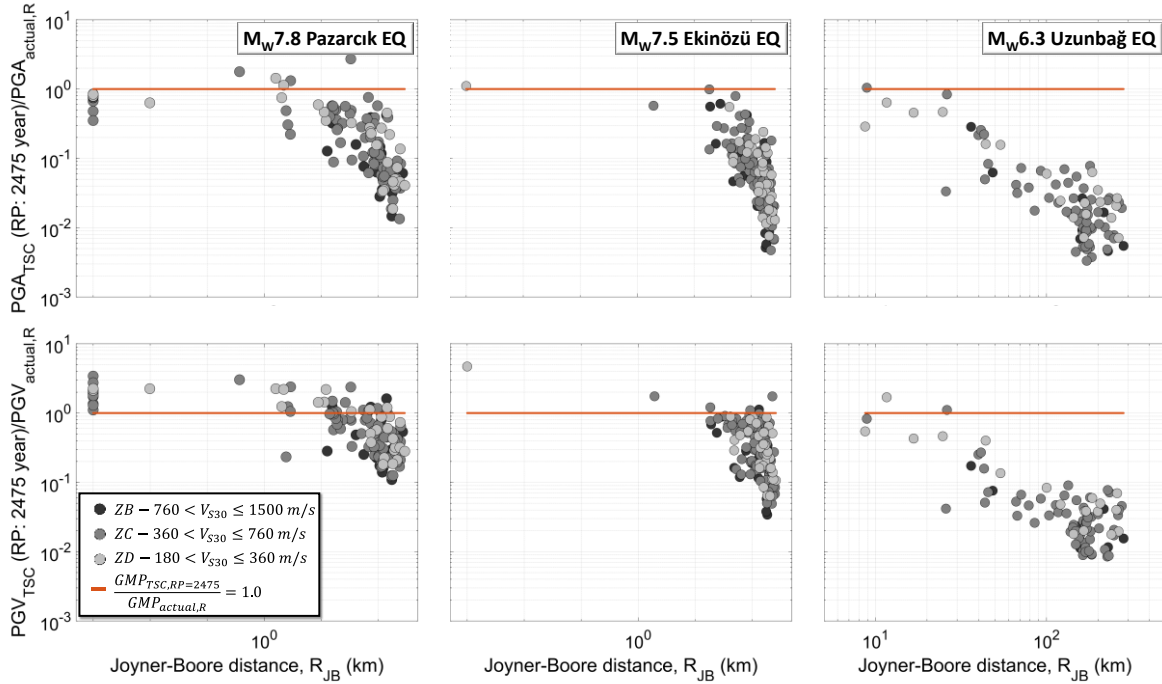
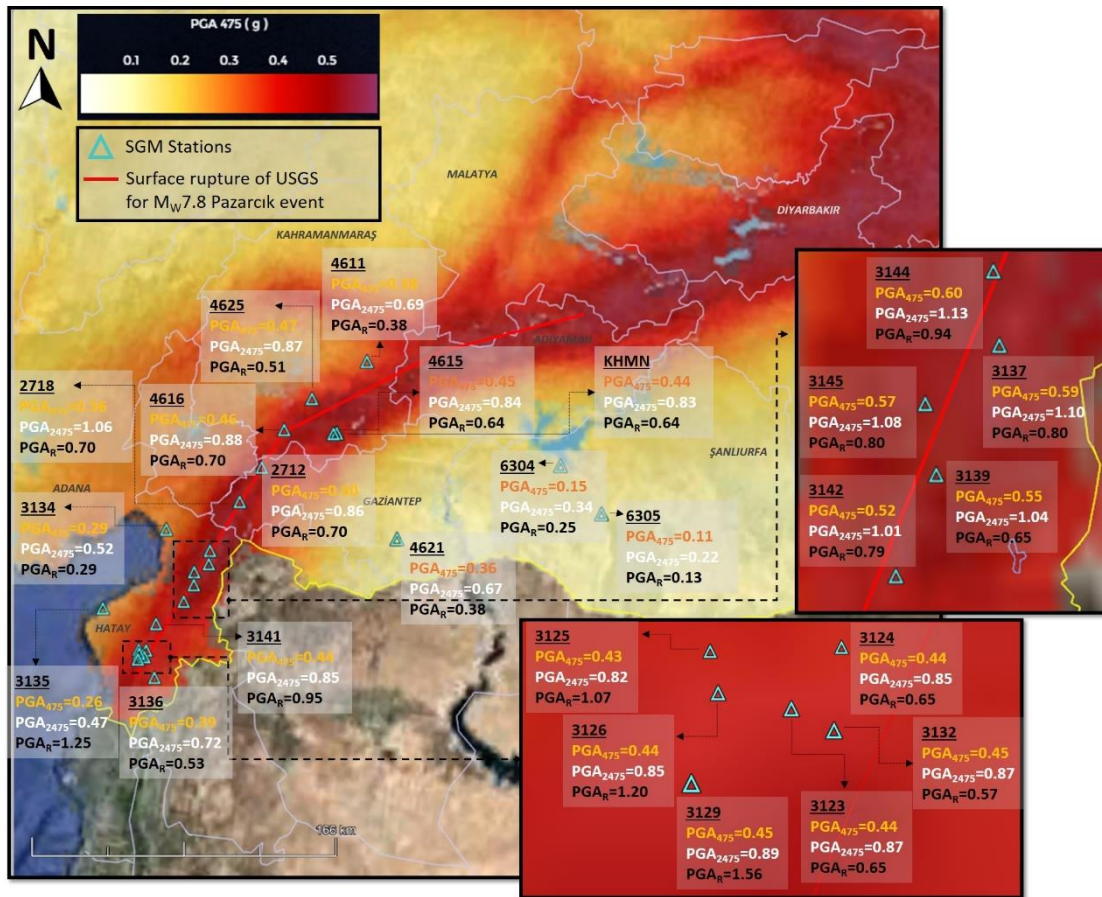
Figure 26: (top) Comparison of PGAs and PGVs of MCE (DD1) level with the resultant GMPs (GMP refers to ground motion parameter such as PGA or PGV) for the $M_w 7.8$ Pazarcık, $M_w 7.5$ Ekinözü, and $M_w 6.3$ Uzunbağ events. (bottom) Earthquake hazard map of Türkiye for $M_w 7.8$ Pazarcık earthquake illustrating the spatial distribution of exceedances of resultant PGAR to MCE (DD1) and SDE (DD2) levels.

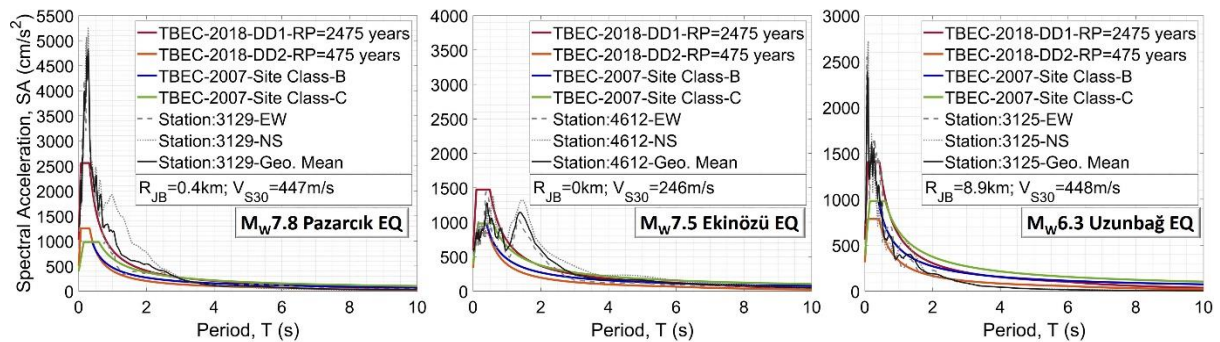
Figure 27: Comparison of largest horizontal acceleration response spectra with design spectra of 2007 and 2019 Türkiye building earthquake code for MW7.8 Pazarcık, MW7.5 Ekinözü, and MW6.3 Uzunbağ events.

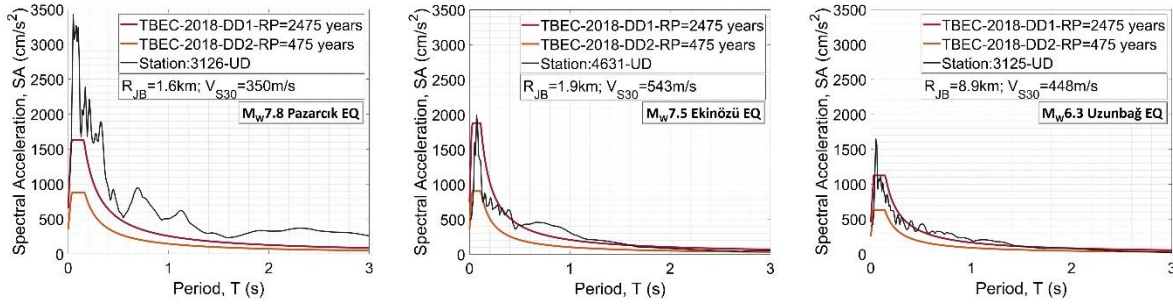
Figure 28: (top) Three-component acceleration time series with the largest vertical PGAs. (bottom) Comparison of largest vertical acceleration response spectra with the 2018 Türkiye design spectra for the MW 7.8 Pazarcık, MW 7.5 Ekinözü and MW 6.3 Uzunbağ events.

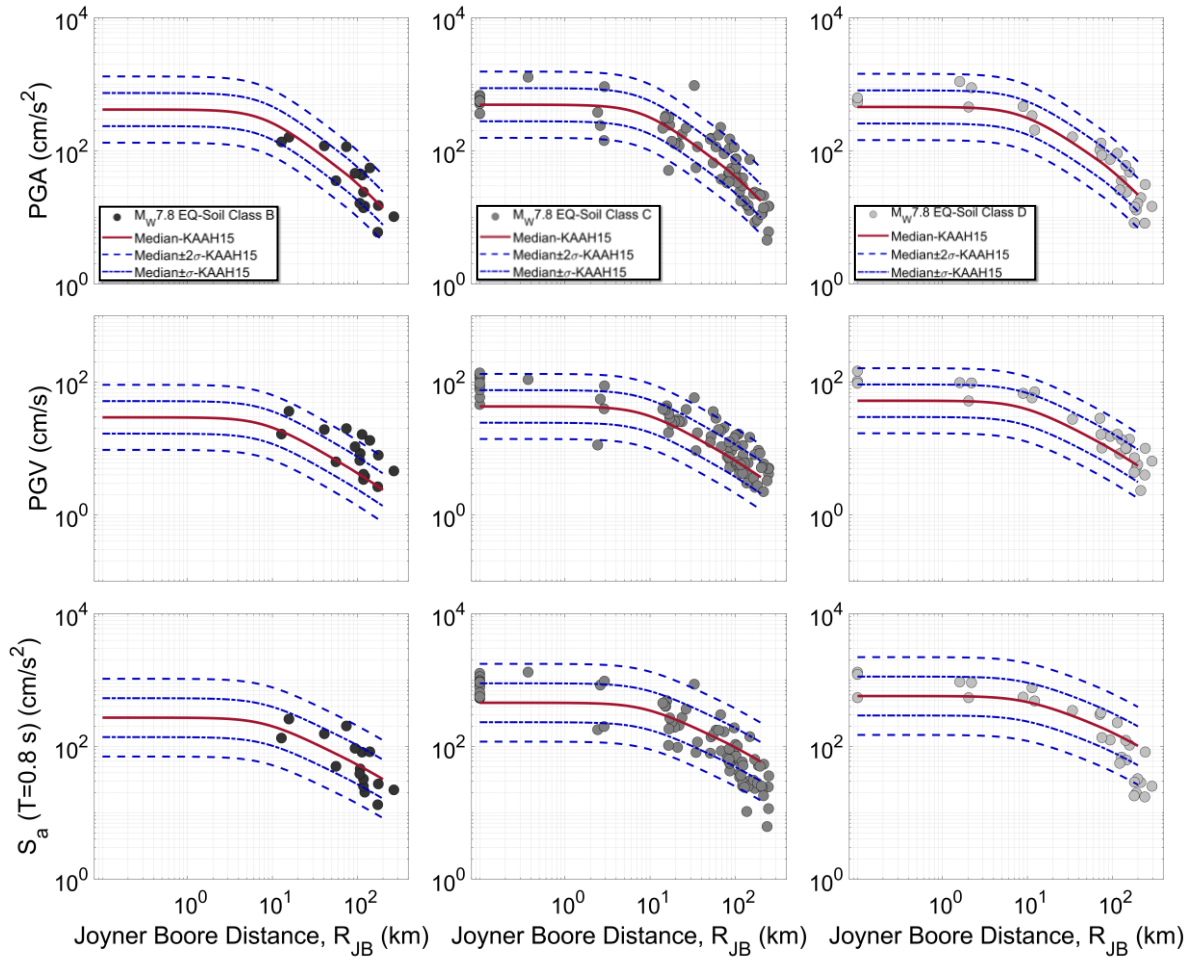
Figure 29: Comparison of the geometric mean of PGA, PGV, and SA ($T=0.8$ s; $\xi=5\%$) with ground motion prediction equation of Kale et al., 2015 (KAAH15) for the M_w 7.8 Pazarcık earthquake.
