THE TÜRKİYE EARTHQUAKE SEQUENCE OF FEBRUARY 2023

A LONGITUDINAL STUDY REPORT BY EEFIT

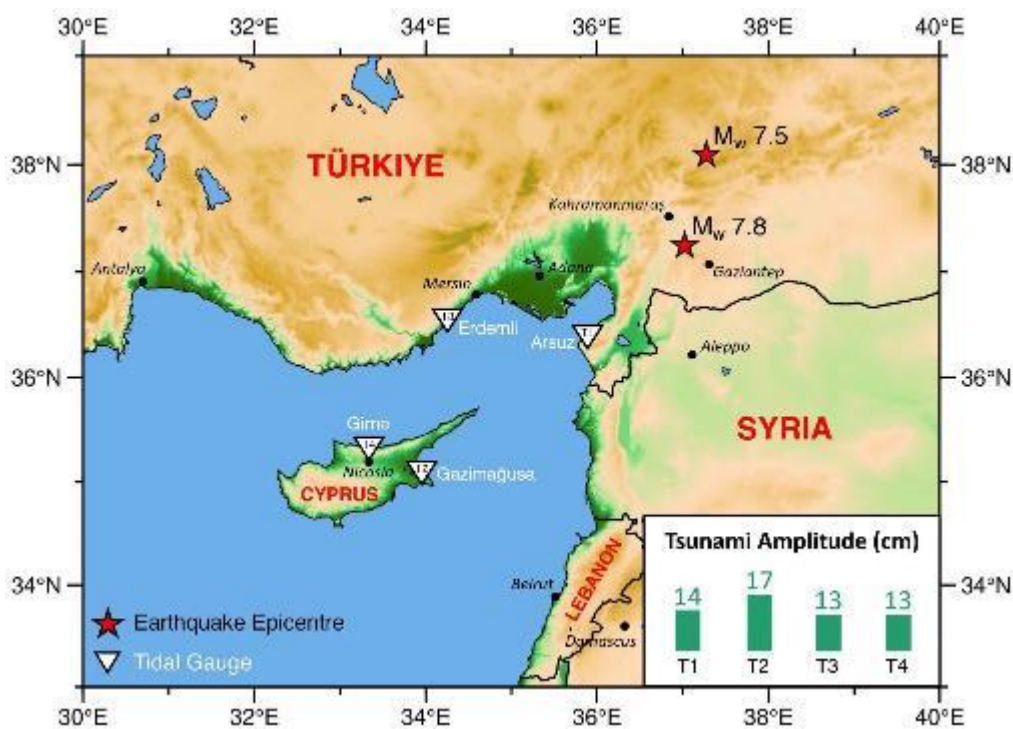
Figure 30: Map of the eastern Mediterranean illustrating where small tsunamis with <0.2 m amplitudes were recorded at Arsuz, Erdemli, Girne and Gazimagusa tidal gauge stations across south-east Türkiye and north-east Cyprus (Cetin et al., 2023).

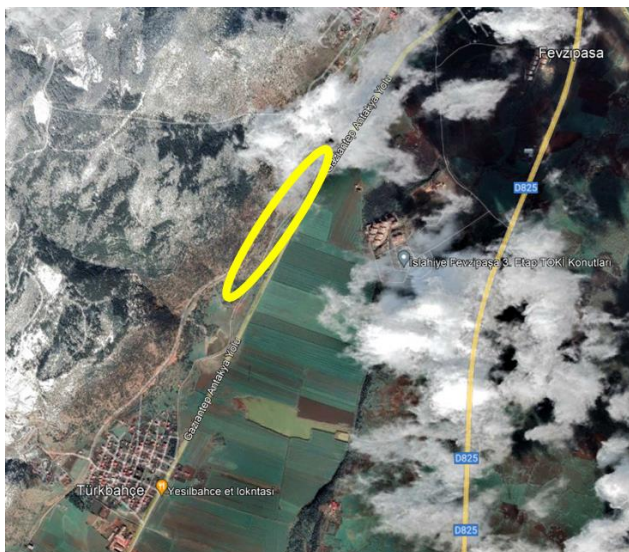
Figure 34: Area of landslides and rockfalls inspected, between Fevzipasa and Türkbahçe (image CNES/Airbus).

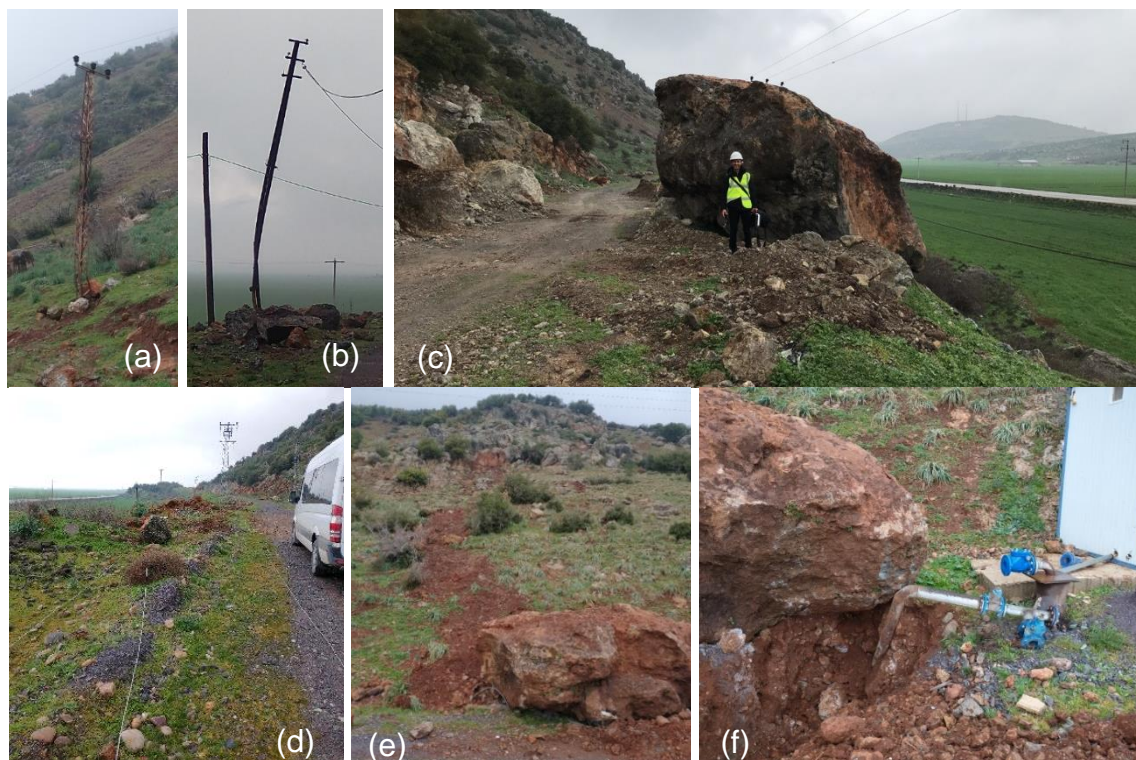
Figure 36: Rockfalls in the Fevzipasa – Türkbahçe area. (a, b) Electricity and phone line poles hit by rocks, (c) Rockfall of a boulder with dimensions 6x5.5x4 m, (d) Electricity wires on the road, (e, f) Rockfall hitting a water line. Dimensions of rock 2.2x6x4 m

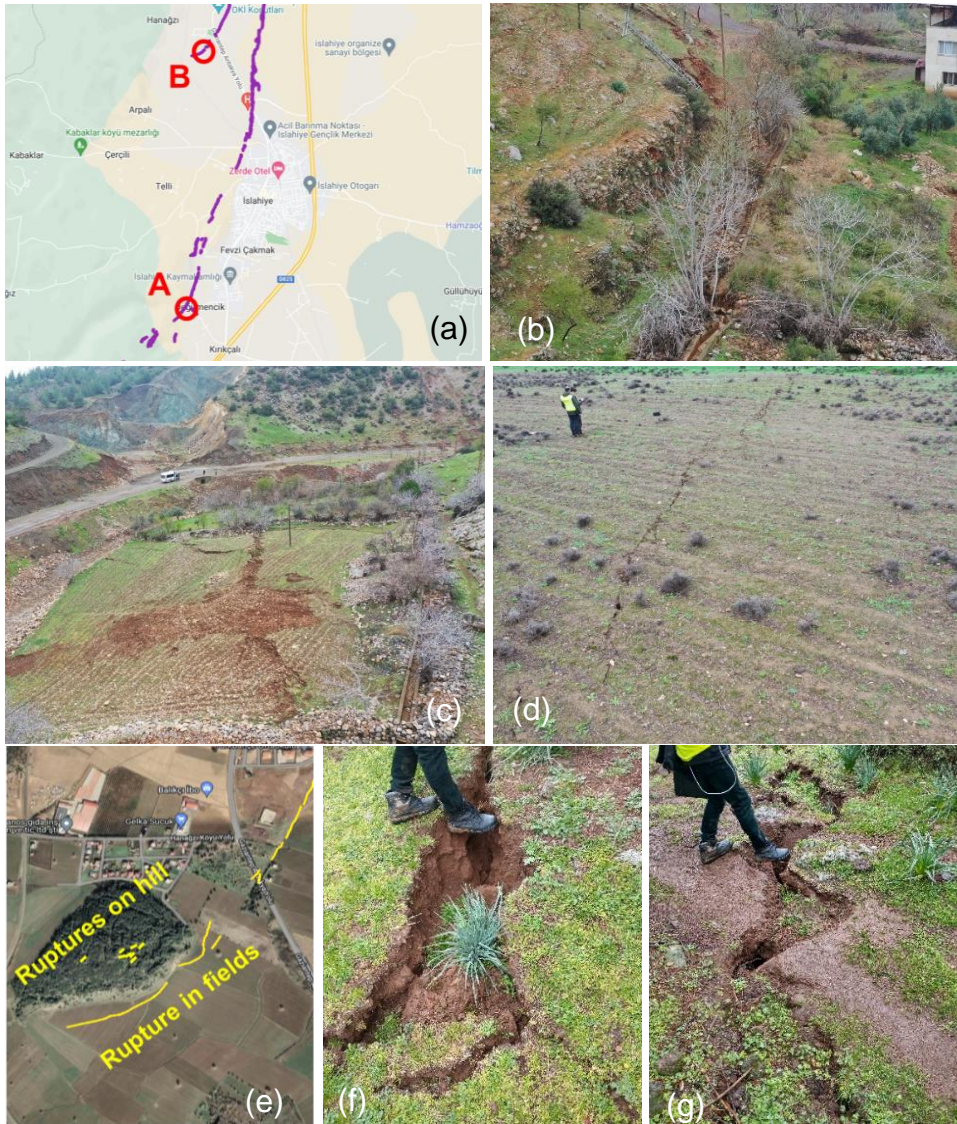
Figure 37: Observations of surface rupture in locations around Islahiye. (a) Areas where the surface rupture was inspected by the field team, (b) Surface rupture manifesting along a slope in area A. Notice the toppled electricity transmission tower and the lateral displacement along the canal. (c) Fault surface rupture in area A. (d) Rupture in the plains of area B. (e-g) Surface rupture on a hill in area B. Multiple fissures were visible, which were deeper and wider than the rupture observed in the fields.

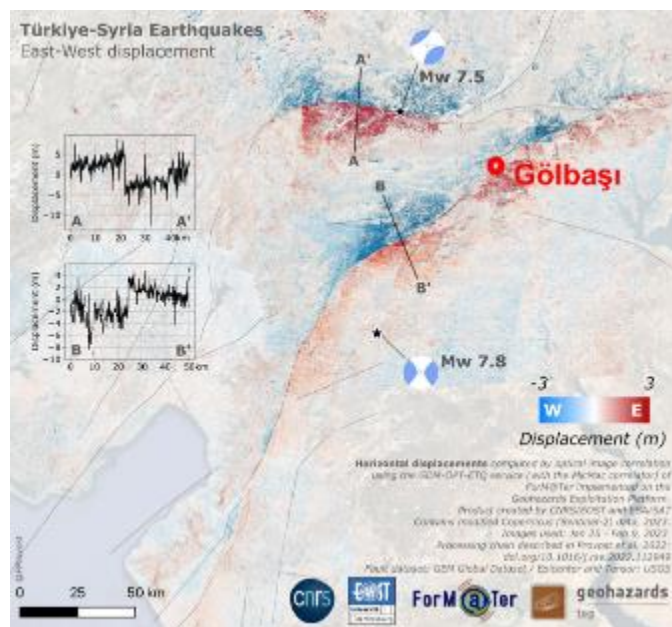
Figure 38: East-west horizontal displacement in the affected area. Image reproduced from ForM@Ter (methodology described by Provost et al. (2022)). The location of Gölbaşı is highlighted.

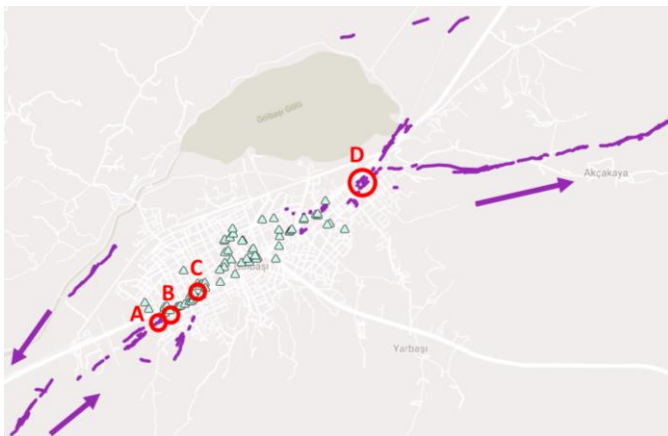
Figure 41: Surface cracks identified from virtual and field reconnaissance. The triangular markers indicate collapsed buildings.

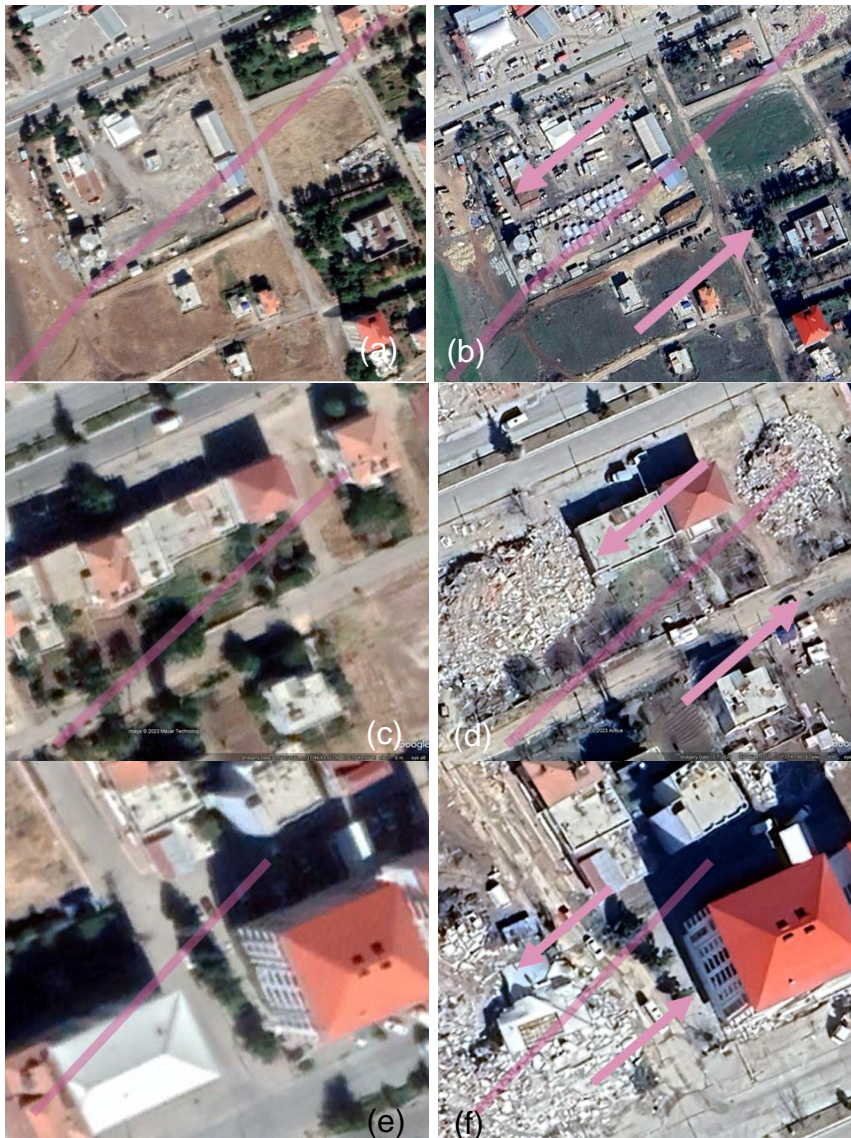
Figure 42: Satellite images before and after the earthquake sequence at locations A, B, C along the surface rupture (locations shown in map of Figure 41. (a) Location A before the earthquake (10/2022 Maxar Technologies) (b) Location A after the earthquake. Lateral displacement along a road and a rotated structure are visible, along with a surface rupture (3/2023 Airbus) (c) Location B before the earthquake (10/2022 Maxar Technologies) (d) Location B after the earthquake. Lateral displacement along the backyards and a road is visible. Structures collapsed along the surface rupture (3/2023 Airbus) (e) Location C before the earthquake (10/2022 Maxar Technologies) (f) Location C after the earthquake. Lateral displacement along a road is visible. Structures collapsed along the surface rupture (3/2023 Airbus)

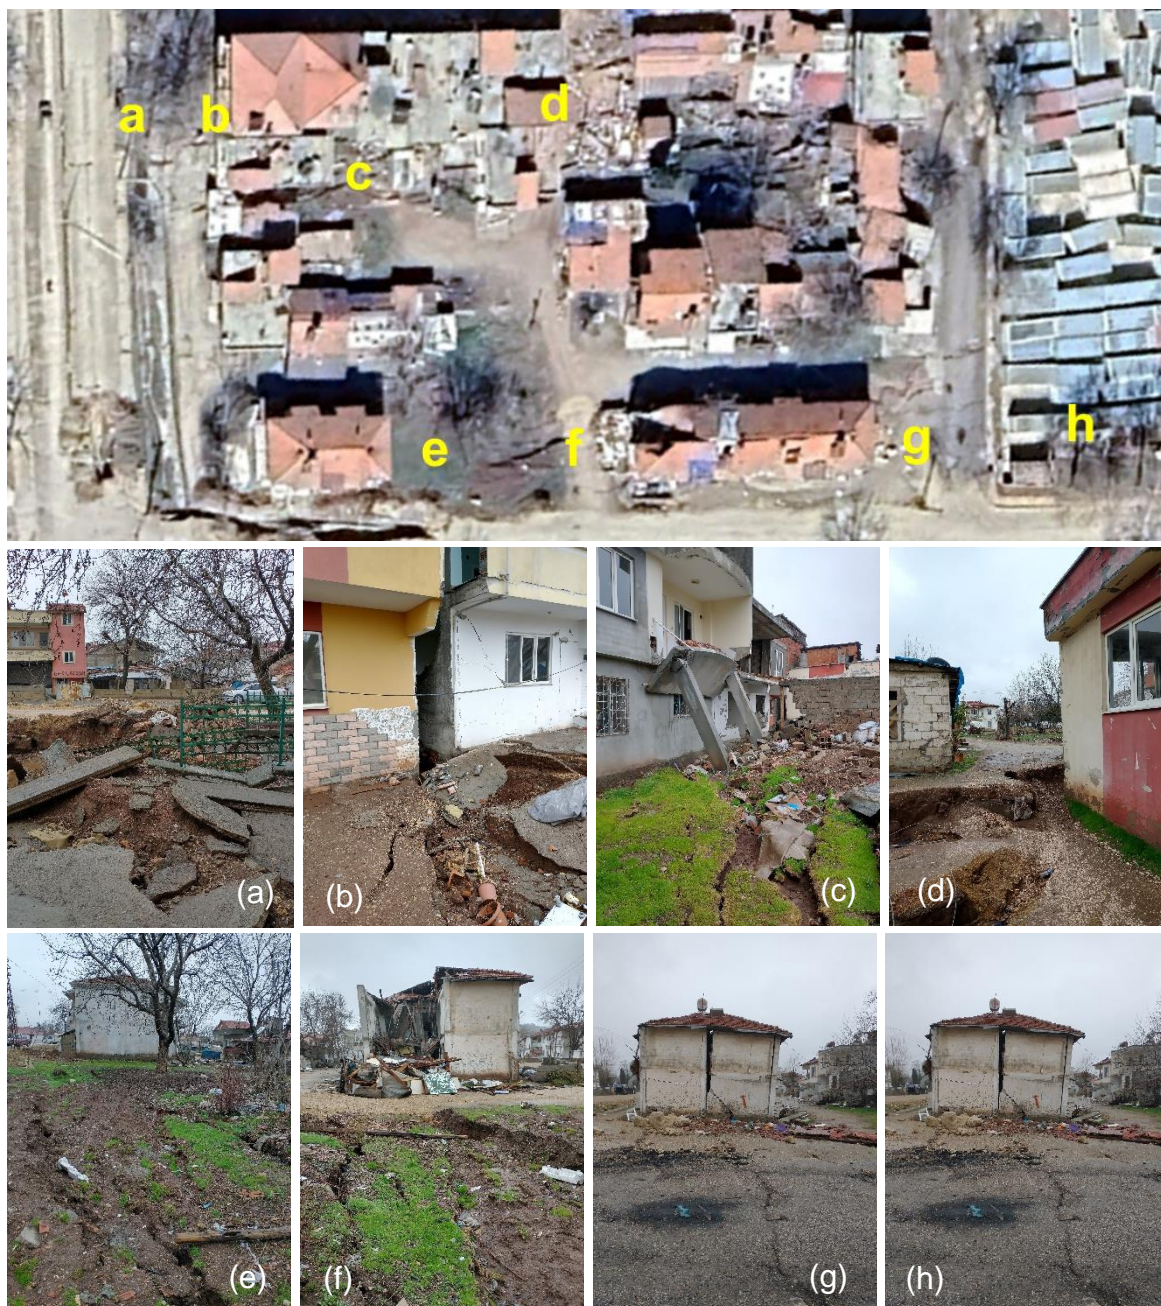
Figure 43: Interaction of surface cracks with buildings in location D of the map of Figure 41 – buildings are shown in the satellite image at the top. Notice the multiple parallel cracks visible on the soil surface. The letters correspond to the locations of the field reconnaissance photos included here.

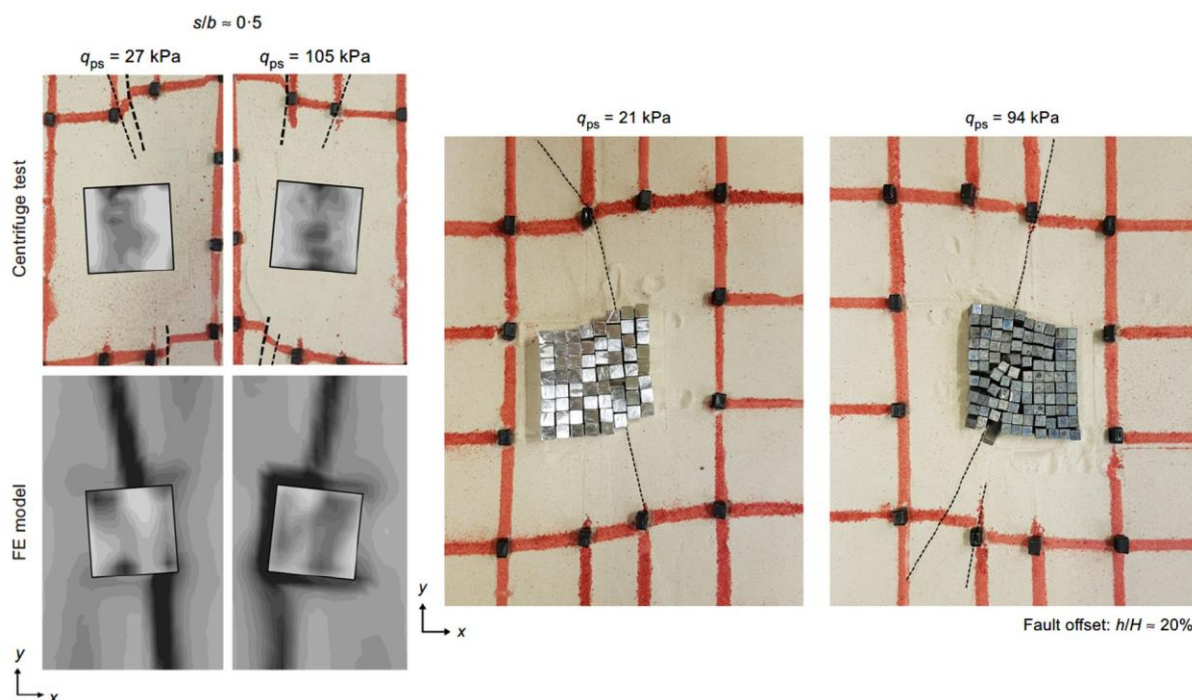
Figure 44: Centrifuge testing and FEM analysis for the response of shallow foundations on strike-slip faults. The diversion of a surface crack is primarily controlled by the kinematic constraint imposed by the foundation. Reproduced from Agalianos et al. (2023). (a) Centrifuge testing and FEM results for shallow foundations along a strike-slip fault rupture (b) Centrifuge testing for a shallow foundation along a strike-slip fault rupture, using elements that apply the required bearing pressure but do not offer a kinematic constraint.

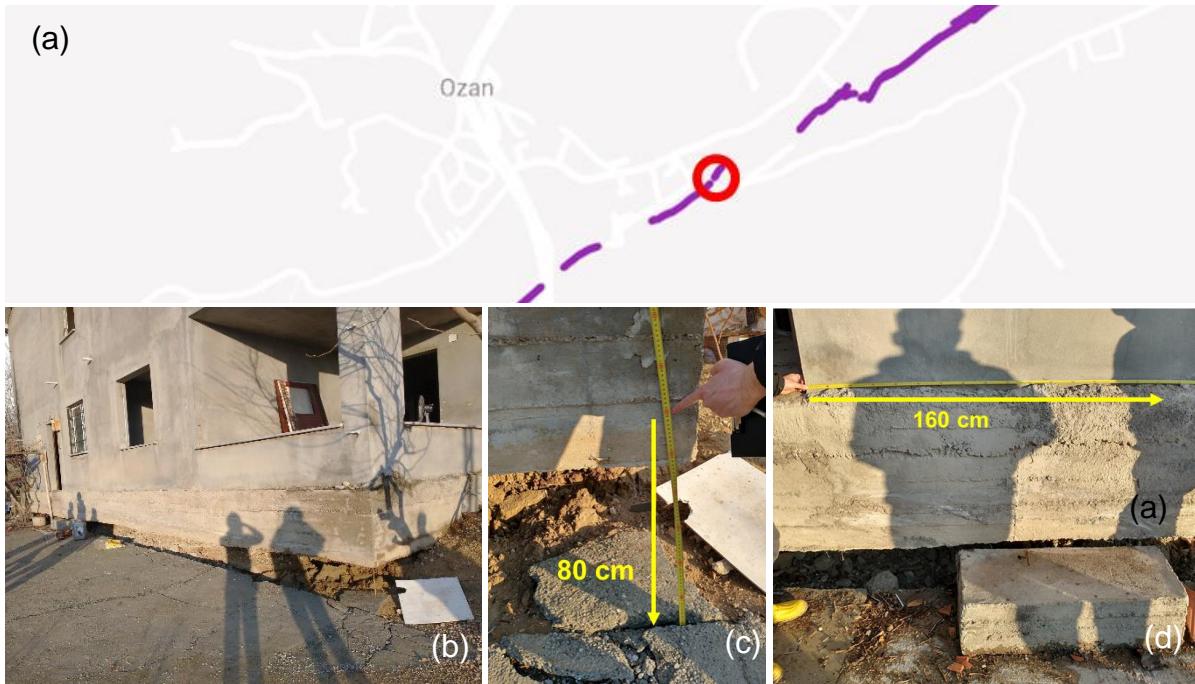
Figure 45: Surface rupture and structure interaction in Ozan, Adiyaman. (a) Map highlighting the location of the structure examined in Ozan (37.820418, 37.685387). (b) Gap between the structure and its patio (c) Vertical offset of 80 cm and (d) Horizontal offset of 160 cm

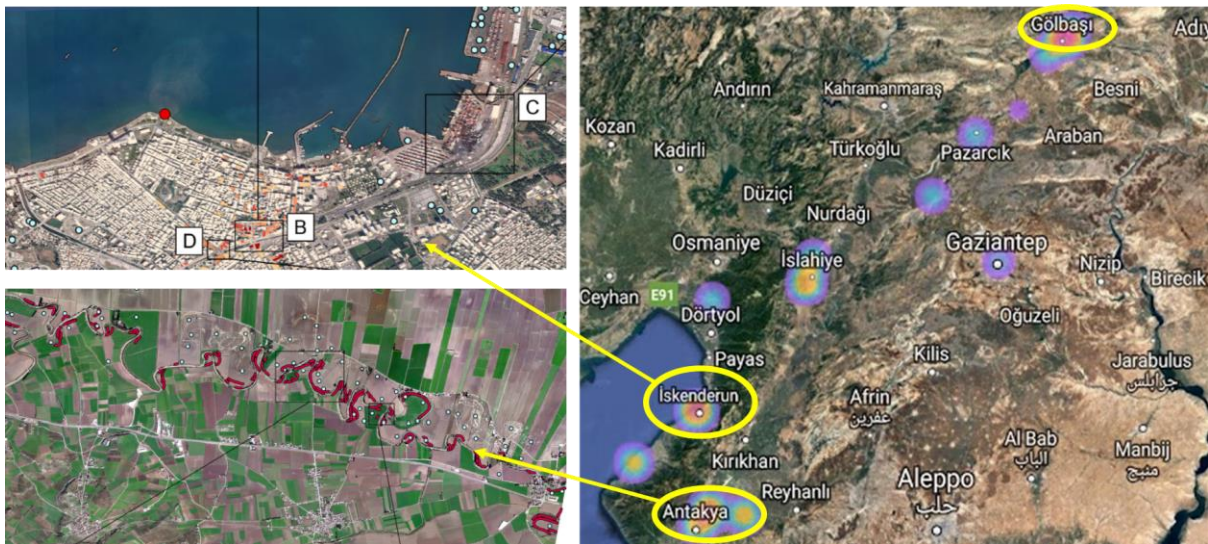
Figure 46: The yellow ellipses show the areas where liquefaction was observed. Satellite images with liquefaction features identified by virtual reconnaissance are included.

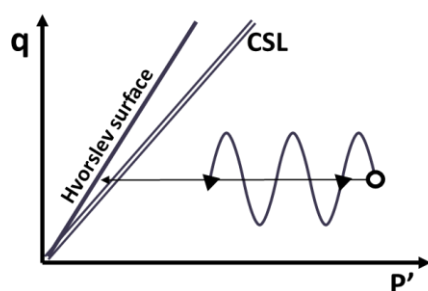
Figure 47: Schematic effective stress evolution during an earthquake, leading to liquefaction. The axes represent p' , which is the mean effective stress, and q , which is the deviator stress.

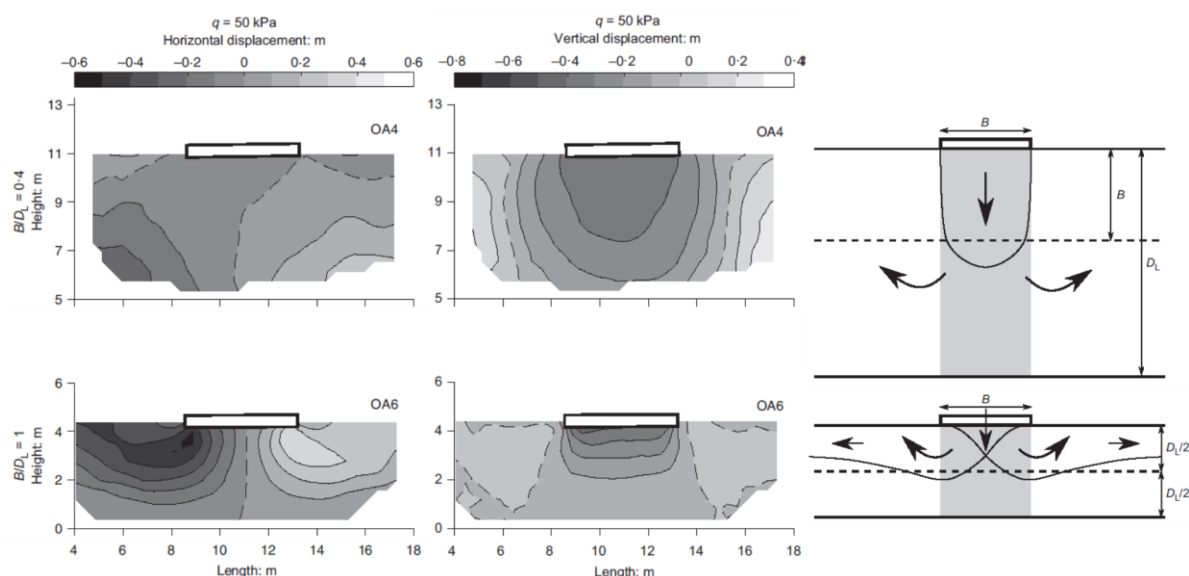
Figure 48: Experimentally observed displacement contours under a structure with a shallow foundation and applied bearing pressure of 50kPa for different depths of liquefied soil. Sketches of simplified deformation mechanisms for different ratios of foundation width are included.

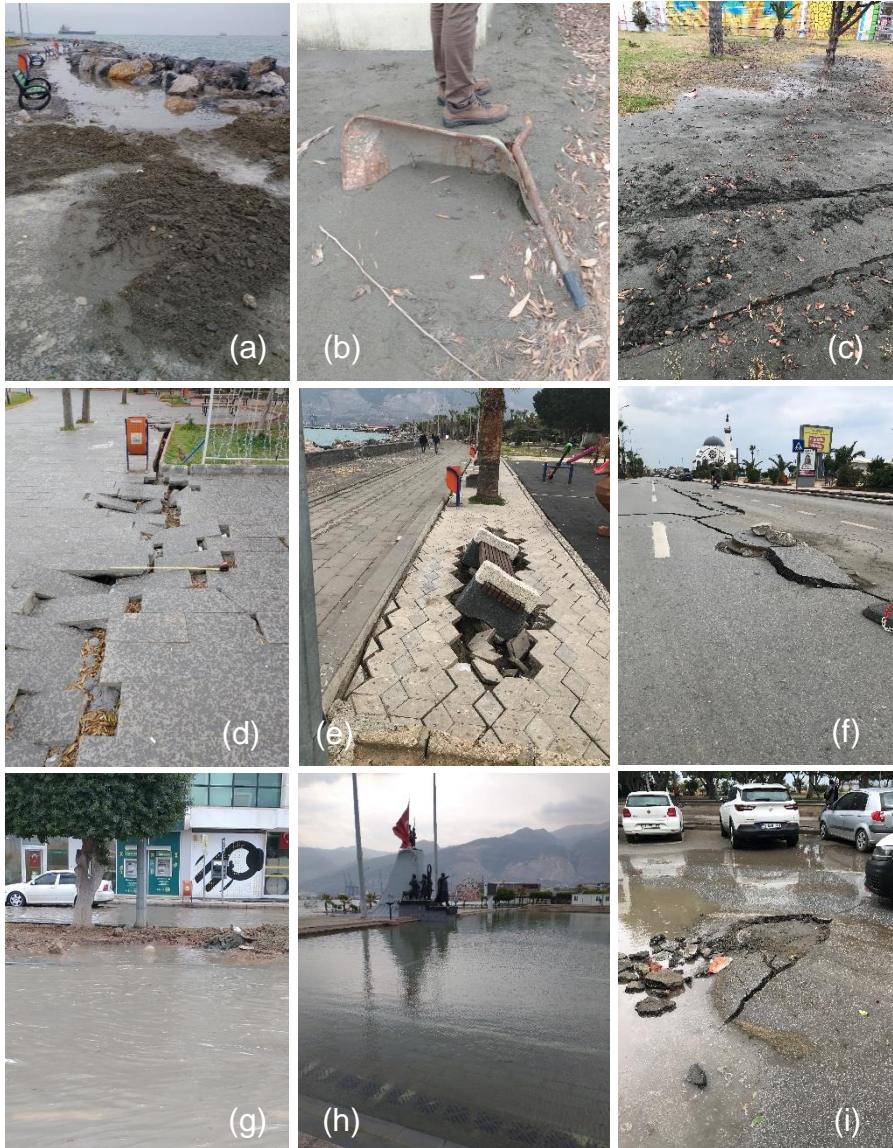
Figure 49: Characteristic surface features of liquefaction in İskenderun. (a) Sea wall movement (b-c) Ejected material (d-e) Lateral spreading crack, Yenişehir district C Boulevard, Pirireis district. (g) Subsidence along Atatürk Boulevard, Yenişehir district. (h) İskenderun Anıt Meydanı square subsidence. (i) Manhole in Atatürk Boulevard, Yenişehir district.

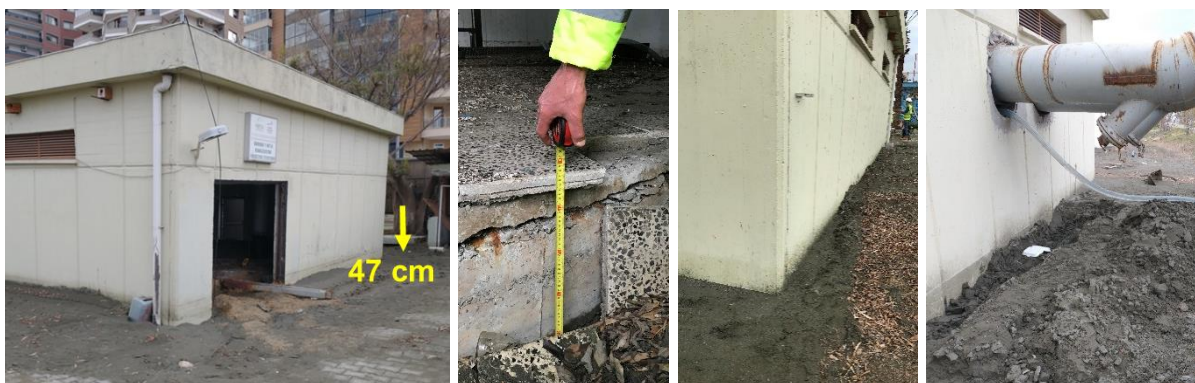
Figure 50: Liquefaction at a water management building close to the seafront (36.590891, 36.175676).

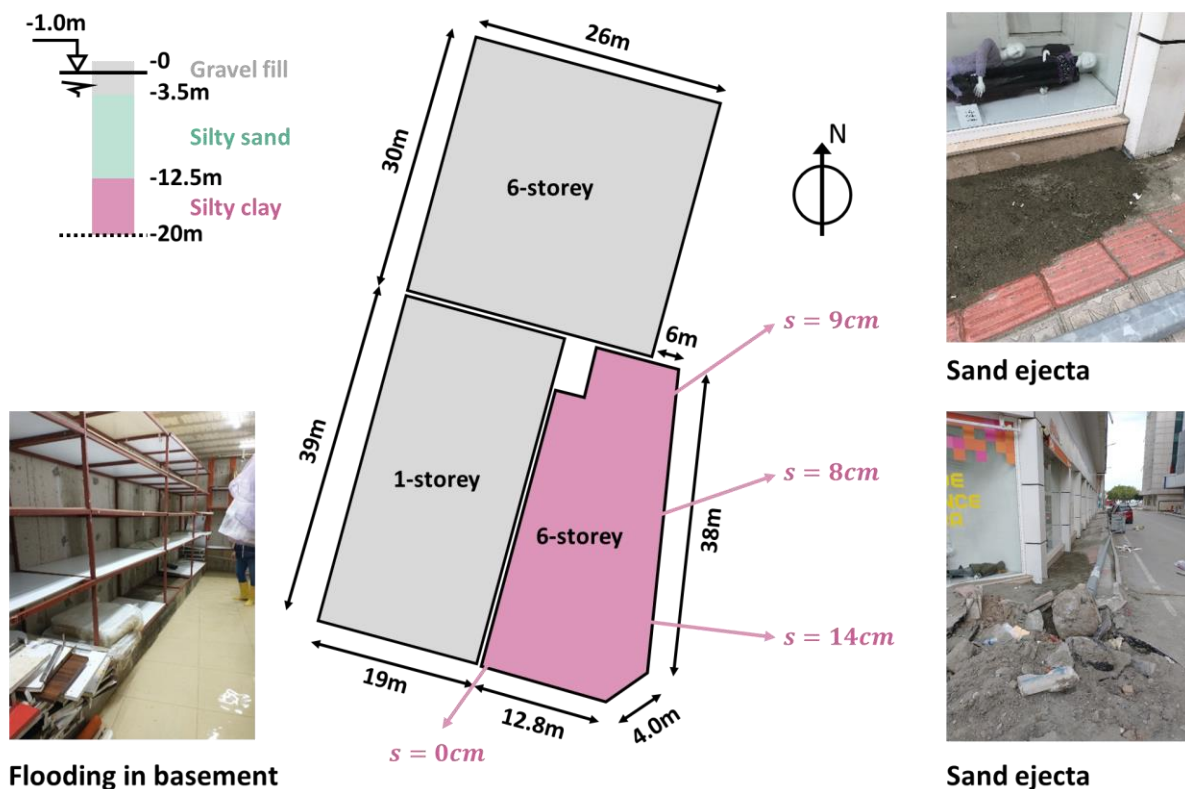
Figure 51: Liquefaction-related settlement for a 6-storey reinforced concrete building with a basement in the Çay district (36.589935, 36.173527).

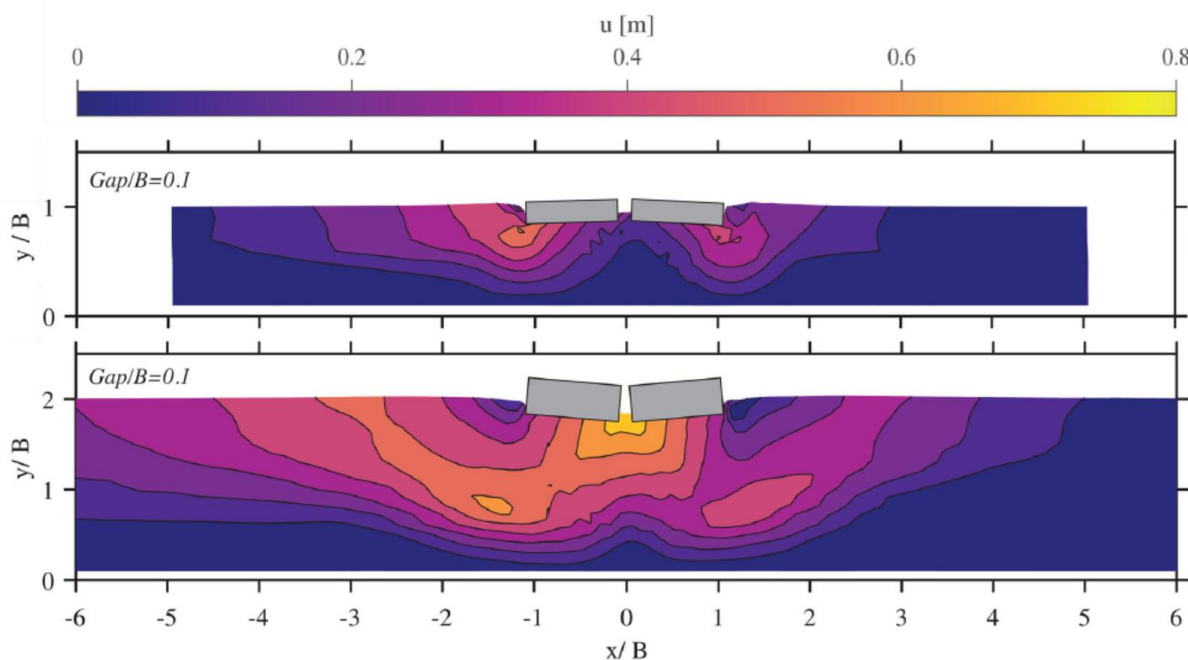
Figure 52: Displacement mechanism under two adjacent neighbouring structures on a liquefiable layer of depth equal to one foundation width (B) or two foundation widths ($2B$), reproduced from Kassas et al. (2022).

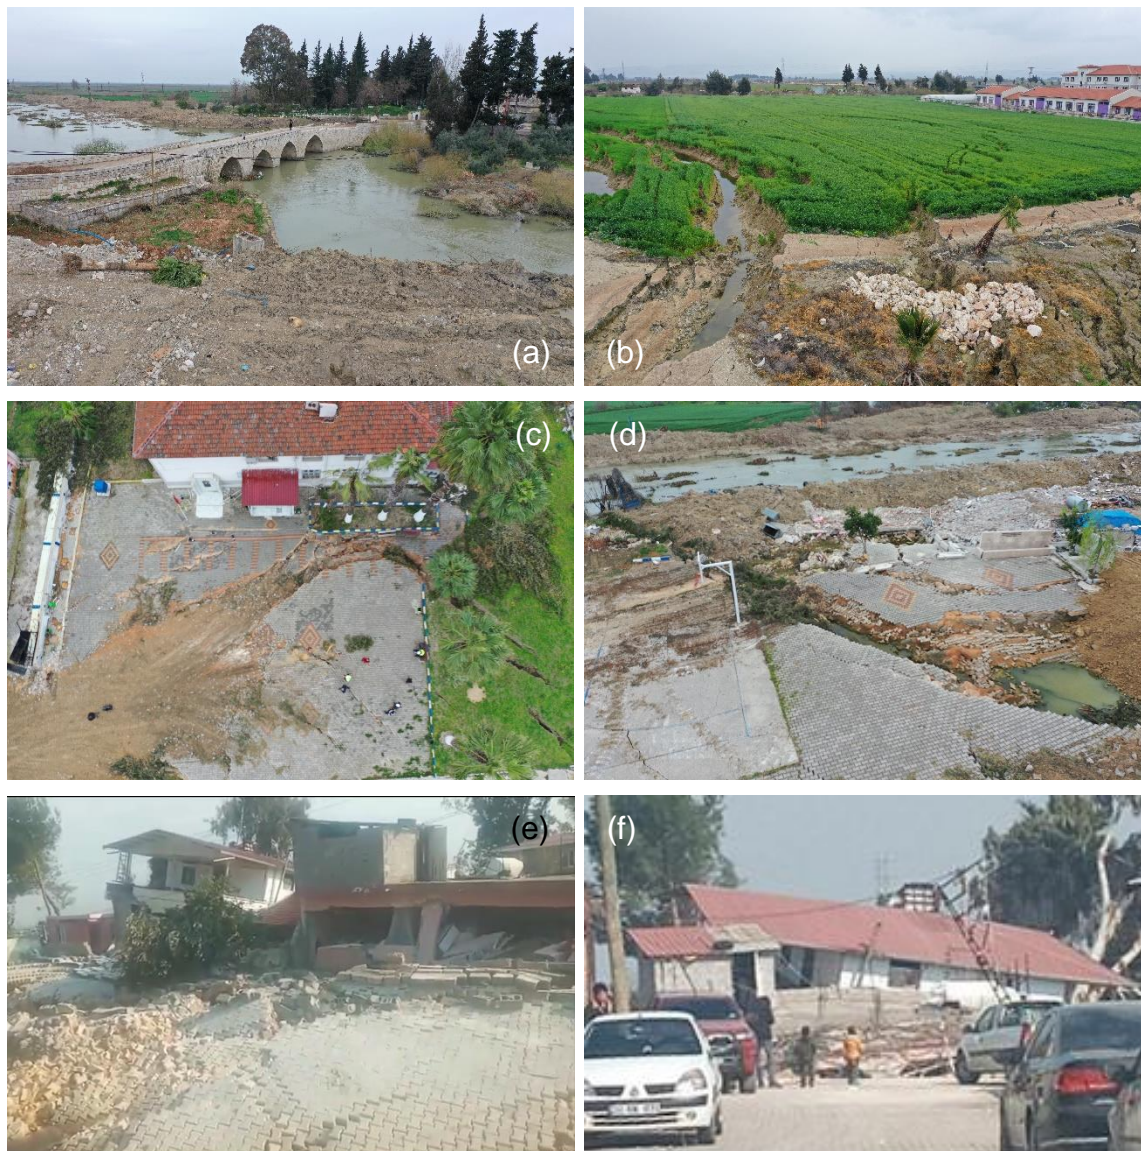
Figure 53: Liquefaction-related failures in Demirköprü. (a) The masonry bridge of Demirköprü did not suffer major damage (36.248750, 36.354769), (b) Lateral spreading cracks in close proximity to the masonry bridge, (c) Lateral spreading at the school of Demirköprü (36.250107, 36.352776), (d) Lateral spreading towards the river, (e-f) Shallow founded structures in the zone of spreading next to the school of Demirköprü

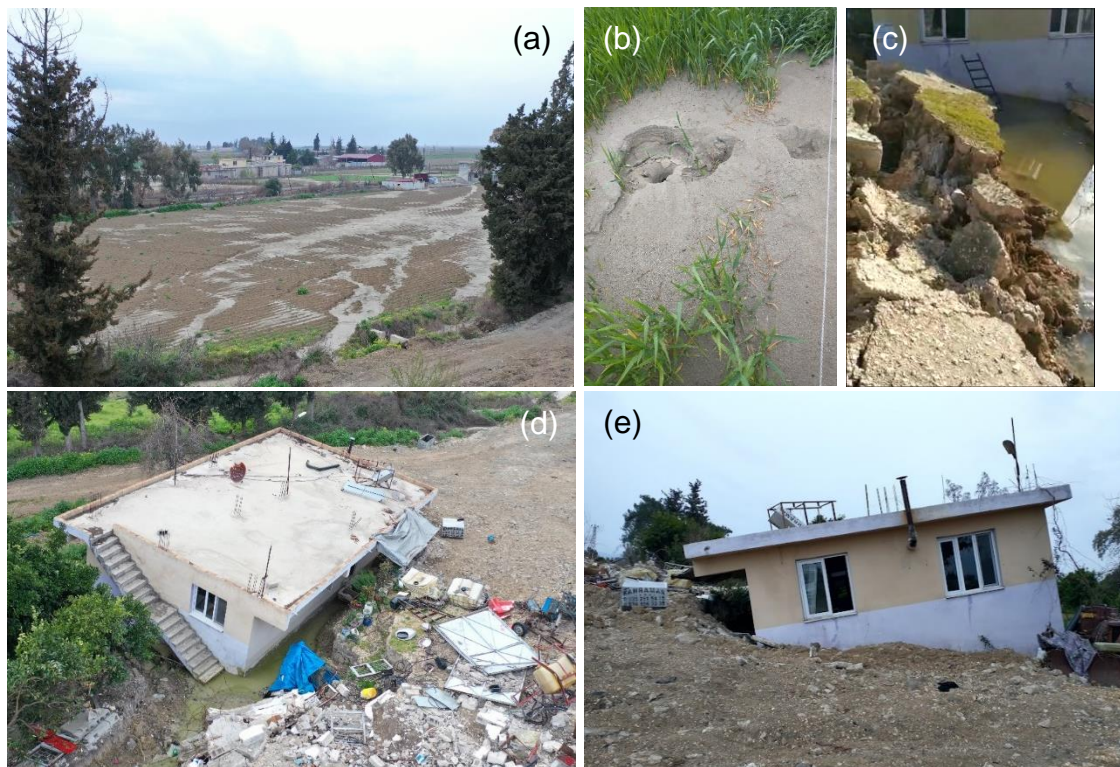
Figure 54: Liquefaction-related damage along the Orontes River. (a) Large features of surface sand boiling (b) Ejected sand (c) Photo directly after the earthquake (d) Drone view of a shallow-founded structure at an area of liquefaction and spreading (36.253701, 36.347800) (e) Excessive settlement and tilting

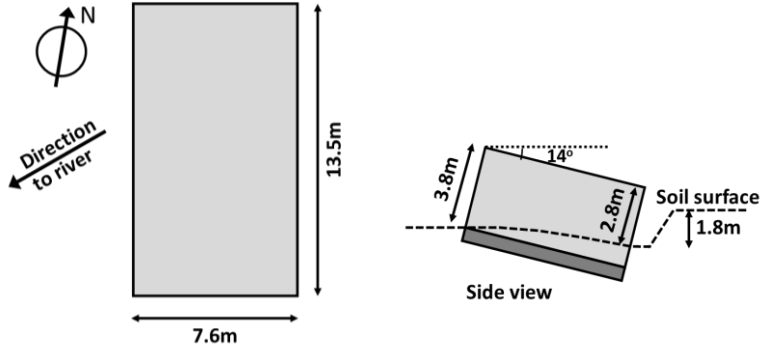
Figure 55: Sketch of single-storey structure in liquefaction zone next to the Orontes River (36.253701, 36.347800).

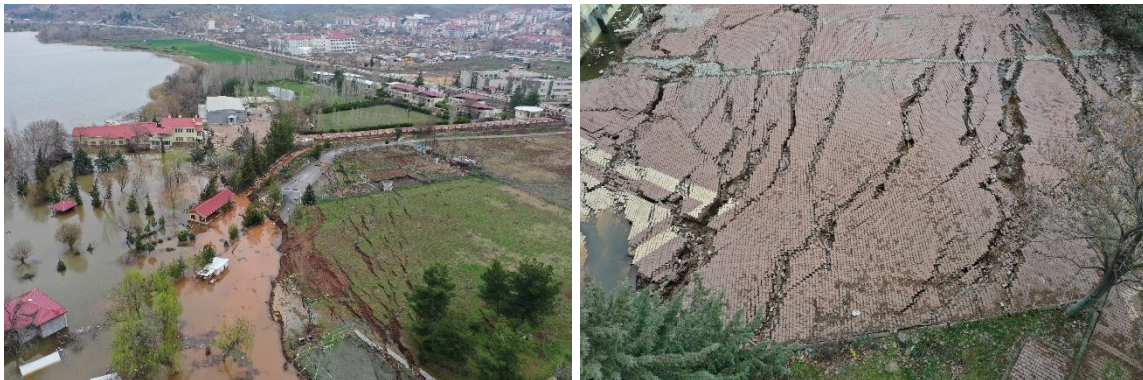
Figure 56: Lateral spreading in a lake-side park in Gölbaşı (37.794157, 37.649400).

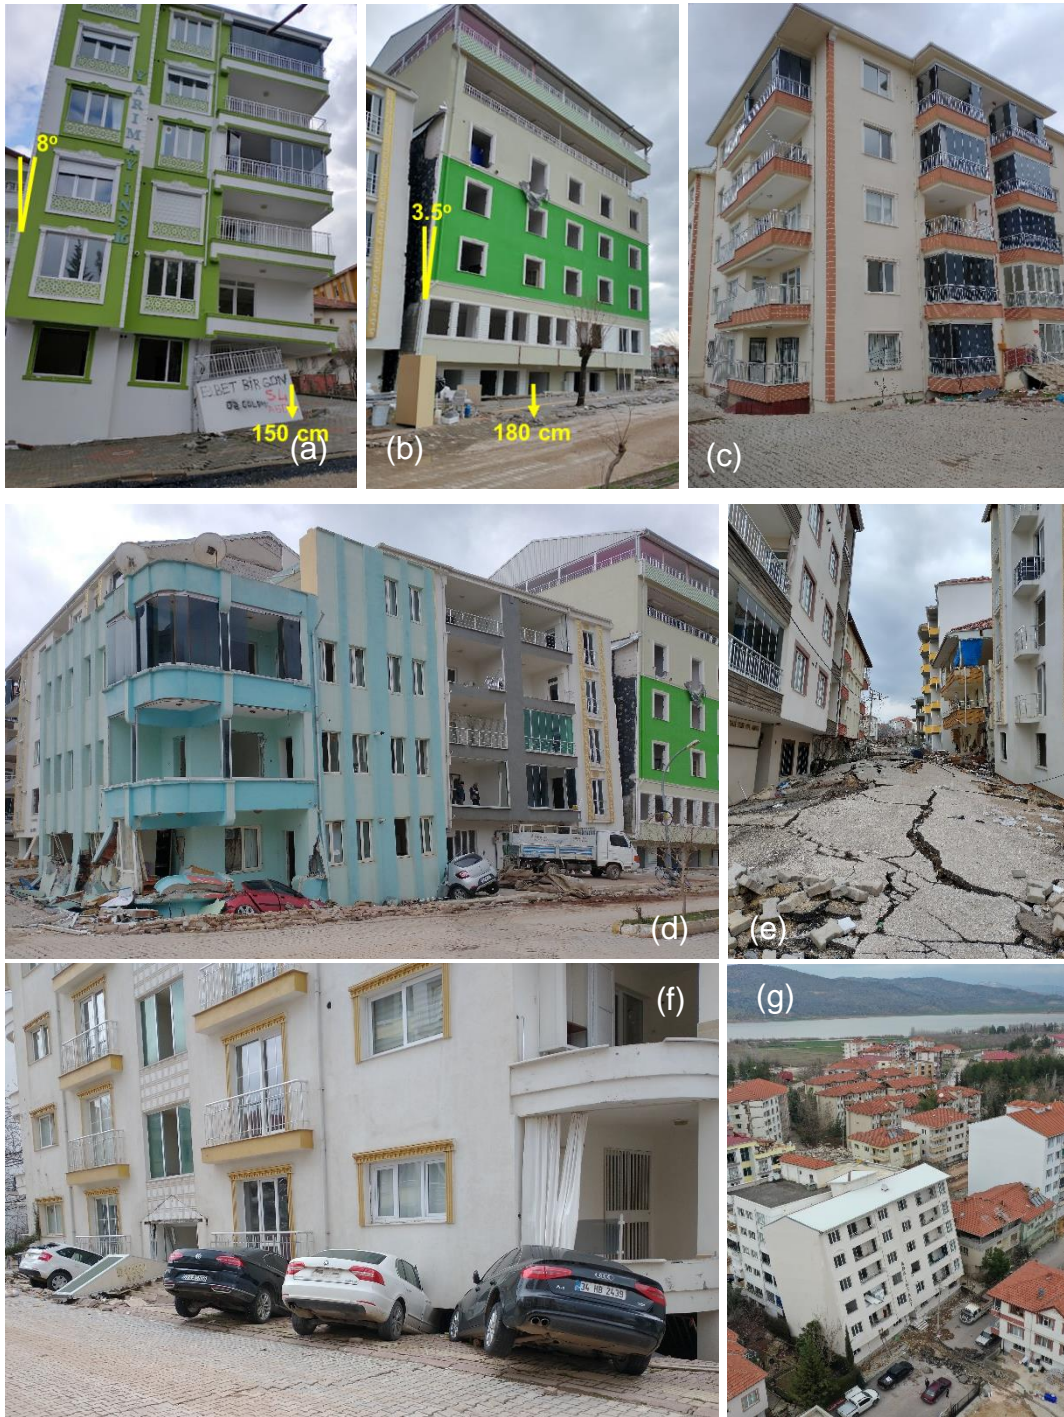
Figure 57: Liquefaction-related damage of buildings in Gölbaşı. (a) Building with a shallow foundation (37.789275, 37.645262) (b) Building founded on piles (37.787486, 37.642252) (c) Settlement of residential building (37.788127, 37.642037) (d) Series of buildings affected by liquefaction (37.787687, 37.642644) (e) Series of buildings affected by liquefaction (37.787367, 37.642858) (f) Large settlement of structure with shallow foundation (37.787958, 37.643190) (g) Significant tilting (37.787730, 37.643366)

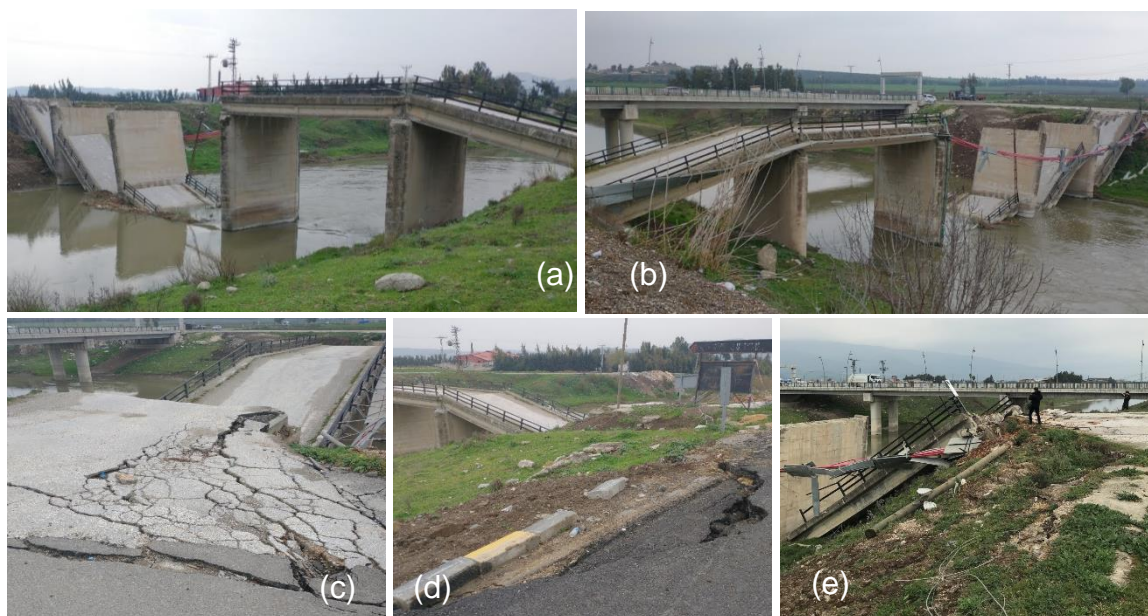
Figure 58: Hatay state hospital bridge (a) the old bridge (b) the new bridge behind the old one (c) slope failure at the connection point of the deck with the ground (d) slope failure next to the bridge (e) slope failure at the connection point of the deck with the ground.

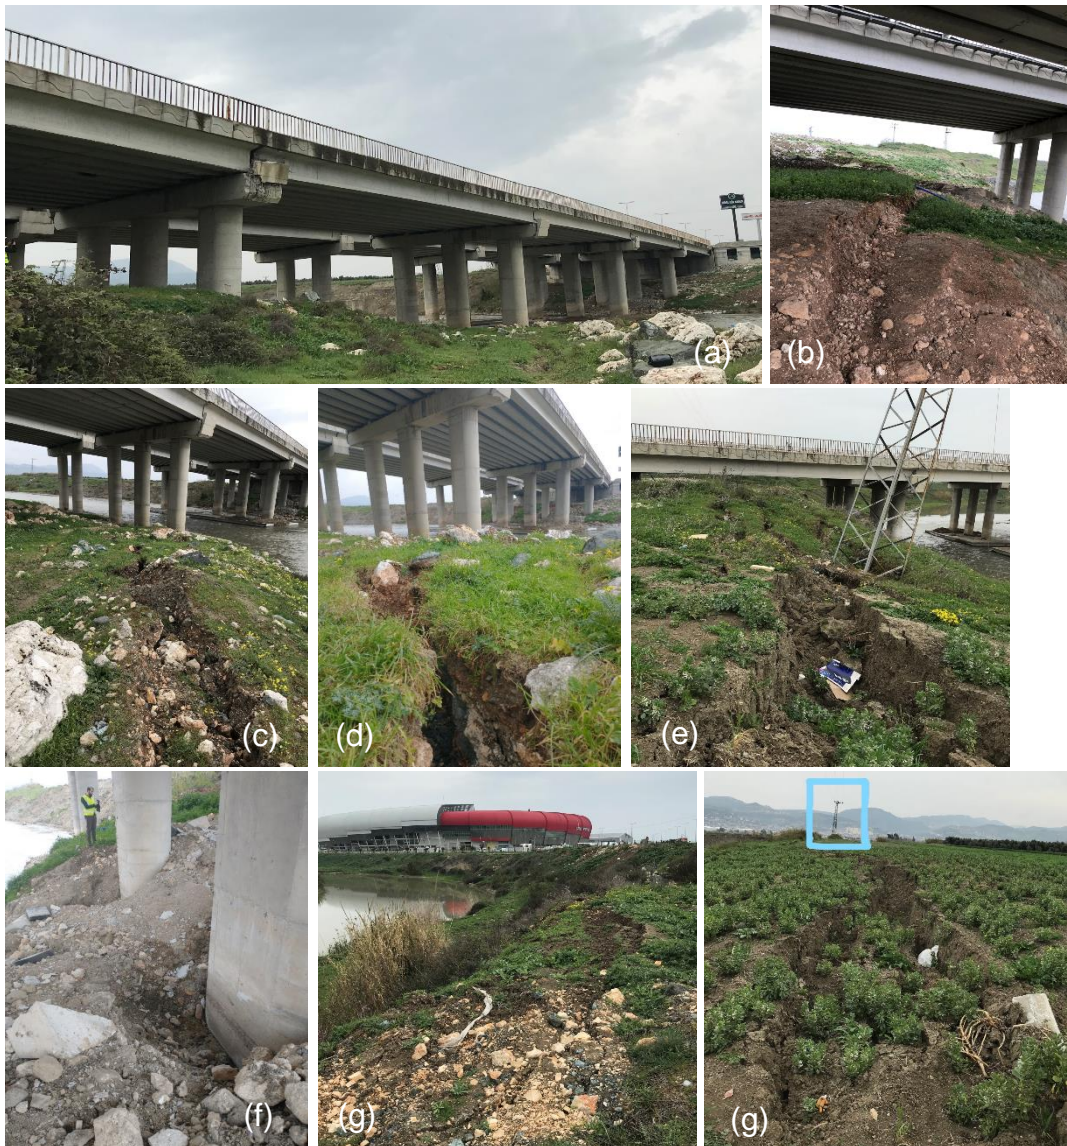
Figure 59: Hatay stadium bridge geotechnical features. (a) general view of the bridge, (b) spread-related movement on the east slope, (c) spread-related movement on the east slope, (d) spread-related movement on the east slope, (e) spread-related movement on the west slope, (f) slope stability failure on the eastern bank, (g) spreading along the eastern riverbank further away from the bridge, (h) spread along the riverbank: an inclined electricity tower far from the bridge

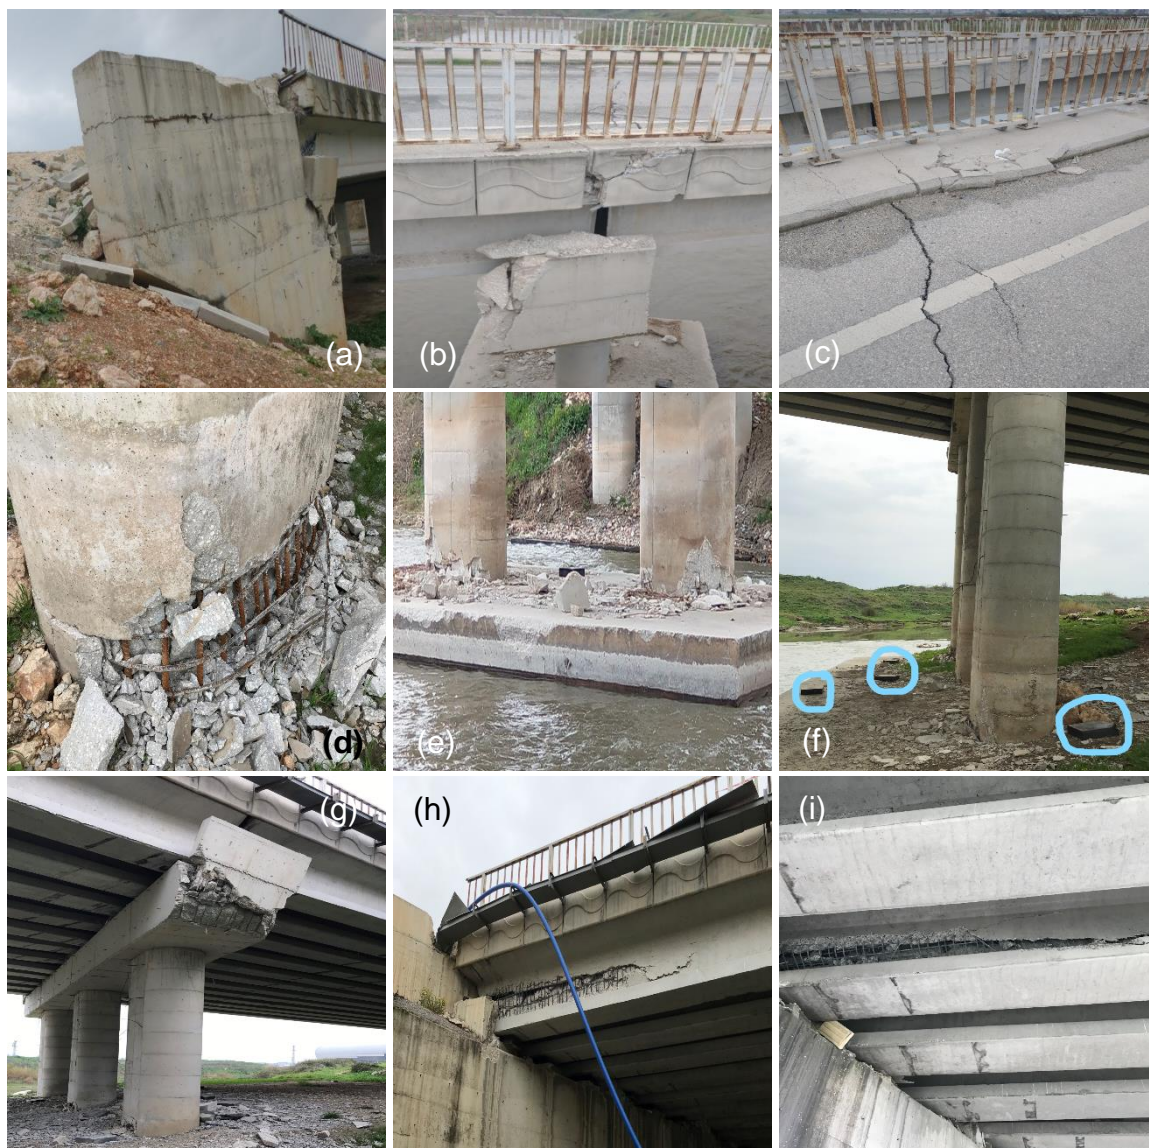
Figure 60: Hatay stadium bridge structural features. (a) movement and tilting of the east abutment, (b-c) deck compression crack, (d) plastic hinging at pillars on west bank (e) plastic hinging at pillars, (f) falling bearings on west bank, (g) shear key failure, (h-i) damaged girder

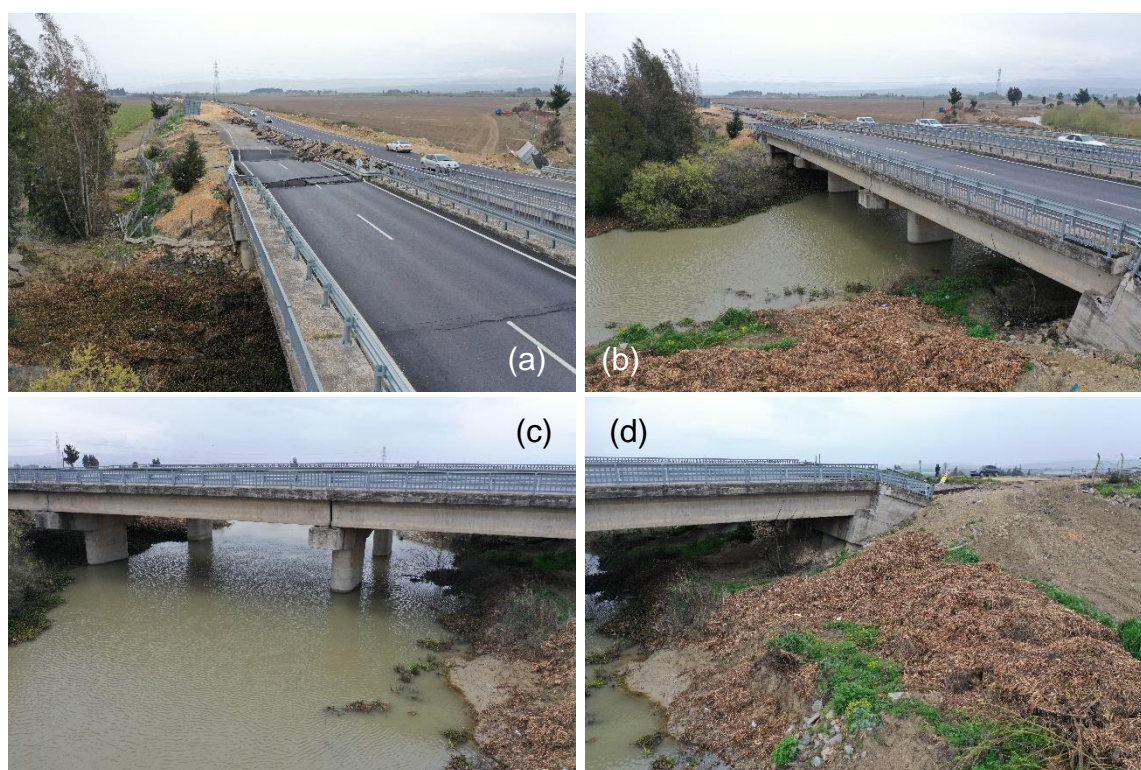
Figure 61: Lateral spreading-related damage of bridge in Demirköprü (36.245878, 36.357019). (a) damage of pavement to the east of bridge (b) View of the bridge from the west side (c) Rotation of piers and visible spreading of soil (d) Rotation of abutment due to spreading.
