THE TÜRKİYE EARTHQUAKE SEQUENCE OF FEBRUARY 2023

A LONGITUDINAL STUDY REPORT BY EEFIT

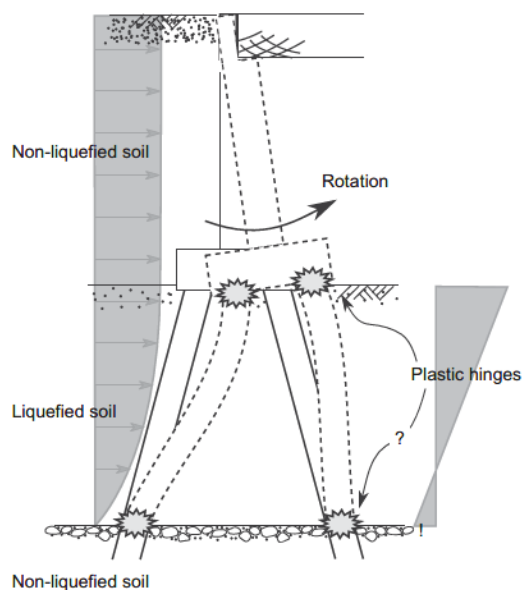
Figure 62: Rotational mechanism of abutment in laterally-spreading soil. Reproduced from Haskell et al. (2013).

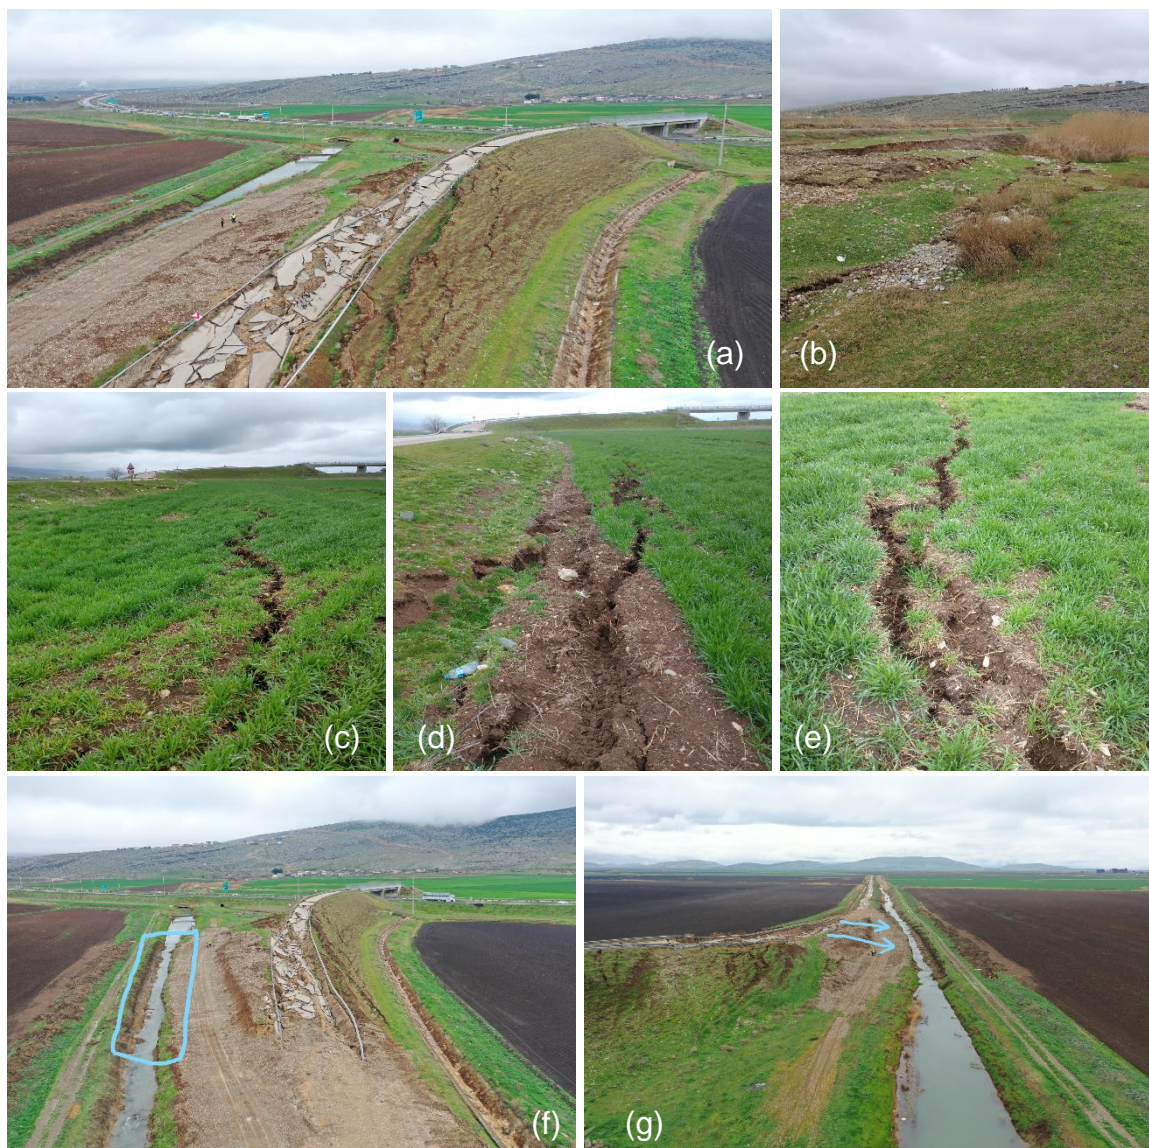
Figure 63: Embankment between the villages of Evri and Çöçelli (37.283724, 37.113888). (a) general view of embankment failure, (b-e) surface crack, (f-g) water channel-related failure

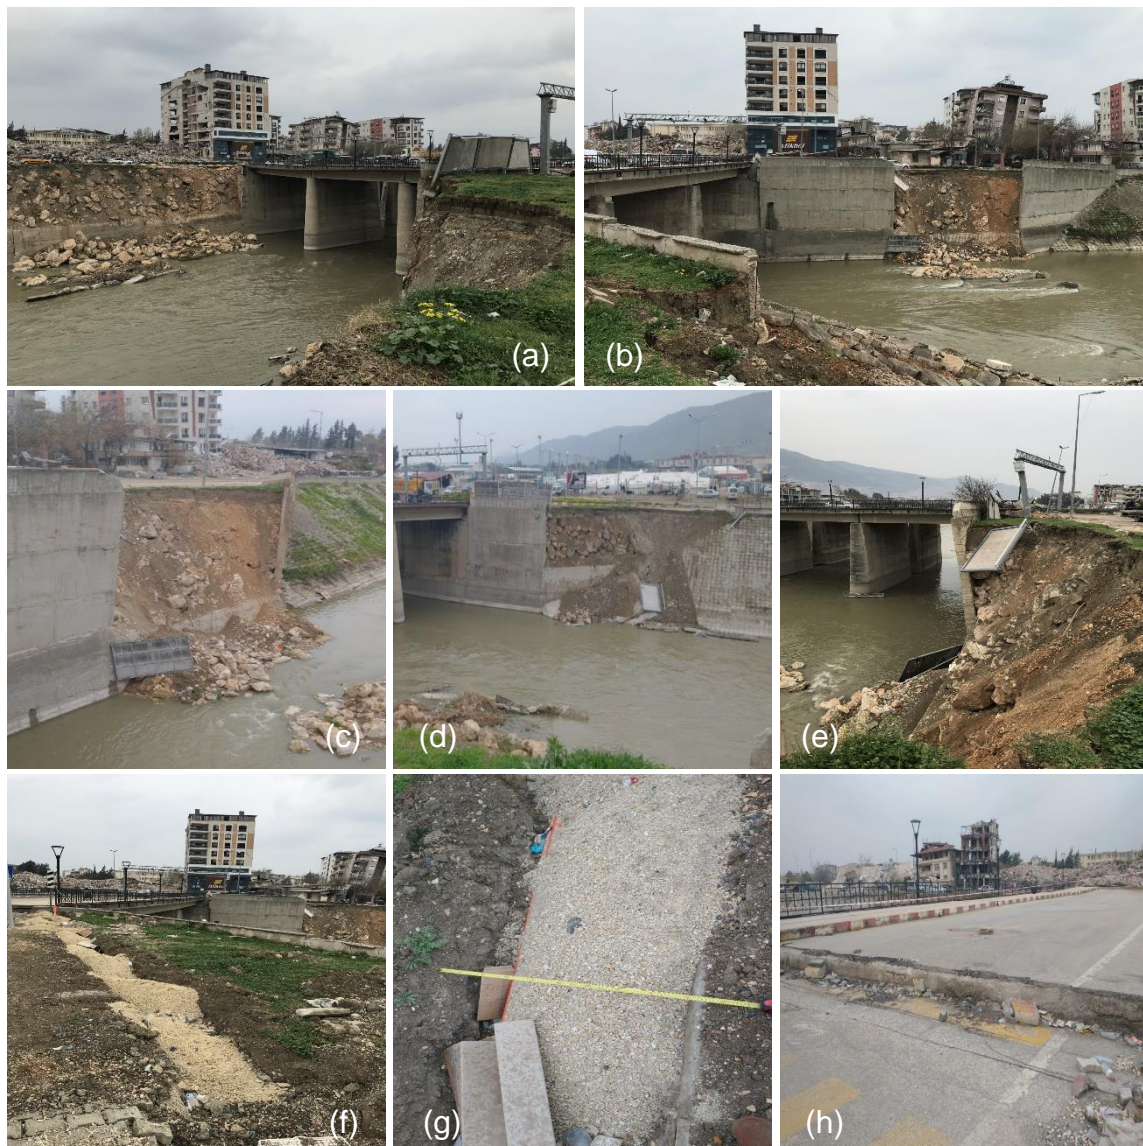
Figure 64: Bekir Karabacak Bridge / Retaining wall failure (36.215443, 36.162129). (a-e) retaining wall failure, (f-g) slope instability related cracks (h) vertical displacement.

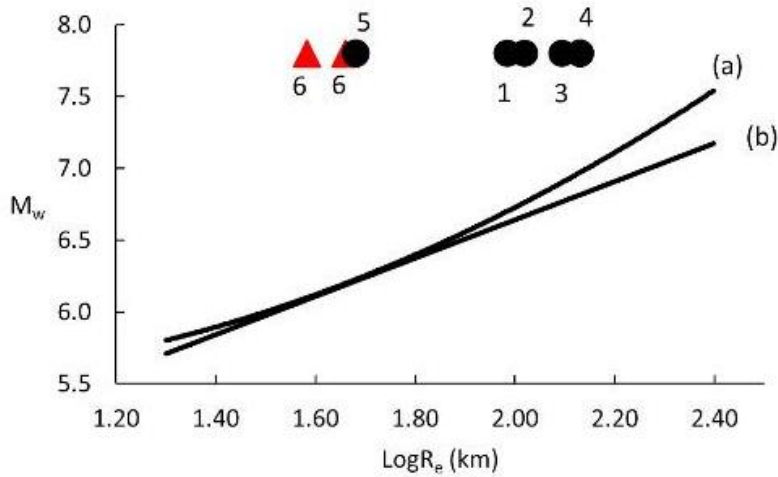
Figure 65: Maximum epicentral distance, R_e , of sites with ground effects. Key for data: solid circle=liquefaction and subsidence, solid triangle=landslides and rockfalls. Numbers from (1) to (6) correspond to numbering of areas listed in Table I. Curves (a) and (b) correspond to formulae (a) and (b) (see text above the figure).

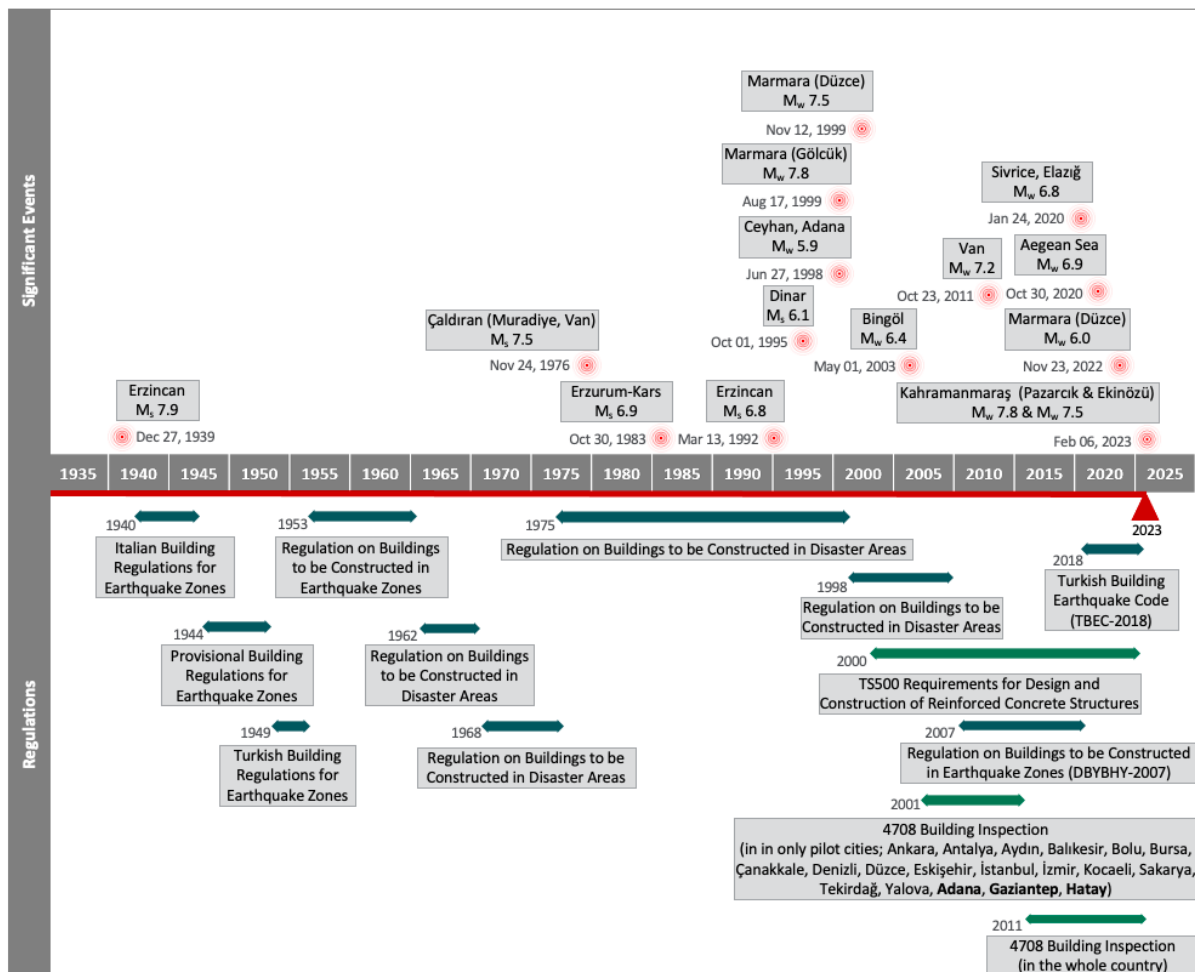
Figure 66: Significant historical events and development of Turkish building regulations.

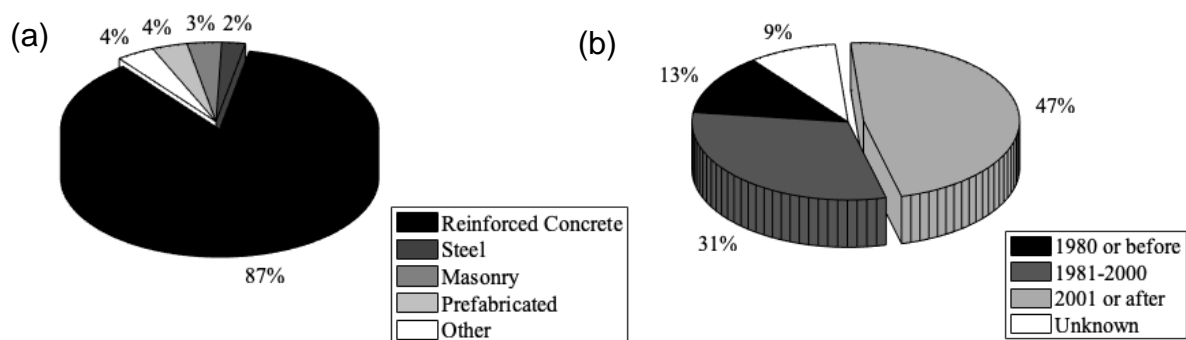
Figure 67: Breakdown of (a) Load-Bearing Systems of Buildings (%) and (b) Building Construction Year (%) in the earthquake-affected region (Numbers are taken from PSB, 2023).

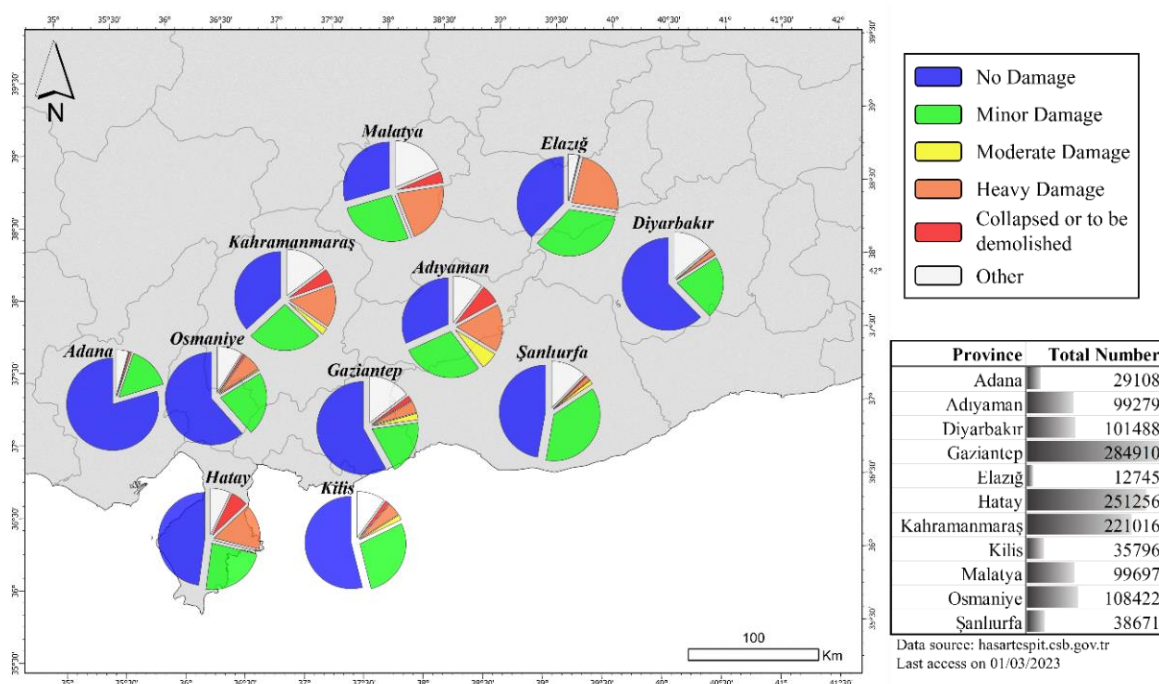
Figure 68: Distribution of the building damage in the eleven provinces declared as disaster region by the Turkish government.

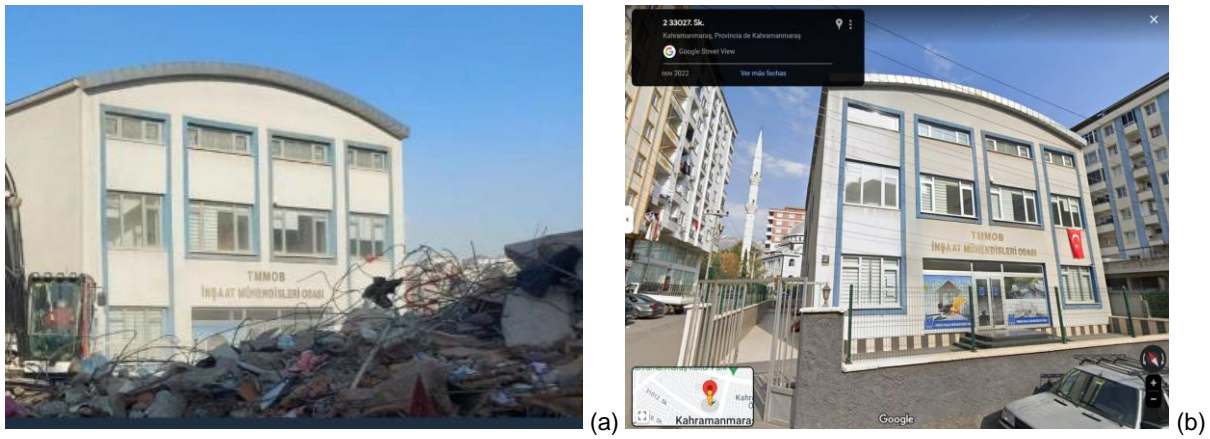
Figure 70: Building used as the Chamber of Civil Engineers in Kahramanmaraş a) after the earthquake taken from Image the American Society of Civil Engineers (ASCE)'s LinkedIn post (<https://www.linkedin.com/feed/update/urn:li:activity:7030213933072277504>) b) before the earthquake taken from Google Street view

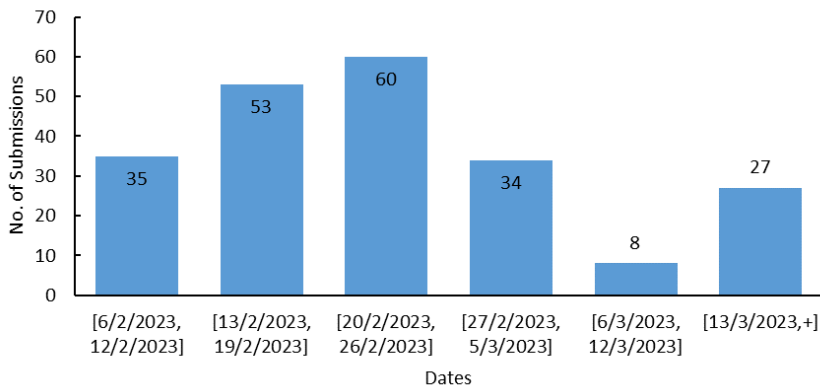
Figure 72: Distribution of remote data by publication dates.

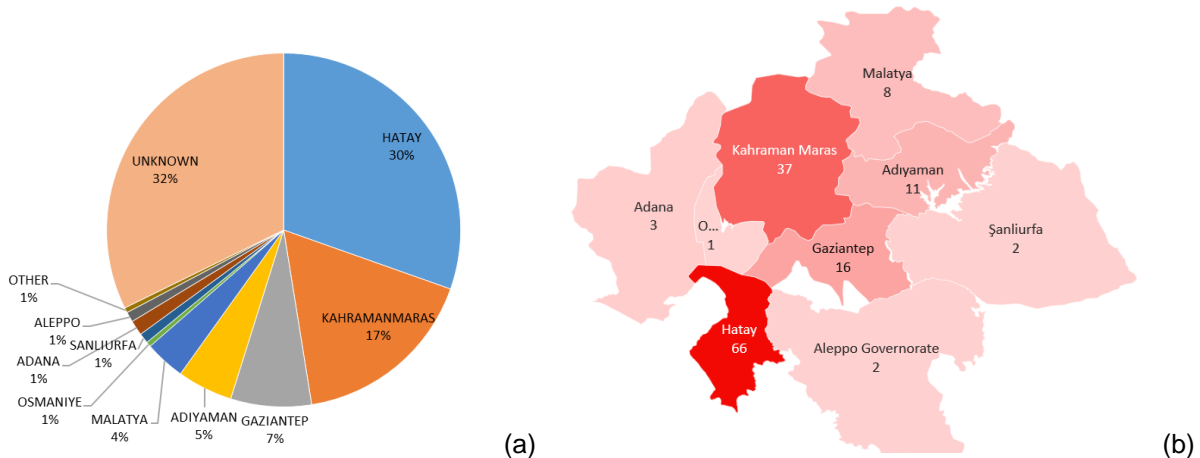
Figure 73: (a) Distribution of remote data by published locations. (b) Map distribution of remote data.

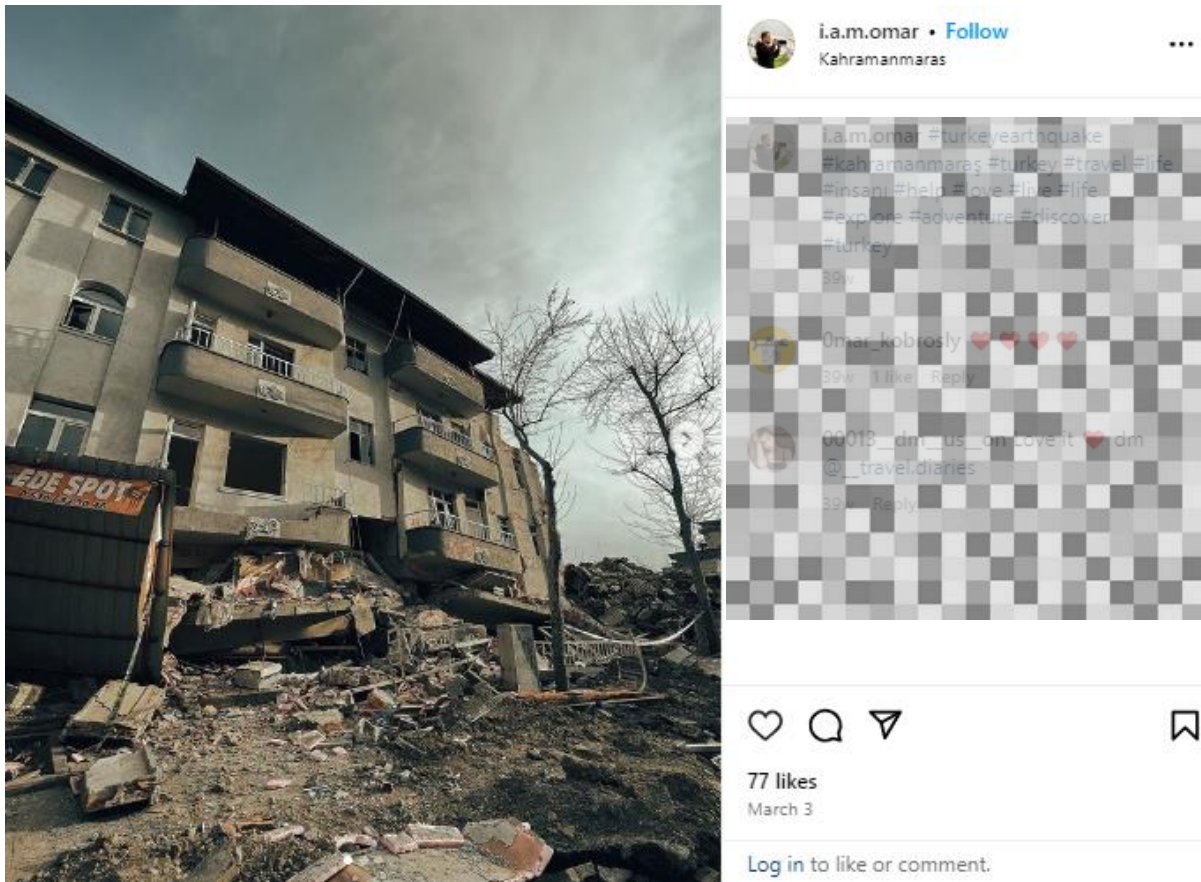
Figure 74: Picture taken from https://www.instagram.com/p/CpVWSV_sjx1/?igsh=cWZxbjQzNGV5a2U4

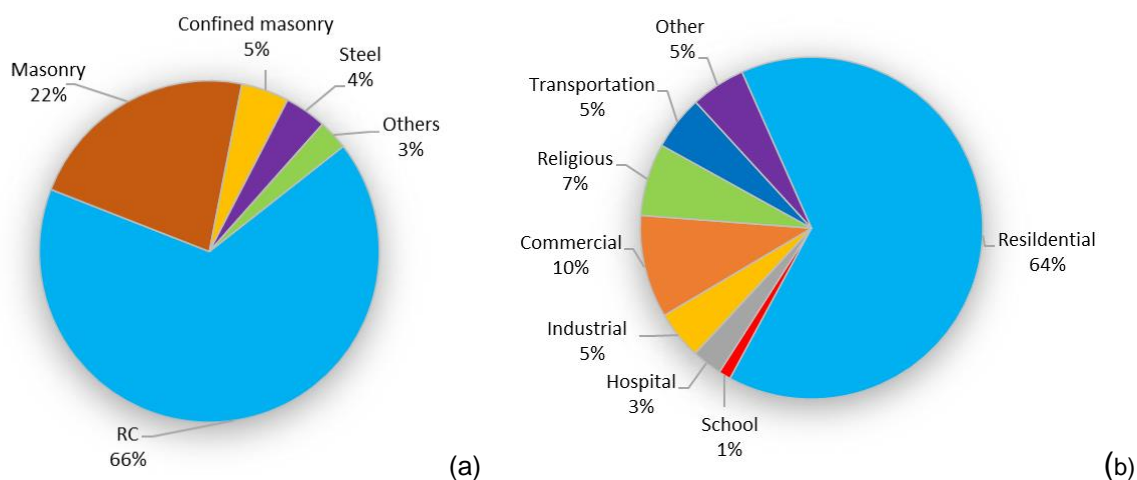
Figure 75: Distribution of remote data by (a) primary structural system and (b) building use.

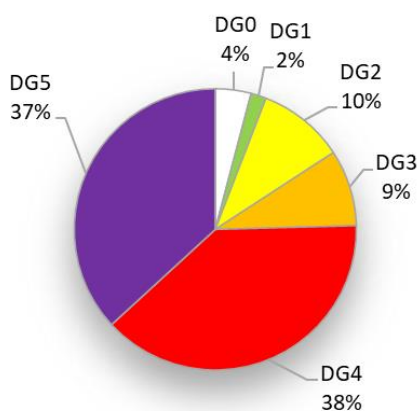
Figure 76: Distribution of remote data by damage grade (EMS-98) classification.

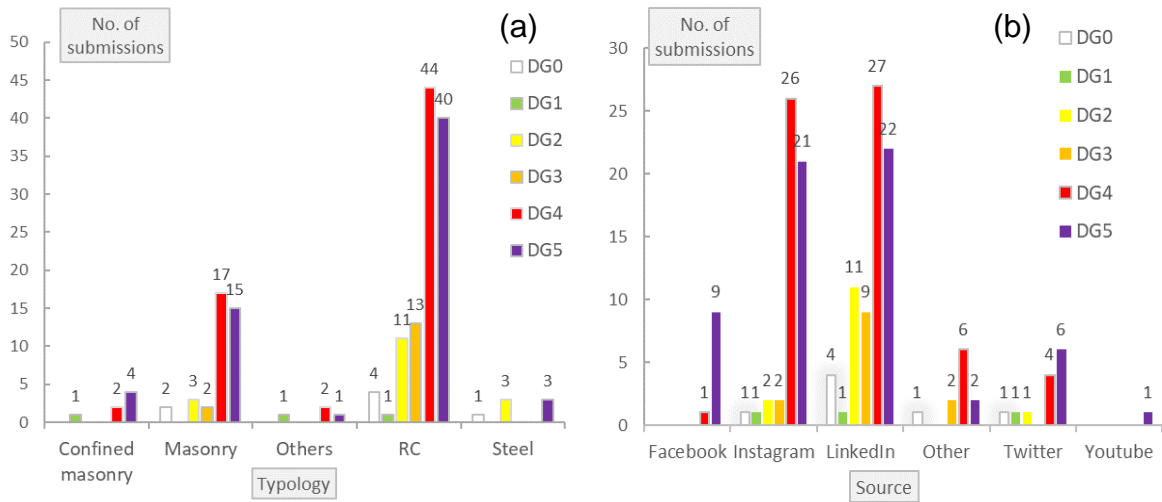
Figure 77: Remote collected data (Remote) - (a) Distribution of Damage Grade (DG) based on primary structural system. (b) Distribution of Damage Grade (DG) based on data source.

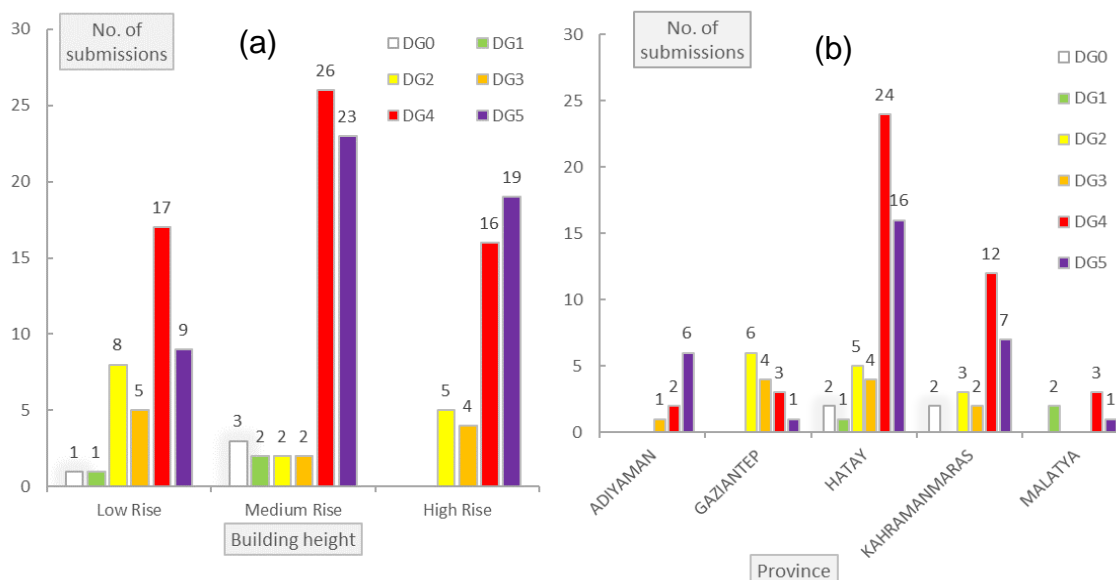
Figure 78: Remote collected data (Remote) – (a) Distribution of Damage Grade (DG) based on number of floors. (b) Distribution of Damage Grade (DG) based on location of source.

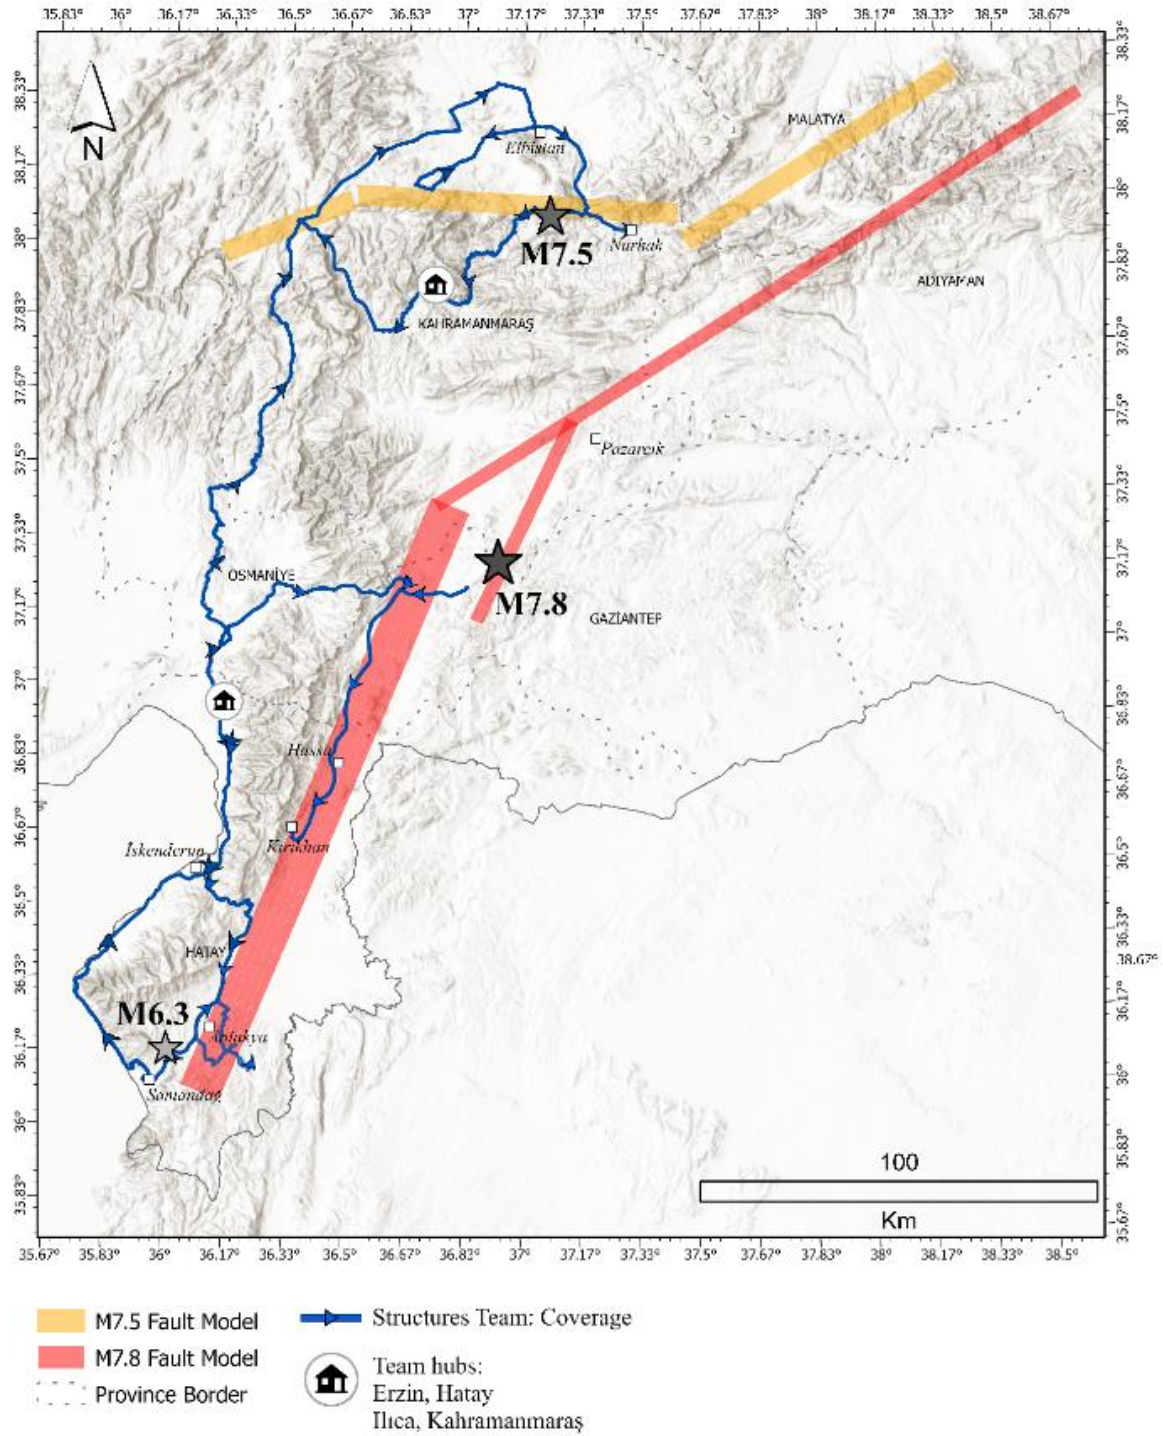
Figure 79: EEFIT March Fieldwork Itinerary

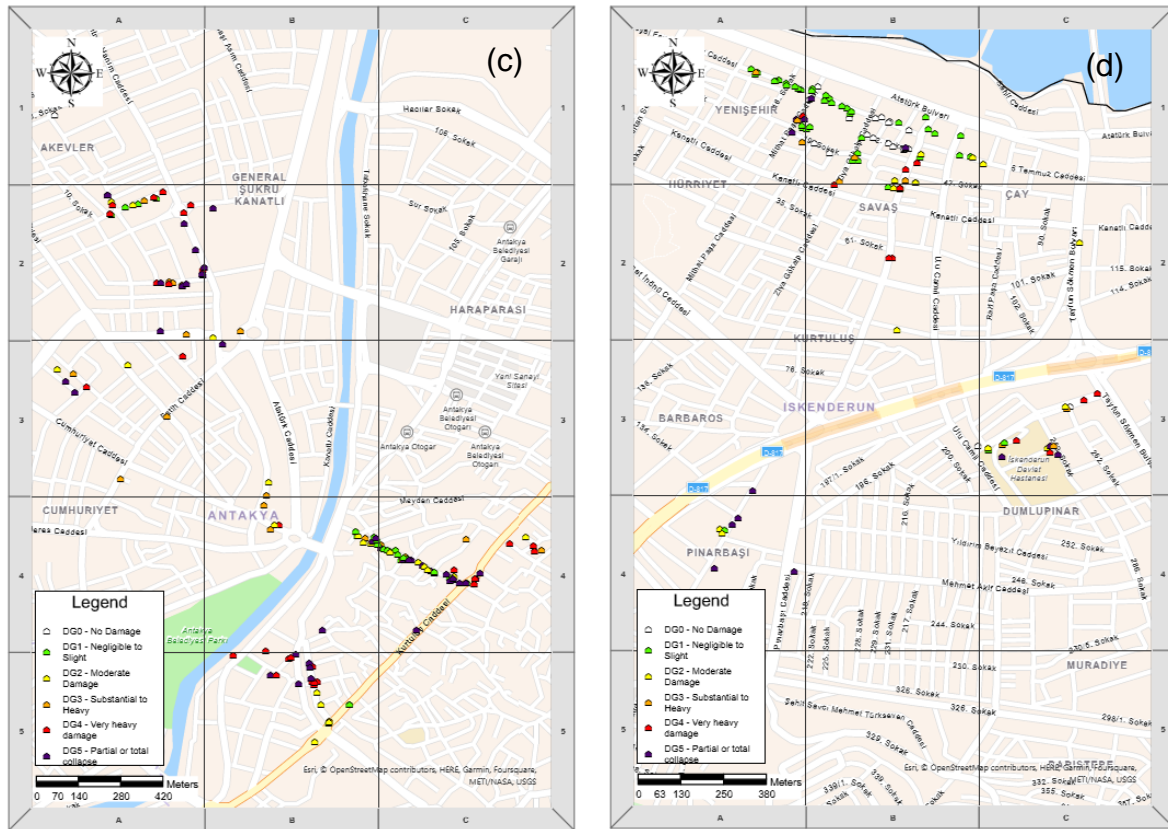
Figure 82 Field-collected data (Field)- Distribution of Damage Grade (DG) in: a) all visited locations, b) Hatay province, c) Antakya, and d) İskenderun

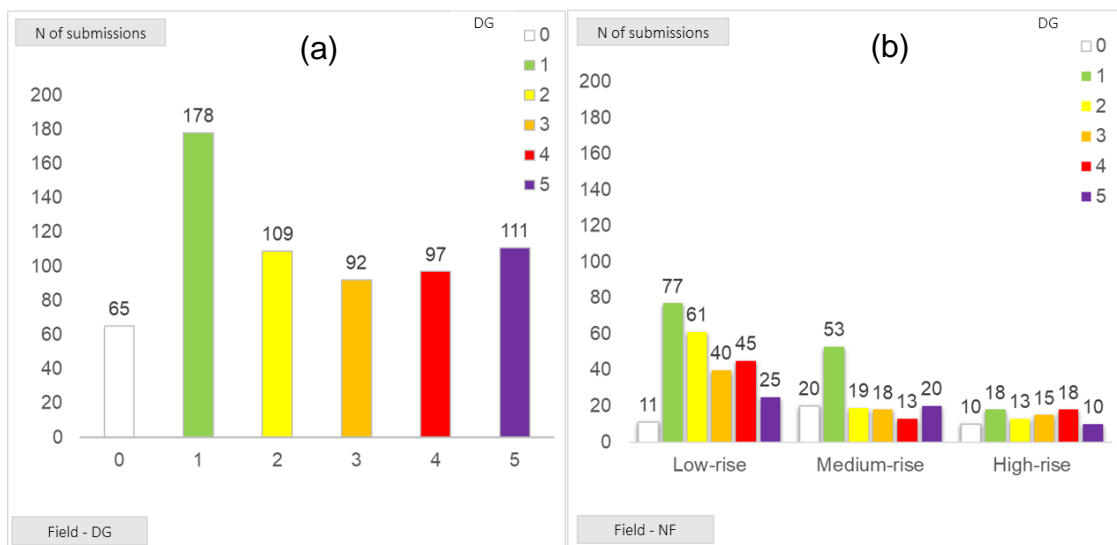
Figure 83: Field-collected data (Field) - a) Distribution of Damage Grade (DG) and b) Distribution of Damage Grade (DG) based on Number of Floors (NF)

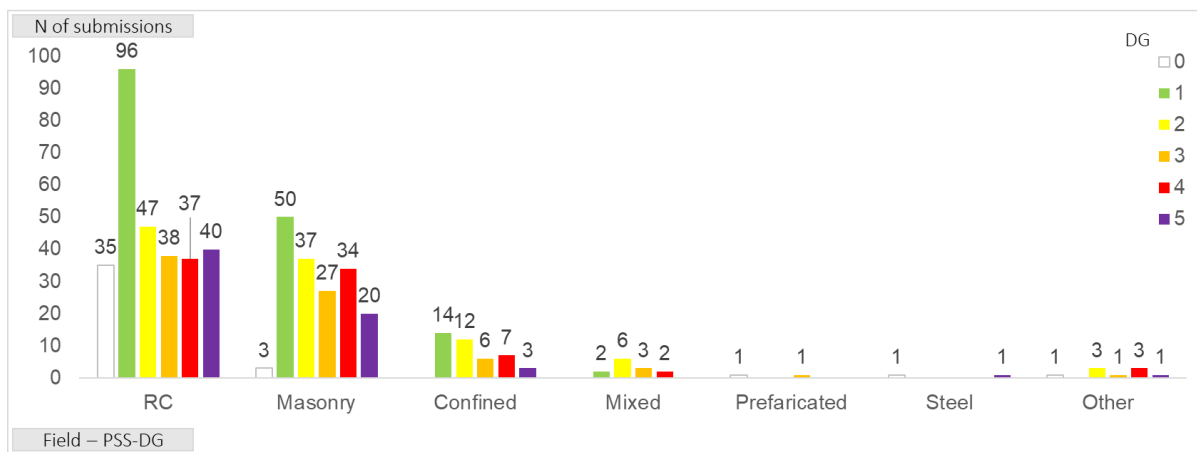
Figure 84: Field-collected data (Field) - Distribution of Damage Grade (DG) based on Primary Structural System (PSS)

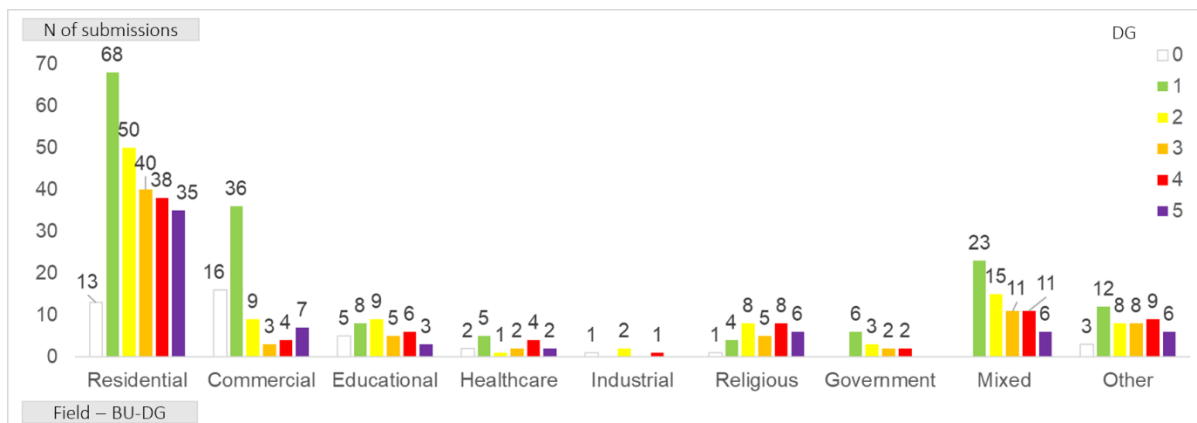
Figure 85: Field-collected data (Field) - Distribution of Damage Grade (DG) based on Building Use (BU)

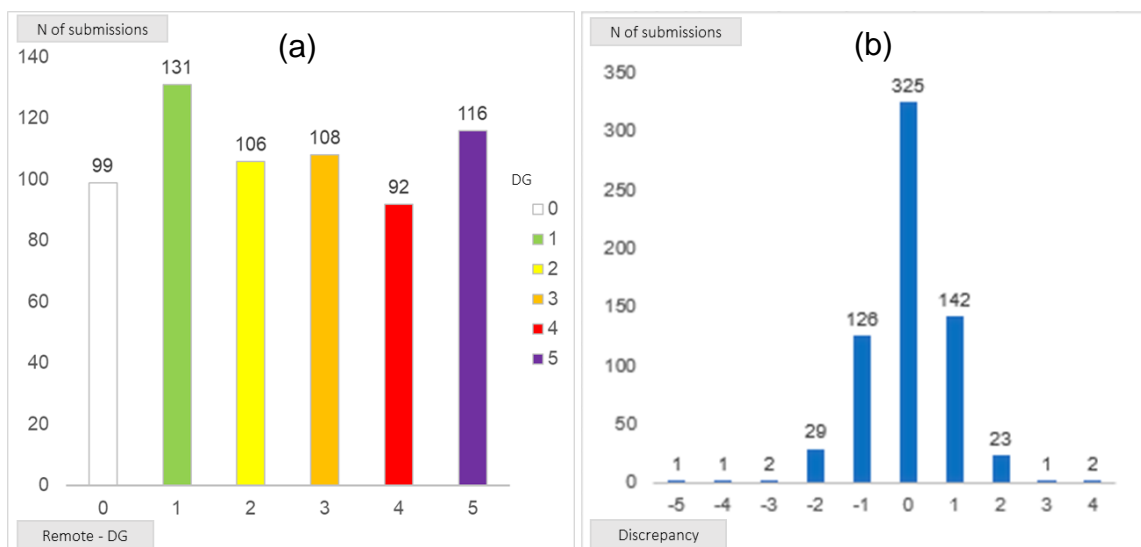
Figure 86: a) Secondary assessment (Remote) Damage Grade (DG) and b) Discrepancy between Field-collected data and secondary assessment.

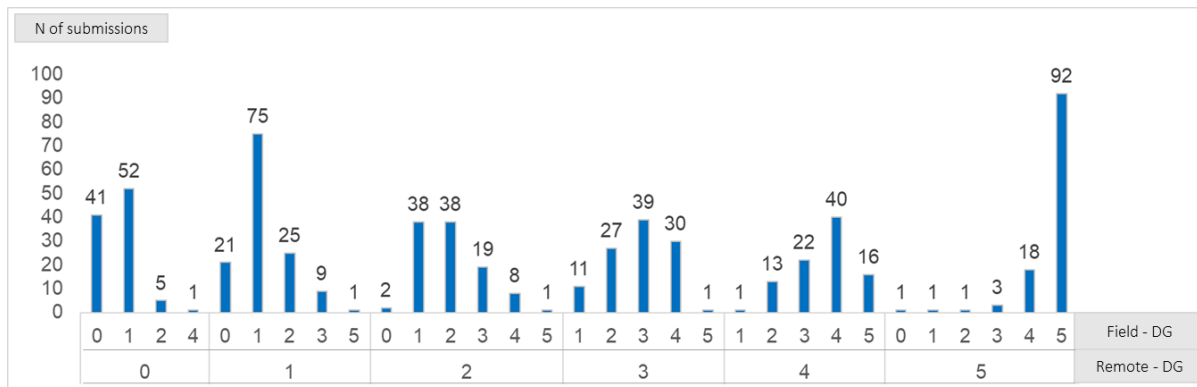
Figure 87: Damage Grade (DG) - Comparison between Field-Collected Data (Field) and Secondary Assessment (Remote) Distributions

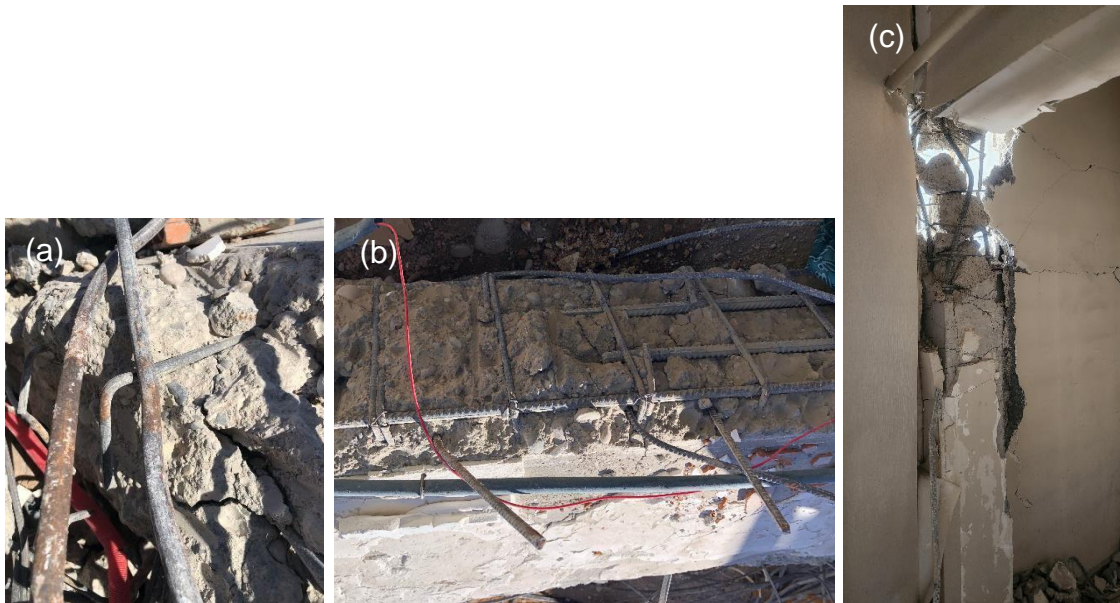
Figure 88: Reinforcing steel details which must be capable of withstanding tensile stresses. (a) Plain round rebars; (b) 90° hooks at the end of stirrups; (c) Stirrup tightening zone.

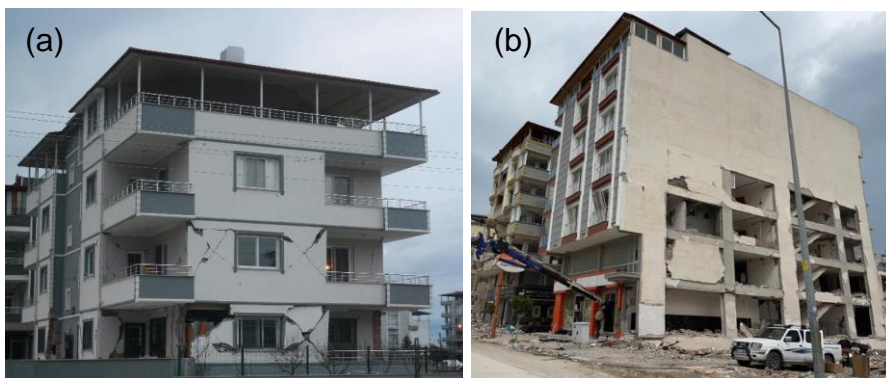
Figure 89: Poor concrete quality and non-adherence. (a) Core sample; (b) Aggregate sample; (c) Trace of removing rebar.

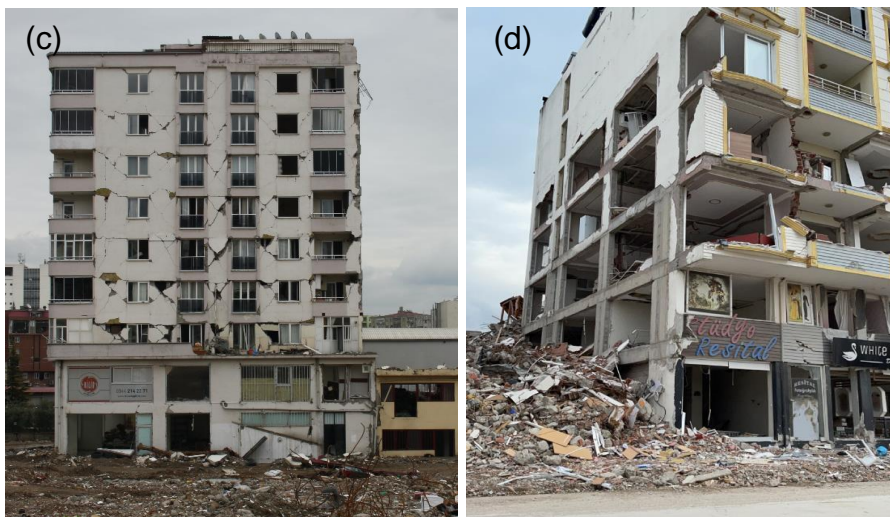
Figure 90: Cracking and fallings of infill walls in (a&c) Kahramanmaraş, (b&d) Samandağ/Hatay).

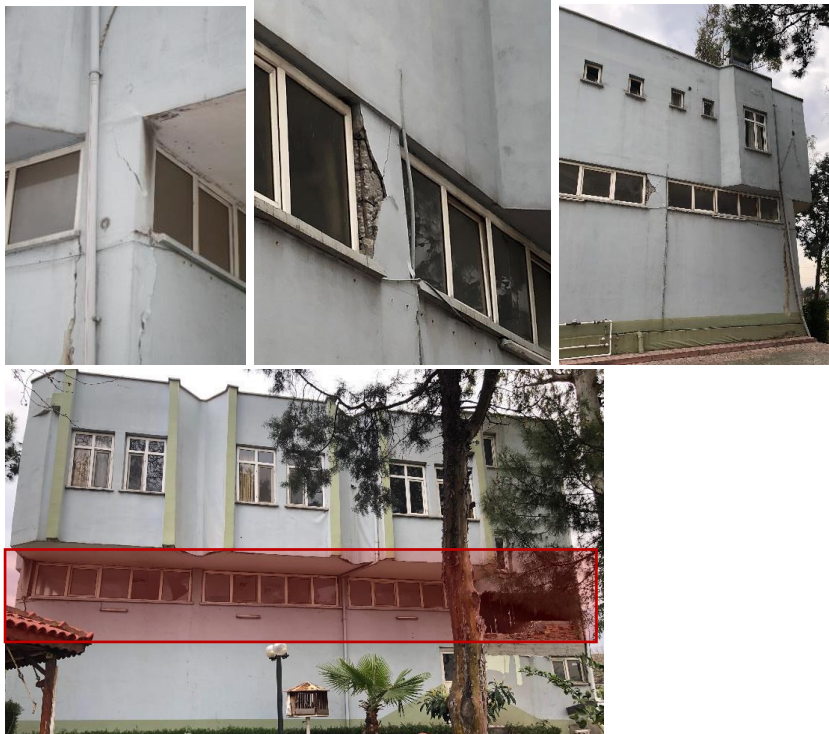
Figure 91: Diagonal cracks in the columns and short column effects (Payas/Hatay).

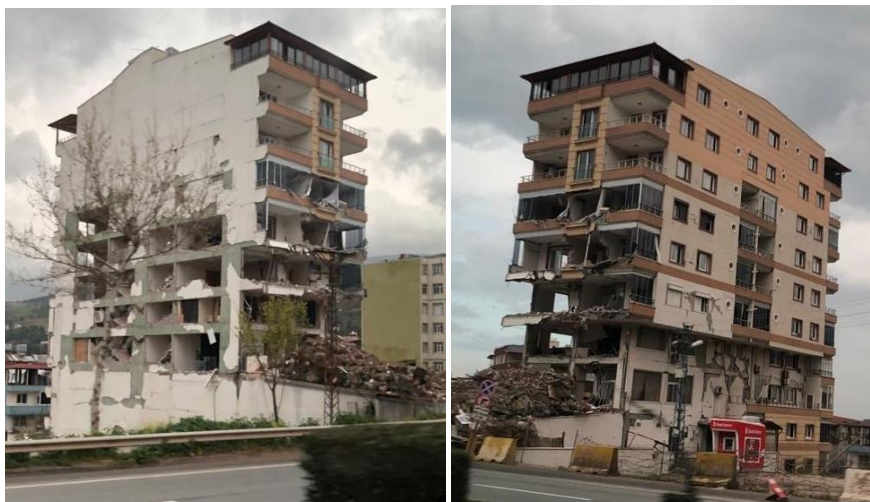
Figure 92: Shear wall damages (Belen/Hatay).

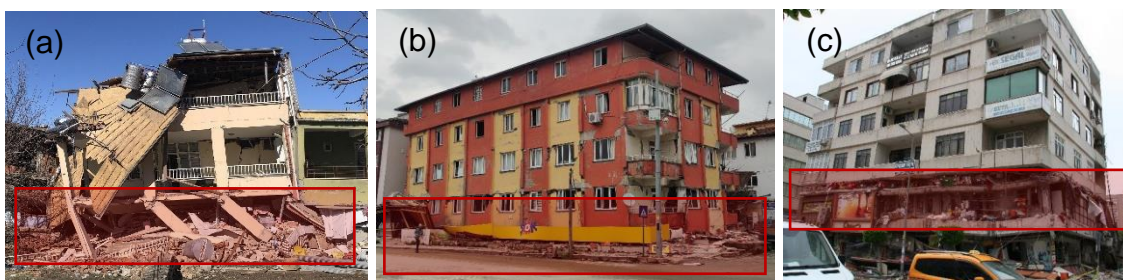
Figure 93: Soft&weak story in (a) Gölbaşı/Adıyaman, (b) Antakya/Hatay, (c) İskenderun/Hatay.

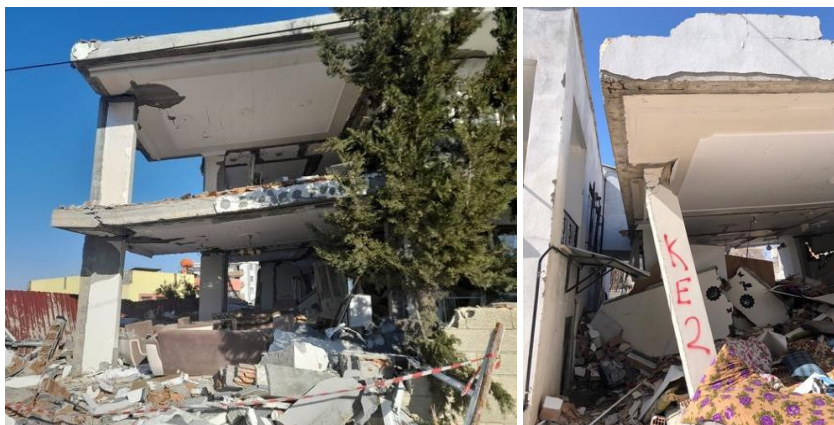
Figure 94: Hollow-tile floor slabs and their strong beam-weaker column effect (City Center/Adiyaman).

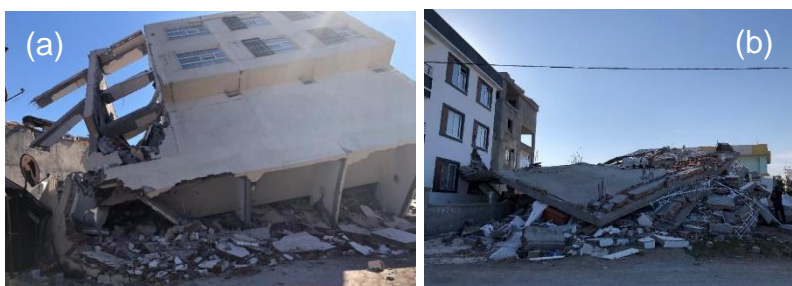
Figure 95: Torsional damage (a) Knife-cut damage in Gölbaşı/Adiyaman; (b) Torsional collapse in Center/Adiyaman.

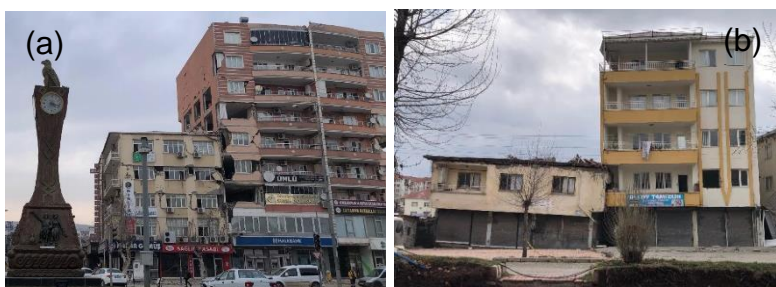
Figure 96: Pounding effects in (a) City Center/Adiyaman; (b) Gölbaşı/Adiyaman.

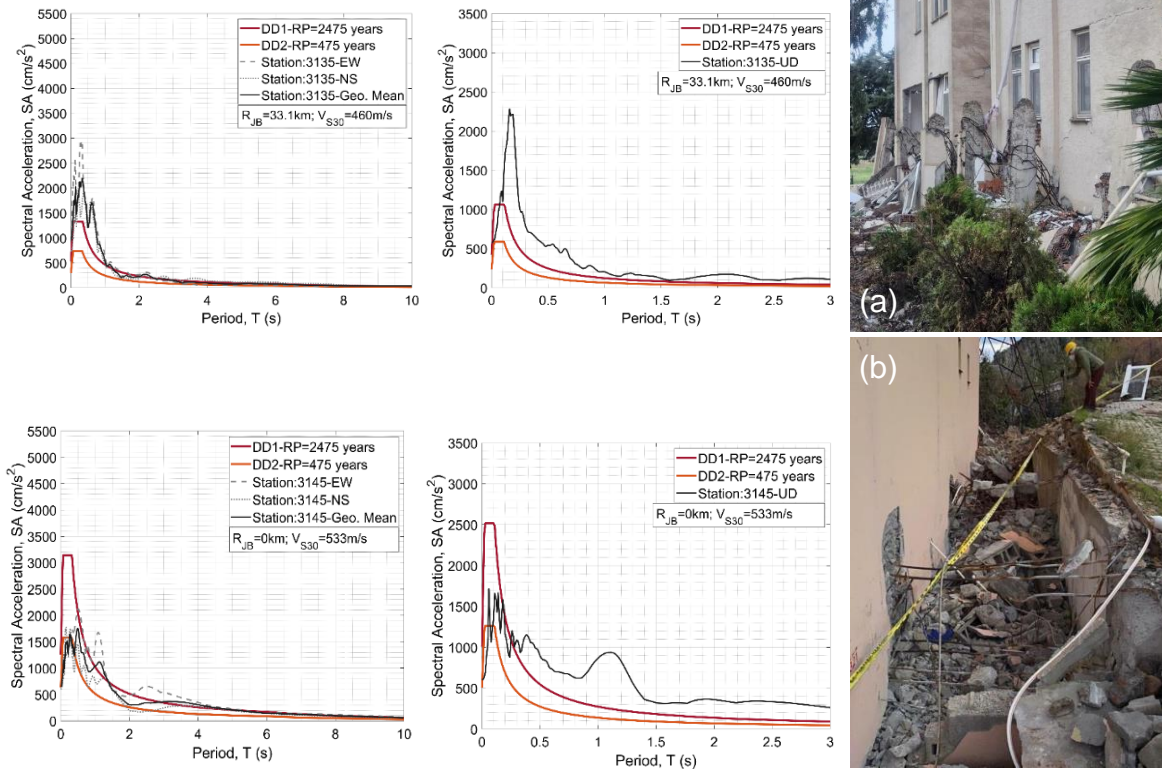
Figure 97: Exceeding the earthquake design levels in the horizontal and vertical directions in (a) Arsuz/Hatay, (b) Bektaşlı/Hatay accompanied by a damage example in these locations.

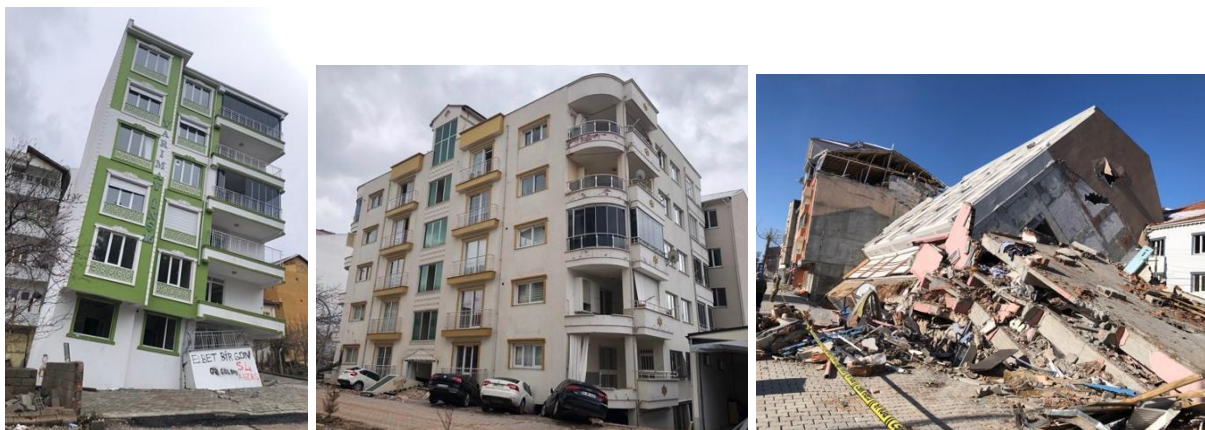
Figure 98: Settlement and liquefaction (Gölbaşı/Adıyaman).

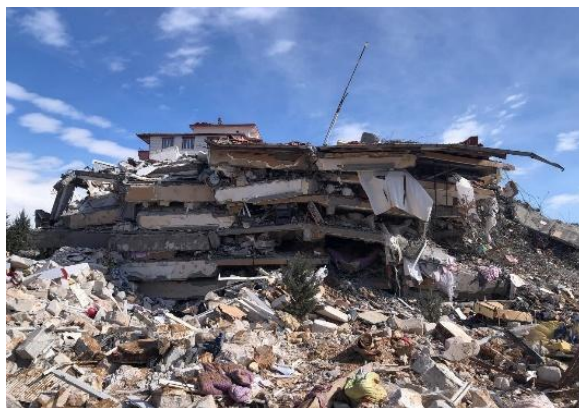
Figure 99: Total collapse and pancake (Besni/Adiyaman).

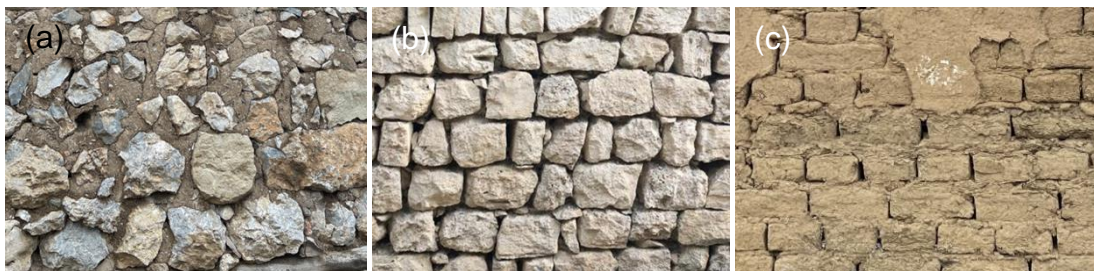
Figure 101: (a) Irregular stones, (b) dry stones and (c) earth blocks (adobe)

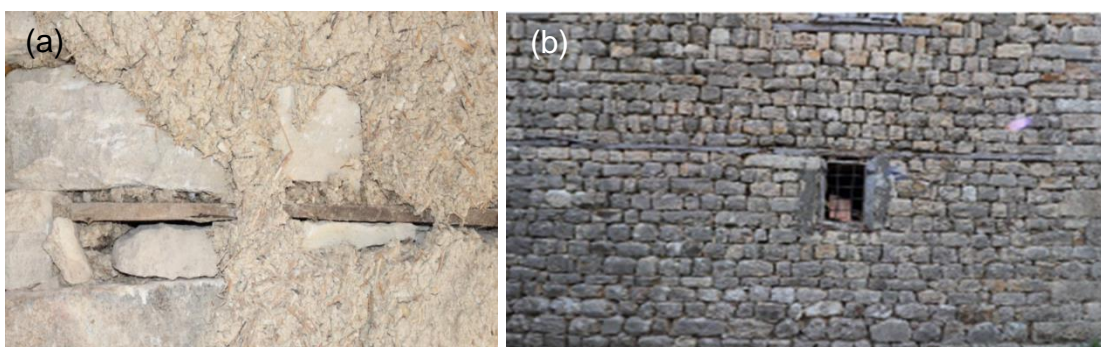
Figure 102: a) Stone with lime mortar reinforced with timber elements b) presence of timber tie-beams serving as lintels and running across openings.

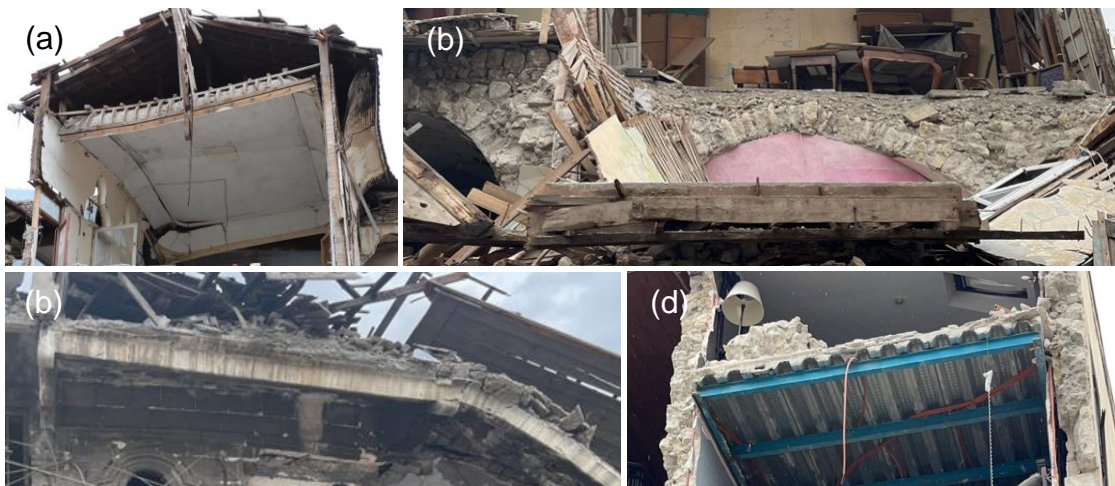
Figure 103: (a) Timber roof, (b) Vaults; (c) RC slabs; and (d) RC slabs supported by steel I beam.
