THE TÜRKİYE EARTHQUAKE SEQUENCE OF FEBRUARY 2023

A LONGITUDINAL STUDY REPORT BY EEFIT

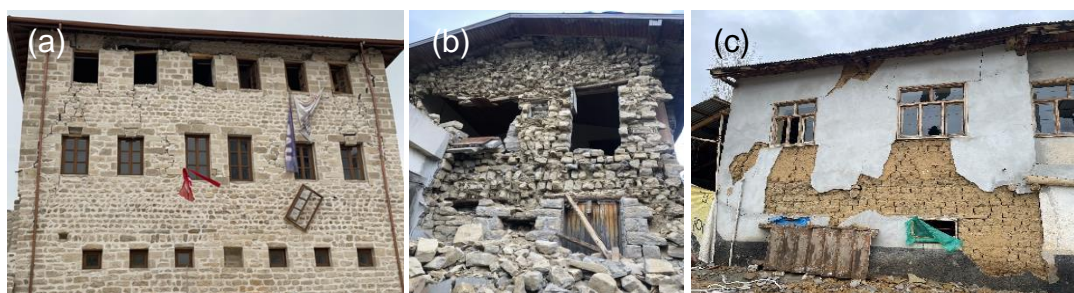
Figure 105: (a) URM made of regular stones with lime mortar, (b) URM made of irregular stones with mud mortar and (c) URM made of earth blocks (adobe)

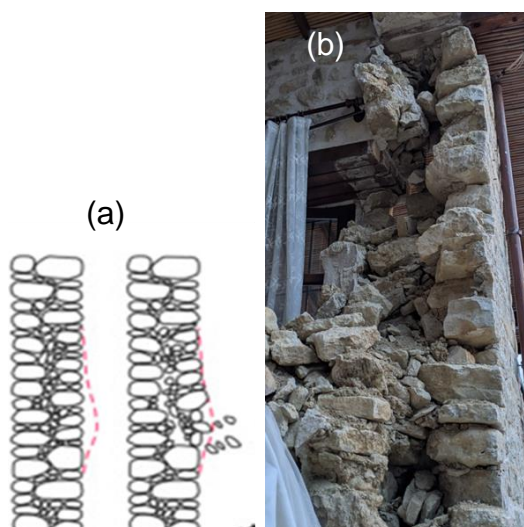
Figure 106: a) Giuffrè, A. (1993) and b) Rubble leaf separation in Vakıflı, Samandağ

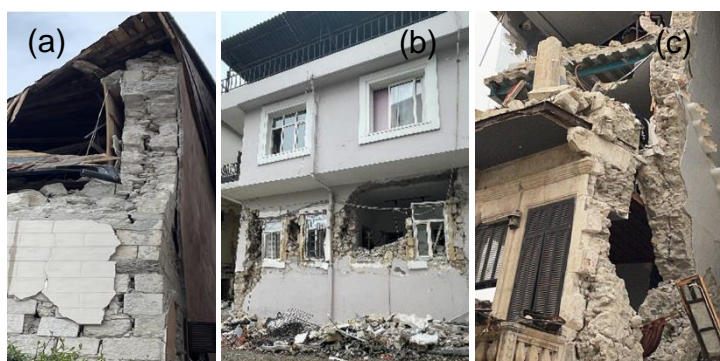
Figure 107: a) Roof failure and severe damage due to leaf separation, b) OOP of localised piers/spandrels; and c) OOP of façade due to lack of connections.

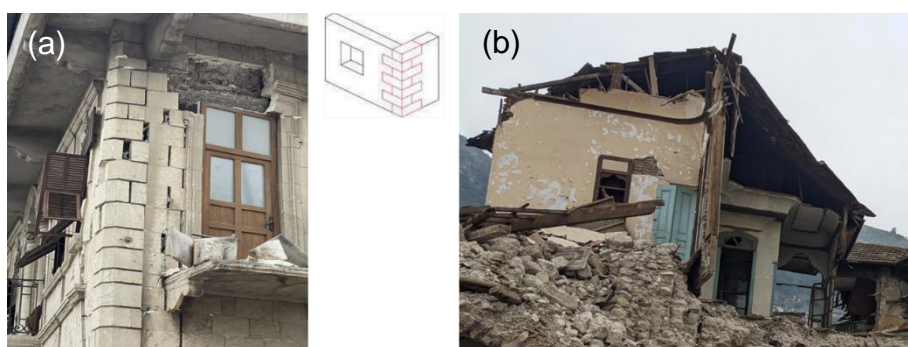
Figure 108: a) Corner failure due to the lack of connections in the quoin induce OOP of the facade, b) OOP failure of the gable.

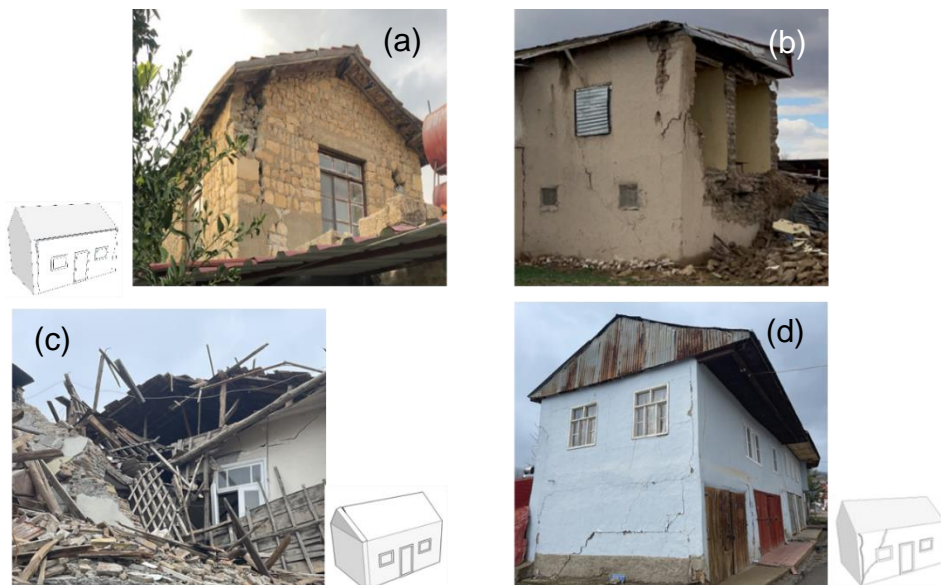
Figure 109: (a) OOP failure due to the absence of connections between external bearing walls; (b) OOP failure due to the lack of connections between external and internal walls; (c) Gable collapse resulting from OOP failures; (d) OOP failure due to the absence of connections on one side of the load-bearing walls. Sketches adapted from Novelli et al. (2021).

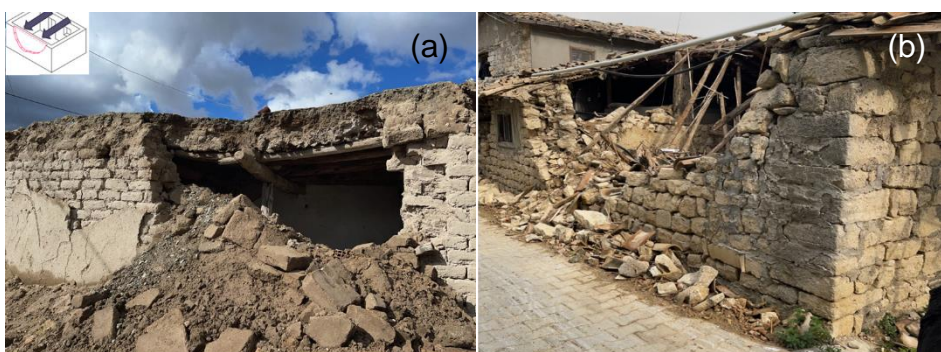
Figure 110: Adobe building failures: (a) Arch failure of the walls due to poor mortar properties; (b) Presence of irregular, small-sized, and round stones or rubble within the wall leaf and a lack of connection between the wall and the roof.

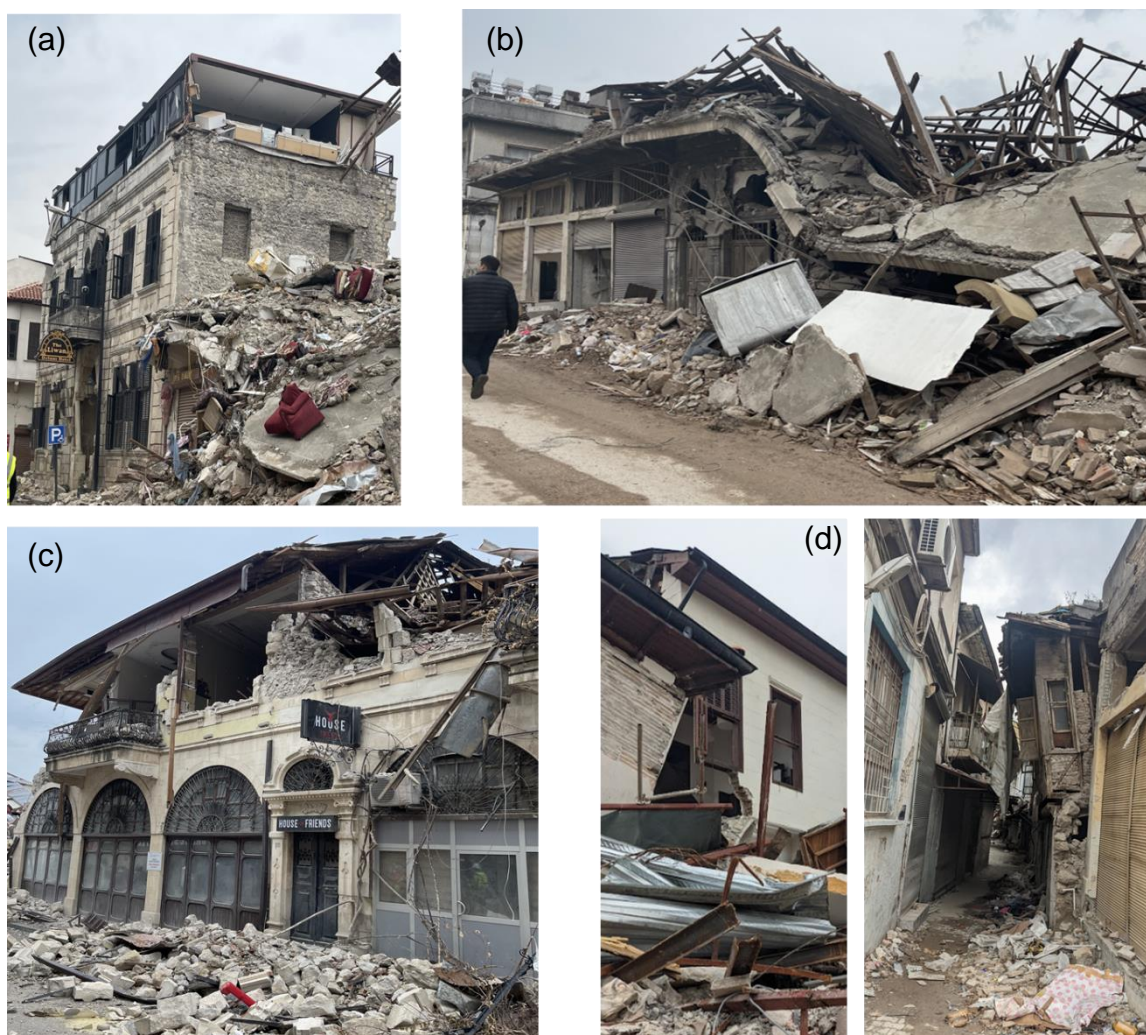
Figure 111: (a) Failure of the veranda built on the original building, (b) Failure of the RC flooring built to replace the original floor, (c) Lack of connections within party walls and bearing walls, and (d) Failure due to pounding.

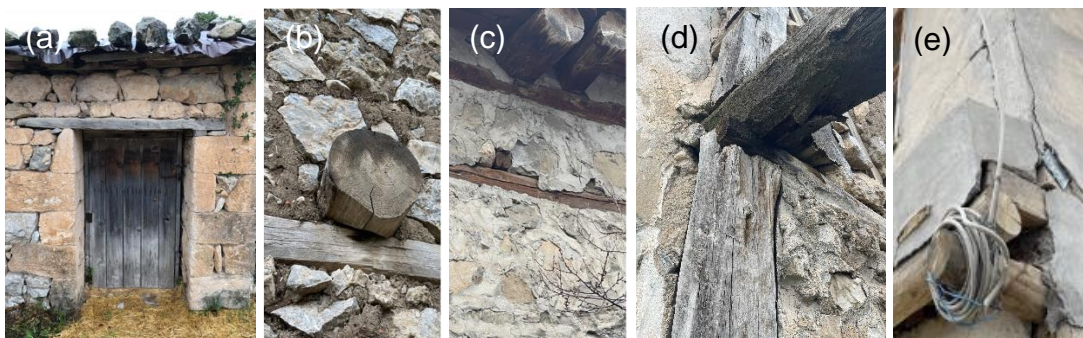
Figure 113: a) Timber lintel support, b) Joist resting on the wall plate, c) Tie-beams running along the wall at the floor level, d) Inadequate joint between vertical post and tie-beam, e) Lack of connection between perpendicular tie-beams.

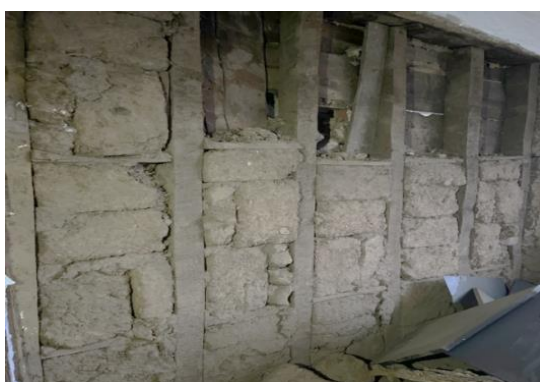
Figure 114: Timber (vertical and horizontal) elements filled with earth blocks (adobe)

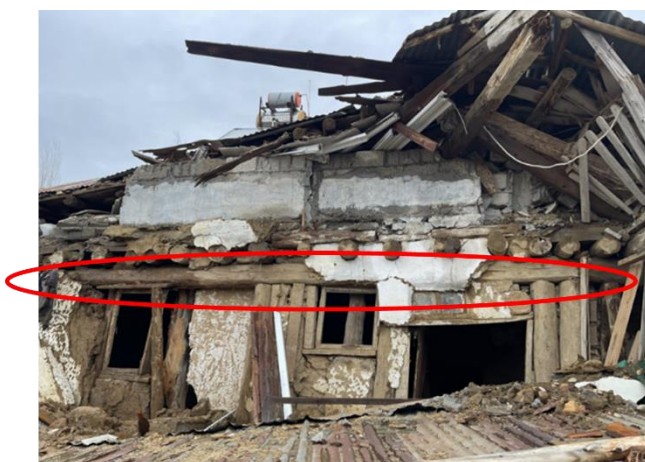
Figure 115: Timber beams on the top of the openings.

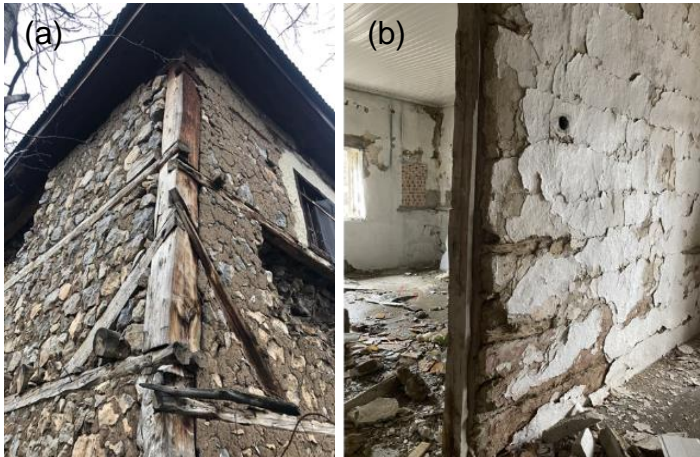
Figure 116: (a) Bracing in the timber frames; (b) Partition wall with timber band.

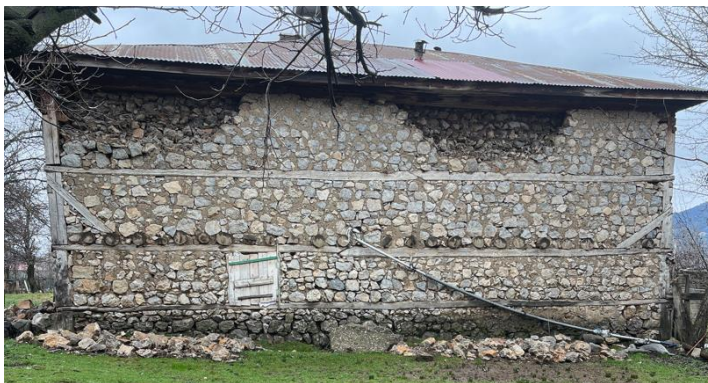
Figure 117: Localised arch failure.

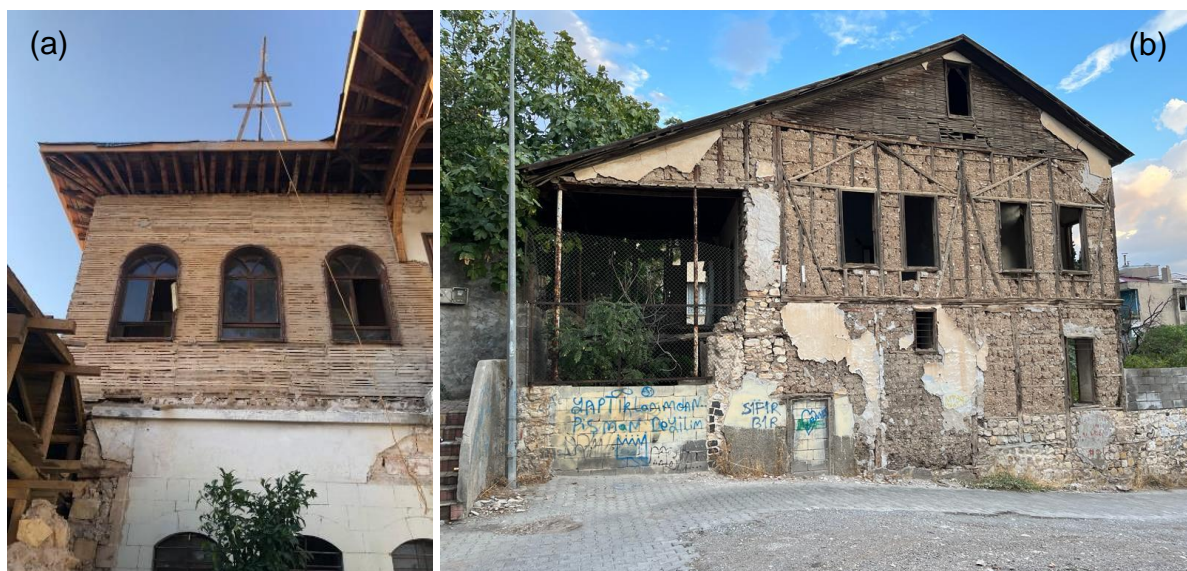
Figure 118: *Hımsı* a) Detail of the wooden (*bağdadi*) cladding; b) timber frame filled with masonry.

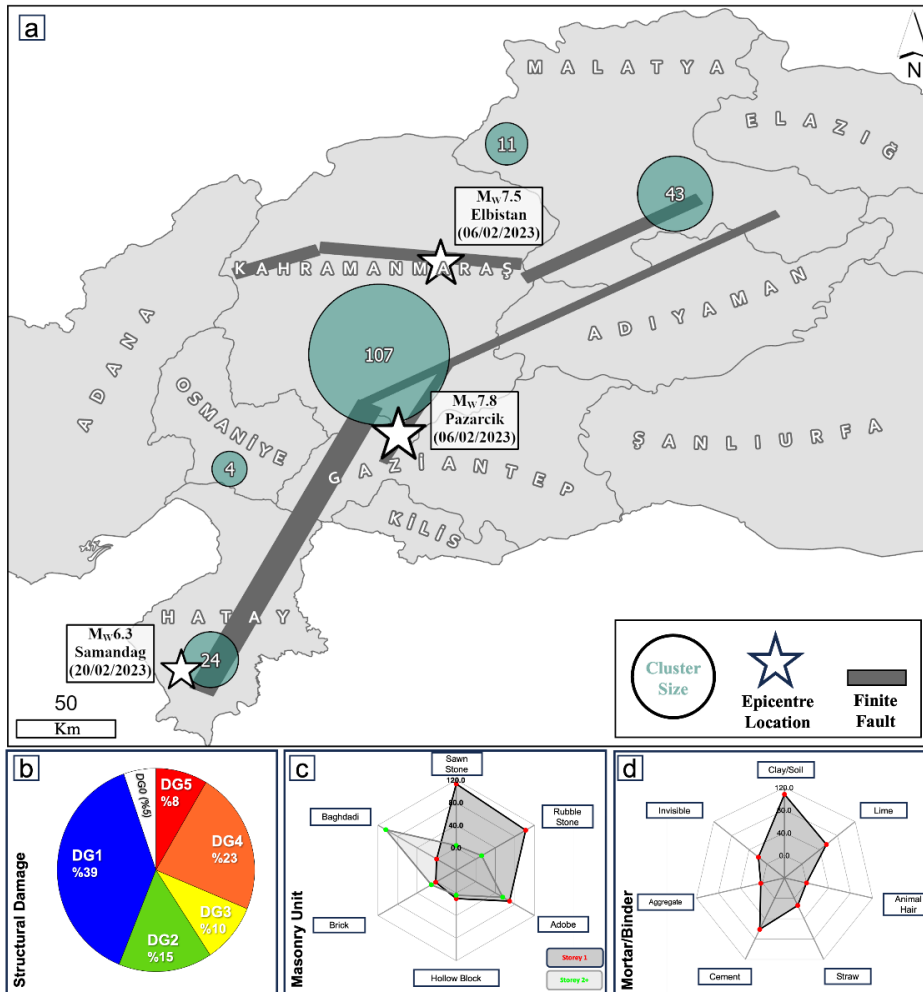
Figure 119: Breakdown of the data collected in June and September/October missions: (a) February 6 earthquakes (MW7.8 and MW7.5), MW6.3 earthquake on February 20, and geographic distribution of *hımış* clusters (N=189); (b) Initial on-site damage assessments; and masonry materials: (c) masonry units per floor and (d) observed binders.

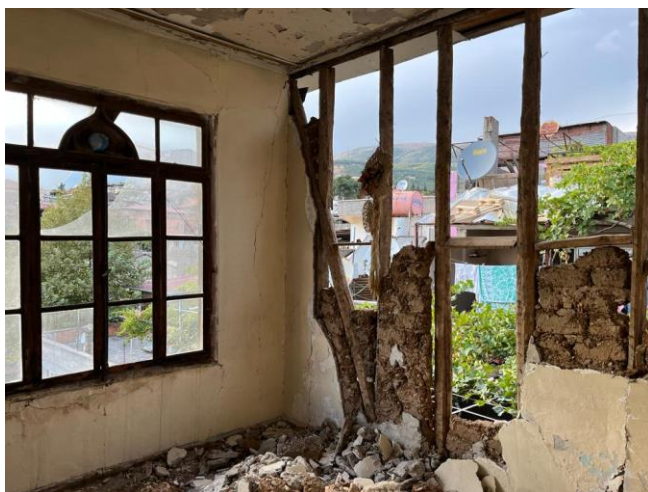
Figure 120: A hımış building in Kahramanmaraş officially categorised as heavily damaged and will therefore be demolished despite the fact that the damage is limited to out-of-place failure of the infill on one portion of one façade.

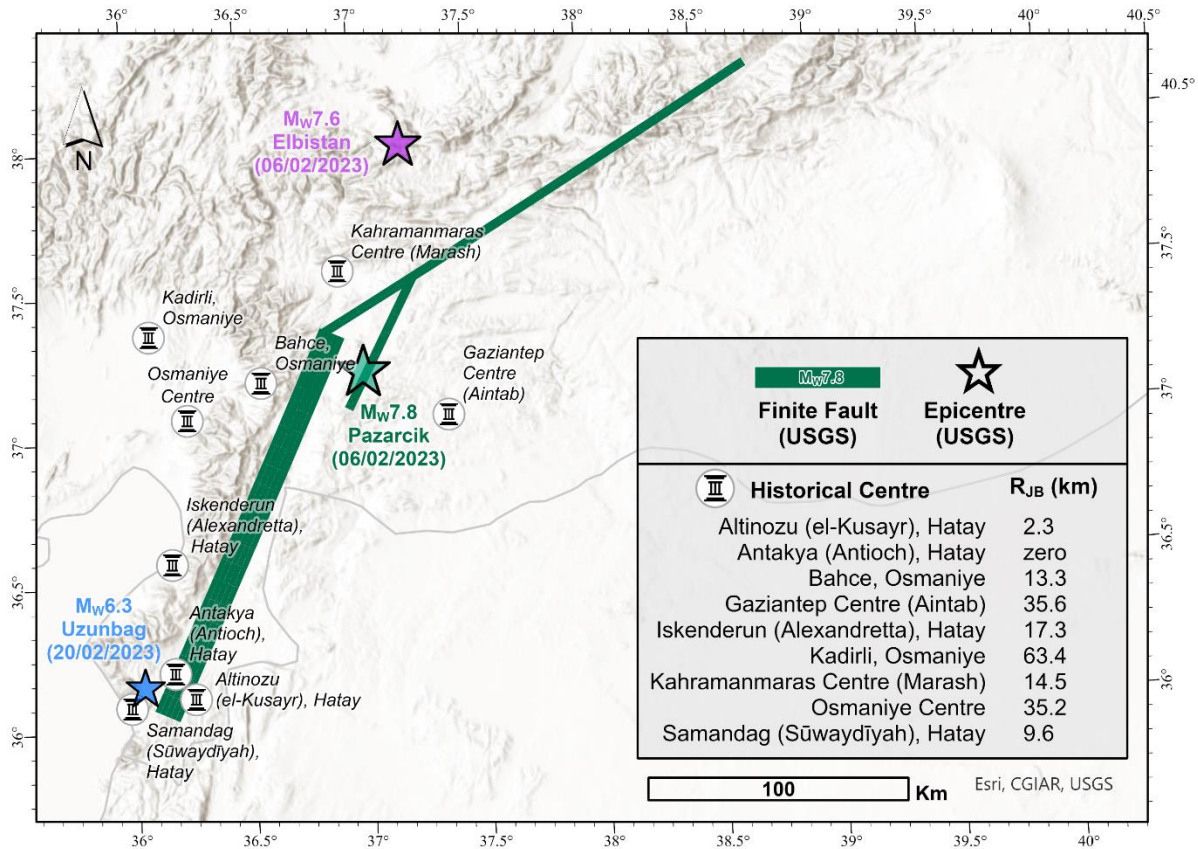
Figure 121: Joyner-Boore Distance (RJB) of historic urban centres in provinces affected by earthquakes. The map highlights the surface projection of rupture plane for the Mw7.8 mainshock on February 6, 2023.

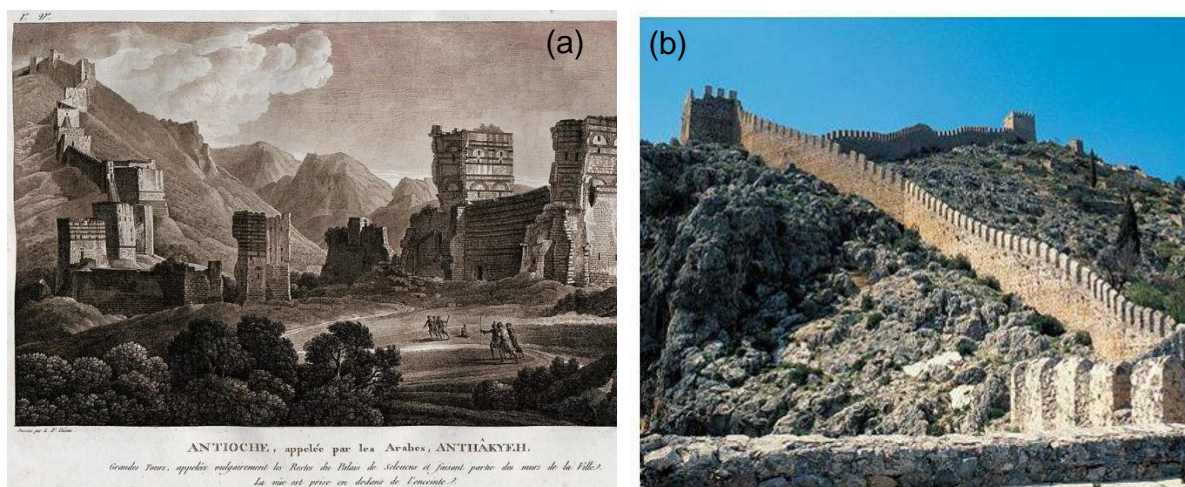
Figure 122: (a) Louis Francois Cassas' 19th century engraving of the ruins of the Seleucid palace in Antioch (known today as Antioch castle), which was damaged during the 526 earthquake. (b) A contemporary photograph of the walls and the towers of the palace. Credit: (a) <https://greekreporter.com/2022/12/03/history-hellenistic-city-antioch/>, (b) <https://secreTürkiye.com/surlari-ile-meshur-antakya-kalesi.html>

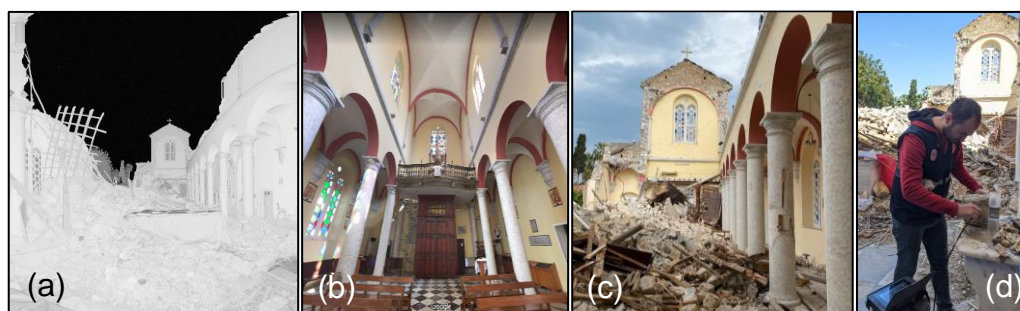
Figure 123: Views towards the northern nave wall of Latin Catholic Church in İskenderun; (a) point cloud of the structure obtained from terrestrial laser scanning. (b) the nave, aisles, colonnade system as photographed in November 2019 (Credit: Google Maps; Adrian E. Loza). (c) the damage observed in April 2023, with the total collapse of the cross vaults of western aisle and the nave, and (d) Ultrasonic Pulse Velocity measurements.

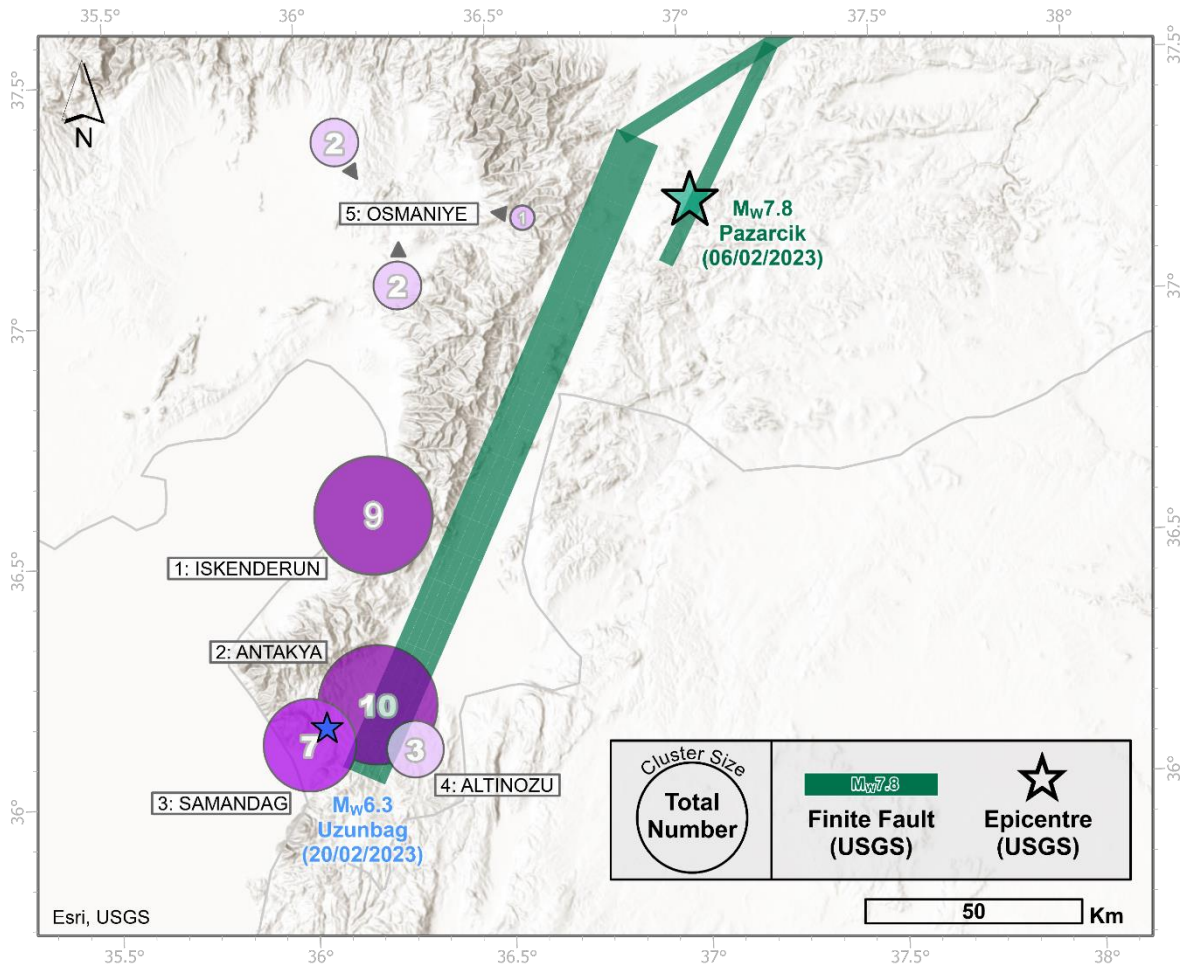
Figure 124: The distribution of monumental structures within the five clusters that have been the geographical focus of field deployments in provinces of Hatay (N=29; Antakya, Altınözü, İskenderun and Samandağ districts) and Osmaniye (N=5; the city centre, Bahçe and Kadirli).

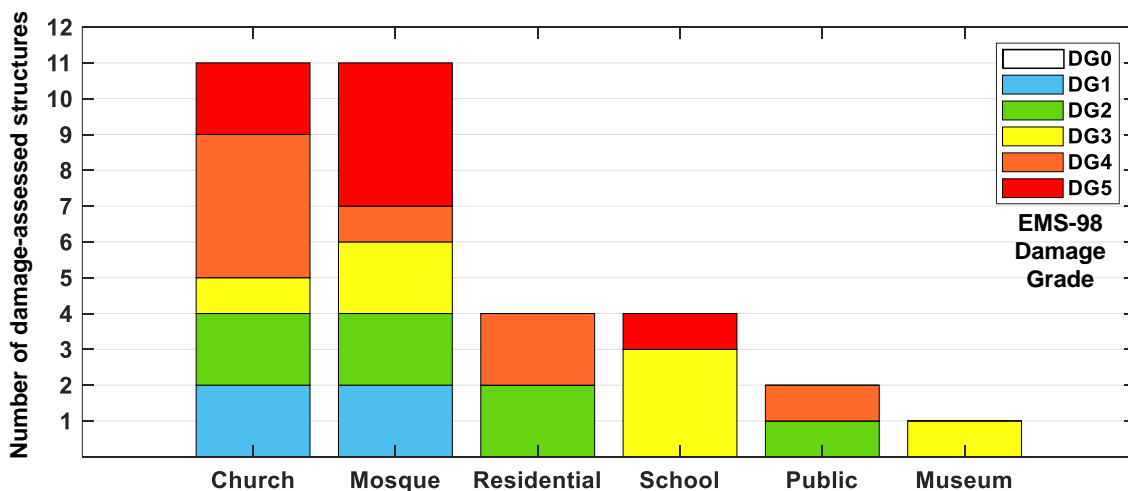
Figure 125: The breakdown of the damage induced by earthquake sequence per asset type.

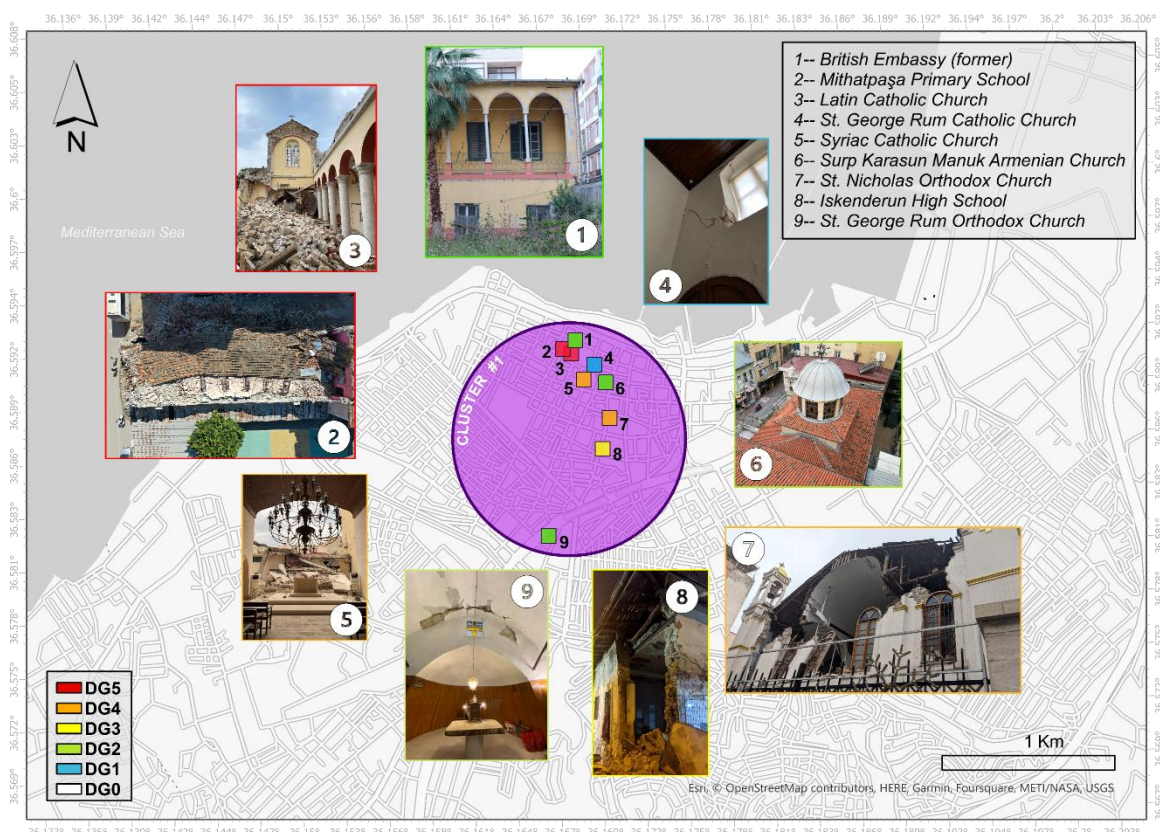
Figure 126: Cluster 1: Historic urban centre of İskenderun.

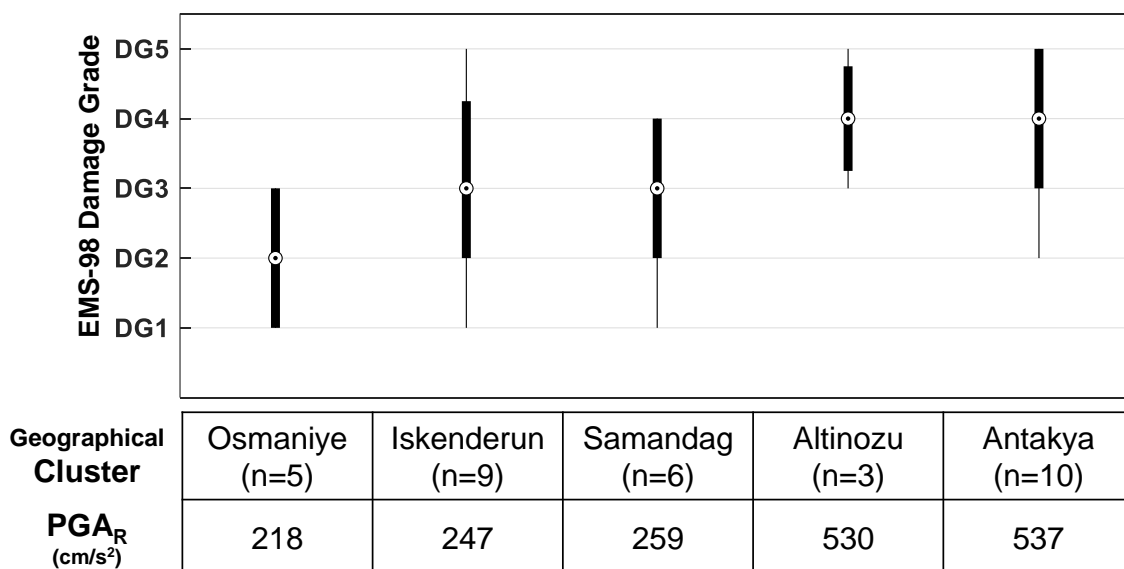
Figure 131: Statistical box plots summarising the main properties of the damage to monumental structures in each cluster, which ordered based on the resultant Peak Ground Acceleration levels from the Pazarcık event. Geometric means were taken for those clusters represented by more than one SGM station (İskenderun, Antakya and Osmaniye).

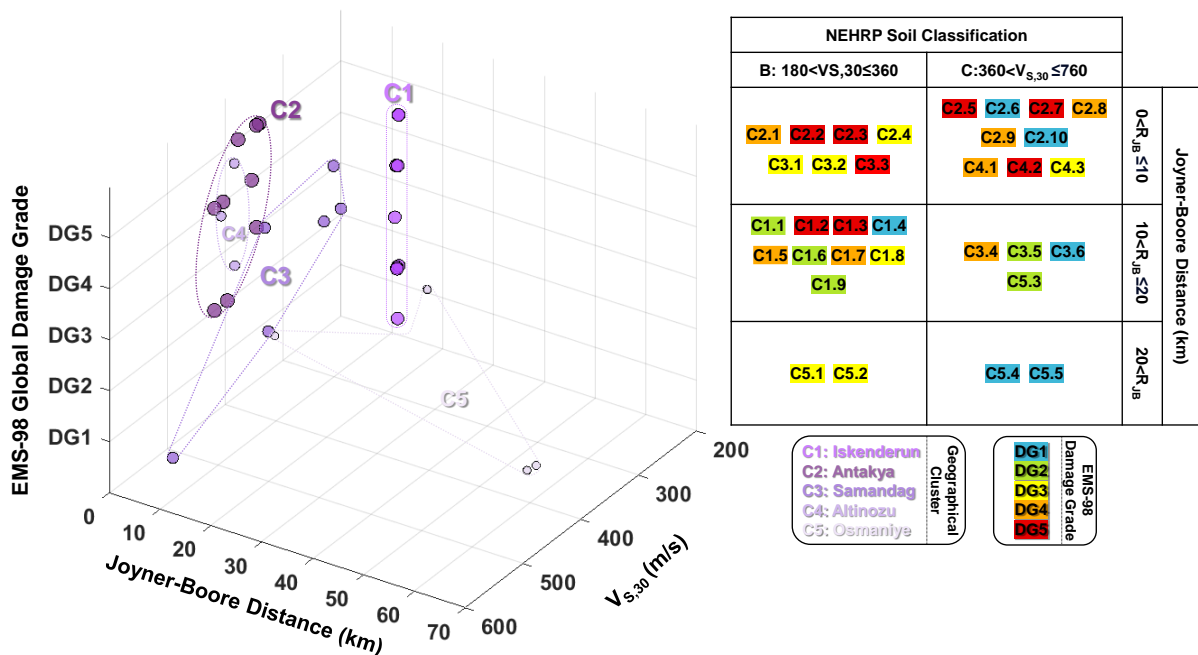
the Pazarcık event, RJB. Structures are also grouped based on their local site conditions (based on NEHRP) and RJB (CX.Y; where X is cluster number, Y indicates the structure number as depicted in cluster damage figures).

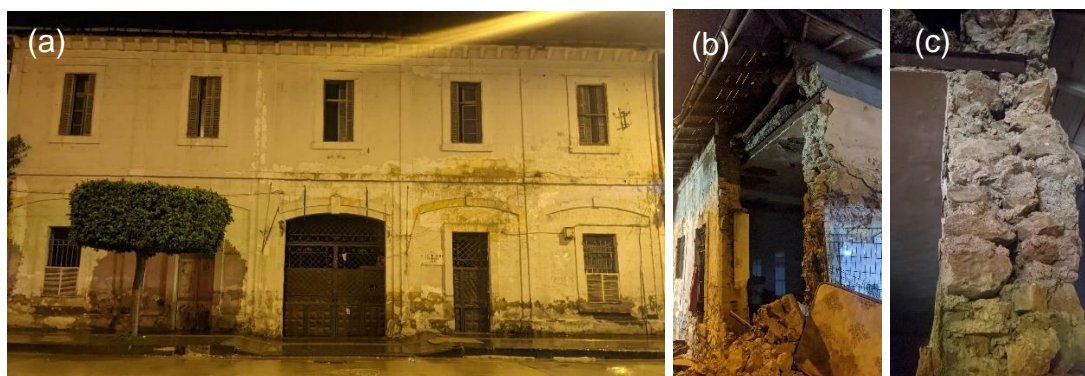
Figure 133: İskenderun High School, photographs of (a) the west façade, (b) the collapsed south-eastern corner, (c) a multi-leaf wall cross-section from the collapsed southeast corner of the building.

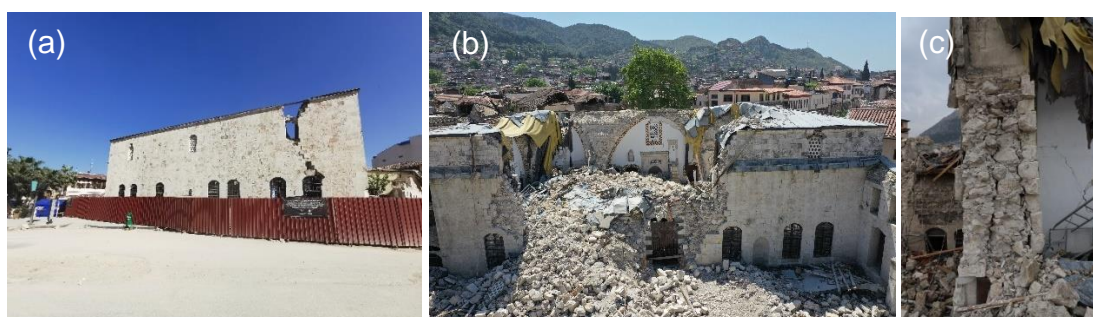
Figure 134: Habibi Neccar Mosque, photographs of (a) the south façade, (b) the collapsed north façade, (c) a multi-leaf wall cross-section from the collapsed north wall of the building.

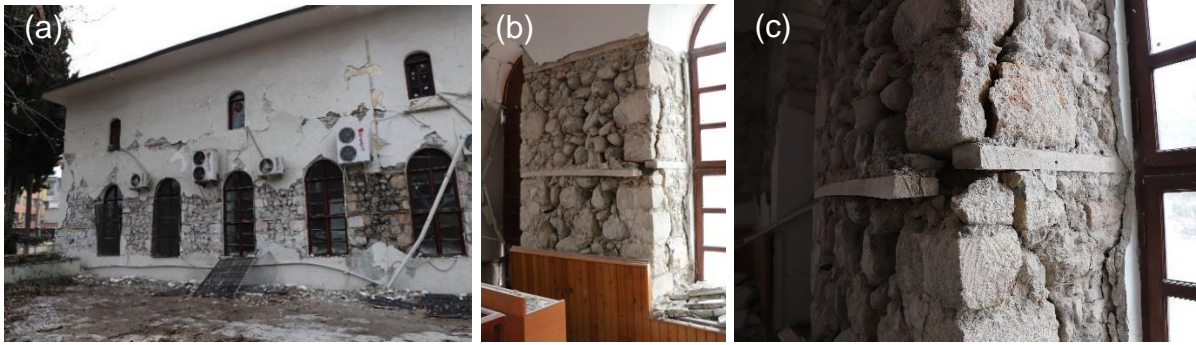
Figure 135: Enverul Hamit Mosque, photographs of (a) the east façade, (b) a rubble pier in the east façade, (c) a large crack around the poorly connected tie-beams in the east façade.

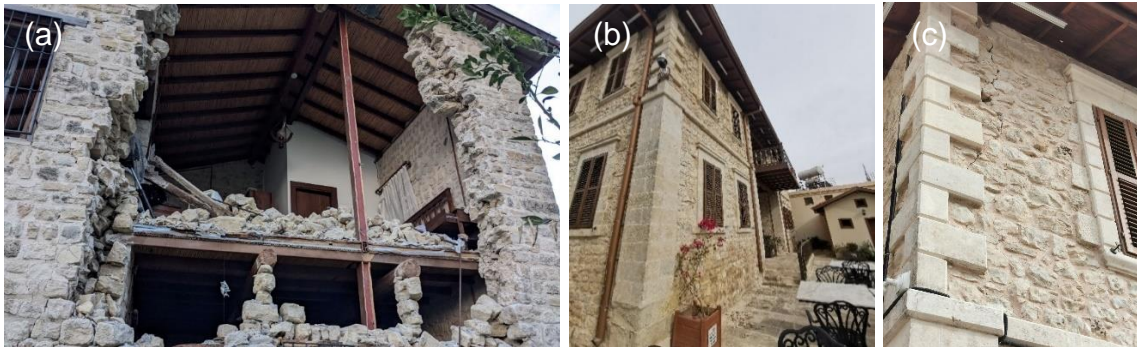
Figure 136: Photographs of two buildings with timber floors (a) east façade of the Vakıflı No.2 house and (b) the north and east facades and (c) damage detail around stone quoins of the Hıdırbey Gastronomy House in Samandağ.

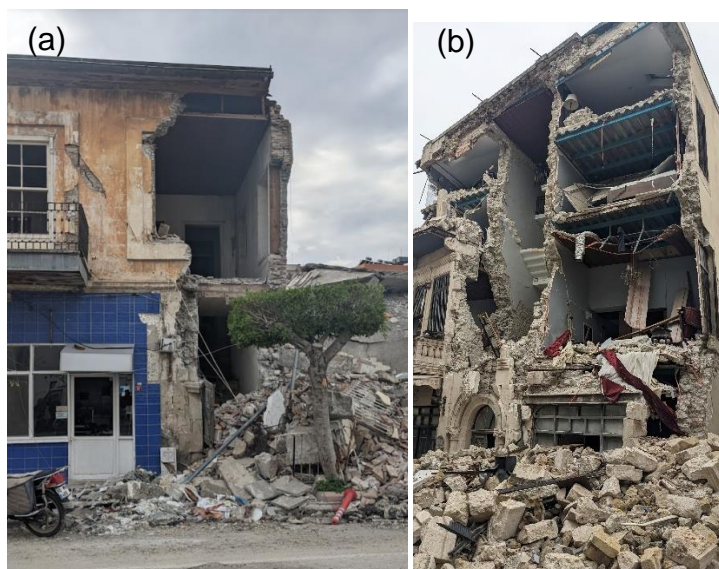
Figure 137: Photographs of damage in two buildings with floor structures spanning in a single direction: (a) a building in İskenderun with a timber floor and (b) the west façade of the early 20th century Liwan Hotel building in Antakya with a retrofitted steel-concrete floor.

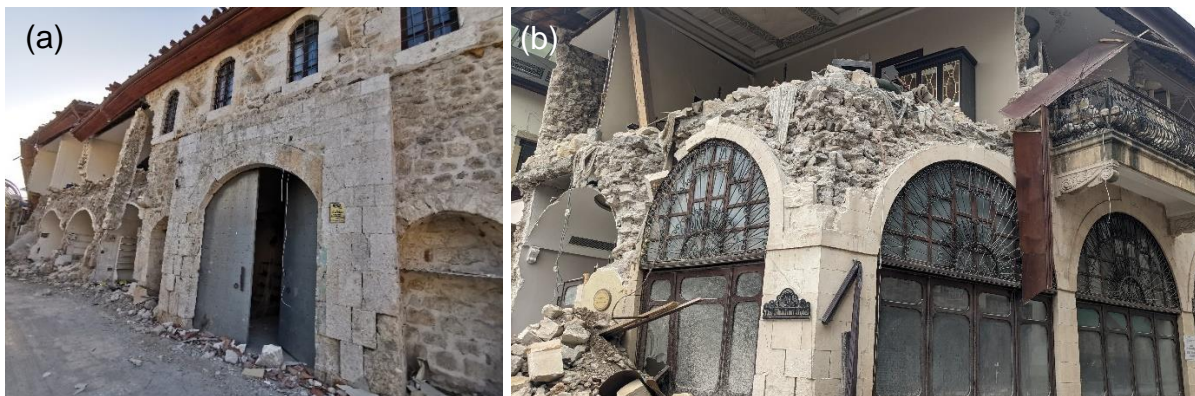
Figure 138: Photographs of damage in two buildings with barrel vaulted floors: (a) south façade of the 16th century Kursunlu Han building in Antakya and (b) the north and west facades of the Shahut hotel building in Antakya.

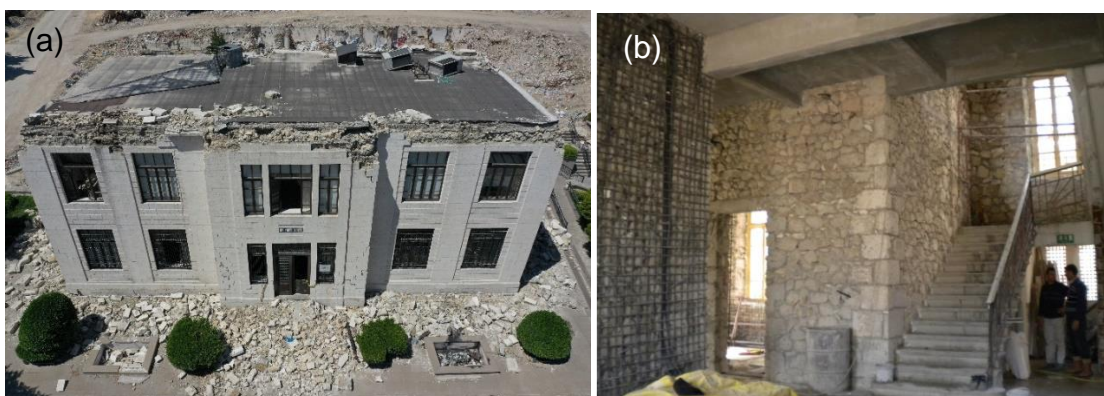
Figure 139: Photographs of: (a) south façade of the early 20th century Hatay Metropolitan Municipality building and (b) the interior of the building during restoration works.

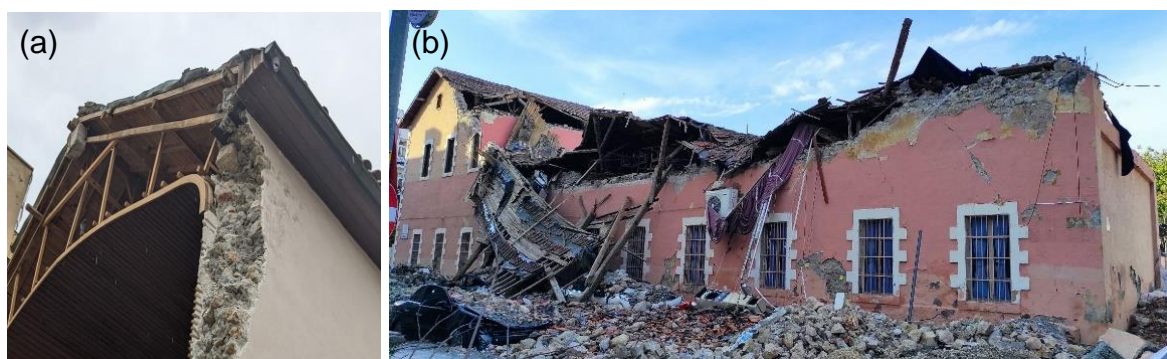
Figure 140: Photographs of damage in structures with roof timber trusses: (a) the Assyrian Catholic Church in İskenderun and (b) the Mithatpasa Primary School in İskenderun.

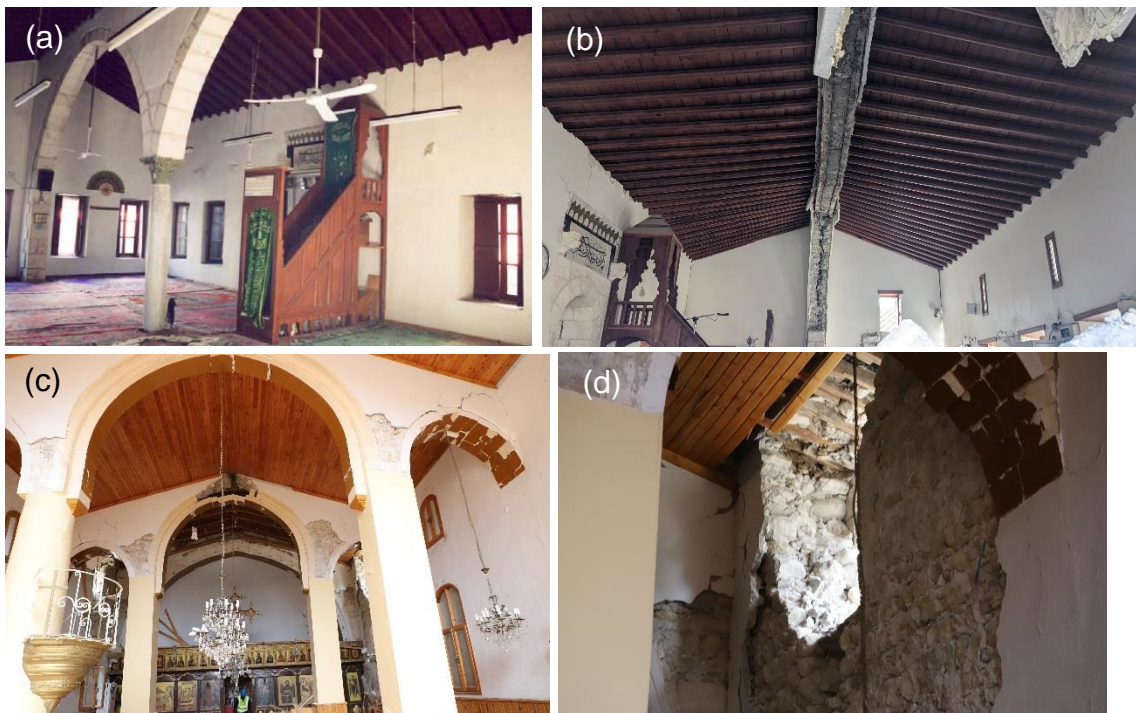
Figure 141: Photographs of the propped roof timber systems and the damage they experienced during the earthquakes: (a-b) Nakip Mosque in Antakya and (c-d) Meryem Ana Church in Samandağ.

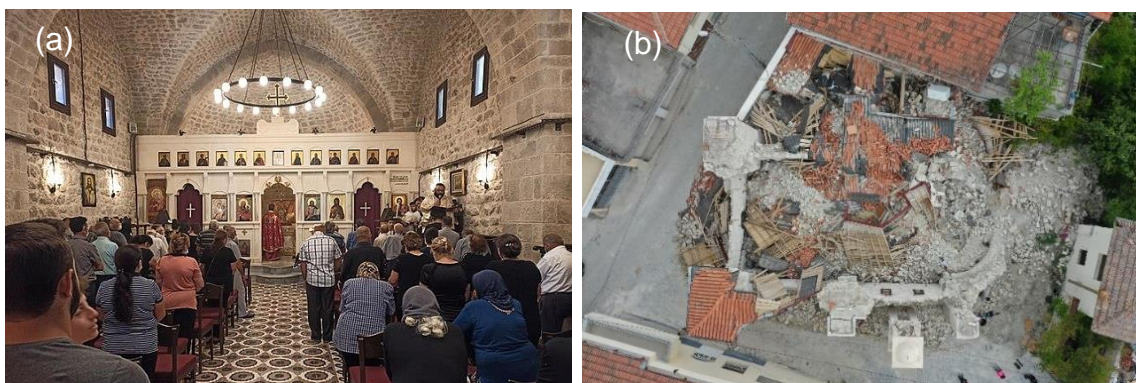
There are several monuments which employ stone vaulted roof structures. Stone vaults are typically used internally, and they are covered by a light external waterproofing roof structure. Cross vaults are the most commonly used vault form in Hatay. Figure 142a and c show the interior of the Meryem Ana Tokacli and Kaddis Mar Circos churches. In Figure 142d, the vault appears to be backfilled to the level of the crown with granular material to provide lateral stability. Figure 142b and d show aerial views of the churches after the earthquakes. In both cases, it is interesting to note that some of the buttresses remain standing although they show signs of disaggregation and are out of plumb in the church nave transverse direction. This may suggest that the vault collapses may have arisen due to large lateral movements of the buttress and wall structures supporting the vaults.

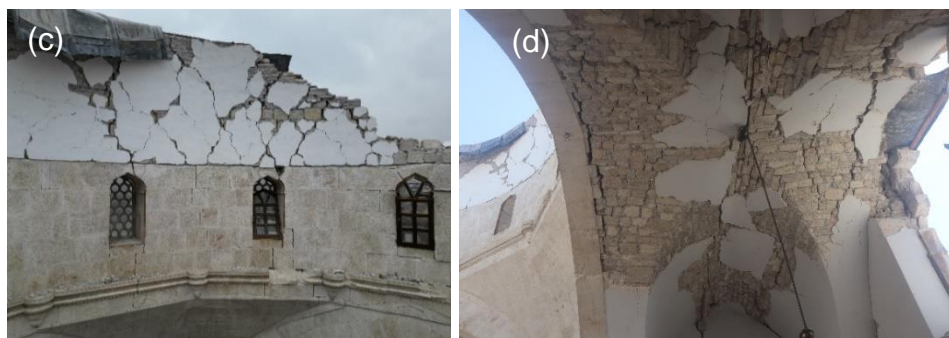
Figure 143: Photographs of (a) Habibi Neccar mosque interior before the earthquakes (Sanci, 2006) (b) Seyh Ali Mosque north and west facades, (c) dome and (d) east vault after the earthquakes.

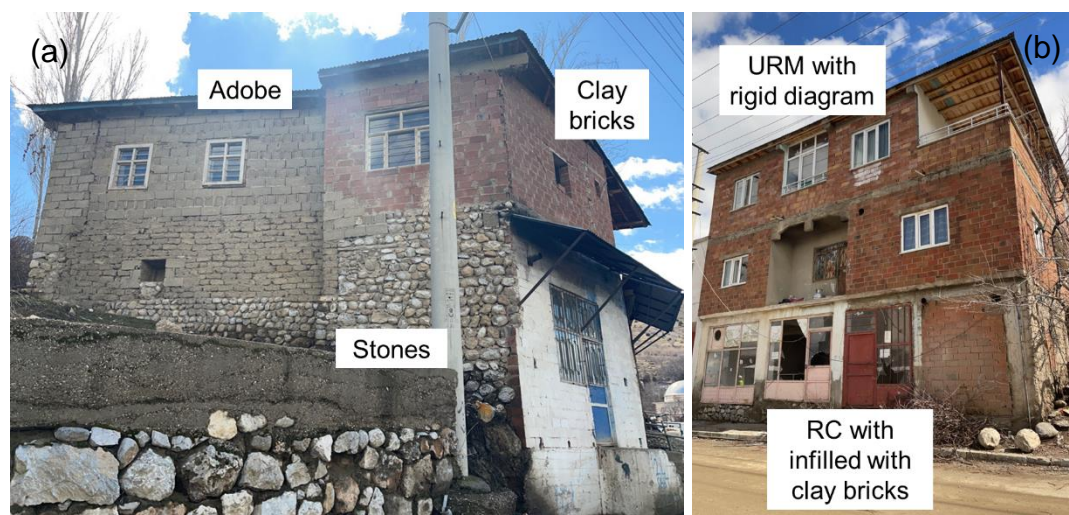
Figure 144: Hybrid buildings with (a) bearing walls made of adobe, clay bricks and stone; (b) a first level made of RC frames and a second level with bearing walls with rigid concrete diaphragms.

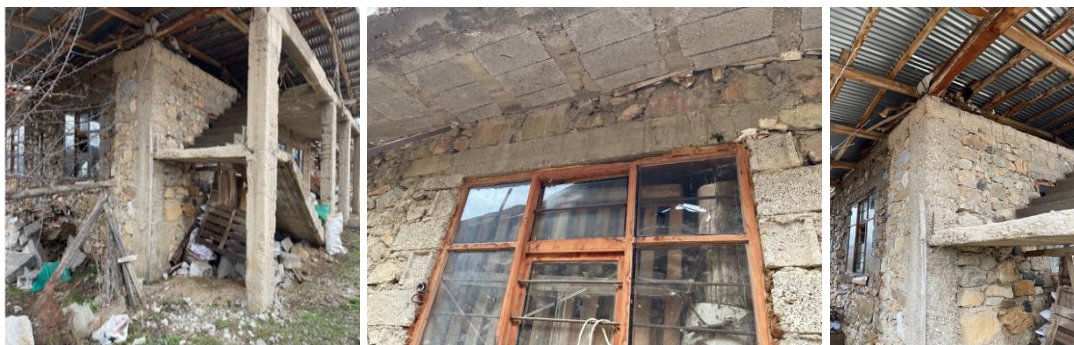
Figure 145: Confined masonry building.

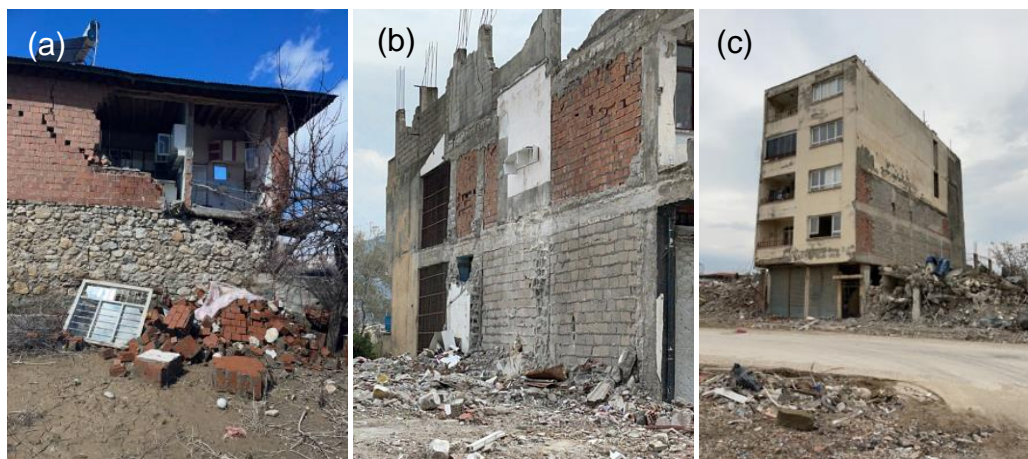
Figure 147: a) OOP failures; b) failed infilled panel and c) Non-Engineered Interventions on a Building with a Vulnerable Soft Storey Due to Large Ground-Floor Openings for Commercial Activities.

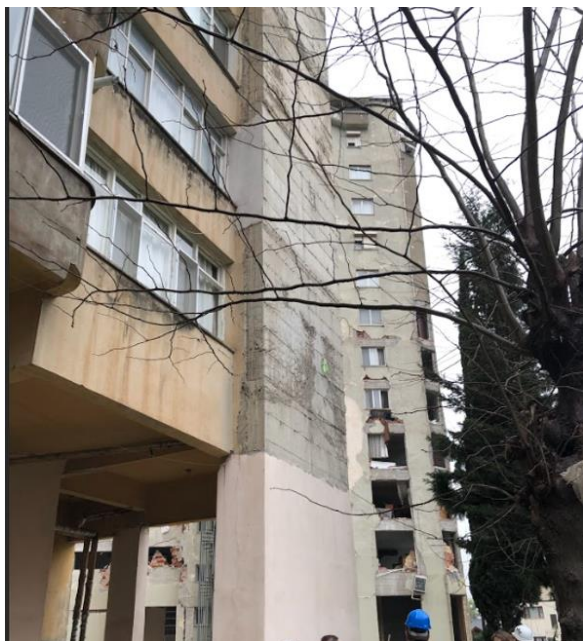
Figure 150: Post earthquake condition of an external shear wall.

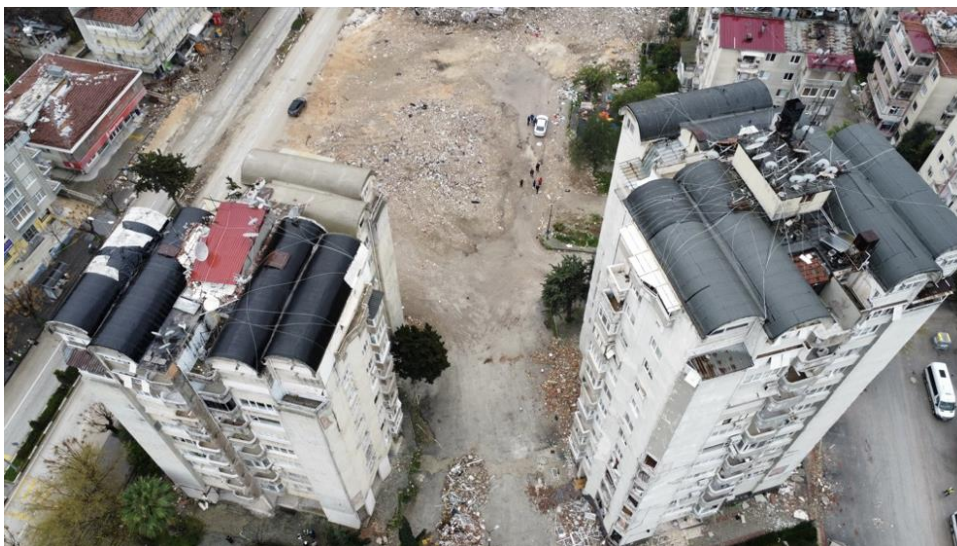
Figure 151: Aerial drone footage of remaining two blocks after the earthquake.

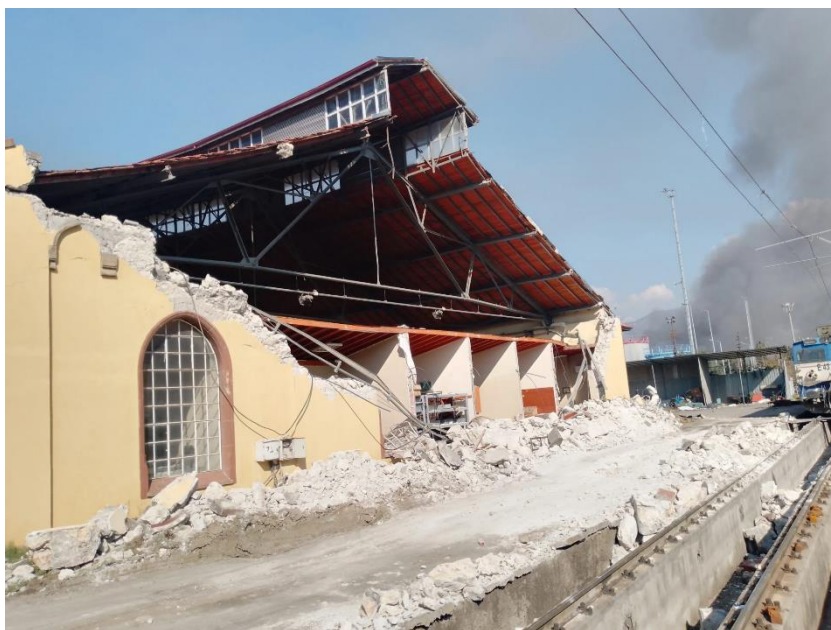
Figure 153: Collapsed building at the Fevzipaşa Train Station [<https://sendikalmucadele.org/btsden-deprem-raporu-demiryollarinda-hasar-fazla/>].

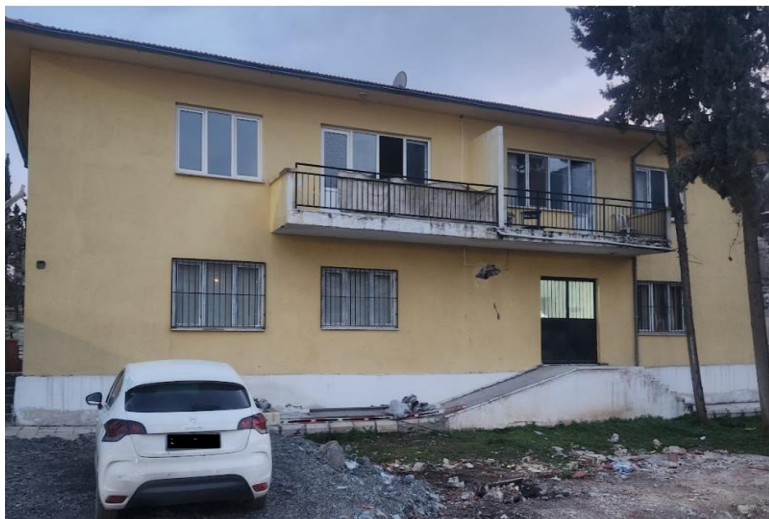
Figure 154: Standing masonry building at Fevzipaşa Train Station.
