THE TÜRKİYE EARTHQUAKE SEQUENCE OF FEBRUARY 2023

A LONGITUDINAL STUDY REPORT BY EEFIT

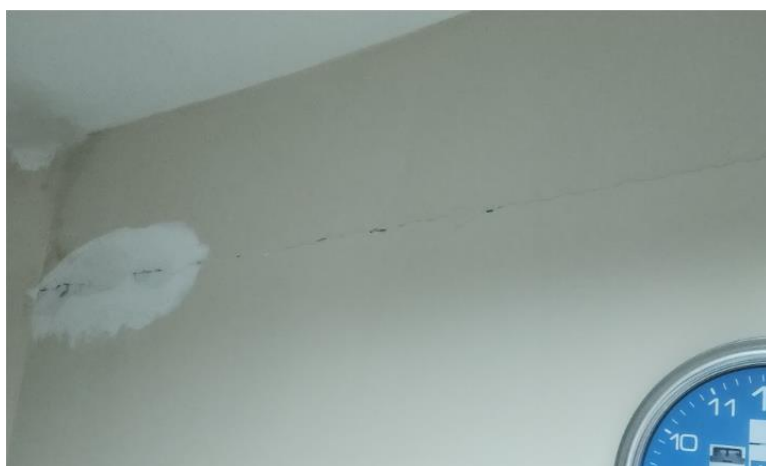
Figure 155: Non-structural crack through the beam-wall connection observed in one of the buildings at Fevzipaşa Train Station.

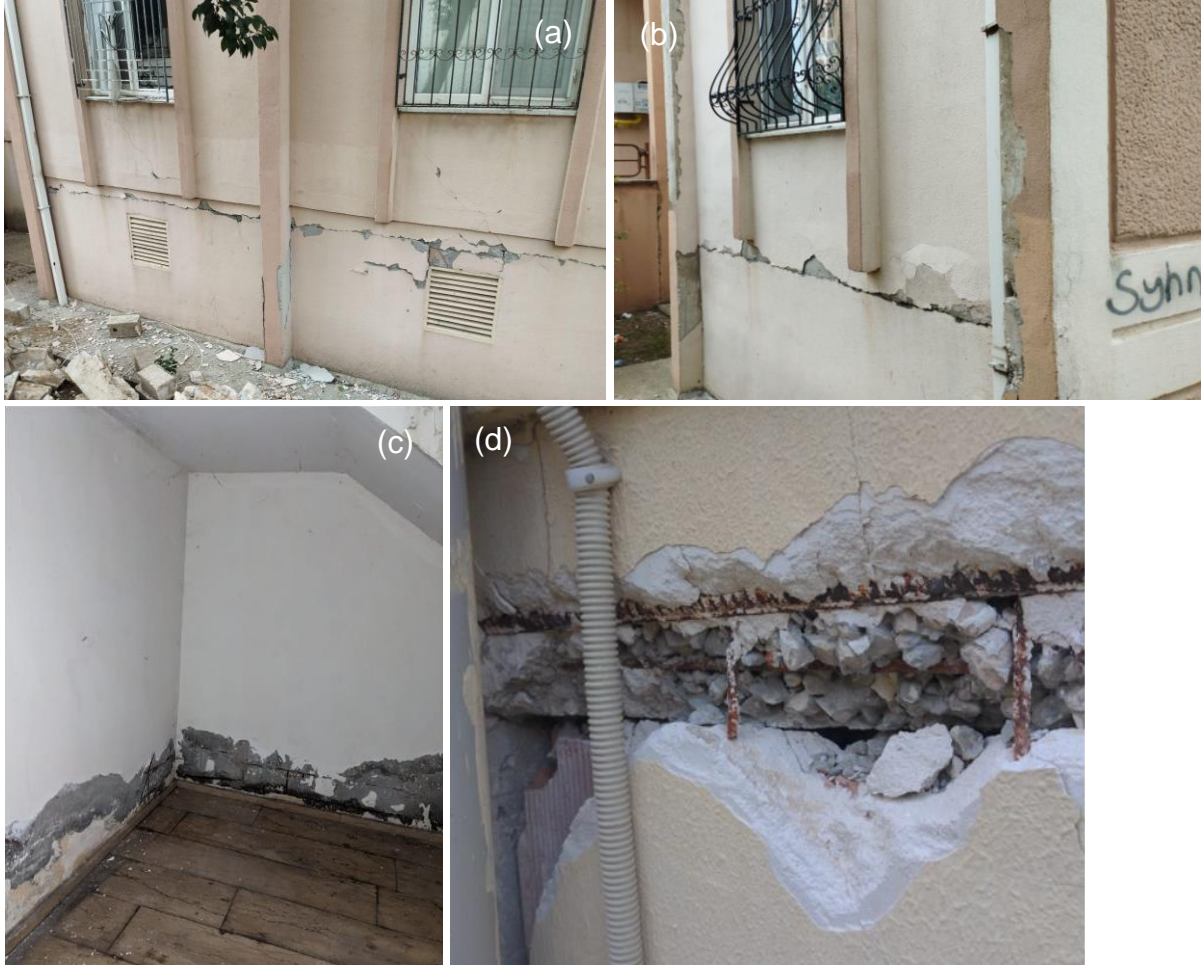
Figure 157: Damage observed in TOKI housing; (a) Separation of infill walls at the ground story and (b) Initiation of cover spalling and separation of infill walls at the ground story; (c) Corrosion of reinforcement on basement floor; (d) Concrete cover spalling and infill wall damage.

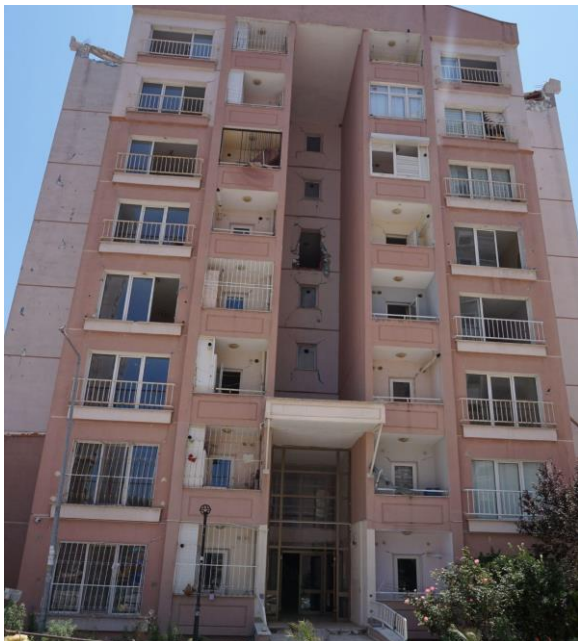
Figure 158: Widespread diagonal cracks in the infills around the window openings.

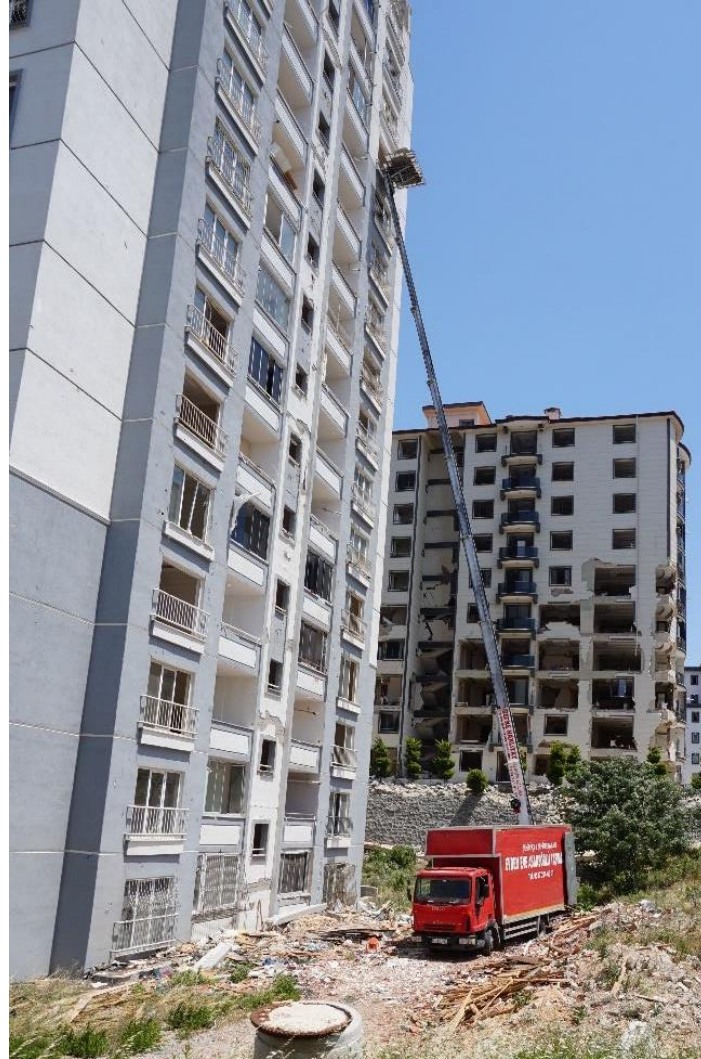
Figure 159: Comparison of a tunnel-form building with a frame building in Antakya.

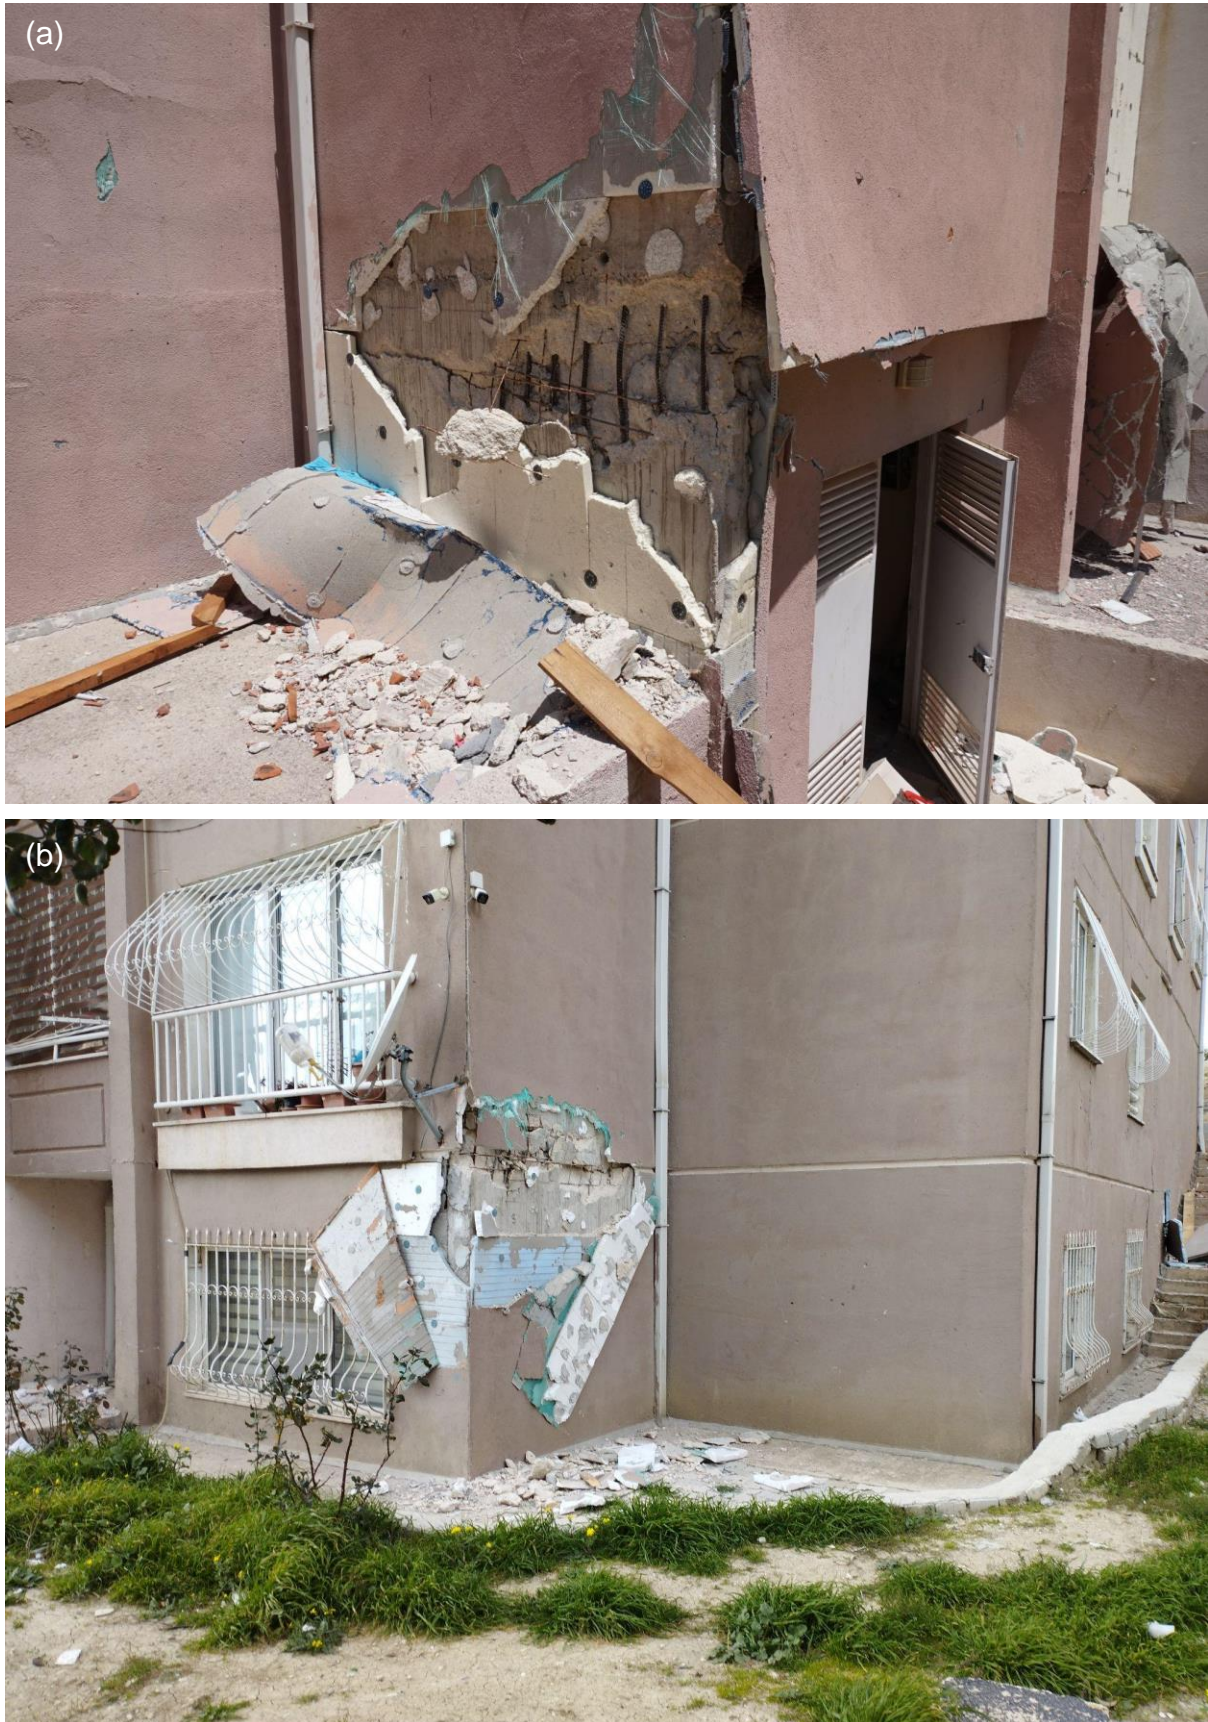
Figure 160: Shear wall damage.

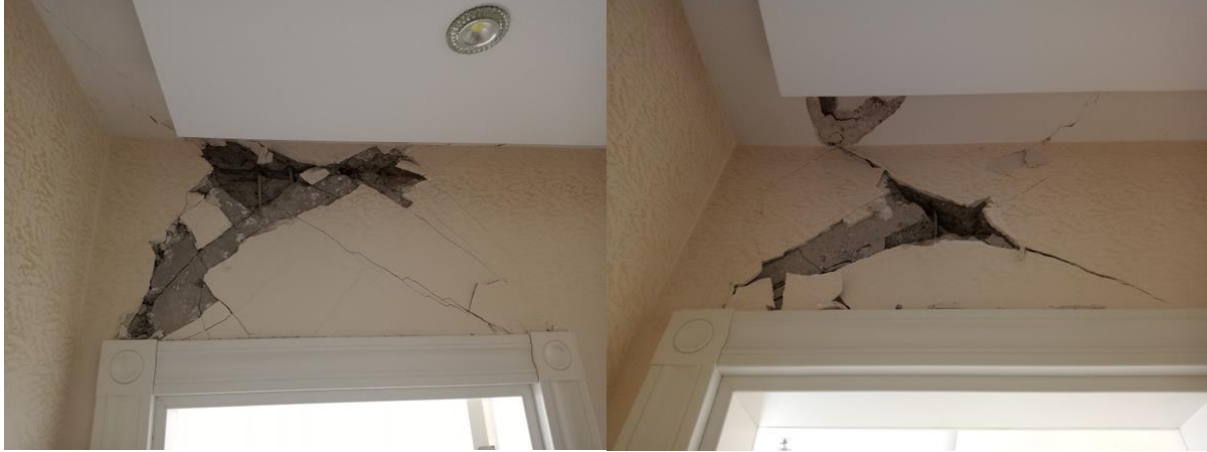
Figure 161: Coupling beam damage.

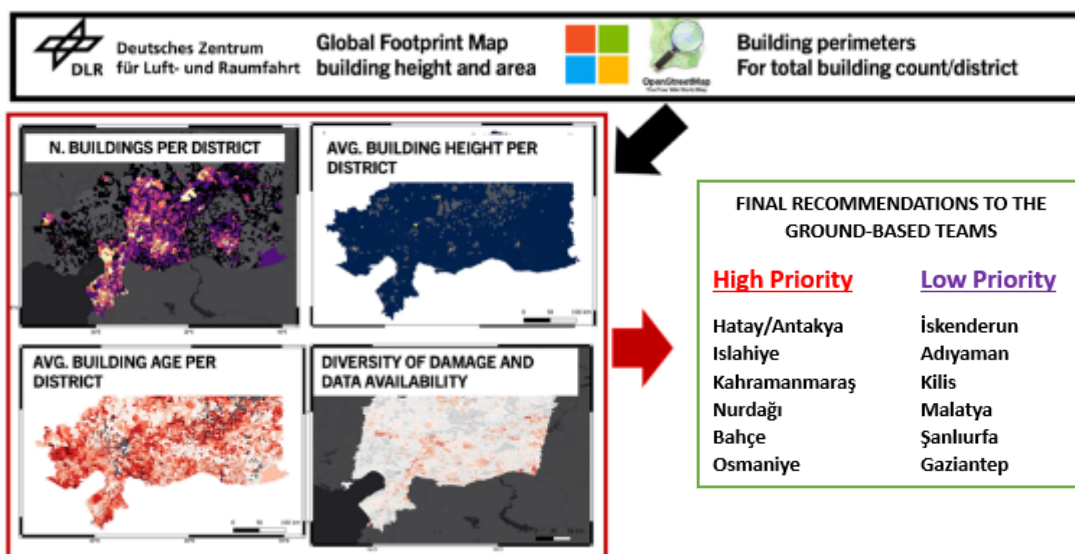
Figure 162: Examples of the outputs generated for delineating the AOIs for the EEFIT Türkiye remote sensing mission.

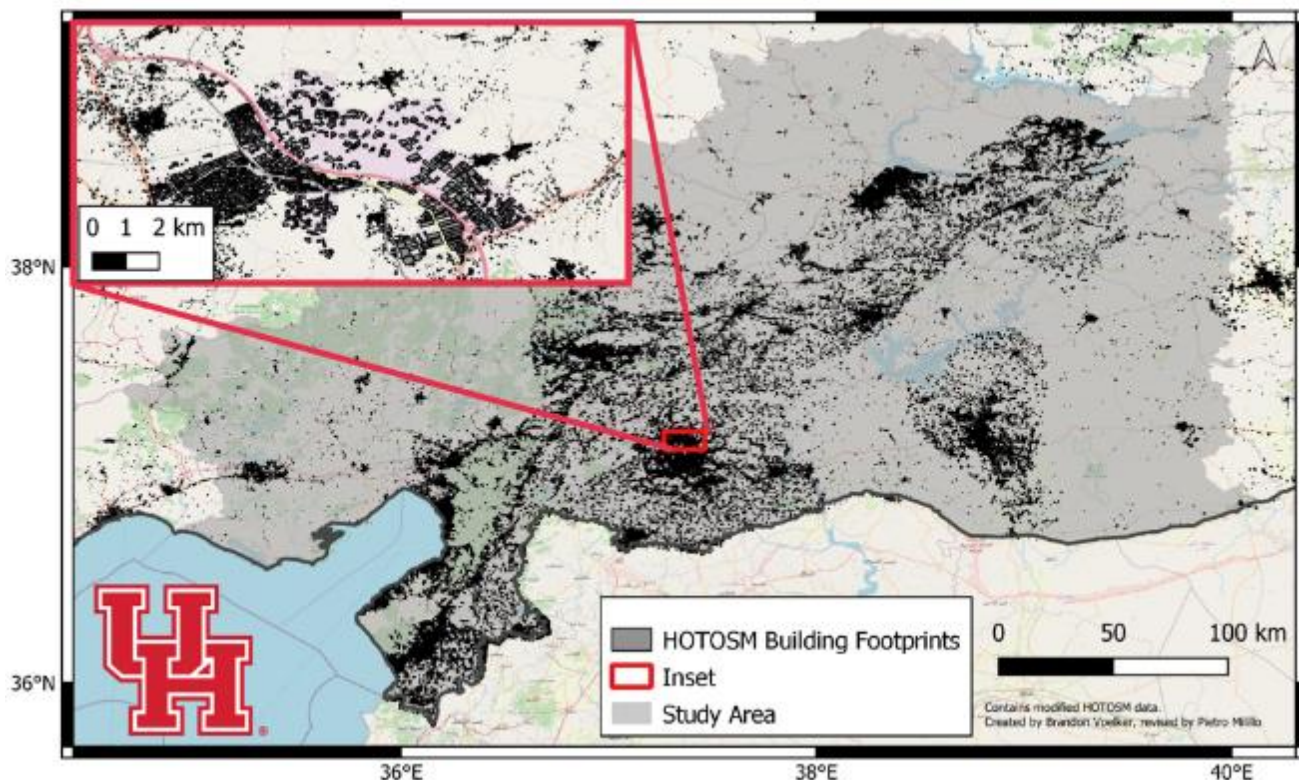
Figure 165: Building footprints in southeast Türkiye from the Humanitarian OpenStreetMap Team, over a basemap of other OpenStreetMap features.

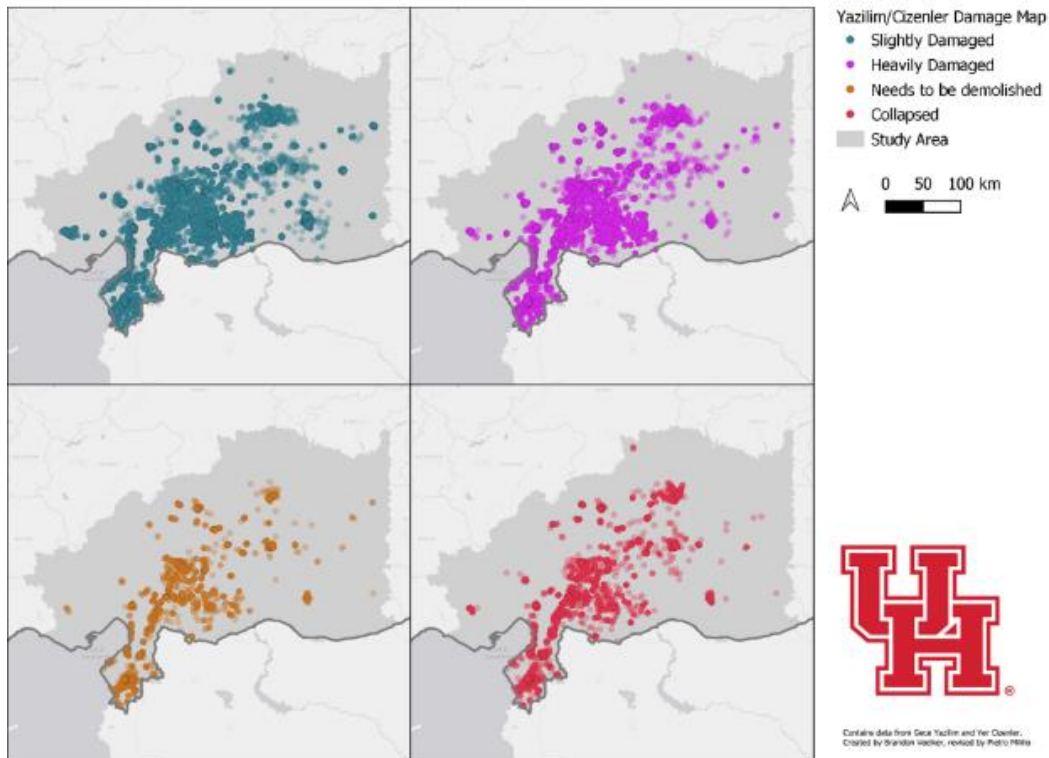
Figure 166: Density plots representing Damage maps from Turkish government reports. Each point represents a building that was classified as slightly damaged, heavily damaged, in need of demolition, and collapsed. Solid colours are used in this map to represent areas where most damaged buildings are located. Faded colours represent areas where fewer buildings (up to 10% of the buildings in the resolution cell) have been characterized by damage.

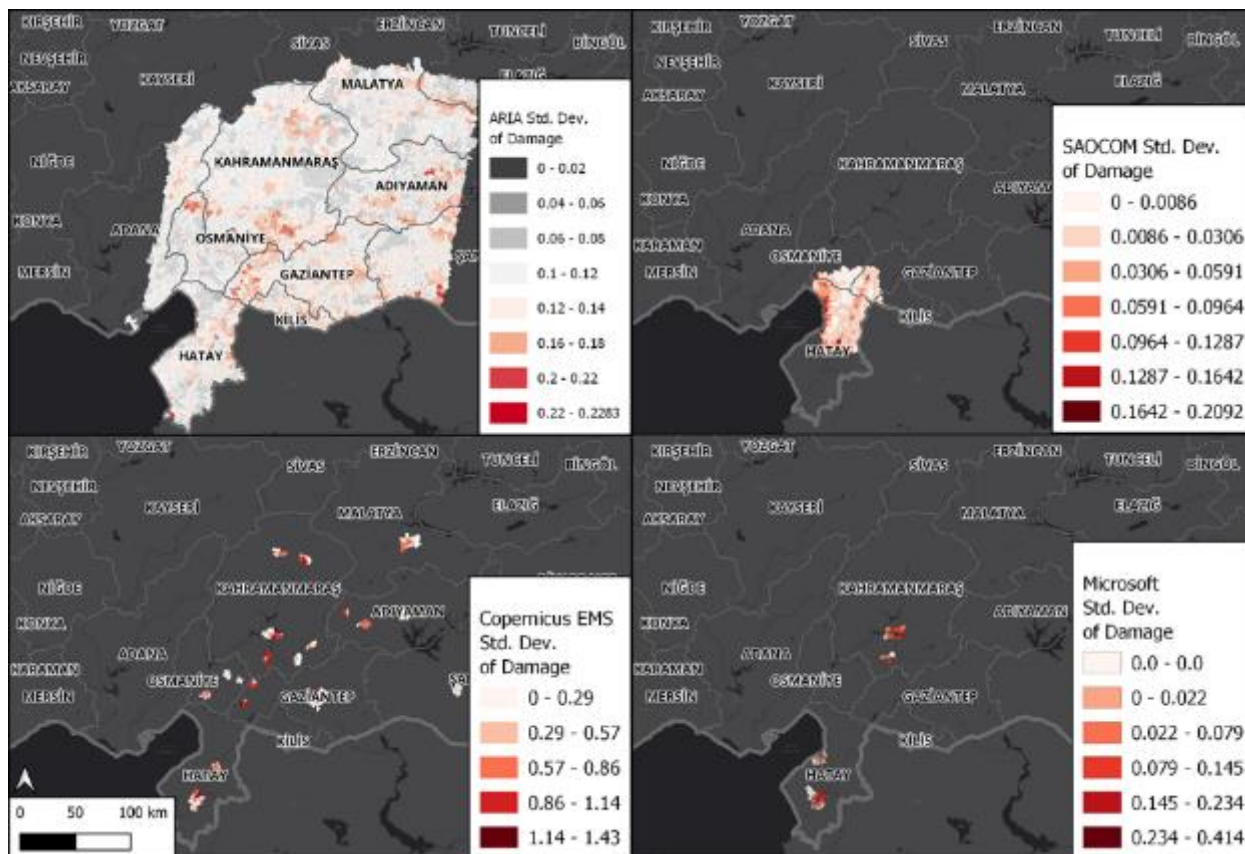
Figure 167: Standard deviation of the available damage proxy maps derived from optical and radar data in the southern part of the study area.

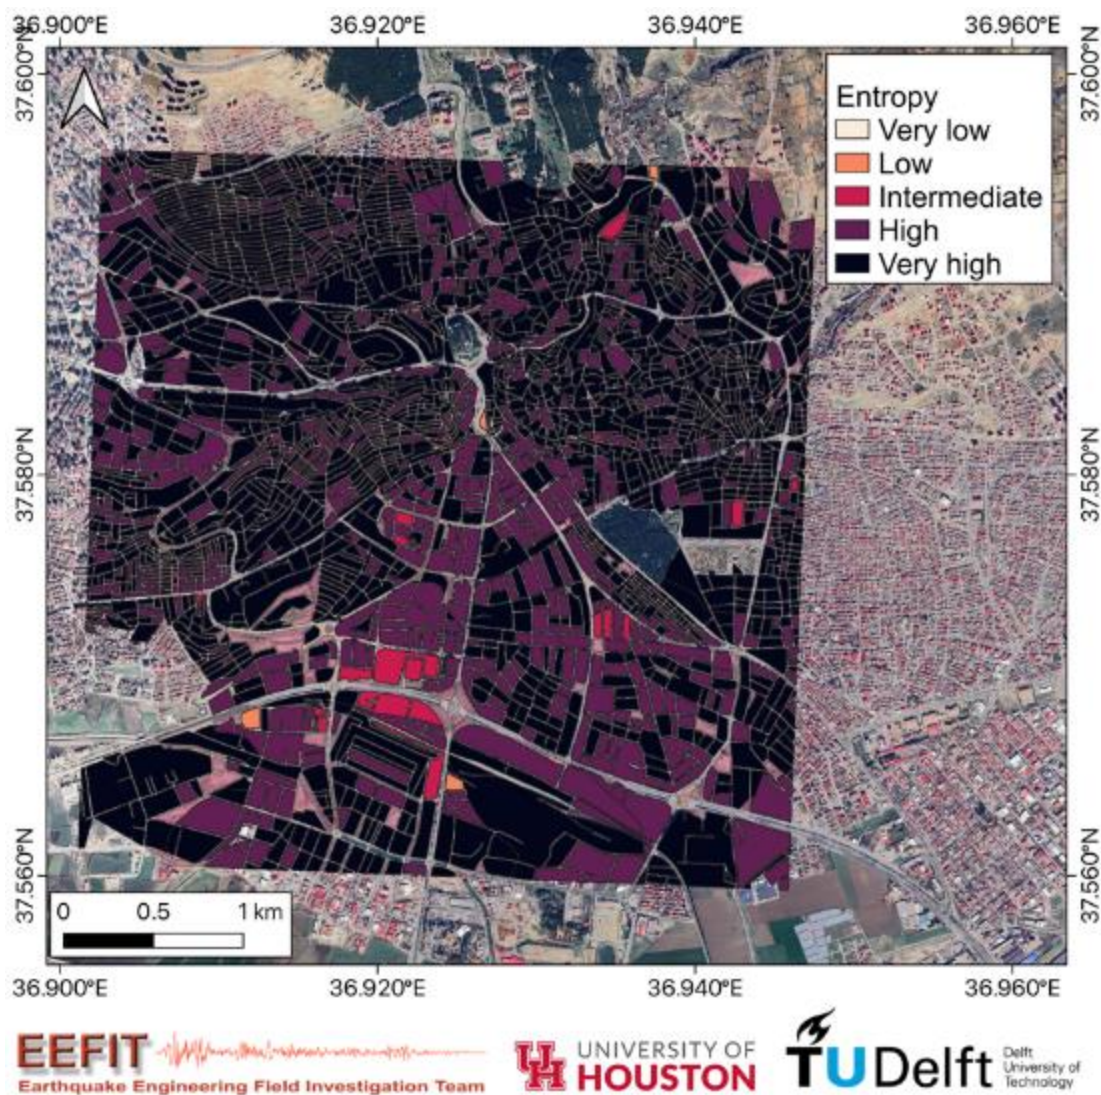
Figure 168: Example of Damage Product generated using Umbra Space satellite data.

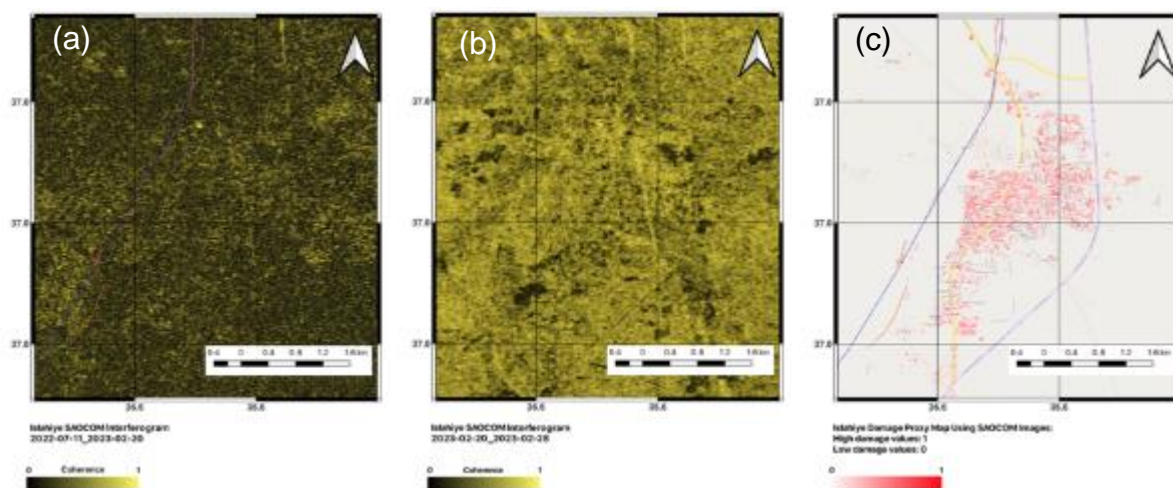
Figure 169: Islahiye SAOCOM coherence and DPM. a) Co-seismic coherence map. b) Post-seismic coherence map. c) DPM masked using the World Settlement Footprint map. Red areas depict highly damaged regions.

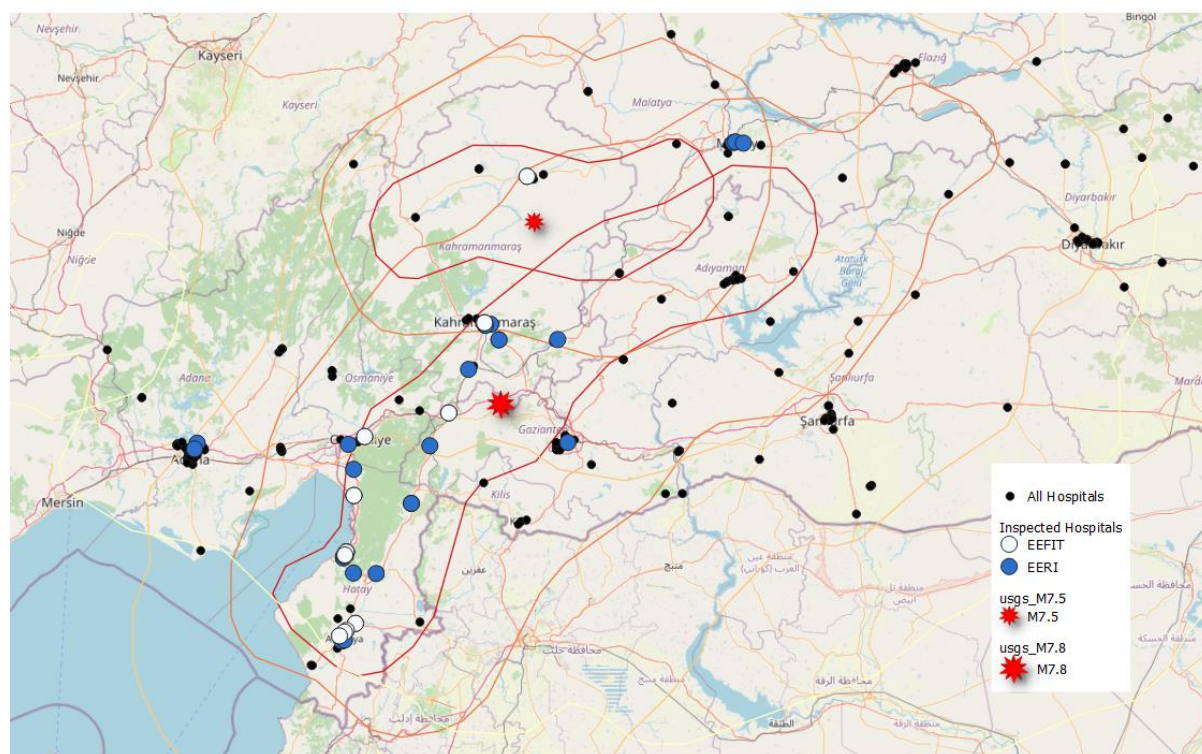
Figure 170: Hospitals visited by EEFIT team [white] and EERI team [blue] (EERI, 2023)

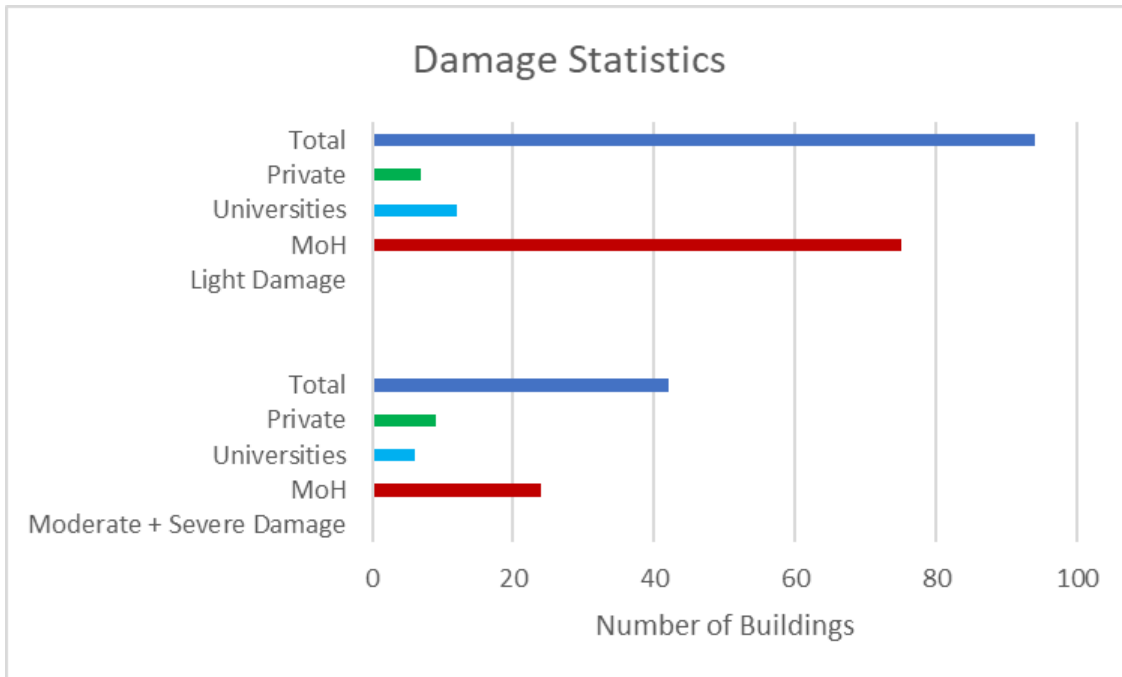
Figure 171: Damage distribution along the healthcare sector.

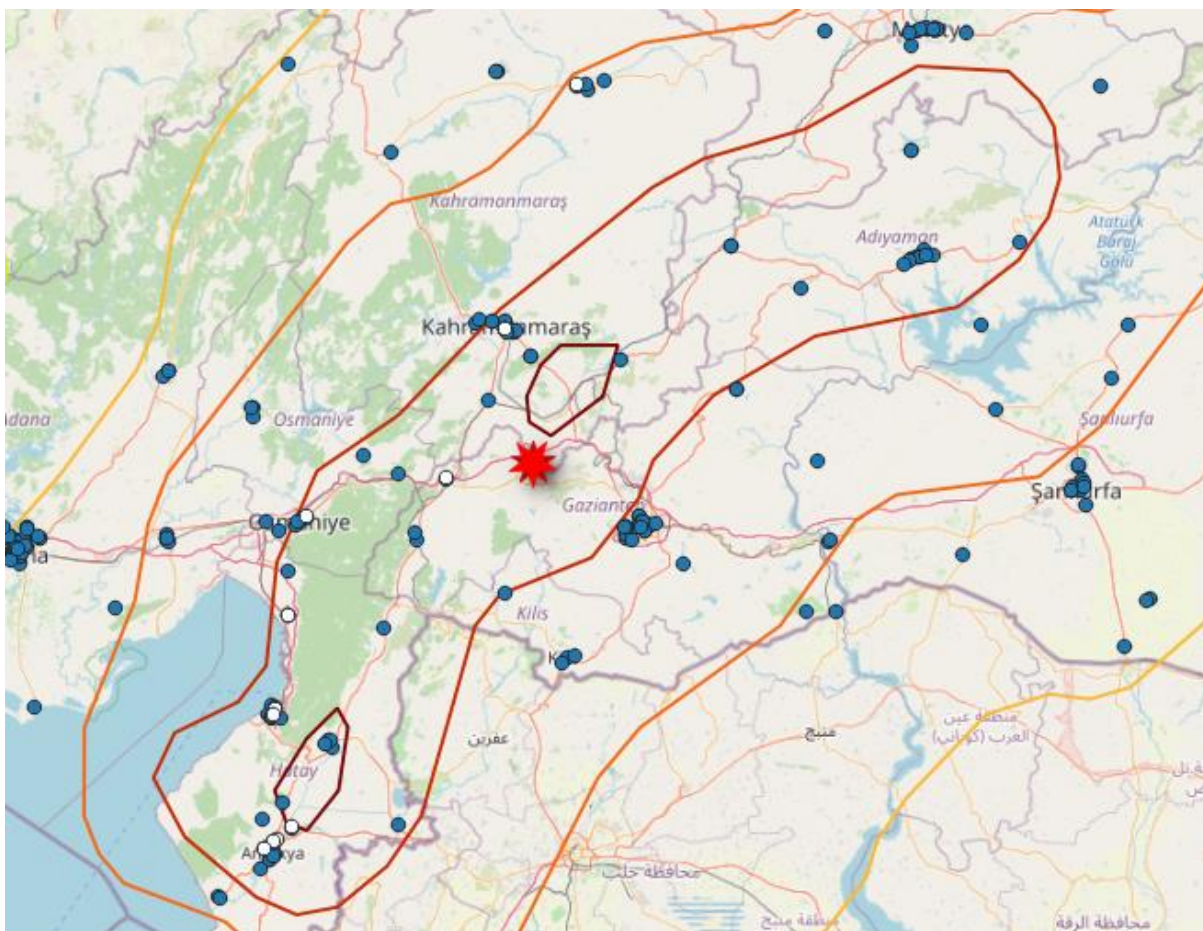
Figure 172: Hospitals visited by EEFIT team.

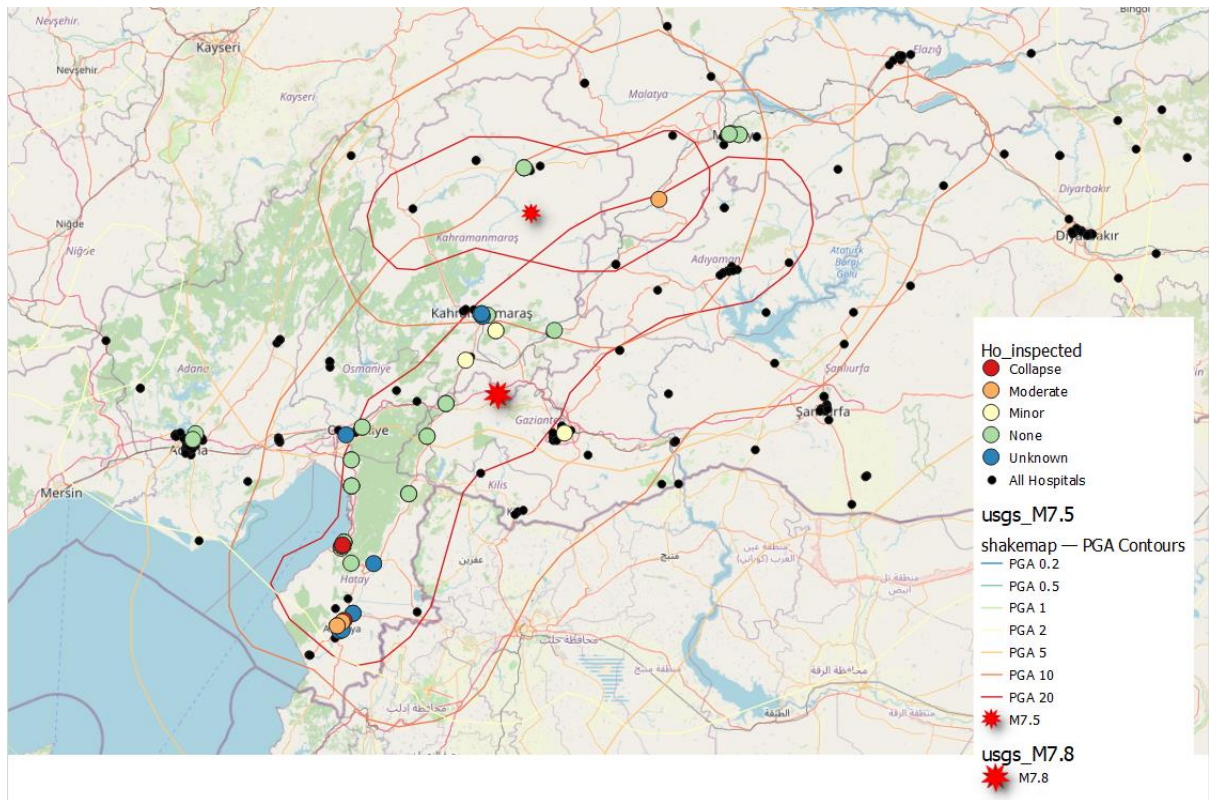
Figure 173: Damage states of the hospitals visited by the EEFIT and EERI (EERI, 2023) missions.

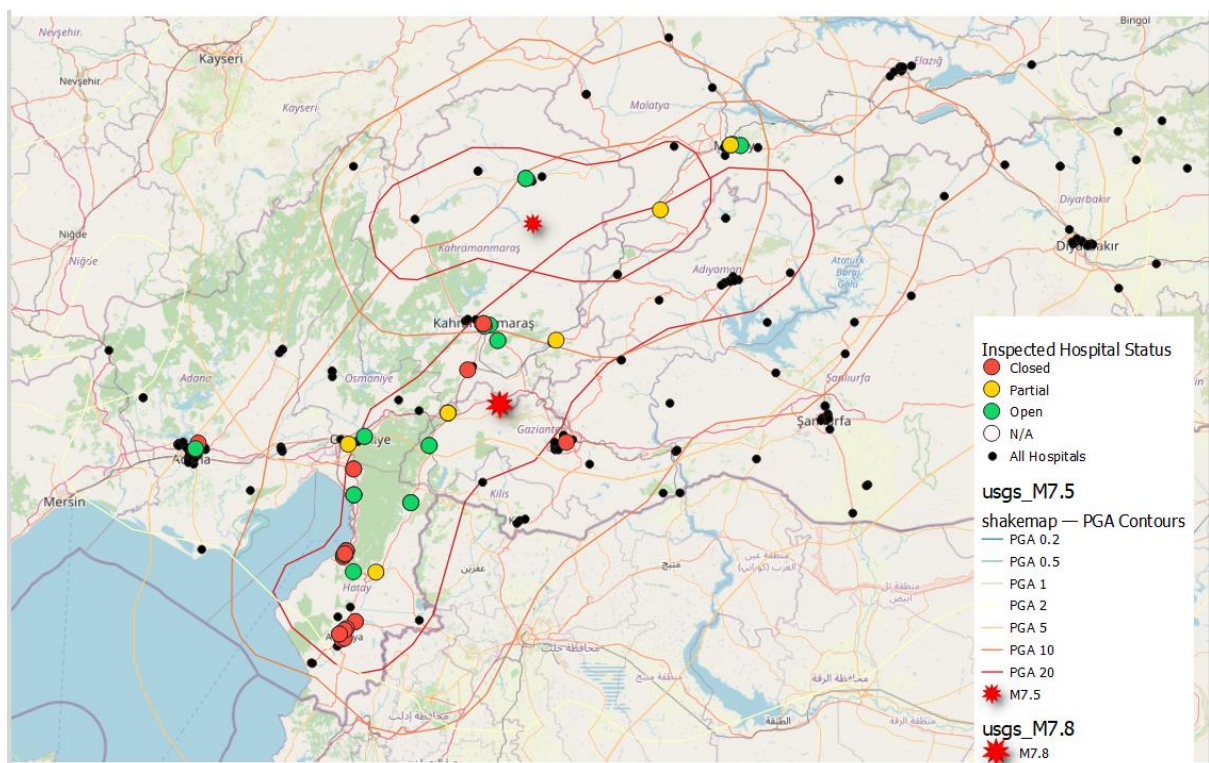
Figure 174: Operational status (closed, open, partially open, unknown) of the hospitals as observed six weeks after the earthquake from the EEFIT and EERI (EERI, 2023) teams/missions.

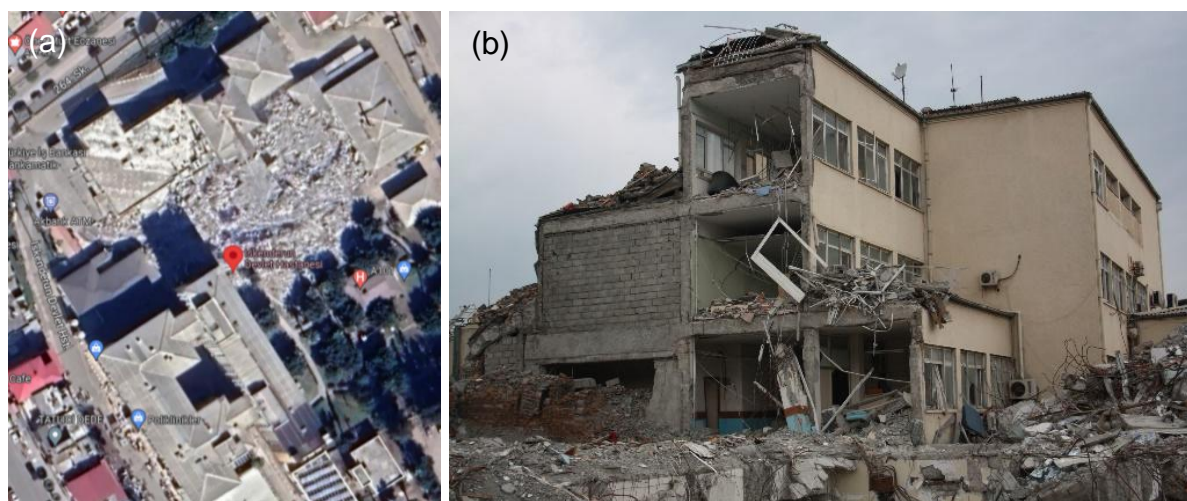
Figure 175: Iskenderun State Hospital: a) satellite view (blue arrows show the location and direction of the taken photographs) and b) as observed on 13 of March 2023

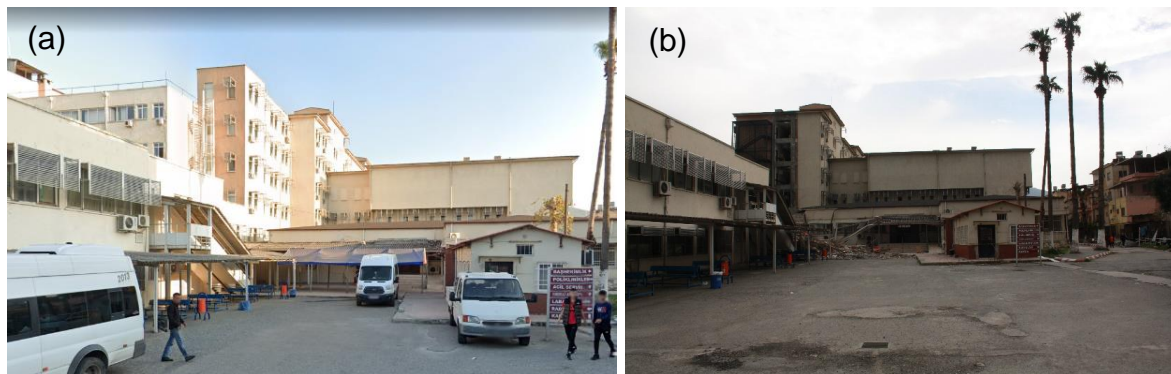
Figure 176: Iskenderun State Hospital: a) before (Google Maps Street view) and b) after the earthquake (as observed on 13 of March 2023)

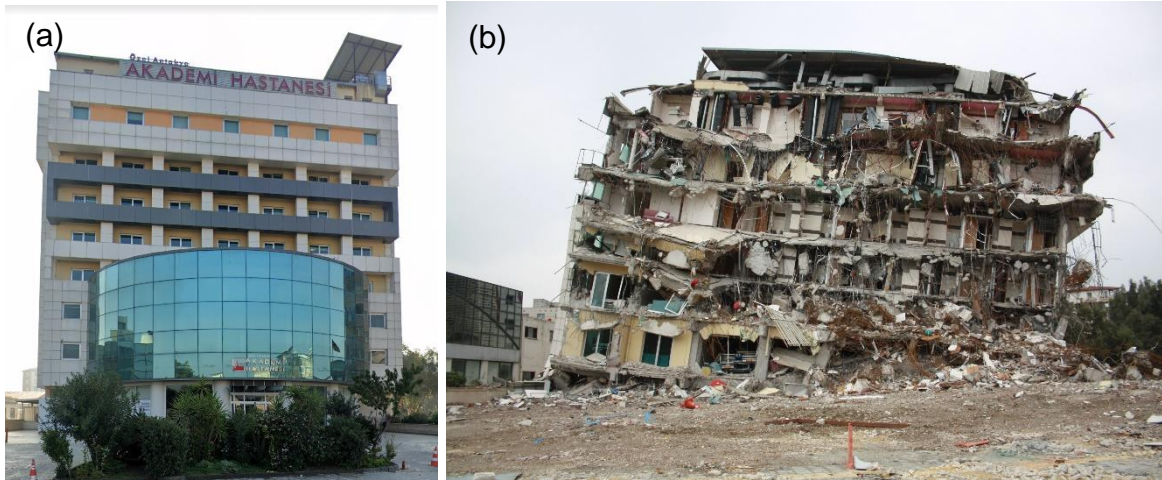
Figure 177: Antakya Private Akademi Hospital: a) before (Google Maps Street view) and b) after the earthquake (as observed on 14 of March 2023)

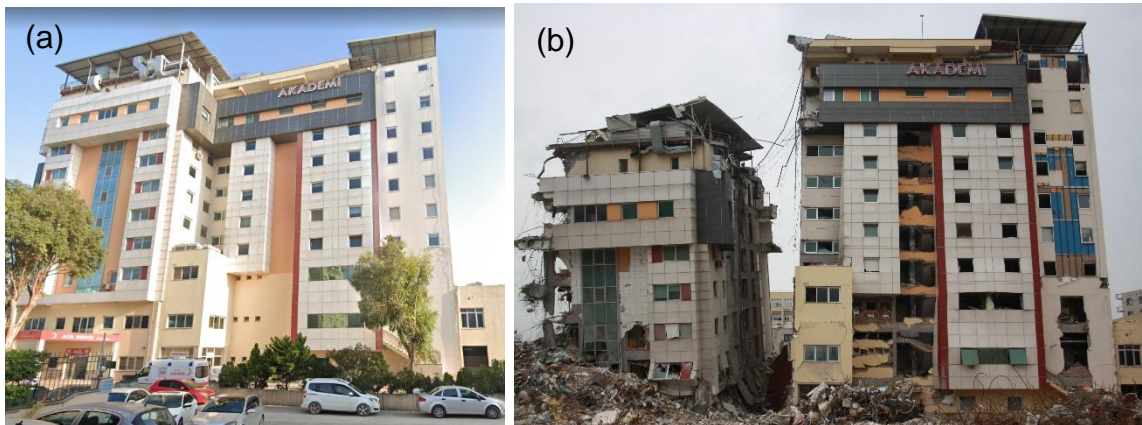
Figure 178: Antakya Private Akademi Hospital: a) before (Google Maps Street view) and b) after the earthquake (as observed on 14 of March 2023)

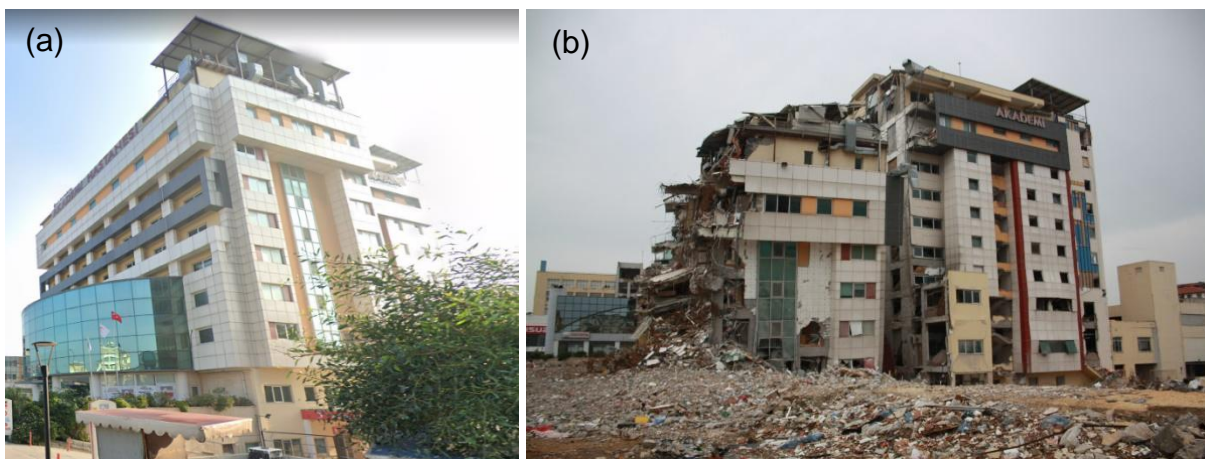
Figure 179: Antakya Private Akademi Hospital: a) before (Google Maps Street view) and b) after the earthquake (as observed on 14 of March 2023)

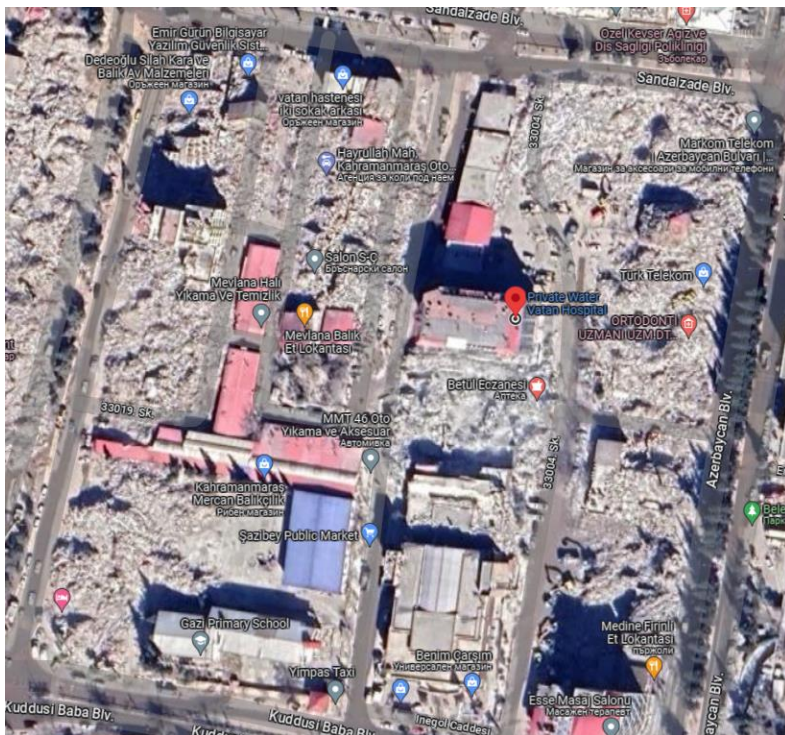
Figure 180: Vatan Private Hospital (Kahramanmaraş): satellite view showing the extent of damage in neighbouring buildings.

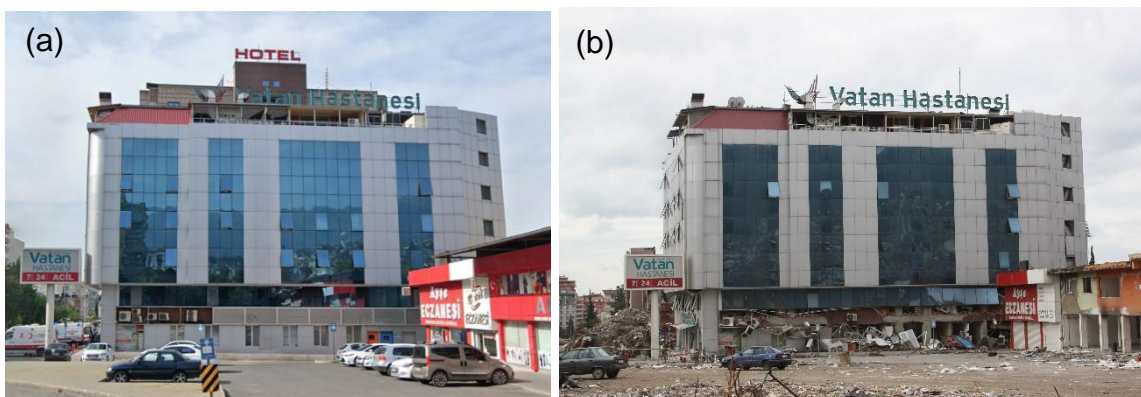
Figure 181: Vatan Private Hospital (Kahramanmaraş), north façade: a) before (Google Maps Street view) and b) after the earthquake (as observed on 16 of March 2023)

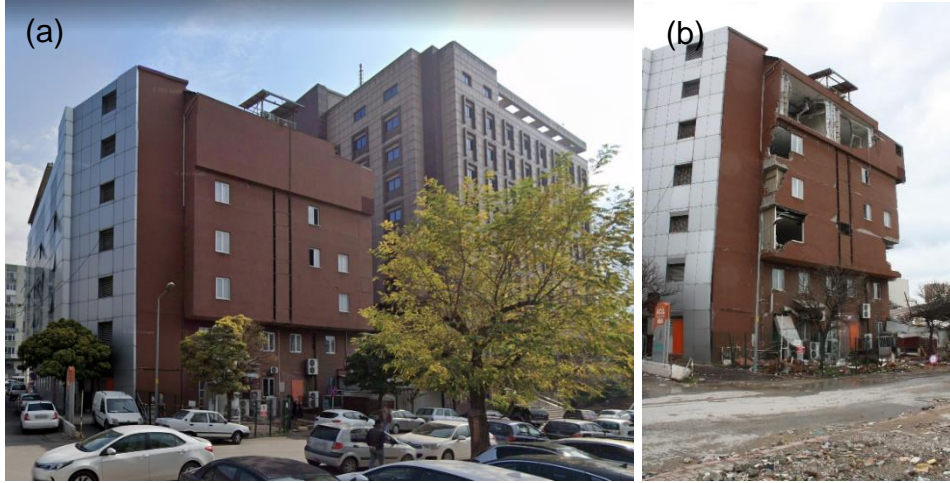
Figure 182: Vatan Private Hospital (Kahramanmaraş), west façade: a) before (Google Maps Street view) and b) after the earthquake (as observed on 16 of March 2023)

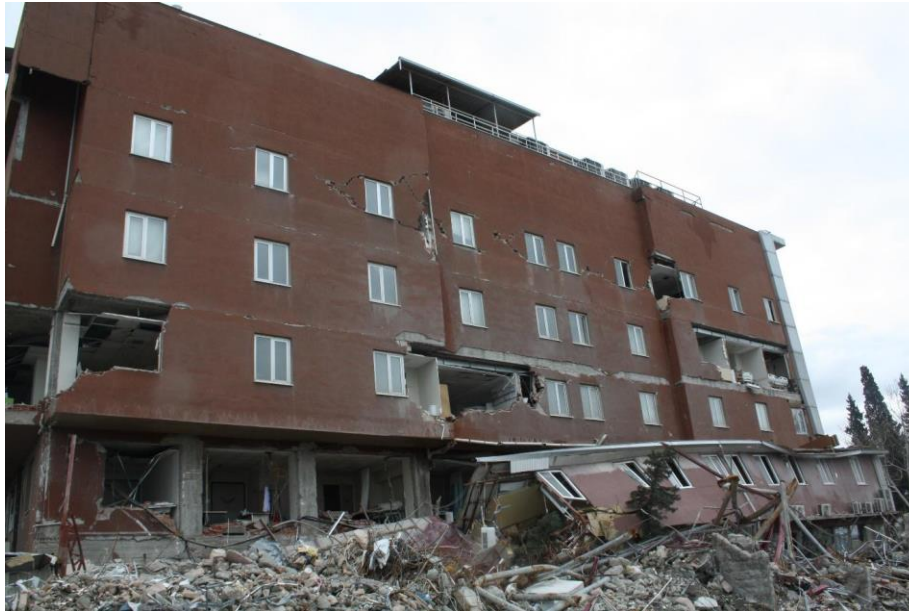
Figure 183: Vatan Private Hospital (Kahramanmaraş), south façade after the earthquake (as observed on 16 of March 2023)

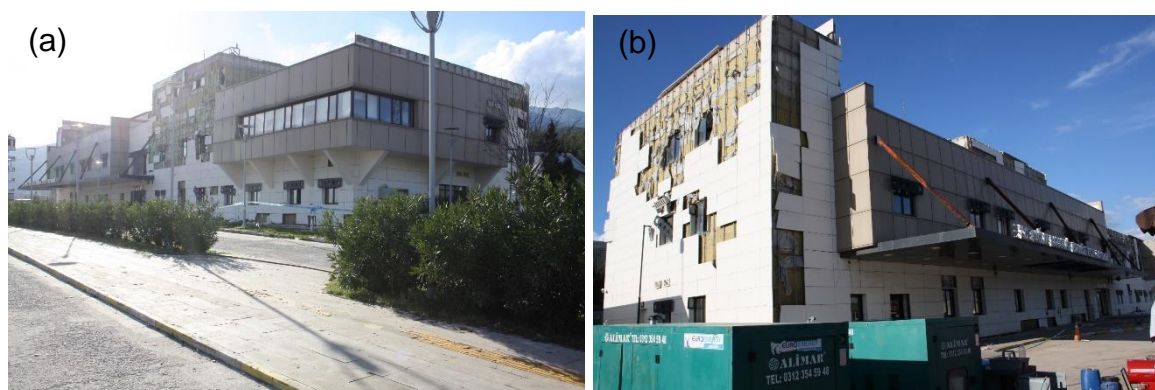
Figure 184: Nurdağı State Hospital (as observed on 15 of March 2023)

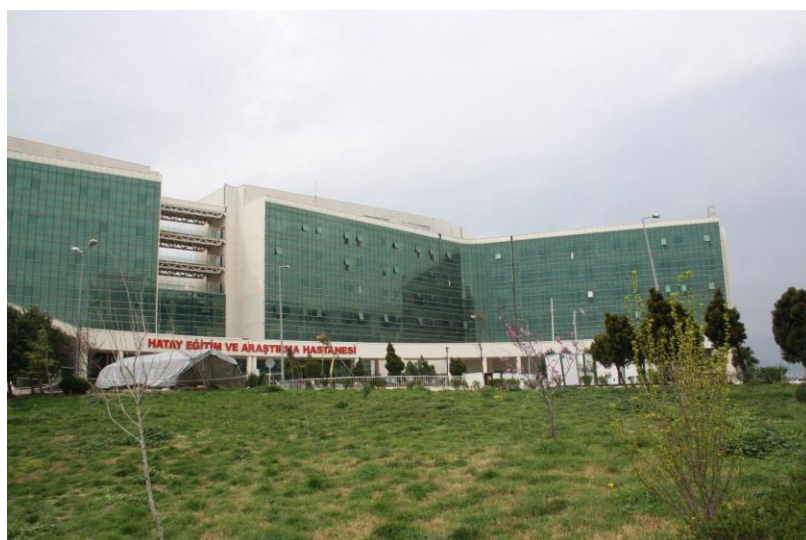
Figure 185: Hatay State Hospital (as observed on 14 of March 2023)

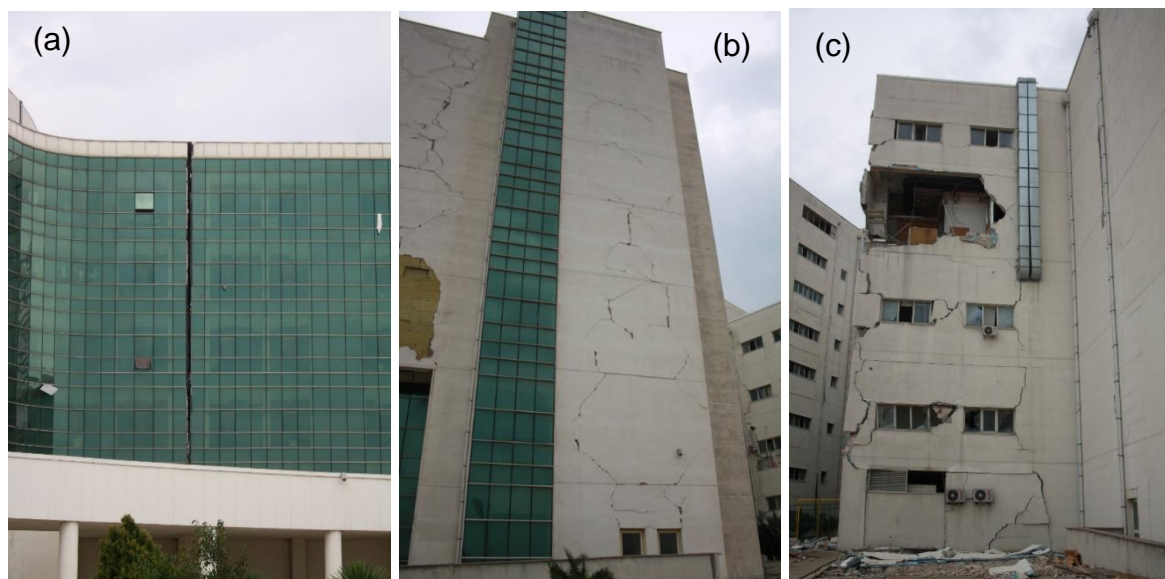
Figure 186: Hatay State Hospital (as observed on 14 of March 2023): a) opened seismic gap between two blocks, b) cracks in exterior walls and c) cracks and complete damage of exterior walls.

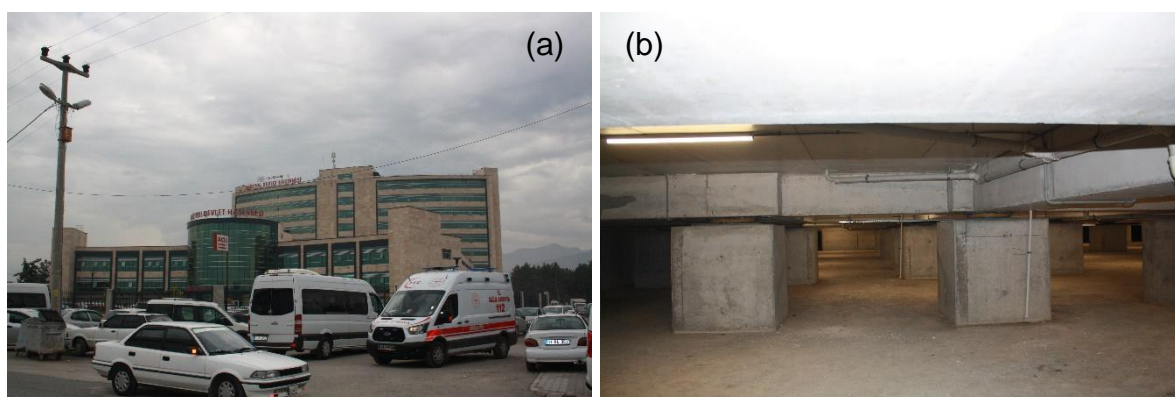
Figure 187: Dörtyol State Hospital (as observed on 13 of March 2023): a) overall view and b) view of the base isolators in the basement.
