THE TÜRKİYE EARTHQUAKE SEQUENCE OF FEBRUARY 2023

A LONGITUDINAL STUDY REPORT BY EEFIT

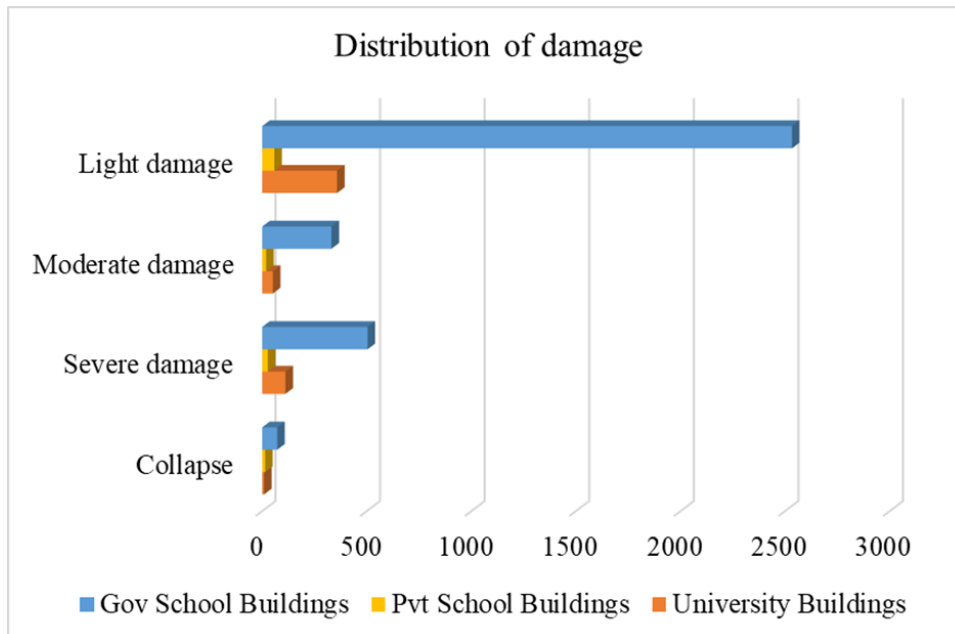
Figure 188: Damage distribution of public schools, private schools and universities.

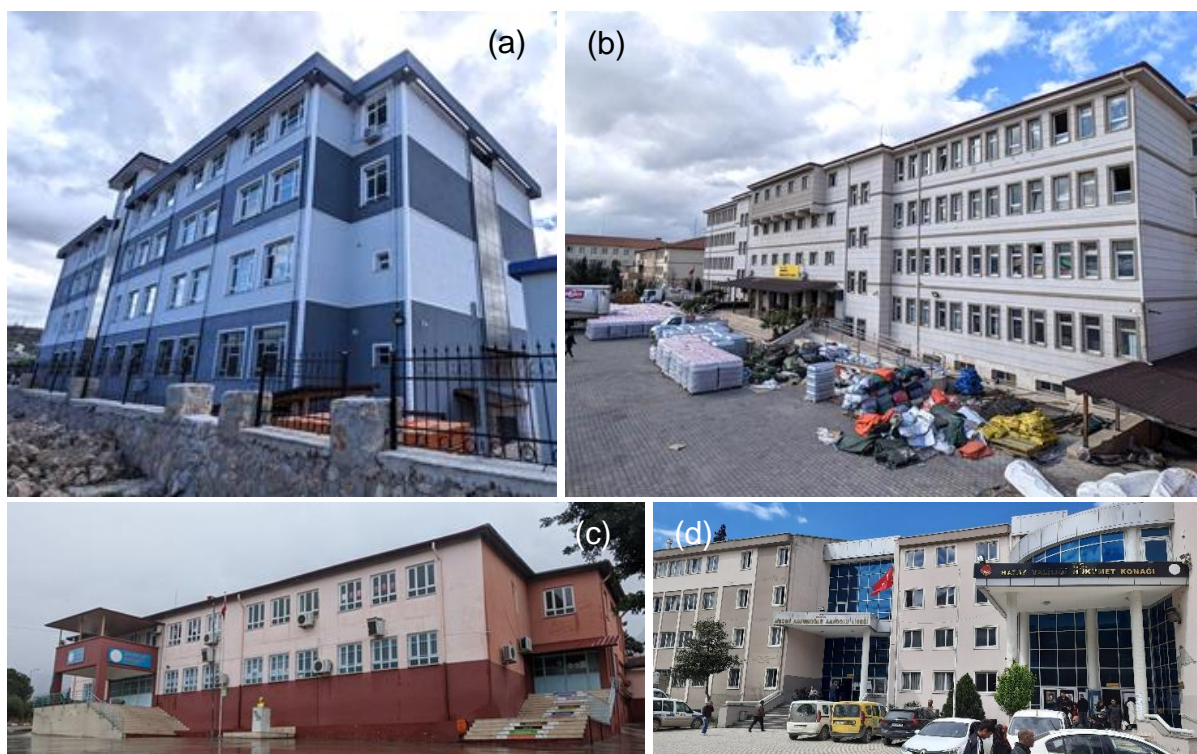
Figure 189: Well-performed schools observed during the field mission: a) Anadolu Imam Hatip Lisesi (Campus 1), Altinozu, Hatay, b) Anadolu Imam Hatip Lisesi (Campus 2), Altinozu, Hatay–The main building is being used a distribution hub of relief material, (c) Fikret Kocak İlkokulu, Iskenderun, Hatay, and d) School from Hatay, being used as a government office

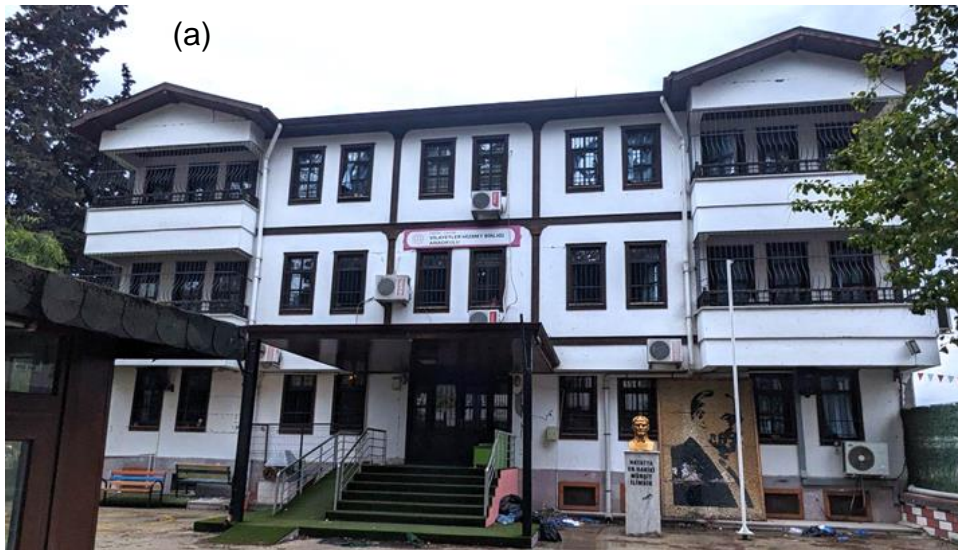
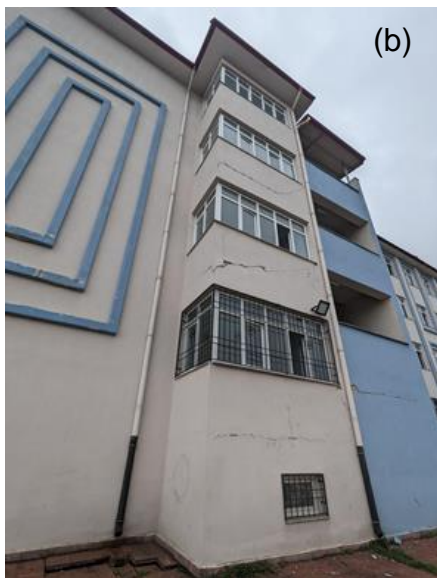
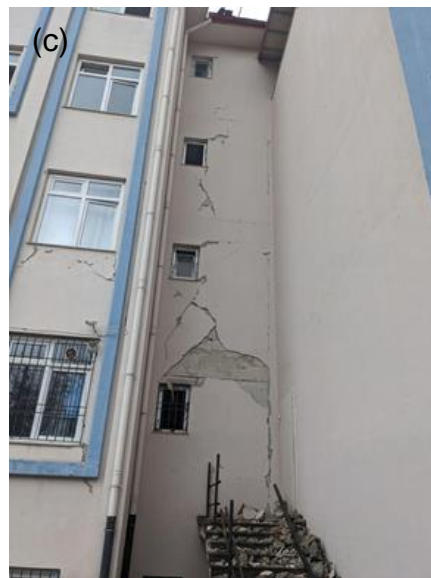
Figure 190: Schools with faced slight to moderate damage, observed during the field mission. a) Vilayetler Hizmet Birliği Anakolu, Defne, Hatay and b) Şehit Sirin Diril Çok Programlı Anadolu Lisesi, Nurdağı, Gaziantep (RC buildings undergoing slight damage, not in use)

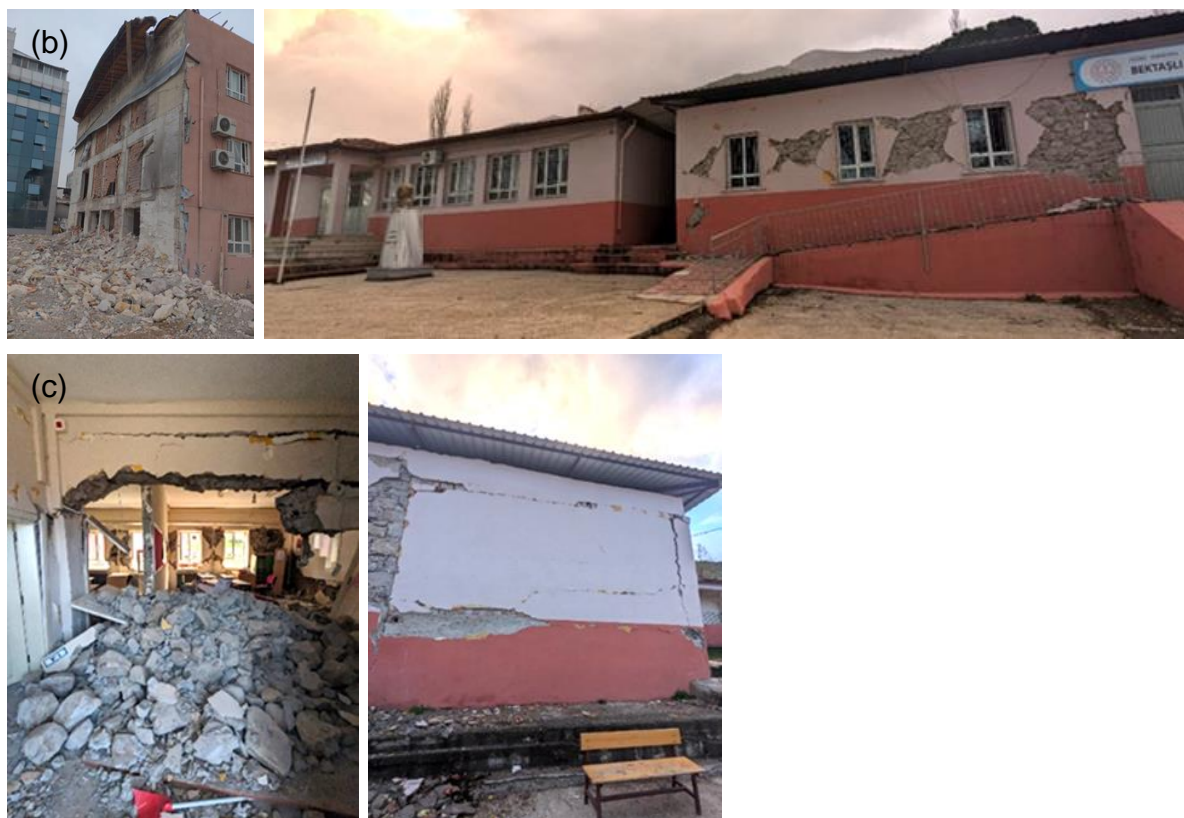
Figure 191: Schools observed to be severely damaged, collapsed or designated for demolition. a) Mithatpasa Ilkokulu, Iskenderun, Hatay– Top floor of one building in stone masonry collapsed, while the remaining buildings were not visibly damaged, b) Inonu Ortaokulu, Antakya, Hatay–RC building. Two other buildings in this compound were demolished and removed and c) Bektasli Ilkokulu, Kirikhan, Hatay– Stone masonry building heavily damaged, while adjacent RC building remained undamaged.

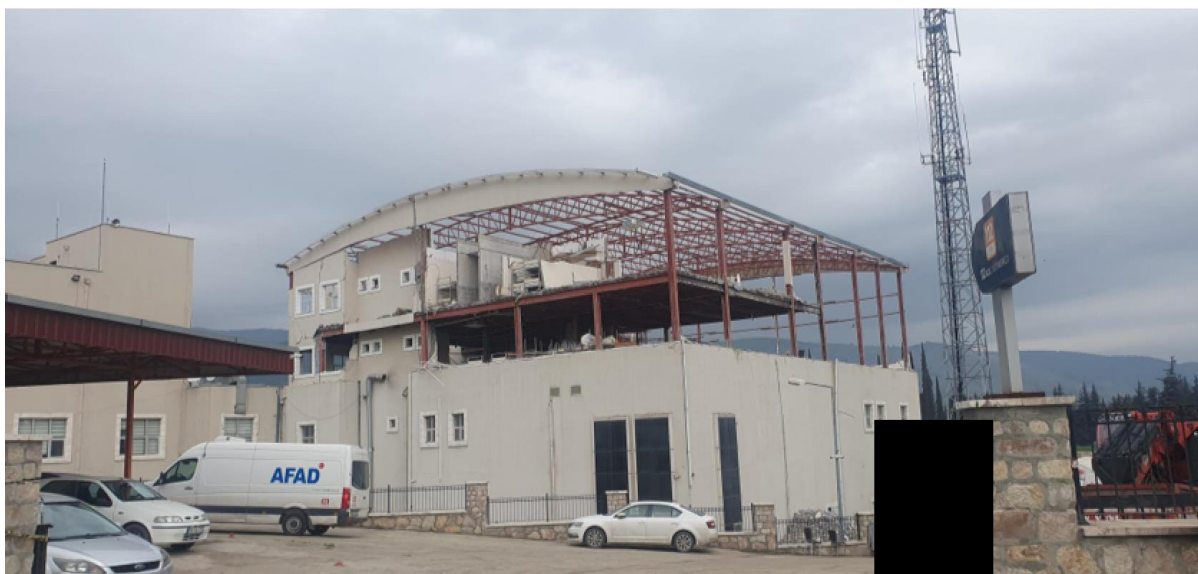
Figure 193: An auxiliary building in the AFAD regional centre for Hatay province as observed on 14 March 2023

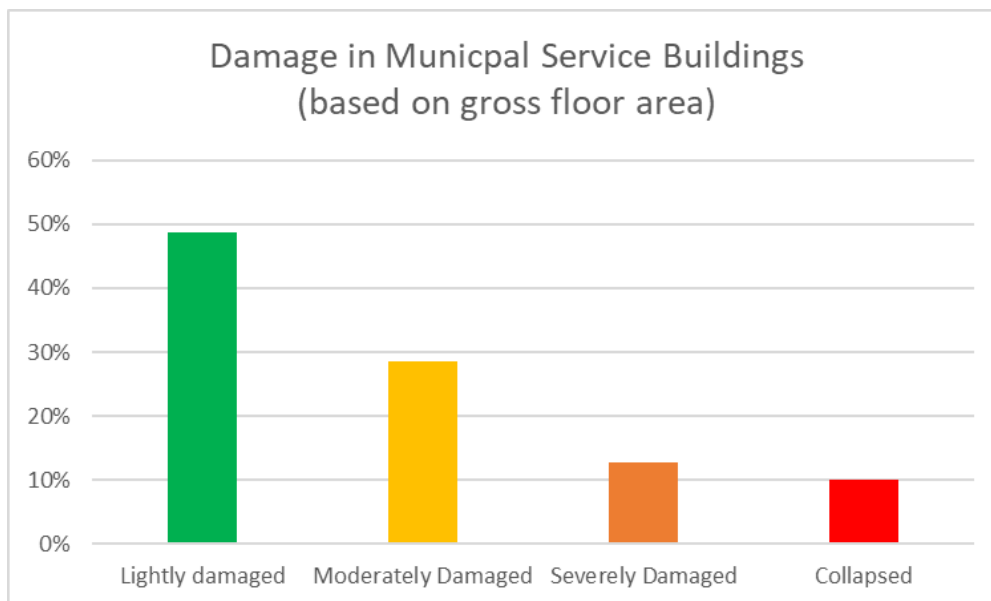
Figure 194: Damage distribution across sub-category: municipal service buildings, fire department service buildings, municipal police buildings and other municipal service buildings (PSB, 2023)

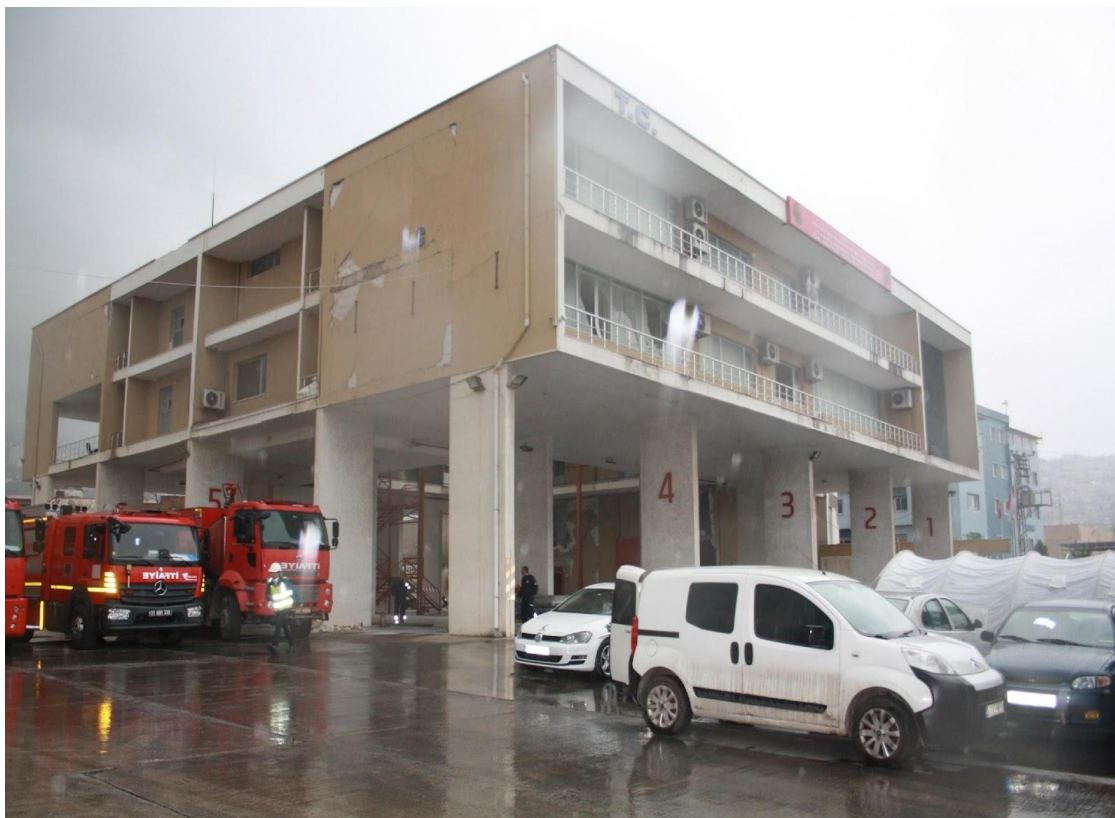
Figure 196: The main building of Iskenderun Fire Department as observed on 13 March 2023

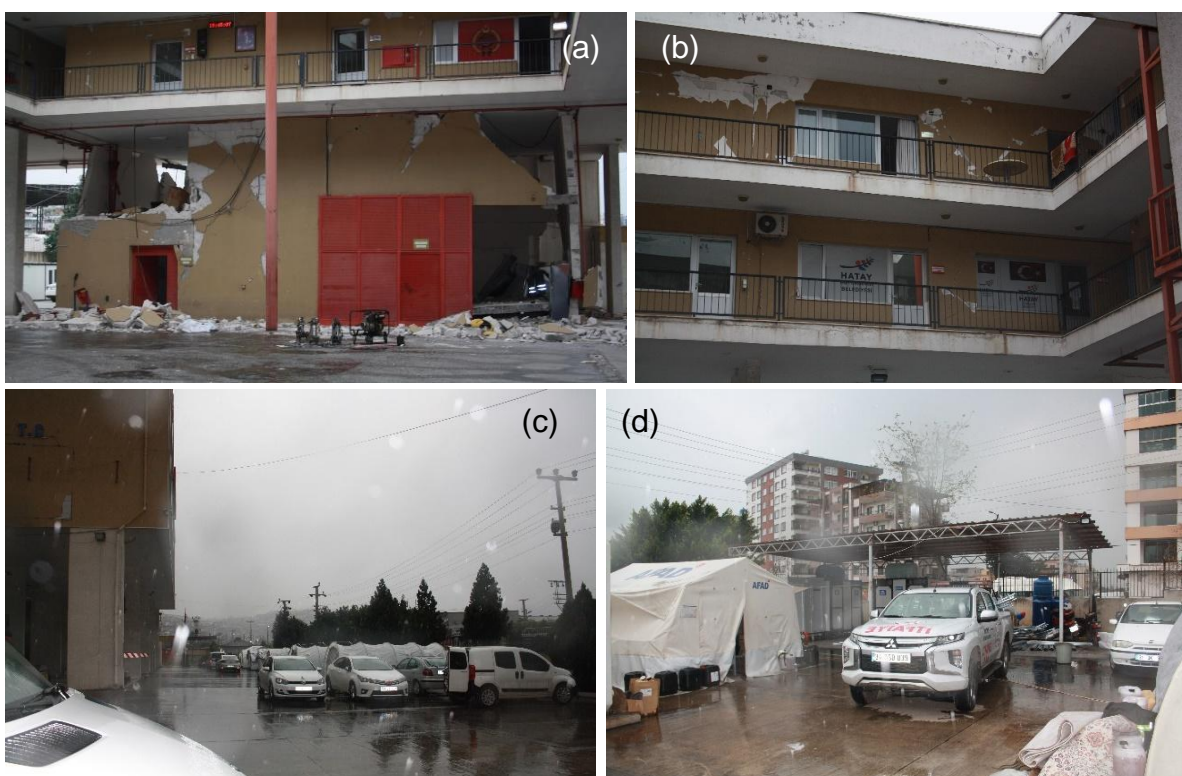
Figure 197: The main building of Iskenderun Fire Department as observed on 13 March 2023: a) damaged exterior walls on the ground floor, b) cracked infill walls on the upper two floors, c) tents used for dormitories for the firefighters on duty and d) tent used for command/dispatcher room.

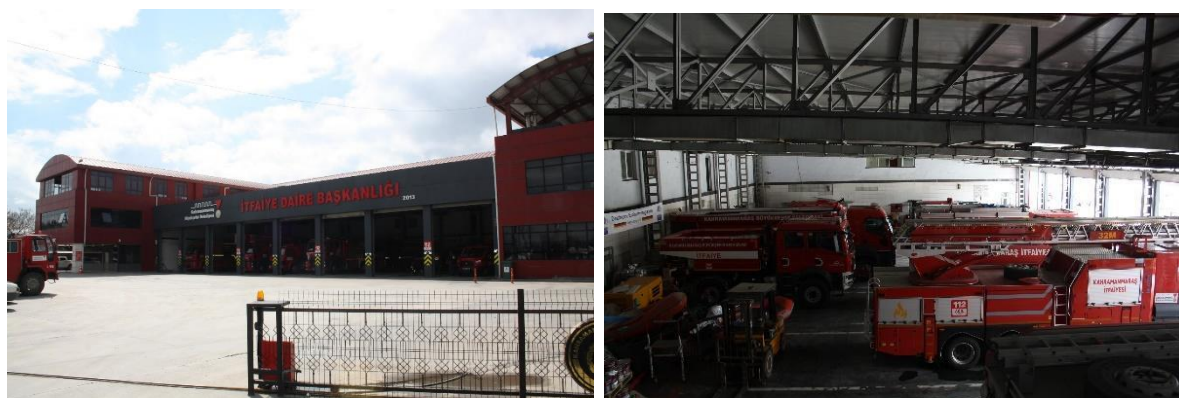
Figure 198: Kahramanmaraş Fire Department as observed on 16 March 2023

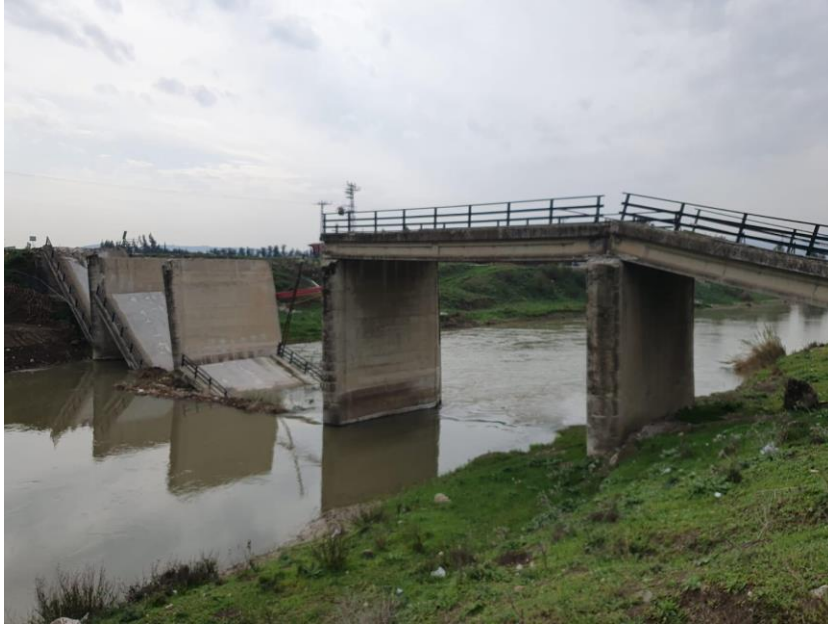
Figure 199: A collapsed bridge crossing the Karasu çayı river (location: Lon 36.2720, Lat 36.2073)

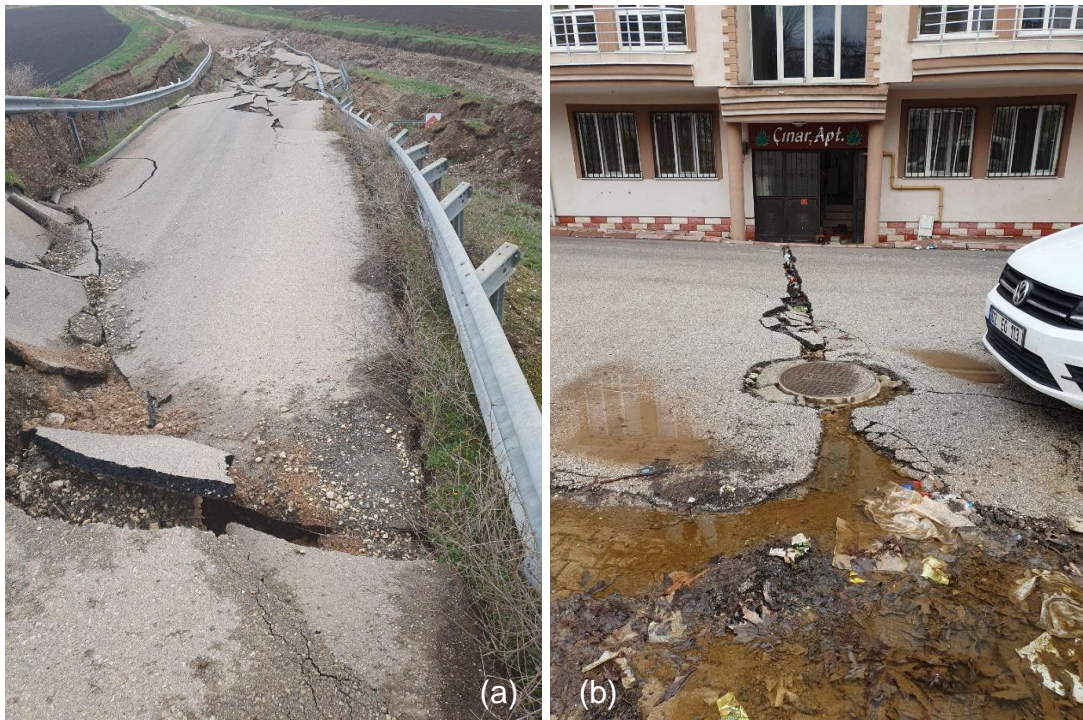
Figure 201: Cracked roadways due to fault lines – photos taken during the field mission (location: a) Lat 37.2836 Lon 37.1141; b) Lat 37.7886 Lon 37.6470

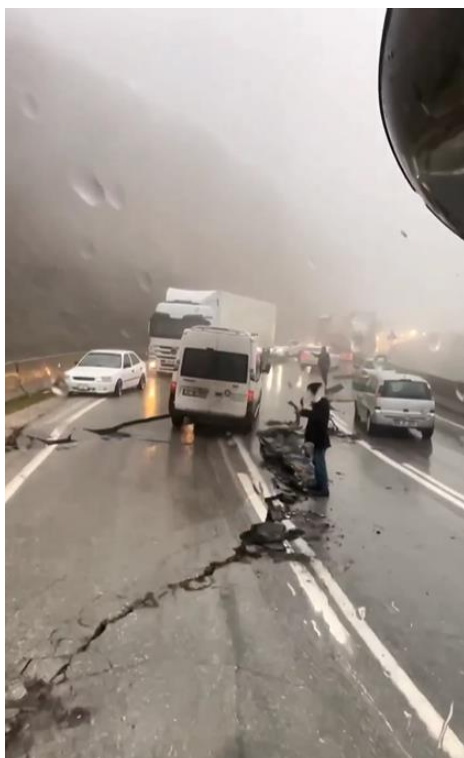
Figure 202: Reduced road capacity by cracked pavement – retrieved from https://www.instagram.com/reel/CpxR_U9ouLT/?ugsgud=YzAyMDM1MGJkZA%3D%3D

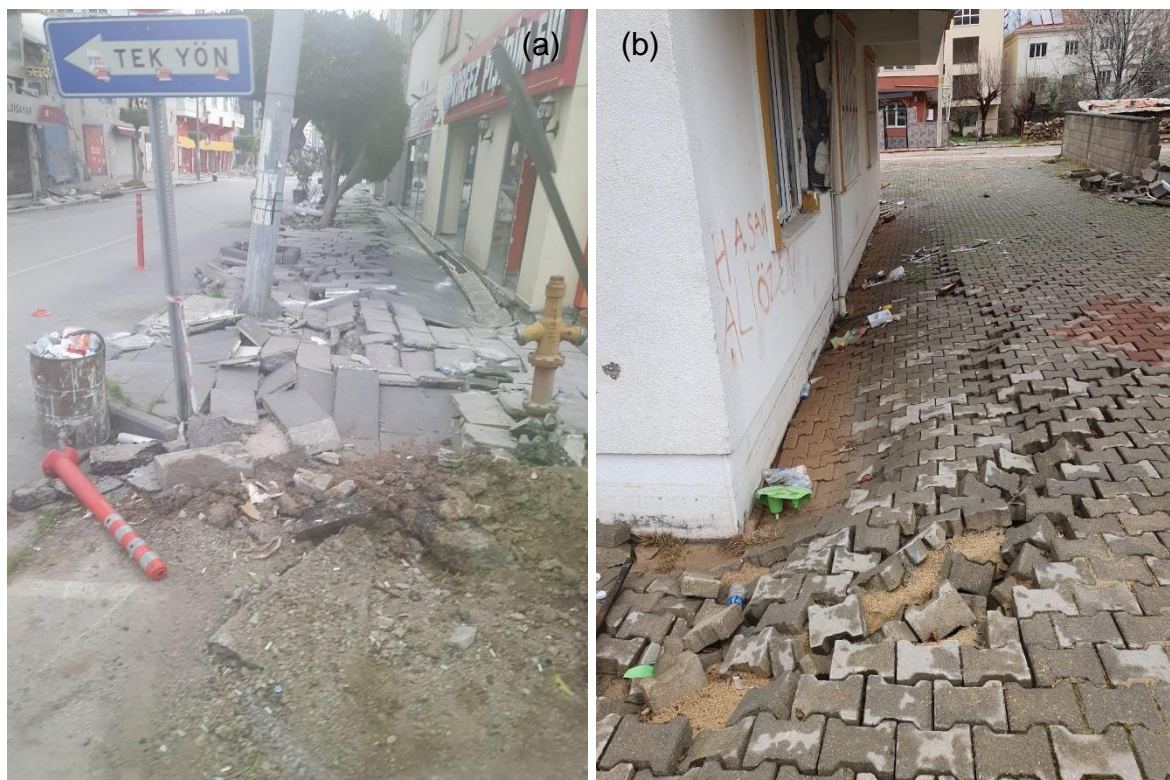
Figure 203: Damaged pedestrian roads – photos taken during the field mission (location: a) Lon 36.5895 Lat 36.1754; b) Lat 37.7887 Lon 37.6482)

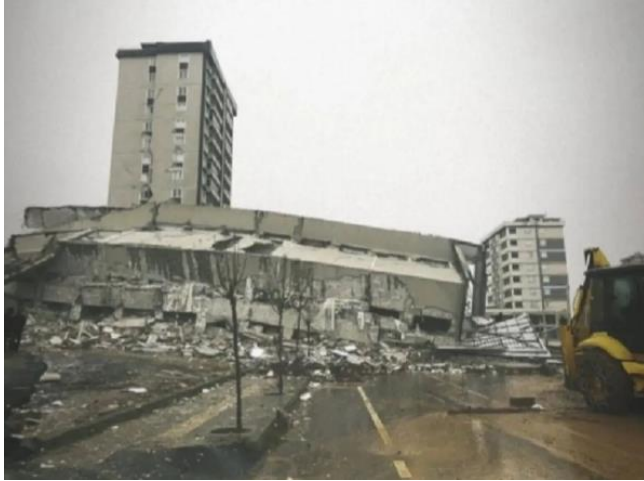
Figure 204: A roadway blocked by an overturned structure – retrieved from https://www.instagram.com/p/Cra0IgPIaM9/?utm_source=ig_web_copy_link&igshid=MzRIODBiNWFIZA%3D%3D

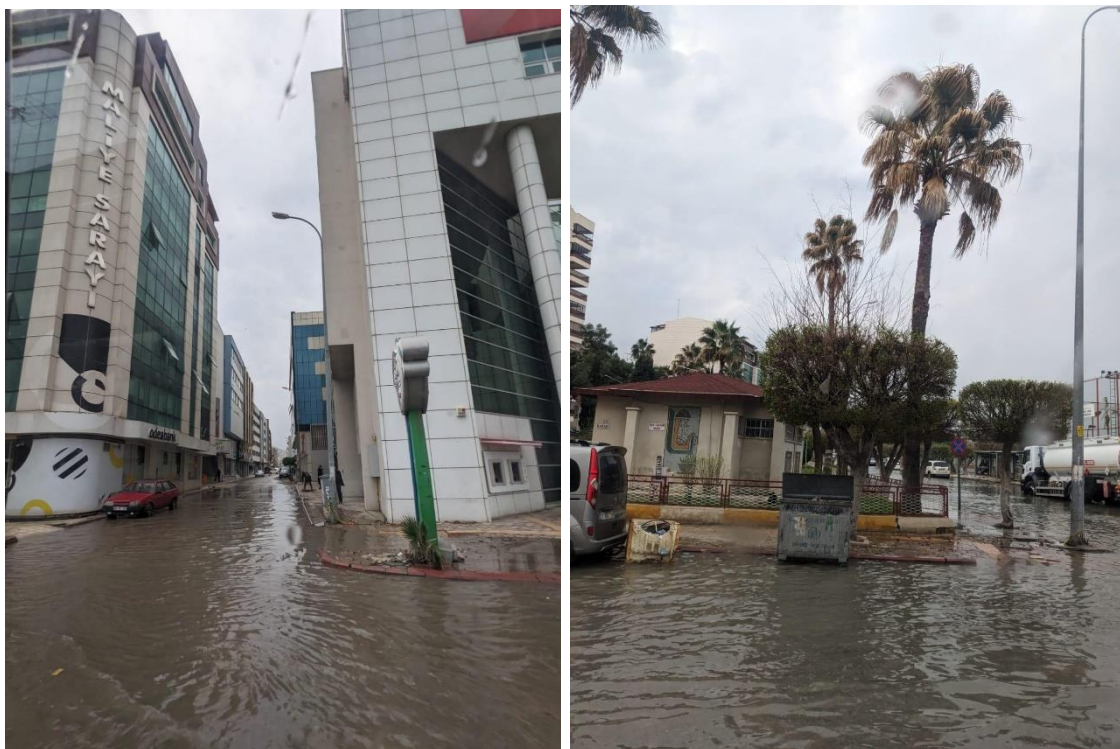
Figure 207: Inundated roadways in Iskenderun – observed during the field mission.

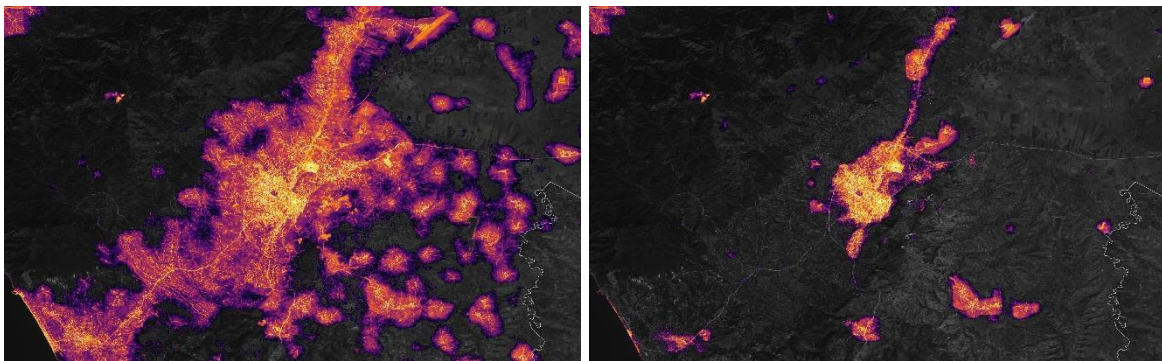
Figure 208: Night satellite image of Antakya before and after the earthquakes: (a) satellite image on the 4th of Feb.2023 and (b) satellite image on the 8th of Feb. 2023 (photos retrieved from NASA – The Black Marble Project, 2023 and NASA – Earth at Night, 2023)

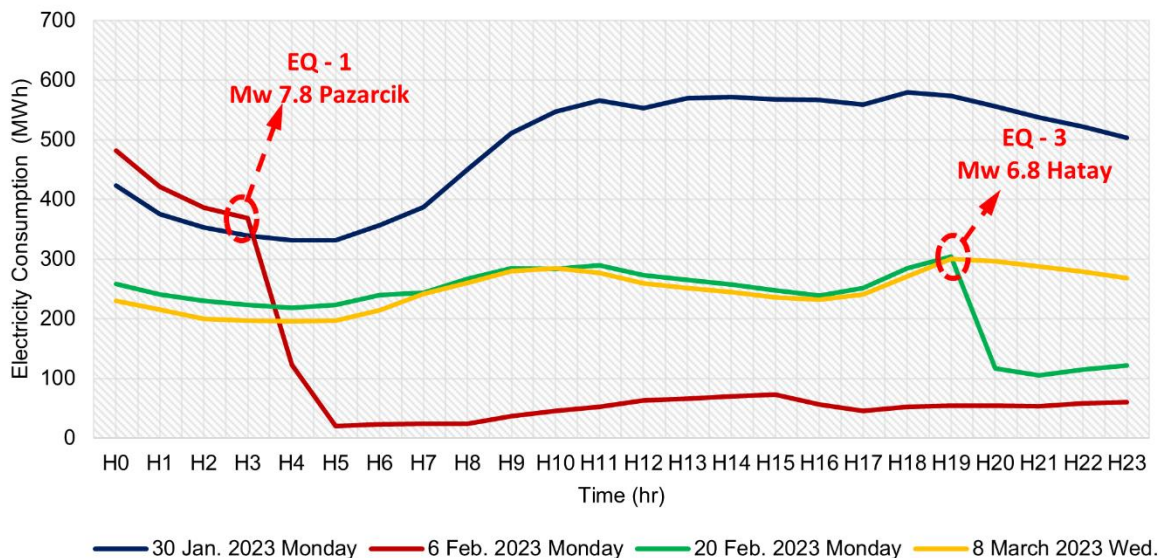
Figure 210: Electric consumption data of Hatay province before and after the earthquakes (Caliskan, 2023).

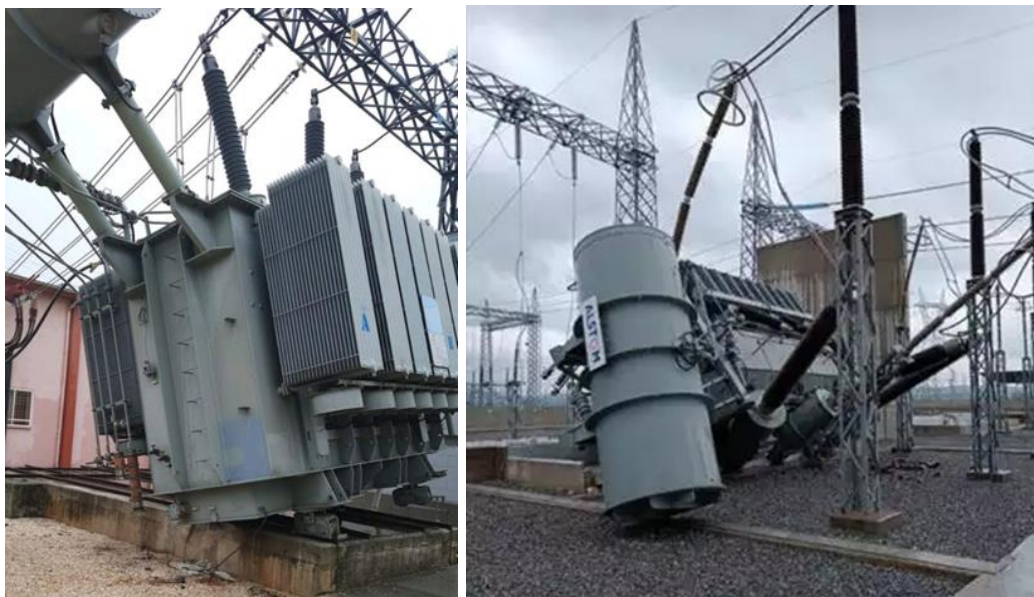
Figure 211: Damaged High Voltage transformers, poor fixing to the rail or foundation: a) Transformer damage, Gaziantep (source : https://www.instagram.com/yuksekerilim_ariza/) and b) Transformer damage, Hatay (source : https://www.linkedin.com/posts/rehasen_deprem-trafo-reee-activity-7028409428567560192-kcvY/?utm_source=share&utm_medium=member_desktop)

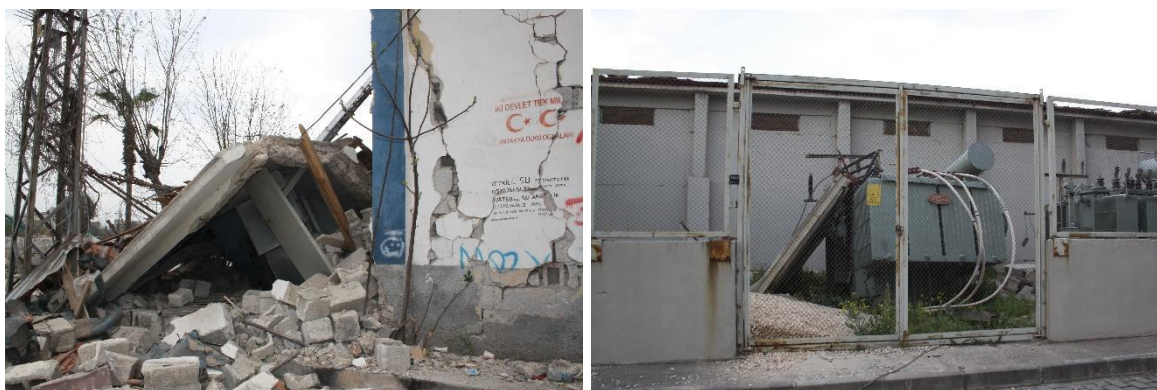
Figure 212: Heavily damaged Low- Medium Voltage transformers observed in Hatay on 17th March.

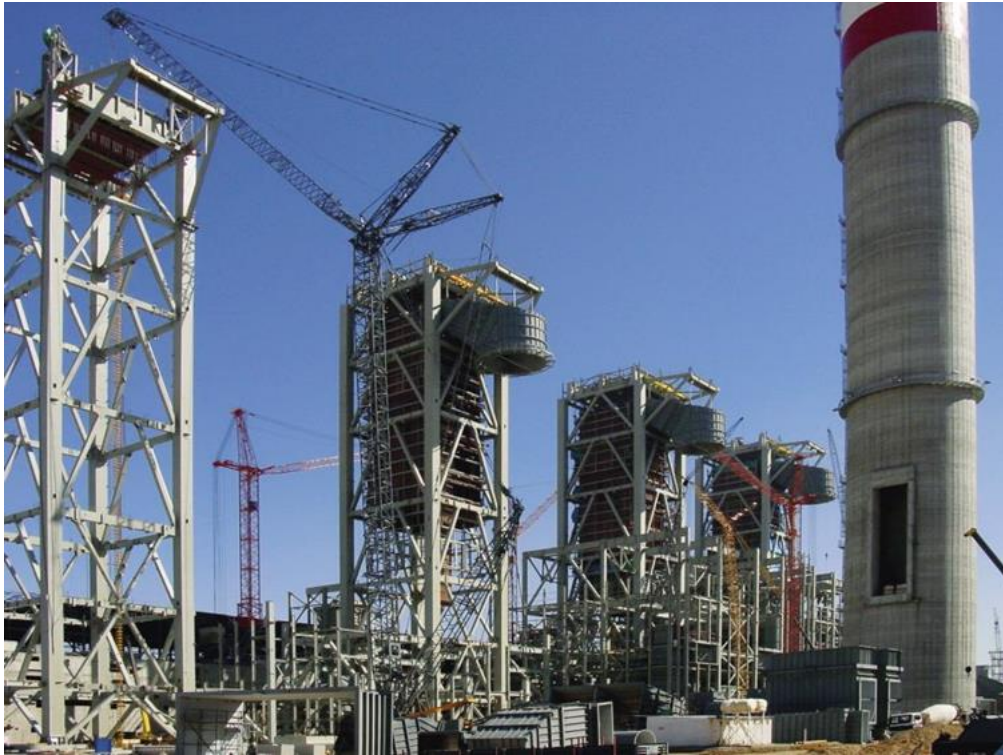
Figure 215: Construction Photo of Afşin-Elbistan B

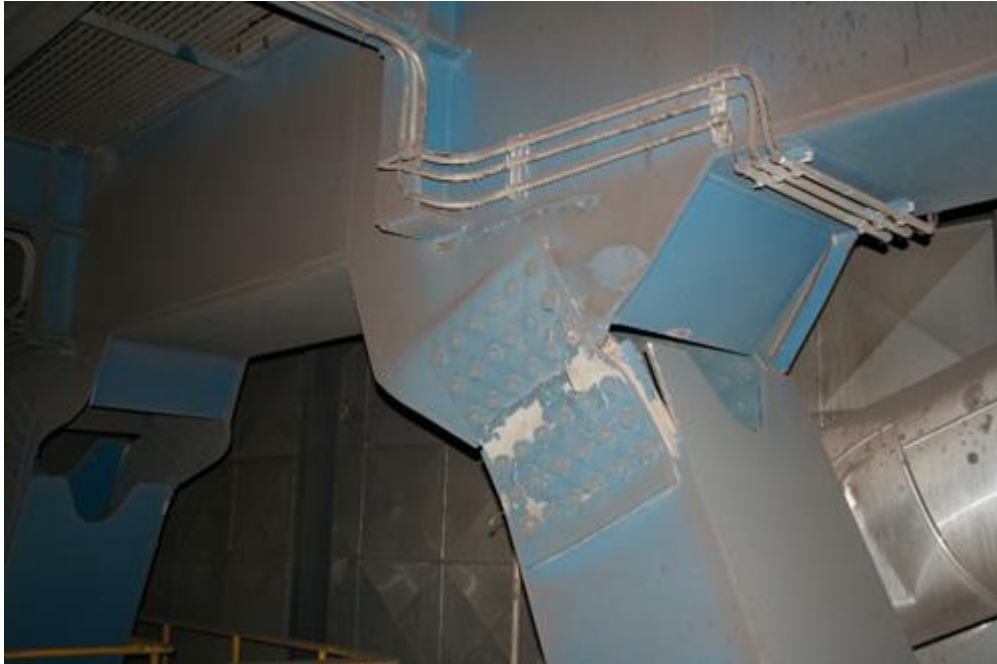
Figure 216: Chevron bracing connection.

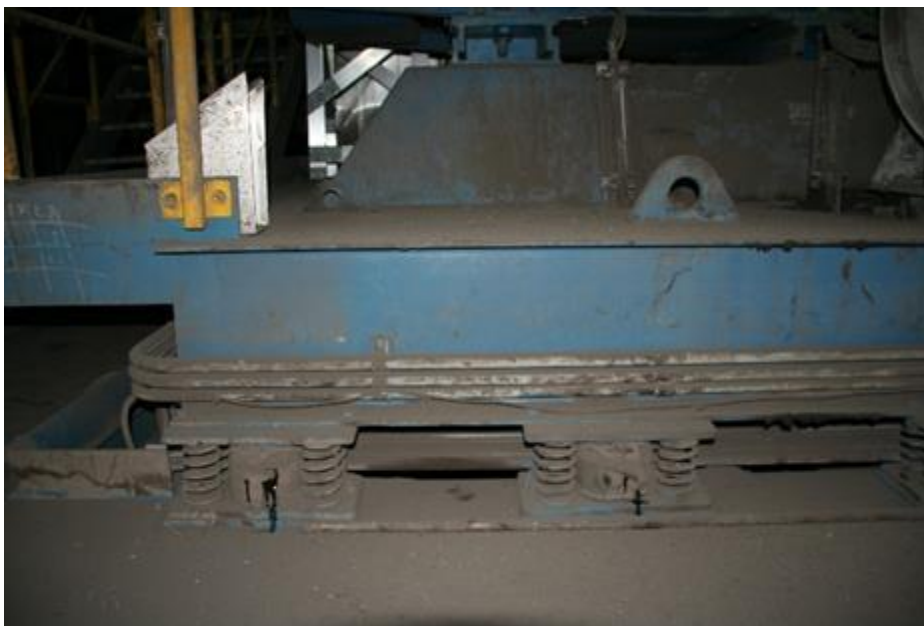
Figure 217: Secondary coal feeding system fallen off the support.

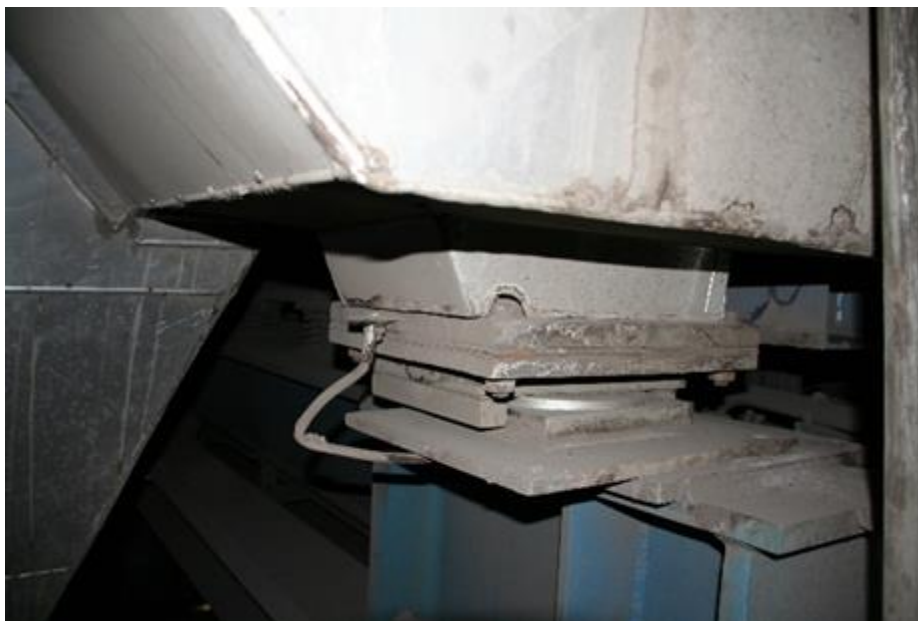
Figure 218: Displacement of secondary coal feed system.

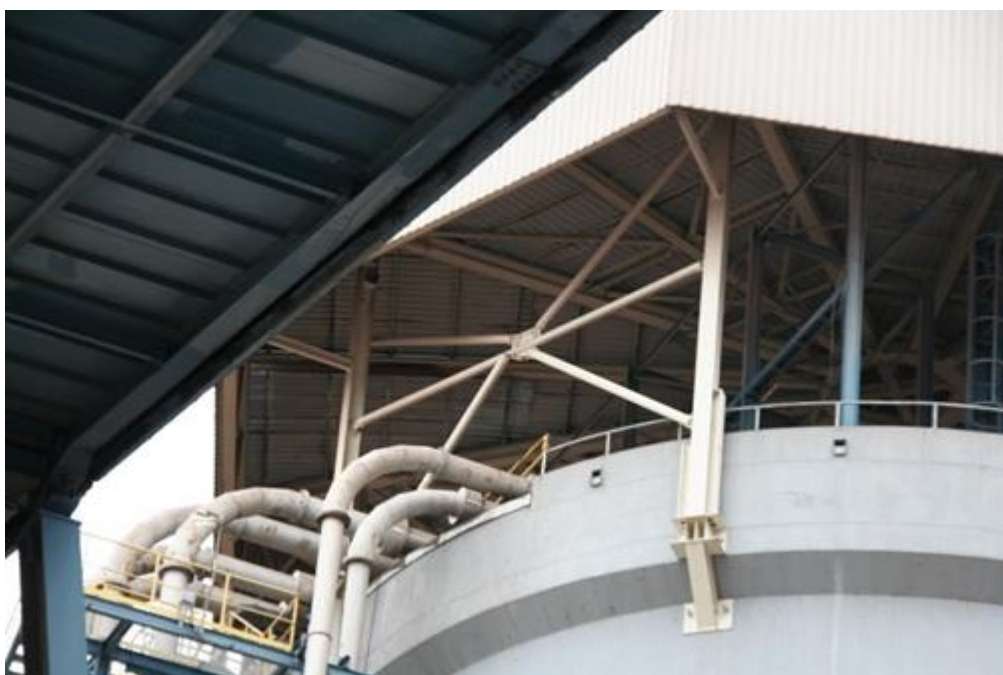
Figure 219: Bracing failure of diesel silo canopy.

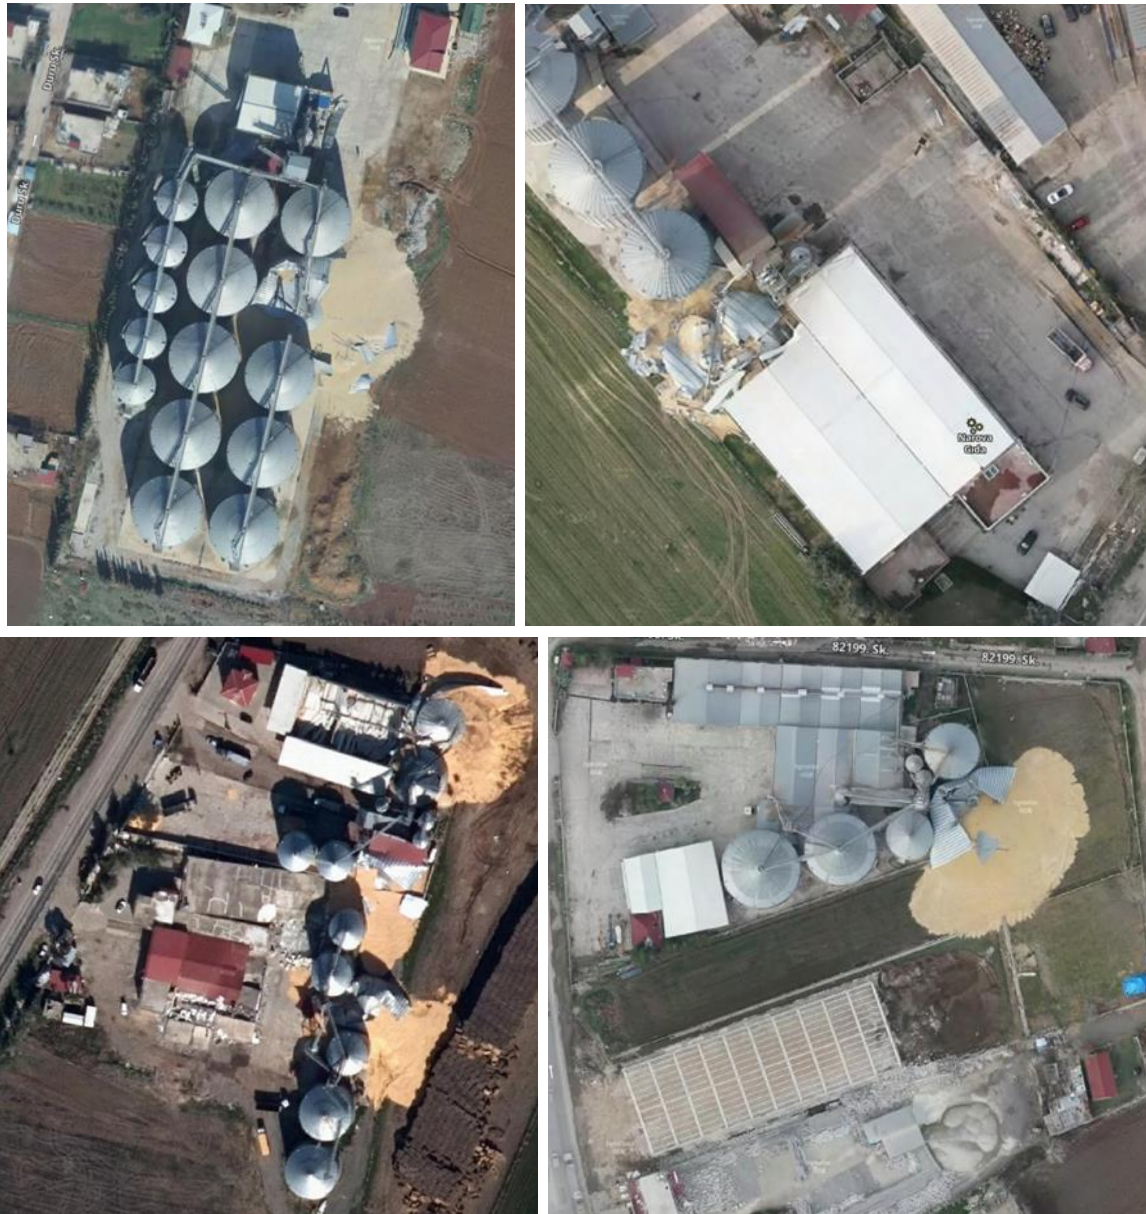
Figure 220: Satellite images of grain silo failures.

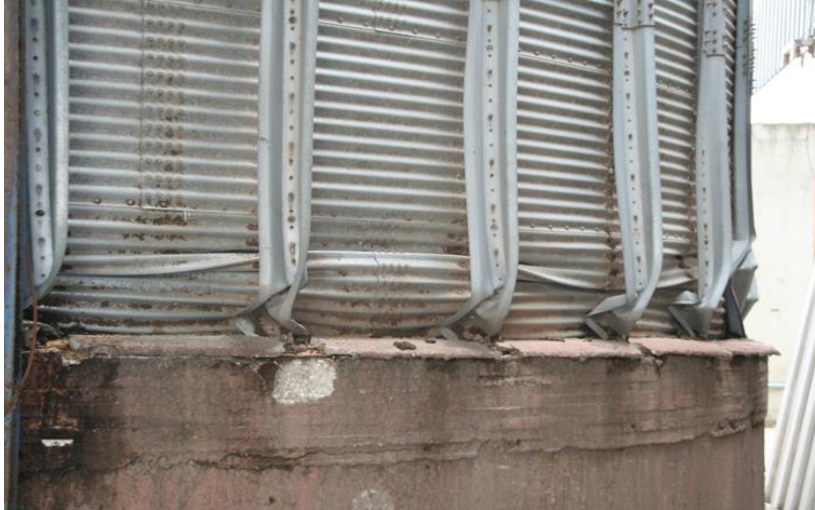
Figure 221: “Elephant foot” failure of silo wall and vertical stiffeners.

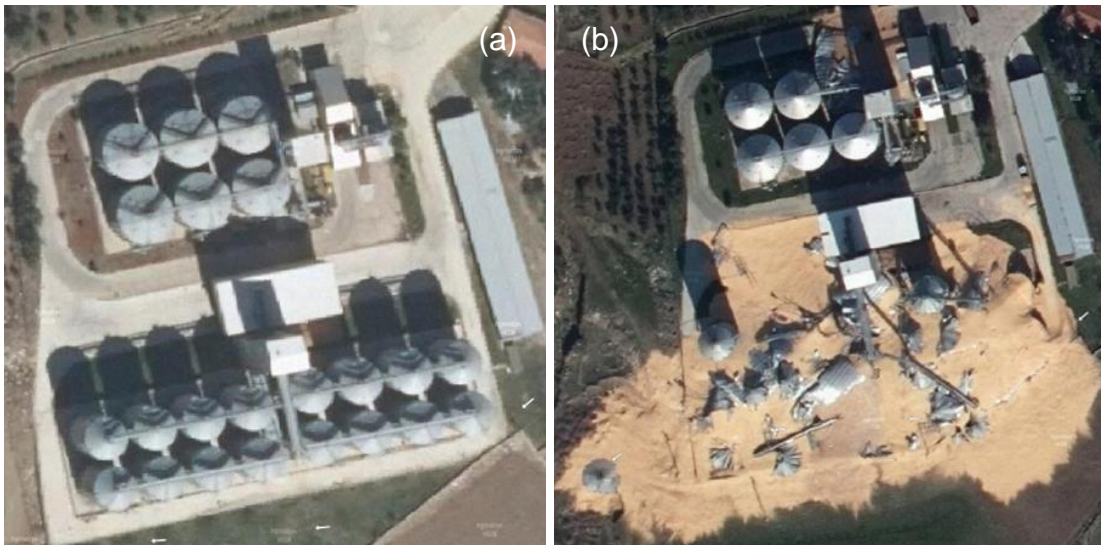
Figure 222: Satellite image of Nurdağı Grain Silos, before (a) and after (b)

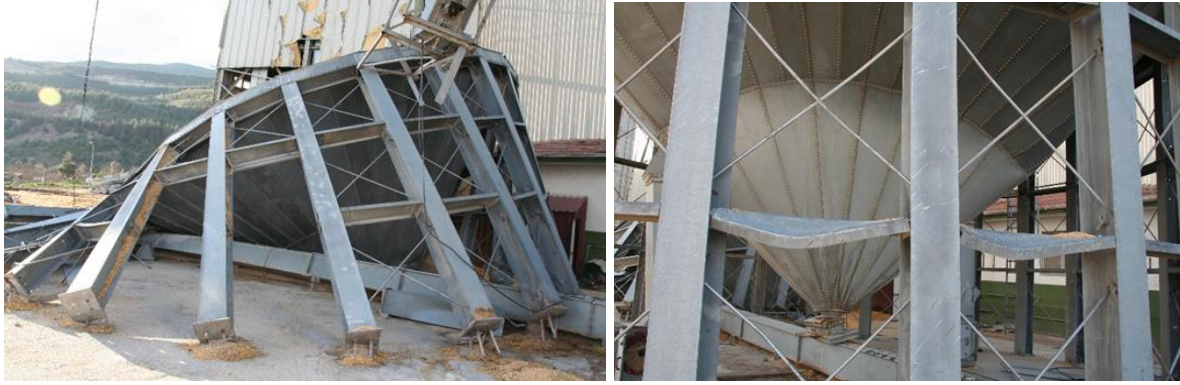
Figure 223: Failure of holding down arrangement and bracing.

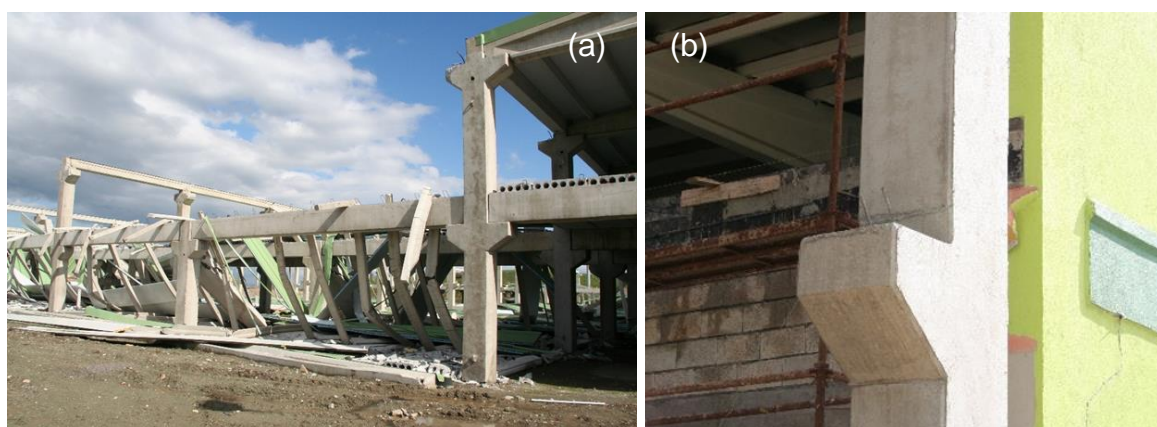
Figure 224: Lightweight precast building (a) Failure of roof beams and cladding (b) Dowels connecting the beams to the column.

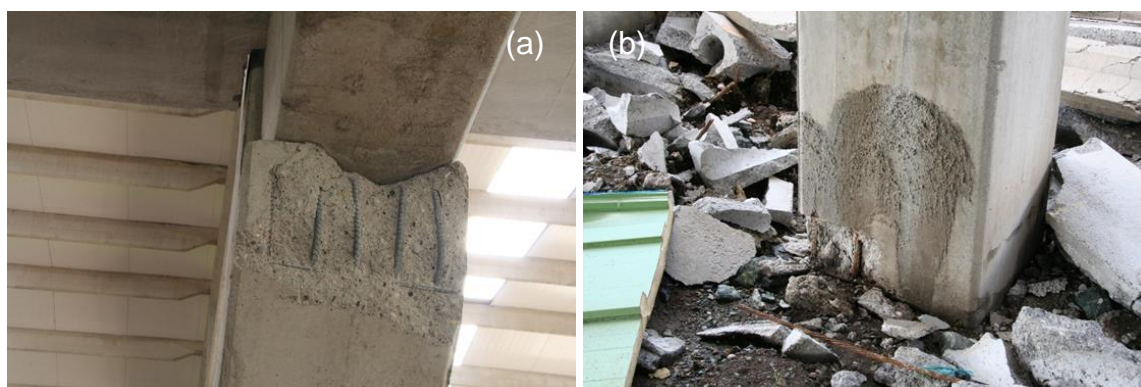
Figure 225: Spalled concrete (a) at the corbel (b) at the column base due to plastic hinge.

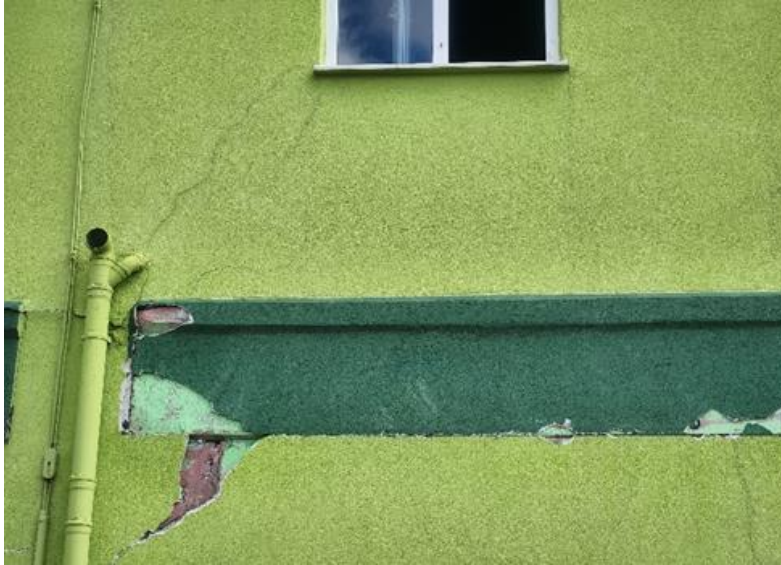
Figure 226: Cracking of infill walls completed unit.

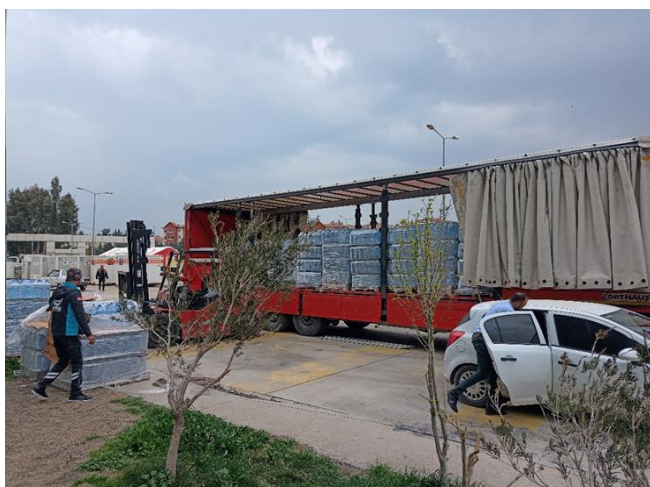
Figure 227: Bottled water supply.

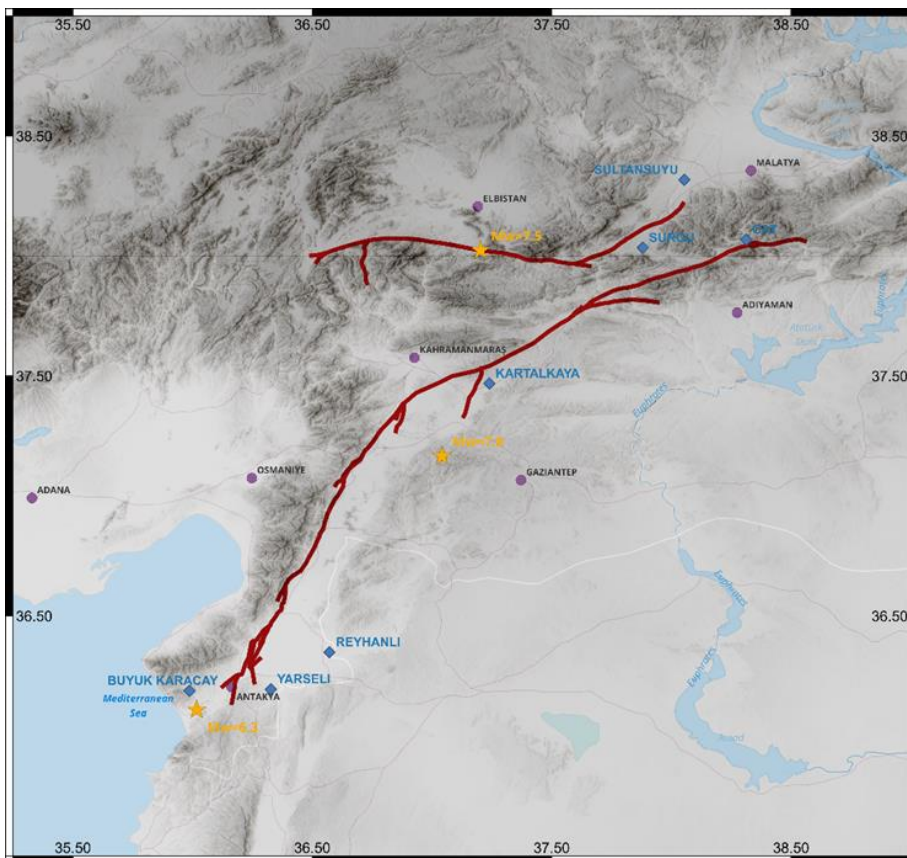
Figure 228: Major dams of the region.

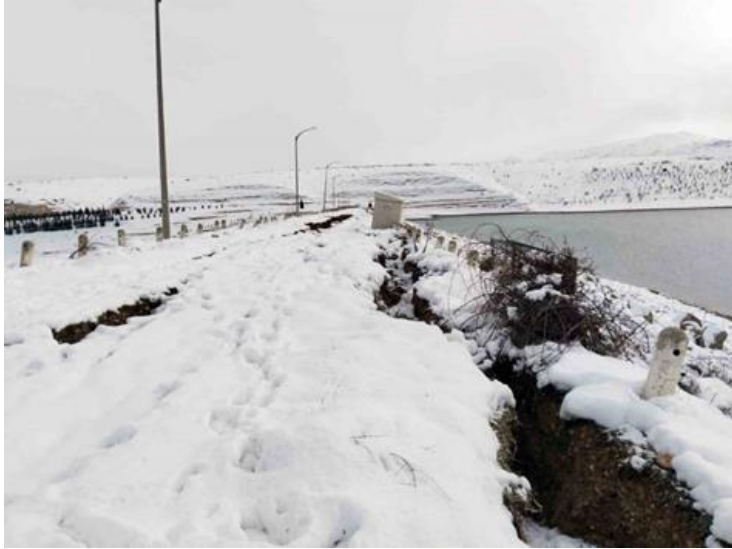
Figure 229: Dam Safety Society – Sultansuyu Dam
