THE TÜRKİYE EARTHQUAKE SEQUENCE OF FEBRUARY 2023

A LONGITUDINAL STUDY REPORT BY EEFIT

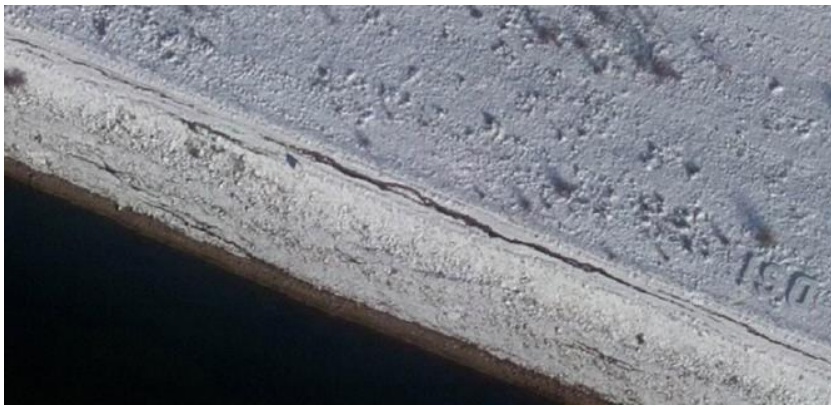
Figure 230: Visible Cracks in Crest – Sultansuyu Dam – Harita Genel Mudurlugu

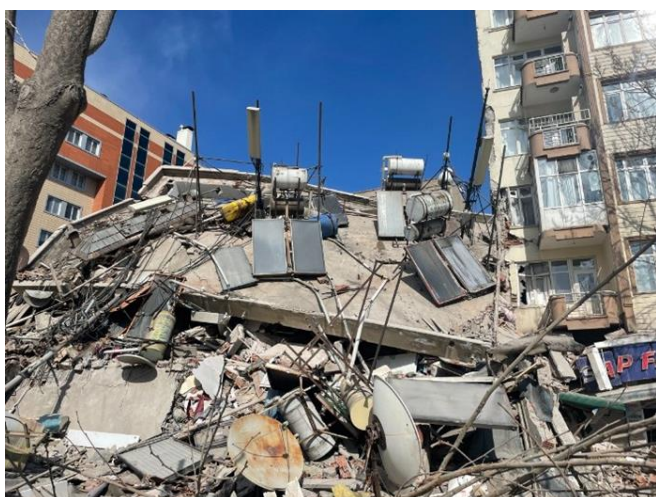
Figure 233: Photo of a collapsed building with a base station (Source: Manset61.com)

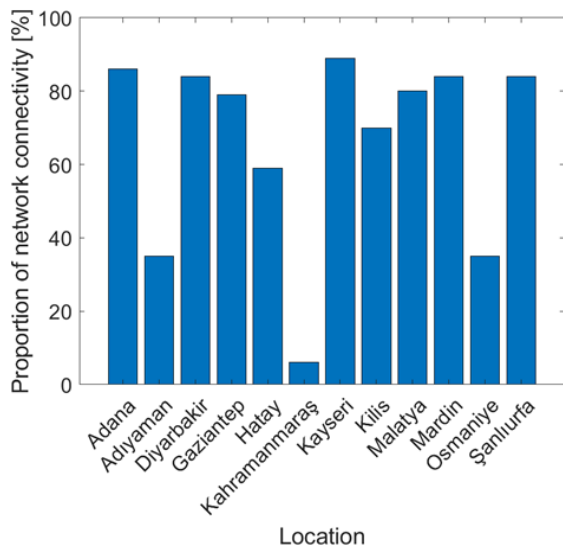
Figure 234: Initial post-disaster network connectivity in the affected areas (Source: netblocks.org).

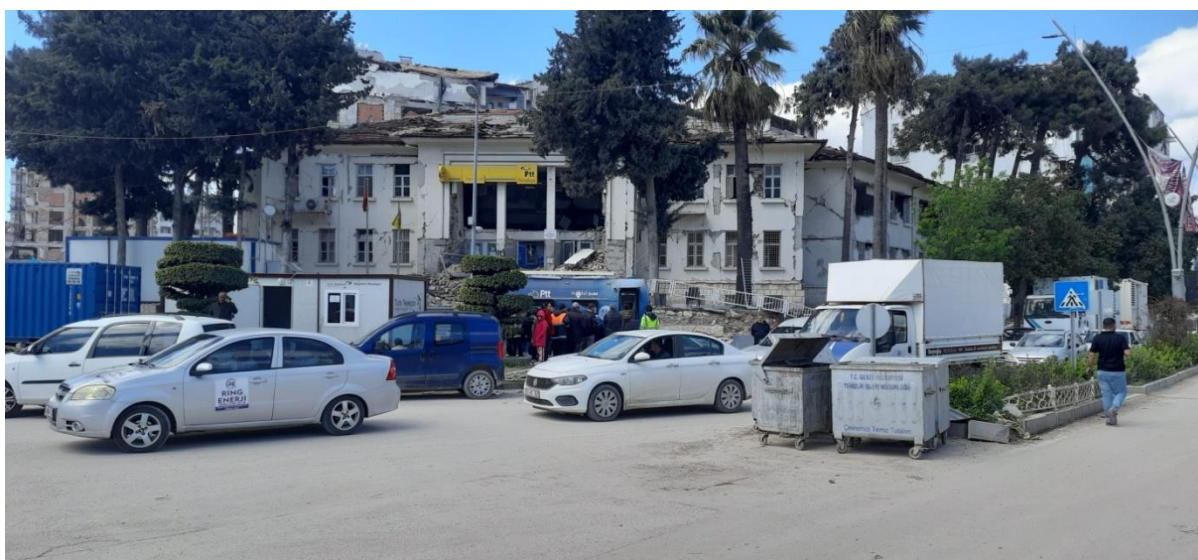
Figure 237: Hatay Government House, April 2023

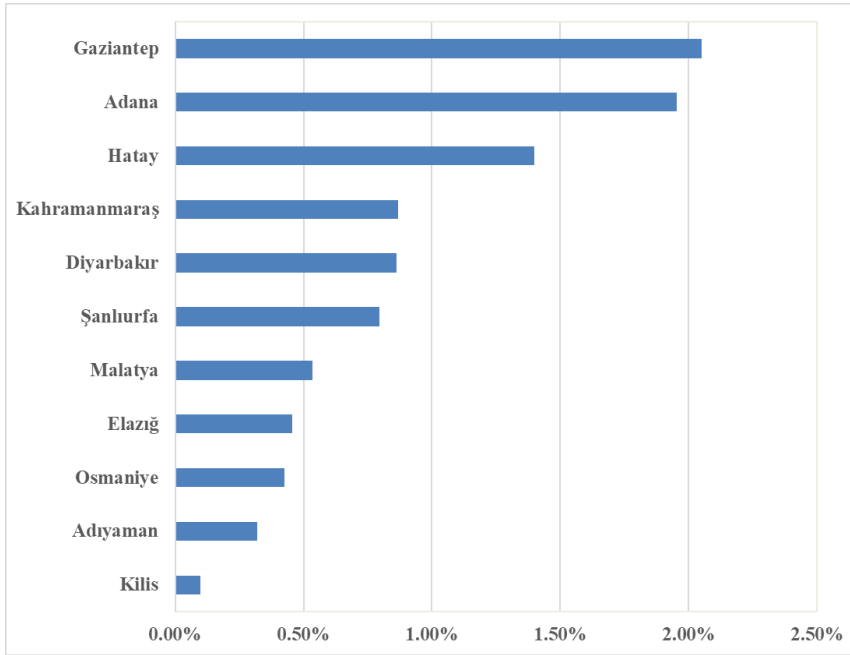
Figure 239: Disaster region's share of GDP in 2021 as percentage of Türkiye's total GDP

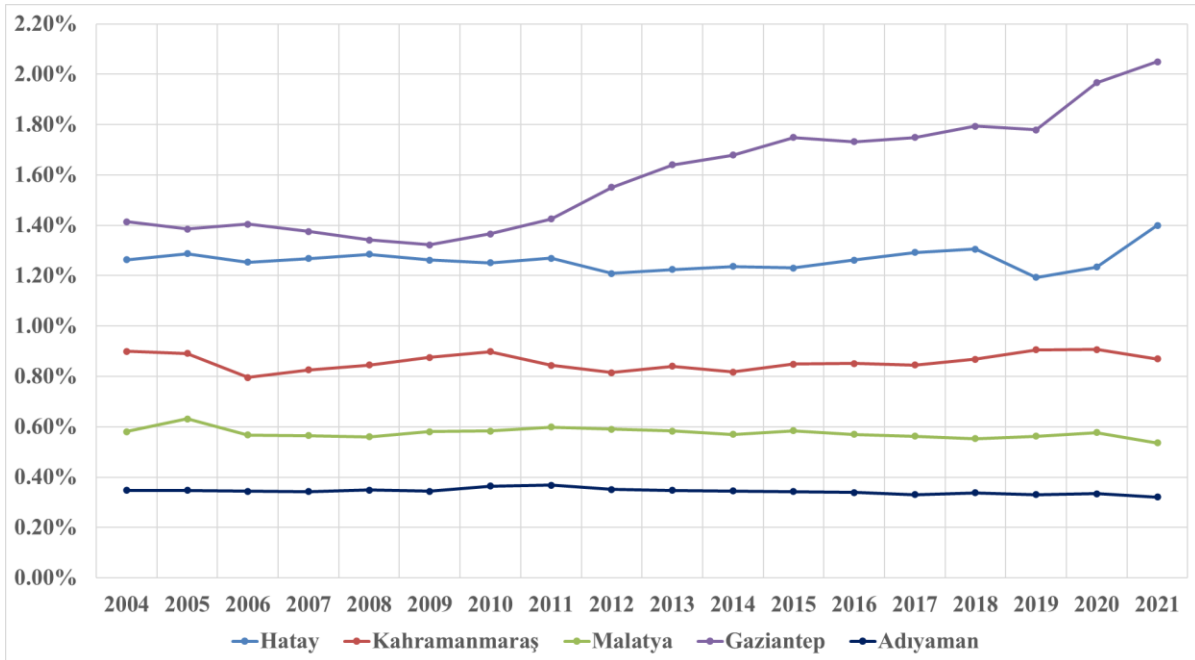
Figure 240: GDP share trend of most severely affected cities in the last eighteen years (taken from TERRA reprrt)

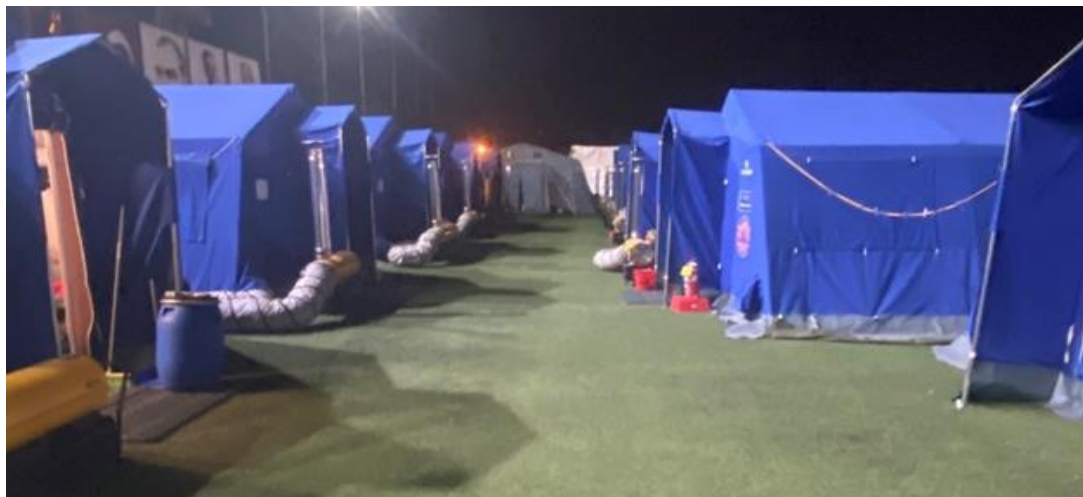
Figure 241: Italian field hospital in Antakya, Hatay

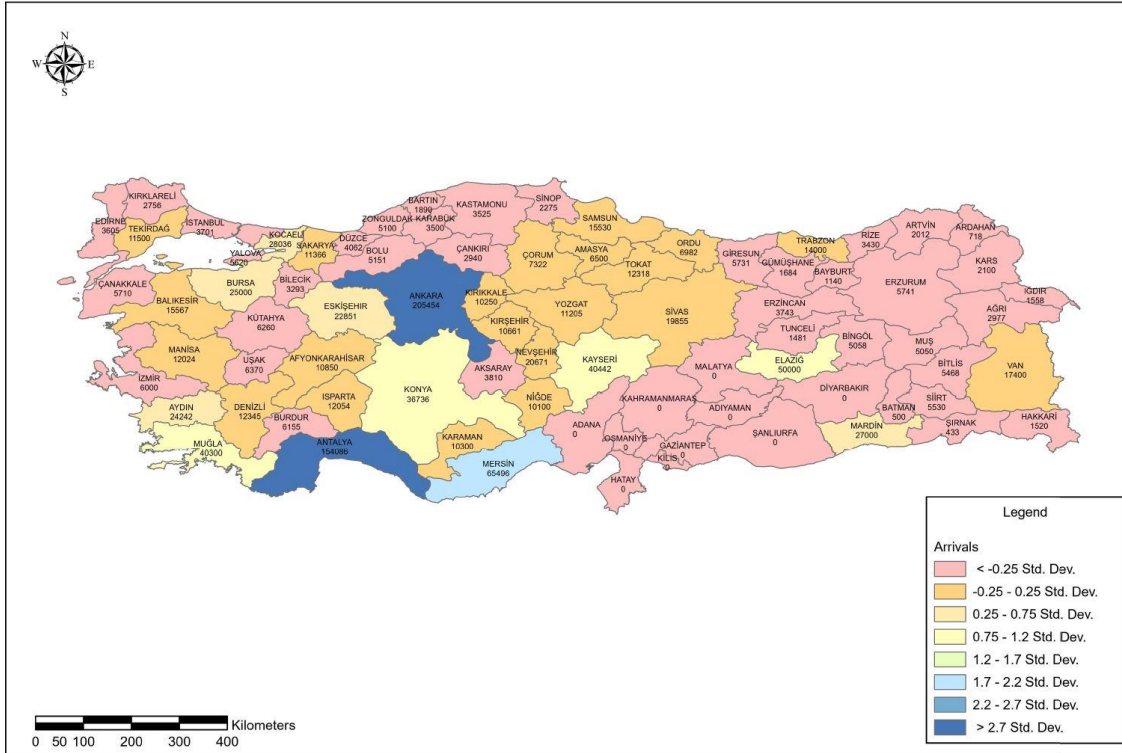
Figure 242: Map of estimated population movement as of 1 March 2023. Standard deviation (Std. Dev.) clearly shows which provinces are had the most in-migration following the earthquake (Map EEFIT team, based on data from Sağiroğlu et al., 2023)

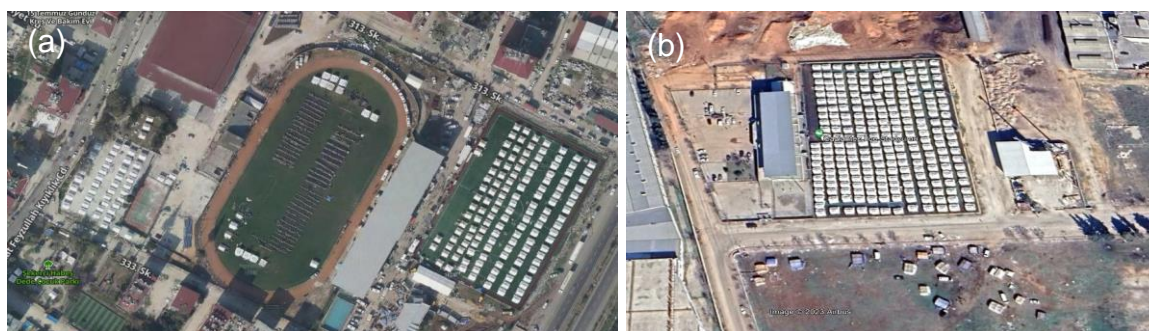
Figure 244: Regular and formal temporary housing units in (a) Kırıkhan / Hatay and (b) Gaziantep İlçe Stadyumu (football stadium) (source: Atlas Map, 2023)

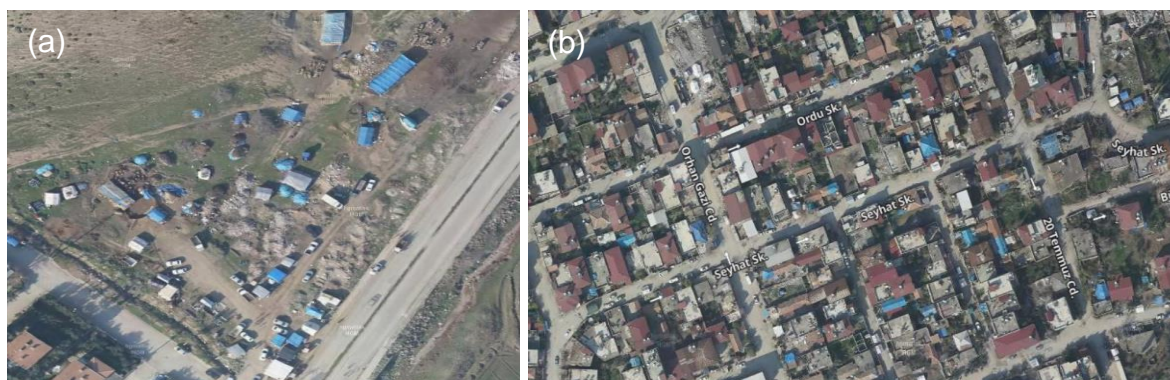
Figure 246: Irregular and informal temporary housing (source: Atlas Map, 2023)

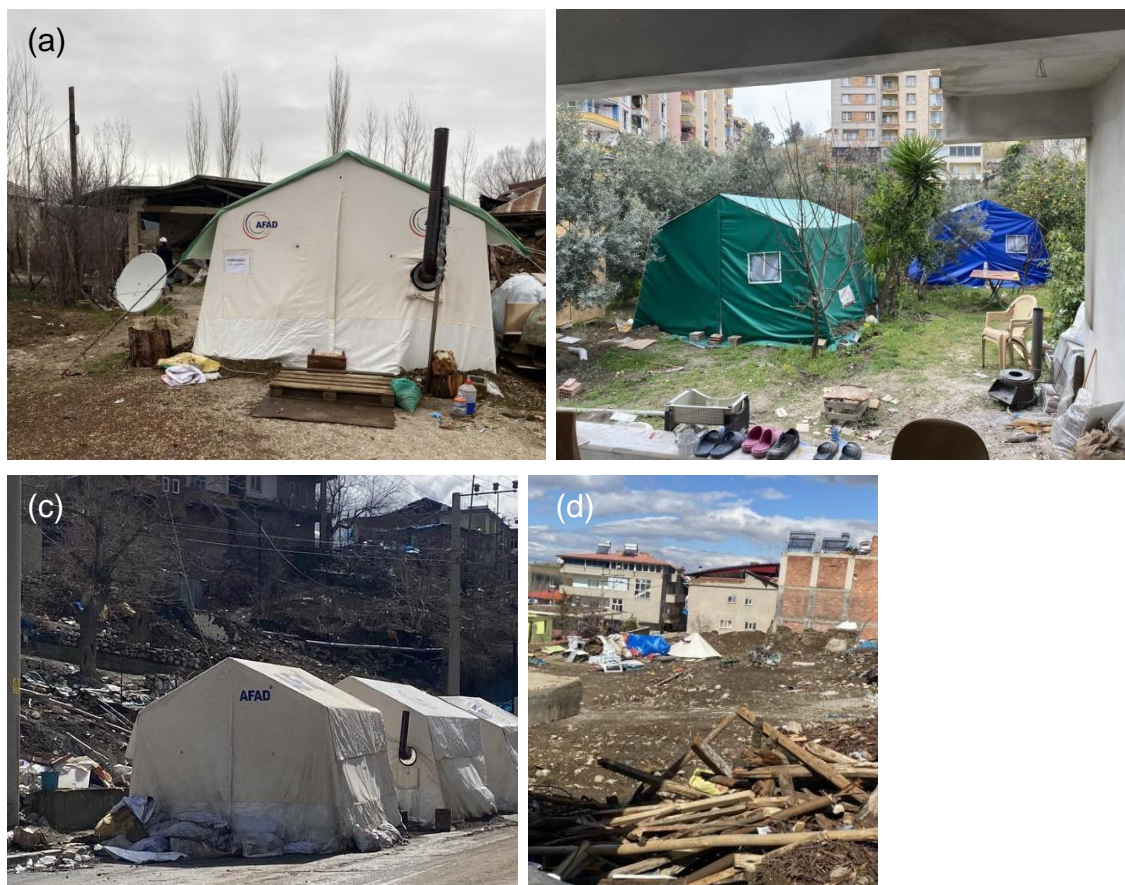
Figure 247: Informal temporary housing units (a) Tent from AFAD near roadway, Göksun; (b) Private camp in garden, Samandıĝ, set up with water, toilets and cooking area; (c) Tents set up along the roadways, Ericek, north of Kahramanmaraş and (d) Tents set up in land where rubble has been cleared, Ericek

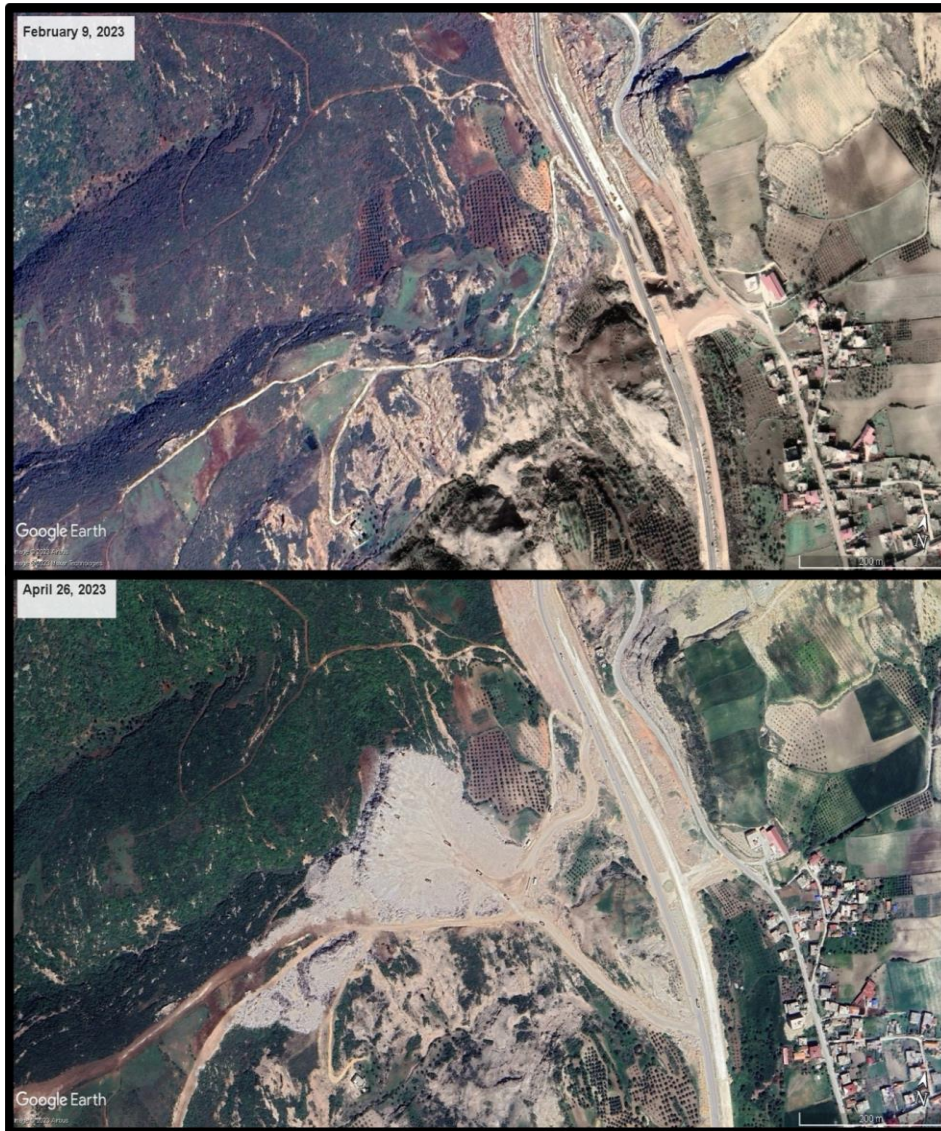
Figure 253: Rubble piles nearby fertile land and residential area in Antakya, Hatay.

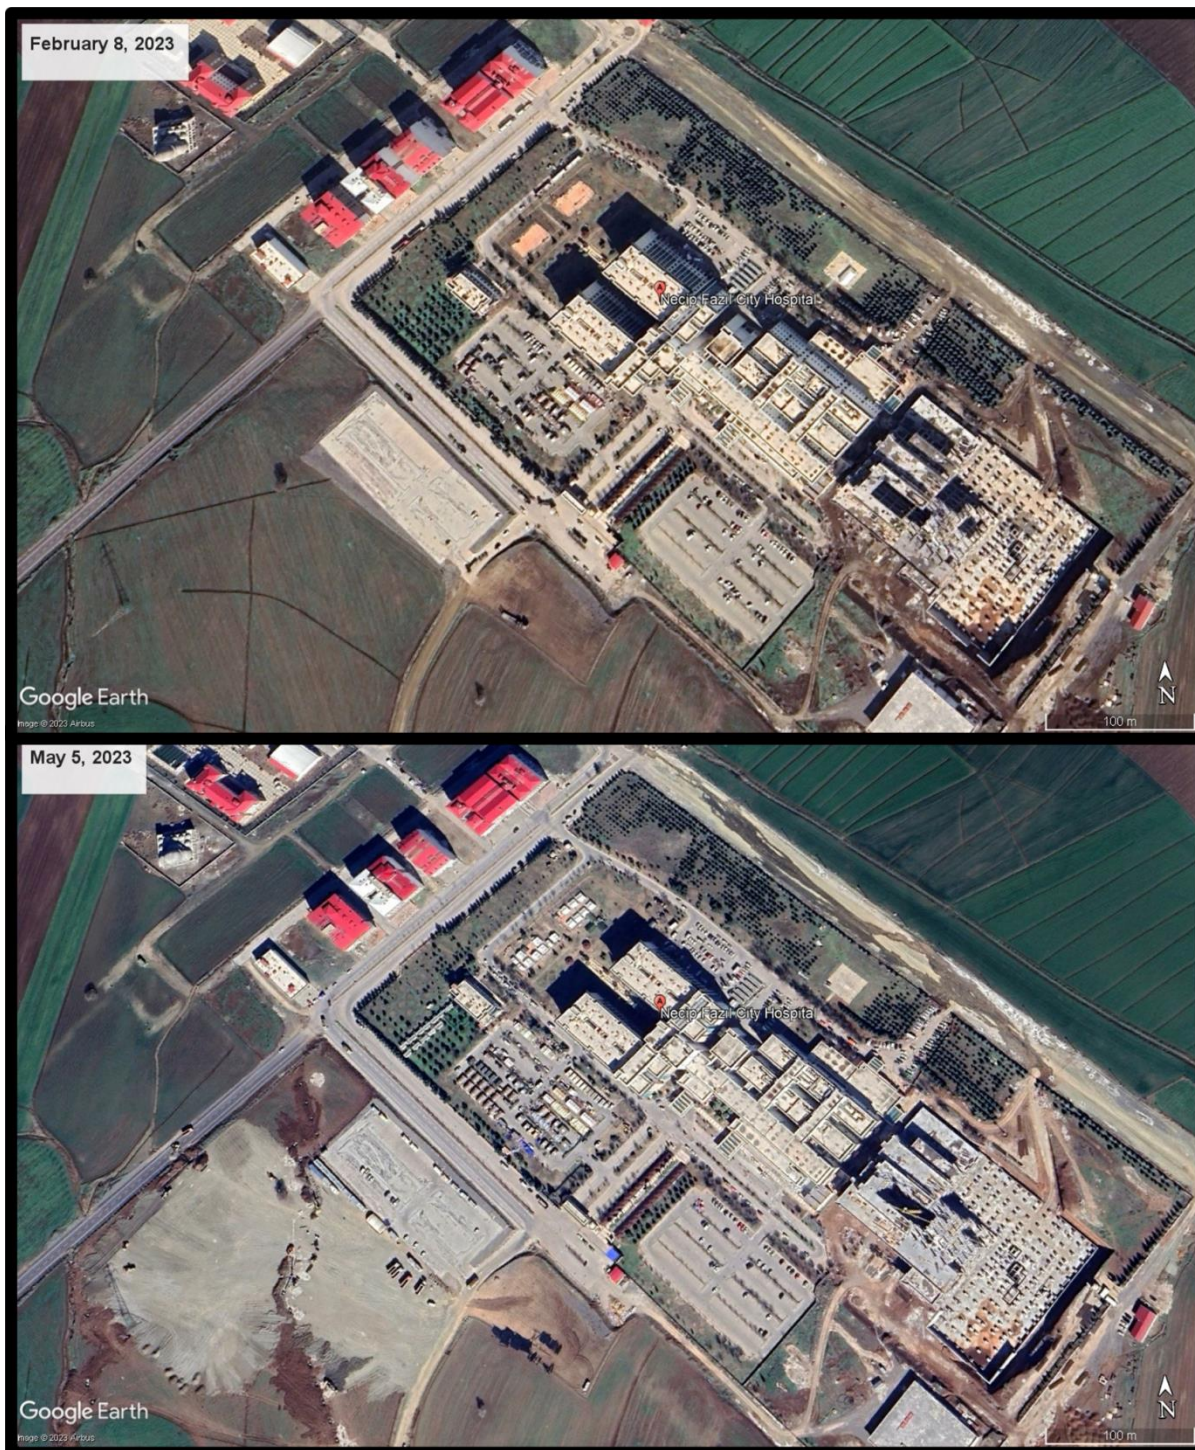
Figure 254: Rubble piles nearby NecipFazıl City Hospital in Dulkadiroğlu, Kahramanmaraş.

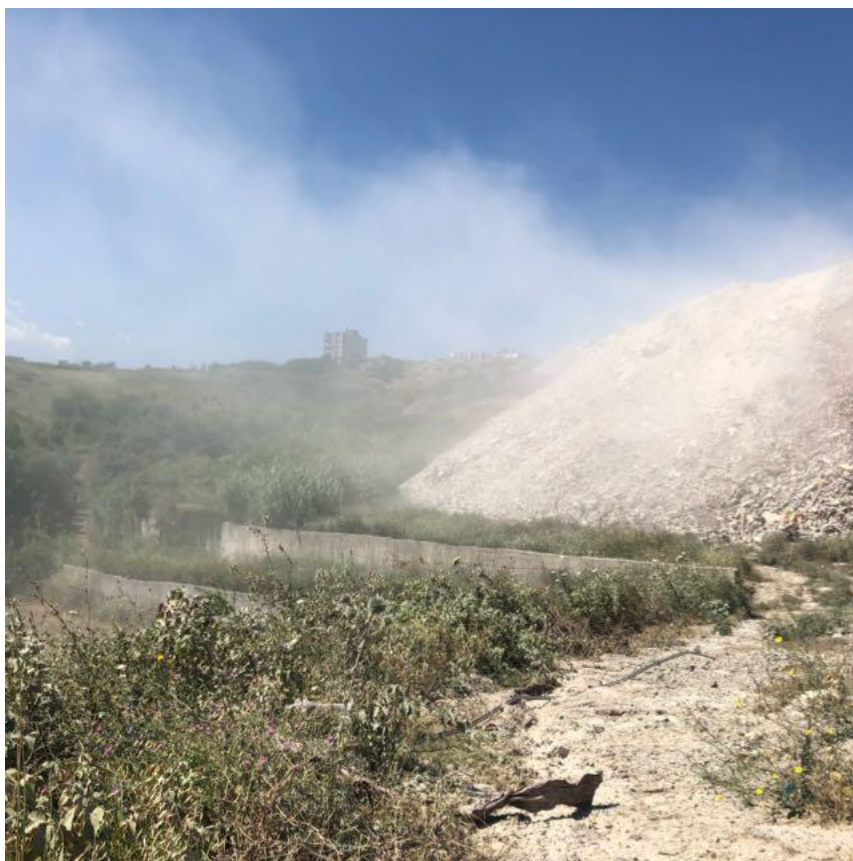
Figure 255: Dumpsite at Güneysöğüt on 23 June 2023

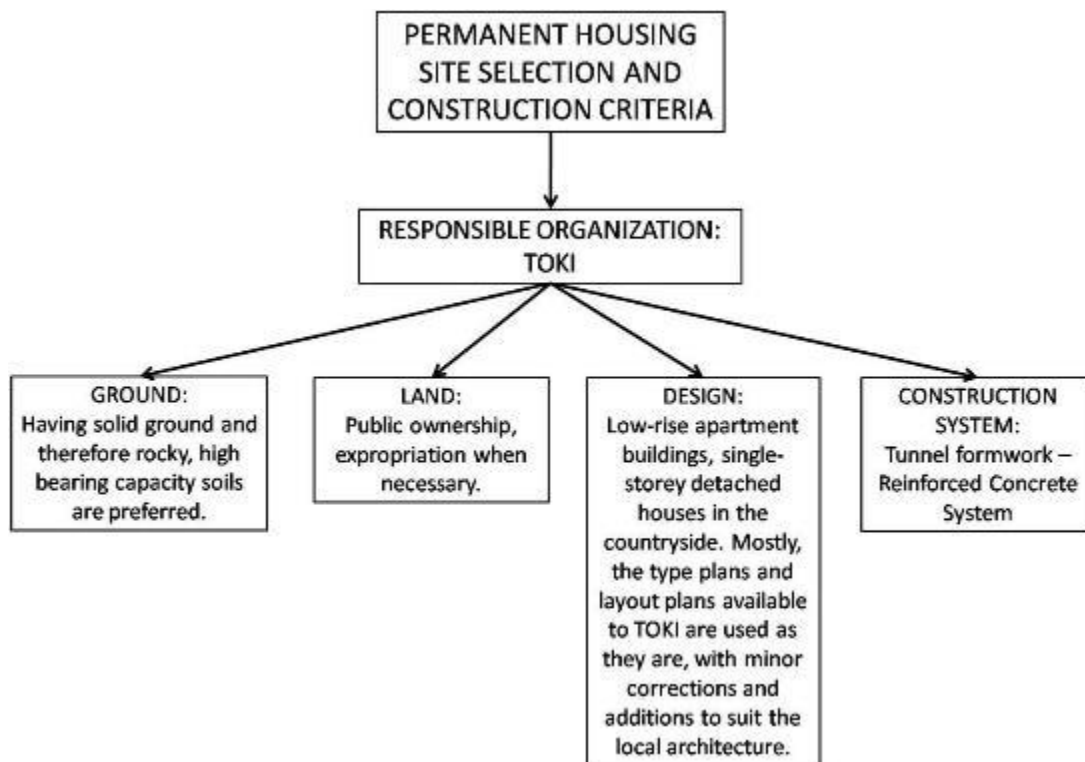
Figure 257: In its simplified form, permanent housing location selection and building production process application approach after the earthquake in Türkiye (Produced by the EEFIT-RRR Group).

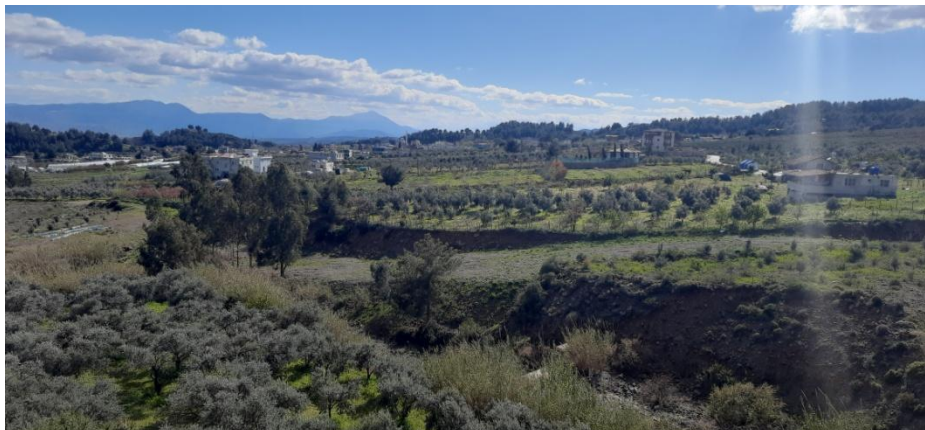
Figure 258: Gülderren Neighbourhood Permanent Housing area in Antakya province

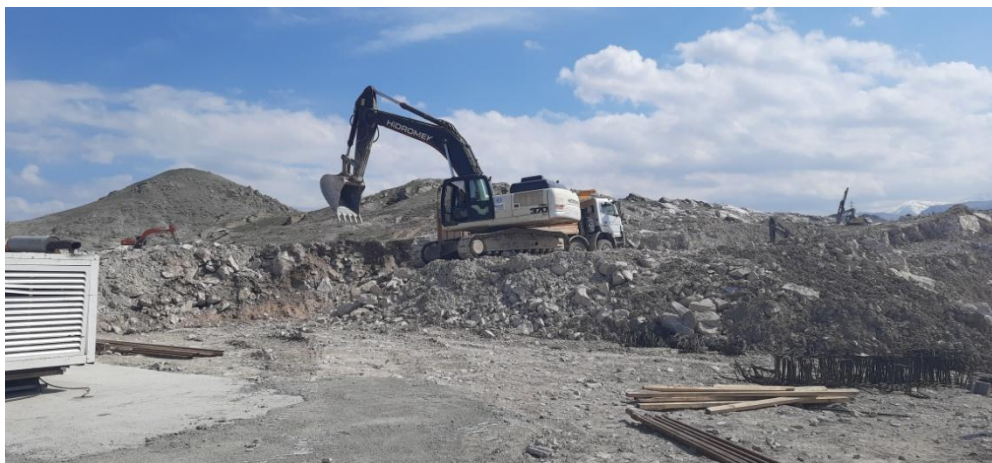
Figure 263: GelincikTepe Permanent Housing Area in Malatya province.

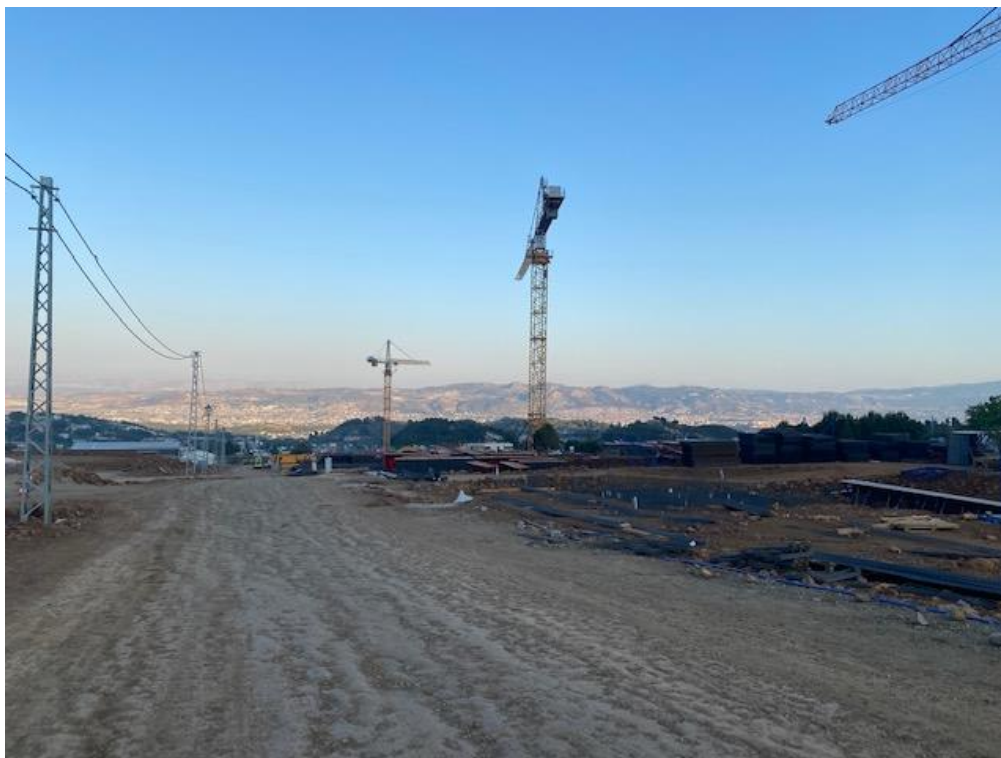
Figure 264: Permanent Housing site under construction in June 2023, Gülderen Neighbourhood, Antakya

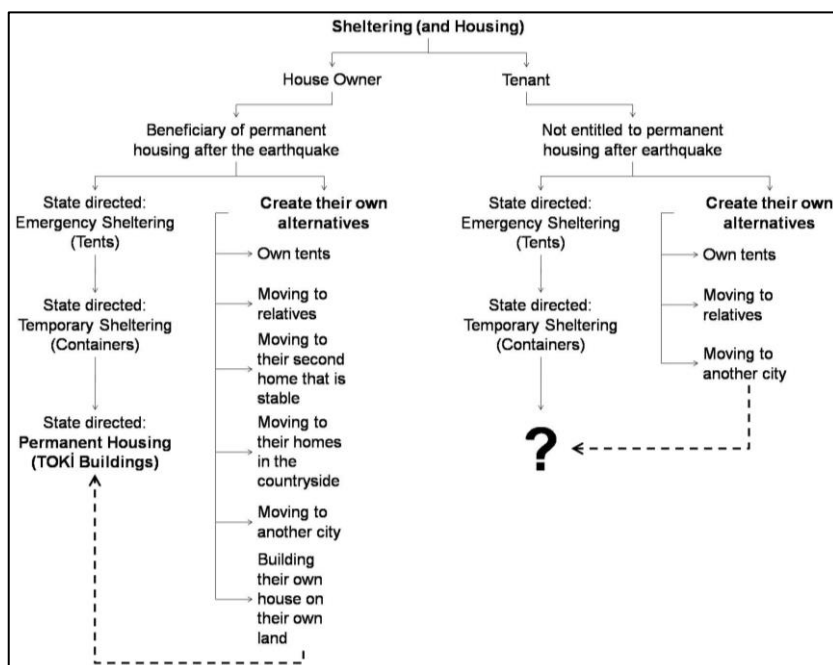
Figure 265: Sheltering and Housing options for disaster victims following February 6 (2023) Kahramanmaraş Earthquakes
