THE M_w 6.3 CHRISTCHURCH, NEW ZEALAND EARTHQUAKE OF 22 FEBRUARY 2011

A FIELD REPORT BY EEFIT

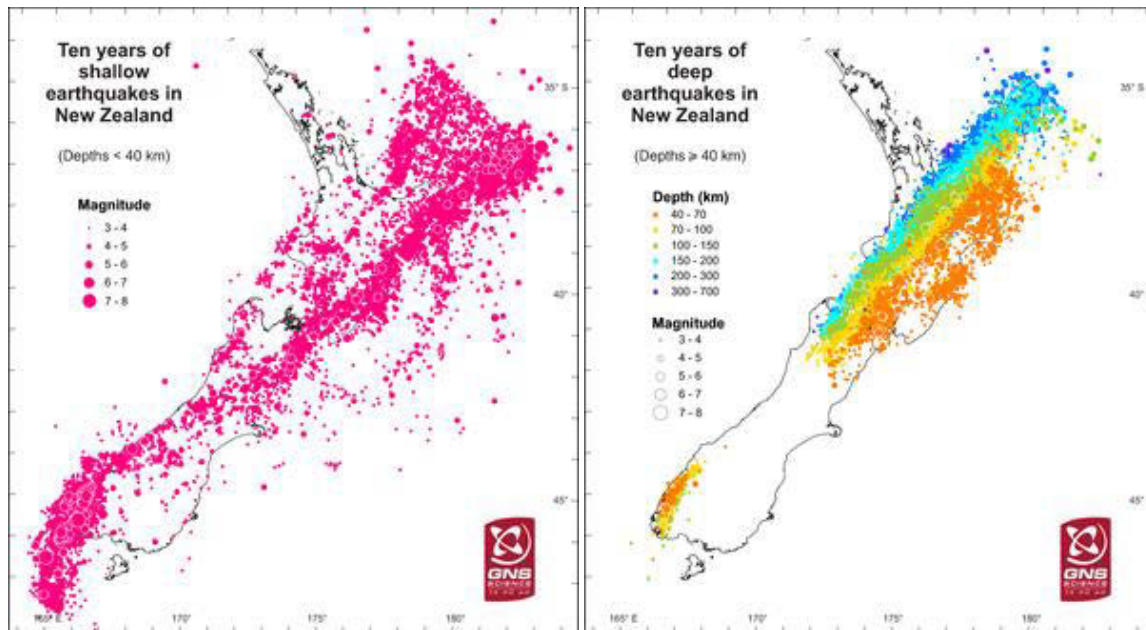
a) Shallow focus b) deep focus

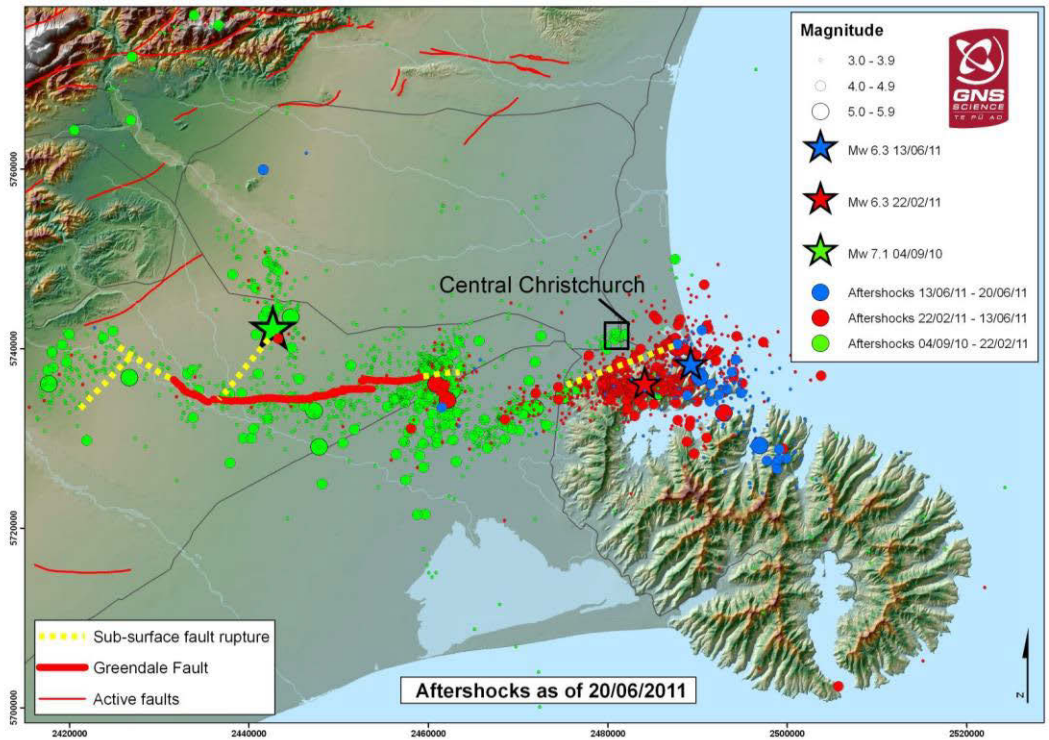
Figure 6 Map showing the locations of Darfield mainshock and the Christchurch aftershock and the smaller aftershock sequence epicentres (GNS, 2011)

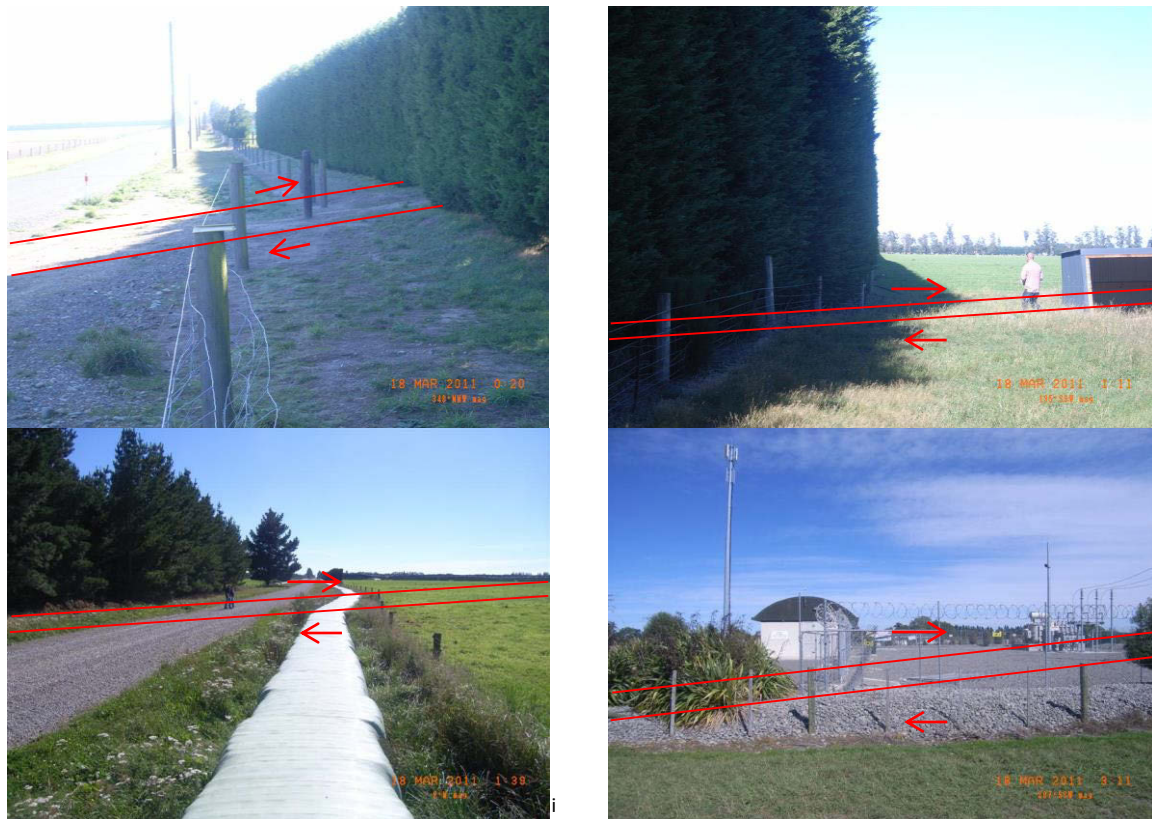
Figure 7 Photographs of right lateral strike-slip displacement offset of fence lines and other features caused by the Darfield earthquake measured in March 2011, about 5 months after the earthquake

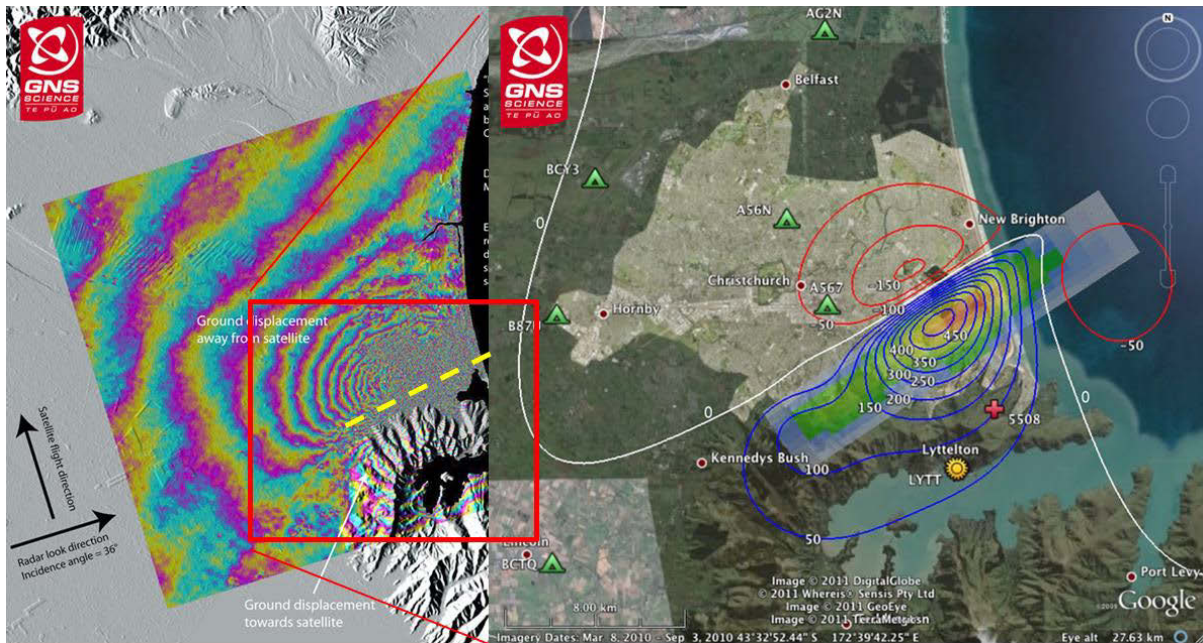
Figure 8 Distribution of permanent ground displacement associated with Christchurch earthquake (GNS, 2011)

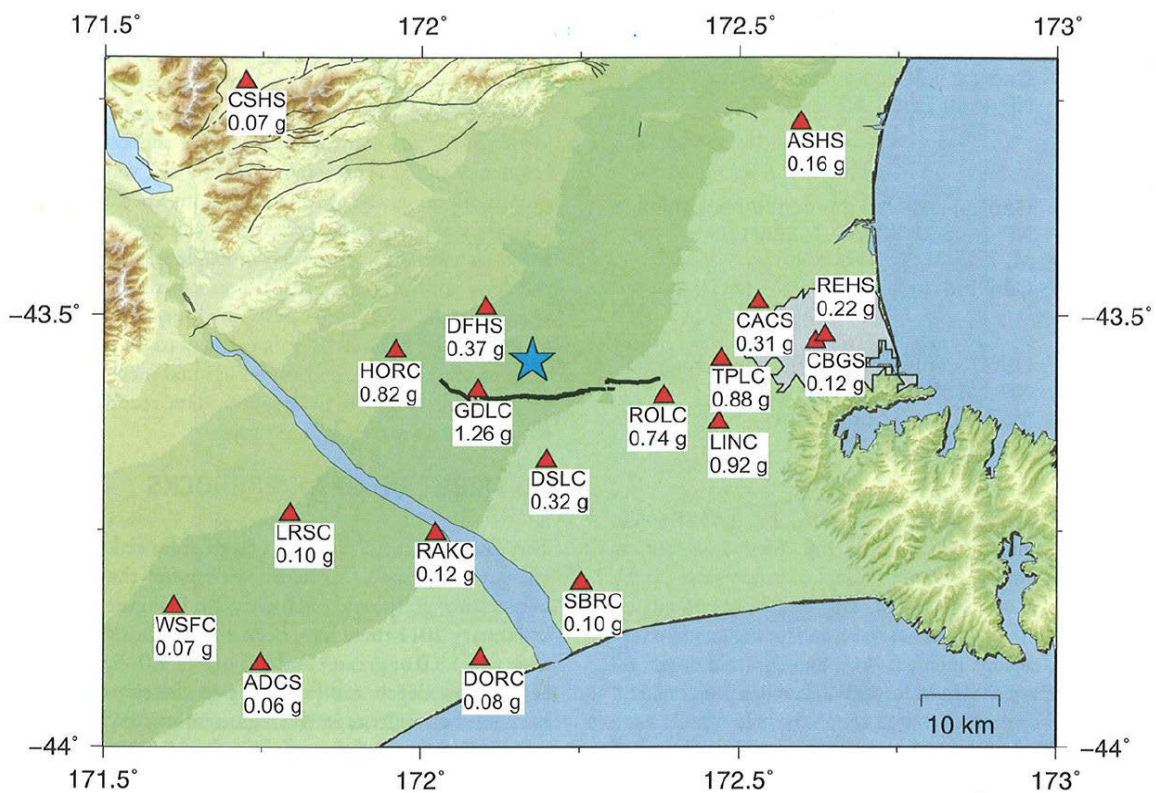
Figure 9 Map of the Canterbury region showing the distribution of peak ground motions at selected strong-motion stations (Gledhill et al., 2011)

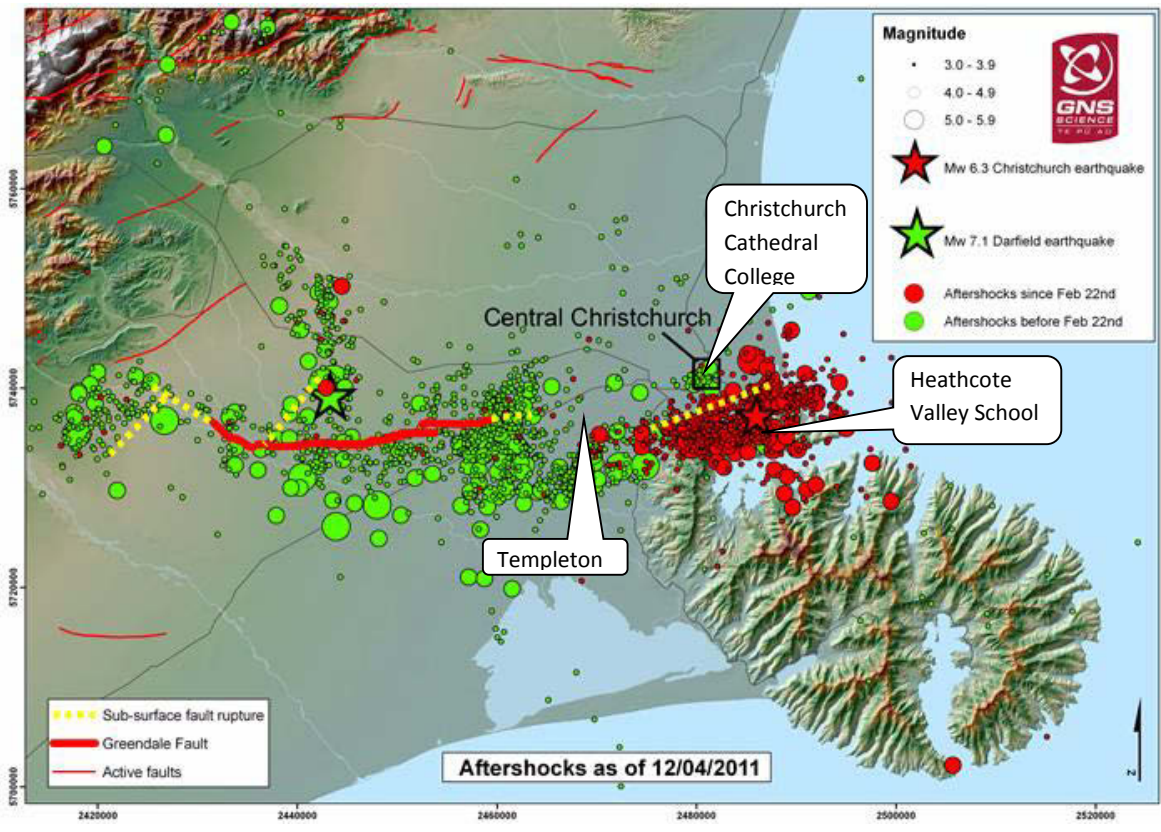
Figure 13 Map of locations of Darfield mainshock and Christchurch aftershock and aftershock sequence epicentres (GNS, 2011) also showing locations of three strong-motion instruments at Heathcote Valley School, Christchurch Cathedral College and Templeton.

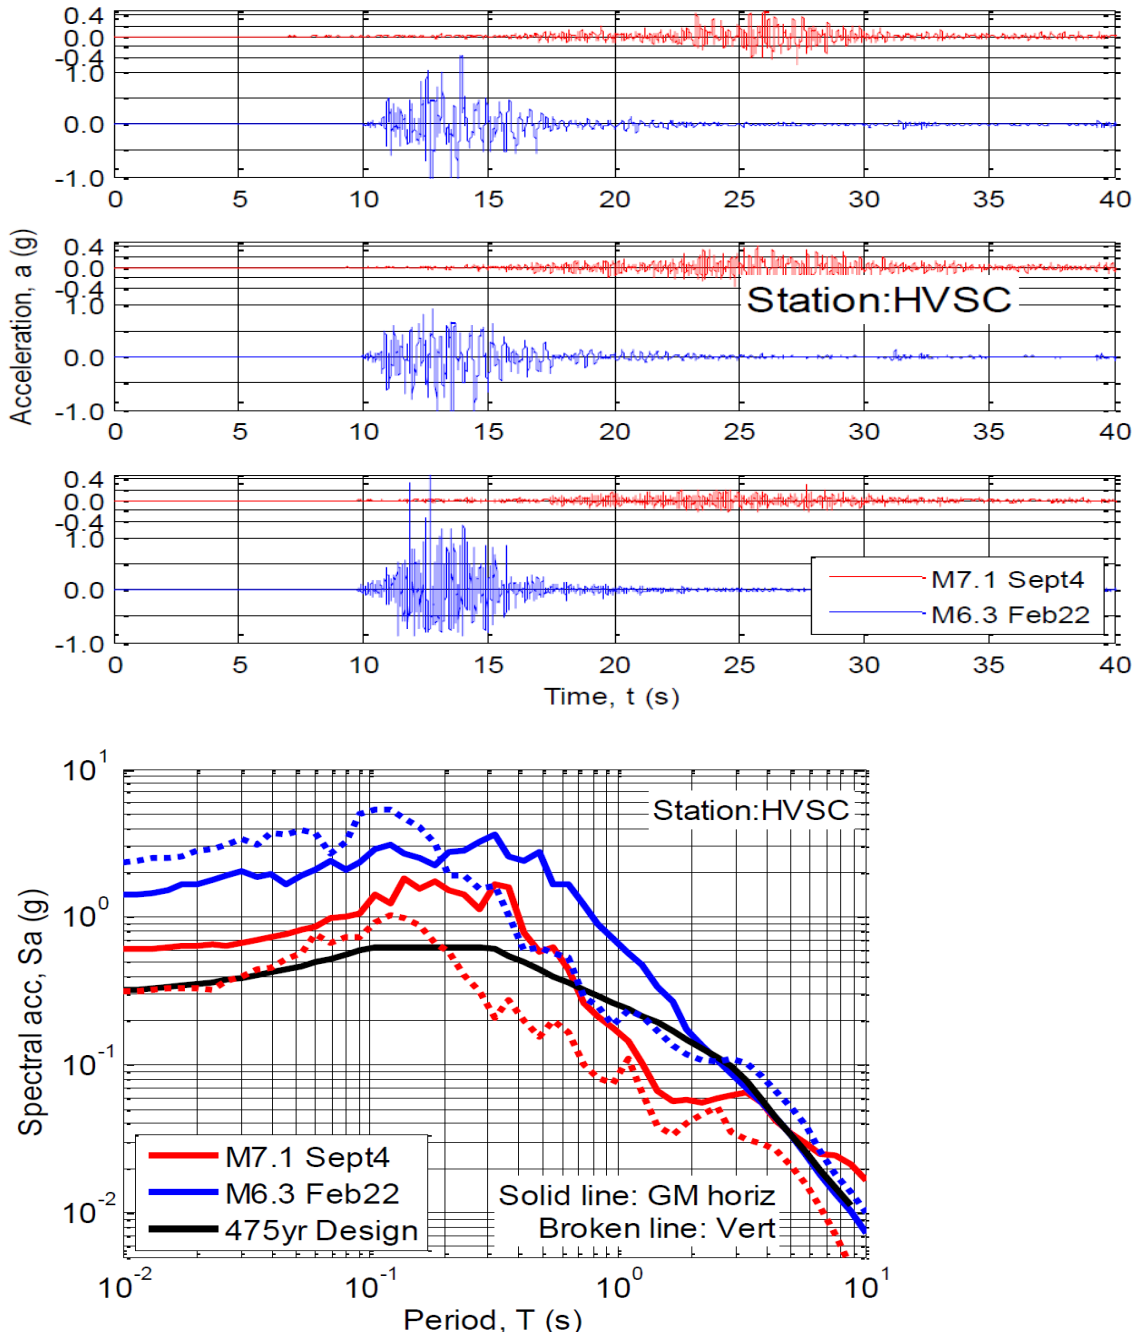
Figure 14 Heathcote Valley School (HVSC) strong motion station acceleration records and ground motion spectra (from Bradley, 2011)

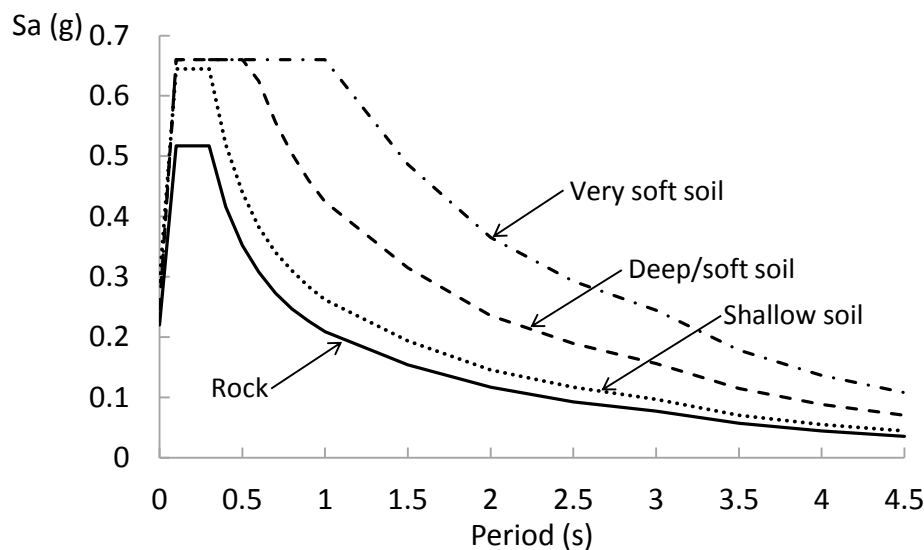
Figure 17 – Elastic site spectra for Christchurch (NZS 1170.5)

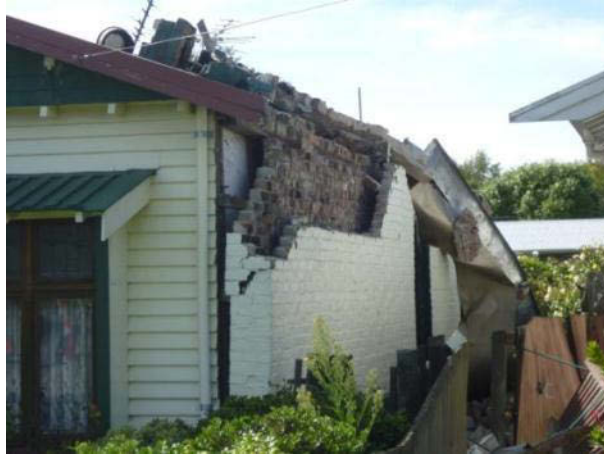
Figure 18 – Masonry wall and chimney collapse on residential timber building. This house has a double-skin masonry wall where the chimney was situated. External assessment shows the timber frame of this building to have performed well, although the masonry wall and chimney have partially collapsed (possibly causing roof damage).

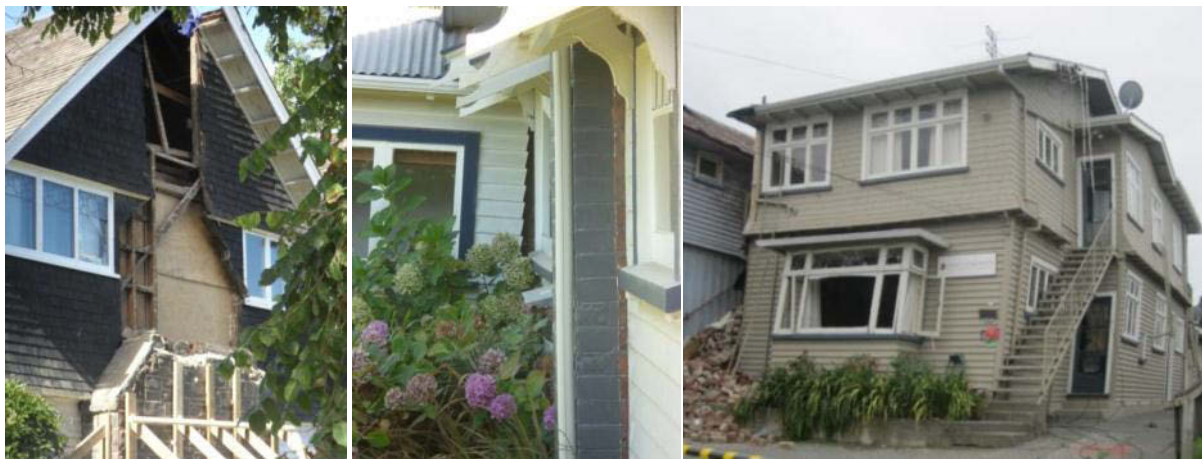
Figure 19 – (a) Collapse of a stone chimney breast on a timber frame house; (b) lateral spreading towards the river (left of photo) has resulted in differential movement and separation at the connection between the small extension and the main house; (c) soft storey failure at the ground floor level of a two storey timber frame house, as well as collapse of masonry facade.

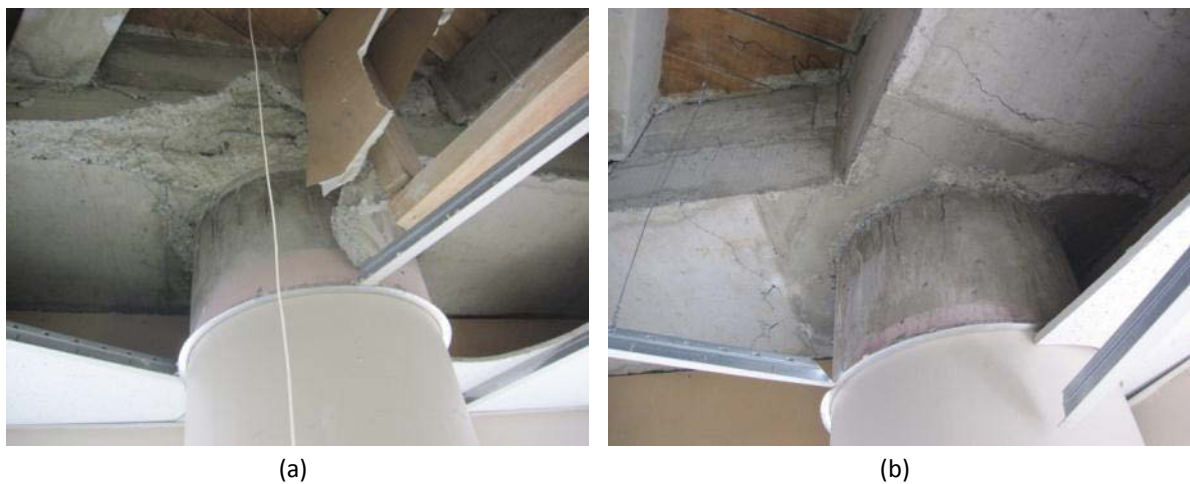
Figure 20 – Beam damage observed on Level 2 (internal) inspection of building on Victoria Street. (a) Internal beam-column joint damage exposing transverse joint reinforcement; (b) flexural cracks on underside of beams at corner beam-column joint.

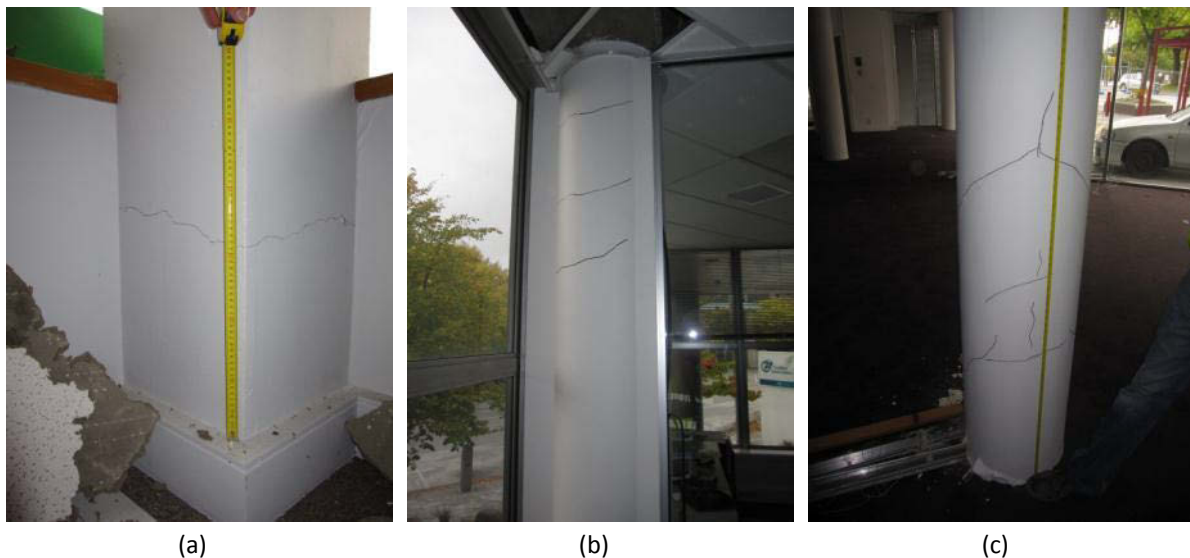
Figure 21 – Column damage observed on Level 2 (internal) inspection of building on Kilmore Street. (a) Flexural crack at ground floor column base; (b) flexural cracking at top of column; (c) potential shear cracking up height of column (note: cracks drawn on column in b and c).

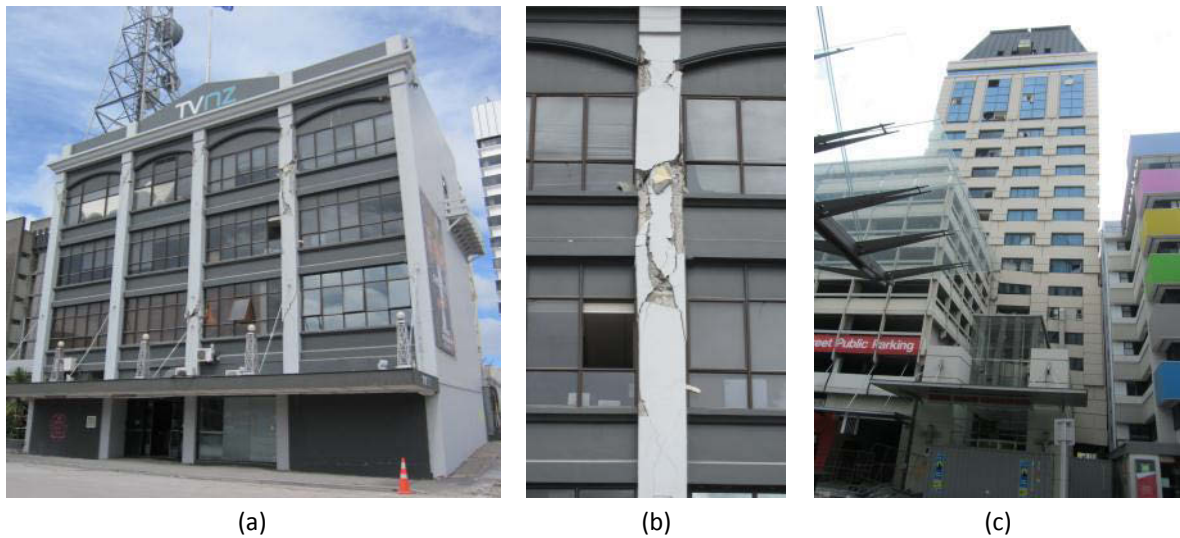
Figure 22 – Problems with structural irregularity. (a) and (b) TVNZ building with open street frontage and infilled frame at rear. (c) Grand Chancellor Hotel building, showing overhang of driveway at ground floor level.

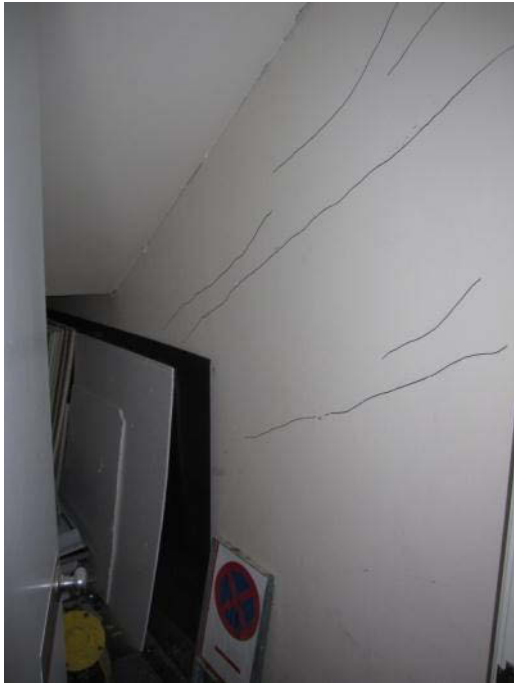
Various degrees of damage were observed to RC structural walls, from no visible cracking, to moderate cracking in plastic hinge zones (Figure 23), to significant crushing of concrete and buckling of longitudinal bars in boundary zones (Figure 24 and Figure 25). It is interesting to contrast the latter two figures, which show similar boundary zone damage, but different quantities of transverse reinforcement.

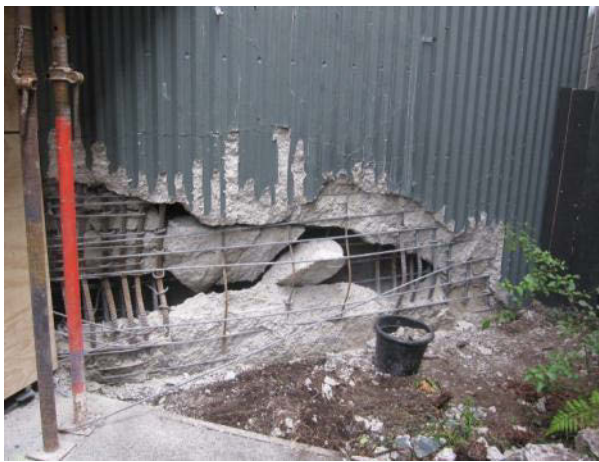
Figure 23 – Moderate cracking in RC structural walls. (a) Cracks drawn on internal core wall in 7-storey building on Kilmore Street; (b) cracking at the base of a wall on Victoria Street. The building in (b) is an “indicator building”, which means that following a significant aftershock, this would be one of the first to be inspected to assess whether more widespread damage is likely.

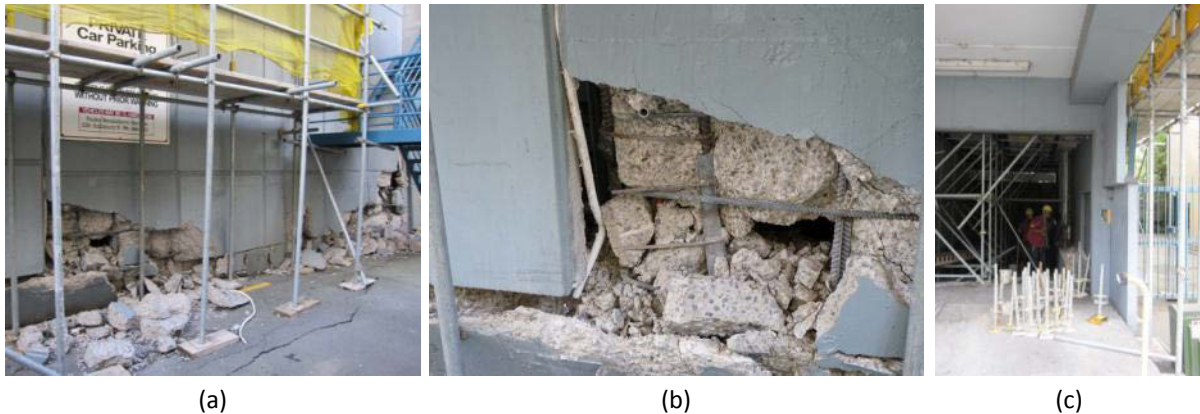
Figure 25 – Significant damage to a wall with poorly-confined boundary zones on Oxford Terrace. (a) Whole wall; building had settled 300–400 mm towards the right of picture; (b) close-up of boundary zone; (c) propping (behind wall) was in place due to damage in September Darfield event.

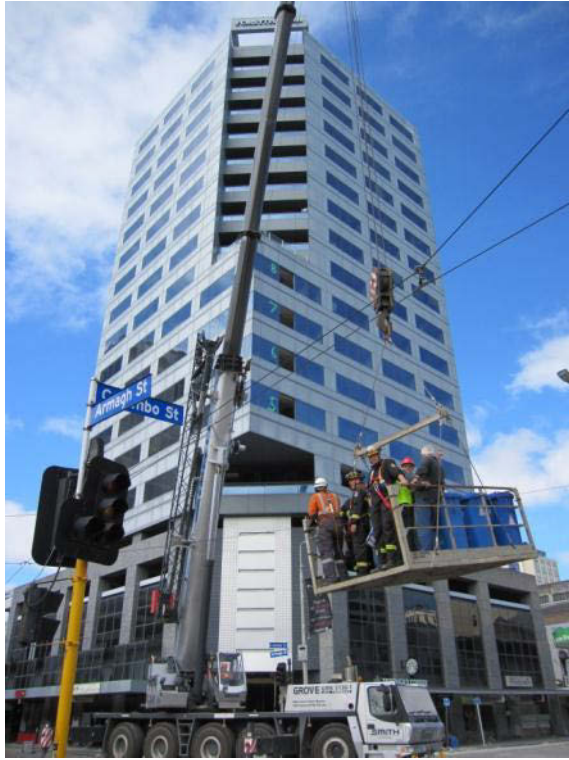
the typical detail which allows movement at the bottom so as not to form a strut between levels. The collapsed stairwell prevented evacuation of the occupants, and impeded search and rescue efforts, clearly not satisfying the “Unassisted evacuation possible” objective from Table 5. Figure 26(a) shows tenants being assisted entry to the building by crane so they could retrieve possessions (note the broken windows that have been labelled at each level by search and rescue teams).

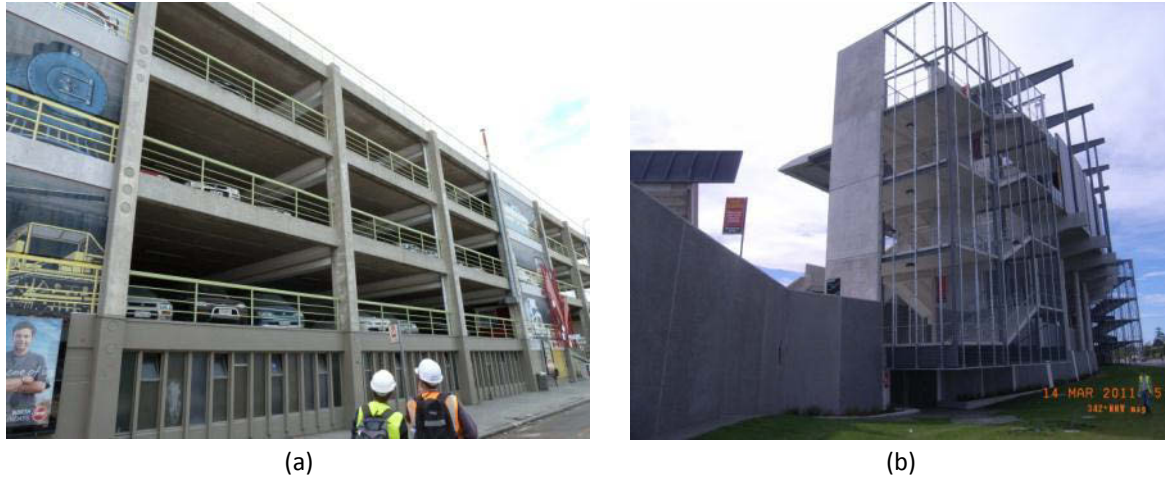
Figure 27 – Precast concrete structures. (a) Parking building on Gloucester Street with post-tensioned, precast beams, showing little damage. (b) AMI Stadium, with little damage visible from the outside (despite significant liquefaction), but reportedly damaged internally (The Press, 2011a).

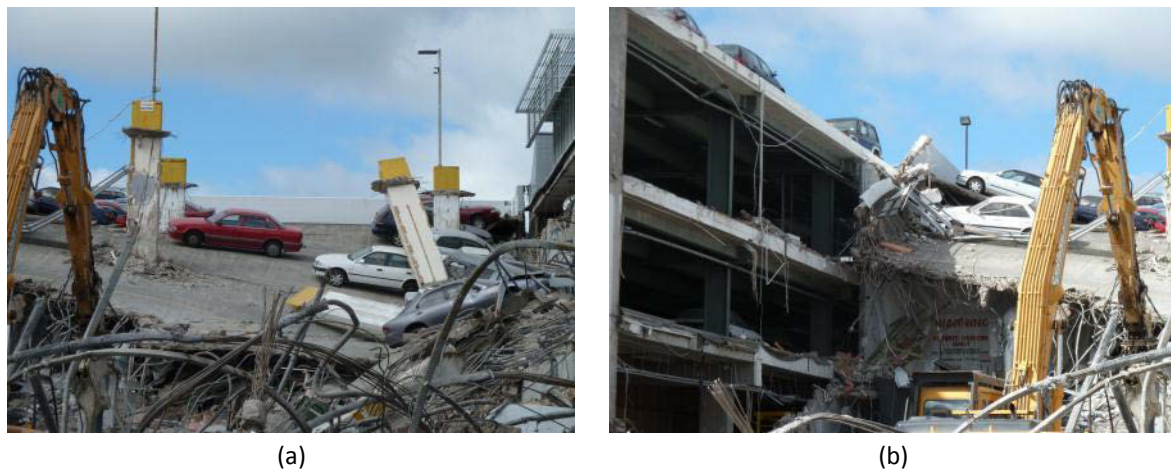
Figure 28 – Eaton Place parking building. (a) Punching shear failure in RC building; (b) no apparent damage to adjacent steel moment frame building.

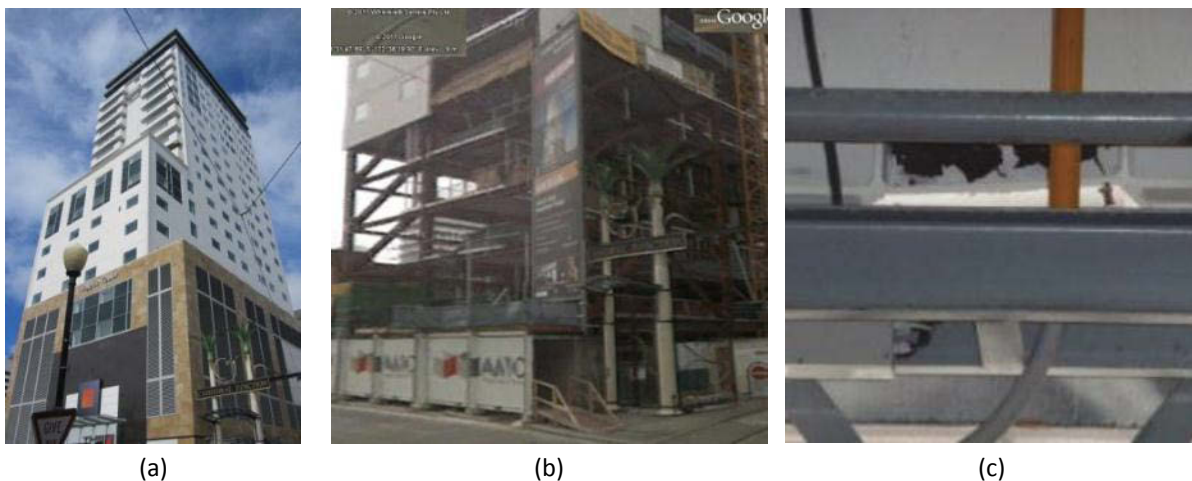
Figure 29 –22-storey steel EBF/Moment Frame building, Pacific Tower, 2010; (a) EEFIT photo from visit; (b) construction photo from Google Streetview, showing perimeter EBFs in lower levels; (c) evidence of EBF link paint flaking due to yielding, and residual deformation, partially obscured by services (Michel Bruneau, from Bruneau et al., 2011).

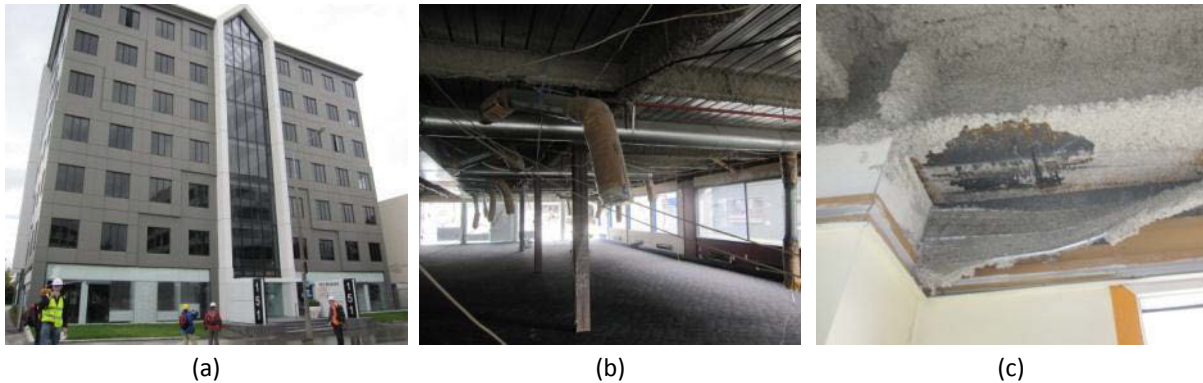
Figure 30 – (a) 7-storey building in Christchurch CBD with concrete moment frame system at ground floor and steel moment frame at higher levels. (b) First floor was being fitted out so beams and columns were exposed, albeit covered in fireproofing. (c) Removal of fireproofing at the end of a beam showed no signs of flange buckling or connection damage.

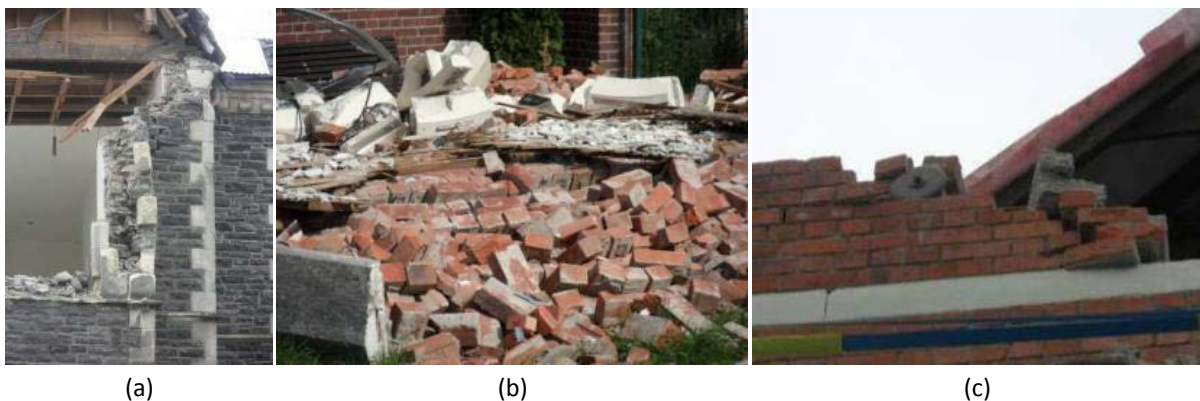
Figure 32 – (a) Example of stonework of historic building. In brick walls, the poor quality mortar and weak bond of masonry units was evident from the complete separation of bricks and from extensive cracking in the mortar joints but hardly affecting the bricks in both (b) collapses of portions of walls and (c) punching failures of anchors.

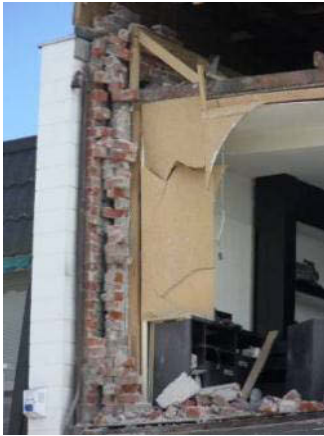
2. Masonry fabric. Whereas a number of buildings were constructed with a regular bond with good through-thickness connection, the lack of internal connection observed in some multi-leaf and cavity walls provoked separation and out-of-plane failure of wall panels (Figure 33).

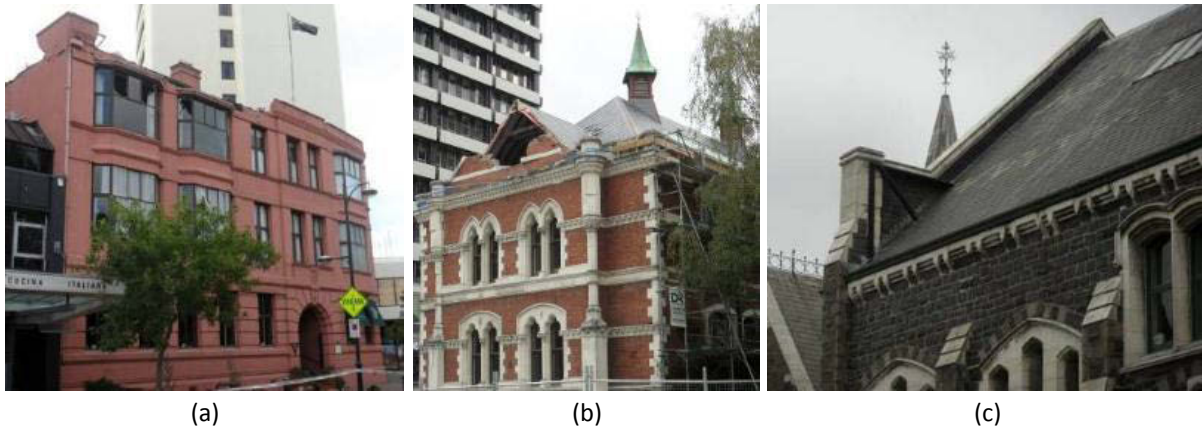
Figure 35 – Example of collapse of free standing elements such as: (a) parapets and (b) gables. (c) Retrofit by bracing, when present, prevented the collapse of elements.

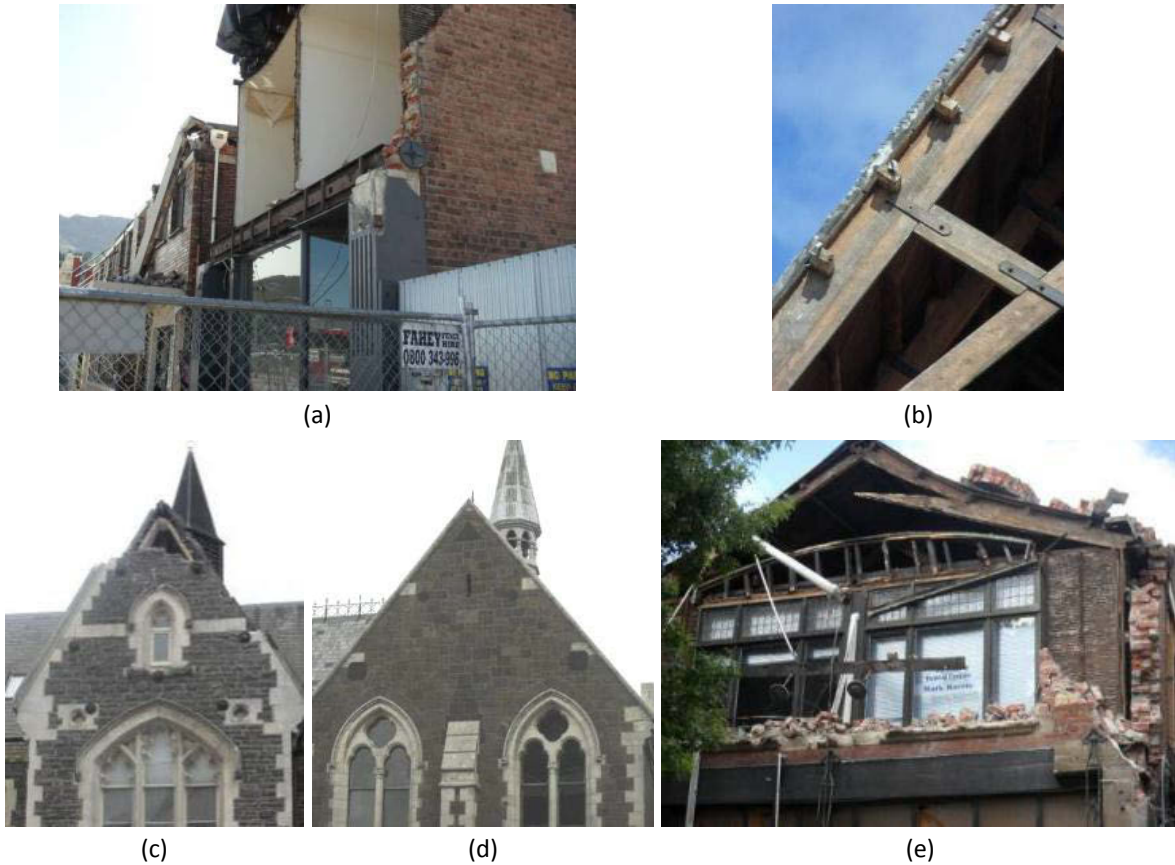
Figure 36 – Metallic anchors: (a) example of application for connection of floor beam to wall. Note that the lack of connection in the other direction determined the out-of-plane failure of the façade. (b) Insufficient size and (c) ineffective positioning of the elements compromised the performance of connectors; yet (d) the better layout and size of elements proved effective in preventing damage in similar structures. (e) Failed steel girt and anchors.

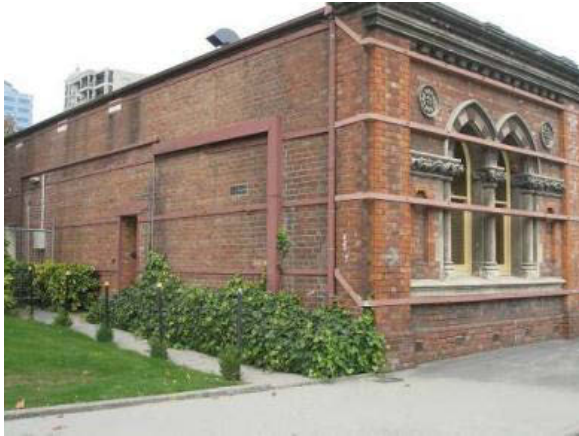
2. Steel strapping. A number of steel strapped masonry structures were observed. The details on these structures were provided as a rapid repair and stabilisation system for the cracking that resulted from the Darfield event. As the ground motions were greater than the design ground motions, the performance of strapped structures can be deemed to be satisfactory (Figure 37a), although in the case of large structures (e.g. Figure 37b) the size of the steel elements seemed inadequate from a damage limitation point of view due to lack of compatibility between the axial deformation of the steel elements and the allowable drift of the façade.

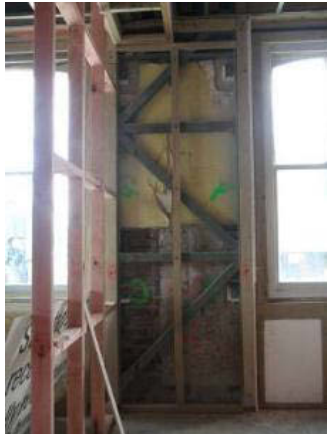
3. Steel bracing and steel frames (Figure 38a–b). Even if frames performed well and prevented the collapse of horizontal structures, the sizing and spacing of connections between braces and walls was insufficient to restrain the out-of-plane mechanism of masonry panels (Figure 38b–c). In fact, a better global performance is likely to be due to better detailing (Figure 38d).
4. Concrete frames (Figure 39) presented the same problems as steel frames: despite behaving well during the quake, they were not sufficiently connected to prevent out-of-plane damage to the masonry walls.

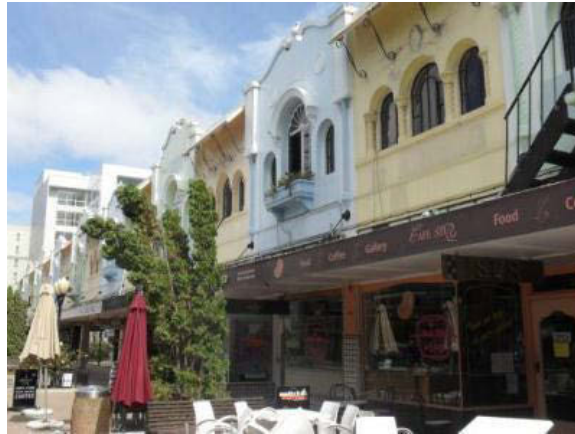
Figure 40 – Row of undamaged or lightly damaged RM buildings.

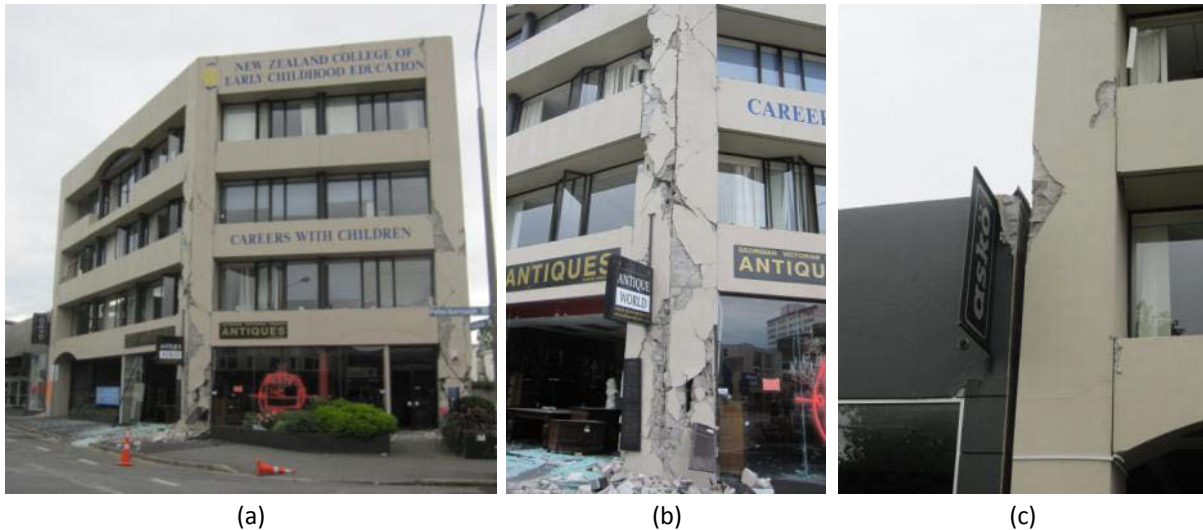
Figure 42 – Heavily damaged commercial RM building on Victoria Street. (a) Irregular layout led to (b) heavy concentration of demand on corner column. (c) Some damage due to pounding with adjacent building was also observed.

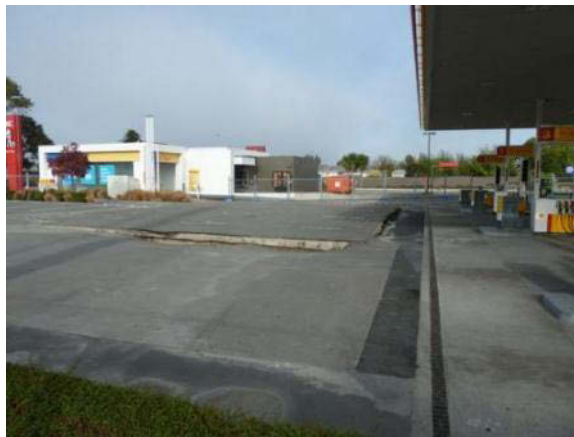
Figure 43 – A petrol station having suffered liquefaction. The underground storage tanks at this station have floated when the soil was in a liquefied state. The station was closed at time of survey.

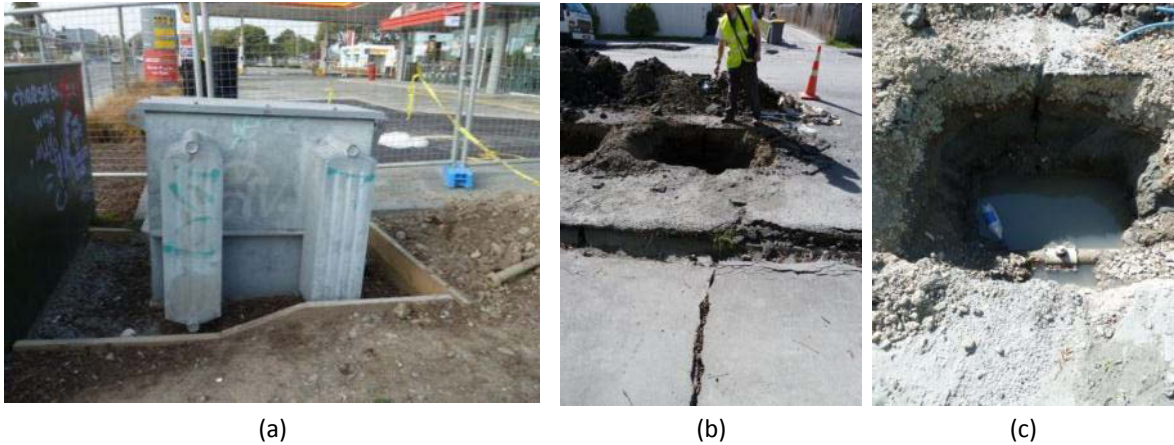
Figure 44 – (a) An electrical services box that had tilted due to liquefaction; it is not known if this resulted in loss of service. (b) A typical services failure that has been exposed ready for repair. This service was located approximately 200m from the river and was damaged from lateral spreading – note the crack in the road substrate in (c), this crack occurred across the entire road surface and is displayed in (b).

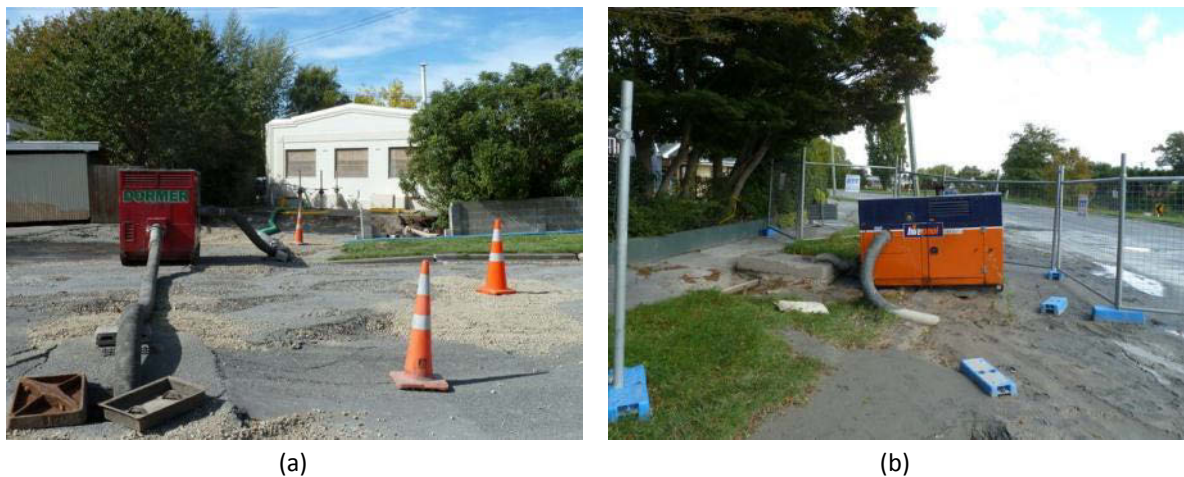
Figure 45 – (a) A pumping station pumping its contents into a storm water drain, and (b) a transportable pump, pumping directly from one manhole into the river.

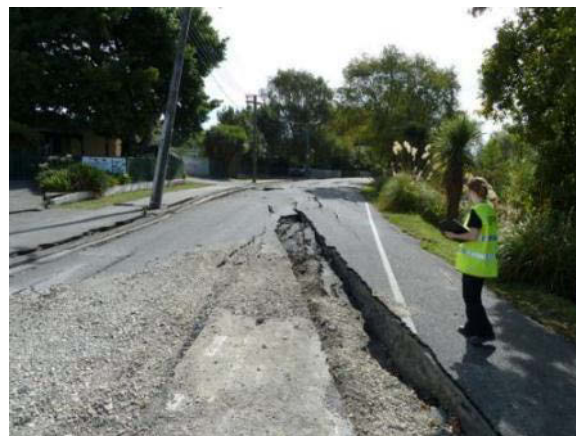
Figure 47 – Stormwater outlet showing that large aggregate could be mobilised. The aggregate shown formed part of the sub-base of the road.

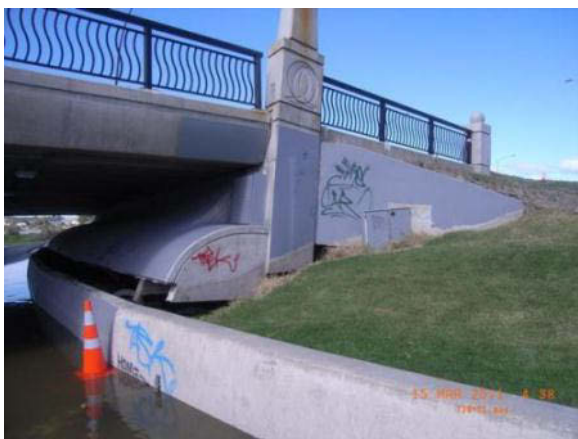
Figure 48 – Fitzgerald Ave Bridges (built in 1964) showing (a) rotation of the abutments, (b) plastic hinging forming in the top of the piles connected to the abutments (not the reinforcing bars connecting the abutments to the pier), (c) settlement of the approach road due to lateral spreading and concrete spalling due to pounding and (d) failure of services again due to lateral spreading. These bridges were not significantly damaged in the Darfield earthquake.

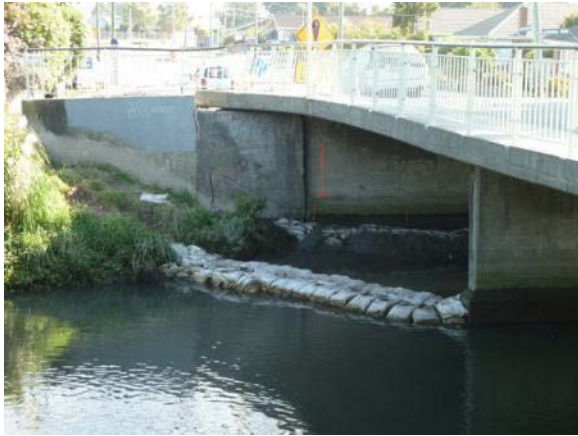
Figure 49 – (a) Abutment failure of the Anzac Drive bridge (built in 2000), caused by lateral spreading. This bridge was founded on steel piles, embedded well into the abutment, and it is assumed that plastic hinges formed in the tops of these piles. (b) Spalling of the bottom of the bridge deck at the abutments.

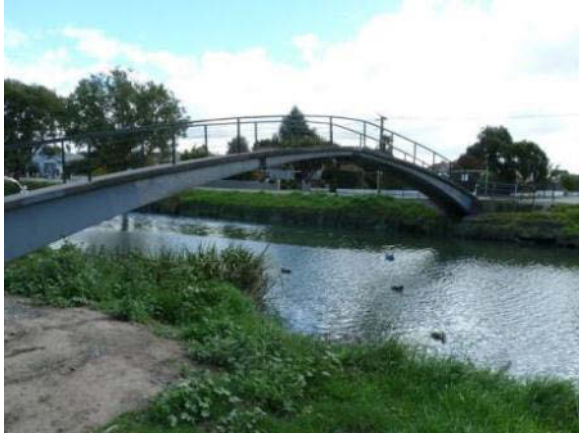
Figure 50 – (a) Gayhurst Road bridge. This bridge was open at the time of survey, but liquefaction under the approach roads and lateral spreading had resulted in (b) large ramps to access the bridge. (c) The deck itself was relatively undamaged, but compatibility between the abutments and the main deck resulted in damage to the wing walls of the abutments as well as severing of services. (d) The base of the abutments had moved inwards resulting in lateral displacement of the central pier and formation of a plastic hinge approximately two thirds of the way up this pier. (e) and (f) The detailing of the connections between the water main under the bridge and the bridge deck enabled the pipe to slide and although some lateral buckling of the pipe did occur it did not fail. At the time of writing, this bridge has been reported as having collapsed in the June 13 aftershock.

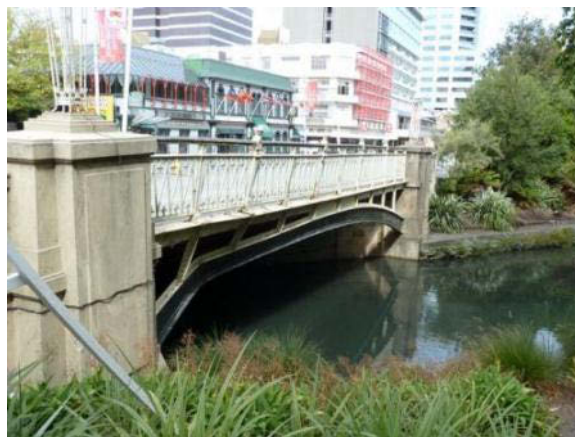
Figure 52 – Steel bridge over Avon River in CBD, showing buckling of outer arch due to movement of abutments resulting from lateral spreading. Although this damage looks significant, the structural system consists of steel girders under the main deck and arches under the footpaths. There was no obvious damage to the main girders.

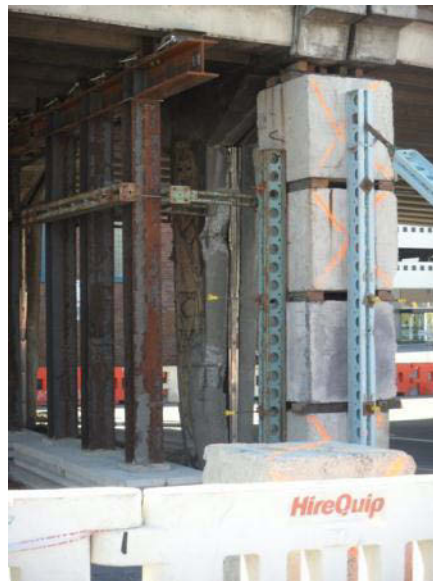
Figure 54 – Moorhouse Avenue overpass, which consisted of many piers (of which two failed). At this particular location the pier consisted of a double column on either side of an expansion joint. The piers were relatively slender about the axis perpendicular to the bridge deck and the pier on one side of the expansion joint formed two plastic hinges about its weak axis due lateral movement of the bridge deck and vertical load. The supporting structure shown in the image was intended to protect the bridge from further damage due to aftershocks rather than to enable reopening. The bridge was still closed at time of survey and was responsible for significant traffic disruption.
