THE M_w 6.3 CHRISTCHURCH, NEW ZEALAND EARTHQUAKE OF 22 FEBRUARY 2011

A FIELD REPORT BY EEFIT

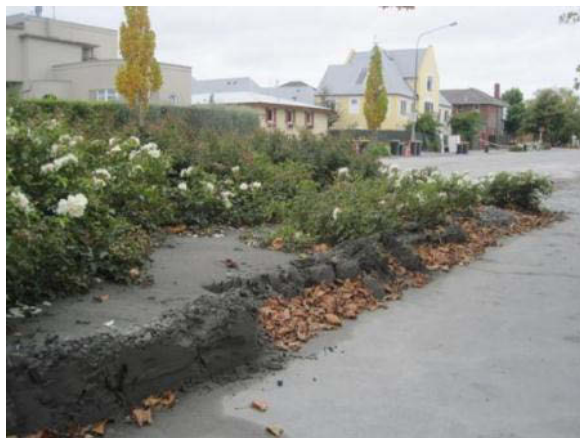
Due to the severe liquefaction in the northern section of the CBD, the chosen case-studies were concentrated in the area inclusive of Armagh St to the south and Salisbury St to the north. This is also where other instances of poor foundation response were noted by the EEFIT team during structural inspections. The described area contains a good cross-section of buildings types, including a variety of multi-storey buildings as described above, as well as several residential complexes. Some blocks within this region were affected by lateral spreading towards the river, while others showed evidence of a more localized slumping. Further research into the historical geological make-up of the area could help verify observations regarding these localized areas.

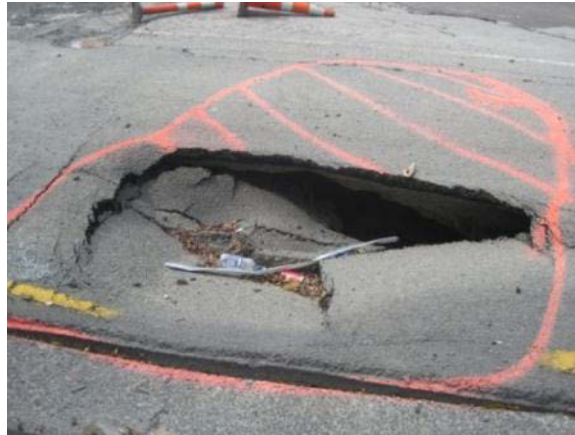
Figure 57 – Ground deformation on Madras St exposing void beneath the pavement.

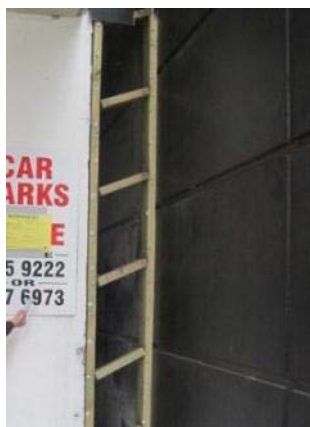
Settlement of shallow founded buildings with the ground was widely observed where signs of severe liquefaction were present. Indications of this type of settlement were not observed in relative movement of the ground and building, but rather in fixed components where the movement of the building can be measured, or in comparison to adjacent buildings that had not settled. Examples of such indicators are shown in Figure 58.

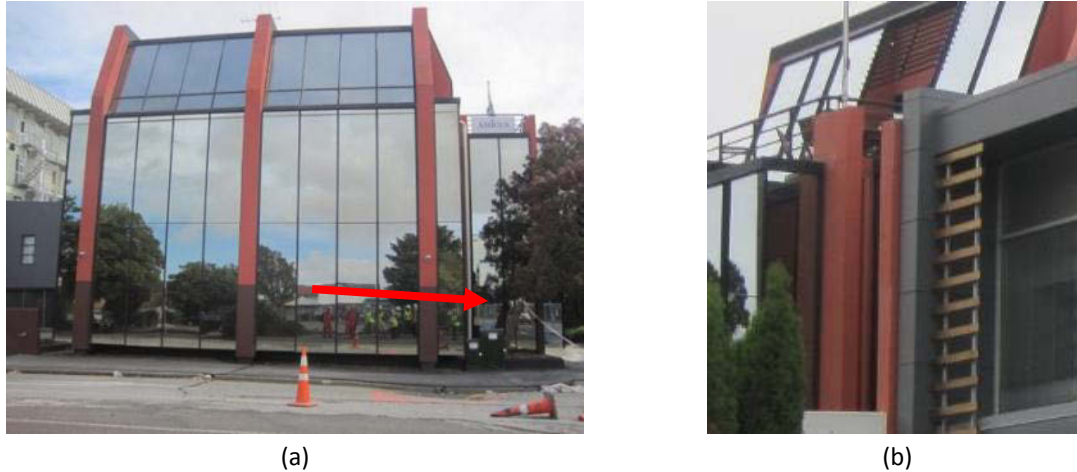
Figure 59 – (a) Building observed to have settled with the ground at one end. (b) Tilt relative to adjacent building. On this particular street, features such as sand boils, pavement compression, voids, and damage to buried services were concentrated near one corner of the building, indicating a localized area of slump (right side of part a).

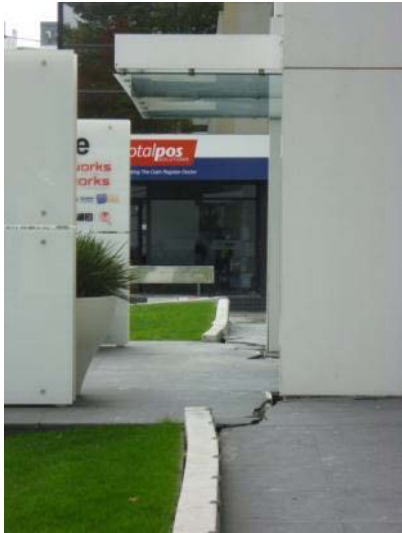
In some cases, building components such as entranceway slabs were observed to settle more than the main structure. This indicates that the foundation of the component was not tied together with that of the main structure. In Figure 60 it can be seen that some damage occurred at the building interface as a result of this settlement. In general, however, many buildings which were seen to settle with the ground – differentially or otherwise – often appeared to act in a rigid manner. Thus, little of the overall damage to the structure could be attributed to the ground failure. In fact, many of these buildings did not appear from the exterior to have suffered excessive structural damage.

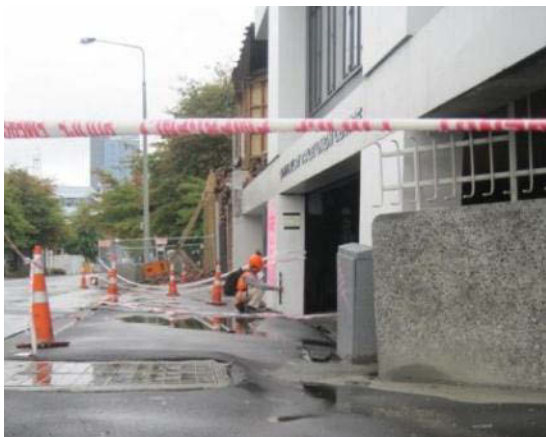
Another observed response in liquefied areas was further settlement of buildings with respect to the ground. Accompanying bulging of the ground outside the building, or heave of floor slabs in the interior, indicated a possible bearing failure of the soil underneath the foundation, as a result of strength loss due to liquefaction (Bray and Stewart, 2000). Examples of these indicators in both the exterior and interior of two buildings are shown in Figure 61 and Figure 62.

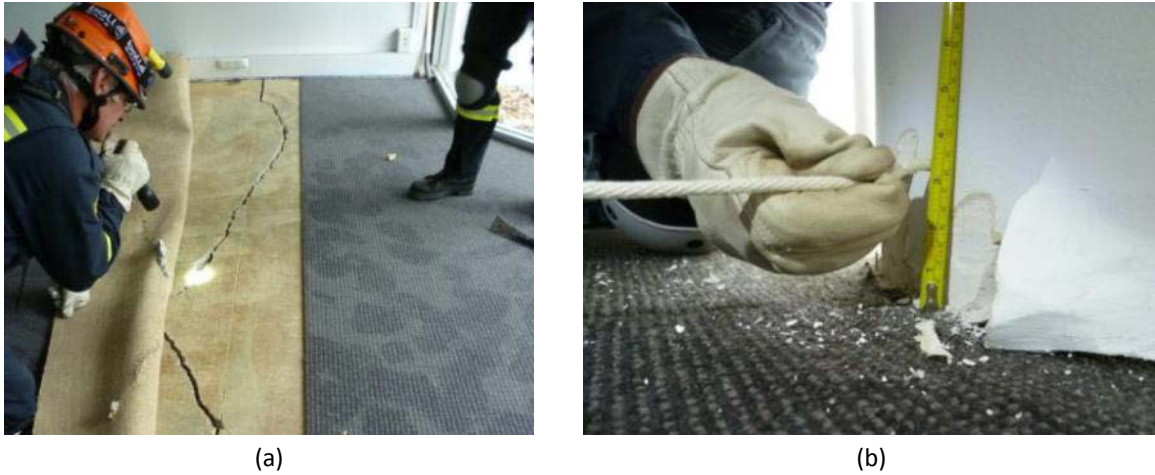
Figure 62 – (a) Cracking in the ground floor slab of a 5 storey building. (b) 75 mm settlement of a column relative to the level of the bulging floor slab.

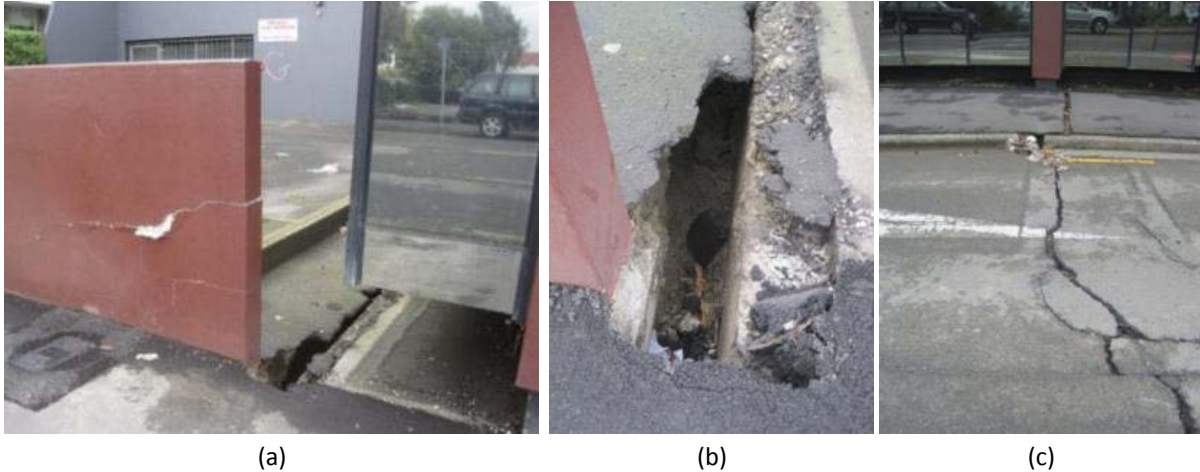
Figure 65 – (a) and (b) 15 cm void at one end of a building, indicating lateral movement of the building. (c) Tension cracks in the pavement at a central column.

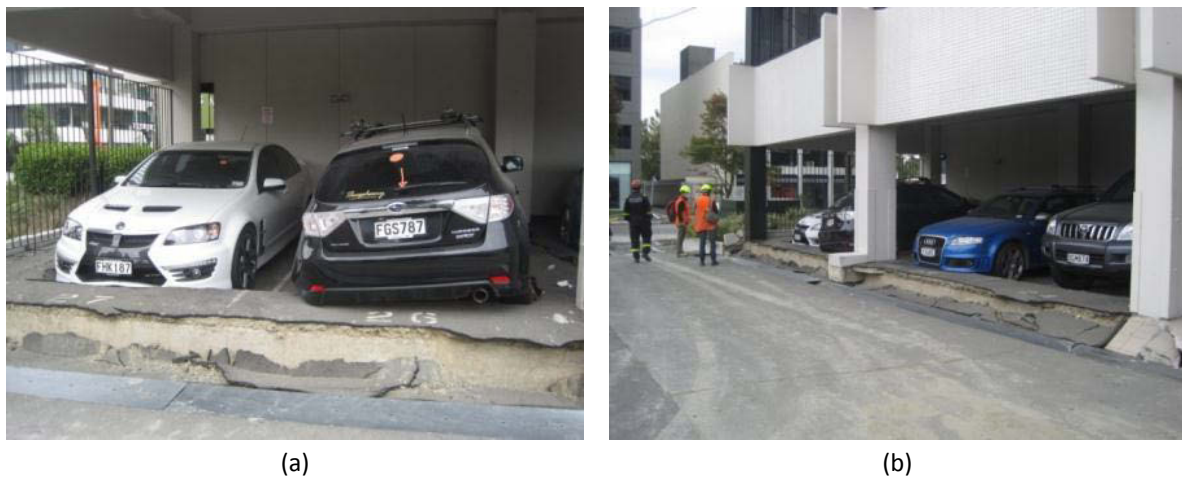
Figure 66 – (a) and (b) Exposed foundation beams in a building with piled foundations.

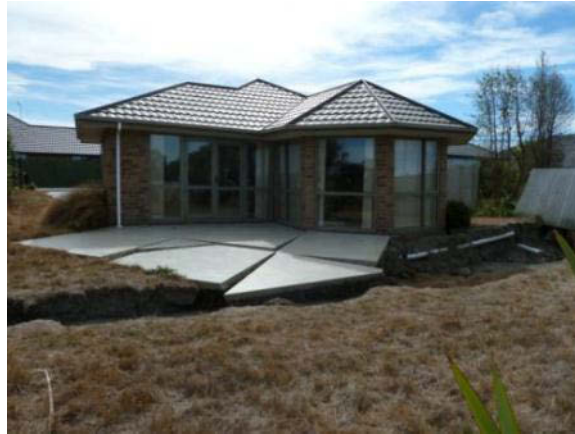
Figure 68 – Lateral spreading in the back yard of a house near the Bexley Wetlands

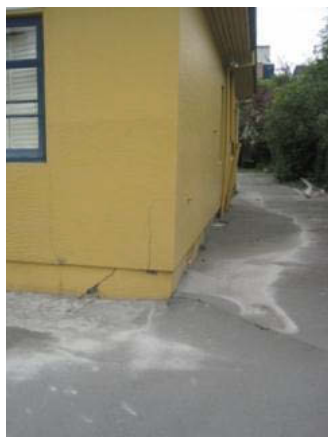
Numerous cases of minor foundation cracking concentrated around airbricks were observed, caused by differential settlement of the concrete slab or footing. In a representative example shown in Figure 69, extensive liquefaction has occurred around the building perimeter, and it appears to have settled relative to the ground. This was confirmed by an internal inspection, where damage to the timber floor boards could be seen (Figure 69c). Multiple cracks seen on the exterior foundation and walls were also observed in the building interior. It was reported by an insurance representative that in general, timber floors performed better than concrete floors in houses that experienced settlement of this nature.

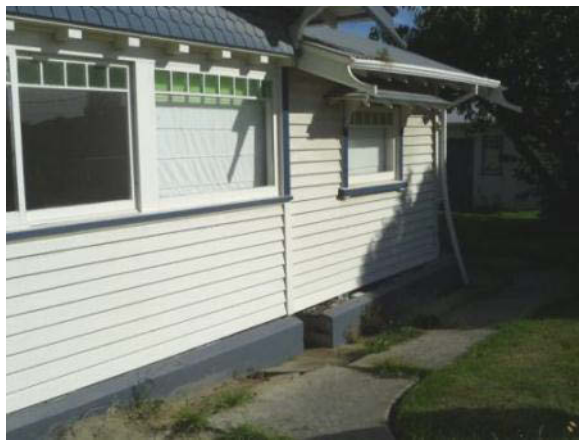
Lateral displacement of concrete slab foundations or concrete/brick ring foundations (with suspended floor joists) was observed in several single storey timber residential buildings, with movement of up to 300 mm in the direction of ground movement. In some cases the building moved as a unit, while in others the timber frame had moved independently from the foundation, indicating inadequate connections between the timber frame and slab foundation (see Figure 70). The impact of lateral spreading in the building was evident in the movement of part of the concrete slab foundation, which has split underneath the timber structure and forced movement of the entire frame. The main timber structure itself appeared to have sustained only minor damage.

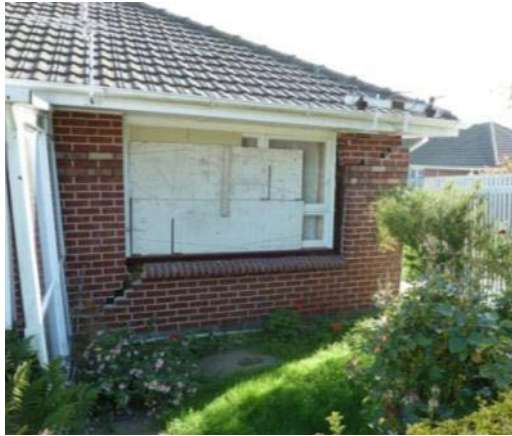
In other observed cases, the main building frame remained in contact with the foundation, but could not withstand the lateral forces induced by the earthquake, resulting in separation of the components. Figure 71 shows examples of masonry and timber buildings that both appeared to have separated in this manner.

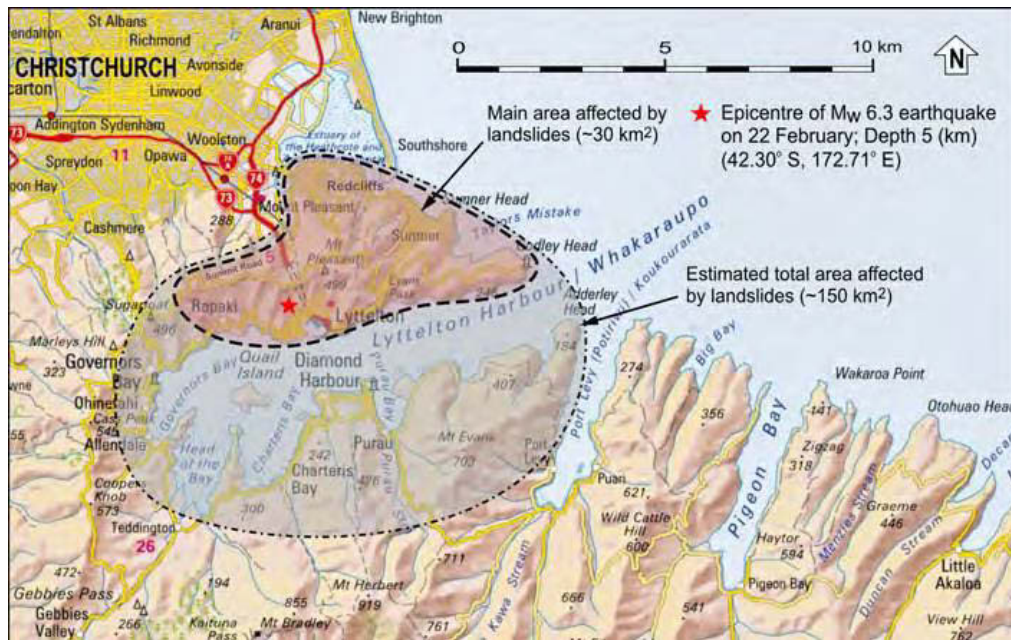
Figure 72 – Map showing area affected by landslides triggered by 22nd February, 2011 earthquake (Source: GNS/Hancox et al., 2011).

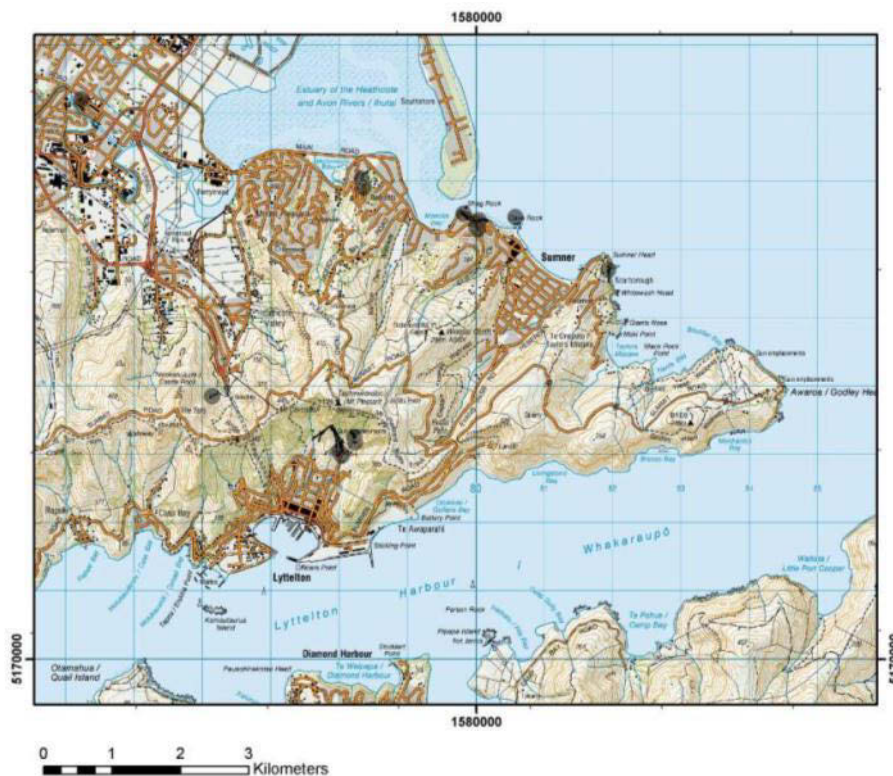
Figure 74 – Map showing the location of sites visited by EEFIT landslide team as Black dots.

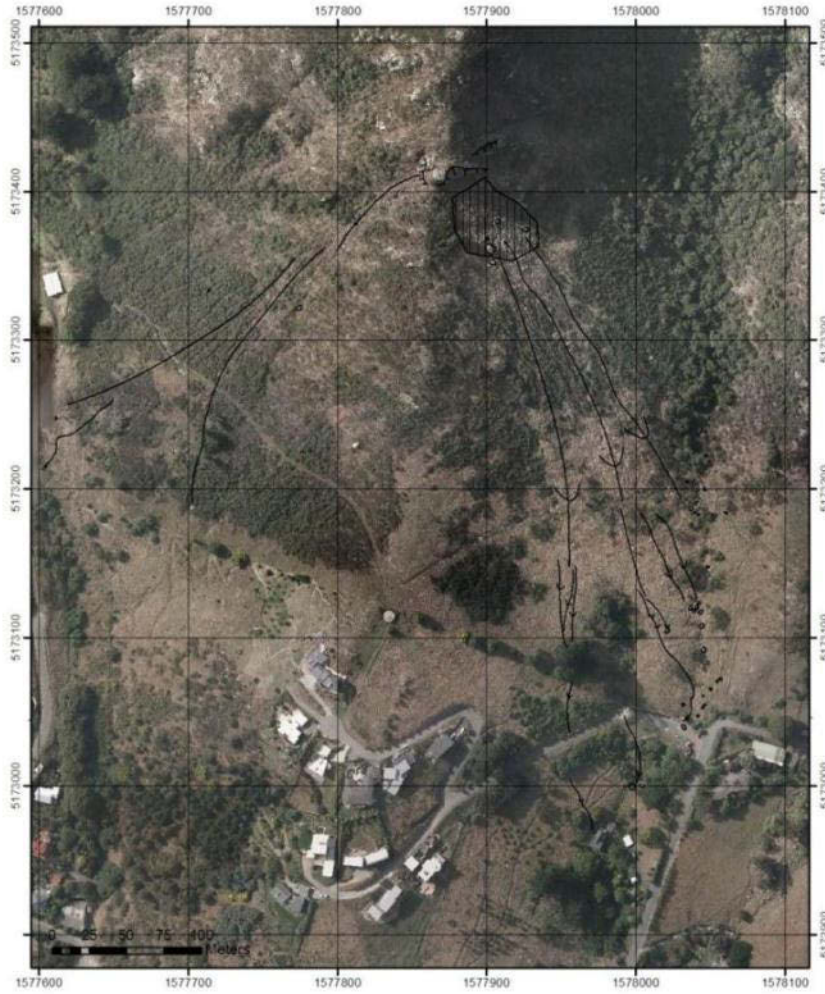
Figure 75 – Above the port town of Lyttelton strong ground shaking mobilised perched boulders. The boulders carved tracks through the vegetation and their tracks, picked out in black, are visible on this air photograph taken by New Zealand Aerial Mapping on 24th February, 2011. Reference grid is NZTM.

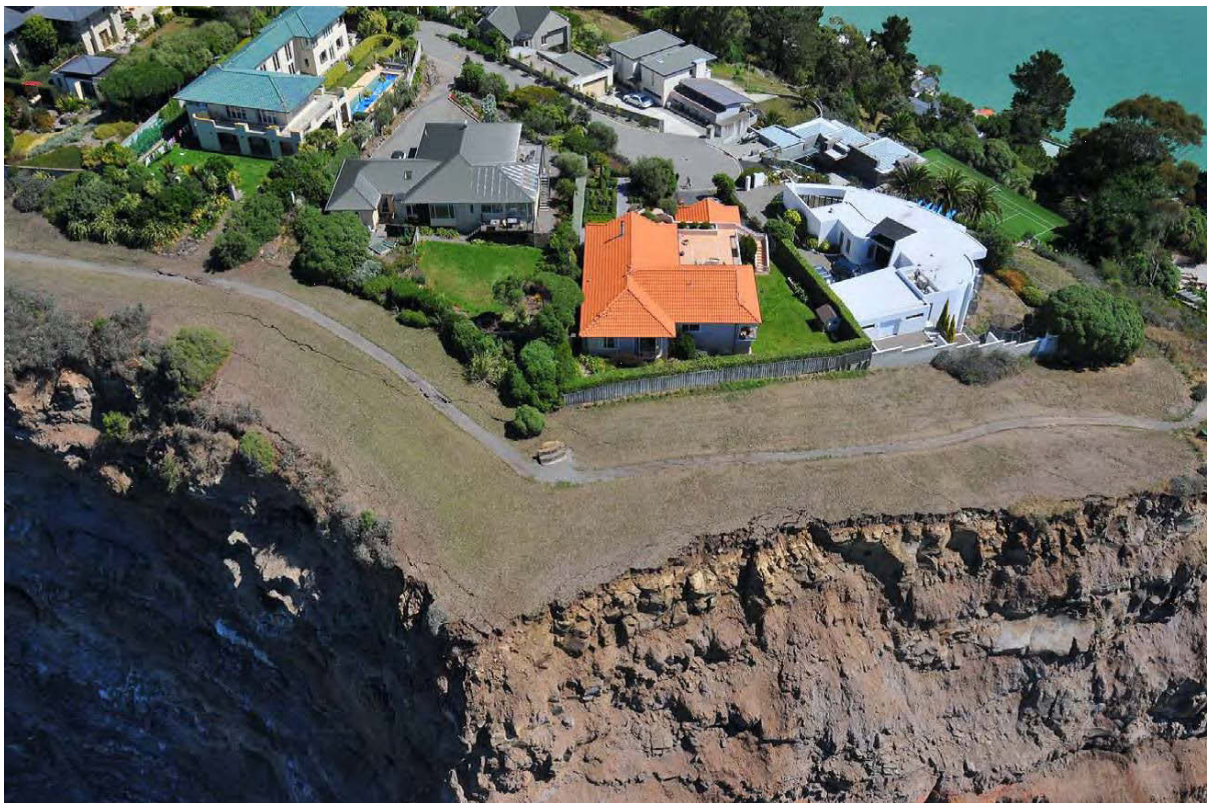
Figure 77 – Tension cracks affected the grass and path along the top of the 80 m high sea cliff at Sumner Head in the eastern Port Hills. NZTM 1581943, 5175709. Photo taken by Graham Hancox/GNS on 24 February 2011.

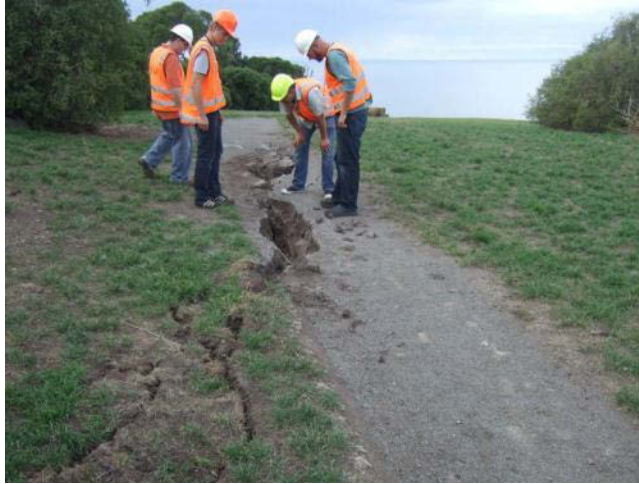
Figure 78 – Deep tension cracks at Sumner Head probably caused by dilation of vertical joints in basalt lava flow. The ground to the right of the crack being inspected was part of a potentially unstable topple block.
Taken from NZTM 1581945, 5175712 facing northeast.

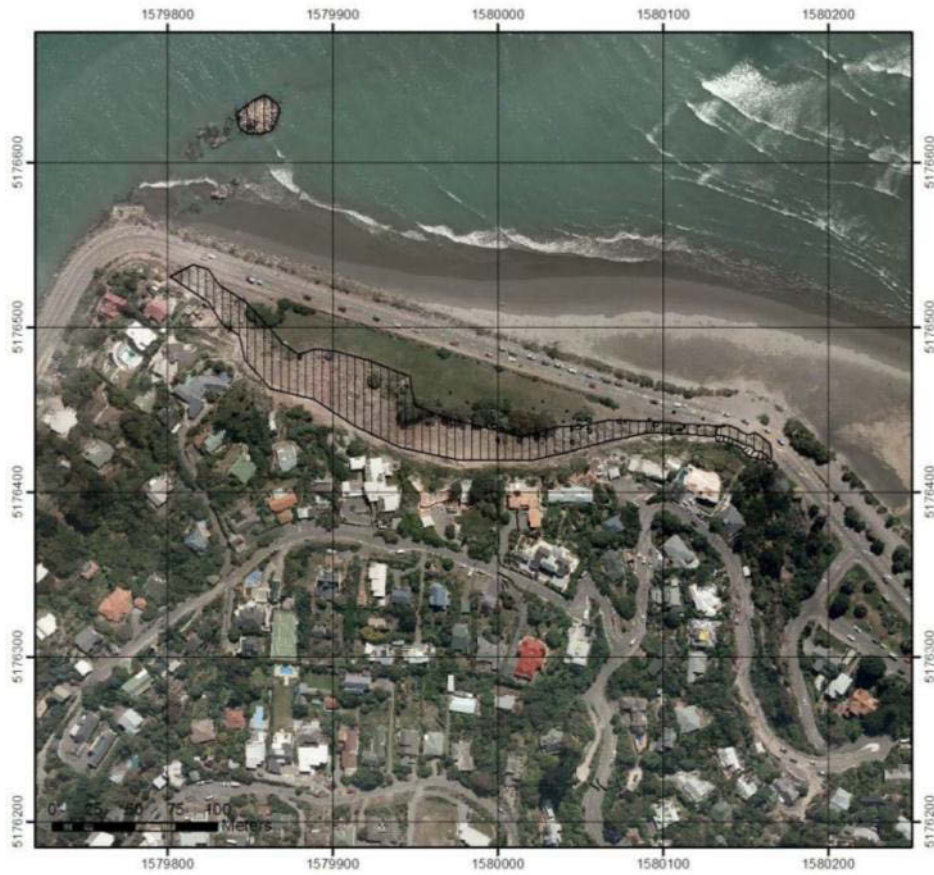
Figure 79 – Aerial photograph taken on 24/02/2011 showing the unstable cliffs above Main Road in Sumner. The hatching shows the area affected by rockfalls. The collapsed sea-stack, locally known as Shag Rock, is indicated offshore. Ground cracks affecting the road and gardens along Kinsey Terrace are also traced in black. Reference grid is NZTM.

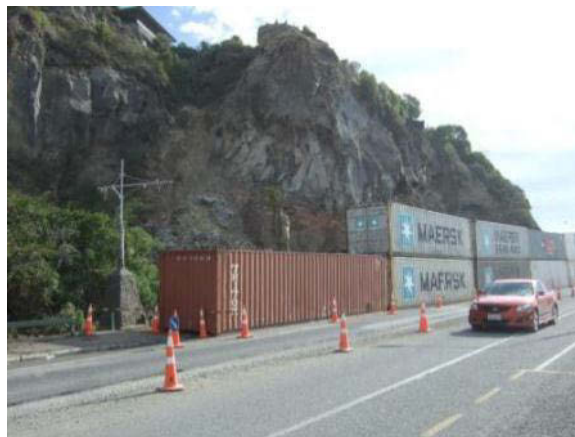
Figure 80 – Cargo containers temporarily placed between the cliff and Main Road to intercept any further falling debris. The rock fall debris obstructed the west bound (left) lane closing it to traffic.

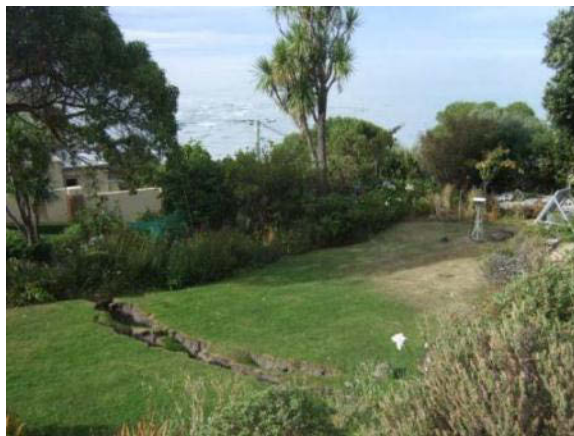
Figure 82 – a wide roughly north-south aligned tension crack (left) opened up in a landscaped garden south of Kinsey Terrace. A continuous GPS station seen in the far right of image was deployed by GeoNet/GNS Science, three days after the event and was sending near-real time slope movement data back to the office for interpretation by experts.

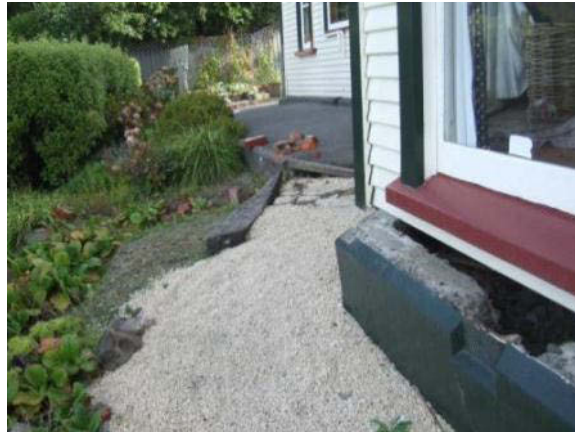
Figure 83 – At this house in Kinsey Terrace the concrete ring foundation had separated from the frame structure due to landslide related ground deformation. Cracks in the garden also occurred and can be seen in the mid-ground

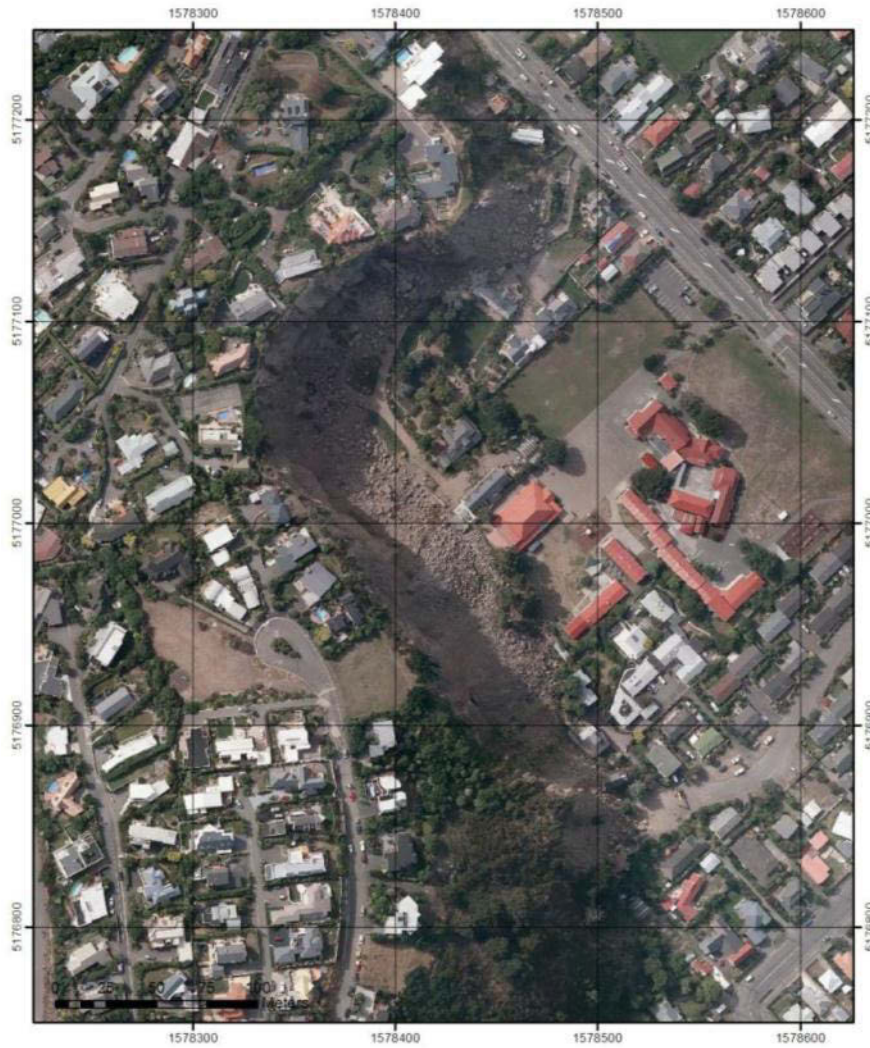
Figure 84 – At Redcliffs a rockfall from the quarried volcanic cliffs caused damage to buildings below, including a school. Cracks had developed along the cliff top and caused damage to roads, houses and gardens. (Credit: New Zealand Aerial Mapping)

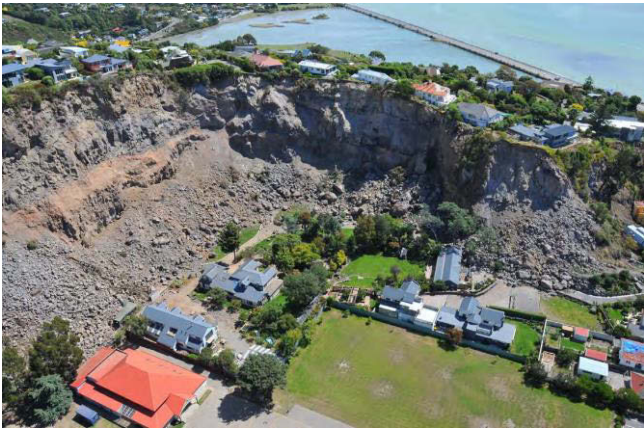
Figure 85 – Large rock falls from the quarried former sea-cliff at Redcliffs affected Redcliffs School and Moa Cave Guest House. The houses along the ridge on top of the slope in the right of the image experienced very intense ground shaking. (Taken by G Hancox, GNS Science)

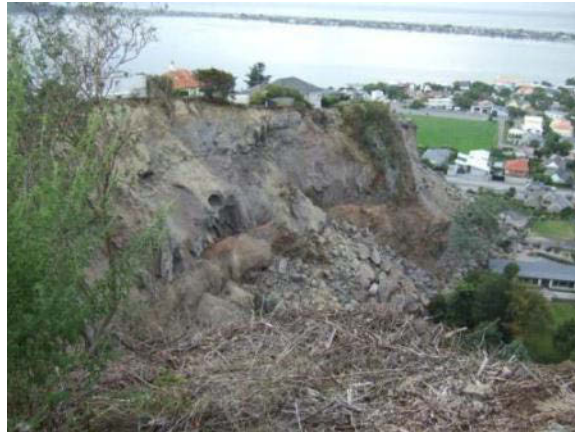
Figure 86 – An alternating bed of jointed basalt, tuff and breccia failed along the former quarry slopes at Redcliffs. Cracks in the cliff top left houses clinging to the edge of the cliff top and others buried by rockfall debris.

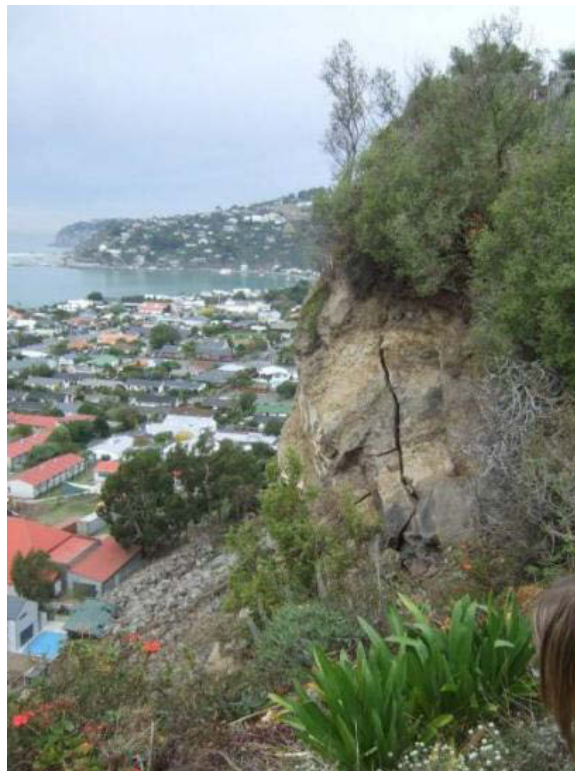
Figure 87 – Cracks along the tops of cliffs at Redcliffs.

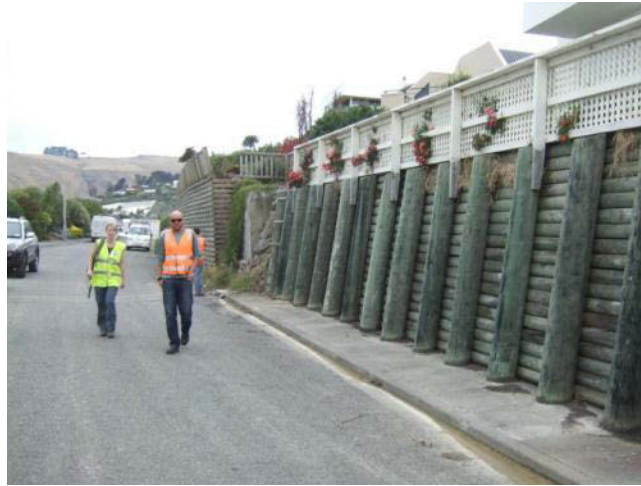
Figure 88 – Earth retaining walls at Glendevere Terrace. The wooden crib wall (far ground) suffered deformation, while the flexible wood pile retainer (near ground) suffered no obvious damage.

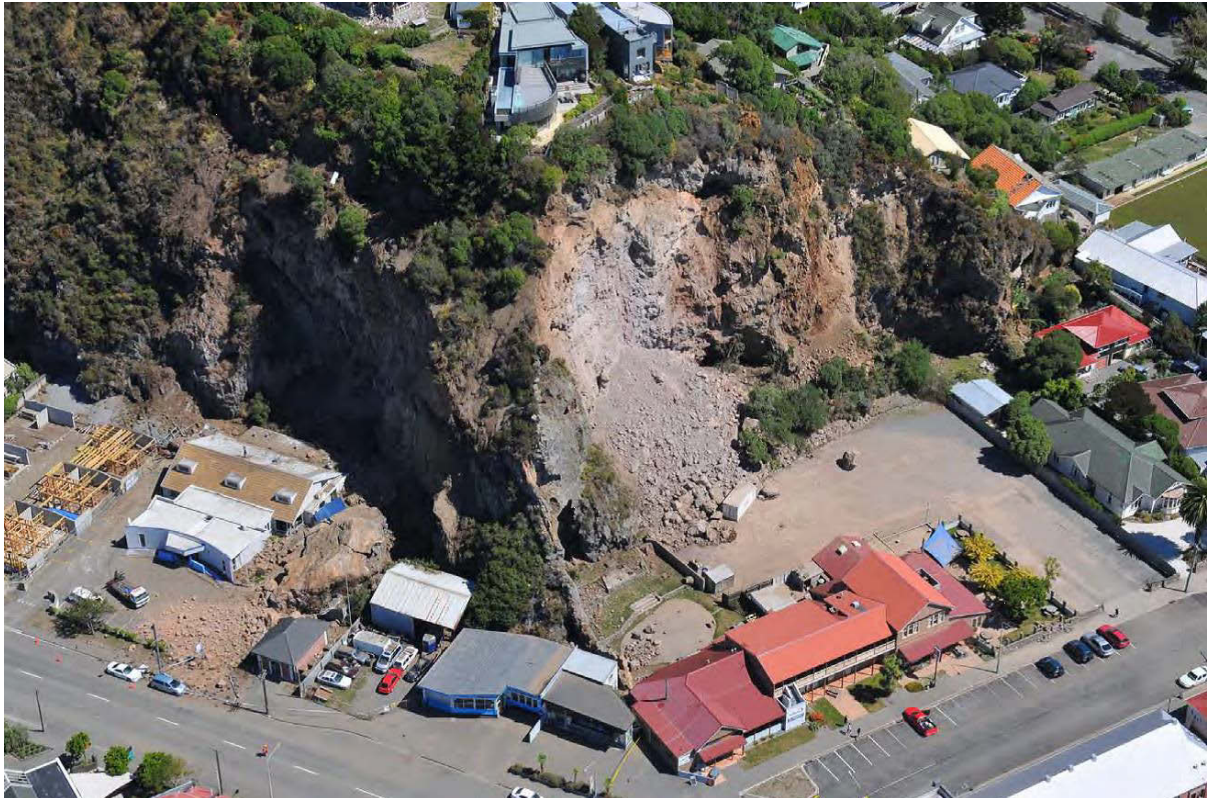
Figure 89 – Rock falls caused damage and loss of life at the corner of Wakefield Ave and Nayland St. (Credit: G Hancox, GNS Science).

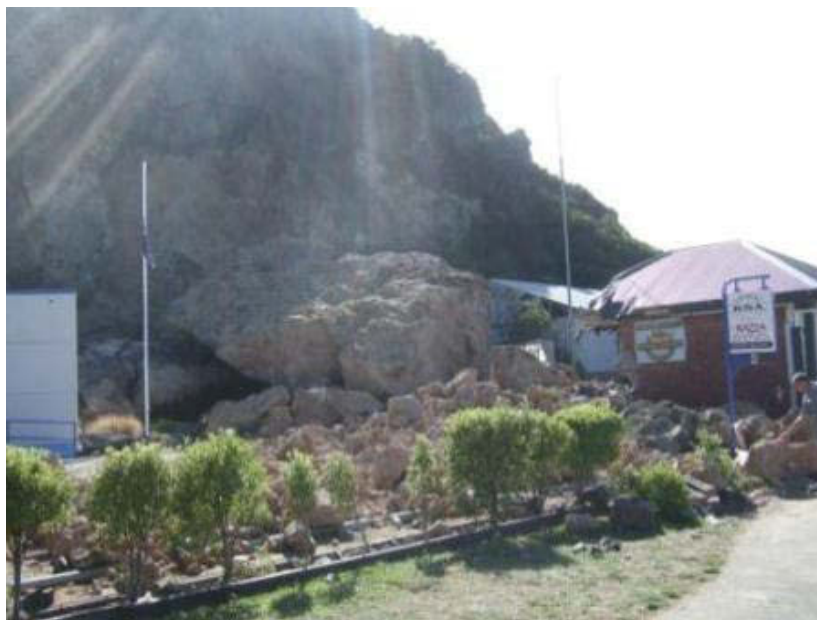
Figure 90 – A 15 m long boulder of tuff toppled from the quarried slope above the RSA building at the northern end of Wakefield Ave. The rock fragmented upon impact with the ground and some boulders bounced across Wakefield Ave for a distance of 60 m, twice the height of the slope.

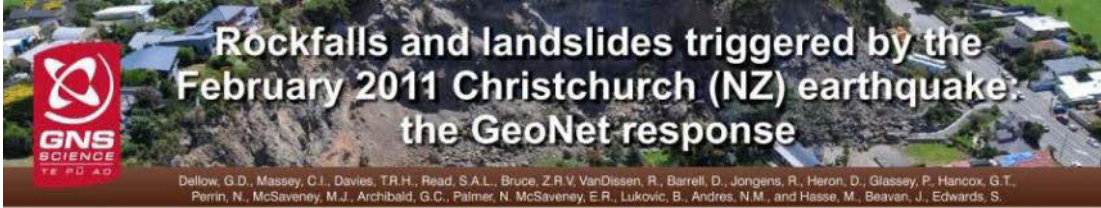
Rockfalls and landslides triggered by the February 2011 Christchurch (NZ) earthquake: the GeoNet response

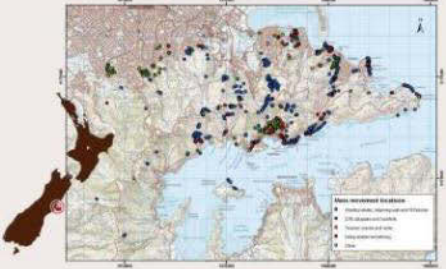
Map showing the distribution of the different types of mass movements (data from field information from the inspection teams and aerial photographs taken after the earthquake by New Zealand Aerial Mapping).

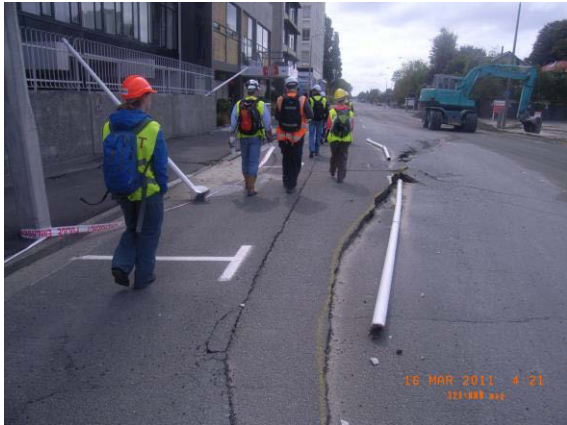
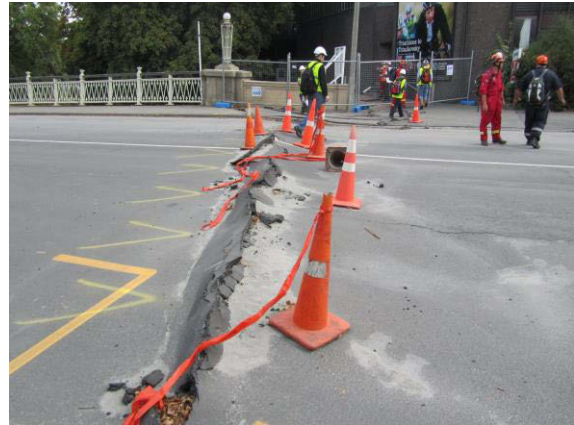
Figure 93 Compression ridges and tension Cracks

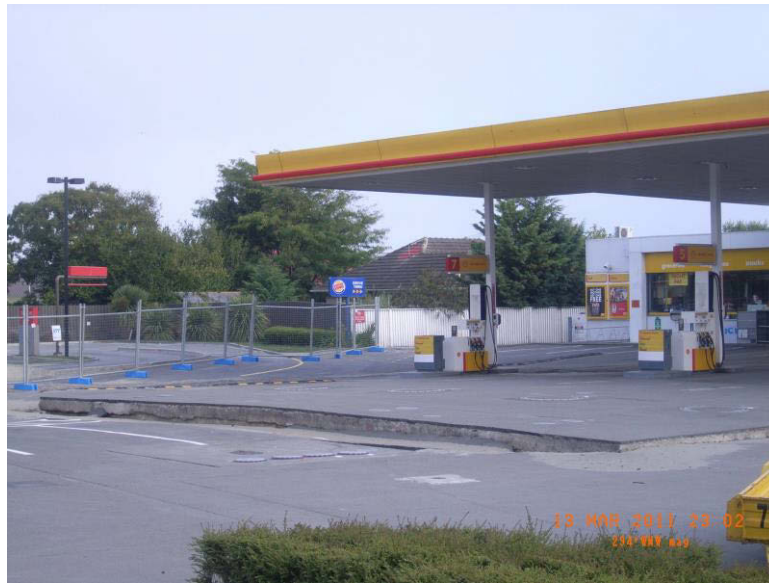
Figure 95 Floatation of a petrol storage tank

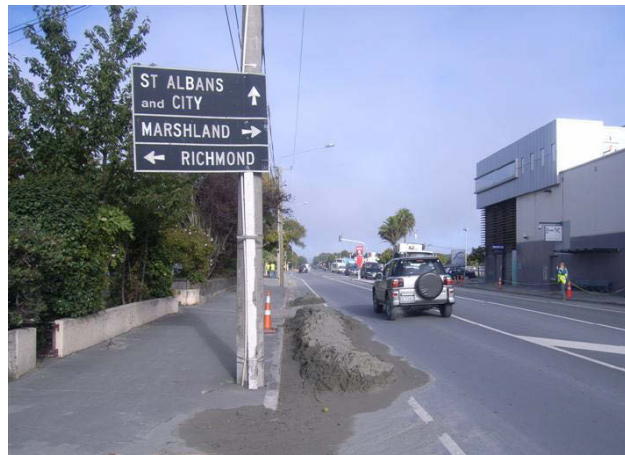
Figure 96 Place and street names reflect that Christchurch was built on low-lying swampy ground

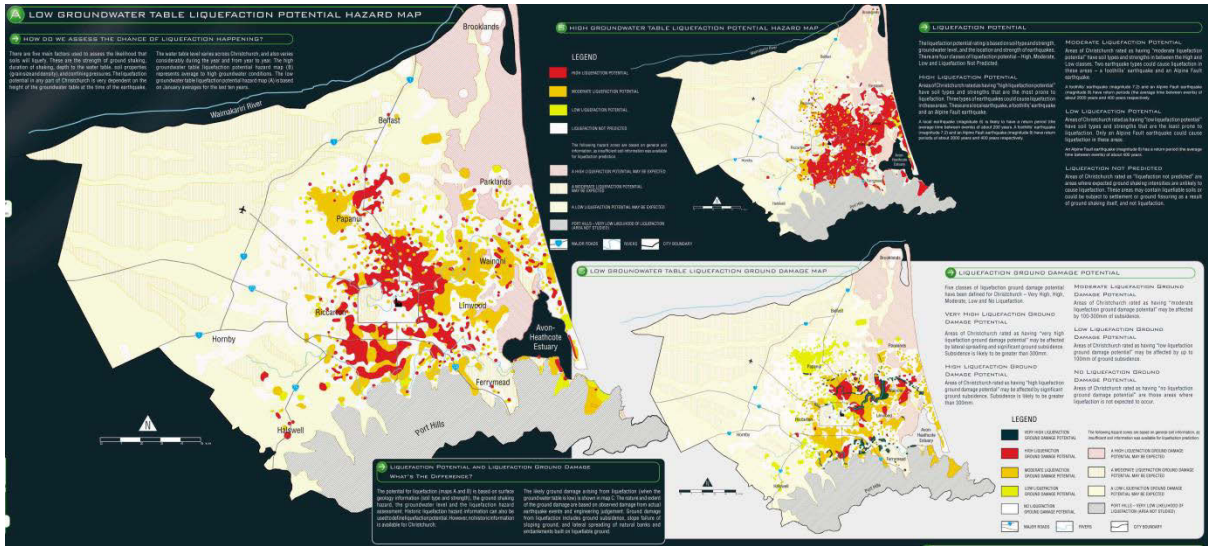
Figure 97 Liquefaction potential hazard maps (from ECan, 2004)

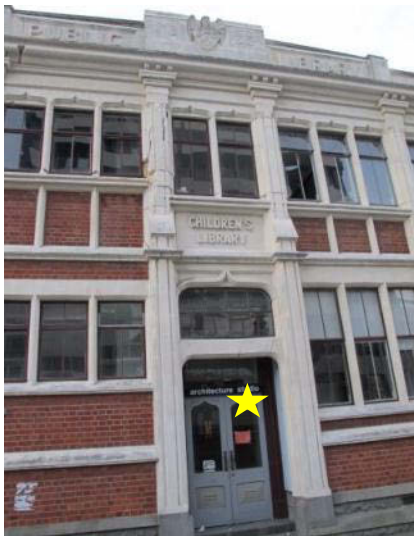
Owners of lightly damaged green placarded buildings were directed to the Earthquake Commission (EQC) whereas owners of yellow or red placarded residential buildings were advised to contact the Christchurch City Council to arrange structural checks by Chartered Professional Structural Engineers. Commercial building owners were advised to directly contact Chartered Professional Structural Engineers for detailed structural assessments.

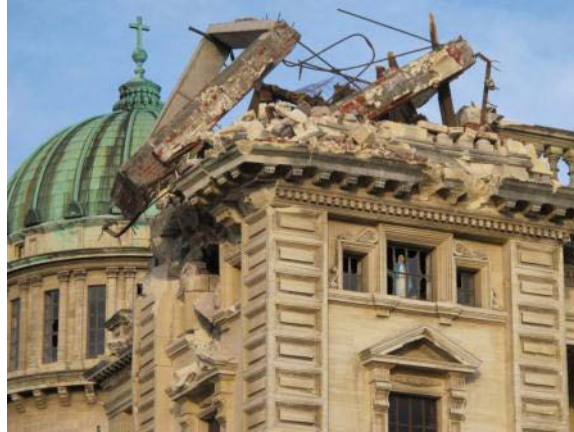
Figure 102 – One of Christchurch’s most notable heritage buildings, the Cathedral of the Blessed Sacrament, built in 1905. The cathedral was closed for repairs and seismic strengthening after the 4 September earthquake. The 22 February earthquake put the building on the demolition list.

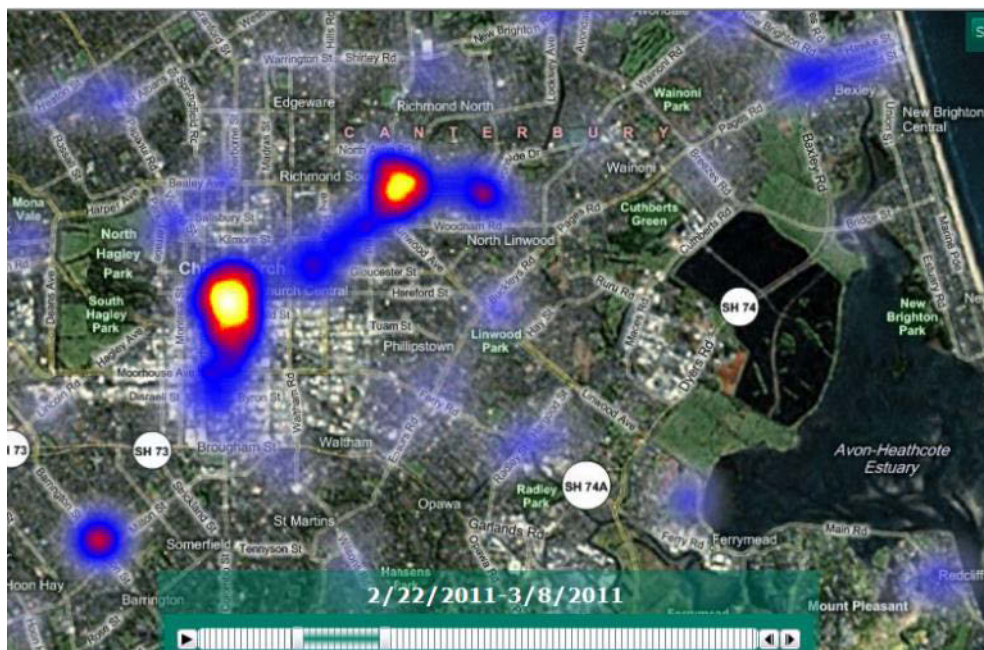
Figure 103 – Ushahidi trend information filtered by ‘hazard’ category between the dates of 22nd February to 8th March. The yellow and red hot spots indicate high activity (Source: www.eqviewer.co.nz)

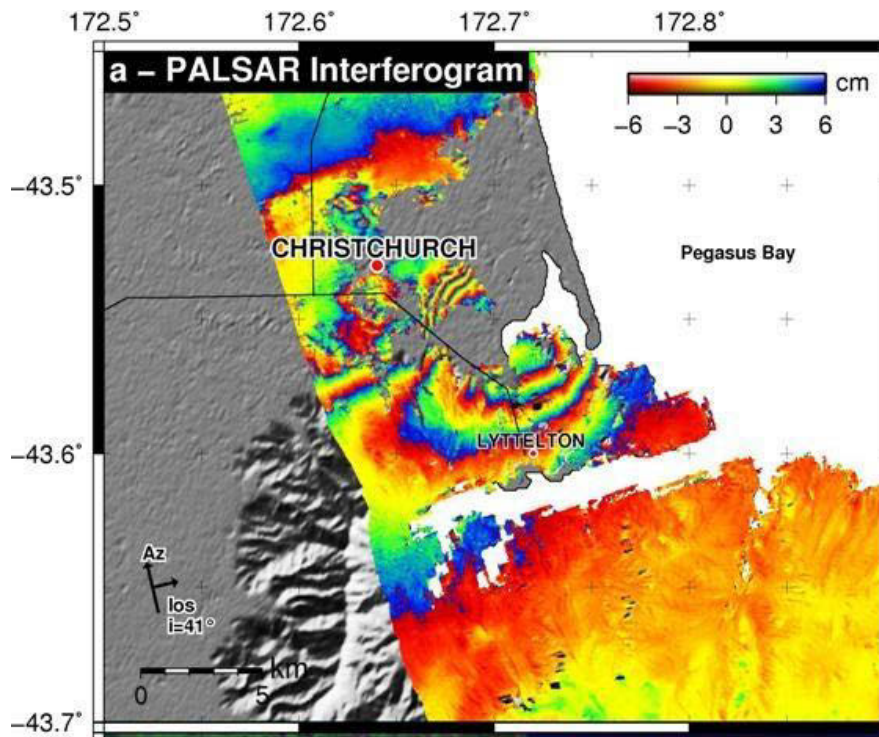
Figure 104 – InSAR showing that the peak ground motion was almost 50 cm of motion towards the satellite
(Source: Elliott, Zhenhong, Parsons, 2011)

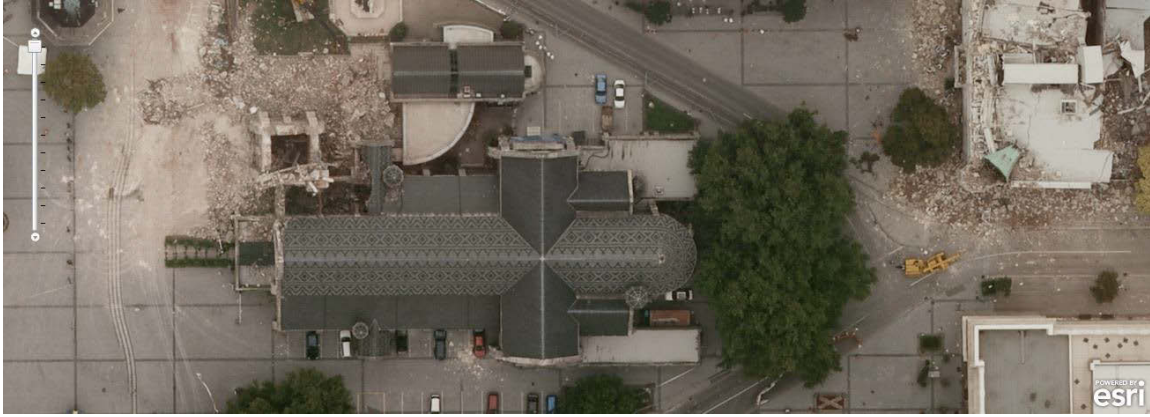
Figure 105 – Damage and debris around the Christchurch Cathedral (Source: NZAM, 2011 Creative Commons Attribution 3.0 NZ)

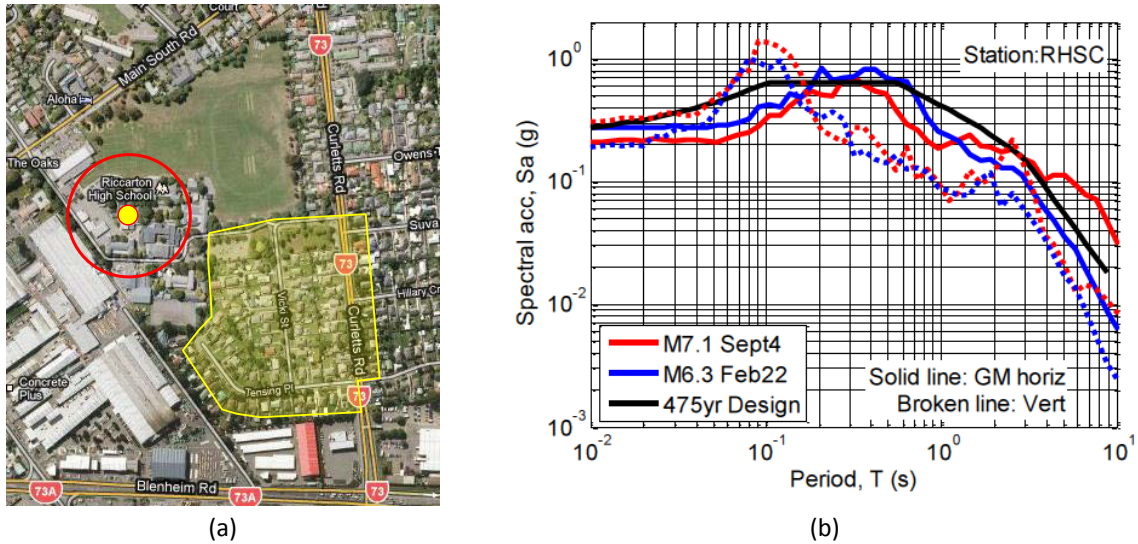
Figure 106 – Riccarton High School accelerometer (a) location of station (yellow circle), 90-m radius around station (red circle) and survey area (yellow area) (marked up Google Maps image); (b) response spectra (Bradley, 2011).

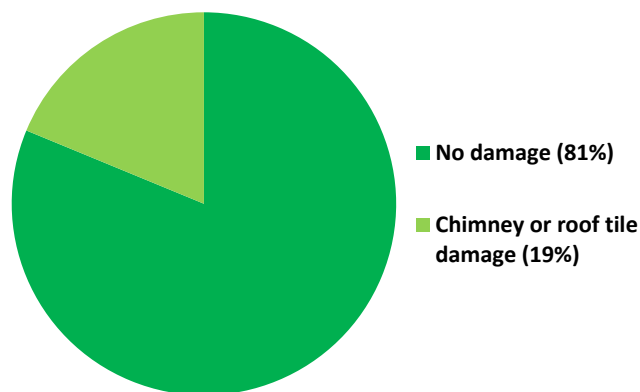
Figure 107 – Observed damage statistics for residential buildings in Riccarton High School study area.

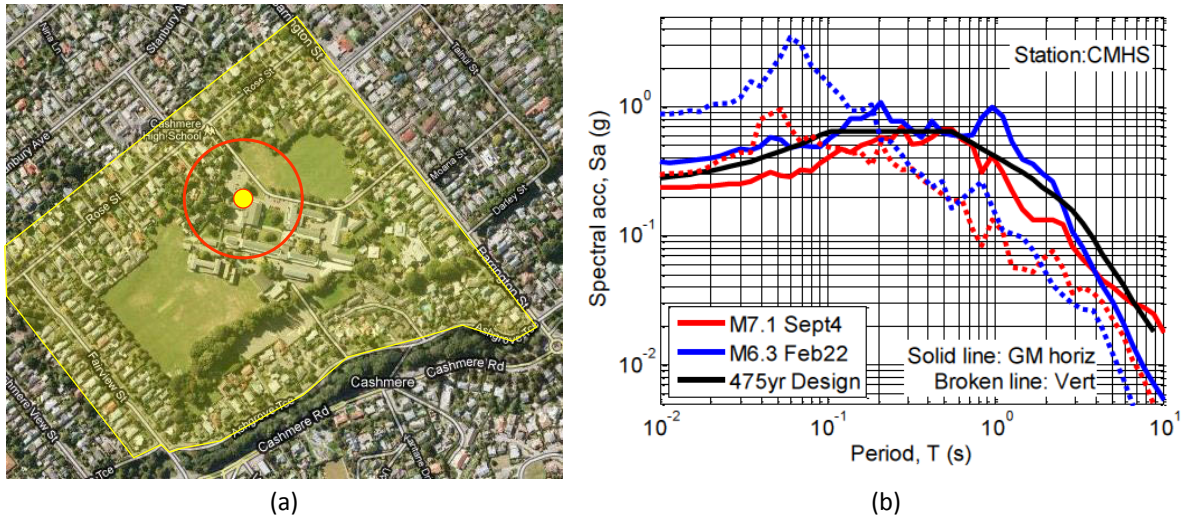
Figure 108 – Christchurch Cashmere High School accelerometer (a) location of station (yellow circle), 90-m radius around station (red circle) and survey area (yellow area) (marked up Google Maps image);(b) response spectra (Bradley, 2011).

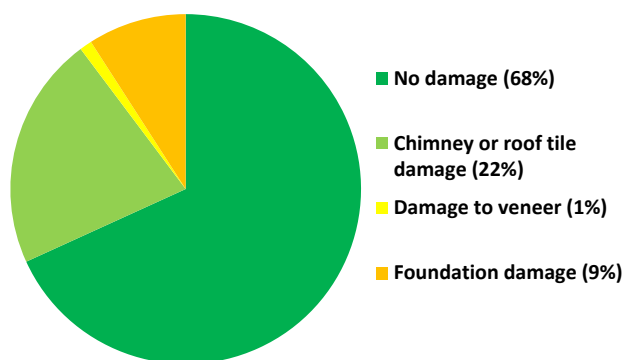
Figure 109 – Observed damage statistics for residential buildings in Christchurch Cashmere High School study area.

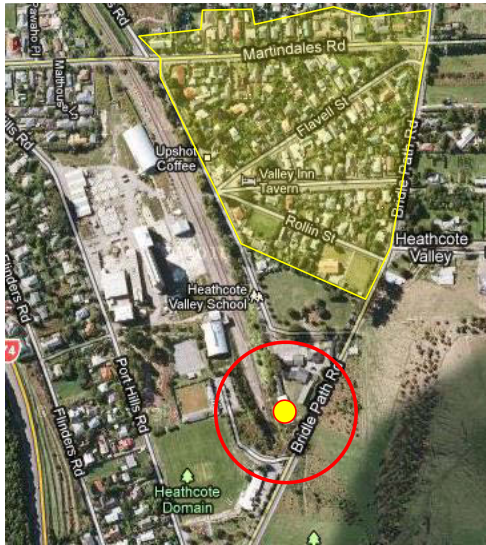
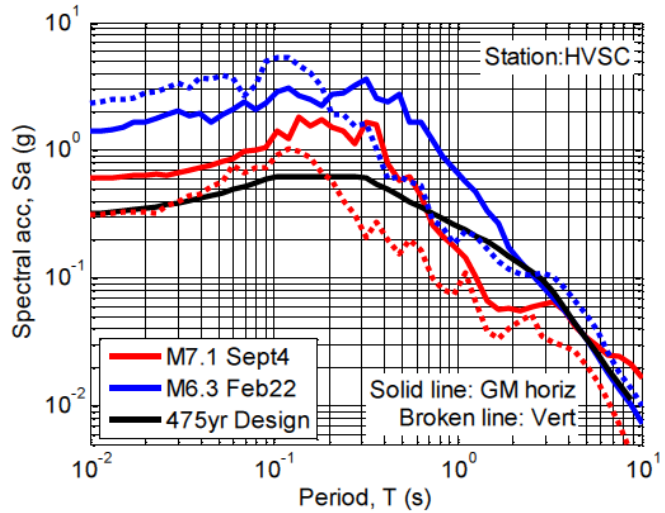
Figure 110 – Heathcote Valley School accelerometer (a) location of station (yellow circle), 90-m radius around station (red circle) and survey area (yellow area) (marked up Google Maps image);(b) response spectra (Bradley, 2011).

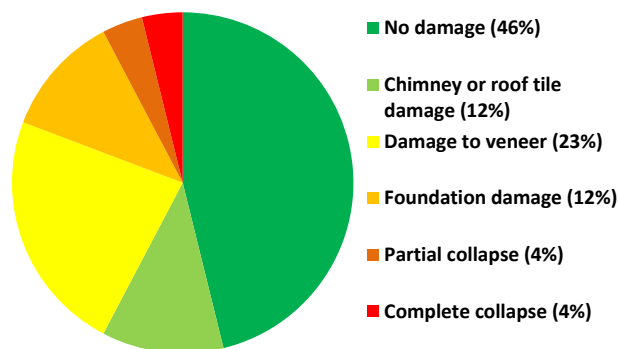
Figure 111 – Observed damage statistics for residential buildings in Heathcote Valley School study area.
