Learning from failures

J. C. Chapman,
FREng, FCGI, BSc,
PhD, FIMStructE, FICE,
FRINA
*Chapman Associates /
Imperial College of
Science, Technology &
Medicine*

Synopsis

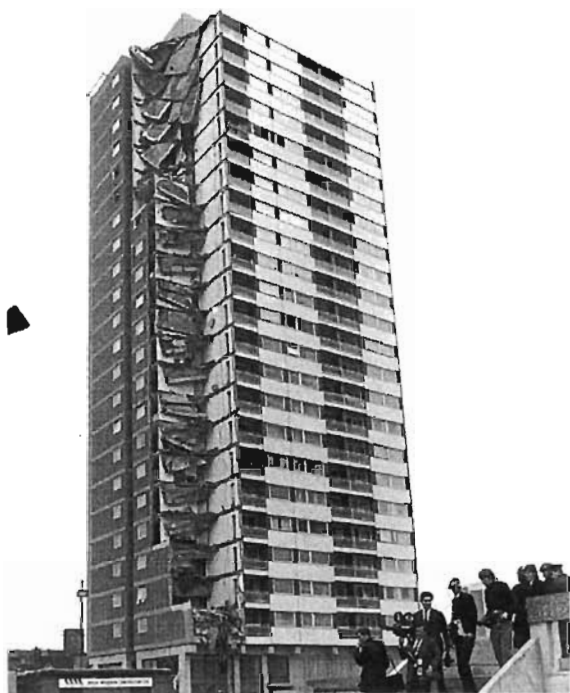
Fig 1. Ronan Point

The cause and nature of collapse was fully reported⁴, but is worth revisiting. Ronan Point was a 22-storey block of flats, constructed from precast wall and floor units. A gas explosion occurred on the 18th floor early one morning, and, because the connection between walls and floors failed, the corner wall units peeled away from the slabs. The slabs were then supported only on two adjacent sides (Fig 1), and falling slabs contributed to the failure of slabs below. The number of people killed was remarkably small.

The connections lacked the strength and ductility that could have resisted the explosion for a sufficient time to enable venting to occur through the double glazing of the windows. Also, they were unable to prevent the progressive collapse which occurred as a result of the local failure.

(5) As a result of the failure and collapse, the regulations were promptly modified to take account of explosions and progressive collapse.

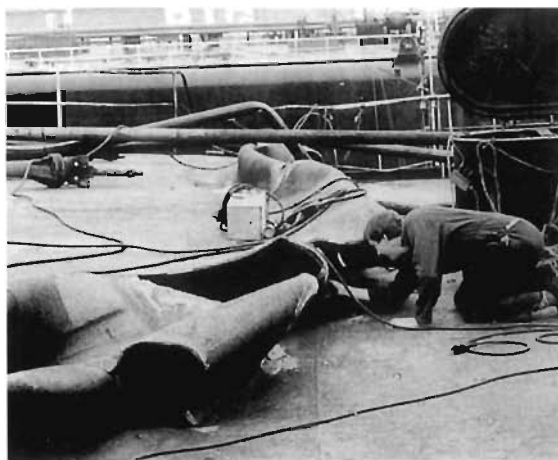
Fig 3. Failure of ship's deck

A tanker was proceeding under pilot's control up an estuary with a navigation channel that was maintained by dredging. The crew noticed a buckle which spread across the deck and down the ship's side. The amplitude of the deck buckle was about 600mm (Fig 3), and the plating had separated from the stiffeners. The failure was caused by the ship momentarily touching bottom, but the deceleration that must have occurred was so slight that it had not been felt by the crew. The buckling of the ship's side caused oil spillage and pollution along the shores of the estuary. When the ship entered dry dock, local scuffing of the bottom shell confirmed that the ship had touched bottom.

The deck was stiffened by bulb flats attached by intermittent welding. It appeared that torsional buckling (tripping) had occurred, and because the weld was insufficient to resist the transverse moment capacity of the stiffener web, the weld had failed and the plating was then unrestrained by the stiffeners. The connection had been adequate for normal loading but insufficient for the accidental (though not uncommon) loading that occurred.

(1) It would be prudent, where exceptional loadings are possible and where the consequences of failure are severe, to design the weld to resist the fully plastic transverse moment capacity of the web.

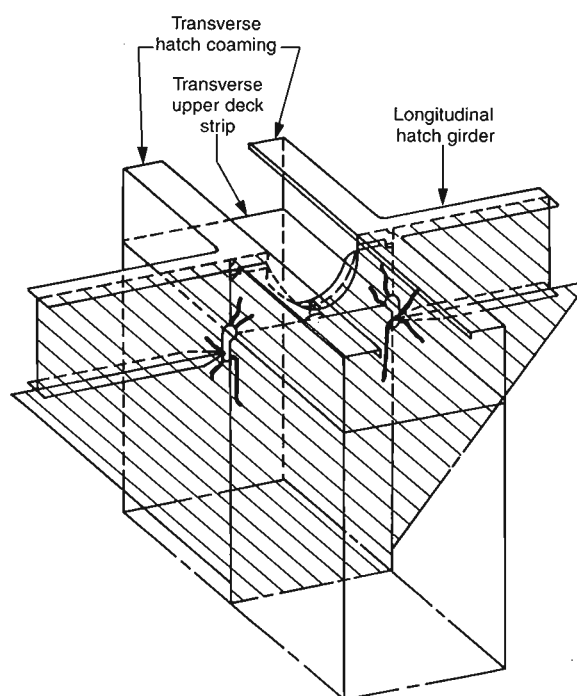
Fig 4. Fatigue cracks in 213m-long container ship

A class of six container ships, 227m long, which entered service in 1969, developed fatigue cracks at the ends of hatch side-girders which were detected after the first voyage⁸. The cracks developed further in subsequent voyages

(Fig 4) but had not extended into the deck plate. The cracking occurred at a discontinuity between hatch girders (curtailment assisted access) and was also attributed to the bow flare, which dispersed the bow wave (the design speed was 22knots) and protected the on-deck containers, but increased the hull bending moment.

A rather radical solution was suggested which was accepted and implemented. The hatch girders were made continuous (so the crew had to climb over) and the ship's sides were continued upwards to a wide bracketed flange which reduced the hull bending stress, increased the stiffness, and enabled additional containers to be carried, with access below. No further cracking occurred.

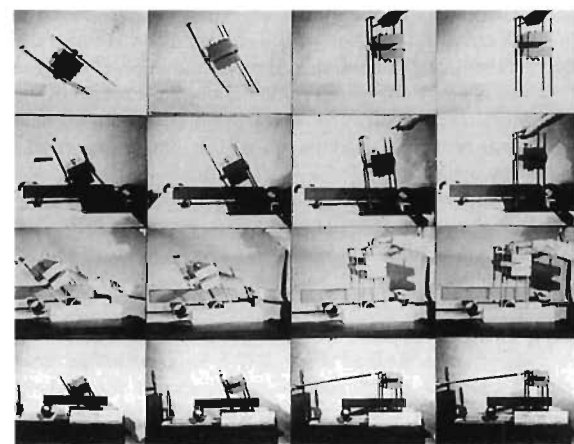
Fig 7. Model of jack-up barge demonstrating mode of failure

A scale model (with ductile legs) was made and taken to the court room, where it was demonstrated that sideways following tie bar failure caused failure of ductile legs, so the collapse could not be attributed to the brittleness of the legs (Fig 7). This had major contractual implications, but, more importantly, it revealed a feature of the design that would need to be taken into account in a risk assessment.

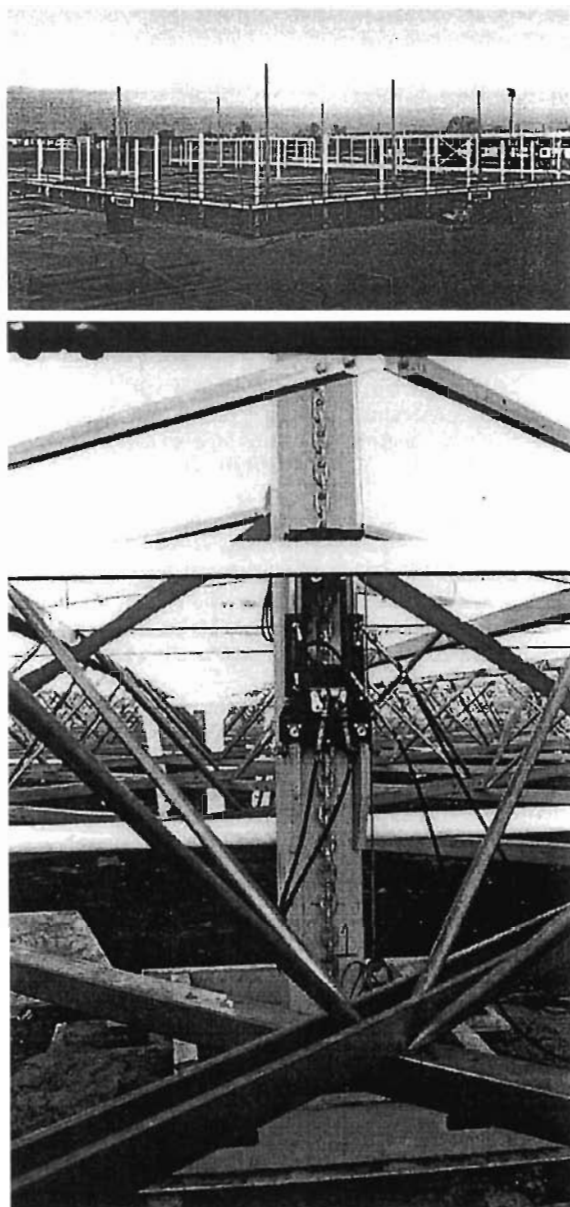
Fig 9. Chain lifting columns

A spaceframe roof structure was being raised by chains supported by six lifting columns. Centrally controlled, hydraulically actuated latches engaged in the chains and ensured that equal vertical displacements were applied at each lifting column. The force in each chain was known from the hydraulic pressure. When the roof was partly lifted, a chain link broke in two, and one piece travelled 50m; the structure was badly damaged. The chain of the adjacent column was then carrying 2.6 times the load carried by the failed chain, but was undamaged. When the

roof was being lowered, a link in another chain failed whilst carrying a load smaller than that at which the first chain failed. The roof was then supported by four chains, none of which failed. The system had been successfully used on a previous occasion (Fig 9).

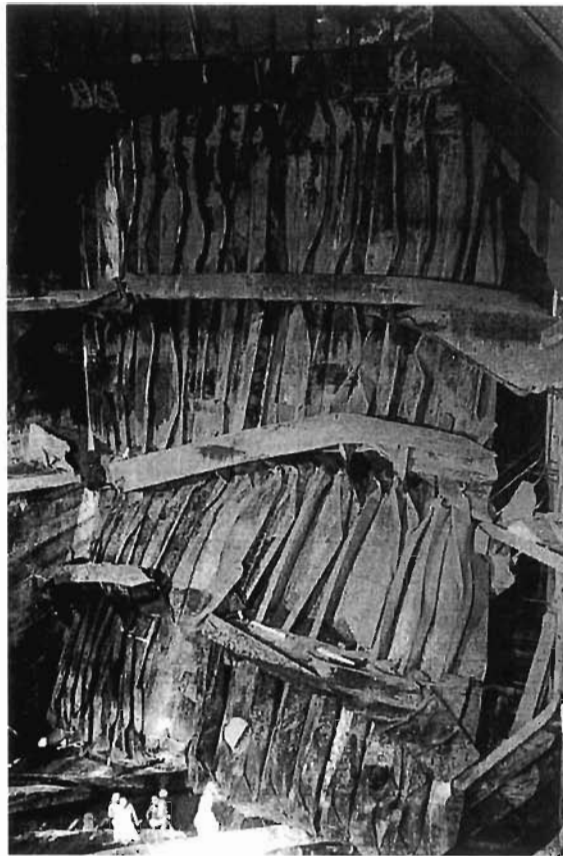
Fig 10. Collapsed ship's bulkhead

Investigation showed that poor fit-up at the junction between the transverse bulkhead, the longitudinal bulkheads, and the bottom plating, had been remedied by the insertion of welding rods and other pieces of steel. Also, the penetration was generally poor: in many areas, the bulkhead, which was nominally 23mm thick, had pulled out, leaving the fillet welds on each side of the plate intact. This did not explain why failure occurred in calm water, having survived seagoing accelerations. There was no evidence that the tank had been over-pumped, and also the failure was said to have occurred 2h after completion of pumping. There was said to be little corrosion, although corrosion is a known problem in tankers⁹.

The piece of bottom plate, 28mm thick, which was found several metres away, was approximately semi-circular, the 690mm diameter coinciding with the bulkhead weld. The failure was initiated at the toe of the fillet weld, progressed by shearing around the circumference, and failed in tension at the crown. The piece had apparently been detached from the bulkhead when it struck a transverse frame. The bulkhead weld failure might have started in a region of deficient welding and progressed to the relatively well-welded region in the vicinity of the piece of bottom plate. The bulkhead weld might have suffered low-cycle fatigue cracking, caused by fore and aft flexing as the ballast and oil tanks were alternately filled, and perhaps high-cycle fatigue, caused by vertical and longitudinal accelerations. Having spread across the bottom of the tank, mostly at the butt weld between the bulkhead plating and the insert plates between the longitudinals, the tearing continued up the attachments to the longitudinal bulkheads. It seems unlikely that the transverse bulkhead would have pulled out the piece of bottom plate unless the bottom plate had suffered some damage. It is possible that fatigue cracking at the weld toe had penetrated into the bottom plate, but that was not revealed by the subsequent examination.

The welding was certainly deficient, and there were important welding deficiencies elsewhere in the structure. It seems unlikely that failure would have occurred if the welding had been satisfactory. Poor welding was the only clear reason that emerged to explain the failure.
