THE MEXICAN EARTHQUAKE OF 19TH SEPTEMBER 1985

A FIELD REPORT BY EEFIT

### Summary of EEFIT's conclusions

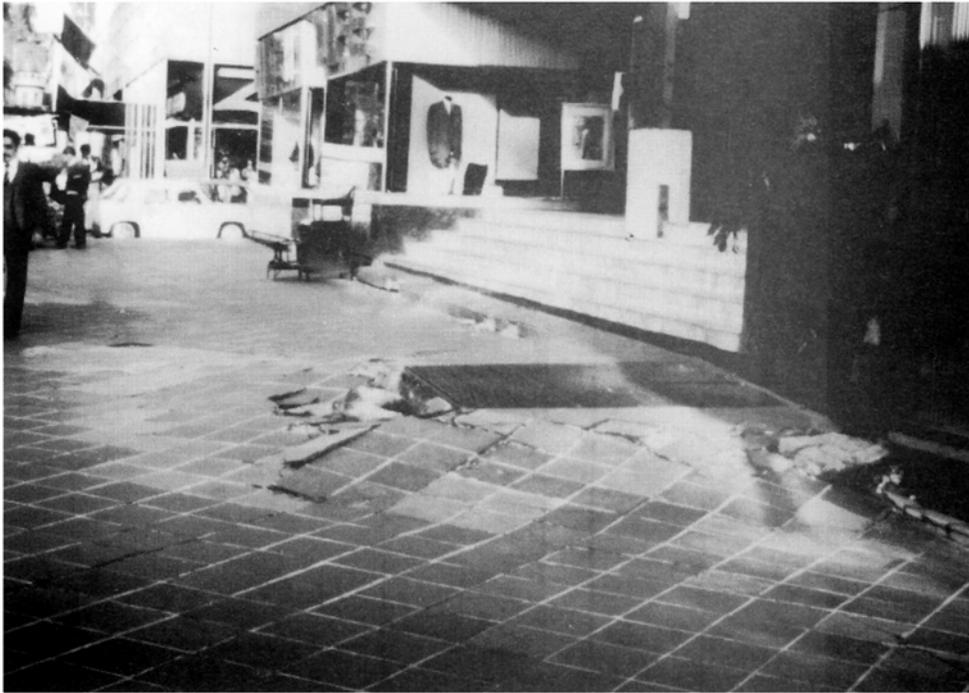
PLATE 3.5

Slight Emergence Damage (Site 28)

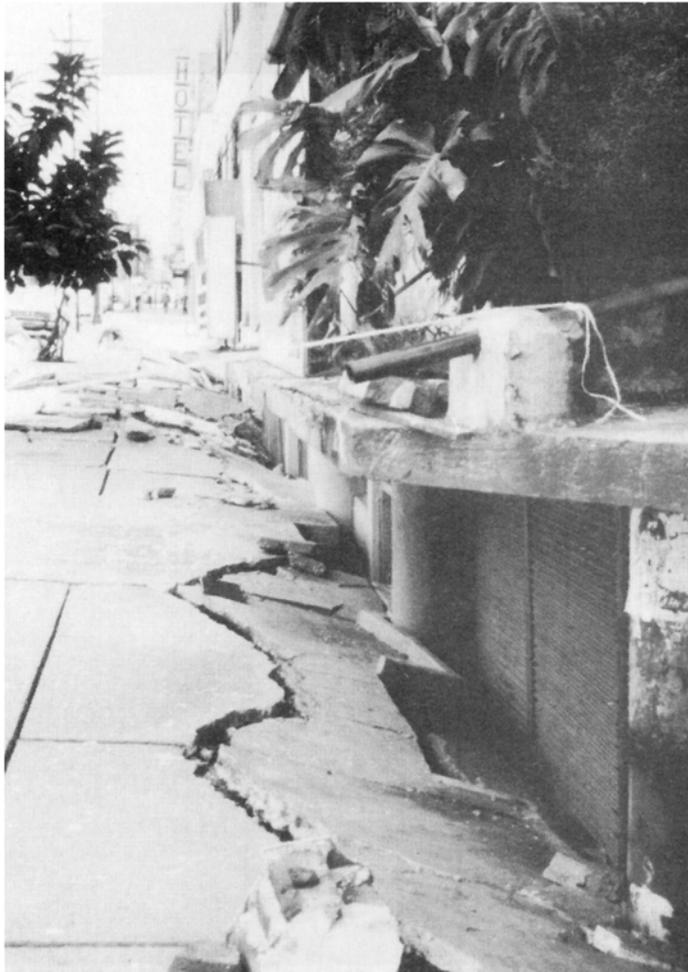
PLATE 3.6

Settled Building (Site 74)

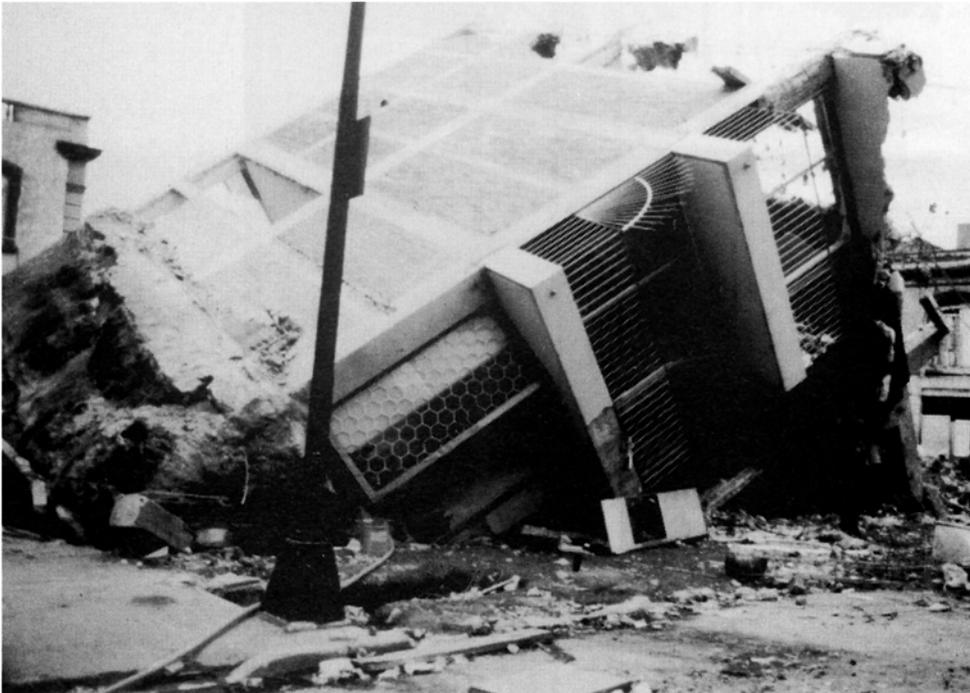
PLATE 3.8

Foundation Failure by Rotation (Site 78)

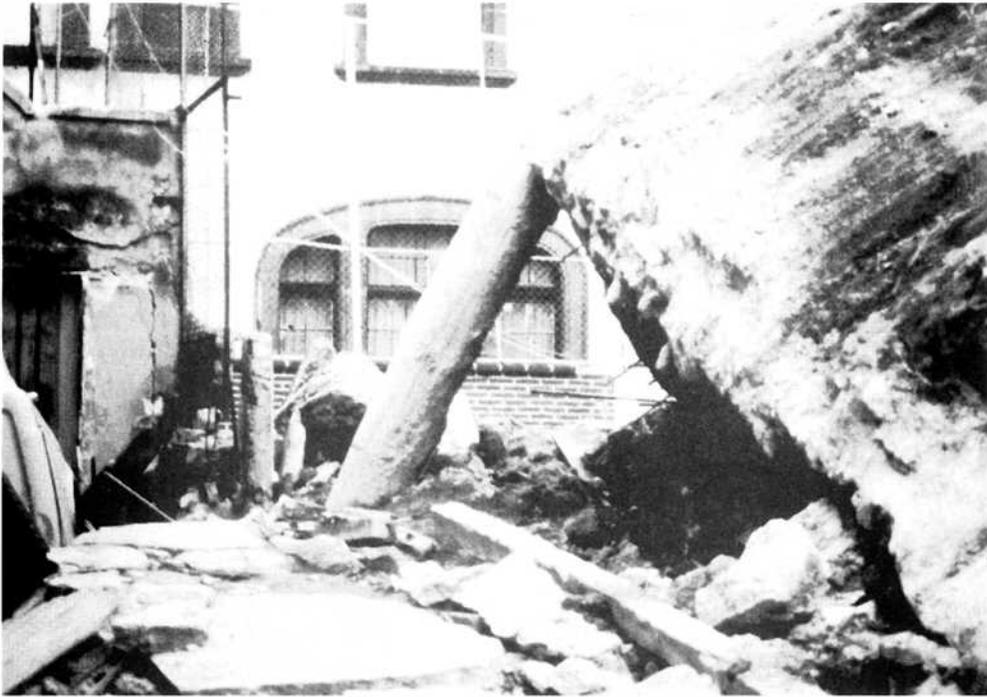
PLATE 3.9

Foundation Failure by Rotation showing extruded pile (Site 78)

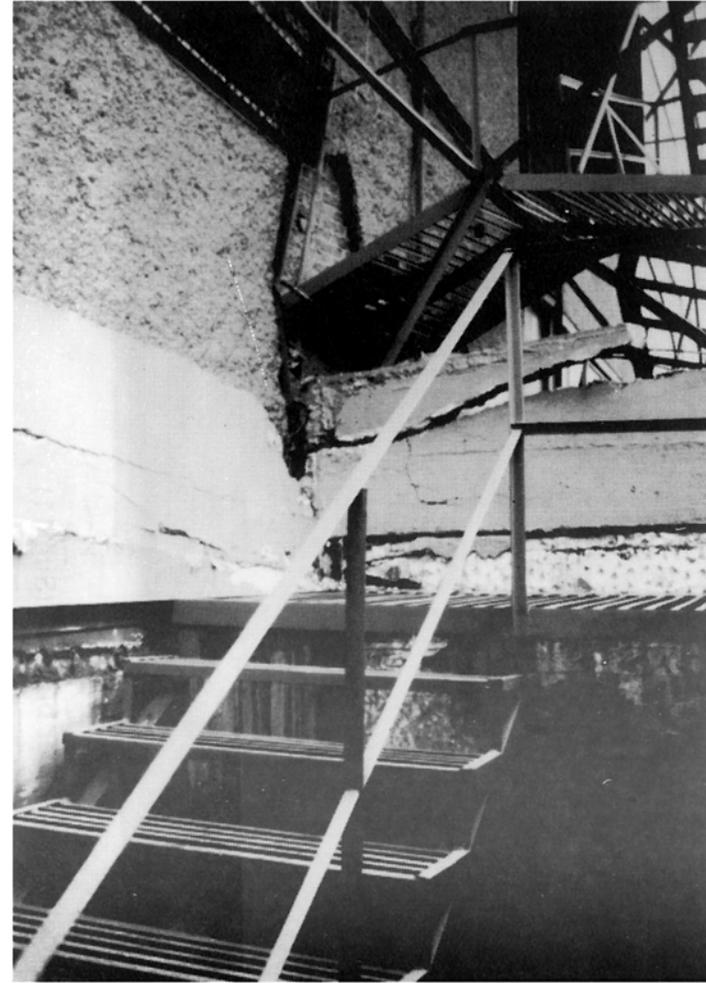
PLATE **3.14**

Staircase - Structural damage at joint of eleven and four storey building (Site 87)

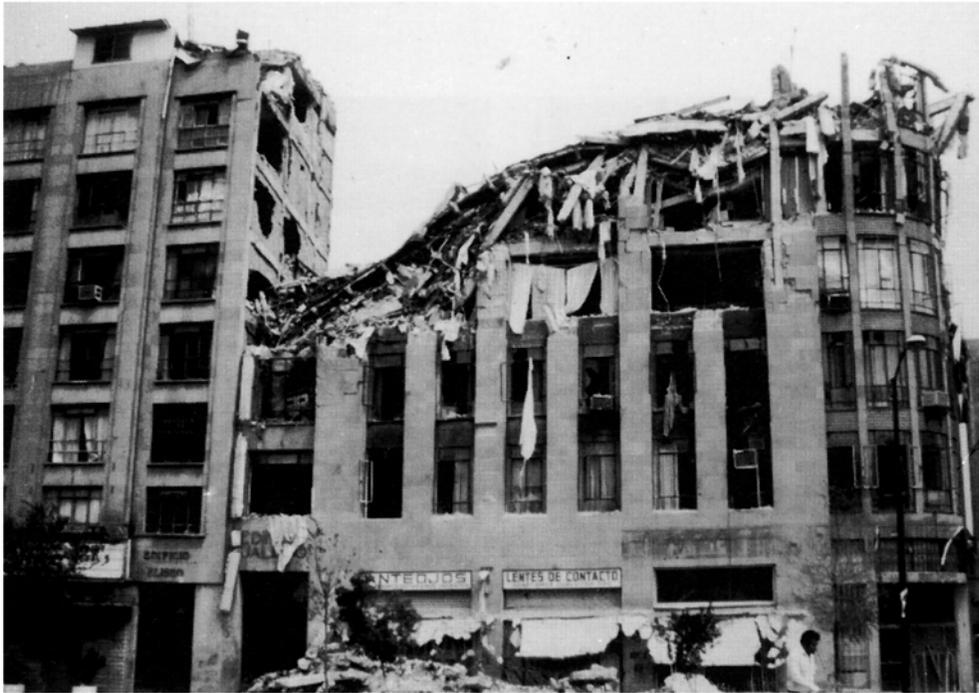
PLATE **3.15**

Top down collapse of older building (Site 11)

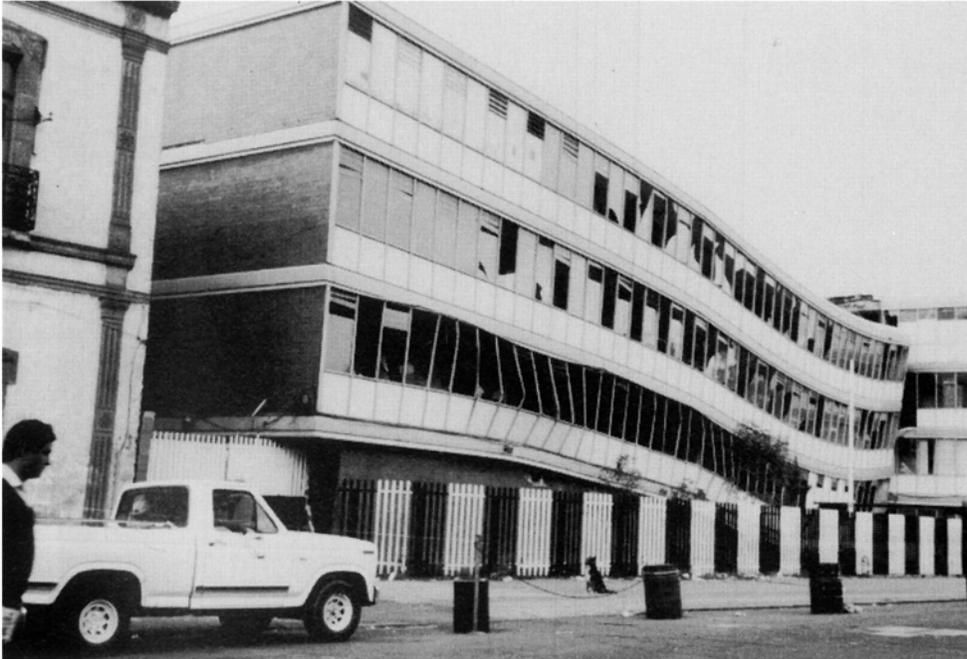
PLATE 3.19

Soft ground floor failure, reinforced concrete building (Site 37)

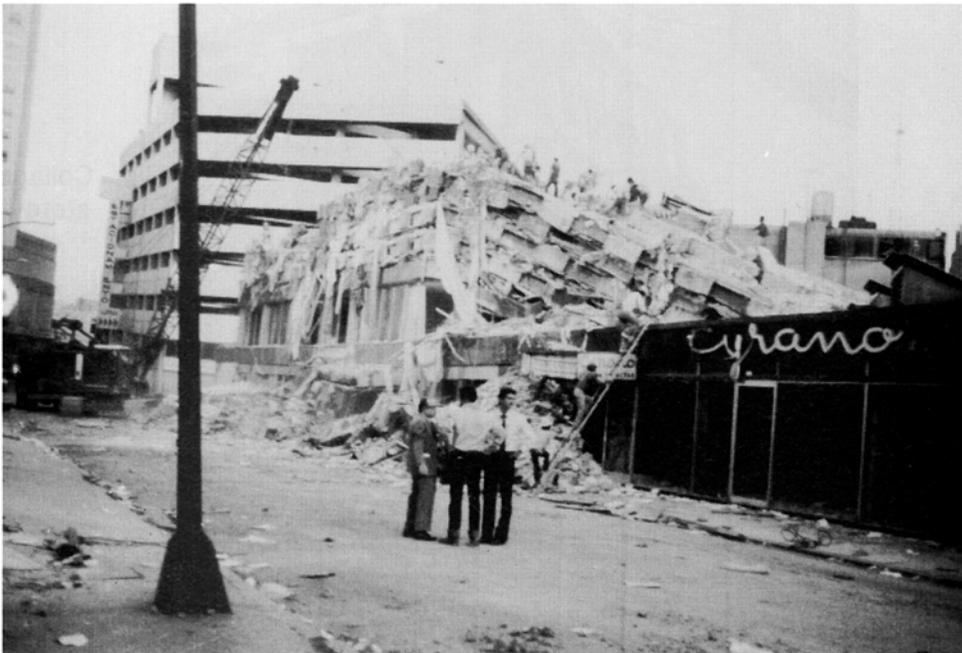
PLATE 3.20

Total pancake collapse (Site 36)

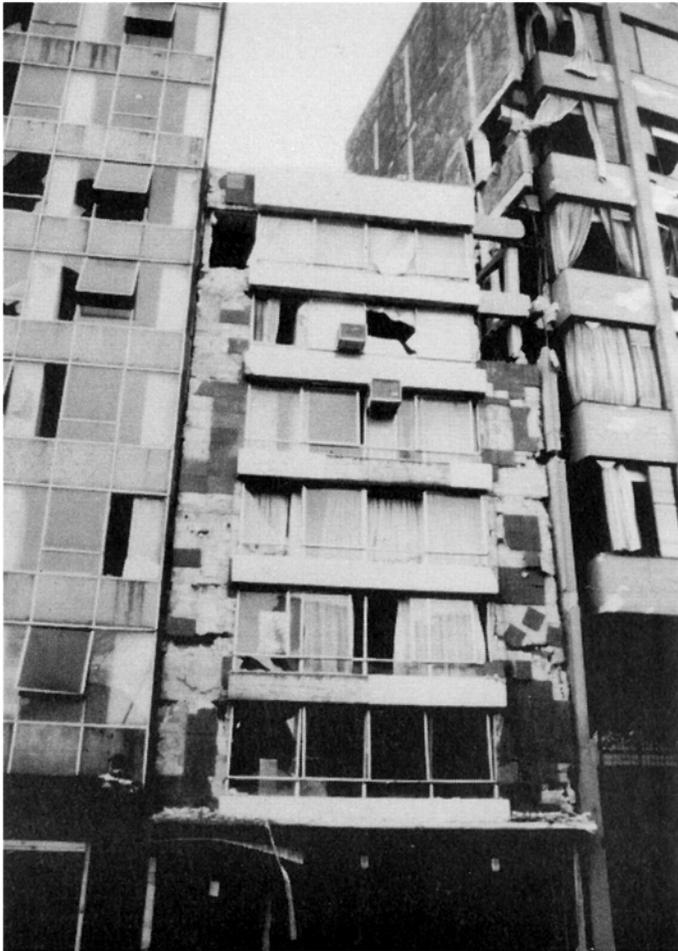
PLATE 3.21

Non-failure in adjacent structures of dissimilar height (Site 24)

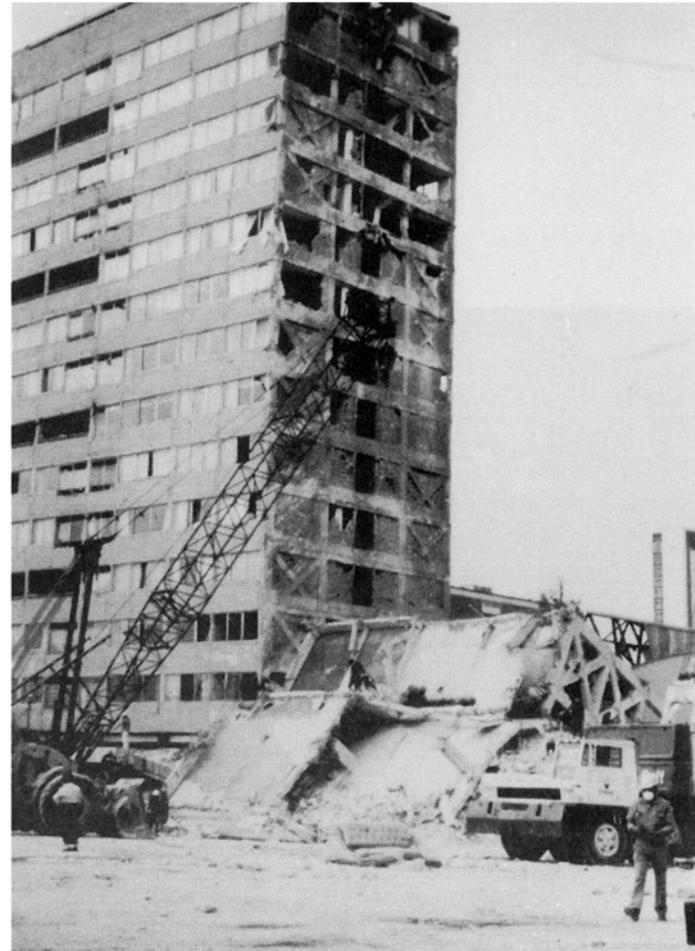
PLATE 3.22

Failure of reinforced concrete x-braced Nuevo Leon Building, Tlatelolco estate (Site 4)

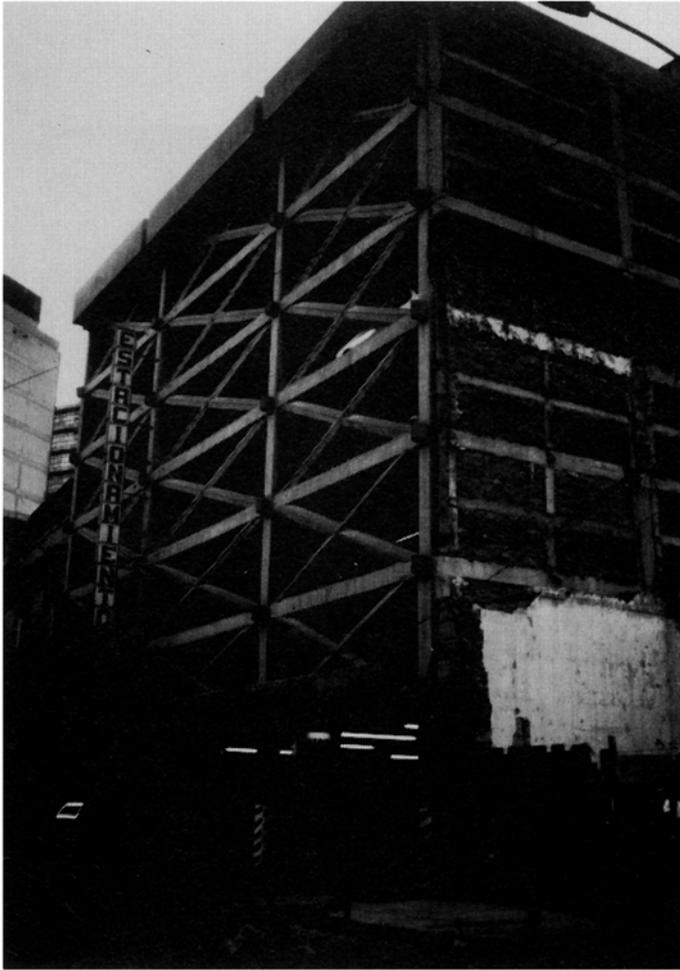
PLATE 3.23

Non-failure of vulnerable soft storey building (Site 23)

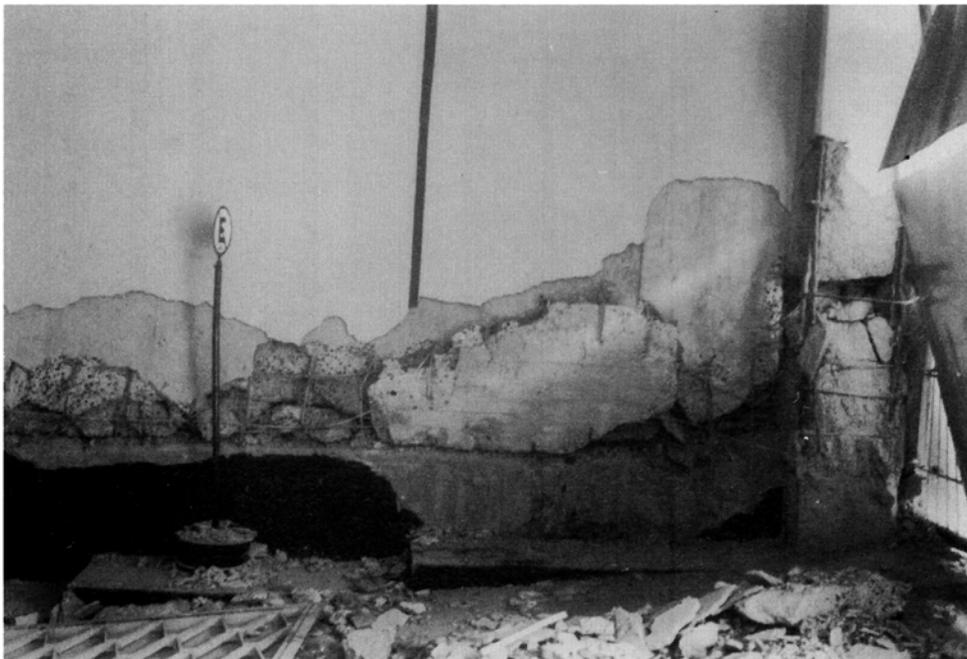
PLATE 3.24

Failure in reinforced concrete shear wall (Site 58)

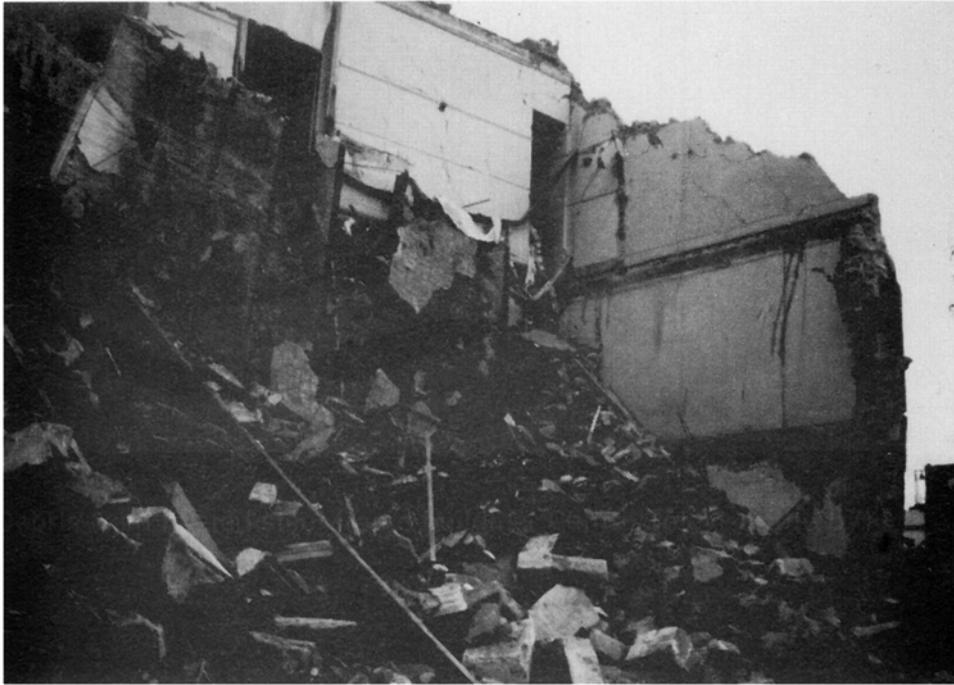
PLATE 3.25

Failure in 3 storey masonry building with steel joists (Site 30)

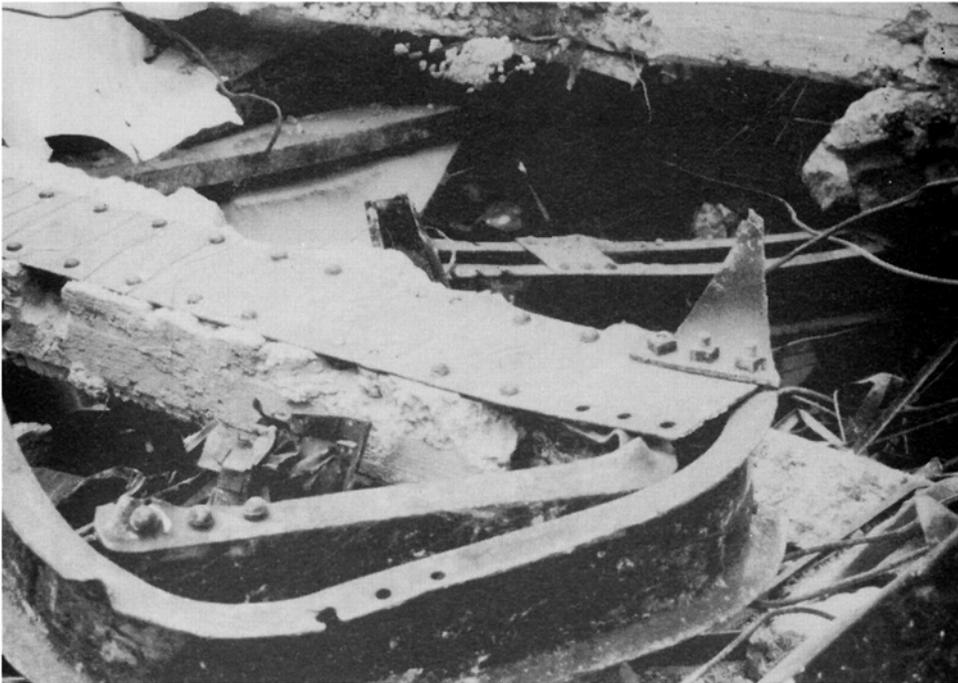
PLATE 3.26

Debris from riveted steel frame building, Centro Televisio Site 57)

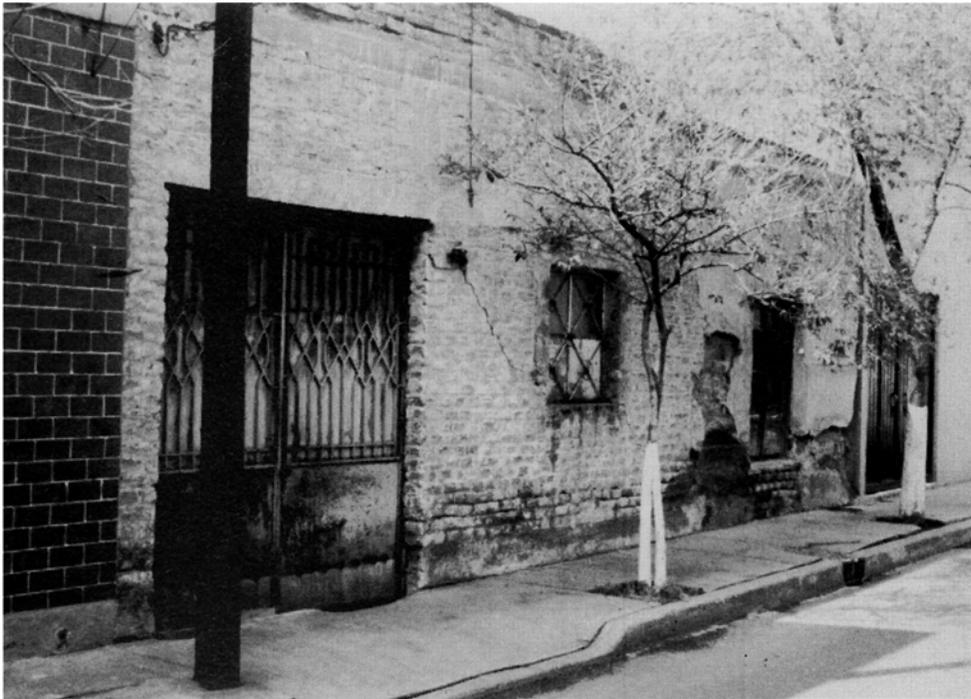
PLATE 3.28

Lightly damaged adobe/brick building (Site 2)

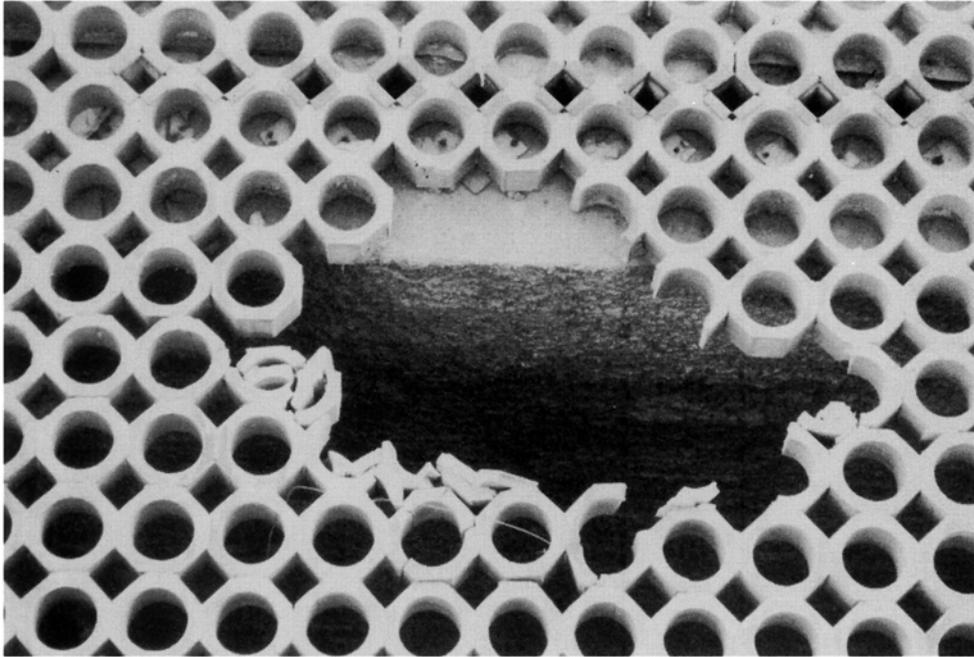
PLATE 3.31

Failure of decorative cladding, Tlatelolco estate

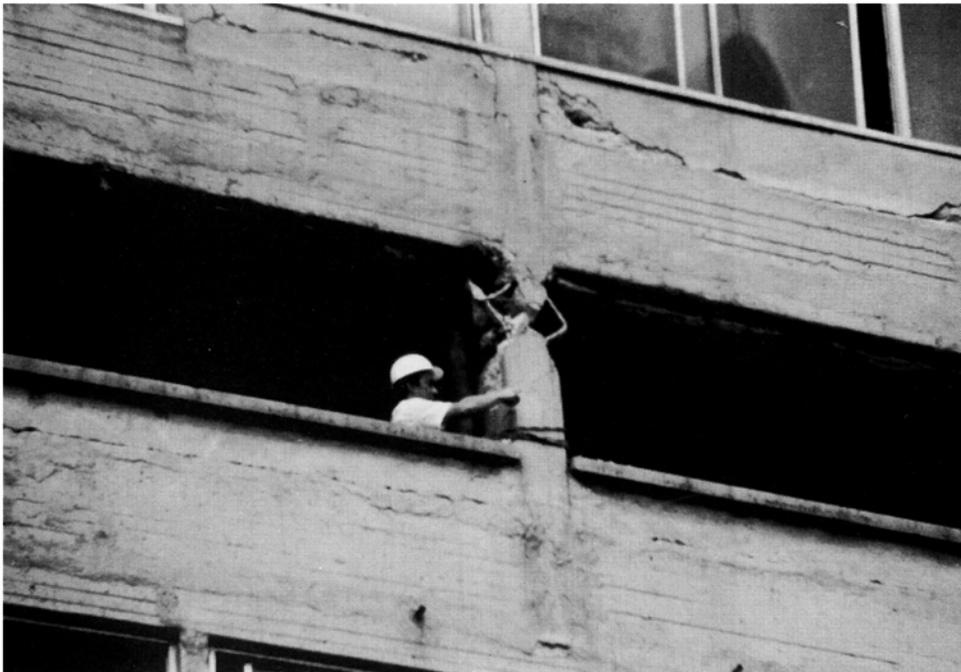
PLATE 3.32

Nuevo Leon - column failure in surviving section

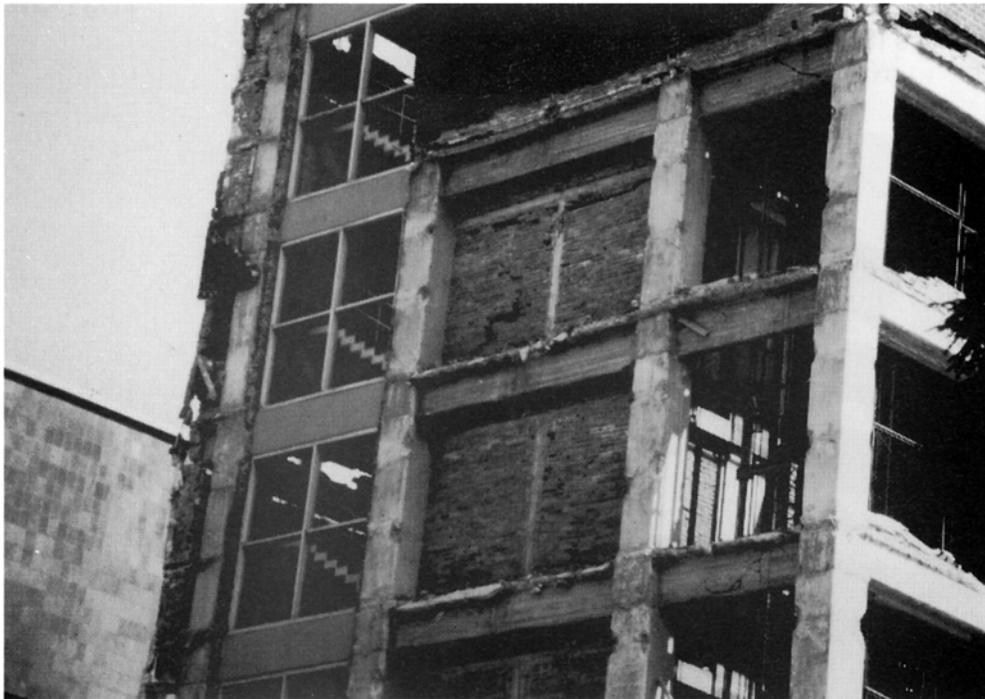
Failed infill with secondary columns and beams, Centro Medico (Site 85) PLATE **3.40**

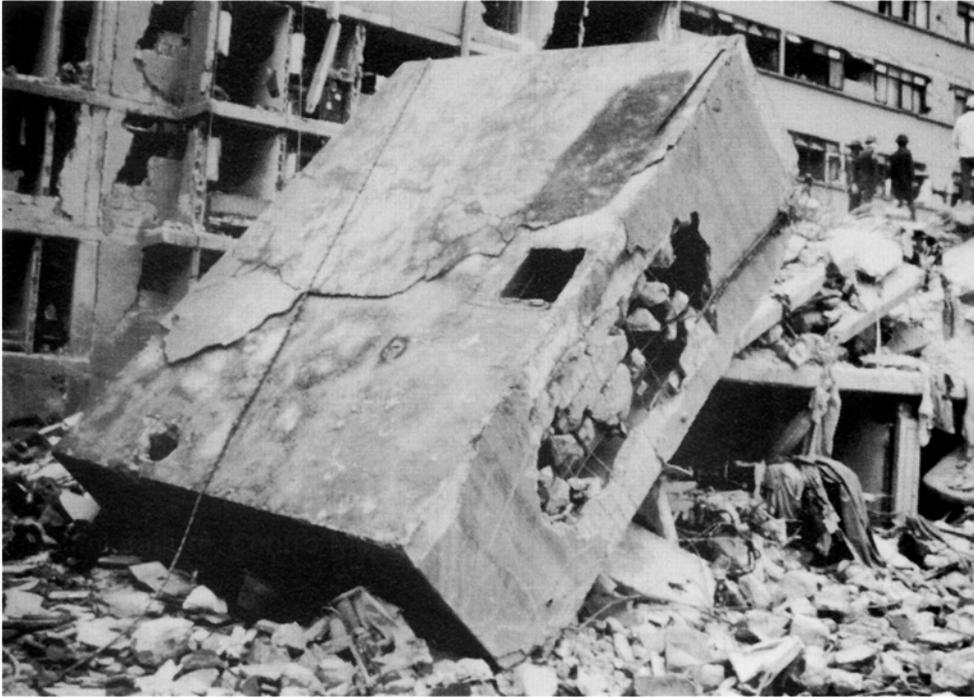
PLATE 3.41

Fallen water tank, Piazza Garibaldi (Site 6)

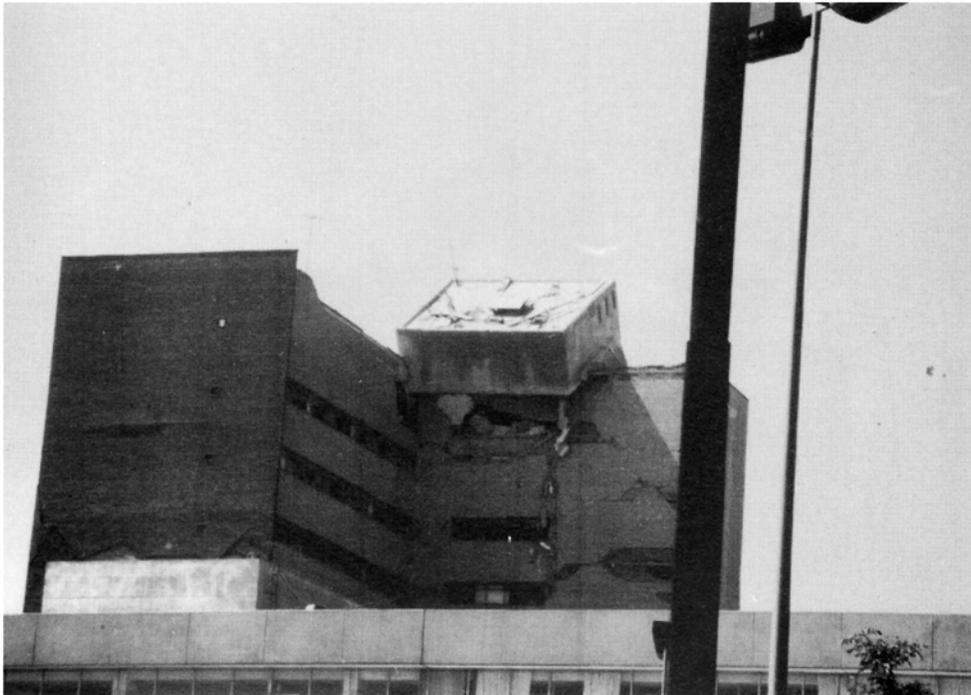
PLATE 3.42

Roof tank failure, Centro Medico (Site 85)

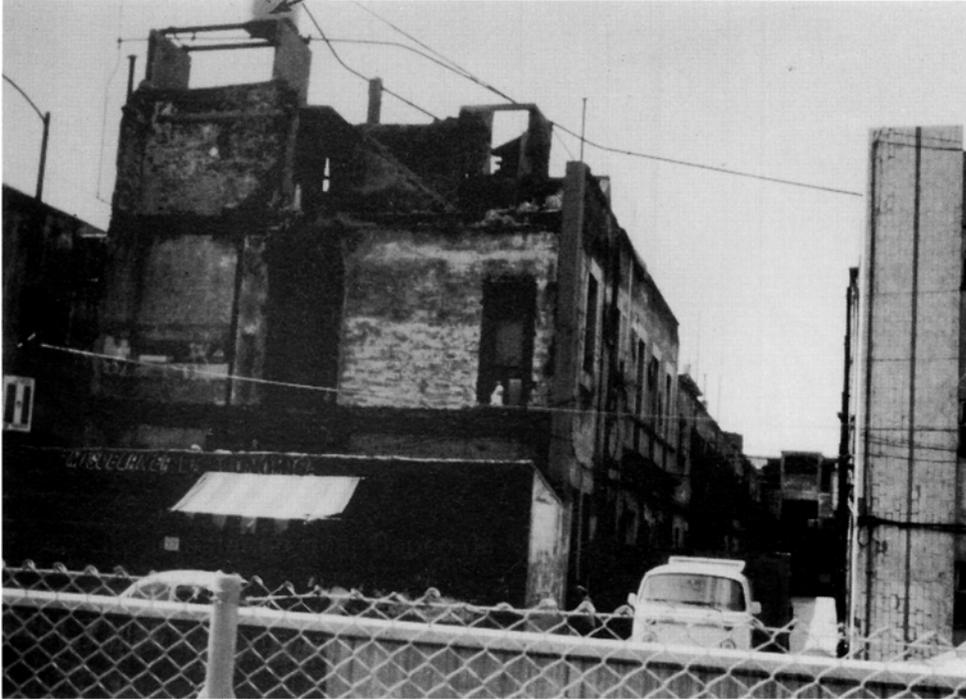
PLATE 3.43

Non-failure of roof mounted tank (Site 75)

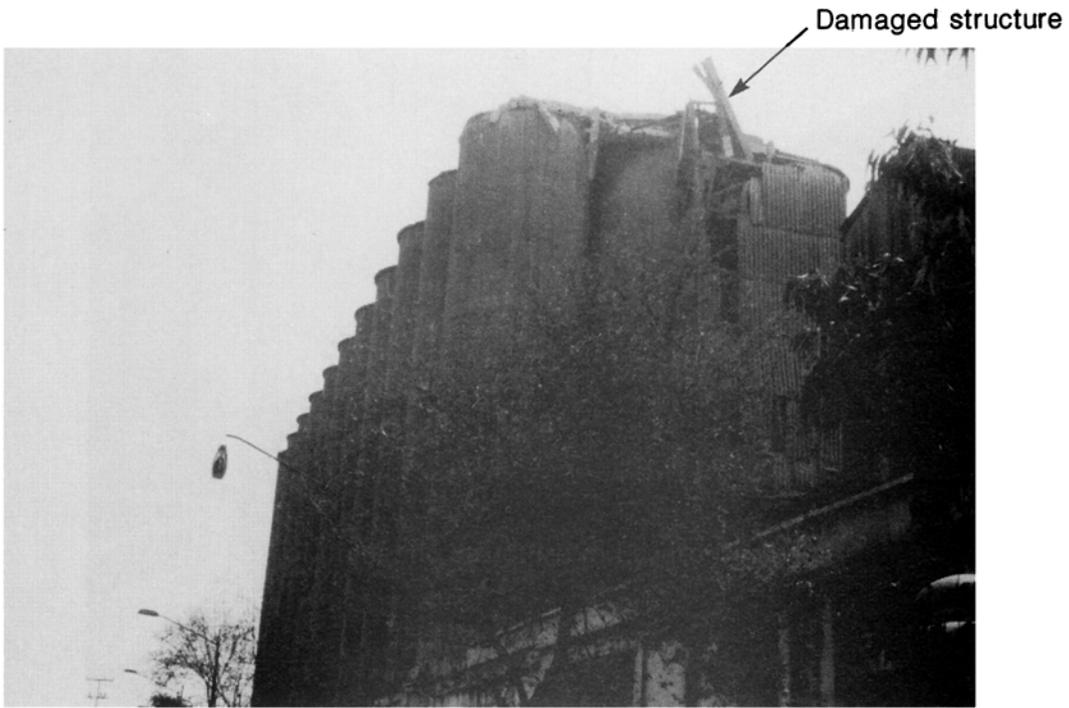
PLATE 3.45

Damage to structure on top of silos (Site 1)

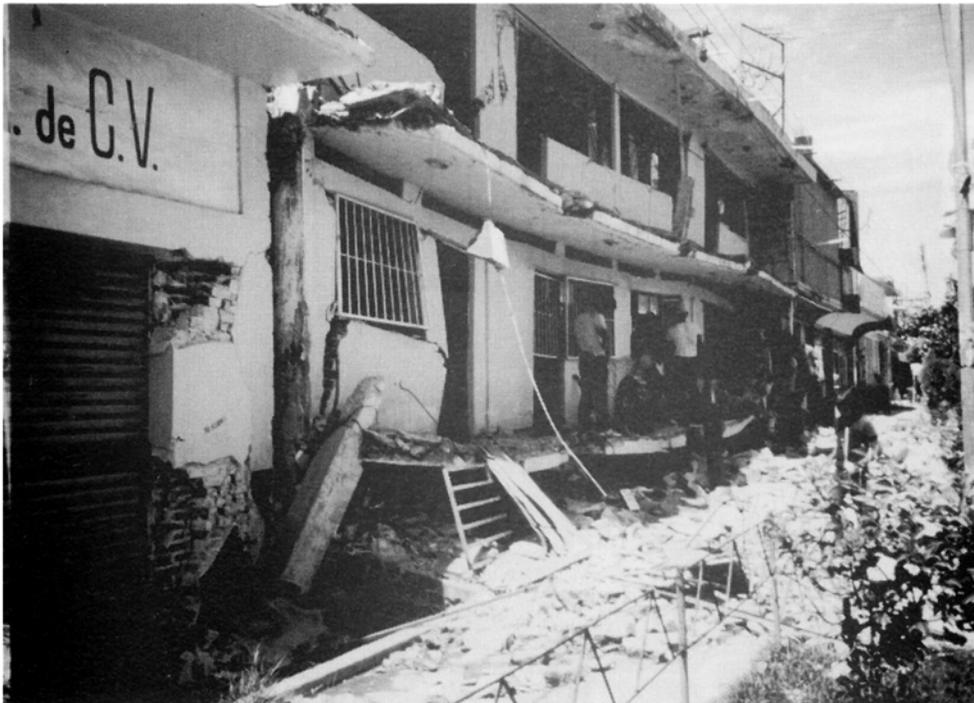
PLATE 4.1

Ground floor collapse of domestic structure in Lazaro Cardenas

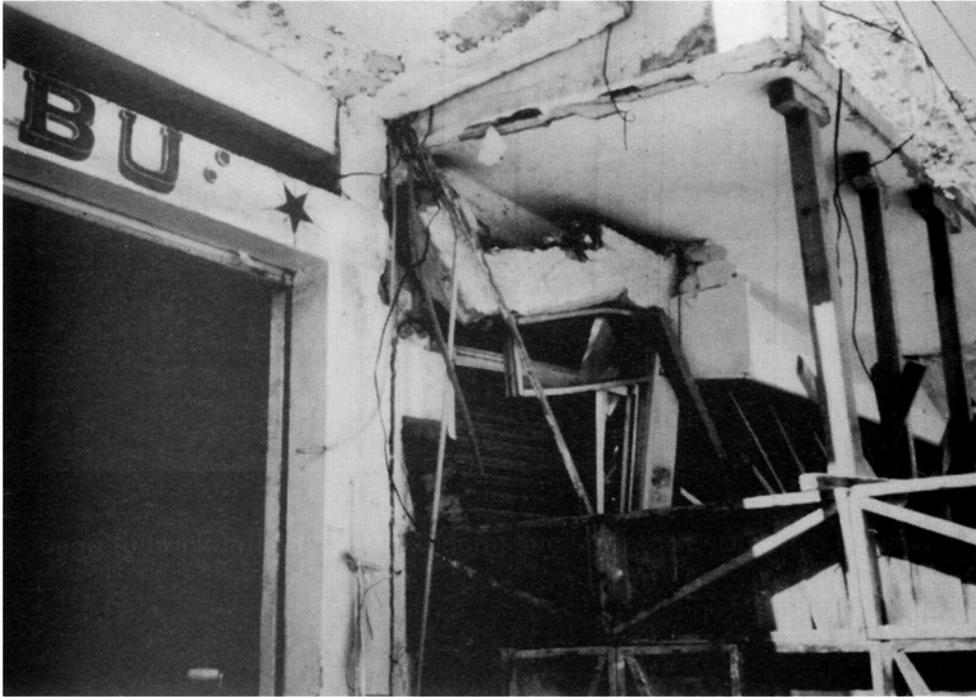
PLATE 4.2

Damage to beam indicating standard of construction of domestic structures in Lazaro Cardenas

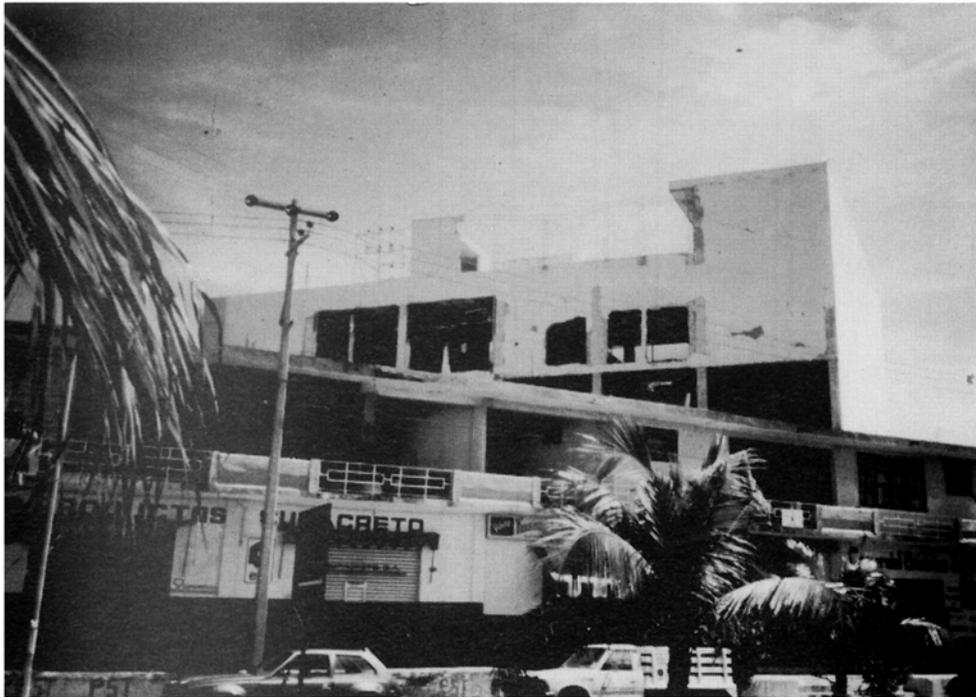
PLATE 4.3

Damage to brick infill in 2 storey domestic structure at Lazaro Cardenas

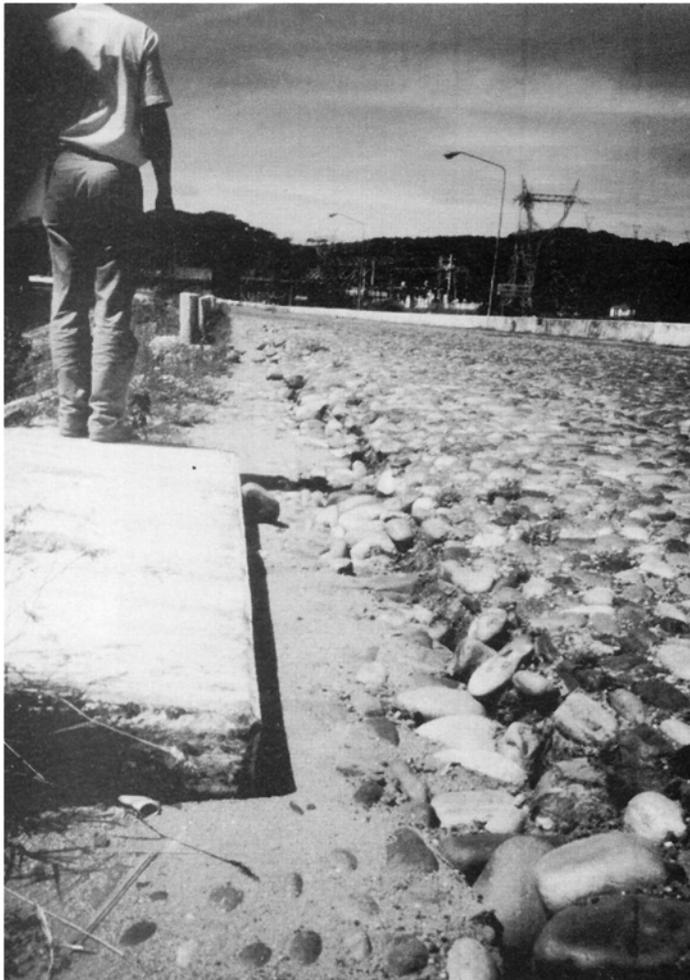
PLATE 4.7

Crest of Jose Maria Morelos Hydro-electric Dam showing longitudinal cracks

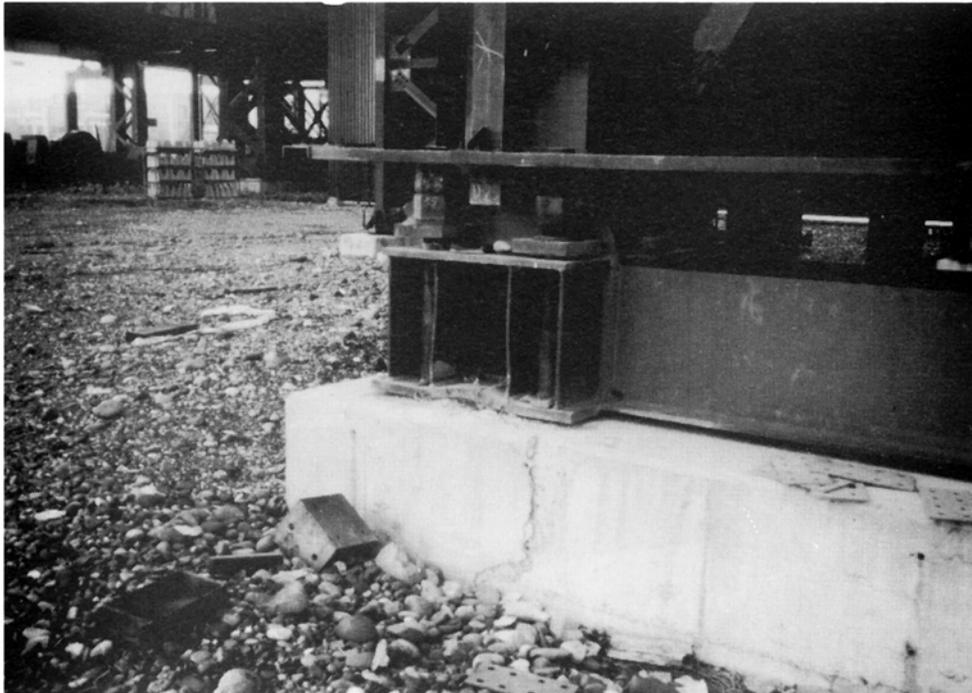
PLATE 4.13

Damage to ungrouted base plates

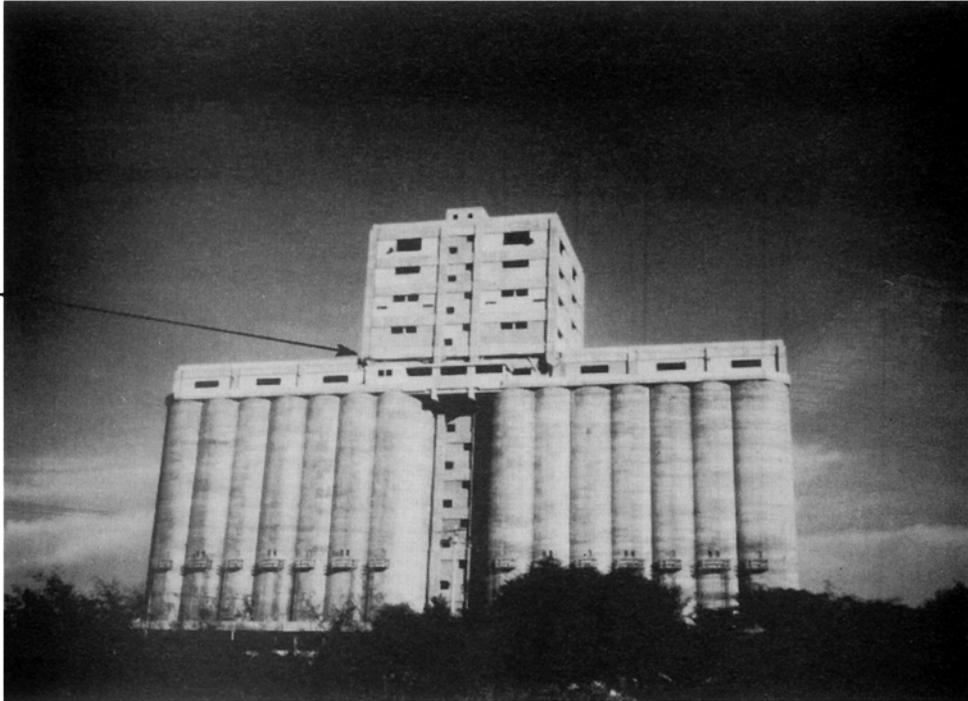
PLATE 4.14

Damage to silos on Cayacal Island

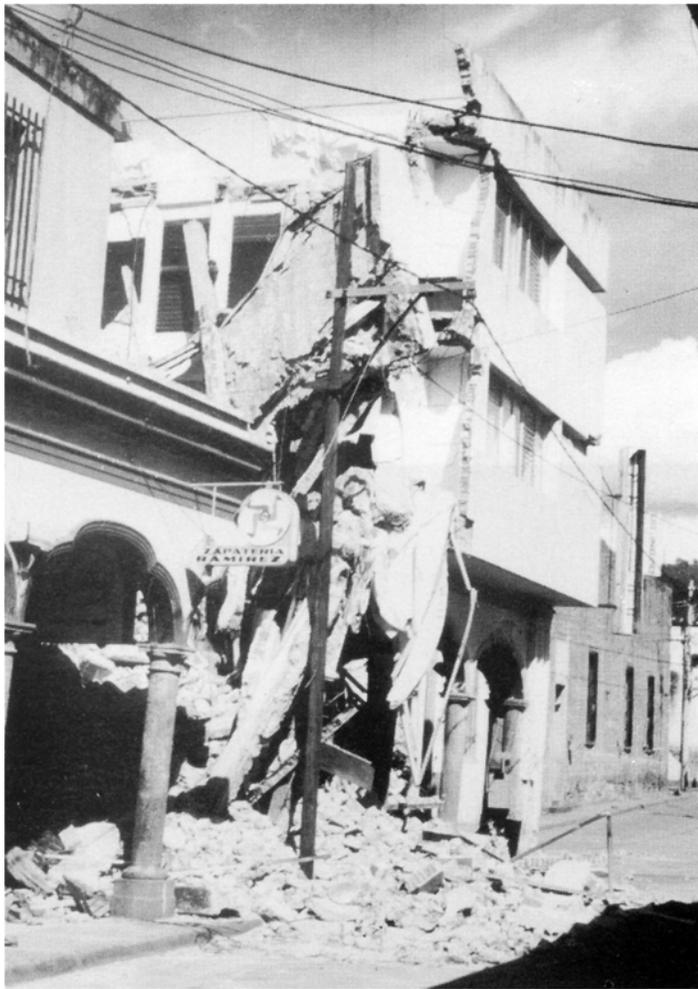
PLATE 4.24

Failure in 3 storey reinforced concrete building (Site 20)
