THE HYOGO-KEN NANBU (KOBE) EARTHQUAKE OF 17 JANUARY 1995

A FIELD REPORT BY EEFIT

EEFIT March 1997

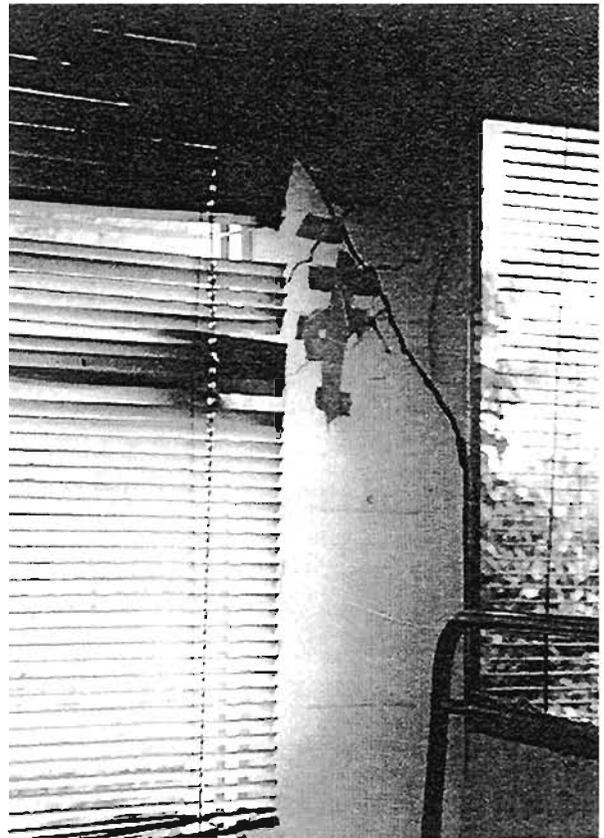
Plate 4.3: Internal RC column damage

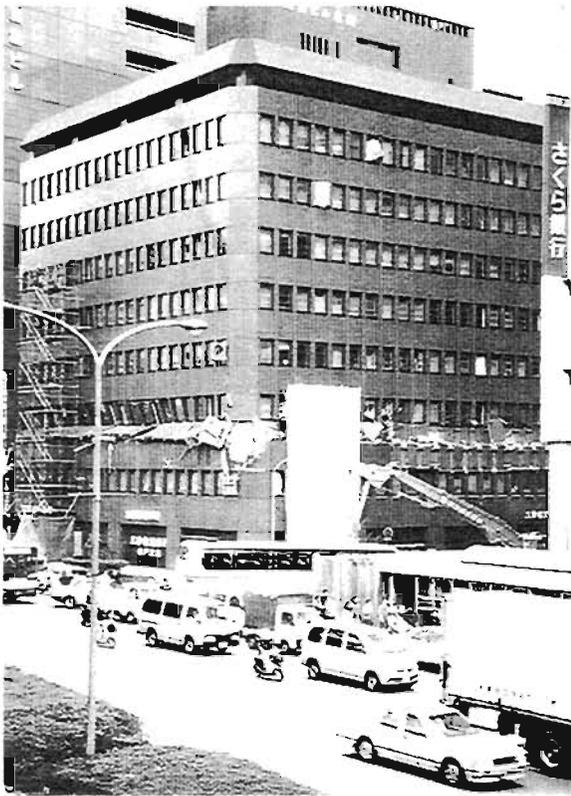
Plate 4.7: RC Building with collapse in 3rd storey

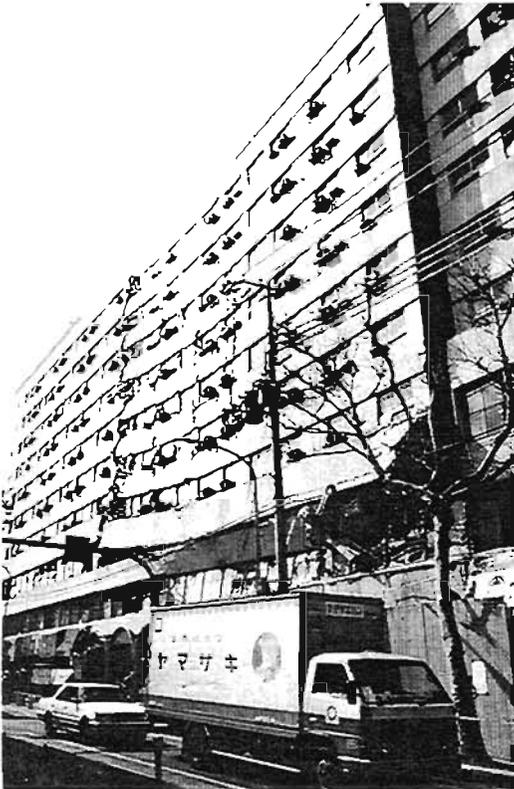
Plate 4.20: Partial storey collapse due to buffering

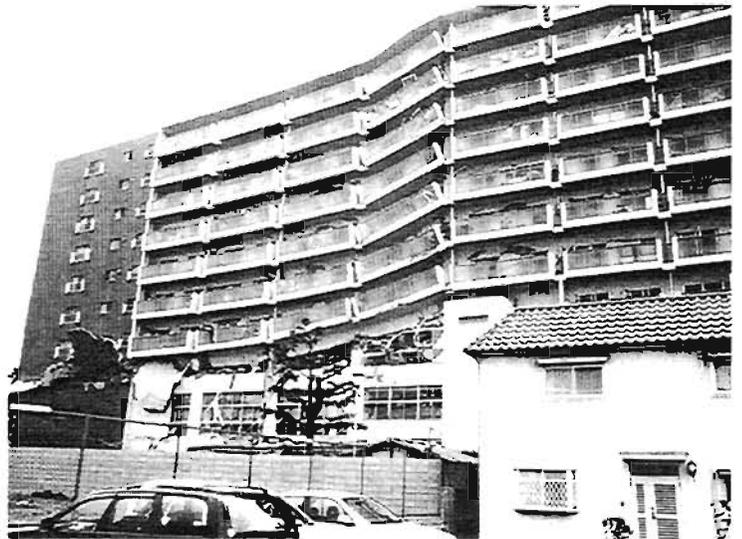
Plate 4.21: Partial storey collapse due to shear wall failure one end of building

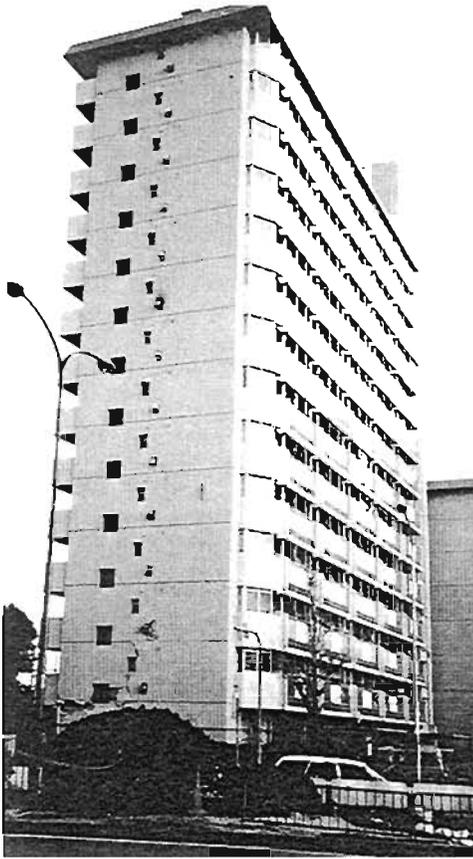
Plate 4.32: Shear wall compression failure with consequential shear fracture along vertical axis

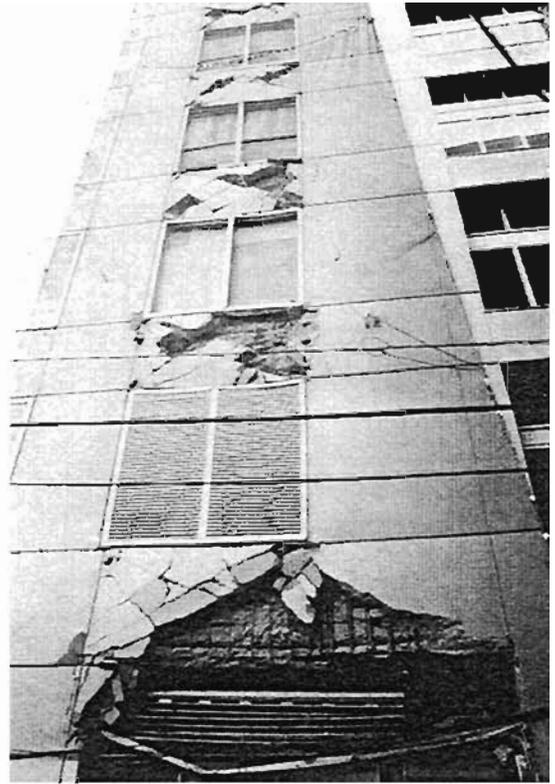
Plate 4.36: Damaged connection beams

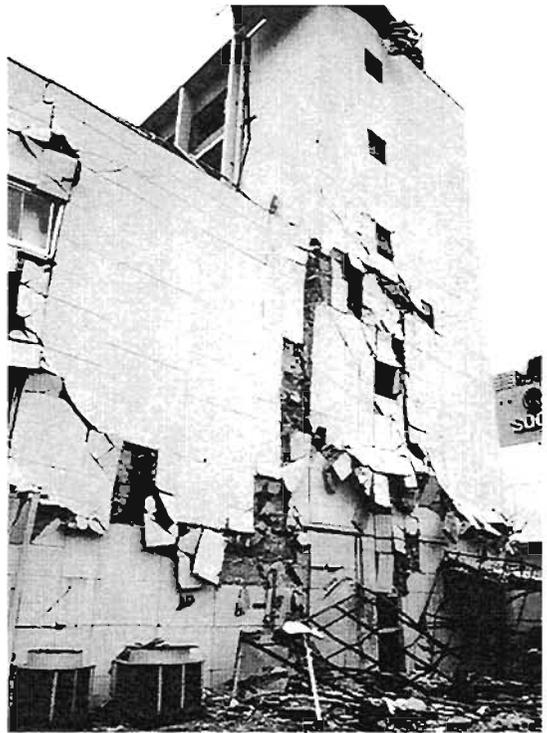
Plate 4.40: Damage at root of tower

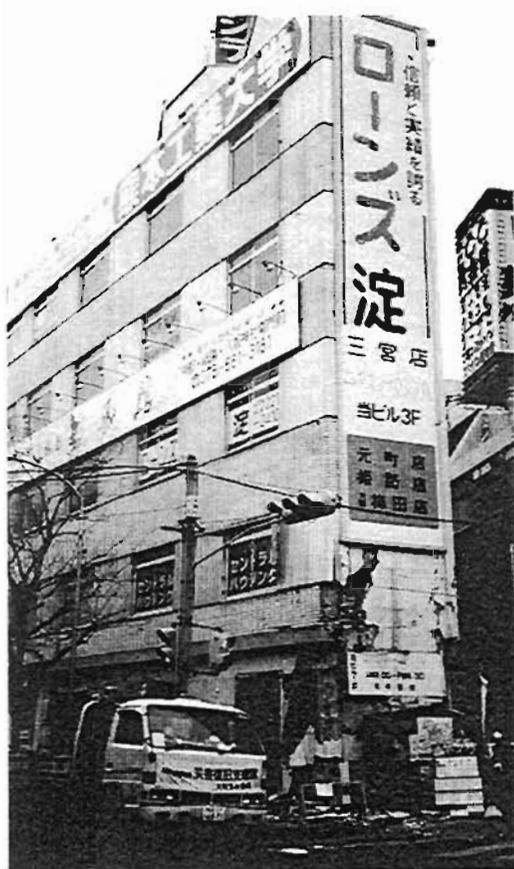
Plate 4.44: Damage at end of heavily tapered building

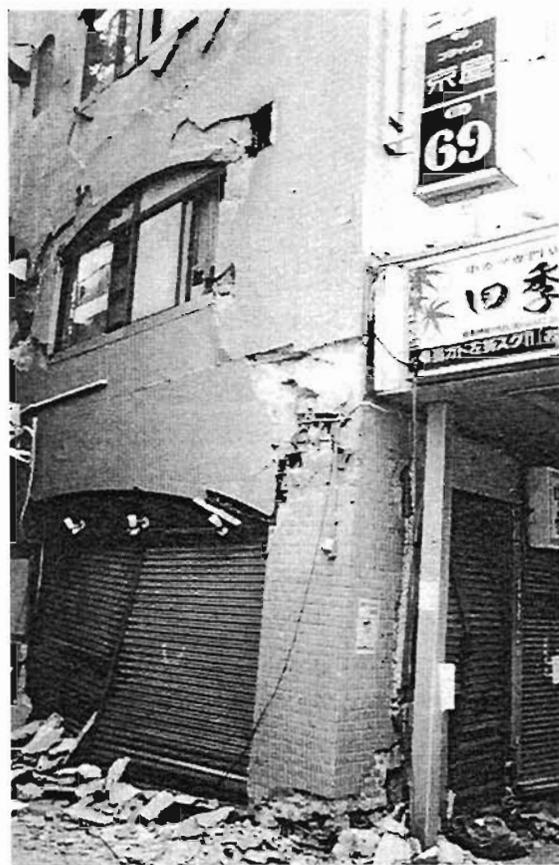
Plate 4.45: Corner joint damage in irregular building

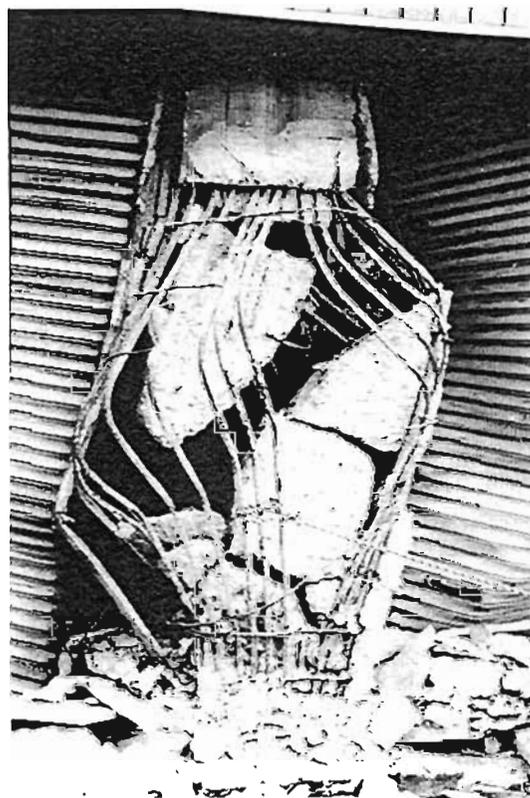
Plate 4.47: Failed off-centre central column

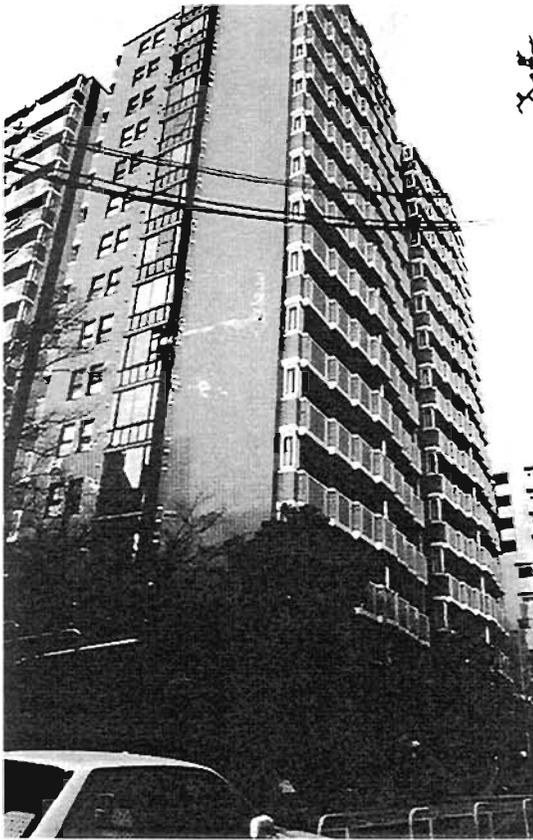
Plate 4.52: Damage in main shear wall of 12 storey flats

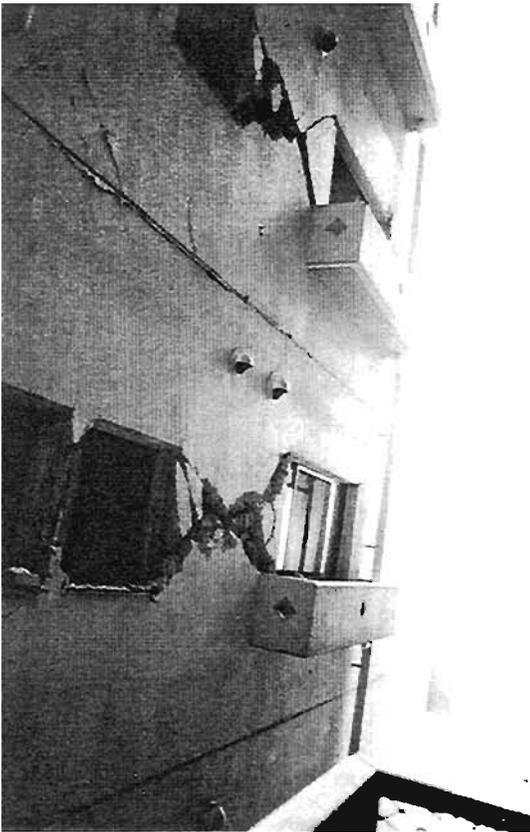
Plate 4.54: X-cracking in perforated shear walls

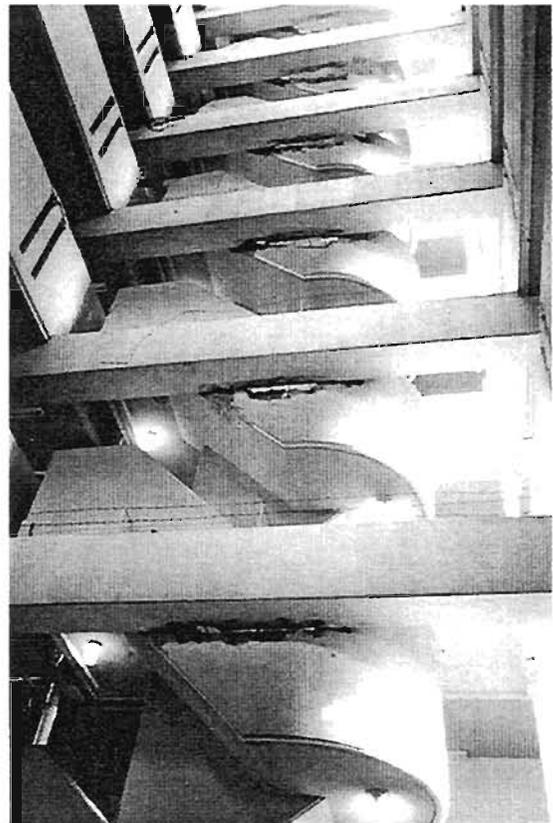
Plate 4.55: Spalling between staircase and stair well cross beam

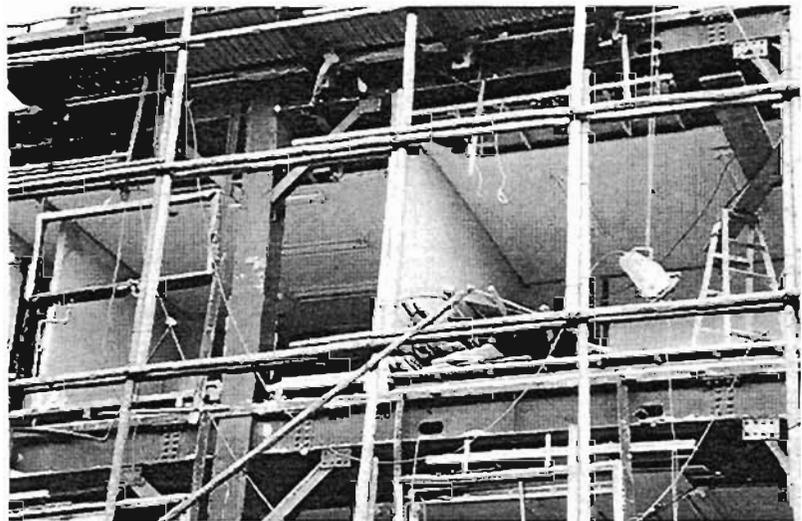
Plate 4.67:

Sway mechanism of bare
frame with hinges at
web-bolted connections

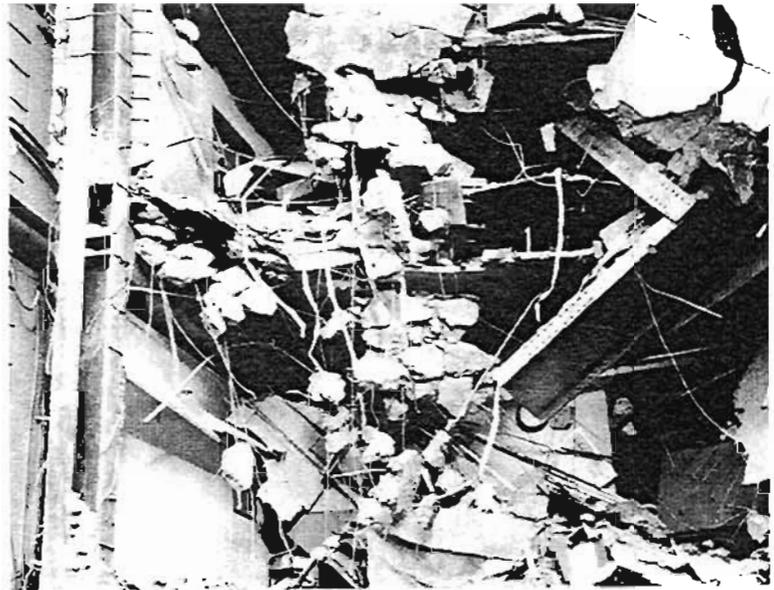
Plate 4.75: Building with failed welds at beam/column connections

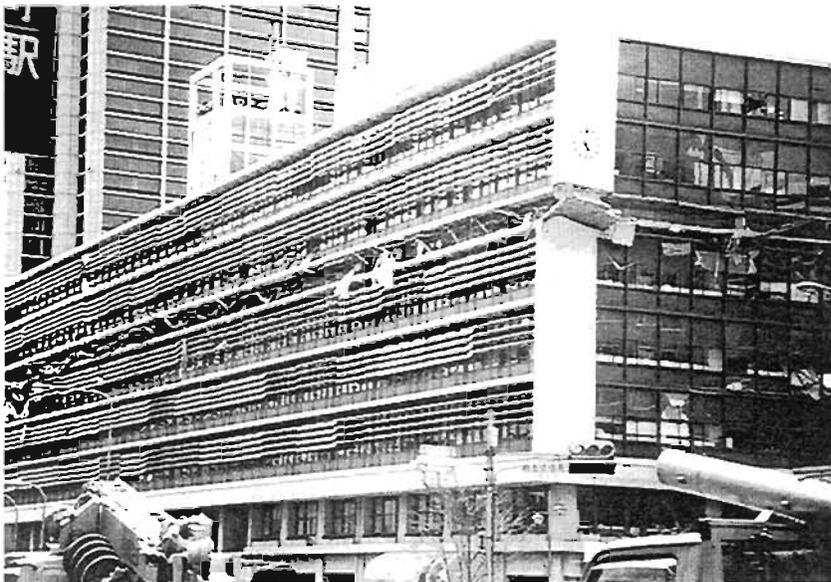
Plate 4.87: The old town hall with collapsed 6th storey

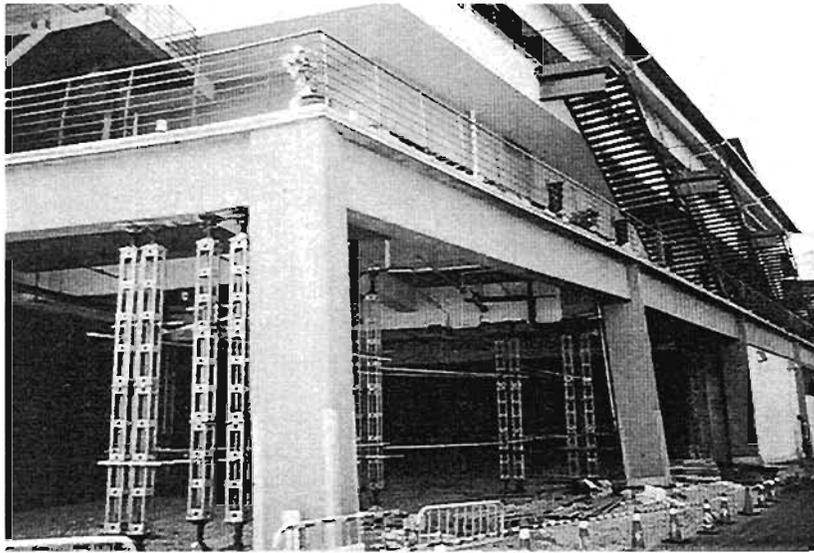
Plate 4.94: Damage attributable to lack of foundation tie beams

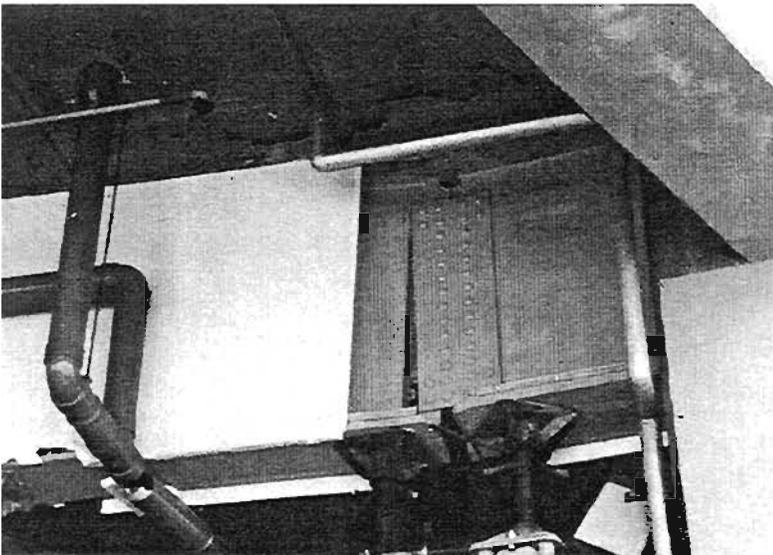
Plate 4.95: Rotated joint with rotation concentrated at span connection

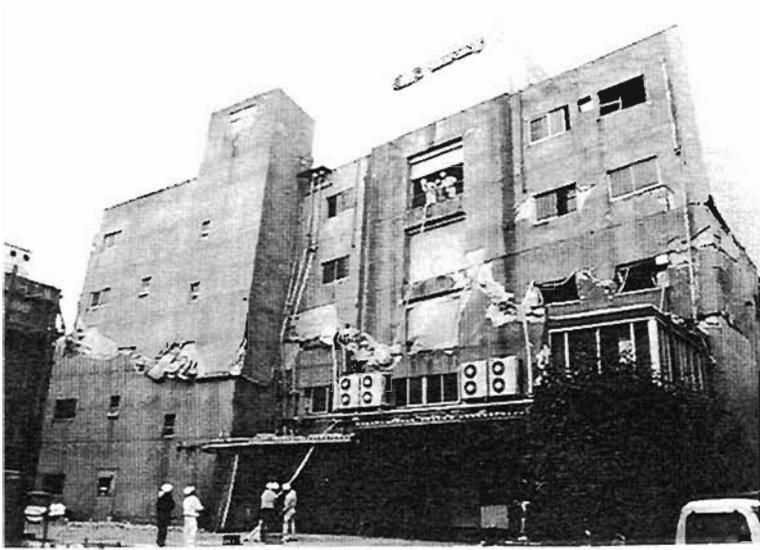
Detail of Plate 4.105

Plate 4.105: Mid-height failure of substantial irregular structure

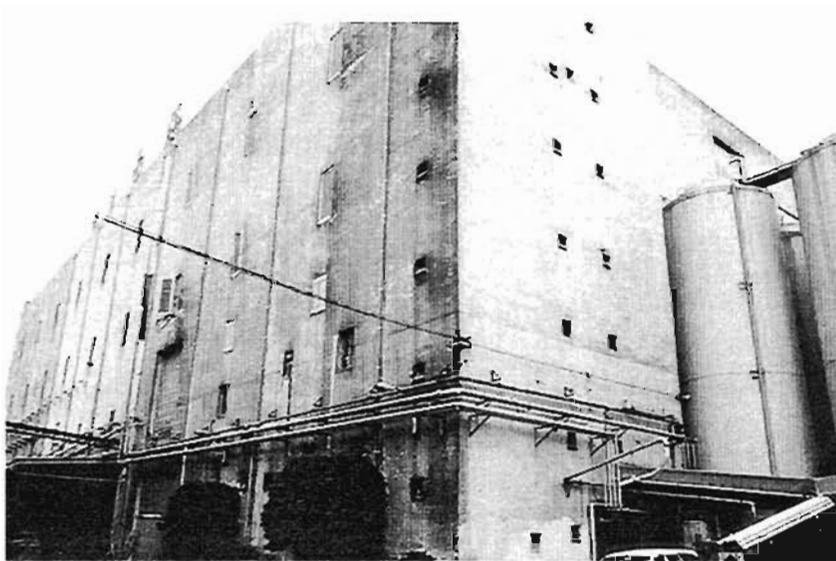
Detail of Plate 4.106 showing damage at expansion joint

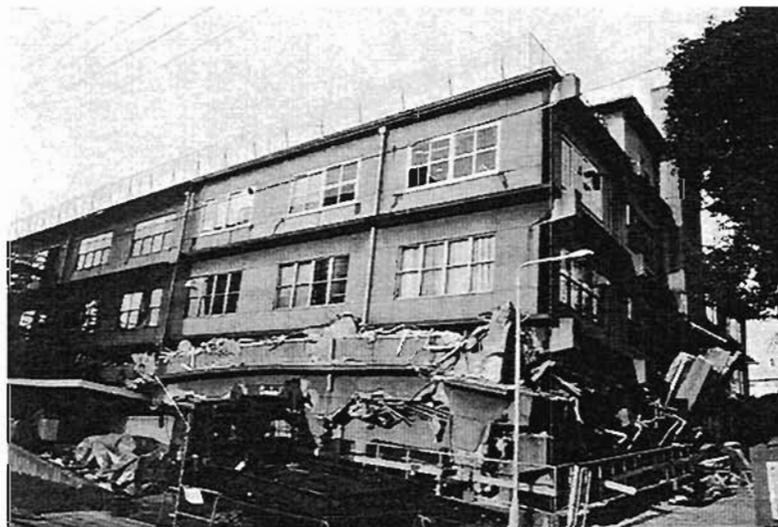
Plate 4.110: Precast concrete building with partial collapse induced by link bridge

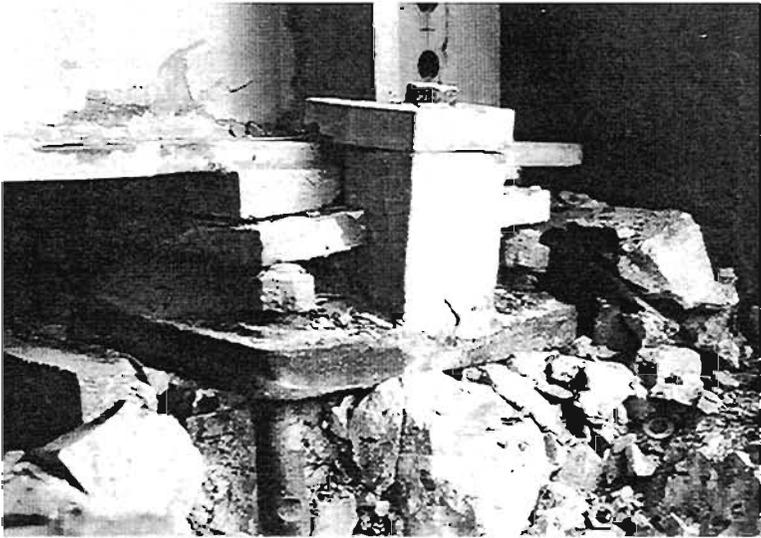
Plate 4.112: A garage base plate which performed well despite the failure of the supporting plinth

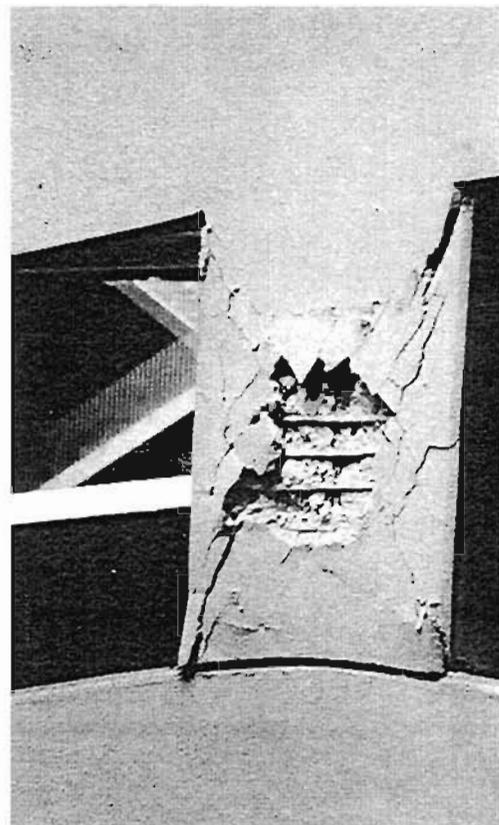
Plate 4.125: Damage to confined concrete at end

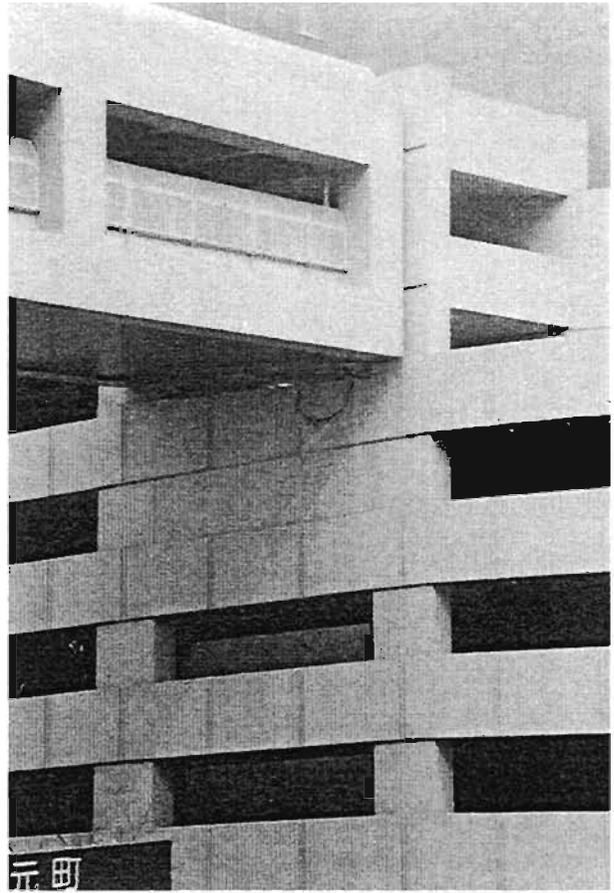
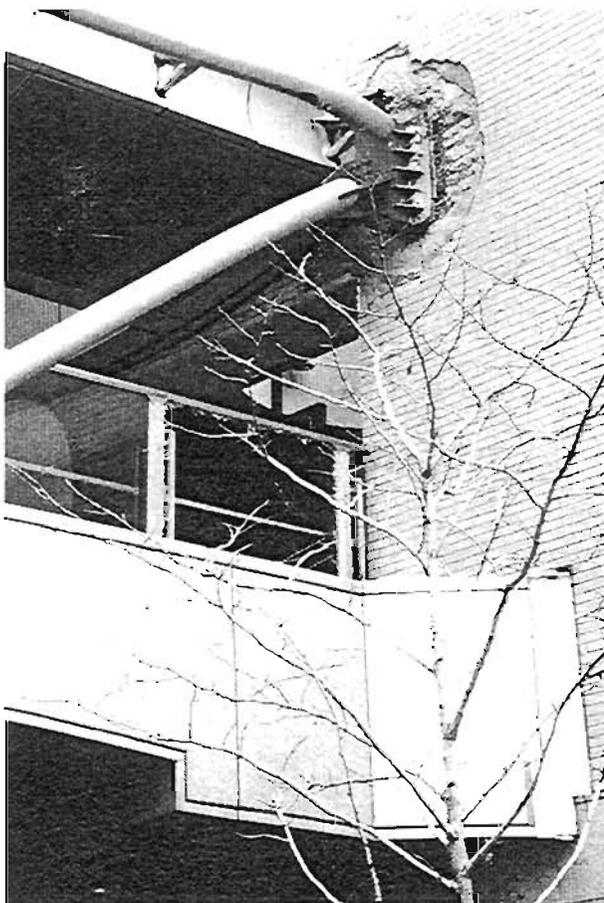
Plate 4.145: Connection damage between new buildings

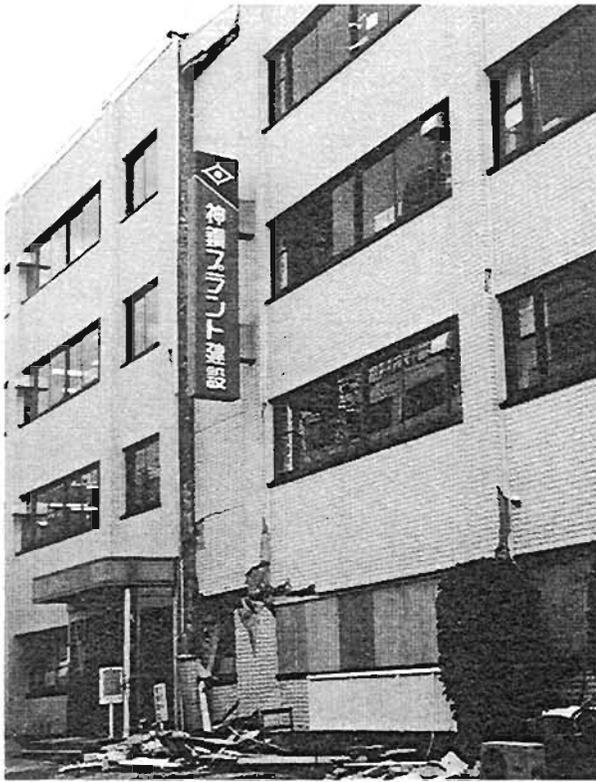
Plate 4.154: Impact damage between buildings of same height

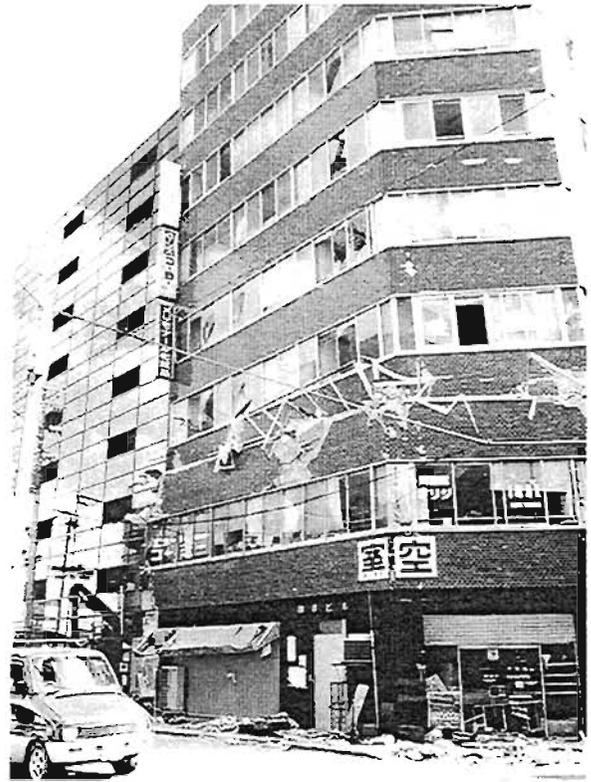
Plate 4.155: Collapse of 3rd storey of corner building due to buffeting

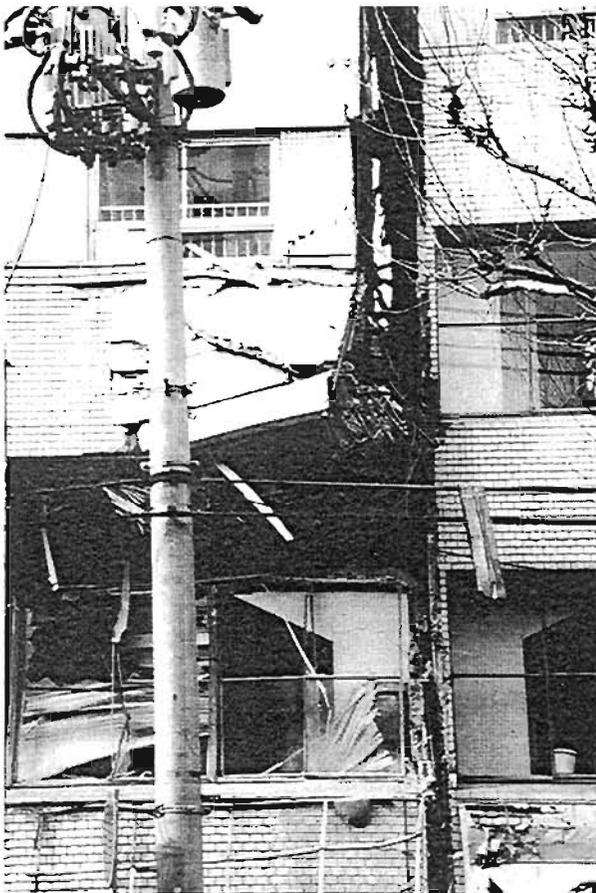
Plate 4.156: Column damage due to buffeting

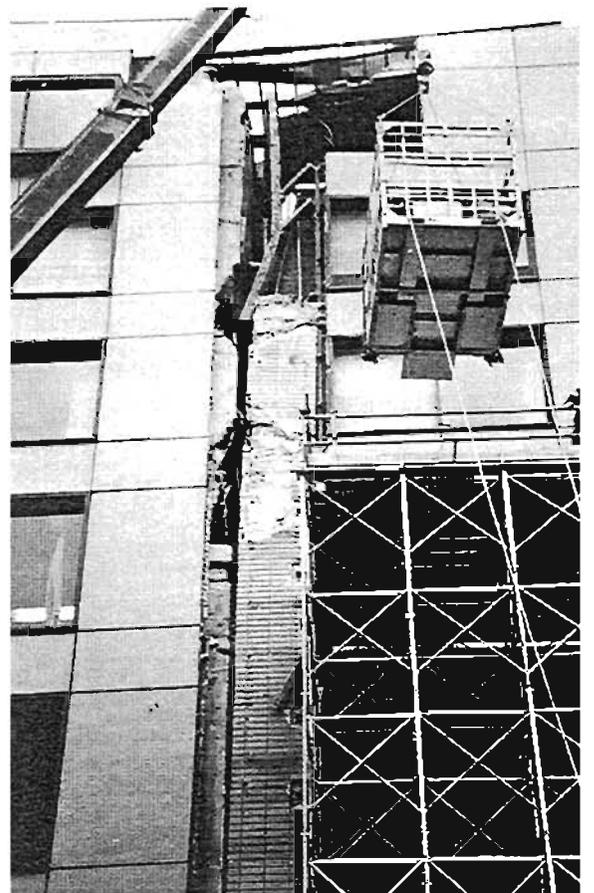
Plate 4.157: Buffeting damage in top storey

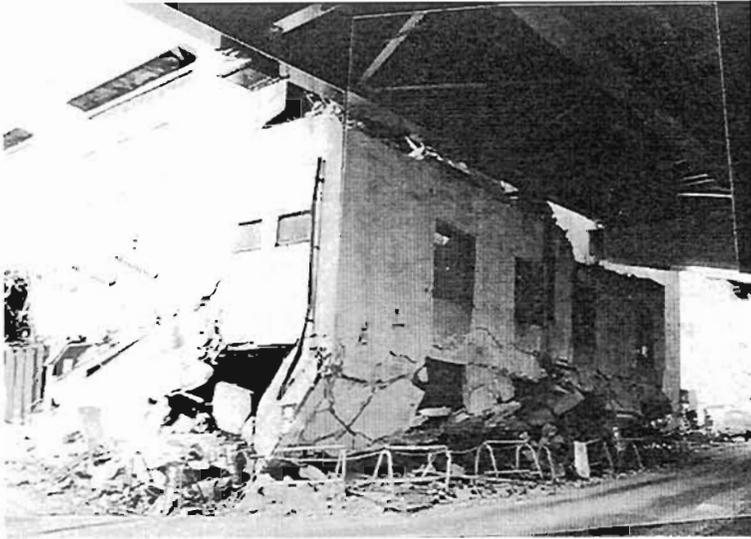
Plate 4.158: Substation collapsed against viaduct damaging viaduct

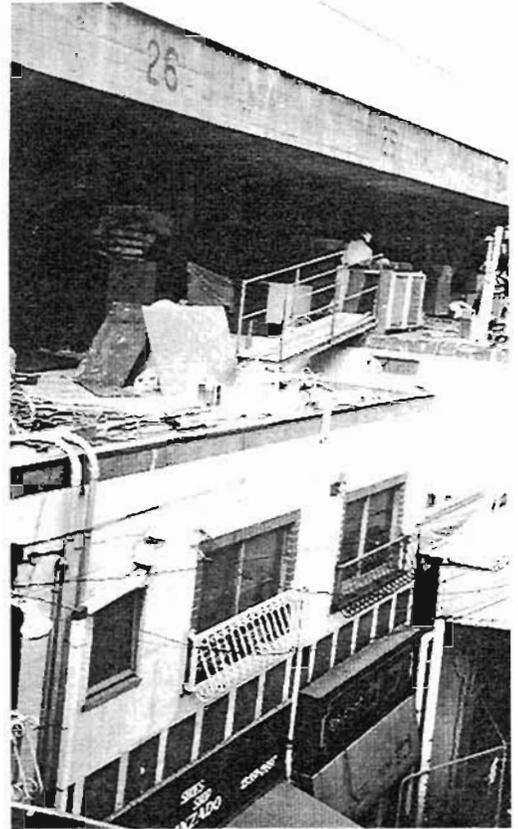
Plate 4.160: Damaged stub column under viaduct due to building restraint

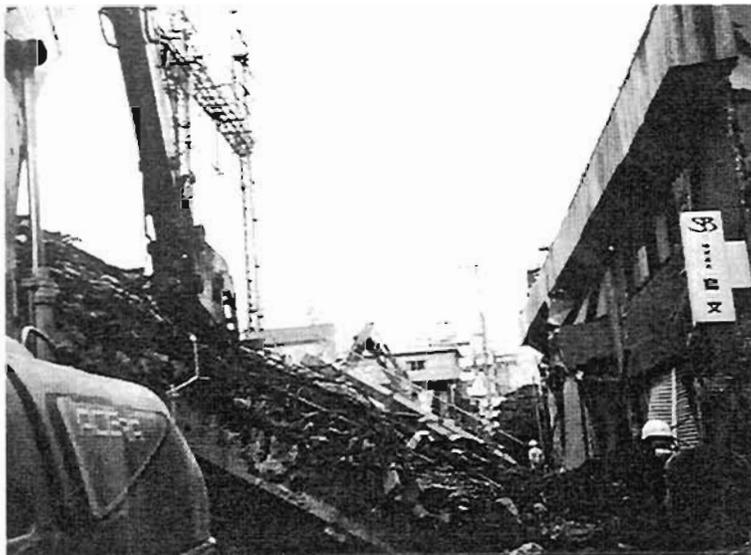
Plate 4.159: Collapse of viaduct span due to building restraint

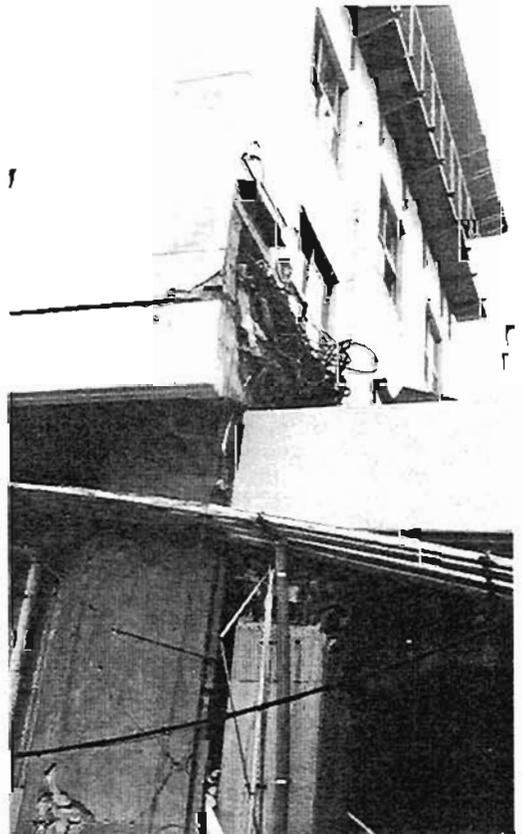
Plate 4.162: First floor column damage due to impact across expansion joint

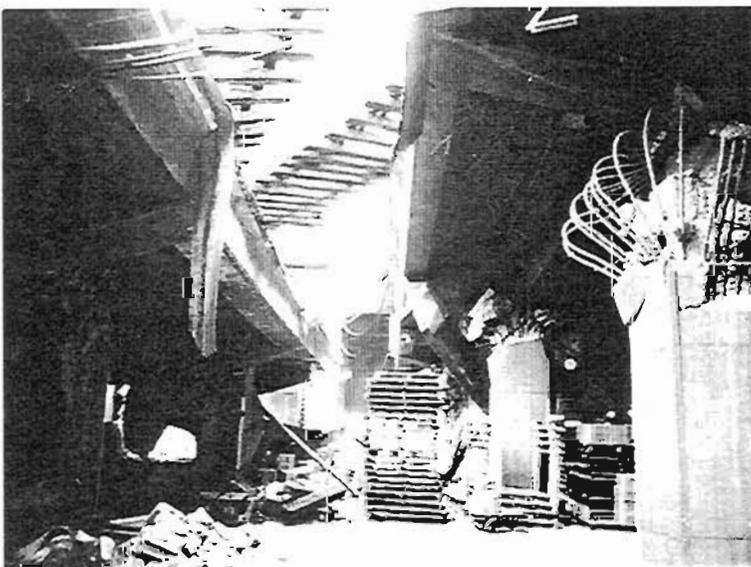
Plate 4.161: Collapsed infill slab due to buffeting between viaduct and warehouse

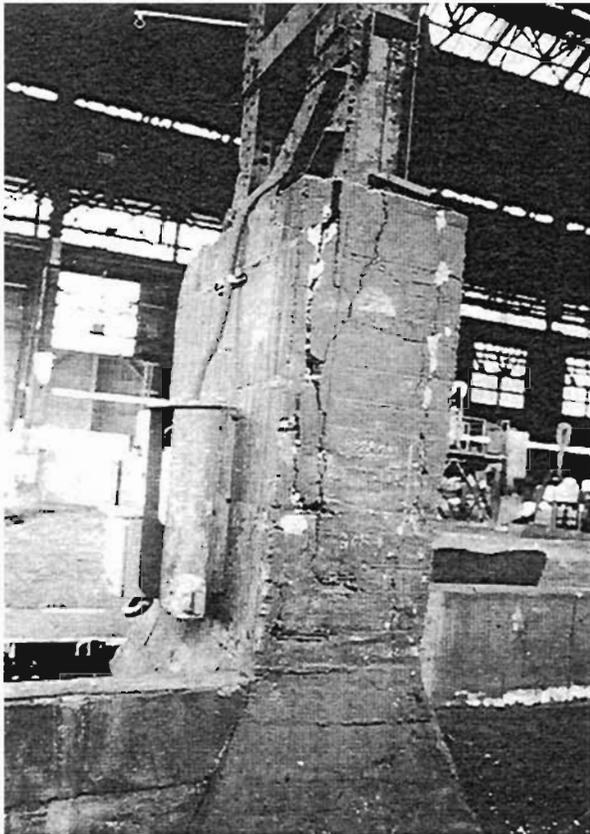
Plate 4.174: Cracked encased base of lattice column

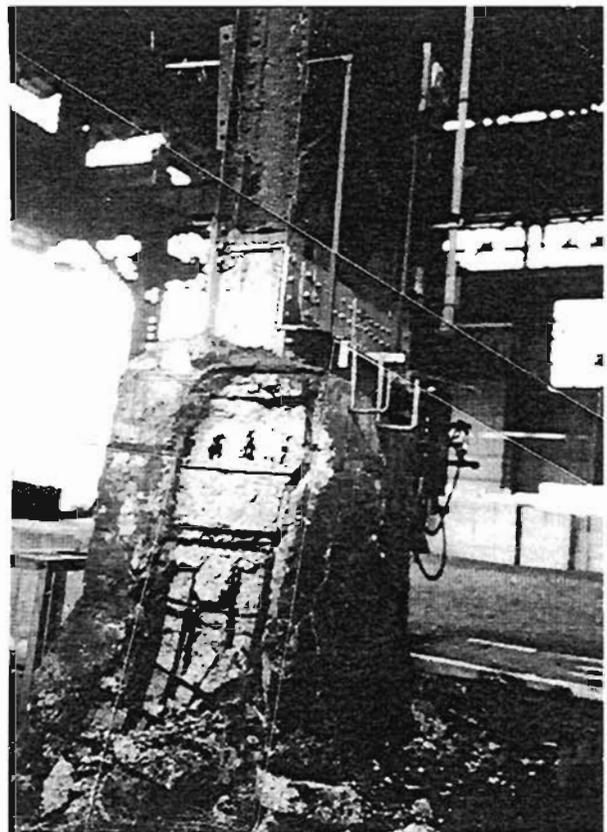
Plate 4.175: As 4.174 but severely corroded

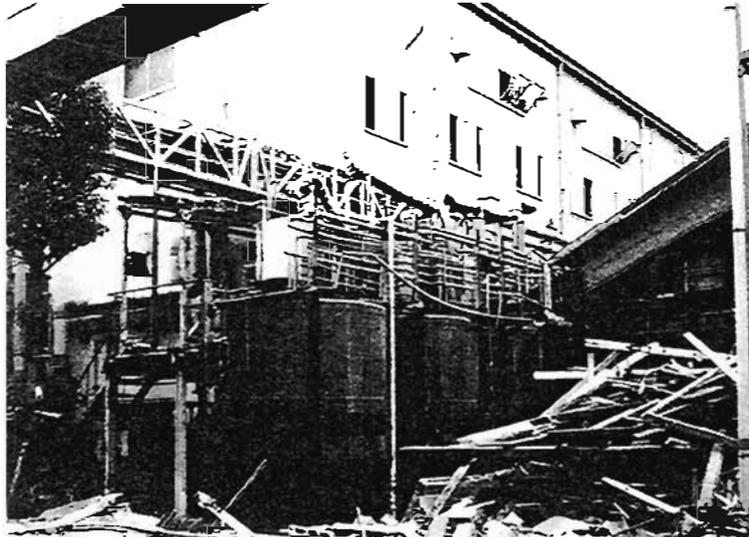
Plate 7.23 Plastic pipes, seriously damaged

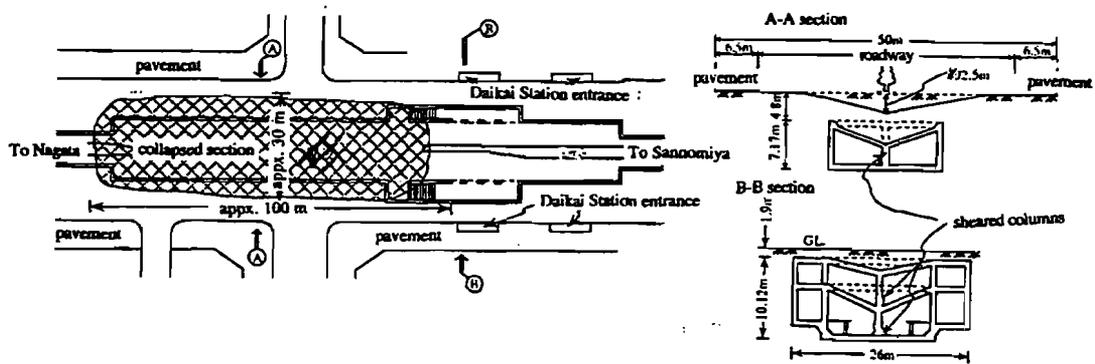
Figure 8.24 Collapsed section of the Daikai station (JSCE, 1995)

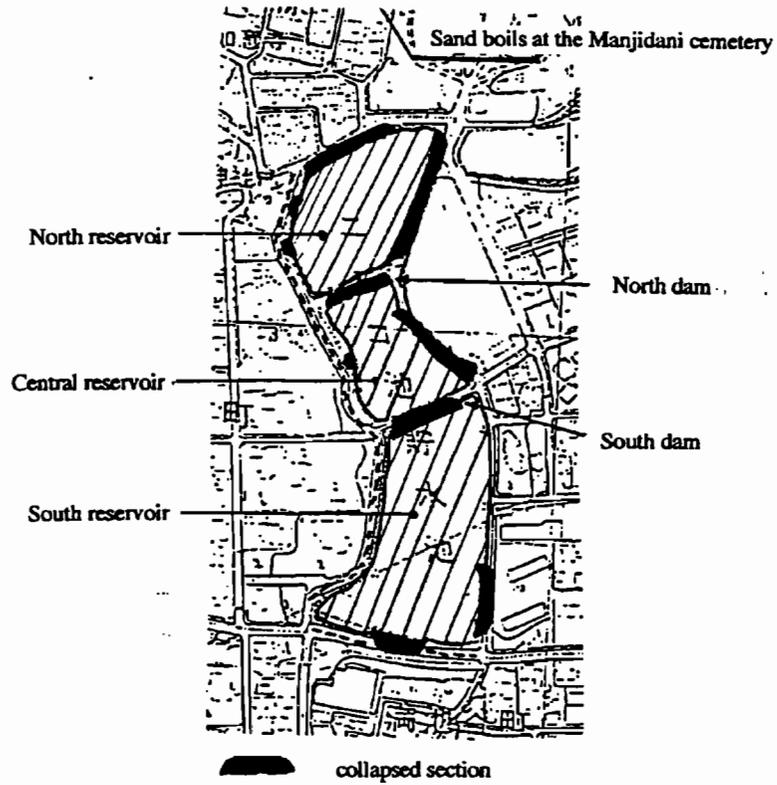
Figure 8.27 Failure of the Niteko dam caused by liquefaction effect

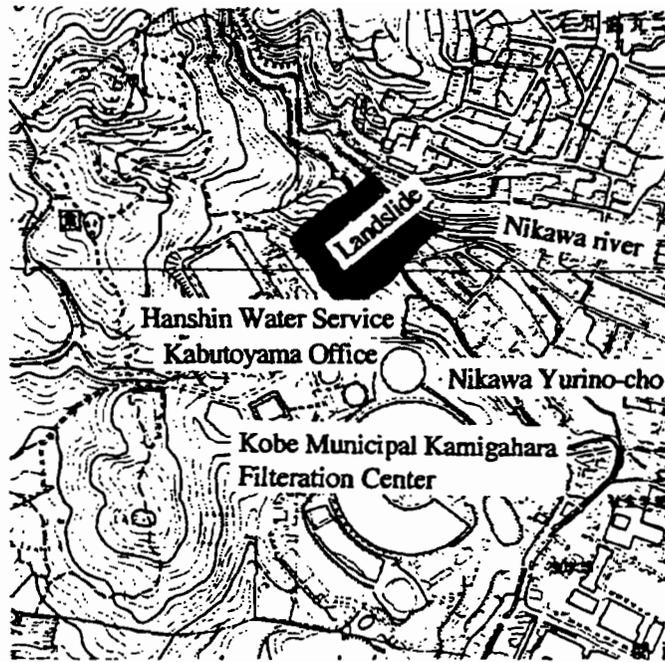
Figure 8.29 The landslide at Nikawa, north of Nishinomiya (after JSCE, 1995)
