# **The Bhuj, India Earthquake of 26<sup>th</sup> January 2001**

## **A FIELD REPORT BY EEFIT**

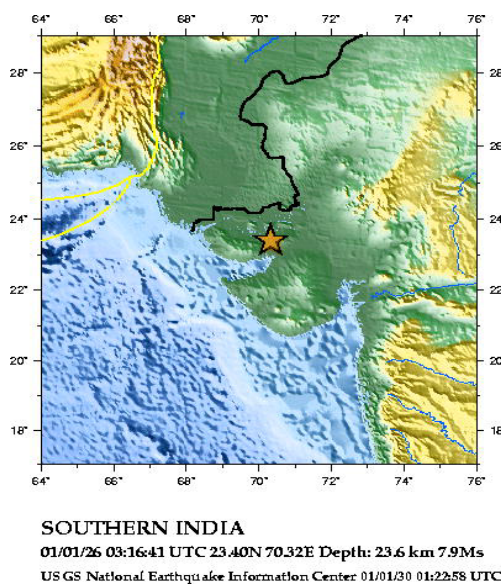
Fig.1 Location of the epicentre as reported by USGS

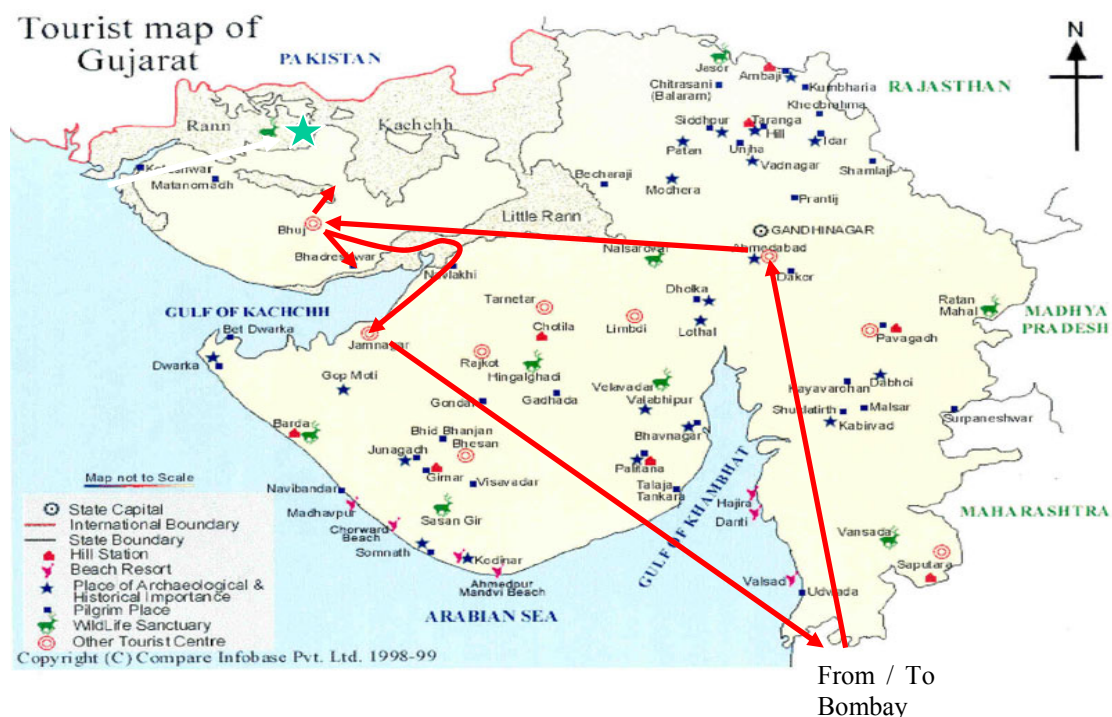
Following this the team travelled west to Bhuj which was the major town closest to the epicentre. The team spent four days at Bhuj and travelled in groups to surrounding regions including Gandhidham and Kandla port and villages that saw extensive damage such as Lodai, Bhachau and Anjar.

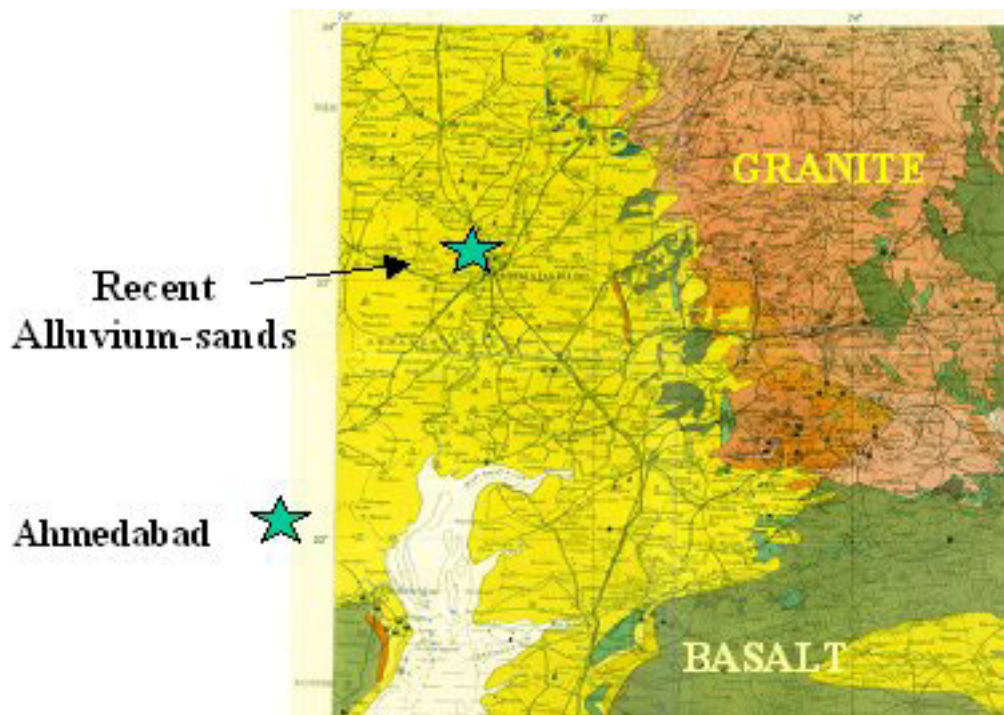
**Figure 3** Geological map of the area surrounding Ahmedabad

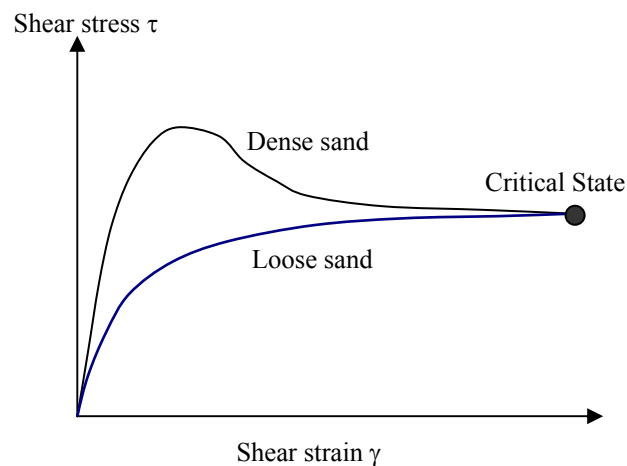
Figure 1 Behaviour of Dense and Loose sands

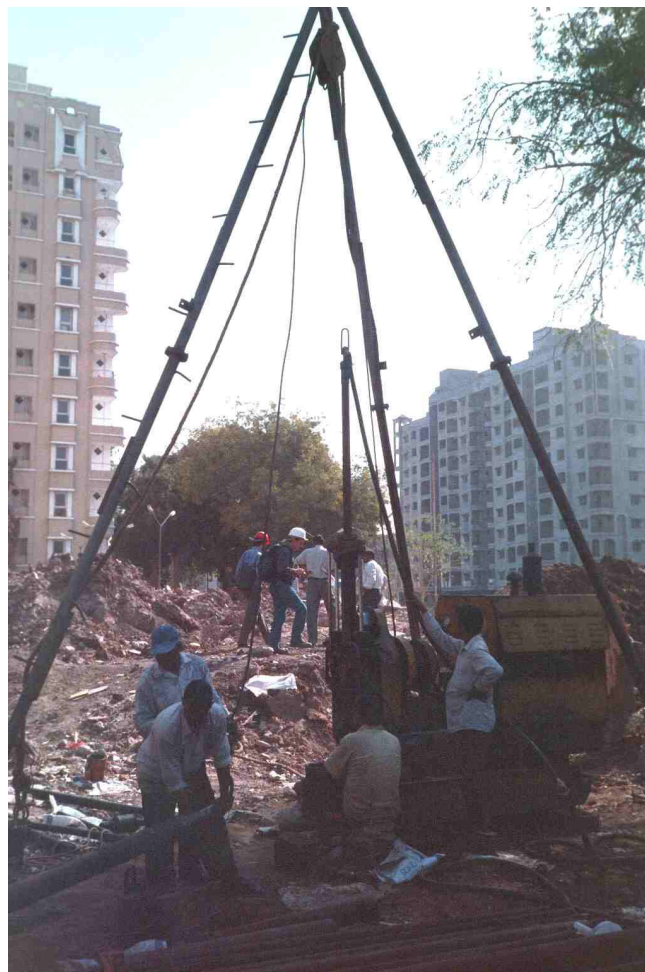
**Figure 2 Soil testing at the site of a collapsed building**

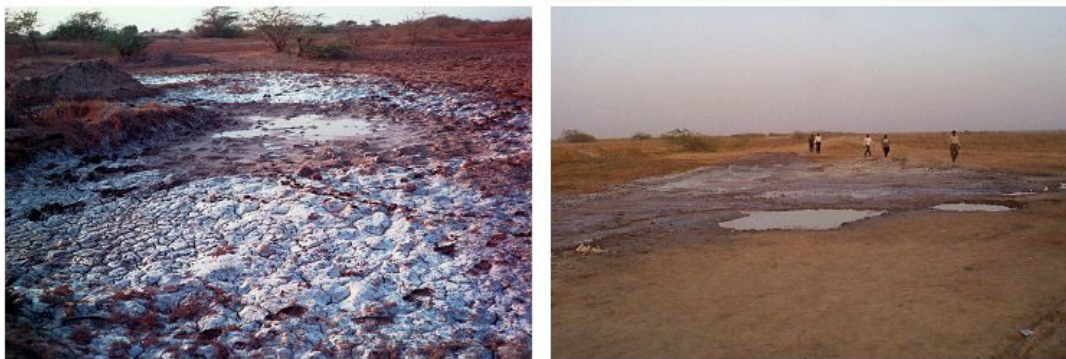
**Figure 3 Sand Boils near Lodhai**

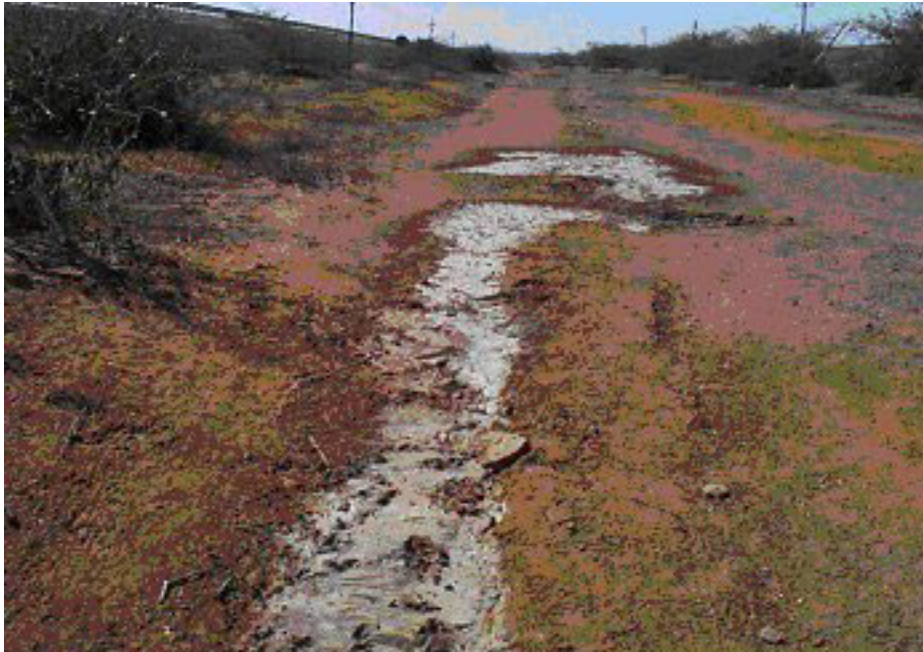
**Figure 4 Linear sand boils following the natural water courses**

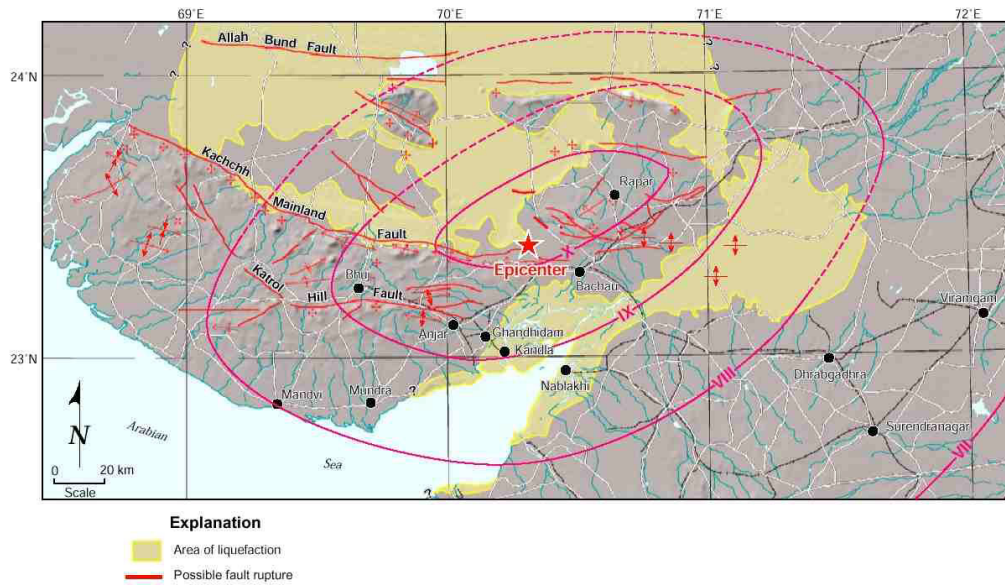
**Figure 5 Aerial distribution of the liquefaction**

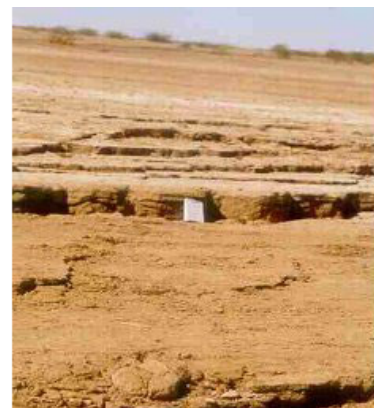
**Figure 7 Cracks due to lateral spreading**  
[courtesy of EERI]

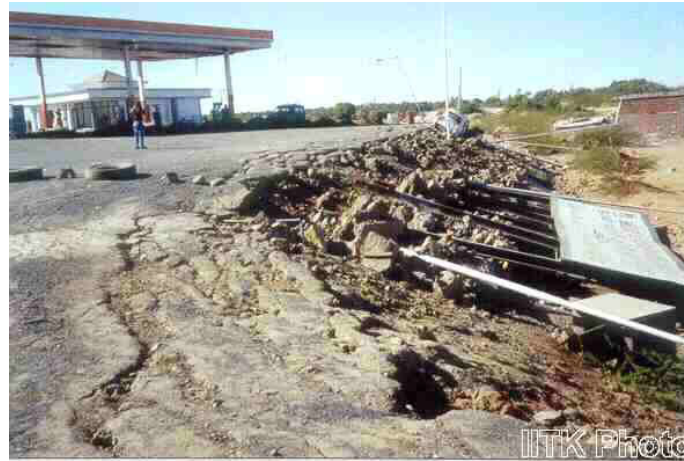
**Figure 8 Lateral spreading resulting in damage to a filling station**

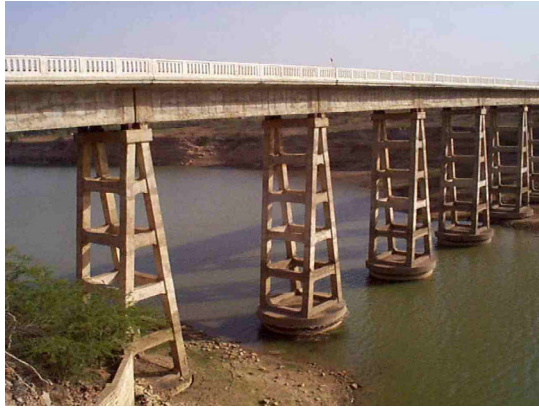
**Figure 9 Overview of the Rudra Matha bridge**

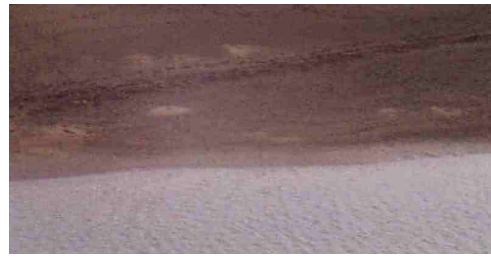
**Figure 10 Sand boils next to waterline**

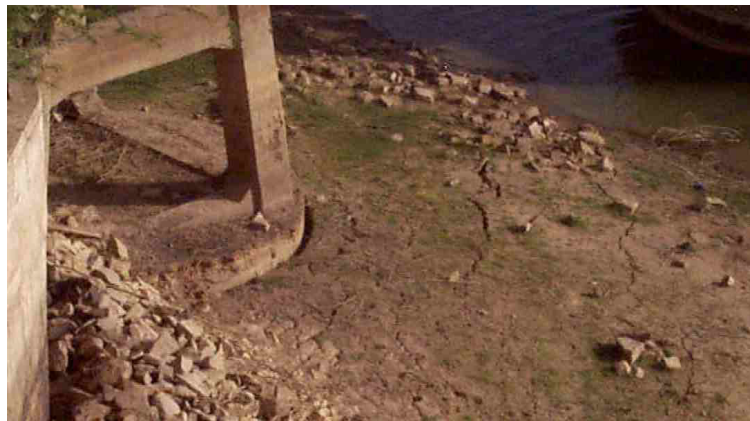
**Figure 11 Lateral spreading next to the well caisson**

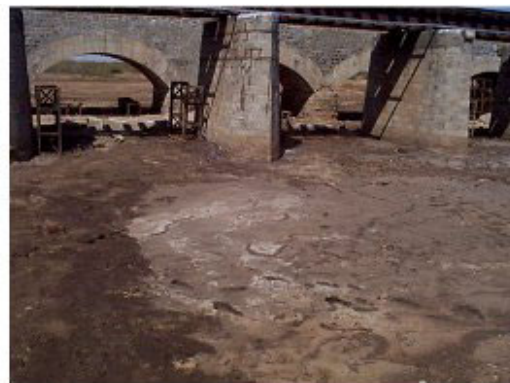
**Figure 13 Extensive liquefaction at the pier bases**

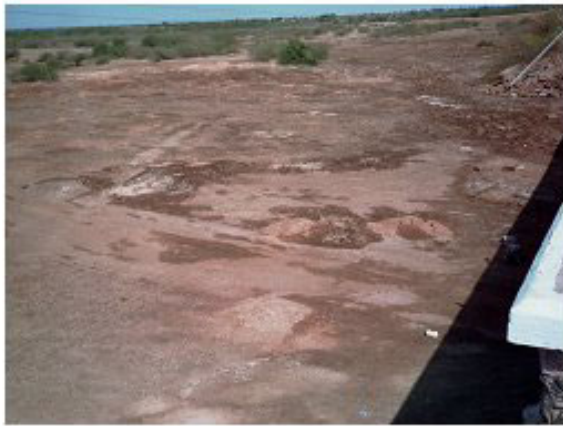
**Figure 14 Sand boils at the bridge site**

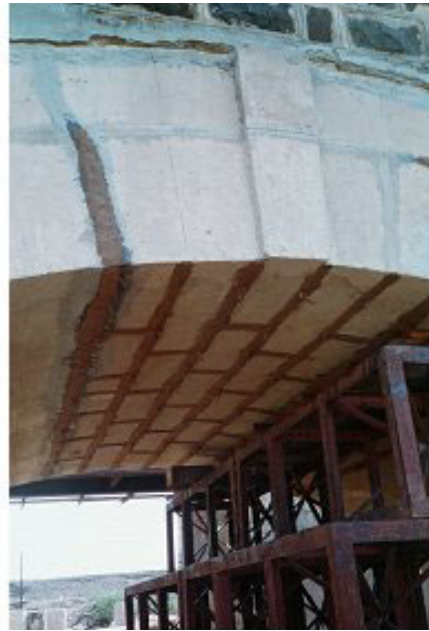
**Figure 15 Damage to the crown blocks of the arch**

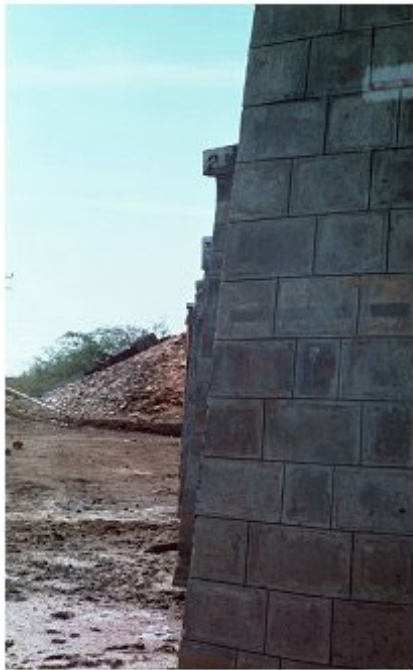
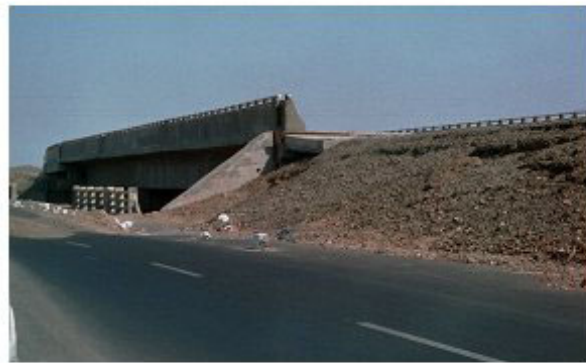
**Figure 16 Plate girder bridge piers suffered rotation**

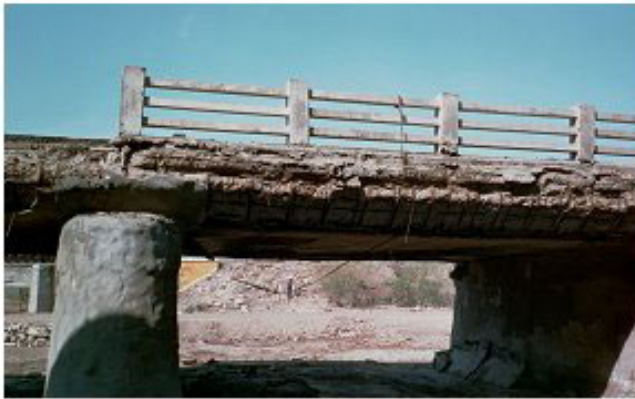
**Figure 18 Extensive spalling of concrete on old highway bridge**

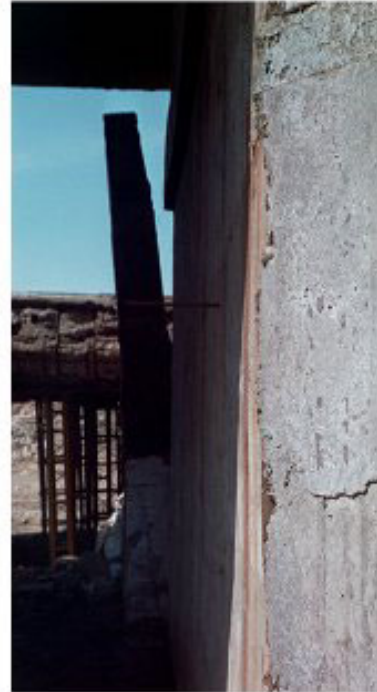
**Figure 19 Failure of the abutment walls of the new highway bridge**

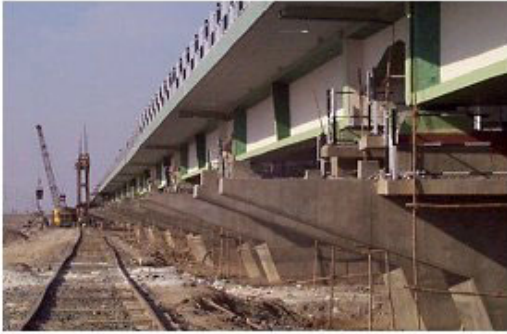
**Figure 20** The new bridge at Suraj Bari

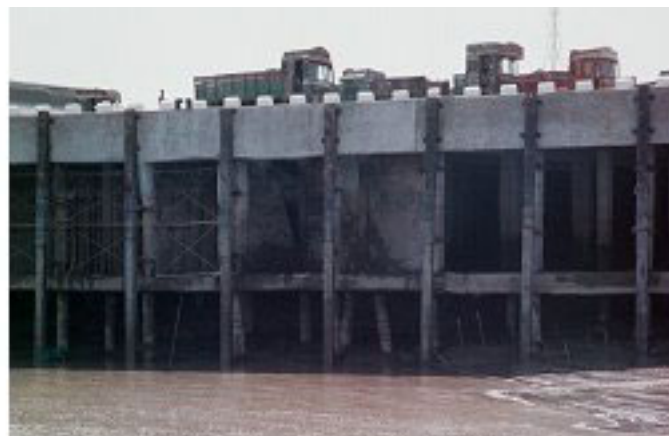
**Figure 22 A view of the old jetties at Kandla Port**

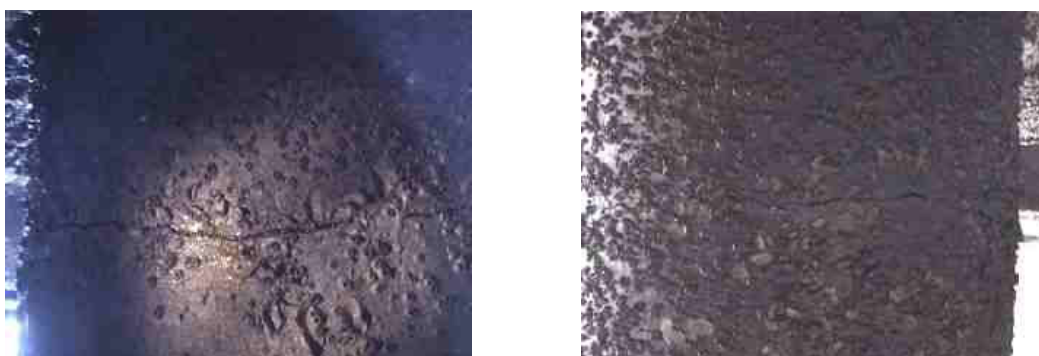
**Figure 23 Cracks developed in some of the piles supporting the old jetties [courtesy of EERI]**

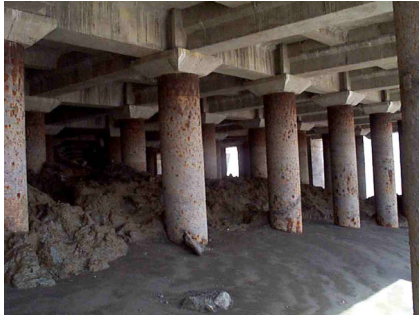
**Figure 24 Steel jacketed piles supporting the new jetties**

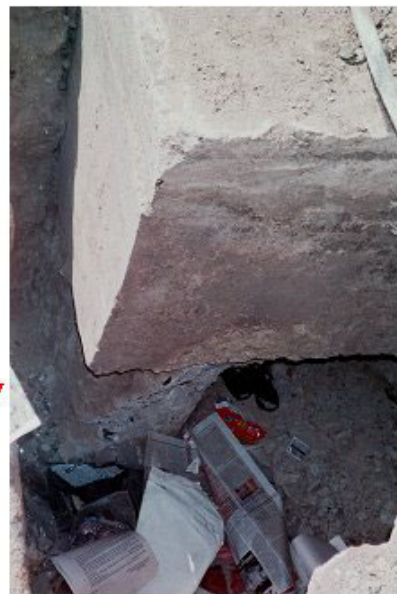
**Figure 27 Trial pit showing the pile foundation on the seaward side**

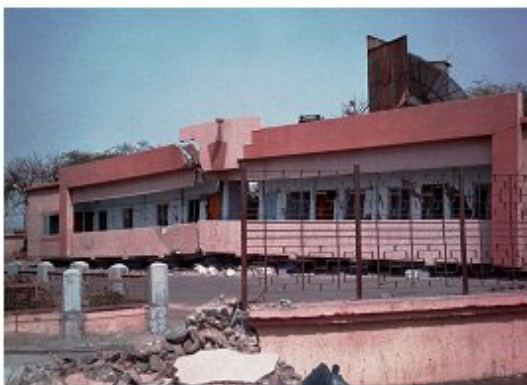
**Figure 28 Collapsed building close to harbourmaster's office**

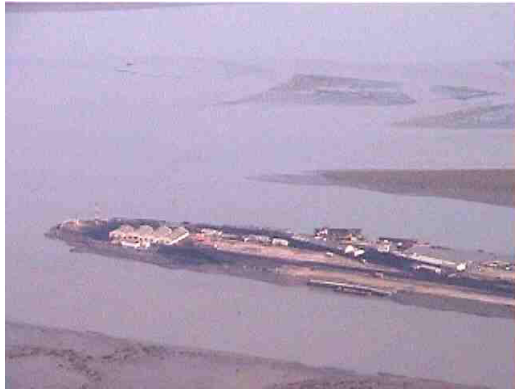
**Figure 30 Aerial view of the Navalakhi port**

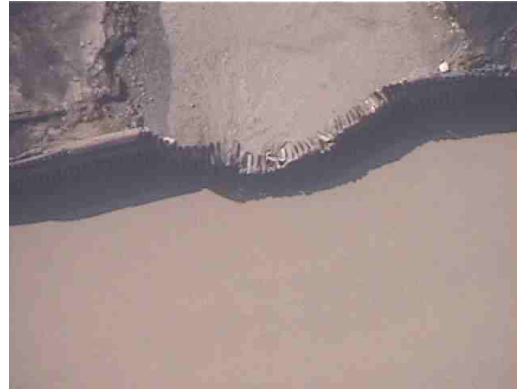
**Figure 31 Failure of a sheet pile wall**

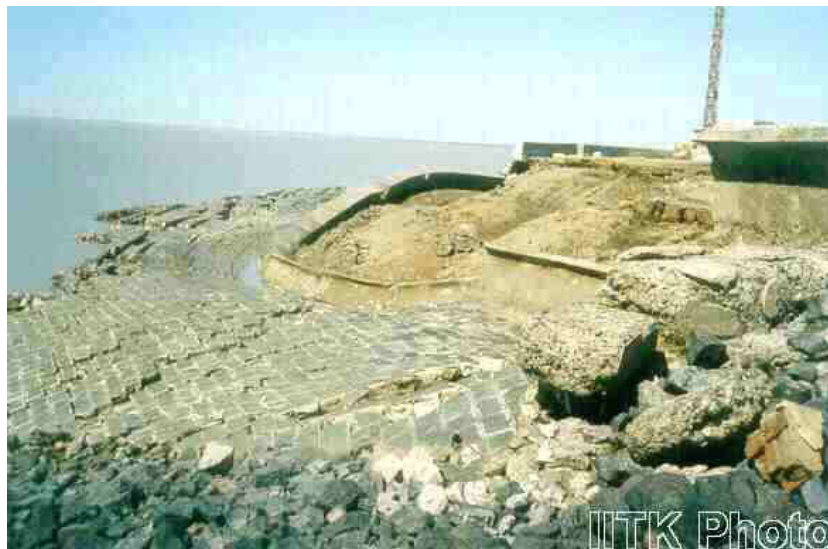
**Figure 32 Lateral spreading resulting in damage to sea revetments [courtesy of IIT Kanpur]**

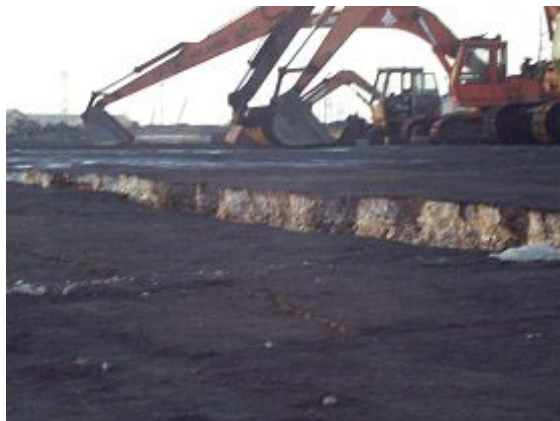
**Figure 33 Settlement of backfill behind the jetties in Navalakhi port.**

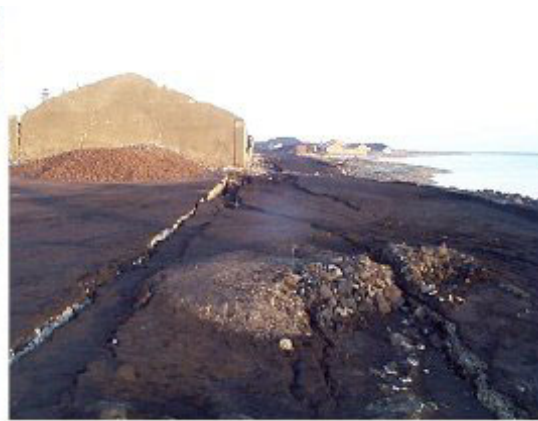
**Figure 34 Severe cracking and lateral spreading of the area adjacent to the jetties**

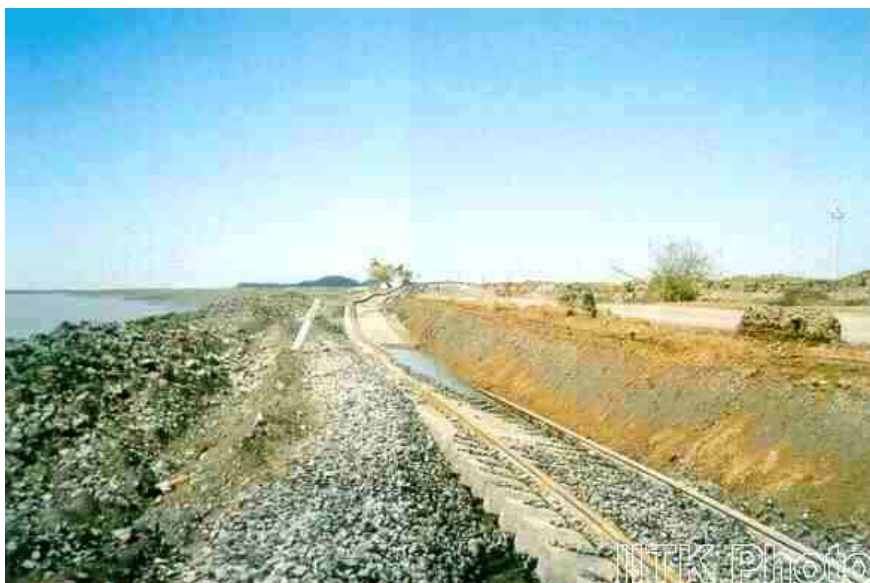
**Figure 35 Damage to the railway line feeding Navalakhi port [courtesy of IIT Kanpur]**

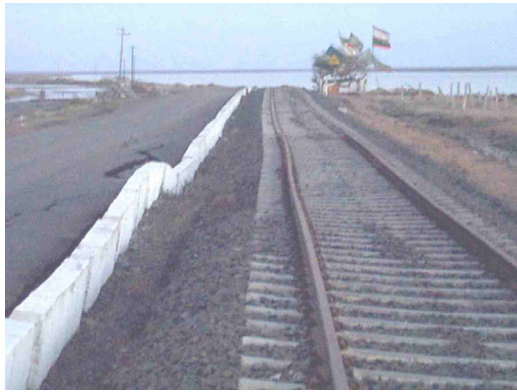
**Figure 36 Sudden change in ground elevation along the track**

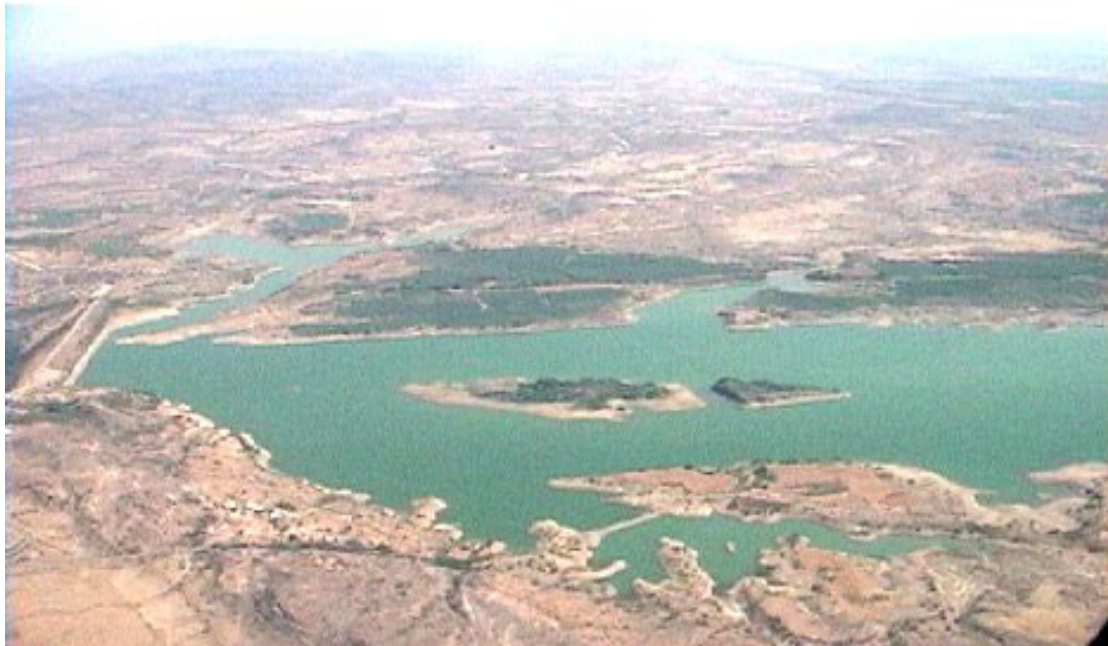
**Figure 38 Aerial view of the Rudra Matha dam [courtesy of EERI]**

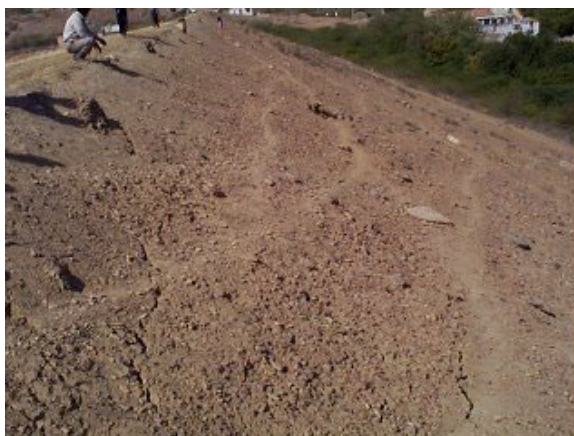
**Figure 39 Longitudinal cracks on the downstream face**

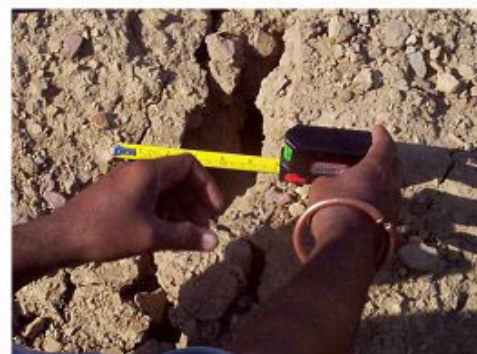
**Figure 40 The largest cracks were over 50 mm wide and extended to the core**

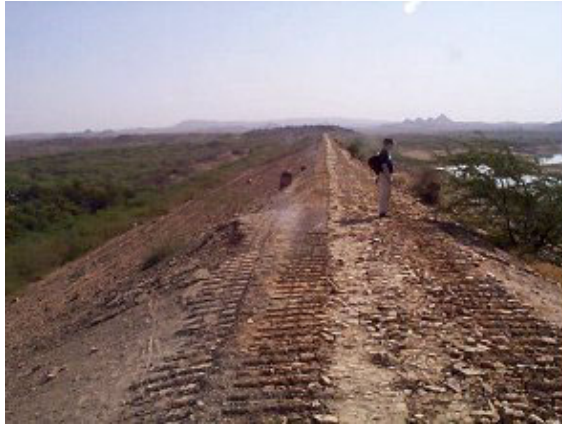
**Figure 41 Settlement of the crest**

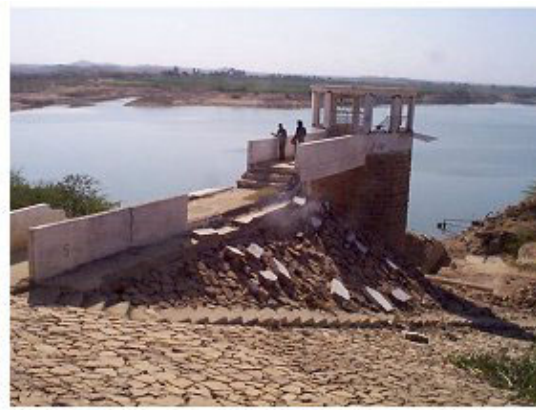
**Figure 42 Failure of the appurtenant structures**

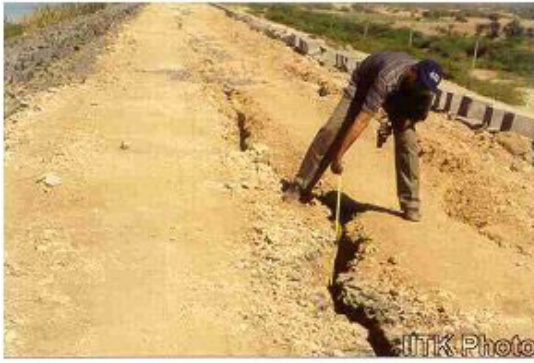
**Figure 44 Longitudinal cracks extending to the core**

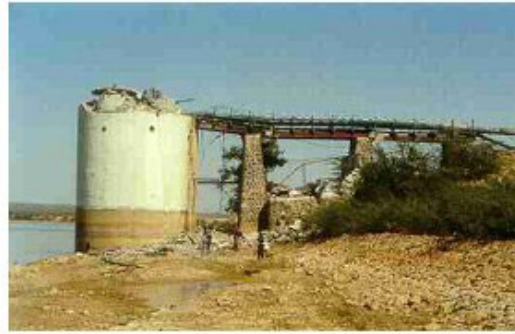
**Figure 45 Severe damage to the intake tower**

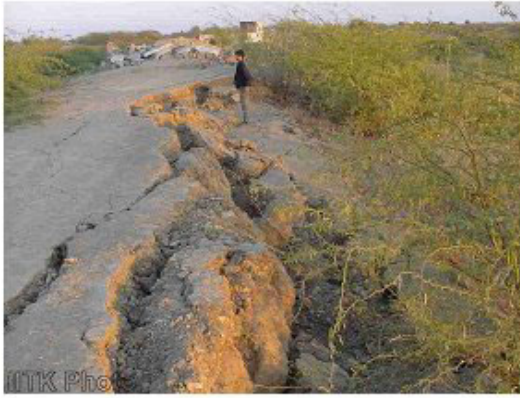
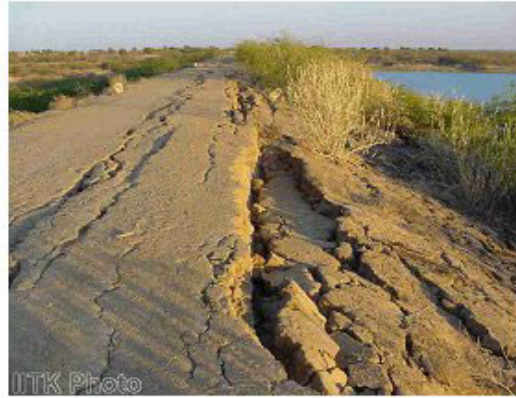
**Figure 46 Extensive cracking of the crest** **Figure 47 Failure of the upstream slope of the dam**  
[courtesy of IIT Kanpur] [courtesy of IIT Kanpur]

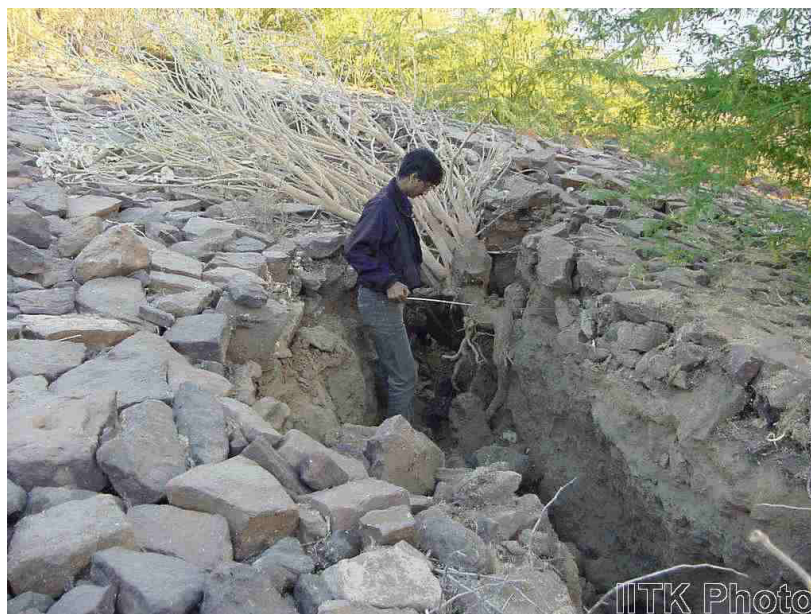
**Figure 48 Deep cracks following the failure of the upstream slope**  
[courtesy of IIT Kanpur]

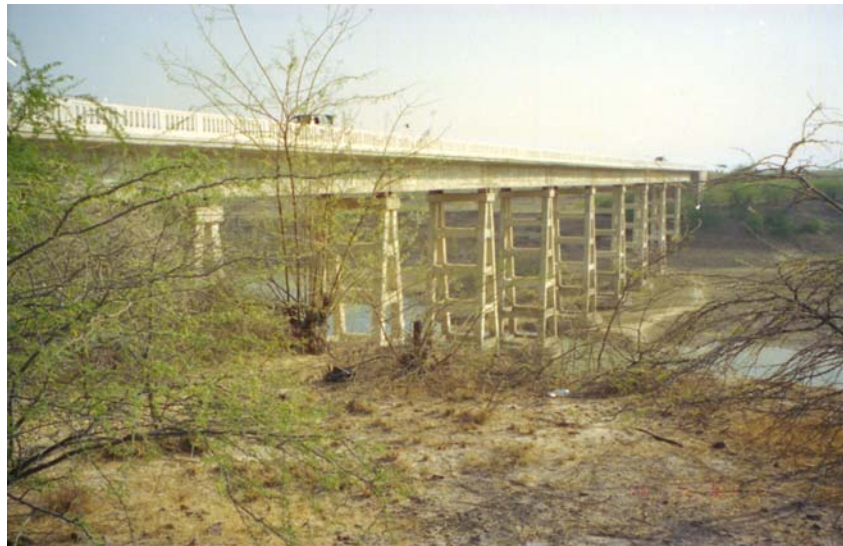
**Figure 1 Rudramata (Khari) Bridge – view from north side**

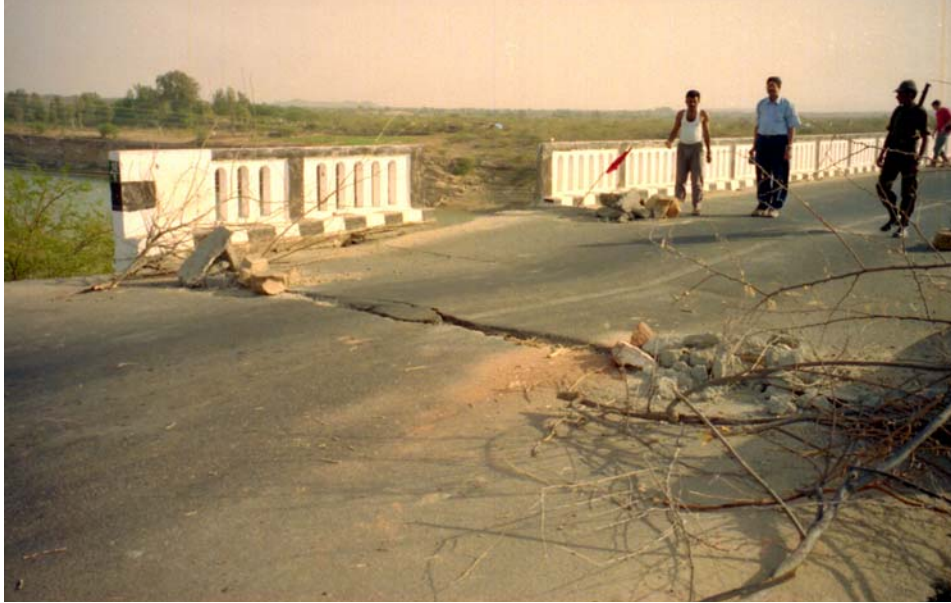
**Figure 2 Rudramata (Khari) Bridge – settlement behind north abutment and missing section of parapet**

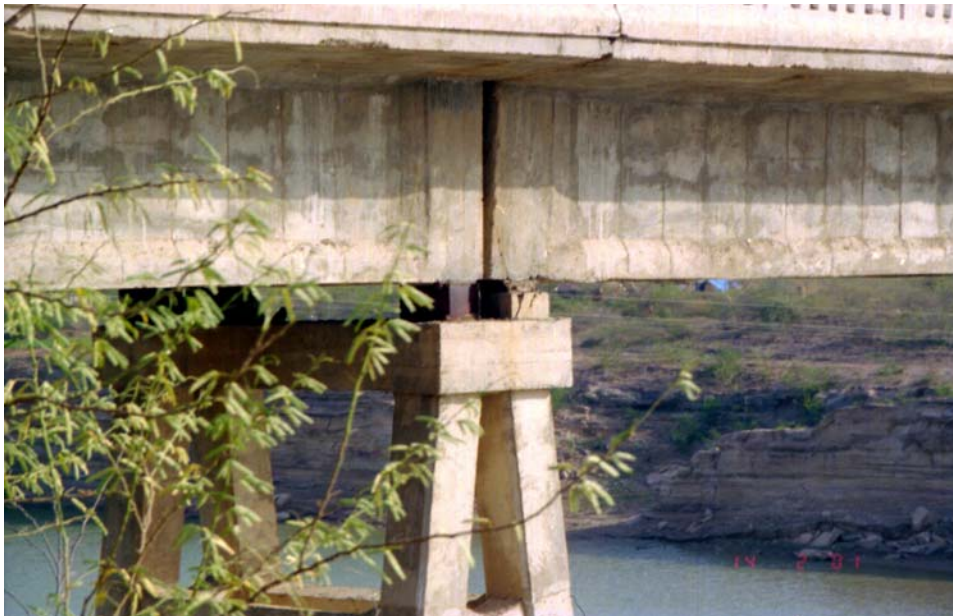
**Figure 3 Rudramata (Khari) Bridge – fractured bearing plinth**

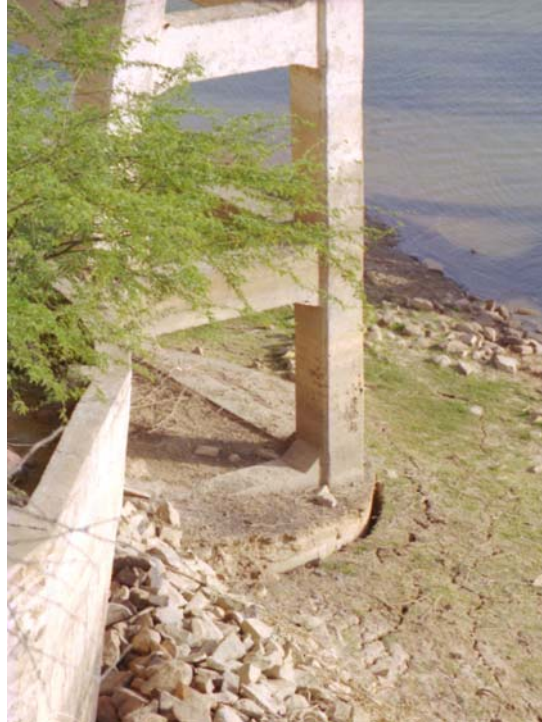
**Figure 4 Rudramata (Khari) Bridge - settlement and lateral spreading of the soil, but caisson unaffected**

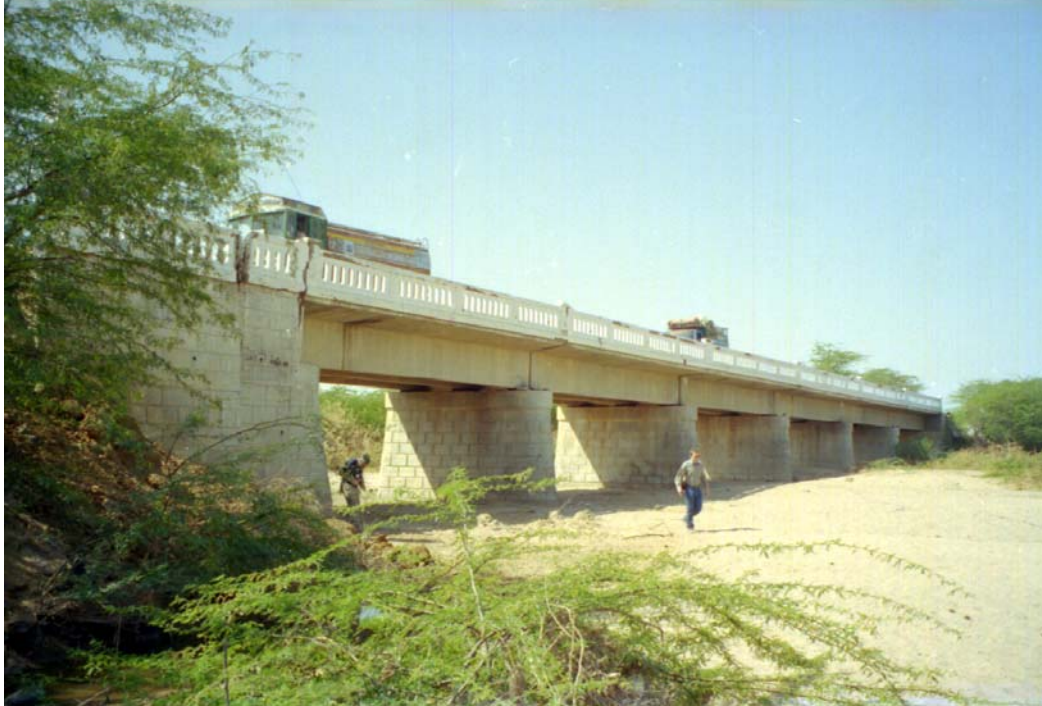
**Figure 5 Six Span Bridge near Dudhai – oriented east-west, 25km from epicentre, probably constructed in the 1960s**

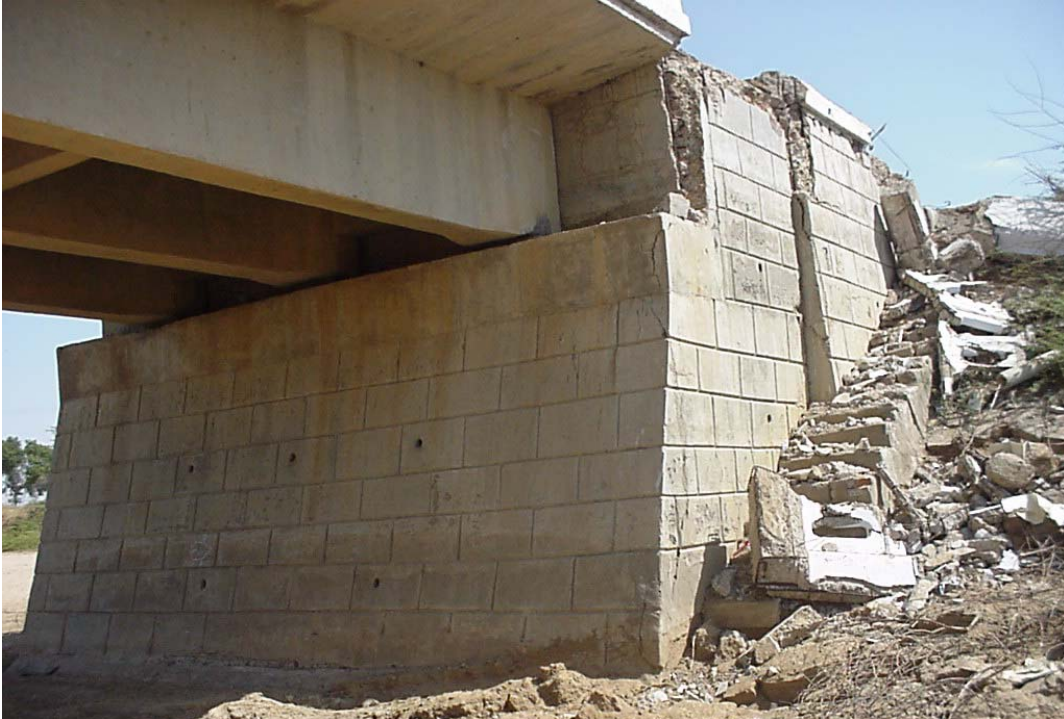
**Figure 7 Six Span Bridge near Dudhai – settlement of the ground in front of the abutment, impact damage to ballast wall and loss of reinforced concrete parapet**

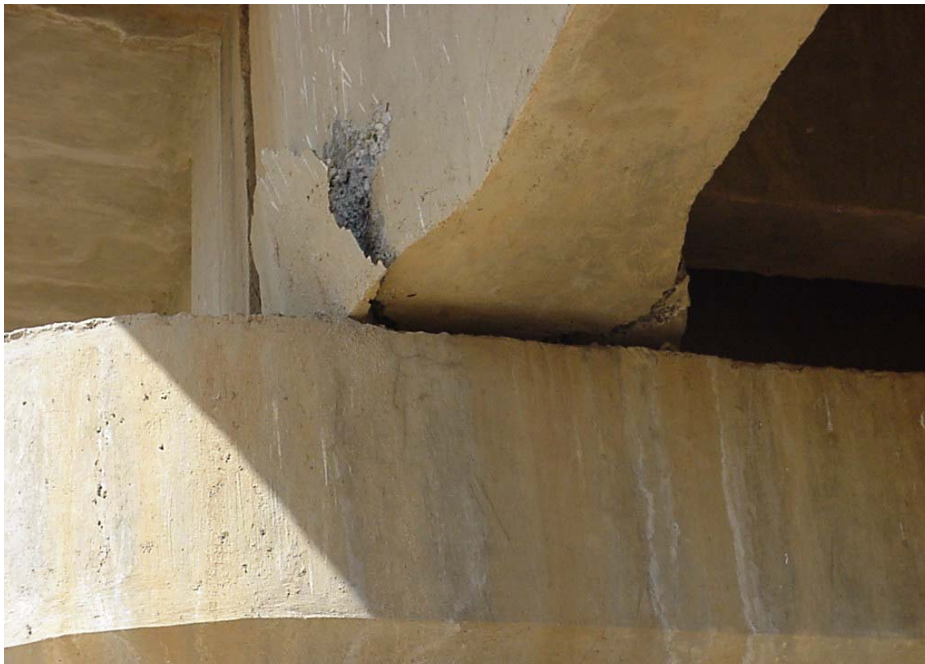
**Figure 8 Six Span Bridge near Dudhai – damage to beams at bearings**

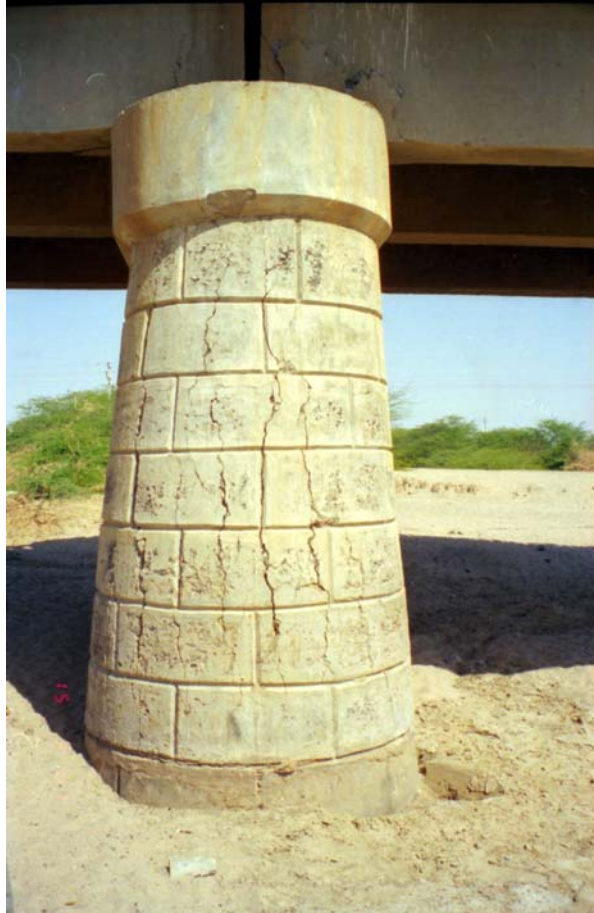
**Figure 9 Six Span Bridge near Dudhai – vertical cracks in ends of piers probably due to reinforcement corrosion possibly made worse by splitting forces from corroded and locked up bearings**

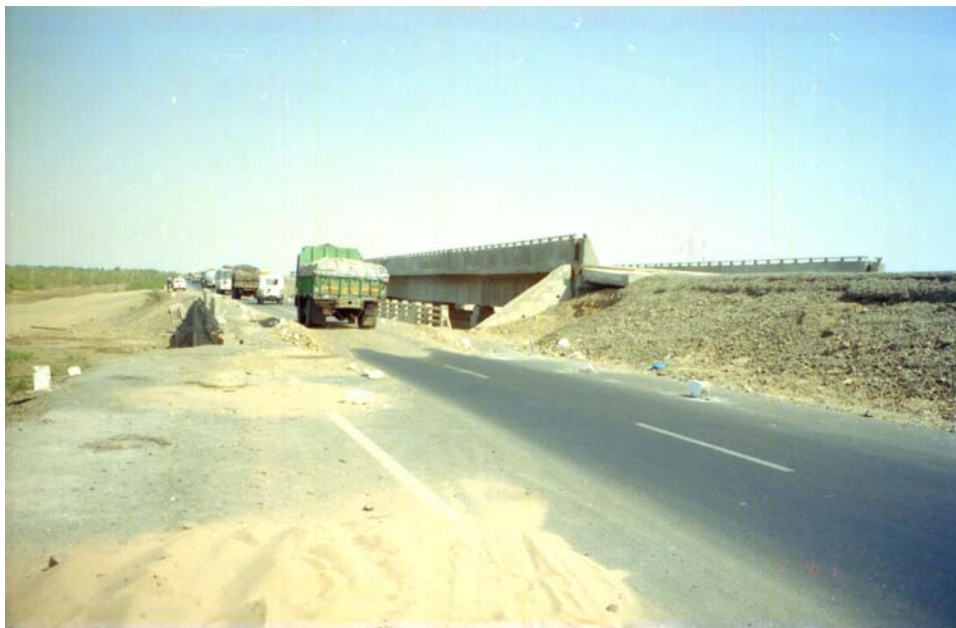
**Figure 10 Four-Bridges Site on NH8A just to east of Bhachau - showing the old and (almost complete) new road bridges**

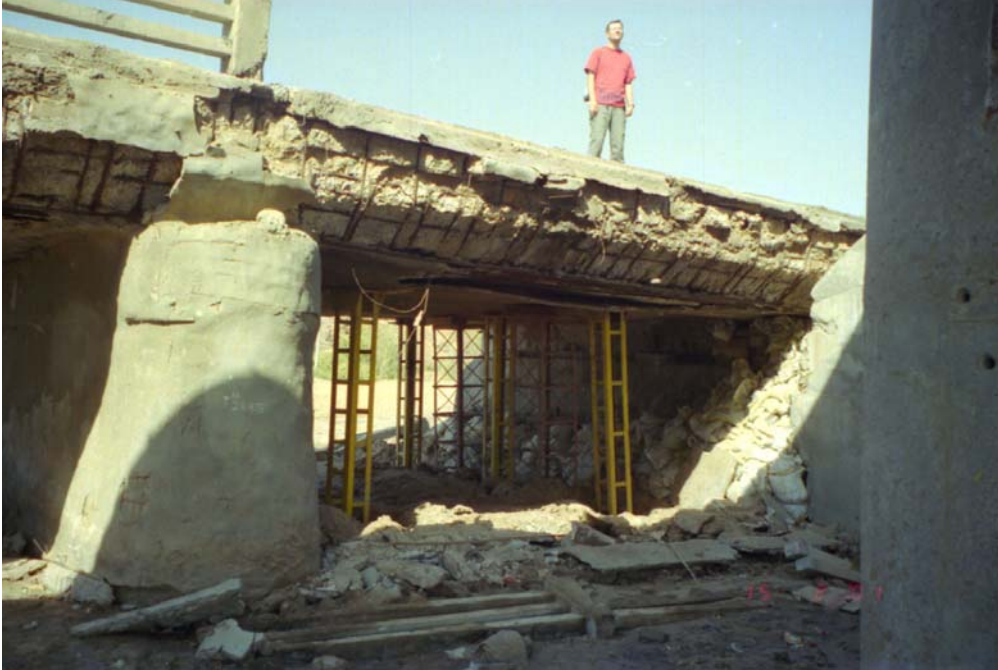
**Figure 11 Four-Bridges Site on NH8A just to east of Bhachau – old road bridge showing badly deteriorated concrete, damage to east abutment, loss of sprayed concrete and parapet on ground. This bridge was carrying all the road traffic on the NH8A**

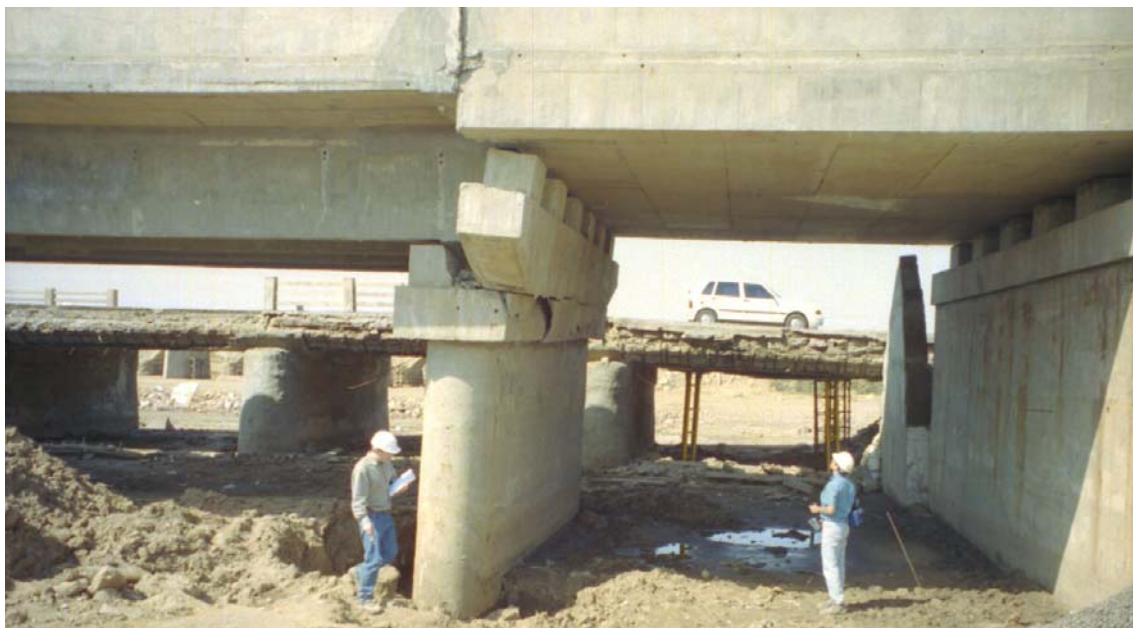
**Figure 12 Four-Bridges Site on NH8A just to east of Bhachau – new (almost completed) road bridge: collision of deck with pier upstand, wing wall has moved forward relative to abutment, marks on pier and abutment show about 500mm settlement of soil**

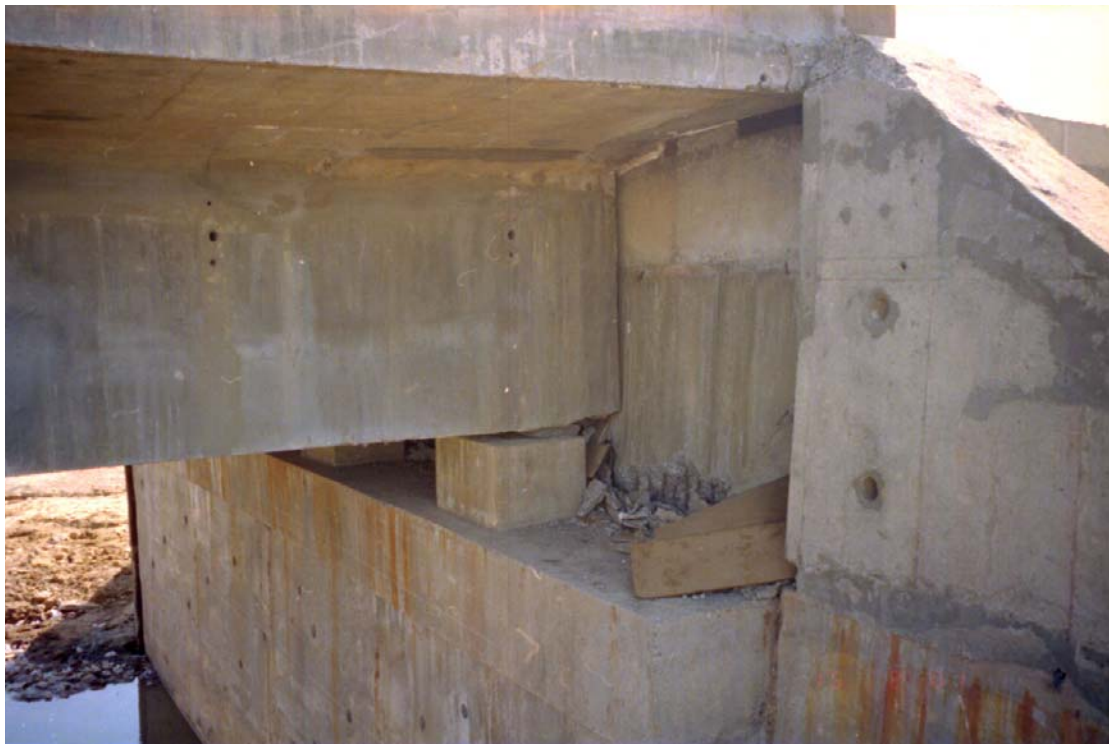
**Figure 16 Four-Bridges Site on NH8A, new road bridge: the west abutment had moved forward by about 200mm and ballast wall had also been damaged, but not as severely as at the east end abutment**

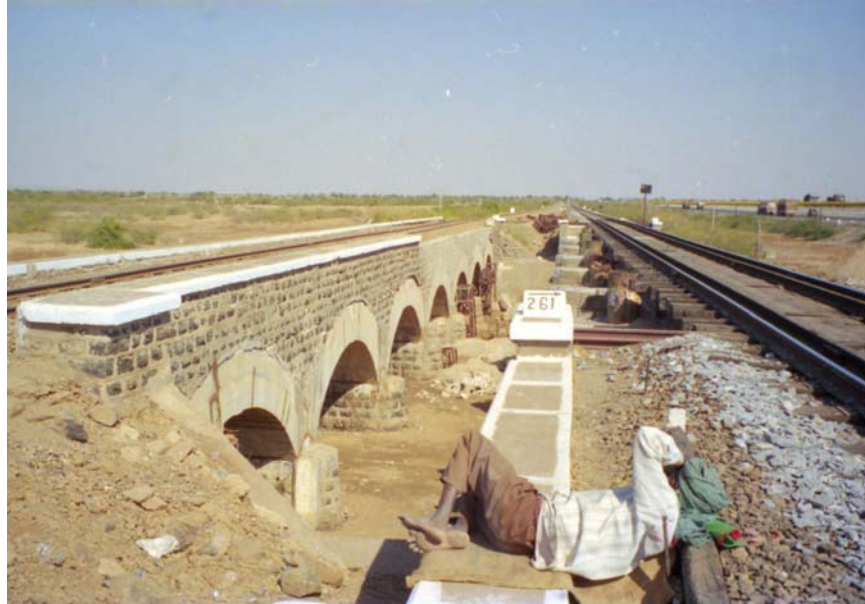
**Figure 17 Four-Bridges Site on NH8A, metre gauge and broad gauge rail bridges: masonry arches support metre gauge, and steel girders support broad gauge. Spandrel wall had collapsed and been reconstructed where white coping stones are missing. Note bulges at crown of arches on this south face.**
