# **The Bhuj, India Earthquake of 26<sup>th</sup> January 2001**

## **A FIELD REPORT BY EEFIT**

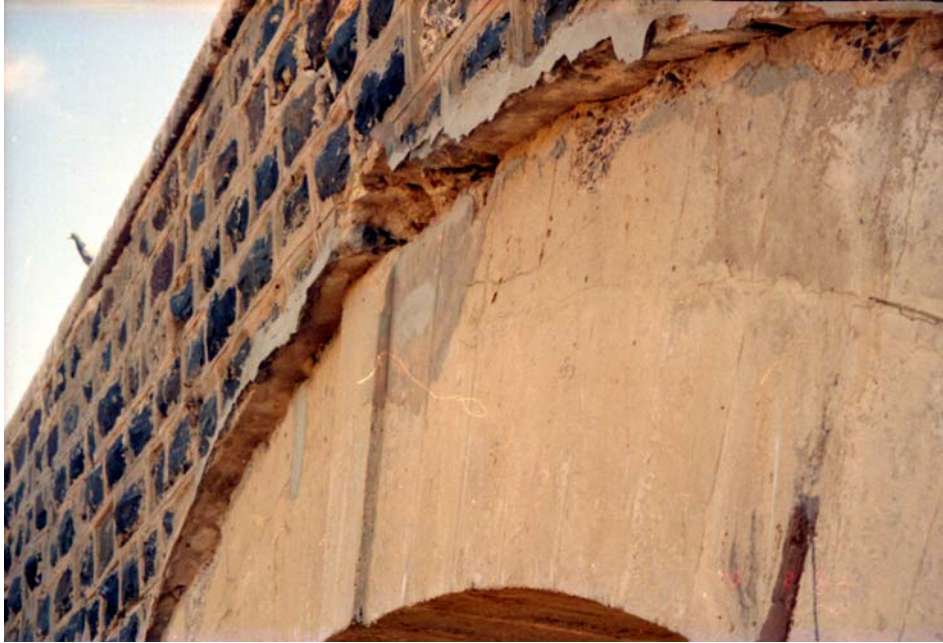
**Figure 18 Four-Bridges Site on NH8A, metre gauge rail bridge: bulging of spandrel wall on north side of bridge**

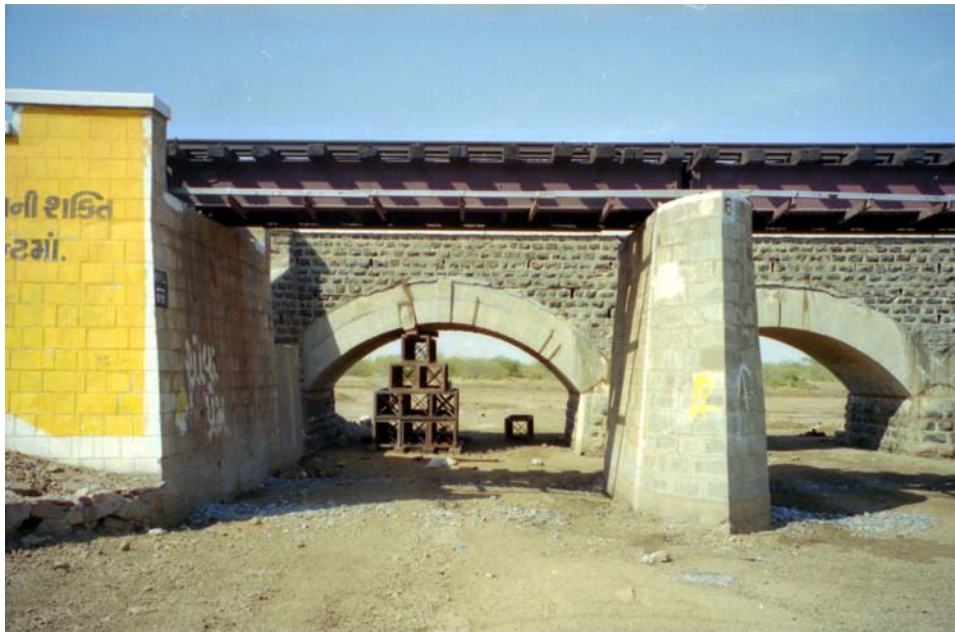
**Figure 19 Four-Bridges Site on NH8A, metre gauge and broad gauge rail bridges: joints between loosened arch blocks had been epoxy injected in west end span. Note it had not been possible to jack blocks back into original position**

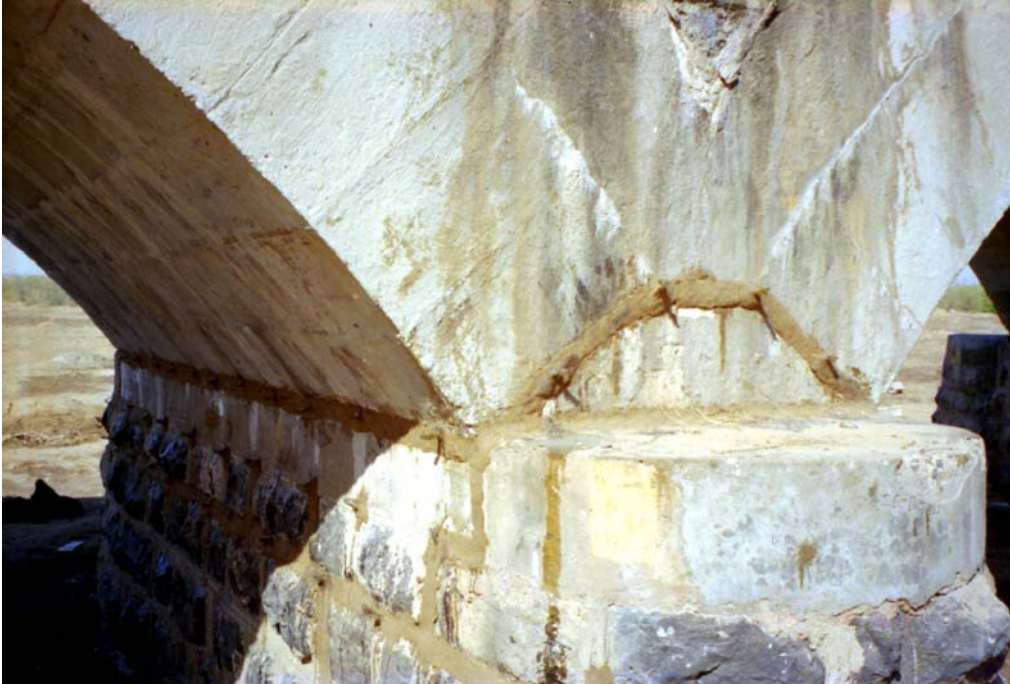
**Figure 20 Four-Bridges Site on NH8A, metre gauge rail bridge: cracks between arch blocks had been injected with epoxy resin – note the surface sealing mortar and injection nipples**

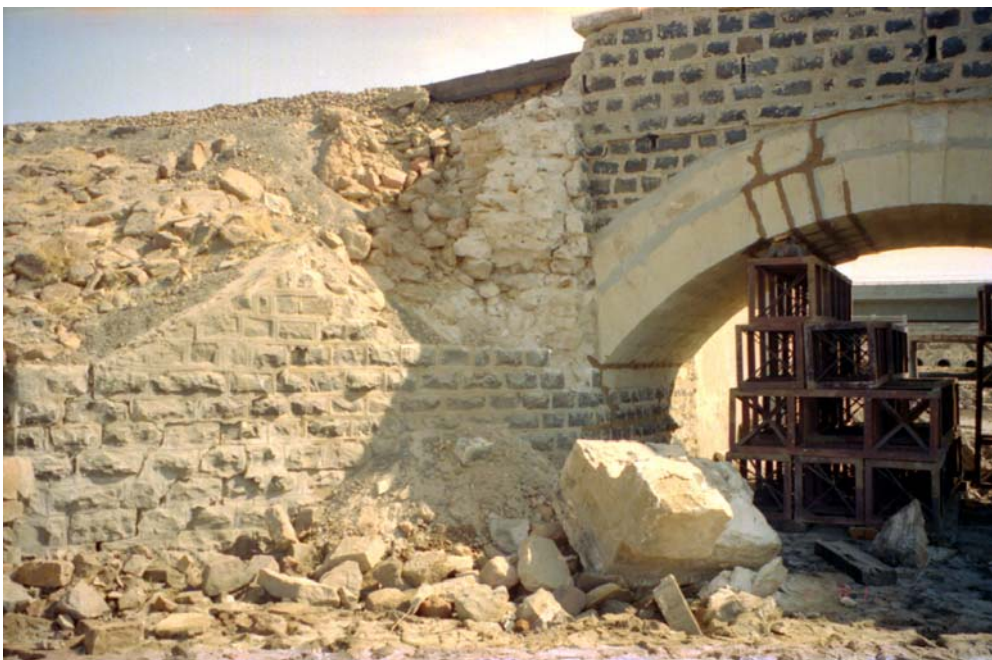
**Figure 21 Four-Bridges Site on NH8A, metre gauge rail bridge: at east end of bridge masonry wing wall had been badly damaged and joints between arch blocks had been injected with epoxy**

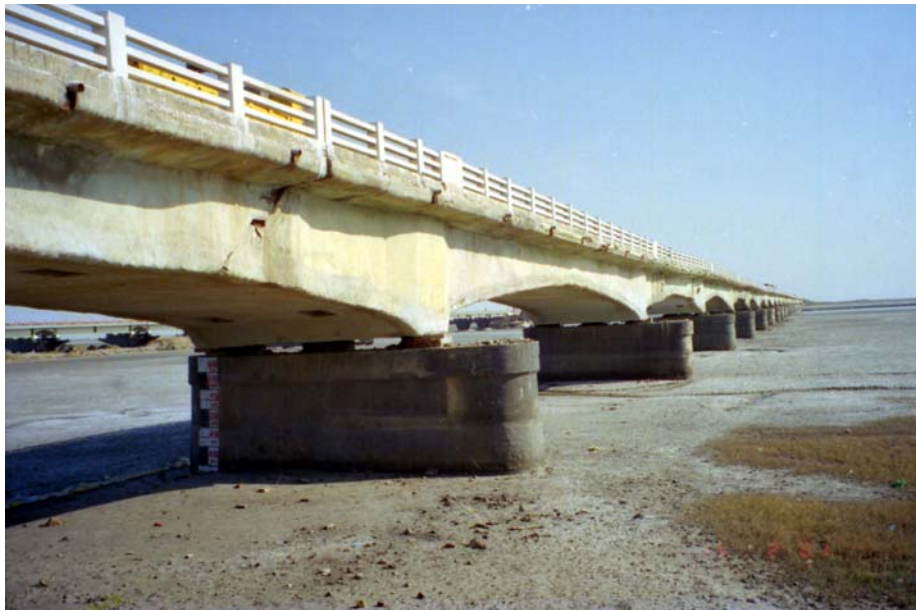
**Figure 22 Surajbari Old Bridge: 37 spans of 32.2m, reinforced concrete box girder supported on r.c. piers and well caissons**

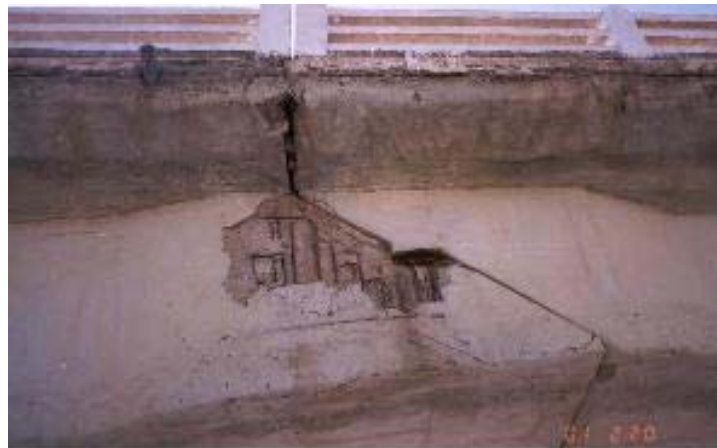
**Figure 24 Surajbari Old Bridge: pounding at joint caused spalling of concrete coating and cover. Note severely corroded reinforcement. [Photo courtesy of Mahesh Tandon].**

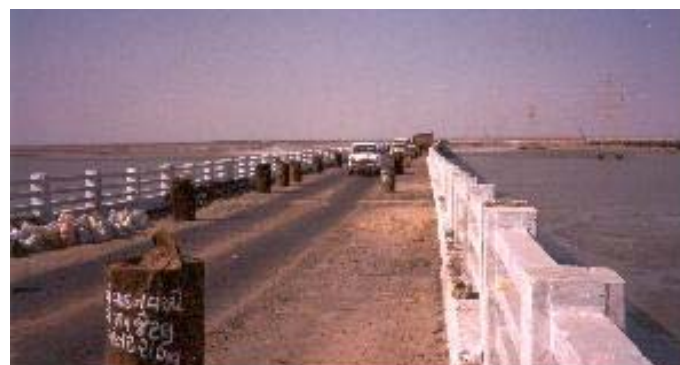
**Figure 25 Surajbari Old Bridge: deck displaced vertically and horizontally, horizontal displacement was a maximum of about 1.5m at Pier P15. [Photo courtesy of Mahesh Tandon].**

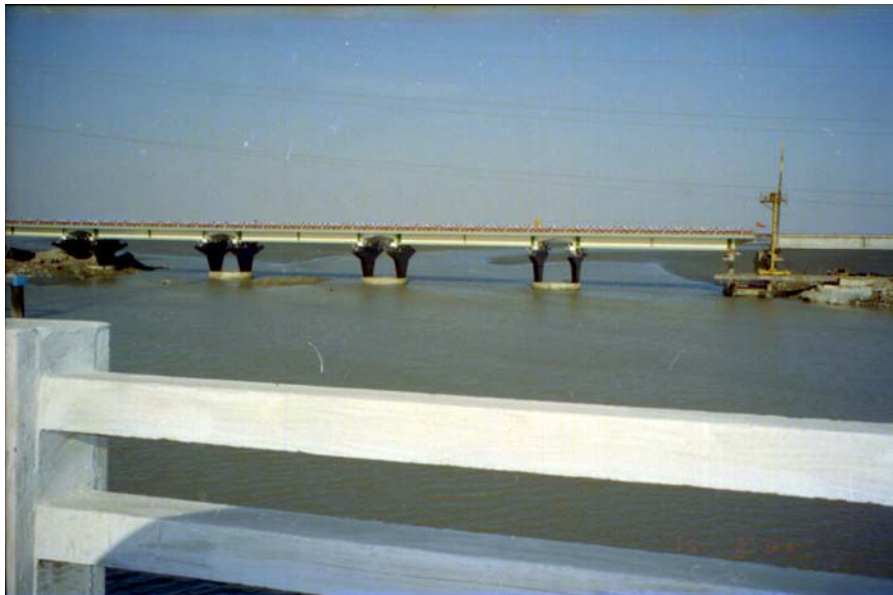
**Figure 26 Surajbari New Bridge: 39 spans of 32.2m, prestressed beams on twin leaf r.c. piers and well caisson foundations**

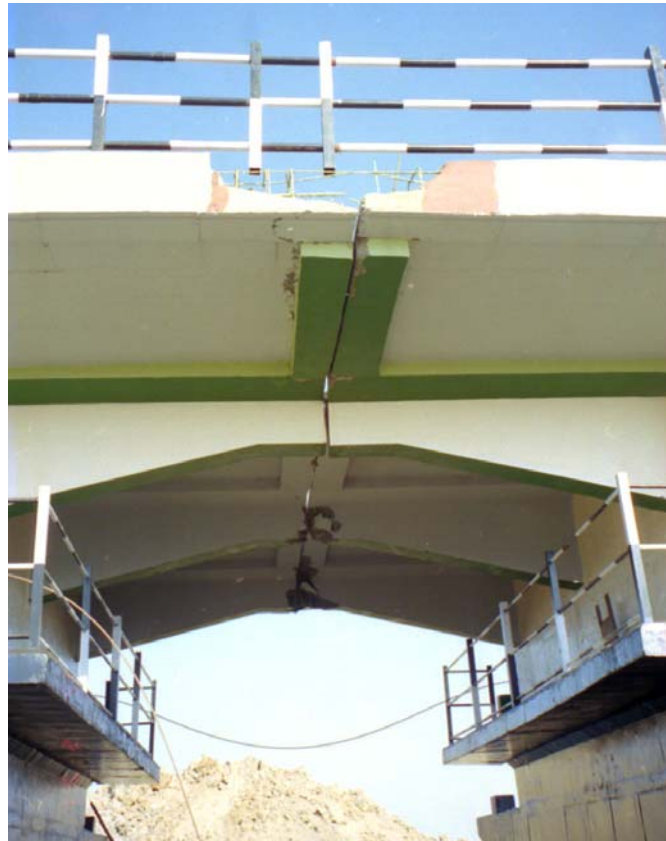
**Figure 27 Surajbari New Bridge: pounding between ends of adjacent spans had caused some damage**

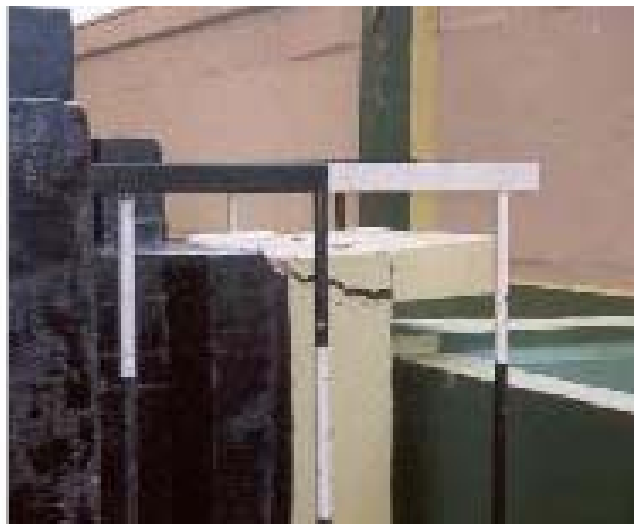
**Figure 28 Surajbari New Bridge: many shear stopper blocks were badly damaged. [Photo courtesy of Mahesh Tandon].**

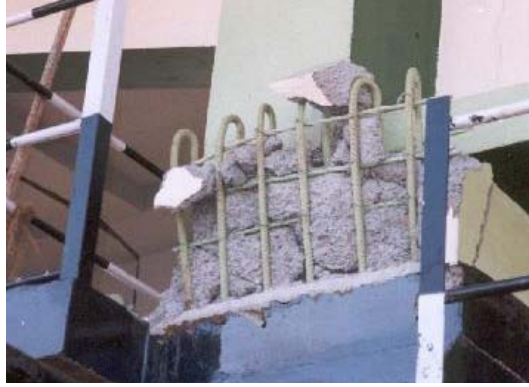
**Figure 29 Surajbari New Bridge: damage to shear stopper block. [Photo courtesy of Mahesh Tandon].**

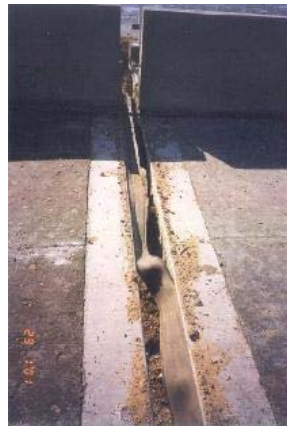
**Figure 30 Surajbari New Bridge: deck joints were moved beyond their capacity and some rubber seals were torn out. [Photo courtesy of Mahesh Tandon].**

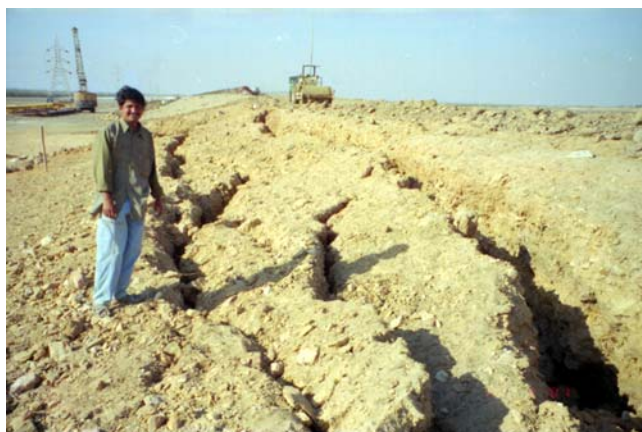
**Figure 31 Surajbari New Bridge: liquefaction of the underlying soil caused settlement and cracks in the approach embankments**

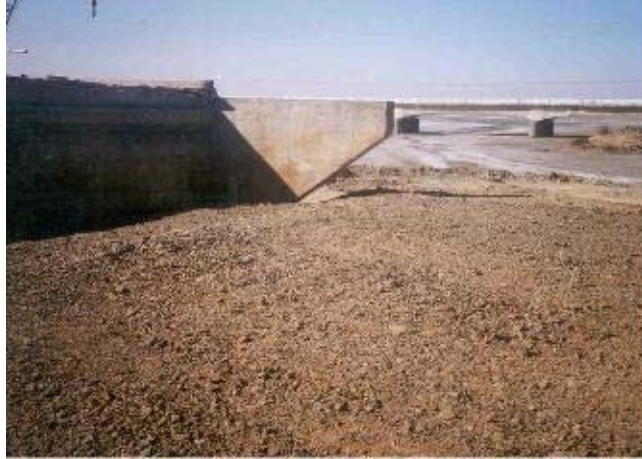
**Figure 32 Surajbari New Bridge: liquefaction caused settlement of 1.3m behind the abutment at the Gandhidam end of the bridge. [Photo courtesy of Gammon India Ltd].**

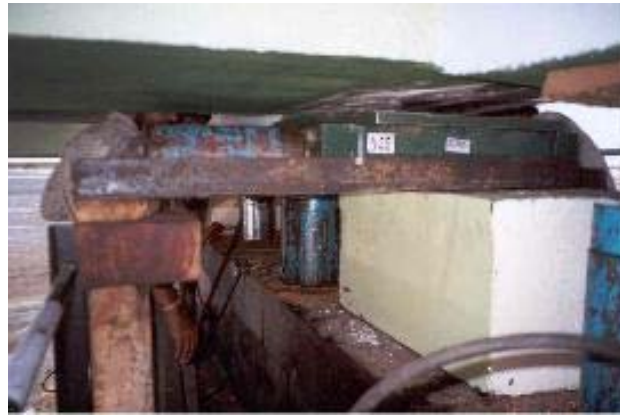
**Figure 33 Surajbari New Bridge: decks had been displaced up to a maximum of 250mm. After jacking a Hillman roller assembly was used to move the deck back to its correct position. [Photo courtesy of Mahesh Tandon].**

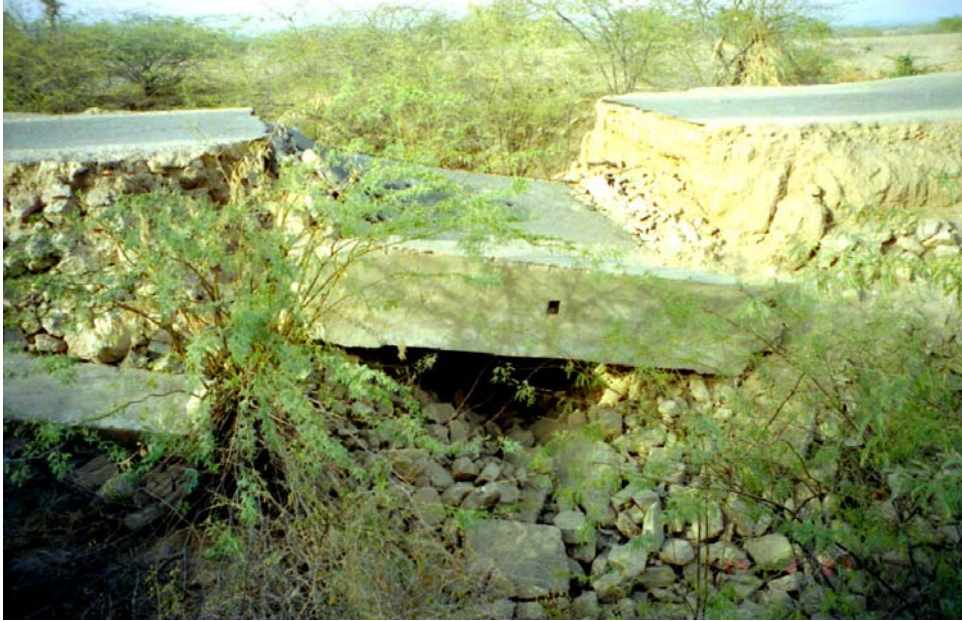
**Figure 34** Small reinforced concrete slab bridge on road from Bhuj to Lodai: masonry abutments were destroyed by violence of shaking

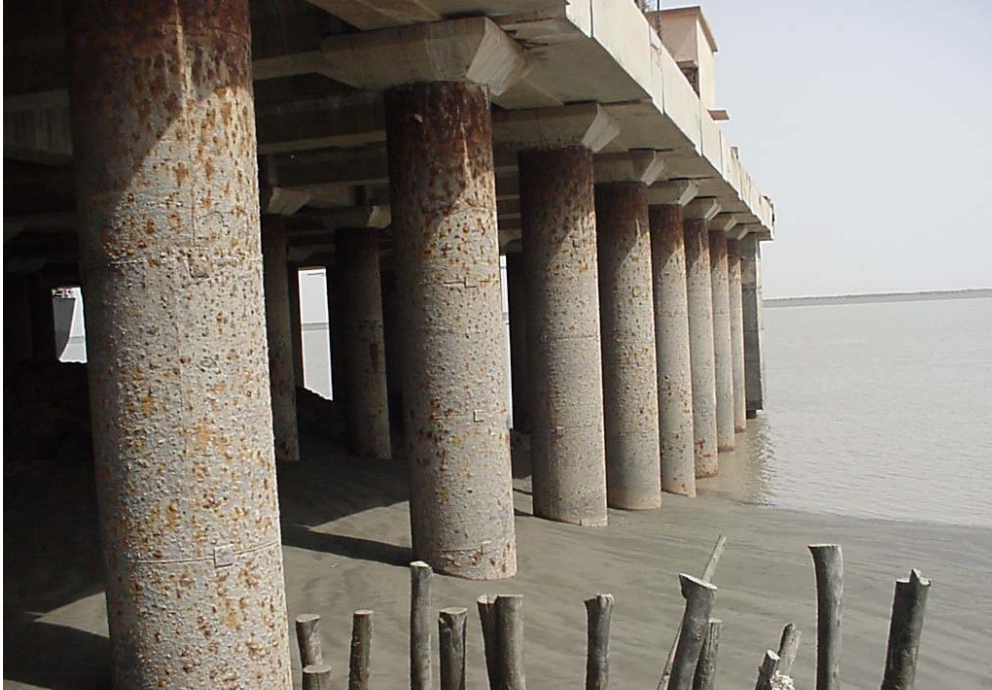
**Figure 36** Kandla Port: new berth completed 4 - 5 years ago - 1000mm diameter reinforced concrete piles cast inside permanent steel casings. Structure appeared to have performed well with virtually no damage or displacement.

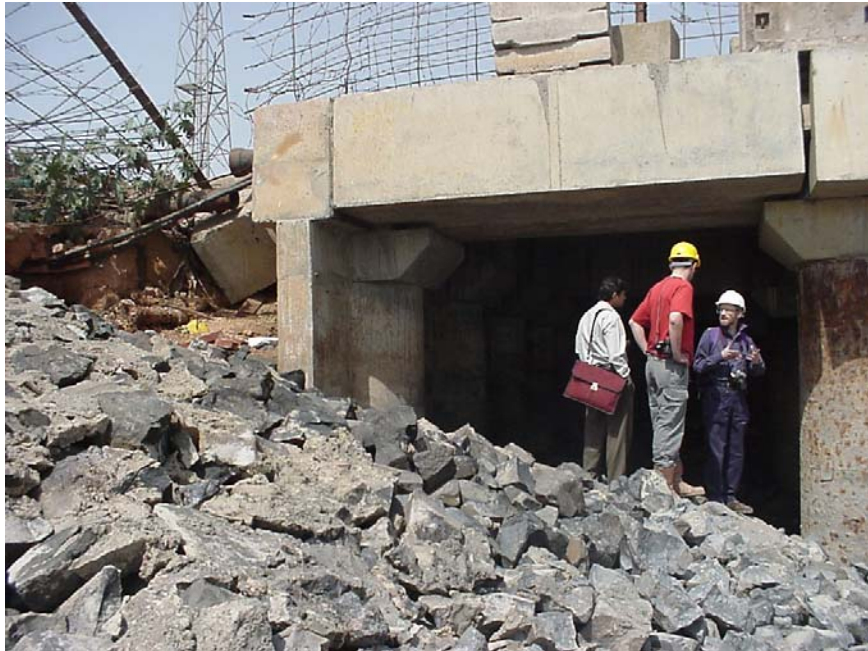
**Figure 37** Kandla Port new berth: retaining wall cast integral with landward edge row of piles. Material had been lost at this free corner due to settlement and lateral spreading. See also Figure 39.

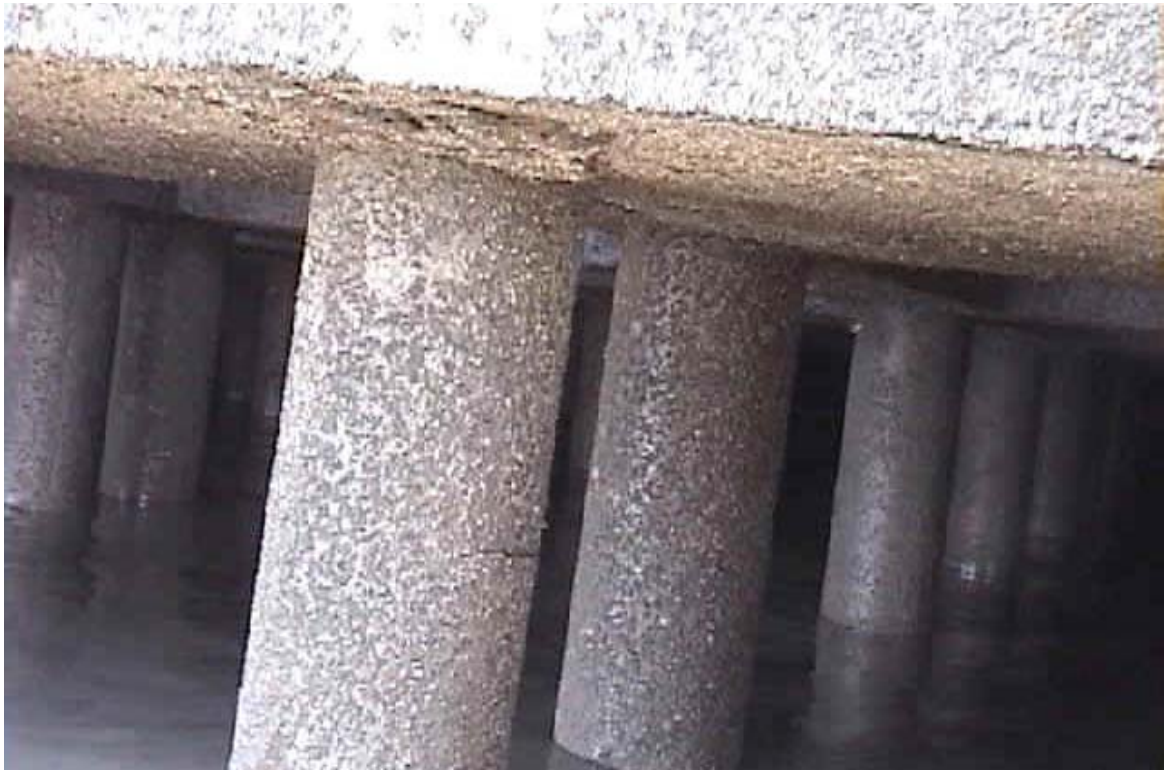
**Figure 41 Kandla Port: 600mm diameter cylinder piles had cracked circumferentially about 300mm below their connection with the r.c. framing members. [Photo courtesy of EERI].**

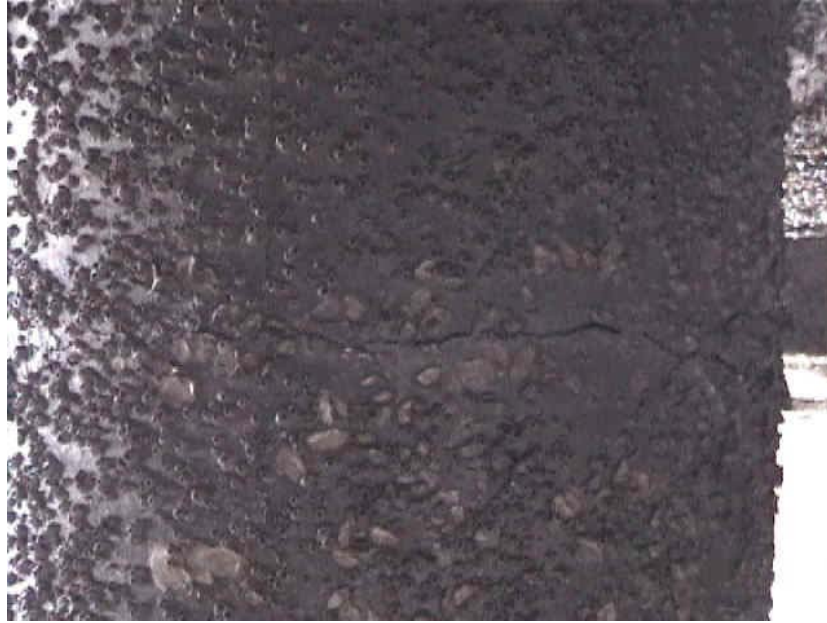
**Figure 42 Kandla Port: a close-up of crack in 600mm diameter cylinder pile. [Photo courtesy of EERI].**

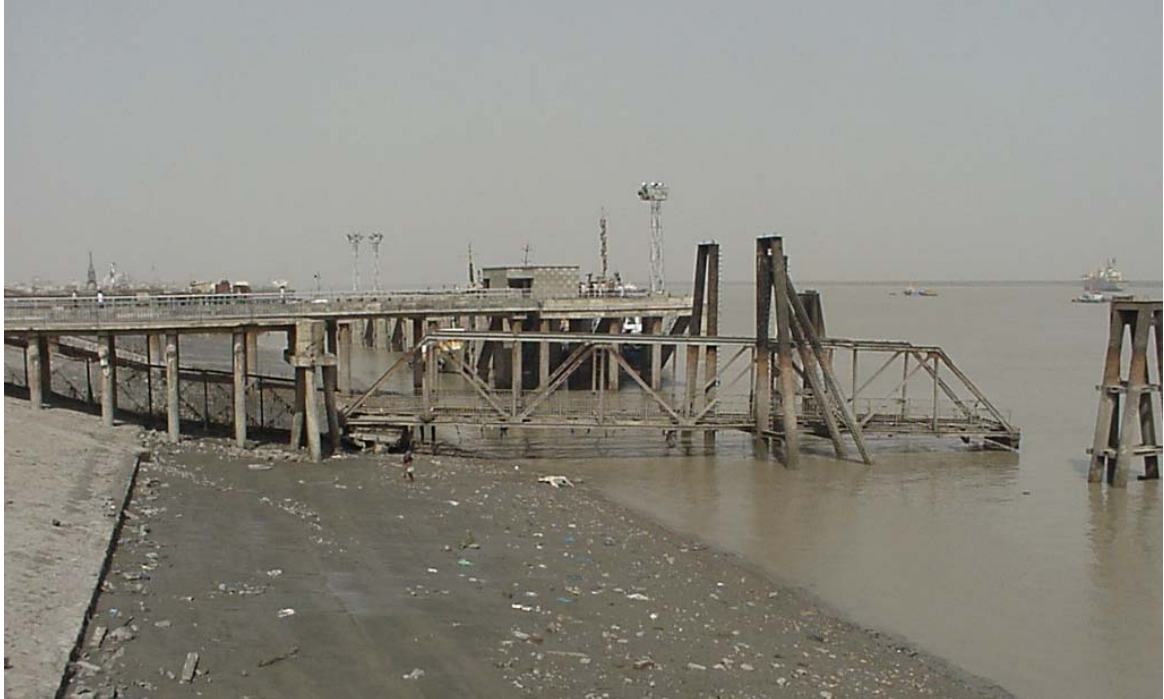
**Figure 43 Kandla Port, launch jetty: steel truss dropped off its support ledge during a devastating cyclone which hit Kandla on 9 June 1998.**

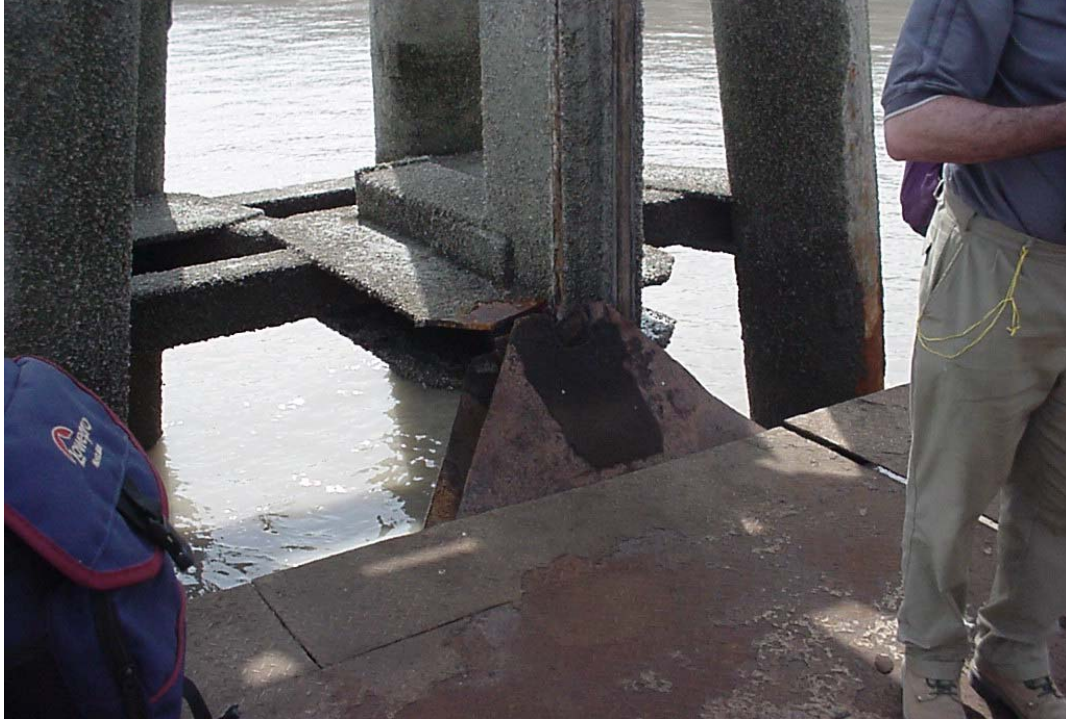
**Figure 45 Kandla Port, launch jetty: pontoon guides were also damaged**

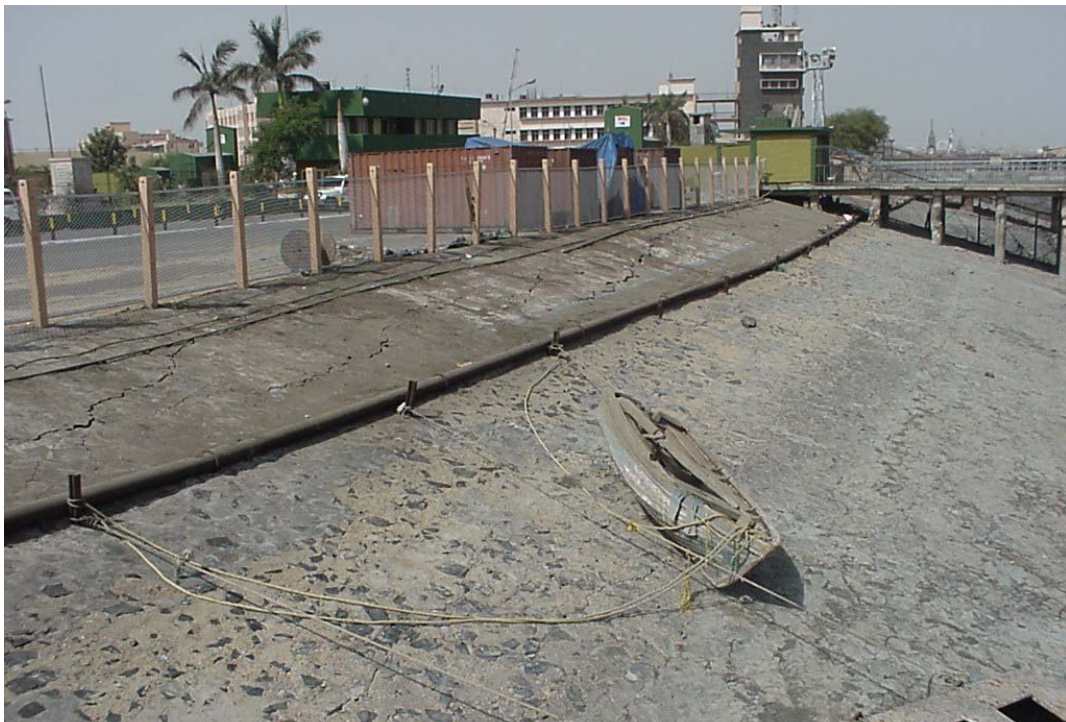
**Figure 46 Kandla Port: armoured slope had longitudinal cracks showing there had been some lateral spreading of the fill**

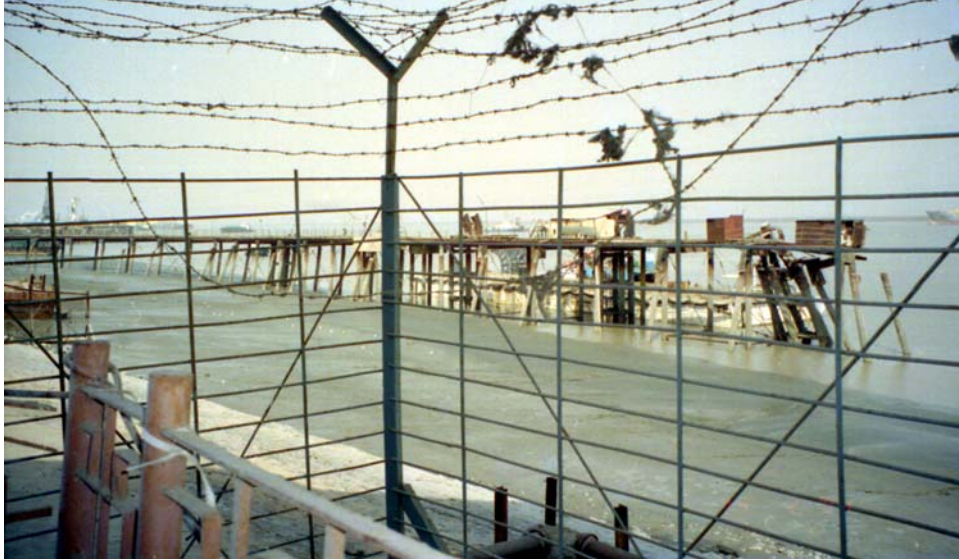
**Figure 47 Kandla Port: jetty for small craft to north of the control tower had been badly damaged by the cyclone and then the earthquake. Reinforcement corrosion had already weakened the structure.**

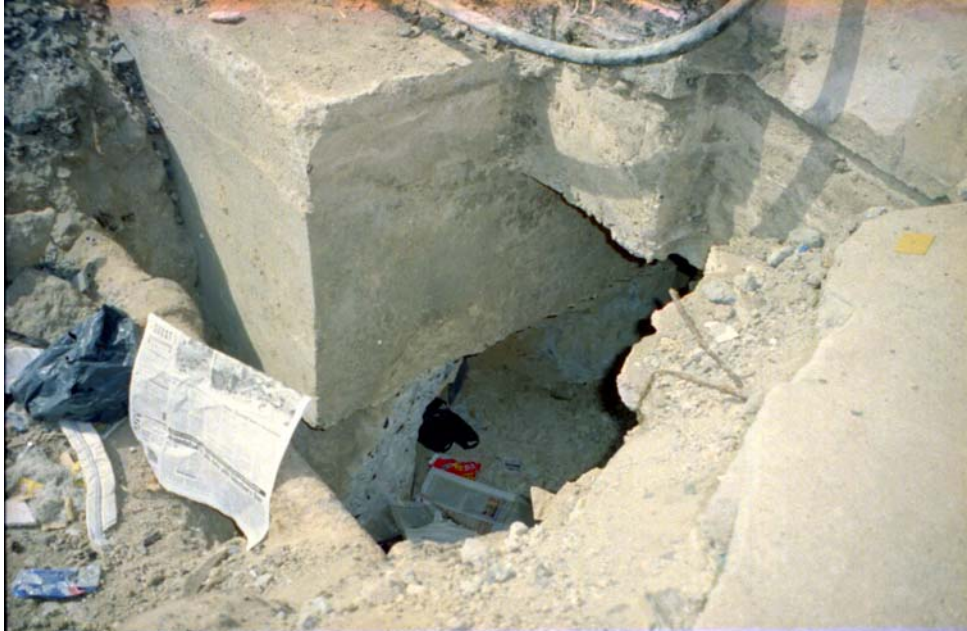
**Figure 51 Kandla Port control tower: freshly spalled surface of corner pile indicated bending distress due to inertia loads and lateral spreading of underlying soil.**

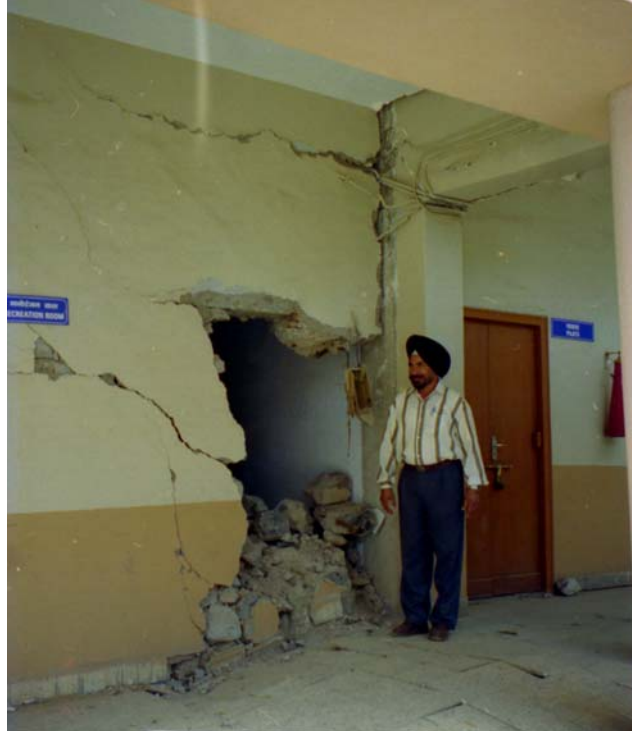
**Figure 52 Kandla Port: single storey annex at the rear of 4-storey administration building had shallow foundations and had suffered from settlement and lateral spread of founding soil**

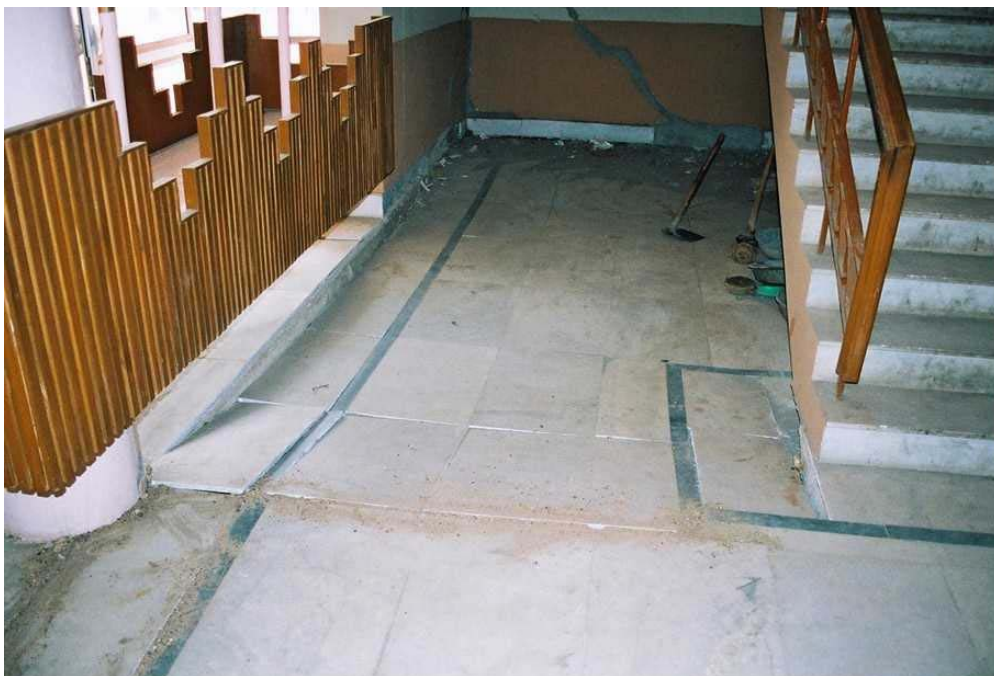
**Figure 53 Kandla Port: Similarly, the ground slab of the main building had settled and required replacement**

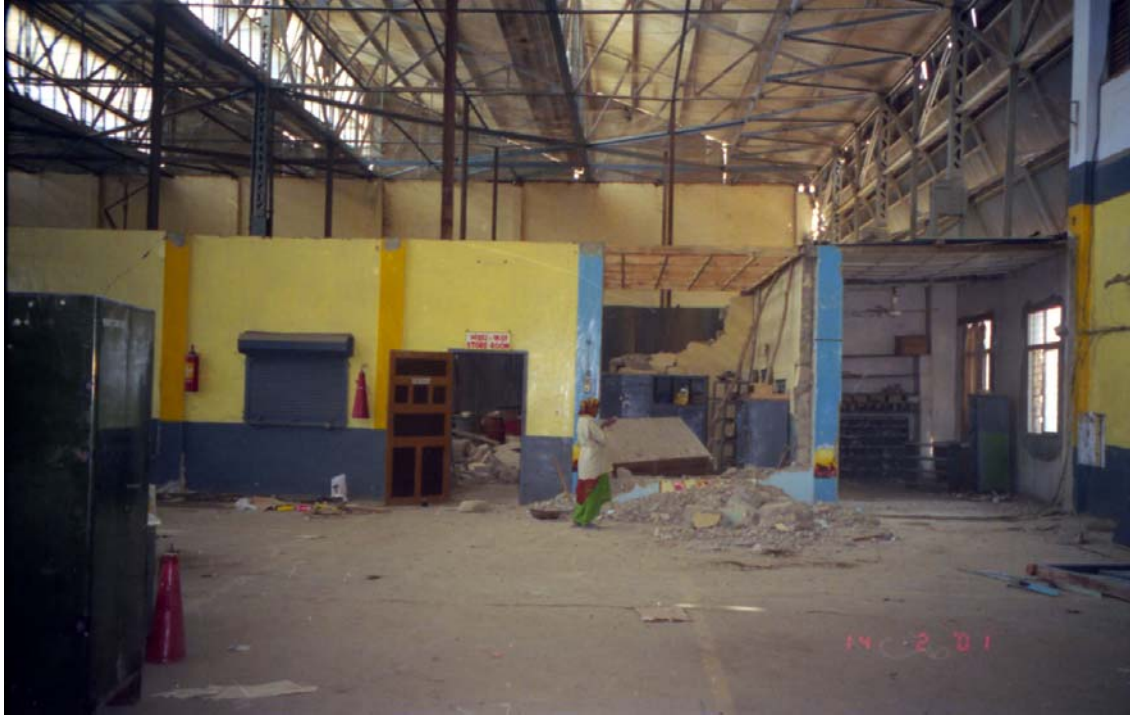
**Figure 54 Kandla Port: some masonry partition walls had collapsed in the workshops**

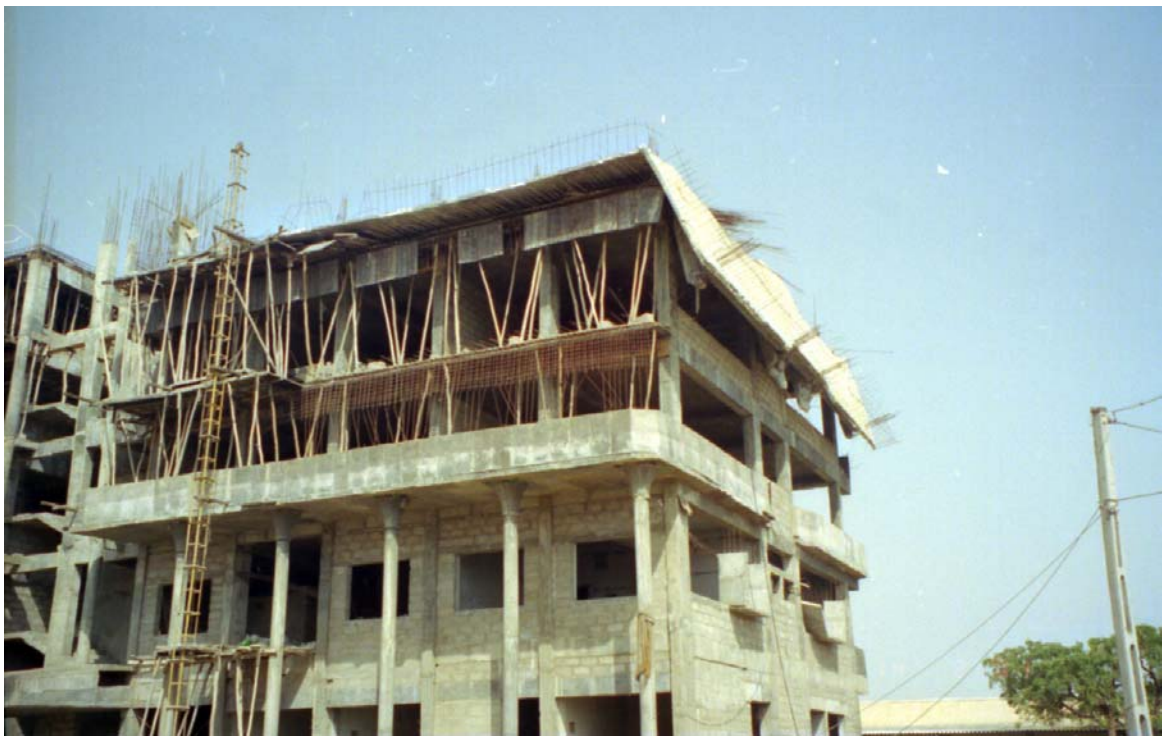
**Figure 55 Kandla Port: collapse of cantilever overhang of building under construction**

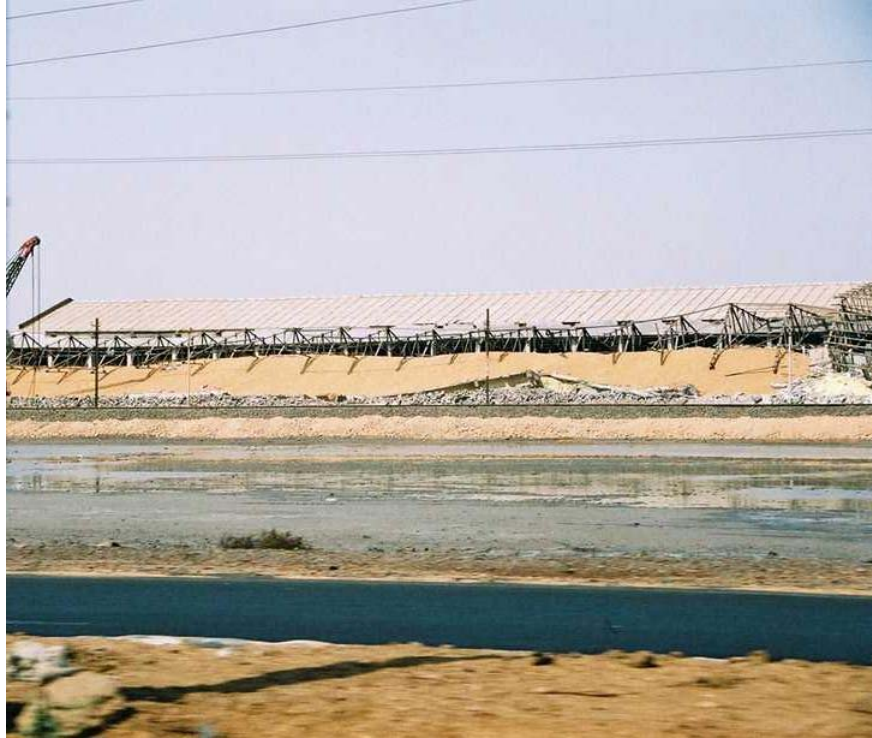
**Figure 56 Collapse of Masonry Walled Bulk Material Warehouse, near Kandla**

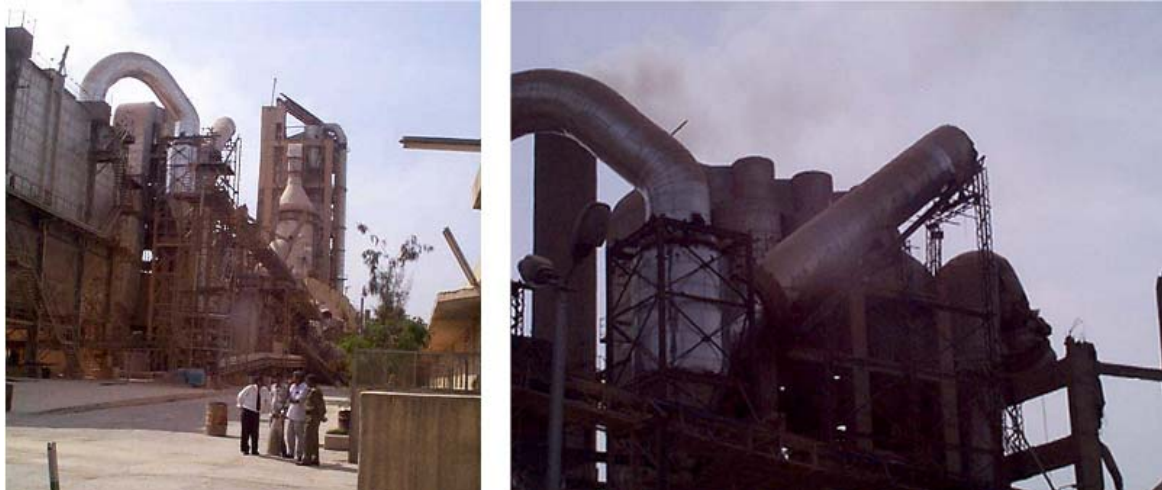
**Figures 60 & 61 Sikka Cement Works**

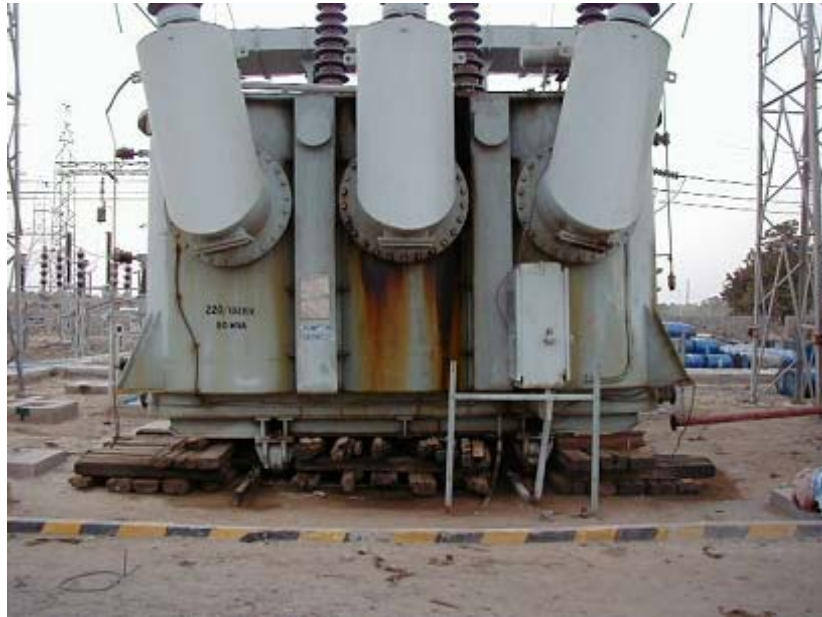
**Figure 62 Transformer on Temporary Supports at Anjar Substation**

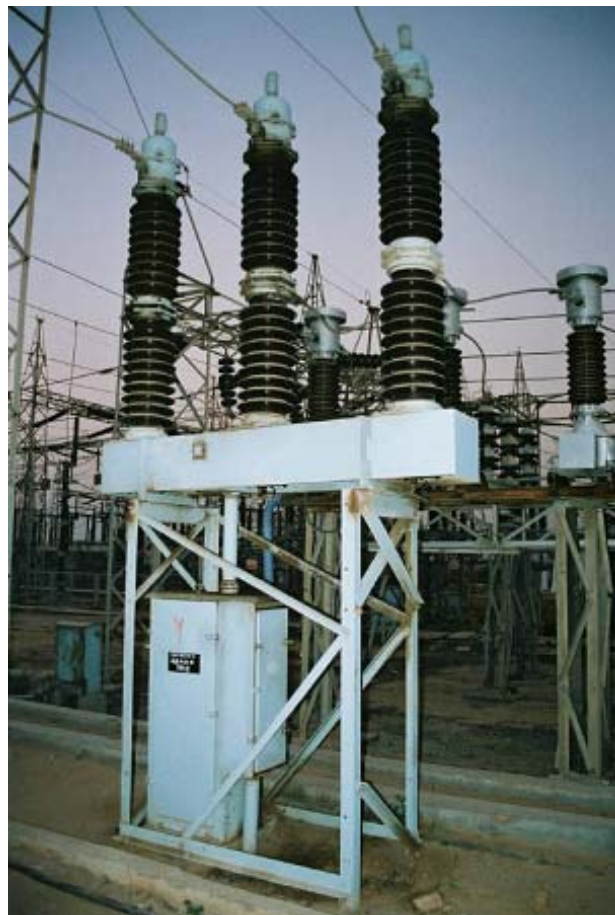
**Figure 63 Repaired Circuit Breaker at Anjar Substation**

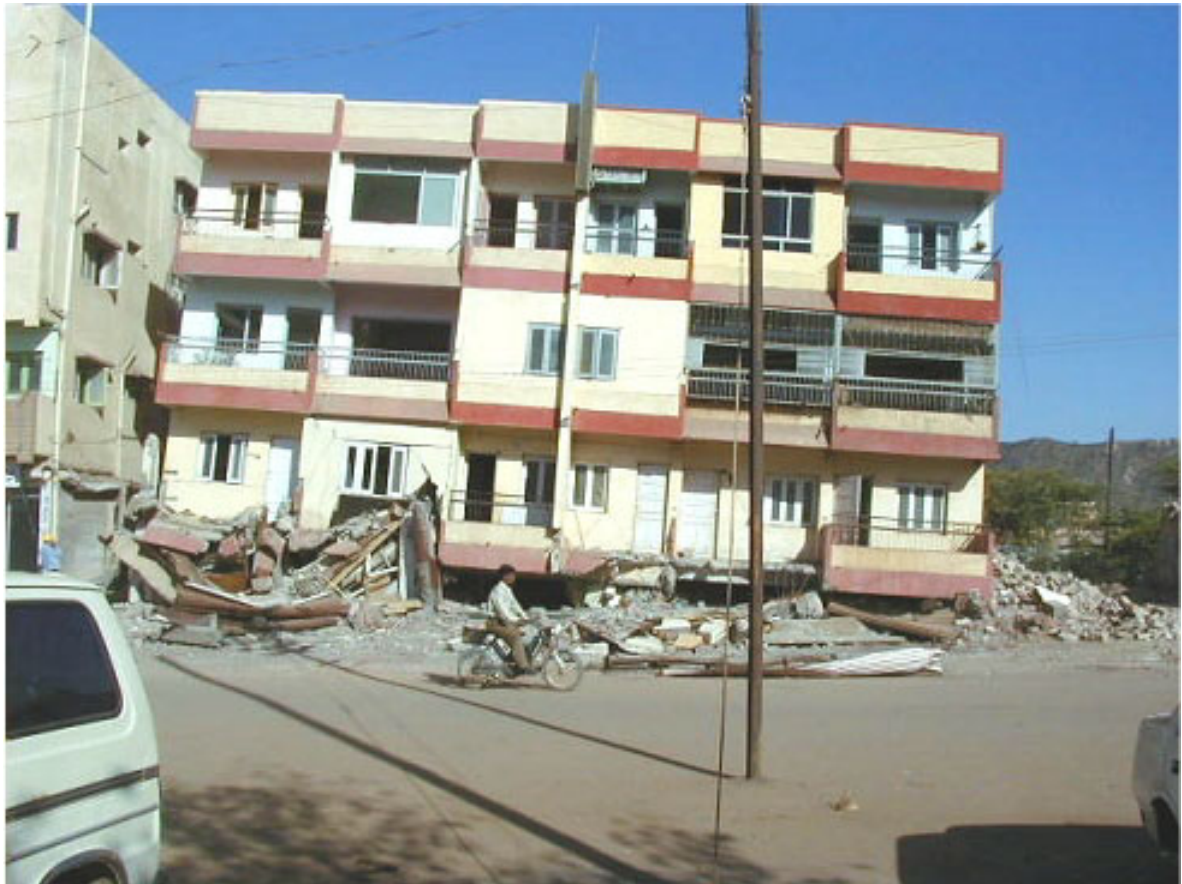
**Figure 1 Typical soft storey collapse in Bhuj**

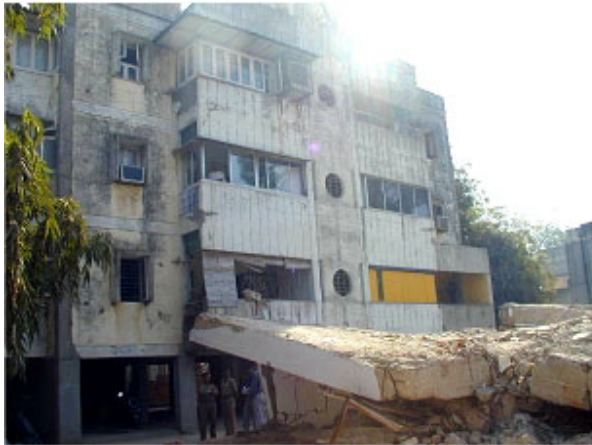
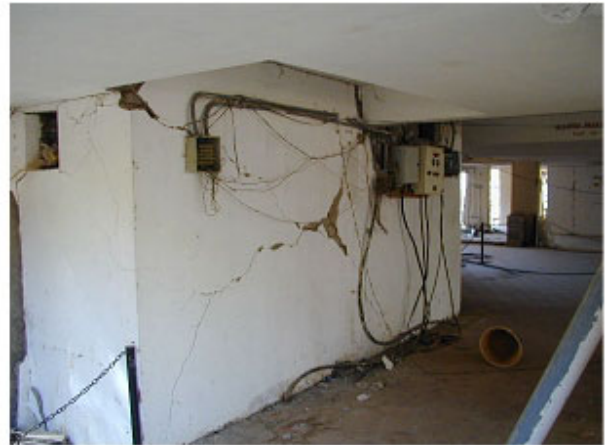
**Figure 2 Soft storey failure in Ahmedabad**

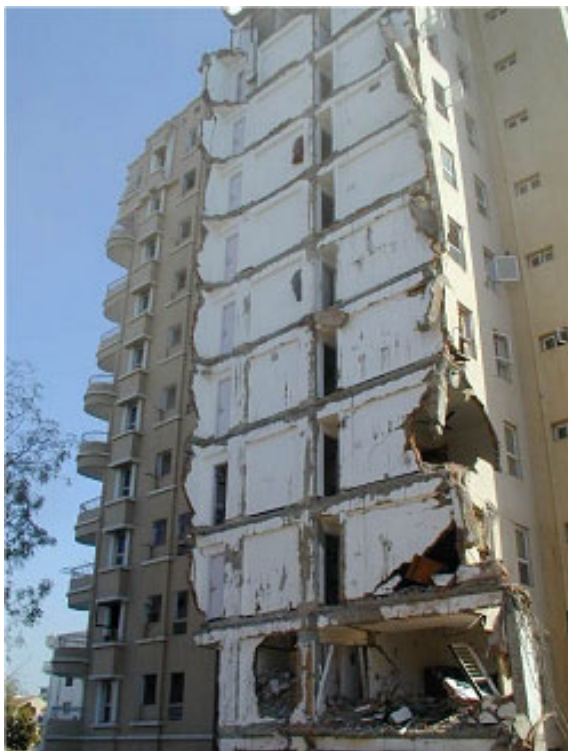
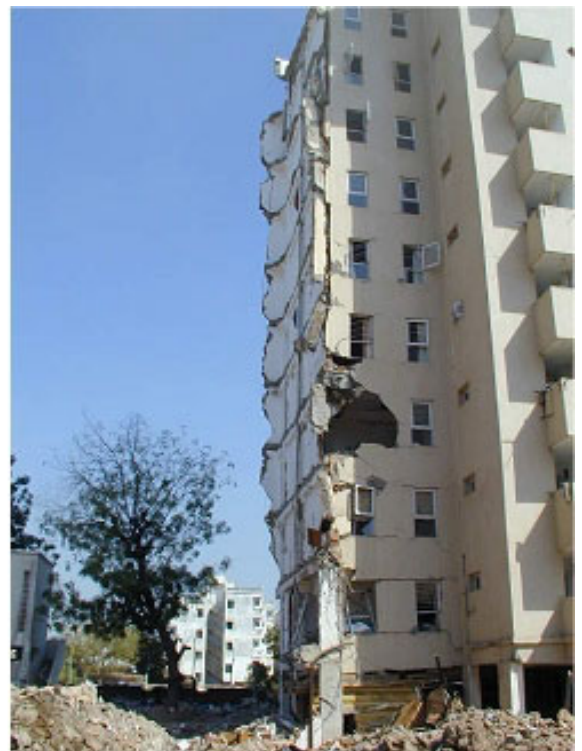
**Figure 3 Soft storey failure in Ahmedabad**

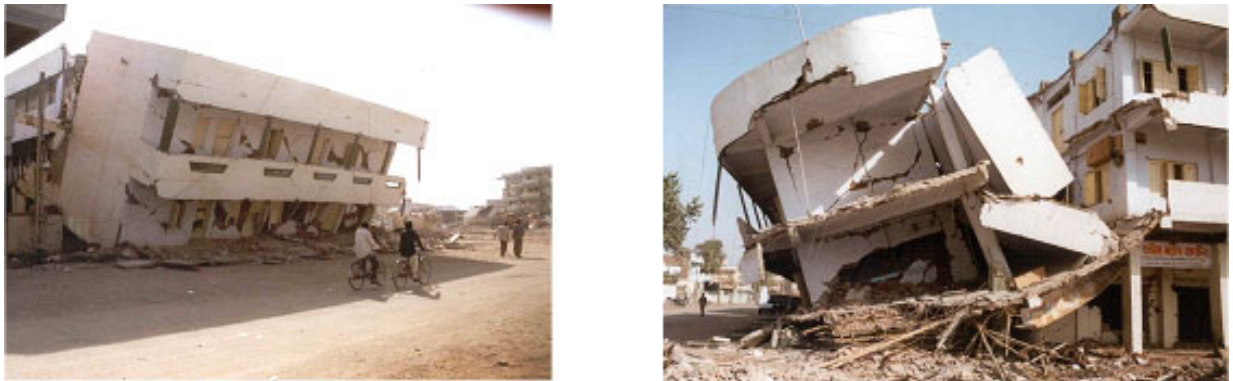
**Figure 4 Soft storey failure in Gandhidham**

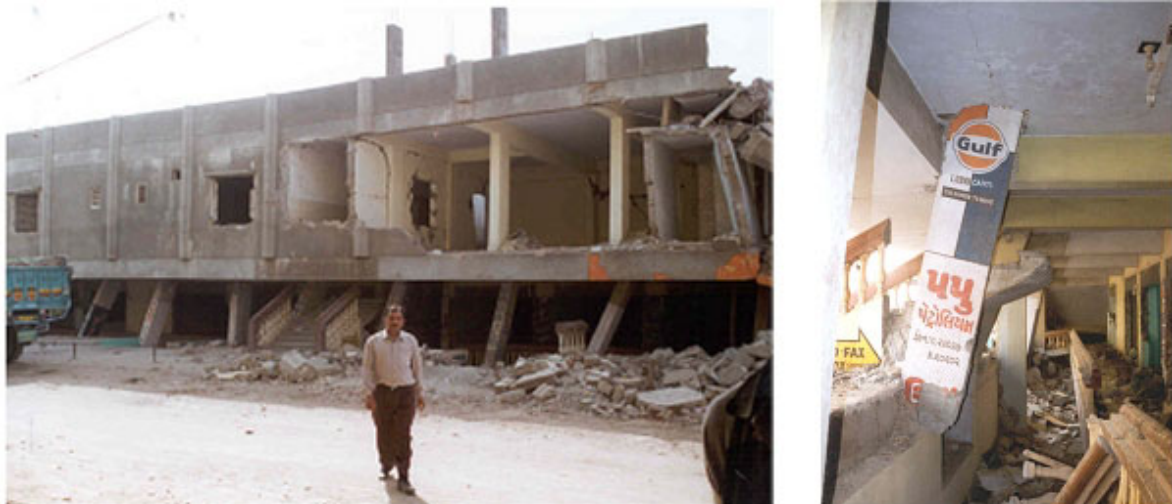
**Figure 5 Soft storey failure in Gandhidham**
