# **The Bhuj, India Earthquake of 26<sup>th</sup> January 2001**

## **A FIELD REPORT BY EEFIT**

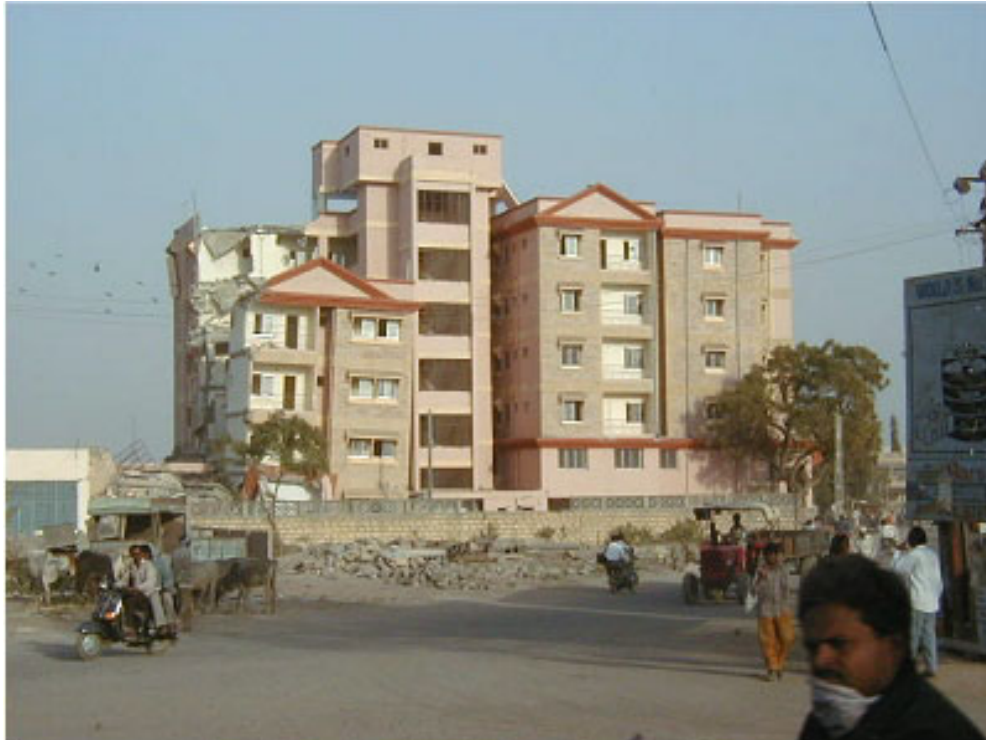
**Figure 6 Partial collapse of an apartment building in Anjar**

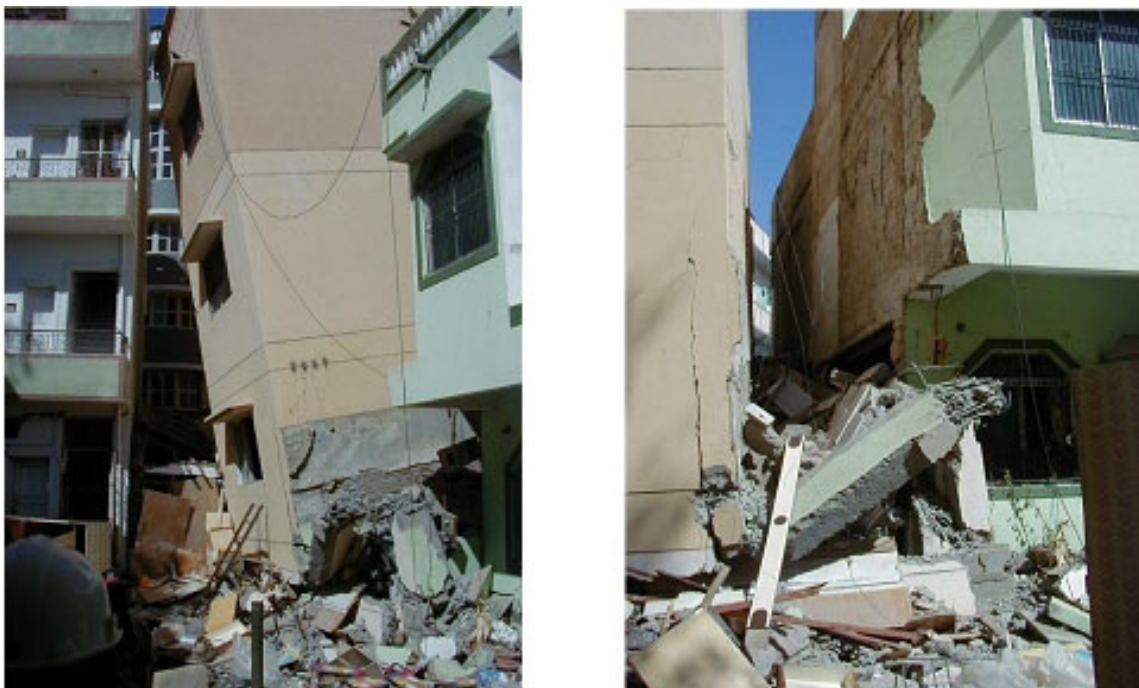
**Figure 7 Soft/weak storey collapse in Bhuj**

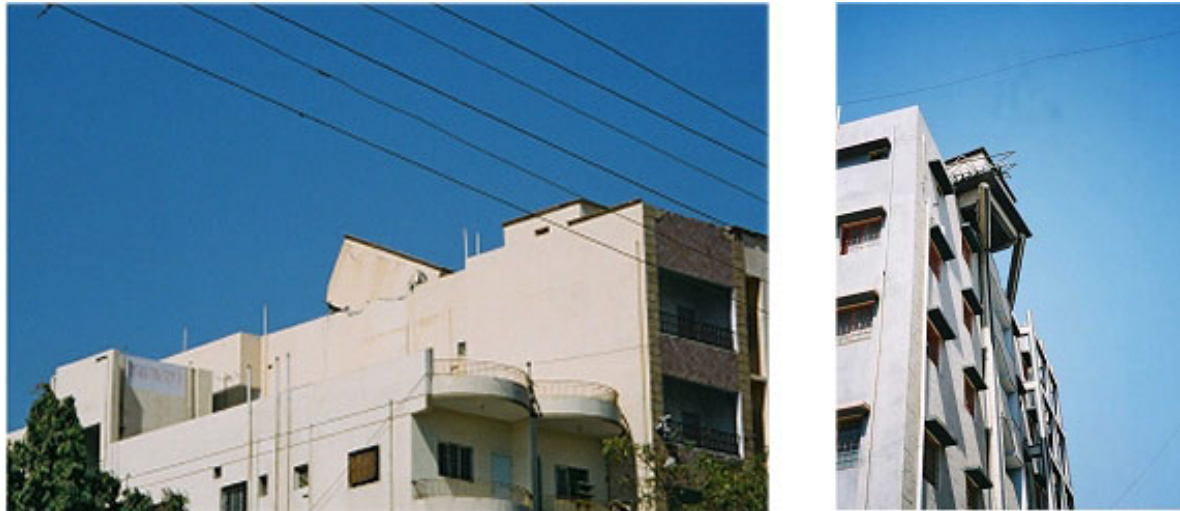
**Figure 8 Water tank failures in Bhuj**

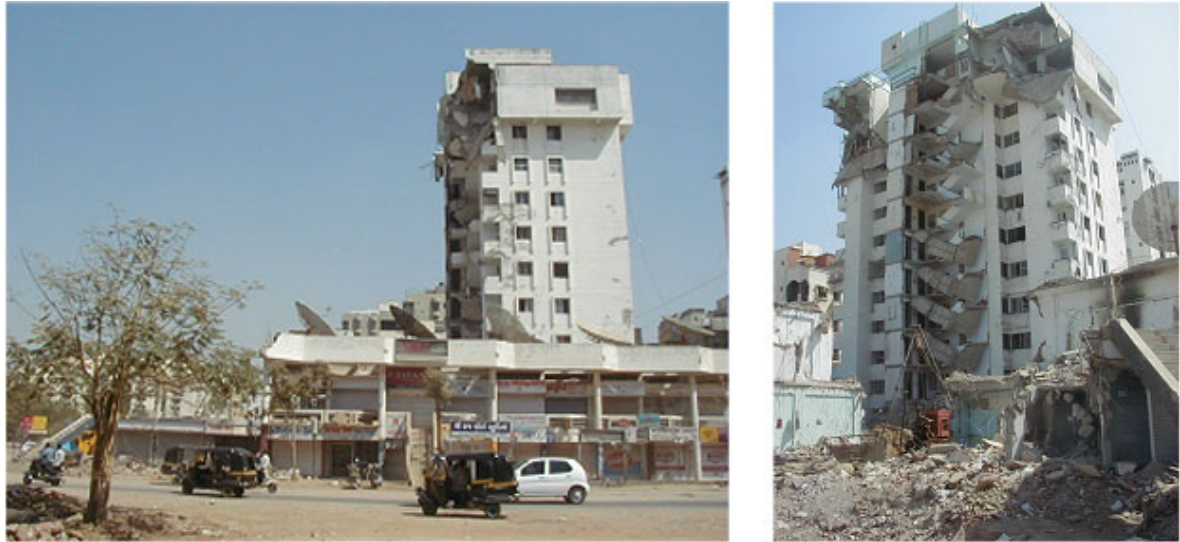
**Figure 9 Mansi Tower (Ahmedabad)**

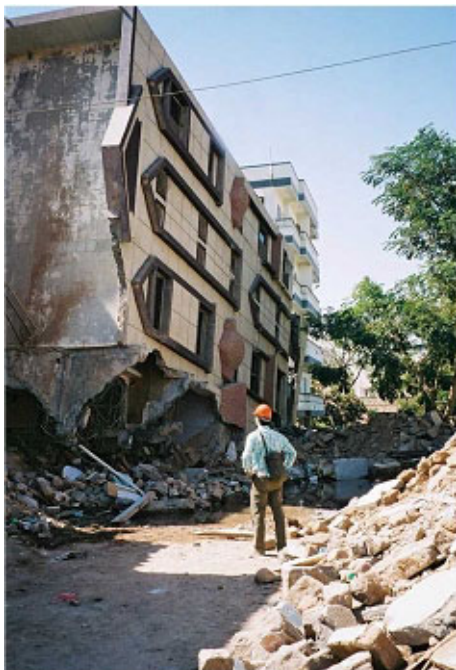
**Figure 10 Overturned building in Bhuj**

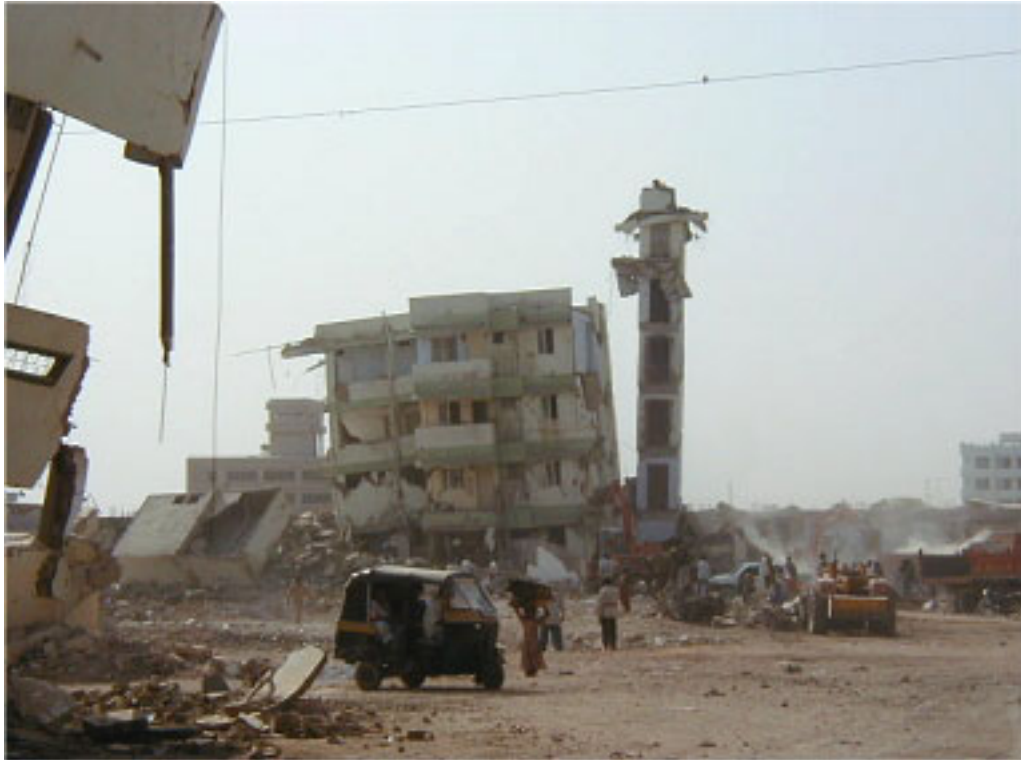
**Figure 12 Combination of collapses in Gandhidham**

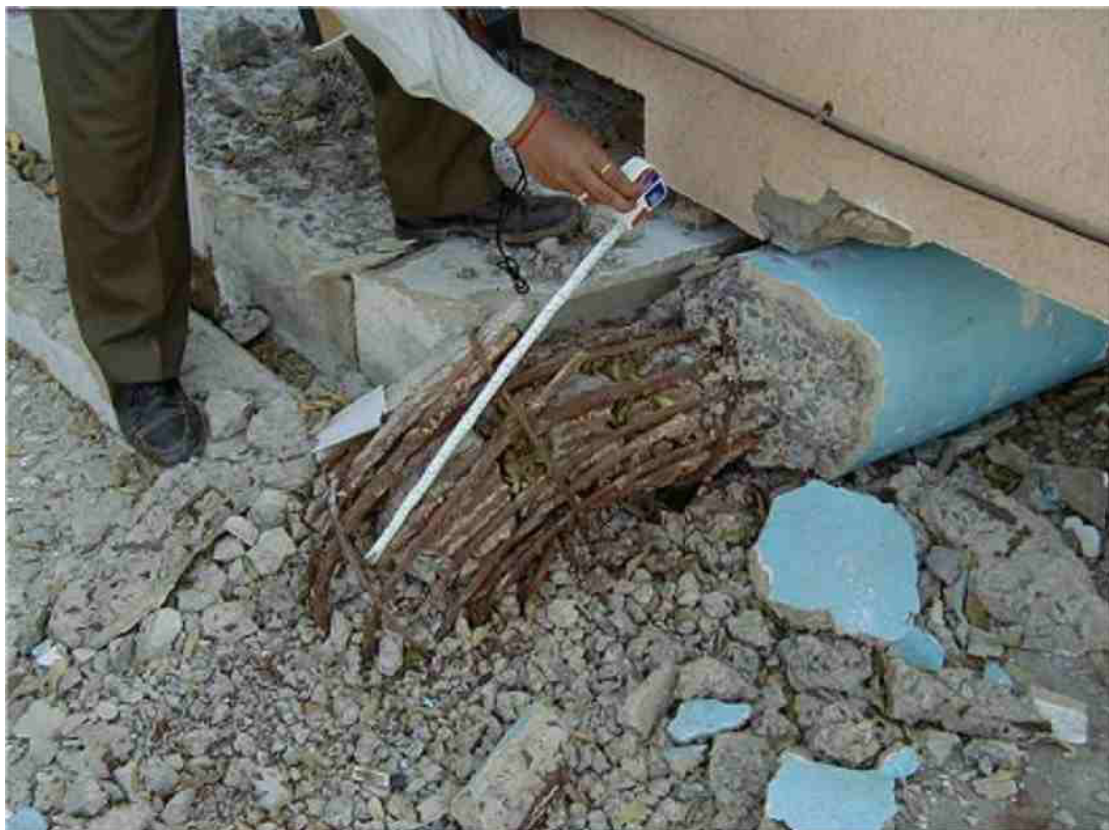
**Figure 13 Poor detailing at Kandla Port**

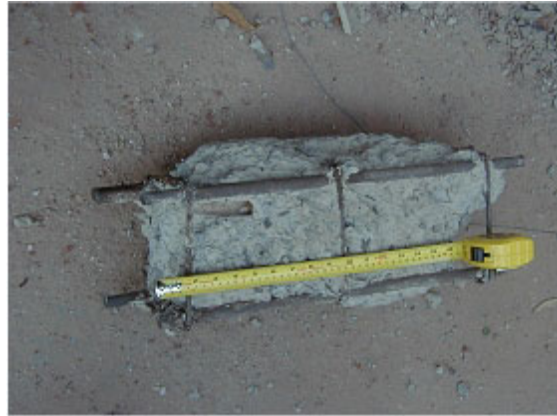
**Figure 14 Burst concrete cover**

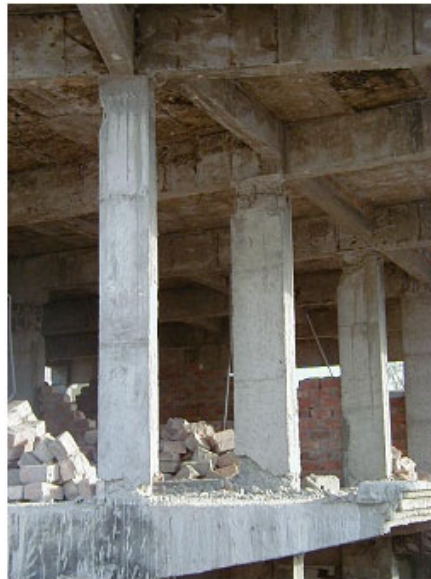
**Figure 15 New building in Anjar**

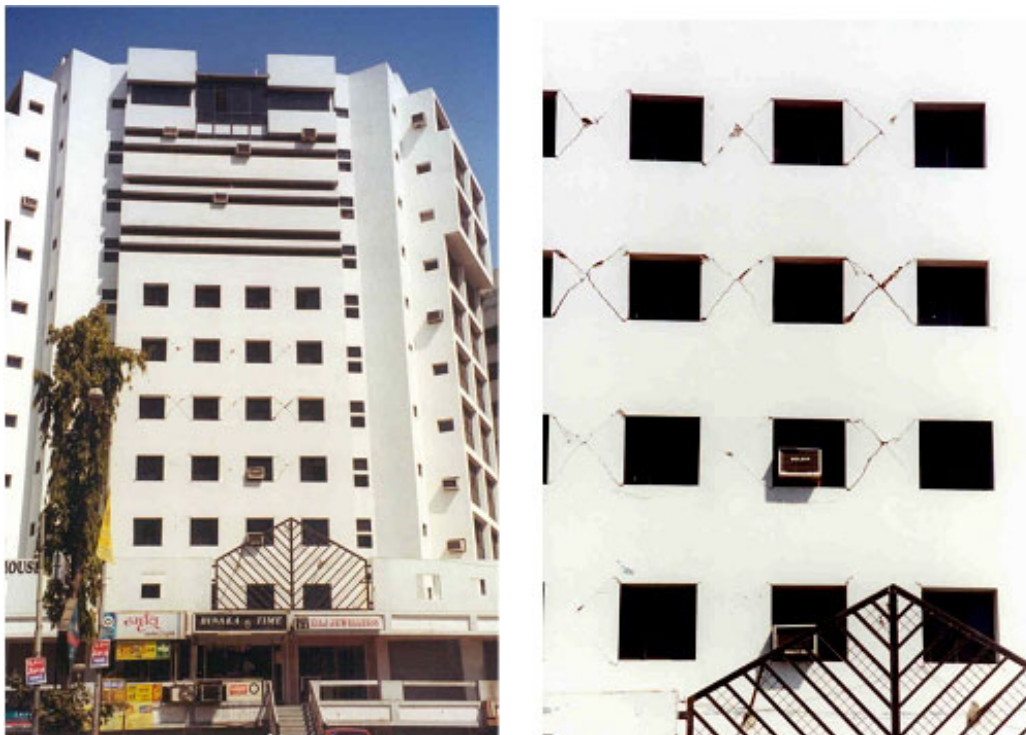
**Figure 16 Diagonal cracking in Ahmedabad**

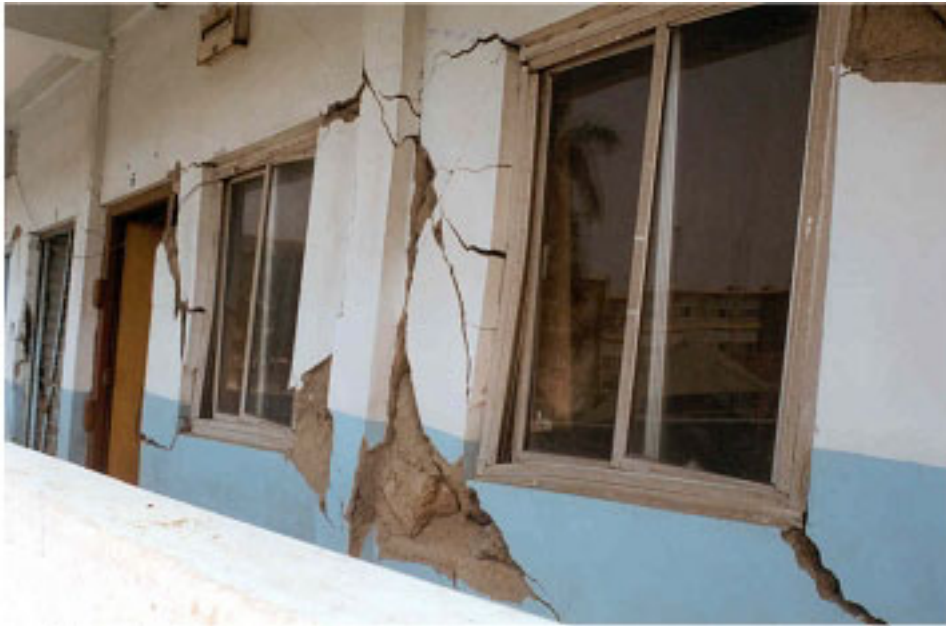
**Figure 17 Heavily cracked building at Kandla Port**

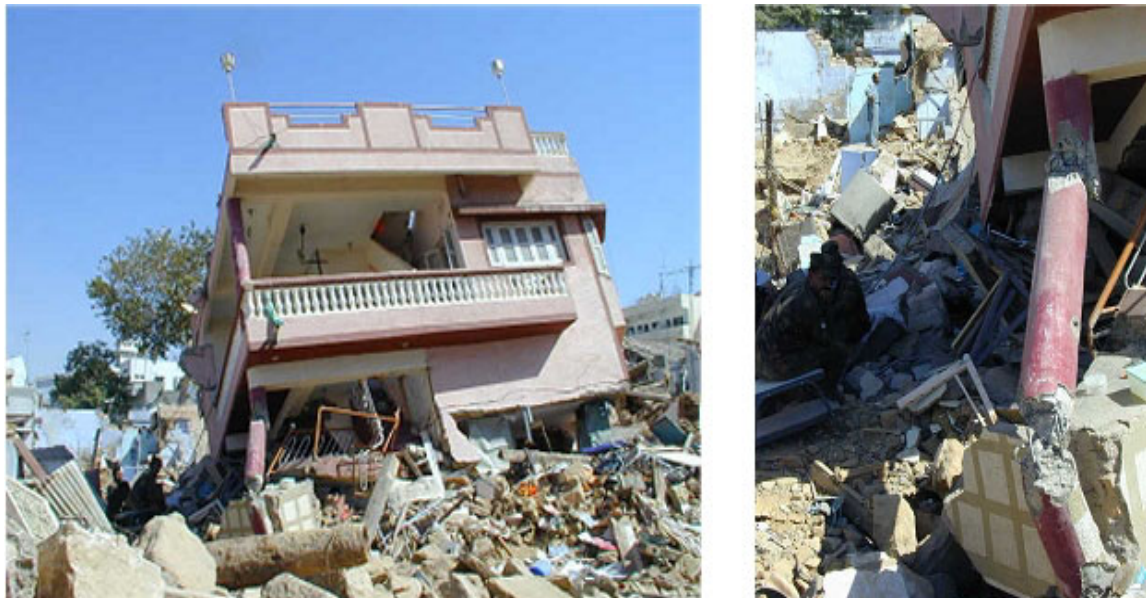
**Figure 18 Building Collapse in Bhuj**

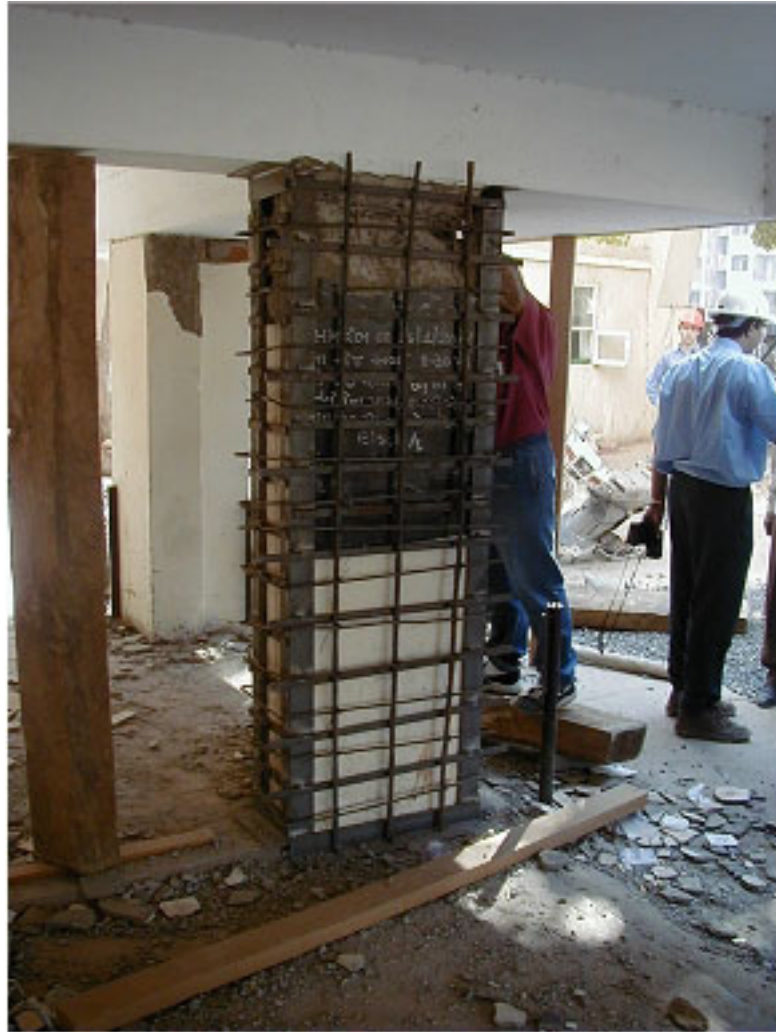
**Figure 19 Column repair in Ahmedabad**

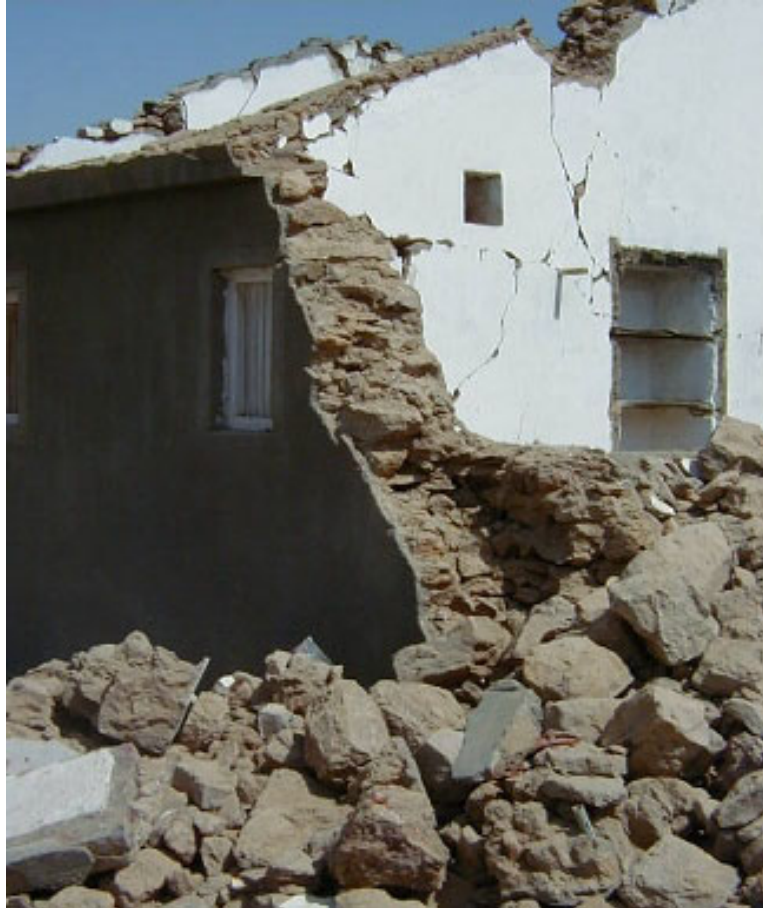
**Figure 1 Typical rubble stone Type A dwelling in a Dharmarkan, West of Bachau**

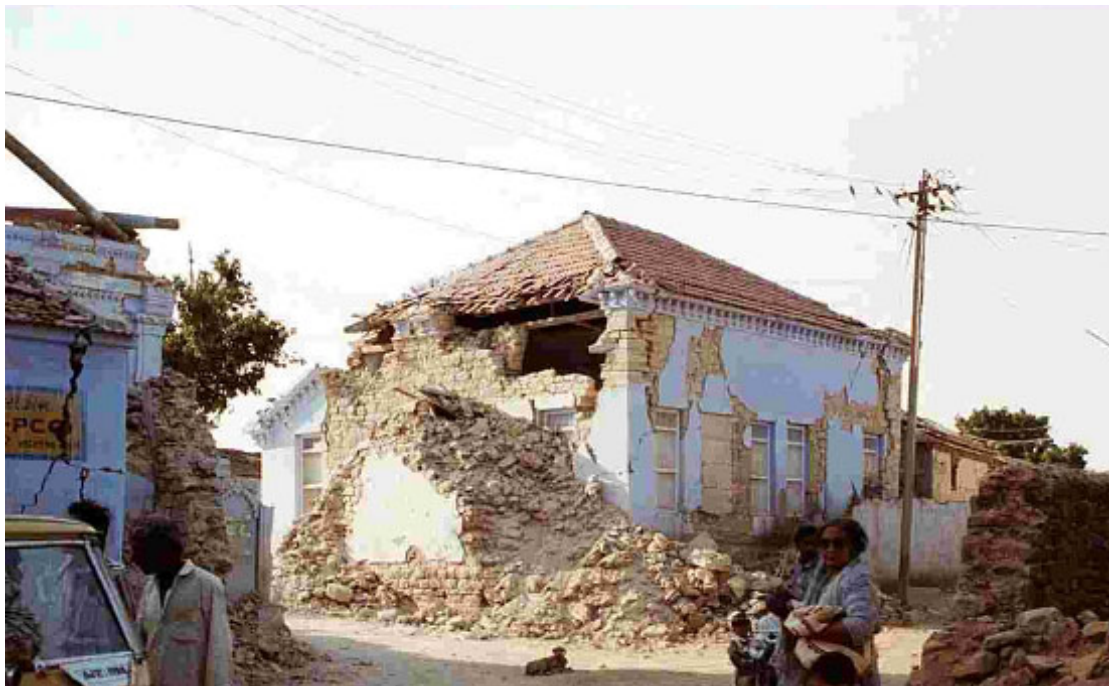
**Figure 2 Typical coursed stone with timber floor Type B dwelling where poor tying in of roof has caused upper wall overturning.**

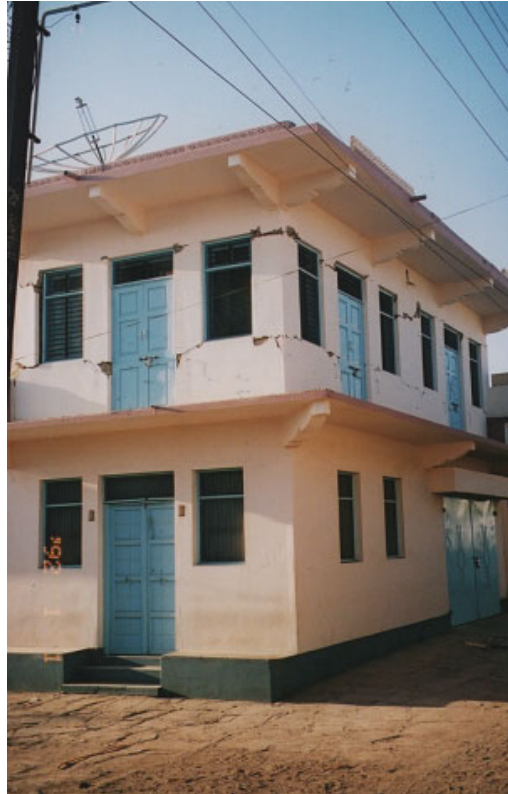
**Figure 3 Typical coursed stone with concrete diaphragms Type C1 building suffering moderate damage in the masonry piers.**

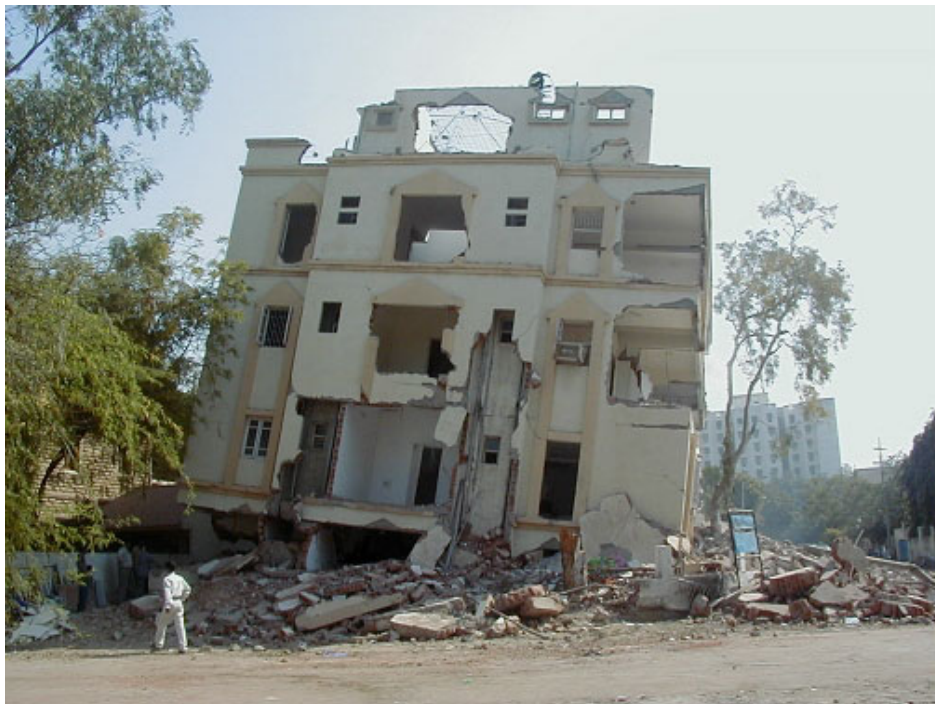
**Figure 4 Typical RC framed Type C2 building in Ahmedabad where ground floor columns have failed in a weak storey mechanism. Note the absence of columns along the perimeter of the building.**

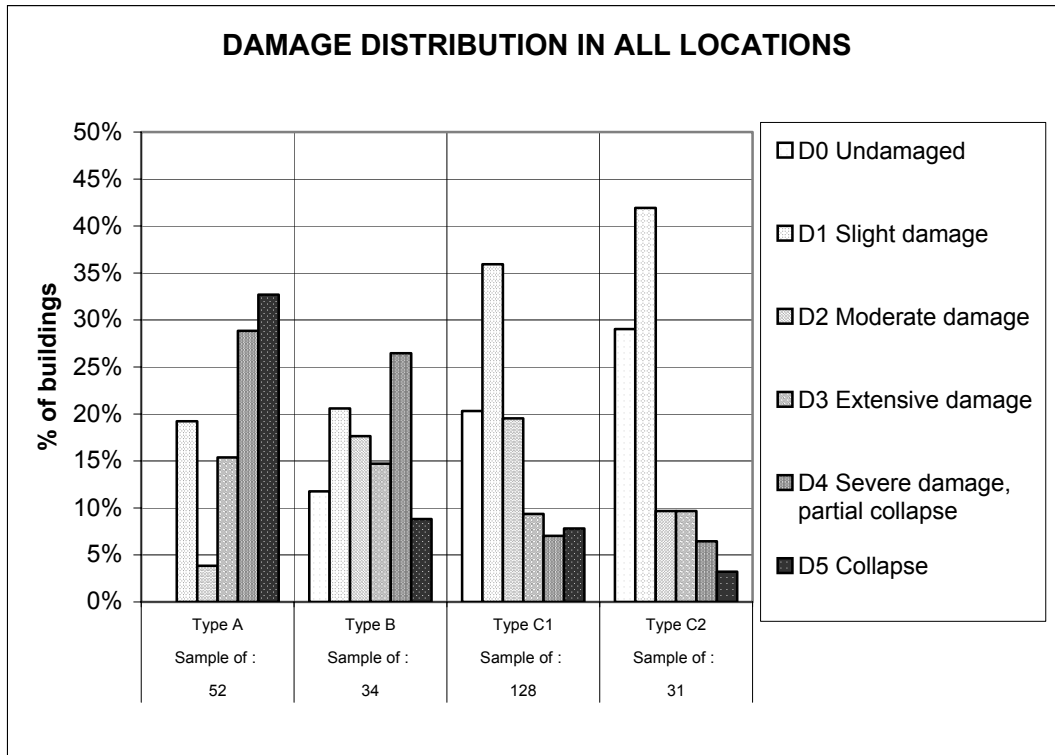
Figure 5 Non-cumulative damage distributions of all buildings surveyed in the various locations in the vicinity of Bhuj

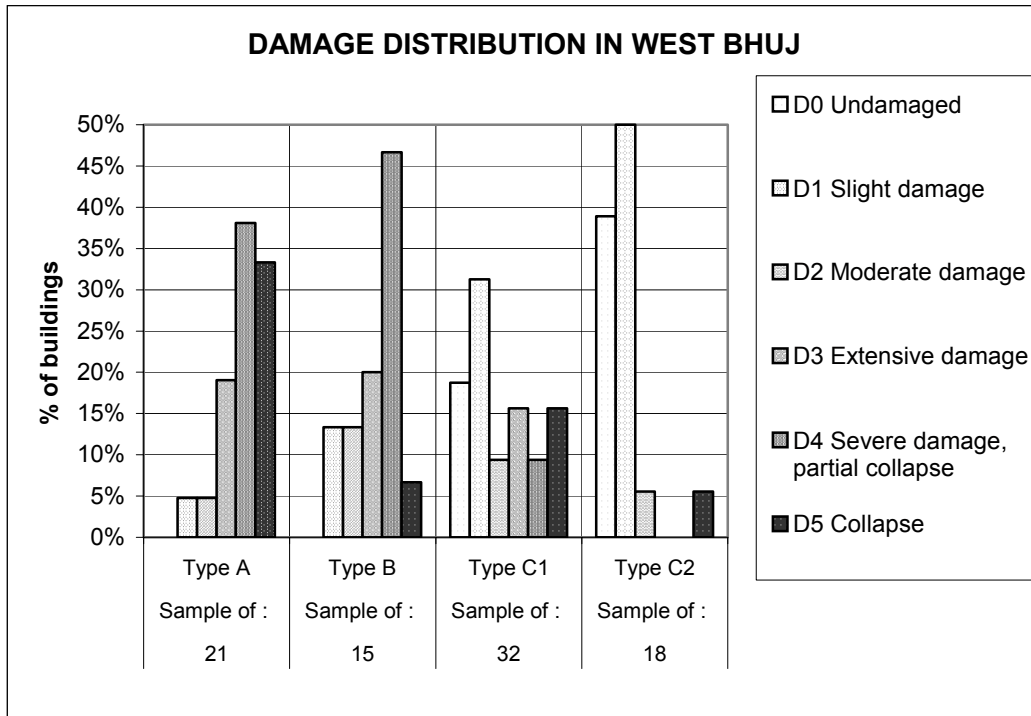
Figure 6 Non-cumulative damage distributions of all buildings surveyed around Uplipar Rd in Bhuj

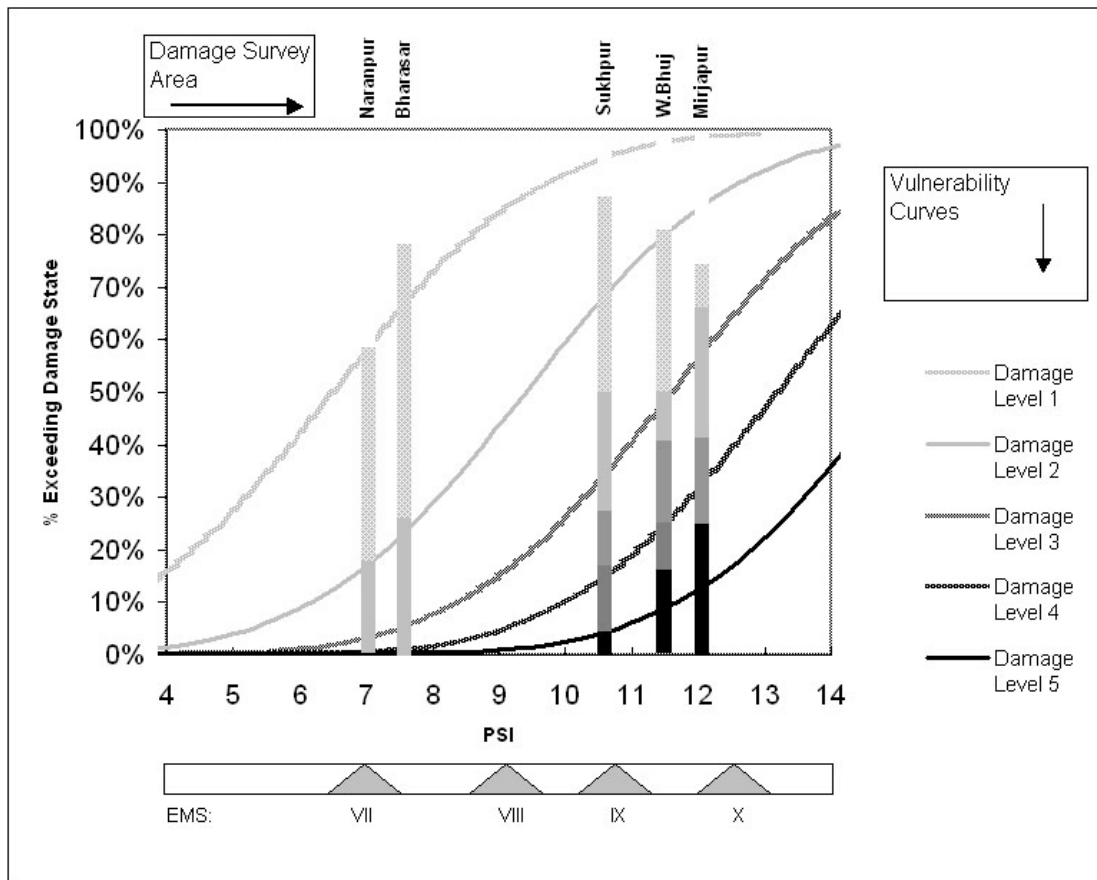
**Figure 7 Comparison of survey results for building type C1 with globally derived vulnerability functions**

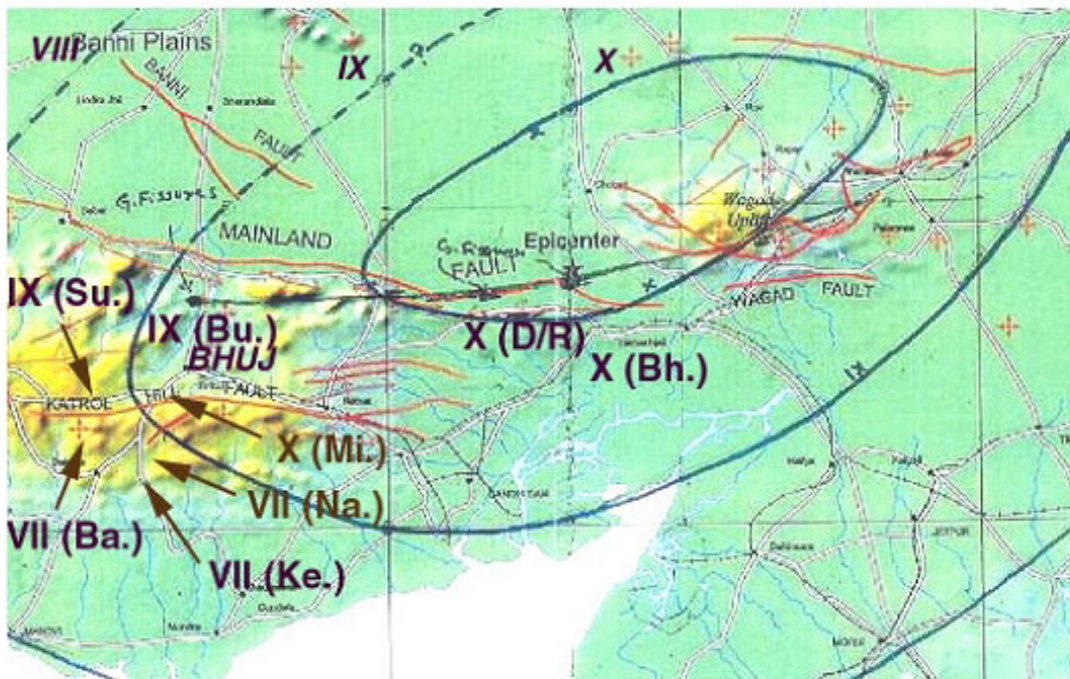
Figure 8 Seismotectonic Base map of the Kachchh area marked with preliminary isoseismals prepared by P.L. Narula of the NICEE. Map shows EEFIT survey estimates of intensity in marked locations. Refer to Table 2 for the full location names.

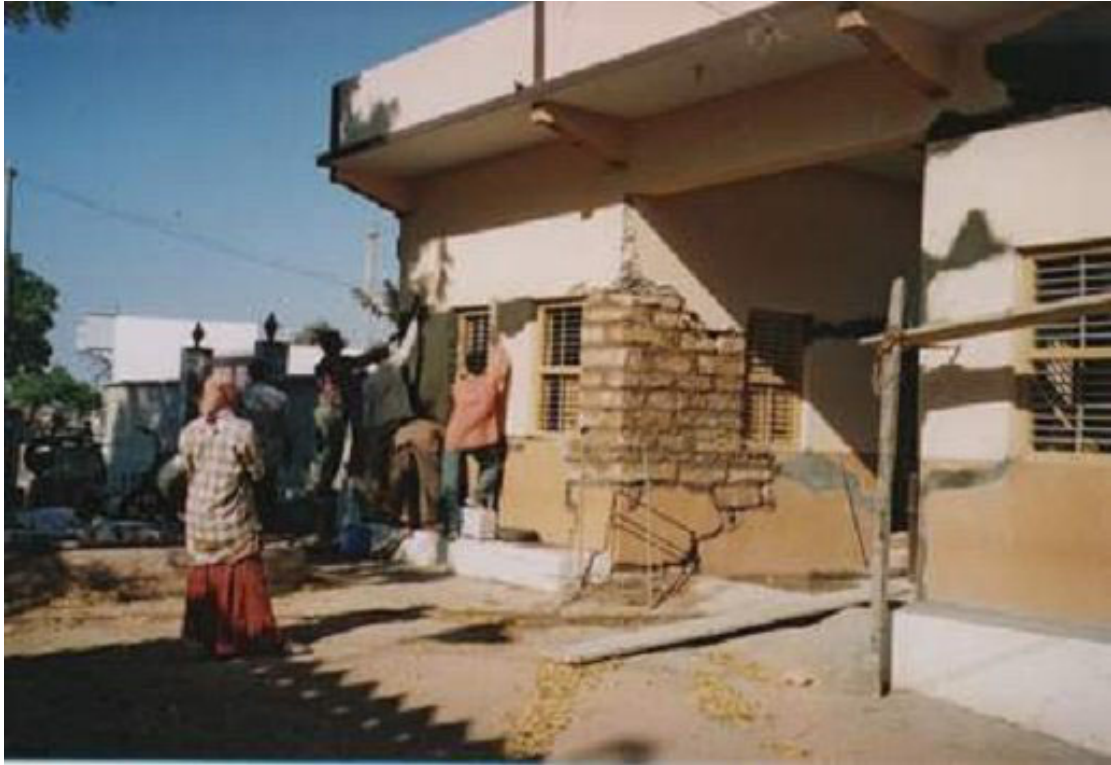
**Figure 9: Making good of damaged masonry corner.**

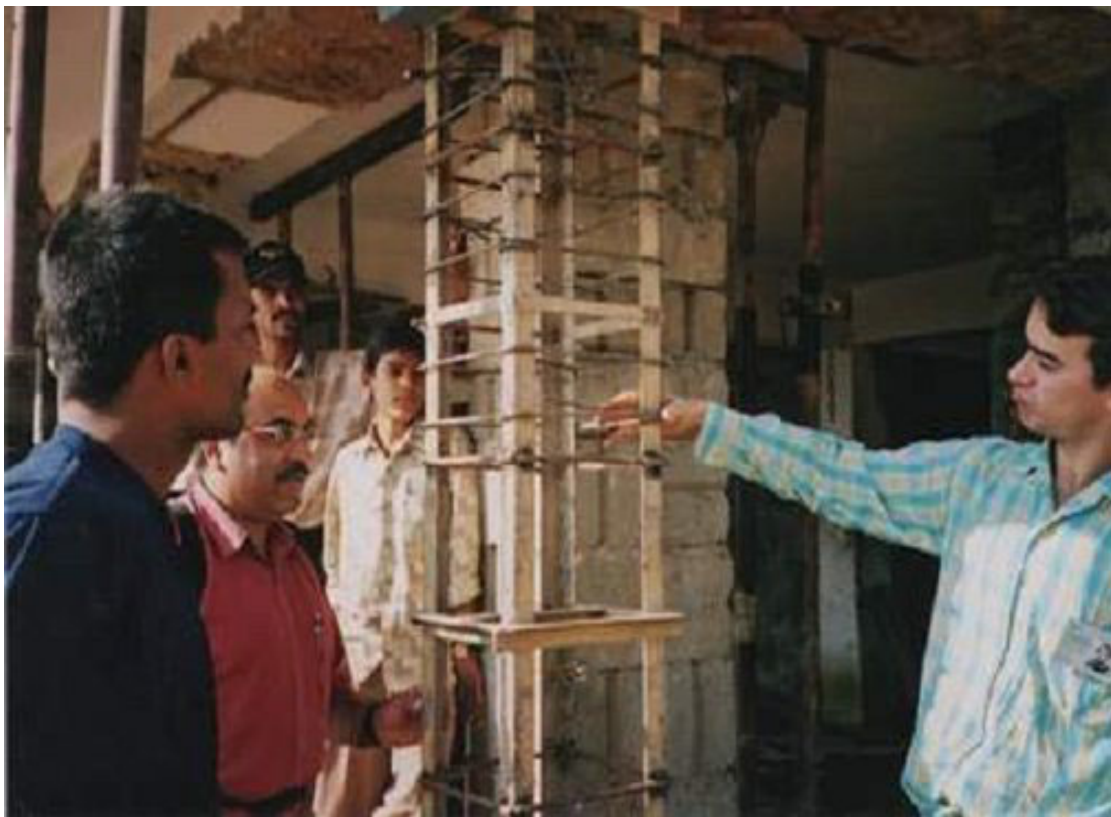
**Figure 10 Repair works to damaged masonry building with RC floor. The new structural element has little connection with the existing structure.**
