# Confidential Reporting on Structural Safety (CROSS): newsletter 55

## 813: Failure of waling beam connected to raking prop

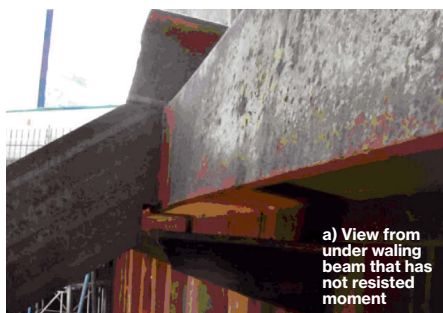
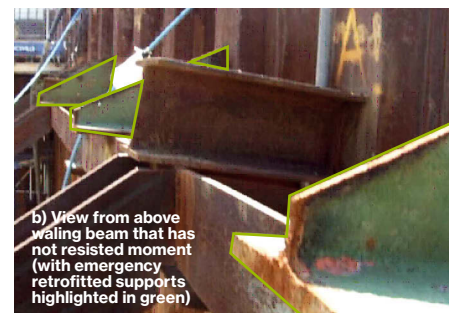
Figure 1  
Failure of waling beam connected to raking prop

Figure 1 shows a detail where the design required a cantilever beam to resist the vertical reaction from a raking prop where it connected to the waling beam. The cantilever beam was welded to the sheet pile behind and the design required that a large fillet weld be applied around the entire beam.

However, the contractor installed the cantilever beam after the waling beam had been fixed and was therefore unable to fully weld around the bottom flange.

The partial weld to the bottom flange failed, allowing the beam to rotate upwards. The weld to the web of the beam seemed to remain intact, with the rotation causing local deformation of the sheet pile at the web.

From the description, the cantilever beam failed upwards, implying tension on the bottom flange, which is the exact location where the weld was omitted. Self-evidently, the resistance of the profile weld must have been significantly less than the design intent.

The reporter adds that additional brackets were welded on as an emergency remedial measure.
