**The Central Sulawesi, Indonesia Earthquake and Tsunami of 28th
September 2018 – A Field Report by EEFIT-TDMRC**

01/11/2019

Prof Tiziana Rossetto, EPICentre, University College London

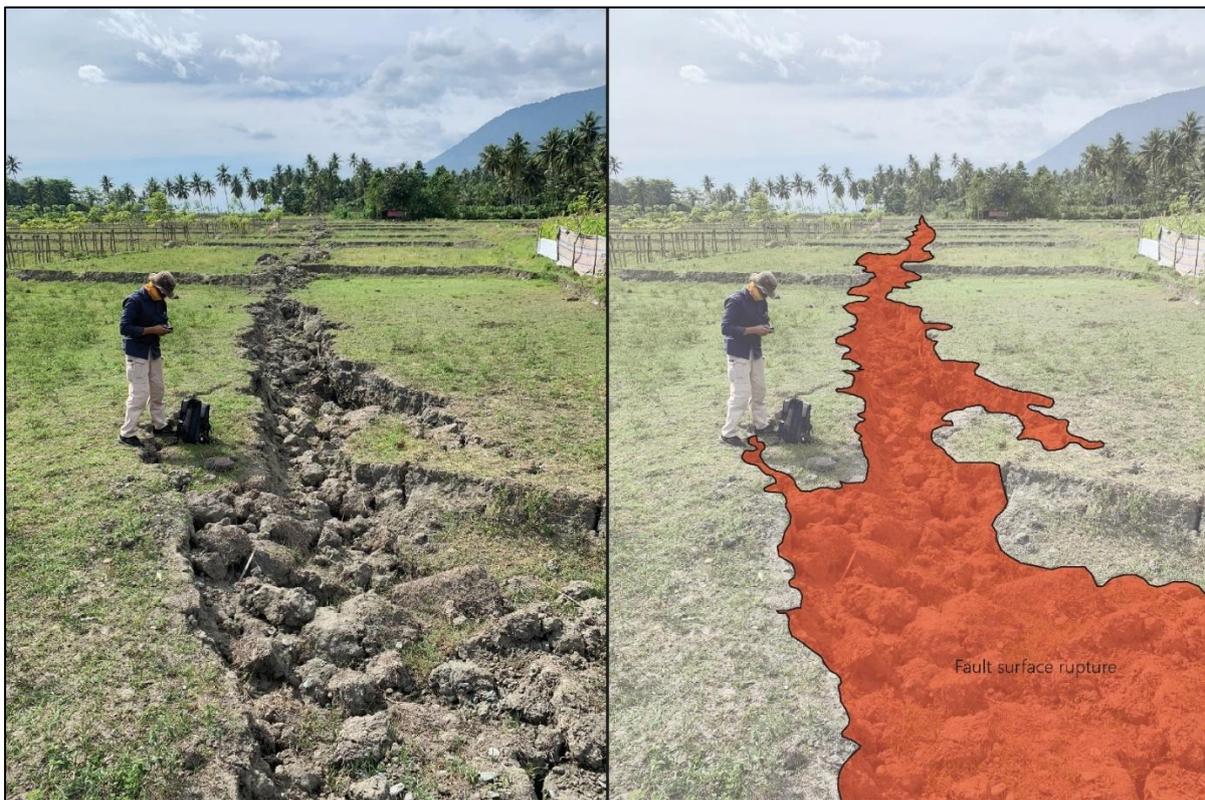
Figure 3.5 – Fault surface rupture through rice paddy field.

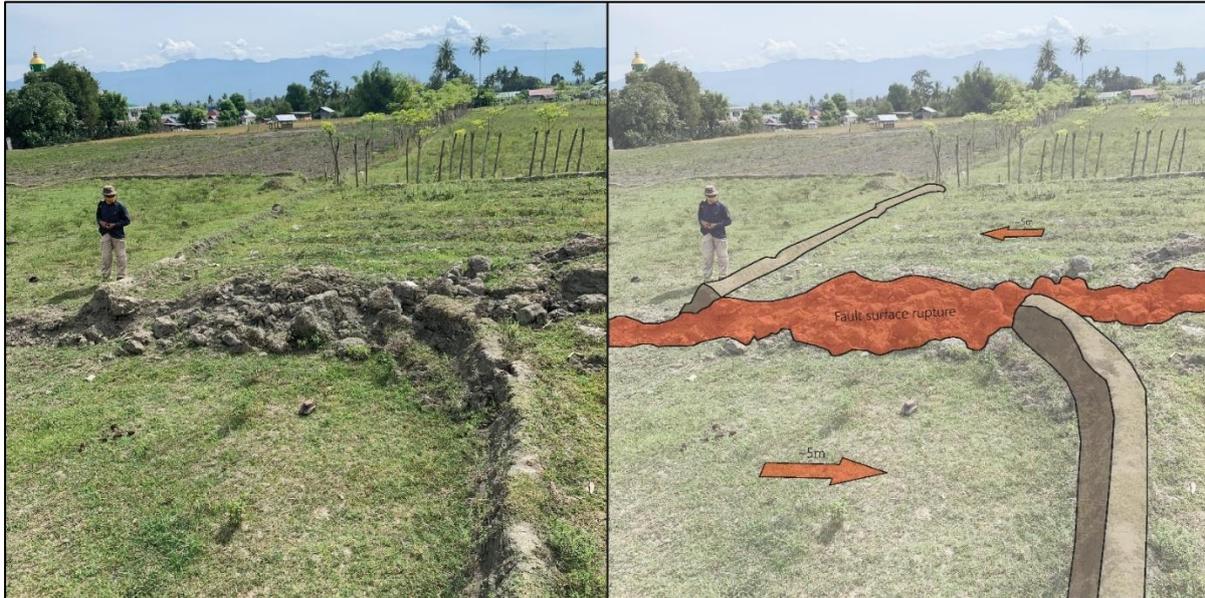
Figure 3.6 – Displacement of approximately 5m along fault surface rupture shown due to offset rice paddy terraces.

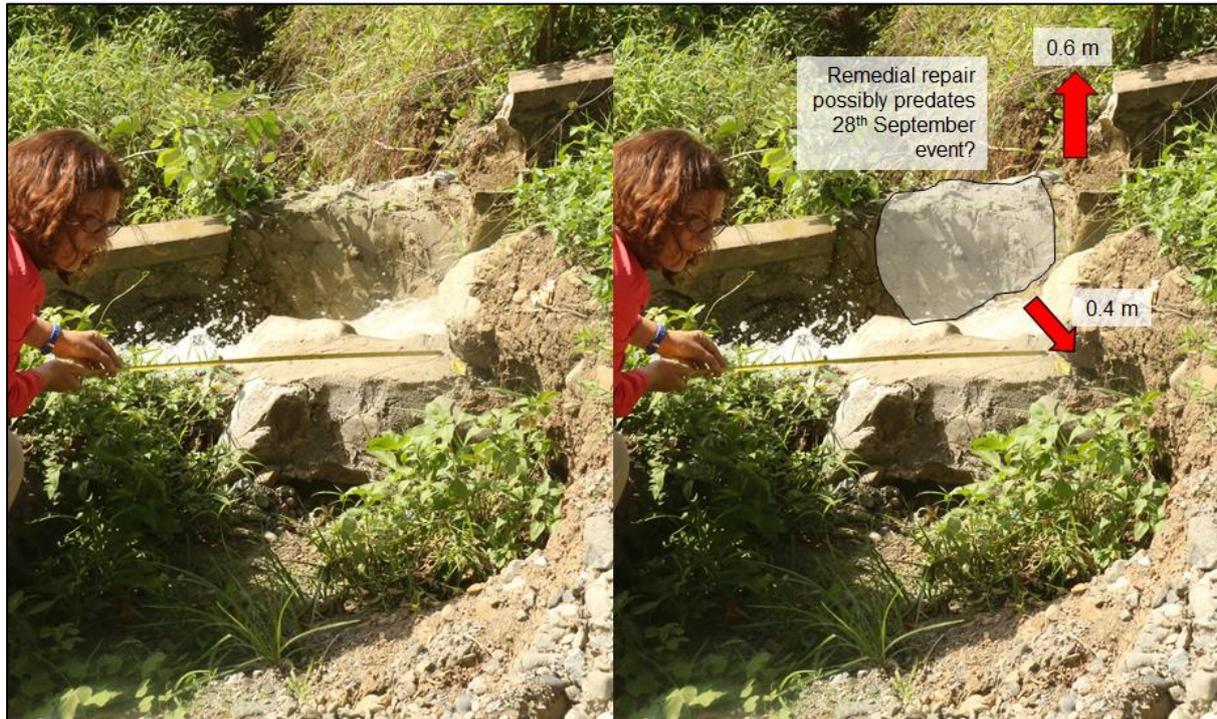
Figure 3.8 – Damage to water channel on North side of large rupture at Labua indicates observed total displacement may be only partly due to 28th September event

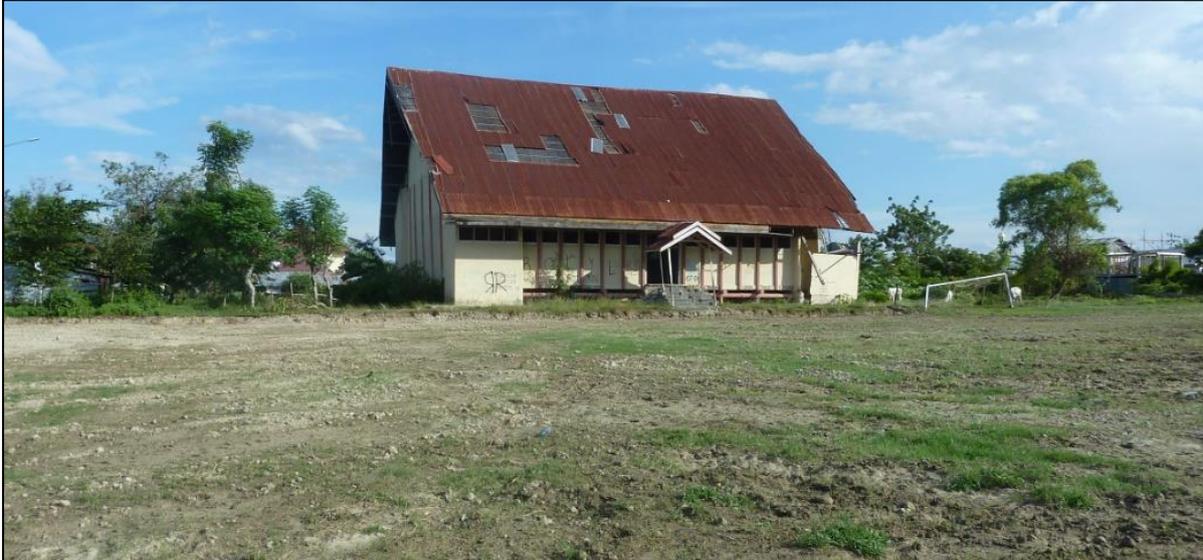
Figure 5.2.- Liquefaction ejecta in a field at Gelanggang Mahasiswa, Kabonena. Observe the vertical offset in front of the pavilion where the field has settled relative to nearby intact ground.

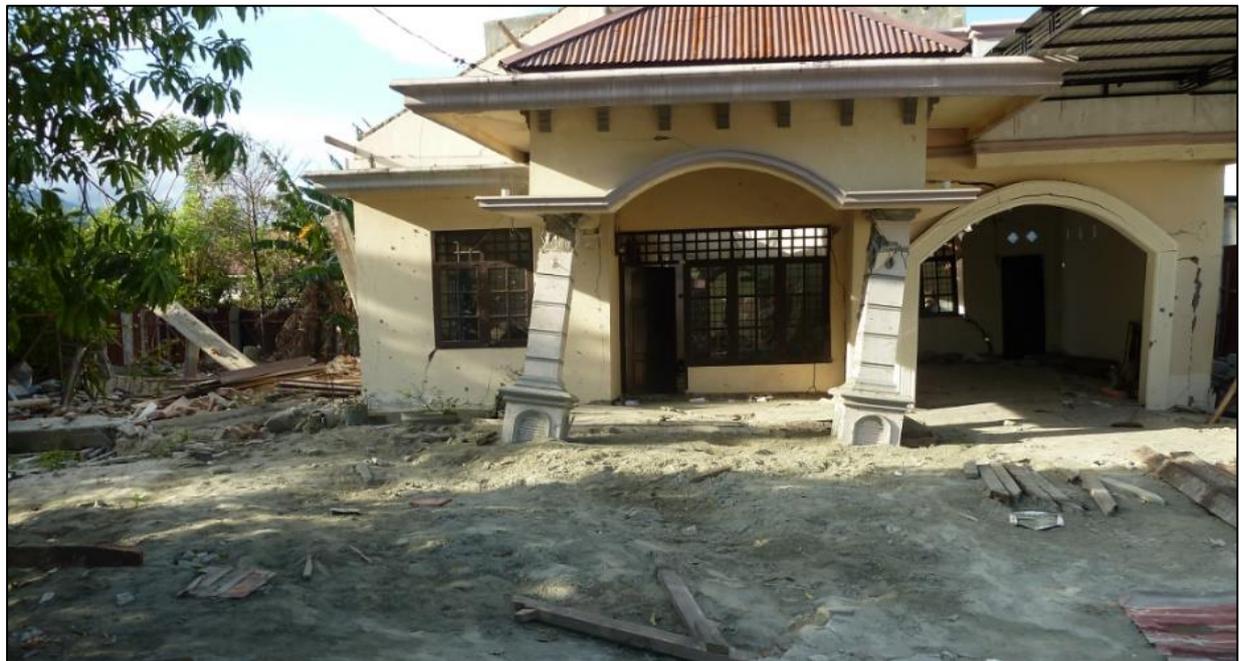
Figure 5.5. - Damage to a one-storey building in Lasoso due to differential settlement induced by liquefaction. Sandy ejecta in garden.

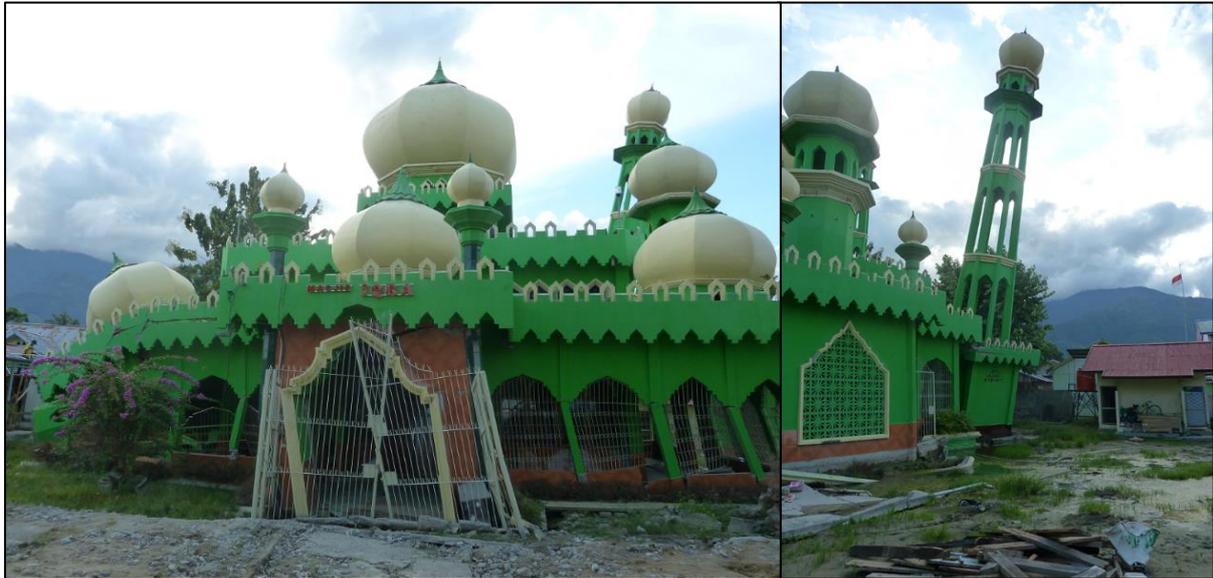
Figure 5.6 – Left: Front of Masjid Iqra. Right: Masjid Iqra in Lasoso. Severe liquefaction-induced damage and tilting of minaret due to liquefaction beneath base.

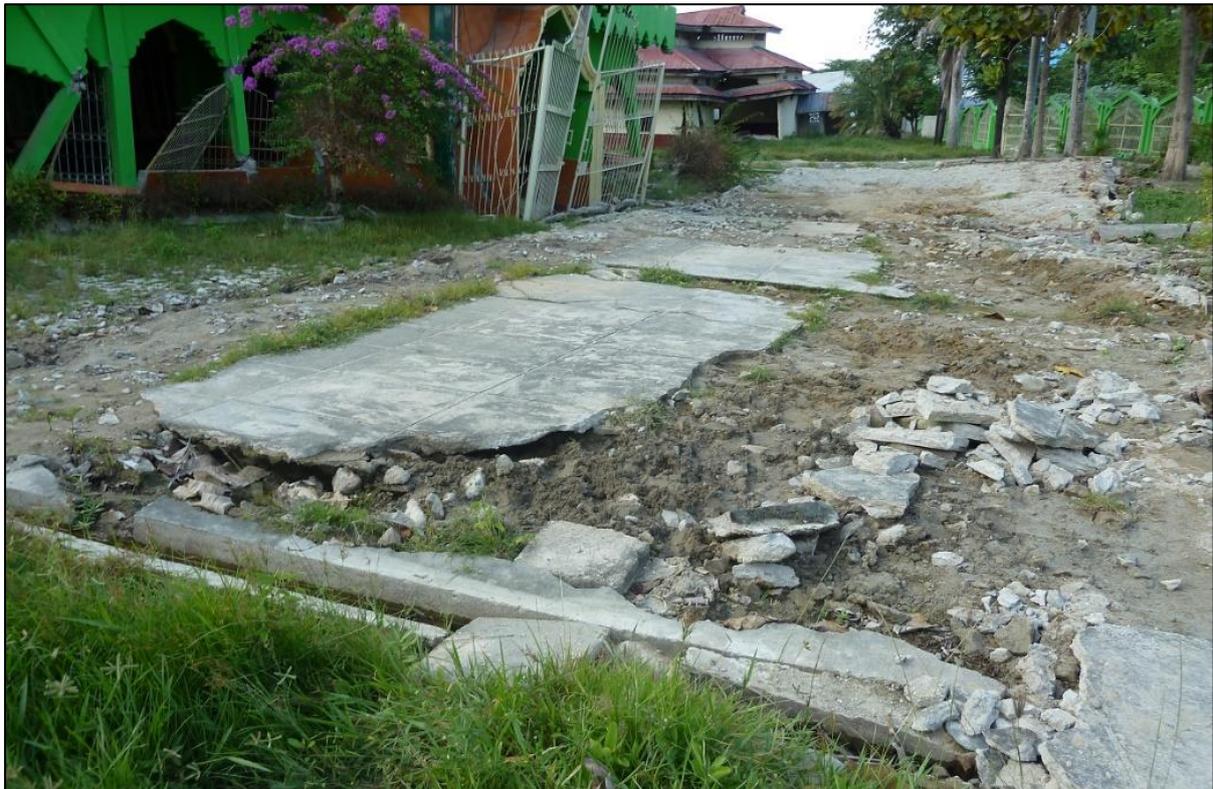
Figure 5.7 -. Masjid Iqra. Failure of garden paving above sandy soil, and ejecta in background.

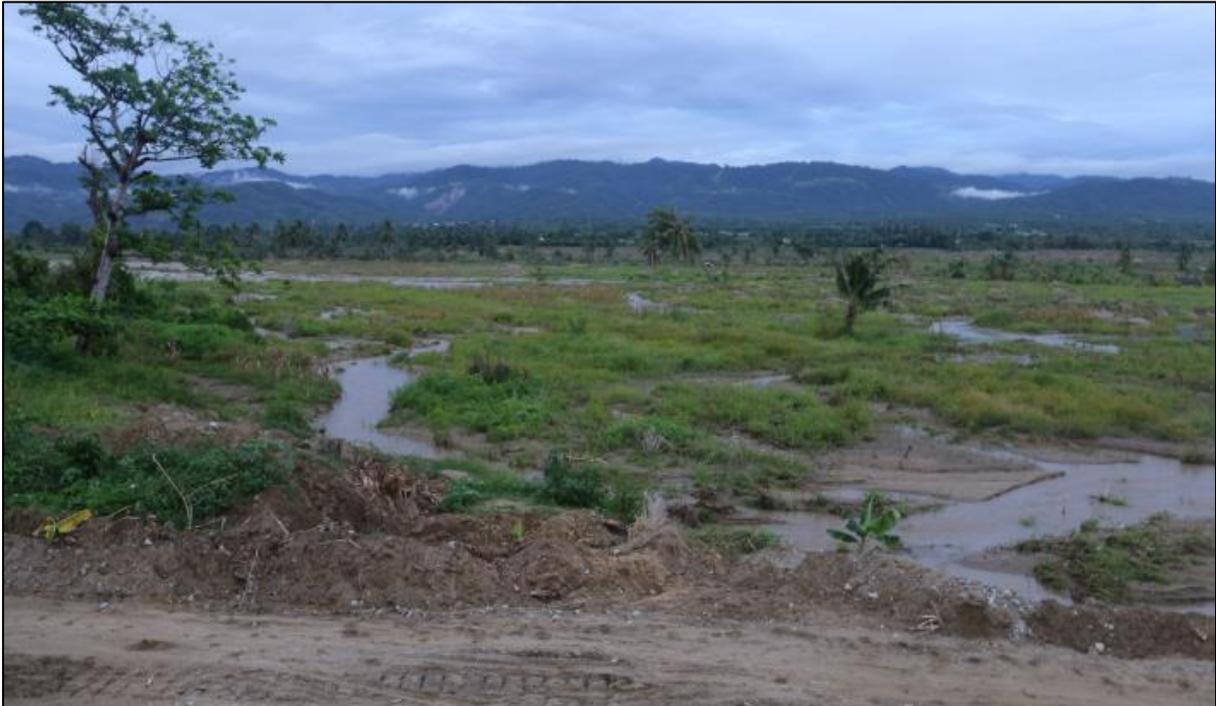
Figure 5.11 - Settlement and spreading cracks outside the town of Sigi

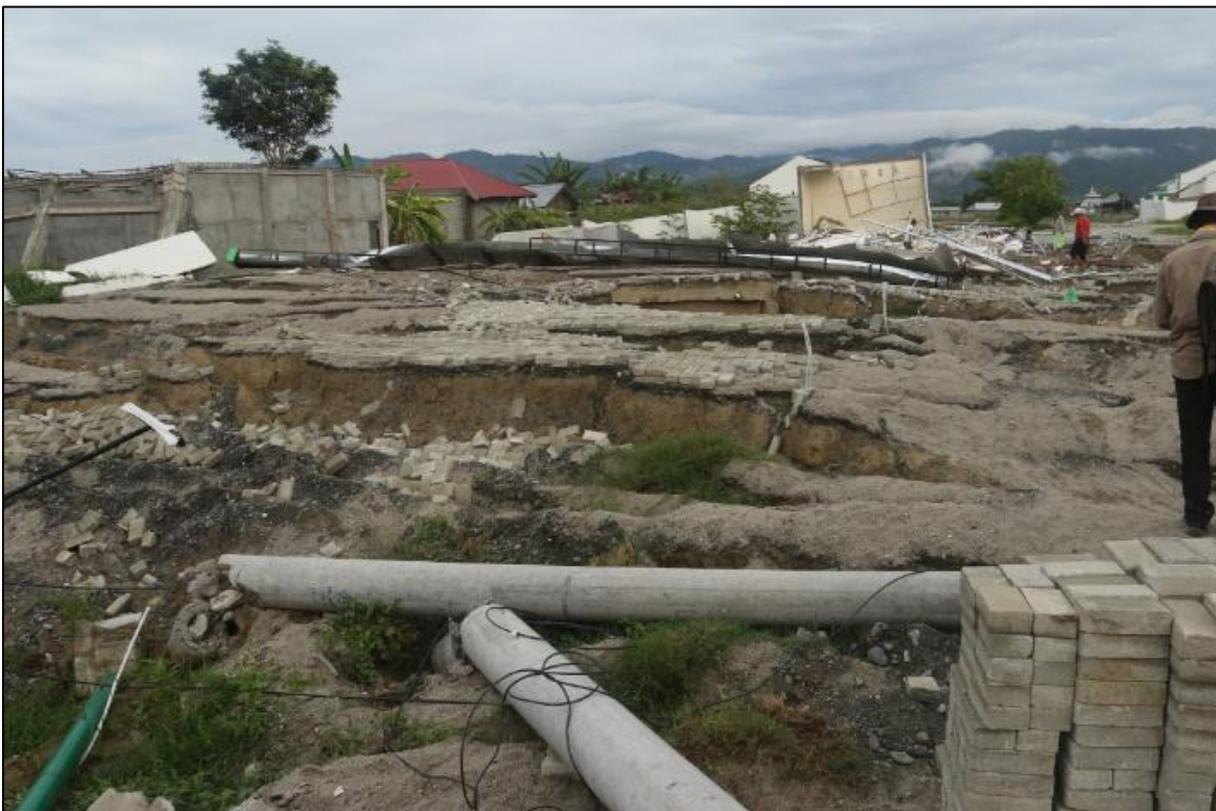
Figure 5.12 - Differential settlement and ground disturbance in Sigi. Pipework in foreground appears to be new rather than uplifted.

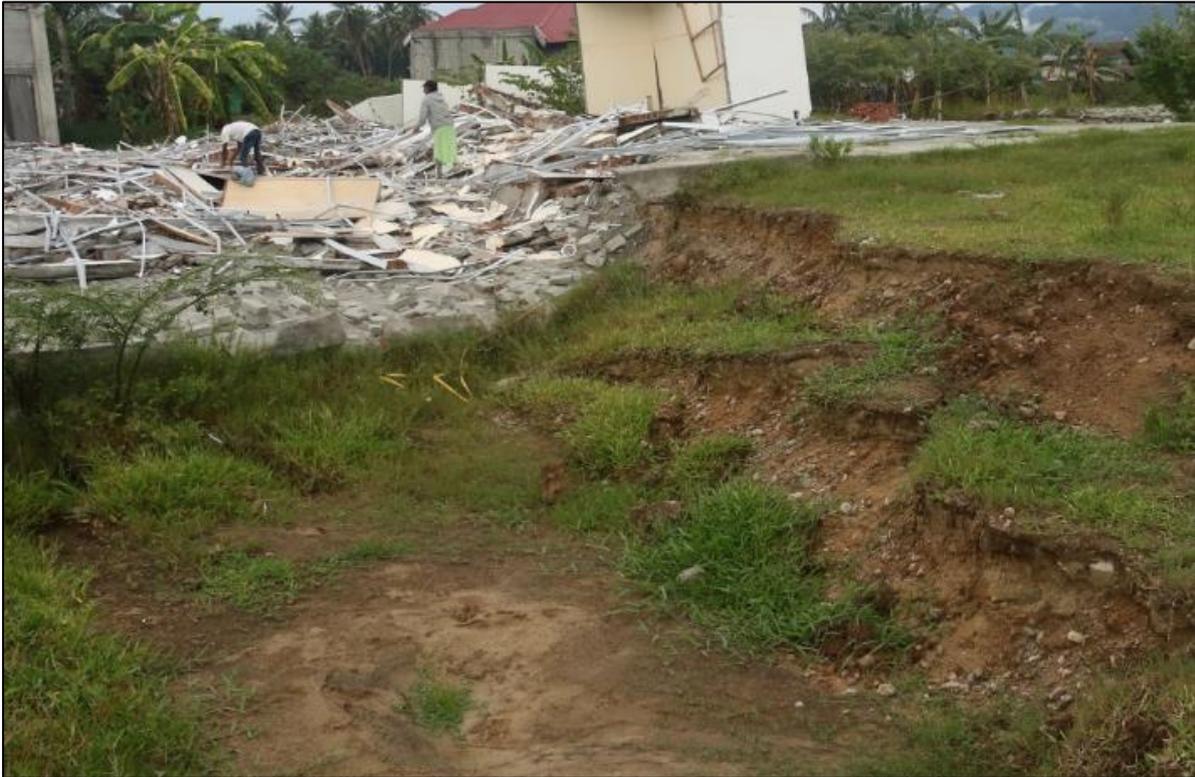
Figure 5.13 - Large settlements with sandy ejecta adjacent to relatively unaffected soil in Sigi.

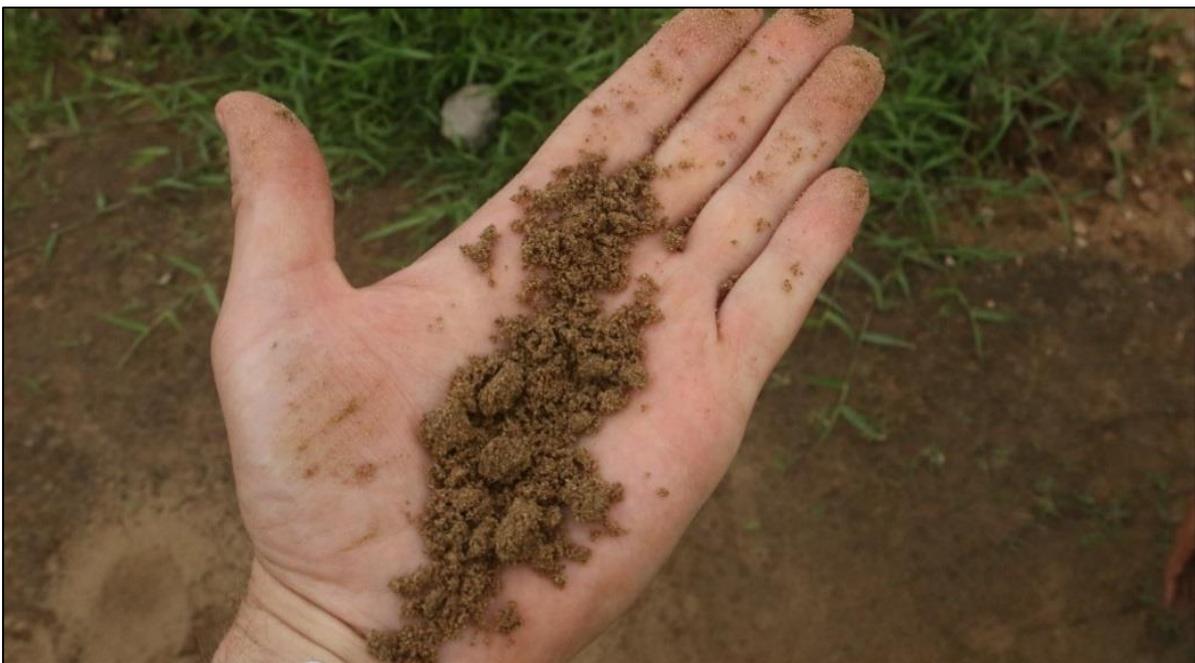
Figure 5.14 - Ejecta at Sigi. Uniform sand, in damp condition.

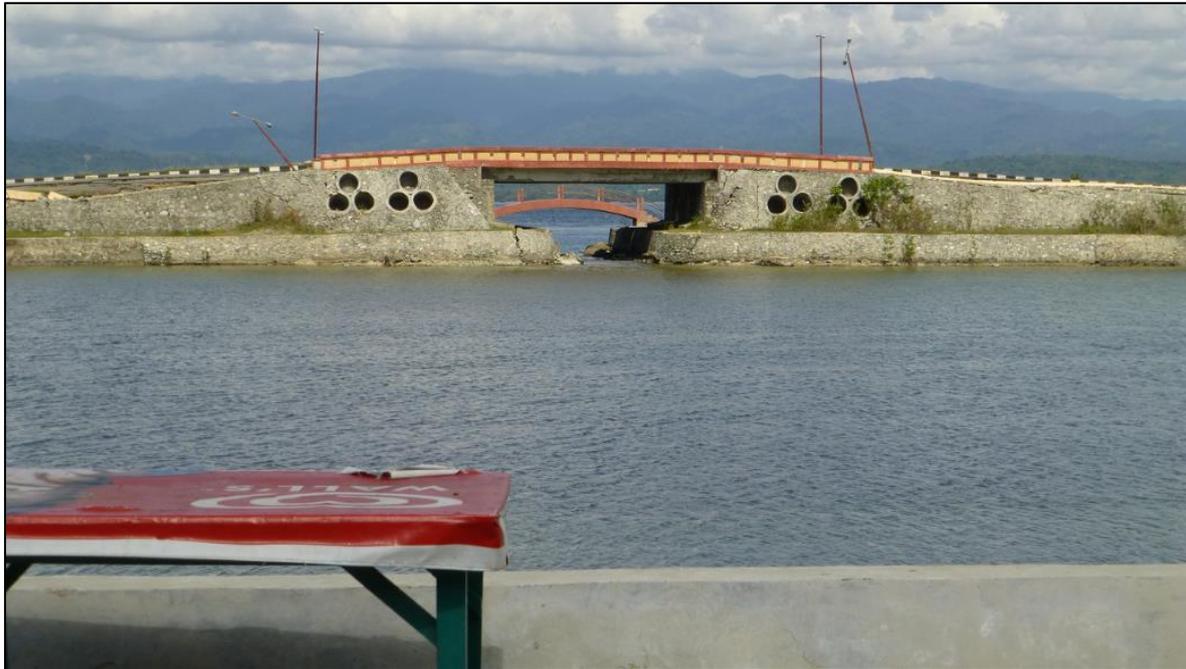
Figure 5.16 - View across dolphin enclosure to sea road. Slight damage to bridge abutments consistent with soil displacements, though bridge remains operational.

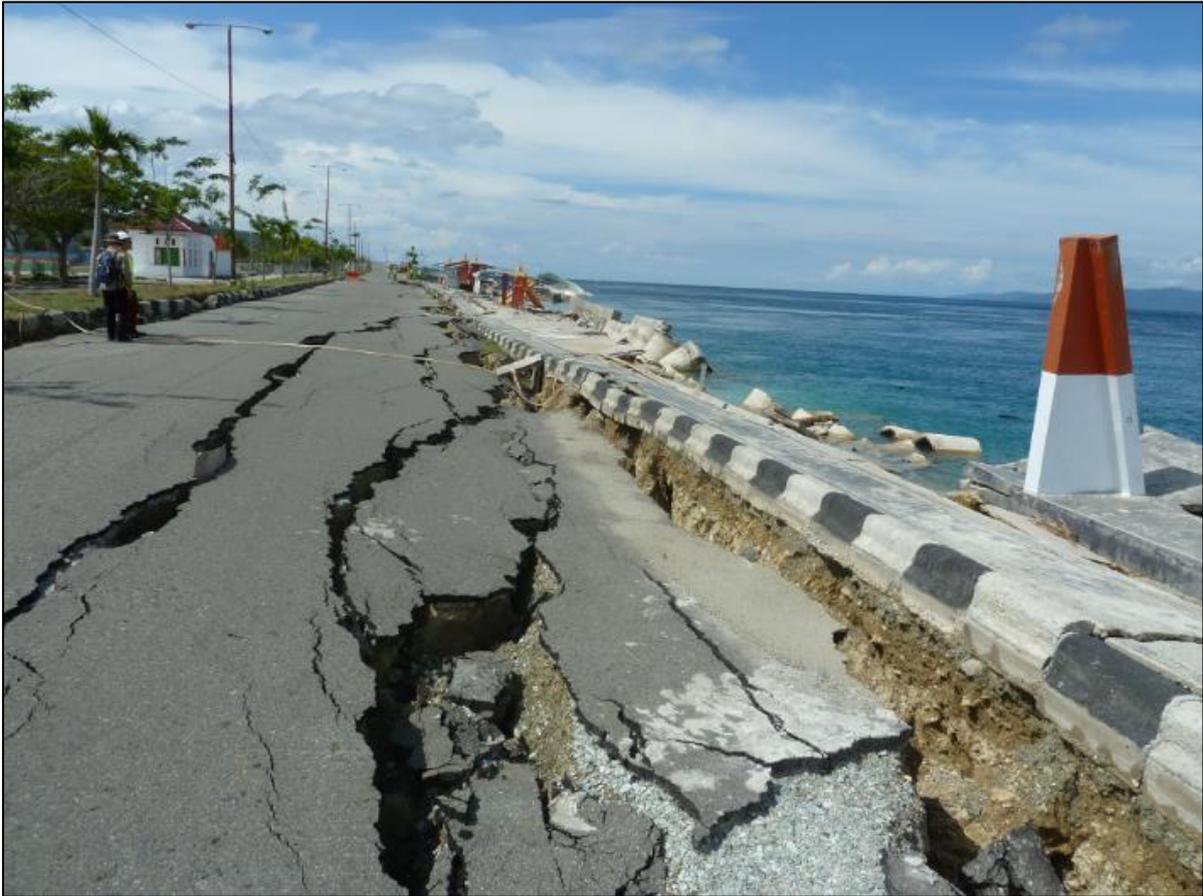
Figure 5.17 - Cracks parallel to coastline, consistent with lateral spreading of the ground.

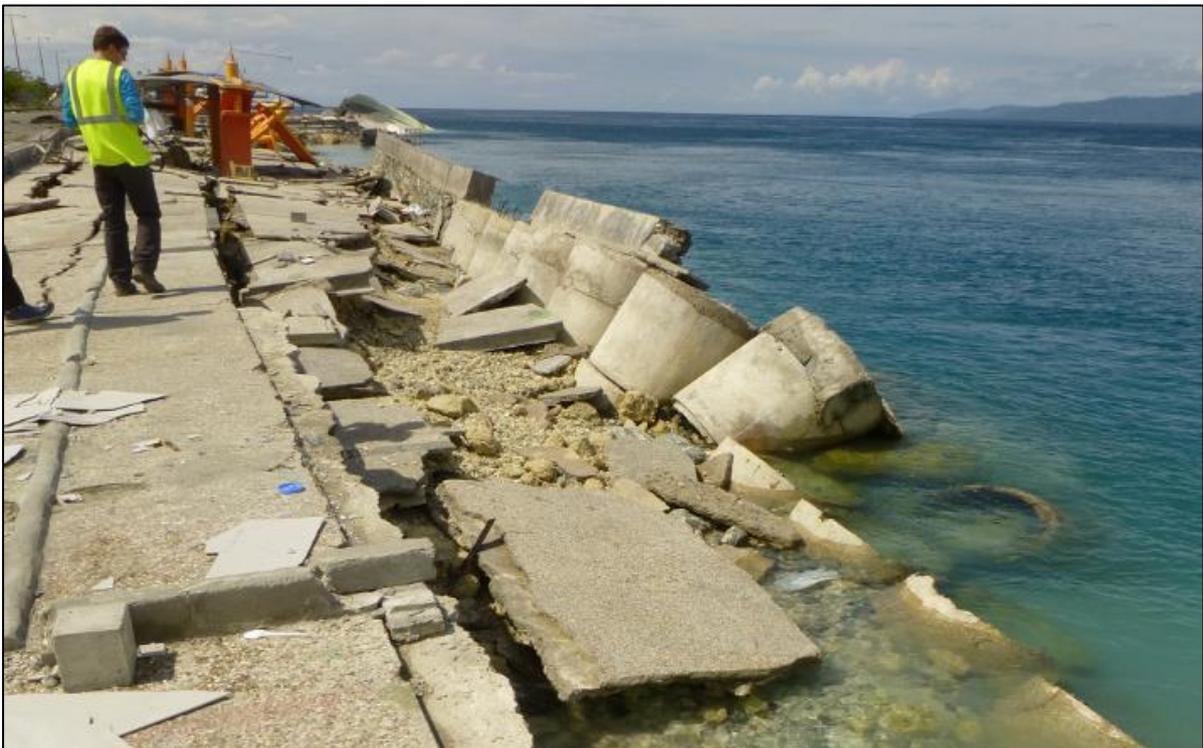
Figure 5.18 - Failure of piled sea wall at Donggala Koto Wisata

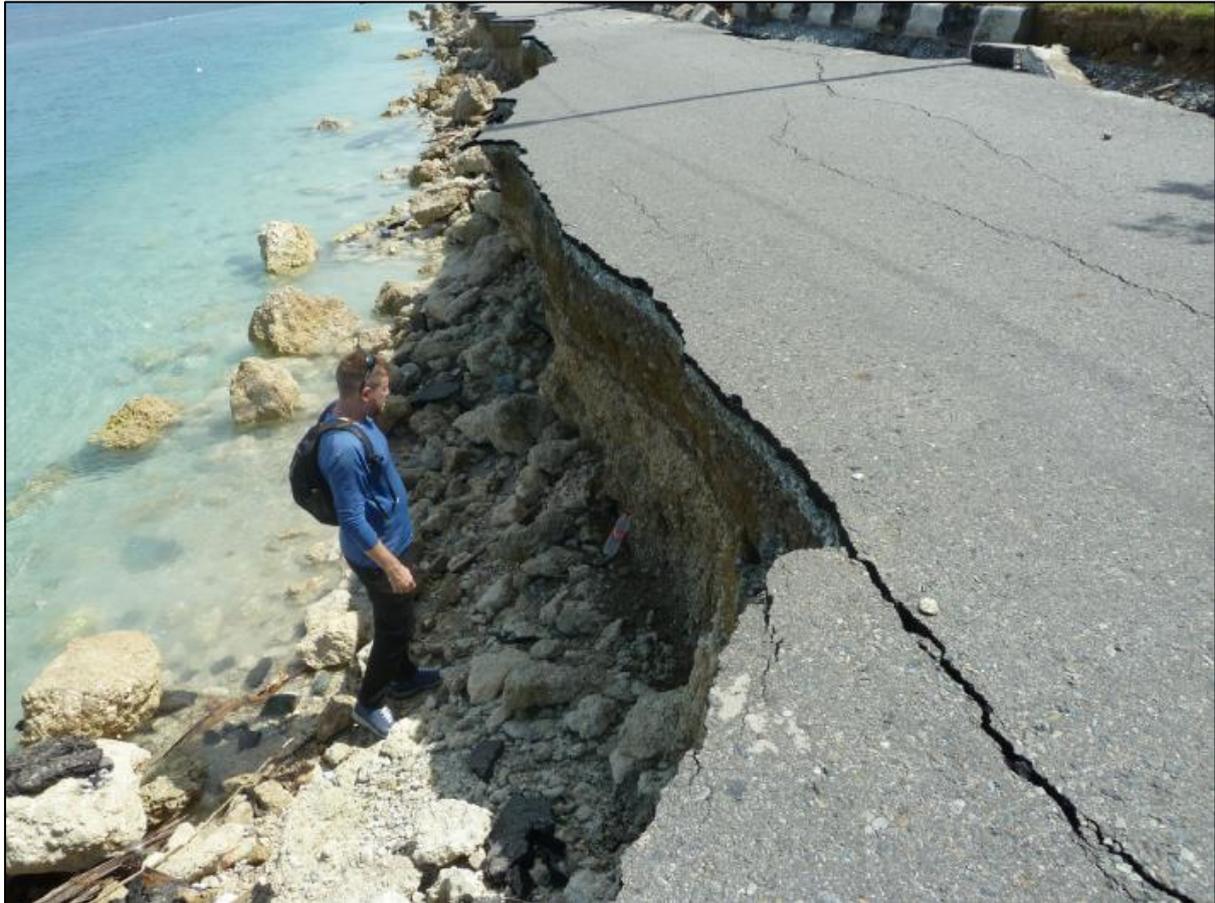
Figure 5.19.- Soil layers exposed by lateral spreading at Donggala Koto Wisata.

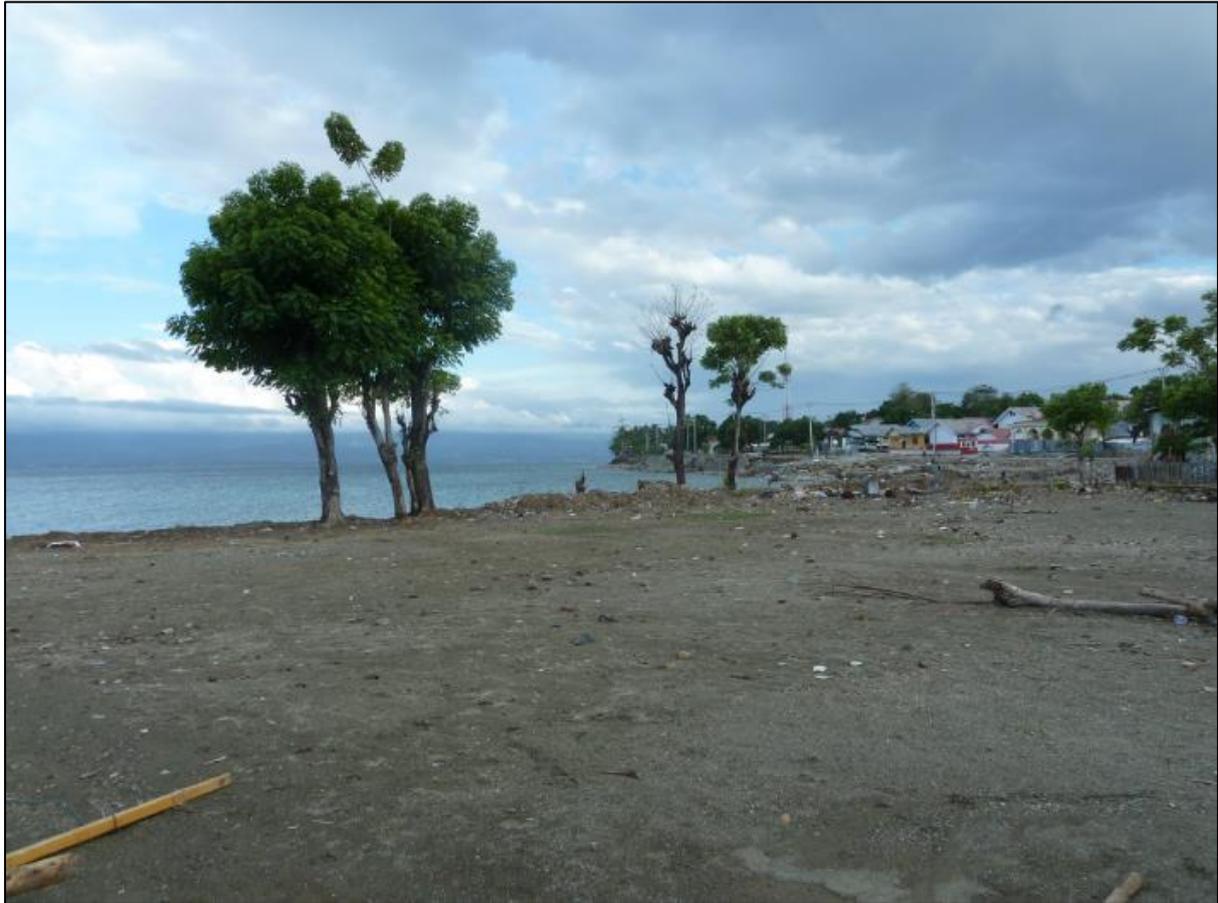
Figure 5.20 - Waterfront at Loli Tasiburi. Note the headland in the background which locals had indicated is now far shorter than before.

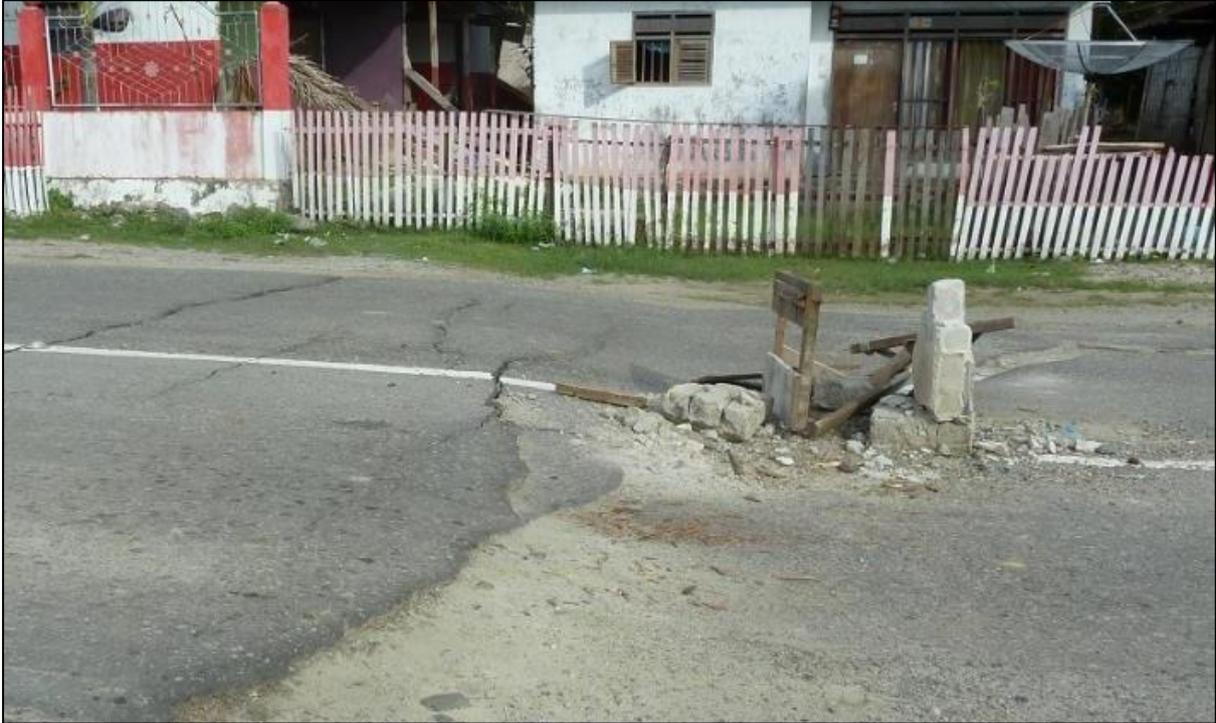
Figure 5.24 – Settlement in the road with sandy soil ejected through cracks.

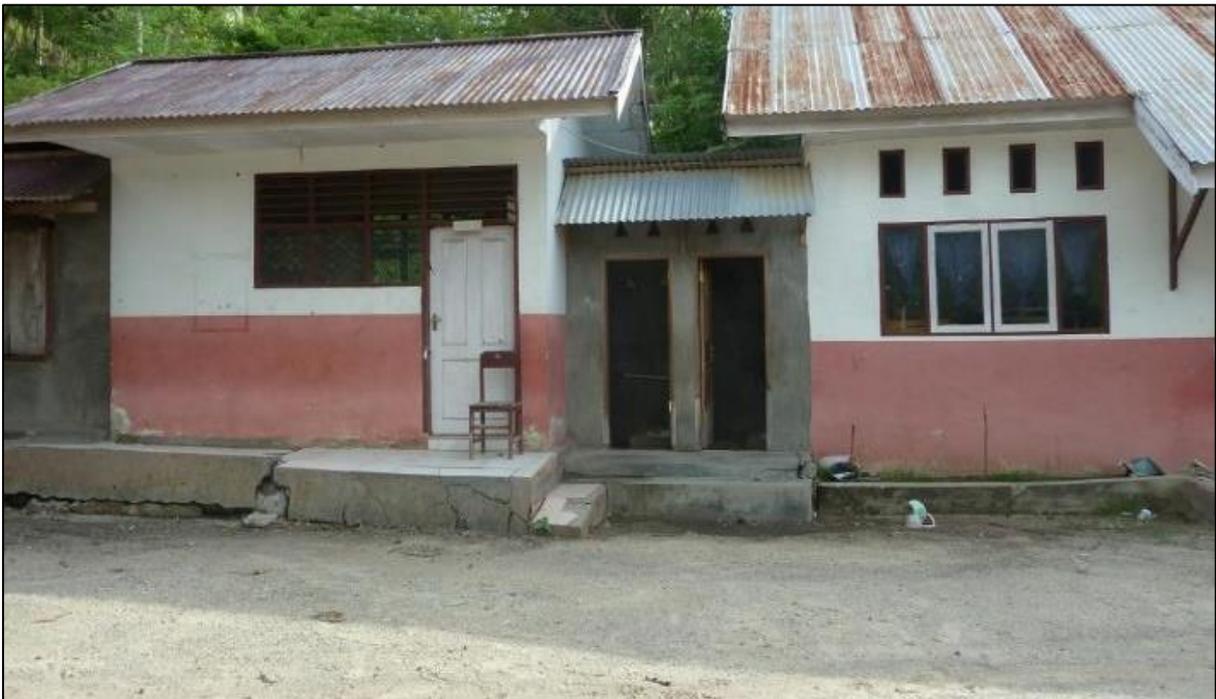
Figure 5.25 – Differential settlement of School in Lero, with liquefaction ejecta in the yard

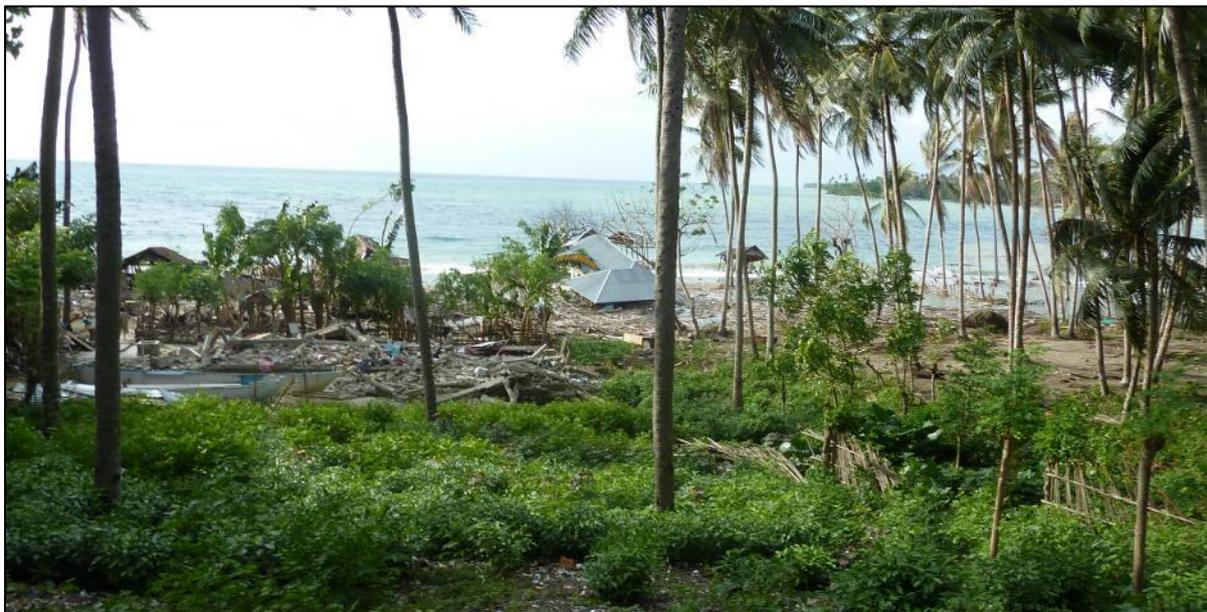
Figure 5.26 – Lero: View down towards the sea. The seafront had previously been the site of seven homes and a road.

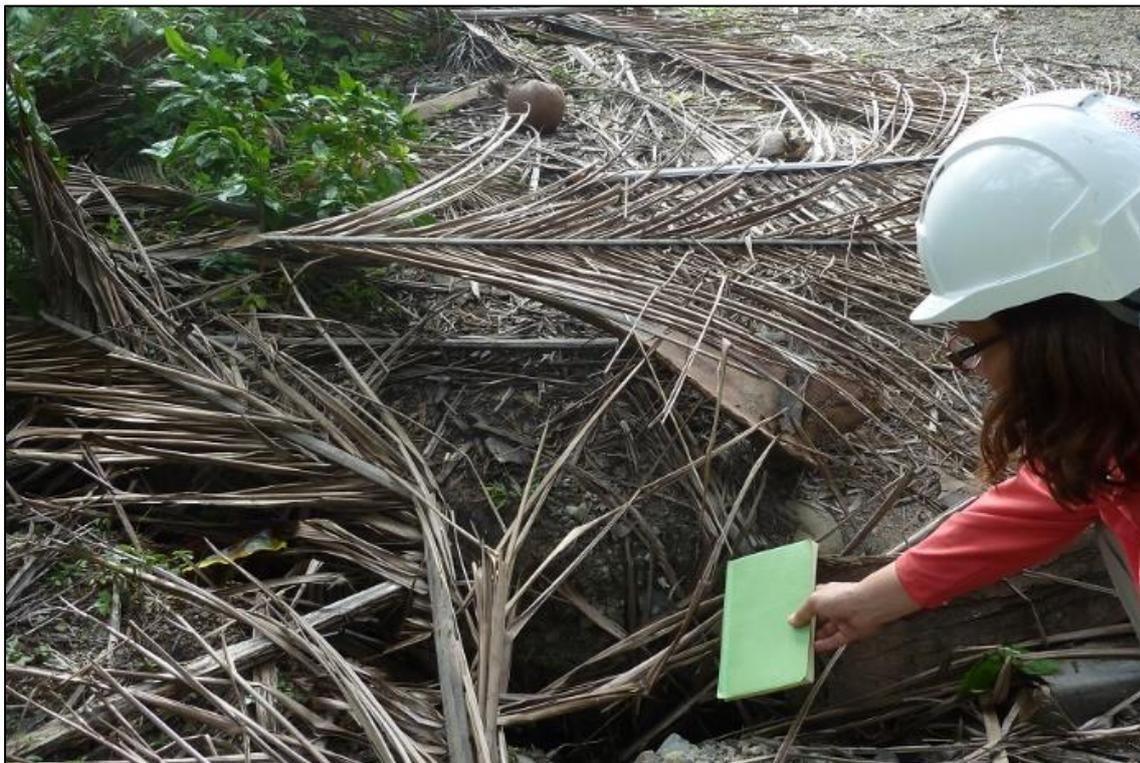
Figure 5.27 – Lero: Cracks observed parallel to shoreline consistent with lateral spreading.

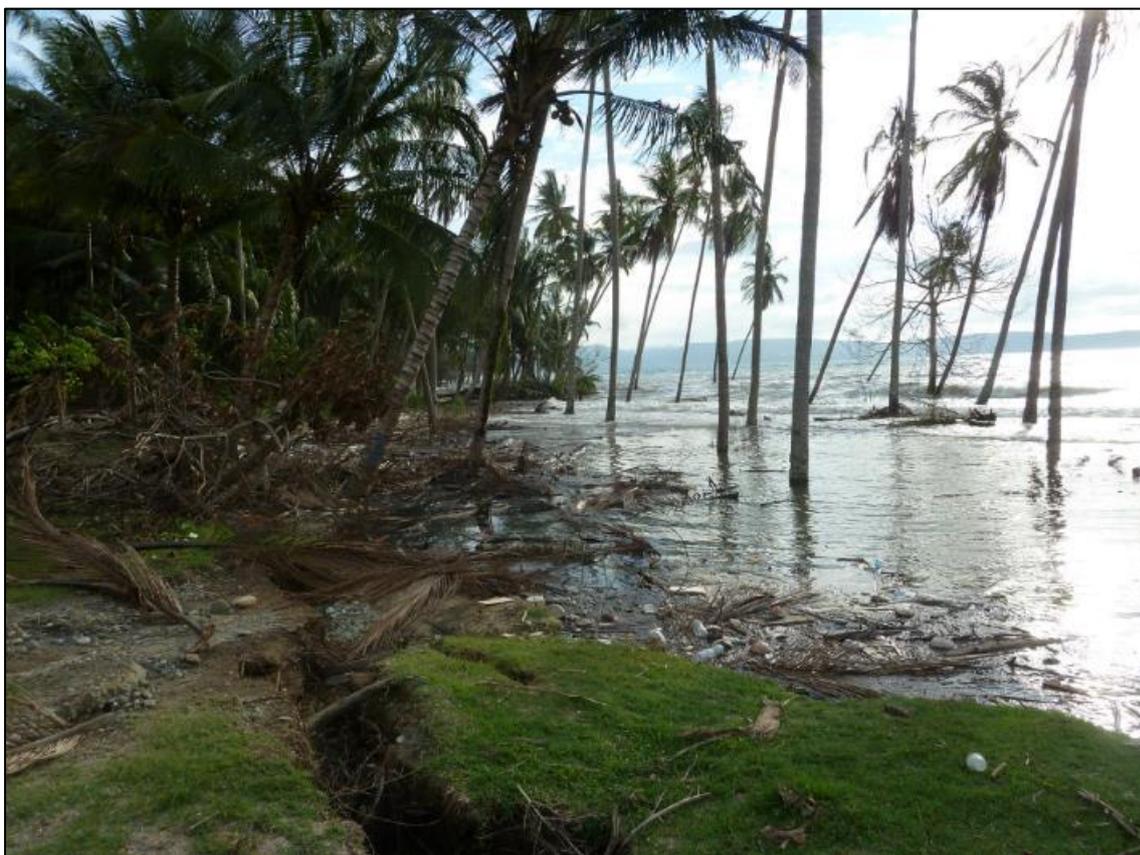
Figure 5.28 – Further cracks, and submerged land and palm trees, in Lero.

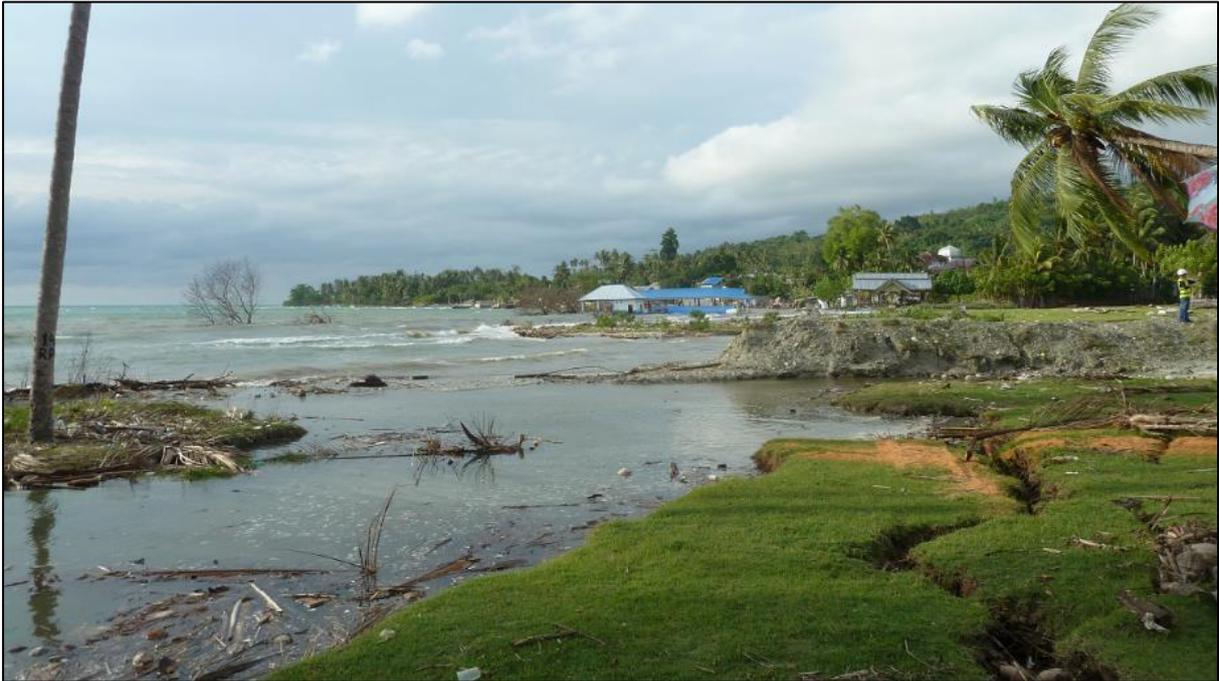
Figure 5.29 – More ground cracks at Lero, and view across the estuary towards a now submerged restaurant.

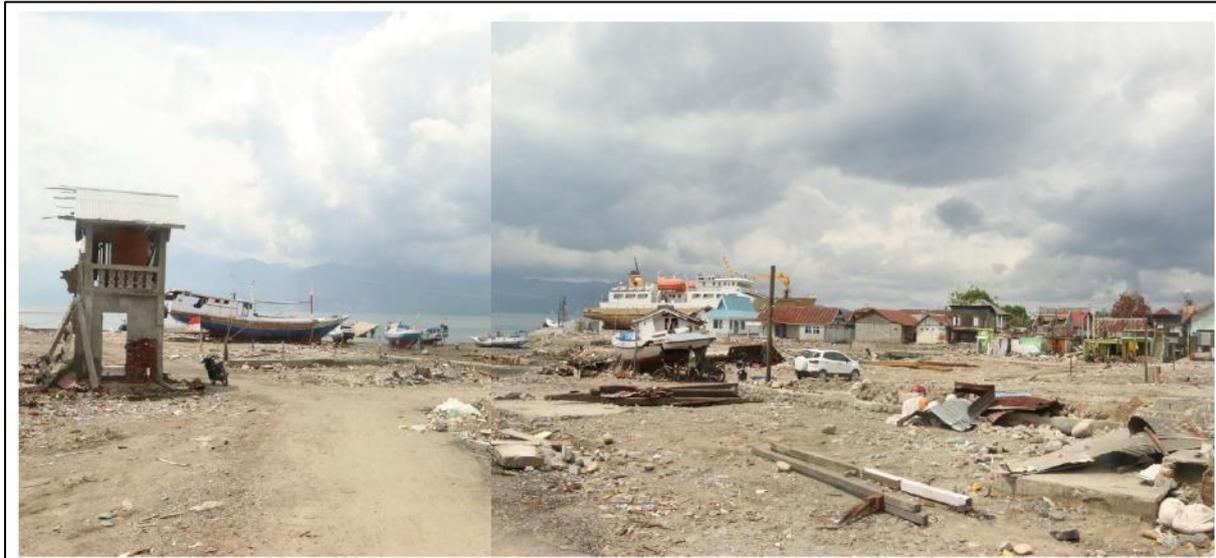
Figure 6.10 - Wani village on the east coast of Palu bay which experienced considerable damage

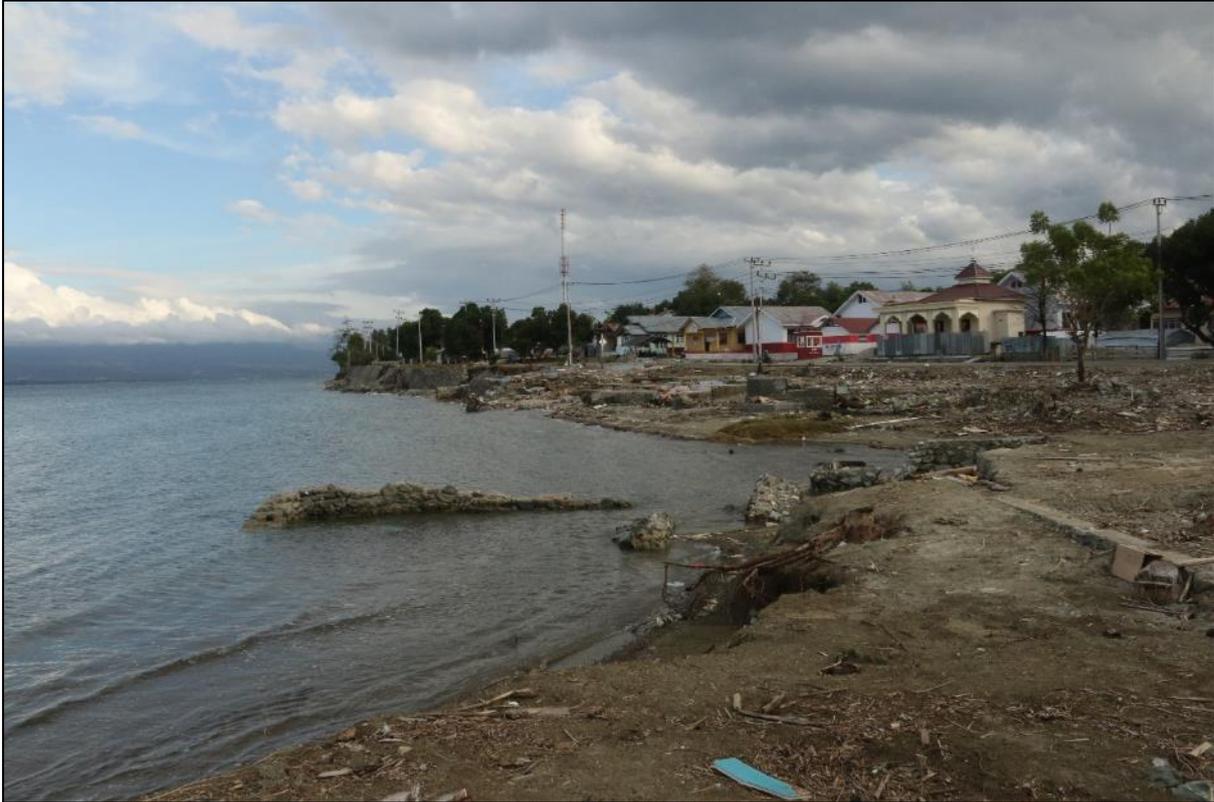
Figure 6.16 - Damage in Labuhan Bajo.

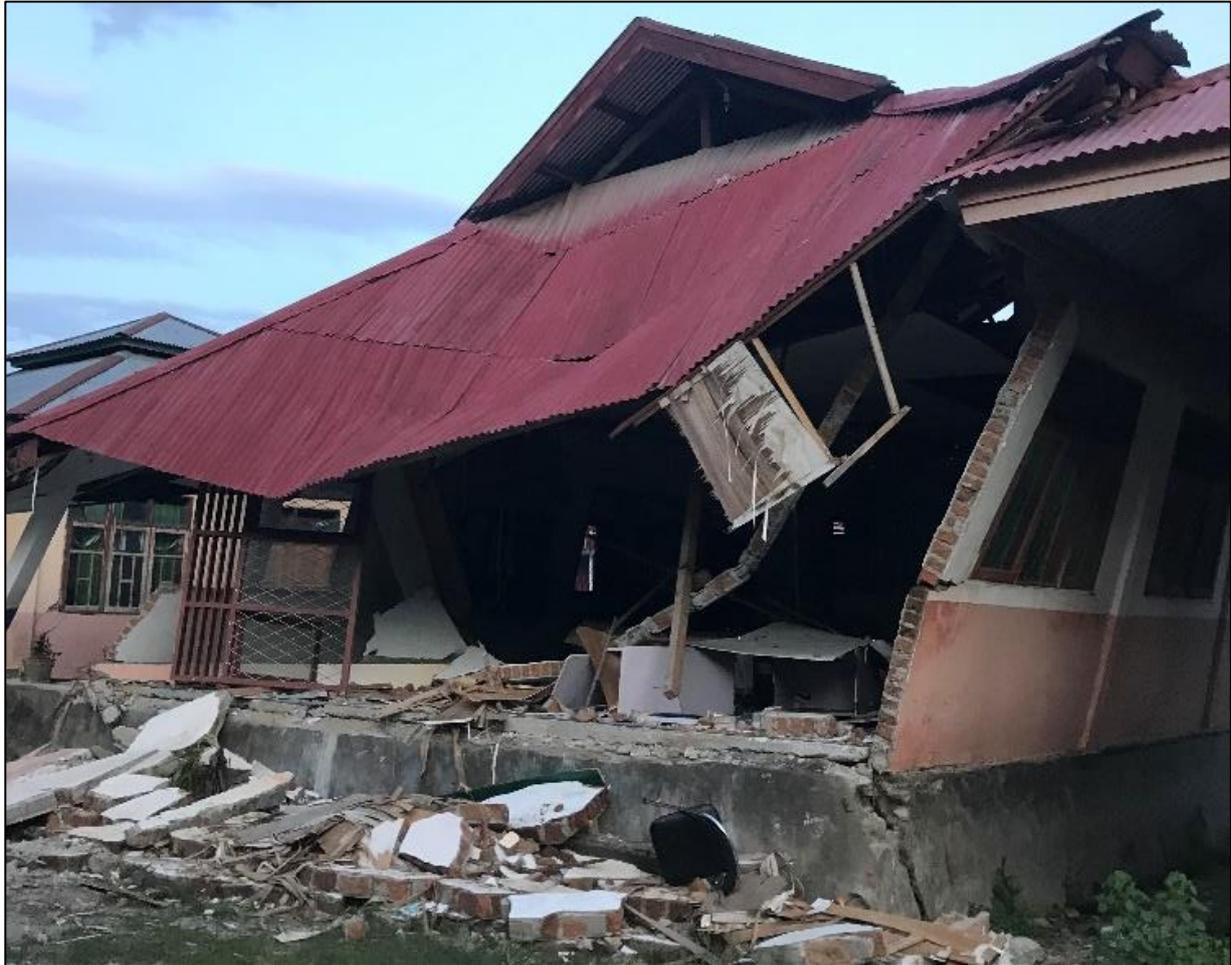
Figure 7.25 - Collapse of a CM school building in SMP Negeri 1 Biromaru School, Sigi.
