**The Central Sulawesi, Indonesia Earthquake and Tsunami of 28th
September 2018 – A Field Report by EEFIT-TDMRC**

01/11/2019

Prof Tiziana Rossetto, EPICentre, University College London

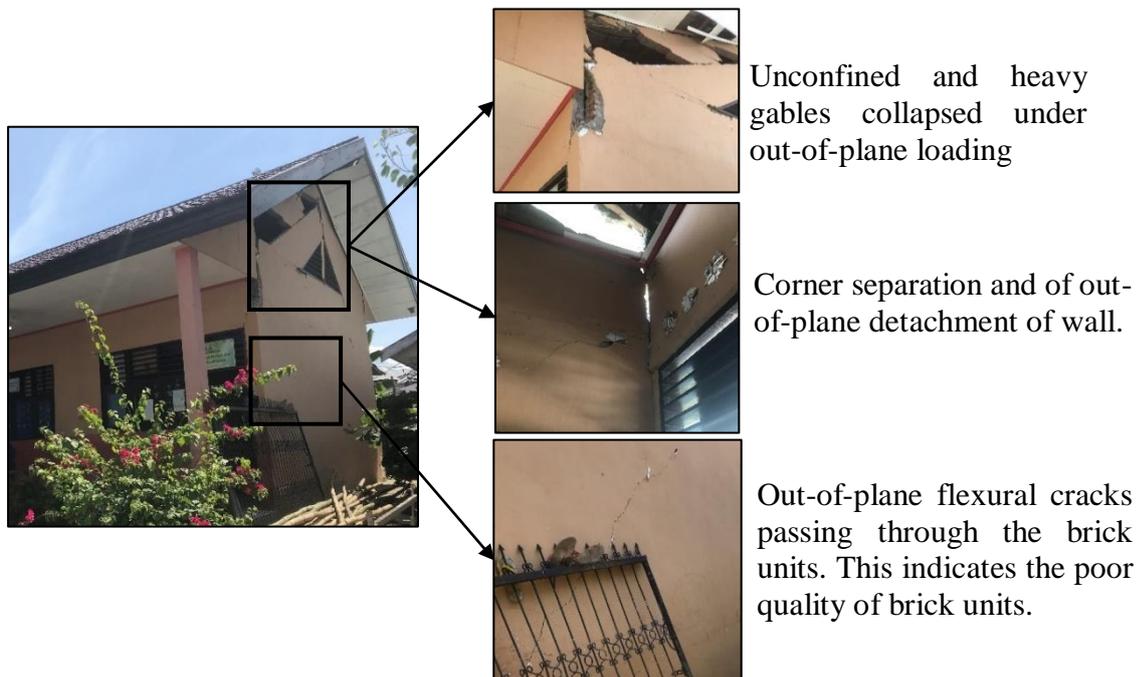
Figure 7.27 - Typical failure mechanisms observed in CM school buildings. Picture shows damage in building A at SD Inpres 1 Talise school.

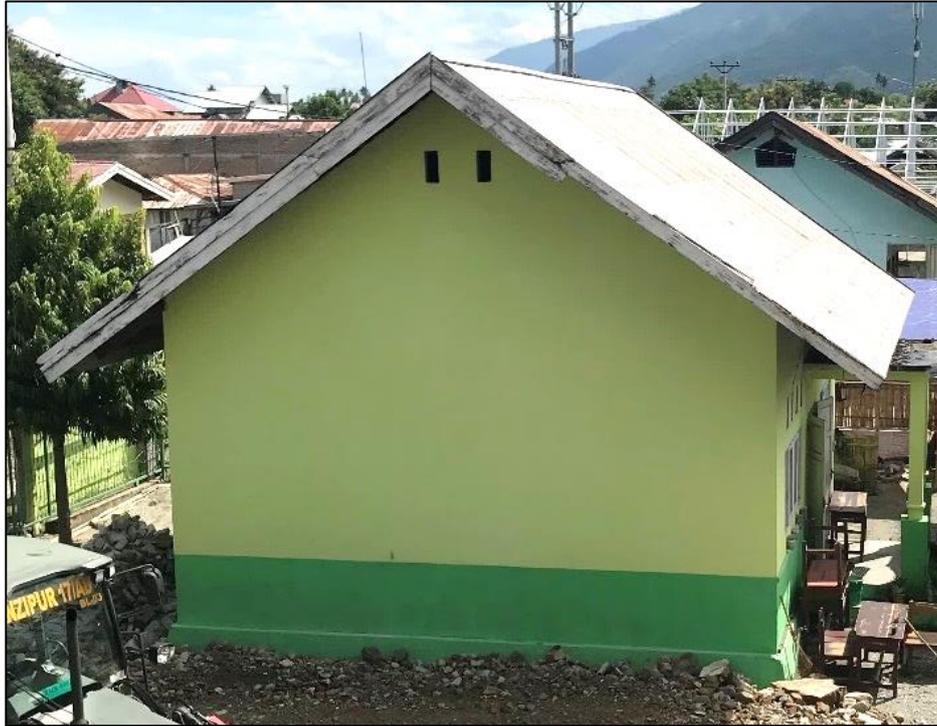
Figure 7.30 - A small plan box-type CM school building that suffered no damage (building B in Fig. 7.24c) in SD Negeri Pengawu school.

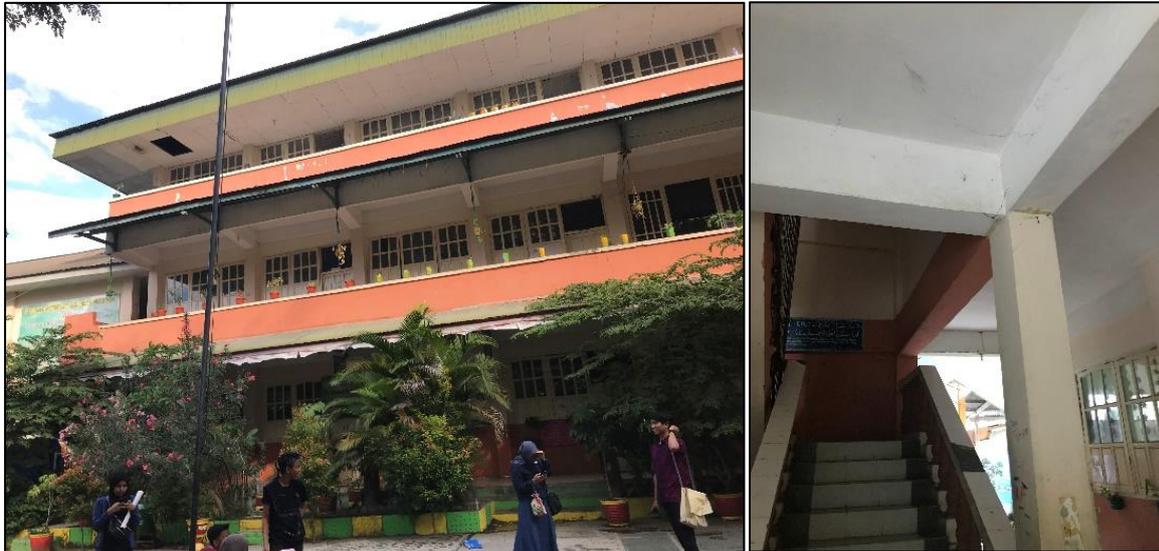
Figure 7.32 - MTS Alkhairaat Pusa Palu School. Left – 3-storey RC frame building that sustained minor damage to infill panels. Right – Typical sizes of beams and columns in RC frame schools.

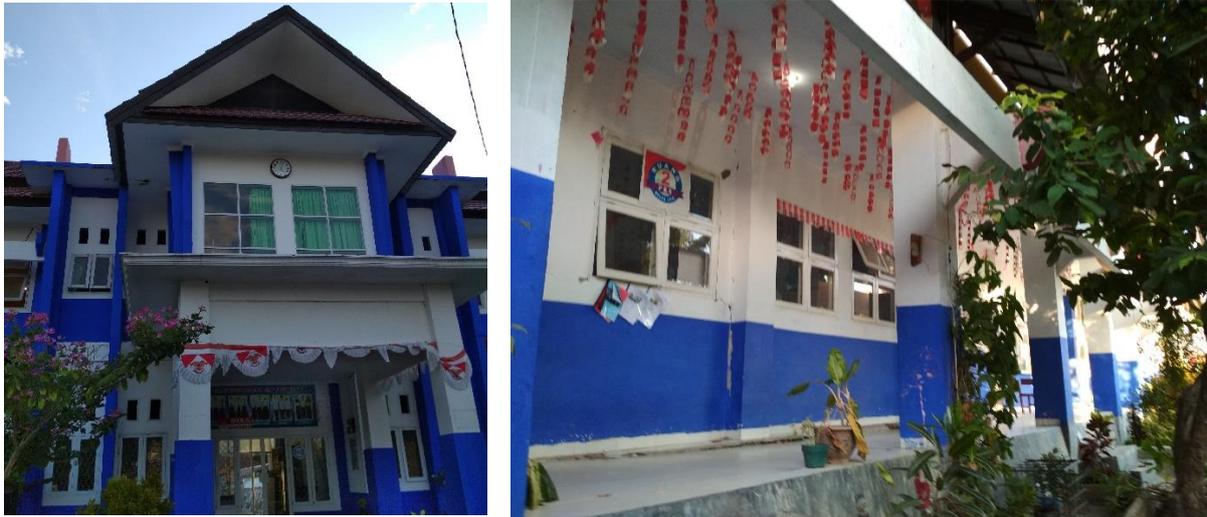
Figure 7.34 - SMP Negeri 1 Biromaru School, Building A in Fig. 7.24a. Left – front entrance to the building. Right – the rear of the building showing columns that support the balcony sited on a 1m high “slab” of made ground covered in concrete screed.

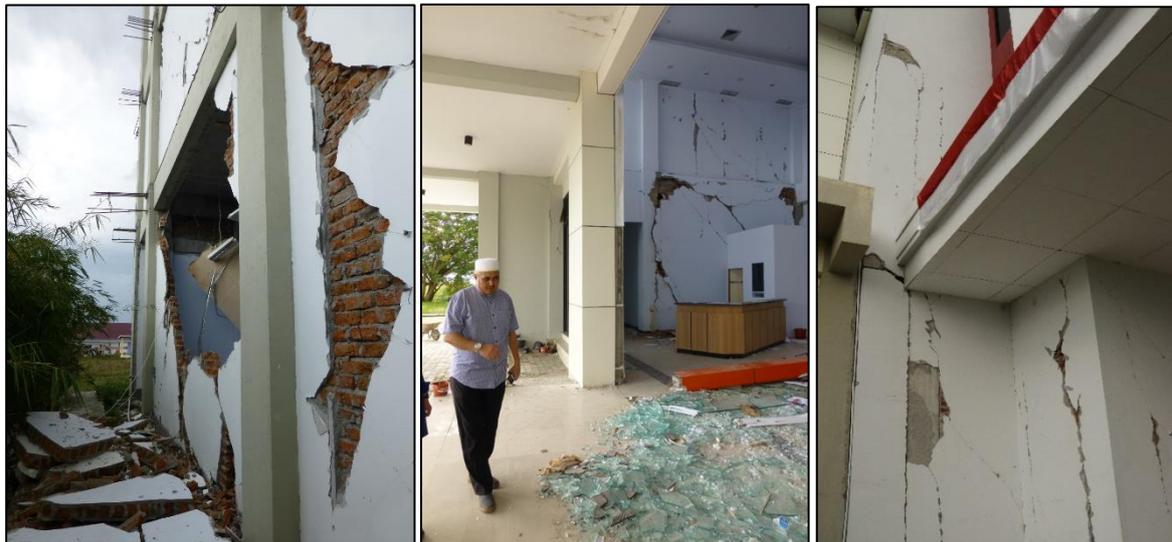
Figure 7.39 - Tadulako University Hospital Buildings: Left - Building A out-of-plane failure of infill walls (plane of walls is E-W). Middle - Damage to entrance and interior fittings of Building A. Right – Detail of damage due to pounding between Buildings A and B.

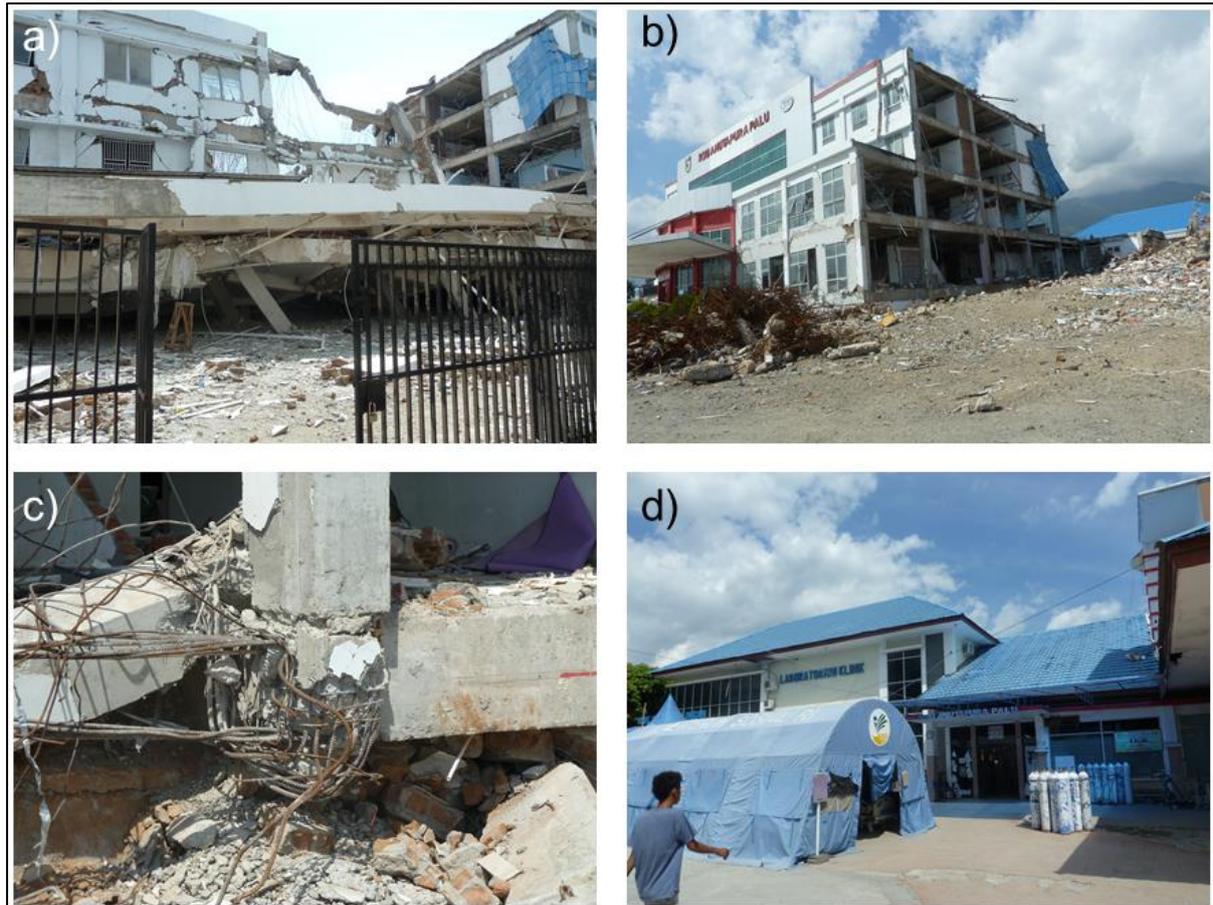
Figure 7.40 - Damage at Anutapura Hospital a) soft story collapse of four story RC frame structure; b) RC frame of remaining structure visible following removal of collapsed debris; c) column=beam joint reinforcement exposed in collapsed structure; d) low-rise hospital structures were relatively undamaged and remained operational.

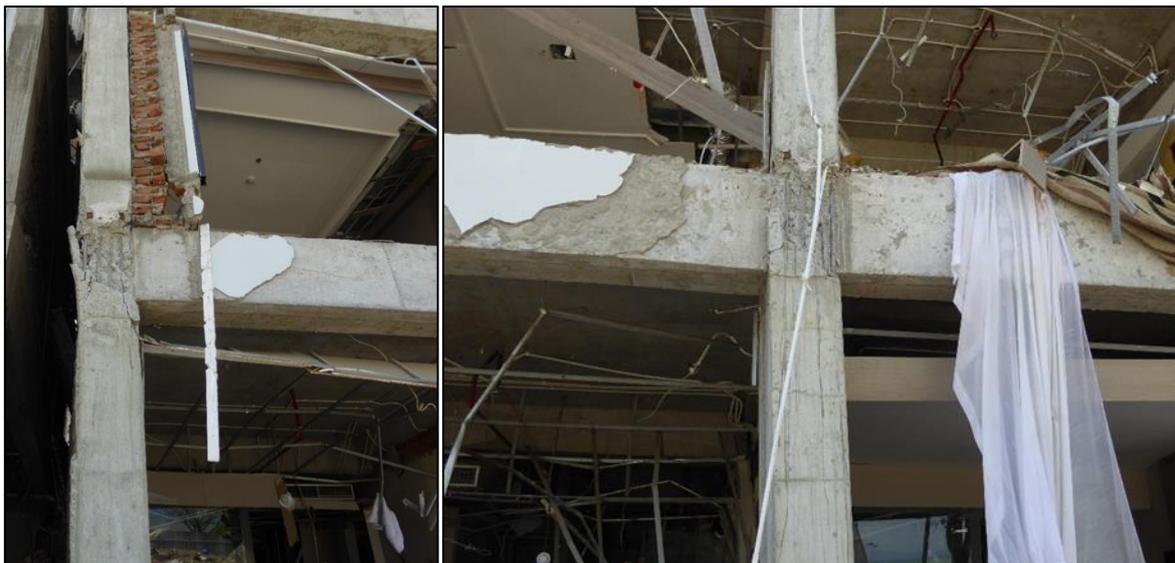
Figure 7.46 – Mercure Hotel – Images of cover spalling in RC frame joints in the second storey of the structure

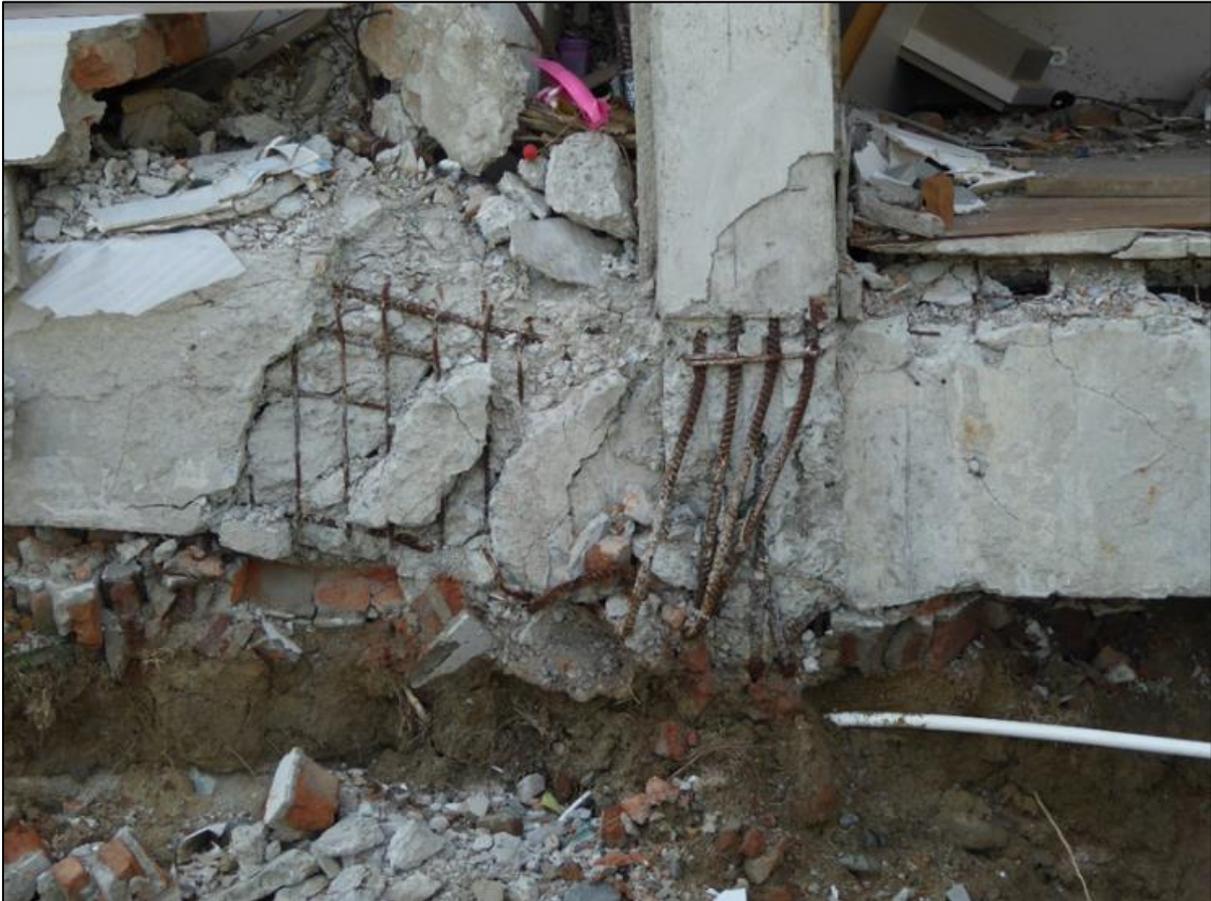
Figure 7.47 – Mercure Hotel – Detail of a joint within the first floor of the building (now at ground level following soft-storey collapse of ground floor).

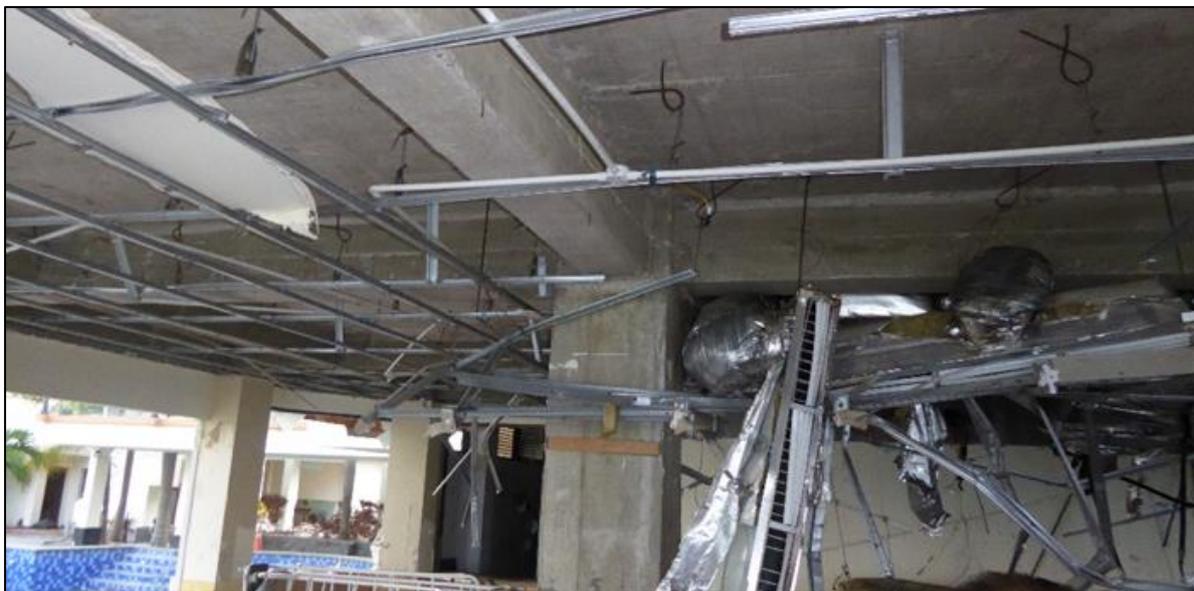
Figure 7.49 - Swiss Belhotel - damage to internal fittings at the ground storey of the shoreward side of the hotel. No structural damage observed in the main RC structure.

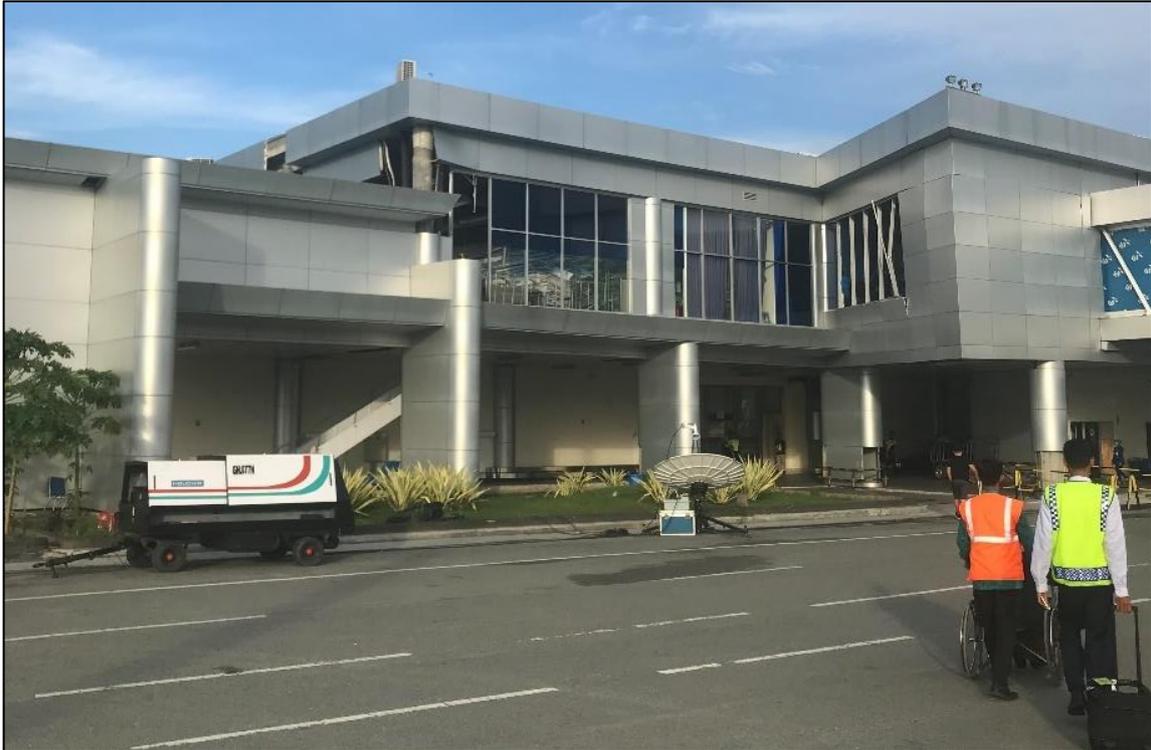
Figure 7.50 - View of Palu Airport passenger building from the runway. Damage to the infill walls at the ground floor is observed. A stack of fallen ceiling cladding can be seen in upper storey window.

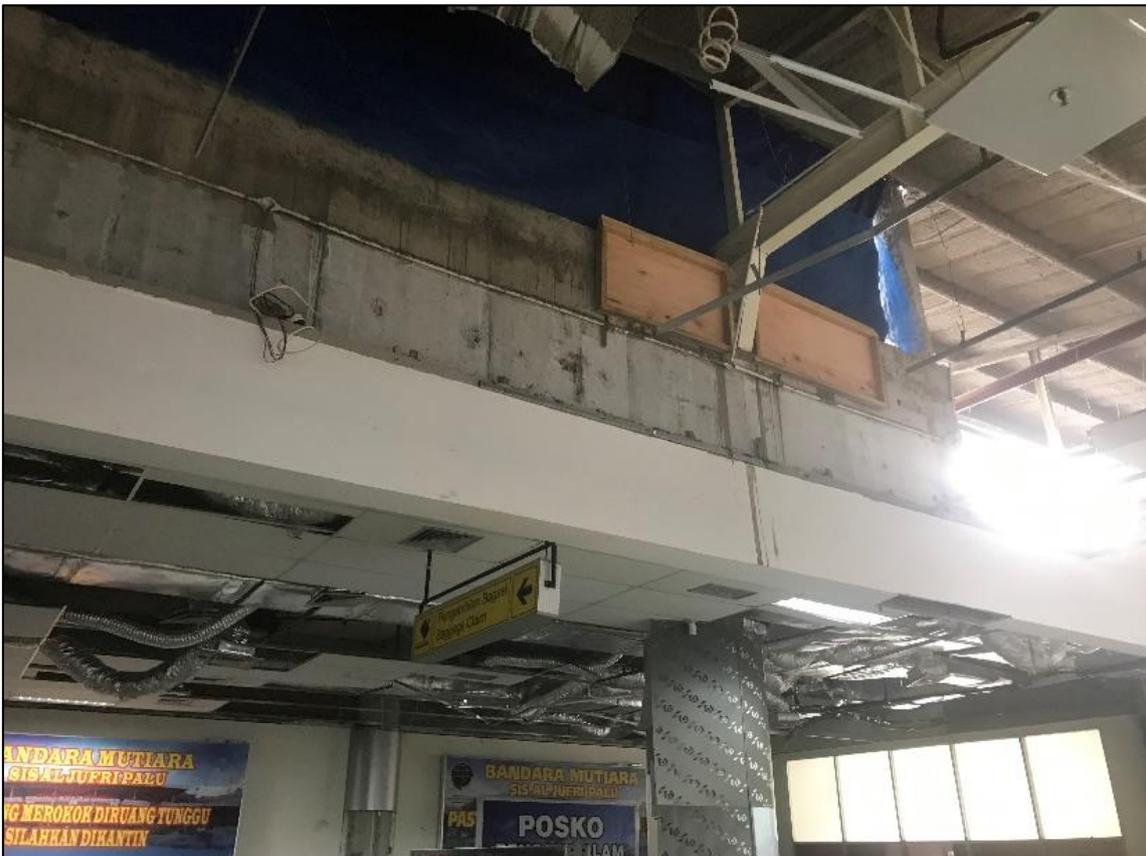
Figure 7.51 - Picture of missing ceiling cladding and damaged fixtures, inside Palu Airport passenger building.

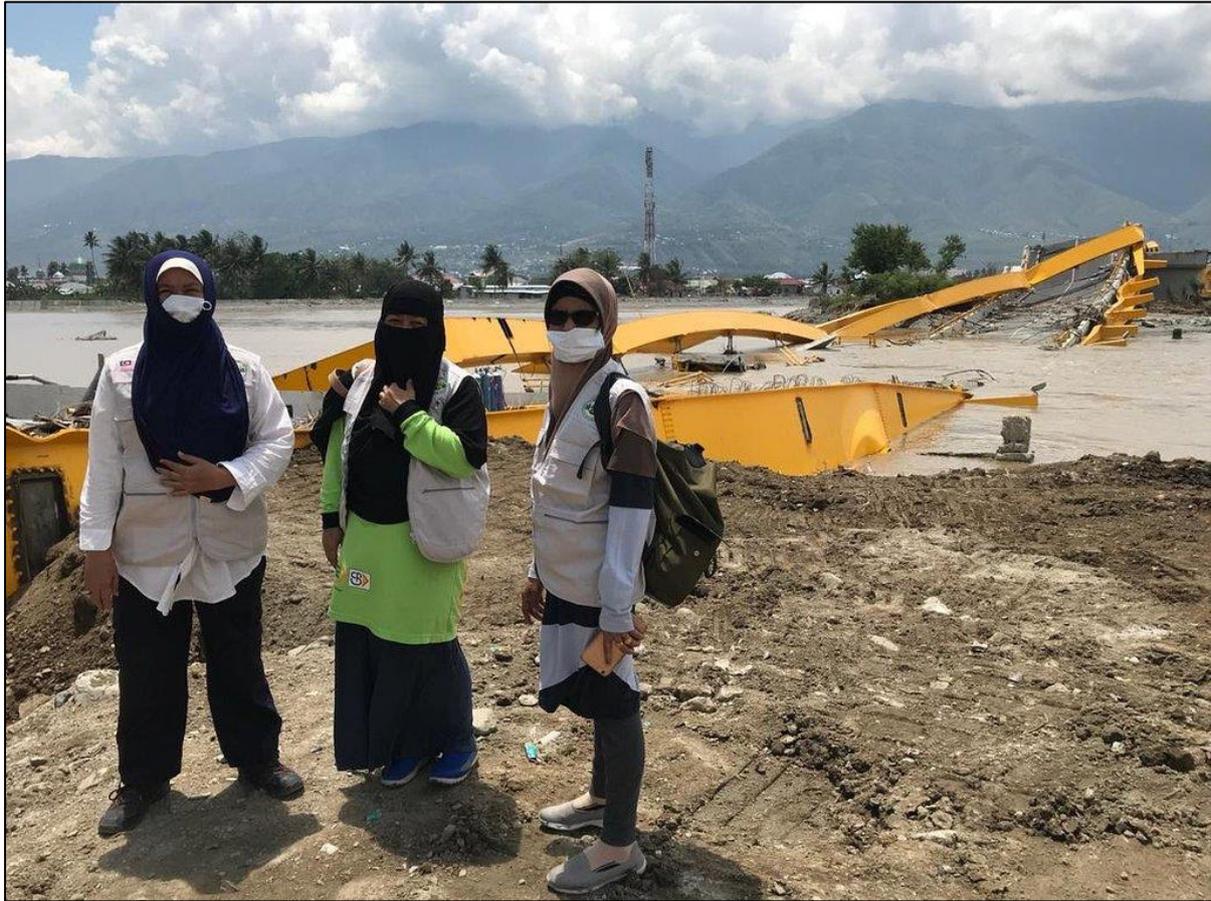
Figure 7.53 - Picture of Ponulele bridge showing the failed deck. Source: Tripadvisor.

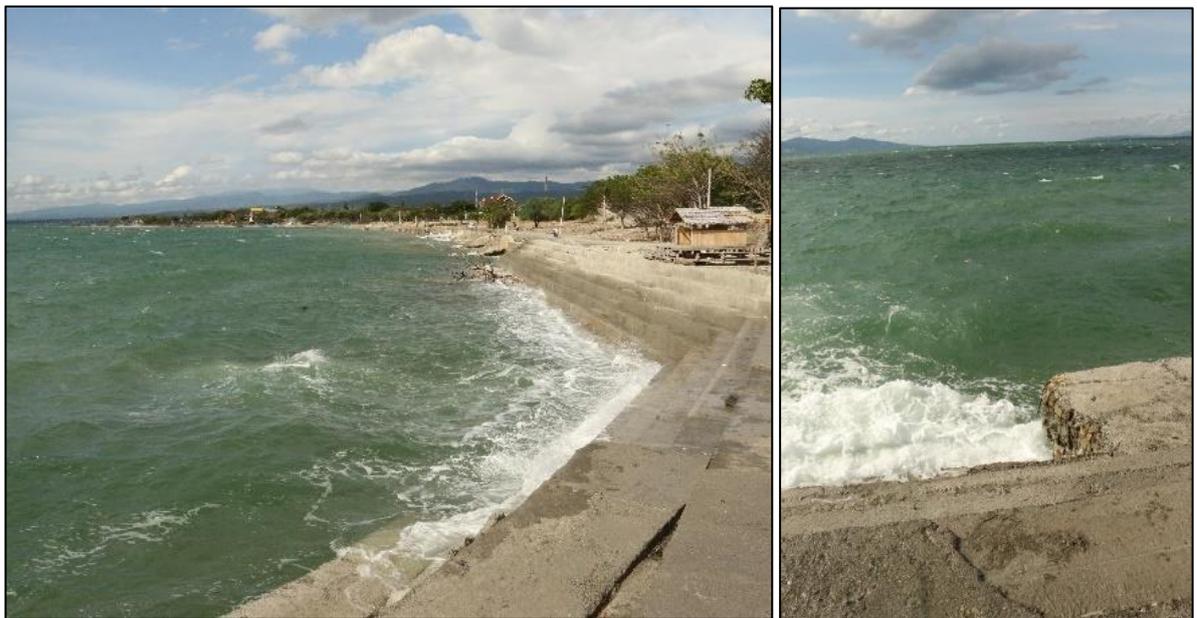
Figure 7.56 - Stepped revetment South of Mamboro missing its crest.

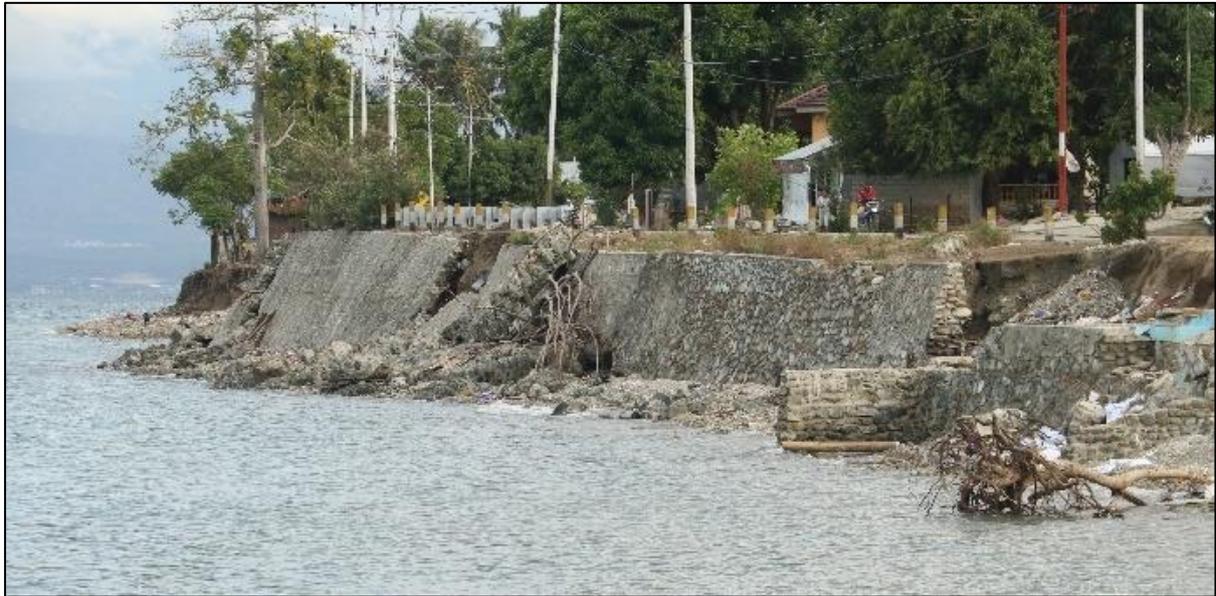
Figure 7.57 - Damaged masonry seawall just to the south of Tasiburi

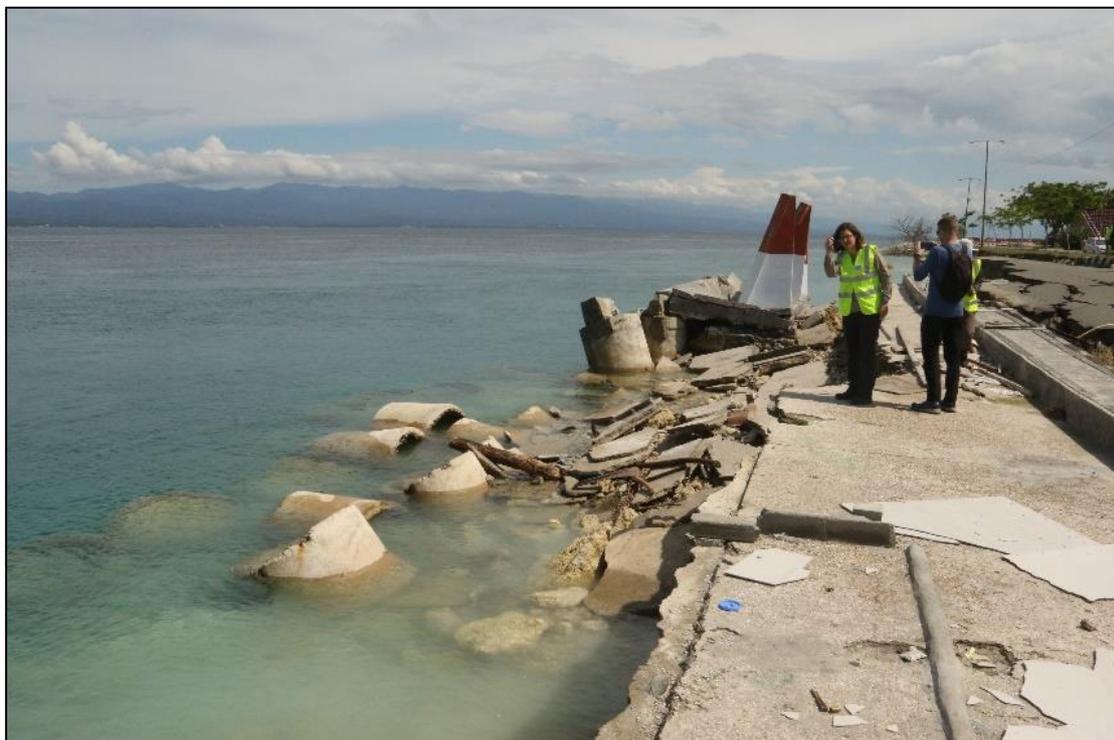
Figure 7.58 - Collapse of quay wall at ‘Dolphin Park’ at Donggala Koto Wisata.

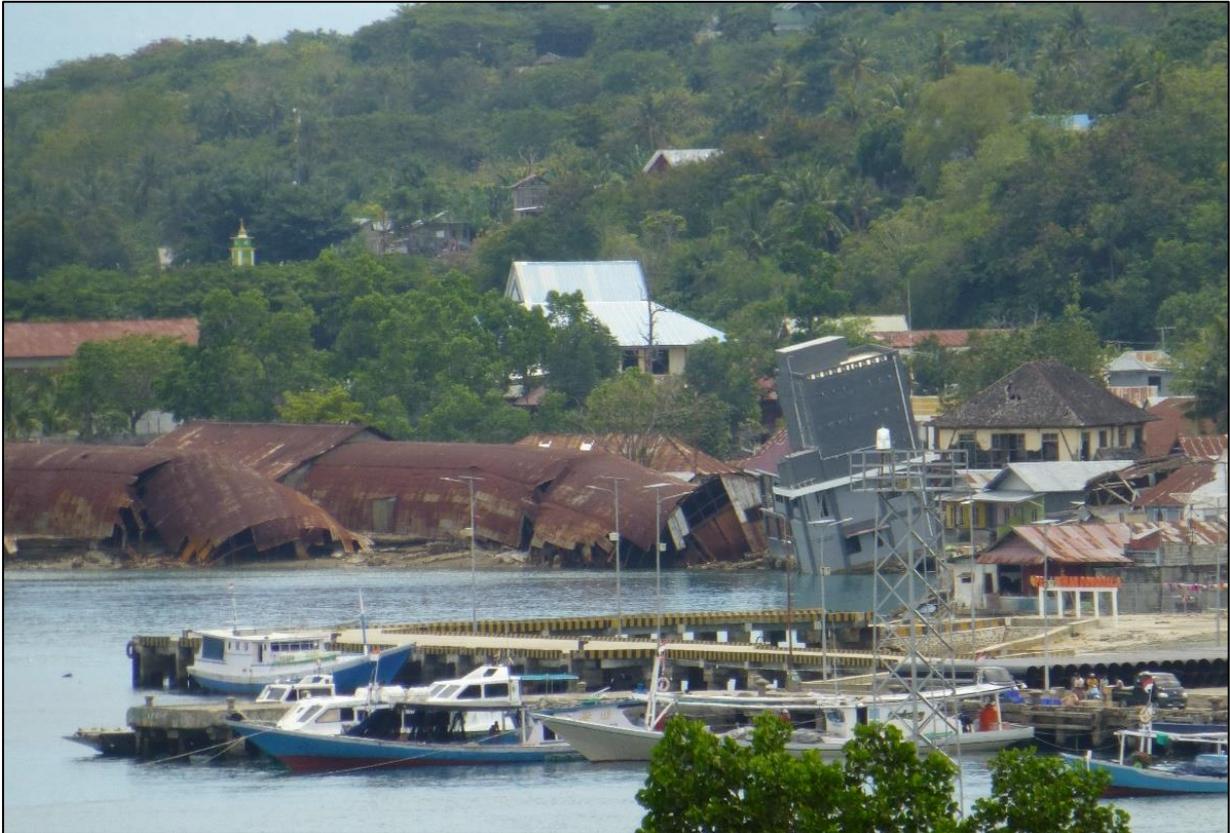
Figure 7.59 - Damage to old port of Donggala

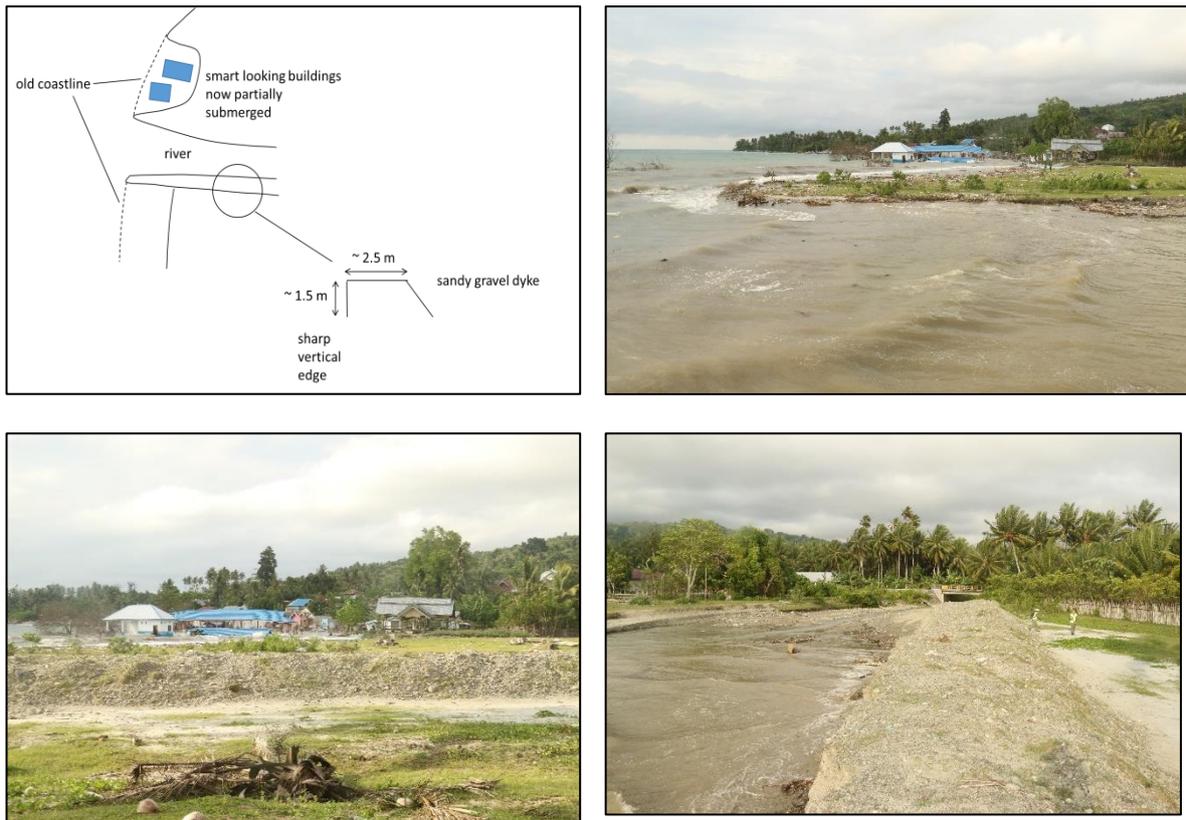
Figure 7.62 - River wall and surroundings at Lero. Top left - Schematic layout of site. Top right - River mouth. Bottom left - Landward side of river wall. Bottom right - Sheared face of river wall.
