## CROSS Safety Report

# Collapse of unusual hybrid concrete-and-steel strand truss on school roof

This month we present a report about the collapse of a school hall roof, which resulted from the failure of one of a number of unusual hybrid concrete-and-steel strand trusses.

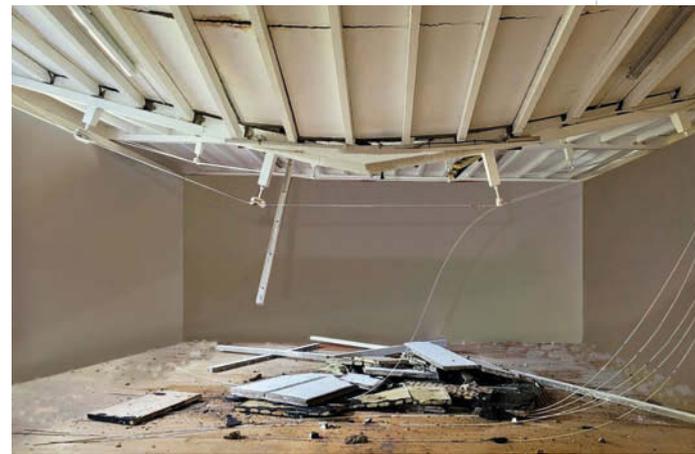
The reporter, a structural engineer, visited the site soon after the collapse. The roof truss had failed with six of the seven steel tensioning strands lying on the ground. The anchorage fixings for the detached end of the loose strands were found in the bearing pocket of the edge beam. The anchorages for the other end of the strands remained with the top chord endplate. The purlins on either side had collapsed or were damaged and hanging from one end, but the felt roof was still intact and holding water.

↑ **FIGURE 1:** Failed truss and partially collapsed roof

The reporter believed the failure possibly resulted from anchorages of the tensioning strands slipping suddenly without warning. This could have led to a global failure of the truss in bending, as witnessed by the significant deflection and damage that occurred at the centre of the span. The reporter reasoned that once the anchorages had slipped, tension was lost in the strands and, owing to the poor detailing of the reinforcement at mid span, combined with the reduced capacity of the concrete chord, the truss likely failed in bending at mid span and collapsed. This caused the purlins to become dislodged and the

roof structure in the two bays on either side of the truss to fail and deflect or collapse to the ground.

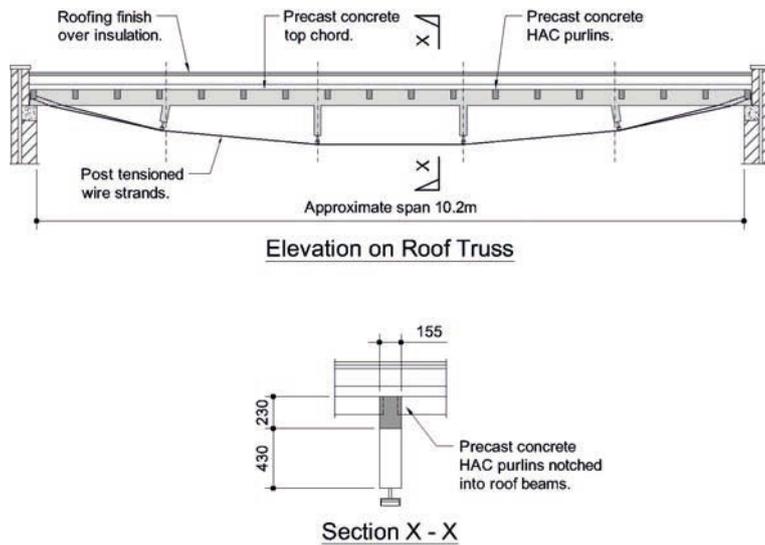
▼ FIGURE 2: Elevation and section through truss

The bottom chord of the truss (**Figure 2**) consisted of seven steel strands. The strands extended for the full length of the truss between anchorage plates cast into either end of the reinforced concrete top chord. The strands passed over four steel mounts located at the ends of concrete verticals cast integral with the top chord. Stability of the top chord was provided through diaphragm action

The reporter goes on to say that concrete from the failed truss was tested in a laboratory and found not to have any significant defects. Some surface corrosion of the reinforcement was observed, but this could be expected from a concrete element of this age. The detailing of the reinforcement, however, did

not appear optimal; the bars were lapped in the middle of the top chord with a non-standard detail. Furthermore, the reinforcement did not fully extend to the beam end and the bearing appeared to be minimally reinforced. There was also minimal link reinforcement at the end of the beam where the anchorages failed, although there was no shear cracking at the end of the failed truss. There was some surface corrosion to anchor plates and the tensioning strands, but no loss of section was visible. Testing confirmed that the concrete in the purlins was made using high alumina cement. Degradation was apparent in some of the purlins which suggests that conversion had taken place and reduced the structural integrity of the purlins. The reporter's inspection did not identify any significant cracking or distress to the hall structure below the eaves level concrete ring beam.

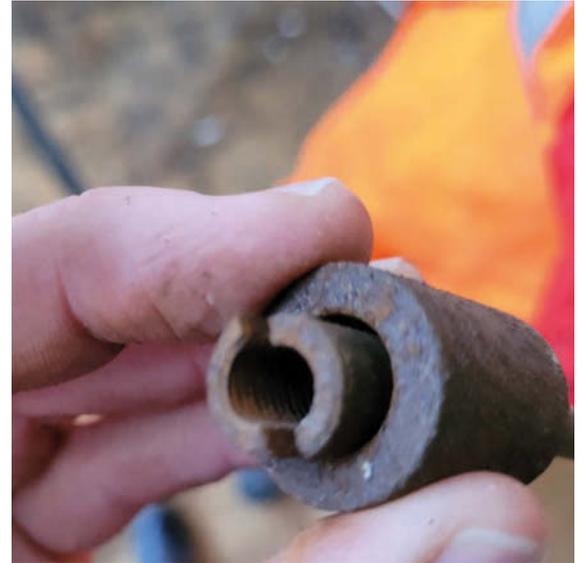
▼ FIGURE 3: Anchoring cylinder with two split wedges

The tensioned strands were held at the endplates using a cylinder with two serrated split wedges (**Figure 3**). The strands were carried over the concrete verticals on support rollers. It was not

The reporter did not know the cause of the failure although they believe it was possibly associated with the strand anchorages. A number of causes could be postulated, and it is likely that a combination of causes led to the collapse. A failure of a tendon or tendon anchorage is one potential cause. Movements at the truss end bearing could be a contributory cause, promoting crack development around the anchorage and loss of anchorage or disruption of the top chord. Creep stretching of the tendons causing sagging of the truss and the potential for rainwater ponding could be an exacerbating factor. Replacement roof coverings could have also had an impact over time.

It is not good practice to have critical details, such as anchorages, in a location where they are not easily inspectable, as appears to be the case with this failure. Any structure which relies on strands or cables for its structural integrity should be designed such that the terminations are visible and easily inspected. The inspection of strand and cable terminations needs an experienced eye as potential issues are often not immediately apparent. Persons inspecting buildings should be mindful that critical parts of a structure may be hidden from view.

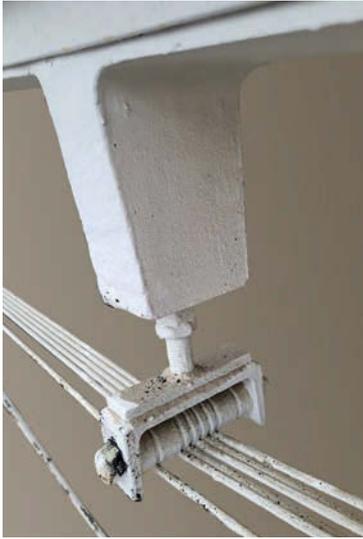
▼ **FIGURE 4:** Steel mount on concrete vertical carrying tensioned strands

clear to the reporter how the truss was originally tensioned. The reporter says that there may have been an initial tensioning at the factory, with further tensioning prior to installation using the threads on the steel mounts to lengthen the verticals, thus tensioning the strands. **Figure 4** shows the steel mounts and strand support rollers.
