CROSS Safety Report

Collapse of folded plate timber roof at a school

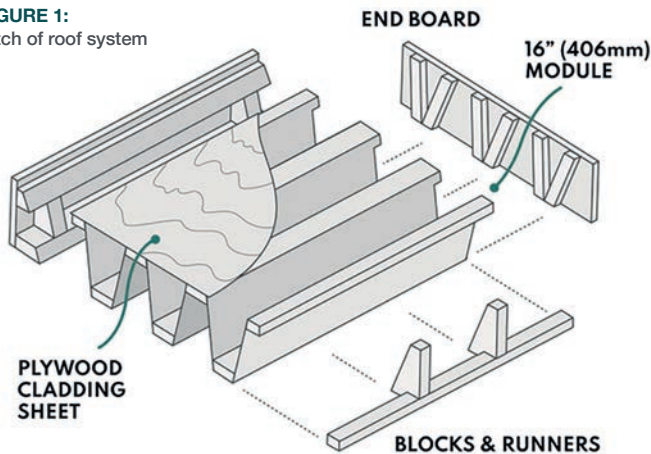
FIGURE 1:
Sketch of roof system

In 2011, the reporter told CROSS (known at that point in time as SCOSS) of a sudden failure of a proprietary timber roof system over a school hall that had been constructed in 1959. In response to the failure, SCOSS issued Report 273 – *Collapse of proprietary timber roof*. The reporter believes that local authorities shared that information to help identify similar roofs. However, the reporter, who is a Chartered structural engineer, has had another enquiry concerning a roof suspected to be of the same type of construction. In researching this enquiry, the reporter has come across a news report of a collapse of another school roof in England in 2019 which appears to be of the same type of construction as that which collapsed in 2011. The construction of the roof appears to be similar to that shown in **Figures 1** and **2**. The age of the roof is not known to the reporter.

The cause of the collapse was not clear, however any structure that relies upon glue and panel pins is unlikely to be robust if water damage occurs at critical connections. It may be that a lack of maintenance permitted water penetration which impacted critical connections and precipitated the collapse. Any roof with suspected water penetration or water shedding problems should be inspected and repaired as a priority, as water degradation can cause structural damage and failures. Water and moisture generally are contributing factors to much

- | Inspect and assess existing buildings, particularly those that are of a significant age, to see if they contain unusual forms of construction, including roofs similar to the reported failure
- | If so, or if there is doubt, arrange for structural inspections and risk assessments to be undertaken by engineers who are suitably qualified and experienced persons – normally Chartered structural or Chartered civil engineers

- | Undertake a risk assessment of old and unusual structures where there is a life safety risk should they fail
- | Consider what combination of causes could lead to a structural failure
- | Understand where structural elements may be beyond their reasonable service life
- | Look out for signs of distress, including those in hidden components or locations
- | Be aware of the risks associated with moisture build-up, particularly where timber is a structurally significant component
