M7.7 Myanmar Earthquake

March 28, 2025

NHERI DesignSafe Project ID: PRJ-5573

JOINT PRELIMINARY VIRTUAL RECONNAISSANCE REPORT (J-PVRR)

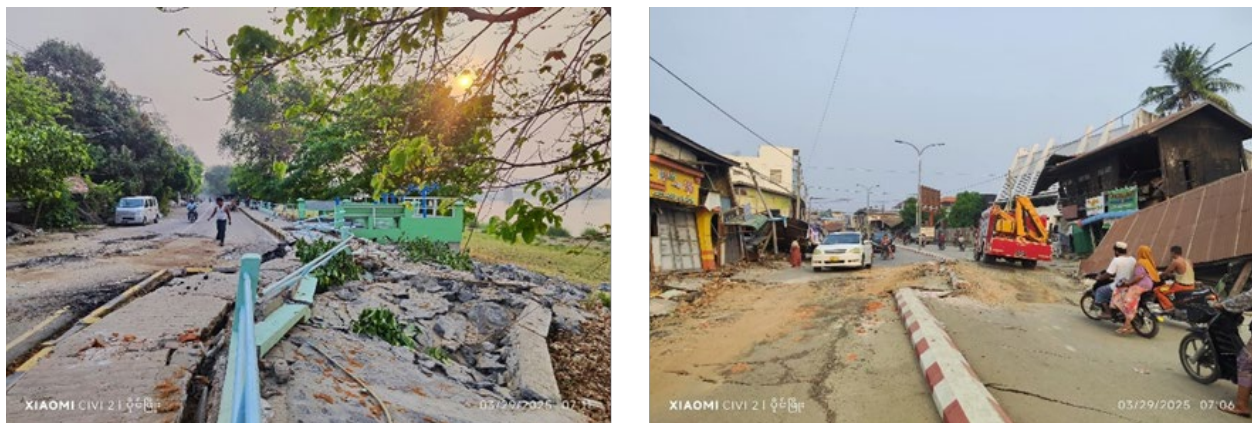
Figure 2.15. Roadways with offset of several feet (21°52'49.27"N, 95°59'5.57"E) (Source: [HMSon @heungburma on X](#)).

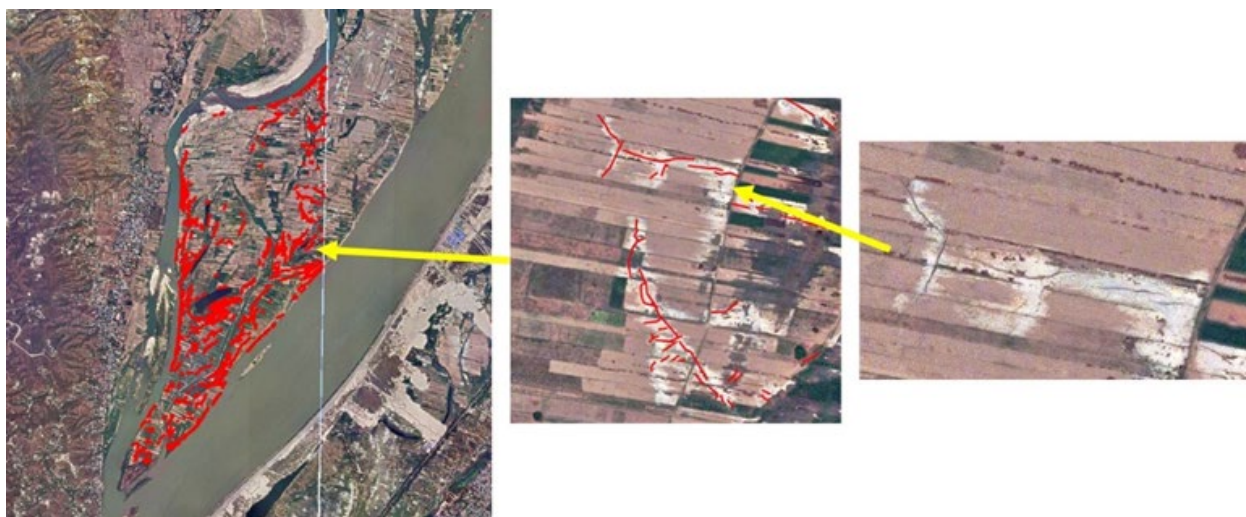
Figure 4.2.1. Mapping of lateral spread features in Area 2. Insets show increasing magnification of targeted subarea showing ejecta. Lateral spread fissures marked in red.

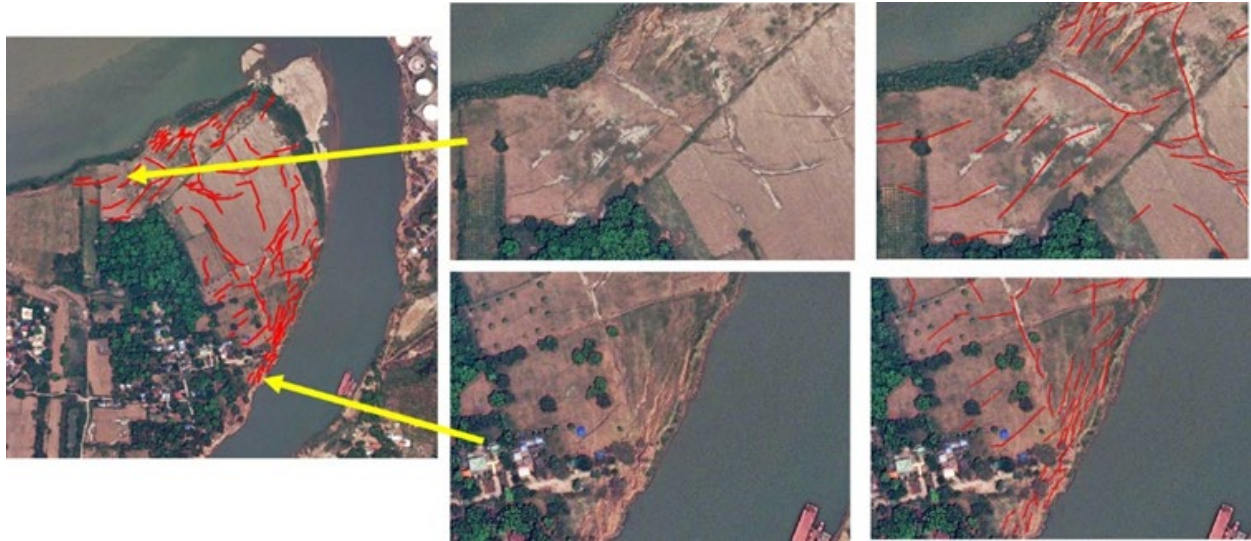
Figure 4.3.1. Mapping of lateral spread features showing differing fissure and ejecta patterns in Area 3. Inset images show magnified views of two subareas. Lateral spread fissures marked in red.

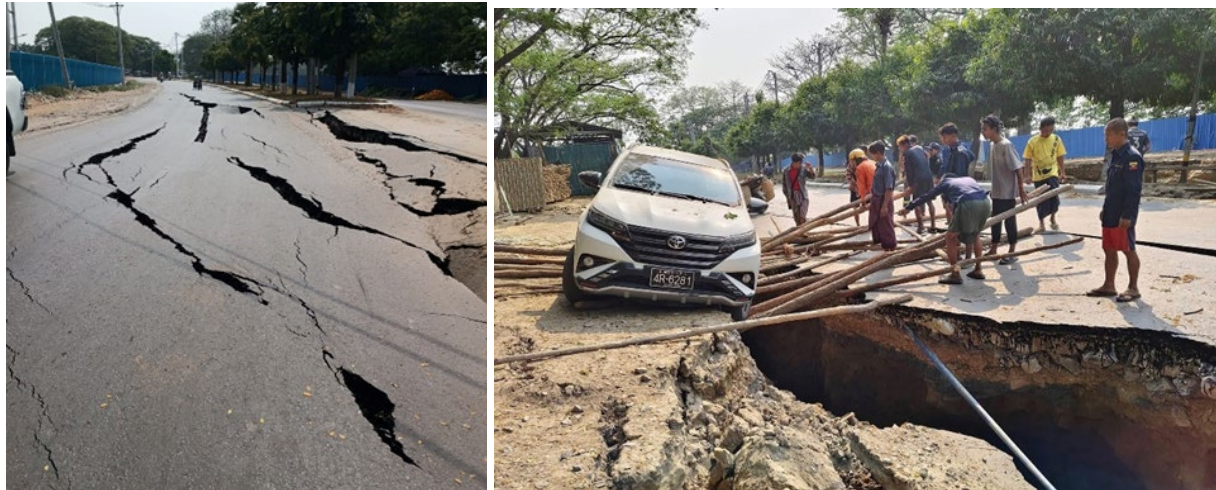
Figure 4.3.3. Extension in pavements along Myo Patt Road [Approximate Location 21.9260, 96.0546] (Credit: ZoMung Thawng).

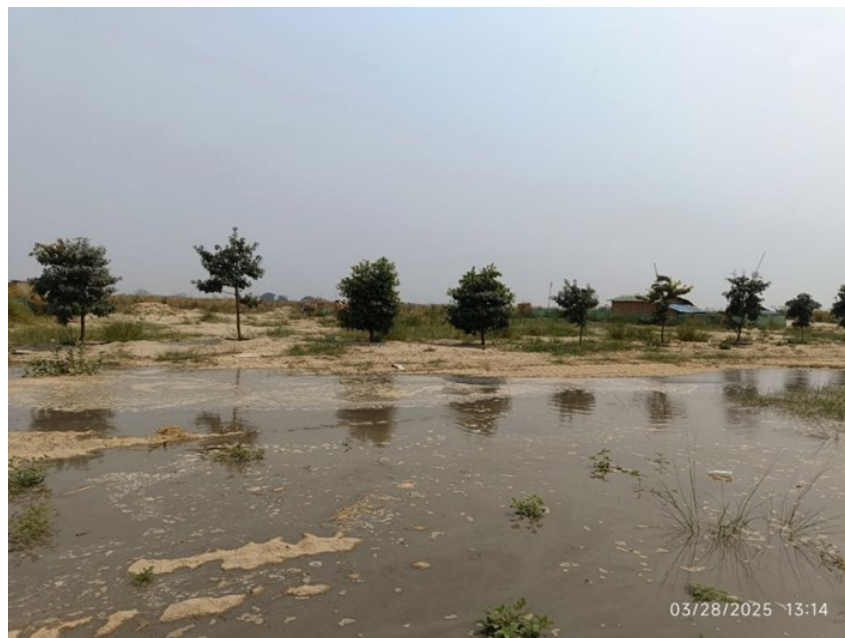
Figure 4.6.3. Liquefaction ejecta post-earthquake in area where ground improvement work for Amarapura Urban Development Project had not yet been completed (Credit: ZoMung Thawng).

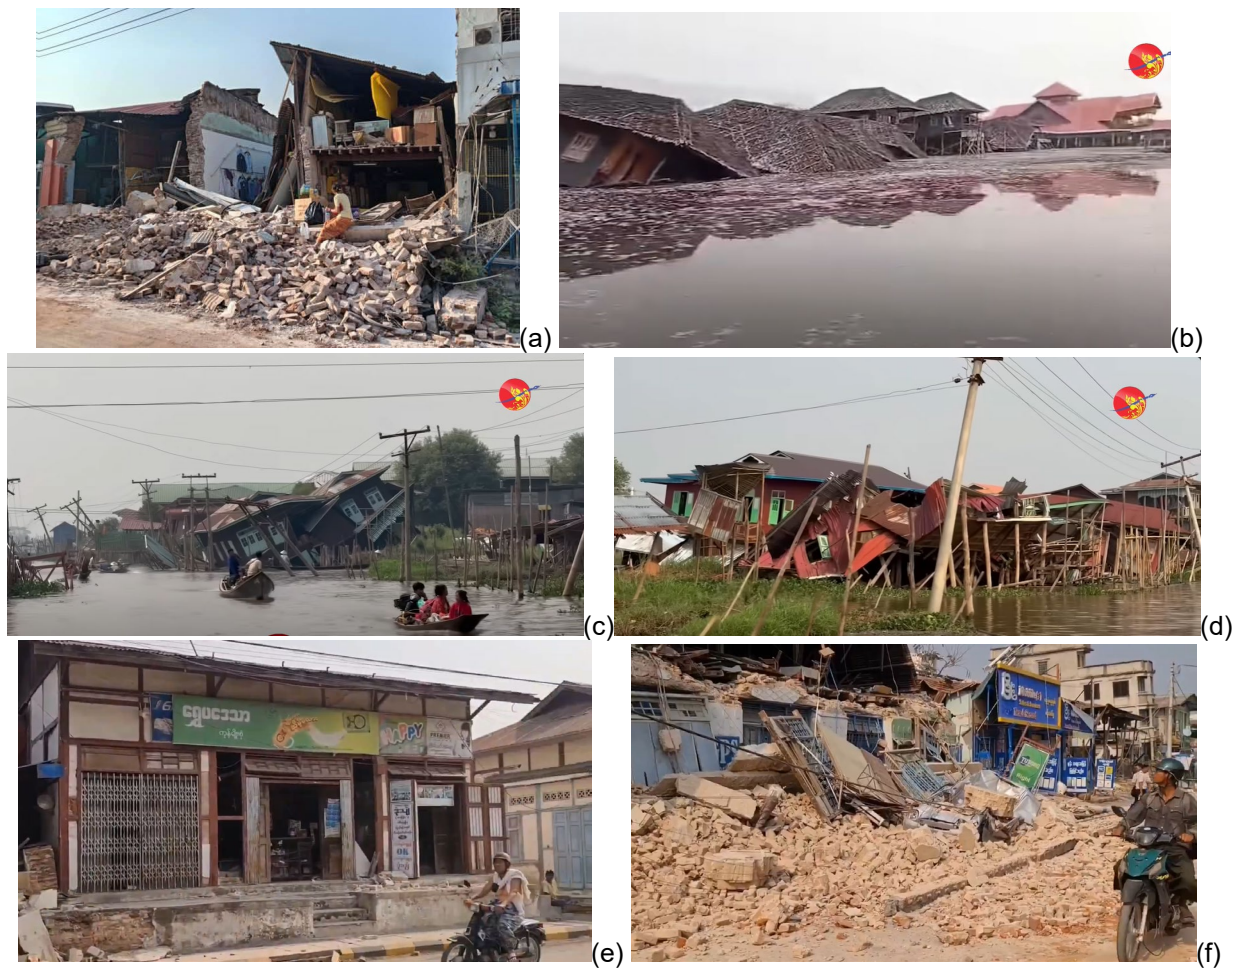
Figure 5.1.1. (a) Partial collapse of a brick-nogging single family house in Pyinmana Township, Nay Pyi Taw, due to the failure of masonry infilled wall (Source: [Pyinmana Update News Facebook](#)); (b-d) traditional buildings around Inle Lake in Nyaungshwe Township (Source: [The Irrawaddy News](#)); (e) timber and masonry traditional type commercial building in Sagaing city with limited visible damage (shedding of bricks from narrow piers by doorway) (Source: Screenshot of [@heungburma on X](#)); (f) partially collapsed brick masonry commercial building in Sagaing City (Source: Screenshot of [@heungburma on X](#)).

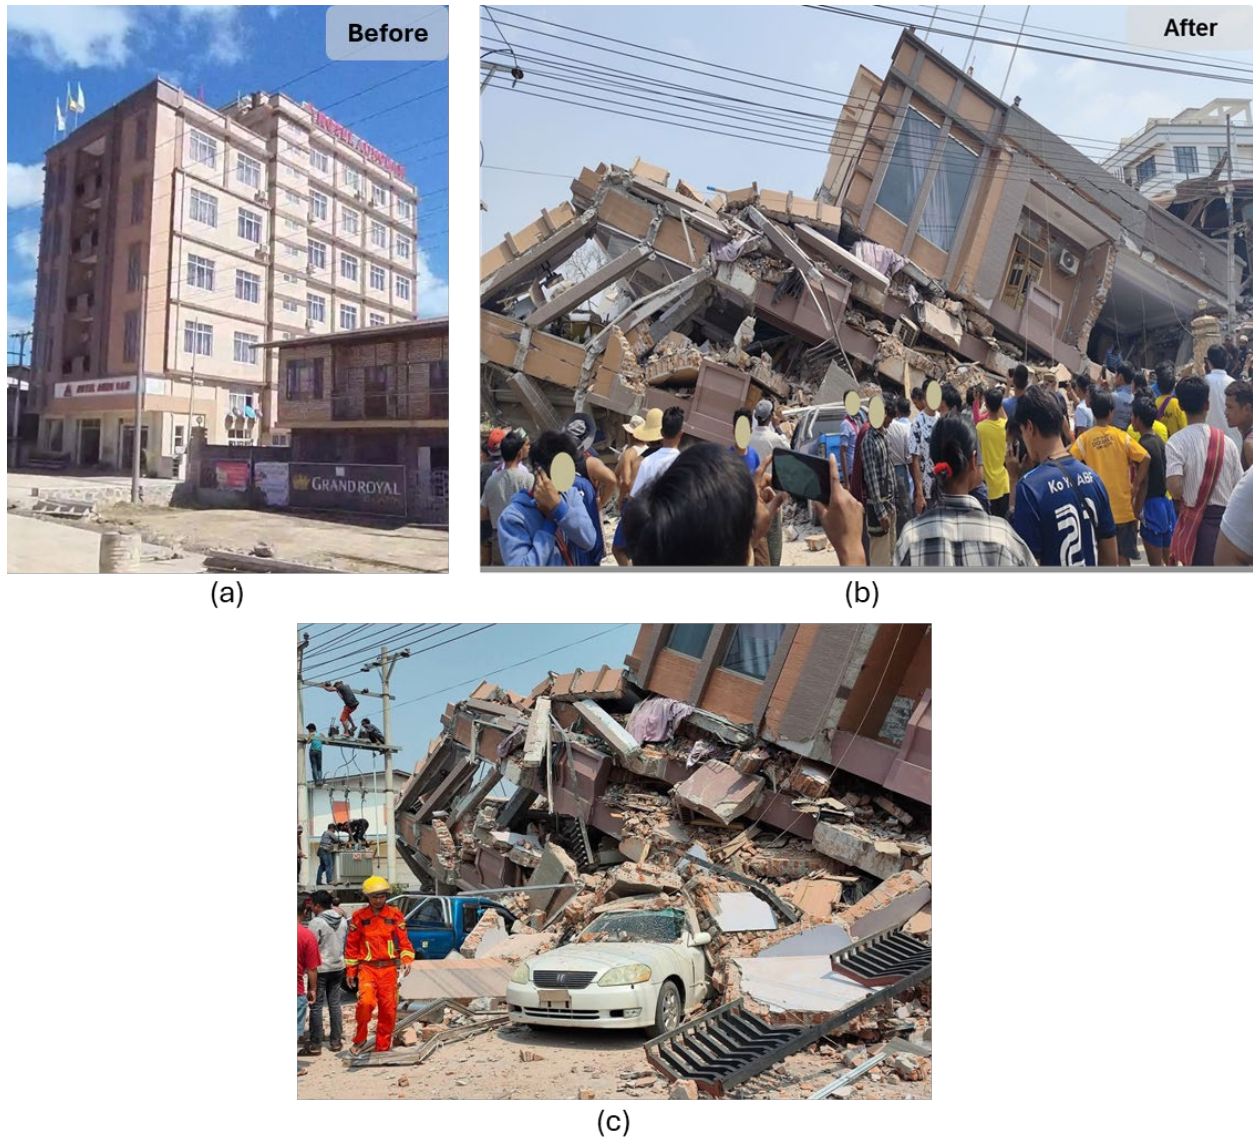
Figure 5.1.4. Hotel Aung Ban, Aungpan, Myanmar [Coordinates: 20.658, 96.632] (a) before and (b-c) after earthquake. (Sources: (a) [Google Maps](https://www.google.com/maps); (b) [@IrrawaddyNews on X](https://twitter.com/IrrawaddyNews); (c) www.ludunwayoo.com).

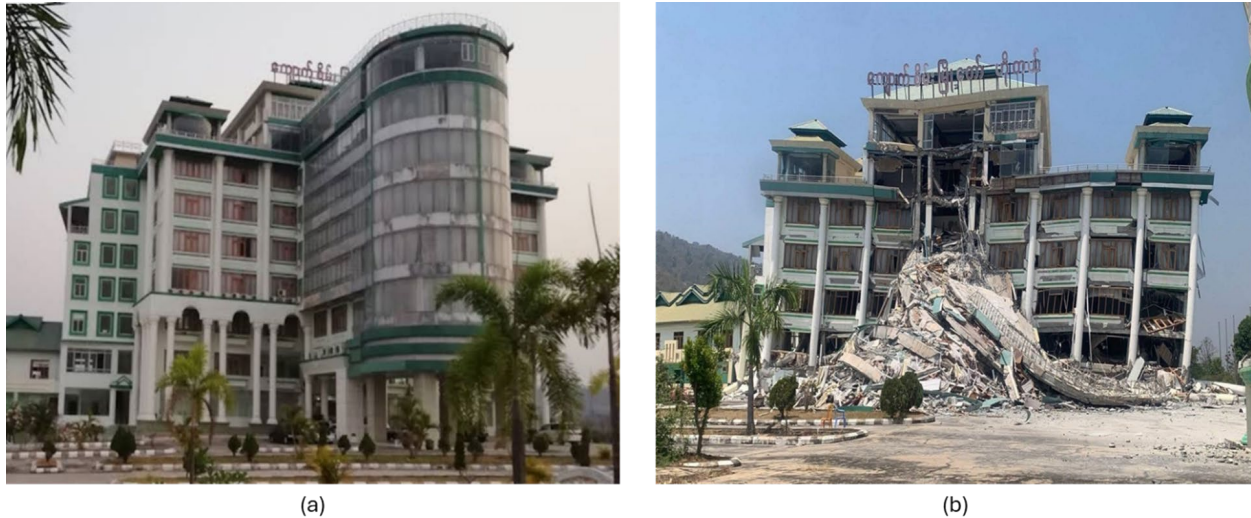
Figure 5.1.5. Jade City Hotel, Nay Pyi Taw, Myanmar [Coordinates: 19.88025,96.15184] (a) before and (b) after the earthquake (Sources: (a) [Google Maps](#); (b) [SiThu Maung on Facebook](#)).

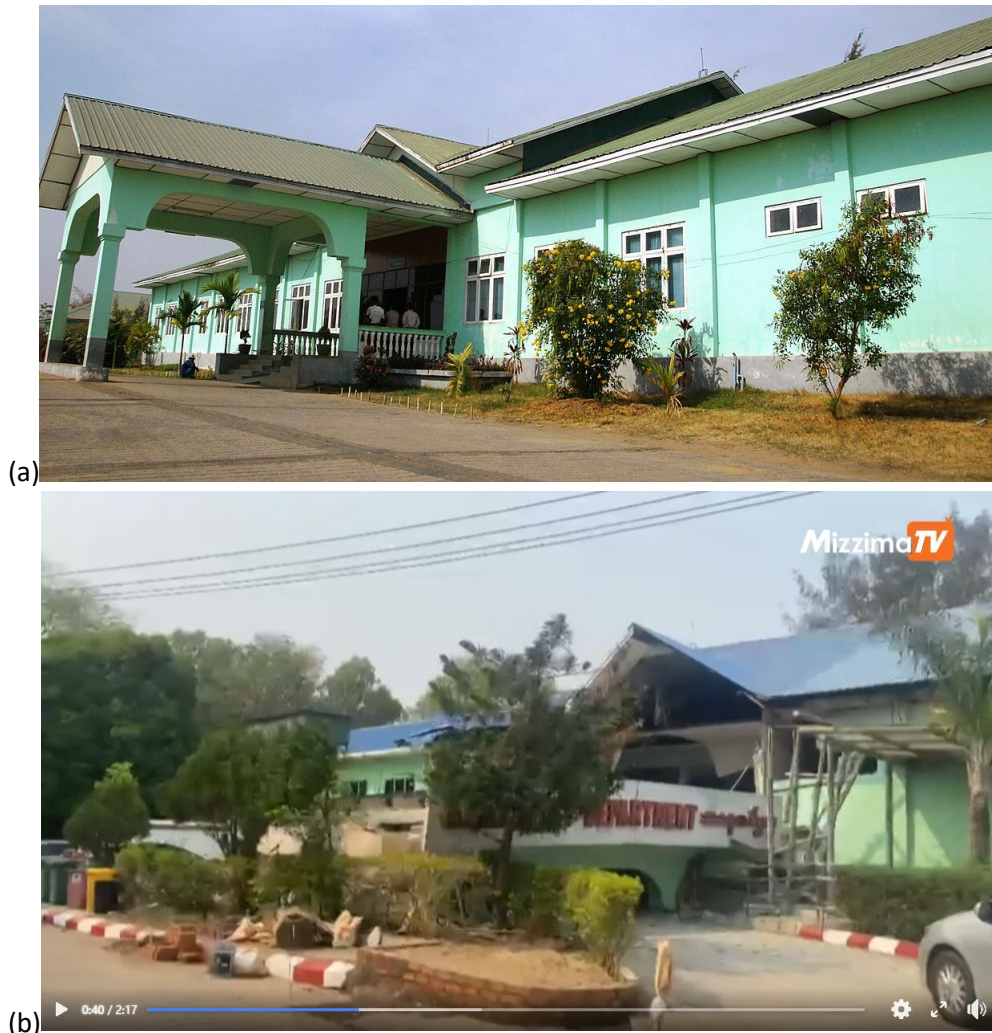
Figure 5.2.2. Nay Pyi Taw General Hospital: (a) back view of the building shows one of the typical reinforced concrete entrance canopies before the earthquake; (b) canopy collapsed at the Emergency Department (Sources: (a) [Wikimedia Commons](#), (b) [Mazzina Myanmar](#), 2025).

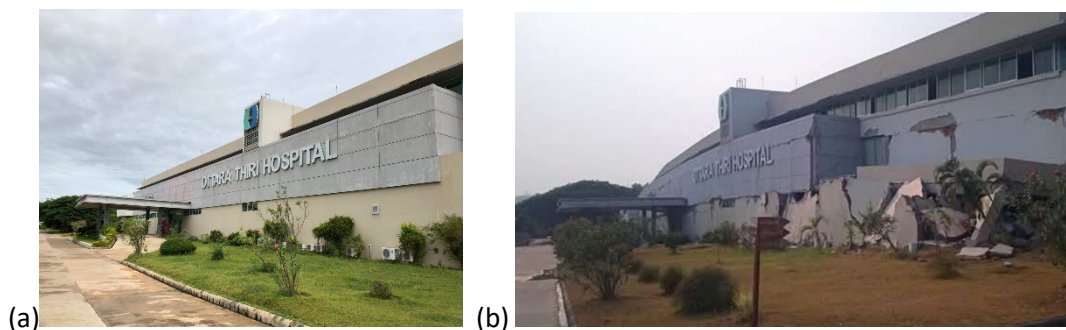
Figure 5.2.3. Before (a) and after (b) images of the entrance frame at Ottara Thiri Private Hospital, which suffered structural collapse due to column failure (Sources: (a) [Ottara Thiri Private Hospital Facebook Page](#); (b) [MMKM Chinese Language Center on Facebook](#)).

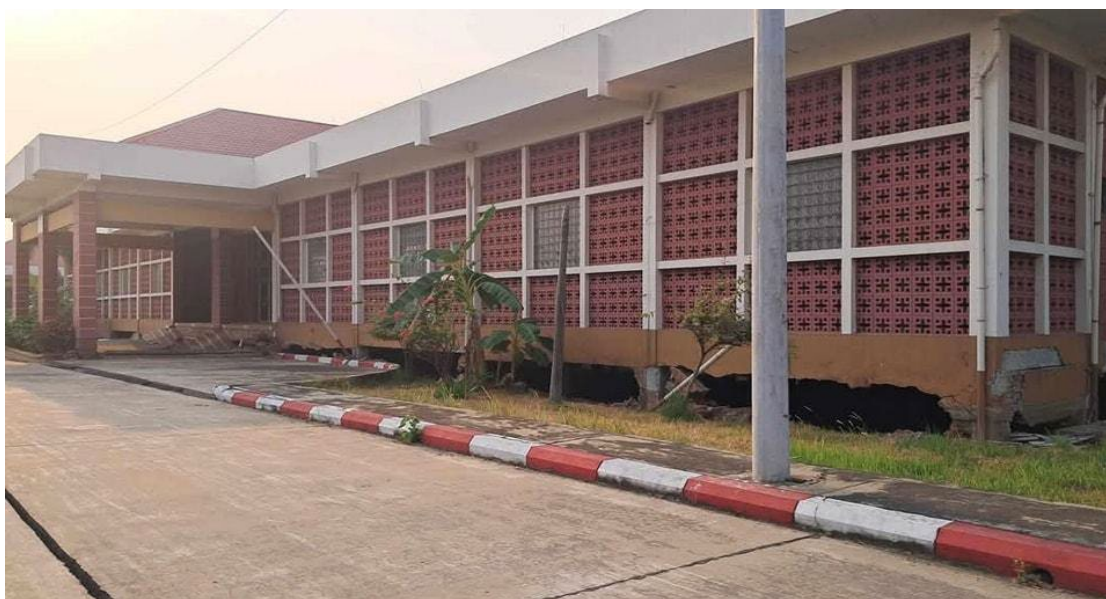
Figure 5.2.4. Wachat Jivitadana Sangha Hospital in Sagaing [Coordinates: 21.915215, 96.001606] was closed due to physical damage at the base of the structure (Source: [Than Lwin Khet News on Facebook](#)).

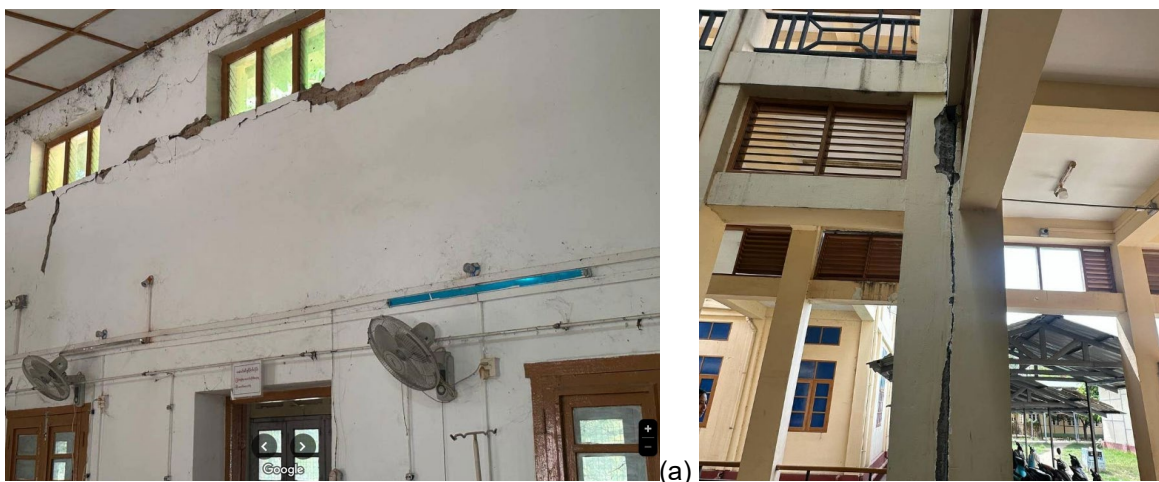
Figure 5.2.5. Evidence of physical damage in the interiors of a building at the Sagaing General Hospital: (a) non-structural damage in facade walls and (b) concrete cover detachment in reinforced concrete columns due to apparent pounding (Source: See Clearly via [GoogleMaps](#)).

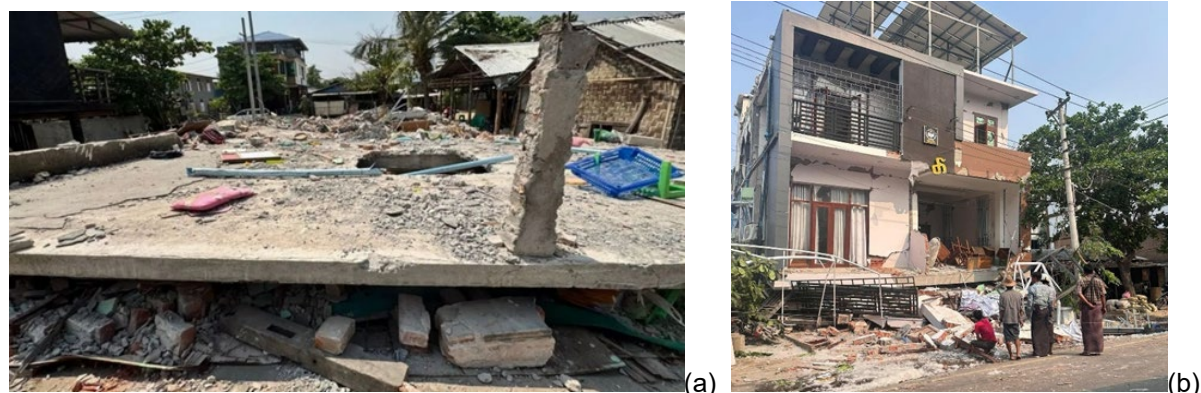
Figure 5.3.1. Collapsed reinforced concrete frames of private schools in Kyaukse (a) and Sagaing (b) (Source: Htet Naing Zaw, [BBC Burmese](#) (a); [BBC Burmese](#) (b)).

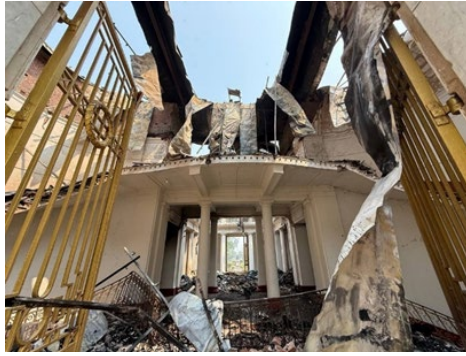
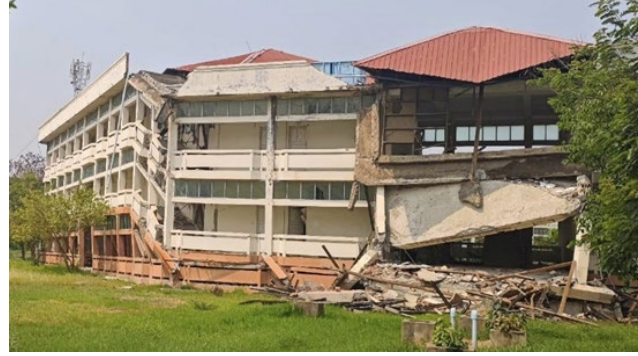
Figure 5.3.2. Earthquake and fire damage to Mandalay University (a) and collapsed ground story at Technological University Kyaukse (b) (Source: [Popular News Journal](#) (a); [student group via Facebook](#) (b)).

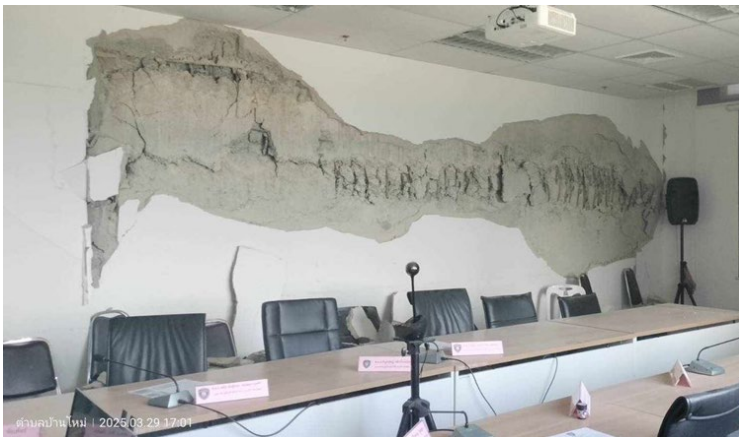
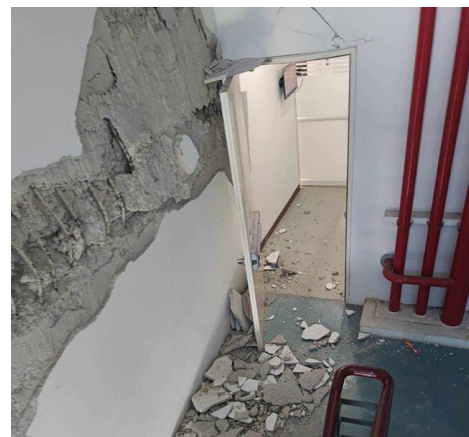
Figure 5.5.2. Shear wall compression and bar buckling failure (Source: [CSI LA Facebook post](#)).

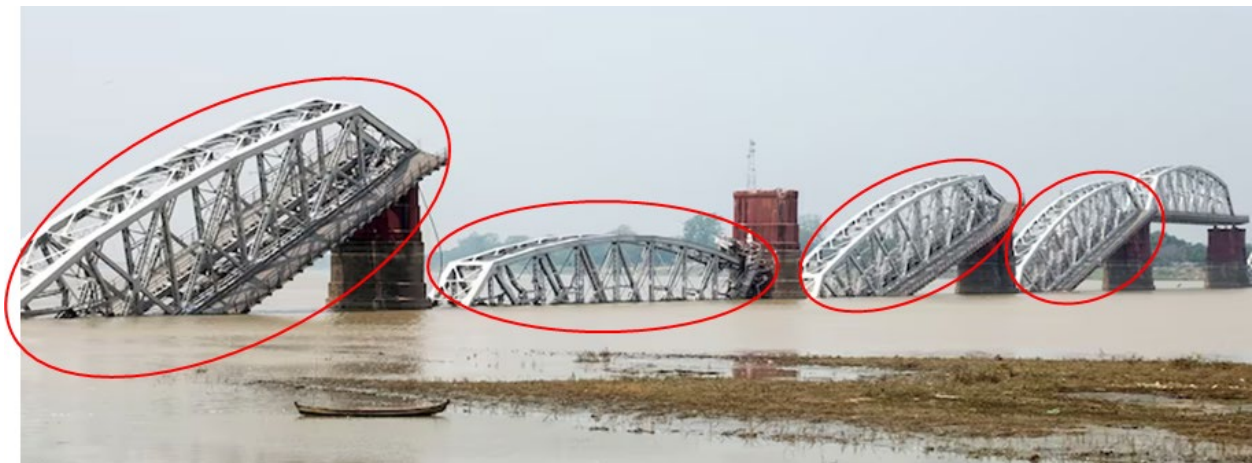
Figure 6.2.2. Unseated bridge decks of the Ava Bridge, noting undamaged piers and fully intact bridge deck sections (Deliso 2025).

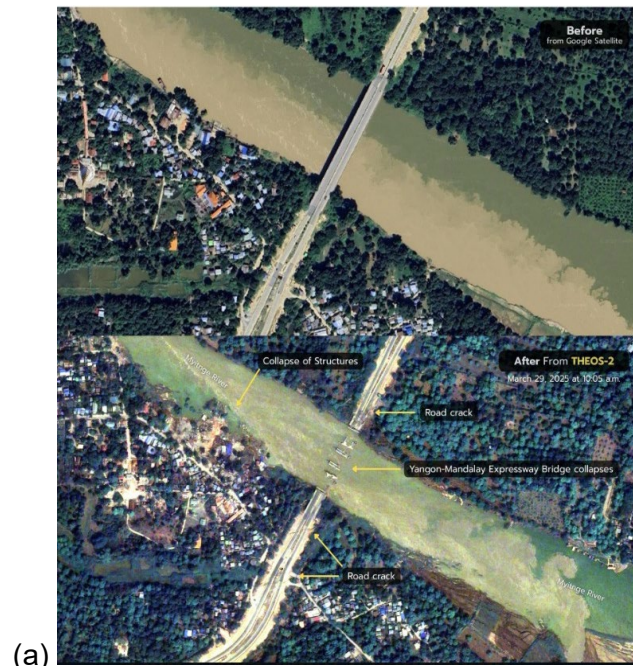
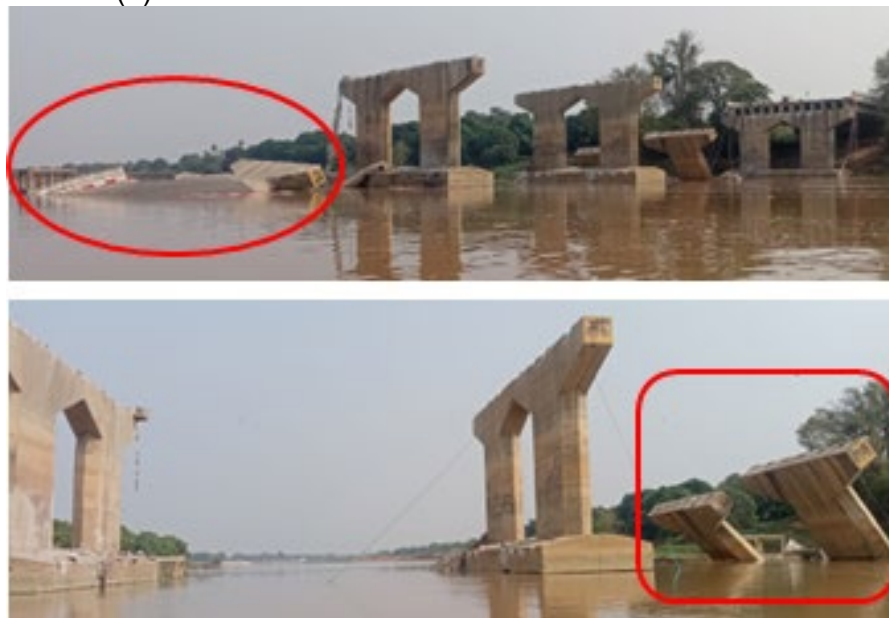
Figure 6.2.3. Dutthawaddy (U Man Lay) Bridge crossing Myitnge River: (a) satellite images before (top) and after (bottom) the earthquake (Credit: Gansu Data and Application Center for High-Resolution Earth Observation System); (b) unseated bridge decks and overturned piers (Source: [Khit Thit Media on Facebook](#)).

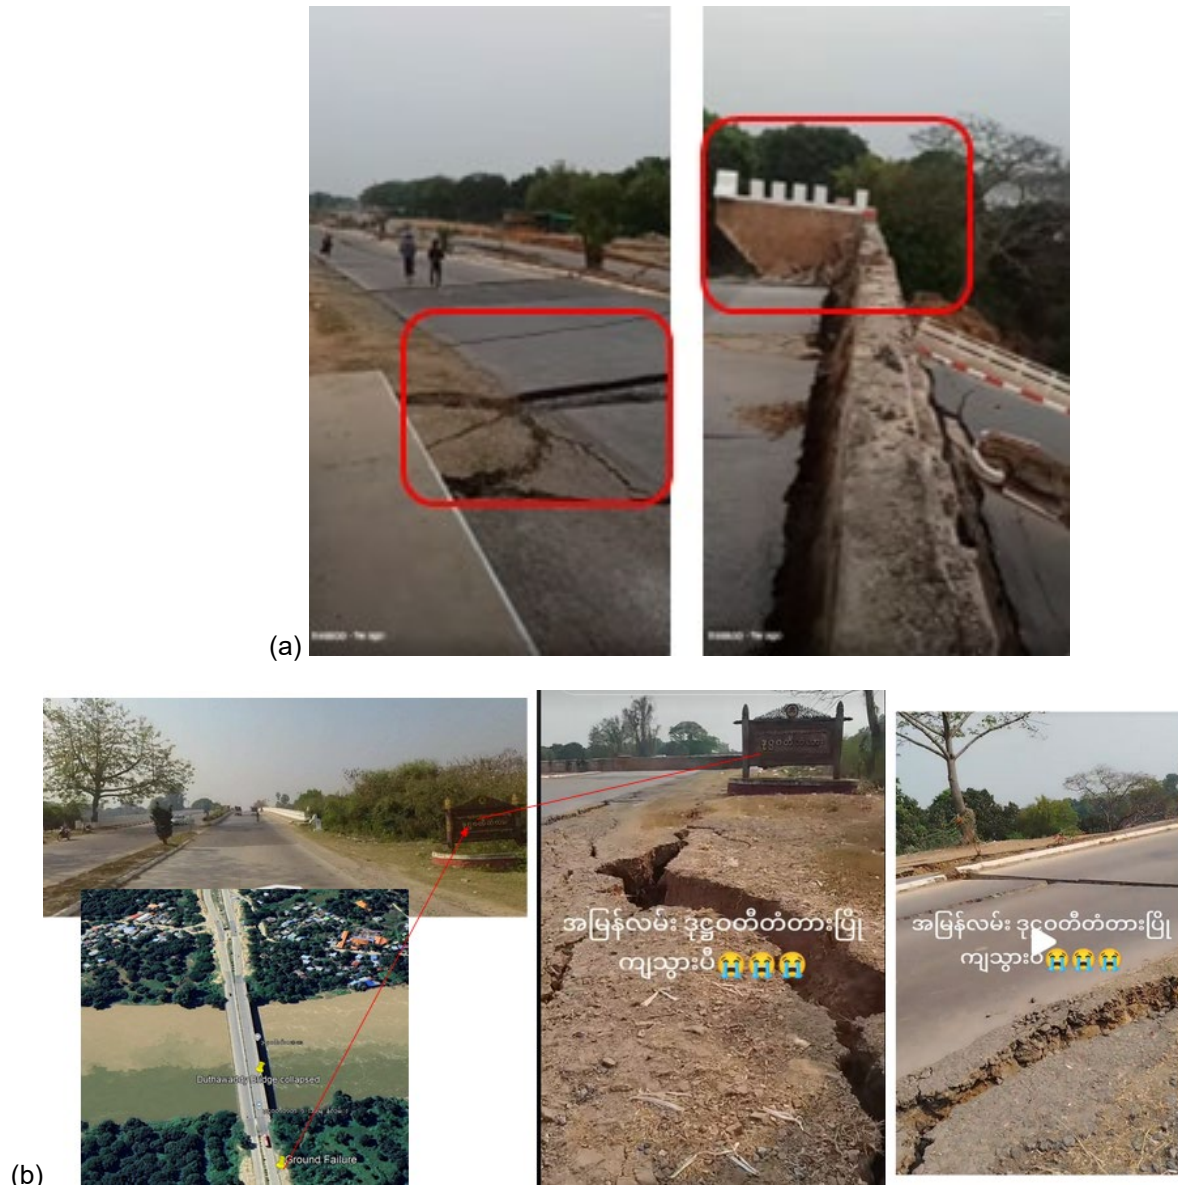
Figure 6.2.4. Dutthawaddy (U Man Lay) Bridge crossing Myitnge River: (a) roadway and abutment damage (Source: Extracted from video from [@fri4800 on TikTok](#)); (b) approach and shoulder road failure with wide separation (Source: Extracted from video from [@aungsl1 on TikTok](#)).

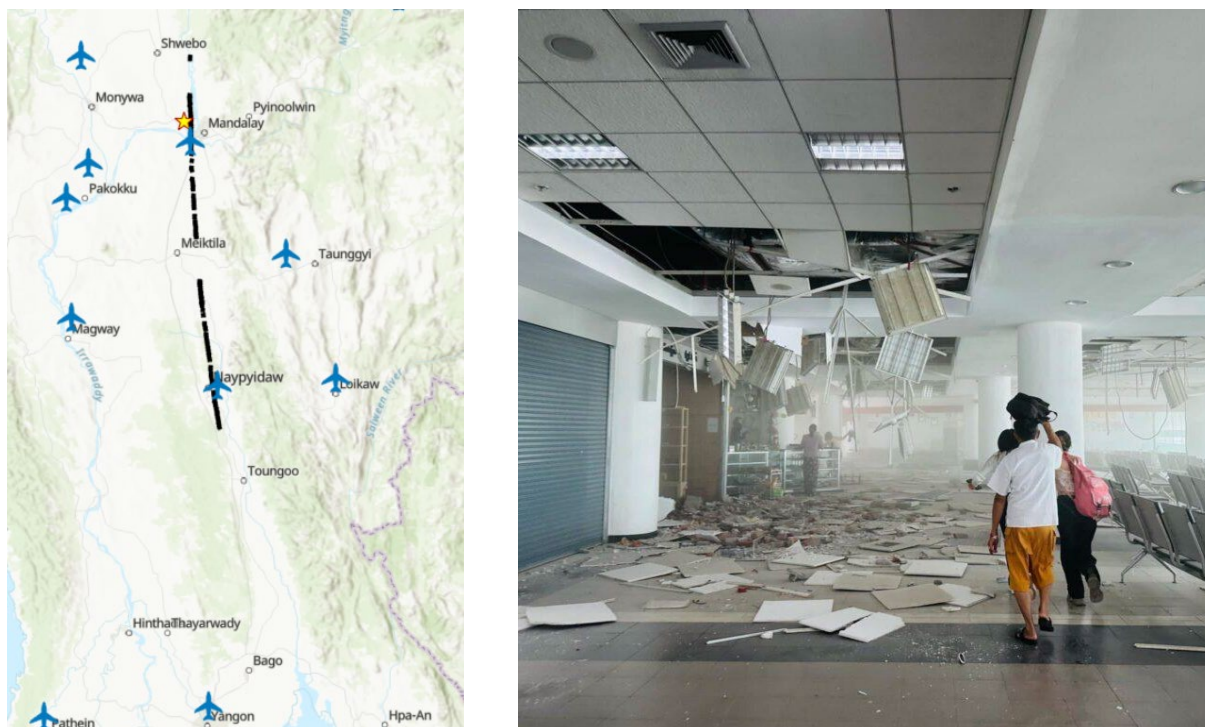
Figure 6.2.6. (left) Locations of major airports in Myanmar relevant to earthquake epicenter and the surface fault rupture trace from USGS (USGS 2025c); (right) suspended ceiling damage in a terminal building at the Mandalay Airport (Source: (Myanmar Now 2025a)).

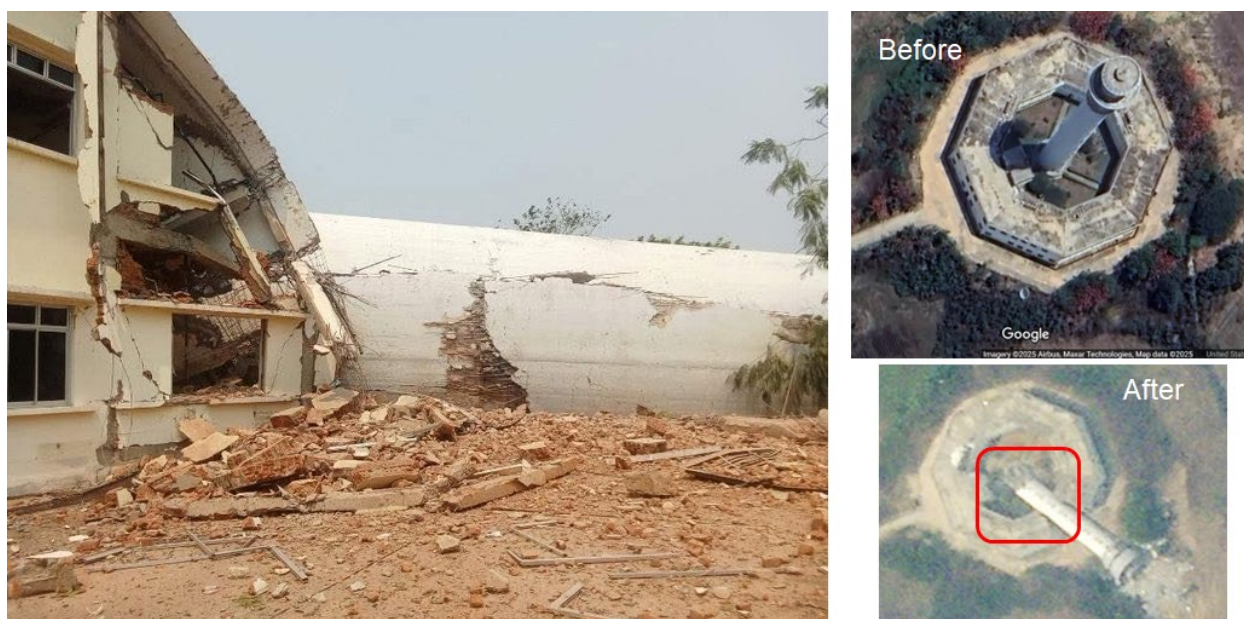
Figure 6.2.7. Collapsed airport control tower of the Nay Pyi Taw airport due to biaxial bending resulting from combined effect of horizontal ground motion components (Source: [@heungburma on X](#)), with aerial imagery of condition before and after earthquake (Sources: before, Airbus, Maxar Technologies; after, Maxar Technologies).
