THE SAN SALVADOR EARTHQUAKE OF 10 OCTOBER 1986

A FIELD REPORT BY EEFIT

This report was prepared by:

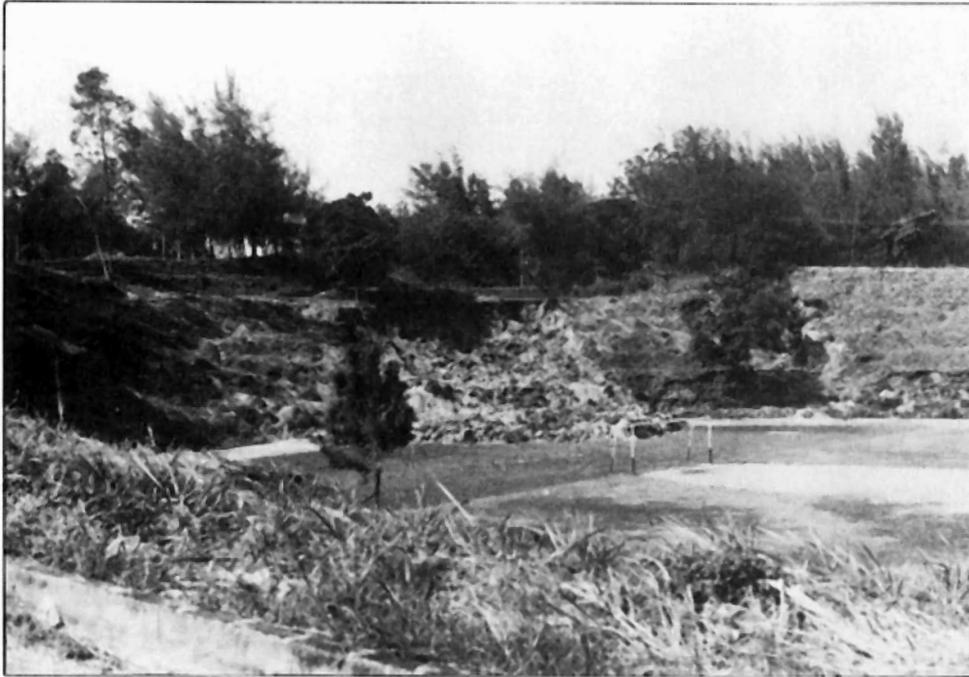
PLATE 1: SMALL SLOPE FAILURE AT THE NATIONAL UNIVERSITY.

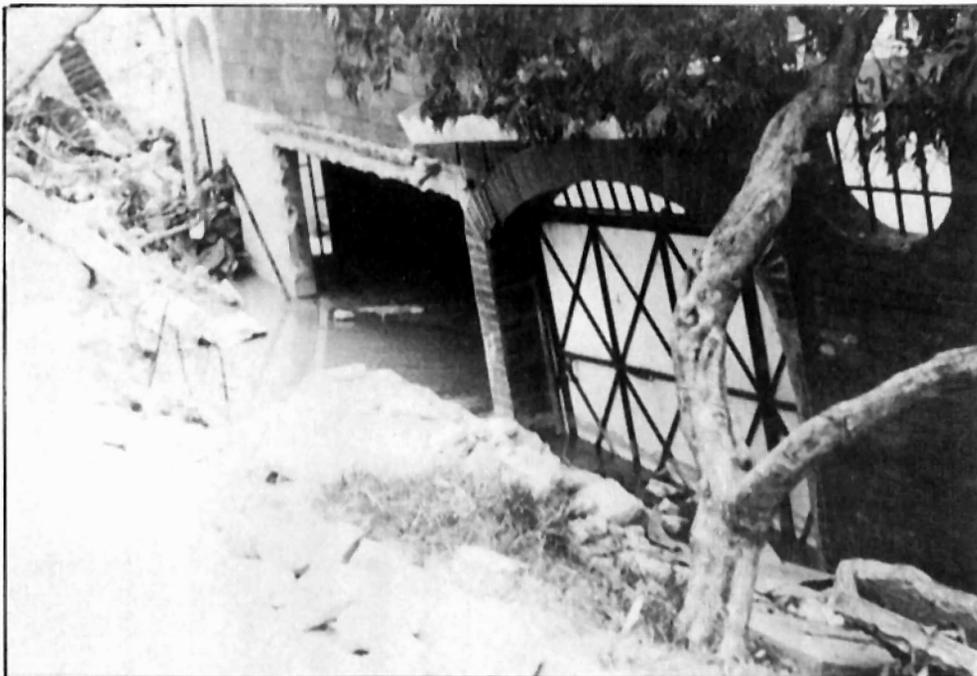
PLATE 2: HOUSE SUNK INTO LIQUEFIED GROUND AT SANTA MARTA.

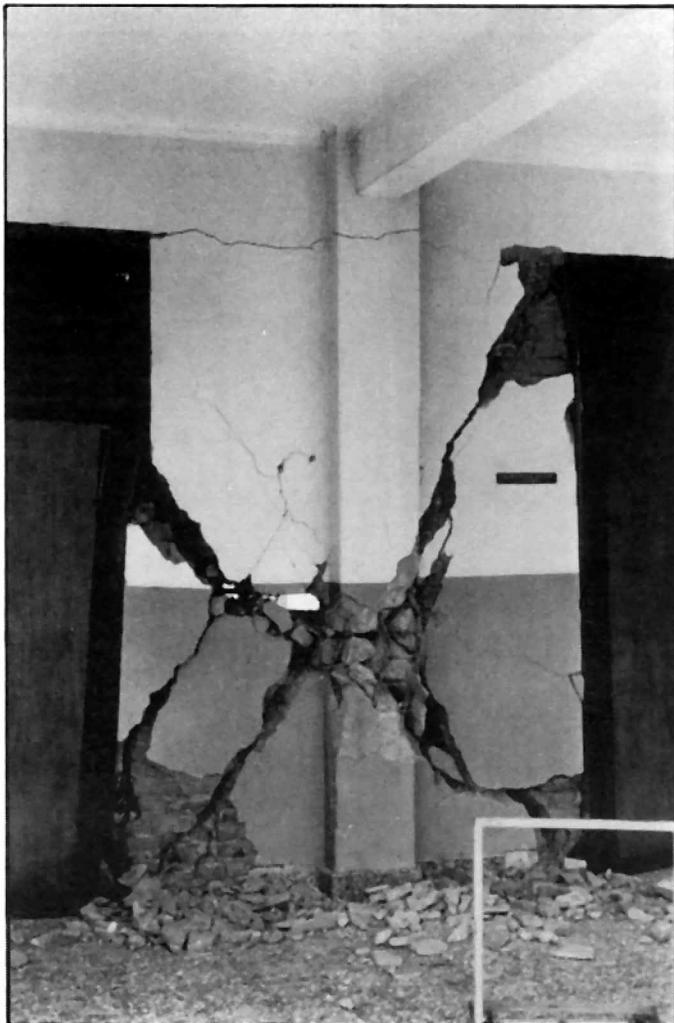
PLATE 5: DAMAGE TO CONCRETE COLUMN AT
EXTERNADO DE SAN JOSE.

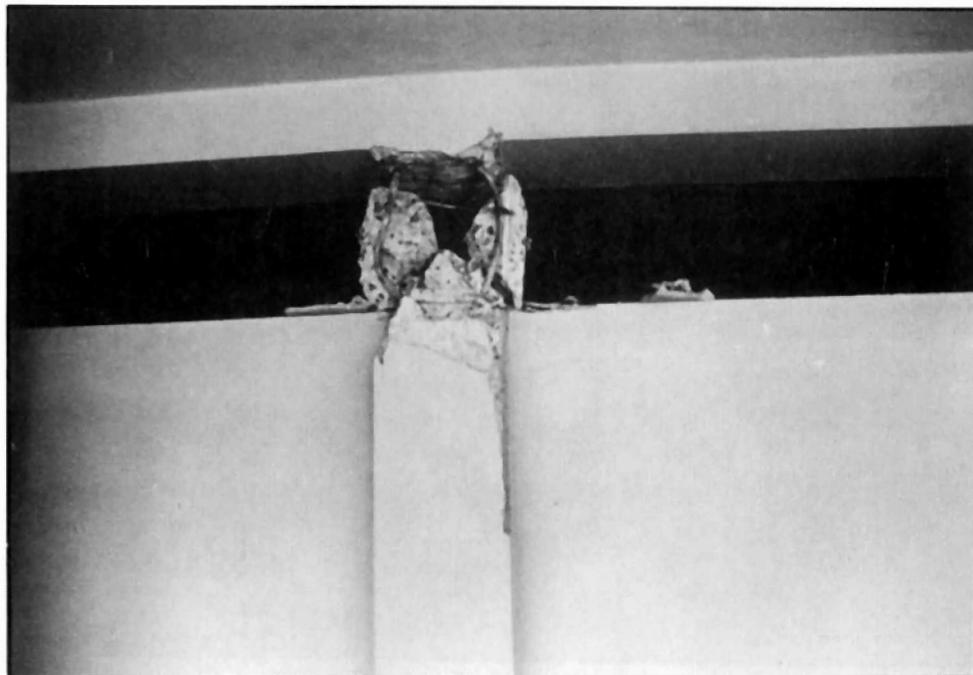
PLATE 8 : DAMAGE TO SHORT COLUMN.

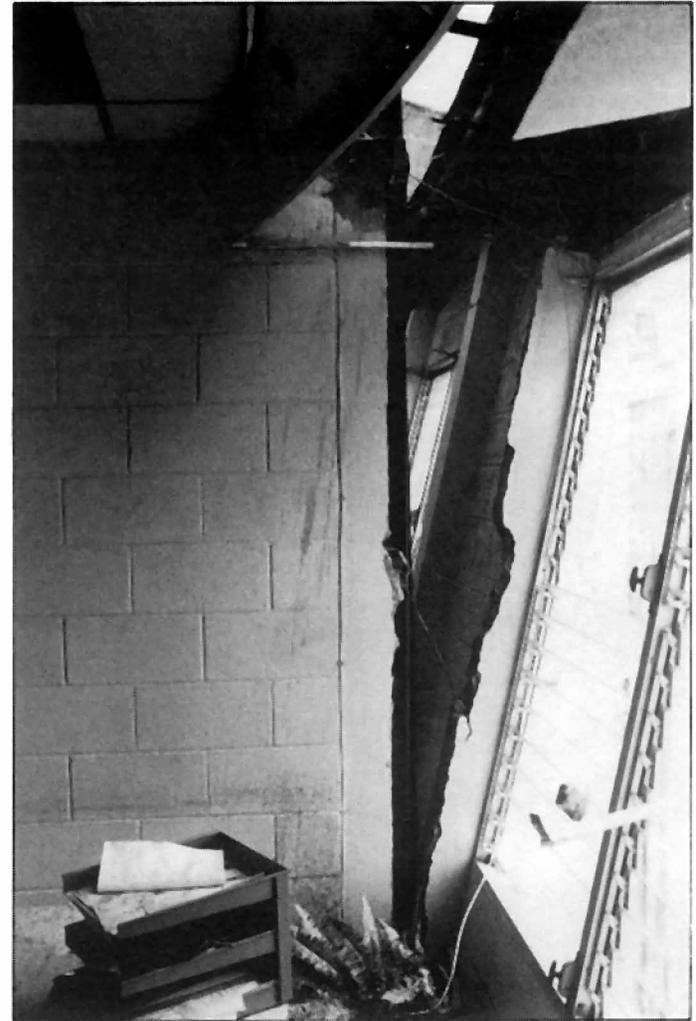
PLATE 14: MINISTRY OF AGRICULTURE, SHOWING SEPARATION OF CLADDING.

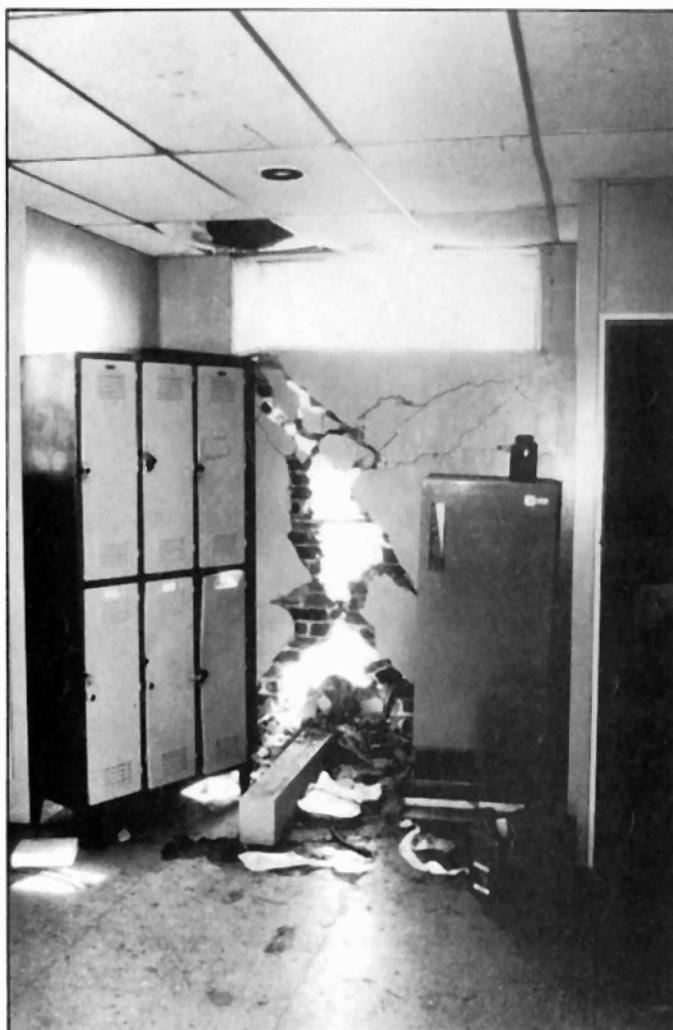
PLATE 16 : HOSPITAL BENJAMIN BLOOM SHOWING FAILURE OF SHEAR PANELS.

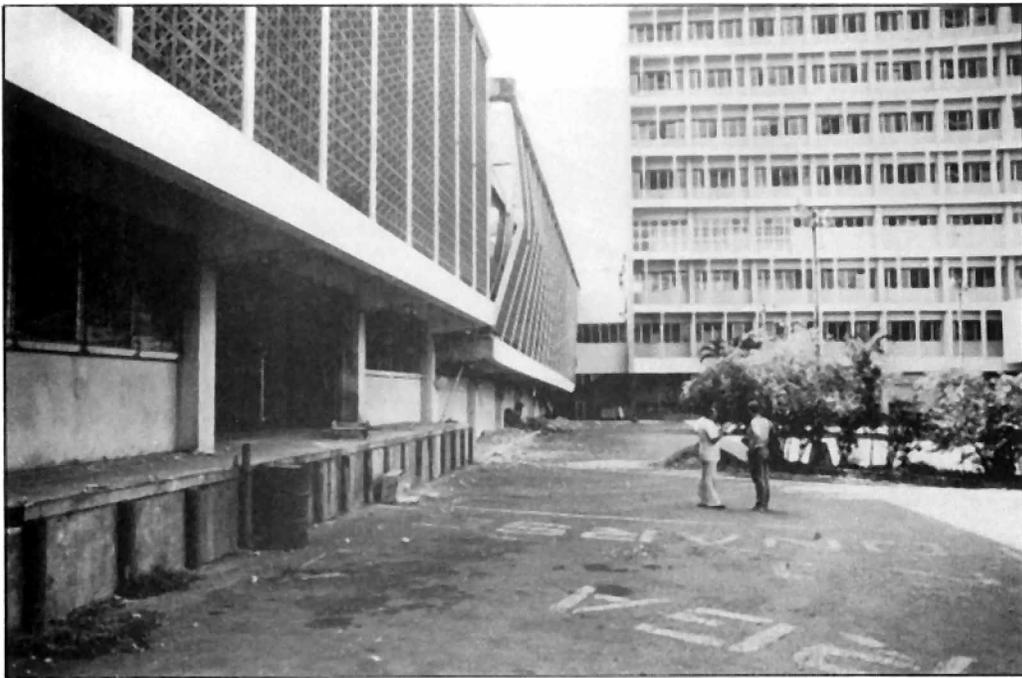
PLATE 17 : HOSPITAL BENJAMIN BLOOM , SHOWING FAILURE OF CHILDRENS HOSPITAL.

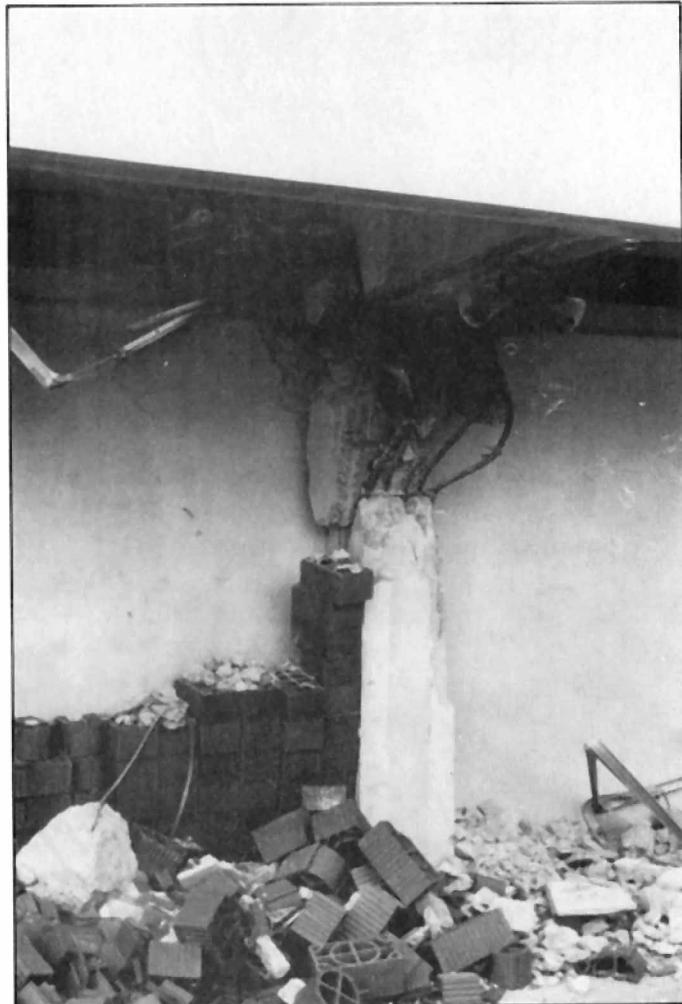
PLATE 18 : COLUMN FAILURE AT HOSPITAL BENJAMIN BLOOM.

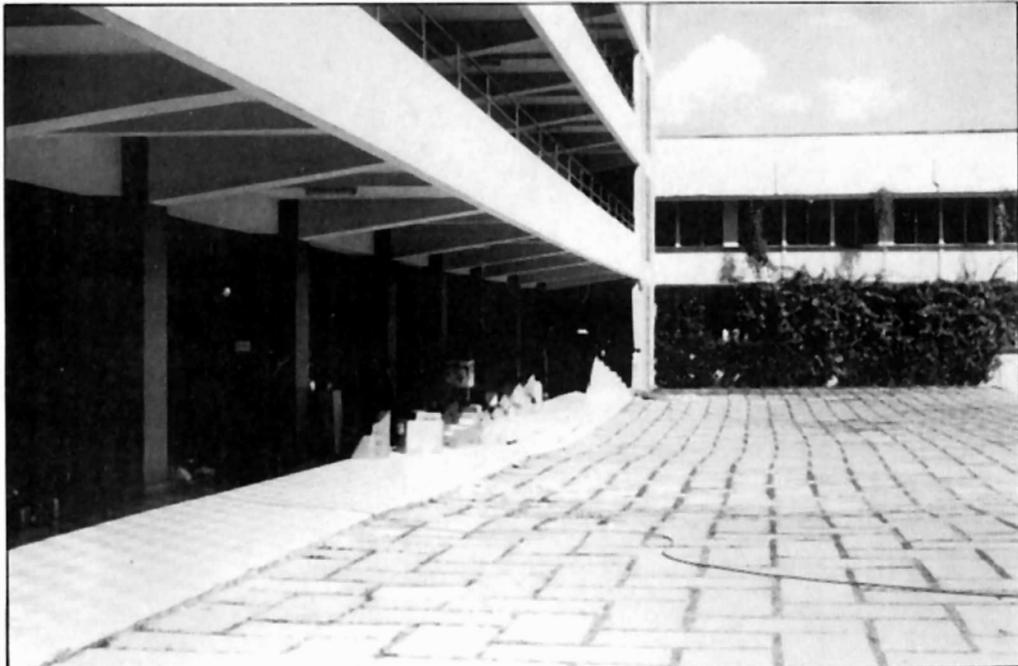
PLATE 20 : COLEGIO GUADALUPANO , SHOWING SETTLEMENT OF FOUNDATIONS.

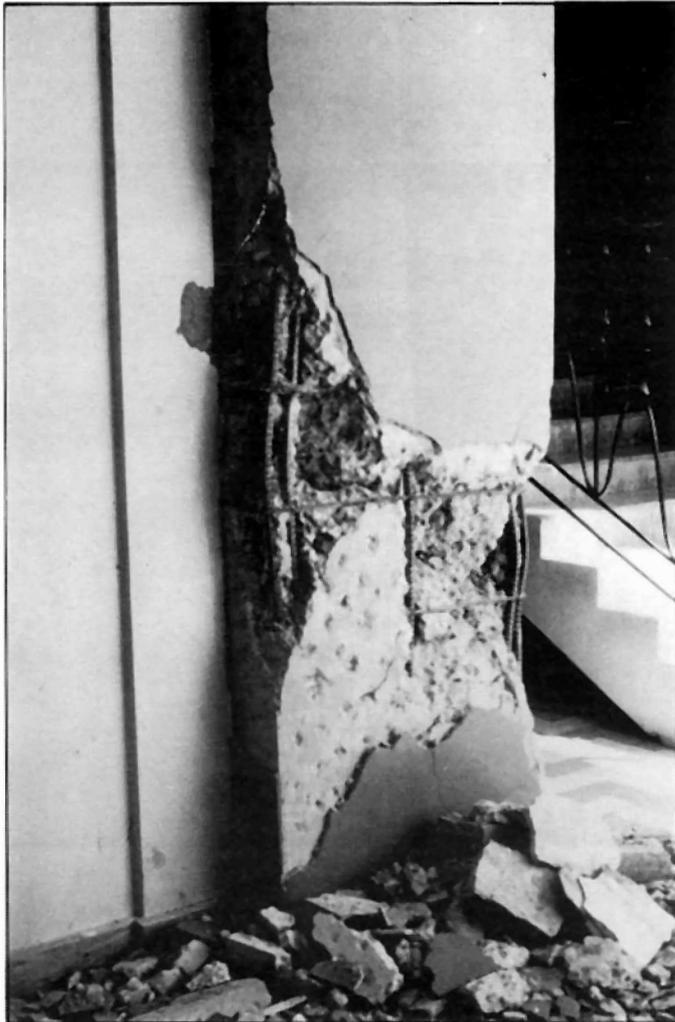
PLATE 21: COLUMN FAILURE AT COLEGIO
GUADALUPANO.

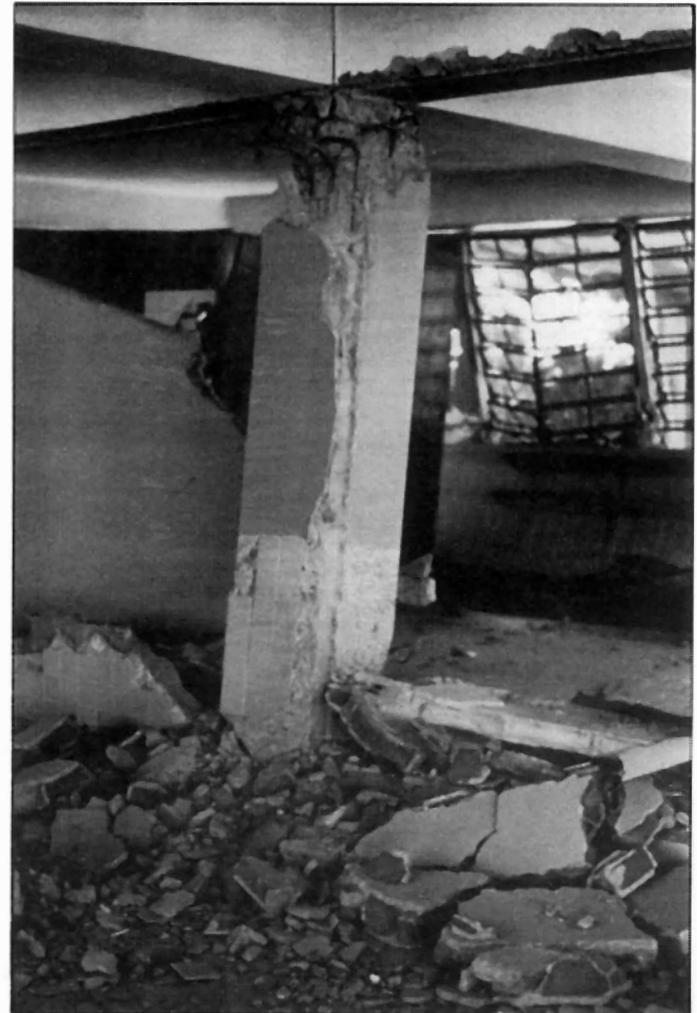
PLATE 22: FAILURE OF INTERNAL WALLS AT
COLEGIO GUADALUPANO.

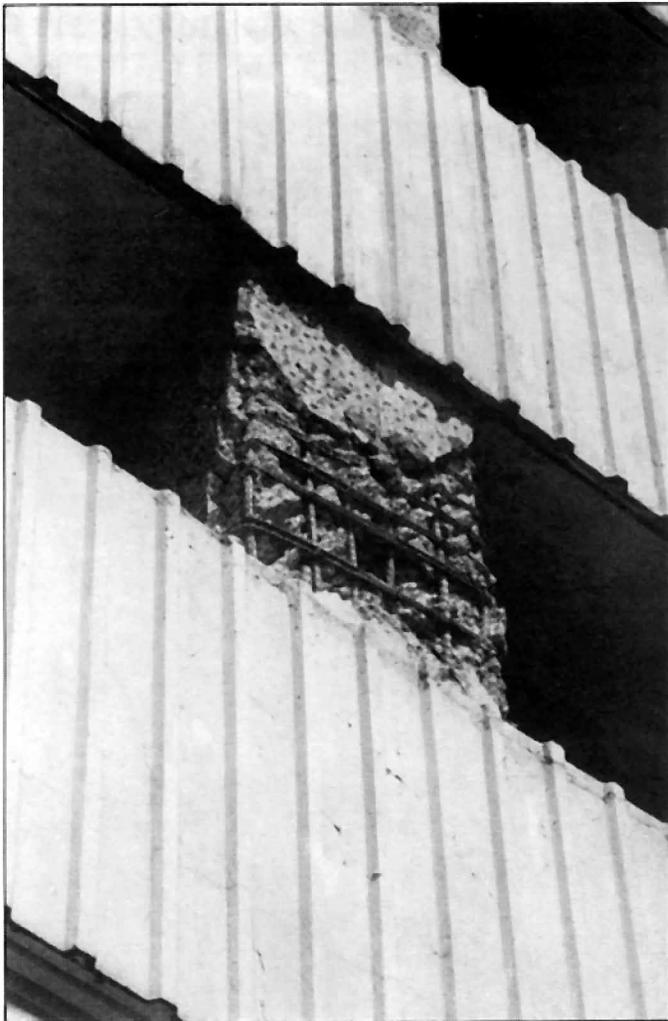
PLATE 25: COLUMN FAILURE AT ALMACENES
SIMAN CAR PARK.

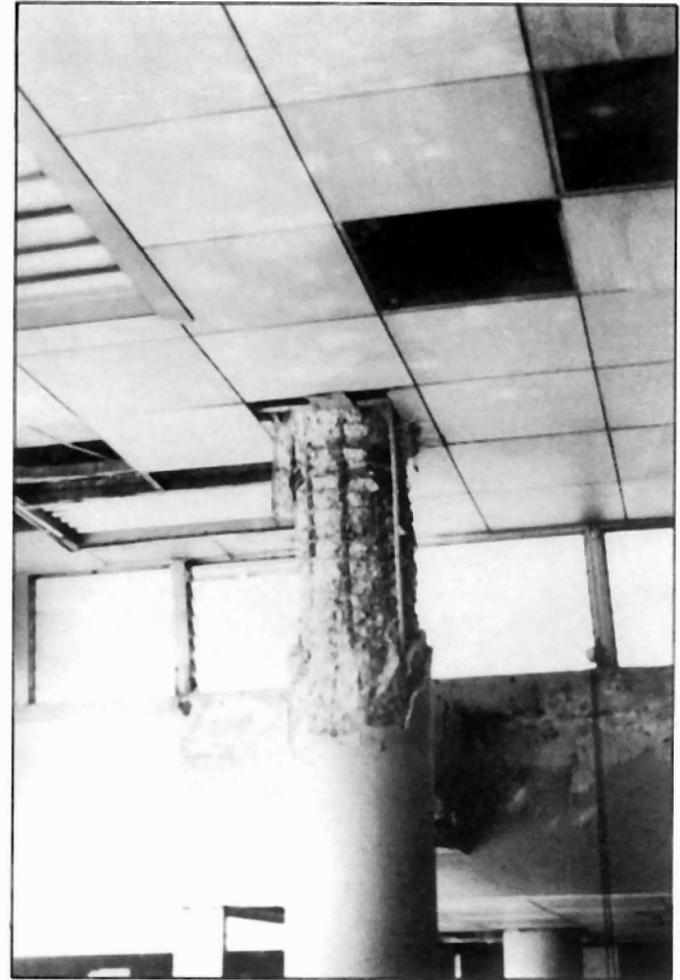
PLATE 30 : COLUMN FAILURE AT NATIONAL LIBRARY.

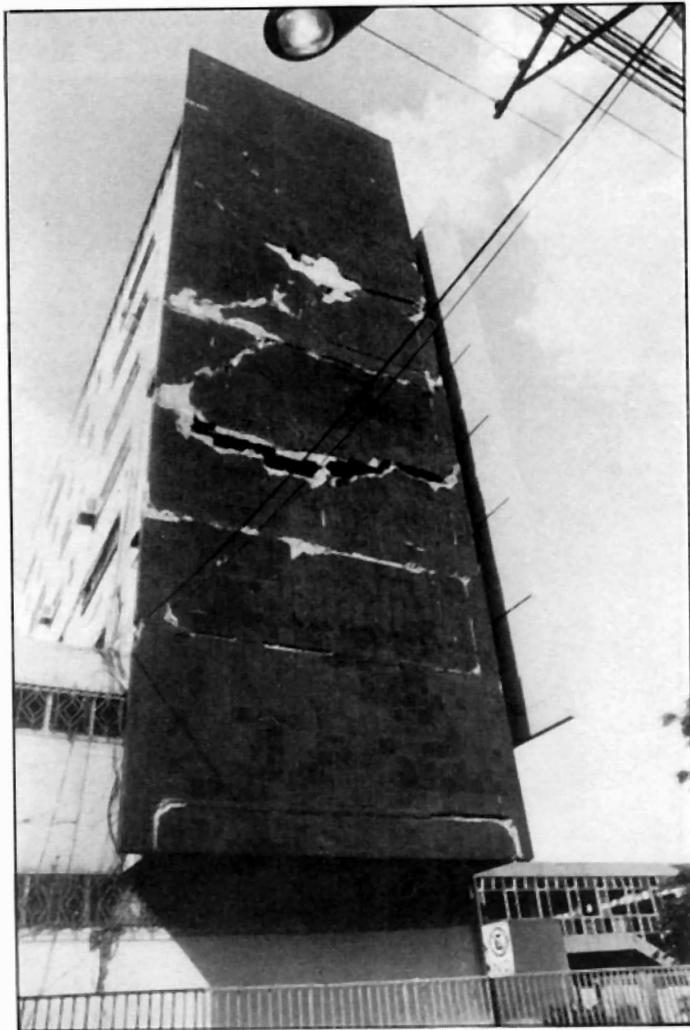
PLATE 31: FAILURE OF MASONRY PANELS
AT MINISTRY OF EDUCATION.

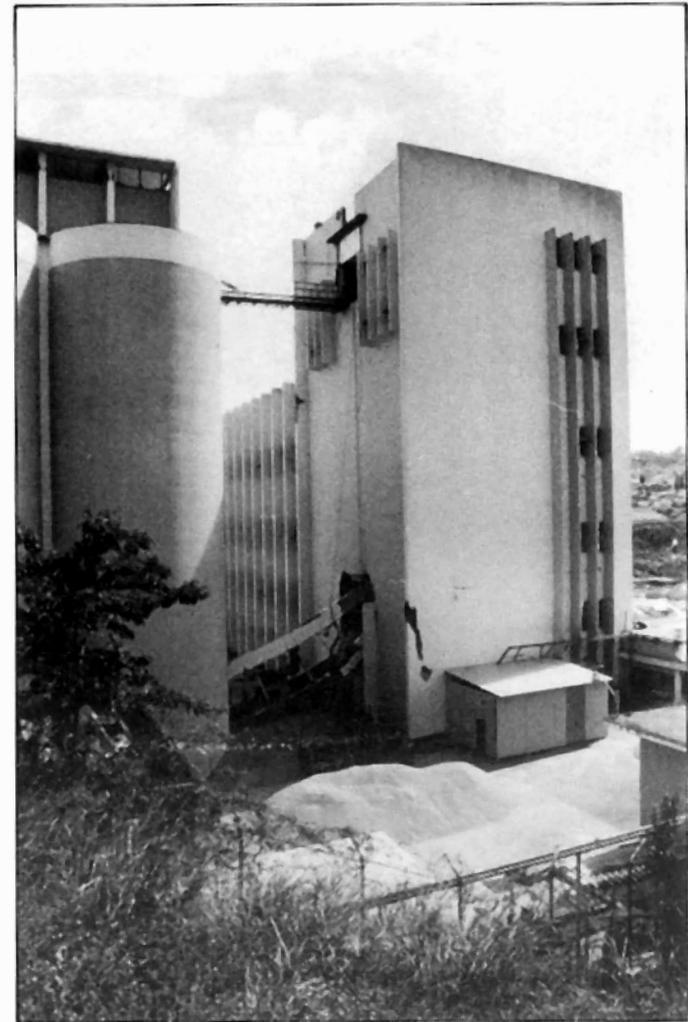
PLATE 32: BRIDGE COLLAPSE AT FLOUR
MILL.

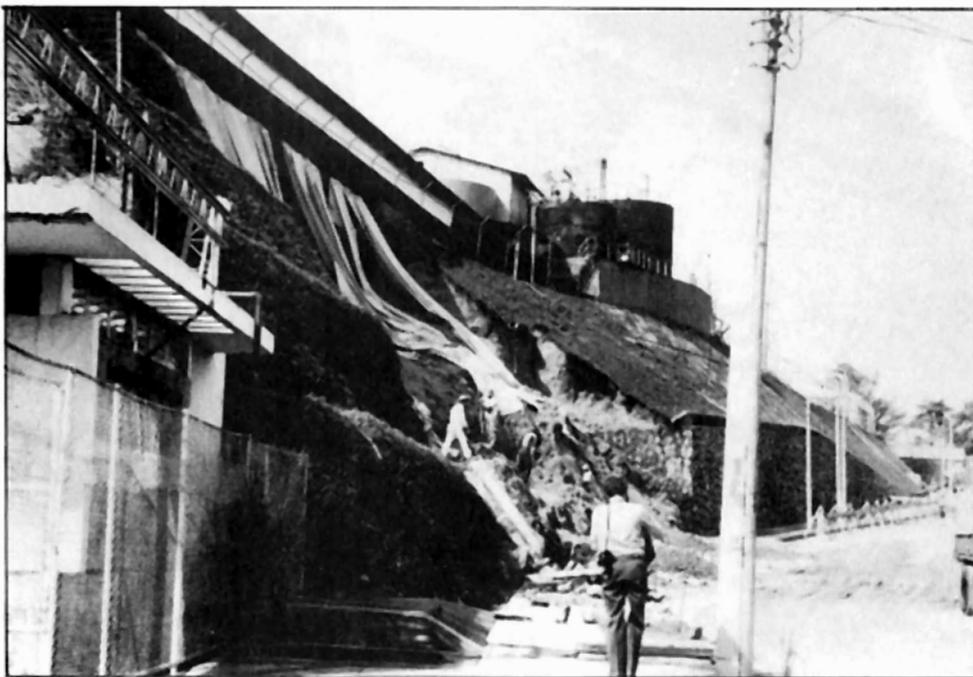
PLATE 34: BANK FAILURE AT EL DORADO PLANT.

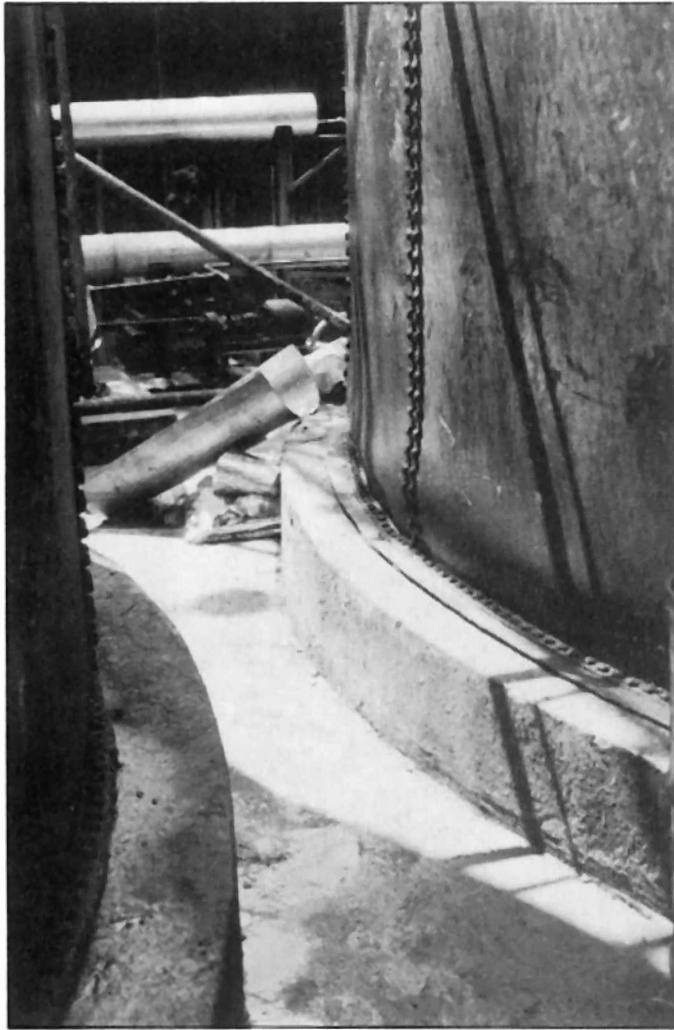
PLATE 35: DAMAGE TO TANK AT EL DORADO PLANT.

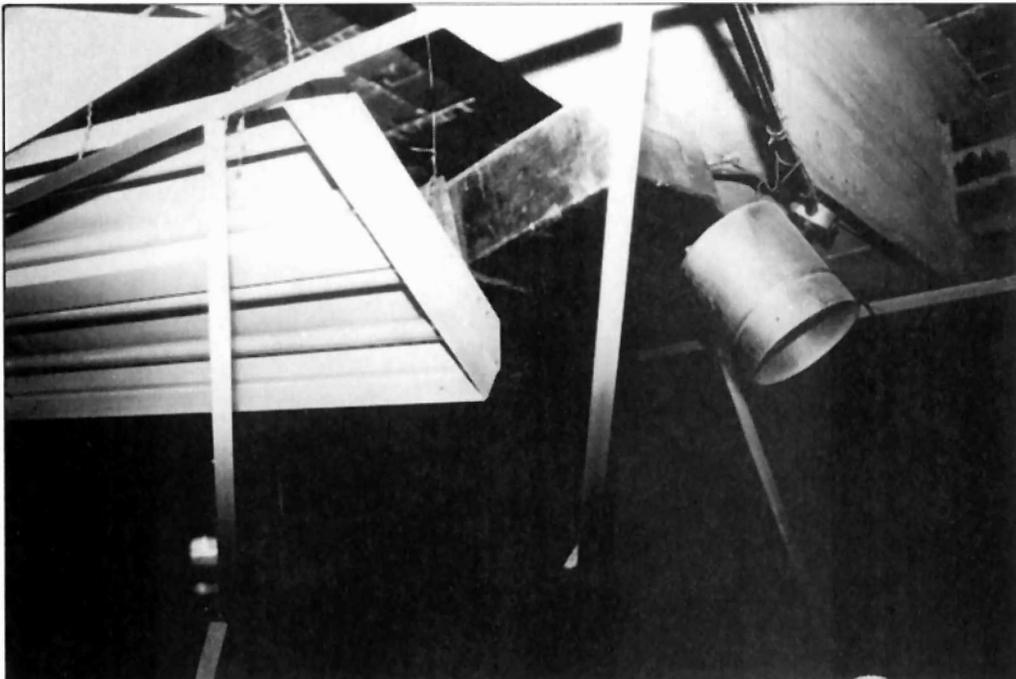
PLATE 36: FAILURE OF SUSPENDED CEILING.

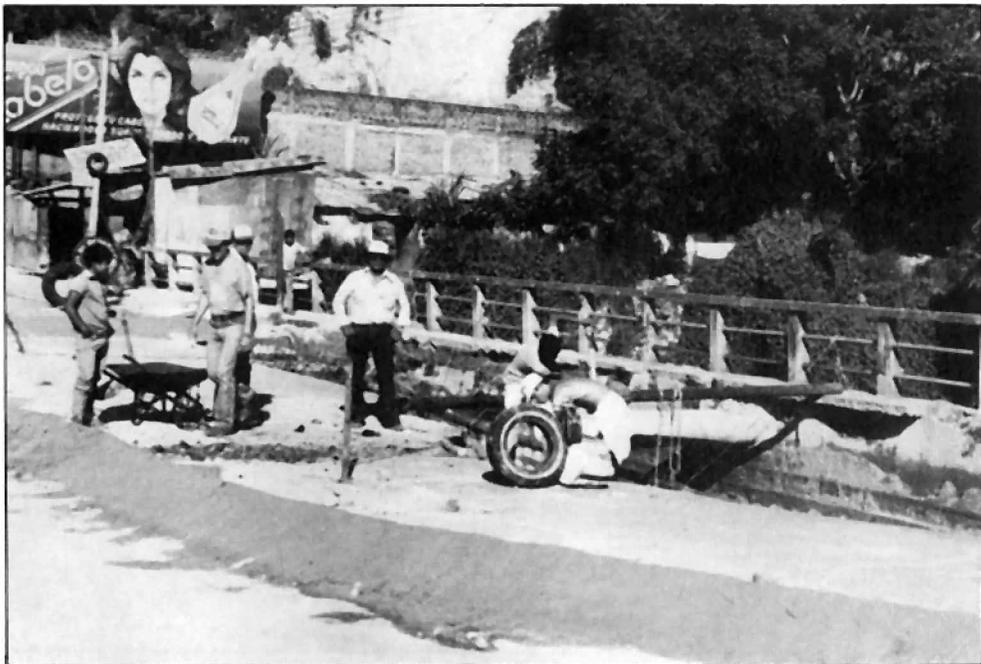
PLATE 38 : DAMAGED BRIDGE IN MEJICANOS.

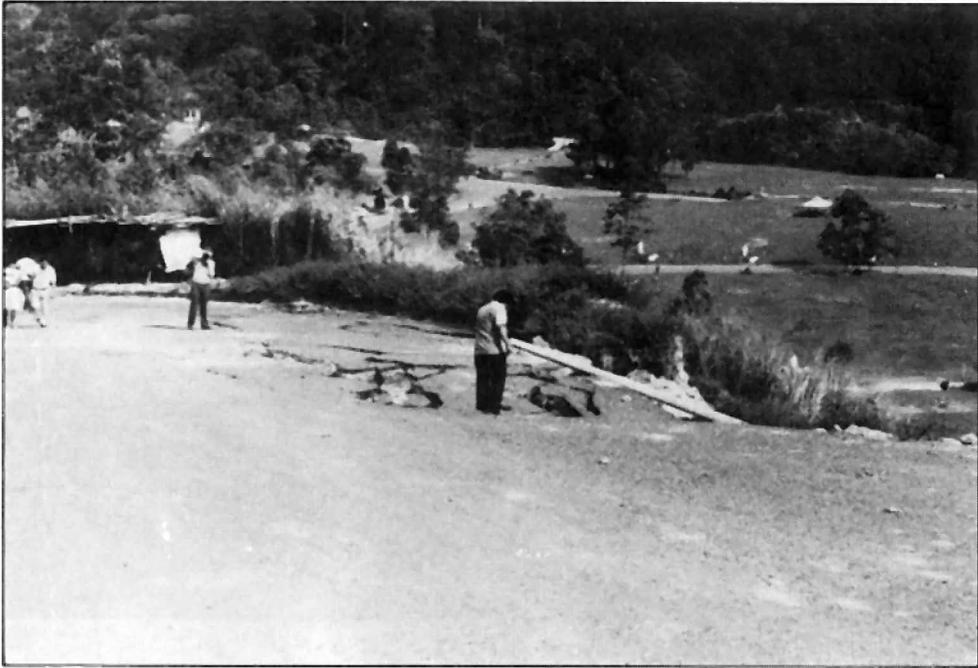
PLATE 39 : DAMAGE TO ROAD CAUSED BY SLOPE FAILURE

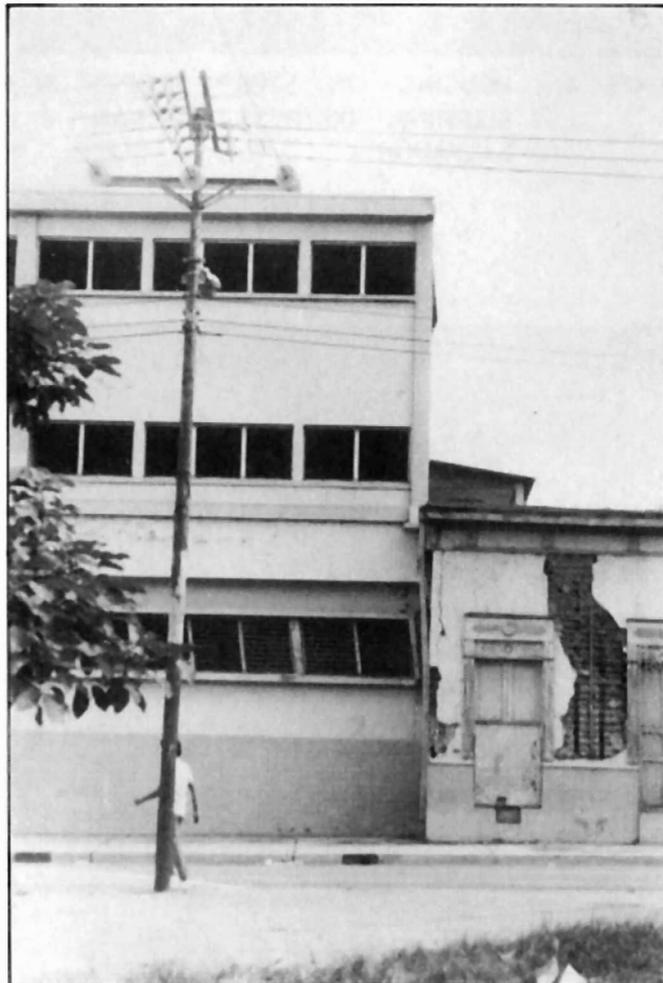
PLATE 44: UNDAMAGED BAHAREQUE HOUSE NEXT TO DAMAGED REINFORCED CONCRETE BUILDING.
