# THE AUGUSTA, SICILY EARTHQUAKE OF 13 DECEMBER 1990

## A FIELD REPORT BY EEFIT

**EEFIT**

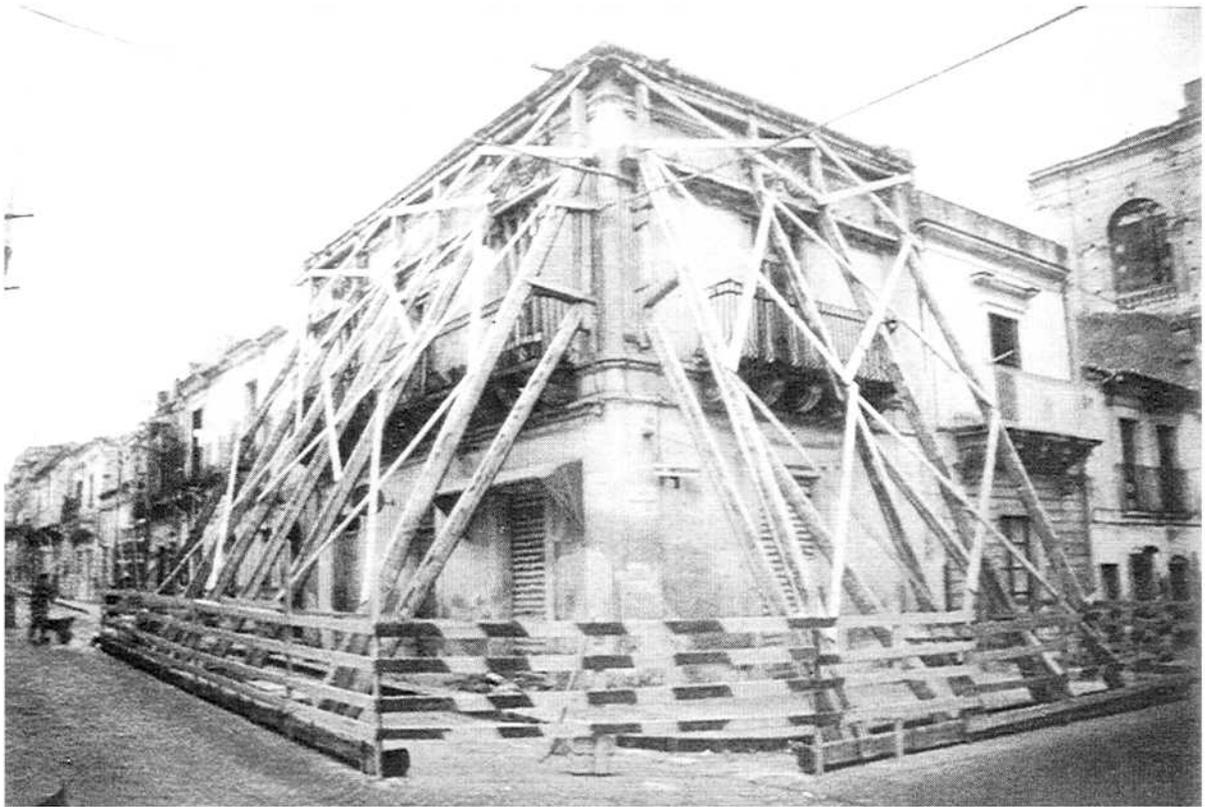
The more severe damage was defined by safety hoardings, shoring and security fences, Plate 5. Hoardings, stopping entrance to buildings, were perhaps indicating dangerous internal conditions, but were rarely seen. Most of the damaged structures had their façades shored indicating the out of plane leaning of the whole wall. In these buildings it is possible that there was sufficient internal structure remaining to permit strengthening and repair. Security fences, limiting passage of pedestrians along the pavement, defined those structures where ashlar stones from the entablatures or where loose roof tiles had fallen off. At these places there was a high probability that other materials could fall off. The bracing of windows and doors was only occasionally seen and was associated with the sagging of the keystones of horizontal multi-piece lintels. Minor movements were noted to arched openings but not affecting their overall in-plane stability.

PLATE 5 *Temporary shoring and safety barriers around a damaged building*

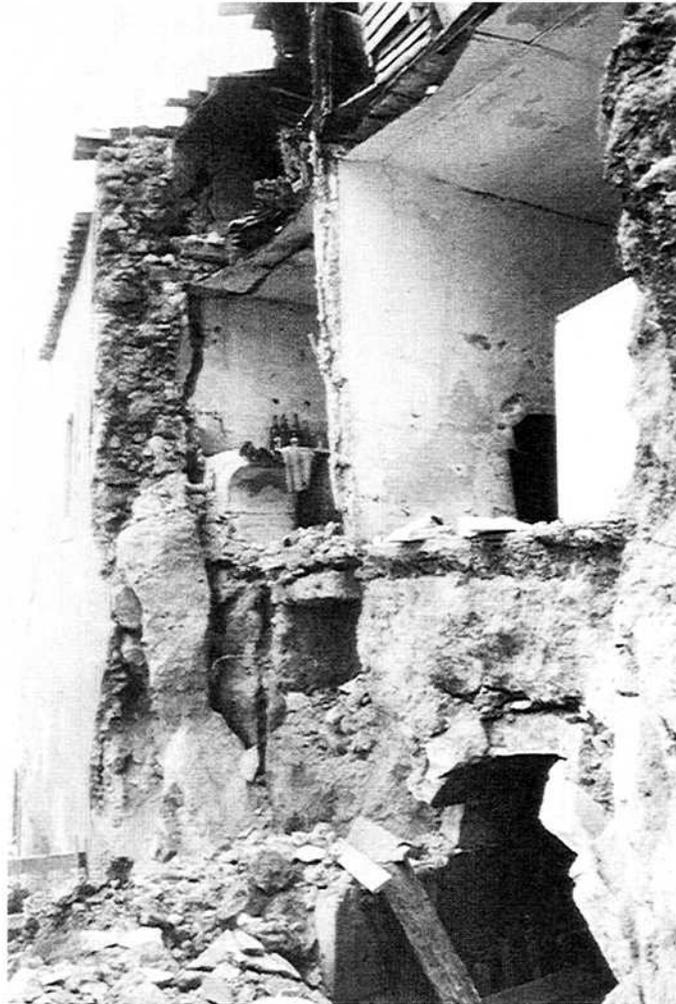
Elsewhere in Noto most damage was found in the upper city in the two storey buildings, Plates 6 and 7. Here damage was recognised by shoring and by pavement barriers and represents the out of plane tilting of walls and entablature failures respectively. Surprisingly, damage of inferior party and side walls was not found, this perhaps reflecting their use for taking floor loads - from the ground floor stone arches and wooden beam system above. In the upper city no churches appear to have their façades shored up.

PLATE 6 *Out of plane wall failure - Noto*

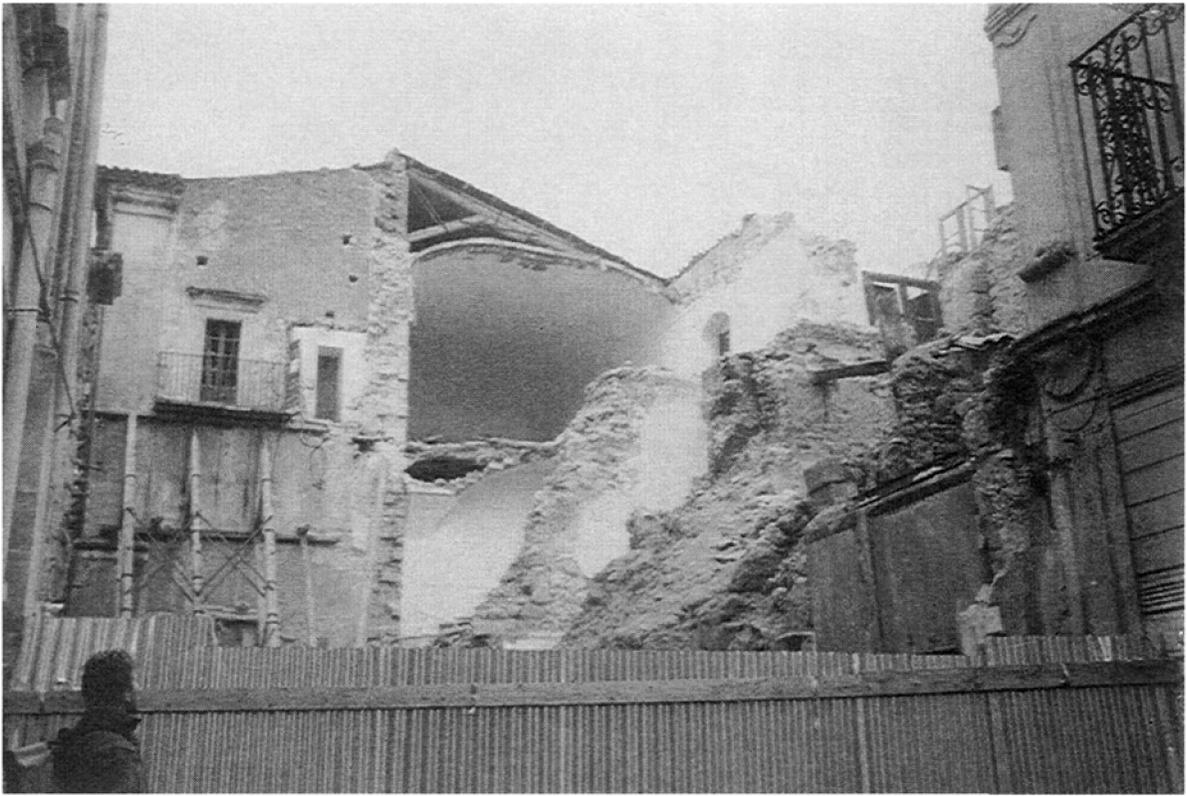
PLATE 7 *Out of plane wall failure - Noto*

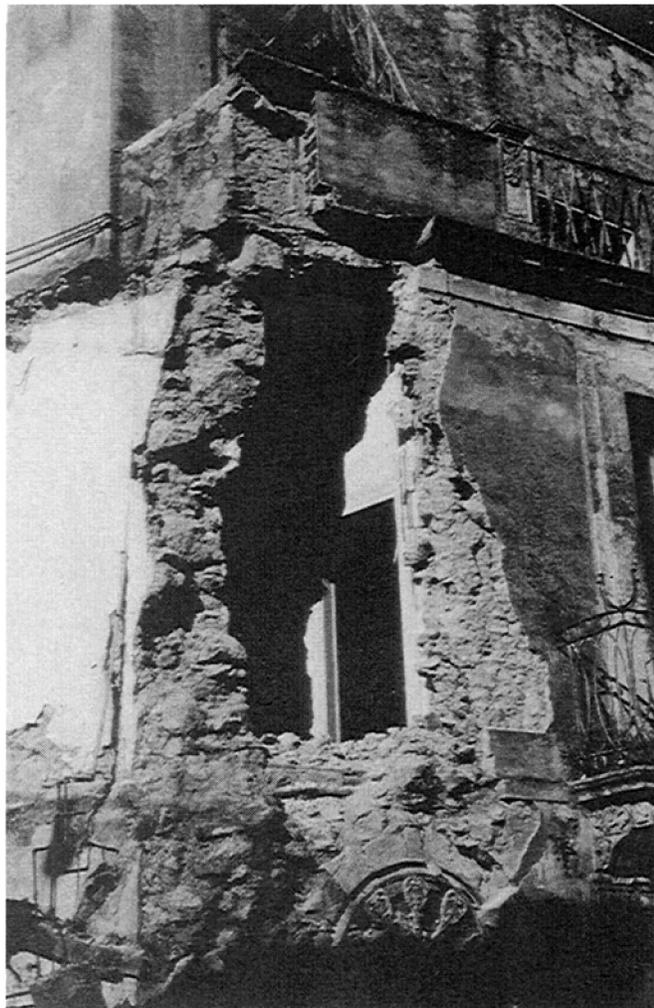
As in Noto there was a noticeable level of damage to corner structures where the pair of adjoining walls both moved out of plane. Only one structure seen had the classic corner wedge failure, Plate 8. A structure adjacent to this had a complete load bearing façade failure. Here the beam ends were found to be severely decayed.

PLATE 8 *Typical corner failure - Melilli*

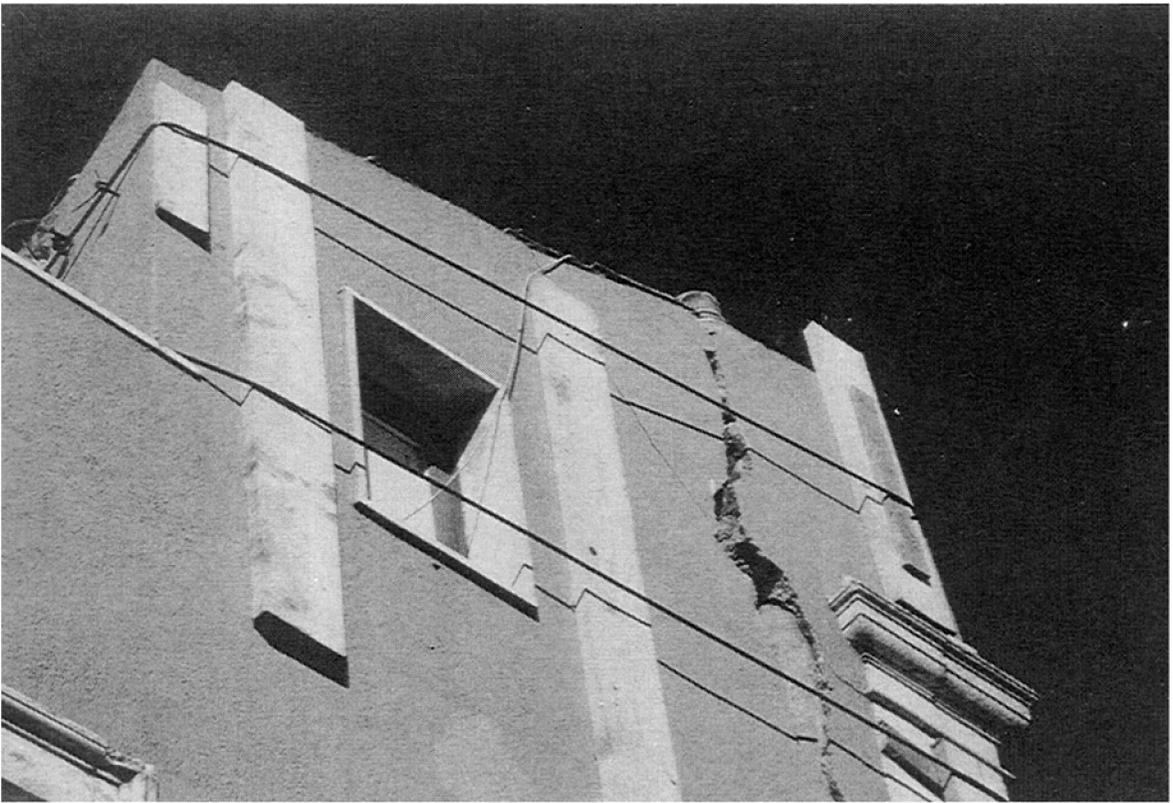
One old structure had been extended with an additional storey and this included insertion of a new chimney duct inside the wall thickness. This structure was severely cracked and was temporarily tied together with a system of steel cable straps (Plate 9). Most of those structures with out of plane tilting of façades had no obvious signs of window/door lintel block displacement. However, as in Noto many structures showed the displacement of ashlar blocks in the entablature.

PLATE 9 *Wire-strapping of residential building in Mellini*

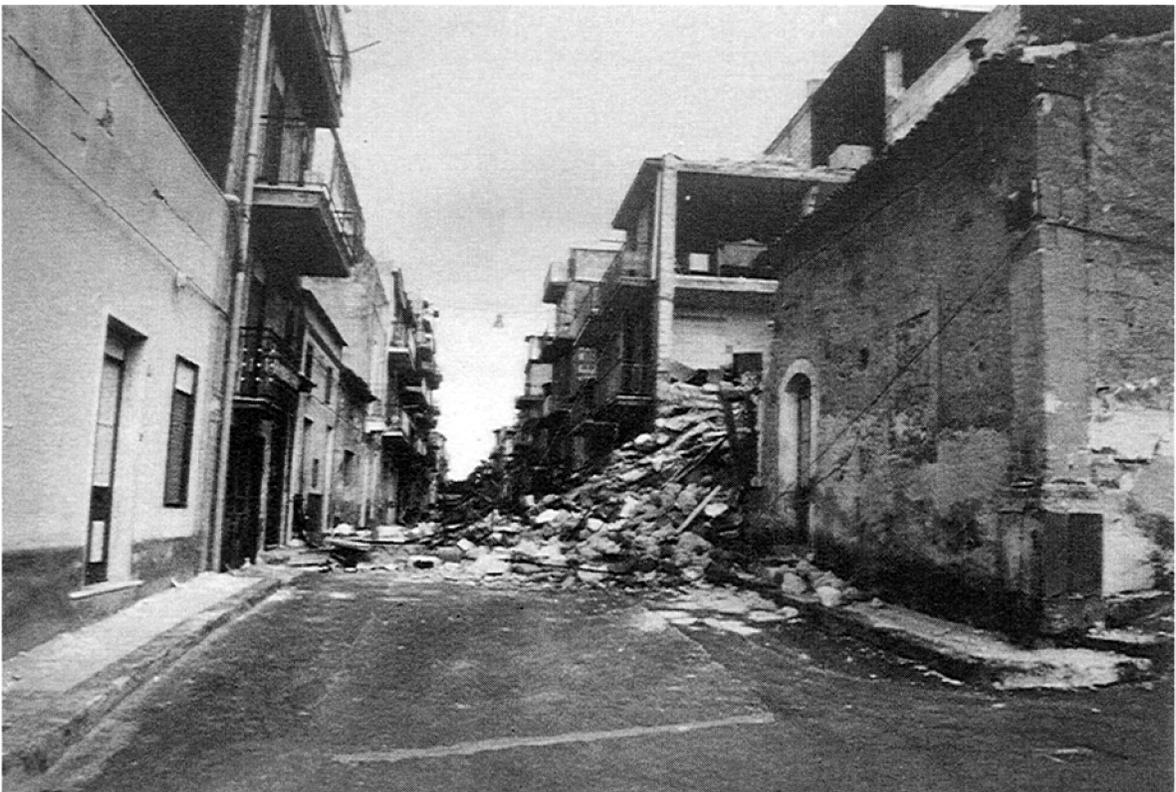
The significant damage in Carlentini occurred in the NW corner of the town near to a cliff edge where there had been significant collapse of modern three storey houses. Approximately 30 street "blocks" had been cordoned off and all the buildings evacuated, Plate 11. Here the damage could have resulted from local site amplification effects, perhaps exacerbated by reuse of old foundations or building over old basements cut into the underlying limestones. Damage to the traditional houses was much less severe than to the new, but with similar failure mechanisms to those seen in Noto and Melilli. Most damage was to two storey houses with out of plane tilting of façades and falling off of insecure entablatures. No exacerbated effects were apparent where the old type of houses were mixed in with the new and had even been modernised, for example, with the covering of the façades with glazed tiles. It was the collapse of structures here (Plates 12 and 13) that caused the reported 19 deaths.

PLATE 12 *Building damage - Carlentini*

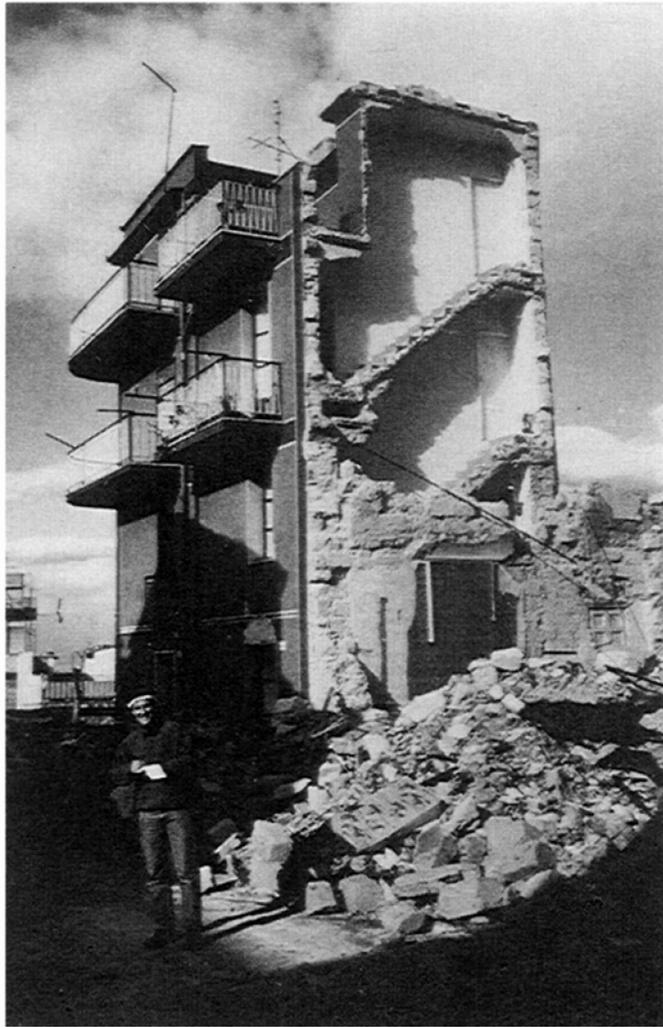
PLATE 13 *Collapse of three storey residential building in Carlentini*

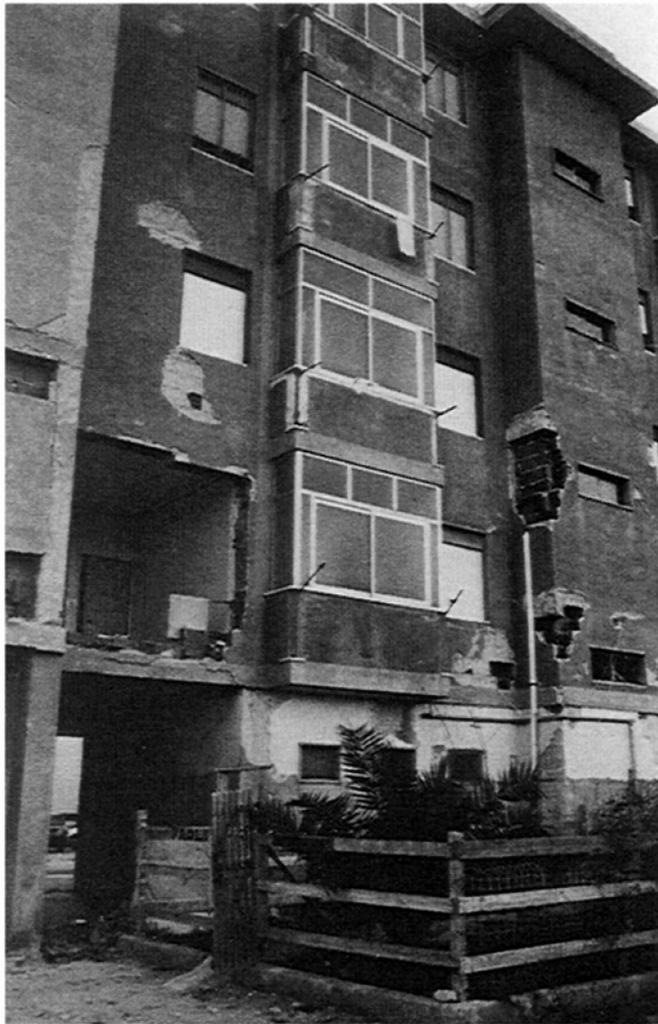
It was immediately apparent that some blocks of flats had suffered significant damage, and were uninhabitable. The masonry infill panels, both internal and external, had suffered particularly badly. Complete panels had collapsed out of plane, away from their supporting frames, leaving no evidence of ties between the two building elements, Plate 15. In-plane failure of masonry panels was evident by the presence of large diagonal cracks which passed through both the bricks/blocks and the bedding joints. In-plane cracks were most significant in ground storey masonry panels measuring up to 60mm in width, Plate 16.

PLATE 15 *Failure (out of plane) of reinforced masonry infill panels*

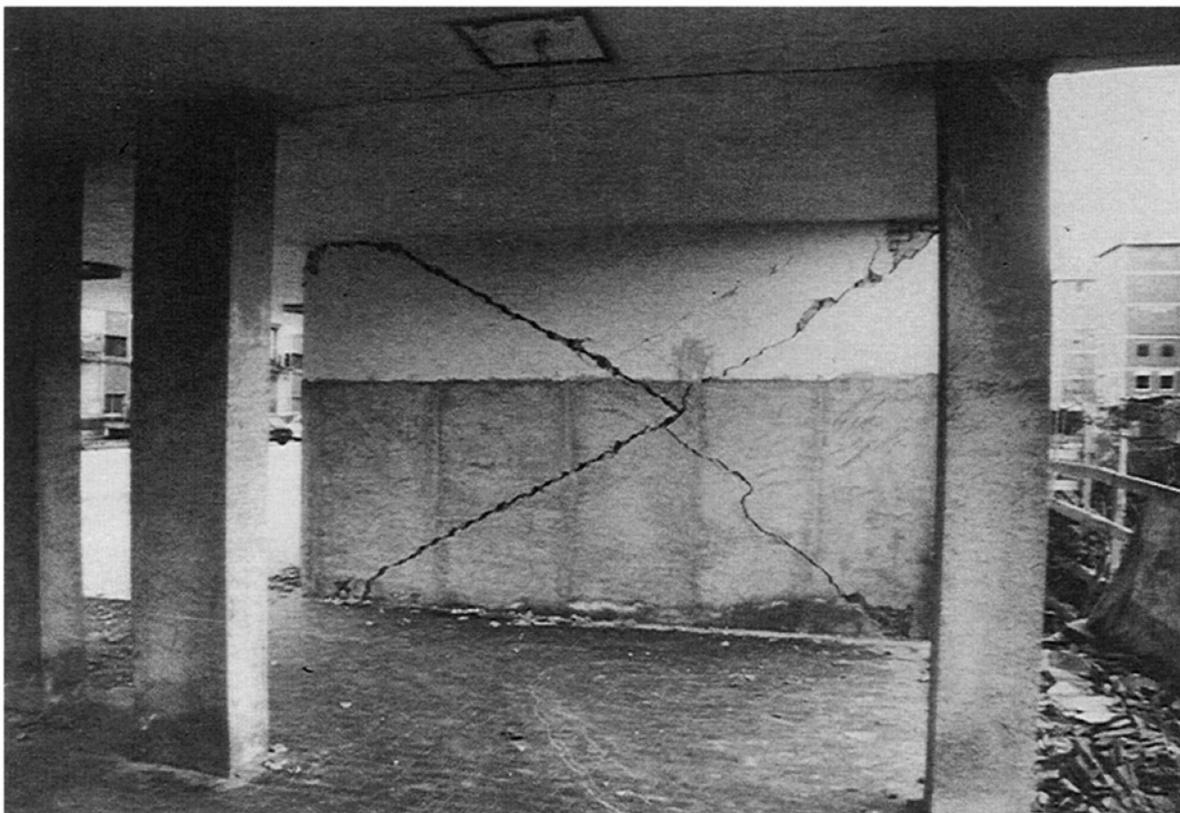
PLATE 16 *Shear failure of stairwell at ground level - Augusta*

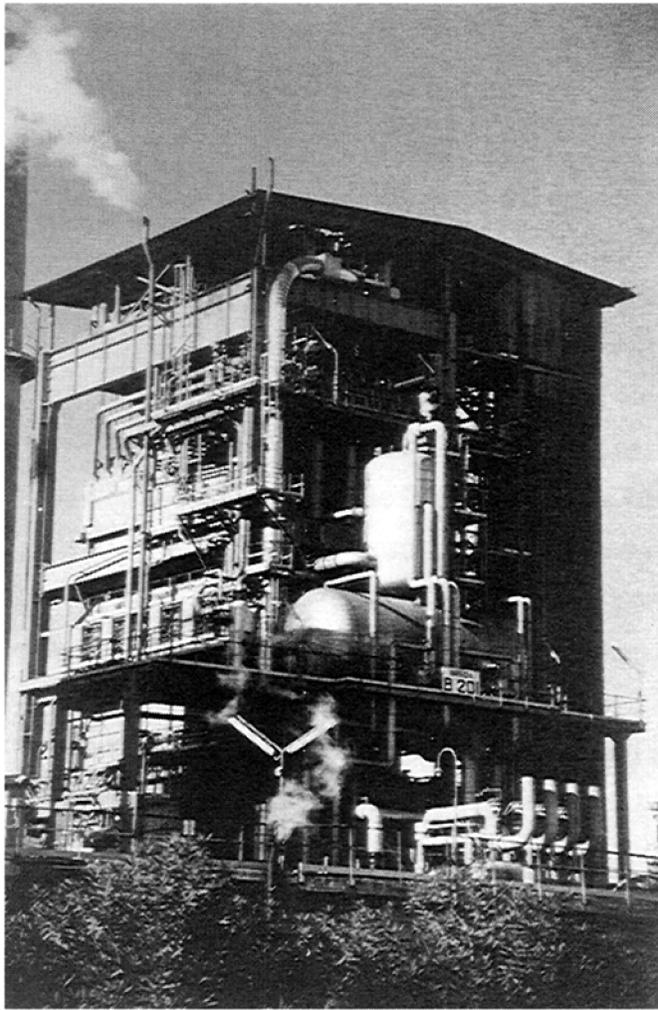
The area north and south of Augusta contains one of the largest concentrations of petrochemical installations in the world. Augusta is located on the coast approximately 10km from the epicentre of the earthquake. Based on the recorded ground accelerations shown in Figure 1, Augusta would have experienced ground motions of the order of 0.1g. Although members of the EEFIT team were unable to arrange access to these industrial facilities during the short visit, observations were carried out from the perimeter of some of the sites. These basic inspections and local comment indicated that no damage had occurred to structural steelwork, storage tanks or main pipework tracks, Plates 17 and 18.

PLATE 17 *Undamaged industrial facilities - Augusta*

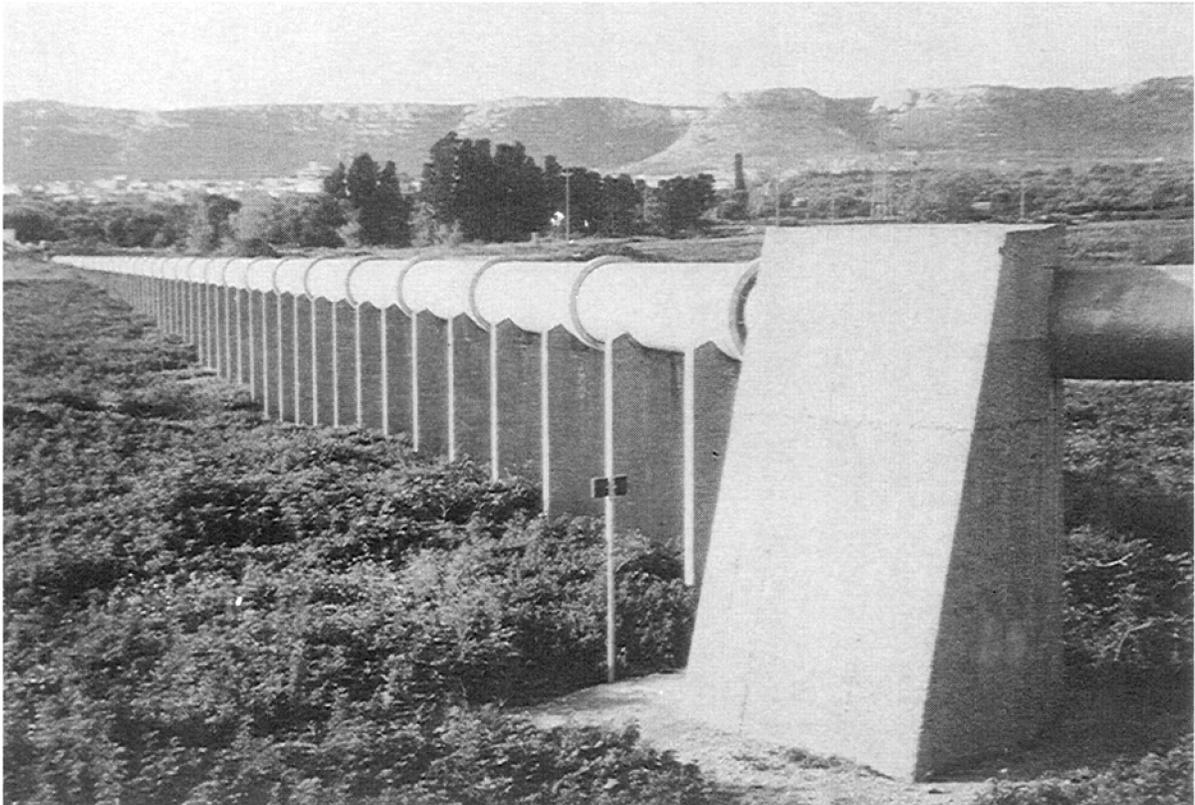
PLATE 18 *Undamaged elevated water main*
