# THE KUMAMOTO JAPAN EARTHQUAKES OF 14 AND 16 APRIL 2016

# A FIELD REPORT BY EEFIT

Dr. Katsu Goda, *University of Bristol* (Team Leader and Editor) Dr. Grace Campbell, *Arup* Ms. Laura Hulme, *Arup* Mr. Bashar Ismael, *University of Manchester* Dr. Lin Ke, *Willis Re Japan* Ms. Rebekah Marsh, *Mott MacDonald* Prof. Peter Sammonds, *University College London* Dr. Emily So, *University of Cambridge*

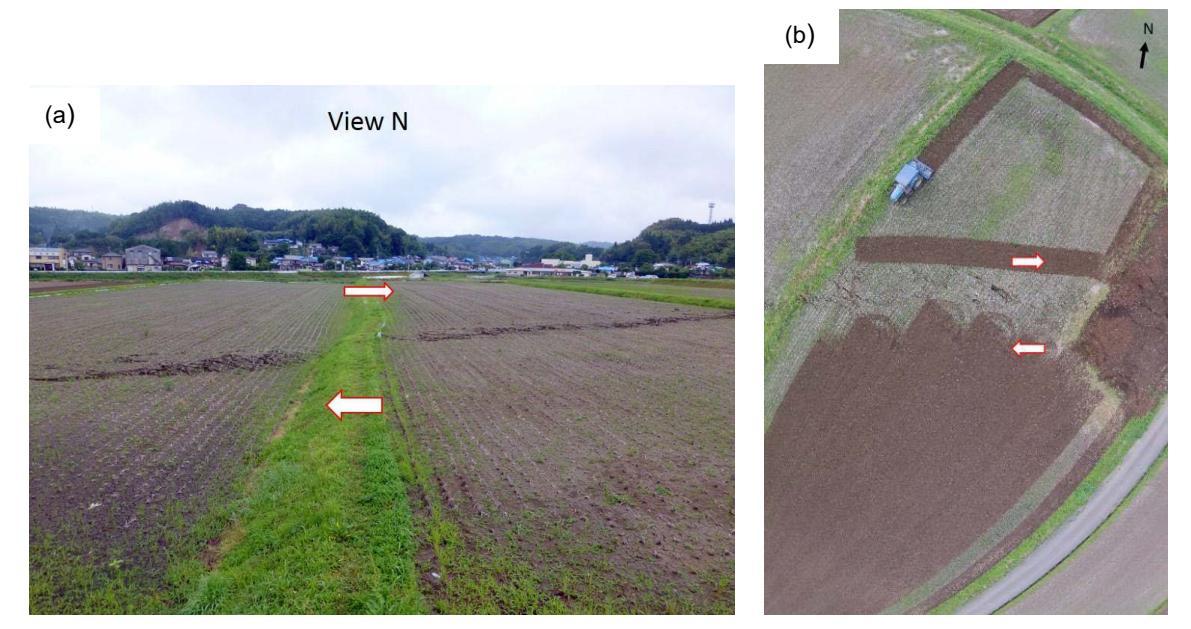
Figure 2.8 (a) Right-lateral offset in rice paddy field and (b) rupture and fresh ploughing (see Figure 2.5 for the photo locations).

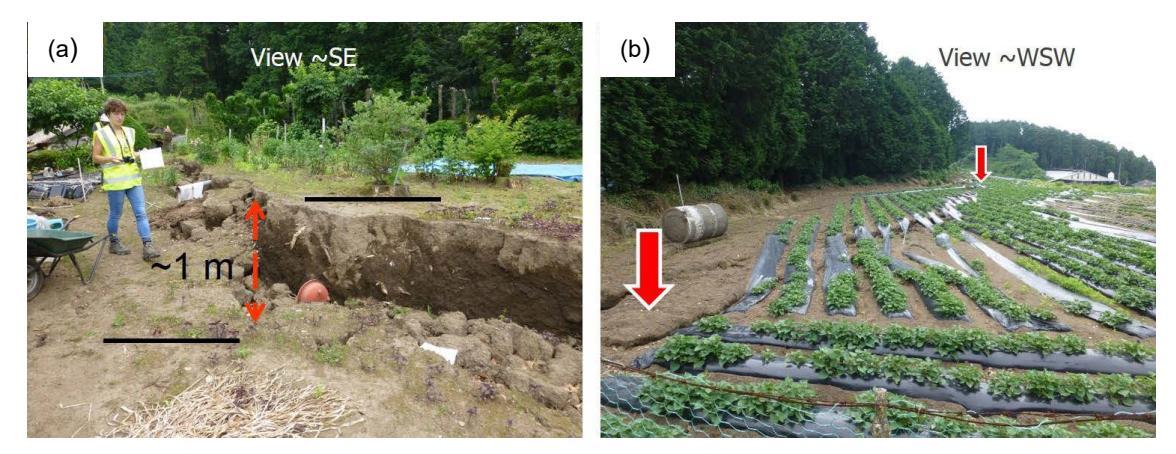
**Figure 2.9** (a) Around 1 m north-side-down vertical offset west of the farm house and (b) normal faulting rupture continuing through the farmer's field, with 0.5 m to 1 m vertical offsets measured.

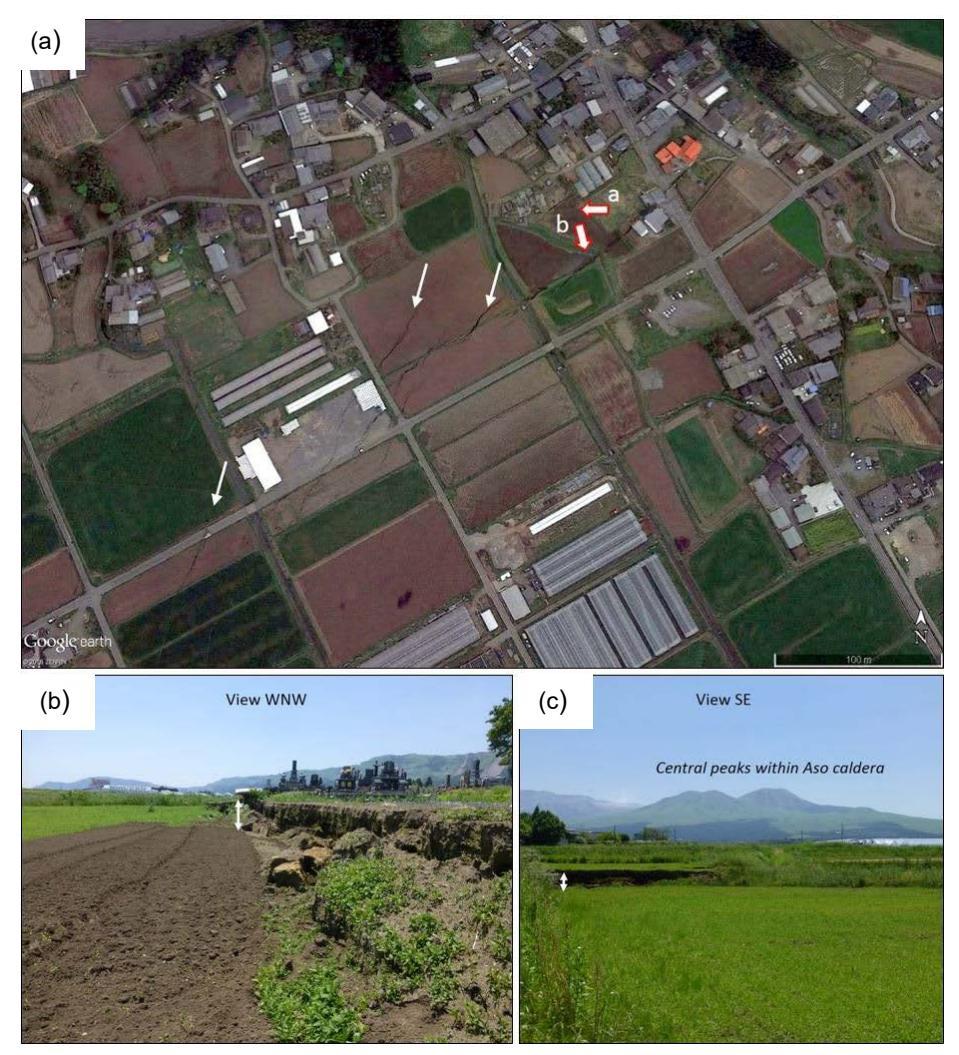
**Figure 2.10** (a) Google Earth imagery showing en-echelon extensional surface ruptures in the north of Aso Caldera (site 3 in **Figure 2.4**). (b) and (c) field photos of the vertical offsets (~1-2 m) at the locations shown in (a).

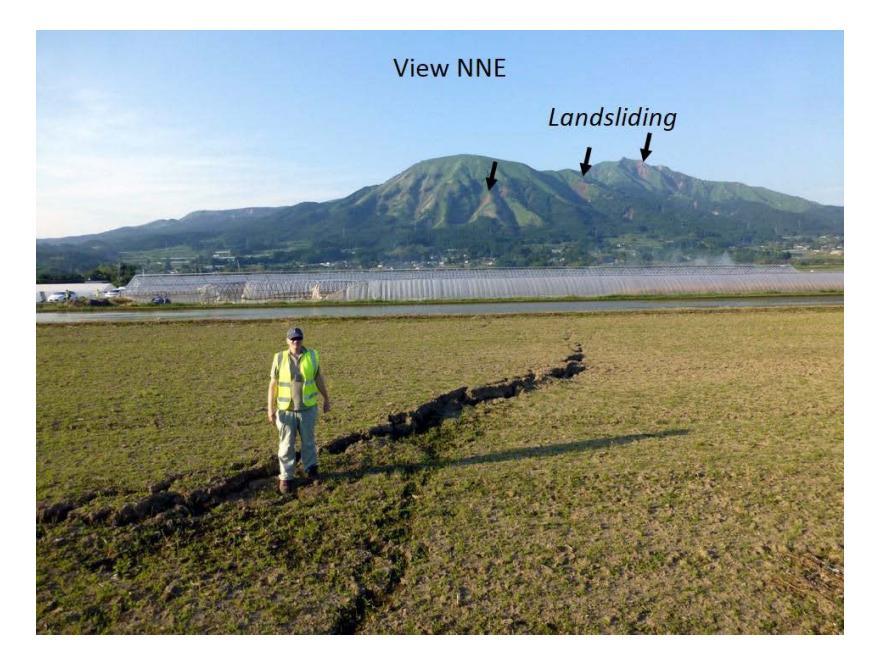
Figure 2.11 Extensional normal surface ruptures in the southwest of Aso Caldera (site 4 in Figure 2.4).

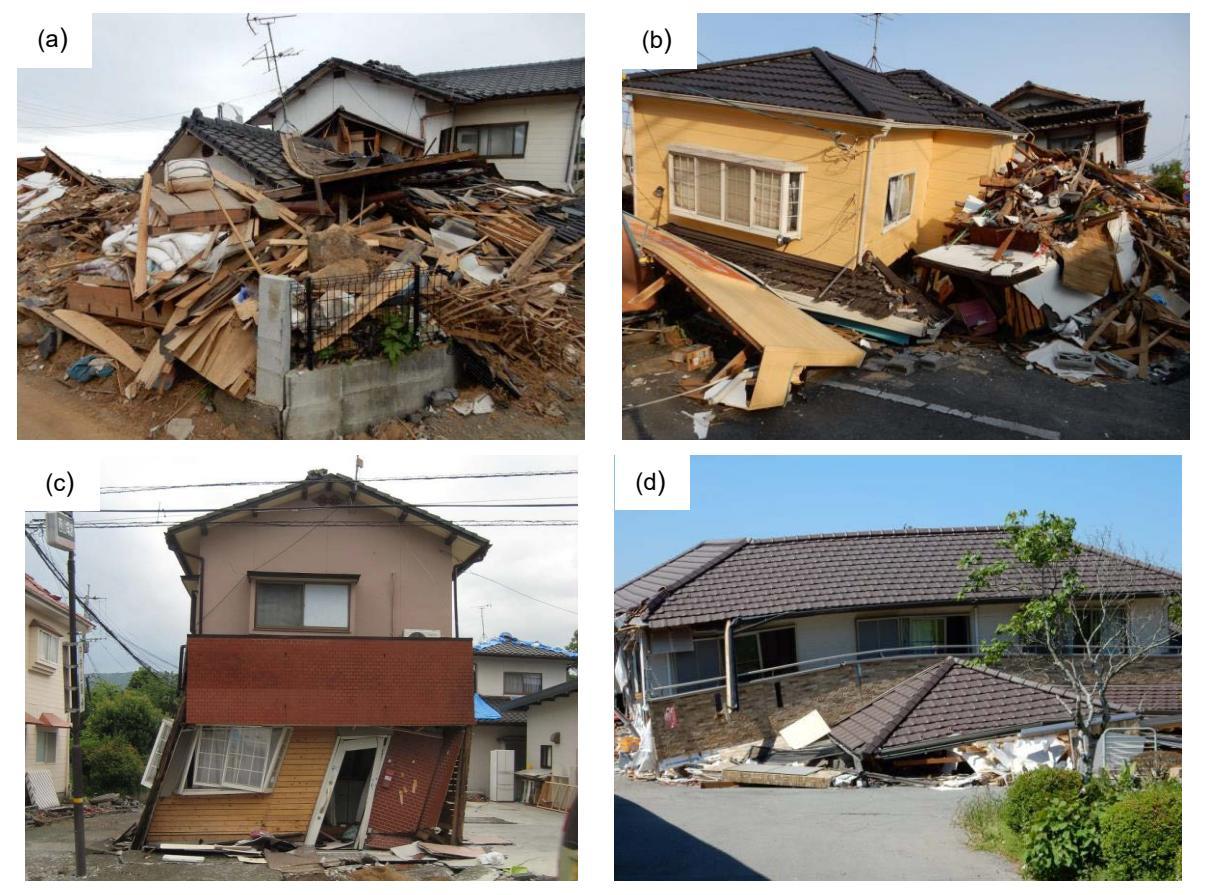
**Figure 4.5** Damage to timber frame houses in Mashiki Town: (a) complete collapse of a pre-1981 structure, (b) bottom storey collapse, (c) significant drift, and (d) soft-storey collapse mechanism of a modern building.

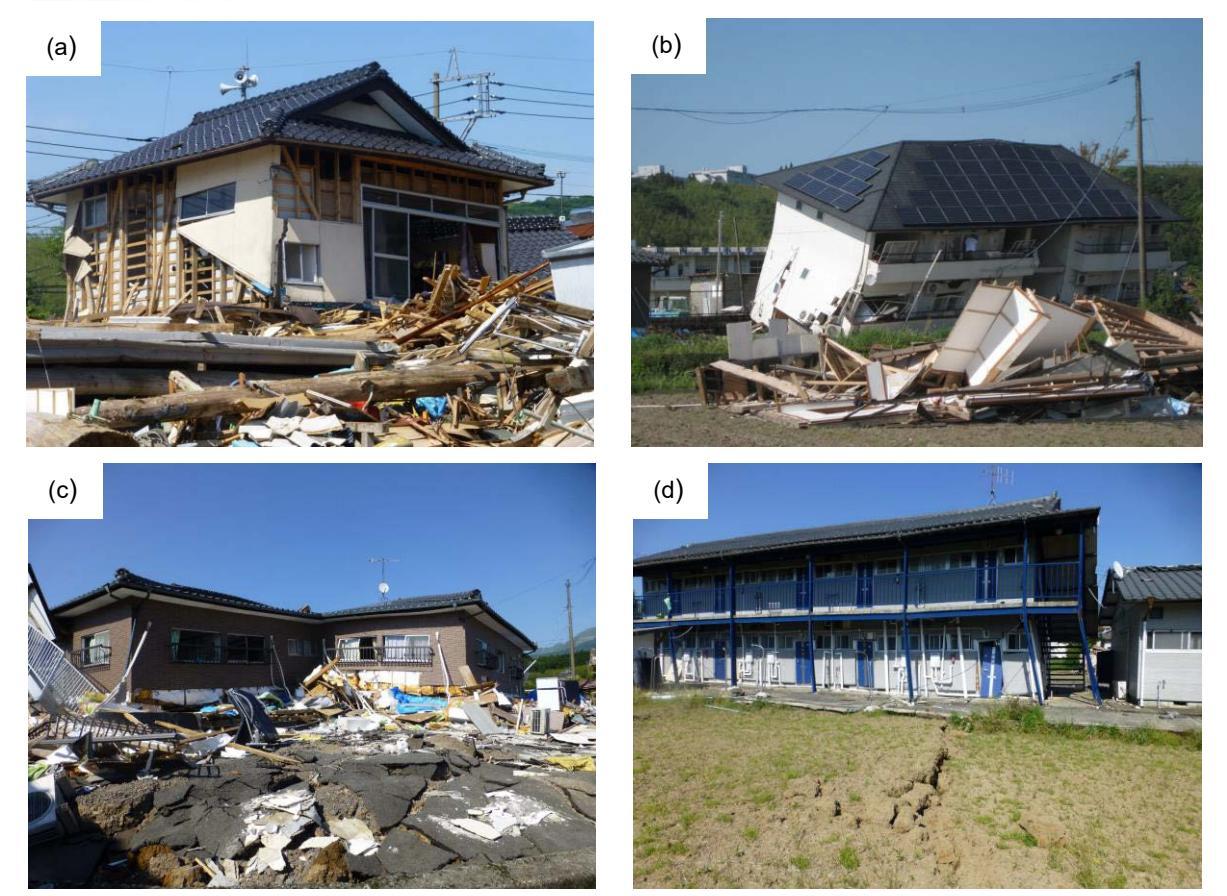
**Figure 4.7** Damage to timber frame buildings in the Kawayo district of Minami Aso Village: (a) heavily damaged house in Area A, (b) Building 1 in Area B, (c) Building 2 in Area B, and (d) Building 3 in Area B with visible traces of the ground rupture that crossed underneath.

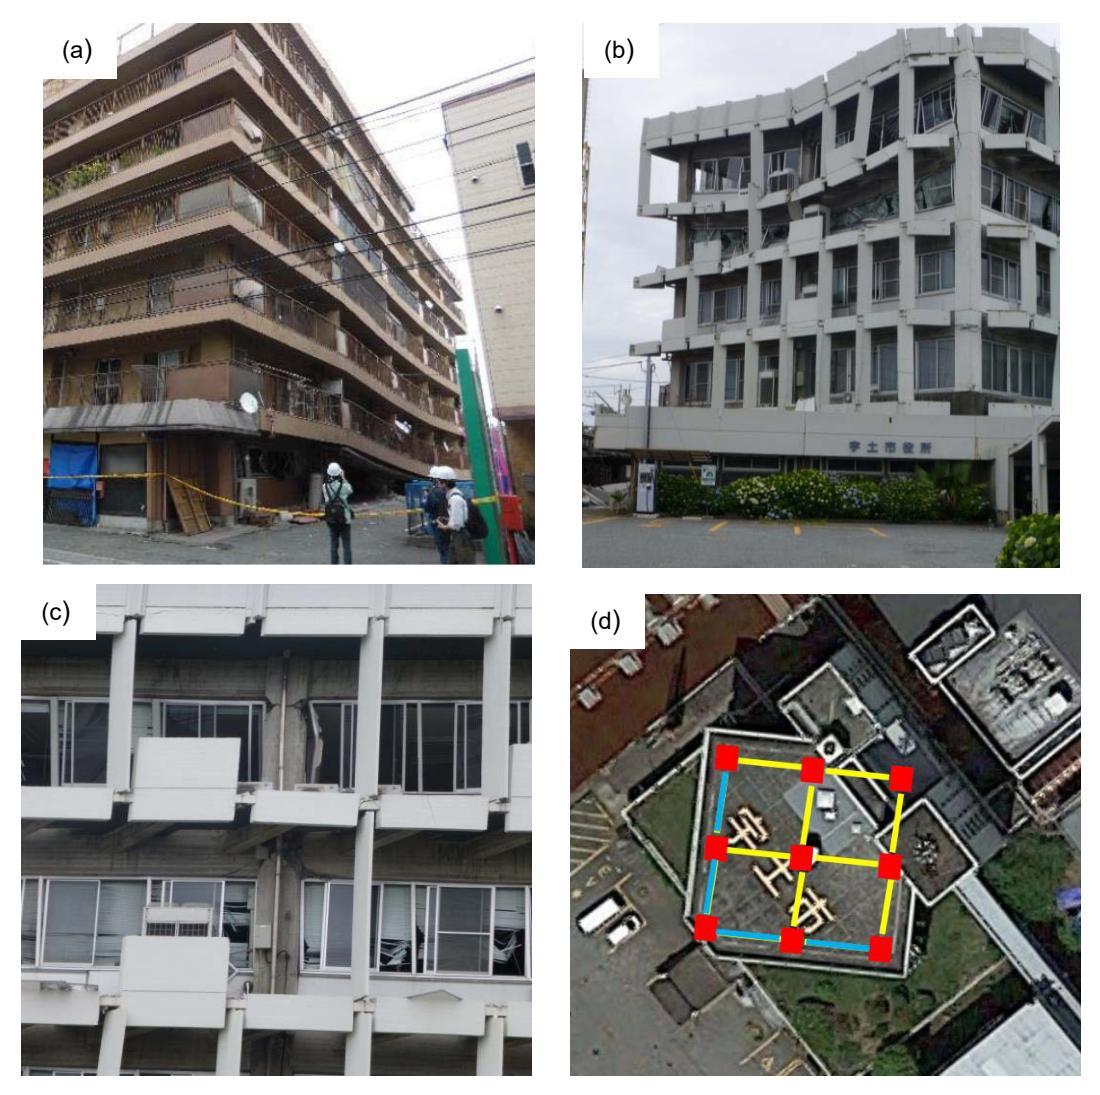
**Figure 4.8** Damage to RC frame buildings: (a) soft-storey collapse of an apartment building in Kumamoto City (Tajiri et al., 2016), (b) west façade of the Uto City Office, (c) column damage to the Uto City Office, and (d) structural layout of the Uto City Office – the blue lines are the front face of the building where structural damage to the RC frame is visible as shown in (b) and (c) (aerial view from Google Earth).

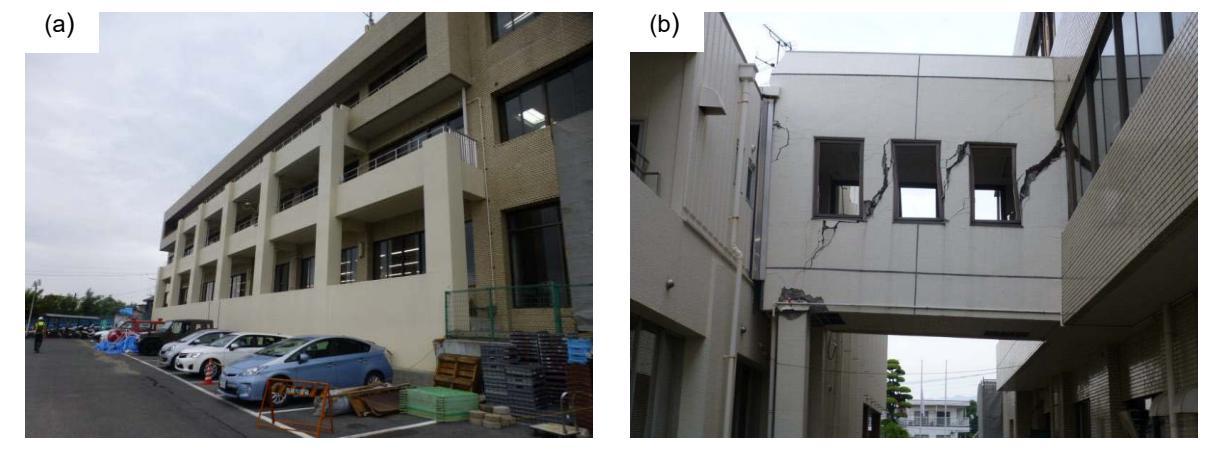
Figure 4.9 Mashiki Town Office (strengthened RC frame): (a) strengthened south elevation and (b) damage to link bridge.

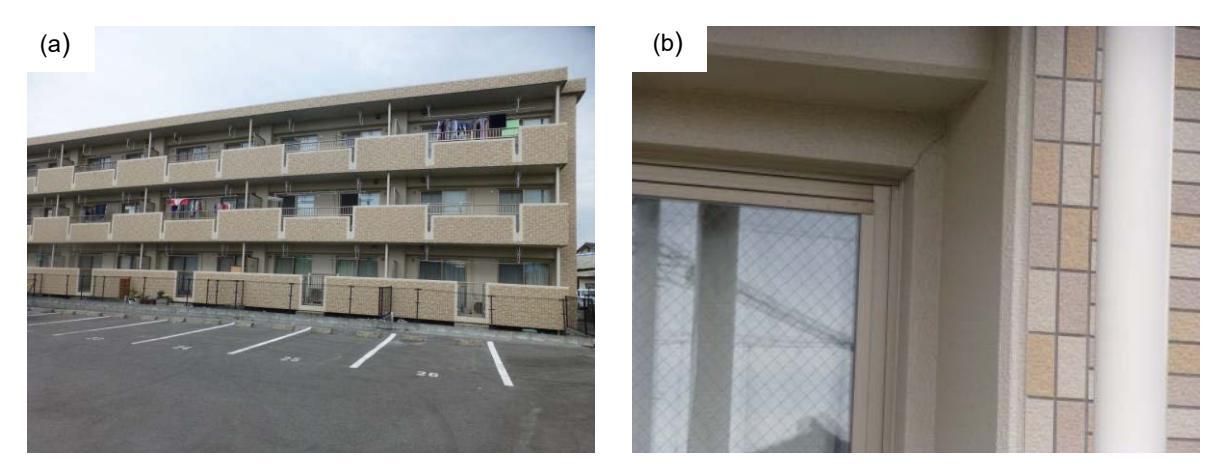
**Figure 4.10** Well-performing RC frame apartment building in Mashiki Town: (a) general view and (b) zoom showing no evidence of fine cracks.

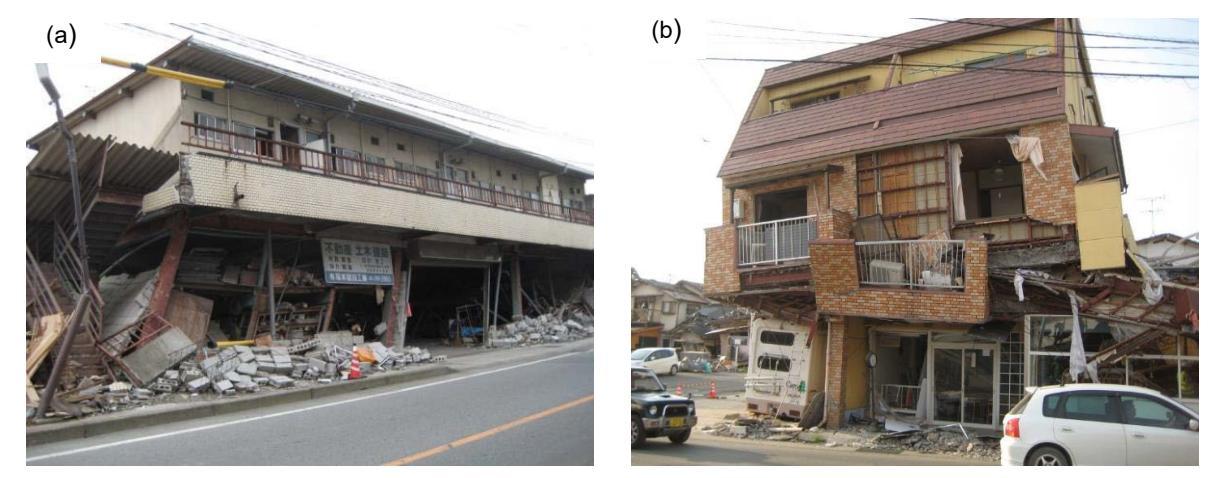
**Figure 4.11** Steel building failures in Mashiki Town: (a) bottom-storey drift to the southern side of Road 28 and (b) four-storey collapse to the northern side of Road 28.

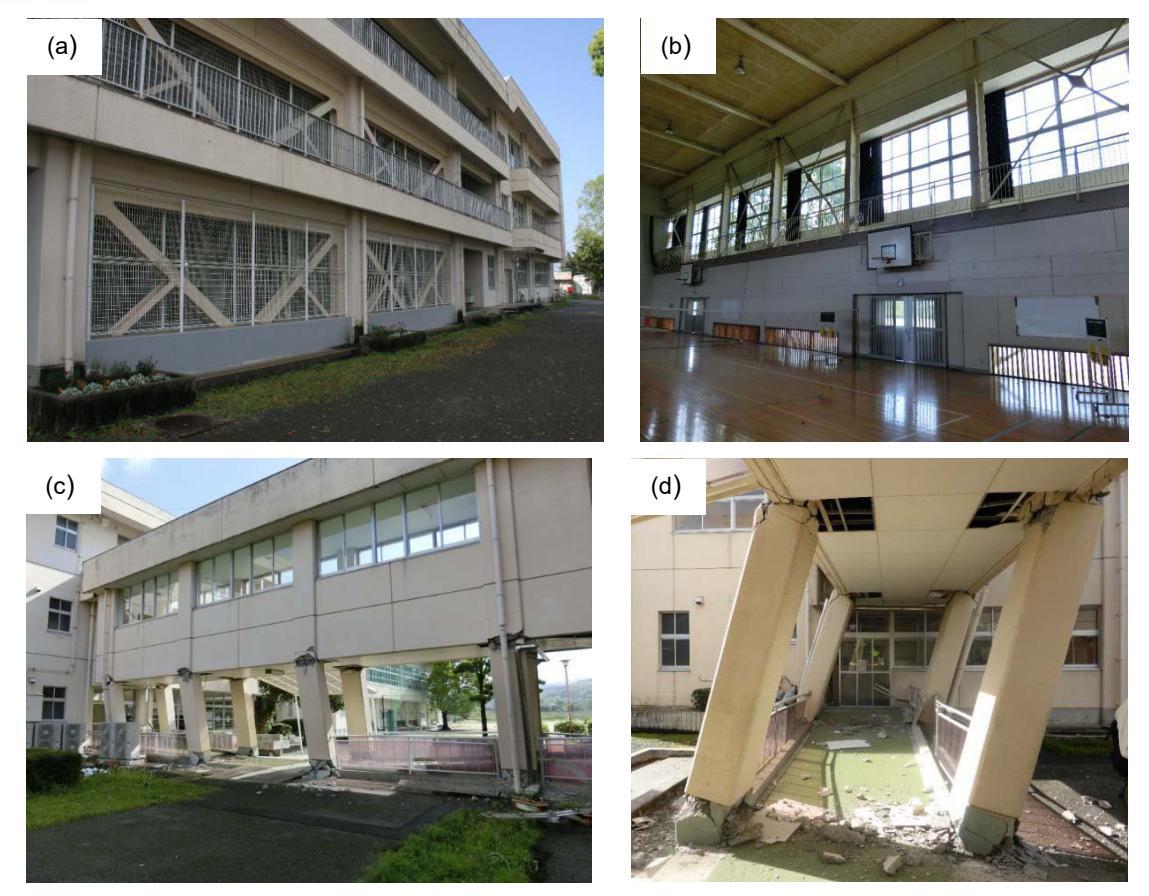
**Figure 4.12** Mashiki Junior High School: (a) RC frame retrofitted with steel bracing (undamaged), (b) buckled bracing to the gymnasium structure, (c) significant drift of link corridor, and (d) detailed picture of the same link corridor (Tajiri et al., 2016).

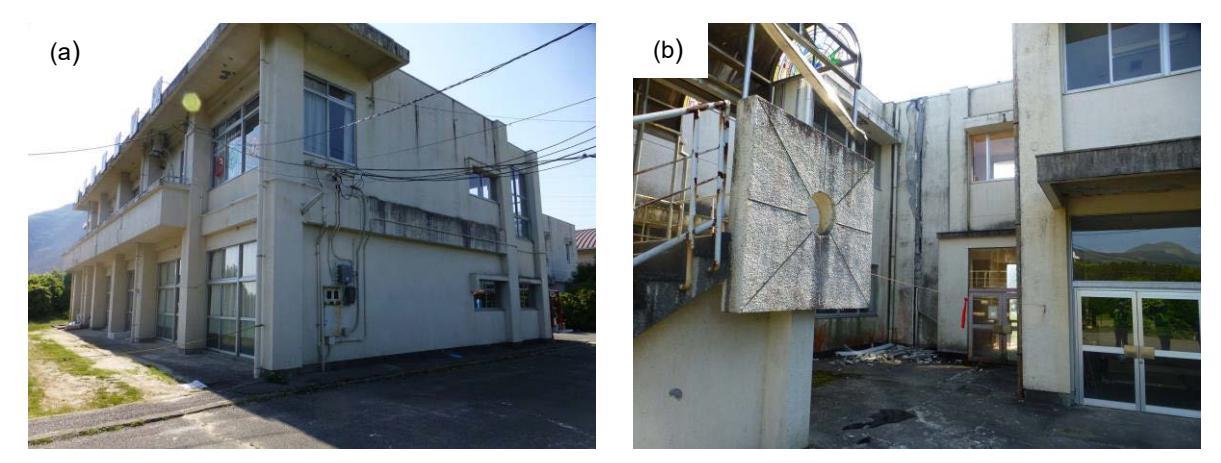
**Figure 4.13** Minami Aso Village Nursery: (a) regular RC frame construction and (b) damage to a movement joint between blocks (yellow-tagged).

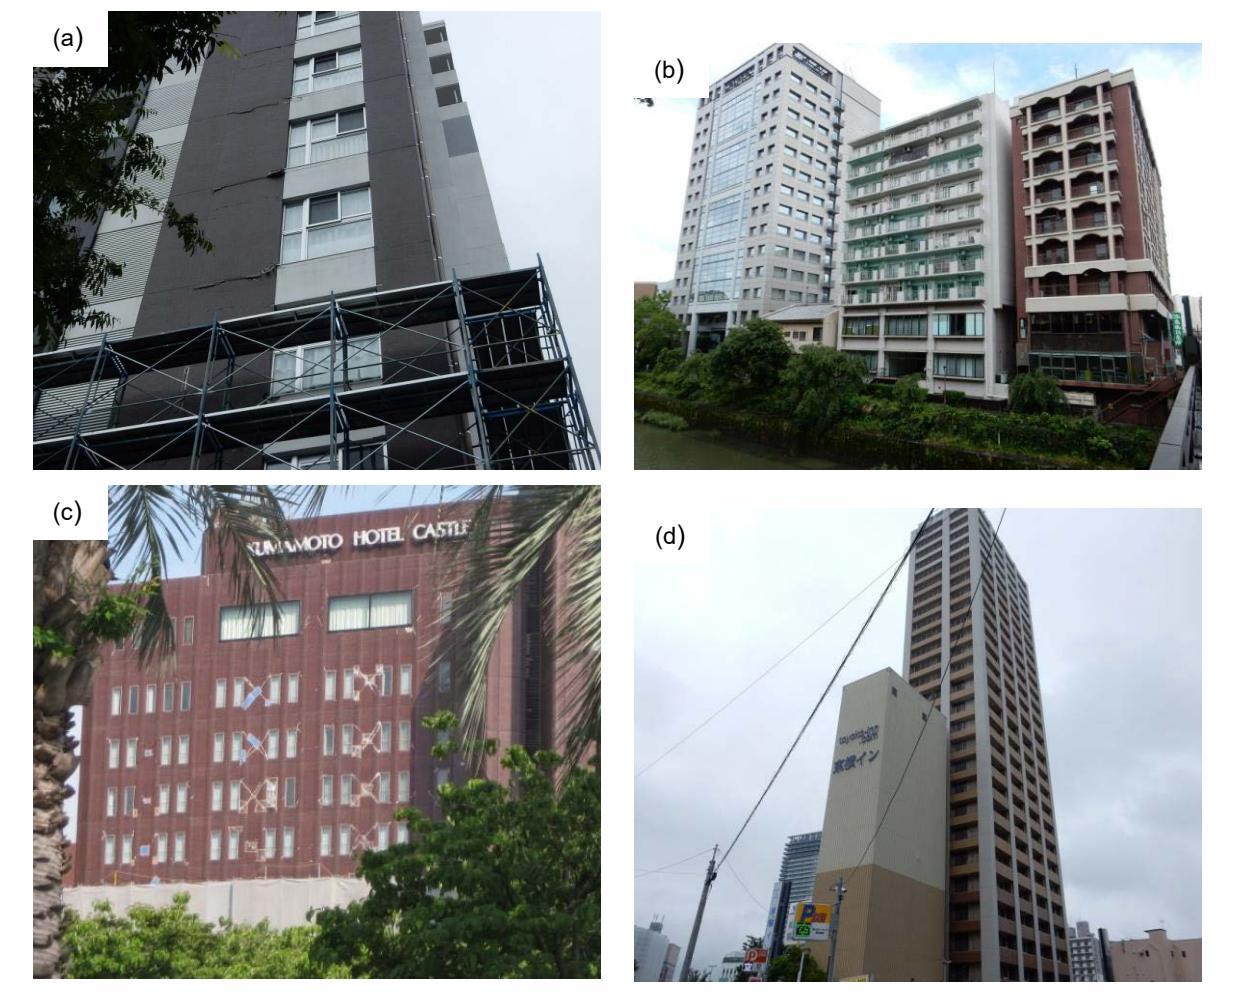
**Figure 4.16** Building damage in Kumamoto city centre: (a) damaged cladding being repaired, (b) buildings next to castle moat (ground damage), (c) shear cracking to façade, and (d) damage to contents and systems of a car elevator tower.

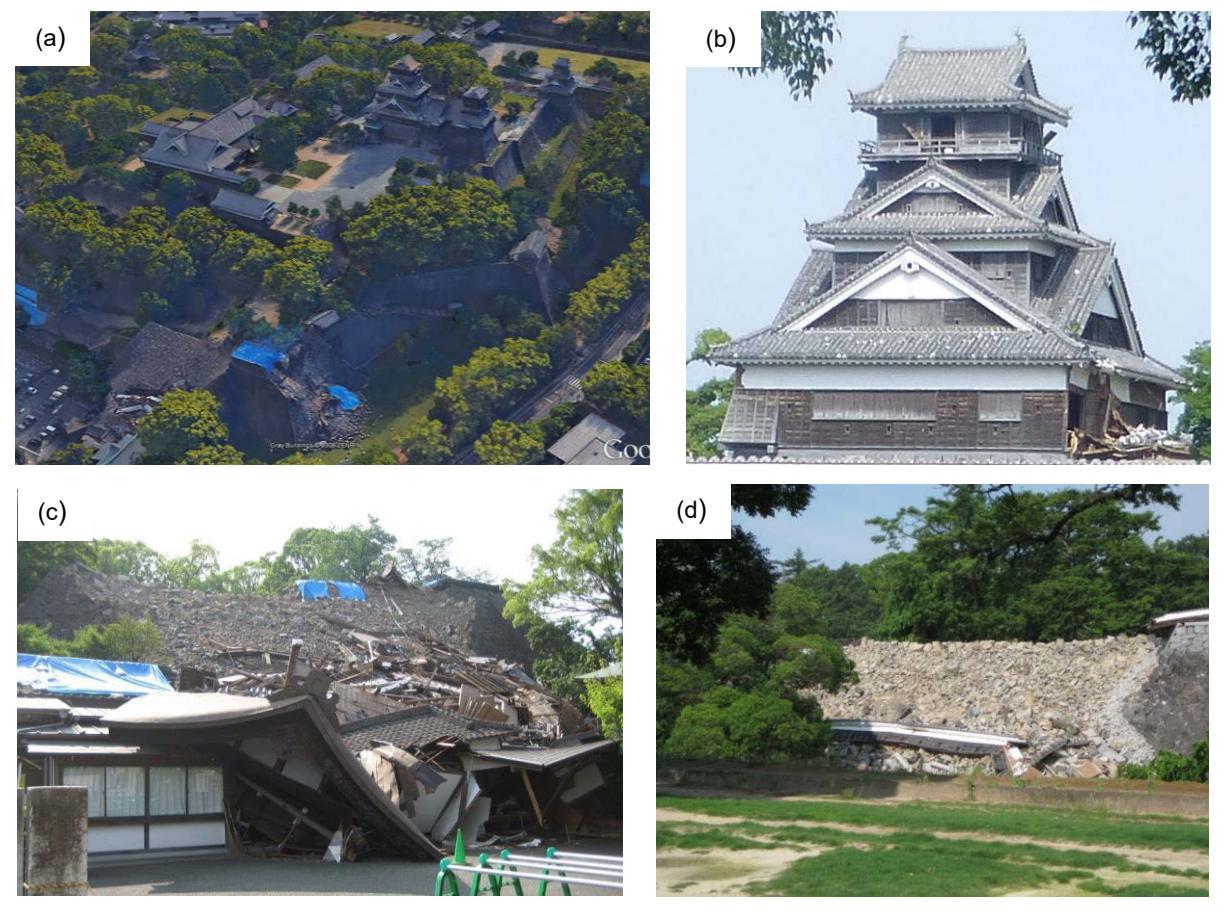
**Figure 4.17** Damage to Kumamoto Castle: (a) aerial view from northeast (image source: Google Earth), (b) main building, (c) north-western corner collapse, and (d) south embankment collapse.

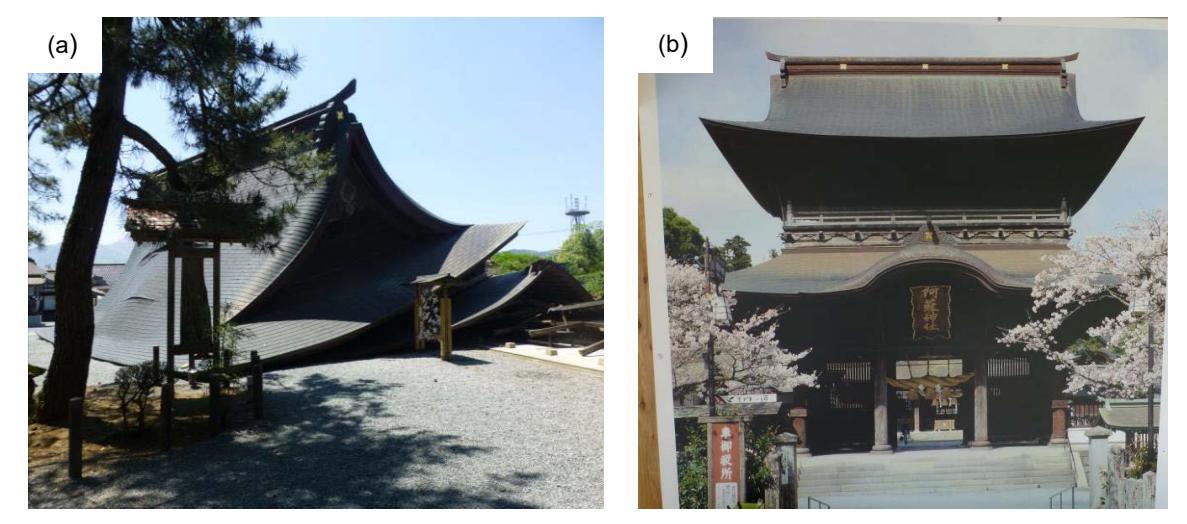
Figure 4.18 Damage to Aso Shrine: (a) collapsed entrance structure and (b) photograph of the same structure prior to the earthquakes.

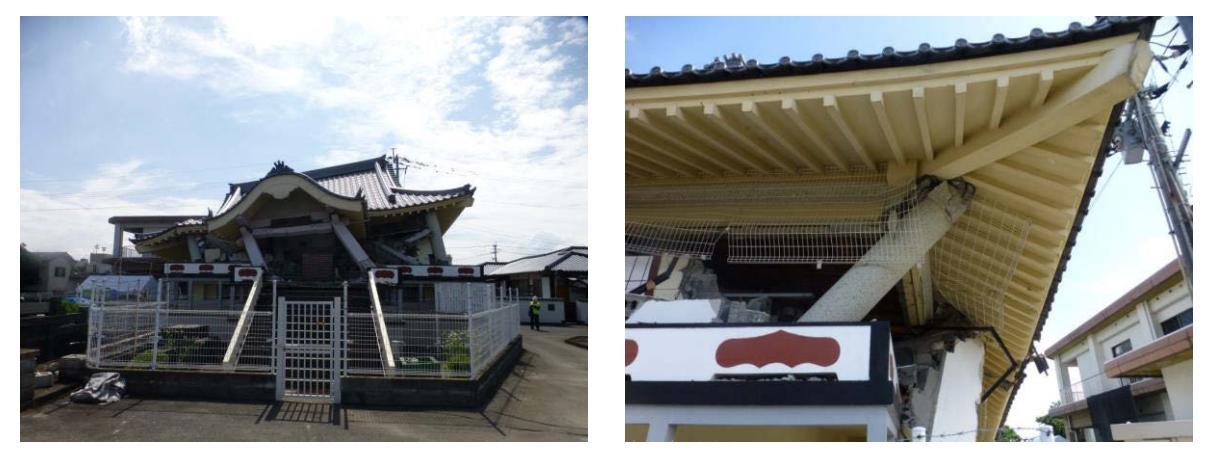
**Figure 4.19** Damage to a concrete temple in Mashiki Town: (a) a view from the eastern side and (b) failure of a column head at the north-western corner.

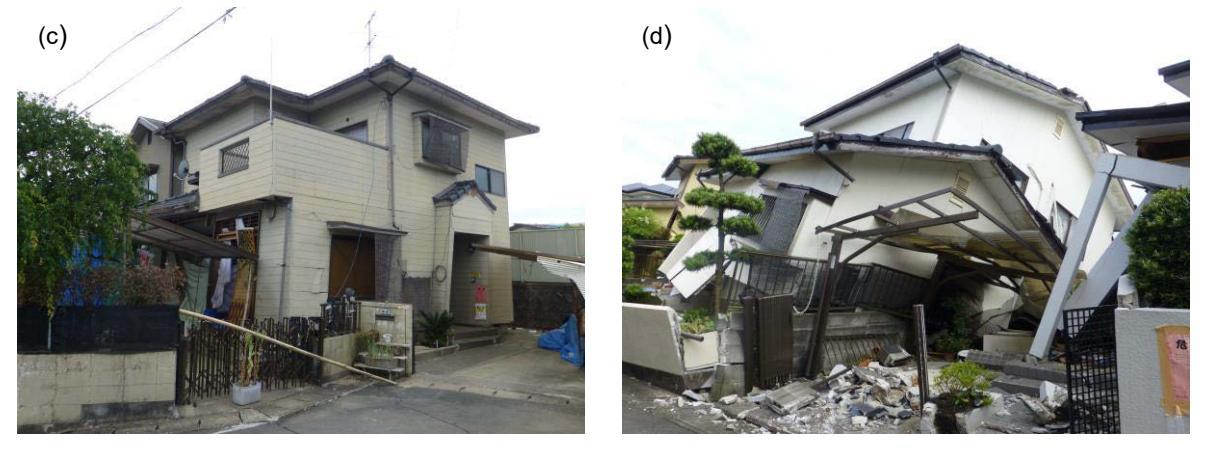
**Figure 4.20** Examples of surveyed timber buildings in Mashiki Town: (a) damage grade 1 or 2, (b) damage grade 3, (c) damage grade 4, and (d) damage grade 5.

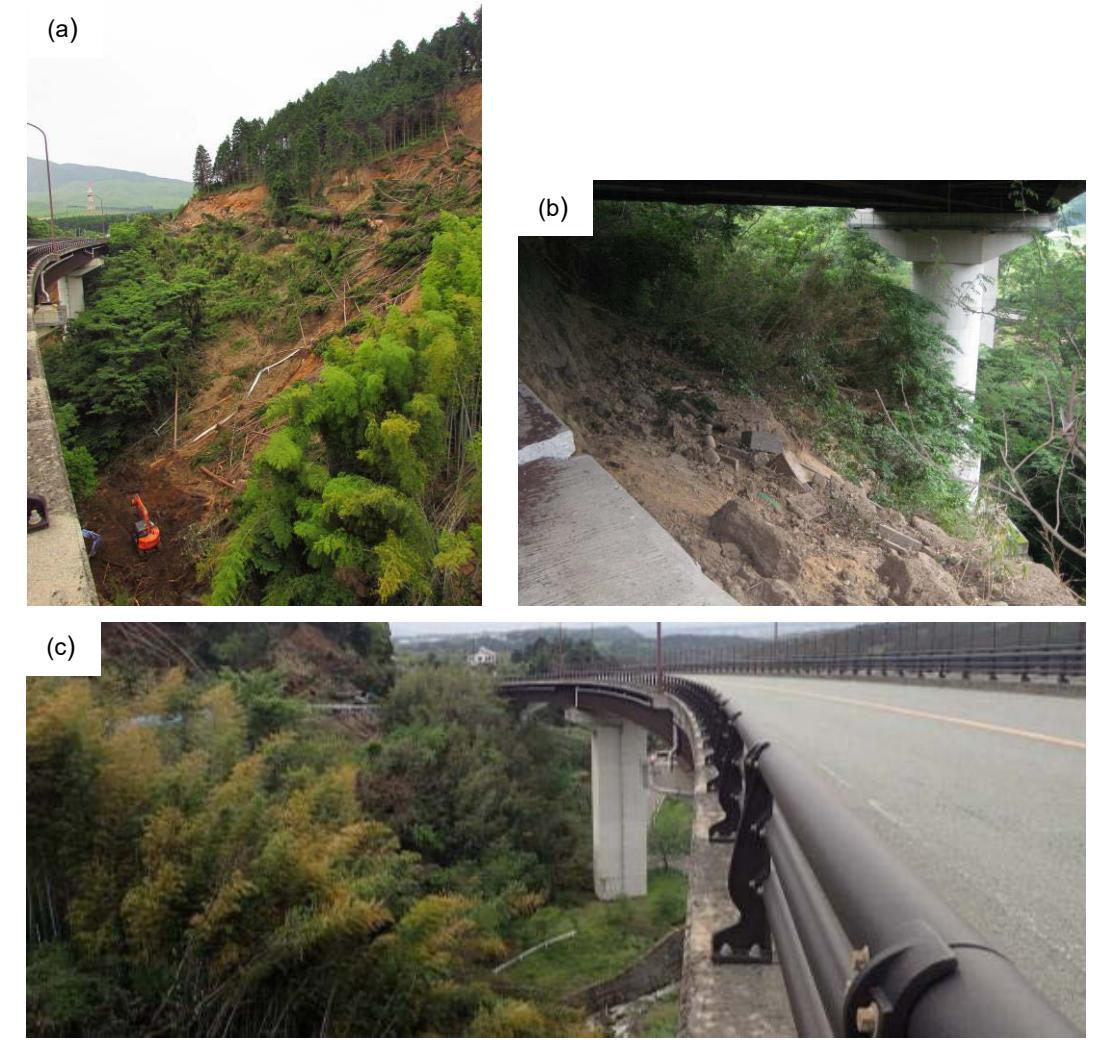
**Figure 5.2** Interaction between the landslide and bridge abutments of the Oogiribata Bridge: (a) view from the western end of the bridge looking east at the toe of the landslide, (b) looking west at the eastern pier from the underside of the bridge on the eastern end, and (c) looking west at the western pier (Ikeda et al., 2016).

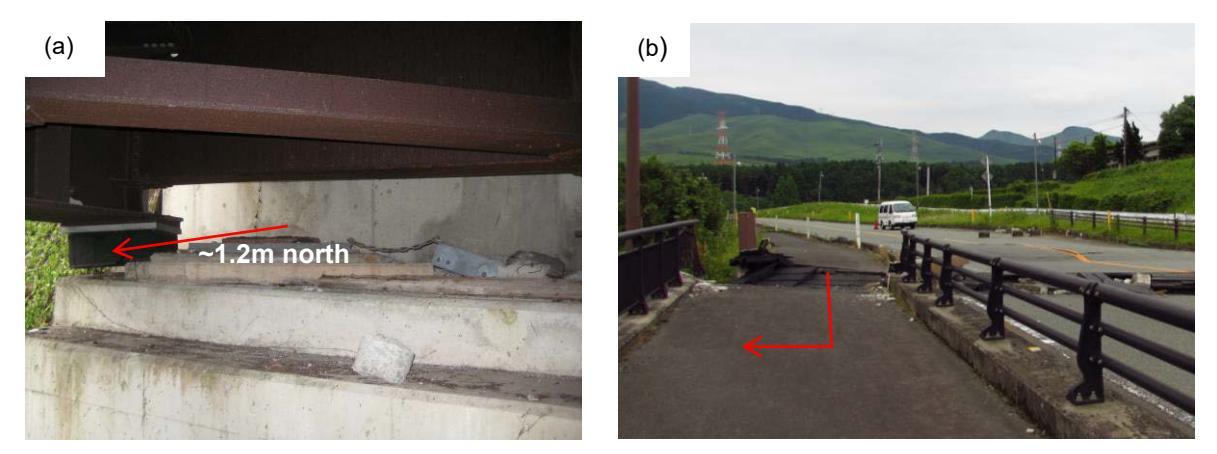
**Figure 5.3** Failure of the bearings beneath the Oogiribata Bridge: (a) view of the failed bearings from the underside of the bridge and (b) view from the top of the bridge.

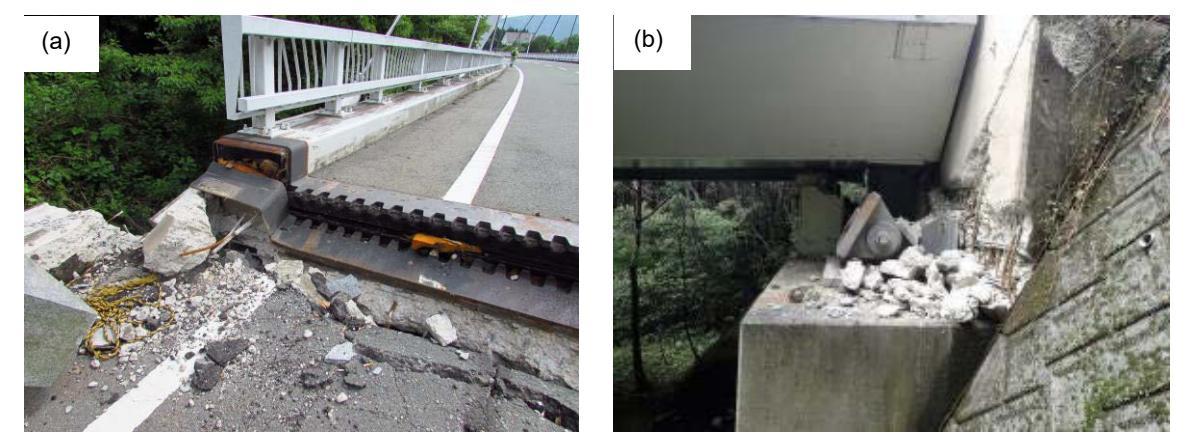
**Figure 5.4** Foundation connection damage of the Kuwatsuru Bridge: (a) failure of deck-abutment connection at the eastern end and (b) damage to the bearing at the eastern end (lkeda et al., 2016).

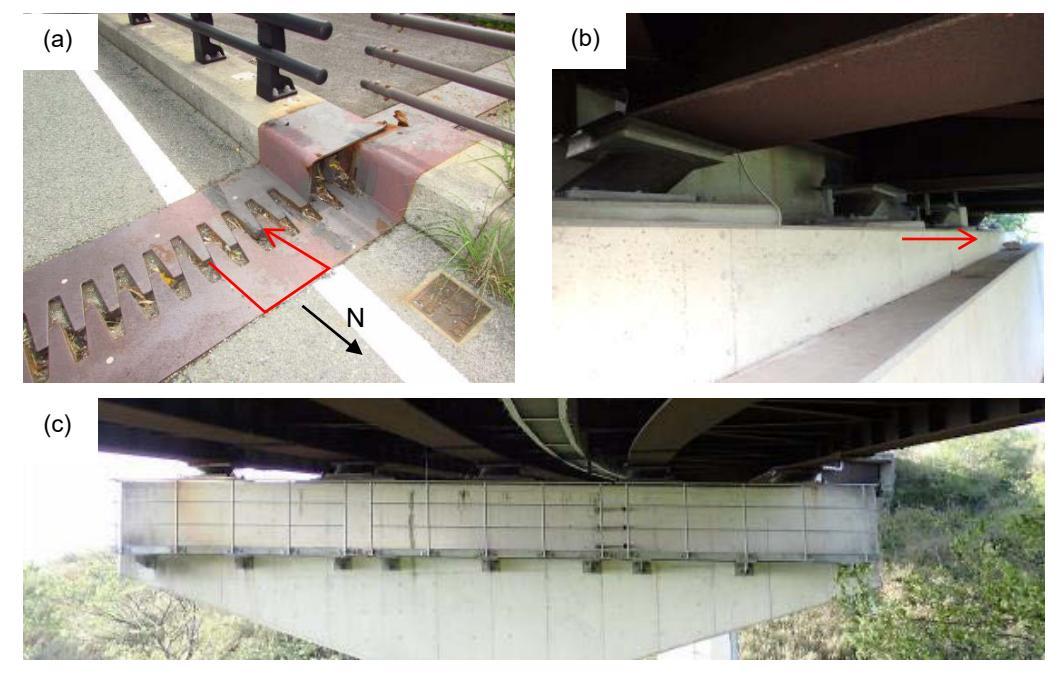
**Figure 5.5** Foundation connection damage of the Ooginosaka Bridge: (a) surface connection at the northern end; the relative movement occurred in N-S and E-W directions, (b) underside of the northern bridge abutment showing oblique shearing of the bearings (Ikeda et al., 2016), and (c) very little damage to the bearings at the top of the concrete columns (Ikeda et al., 2016).

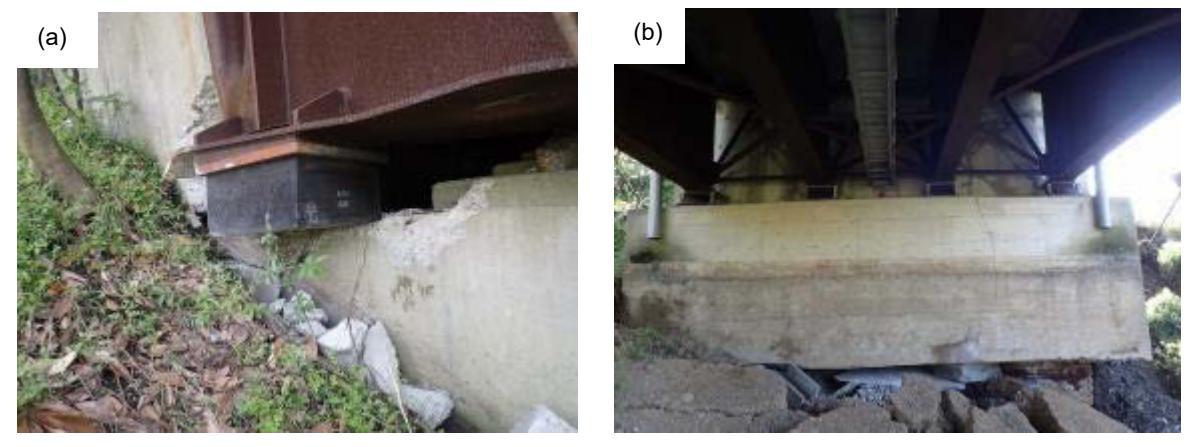
**Figure 5.6** Damaged foundation connections of the Tawarayama Bridge (Ikeda et al., 2016): (a) movement of the bearings at the eastern abutment and (b) damage to the foundations of the abutment of the west end.

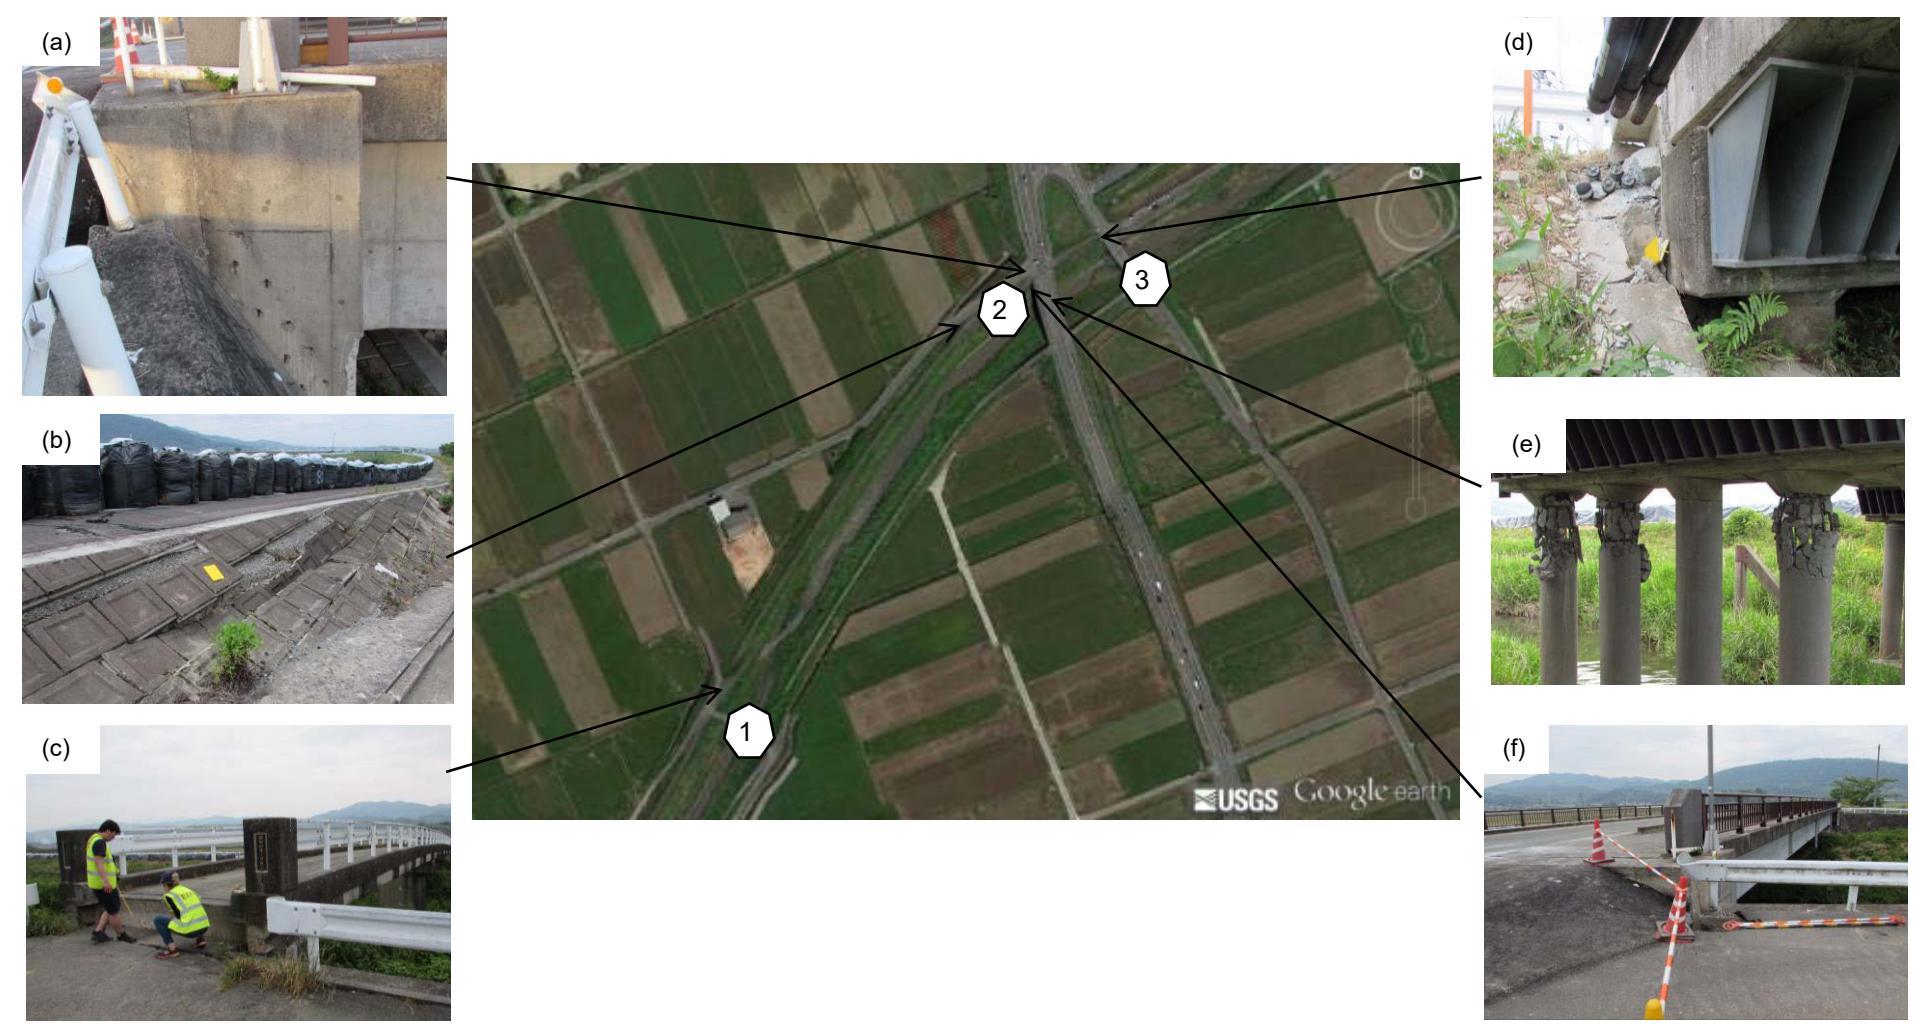
**Figure 5.7** Settlements of flood defences and damage to bridges along the Kiyama River: (a,d) settled embankments relative to the bridge abutments, (b) embankment settlements causing collapse of concrete protection, (c,f) vertical displacement between the road on the embankments and the bridges, and (e) damage to bridge piers (image source: United States Geological Survey and Google Earth).

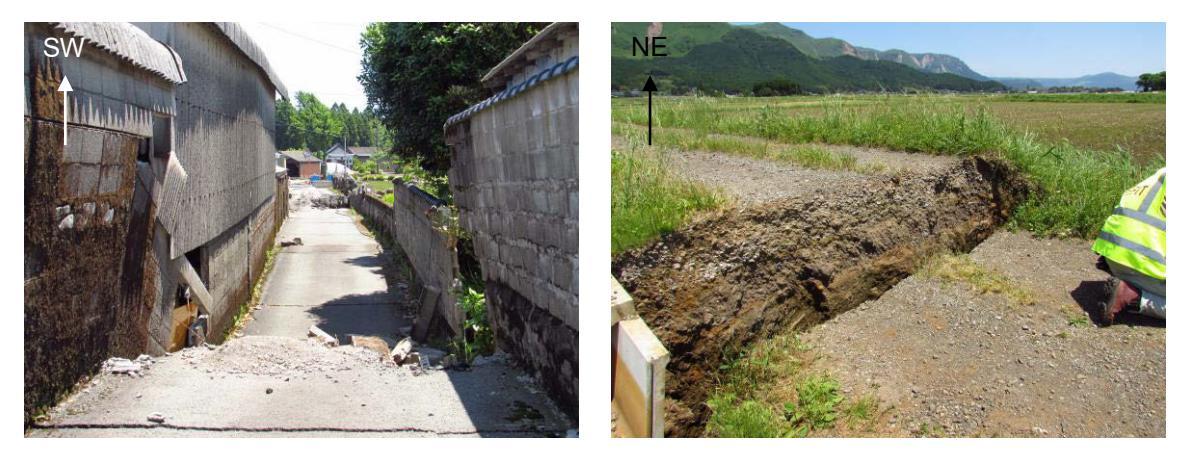
Figure 5.9 Vertical road displacements in the northern area of Aso Caldera.
